## Educational Suitability Summary Report

Gullet Elementary School

Date: 08/04/2016

**Score 53% Average**

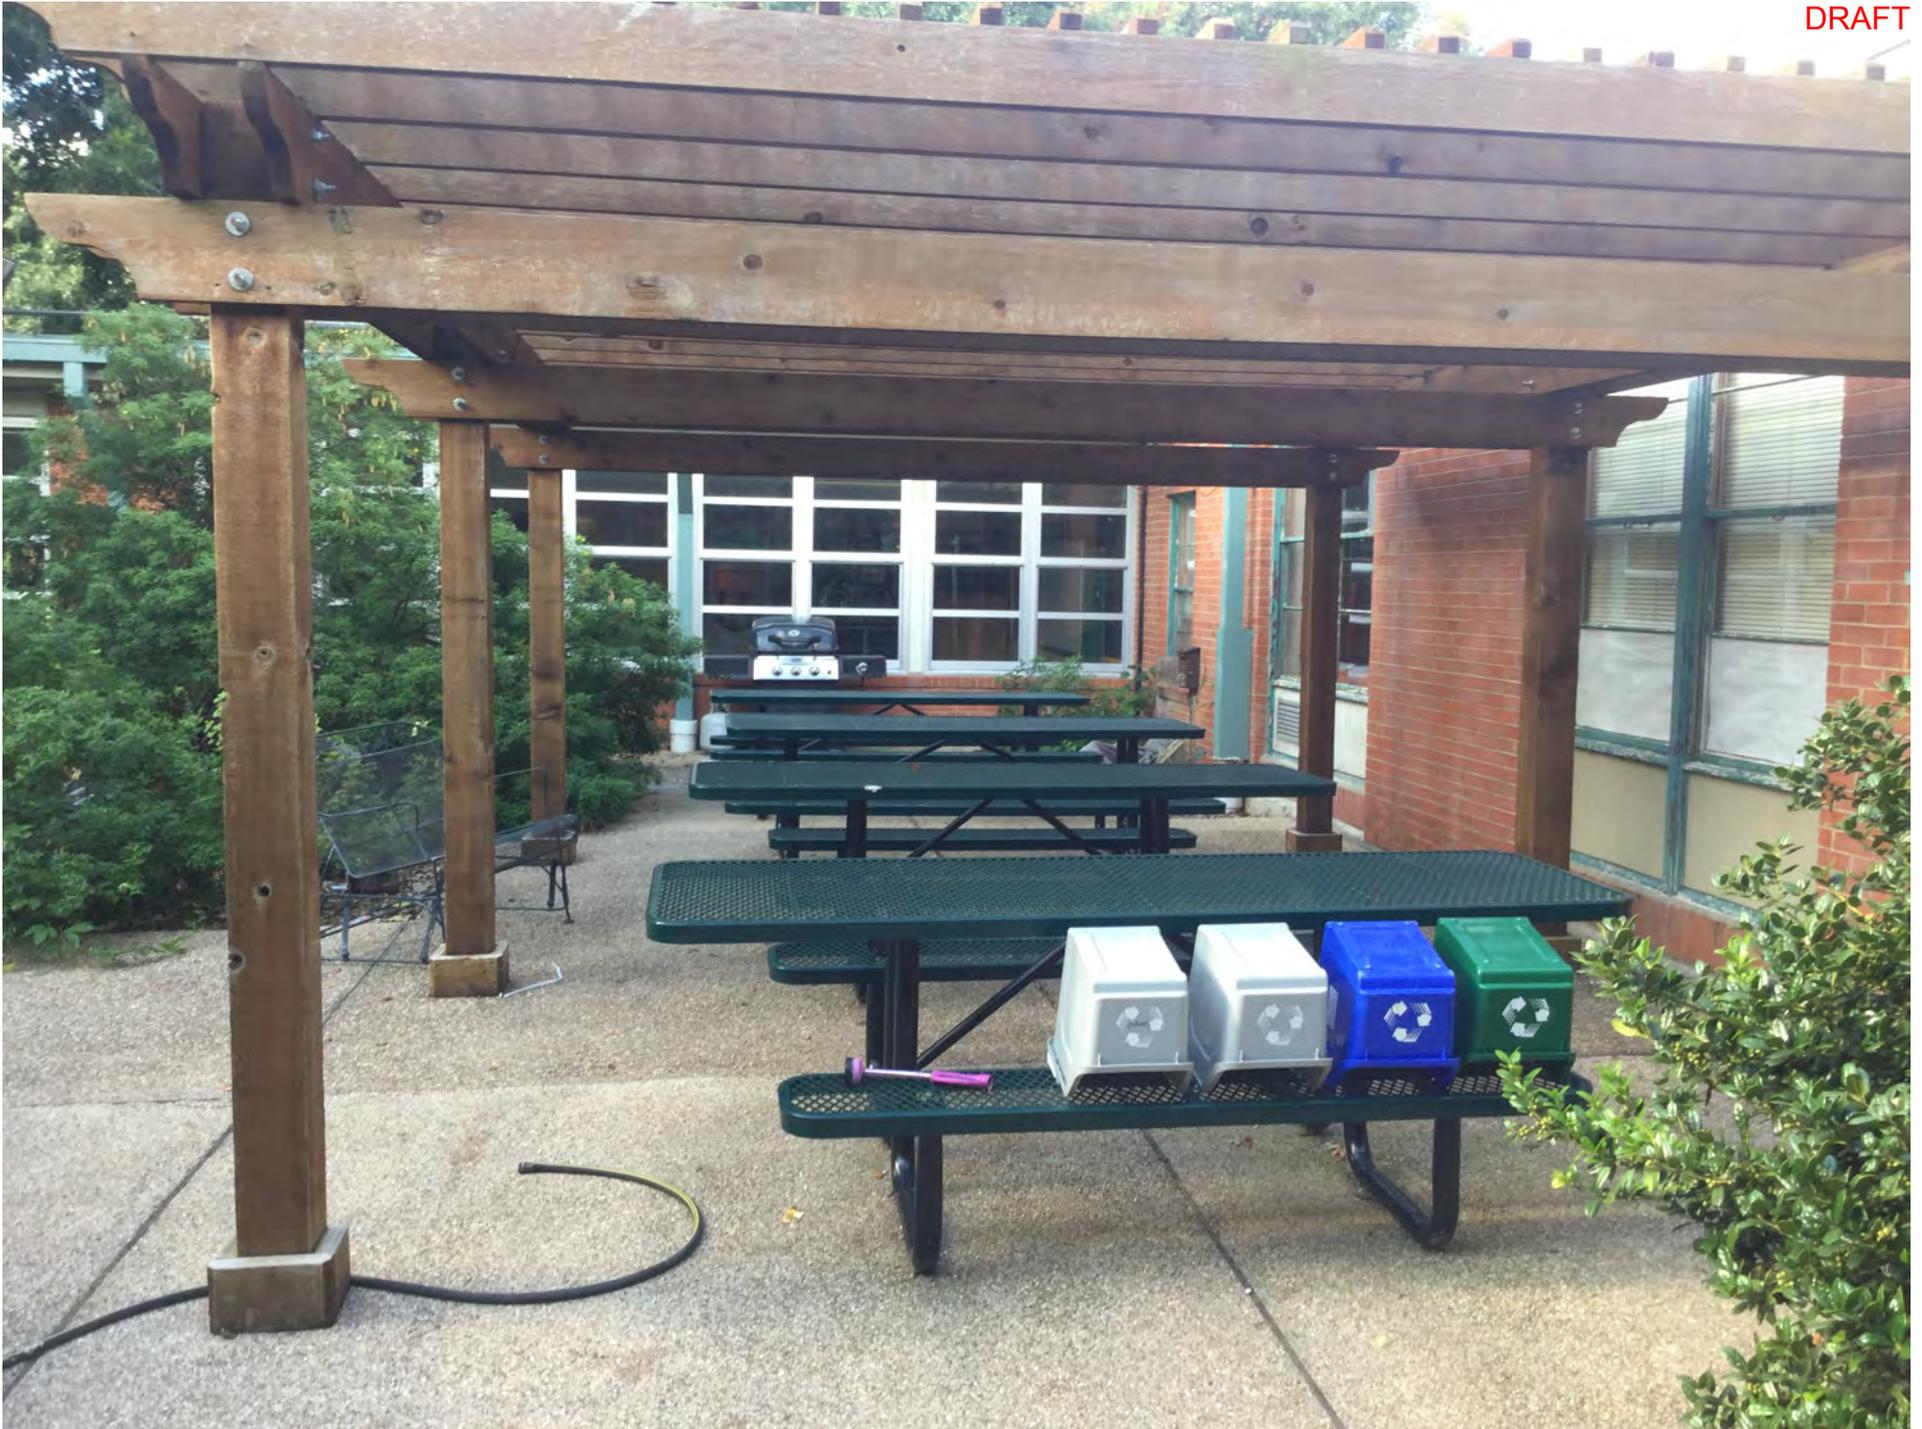
Photo 2.  
1.3 Outdoor Classroom

1.3	Are outdoor play spaces and playfields adequate in size and configuration?			3				Comments	1.00	3.00
1) Outdoor play space exists, not developed 2)Outdoor play space exists but is not connected to gym or other athletic support areas or is too small. 3. Outdoor play spaces exist, are connected to other athletic areas, are the right size, but are not in good condition. 4. Outdoor play spaces need minor improvements to function well. 5. Outdoor play spaces are in excellent condition. N/A) Does not apply.								There are multiple playgrounds onsite. The smaller playground is too small for the age of the children.

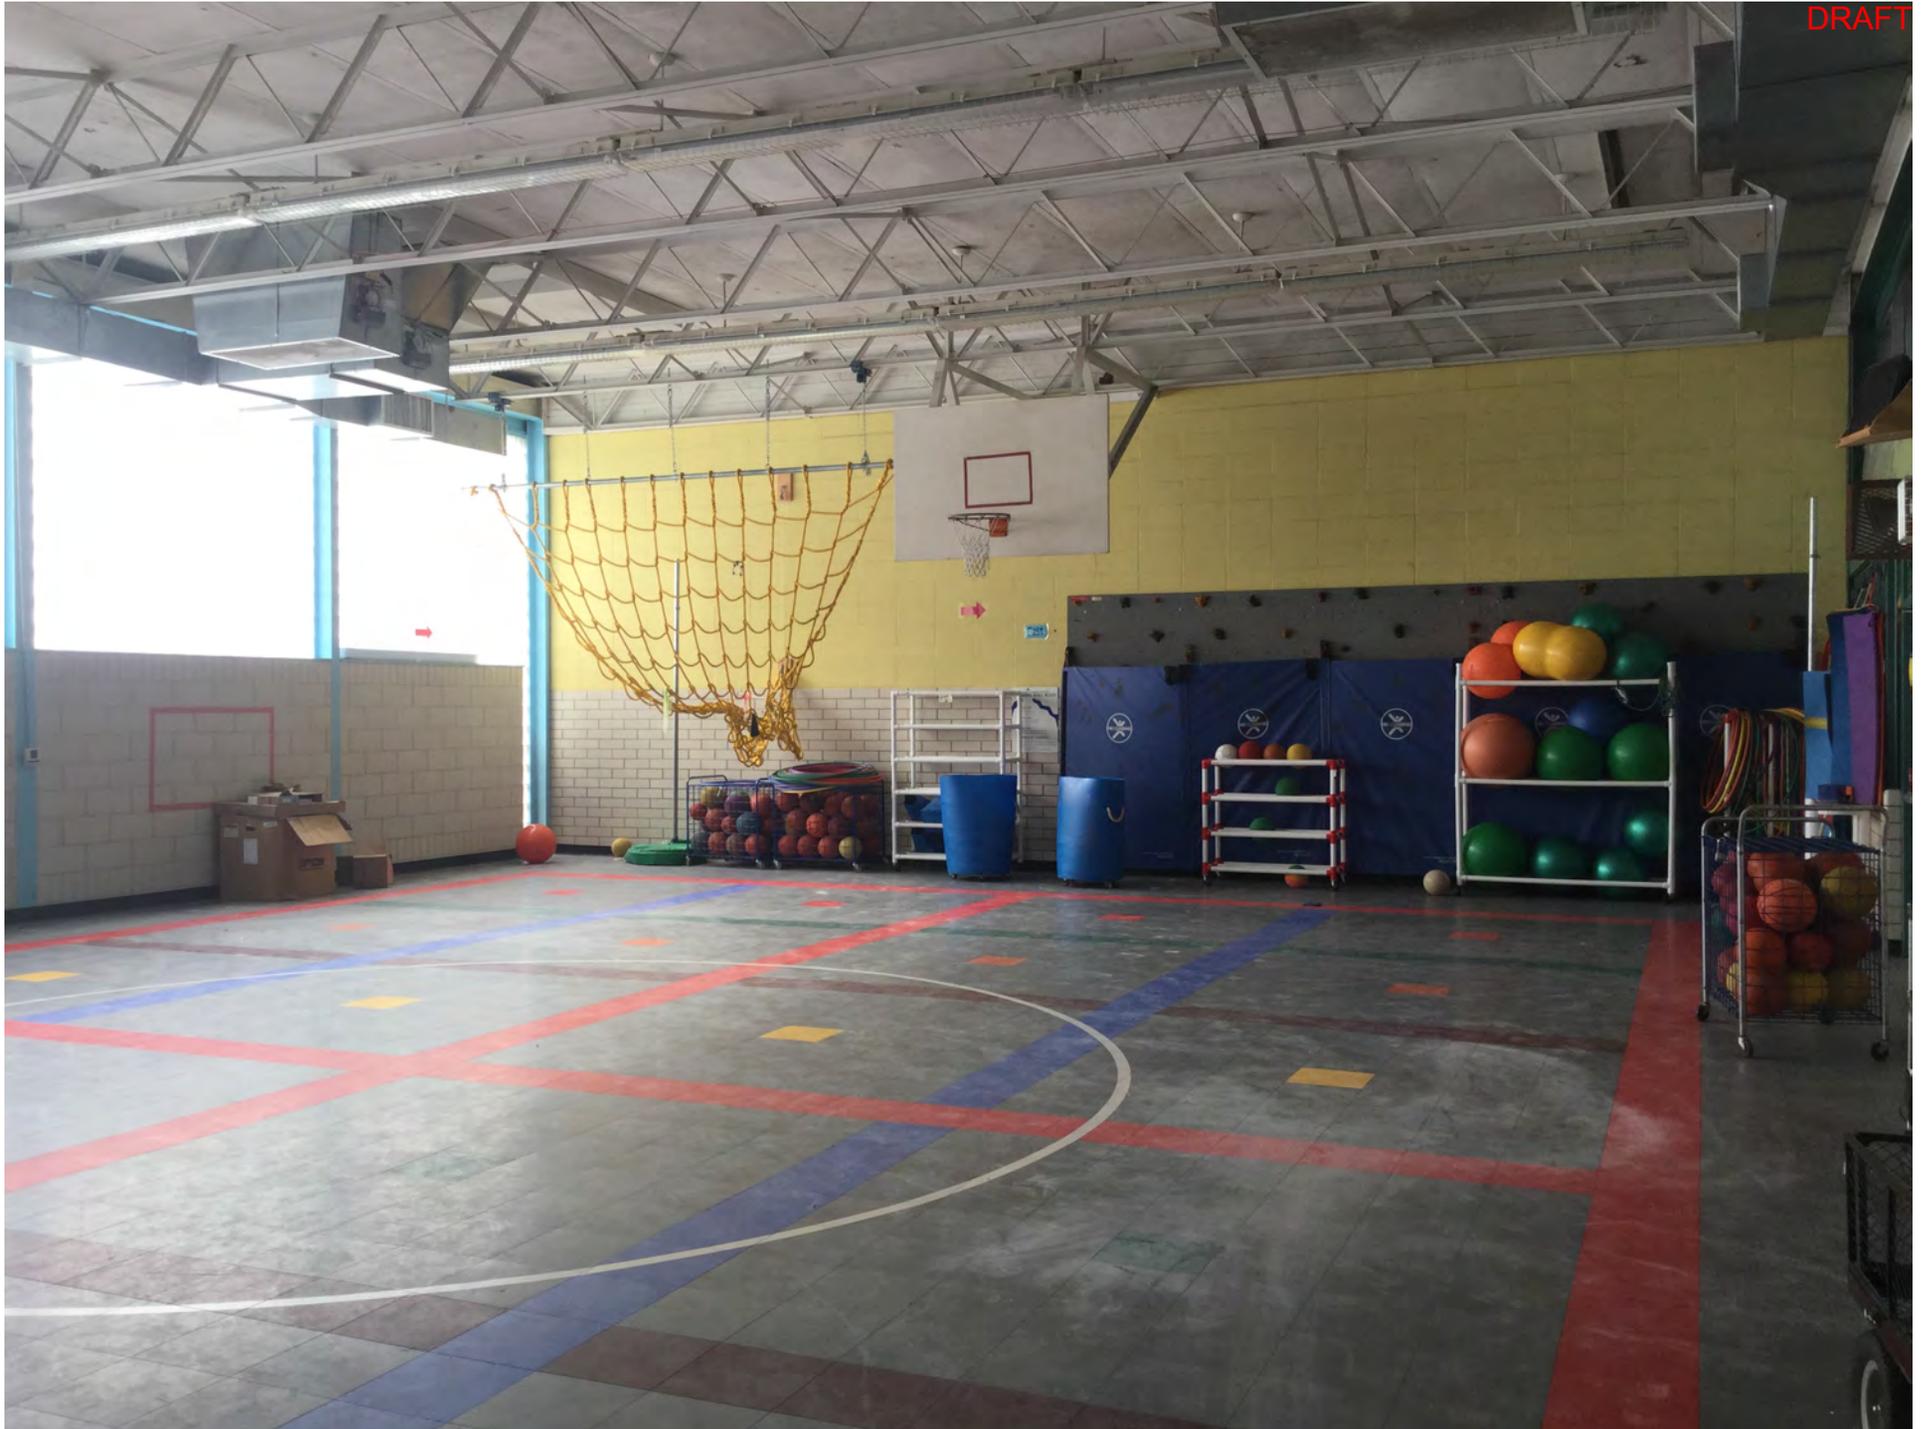
Photo 3.  
3.6 Gym

1) Very unsatisfactory 2) Unsatisfactory 3) Average 4) Good 5) Very good N/A) Does not apply.		The gym does not have direct access to the playgrounds and some of the equipment is dated and insufficient.

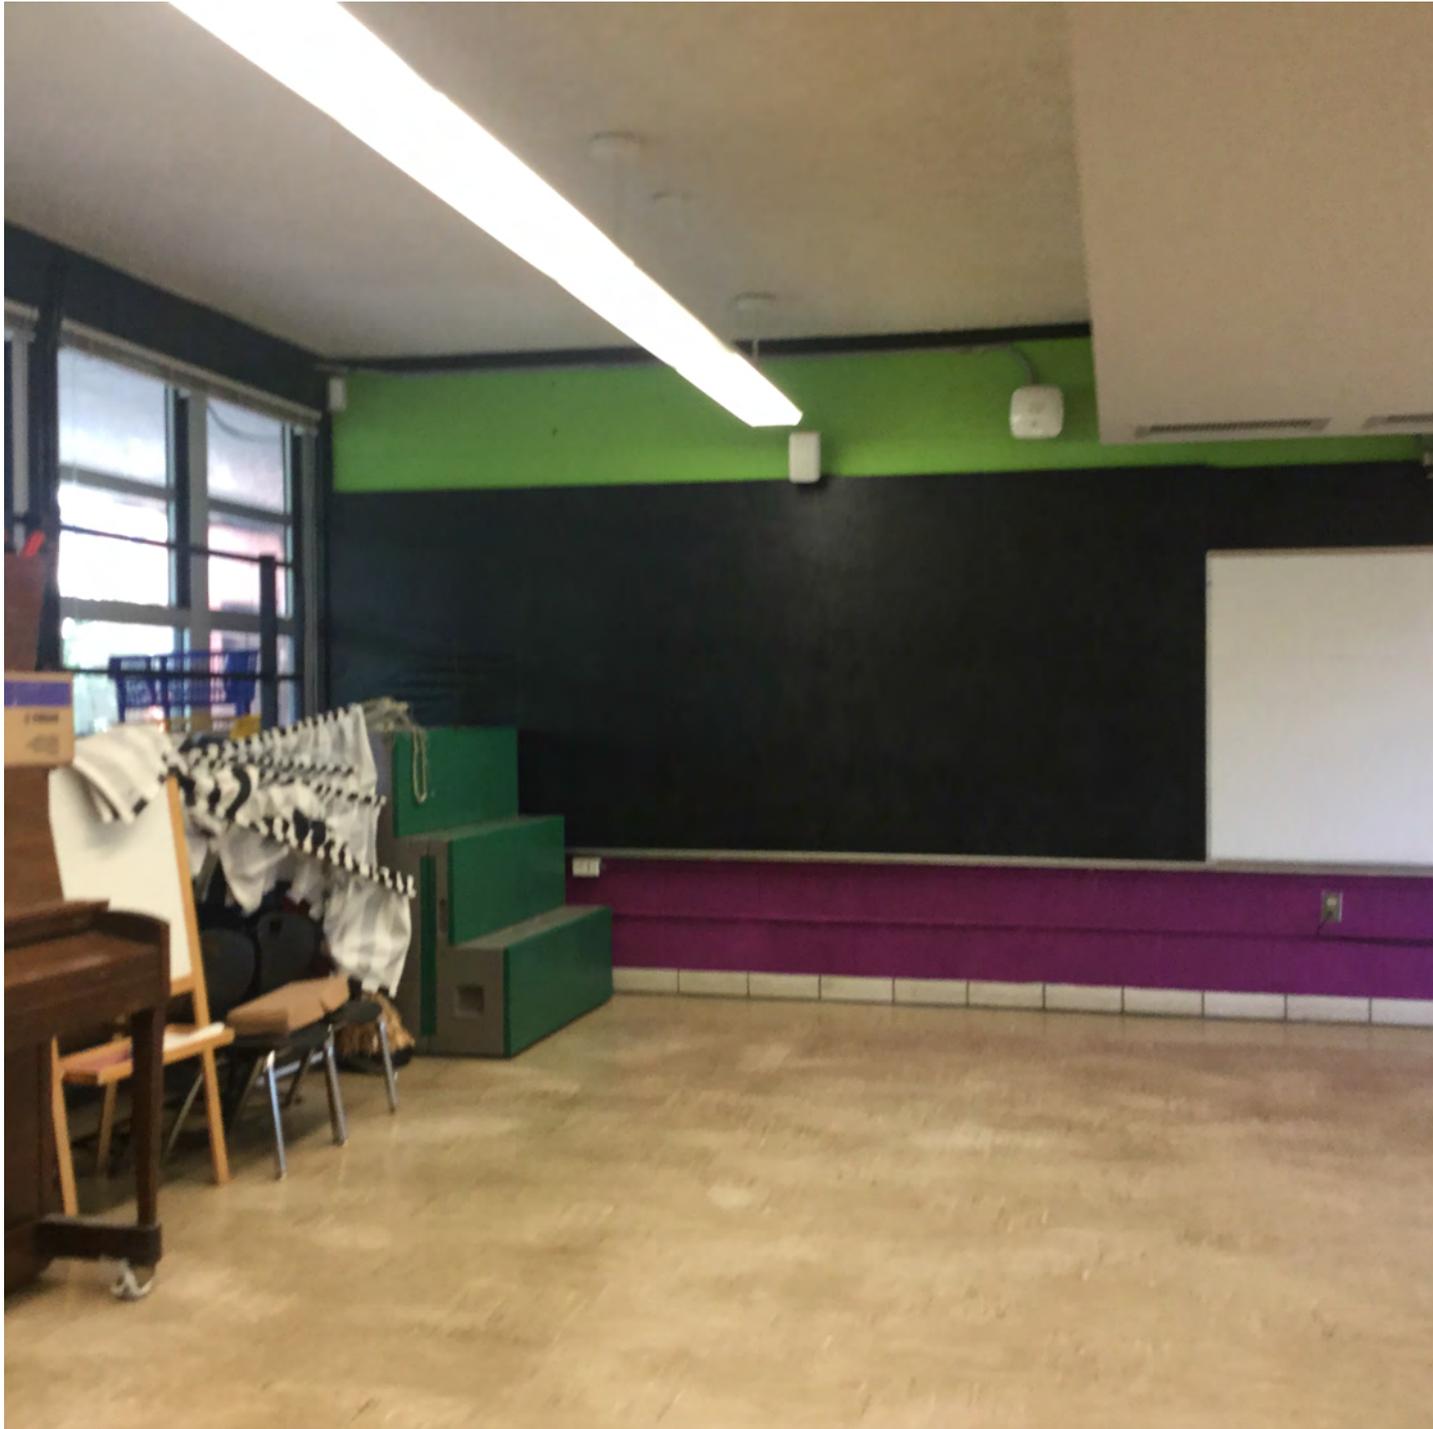
Photo 4.  
3.8 Music Room

3.8	Are music, drama, or performance spaces appropriately configured per the ed spec?			3				Comments	1.00	3.00
1) Very unsatisfactory 2) Unsatisfactory 3) Average 4) Good 5) Very good N/A) Does not apply.		The music class takes place in a standard classroom that was converted.

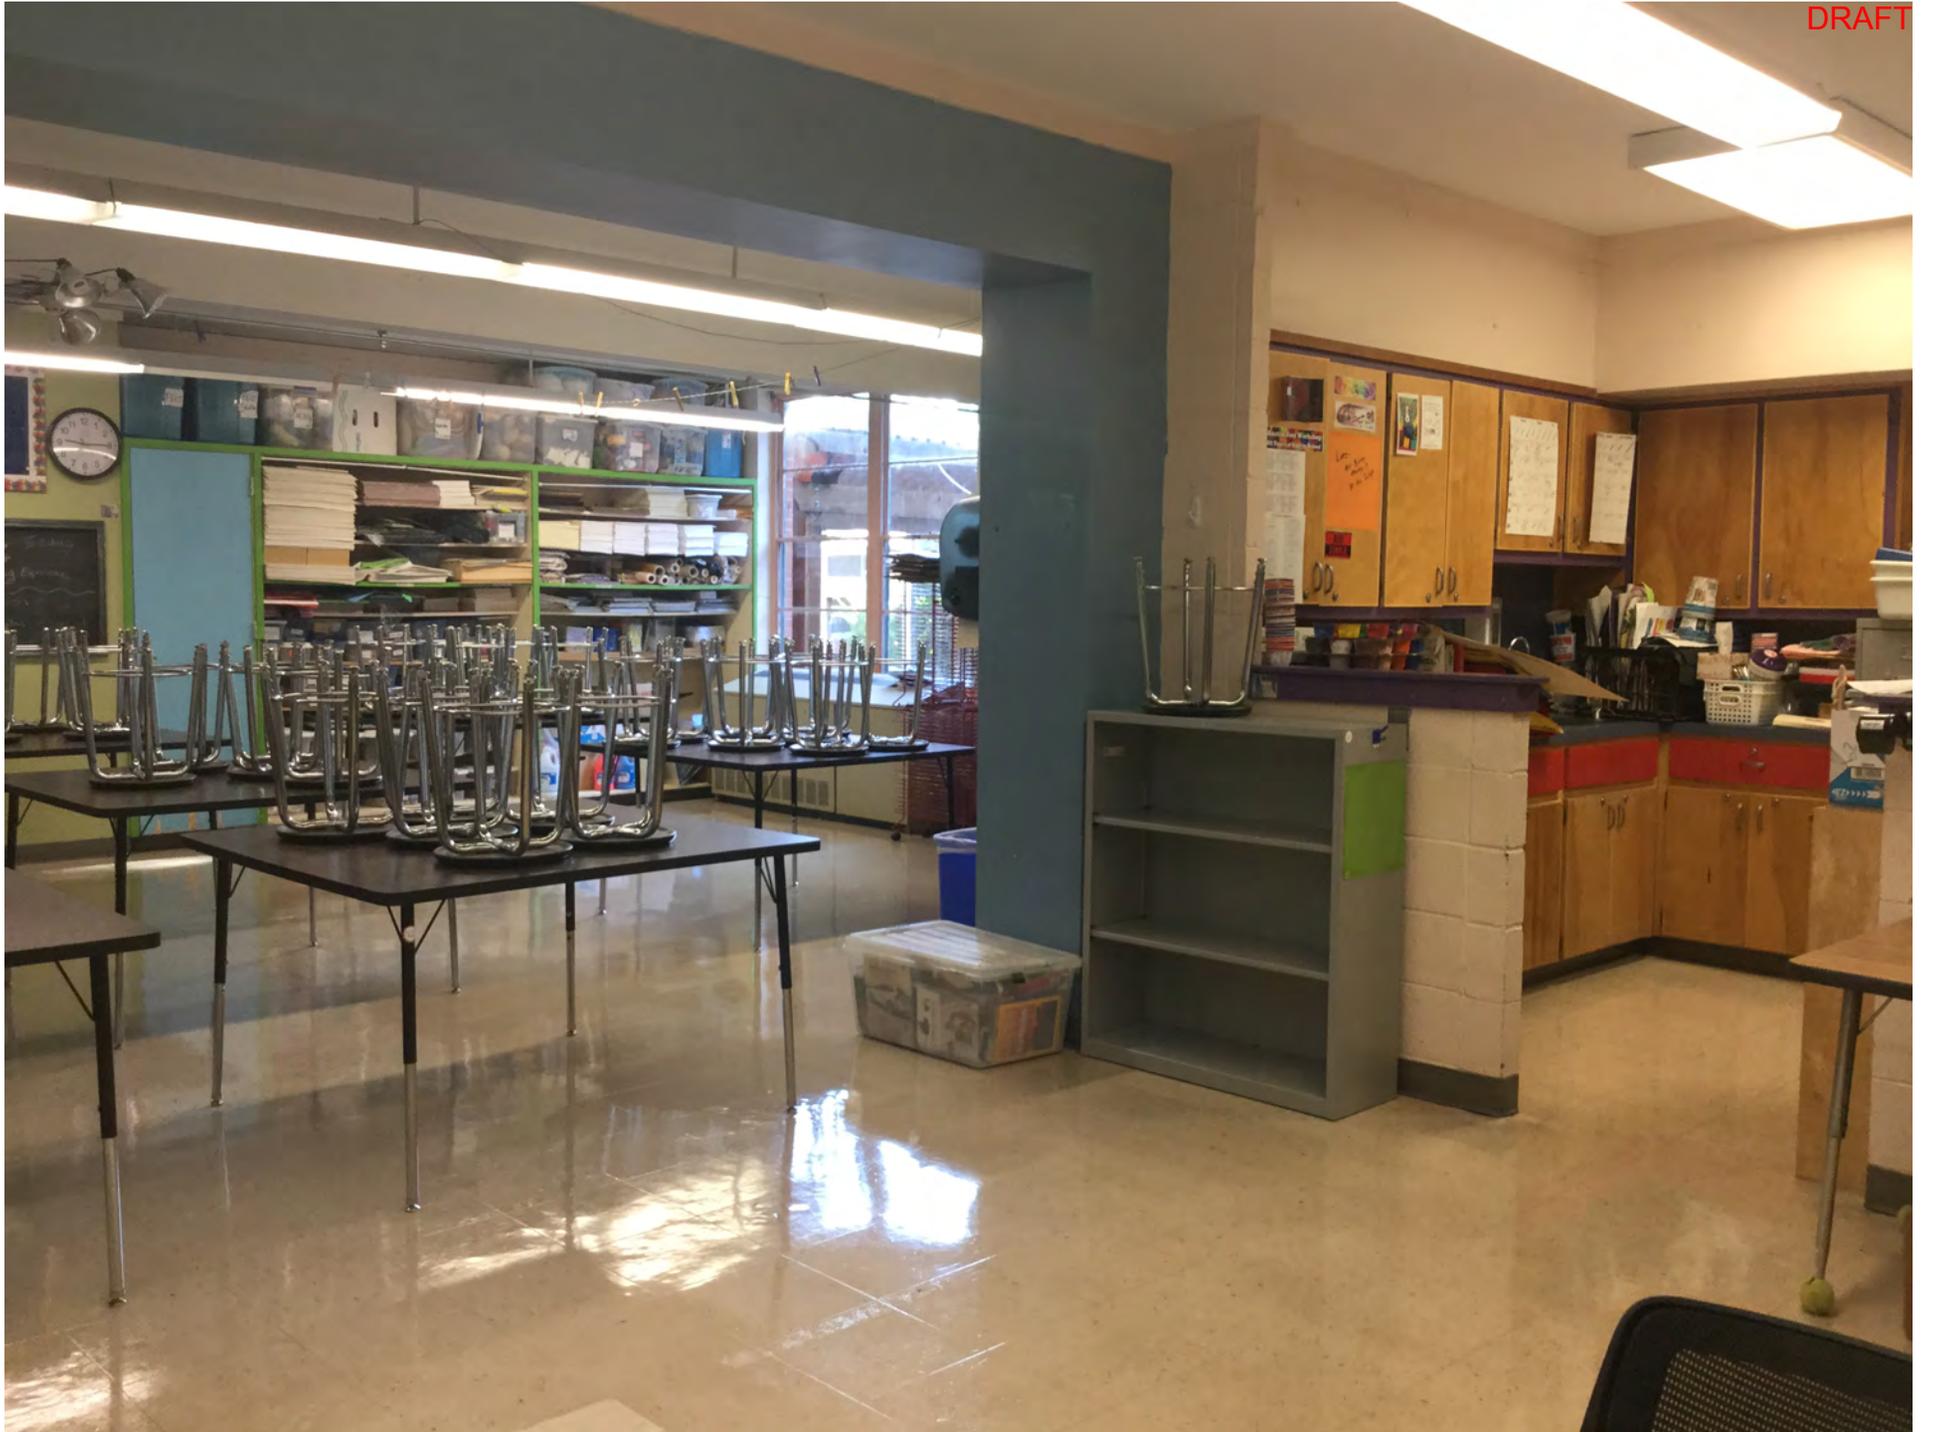
Photo 5.  
3.10 Art Room

1) Very unsatisfactory 2) Unsatisfactory 3) Average 4) Good 5) Very good N/A) Does not apply.		The art classroom used to be the campus lounge. There is currently only one sink, and the storage is actually the old kitchenette for the lounge.

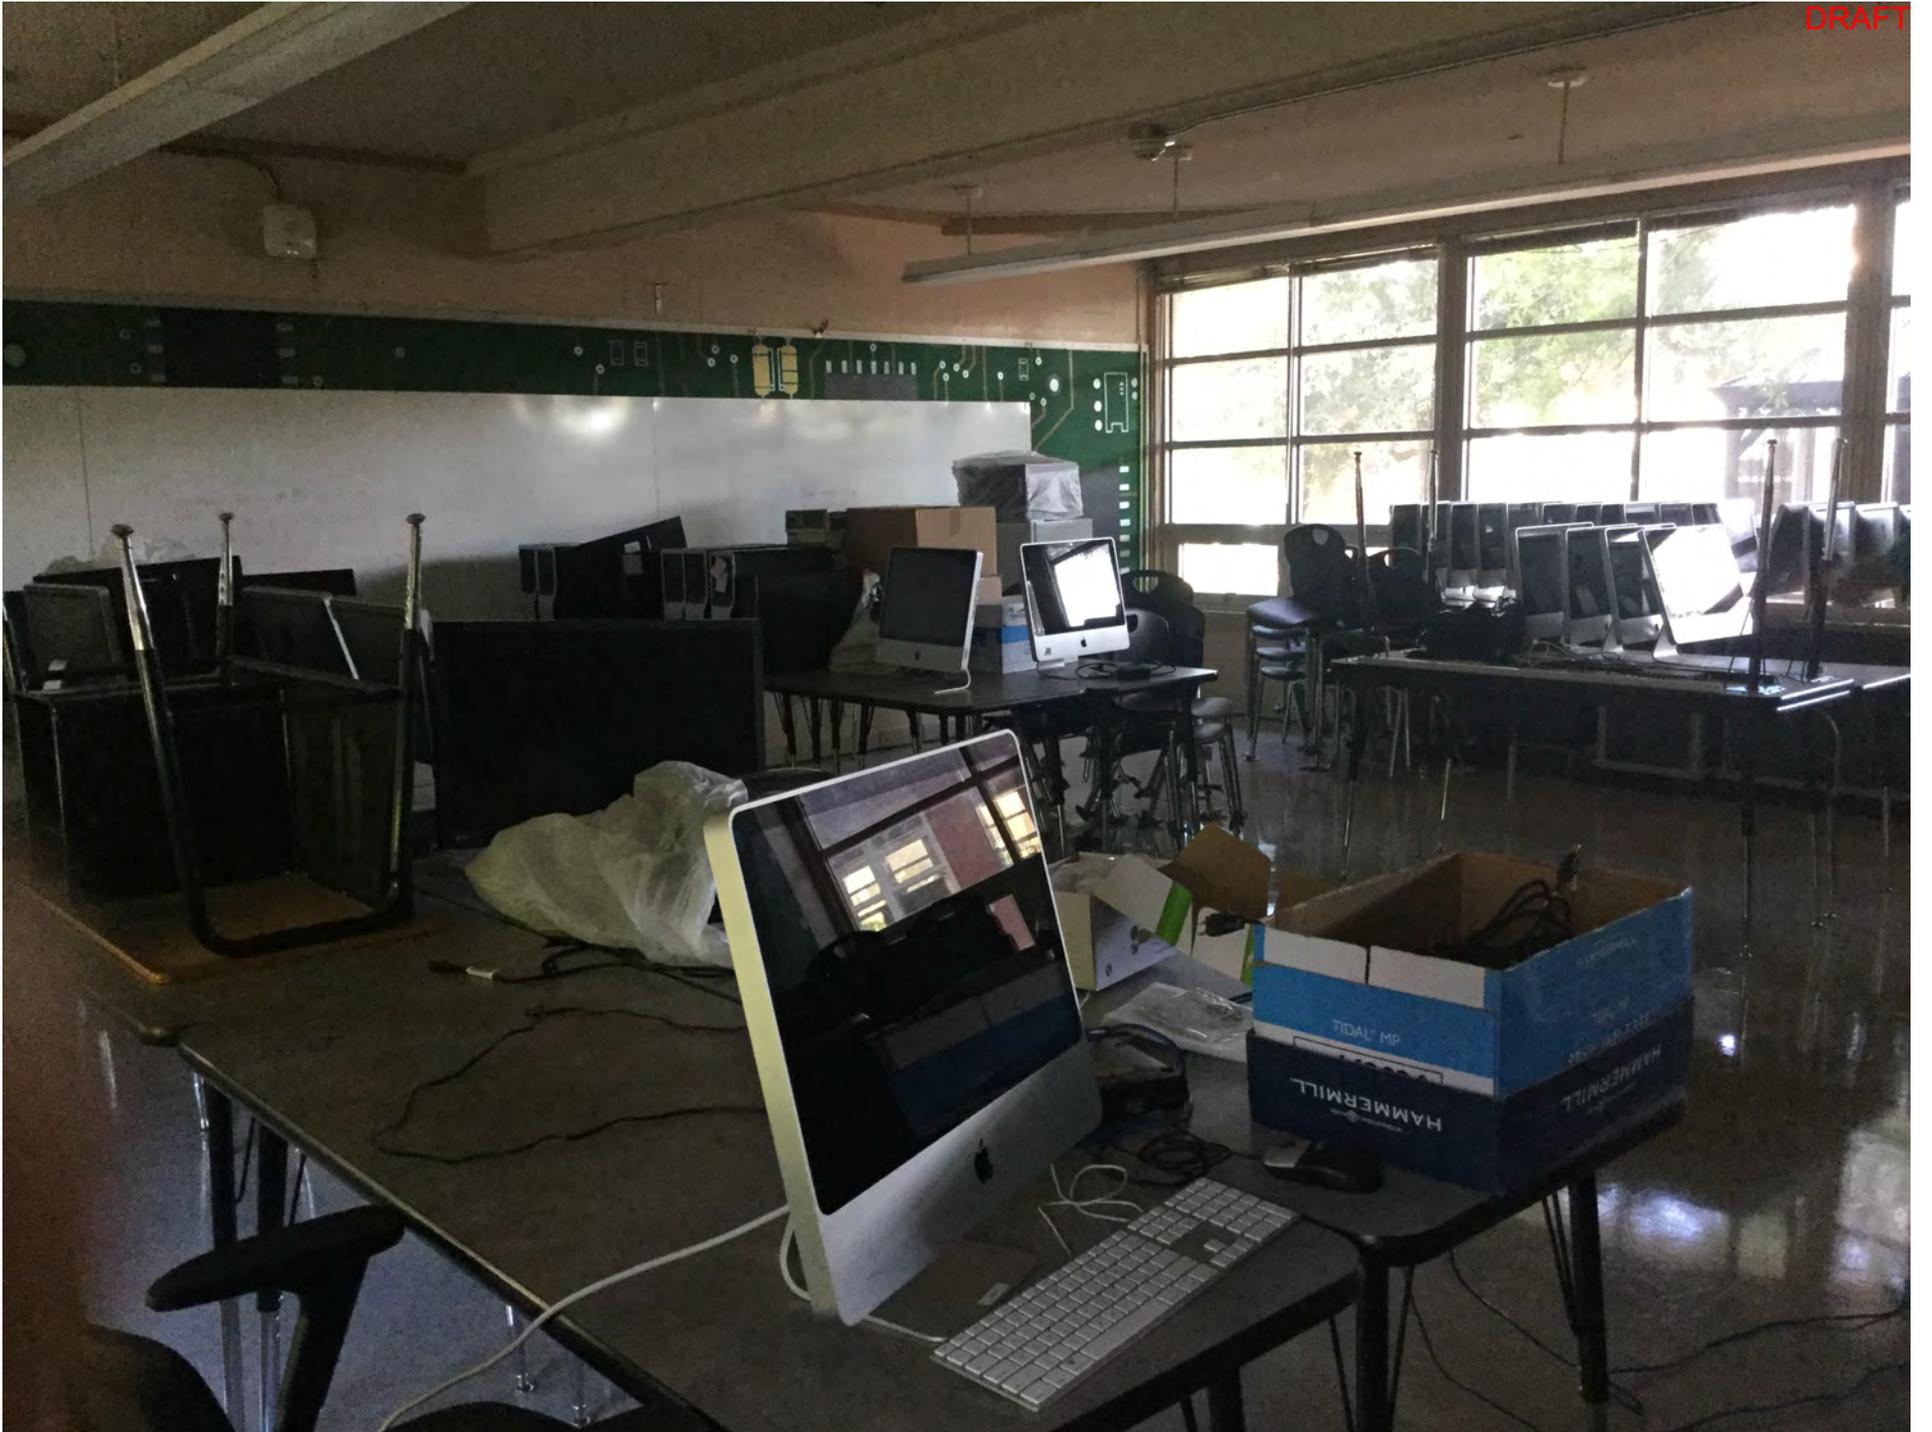
Photo 6.  
3.13 Computer Lab

3.13	Are computer lab <b>support</b> spaces appropriately configured?		2					Comments	1.00	2.00
1) Very unsatisfactory - Support spaces are disconnected from served spaces, too small, do not meet needs 2) Unsatisfactory - Support spaces are connected, but too small, inadequate for needs 3) Average - Connected, moderate size, but need some renovations or updates to function well 4) Good - Connected, good size/layout, meets needs/functions well 5) Very good - connected, generous size, nice condition, functions appropriately N/A) Does not apply.		No storage is provide for the lab, as it is converted from a standard classroom.

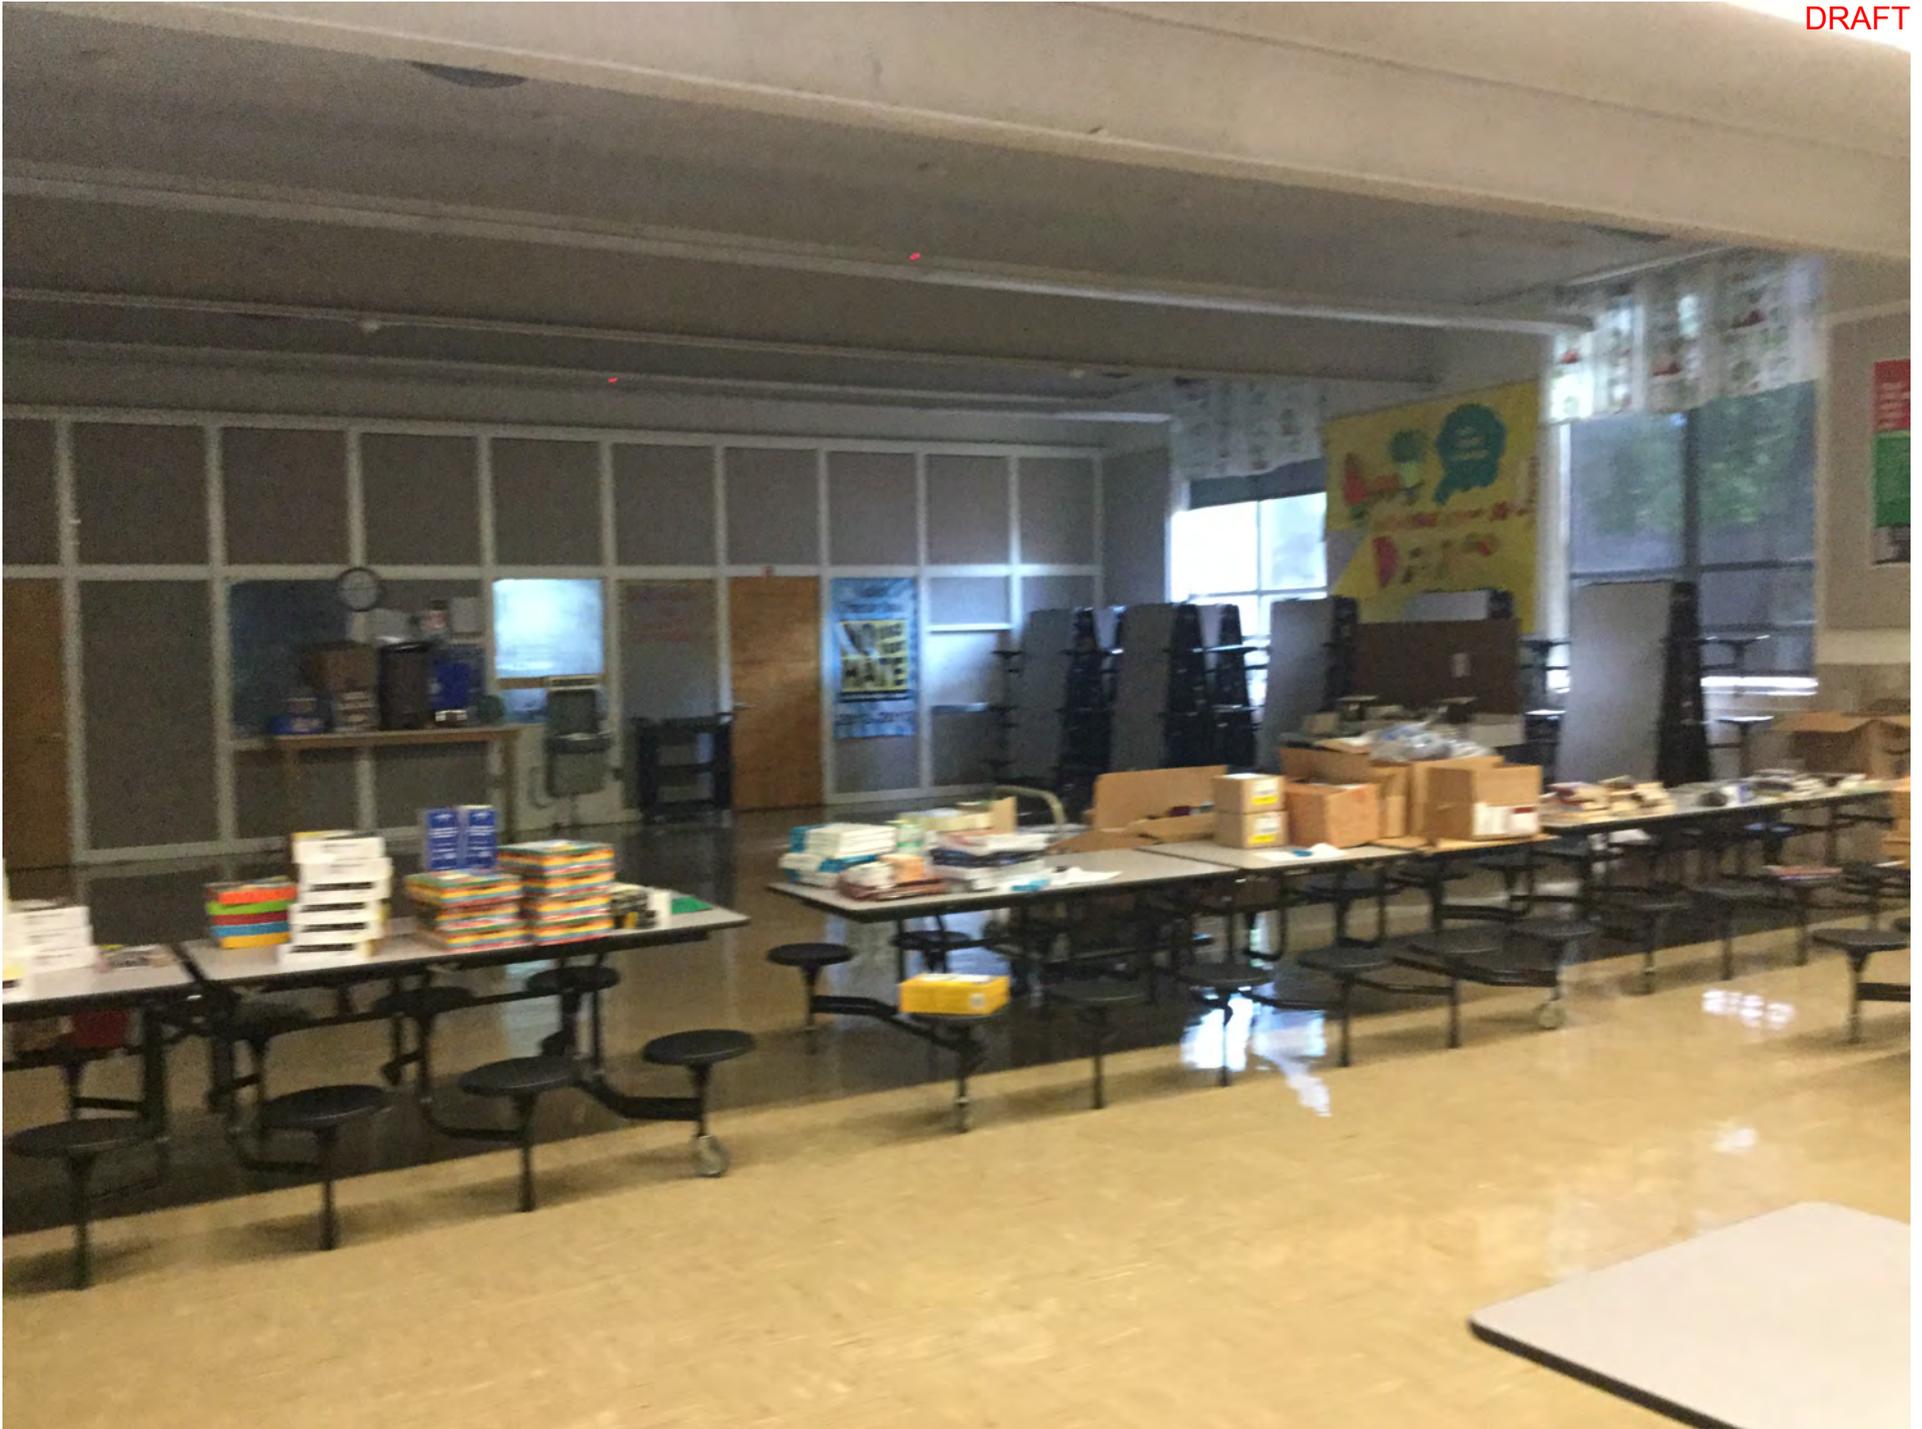
Photo 7.  
3.16 Cafetorium

3.16	Are the student dining facilities appropriately configured?		2										Comments	1.00	2.00
1) Very unsatisfactory - Too small, poor circulation, inflexible seating in poor condition 2) Unsatisfactory - Too small or inadequate circulation, seating in poor condition 3) Average - moderate size, with adequate circulation, seating in okay condition 4) Good - good size, adequate circulation, seating in good condition 5) Very good - good size, adequate circulation, seating in good condition, with more than one option for eating space (ex: connection to outdoor eating space) N/A) Does not apply.

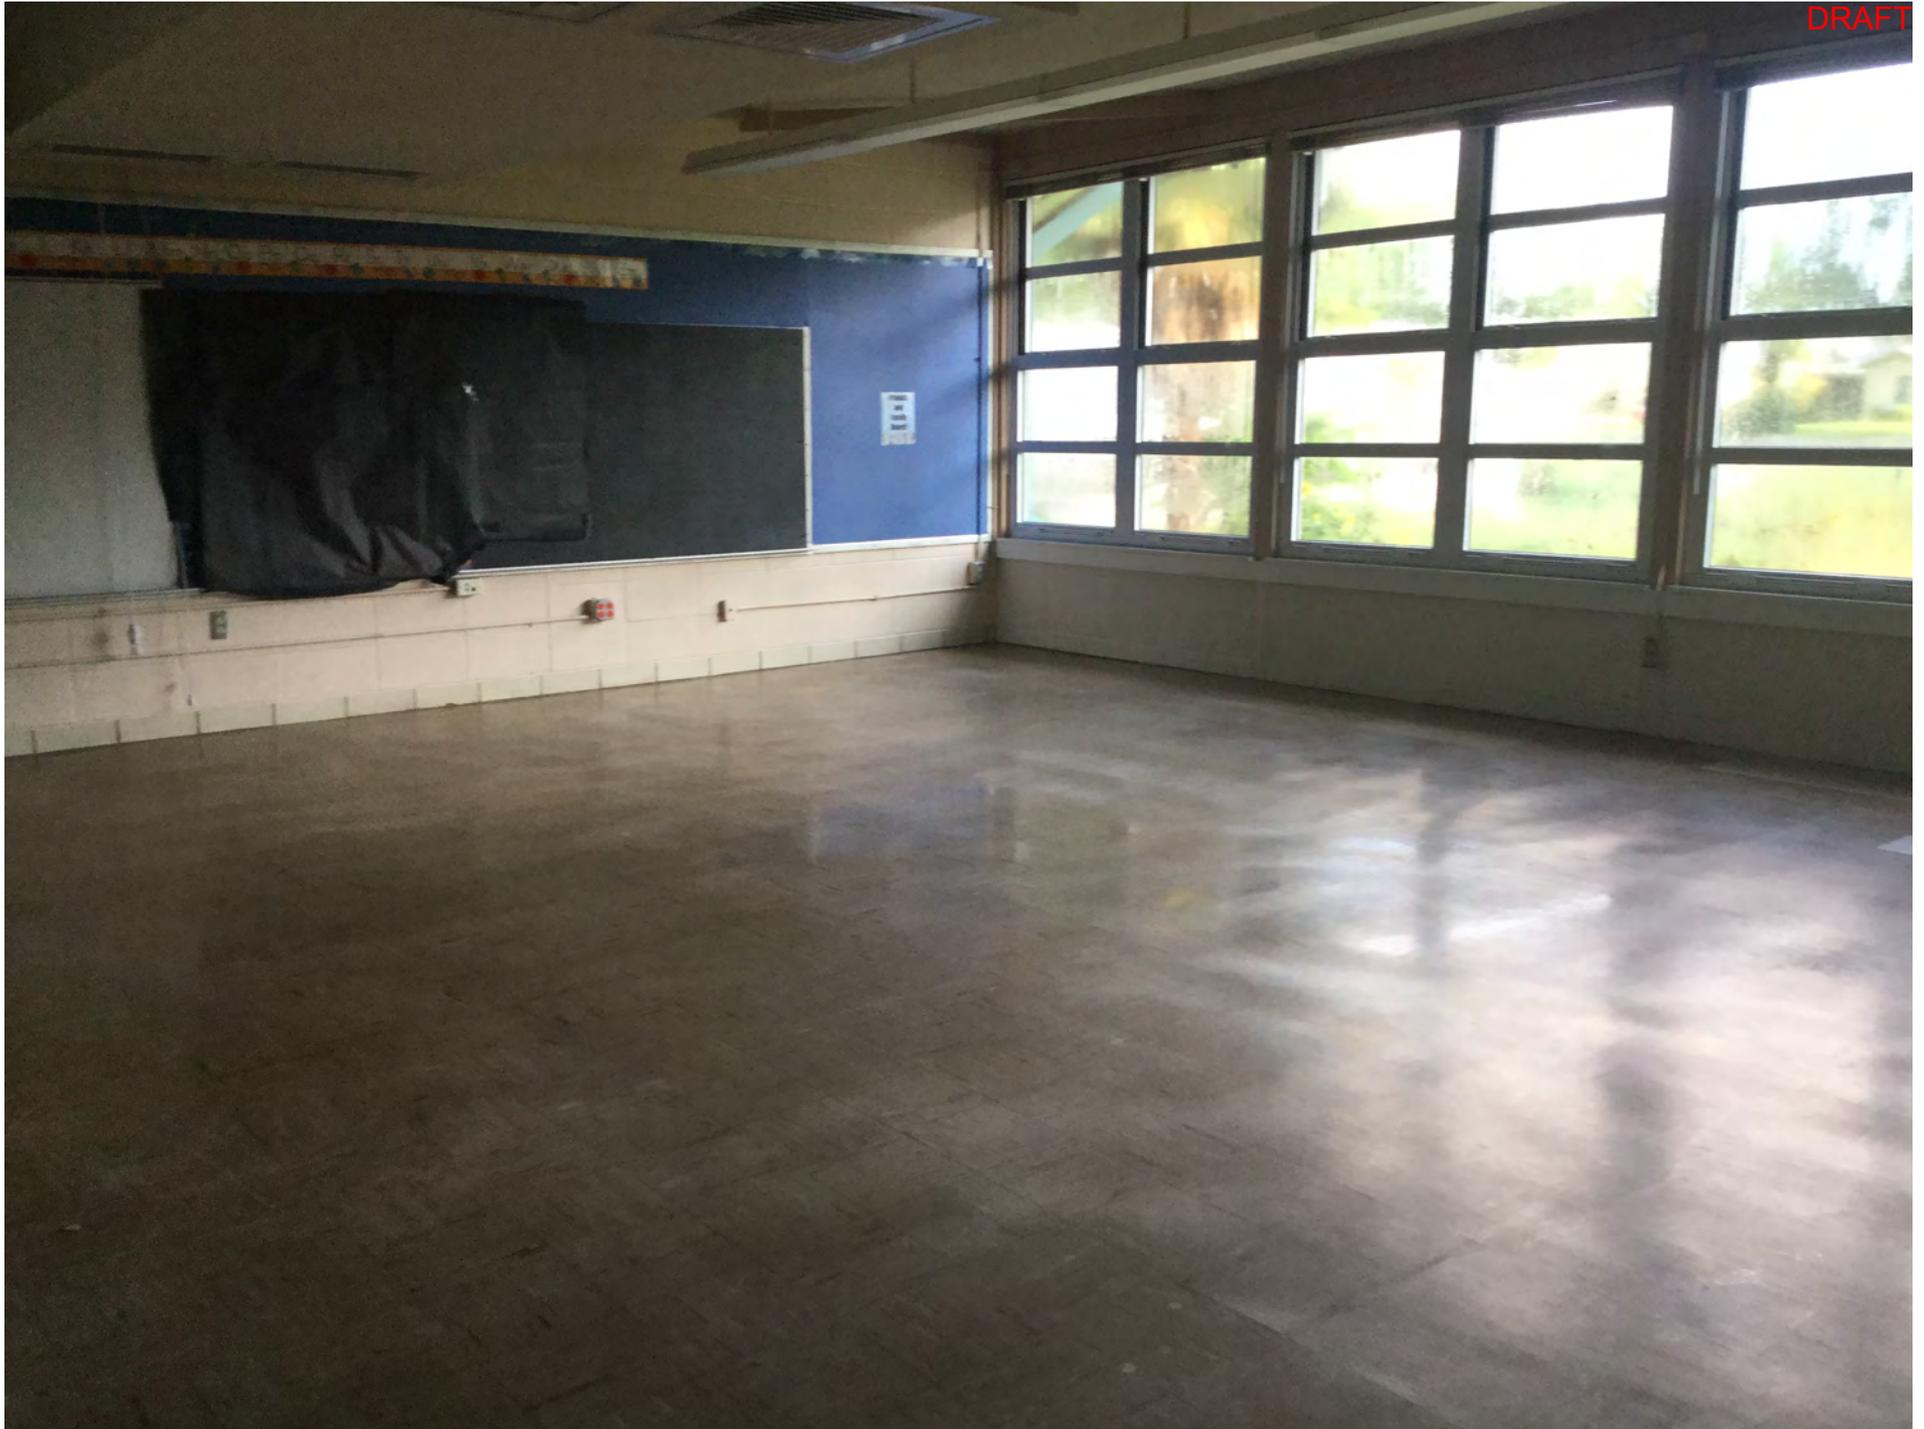
Photo 8.  
4.2 Standard Classroom

4.2	Are general classrooms large enough to support project-based learning and multiple teaching modalities?			3				Comments	1.00	3.00
1) Very unsatisfactory -too small to move, set for lecture only, no connectivity, no flexibility 2) Unsatisfactory - adequate size but set for lecture only, no connectivity, no flexibility 3) Neutral - have flexibility and space for hands on or project based learning 4) Satisfactory - have flexibility and space for hands on or project based learning and connectivity for global learning 5) Very Satisfactory - space for hands on learning, flexibility for different groupings, and connectivity for global classrooms N/A) Does not apply.

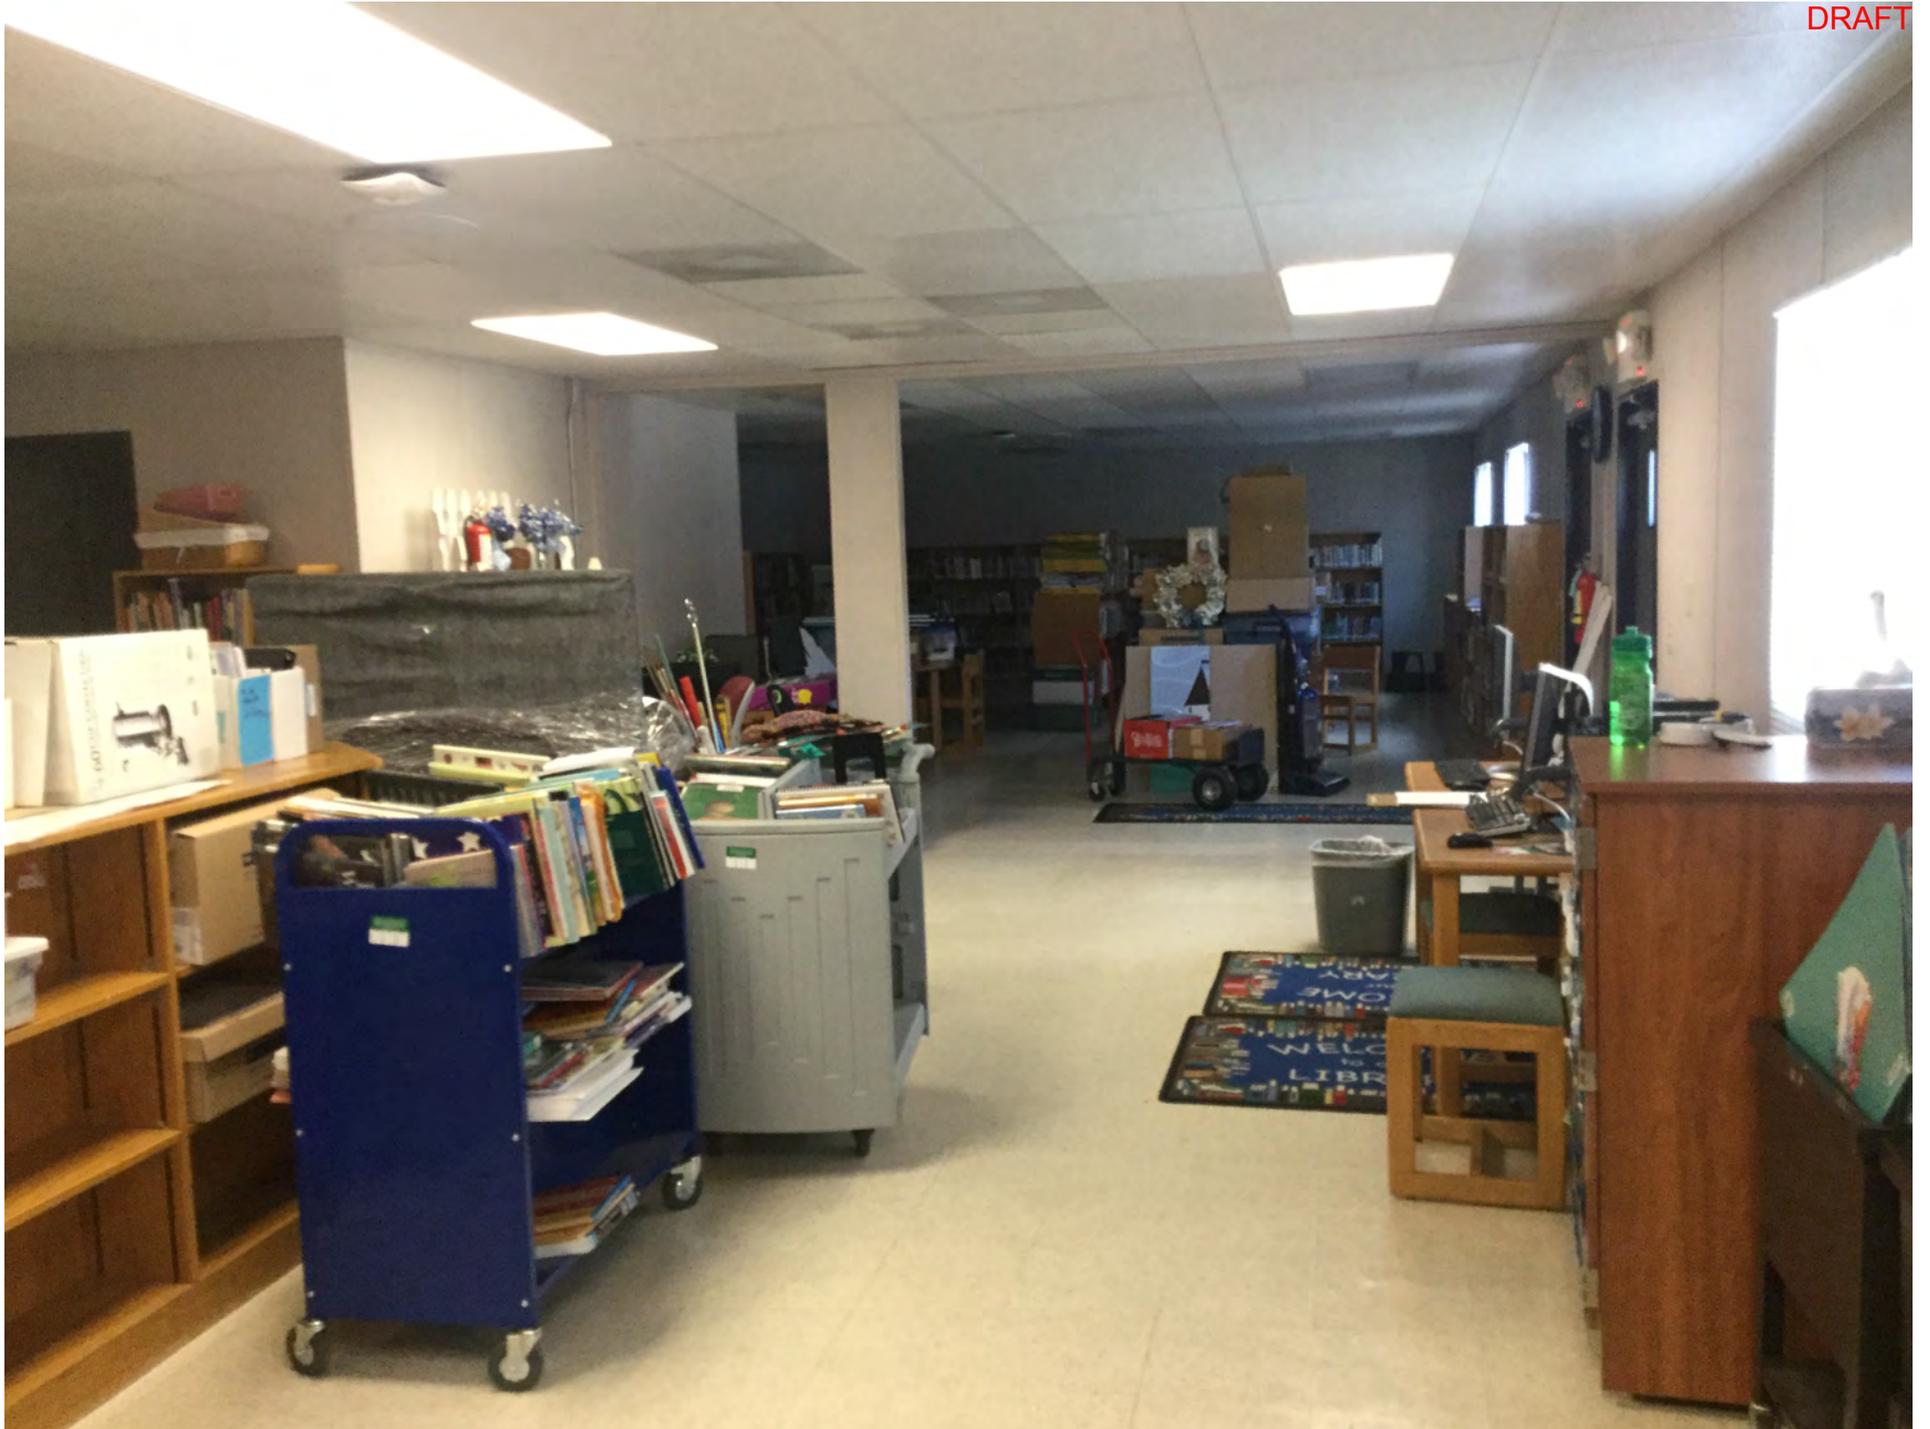
Photo 9.  
5.4 Temporary Library

1) Very unsatisfactory 2) Unsatisfactory 3) Average 4) Good 5) Very good N/A) Does not apply.		The school is currently undergoing construction for a new library. The scores reflect the current library which is in a portable.
