## Educational Suitability Summary Report

Harris Elementary School – BLDG 118

Date:06/14/2016

### Austin ISD Educational Suitability Assessment Criteria

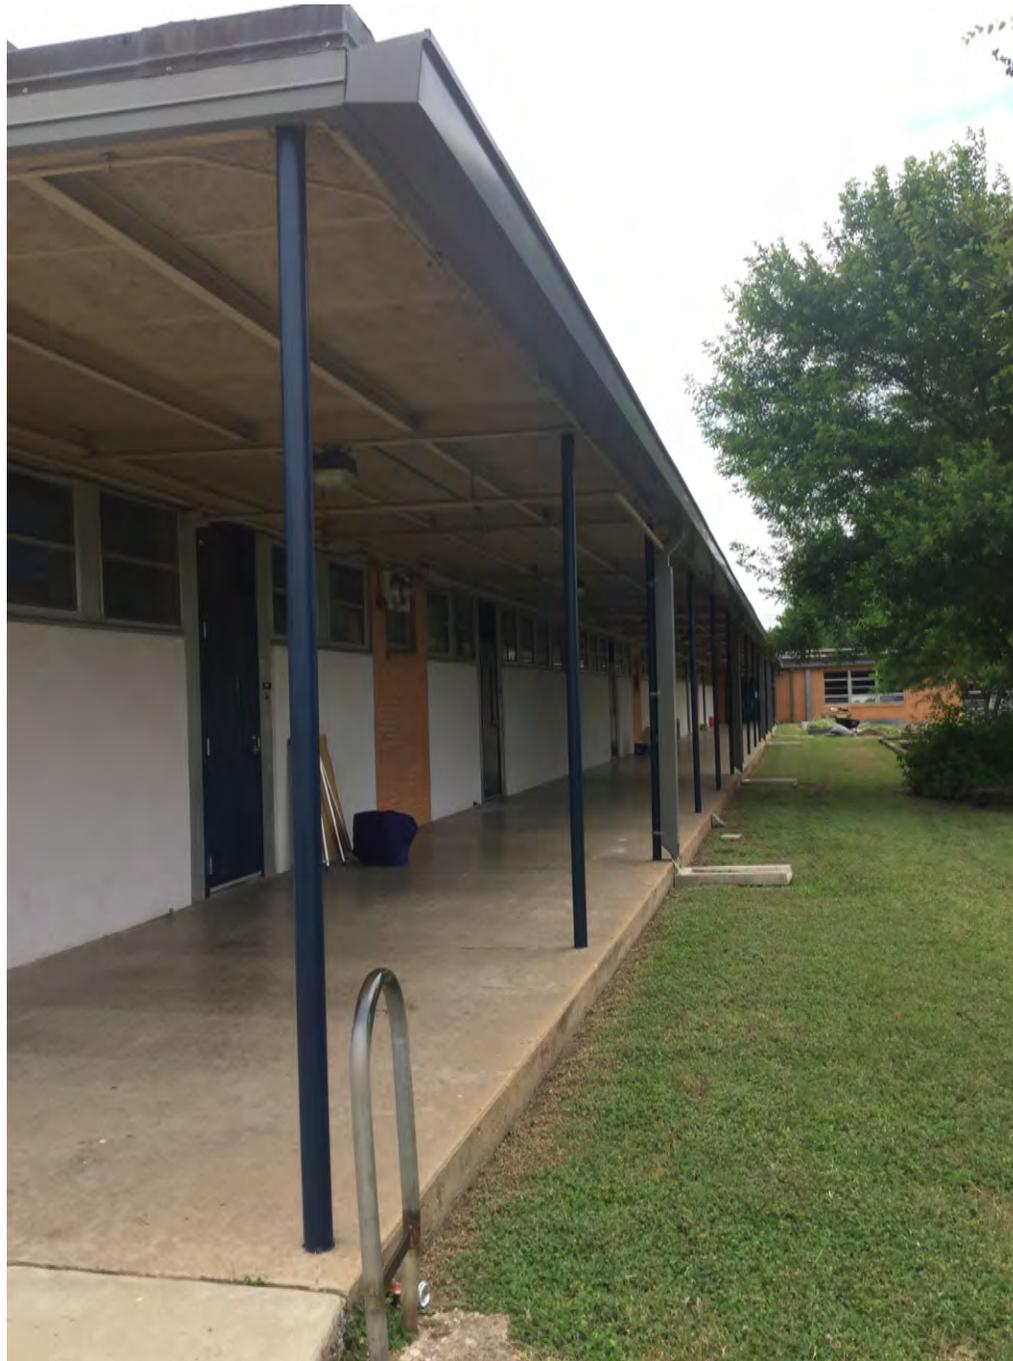
Photo 3. Exposed Corridor

4.4	Are there adequate places to display the evidence and artifacts of learning (both 2D and 3D)?		2					Comments	1.00	2.00
1) Very unsatisfactory - No display cases or wall space for display 2) Unsatisfactory - 1 wall in classrooms or very few spaces for display 3) Average - 2 walls in classrooms or some hallway spaces for display 4) Good - 3 walls in classrooms or multiple hallway spaces for display 5) Very good - ample classroom display space or many hallway spaces, including display cases N/A) Does not apply.		There is limited wall space for displays due to the exposed corridors to the exterior.

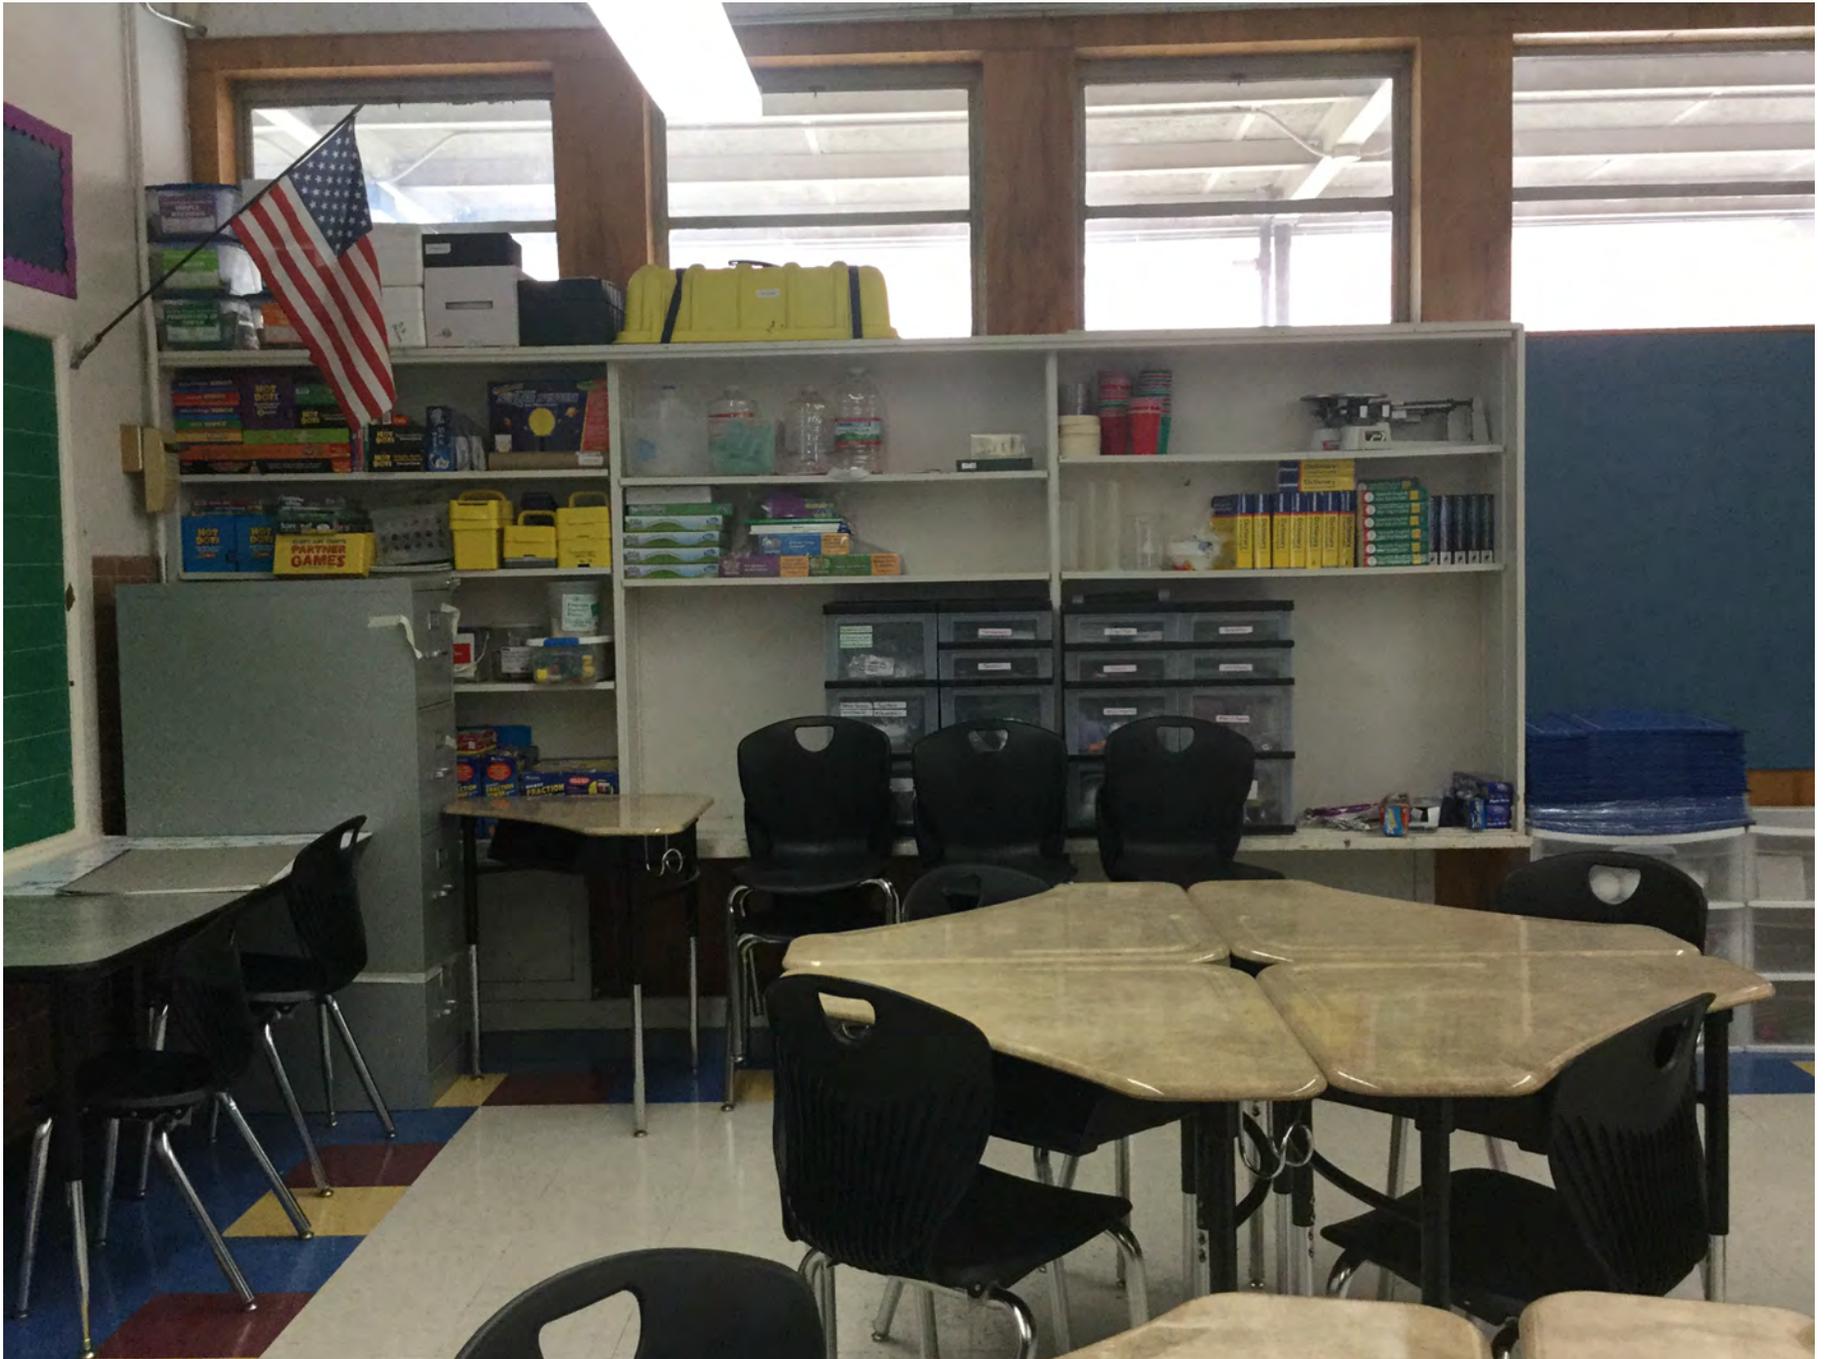
Photo 5. Storage

3.3	Do Pre-K and Kinder have appropriate support spaces such as restrooms and storage per the ed spec? (elementary only)			3				Comments	1.00	3.00
1) Very unsatisfactory - No storage, casework, or restrooms 2) Unsatisfactory - unsatisfactory size or condition of storage, casework, or restrooms 3) Neutral - Moderate size or moderate condition storage, casework, and restrooms 4) Satisfactory - Satisfies ed spec for storage, casework, and restrooms 5) Very Satisfactory - exceeds ed spec for storage, casework, and restrooms N/A) Does not apply.		The pre-k classroom had small bathrooms and insufficient storage.								
		Ref. Photo 5-Storage

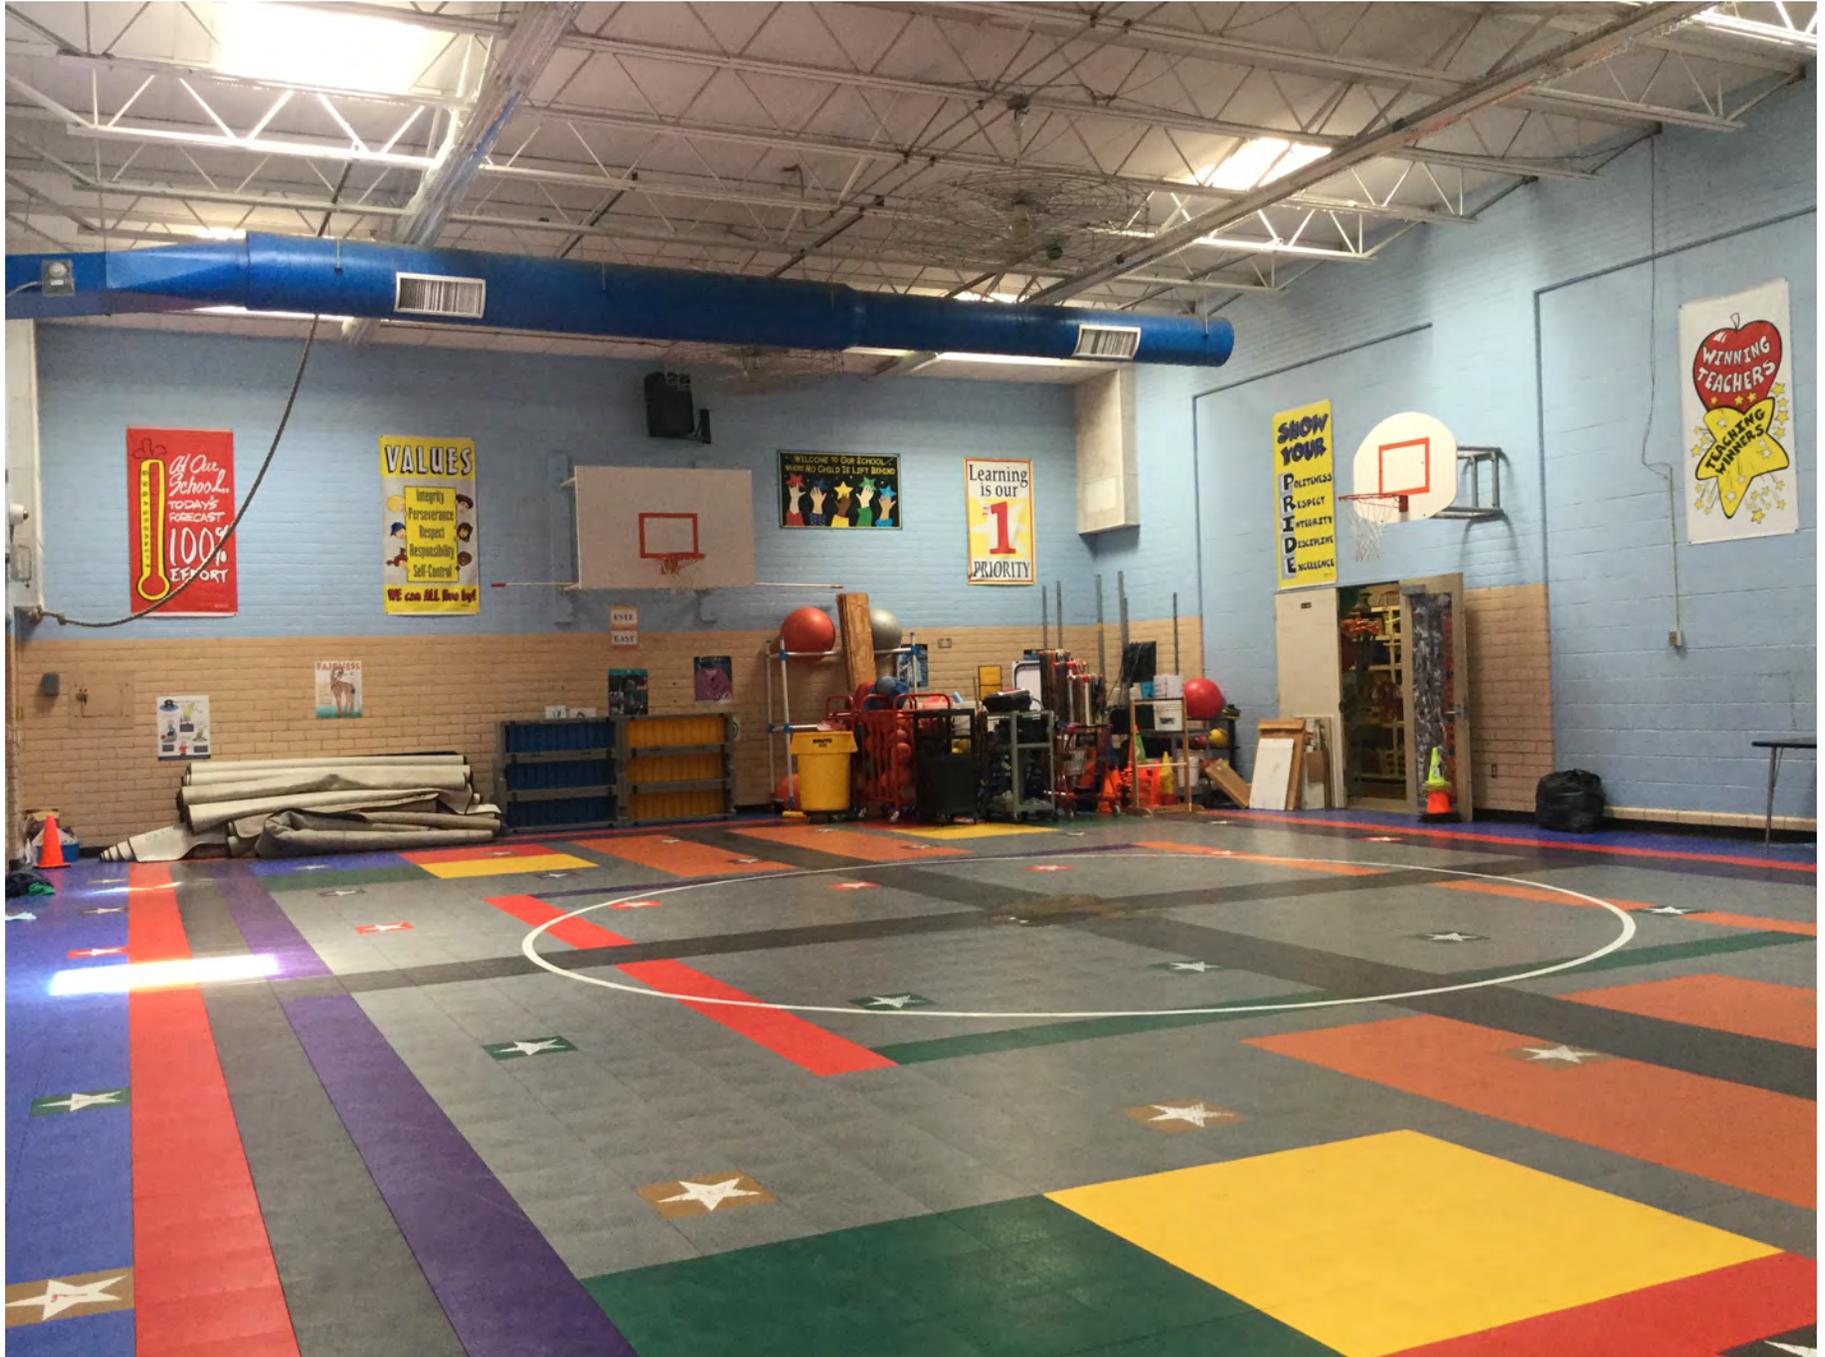
Photo 6. Gym

1) Very unsatisfactory 2) Unsatisfactory 3) Average 4) Good 5) Very good N/A) Does not apply.								Ref. Photo 6-Gym	
3.7	Are Physical Education and Athletic <b>support</b> spaces appropriately configured per the ed spec?			3				Comments	1.00 3.00

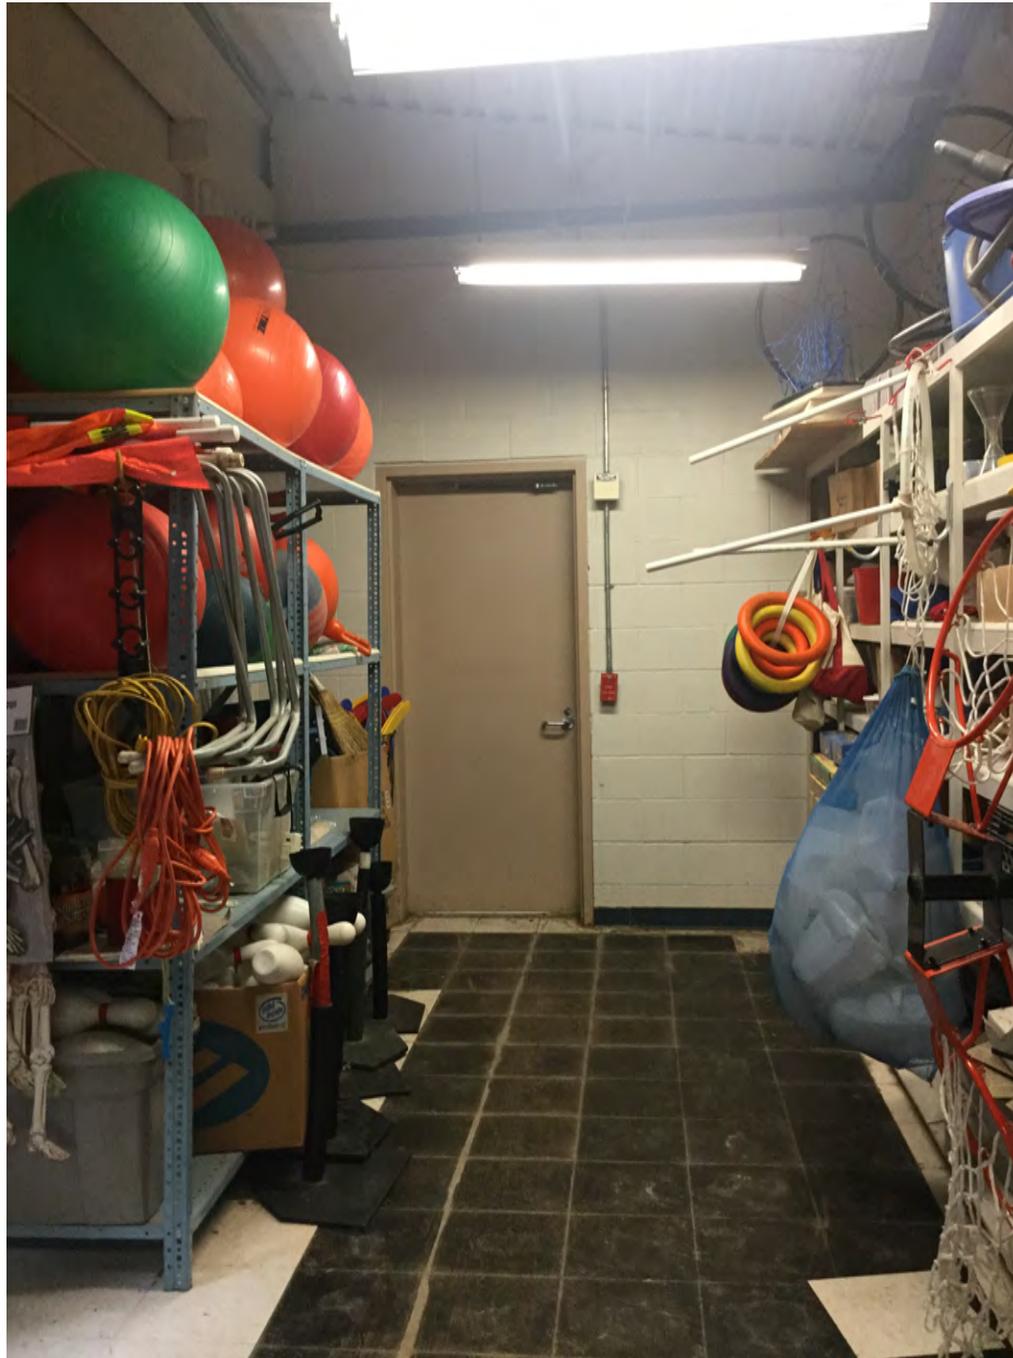
Photo 7. Gym Storage.

1) Very unsatisfactory - Support spaces are disconnected from served spaces, too small, do not meet needs 2) Unsatisfactory - Support spaces are connected, but too small, inadequate for needs 3) Average - Connected, moderate size, but need some renovations or updates to function well 4) Good - Connected, good size/layout, meets needs/functions well 5) Very good - connected, generous size, nice condition, functions appropriately N/A) Does not apply.								Ref. Photo 7-Gym Storage

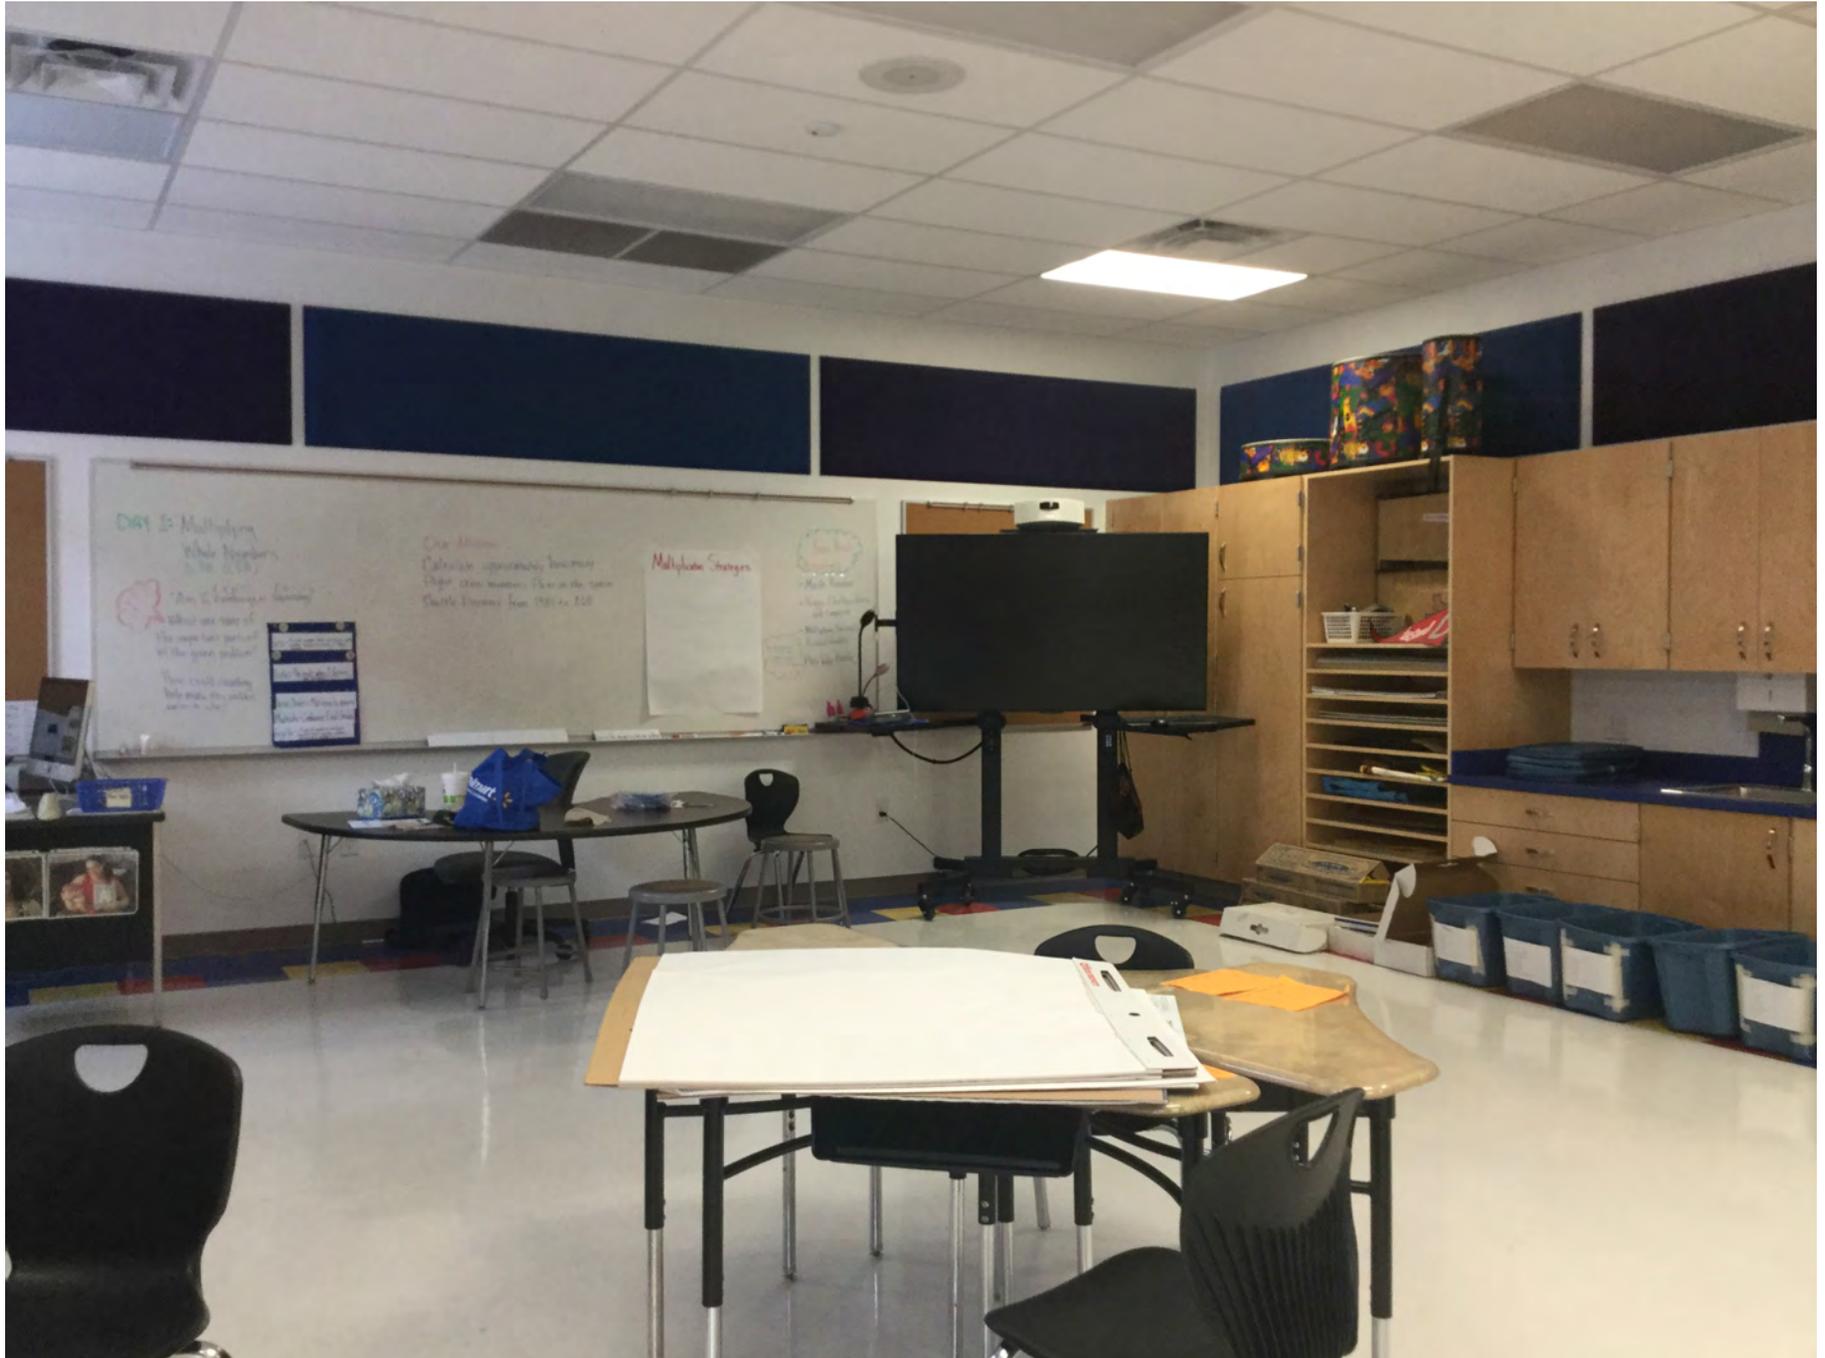
Photo 8. Music Room

3.8	Are music, drama, or performance spaces appropriately configured per the ed spec?				4			Comments	1.00 4.00
1) Very unsatisfactory 2) Unsatisfactory 3) Average 4) Good 5) Very good N/A) Does not apply.								Ref. Photo 8-Music Room

3.9	Are music, drama, or performance <b>support</b> spaces appropriately configured per the ed spec?			3				Comments	1.00 3.00
1) Very unsatisfactory - Support spaces are disconnected from served spaces, too small, do not meet needs 2) Unsatisfactory - Support spaces are connected, but too small, inadequate for needs 3) Average - Connected, moderate size, but need some renovations or updates to function well 4) Good - Connected, good size/layout, meets needs/functions well 5) Very good - connected, generous size, nice condition, functions appropriately N/A) Does not apply.								Ref. Photo 8-Music Room

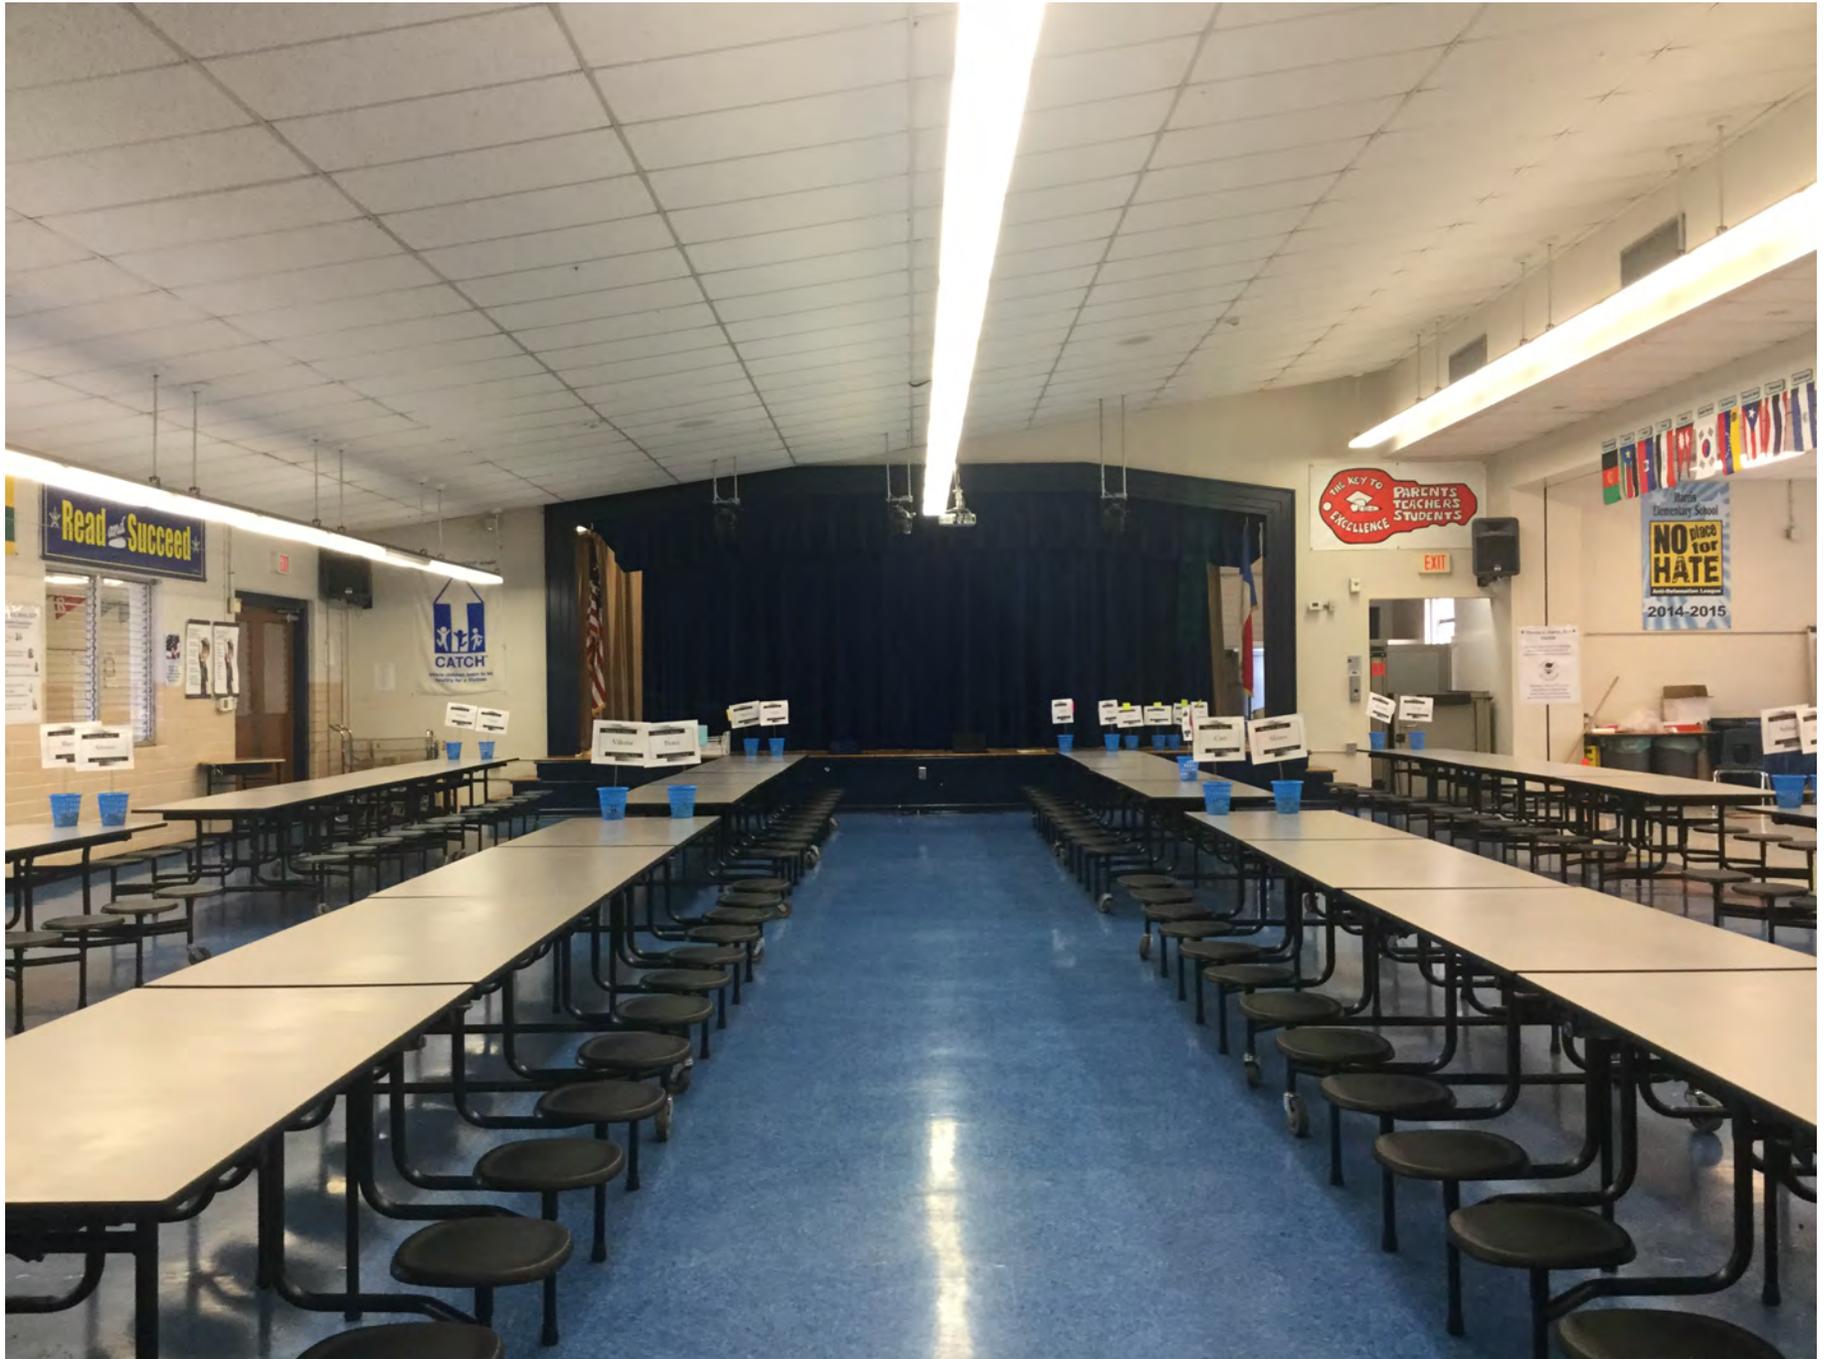
Photo 9. Cafeteria

3.16	Are the student dining facilities appropriately configured?				4			Comments	1.00	4.00
1) Very unsatisfactory - Too small, poor circulation, inflexible seating in poor condition 2) Unsatisfactory - Too small or inadequate circulation, seating in poor condition 3) Average - moderate size, with adequate circulation, seating in okay condition 4) Good - good size, adequate circulation, seating in good condition 5) Very good - good size, adequate circulation, seating in good condition, with more than one option for eating space (ex: connection to outdoor eating space) N/A) Does not apply.								Ref. Photo 9-Cafereria

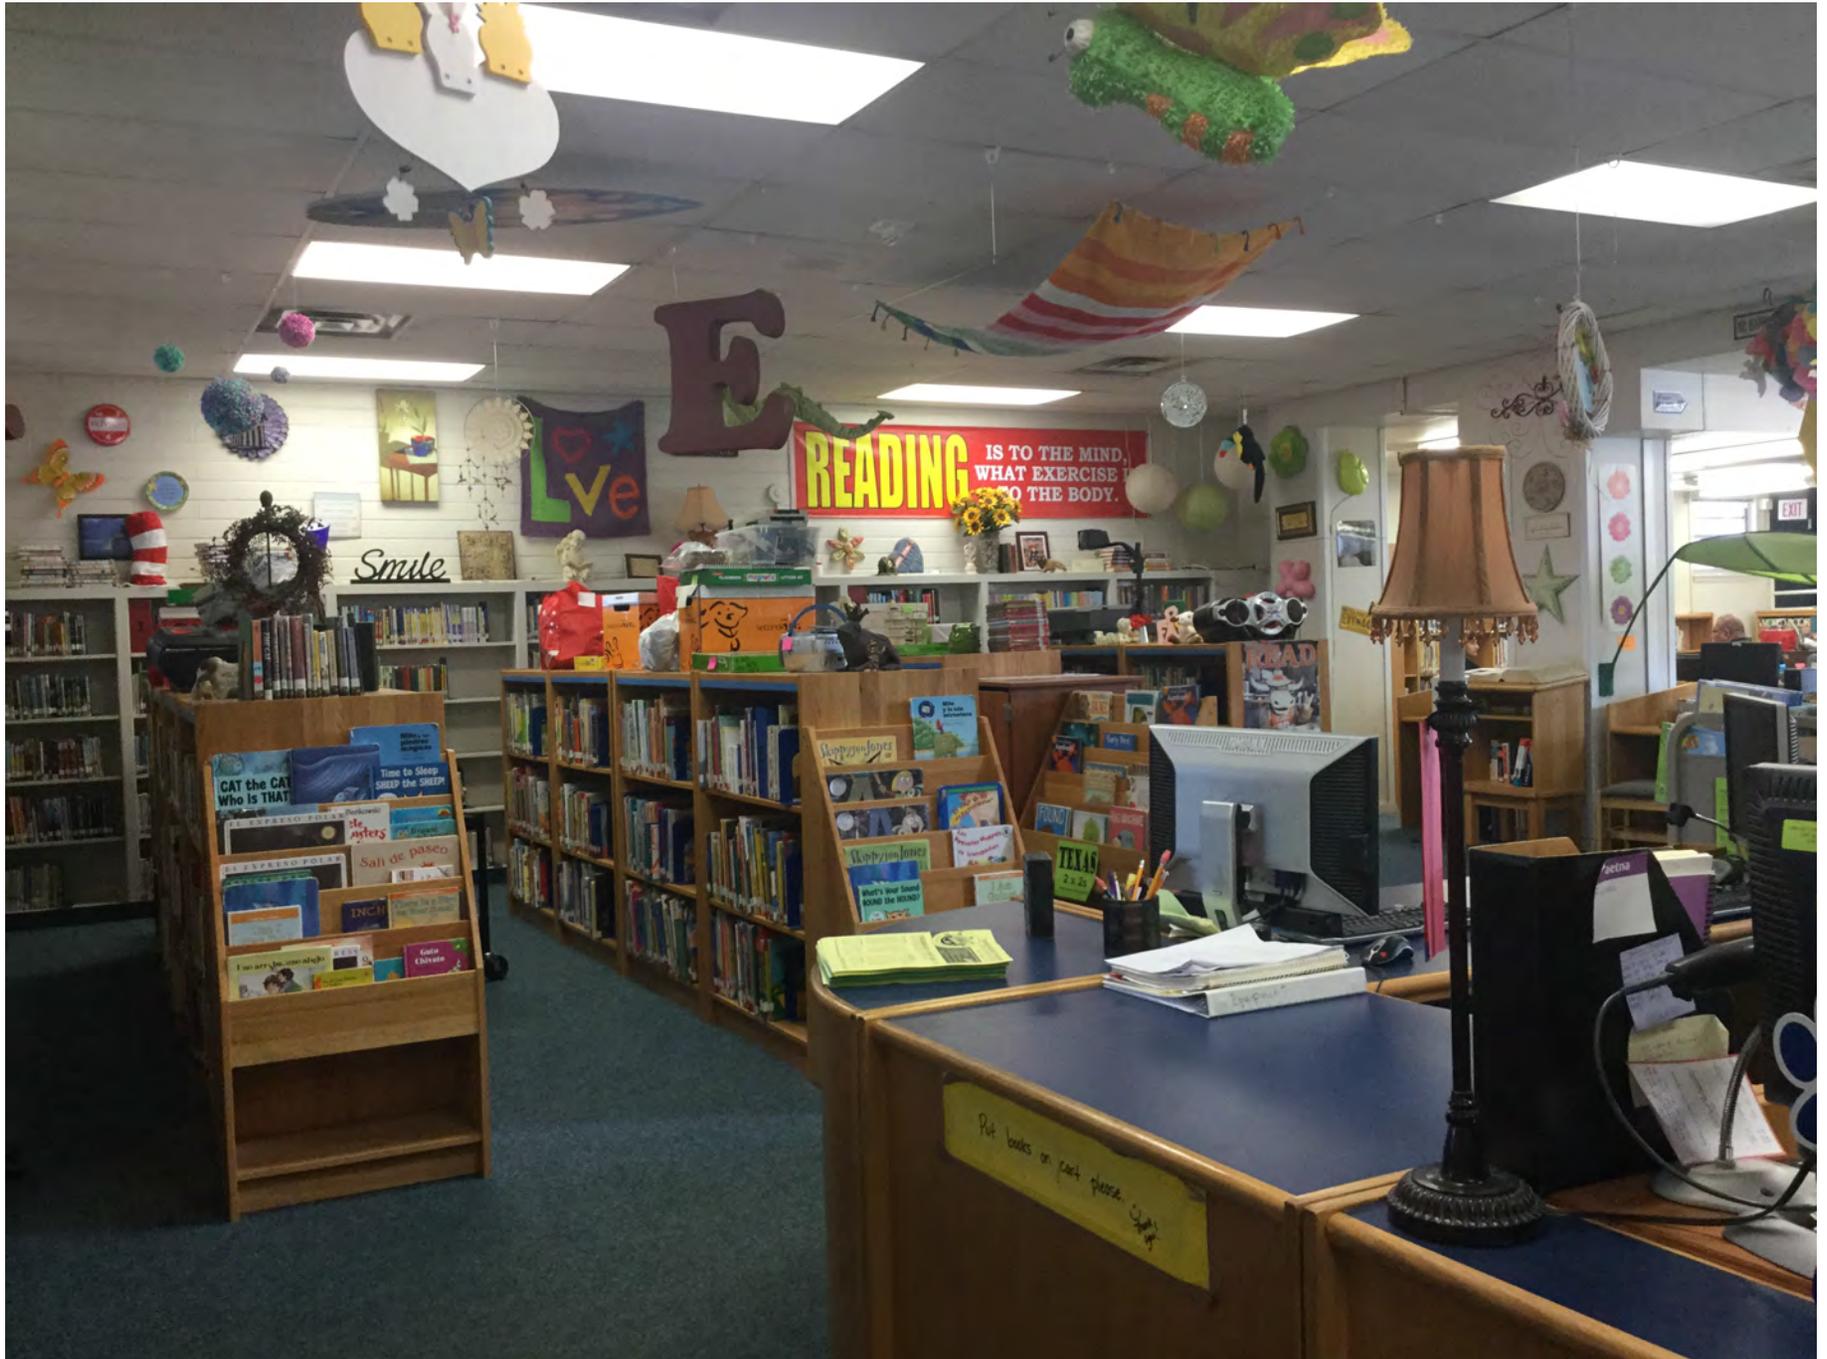
Photo 10. Library

The library has a lack of space and flexibility for collaborative work of different group sizes. There is a need for other casual seating to support social interaction and separation for areas of individual study. In addition, the library has unsatisfactory technological support and minimal storage space. There is concern of exiting the library with stairs. The space is dated and needs updates.

1) Very unsatisfactory 2) Unsatisfactory 3) Average 4) Good 5) Very good N/A) Does not apply.										
										<b>Ref. Photo 10-Library</b>
5.4	How well does the Library/Media Center support collaborative work in small groups (4-8 students)?			3				Comments	1.00	3.00
