## Educational Suitability Summary Report

Hart Elementary School

Date: 07/21/2016 (Rev 1 – 12/20/16 – Survey Responses and CAC Comments) **Score 63% Average**

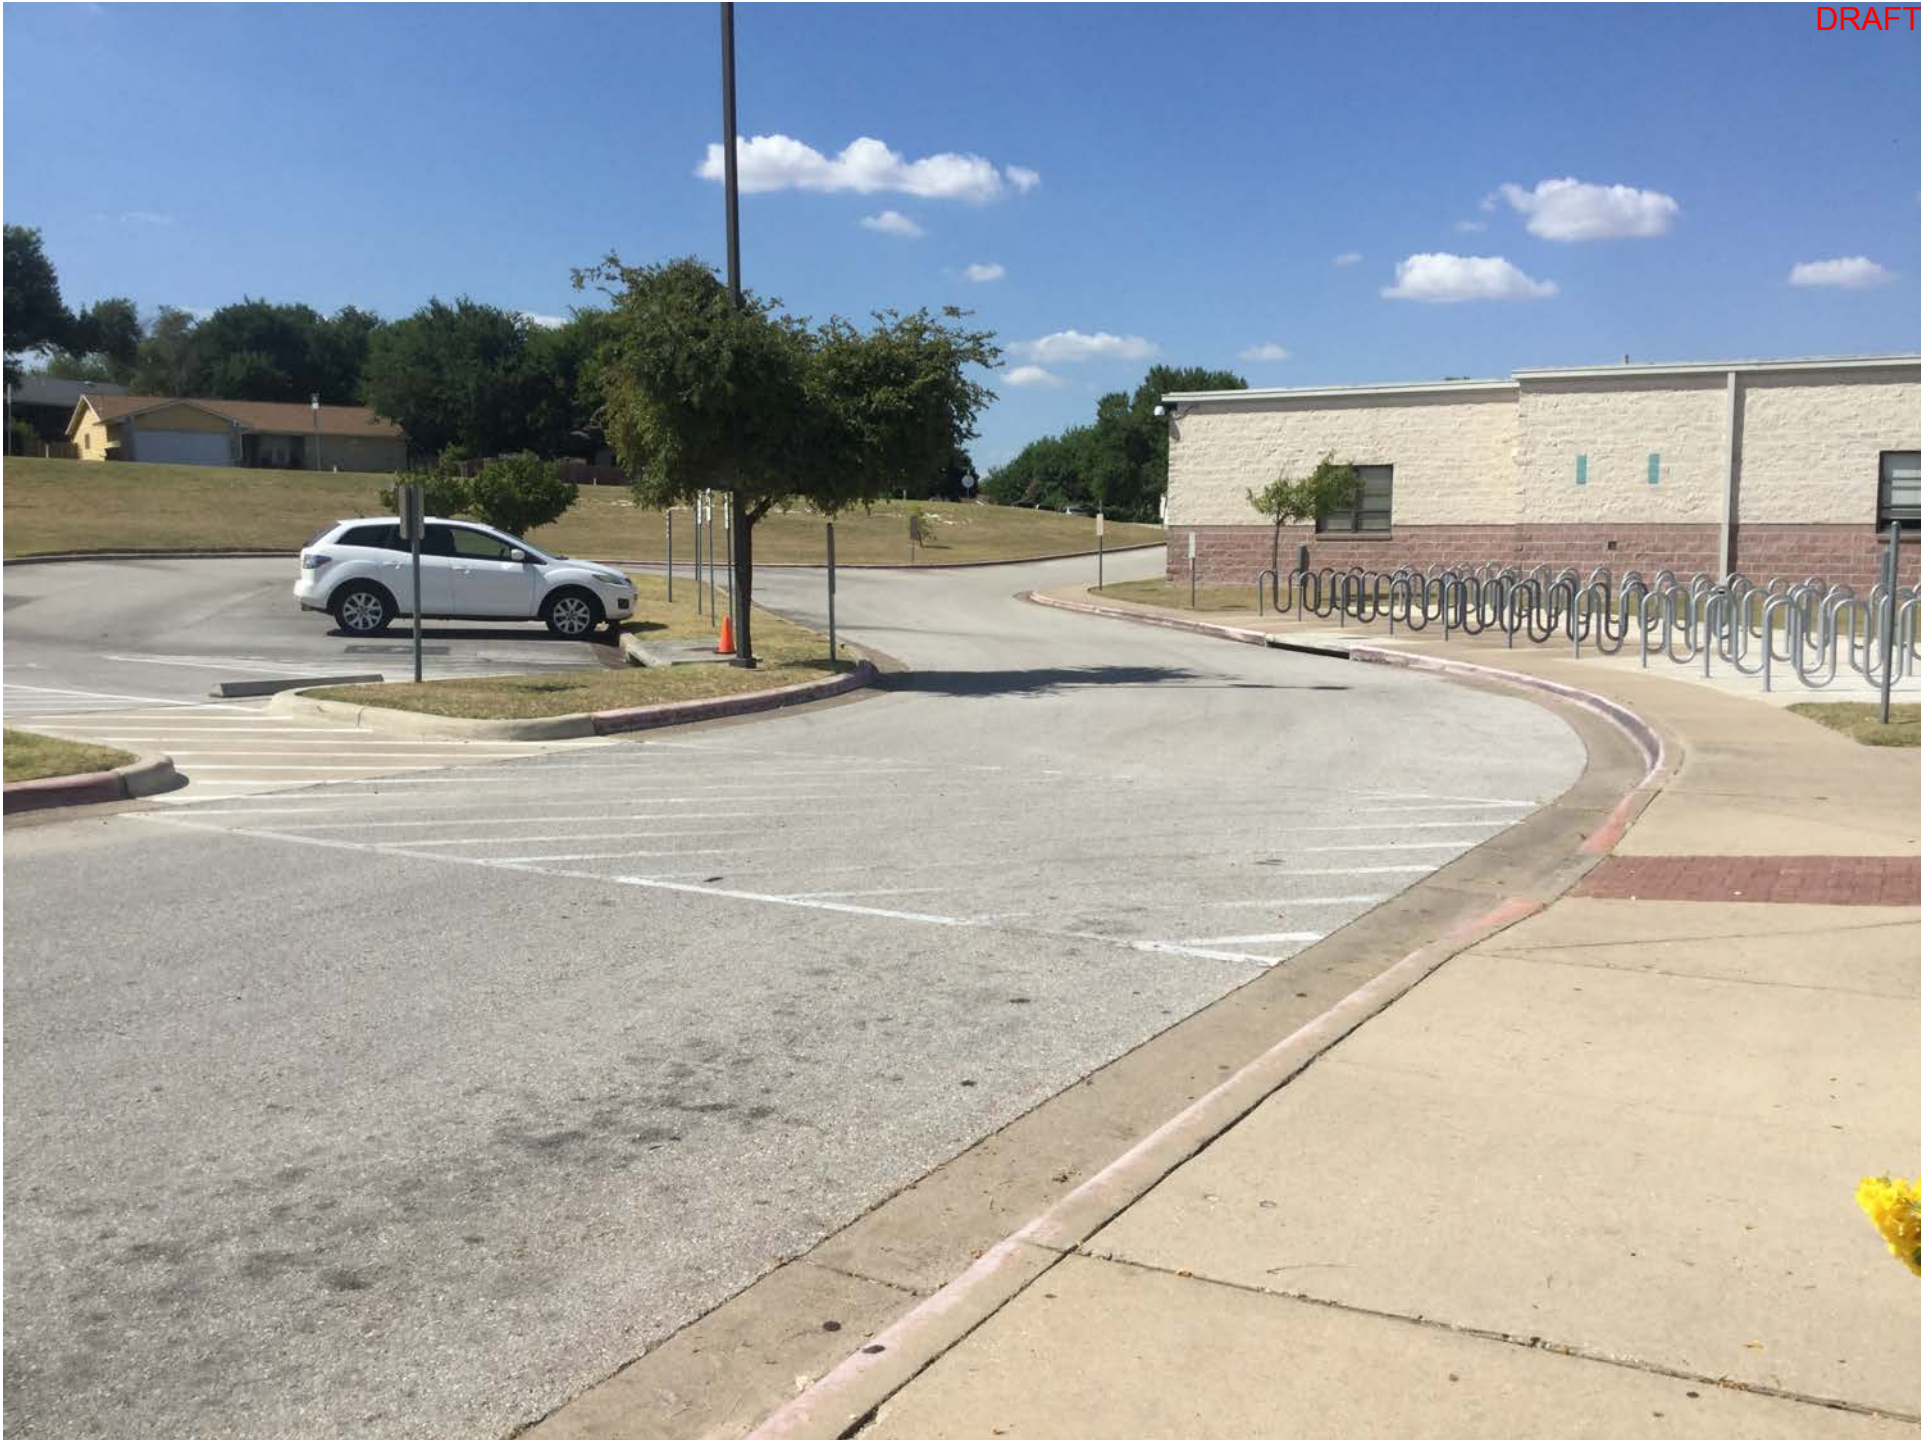
Photo 1. Parking

1 - Exterior		1	2	3	4	5	N/A	8.75	
1.1	Does the site permit desirable separation of vehicular, bus and pedestrian traffic?			3				Comments	1.00 3.00
1) Bus , car and pedestrian all happen at the same location. 2) Cars and buses mix, pedestrians are separated. 3) Buses, cars, and pedestrians are separate but stack space is small. 4) Buses, cars, and pedestrians are separate but drop off does not have a canopy or a holding place like a commons or cafeteria. 5) Buses, cars, and pedestrians are separate and drop off area has a canopy and destination. N/A) Does not apply.								Site circulation is a problem with people walking across the street where traffic is building up at pick-up and drop-off.	See image 1

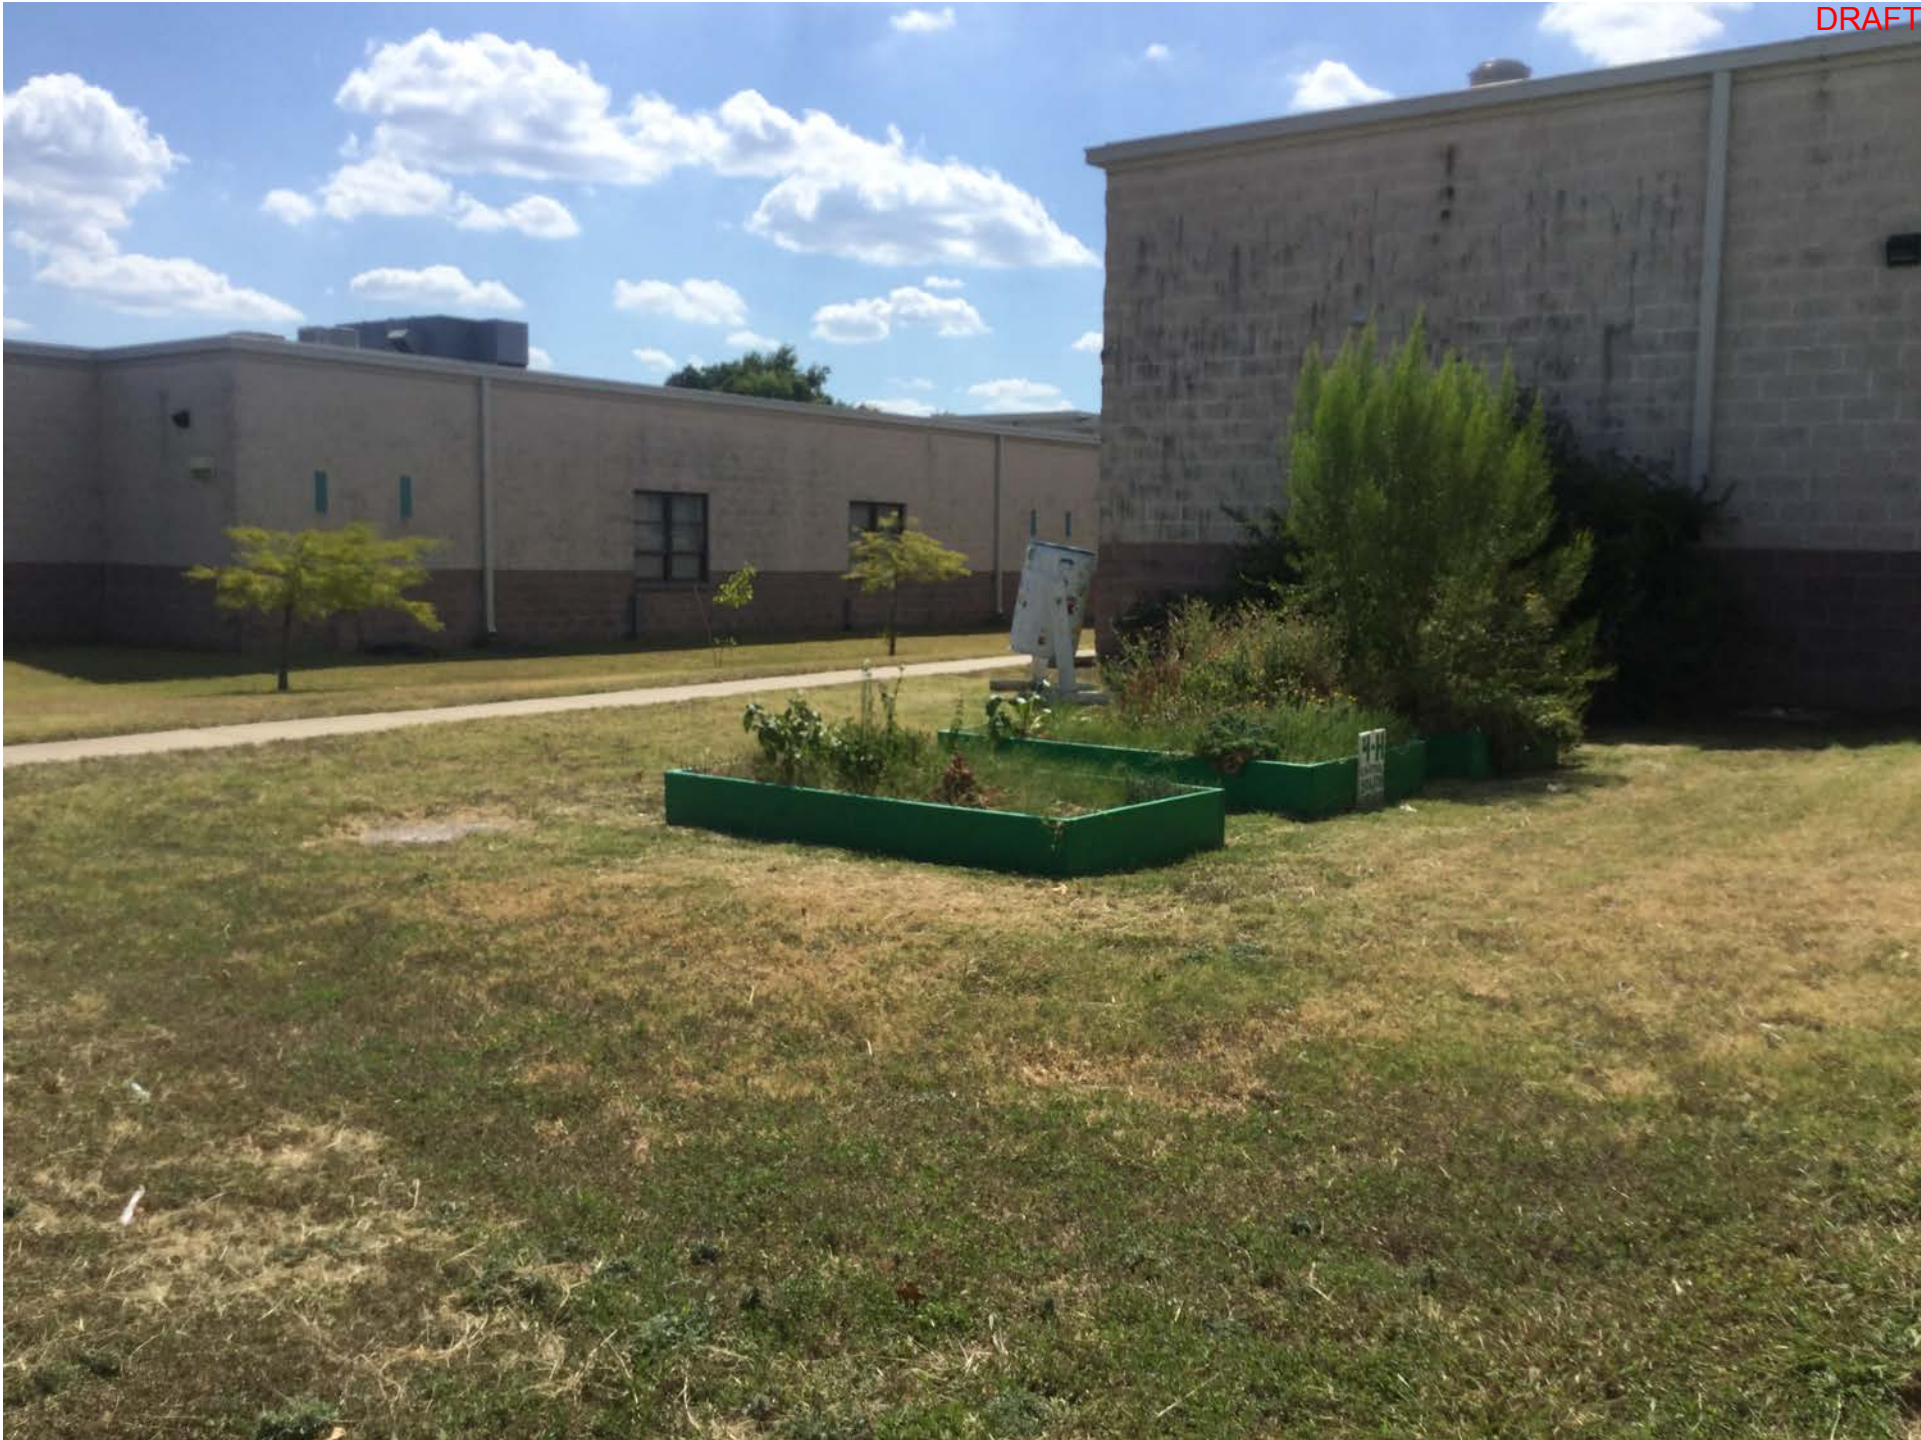
Photo 2. Outdoor space

1.2	Are opportunities provided for outdoor learning (outdoor classrooms, gardens, etc.)?		2					Comments	1.00 2.00
1) Outdoor space exists is not developed 2) Outdoor space for learning exists but not connected to classroom learning areas. 3. Outdoor learning spaces exist and are accessible but not in good condition. 4. Outdoor learning spaces need minor improvements to function well. 5. Outdoor learning spaces are in excellent condition. N/A) Does not apply.								Opportunities are present for outdoor learning but they need to be developed and shaded.	See image 2

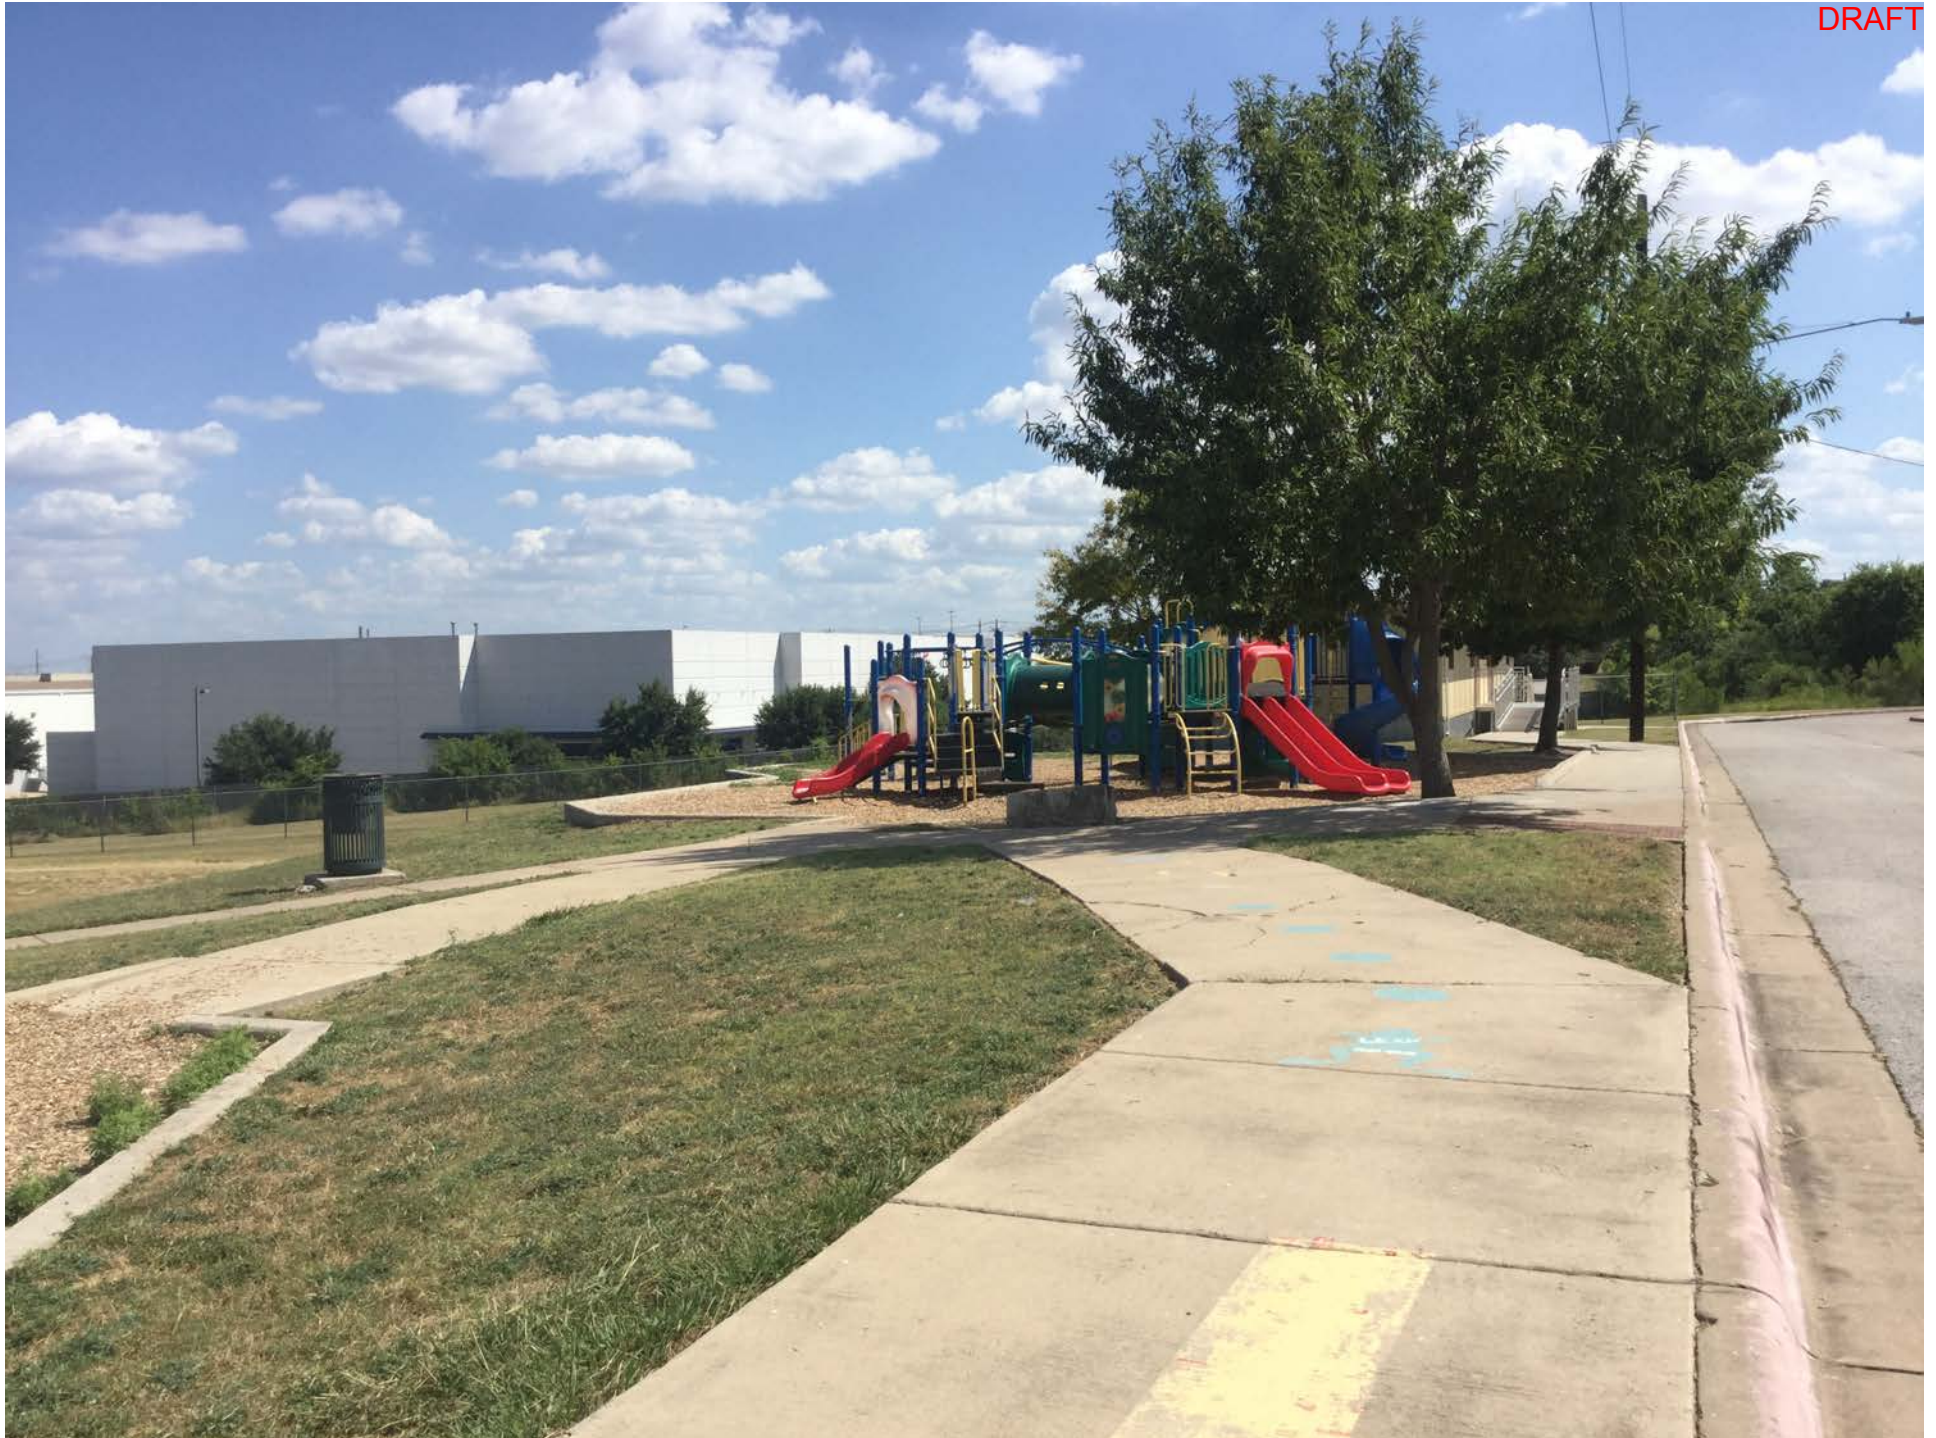
Photo 3. Play space

1.3	Are outdoor play spaces and playfields adequate in size and configuration?			3				Comments	1.00 3.00
1) Outdoor play space exists, not developed 2) Outdoor play space exists but is not connected to gym or other athletic support areas or is too small. 3. Outdoor play spaces exist, are connected to other athletic areas, are the right size, but are not in good condition. 4. Outdoor play spaces need minor improvements to function well. 5. Outdoor play spaces are in excellent condition. N/A) Does not apply.								The playground is inadequate in size. It needs an accessible route to the building and accessible playground equipment. Track is in poor shape. The playground would also benefit from additional shade.	See image 3

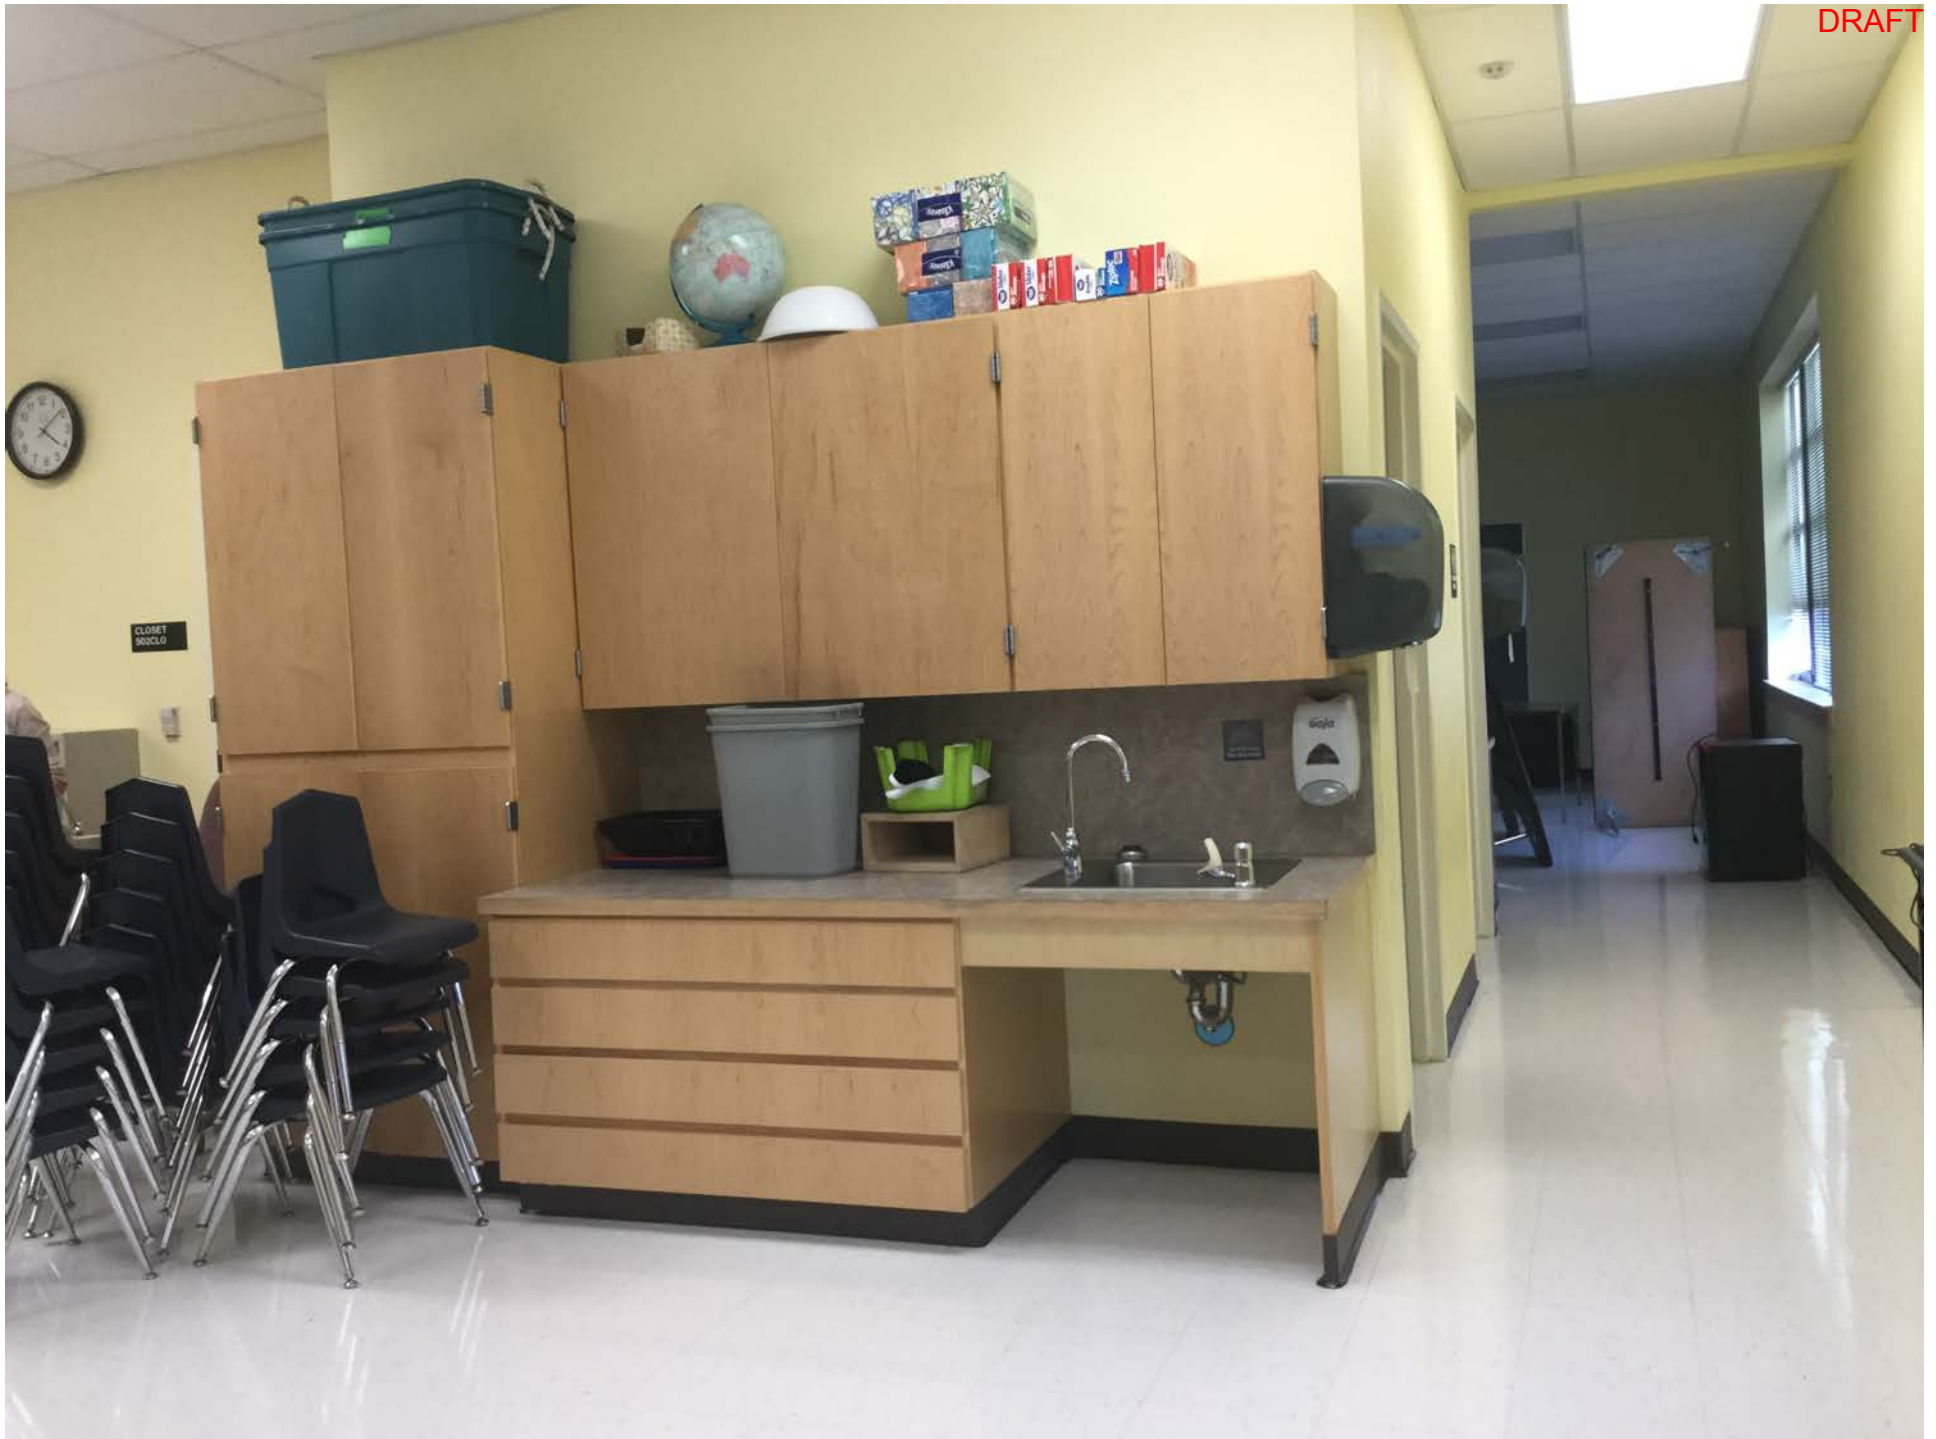
Photo 4. classroom

3 - Academic & Co-Curricular Support		1	2	3	4	5	N/A	36.00	
3.2	Are Pre-K and Kinder classrooms appropriately configured per the ed spec? (elementary school only)			3				Comments	1.00 3.00
<div>1) Very unsatisfactory - Too small, awkward layout, does not meet needs</div> <div>2) Unsatisfactory - Too small, only one area for all teaching methods, limited flexibility</div> <div>3) Neutral - Moderate size, two areas for different teaching methods, some flexibility, access to student storage/casework</div> <div>4) Satisfactory - Good size, at least two zones for different teaching methods, flexibility and student storage, not new</div> <div>5) Very Satisfactory - Good size, two zones for different teaching methods, flexibility and student storage/casework, adequate display area and visual teaching tools</div> <div>N/A) Does not apply.</div>								See image 4

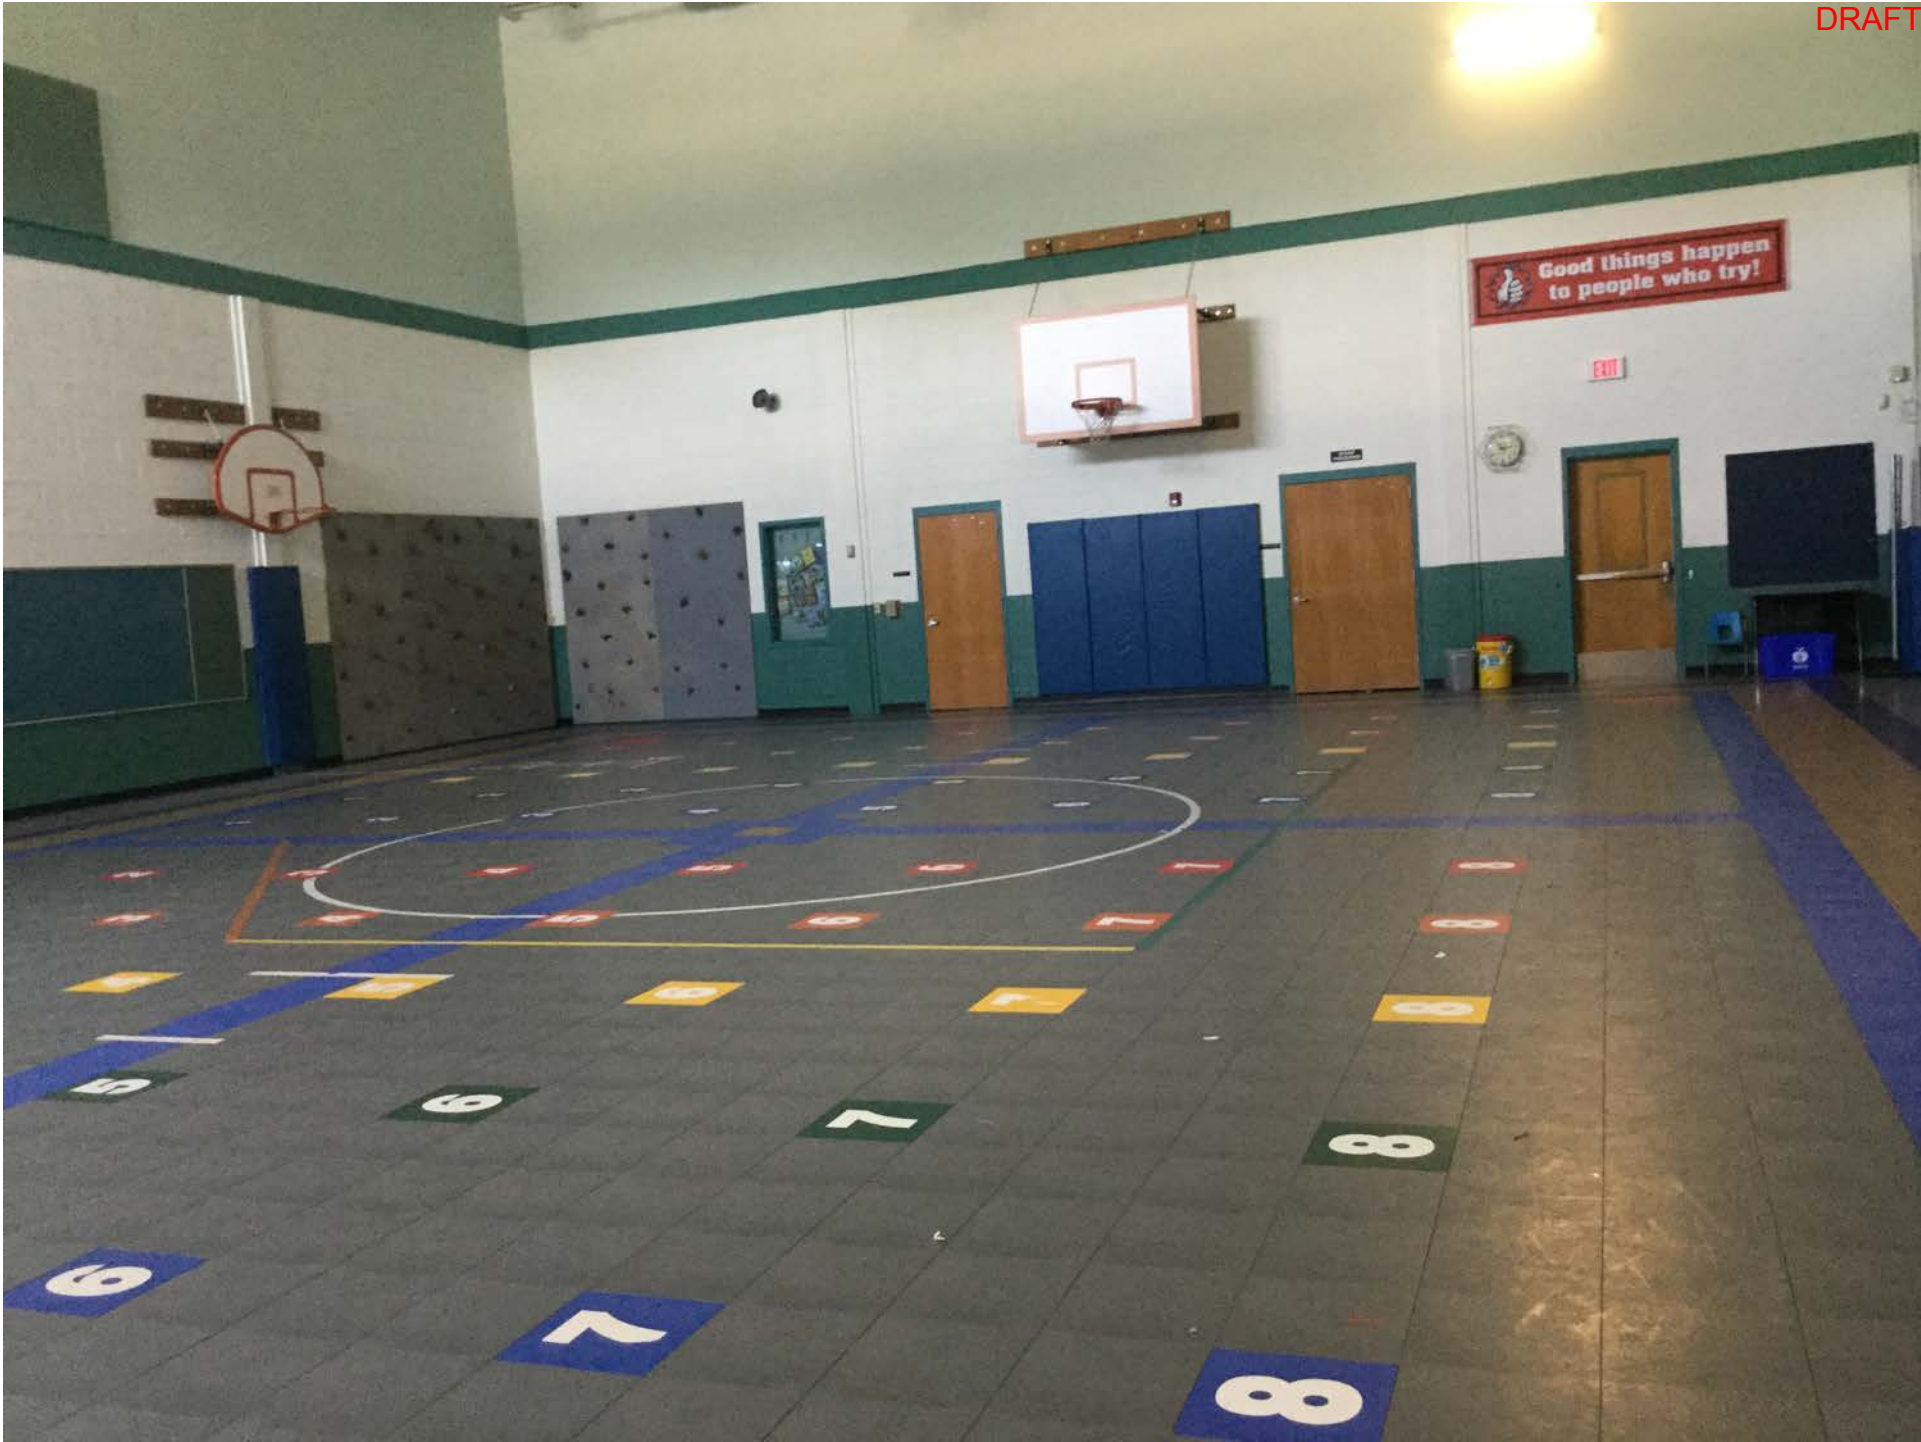
Photo 5. Gymnasium

3 - Academic & Co-Curricular Support - Continued		1	2	3	4	5	N/A		
3.6	Are Physical Education and Athletic spaces appropriately configured per the ed spec?		2					Comments	1.002.00
<div>1) Very unsatisfactory</div> <div>2) Unsatisfactory</div> <div>3) Average</div> <div>4) Good</div> <div>5) Very good</div> <div>N/A) Does not apply.</div>								Gym is inadequate in size, but there is an additional shaded outdoor athletic space.	See image 5

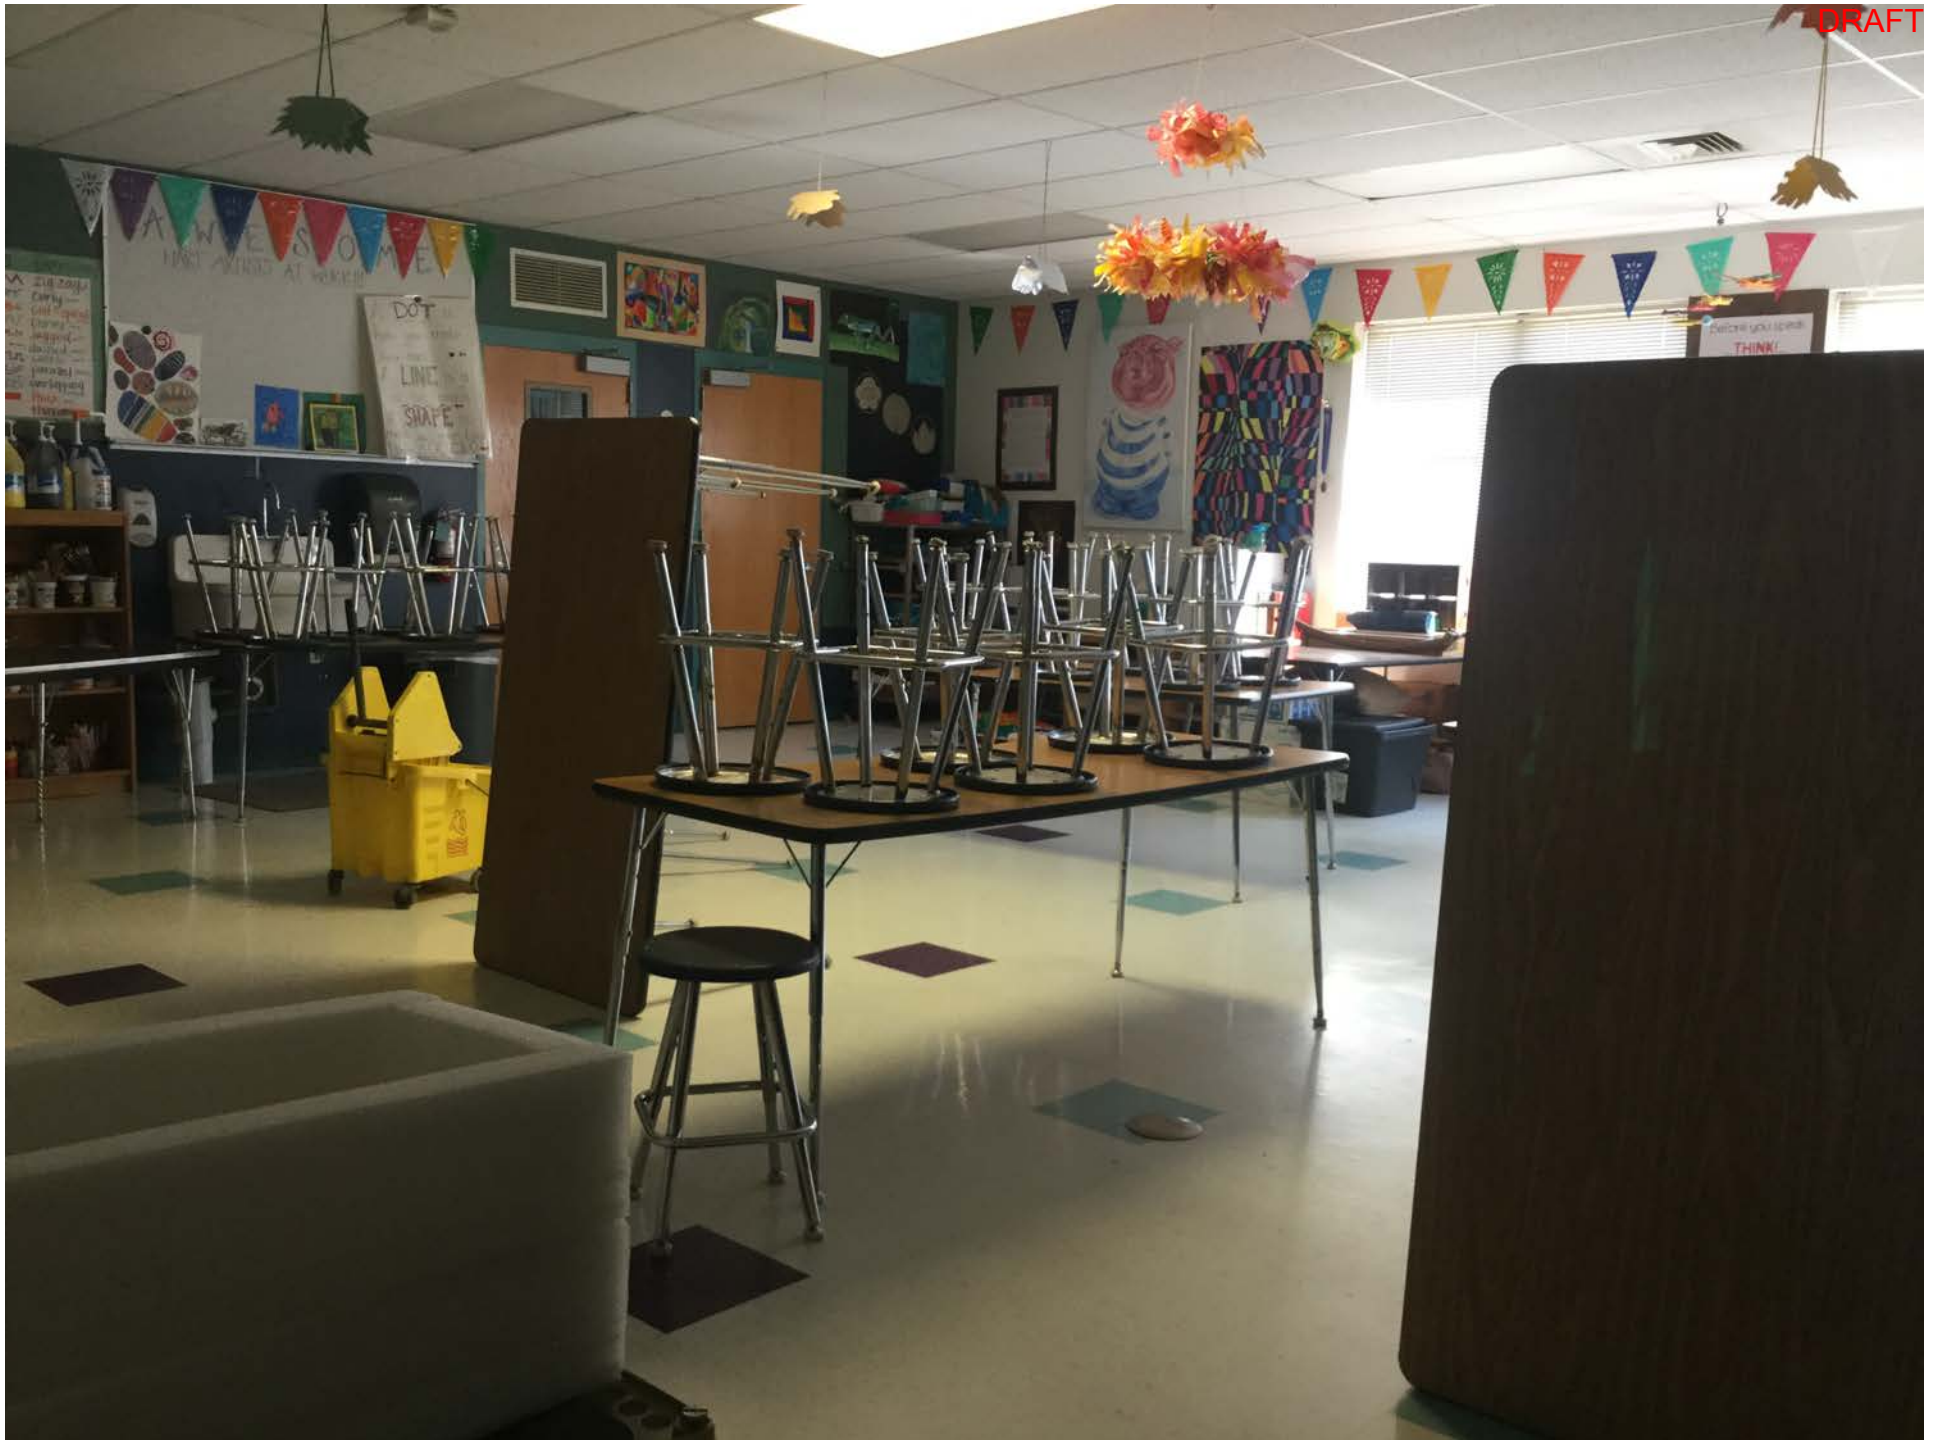
Photo 6. Art Room

1) Very unsatisfactory 2) Unsatisfactory 3) Average 4) Good 5) Very good N/A) Does not apply.							Visual arts space in portables is not ideal in size; however, there is an art room which is located inside the building that is a good size with appropriate support space.		
See image 6

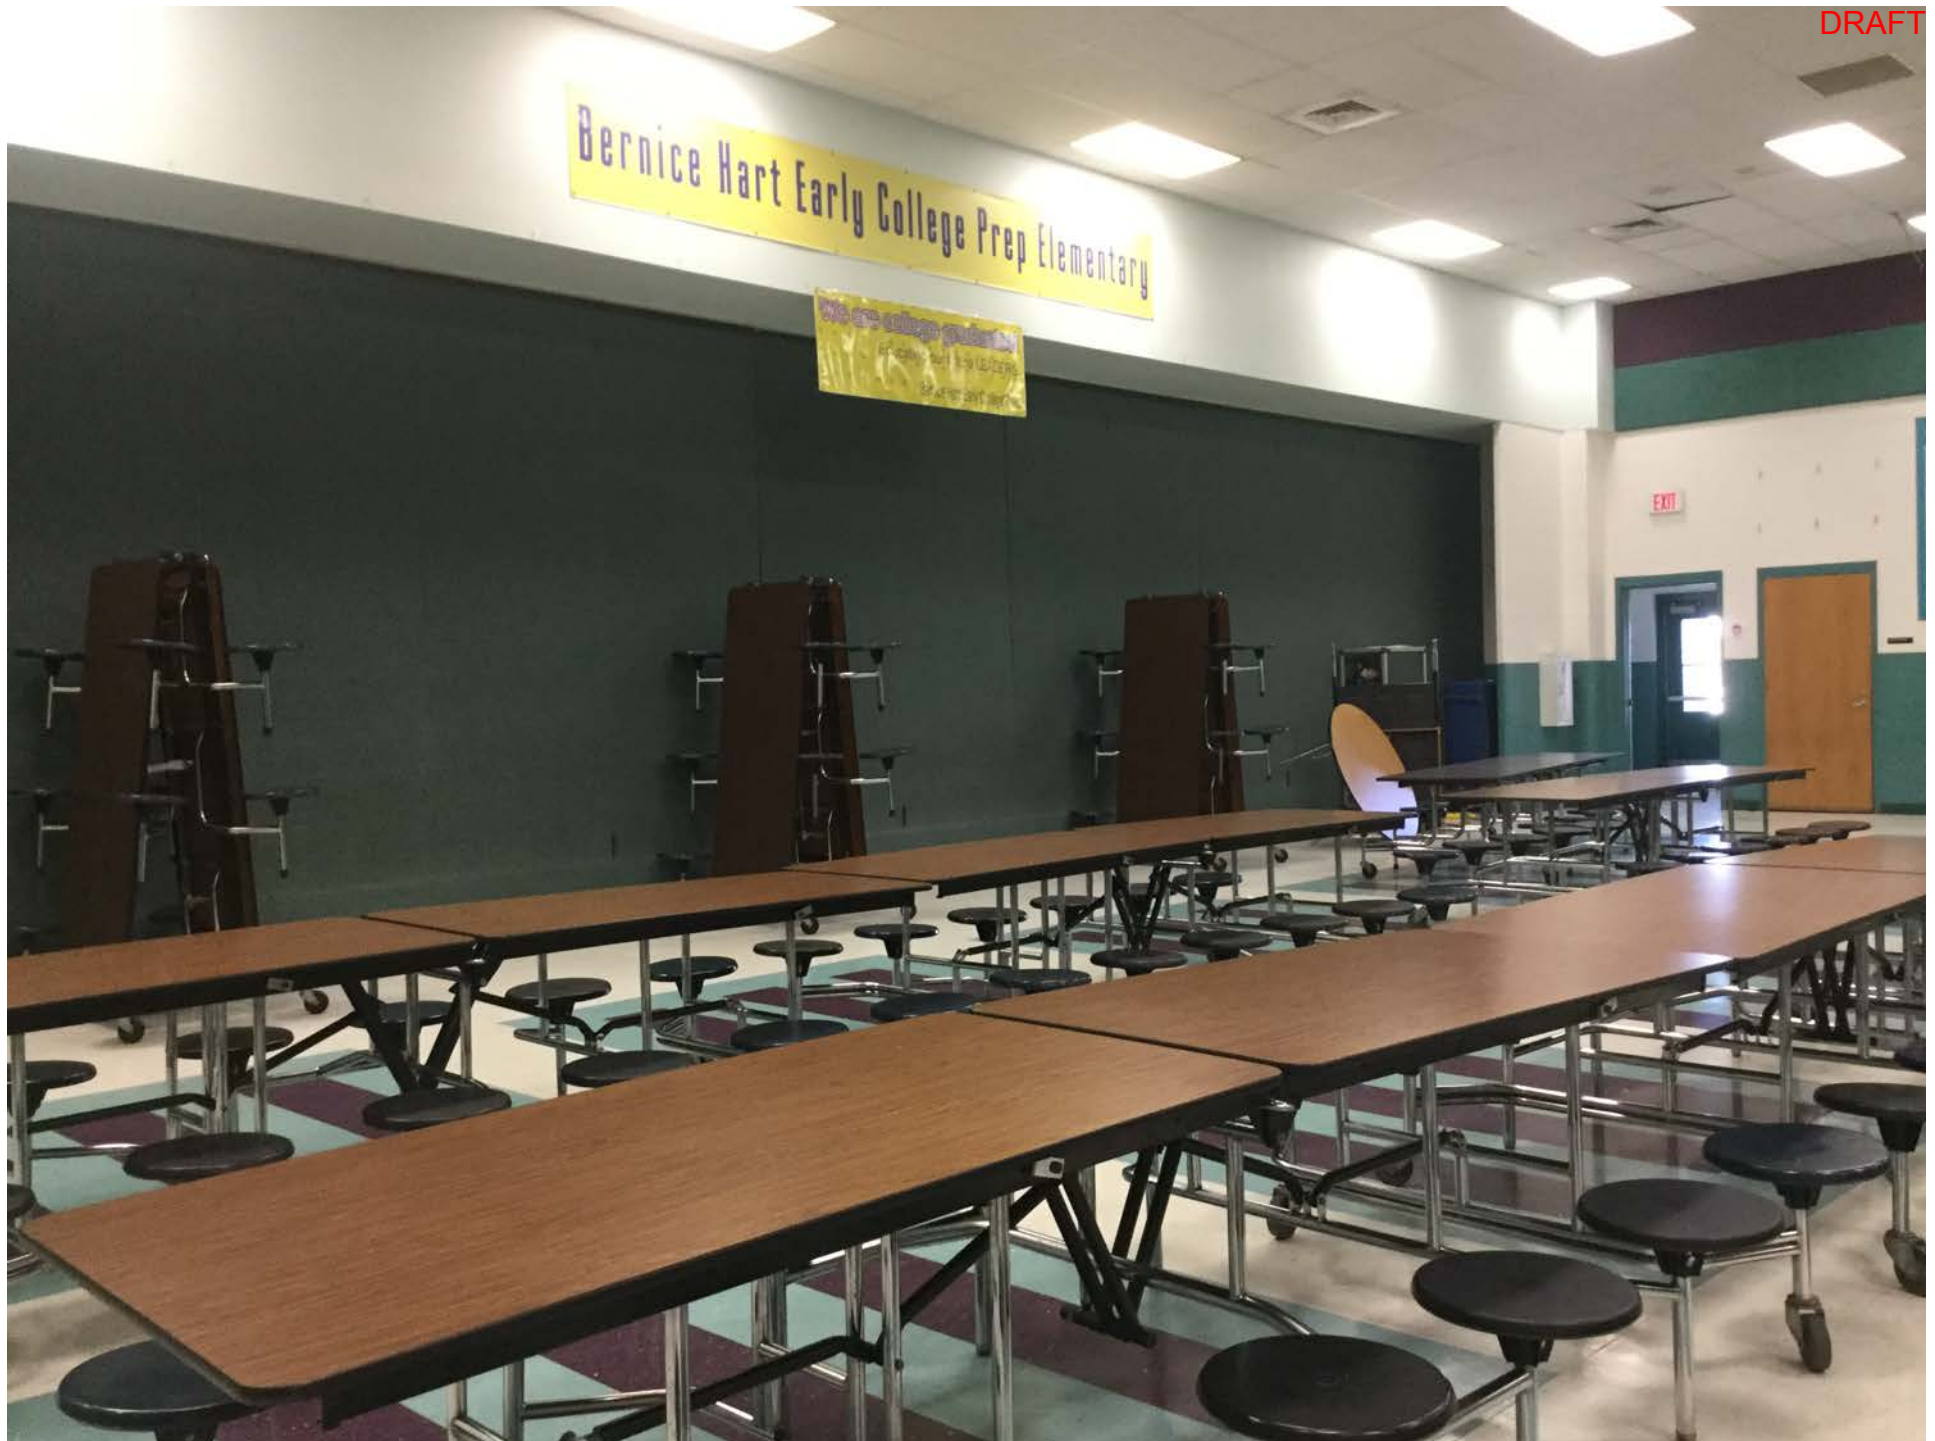
Photo 7. Cafeteria

3.16	Are the student dining facilities appropriately configured?							2						Comments	1.00	2.00
1) Very unsatisfactory - Too small, poor circulation, inflexible seating in poor condition 2) Unsatisfactory - Too small or inadequate circulation, seating in poor condition 3) Average - moderate size, with adequate circulation, seating in okay condition 4) Good - good size, adequate circulation, seating in good condition 5) Very good - good size, adequate circulation, seating in good condition, with more than one option for eating space (ex: connection to outdoor eating space) N/A) Does not apply.													The cafeteria is undersized for the size of the school.			
See image 7
