## Educational Suitability Summary Report

Hart Elementary School

Date: 07/21/2016 (Rev 1 – 12/20/16 – Survey Responses and CAC Comments) **Score 63% Average**

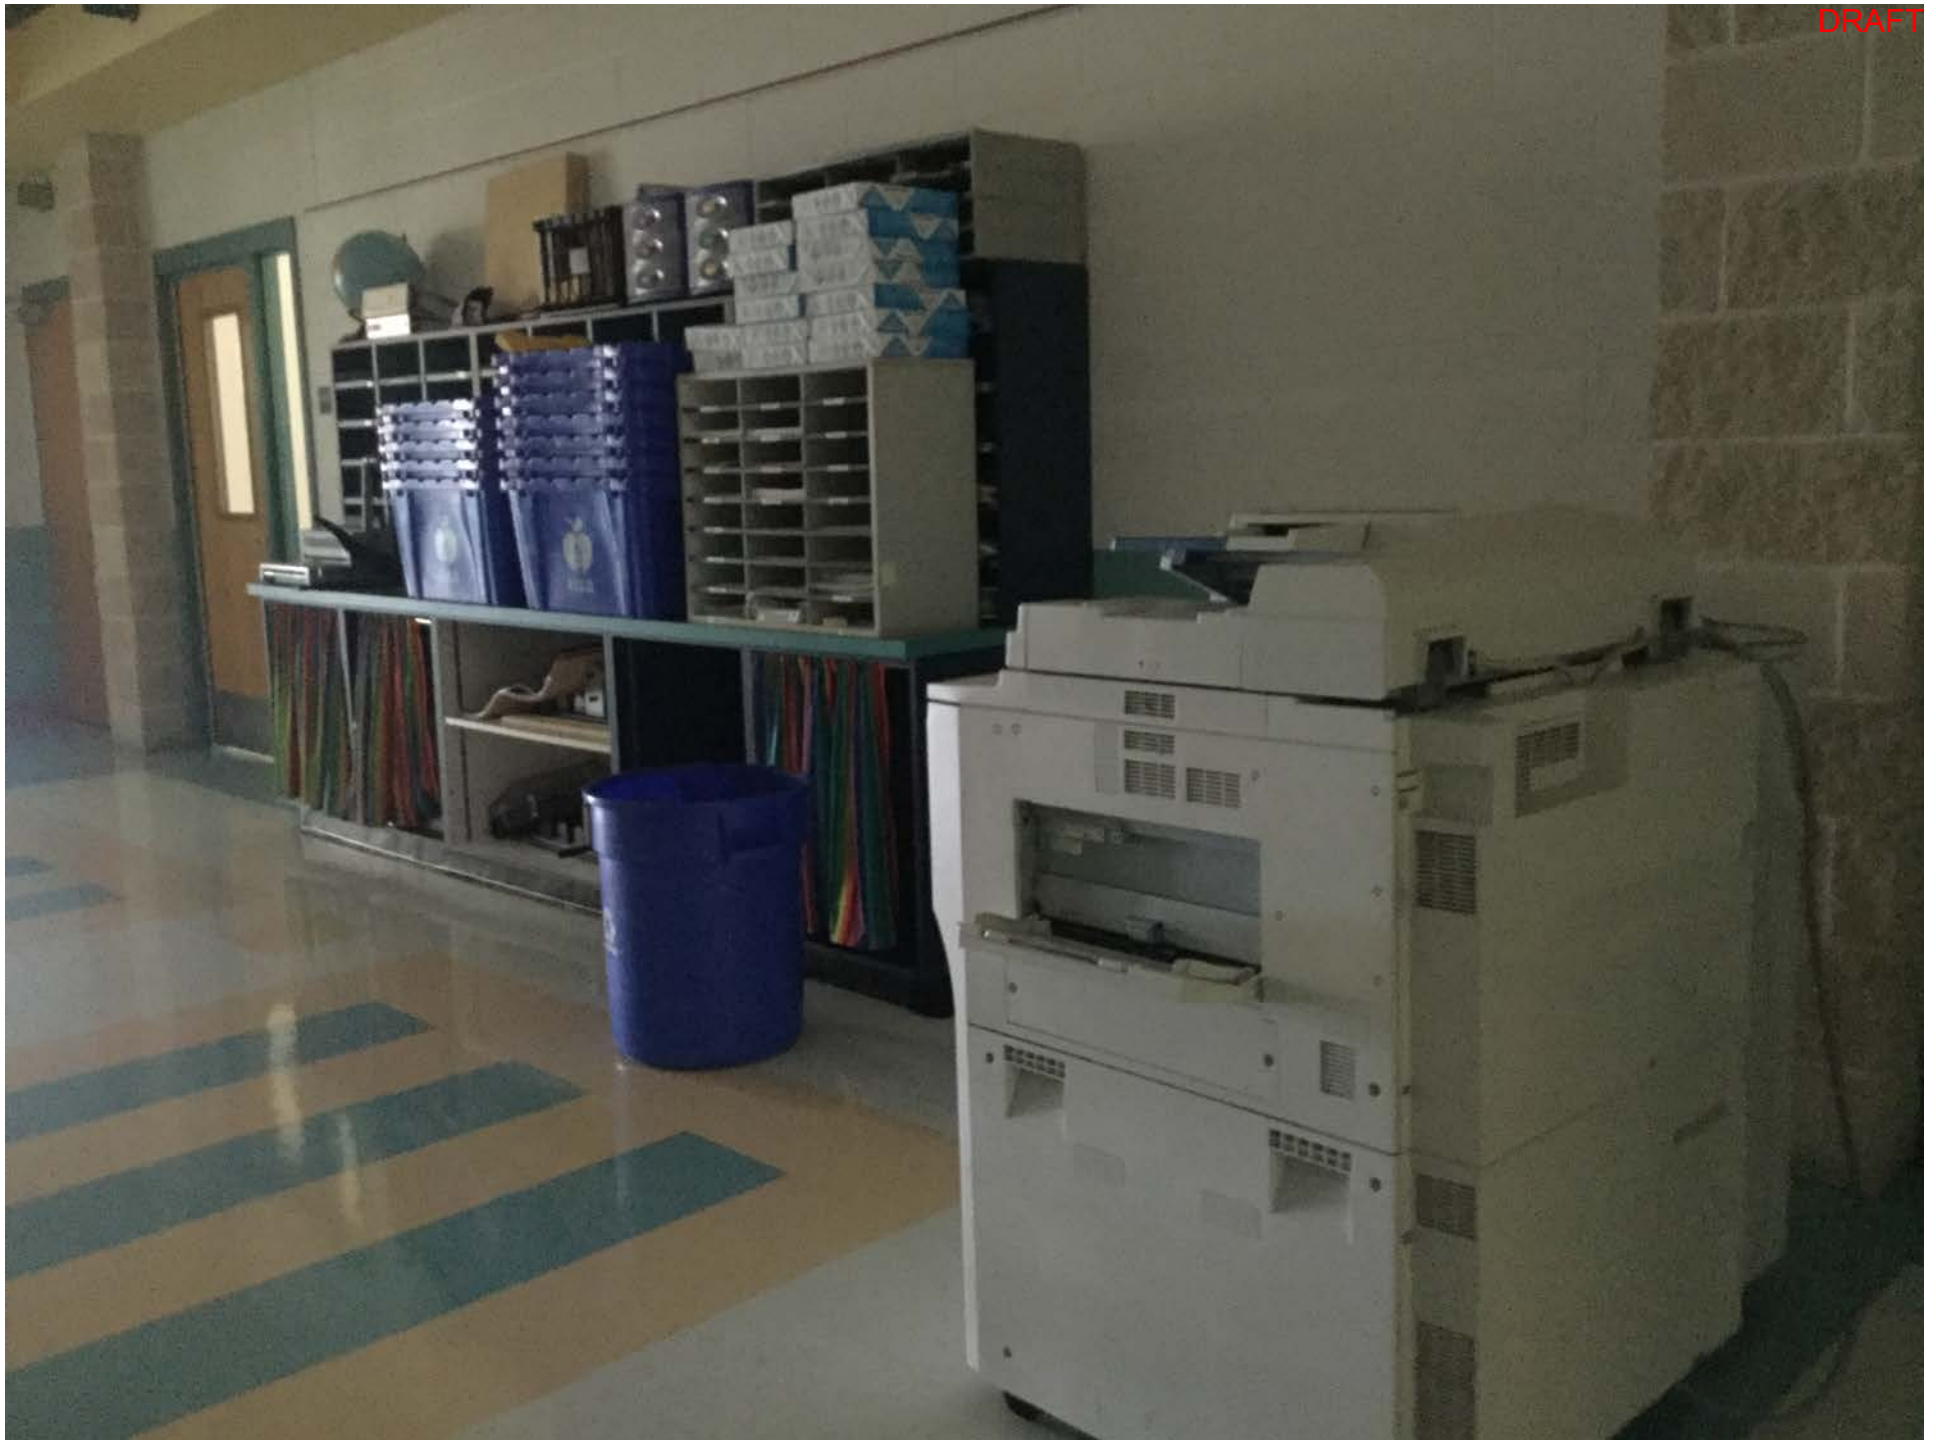
Photo 8. Teacher's Work space

1) Very unsatisfactory - no common spaces or meeting rooms or in very poor condition 2) Unsatisfactory - a few common spaces or meeting rooms in unsatisfactory condition 3) Average - a few common spaces and meeting areas needing updates 4) Good - multiple common spaces and meeting rooms in good condition 5) Very good - adequate common spaces and meeting rooms of excellent quality N/A) Does not apply.								See image 8

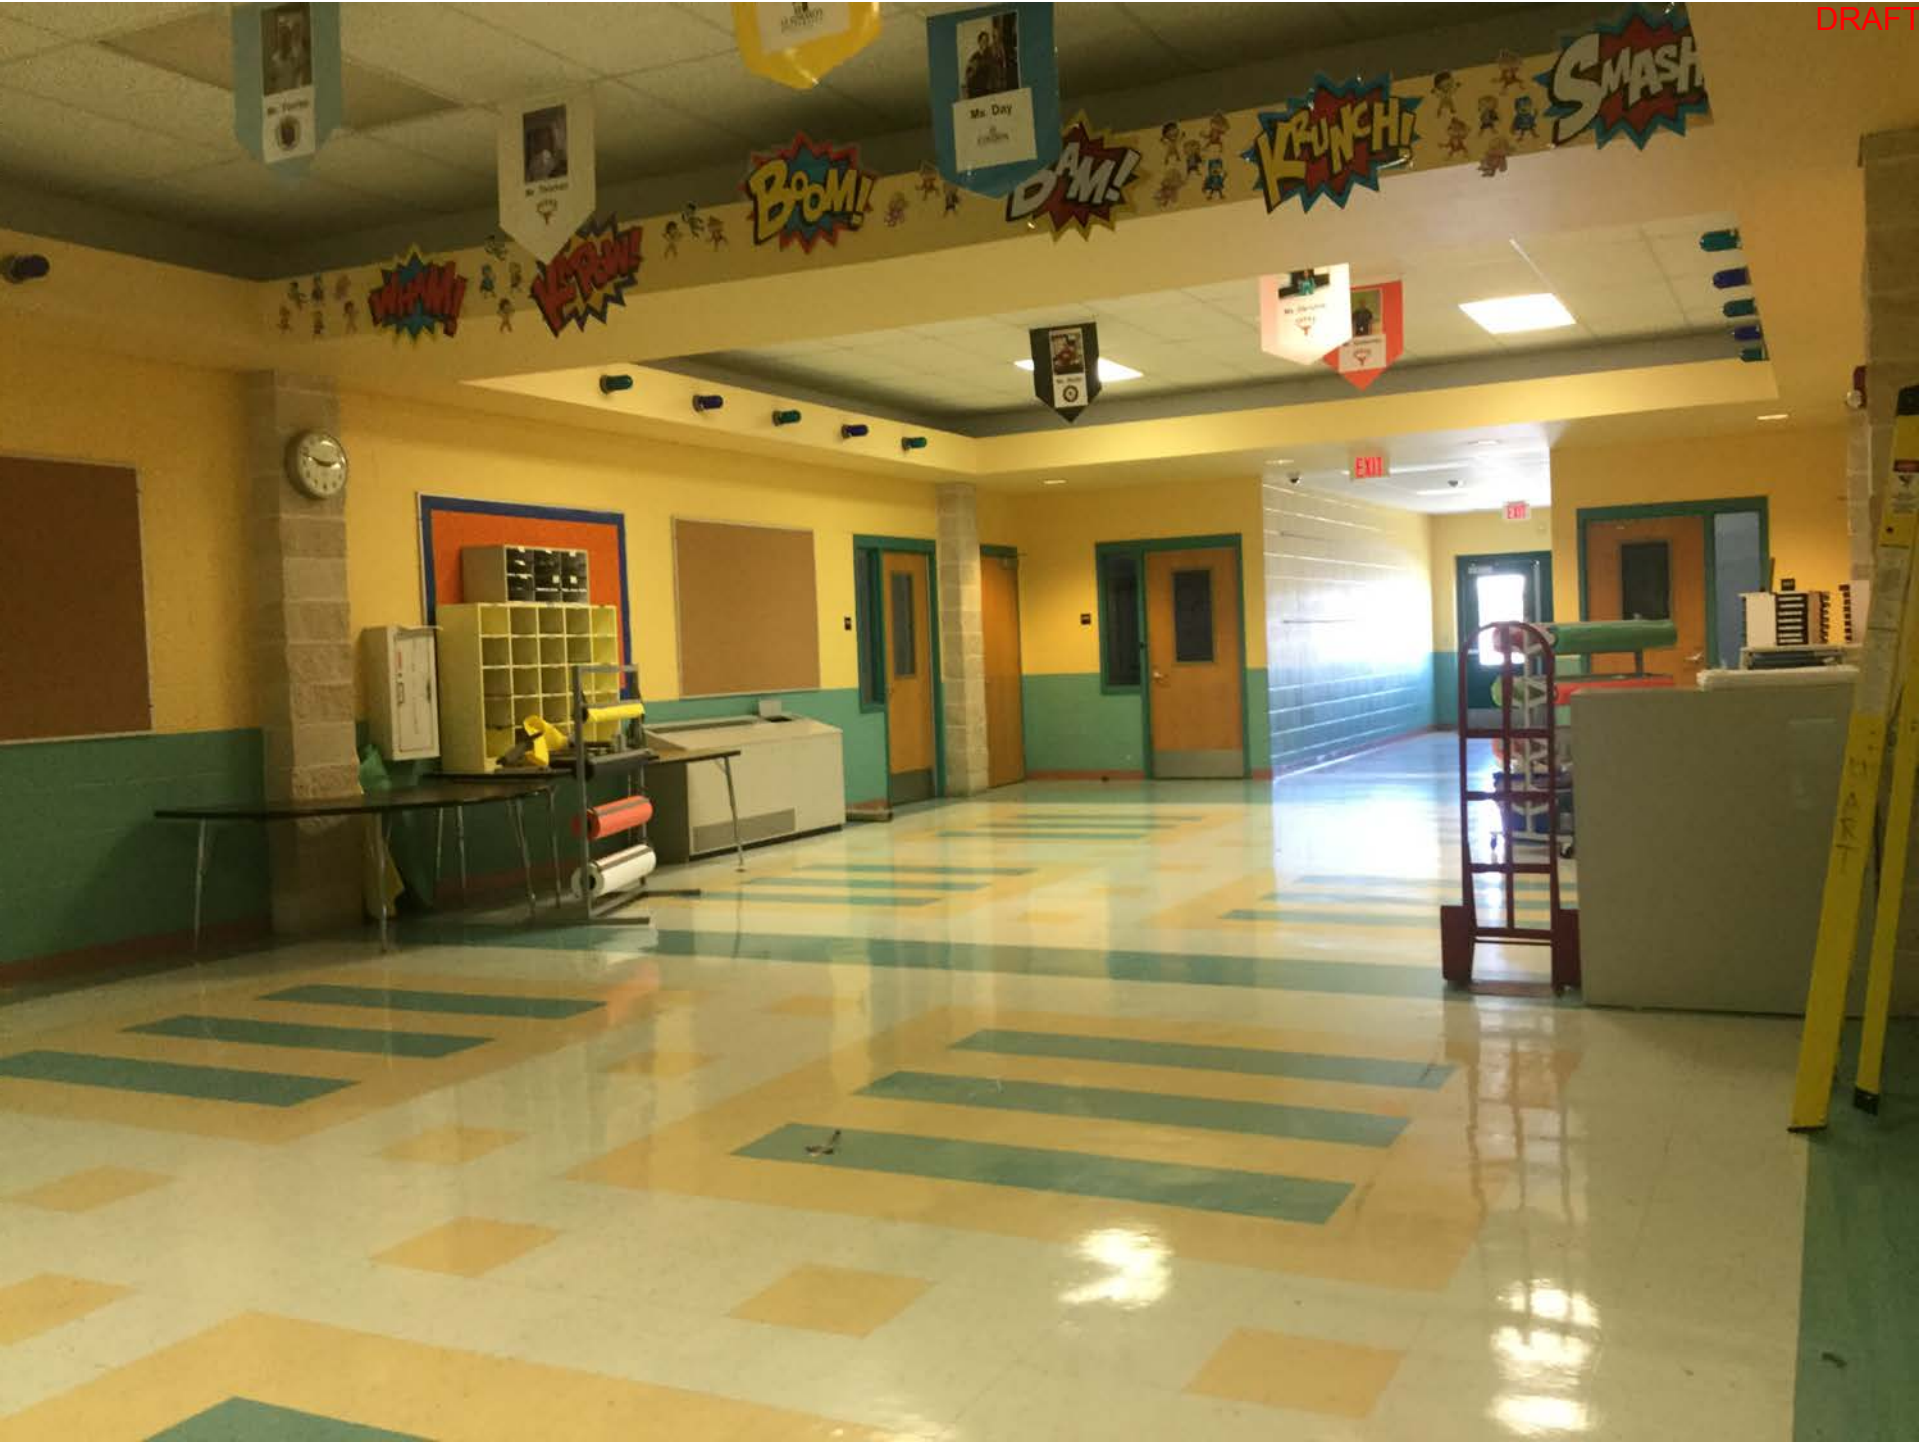
Photo 9. Flex space

4.6	Does the building provide opportunities for informal interaction?			3				Comments	1.00 3.00
1) Very unsatisfactory - no gathering areas or areas in very poor condition 2) Unsatisfactory - one exterior or interior common space with no seating or unsatisfactory condition 3) Average - one exterior or interior common space with seating needing updates 4) Good - 2 exterior or interior common spaces with appropriate seating/good condition 5) Very good - multiple exterior and interior commons spaces with appropriate seating in excellent condition N/A) Does not apply.								See image 9

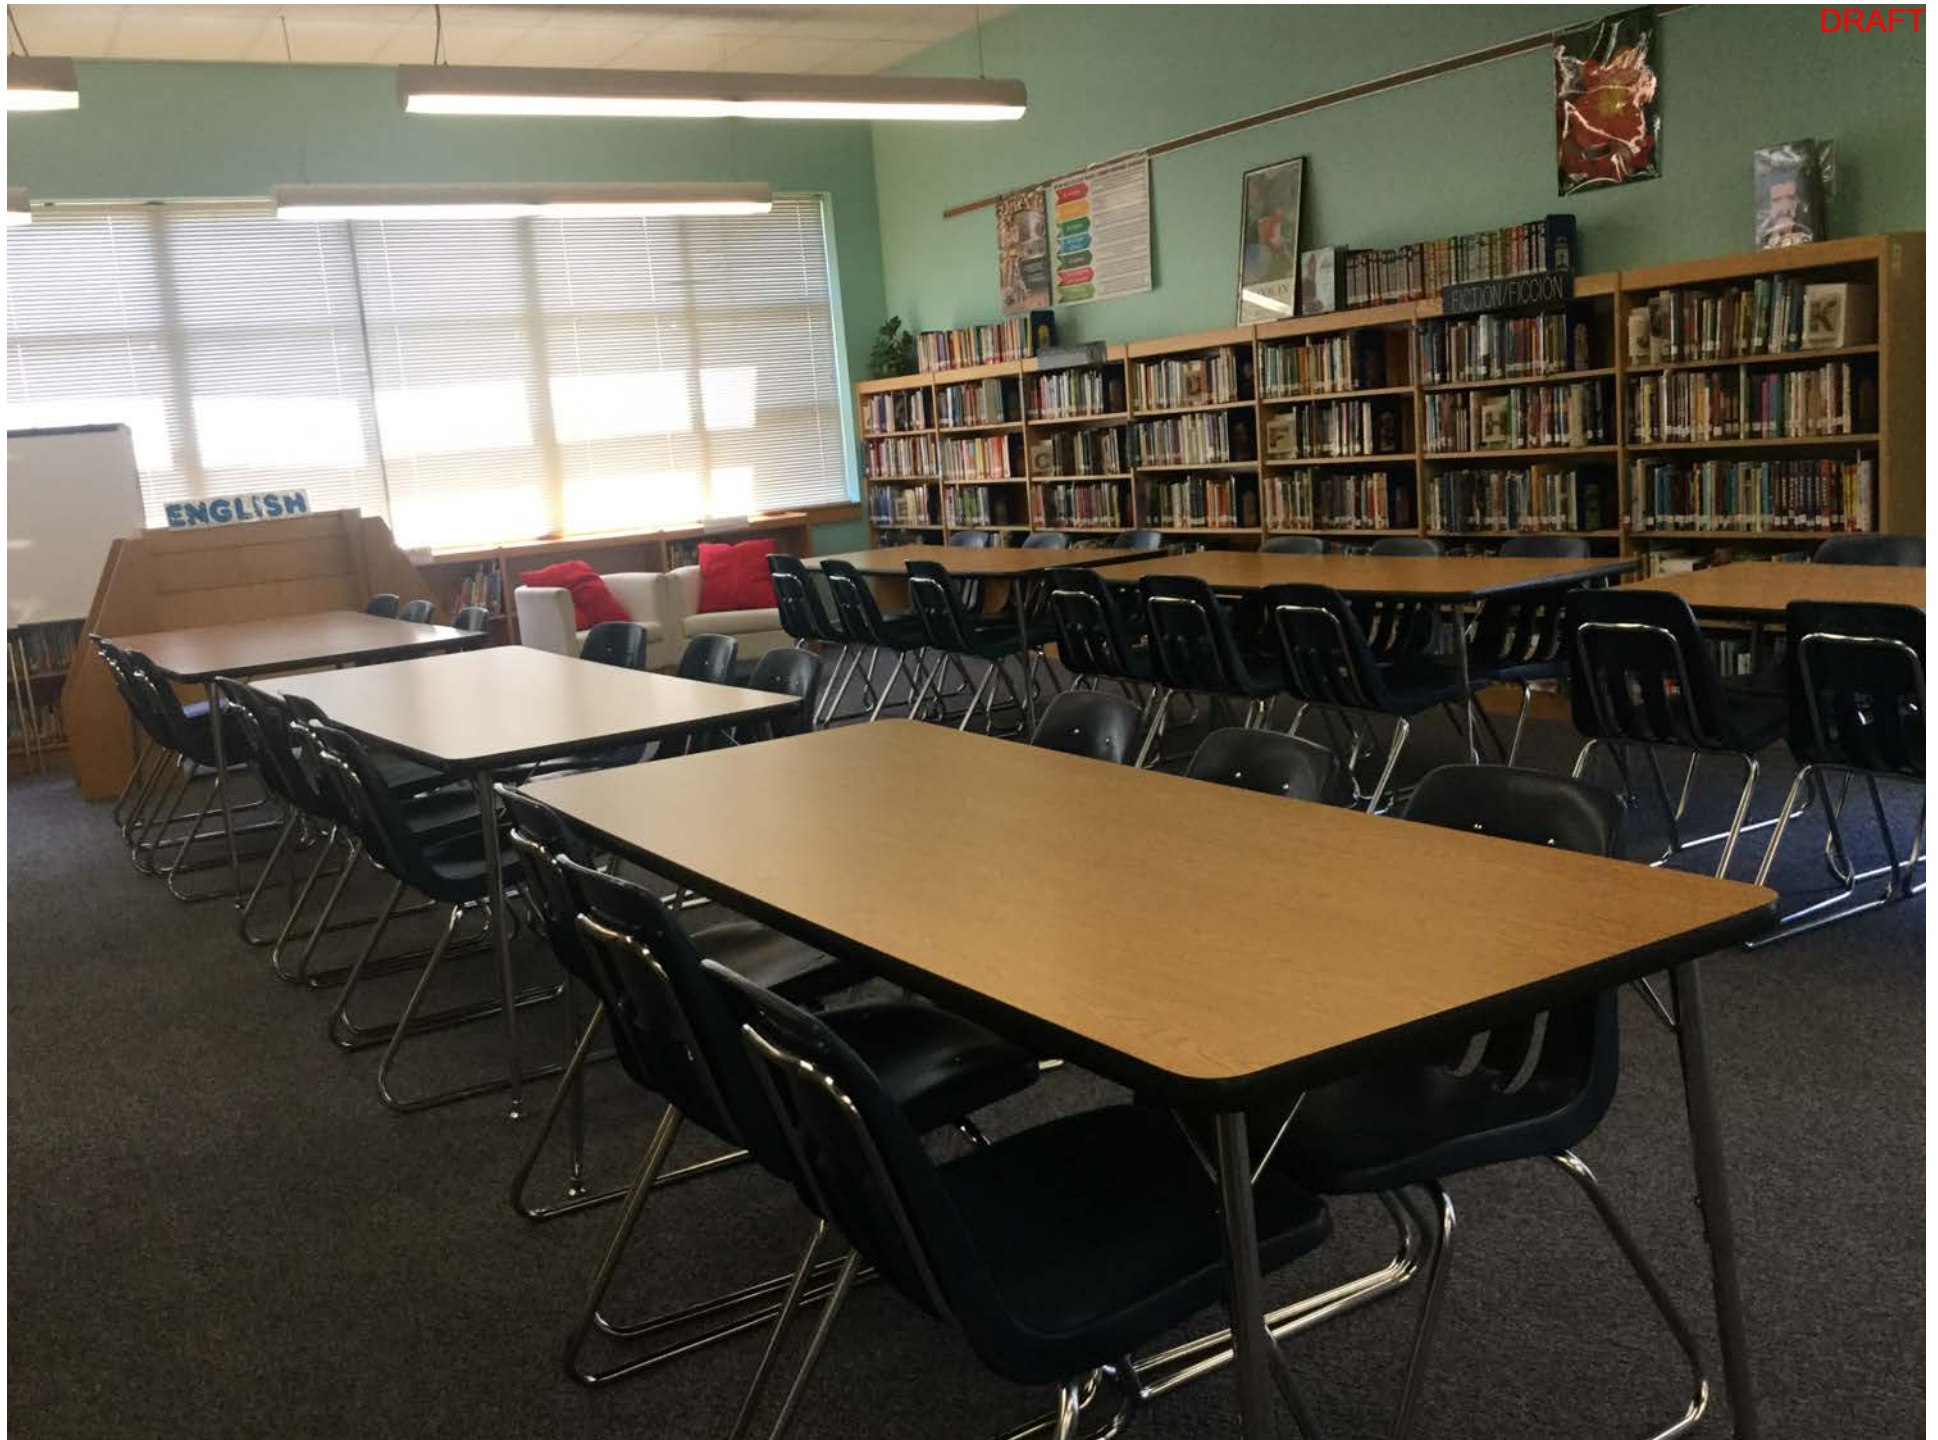
Photo 10. Library

5.4	How well does the Library/Media Center support collaborative work in small groups (4-8 students)?					5		Comments	1.005.00
1) Very unsatisfactory 2) Unsatisfactory 3) Average 4) Good 5) Very good N/A) Does not apply.								The library has a good furniture configuration for large or small groups.	
								See image 10
