Educational Suitability Summary Report

Houston Elementary School

Date: 07/11/2016

Score 44% Unsatisfactory

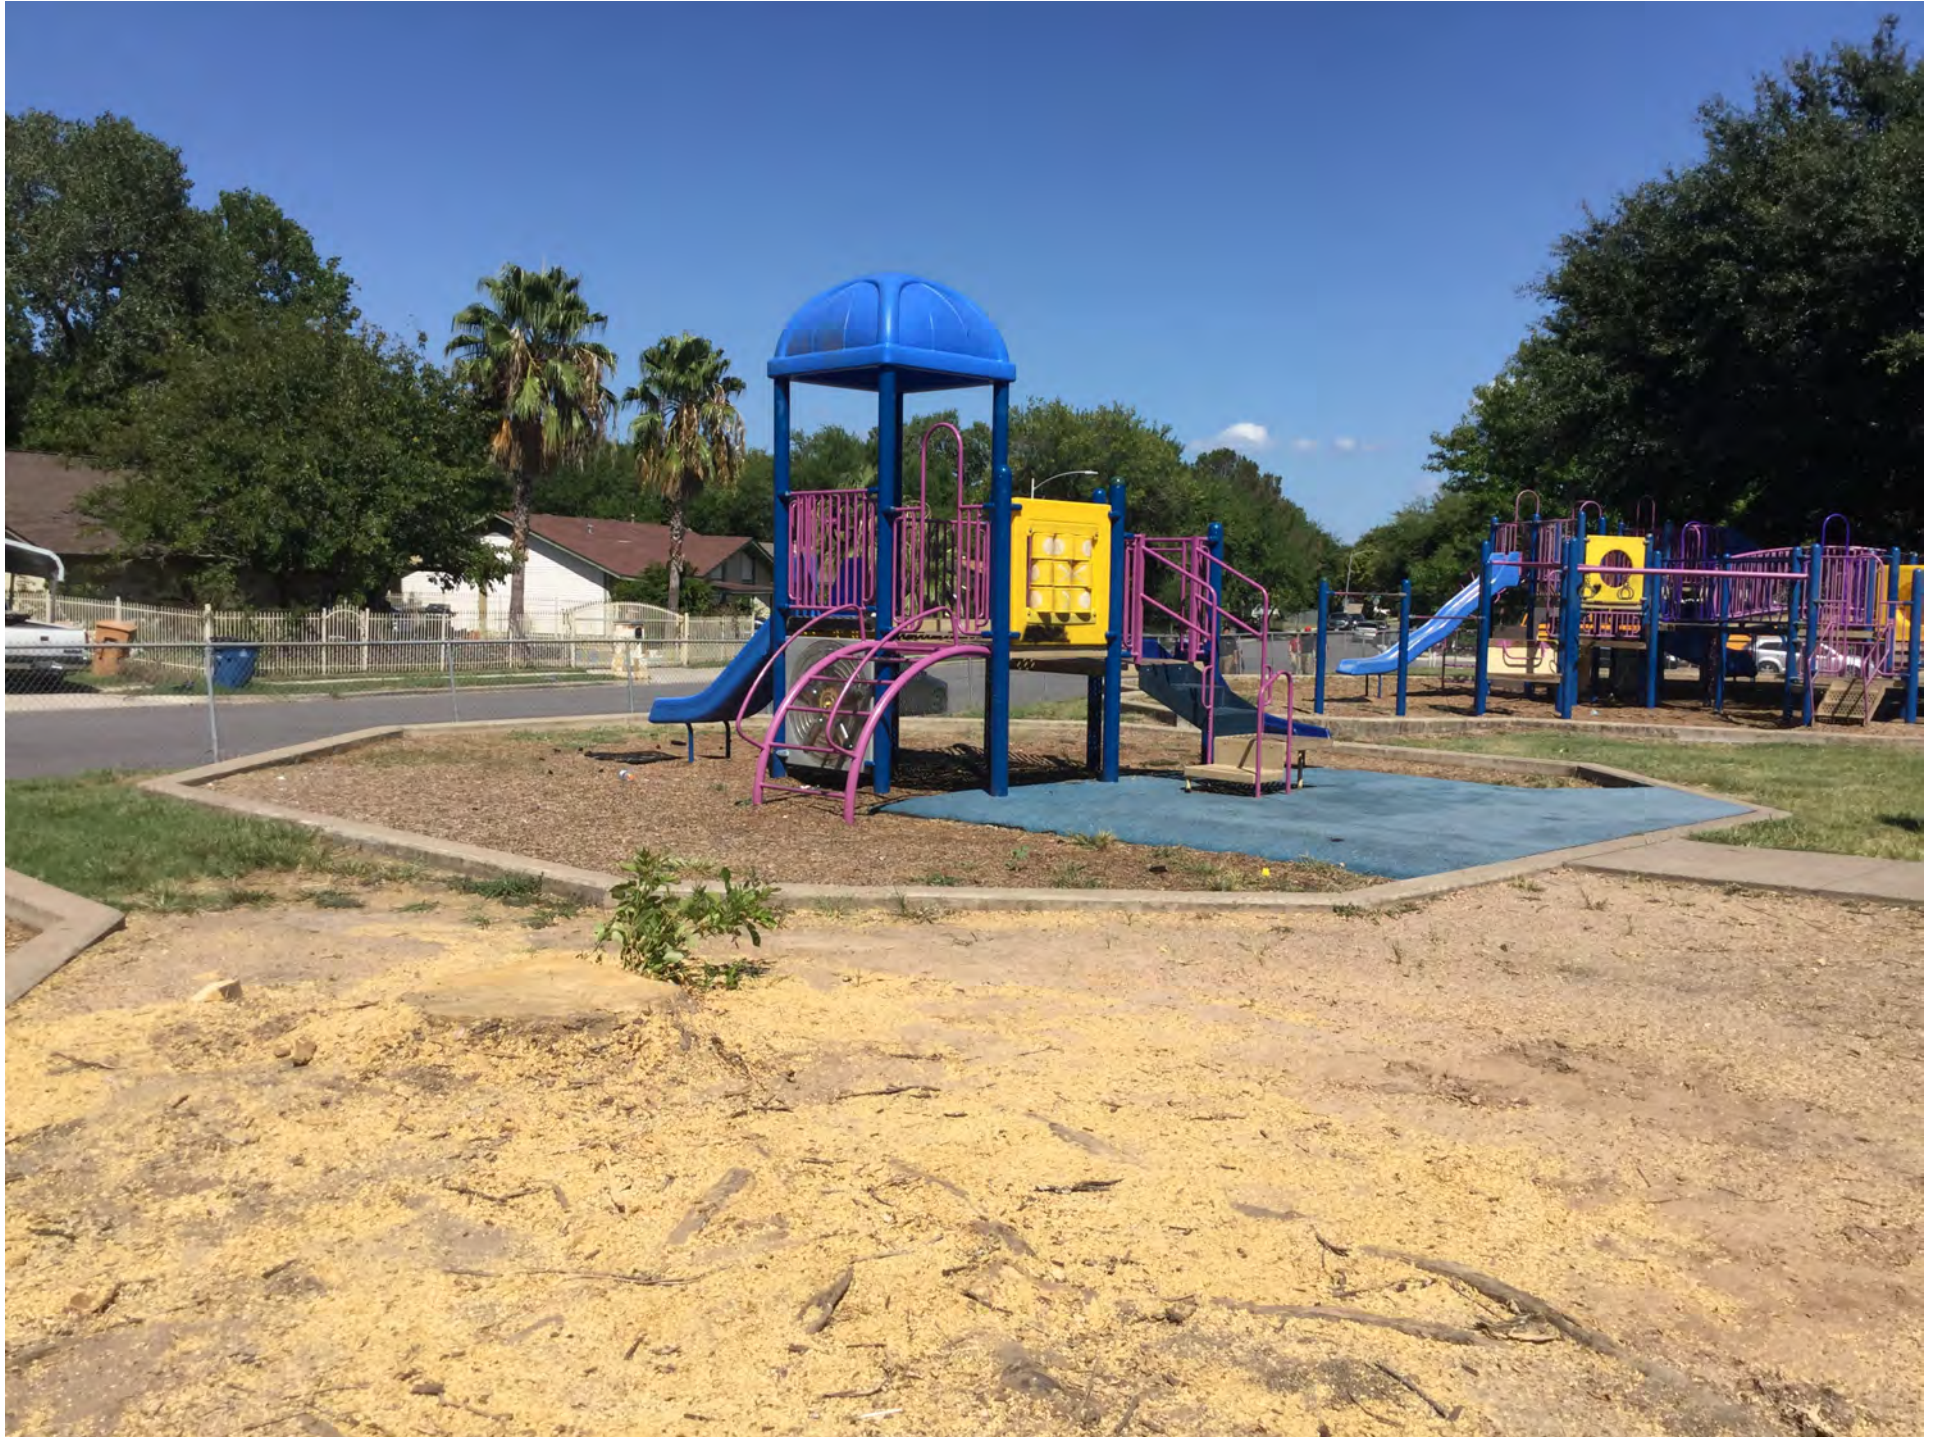
Photo 1.3 Playground

1.3	Are outdoor play spaces and playfields adequate in size and configuration?		2					Comments	1.00 2.00
	1) Outdoor play space exists, not developed 2) Outdoor play space exists but is not connected to gym or other athletic support areas or is too small. 3. Outdoor play spaces exist, are connected to other athletic areas, are the right size, but are not in good condition. 4. Outdoor play spaces need minor improvements to function well. 5. Outdoor play spaces are in excellent condition. N/A) Does not apply.							There is a covered basketball court and a dirt track space. The playgrounds need updates. The equipment shows wear and with the recent loss of a nearby tree, they need additional shade.	
									See Image 1

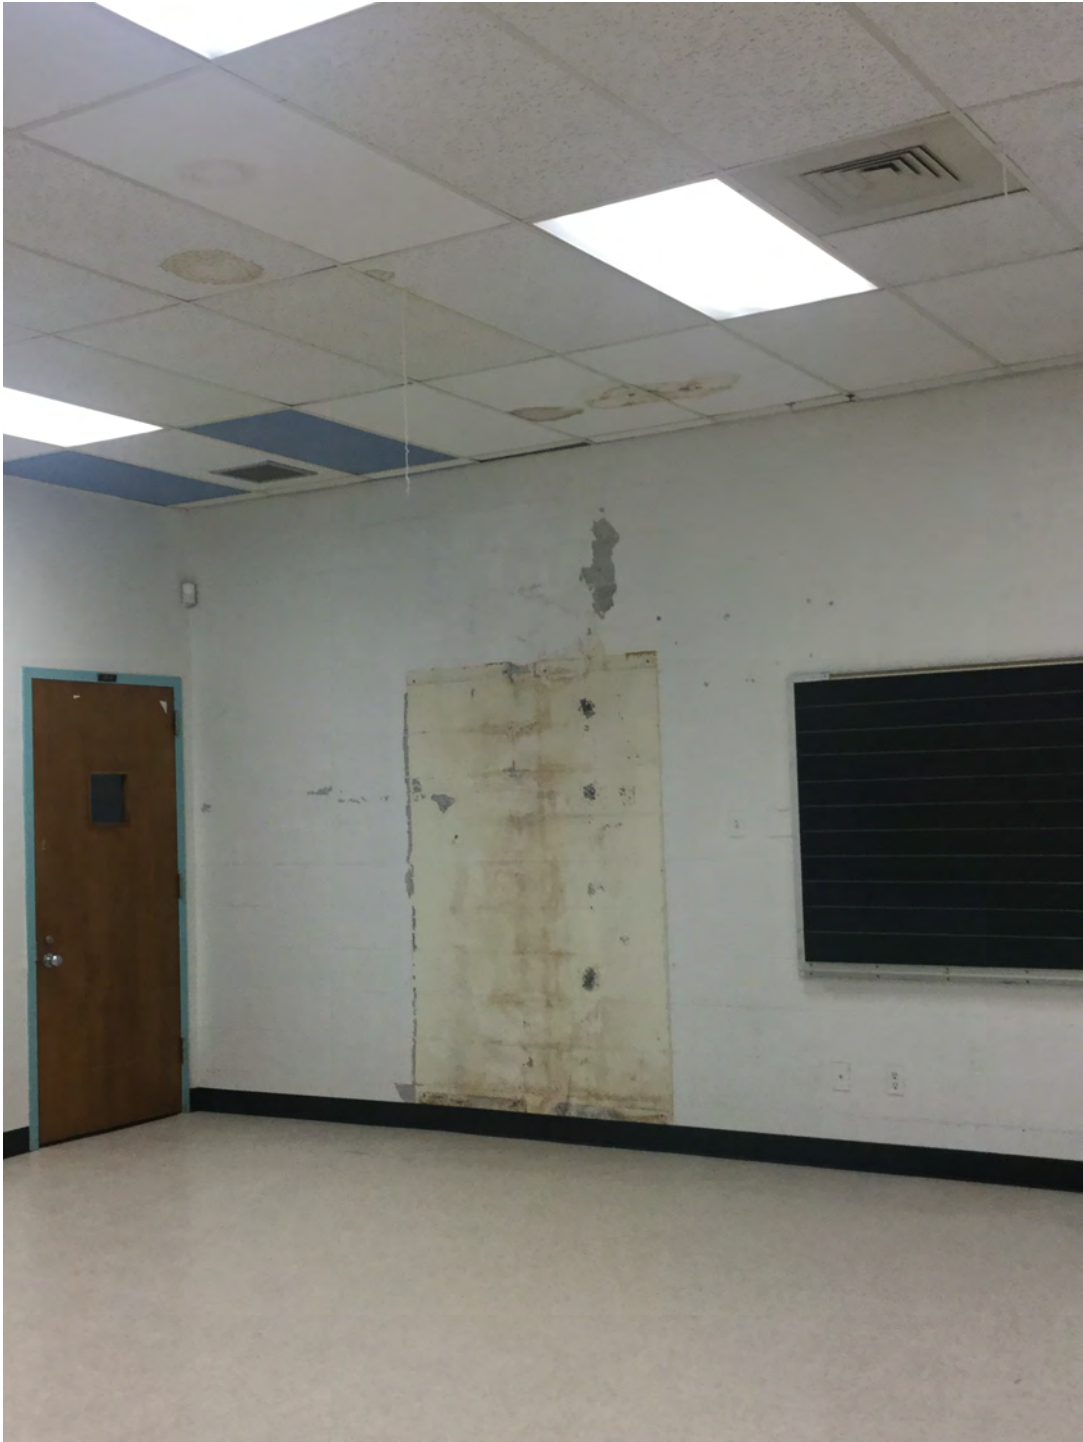
2.3	Does the general appearance of the school evoke pride for the students and community?	1						Comments	0.25	0.25
1) General appearance is poor. 2) General appearance is aged but ok. 3) General appearance is good. 4) General appearance shows pride in campus and student works. 5) General appearance shows pride in campus and student works and is welcoming to the community. N/A) Does not apply.							There is visible water damage throughout. There are large holes in the ceiling tiles and visible damage to walls. It is not uniformly painted.			
See Image 2

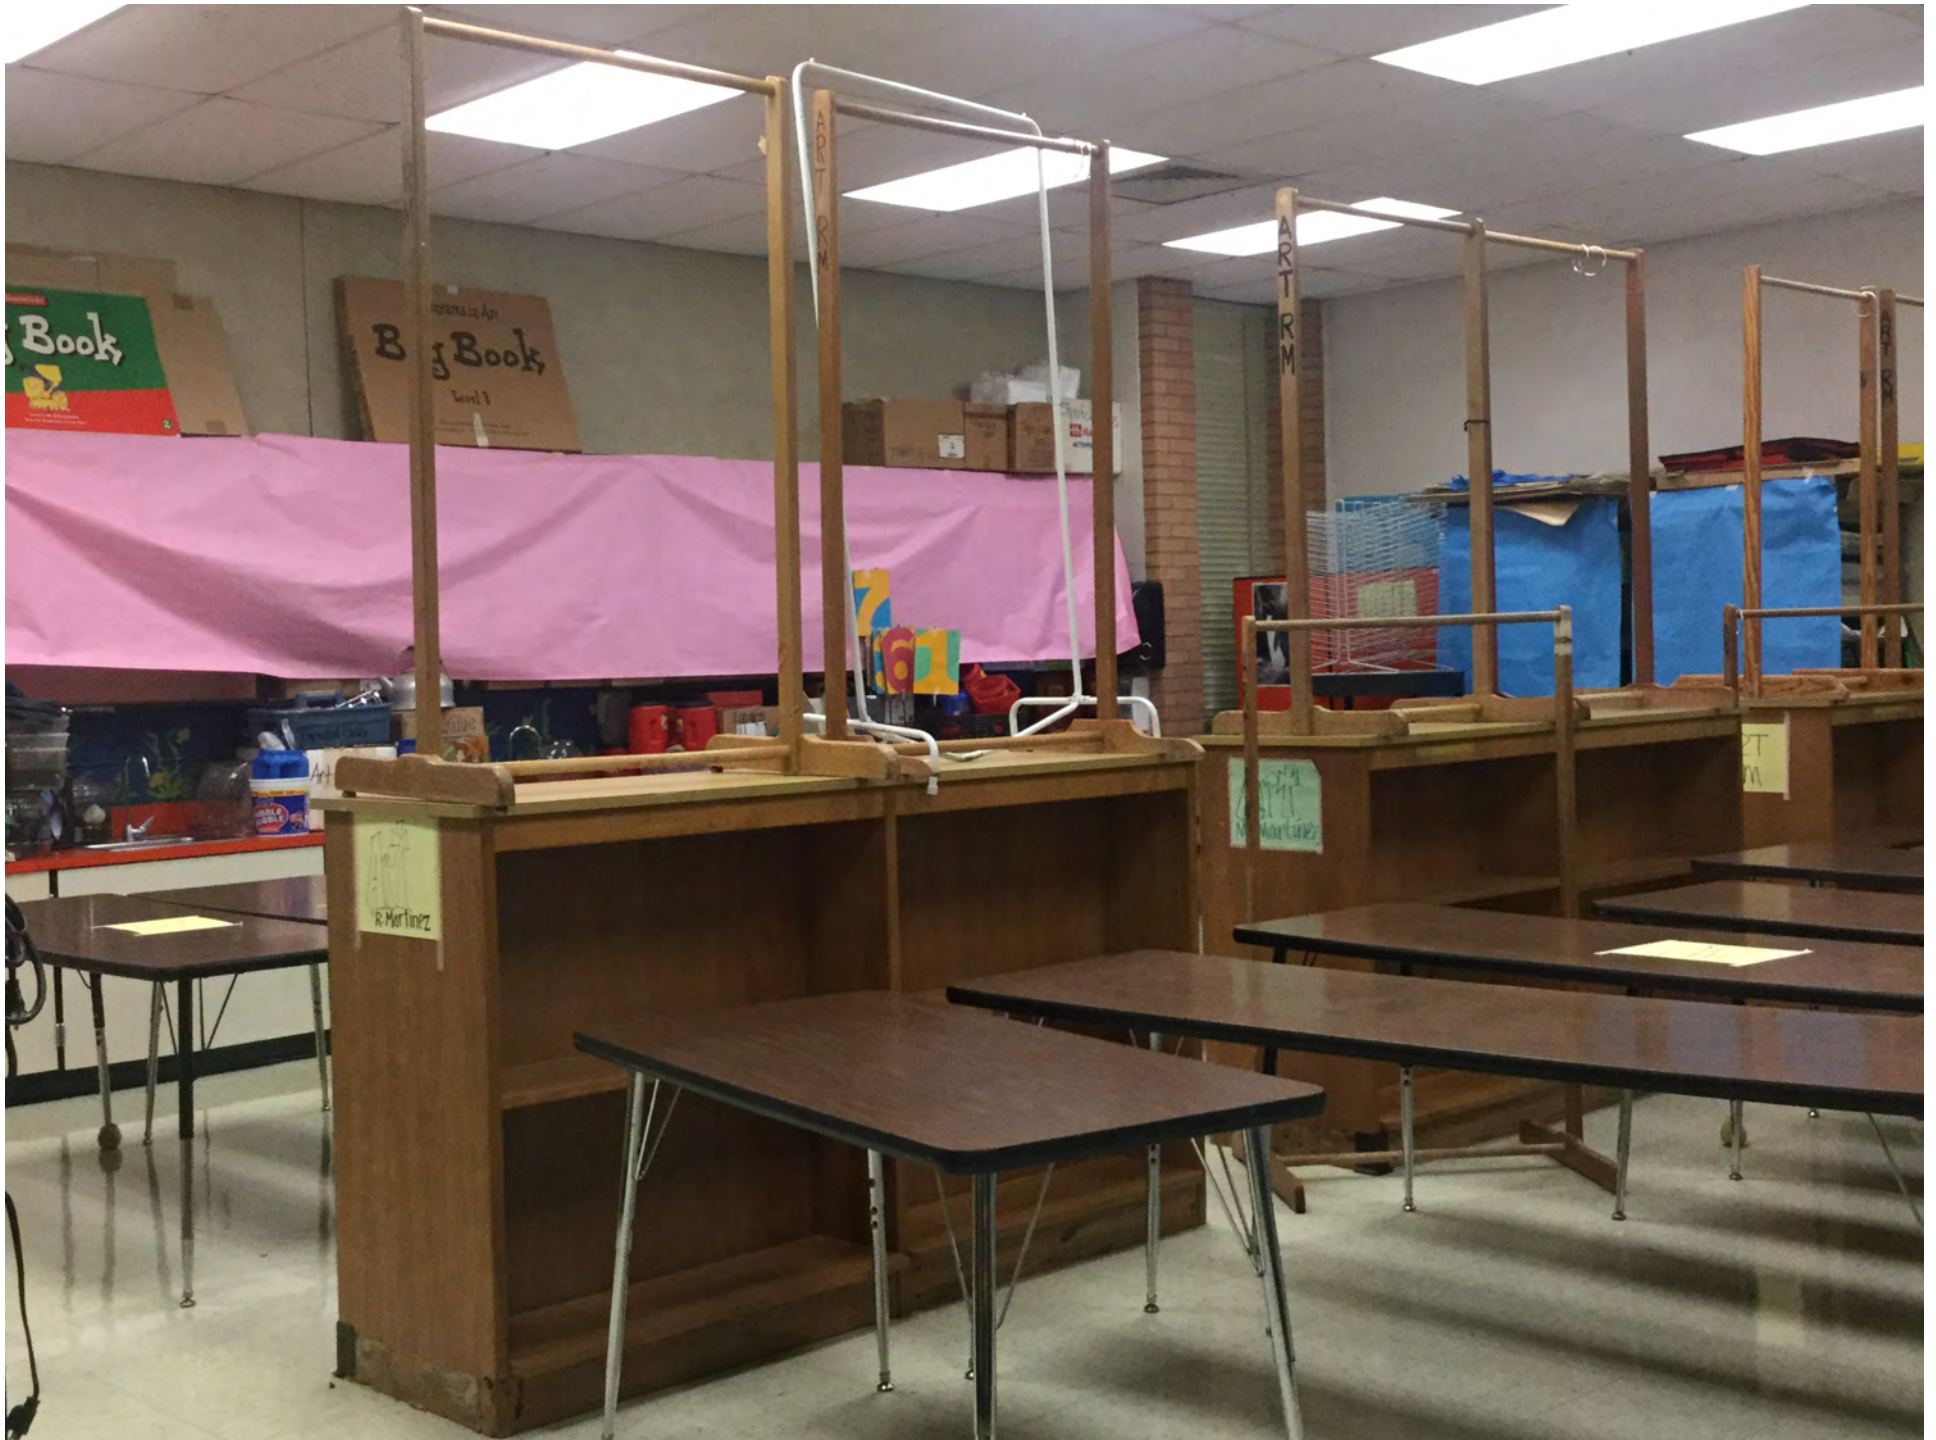
1) Very unsatisfactory 2) Unsatisfactory 3) Average 4) Good 5) Very good N/A) Does not apply.								The visual arts area is too crowded to function well. There is little natural light, although artificial light is bright. The limited artificial lighting control is unsatisfactory. The furniture is not appropriate per the ed spec.				See Image 3

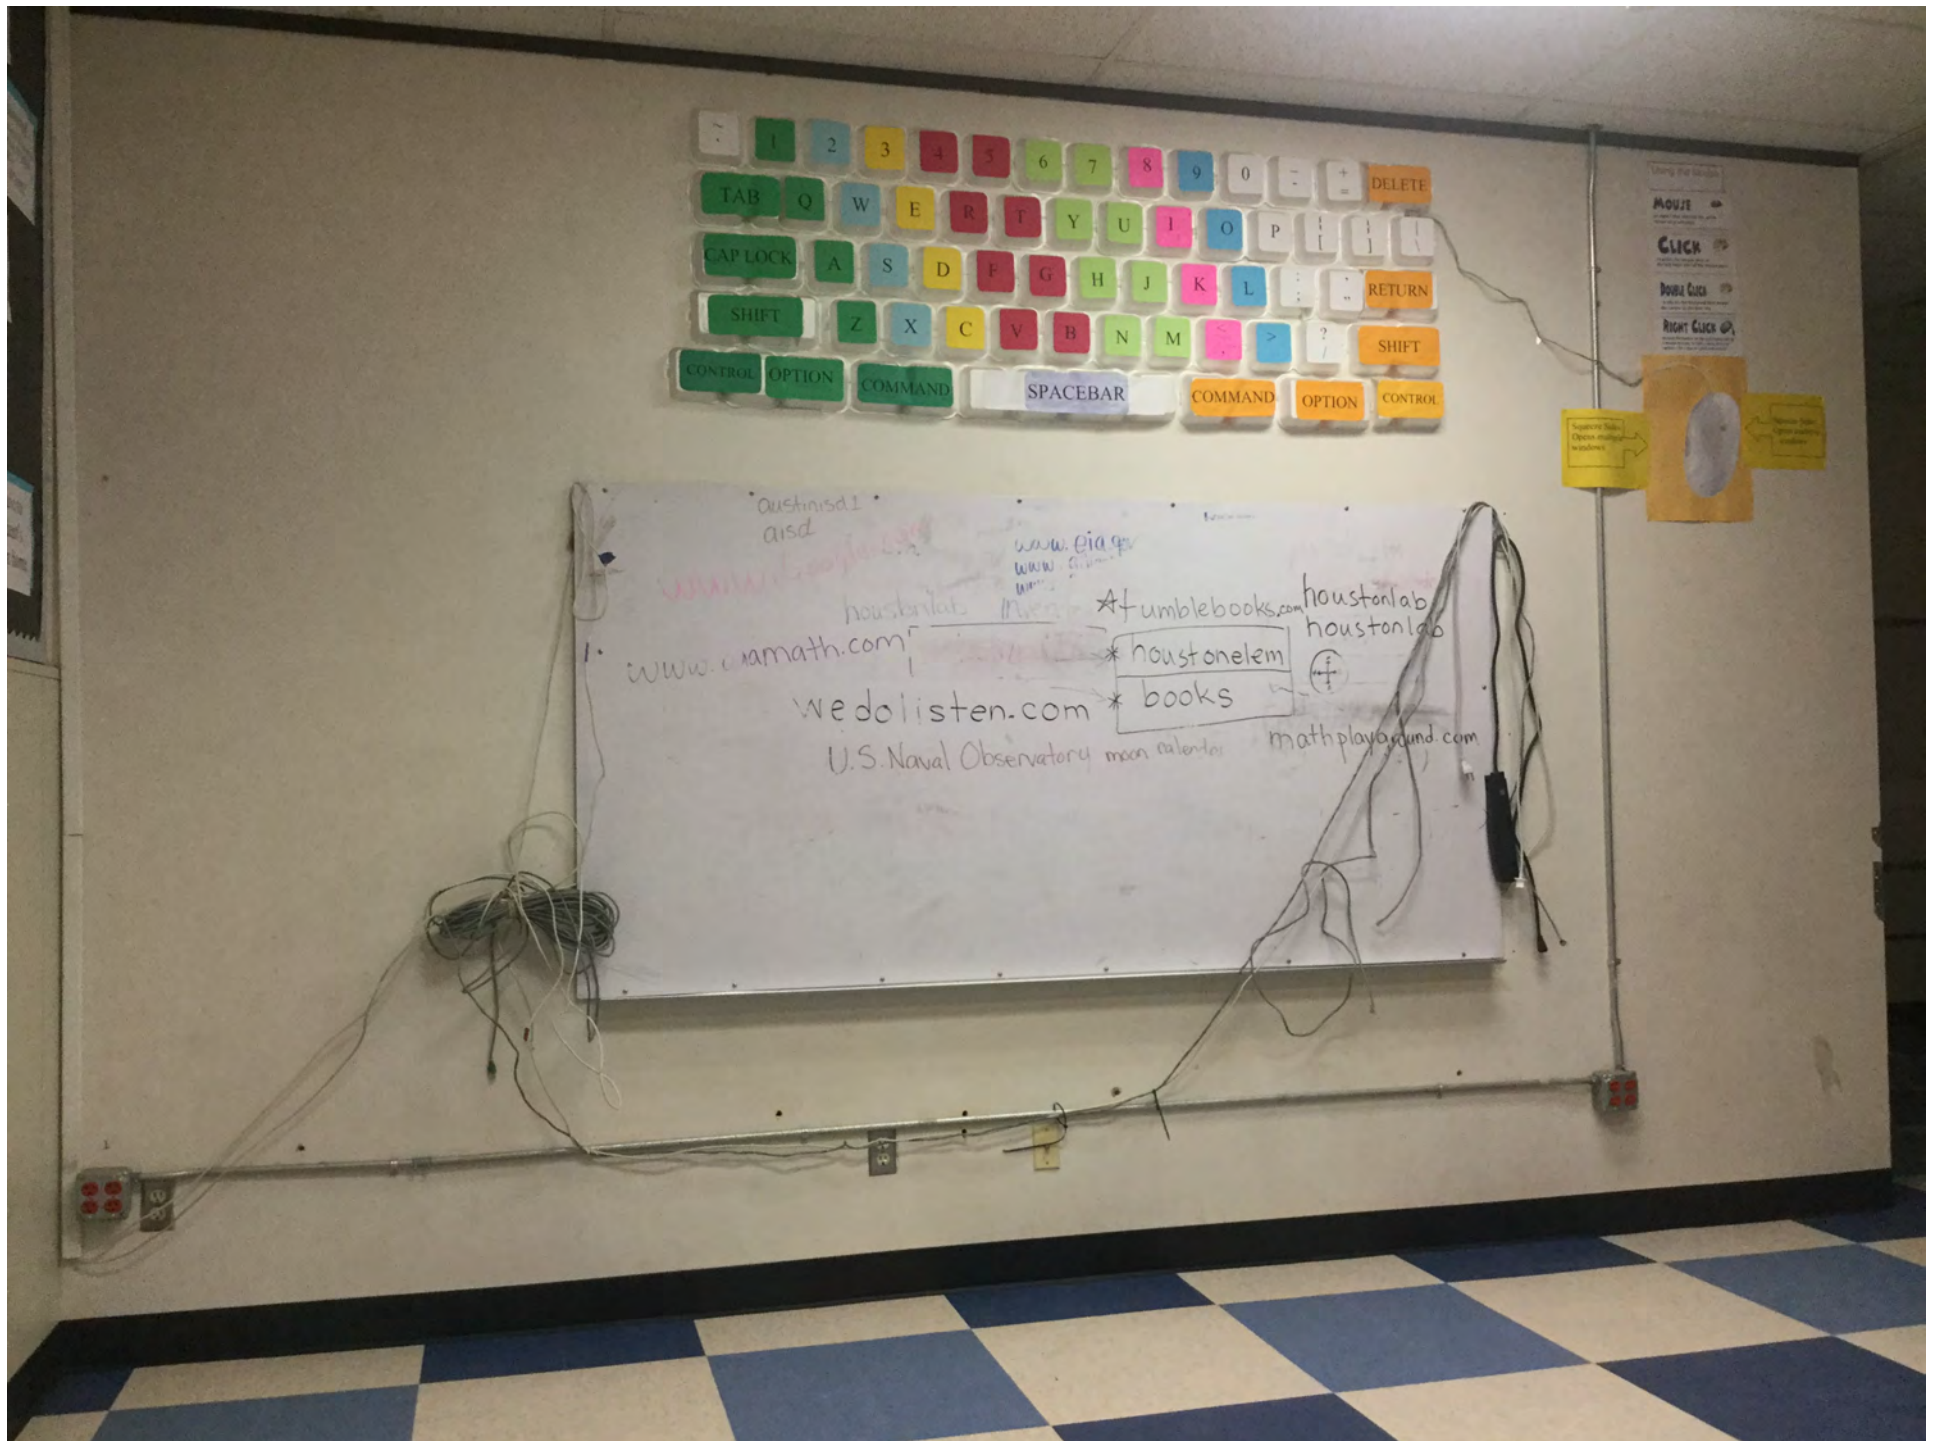
3.12	Are computer lab spaces appropriately configured?	1						Comments		1.00	1.00				
1) Very unsatisfactory 2) Unsatisfactory 3) Average 4) Good 5) Very good N/A) Does not apply.								The computer labs have a strange L-shaped configuration, are undersized, and inadequate.				See Image 4

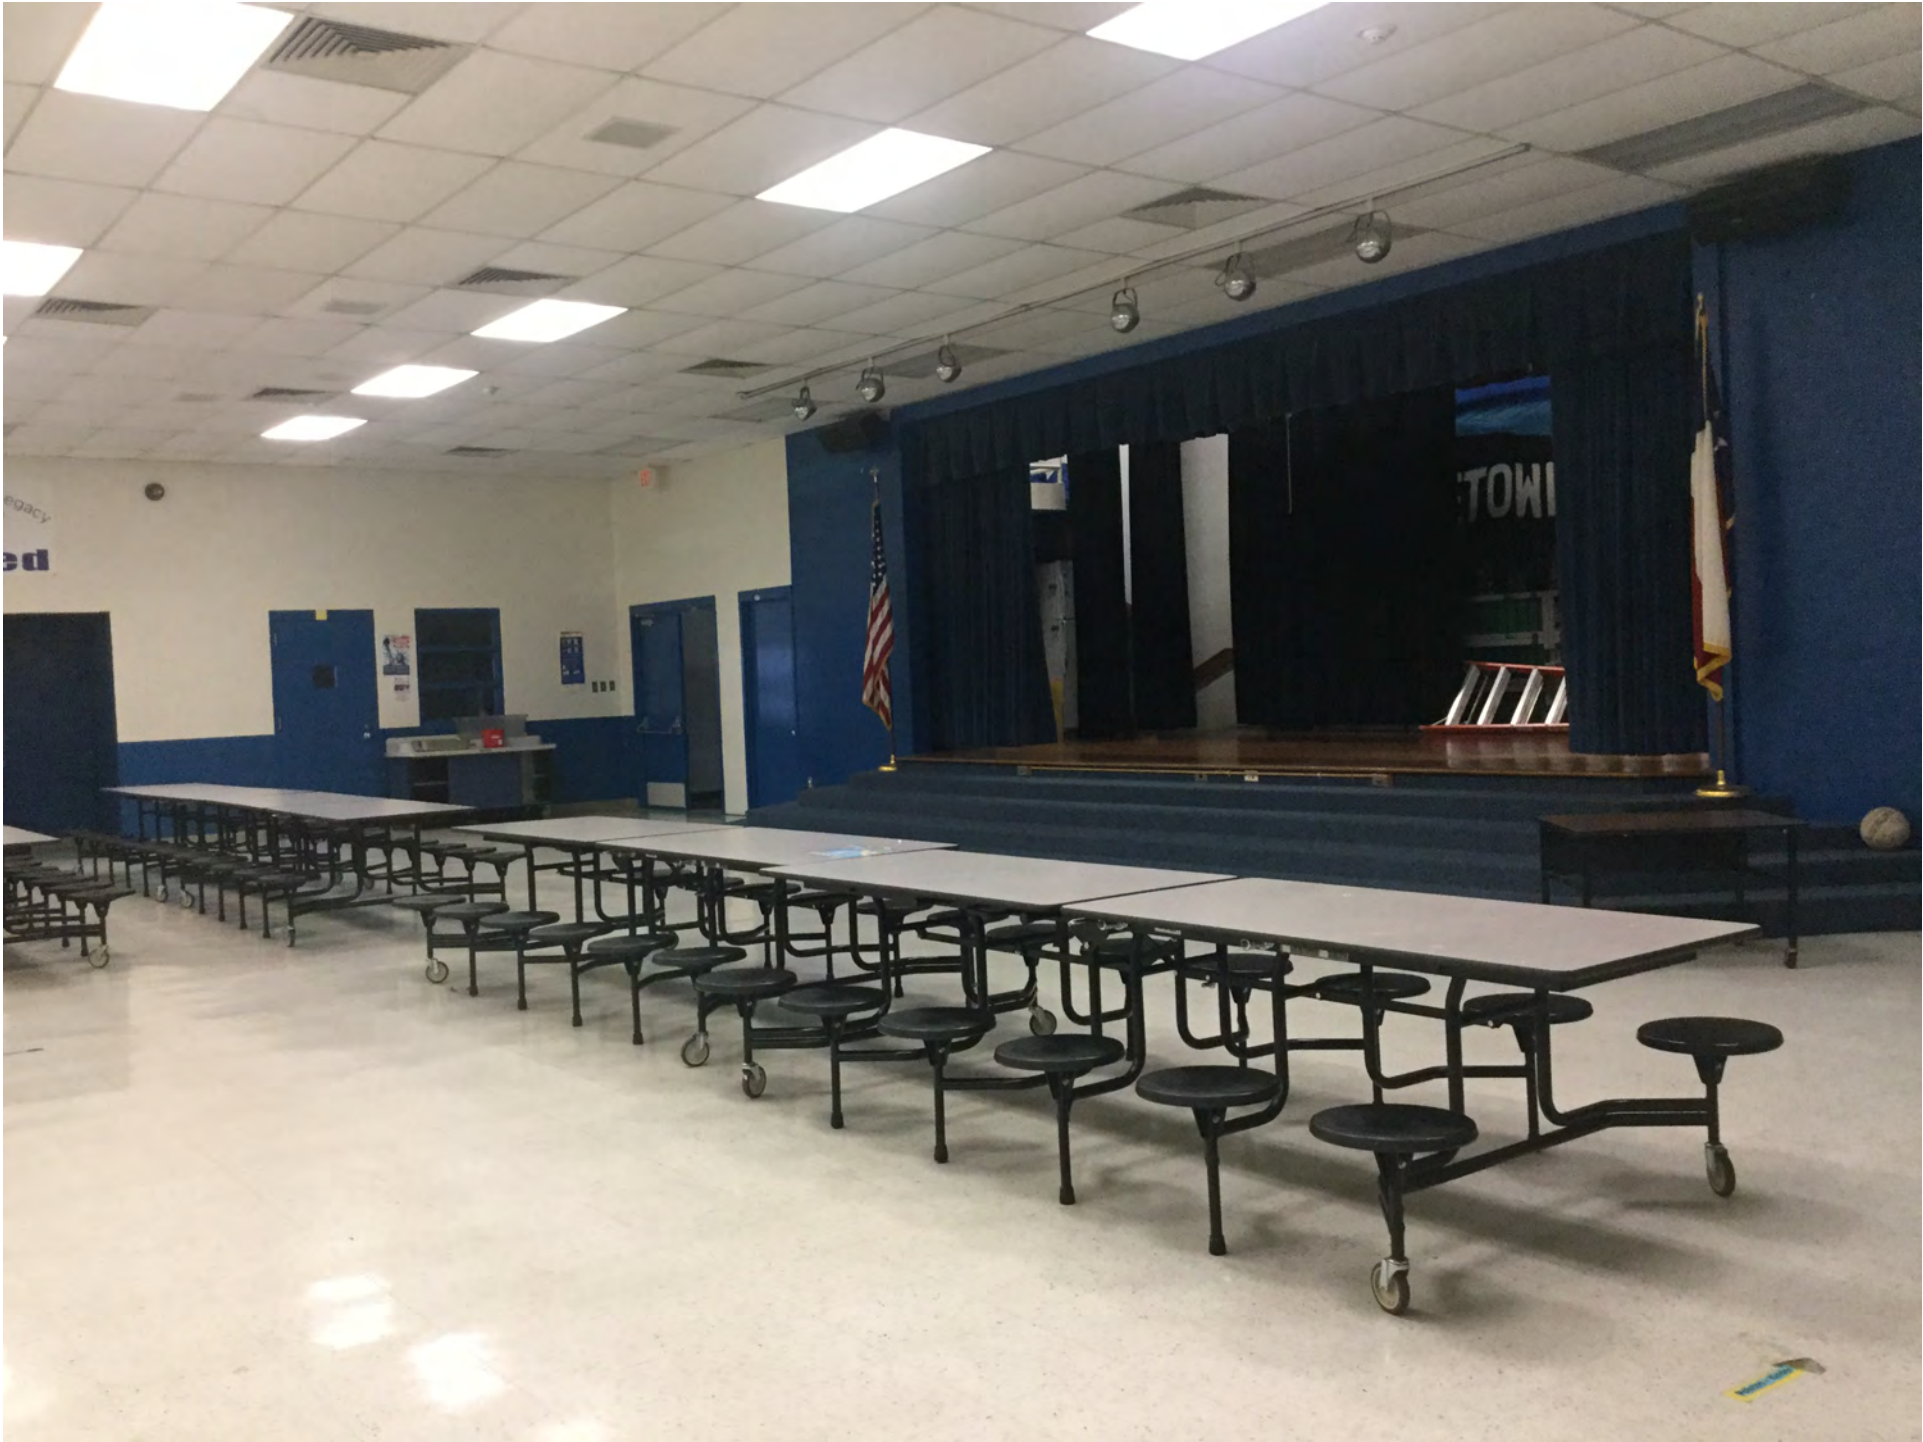
3.16 Cafetorium

3.16	Are the student dining facilities appropriately configured?			3				Comments	1.00 3.00
1) Very unsatisfactory - Too small, poor circulation, inflexible seating in poor condition 2) Unsatisfactory - Too small or inadequate circulation, seating in poor condition 3) Average - moderate size, with adequate circulation, seating in okay condition 4) Good - good size, adequate circulation, seating in good condition 5) Very good - good size, adequate circulation, seating in good condition, with more than one option for eating space (ex: connection to outdoor eating space) N/A) Does not apply.							<div>See Image 5</div>

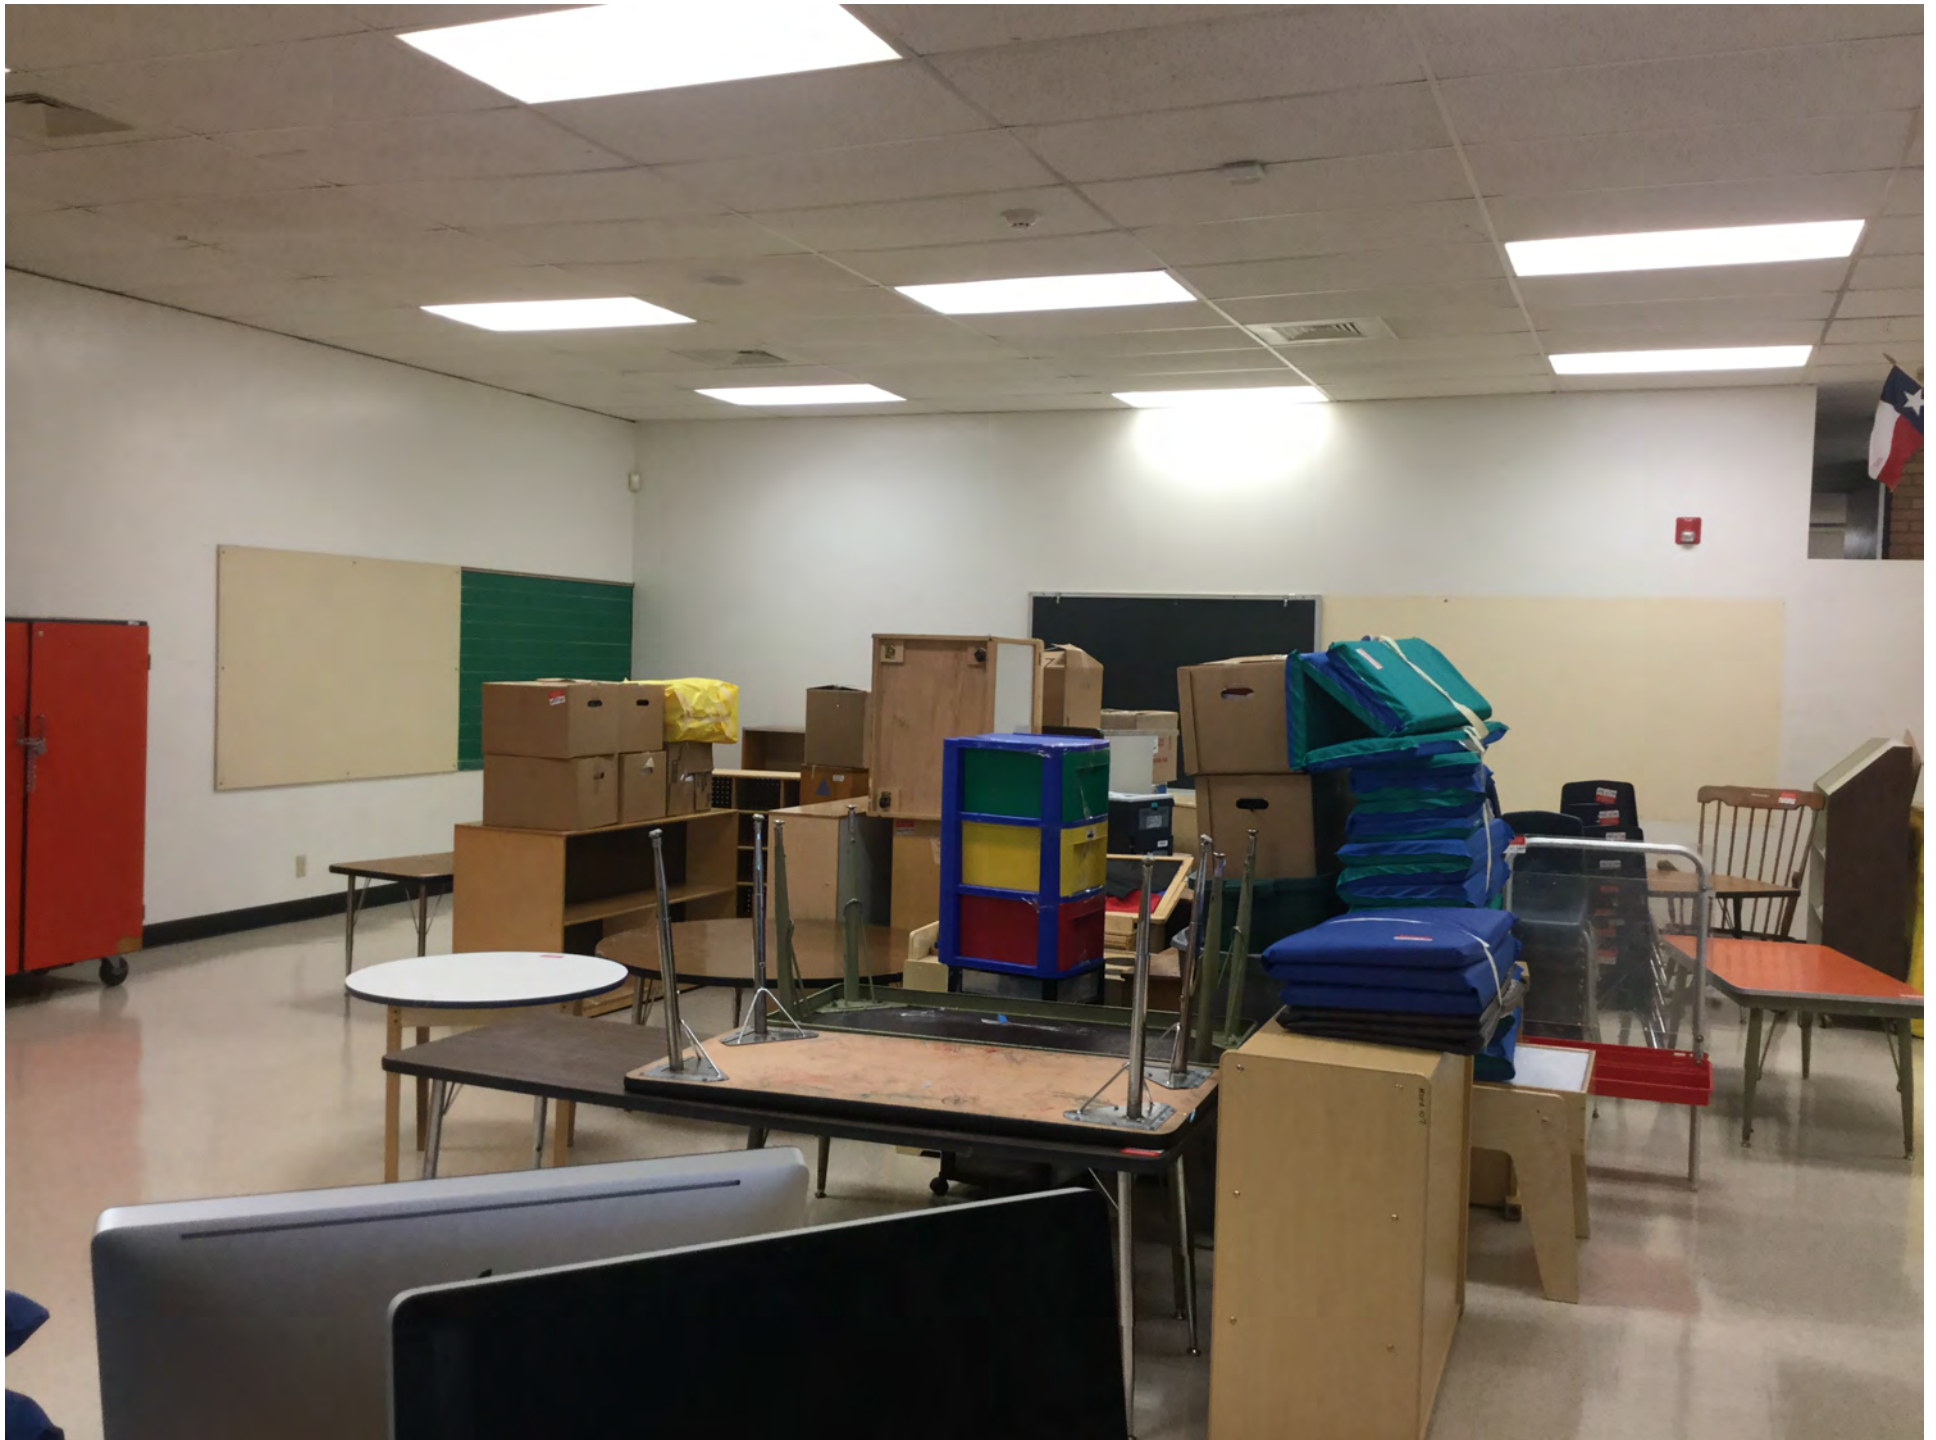
4.10 Visual Communication Tools

4.10	Does the building have adequate visual communication tools?	1						Comments	1.001.00
1) Very unsatisfactory - No vis comm tools 2) Unsatisfactory - outdated, poorly functioning, or insufficient 3) Good - mix of old and new whiteboards/projectors/etc. 4) Good - projectors, marker boards, smart boards in most spaces - good condition 5) Very good - projectors, marker boards, smart boards in most spaces - new condition N/A) Does not apply.								There are very few visual communication tools. The spaces have one wall for a chalkboard. Very rarely observed a projector that is in outdated condition. Technology is very outdated and in poor condition. The newer portions of the campus have projection and innovation stations.	See Image 7

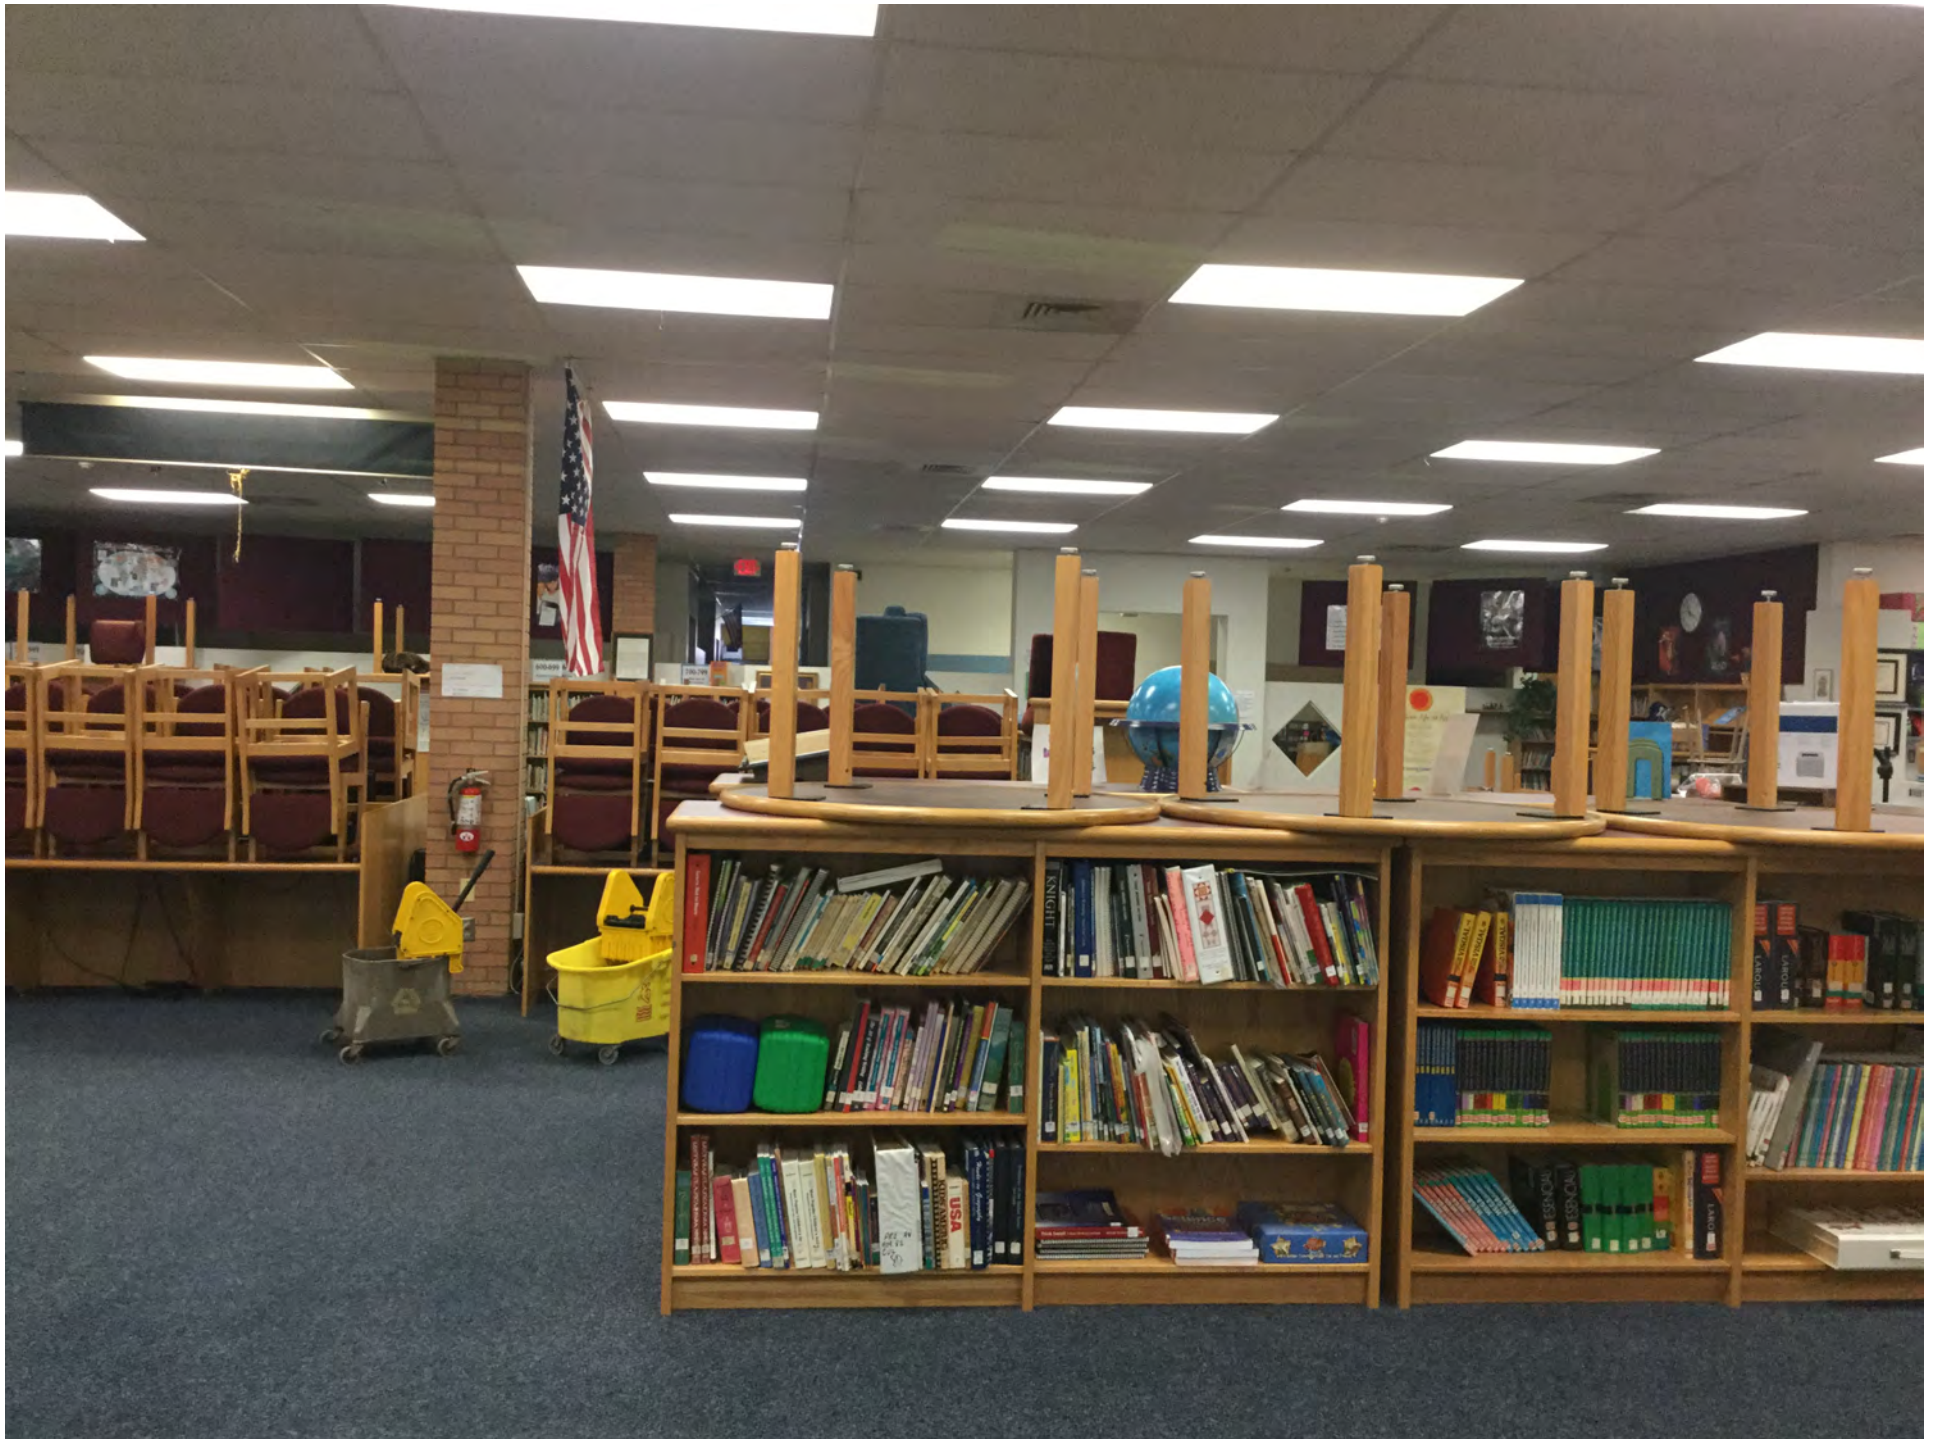
5.4 Library

5.4	How well does the Library/Media Center support collaborative work in small groups (4-8 students)?		2					Comments	1.002.00
1) Very unsatisfactory 2) Unsatisfactory 3) Average 4) Good 5) Very good N/A) Does not apply.								There are some limited small group areas.

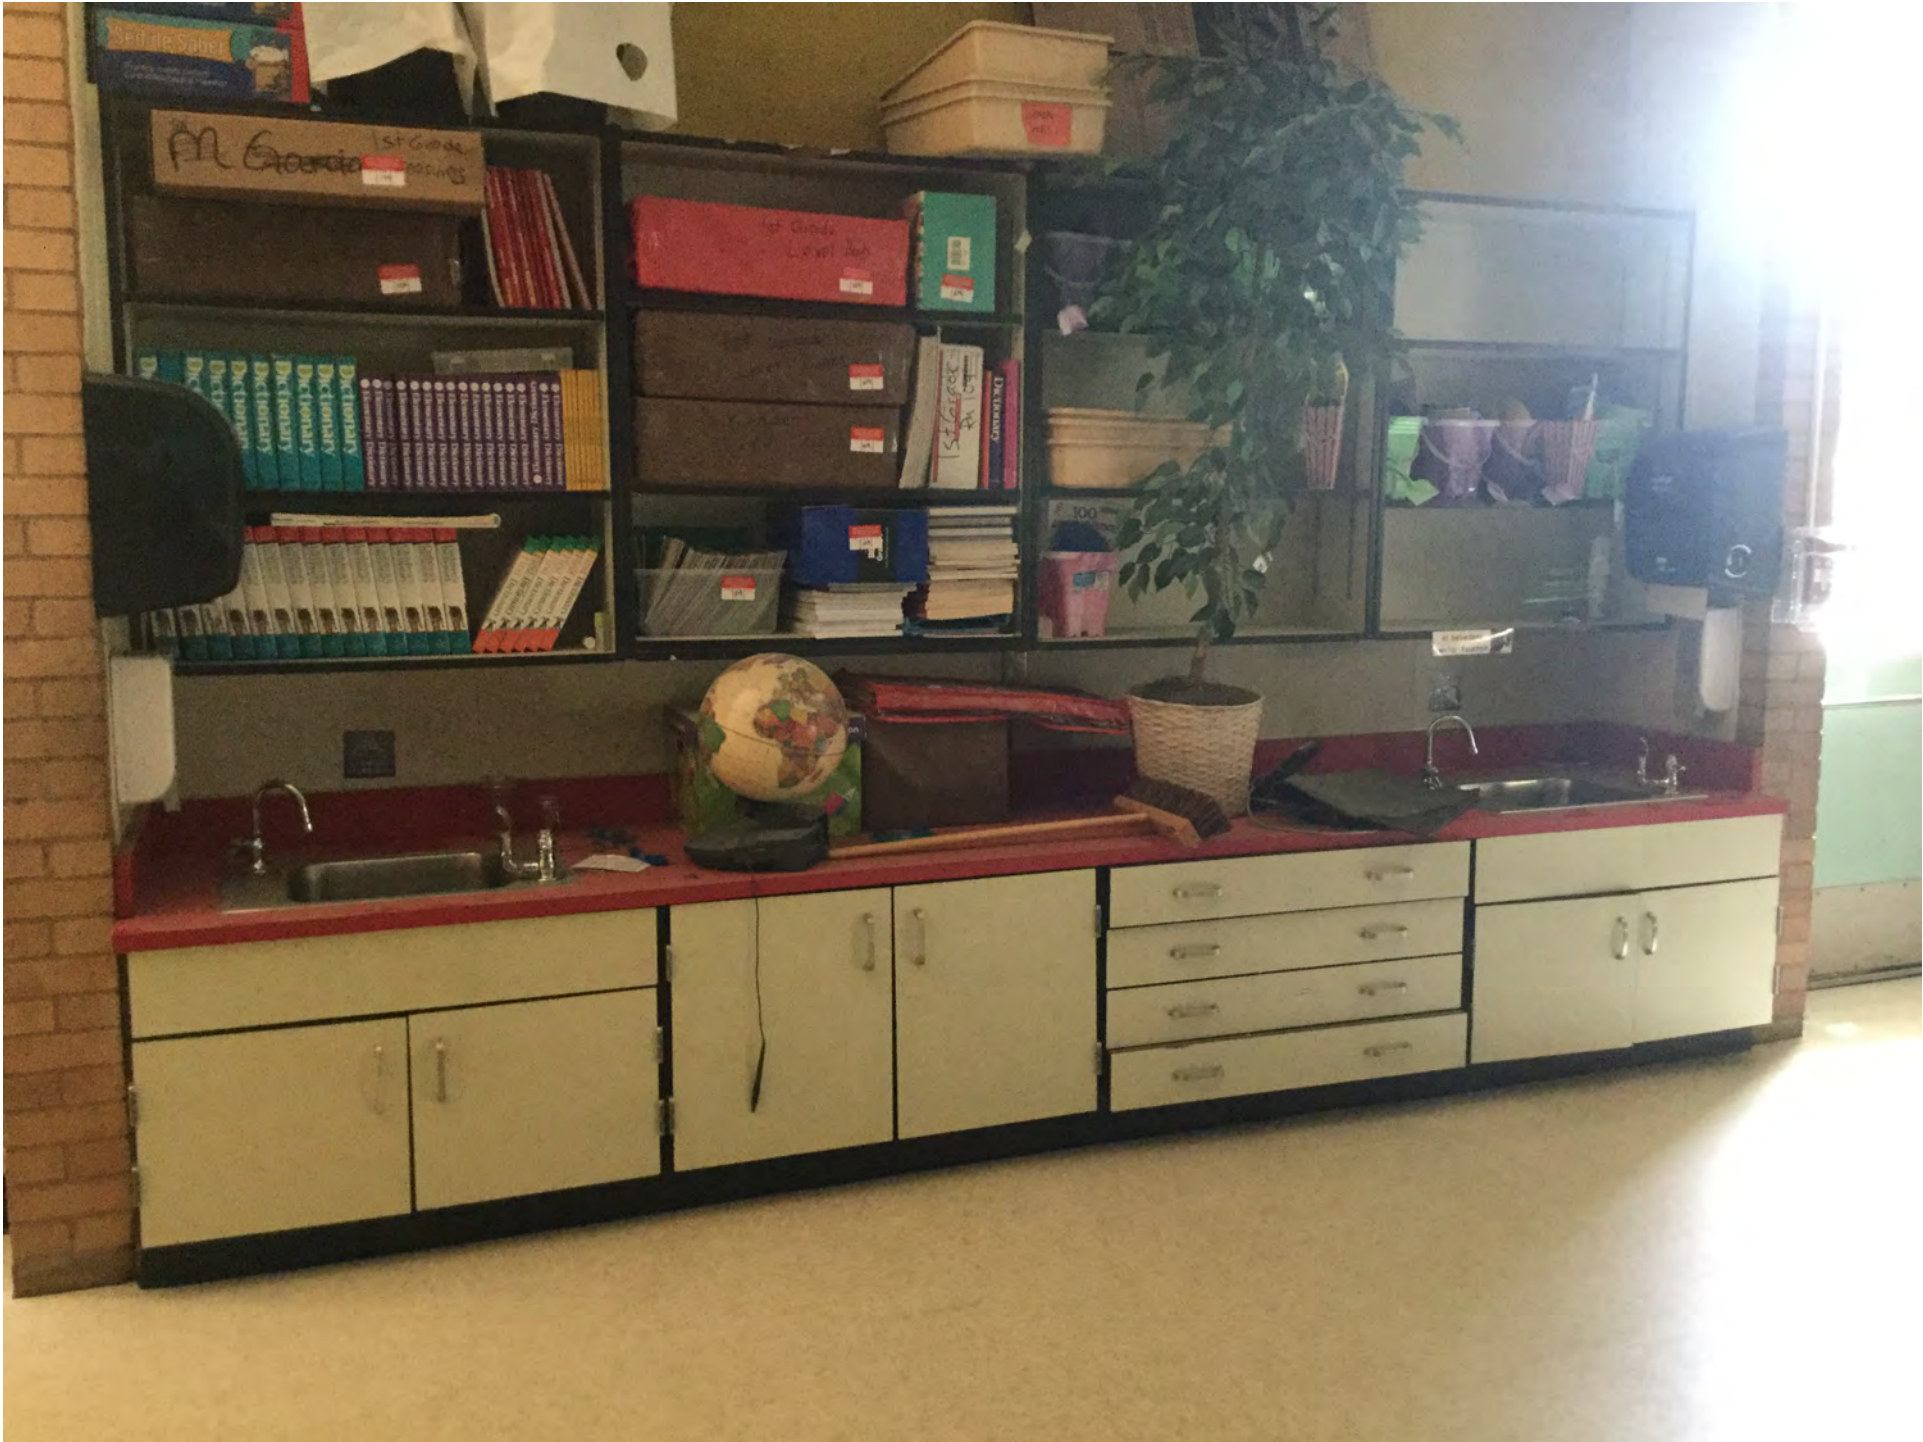
8.2 Storage

8 - Storage		1	2	3	4	5	N/A	6.00	
8.1	Is there adequate general storage in the building?		2					Comments	1.00 2.00
1) Very unsatisfactory 2) Unsatisfactory 3) Average 4) Good 5) Very good N/A) Does not apply.								There were very few storage areas observed.	
8.2	Is there adequate classroom storage?		2					Comments	1.00 2.00
1) Very unsatisfactory 2) Unsatisfactory 3) Average 4) Good 5) Very good N/A) Does not apply.								There is some casework only in the perimeter classroom spaces; it is shared between two classrooms and is in unsatisfactory condition. The newer classrooms have better storage capacity.	
								See Image 9	
8.3	Is there adequate student storage?		2					Comments	1.00 2.00
1) Very unsatisfactory 2) Unsatisfactory 3) Average 4) Good 5) Very good N/A) Does not apply.								The student storage is limited to wall hooks.
