Educational Suitability Summary Report

Jordan Elementary School – BLDG # 178

Date: 06/14/2016

Score 72% Good

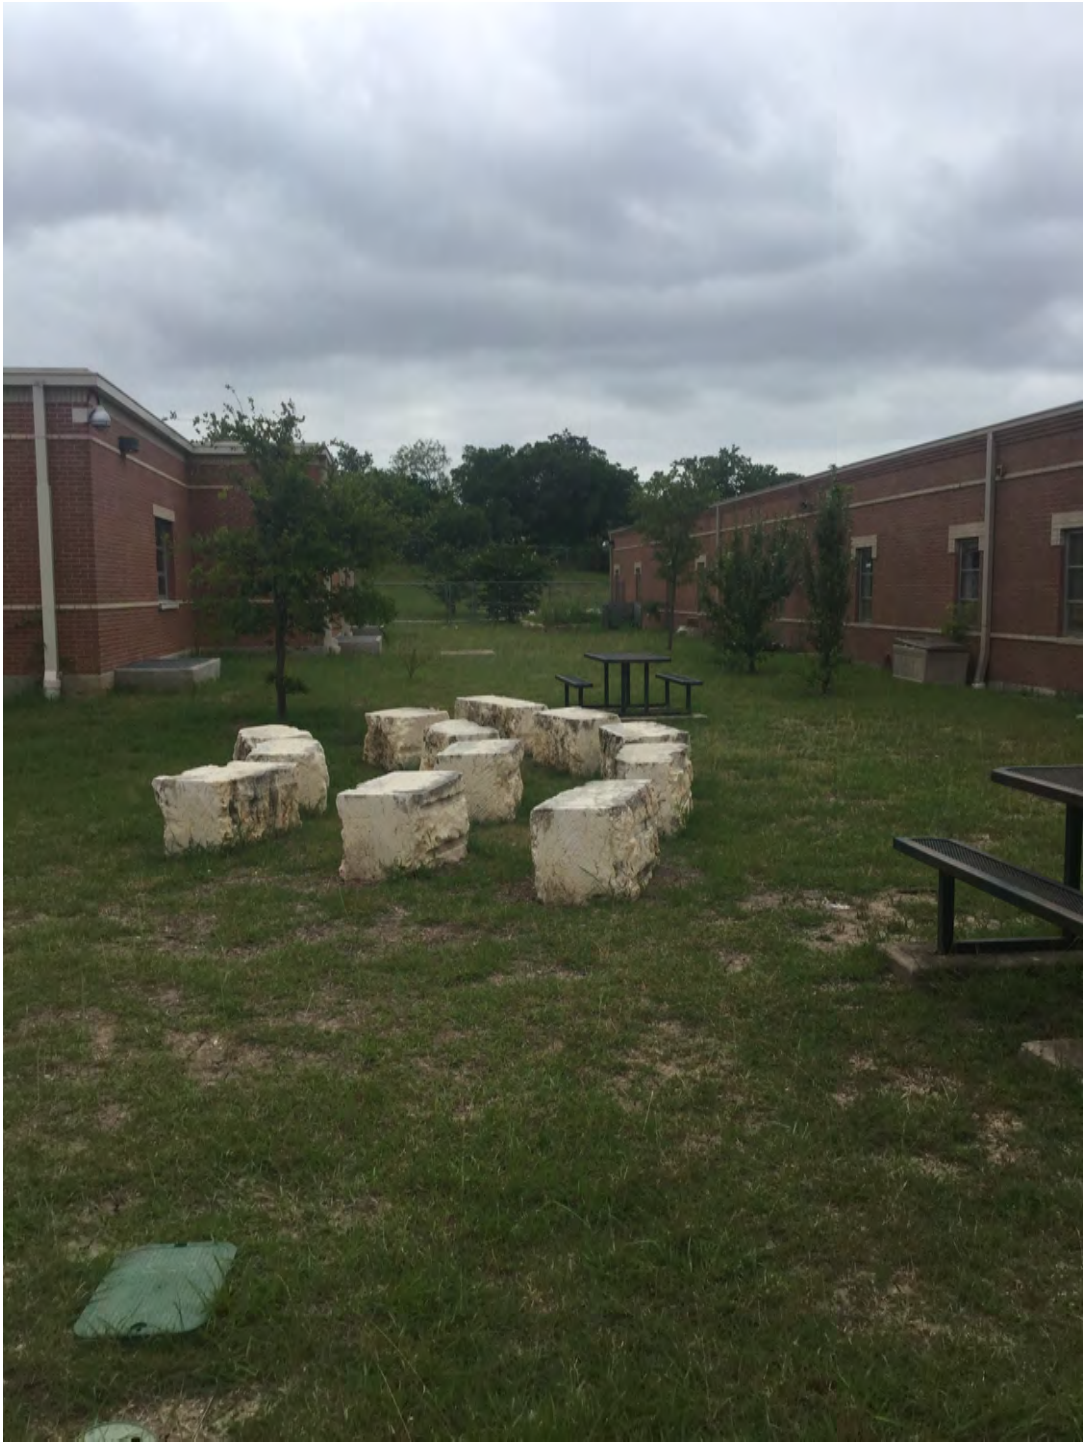
1.2 Garden Space

1.2	Are opportunities provided for outdoor learning (outdoor classrooms, gardens, etc.)?			3				Comments	1.00 3.00
	1) Outdoor space exists is not developed 2) Outdoor space for learning exists but not connected to classroom learning areas. 3. Outdoor learning spaces exist and are accessible but not in good condition. 4. Outdoor learning spaces need minor improvements to function well. 5. Outdoor learning spaces are in excellent condition. N/A) Does not apply.							There is a nice outdoor seating area, but it lacks shade. What is present is not used due to safety concerns or exposure to the elements. Overall, there is very little shade present across school grounds.

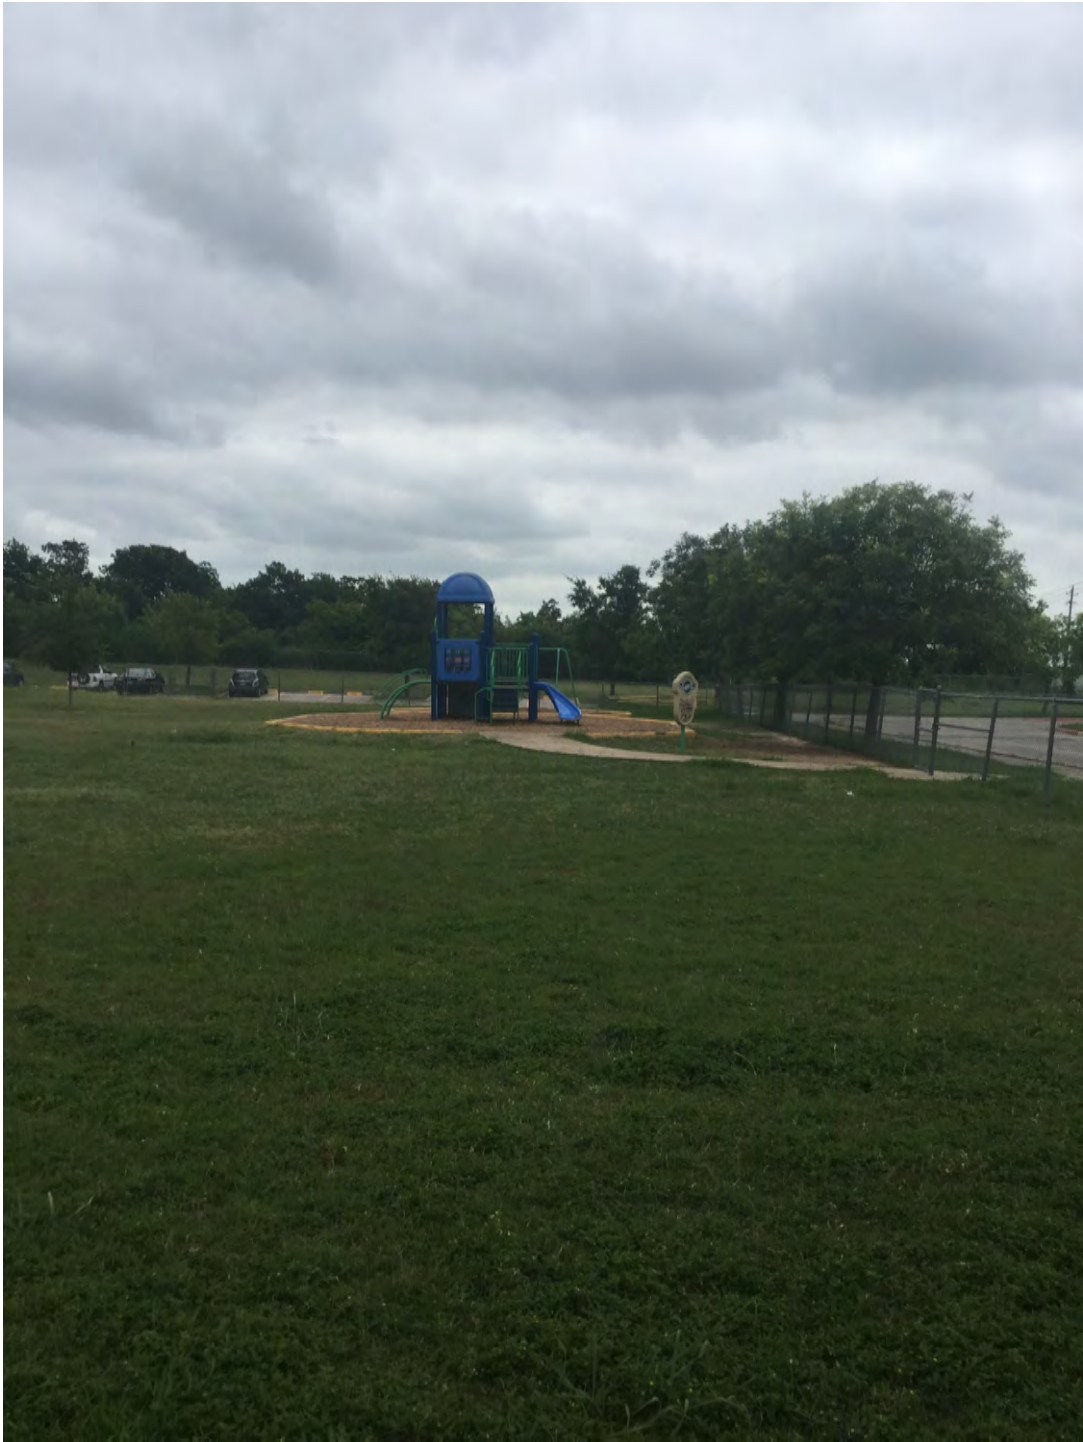
1.3 Play Set

1.3	Are outdoor play spaces and playfields adequate in size and configuration?					5		Comments	1.00 5.00
	1) Outdoor play space exists, not developed 2) Outdoor play space exists but is not connected to gym or other athletic support areas or is too small. 3. Outdoor play spaces exist, are connected to other athletic areas, are the right size, but are not in good condition. 4. Outdoor play spaces need minor improvements to function well. 5. Outdoor play spaces are in excellent condition. N/A) Does not apply.							The preschool and kindergarten play ground is functional, but not used due to the lack of shade.

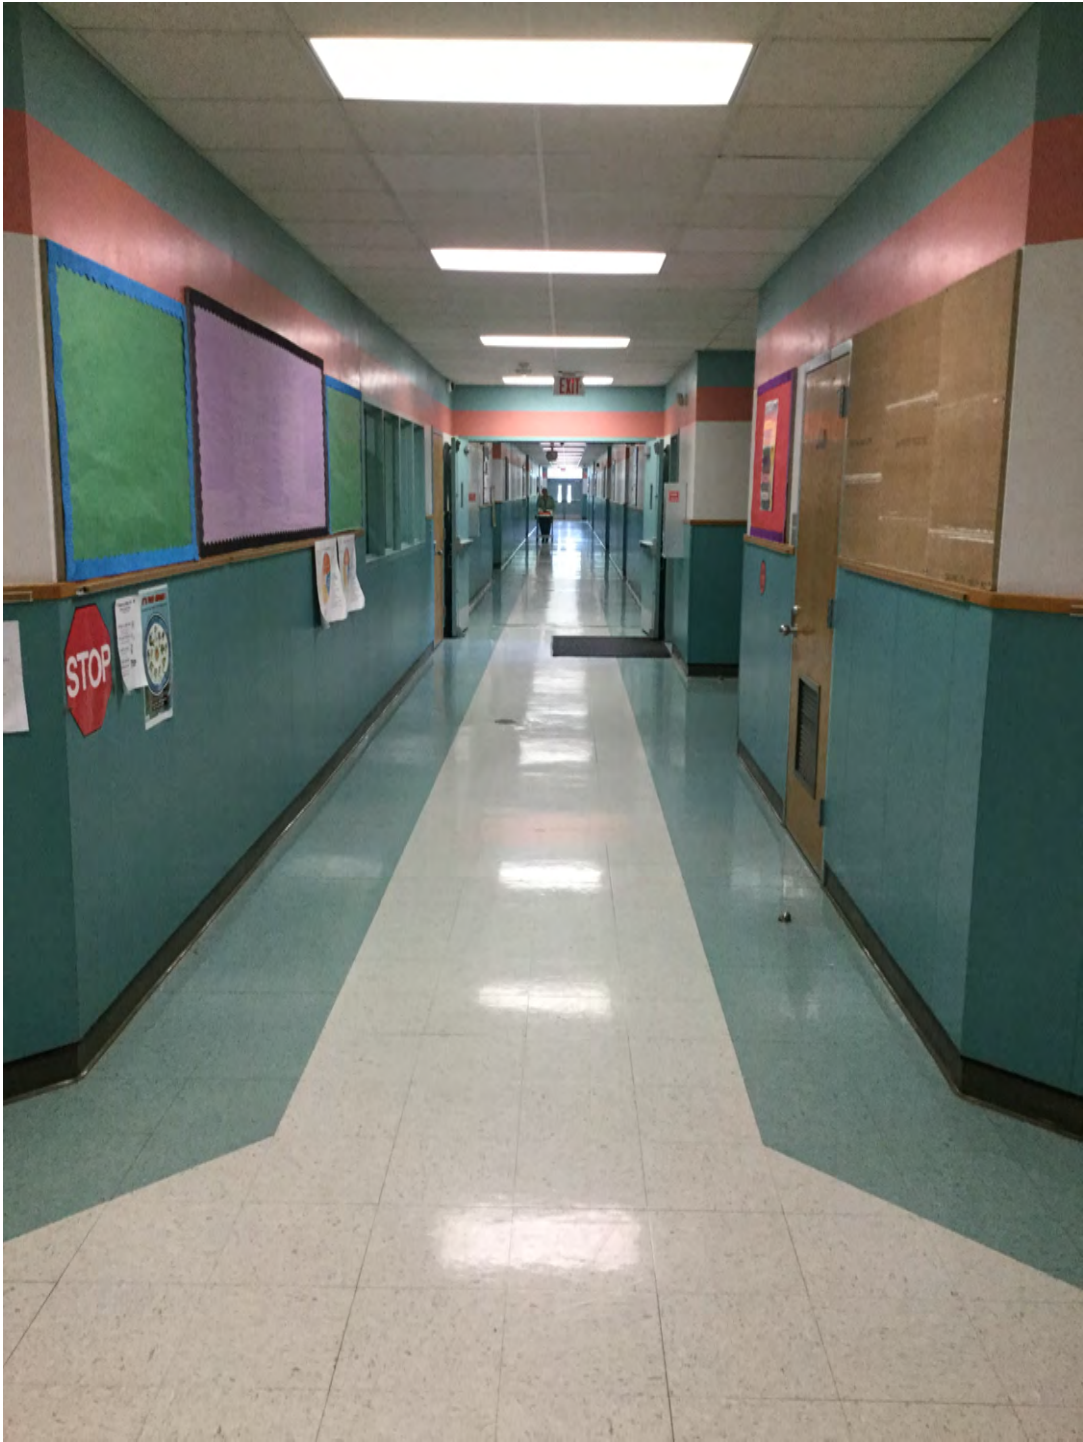
2.1 Corridor

2 - General Building		1	2	3	4	5	N/A	3.75		
2.1	Are interior circulation routes wide enough to safely and effectively accommodate student movement?				4			Comments	0.50	2.00

1) Primary circulation is 5'-0" to 6'-0" wide. 2) Primary circulation is 6'-0" to 7'-0" wide 3) Primary circulation is 7'-0" to 8'-0" wide 4) Primary circulation is 8'-0"-10'-0" wide 5) Primary circulation is 10'-0"+ wide N/A) Does not apply.

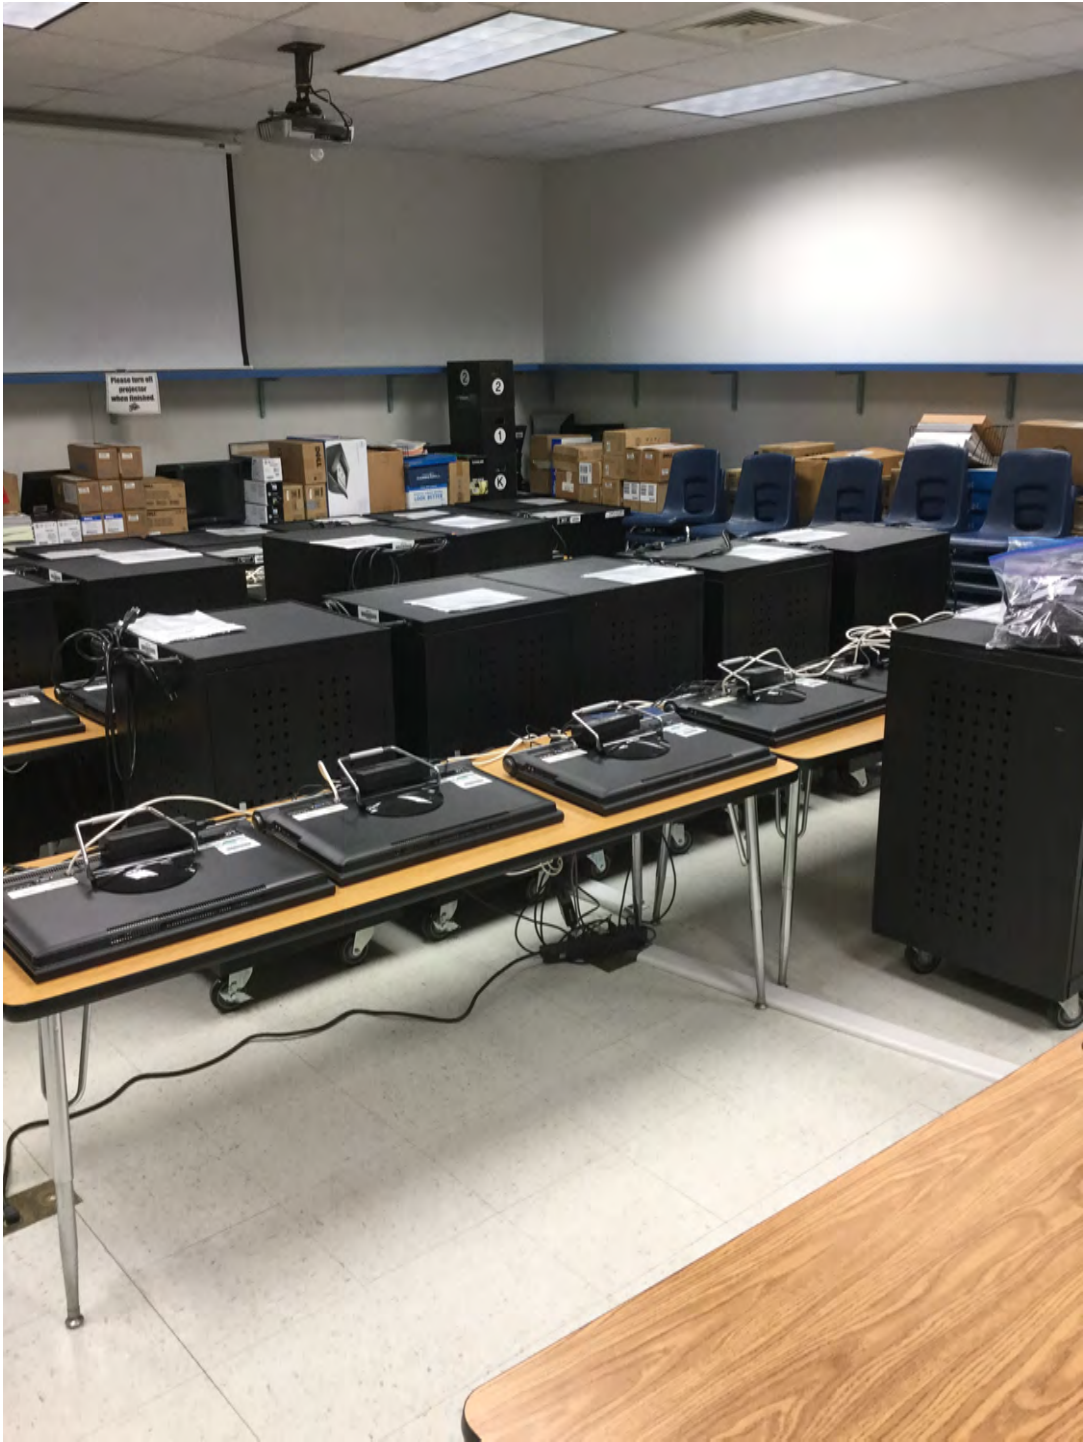
3.1 Classroom

Furniture is satisfactory in condition and size and allows for easy reconfiguration of the space for different learning groups.

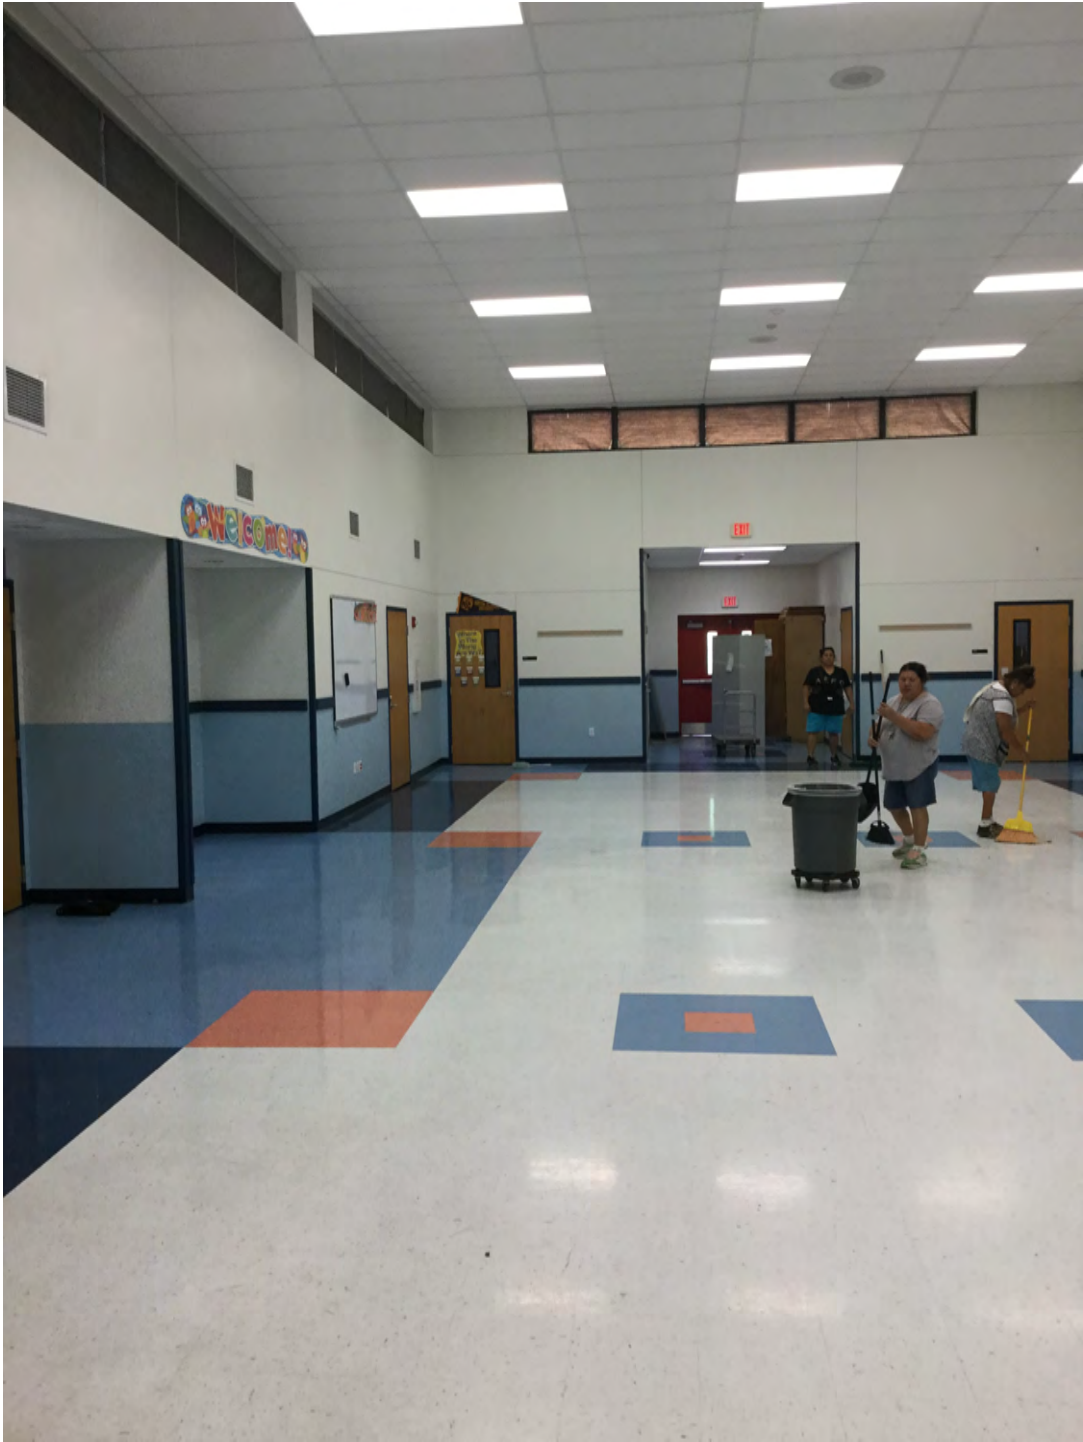
4.6 Common Space

4.6	Does the building provide opportunities for informal interaction?					5		Comments	1.00 5.00
1) Very unsatisfactory - no gathering areas or areas in very poor condition 2) Unsatisfactory - one exterior or interior common space with no seating or unsatisfactory condition 3) Average - one exterior or interior common space with seating needing updates 4) Good - 2 exterior or interior common spaces with appropriate seating/good condition 5) Very good - multiple exterior and interior commons spaces with appropriate seating in excellent condition N/A) Does not apply.								The common space in the main lobby functions well.

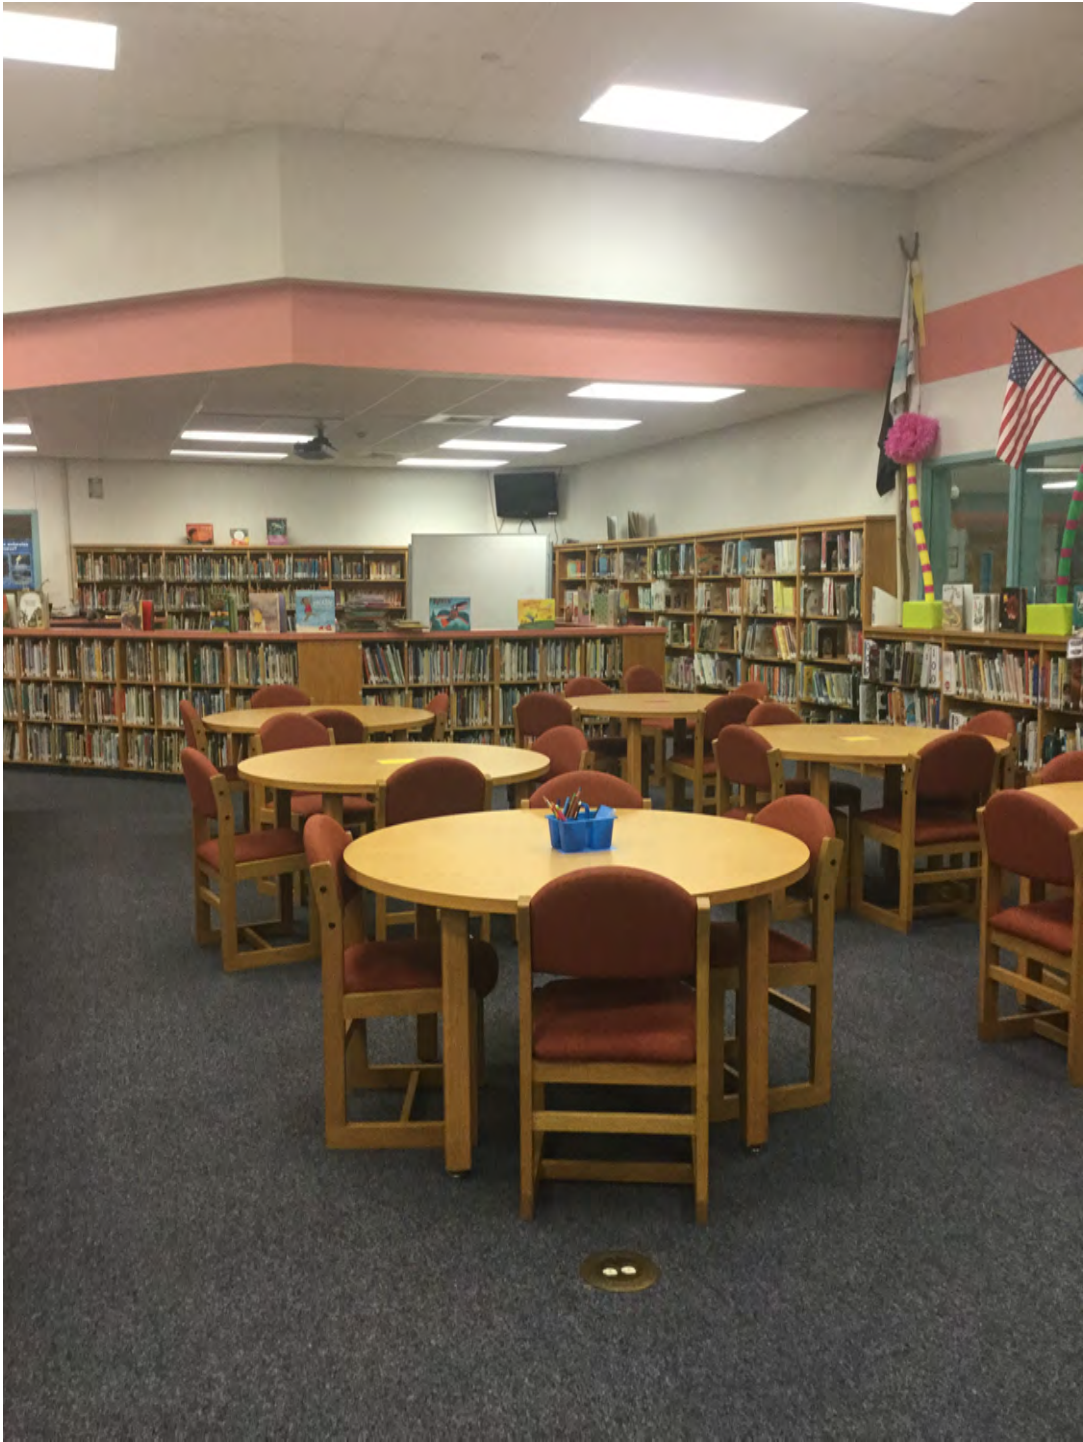
5.3 Library

1) Very unsatisfactory 2) Unsatisfactory 3) Average 4) Good 5) Very good N/A) Does not apply.									
5.3	How well does the Library/Media Center support social interaction?					5		Comments	1.005.00

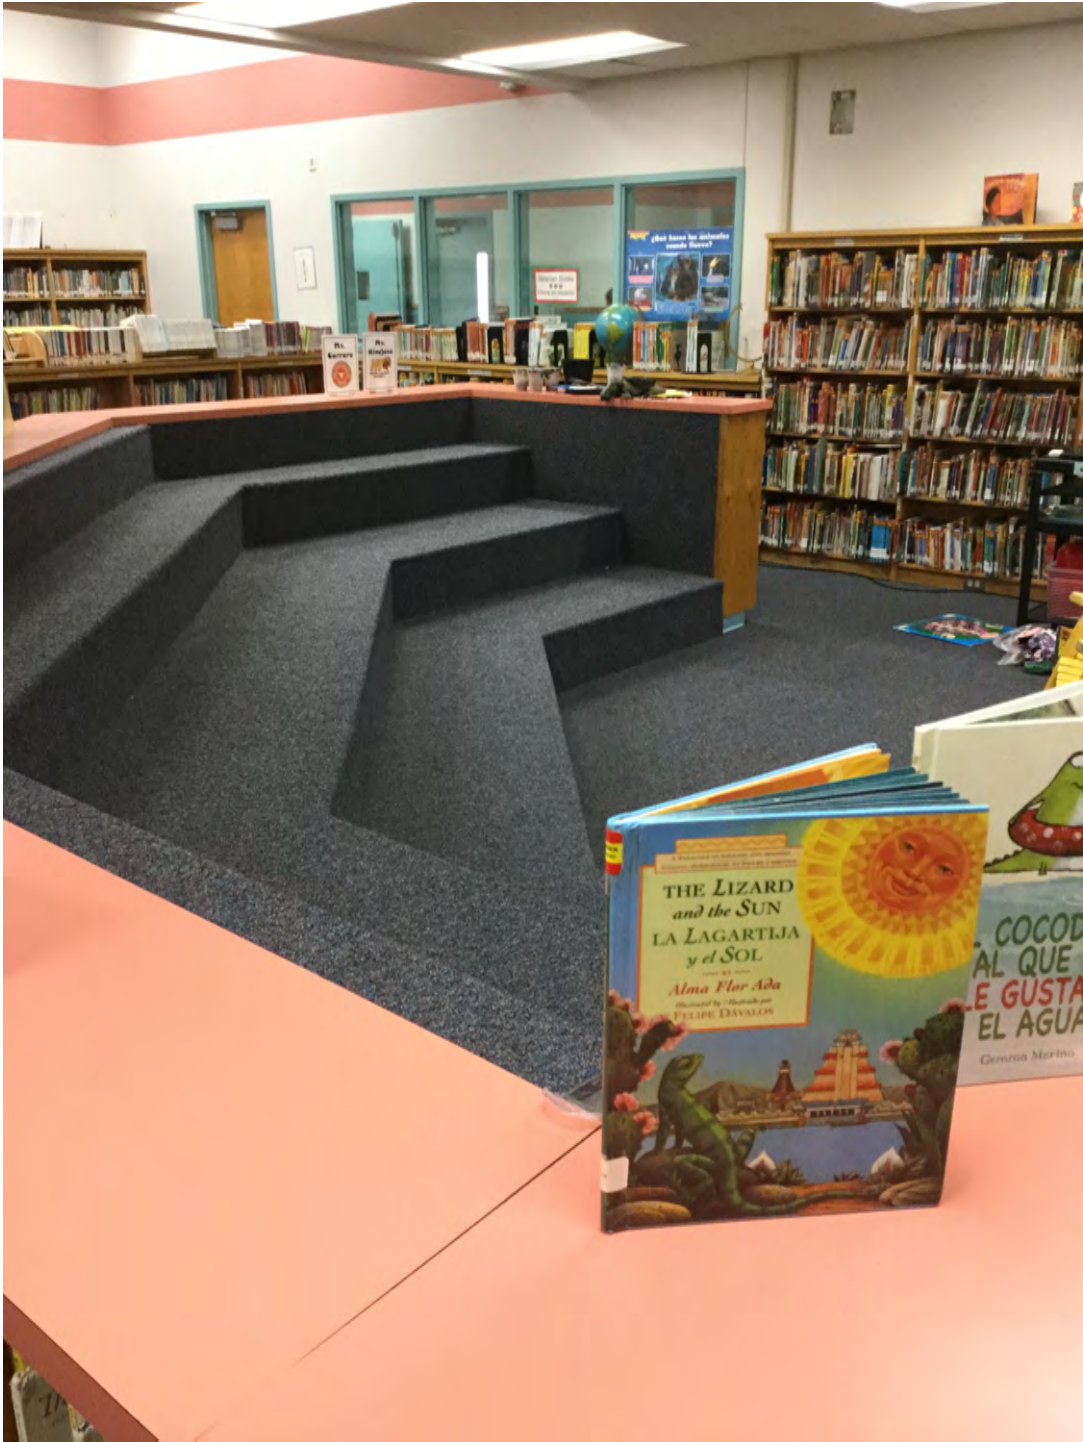
5.6	How well does the Library/Media Center support technology?				4			Comments	1.004.00
1) Very unsatisfactory - Very inadequate power outlets, no Wi-Fi capability, no computers, tablets, laptops, media carts or screens for use 2) Unsatisfactory - Some power, no Wi-Fi capability, outdated and inadequate technology available 3) Average - Some power outlets, network connectivity, technology available 4) Good - Adequate power outlets available, network connectivity, appropriate number of computers/tablets/laptops/media carts or screens available 5) Very good - Adequate power outlets available, good network connectivity, computers, tablets, laptops and media carts or screens available and adequate for number of students N/A) Does not apply.
