## Educational Suitability Summary Report

Joslin Elementary School

Date: 07/11/2016

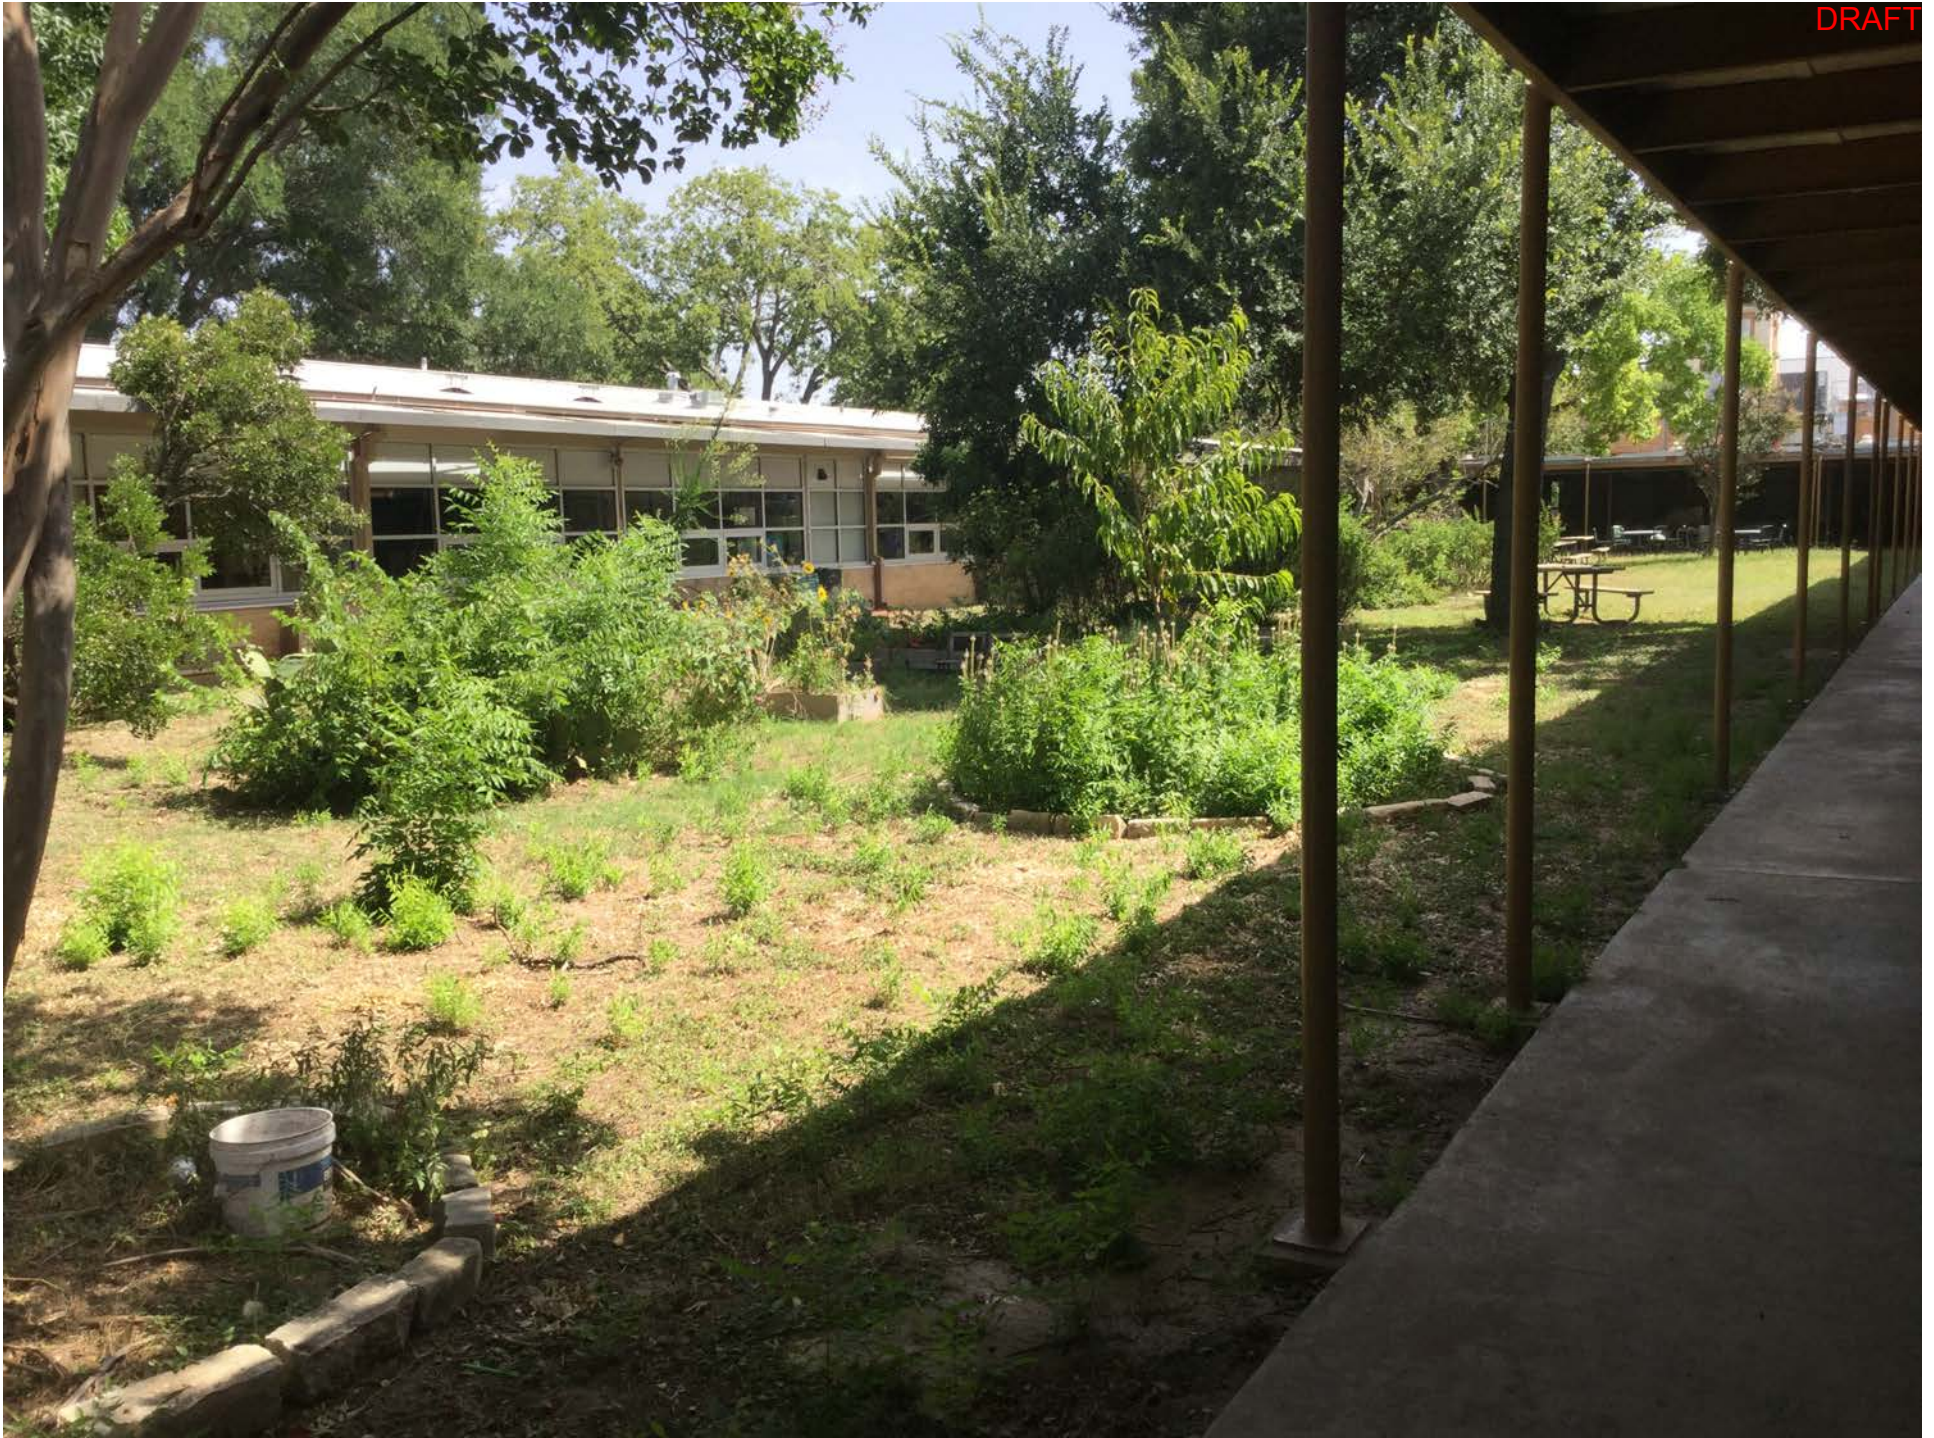
Photo 1.  
1.2 Outdoor Space

1.2	Are opportunities provided for outdoor learning (outdoor classrooms, gardens, etc.)?				4			Comments	1.00 4.00
	1) Outdoor space exists is not developed 2)Outdoor space for learning exists but not connected to classroom learning areas. 3. Outdoor learning spaces exist and are accessible but not in good condition. 4. Outdoor learning spaces need minor improvements to function well. 5. Outdoor learning spaces are in excellent condition. N/A) Does not apply.								see photo 1

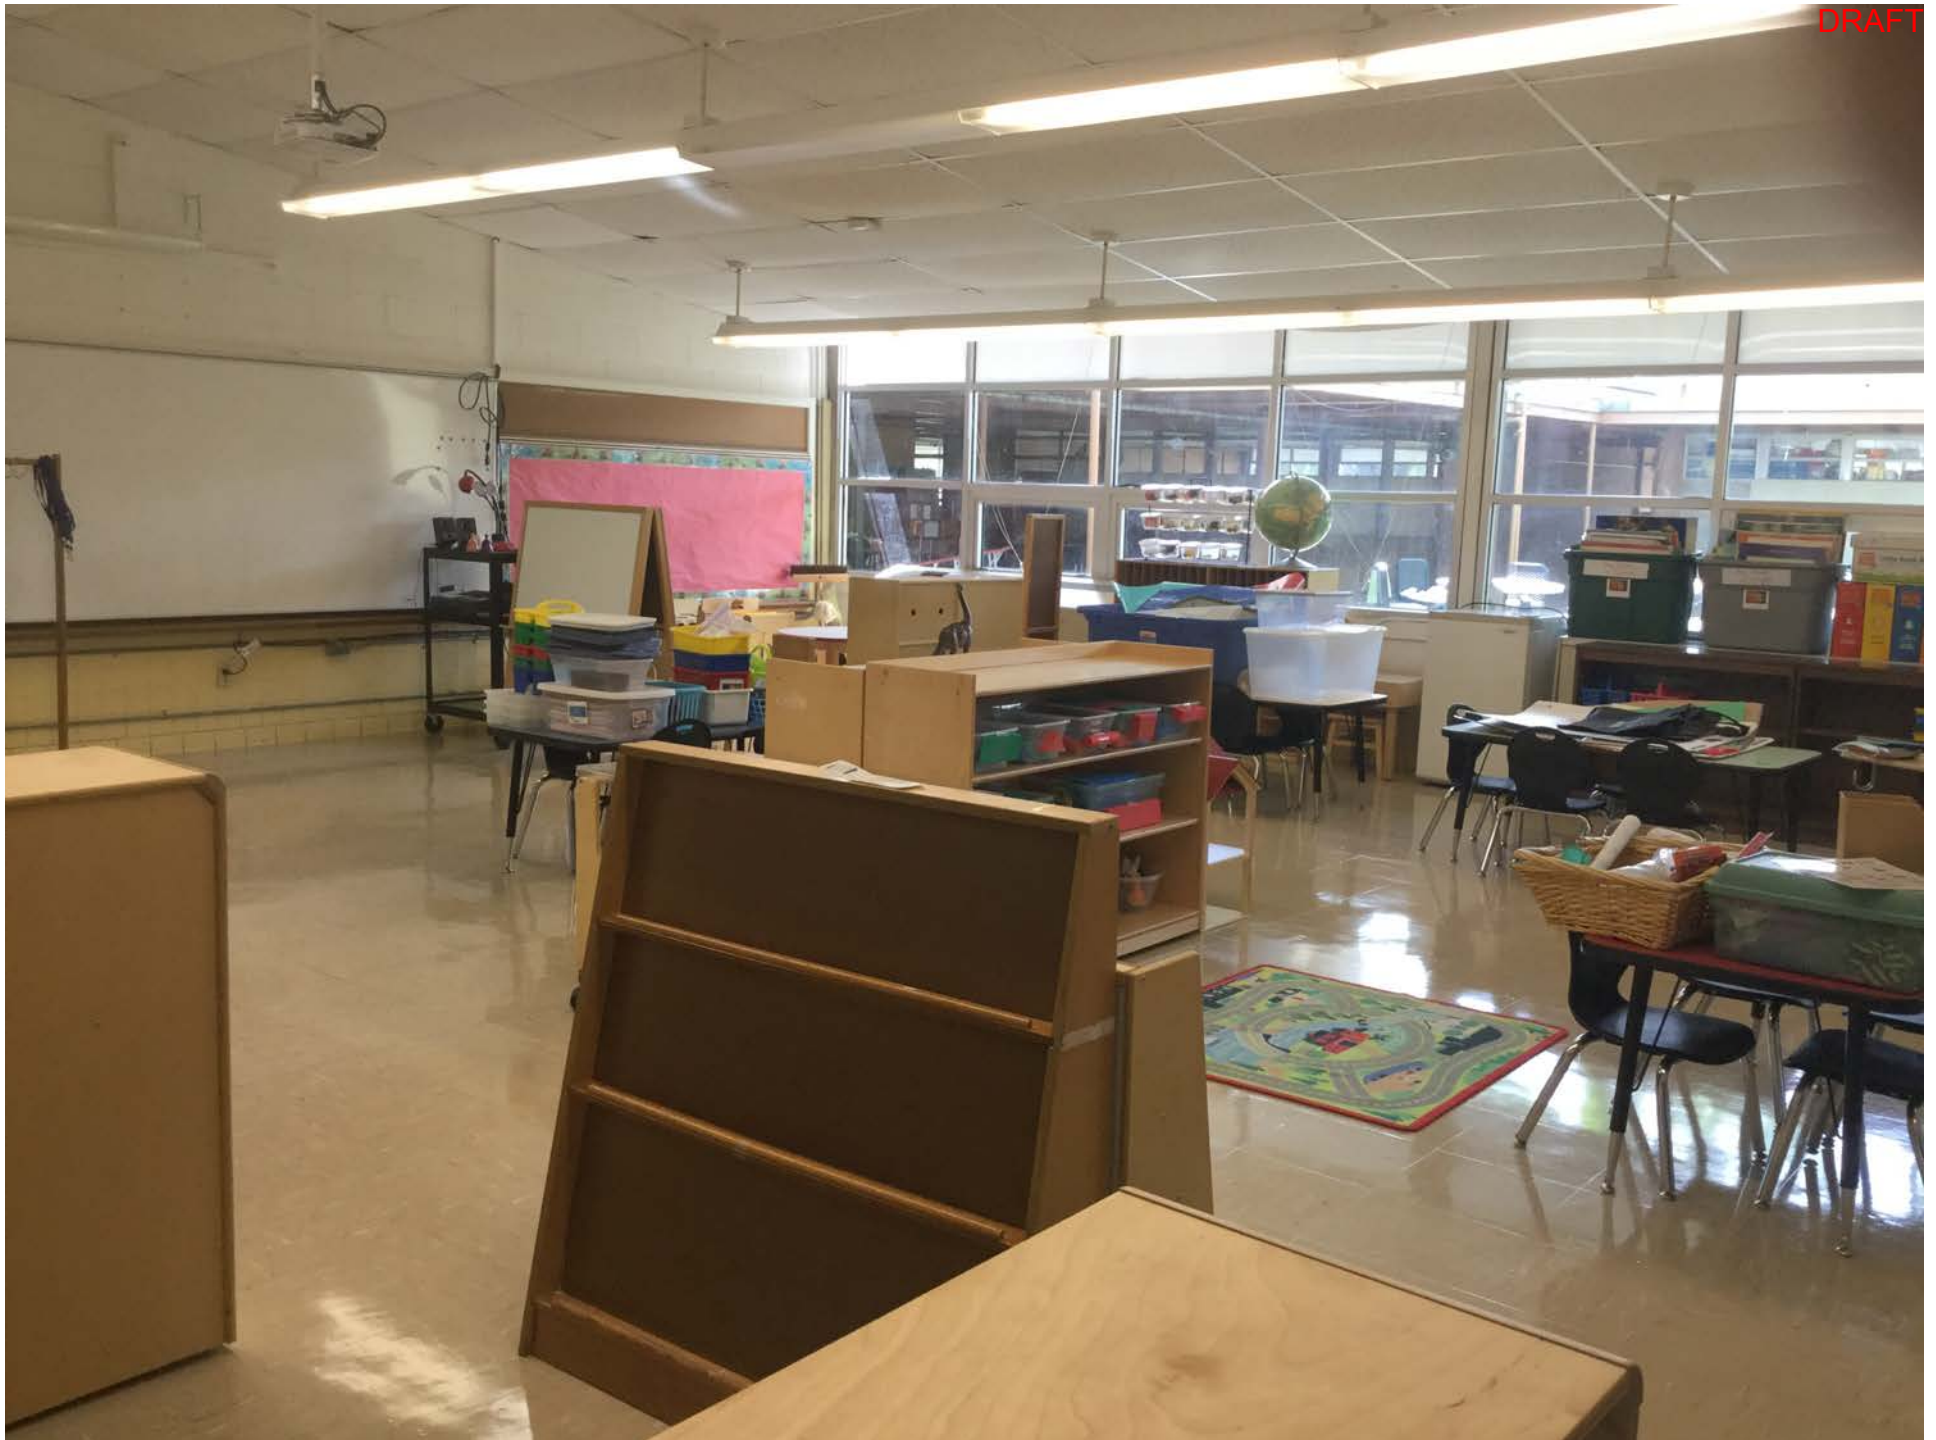
Photo 2.  
3.2 Pre K Space

1) Very unsatisfactory - Too small, awkward layout, does not meet needs 2) Unsatisfactory - Too small, only one area for all teaching methods, limited flexibility 3) Neutral - Moderate size, two areas for different teaching methods, some flexibility, access to student storage/casework 4) Satisfactory - Good size, at least two zones for different teaching methods, flexibility and student storage, not new 5) Very Satisfactory - Good size, two zones for different teaching methods, flexibility and student storage/casework, adequate display area and visual teaching tools N/A) Does not apply.									see photo 2

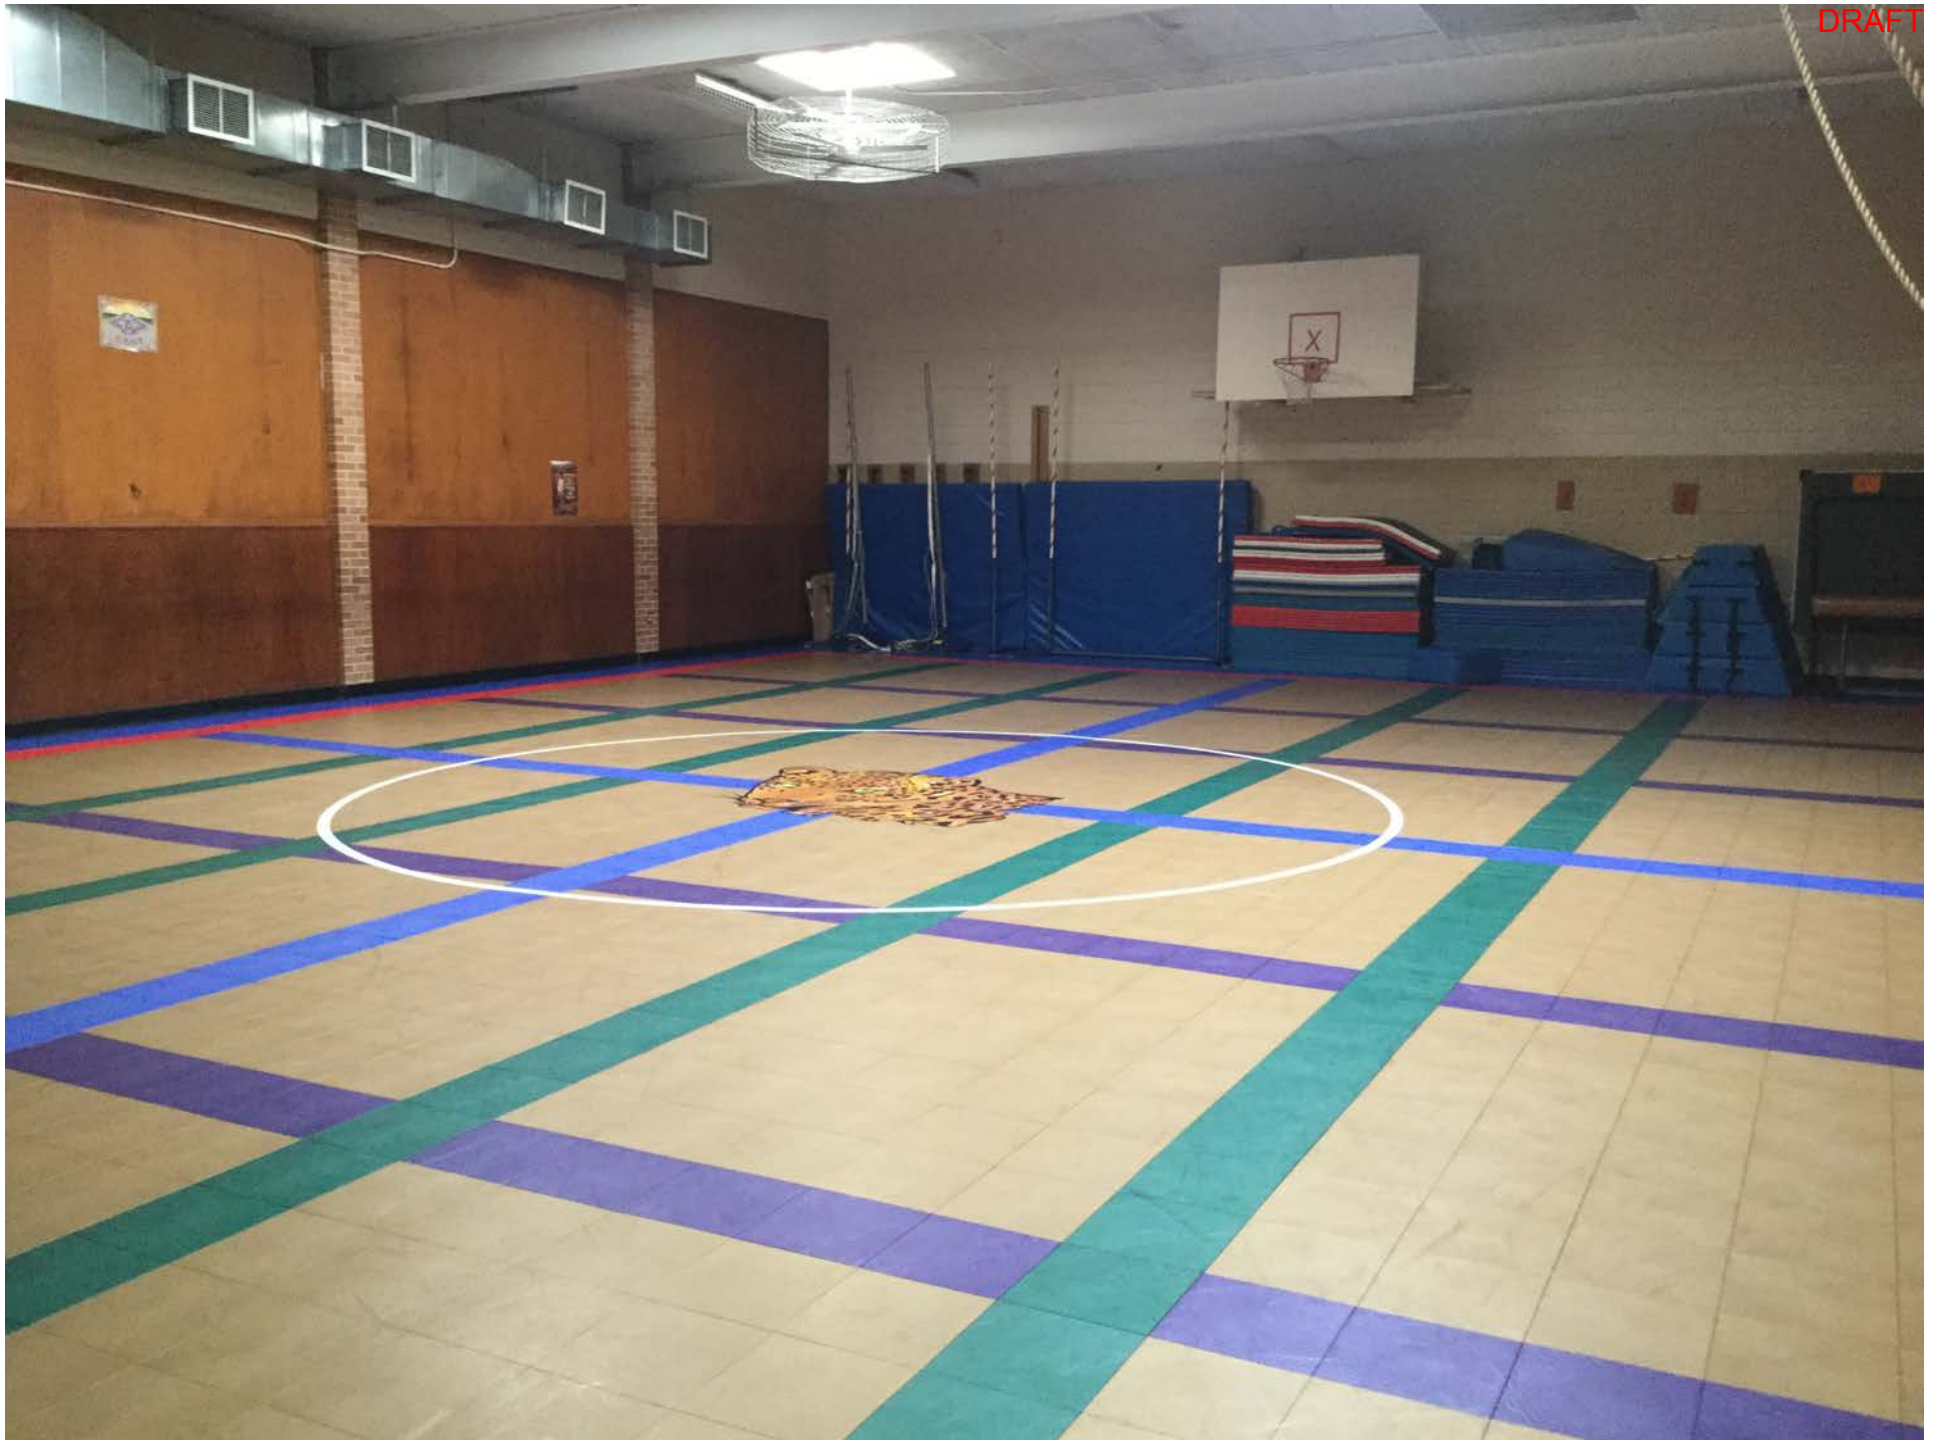
Photo 3.  
3.6 Gym

1) Very unsatisfactory 2) Unsatisfactory 3) Average 4) Good 5) Very good N/A) Does not apply.								Although the floor mats are new, the overall gym space is small and the basketball hoops are inadequate.	see photo 3

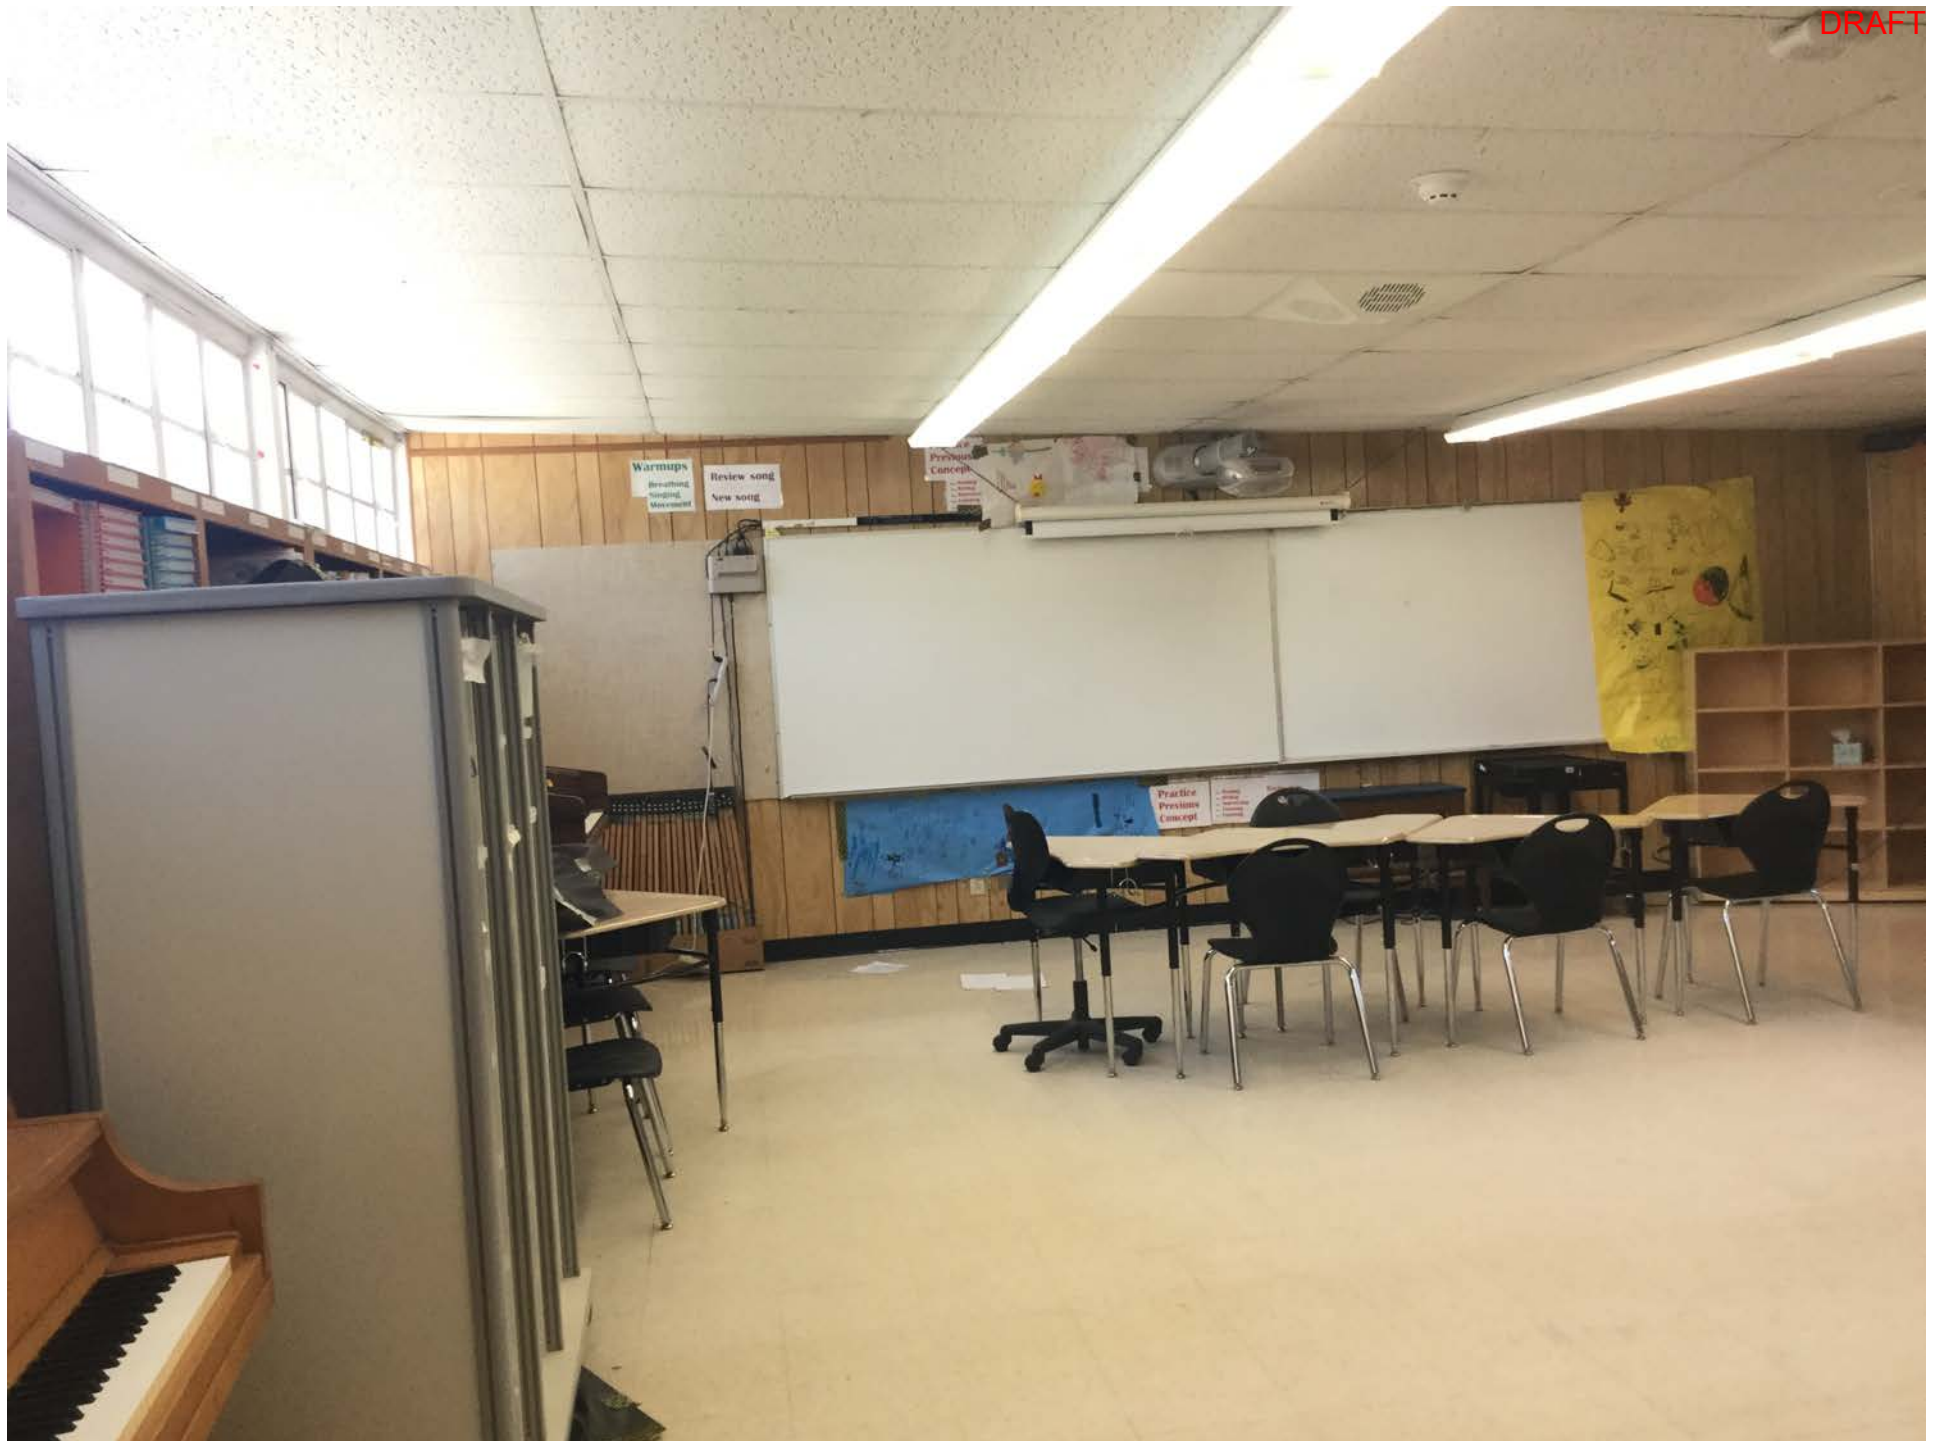
Photo 4.  
3.8 Music Room

3.8	Are music, drama, or performance spaces appropriately configured per the ed spec?	1						Comments	1.001.00
1) Very unsatisfactory 2) Unsatisfactory 3) Average 4) Good 5) Very good N/A) Does not apply.								The music space is in a portable. There is no real performance stage area and the stage in the cafetorium is dated.	see photo 4

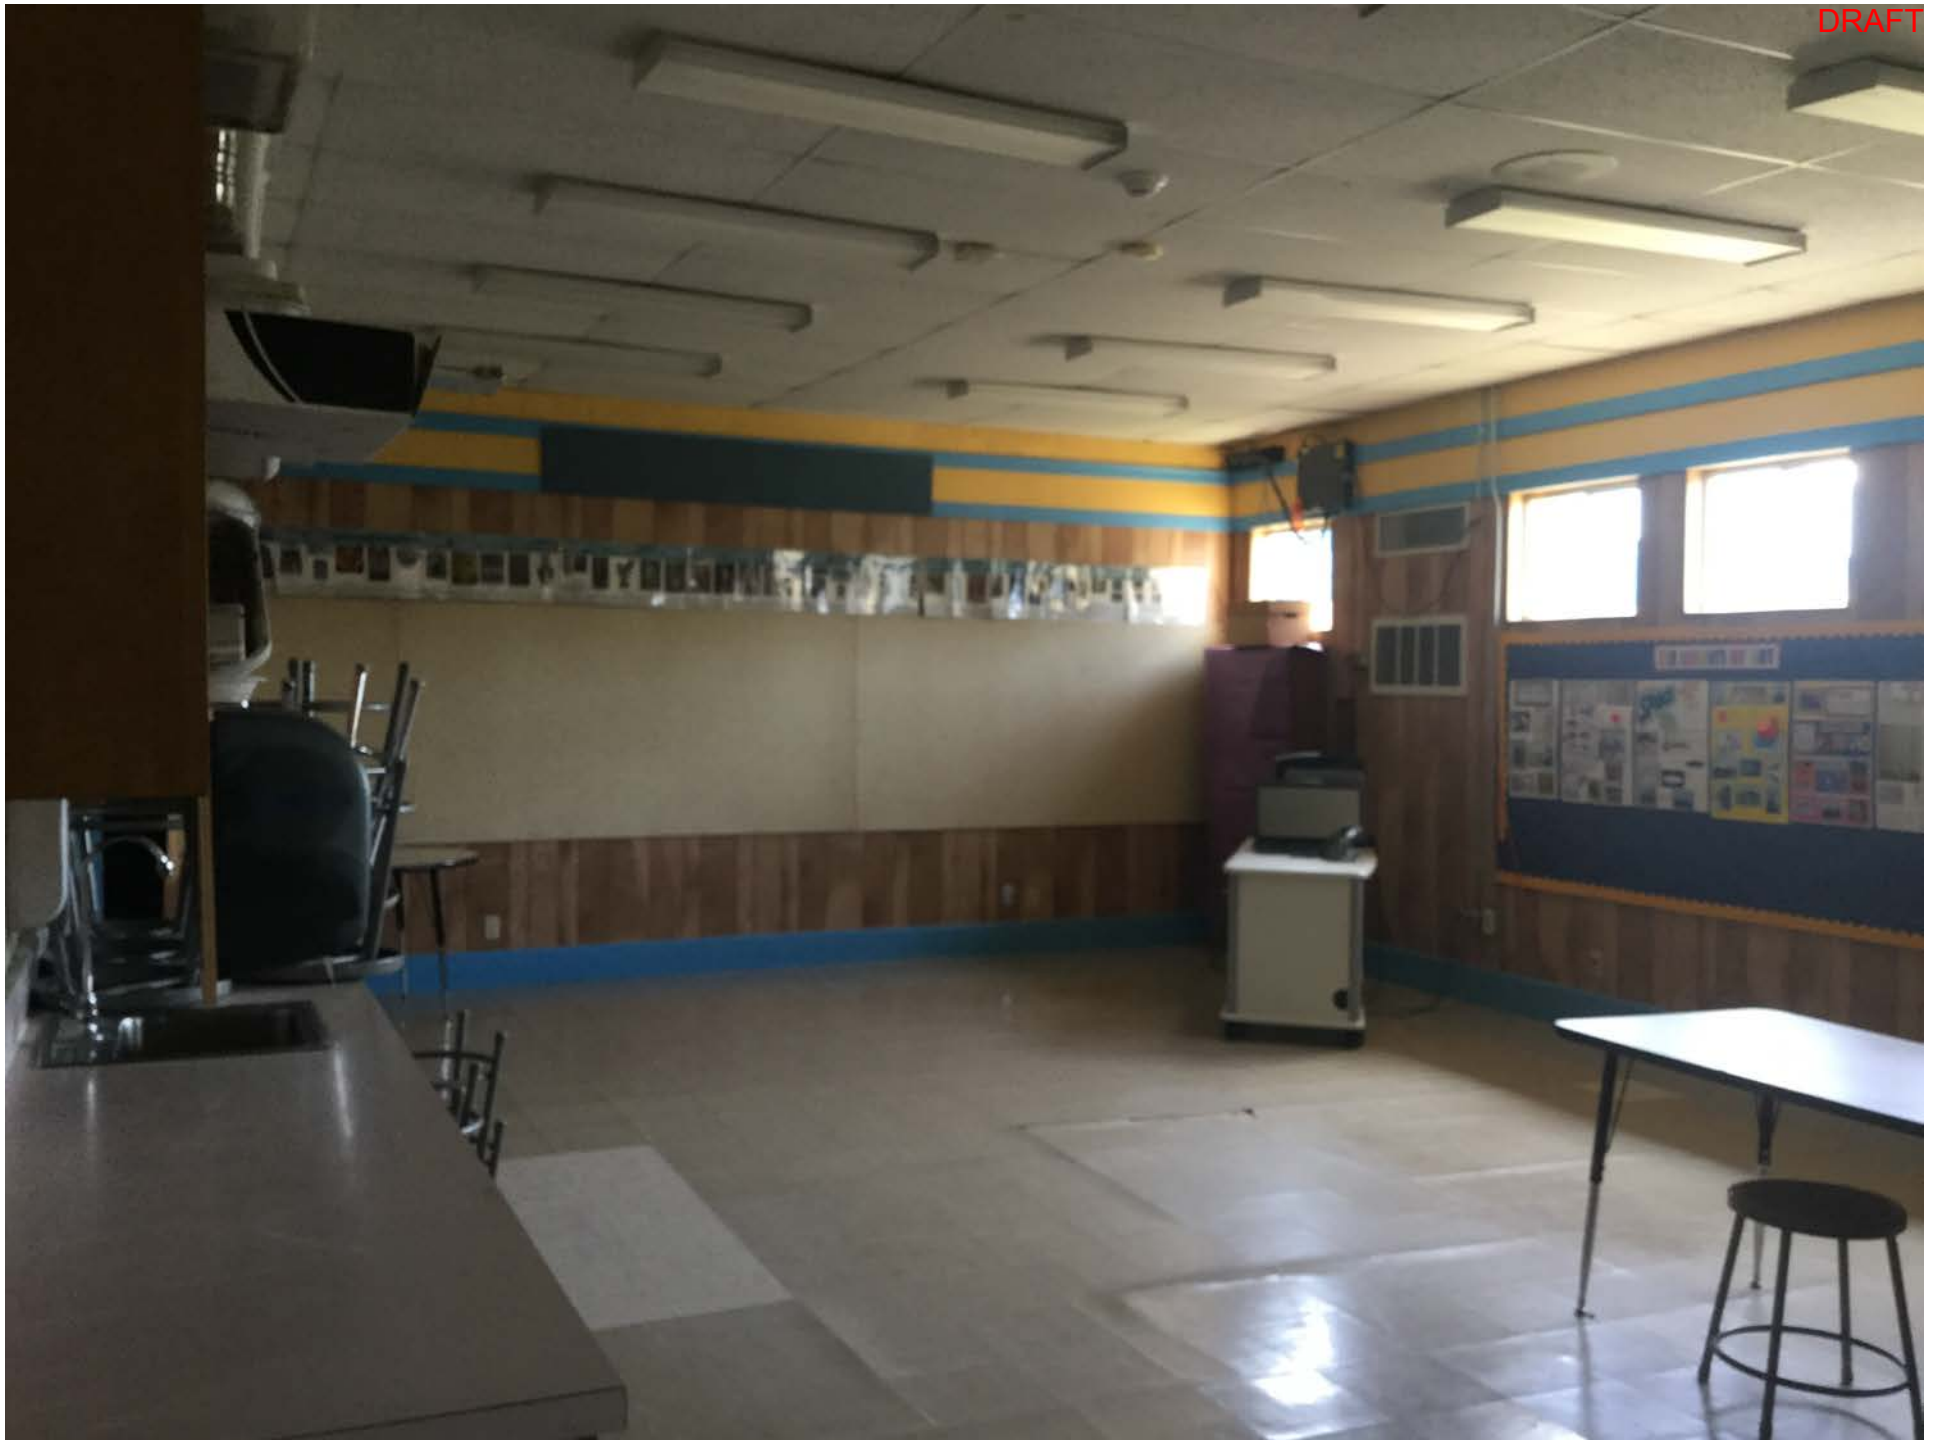
Photo 5.  
3.10 Art Room

1) Very unsatisfactory 2) Unsatisfactory 3) Average 4) Good 5) Very good N/A) Does not apply.								The art room is in very old portable with inadeqaute space and storage.				see photo 5

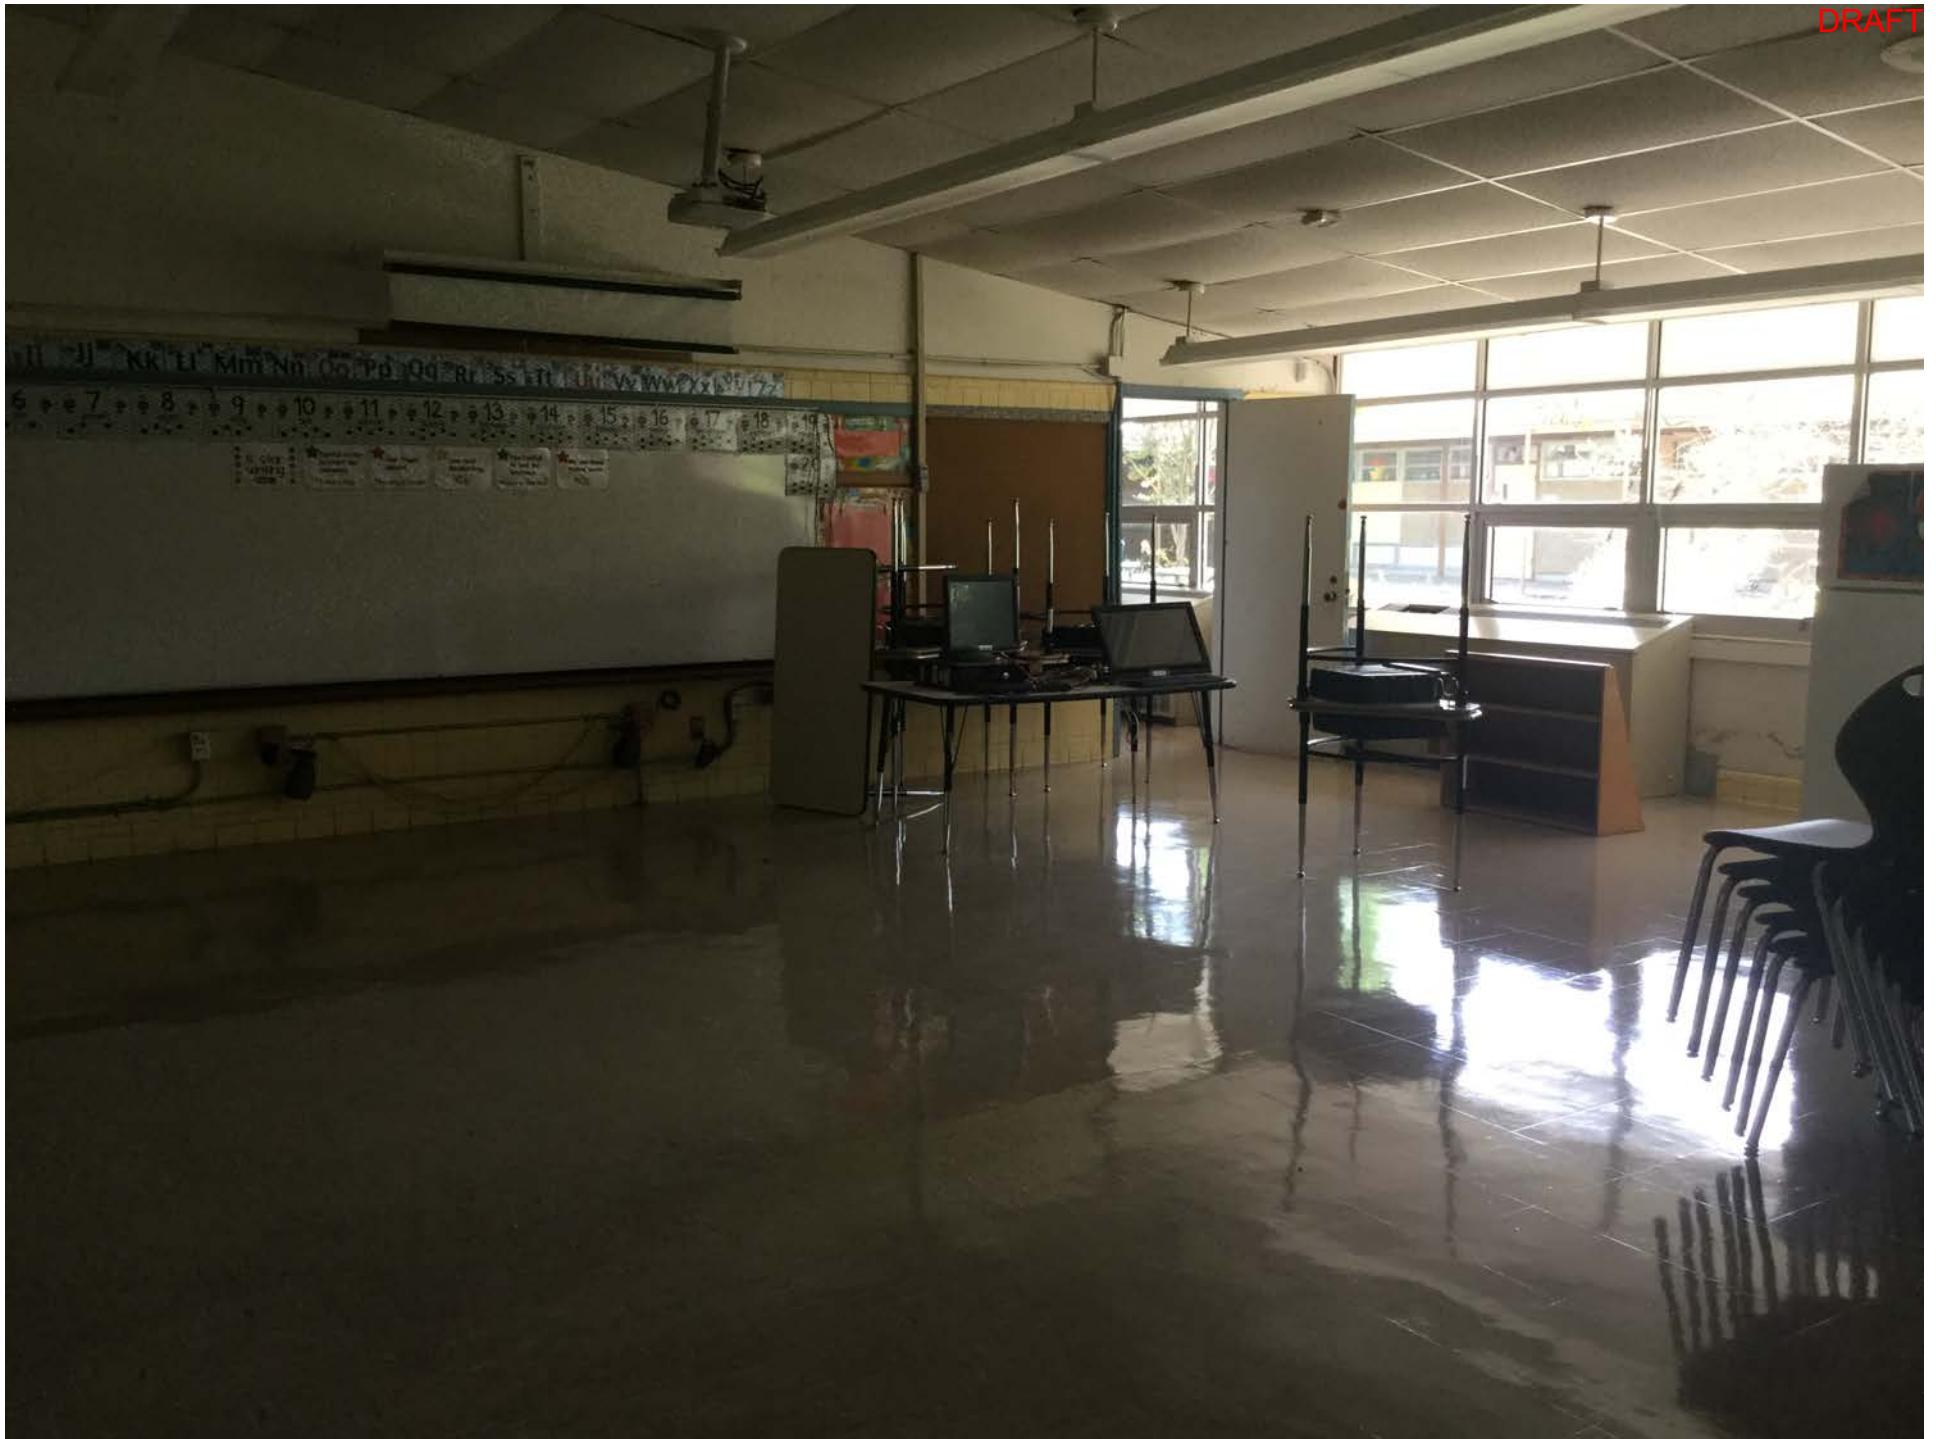
Photo 6.  
4.2 Standard Classroom

4.2	Are general classrooms large enough to support project-based learning and multiple teaching modalities?			3				Comments	1.00 3.00
1) Very unsatisfactory -too small to move, set for lecture only, no connectivity, no flexibility 2) Unsatisfactory - adequate size but set for lecture only, no connectivity, no flexibility 3) Neutral - have flexibility and space for hands on or project based learning 4) Satisfactory - have flexibility and space for hands on or project based learning and connectivity for global learning 5) Very Satisfactory - space for hands on learning, flexibility for different groupings, and connectivity for global classrooms N/A) Does not apply.

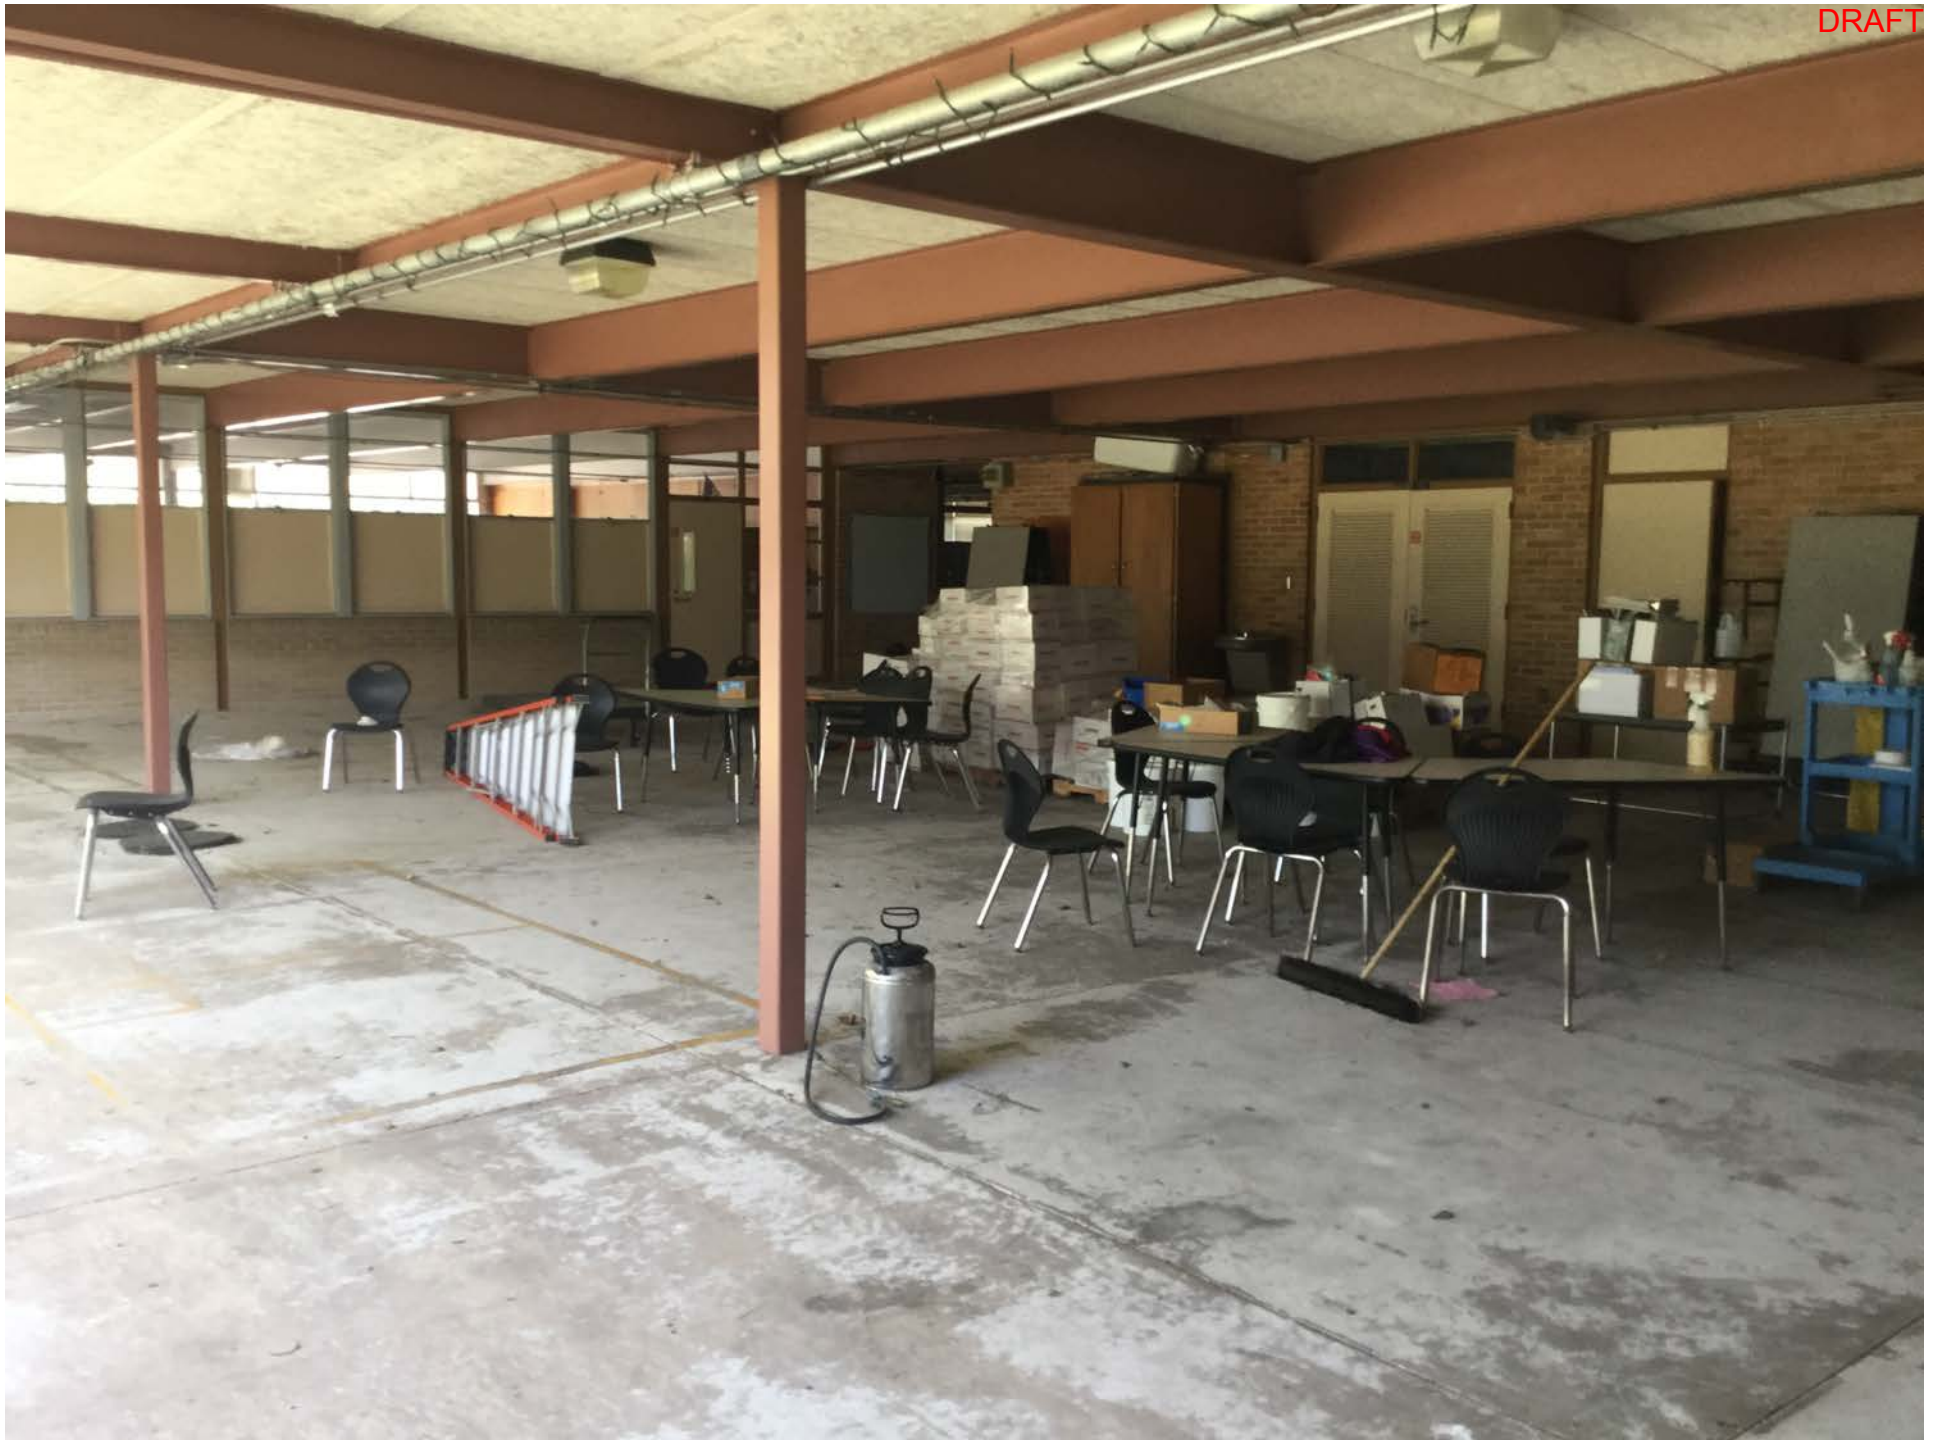
Photo 7.  
4.5 Courtyard Space

1) Very unsatisfactory - no common spaces or meeting rooms or in very poor condition 2) Unsatisfactory - a few common spaces or meeting rooms in unsatisfactory condition 3) Average - a few common spaces and meeting areas needing updates 4) Good - multiple common spaces and meeting rooms in good condition 5) Very good - adequate common spaces and meeting rooms of excellent quality N/A) Does not apply.								see photo 7

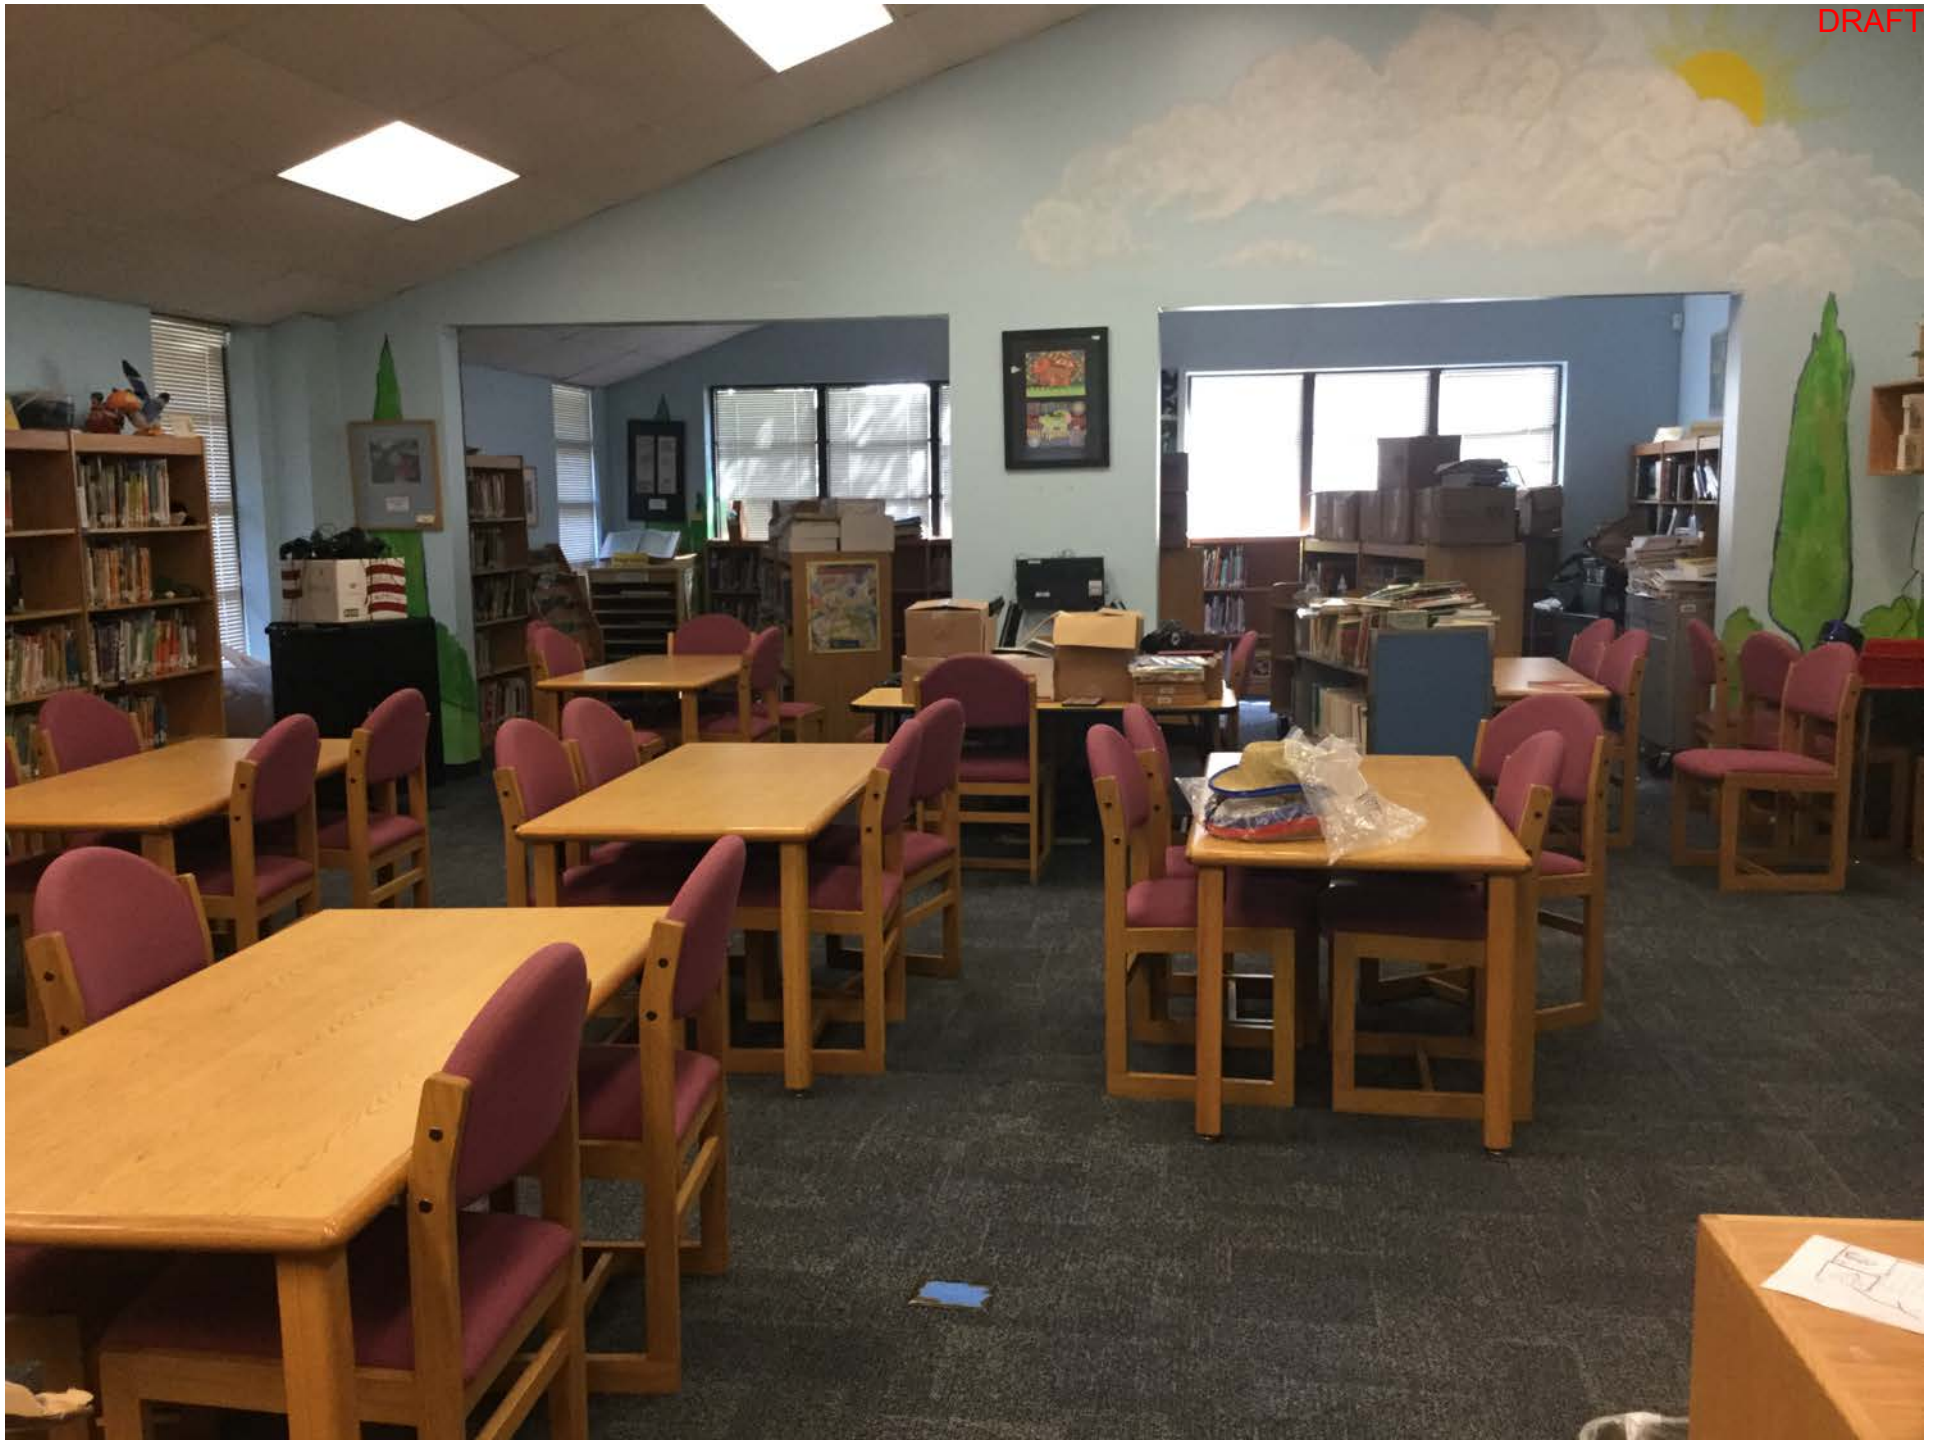
Photo 8.  
5.3 Library

5.3	How well does the Library/Media Center support social interaction?		2					Comments	1.002.00
1) Very unsatisfactory 2) Unsatisfactory 3) Average 4) Good 5) Very good N/A) Does not apply.								There are no common reading stairs, and the principal stated that social interaction was an issue.	
								see photo 8
