## Educational Suitability Summary Report

Joslin Elementary School

Date: 07/11/2016

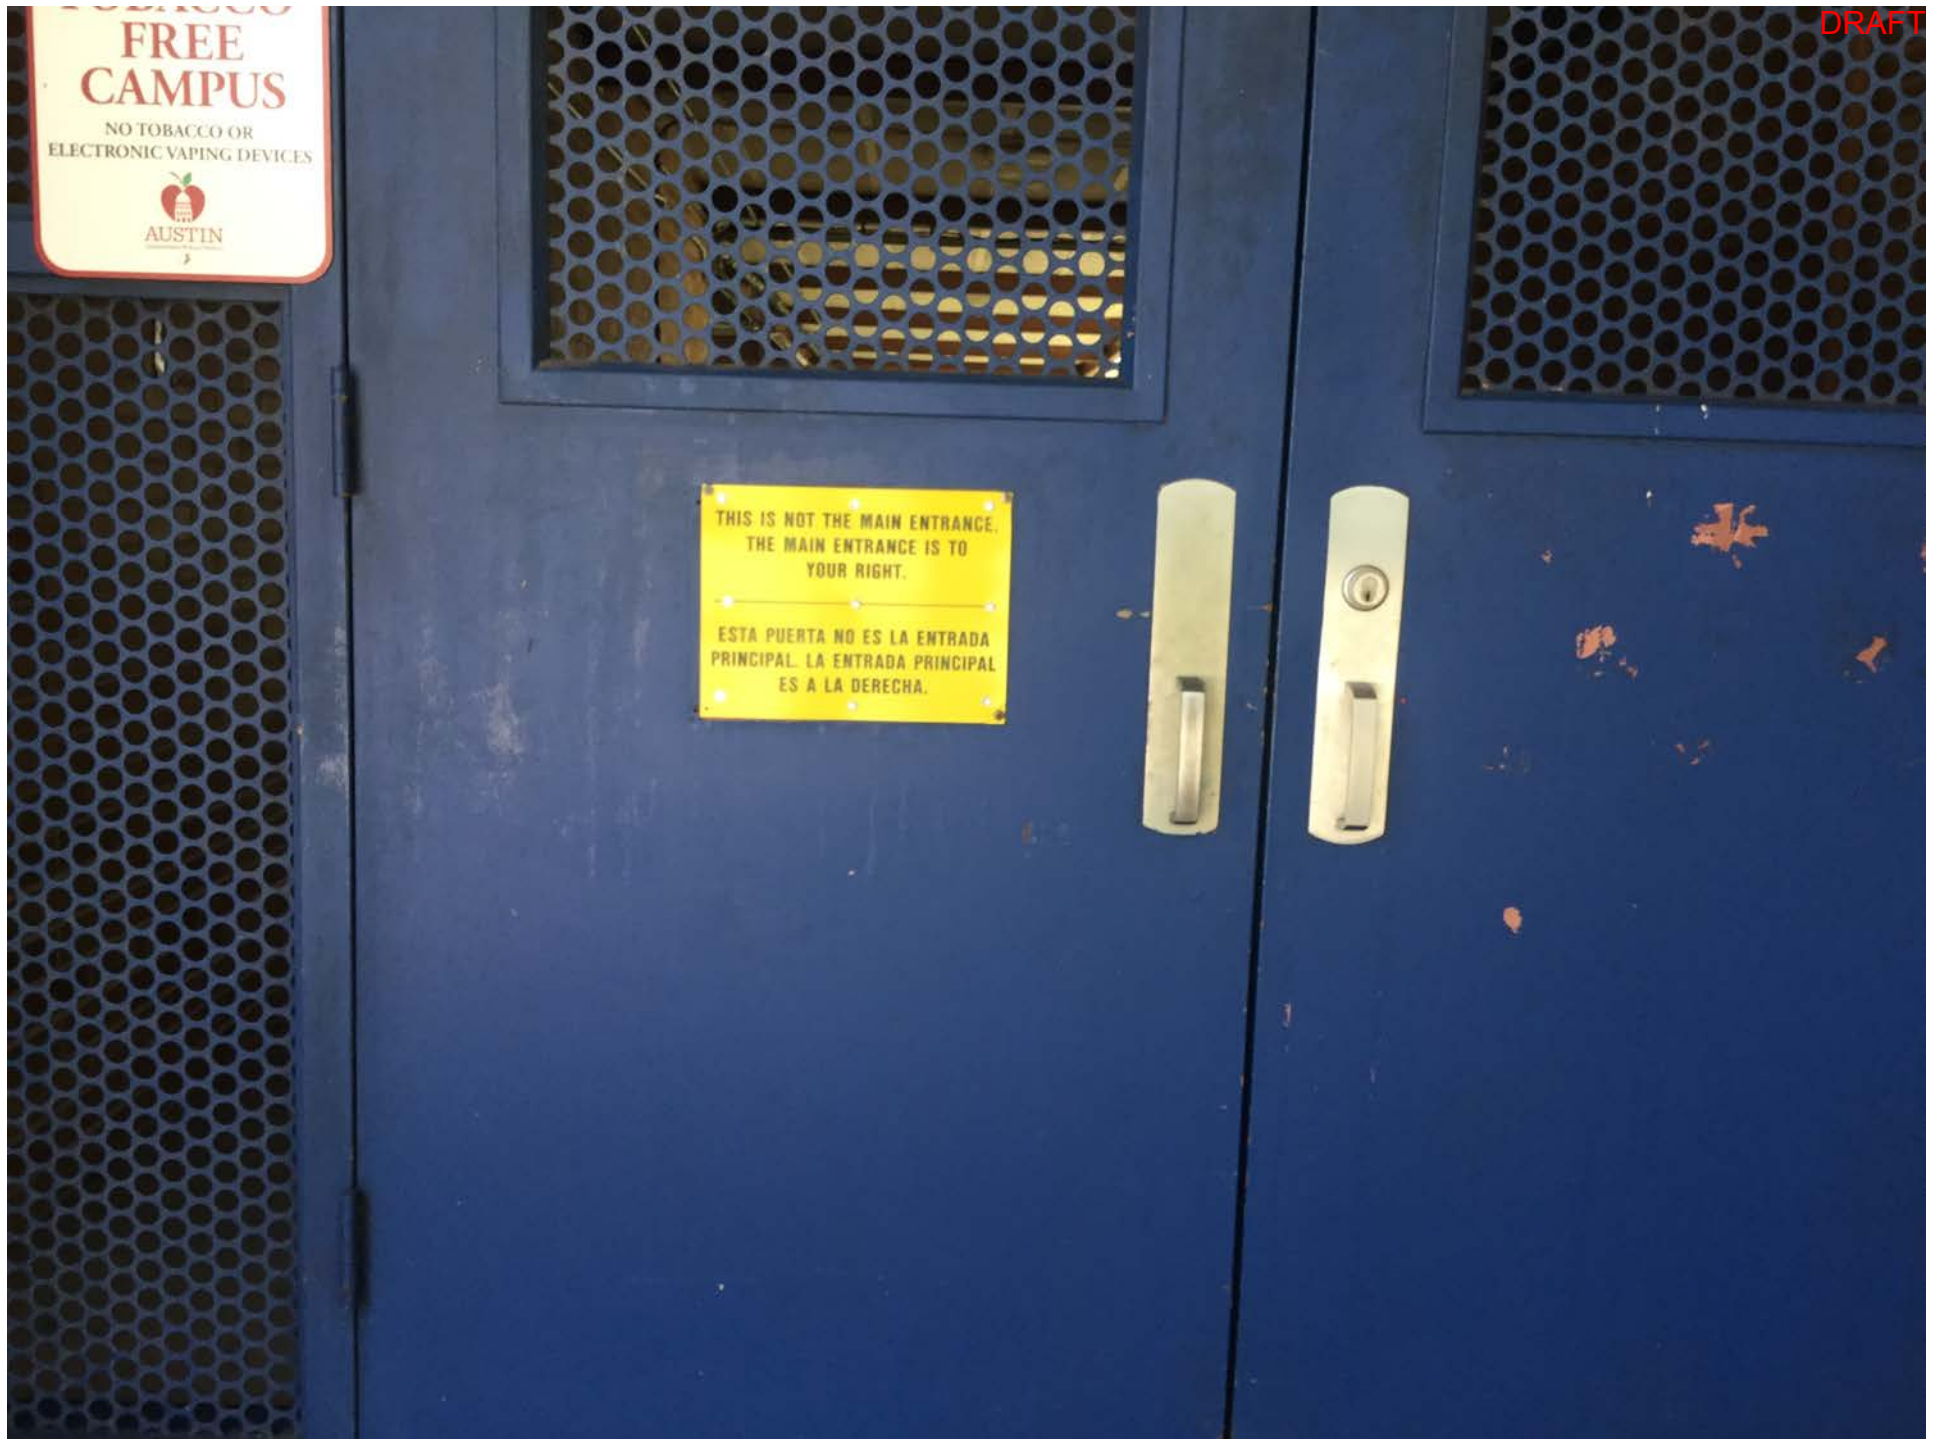
Photo 9.  
6.3 Main Entrance

6.3	Is the main office properly located and configured with a secure vestibule to the main corridor?		2					Comments	1.00 2.00
1) Very unsatisfactory - No secure vestibule, office located far from main entry. Allows visitors access to school unsupervised. 2) Unsatisfactory - No secure vestibule, office located somewhat far from main entry, minimal supervision of visitors. 3) Average - Office close to entry, views of front door, but no secure vestibule 4) Good - Office is well-located with a secure vestibule, but needs updates 5) Very good - Office well-located with secure vestibule and all appropriate security features. N/A) Does not apply.								see photo 9

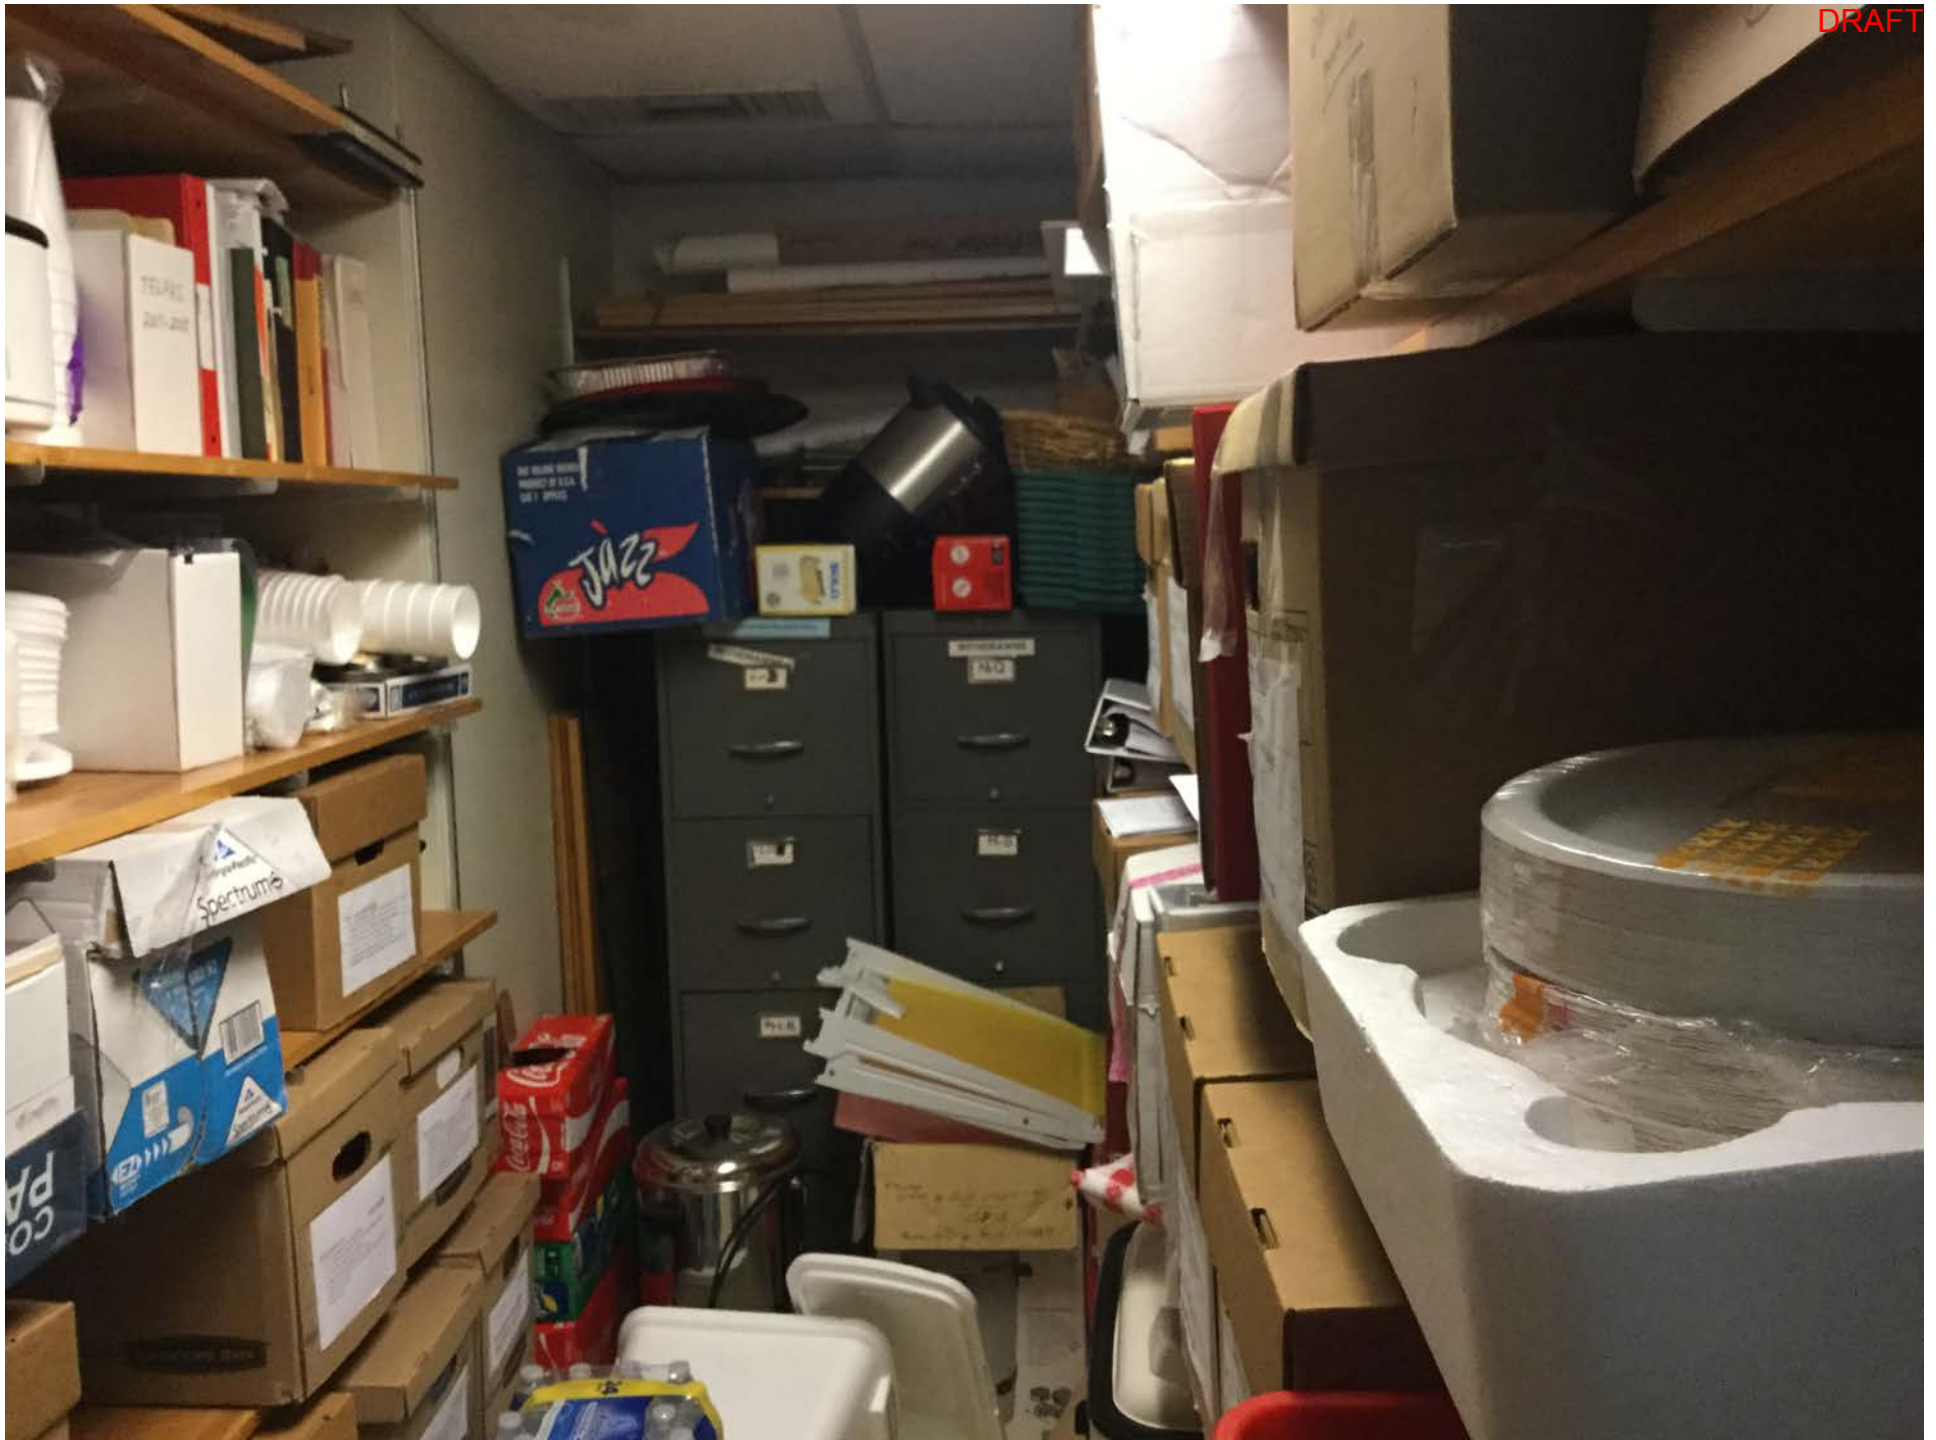
Photo 10.  
8.1 Storage

8 - Storage		1	2	3	4	5	N/A	4.00	
8.1	Is there adequate general storage in the building?	1						Comments	1.00 1.00
1) Very unsatisfactory 2) Unsatisfactory 3) Average 4) Good 5) Very good N/A) Does not apply.								There are very few storage rooms throughout the building and the current ones are too small.	see photo 10
8.2	Is there adequate classroom storage?		2					Comments	1.00 2.00
1) Very unsatisfactory 2) Unsatisfactory 3) Average 4) Good 5) Very good N/A) Does not apply.								The built in furniture is very inadequate.	
8.3	Is there adequate student storage?	1						Comments	1.00 1.00
1) Very unsatisfactory 2) Unsatisfactory 3) Average 4) Good 5) Very good N/A) Does not apply.								There is inadequate student storage.
