## Educational Suitability Summary Report

Kiker Elementary School – BLDG # 180

Date: 8/1/2016 (REV1 – 12/12/2016 – Survey, CAC & Principal comments)

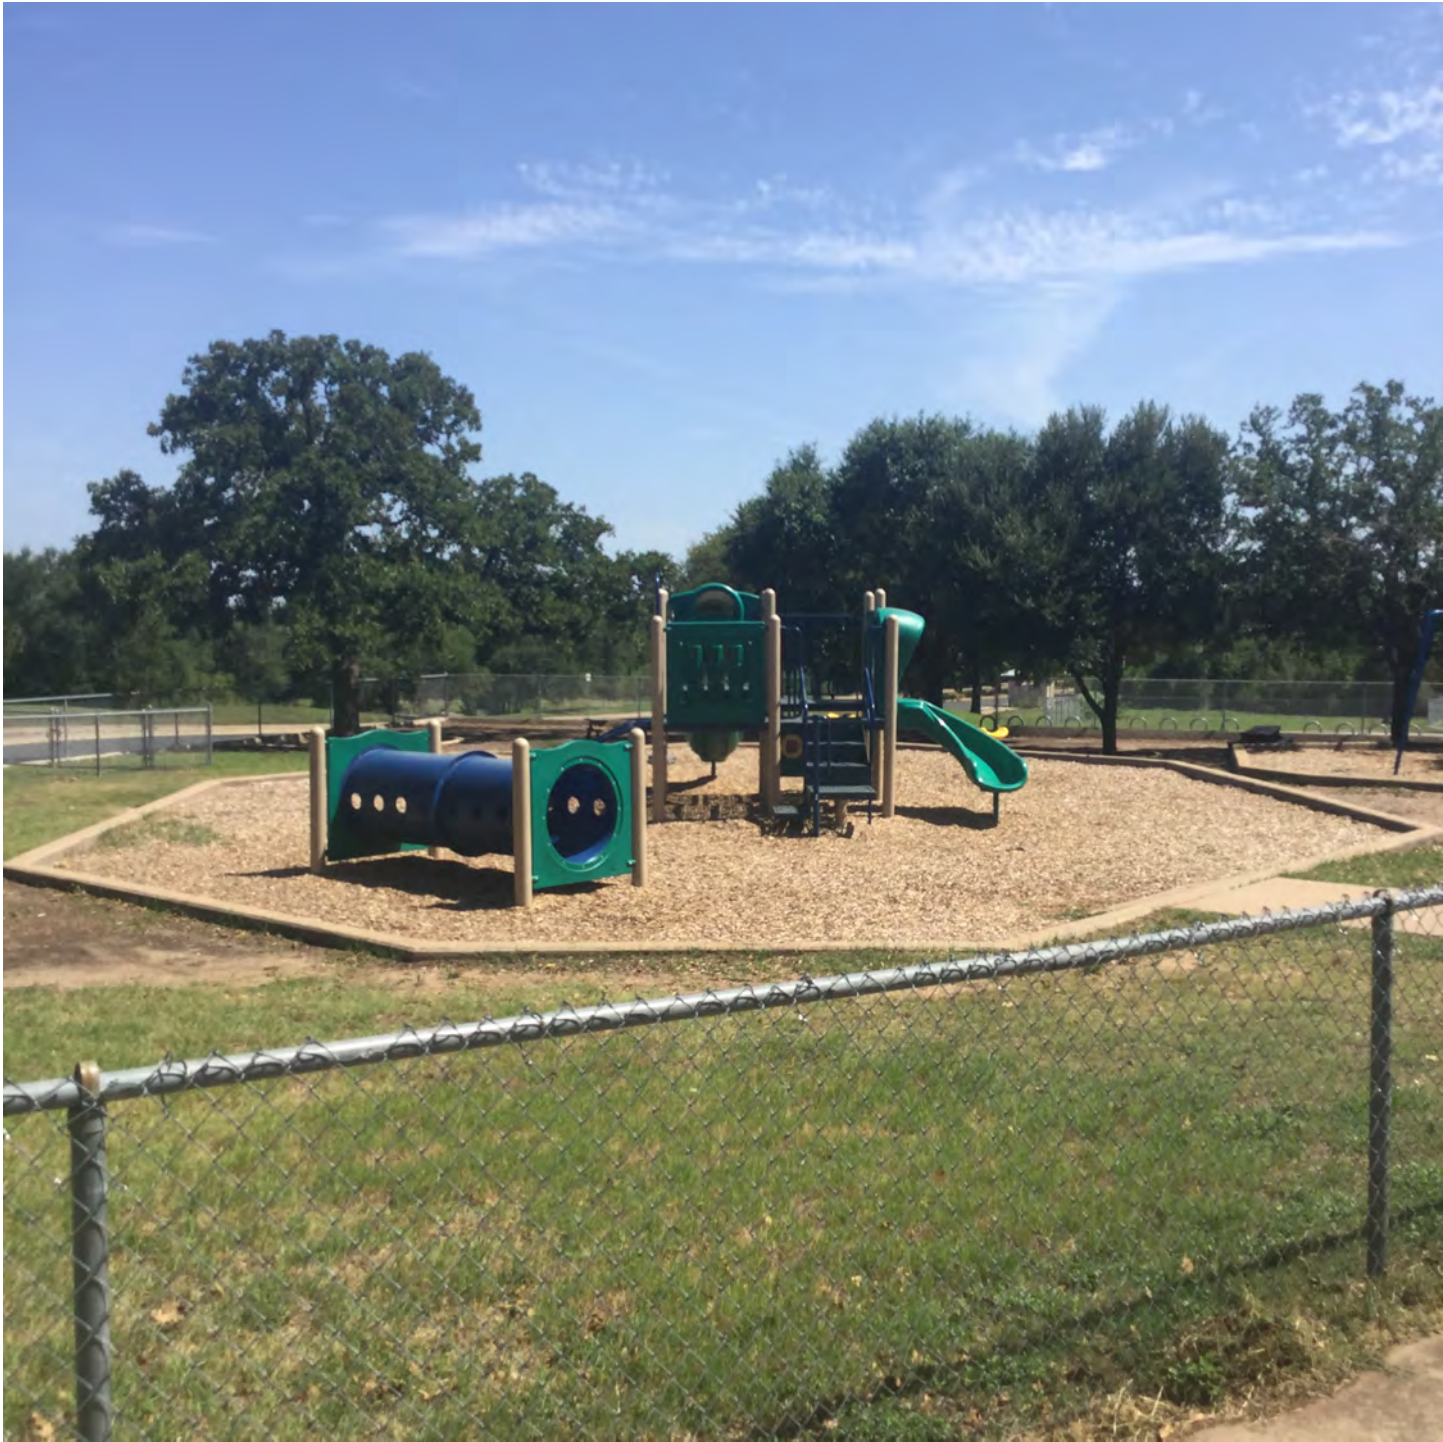
1.3 Playground

1.3	Are outdoor play spaces and playfields adequate in size and configuration?		2					Comments	1.00 <b>2.00</b>
	1) Outdoor play space exists, not developed 2) Outdoor play space exists but is not connected to gym or other athletic support areas or is too small. 3. Outdoor play spaces exist, are connected to other athletic areas, are the right size, but are not in good condition. 4. Outdoor play spaces need minor improvements to function well. 5. Outdoor play spaces are in excellent condition. N/A) Does not apply.							Due to the lack of space within the building, and lack of open space on the surrounding the campus, portables have been placed near the playgrounds and play spaces. This limits the play space and playgrounds for the kids. <i>CAC comments: CAC recommends a score of 2, that reflects the original comments above. The score for this section has been adjusted to a 2.</i>

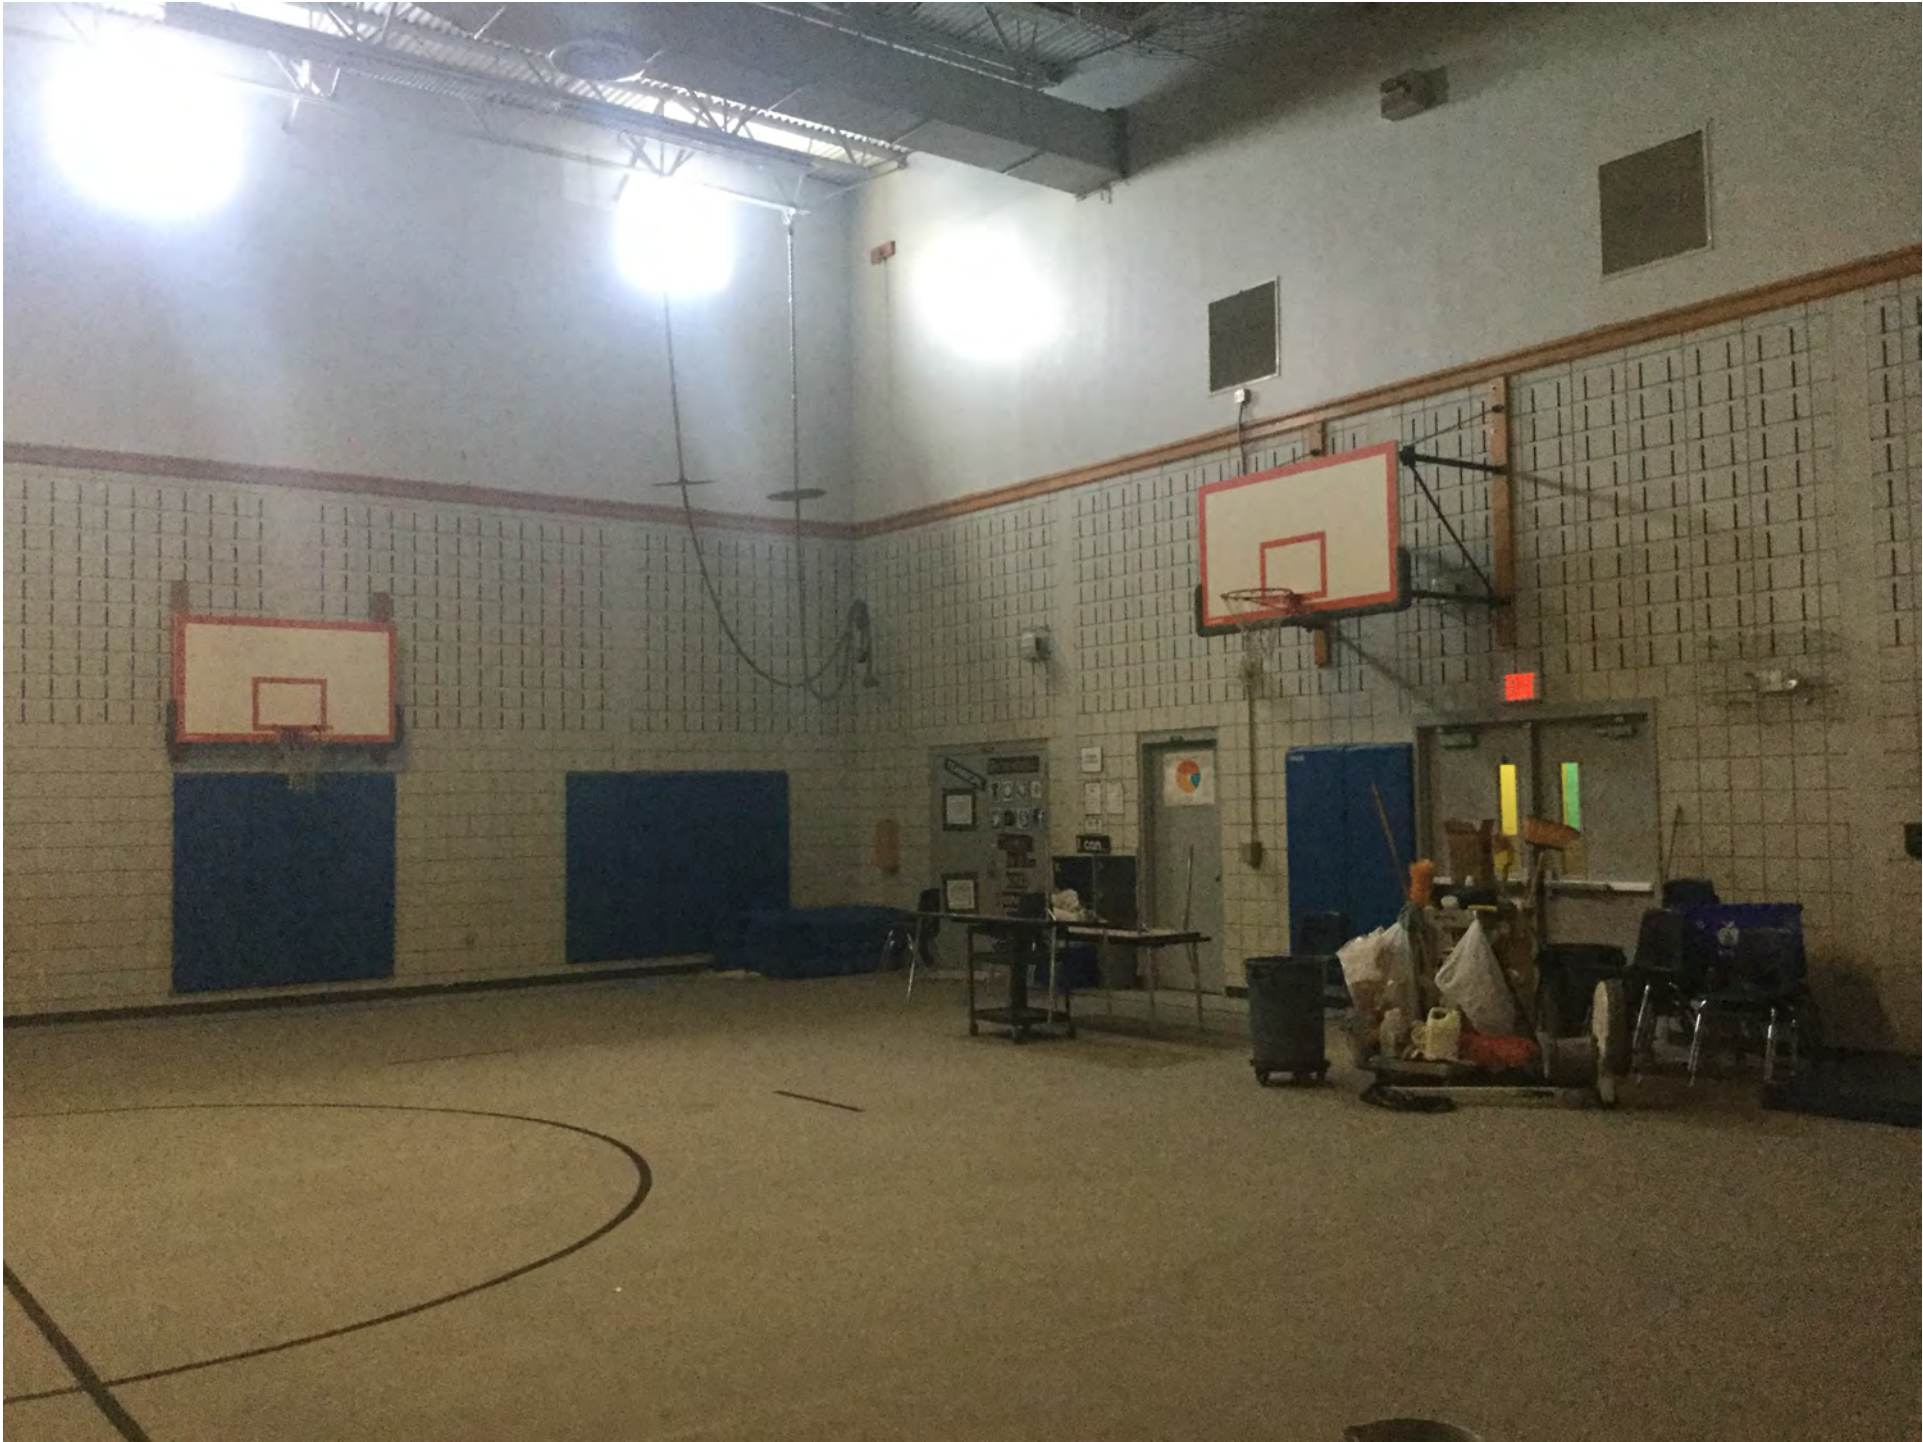
3.6 Gym

1) Very unsatisfactory 2) Unsatisfactory 3) Average 4) Good 5) Very good N/A) Does not apply.						Comments The gym is adequately sized. Carpet in the gym is not ideal for gym activities or cleaning purposes. <i>CAC comment: Due to space limitations and staffing constraints, sometimes 1.5 to 2 classes must use the gym at a time. Principal notes: only supports classes . The 2 other PE teachers either use blacktop or portable.</i>

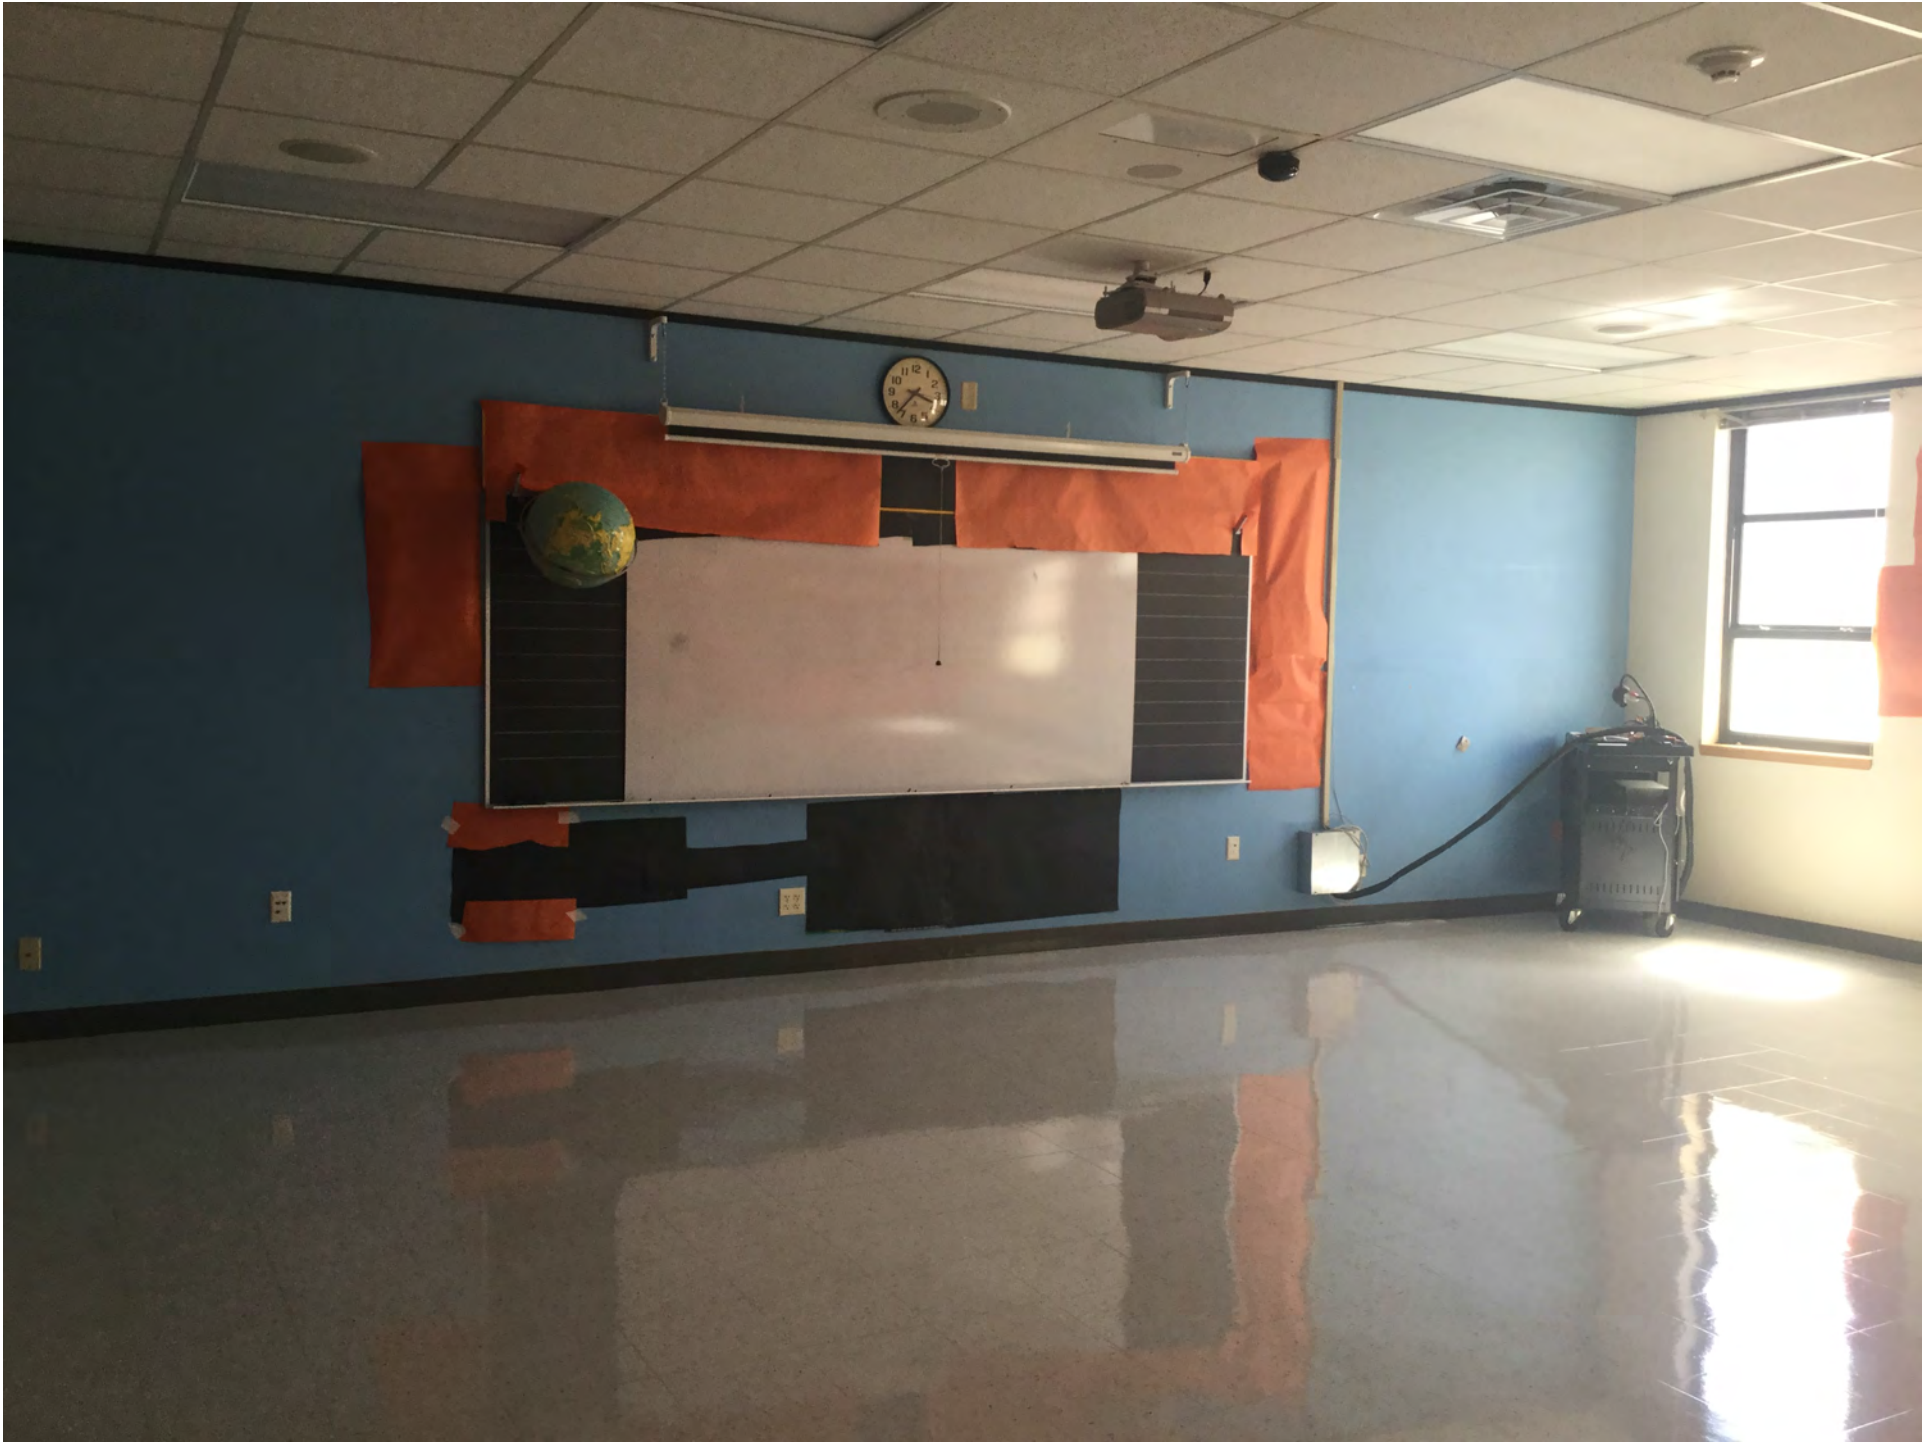
4.10 Visual Communication

4.10	Does the building have adequate visual communication tools?			3				Comments	1.00 3.00
1) Very unsatisfactory - No vis comm tools 2) Unsatisfactory - outdated, poorly functioning, or insufficient 3) Good - mix of old and new whiteboards/projectors/etc. 4) Good - projectors, marker boards, smart boards in most spaces - good condition 5) Very good - projectors, marker boards, smart boards in most spaces - new condition N/A) Does not apply.

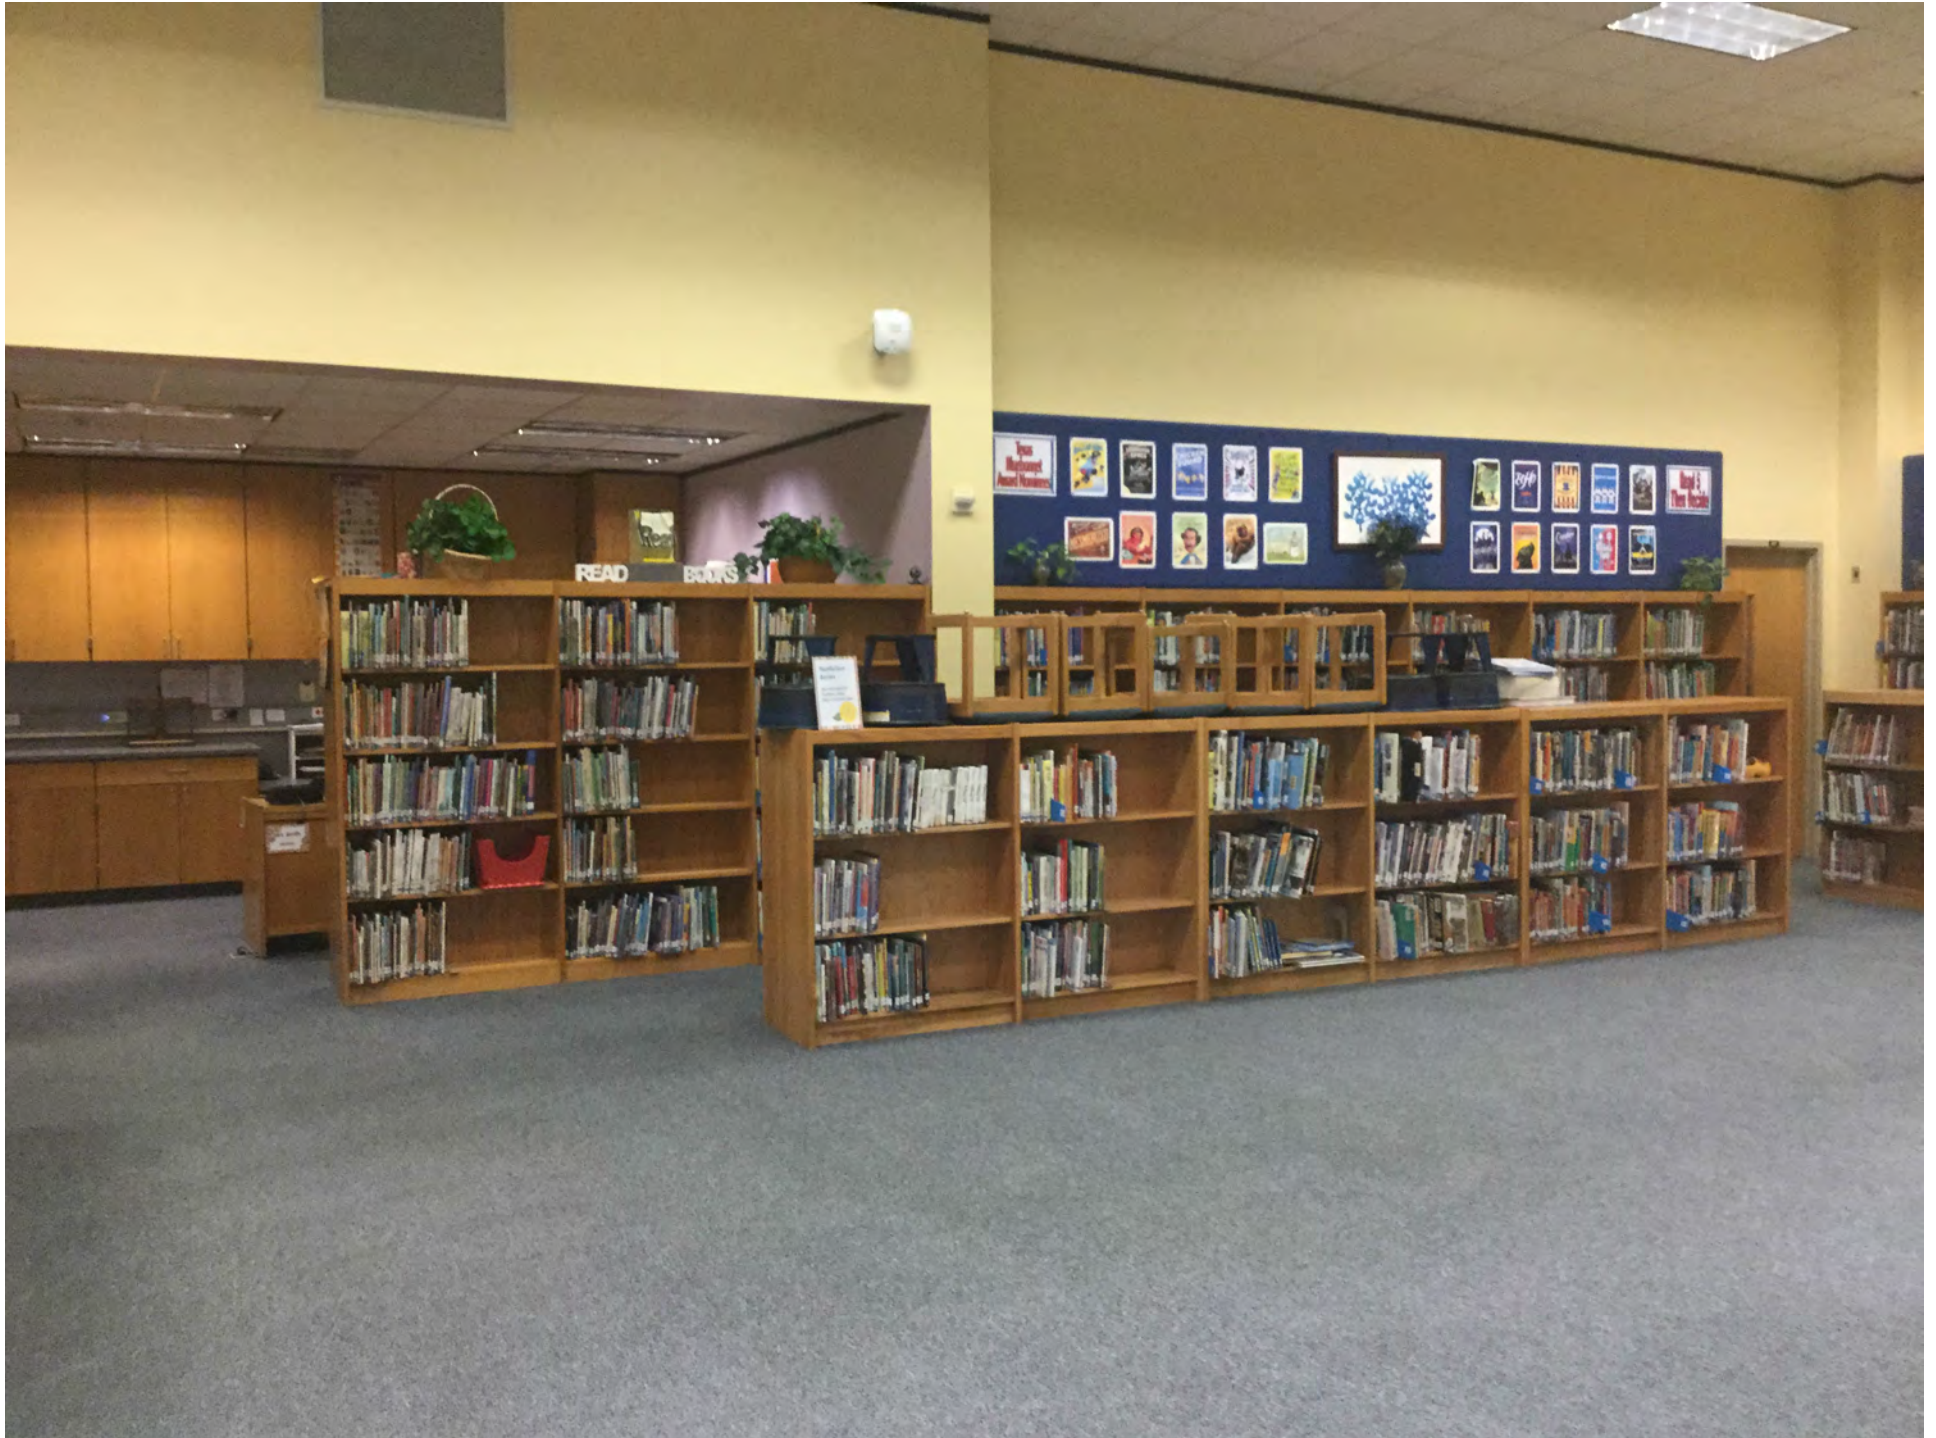
5.1 Library

1) Very unsatisfactory 2) Unsatisfactory 3) Average 4) Good 5) Very good N/A) Does not apply.								The library is not located to a main entrance. A visitor would be well within the building before they reached the entry to the library.
