Educational Suitability Summary Report

Kocurek Elementary School

Date: 07/21/2016

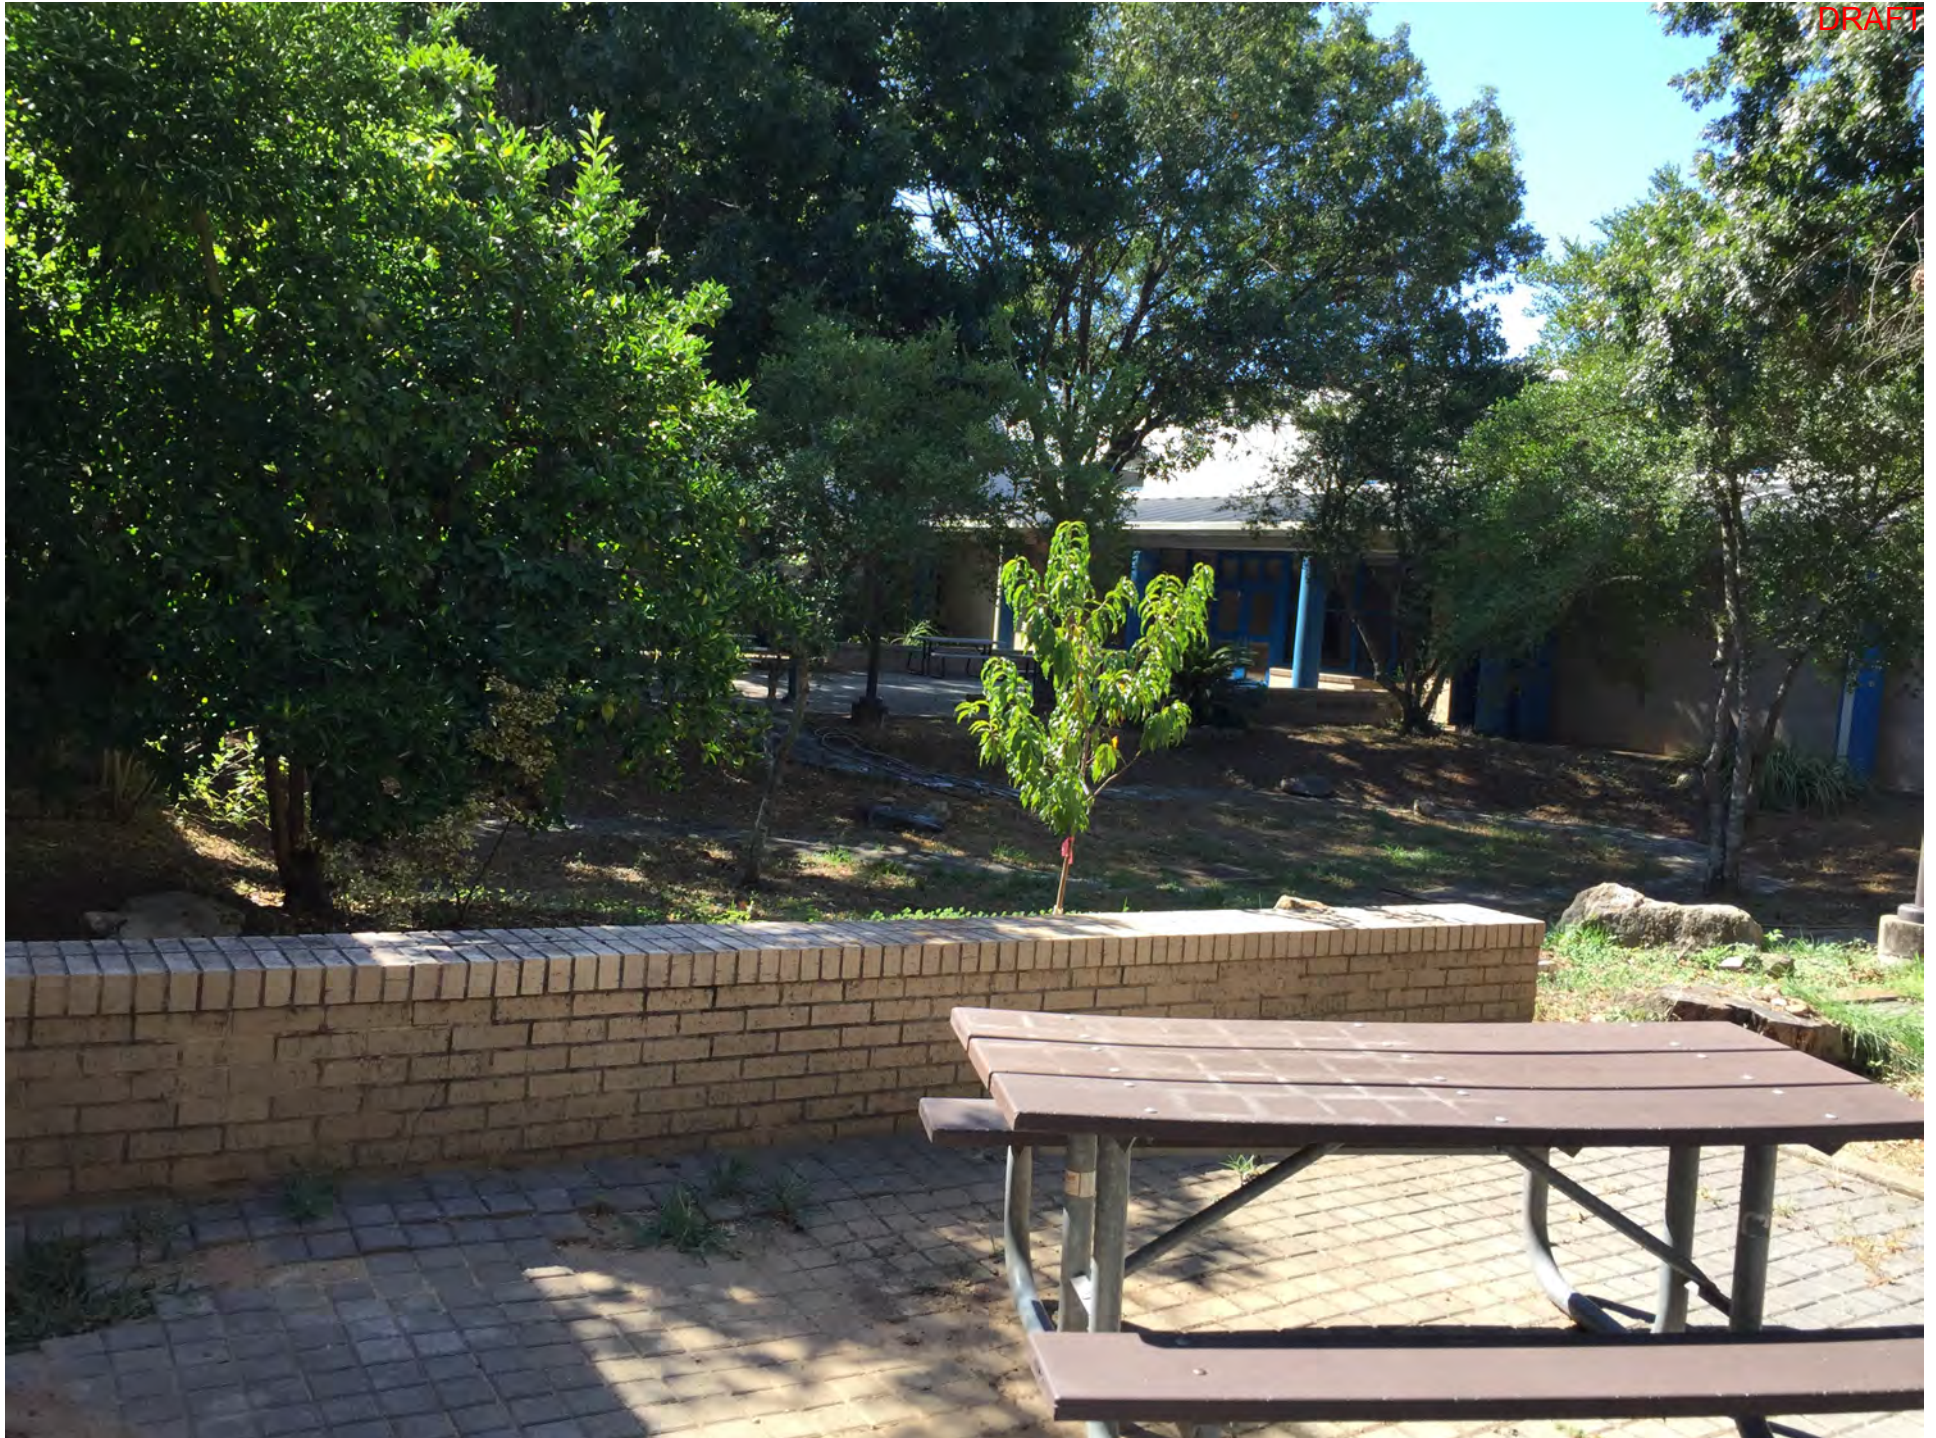
Photo 1.
1.3 Outdoor Space

1.3	Are outdoor play spaces and playfields adequate in size and configuration?				4			Comments	1.00 4.00
	1) Outdoor play space exists, not developed 2) Outdoor play space exists but is not connected to gym or other athletic support areas or is too small. 3. Outdoor play spaces exist, are connected to other athletic areas, are the right size, but are not in good condition. 4. Outdoor play spaces need minor improvements to function well. 5. Outdoor play spaces are in excellent condition. N/A) Does not apply.							The track is in poor condition. Landscaping is needed.	
									see photo 1

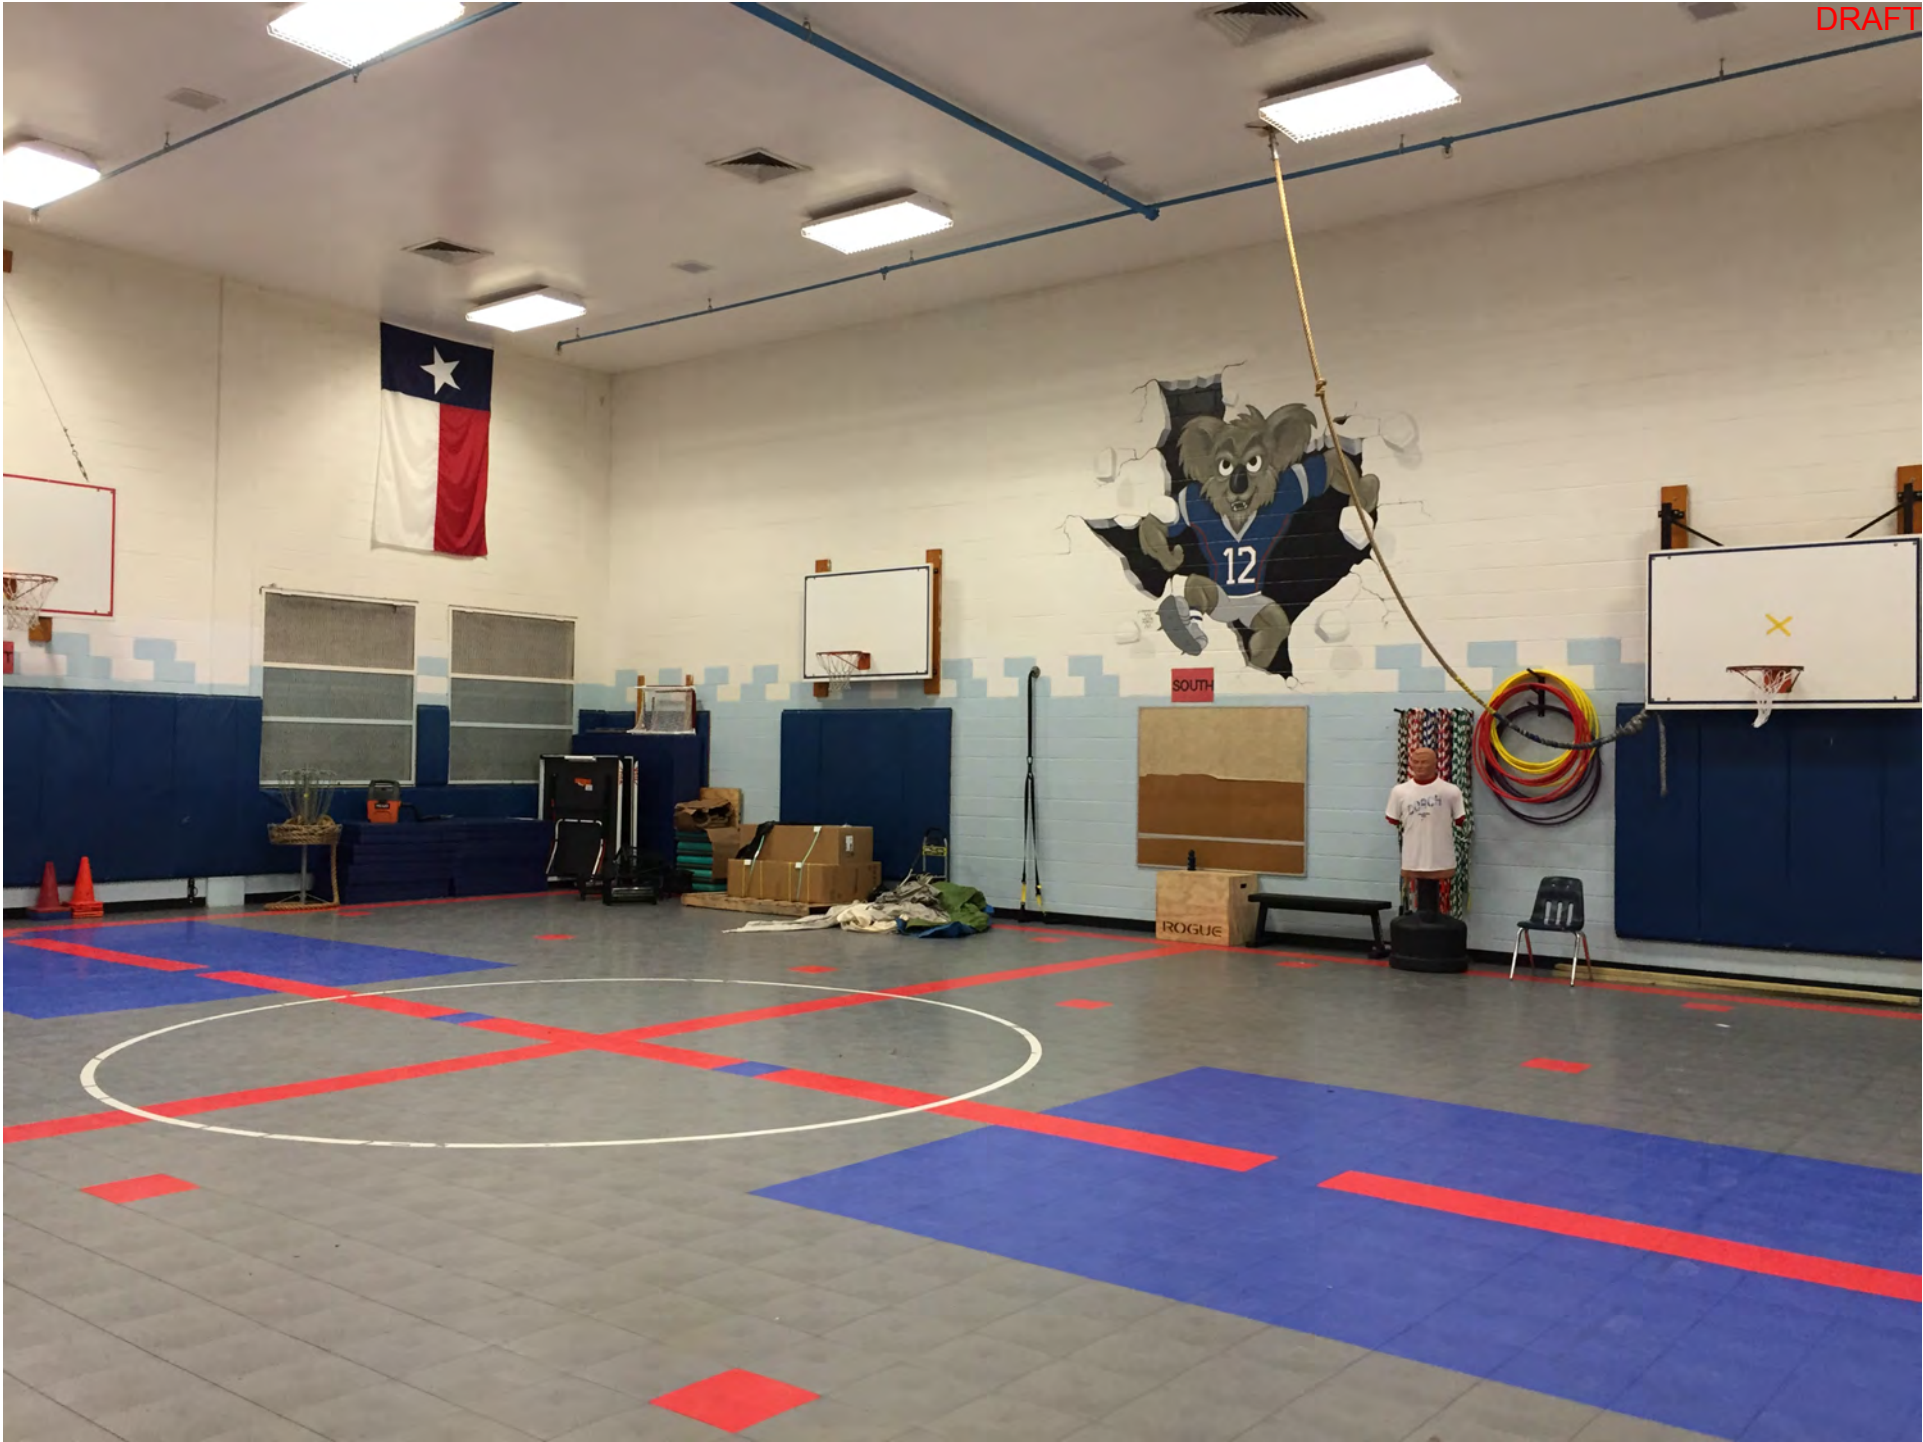
Photo 2.
3.7 Gym

3.7	Are Physical Education and Athletic support spaces appropriately configured per the ed spec?			3				Comments	1.003.00
<div>1) Very unsatisfactory - Support spaces are disconnected from served spaces, too small, do not meet needs</div> <div>2) Unsatisfactory - Support spaces are connected, but too small, inadequate for needs</div> <div>3) Average - Connected, moderate size, but need some renovations or updates to function well</div> <div>4) Good - Connected, good size/layout, meets needs/functions well</div> <div>5) Very good - connected, generous size, nice condition, functions appropriately</div> <div>N/A) Does not apply.</div>								The athletic support spaces are not connected to the gym and are moderate in size.	
								see photo 2

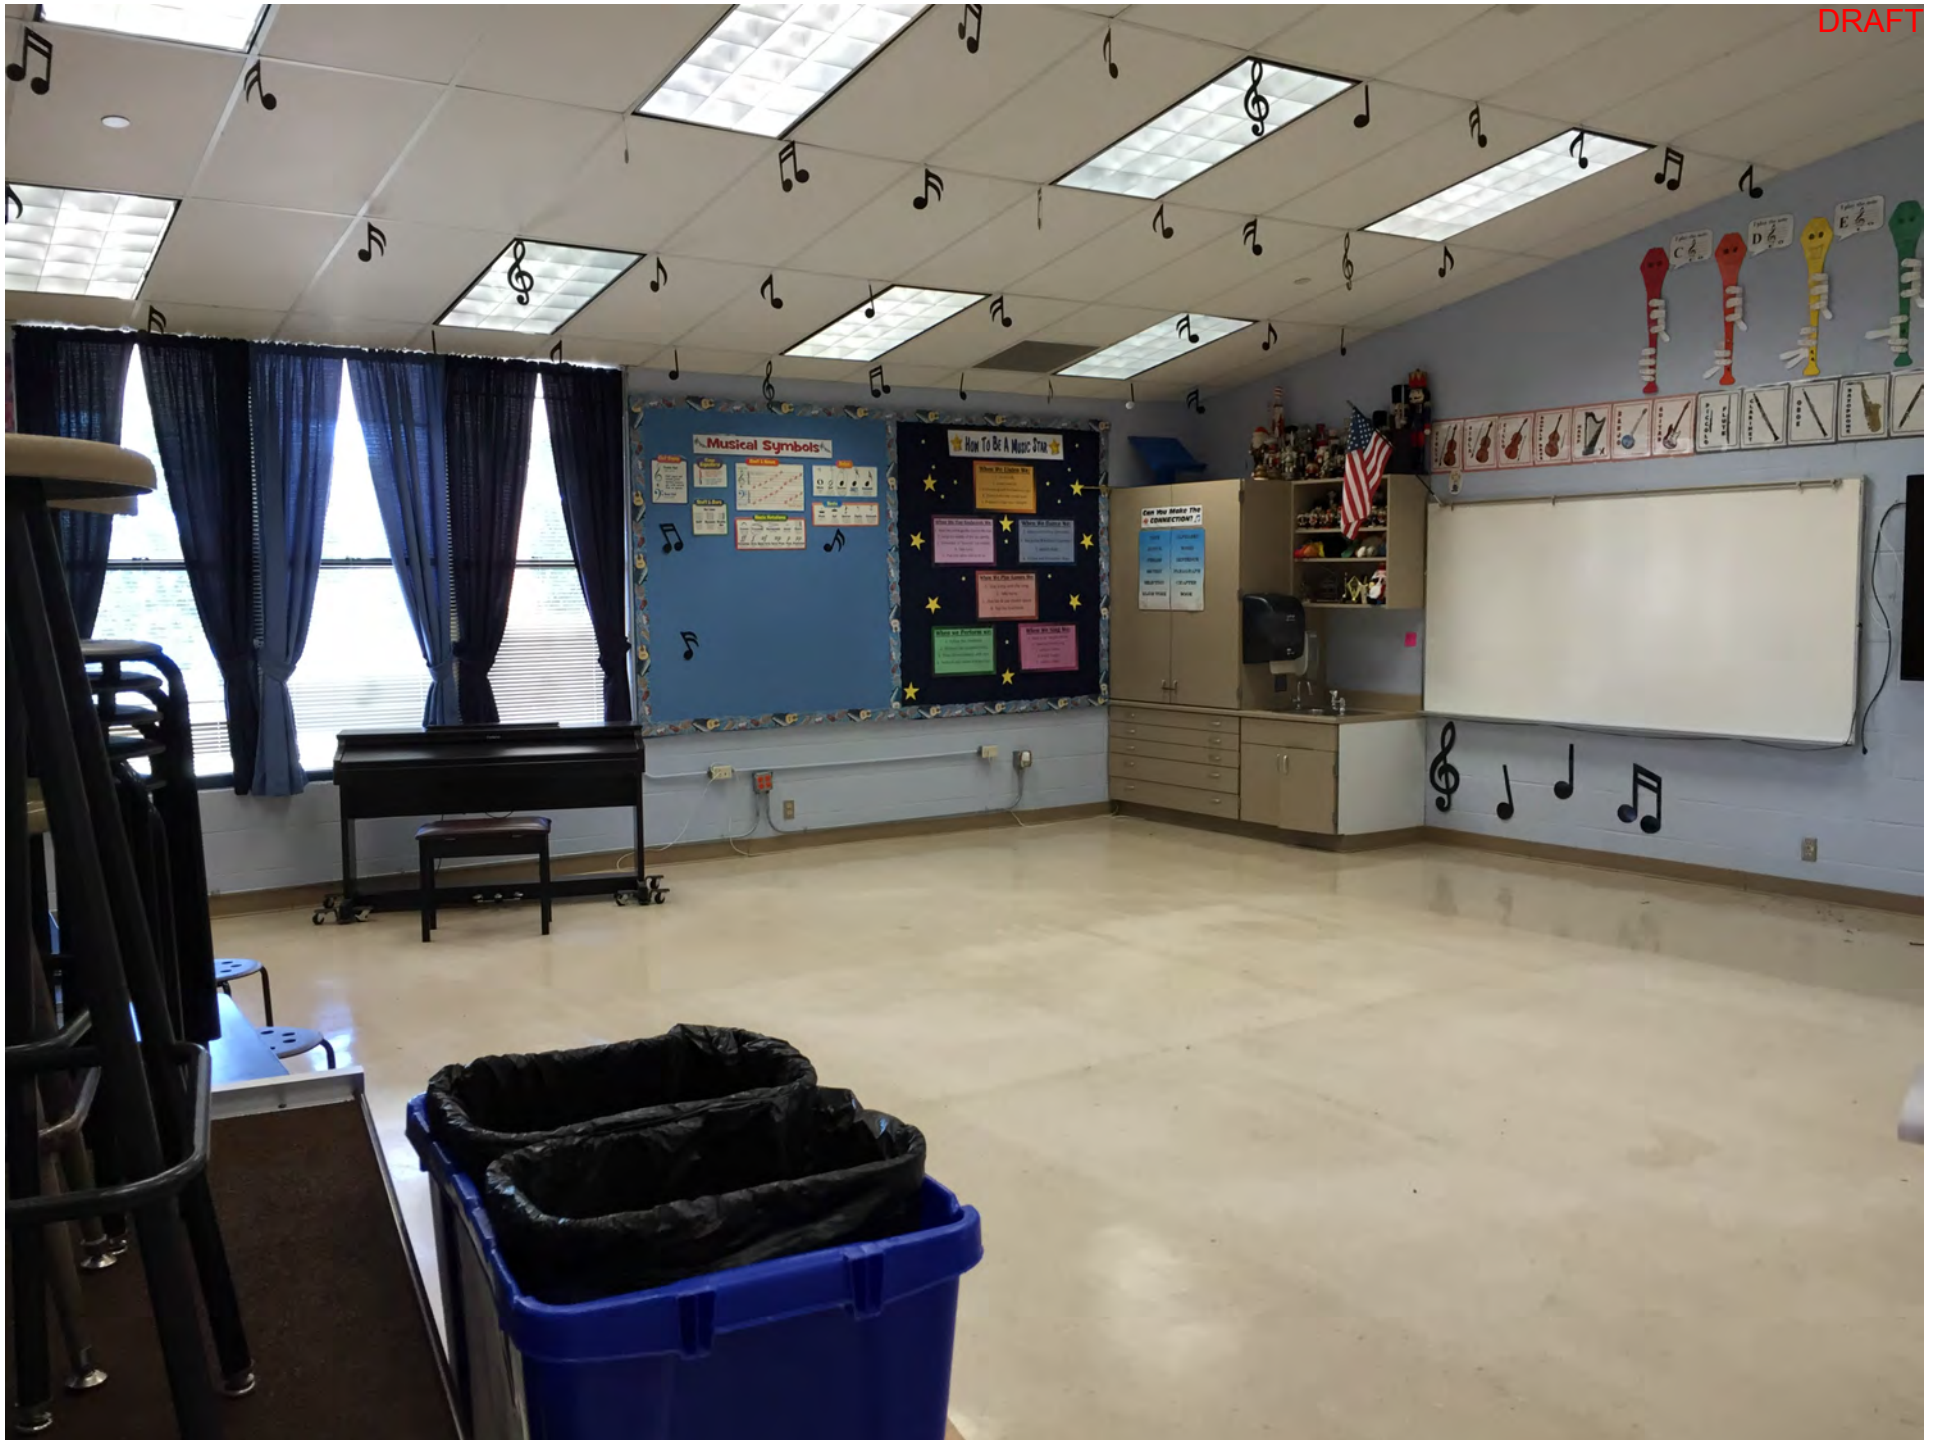
Photo 3.
3.8 Music Room

3.8	Are music, drama, or performance spaces appropriately configured per the ed spec?					5		Comments	1.005.00
<div>1) Very unsatisfactory</div> <div>2) Unsatisfactory</div> <div>3) Average</div> <div>4) Good</div> <div>5) Very good</div> <div>N/A) Does not apply.</div>									
								see photo 3

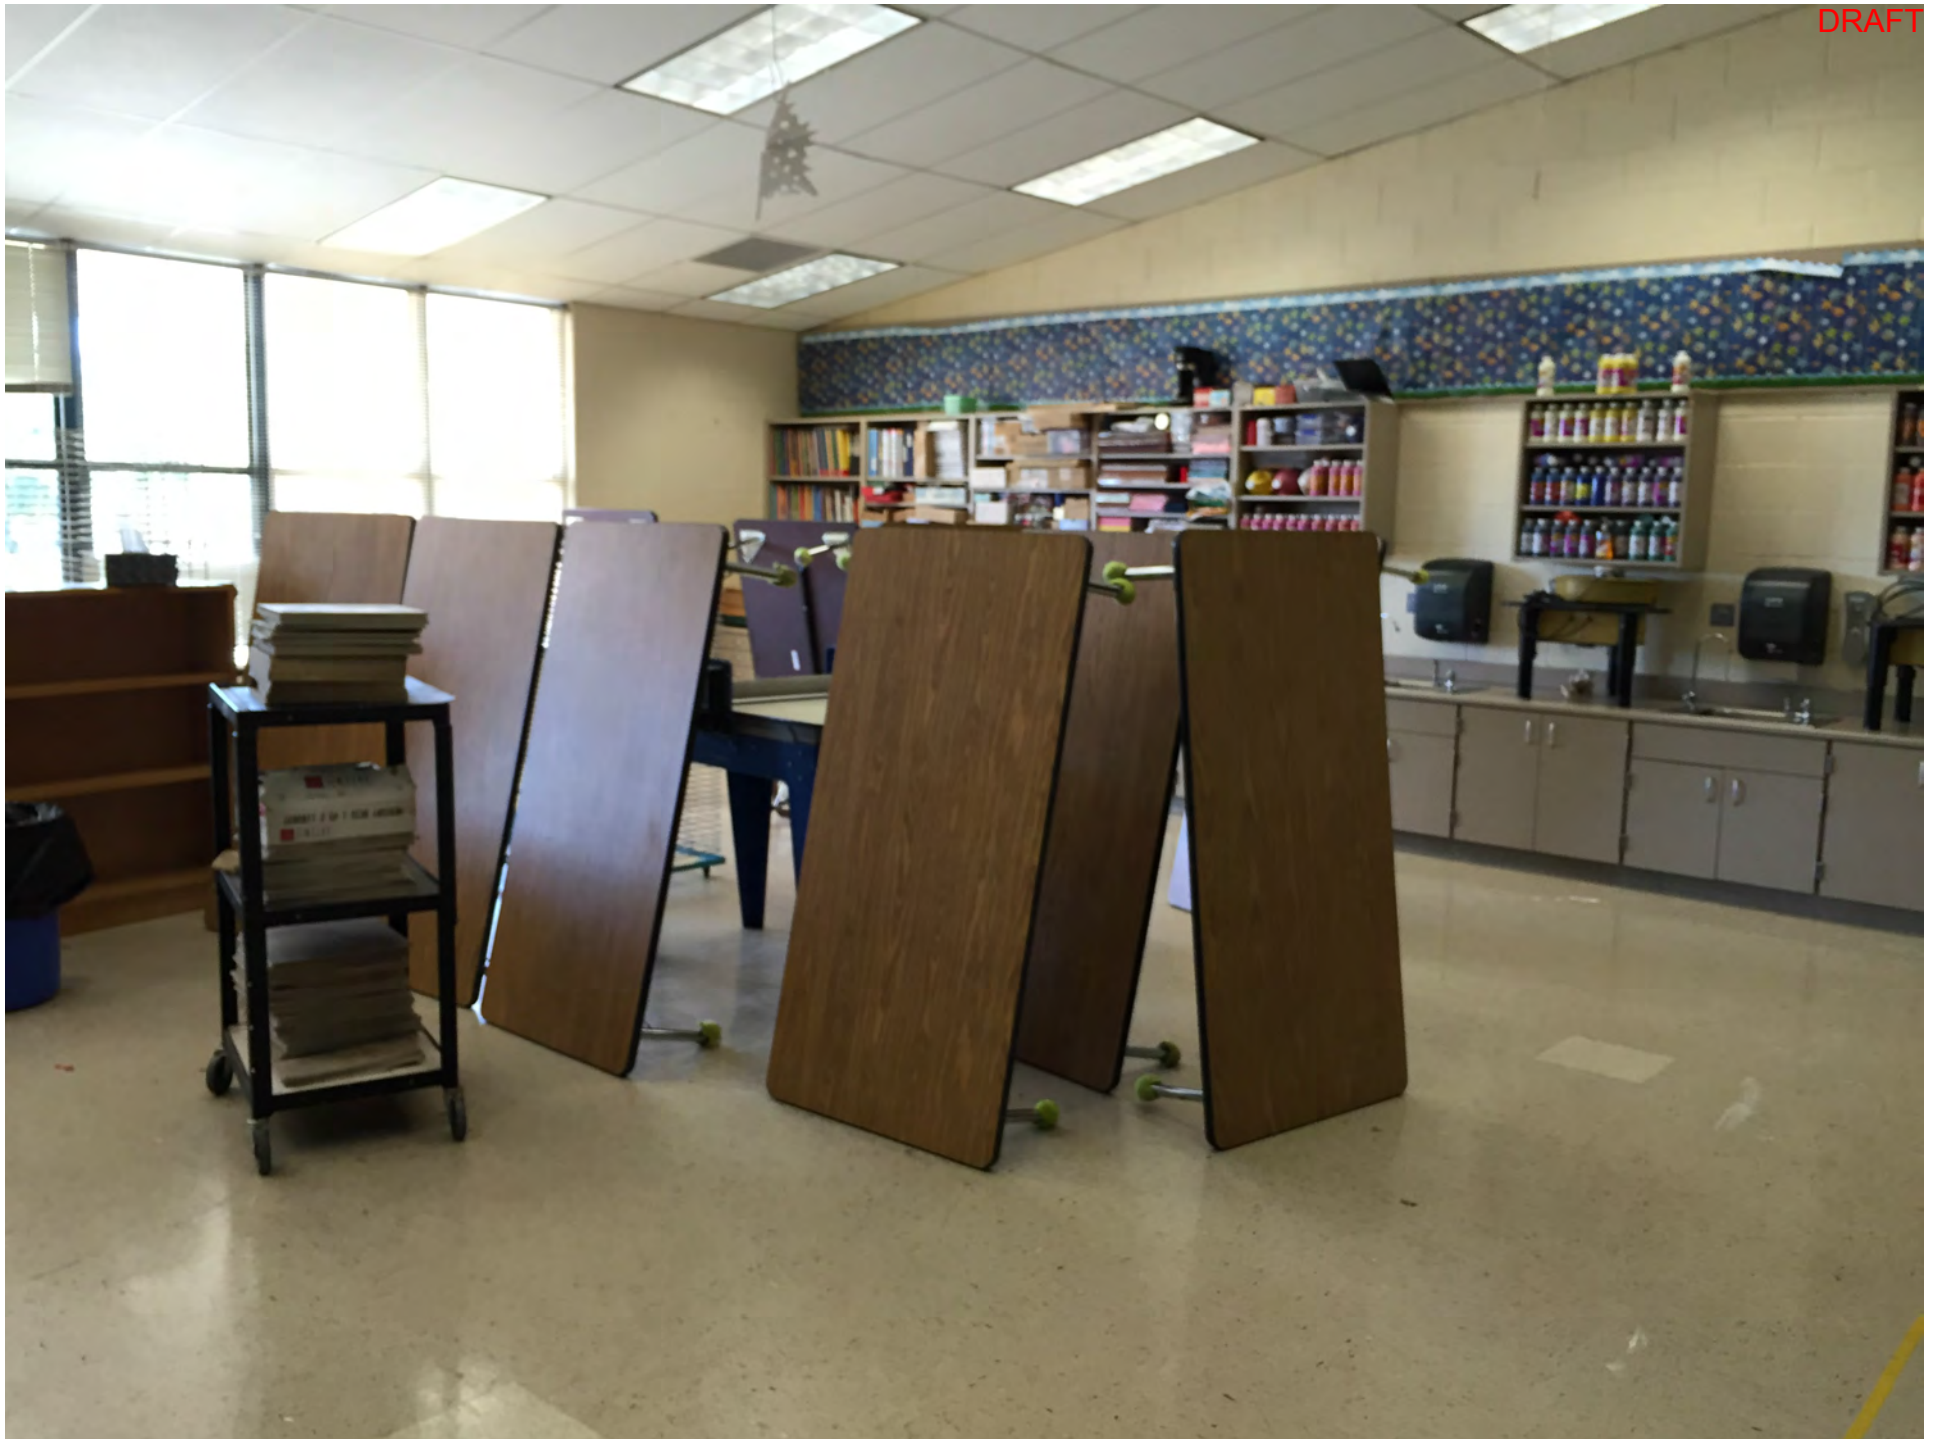
Photo 4.
3.11 Art Room

3.11	Are Visual Arts support spaces appropriately configured per the ed spec?					5							Comments	1.00	5.00
<div>1) Very unsatisfactory - Support spaces are disconnected from served spaces, too small, do not meet needs</div> <div>2) Unsatisfactory - Support spaces are connected, but too small, inadequate for needs</div> <div>3) Average - Connected, moderate size, but need some renovations or updates to function well</div> <div>4) Good - Connected, good size/layout, meets needs/functions well</div> <div>5) Very good - connected, generous size, nice condition, functions appropriately</div> <div>N/A) Does not apply.</div>													see photo 4

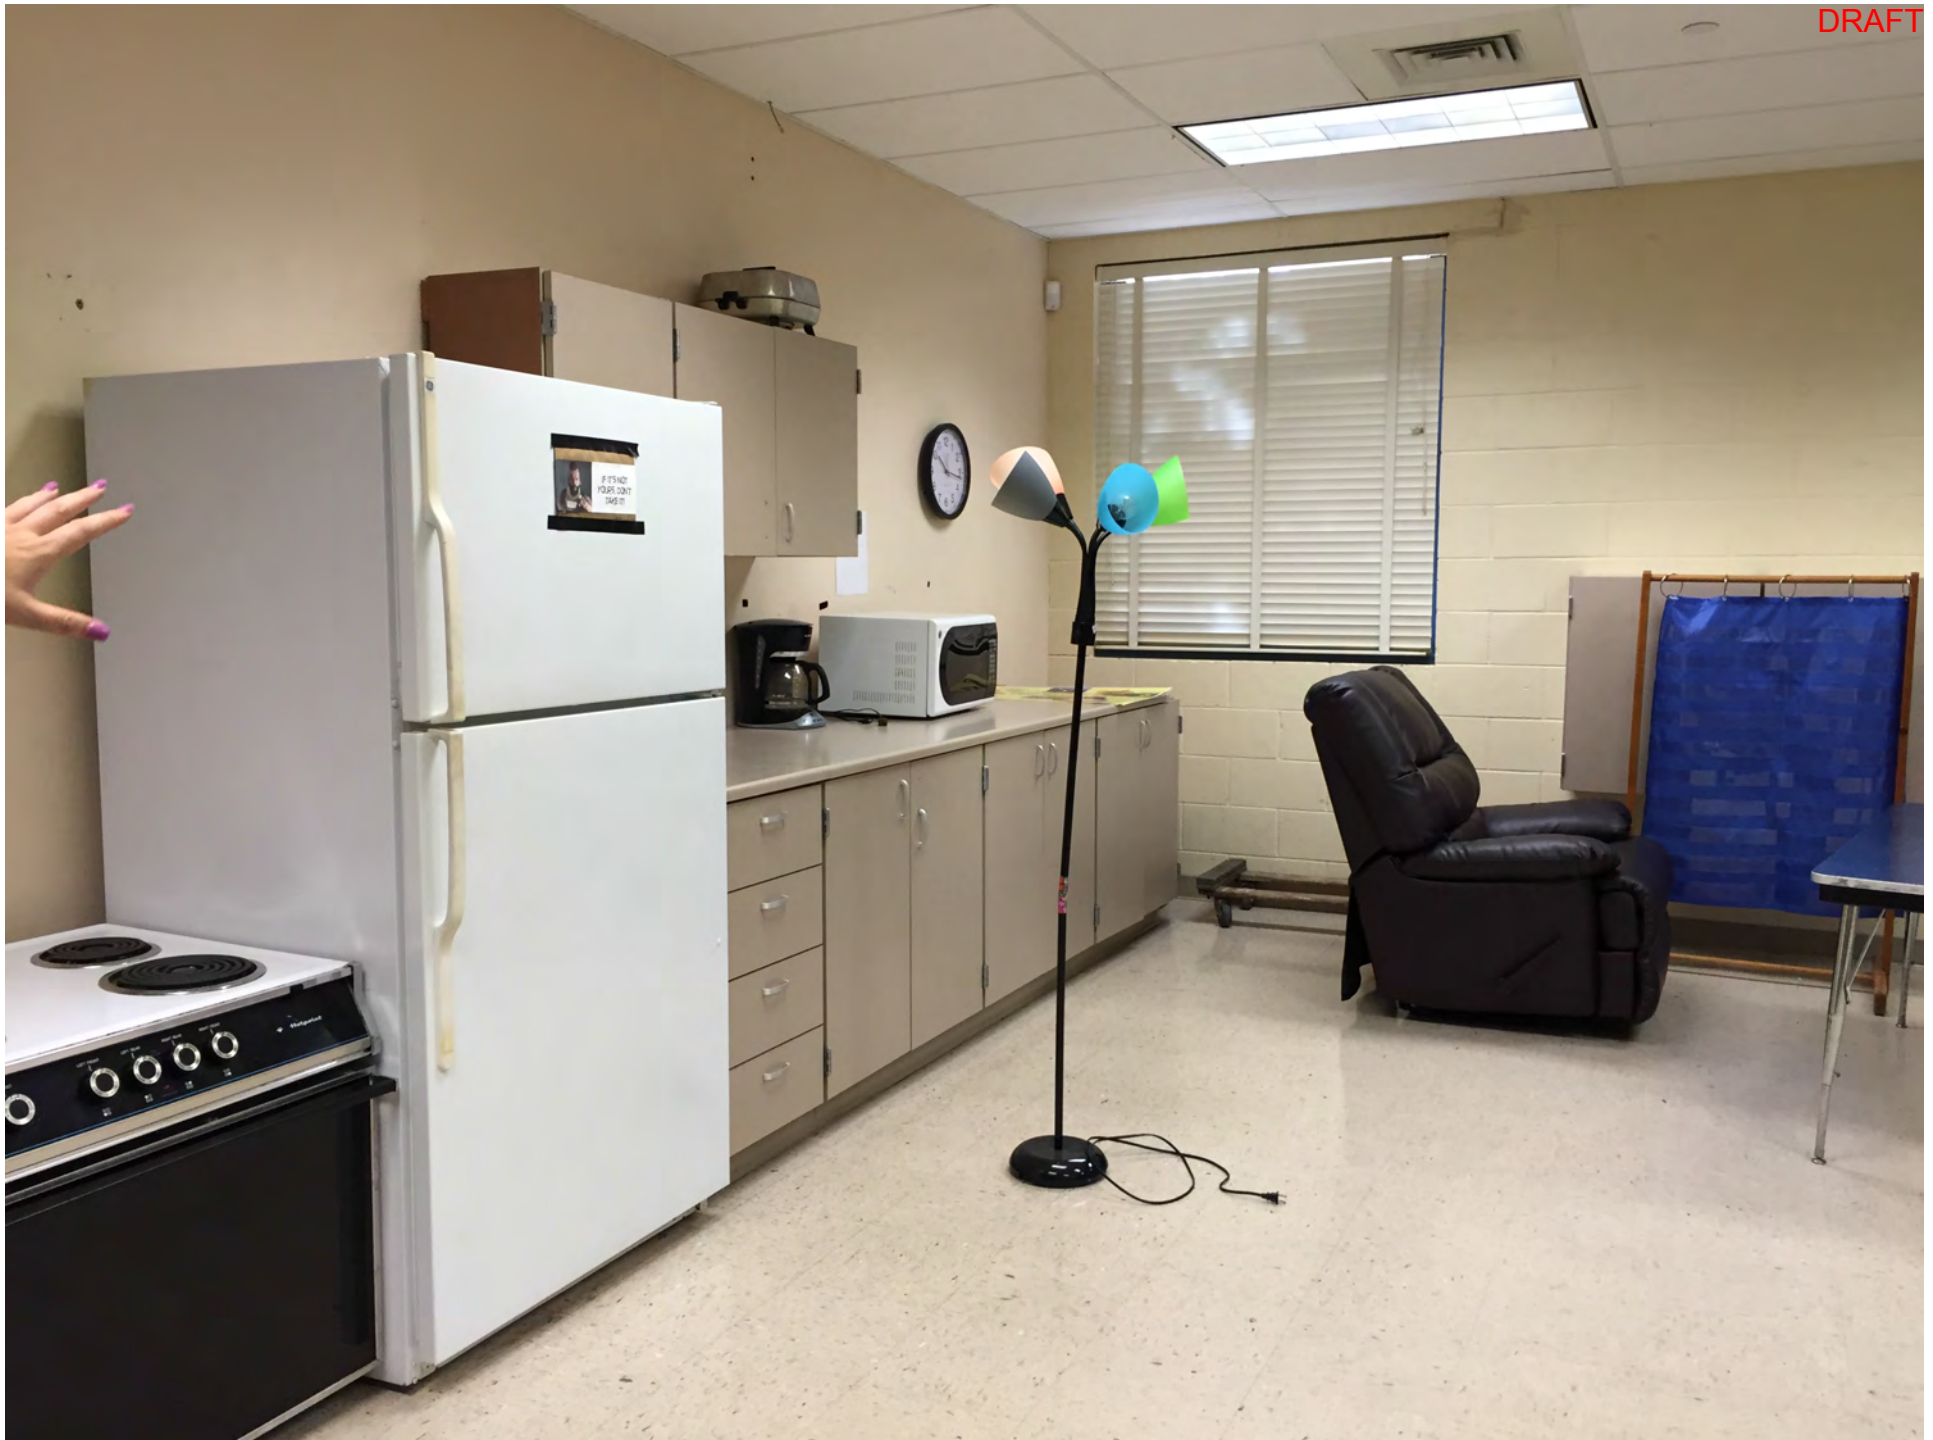
Photo 5.
3.15 Special Ed Support Space

3.15	Are Special Education support spaces appropriately configured per the ed spec?													5		Comments	1.00	5.00	
1) Very unsatisfactory - Support spaces are disconnected from served spaces, too small, do not meet needs 2) Unsatisfactory - Support spaces are connected, but too small, inadequate for needs 3) Average - Connected, moderate size, but need some renovations or updates to function well 4) Good - Connected, good size/layout, meets needs/functions well 5) Very good - connected, generous size, nice condition, functions appropriately N/A) Does not apply.																			A new restroom is being constructed with a shower. There is no office space.
																			see photo 5

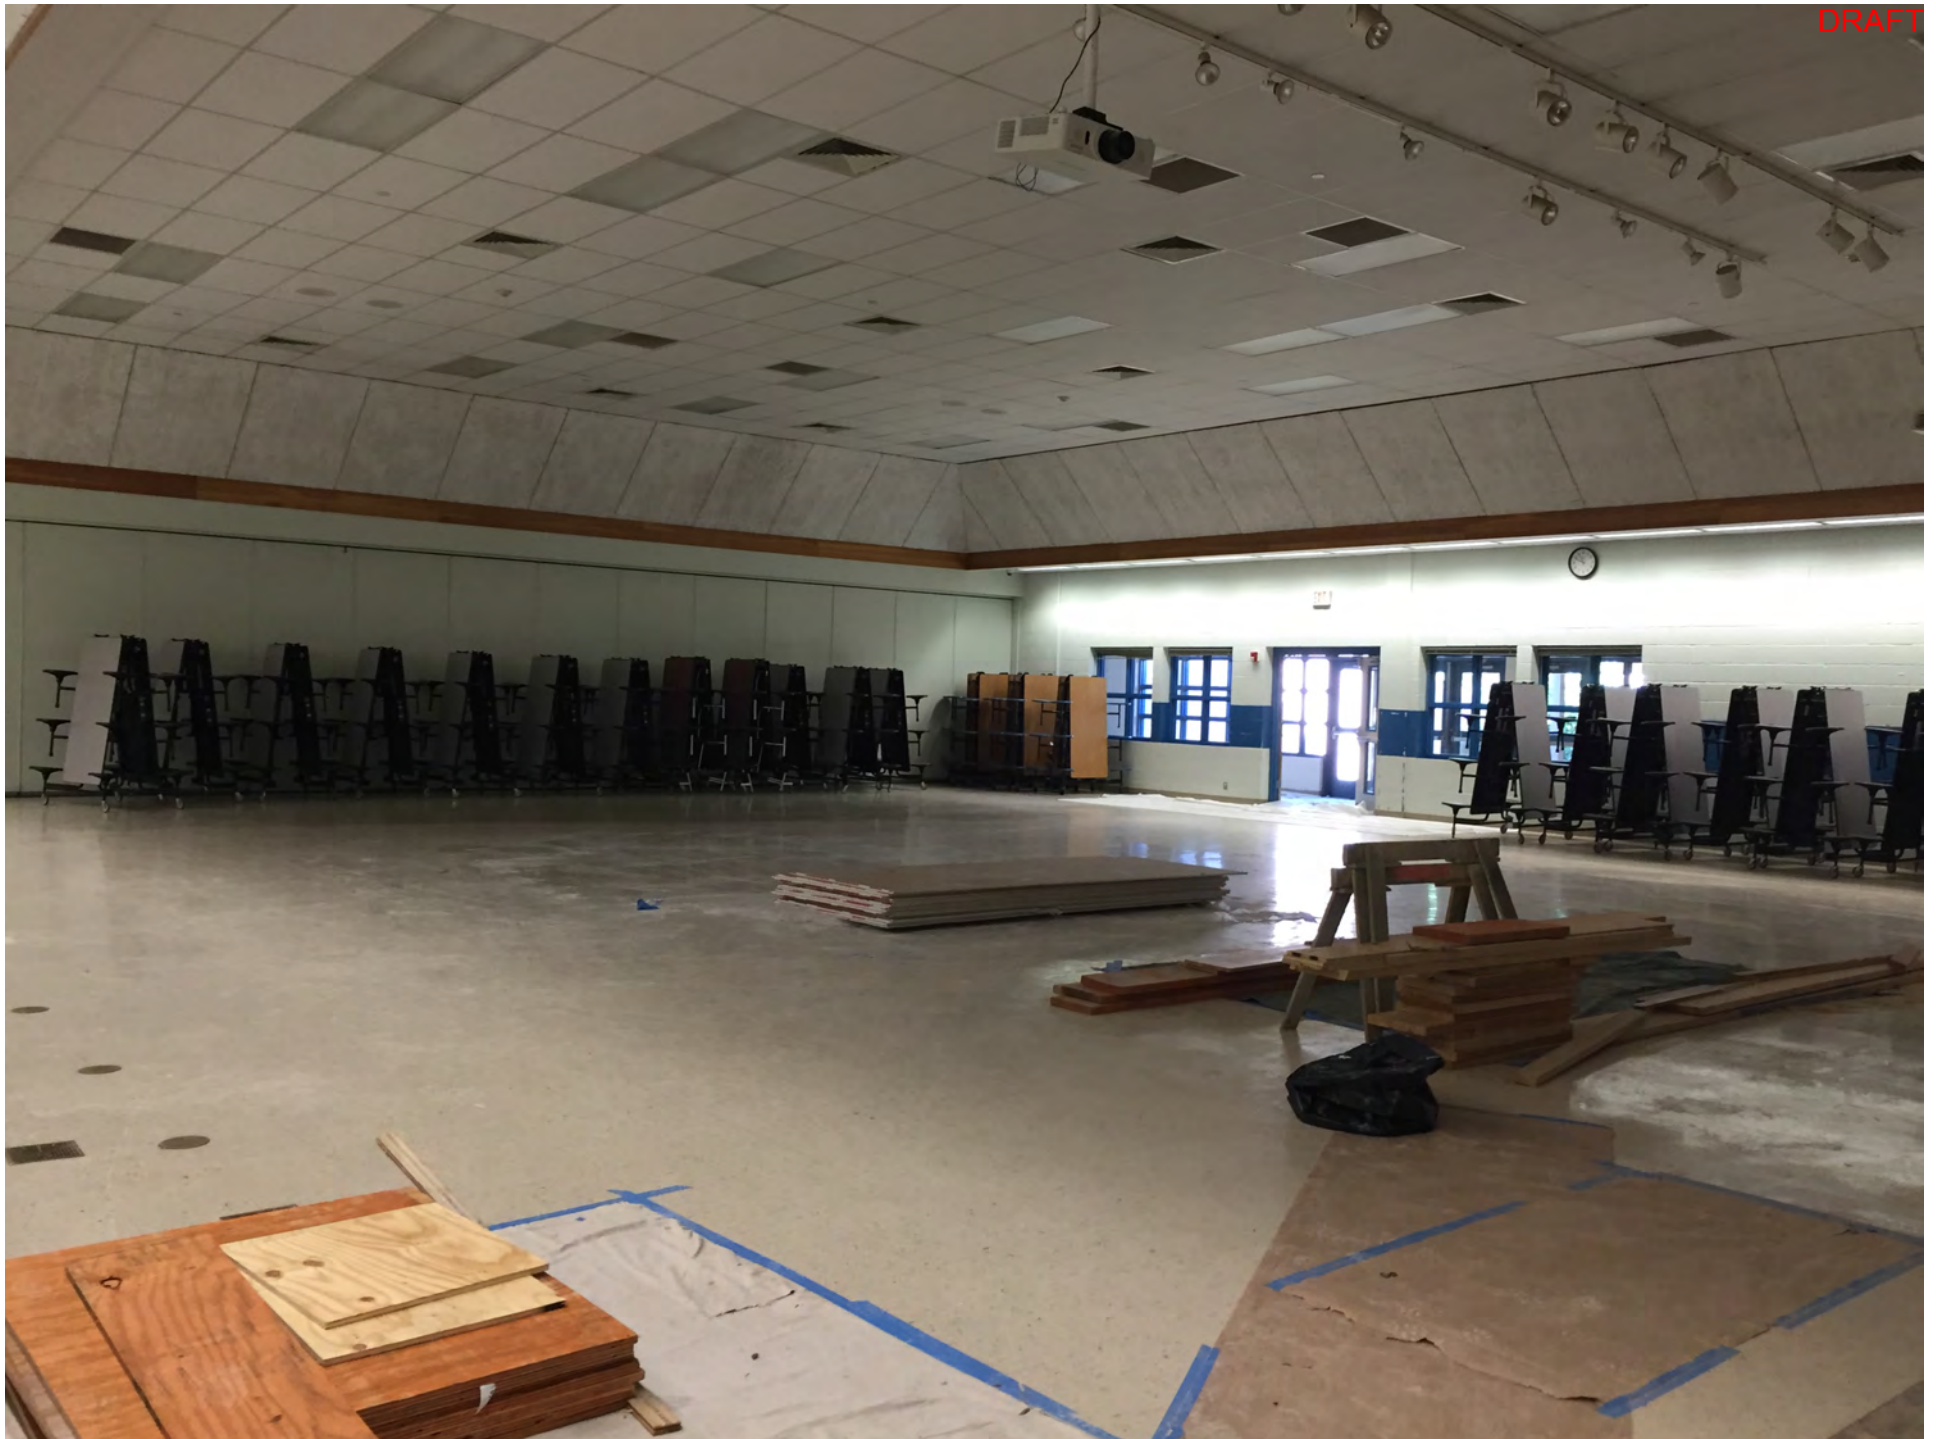
Photo 6.
3.16 Cafetorium

3.16	Are the student dining facilities appropriately configured?													5		Comments	1.00	5.00	
1) Very unsatisfactory - Too small, poor circulation, inflexible seating in poor condition 2) Unsatisfactory - Too small or inadequate circulation, seating in poor condition 3) Average - moderate size, with adequate circulation, seating in okay condition 4) Good - good size, adequate circulation, seating in good condition 5) Very good - good size, adequate circulation, seating in good condition, with more than one option for eating space (ex: connection to outdoor eating space) N/A) Does not apply.																			There is an opportunity for outdoor eating if the courtyard space was set up for this purpose.
																			see photo 6

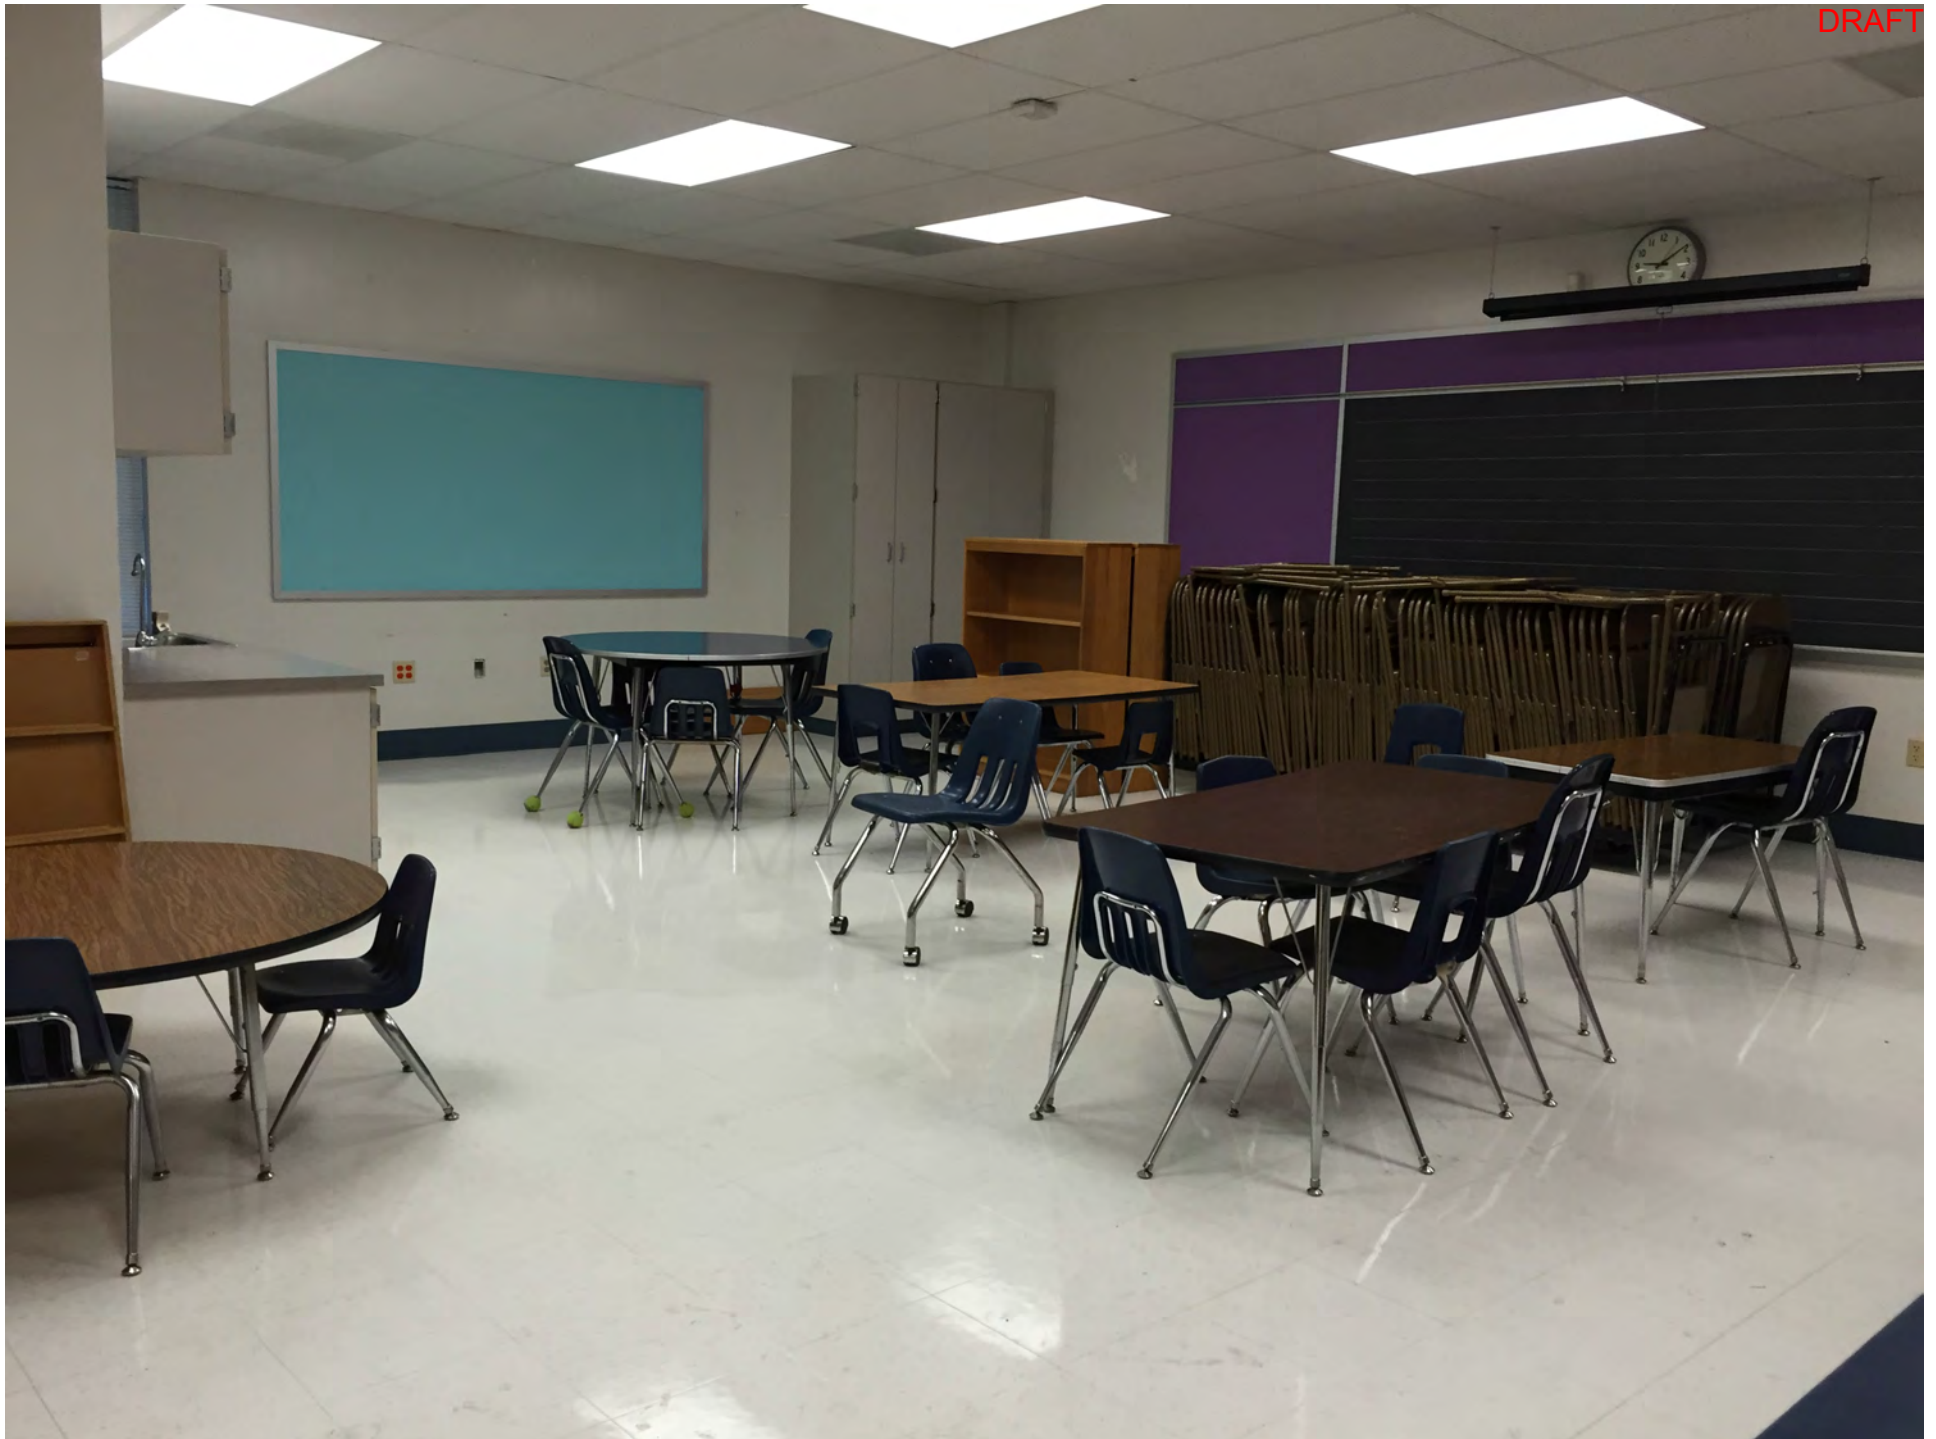
Photo 7.
4.2 Standard Classroom

4.2	Are general classrooms large enough to support project-based learning and multiple teaching modalities?				4			Comments	1.00 4.00
1) Very unsatisfactory -too small to move, set for lecture only, no connectivity, no flexibility 2) Unsatisfactory - adequate size but set for lecture only, no connectivity, no flexibility 3) Neutral - have flexibility and space for hands on or project based learning 4) Satisfactory - have flexibility and space for hands on or project based learning and connectivity for global learning 5) Very Satisfactory - space for hands on learning, flexibility for different groupings, and connectivity for global classrooms N/A) Does not apply.								Kindergarten, 2nd grade, music , and art rooms are extremely spacious while the rest of the classrooms could benefit from more space.	
								see photo 7
