Educational Suitability Summary Report

Kocurek Elementary School

Date: 07/21/2016

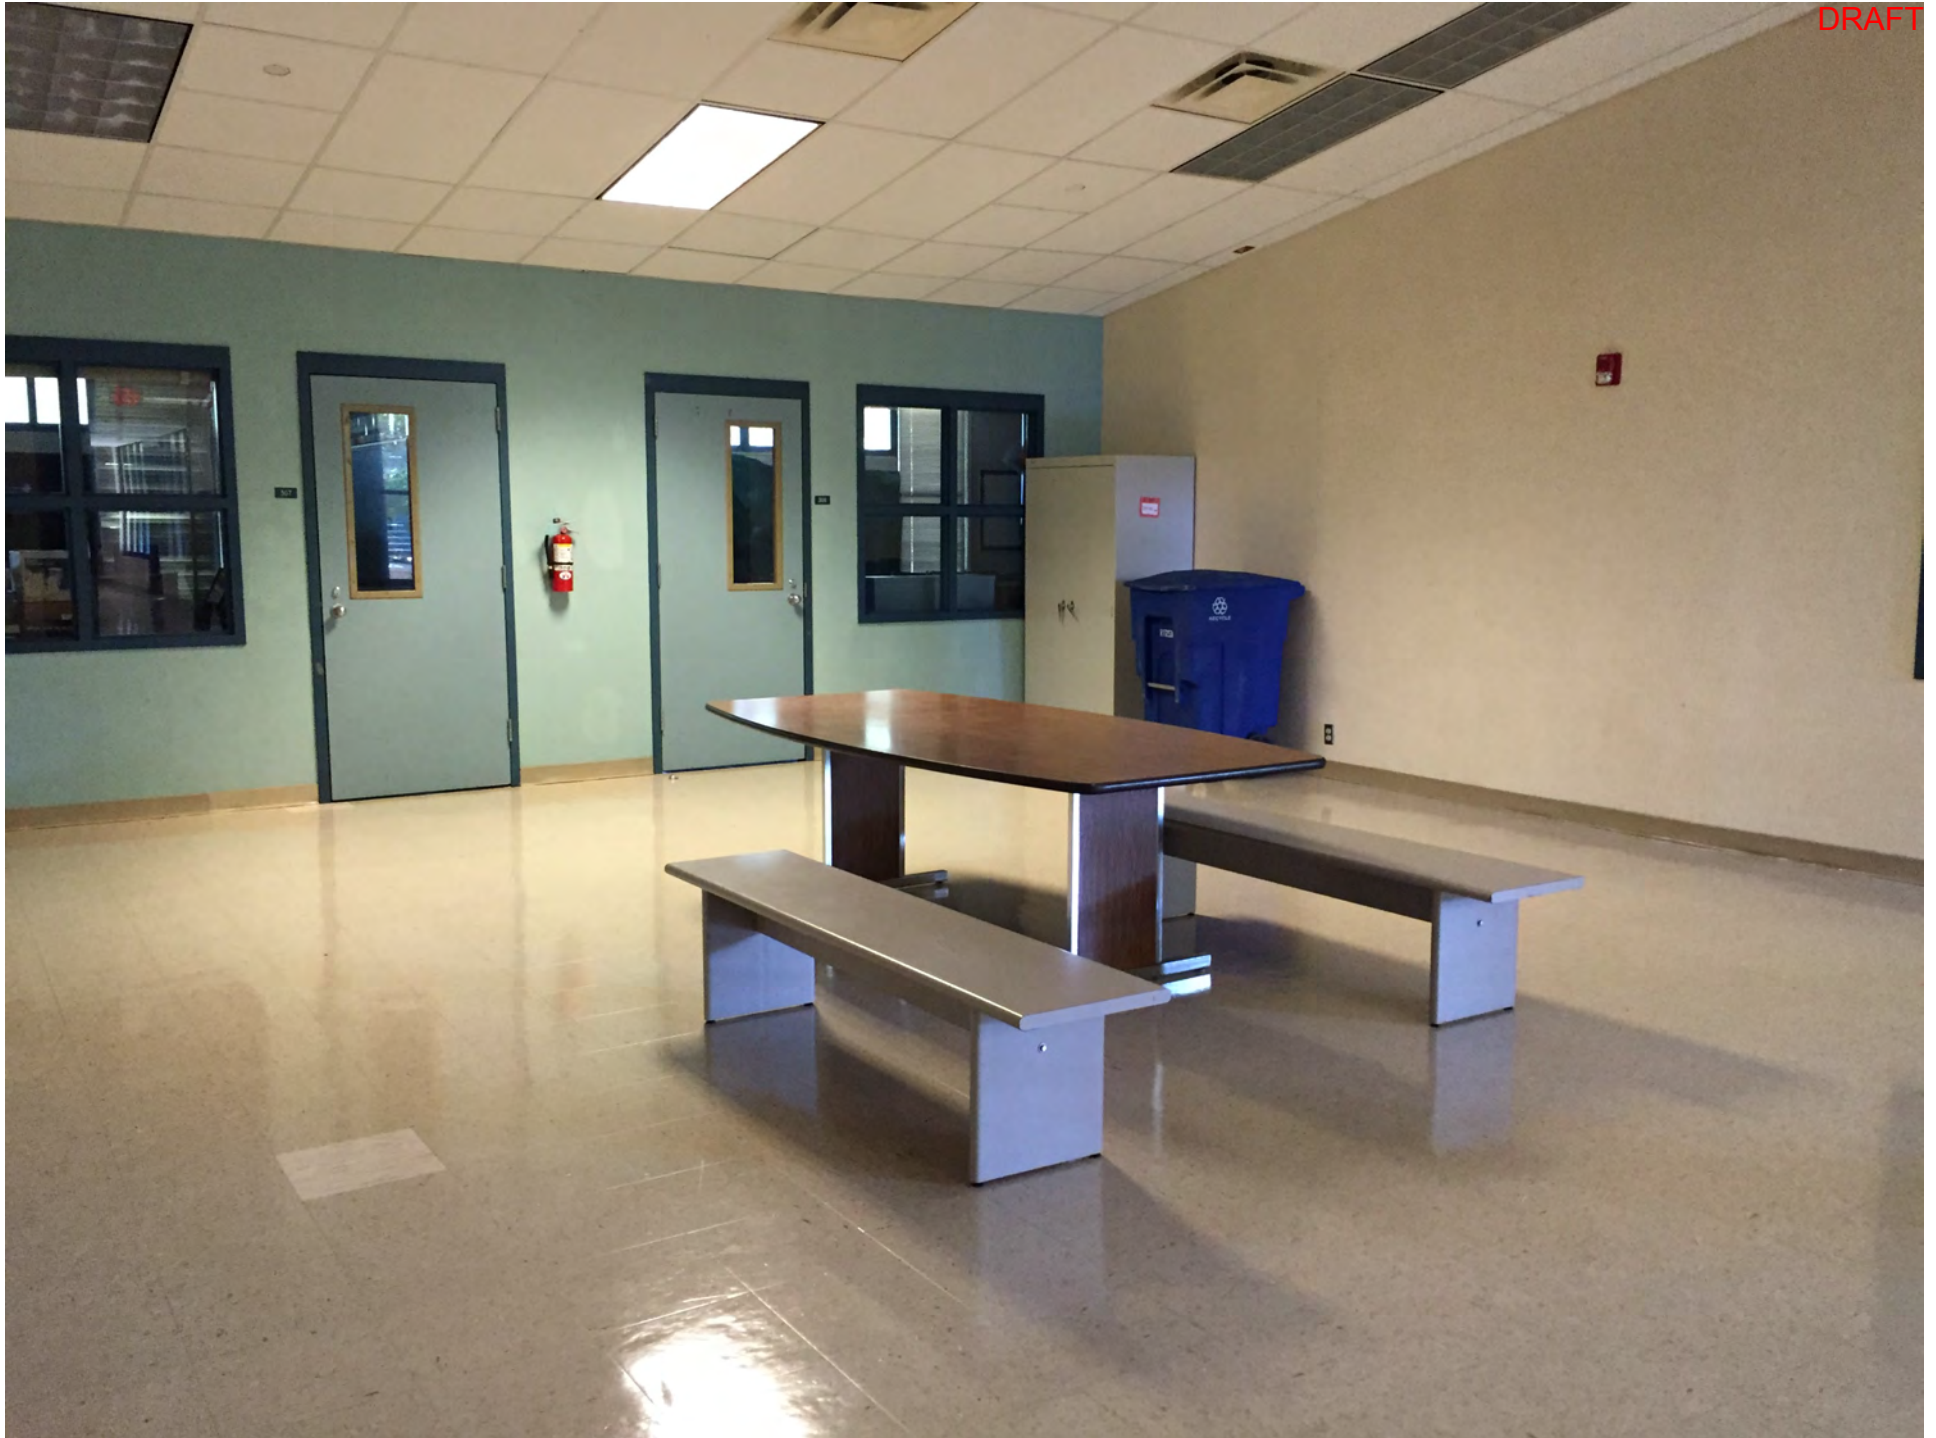
Photo 8.
4.5 Collaborative Space

1) Very unsatisfactory - no common spaces or meeting rooms or in very poor condition 2) Unsatisfactory - a few common spaces or meeting rooms in unsatisfactory condition 3) Average - a few common spaces and meeting areas needing updates 4) Good - multiple common spaces and meeting rooms in good condition 5) Very good - adequate common spaces and meeting rooms of excellent quality N/A) Does not apply.								Teacher collaborative spaces are lacking and conference rooms are inadequate.	see photo 8

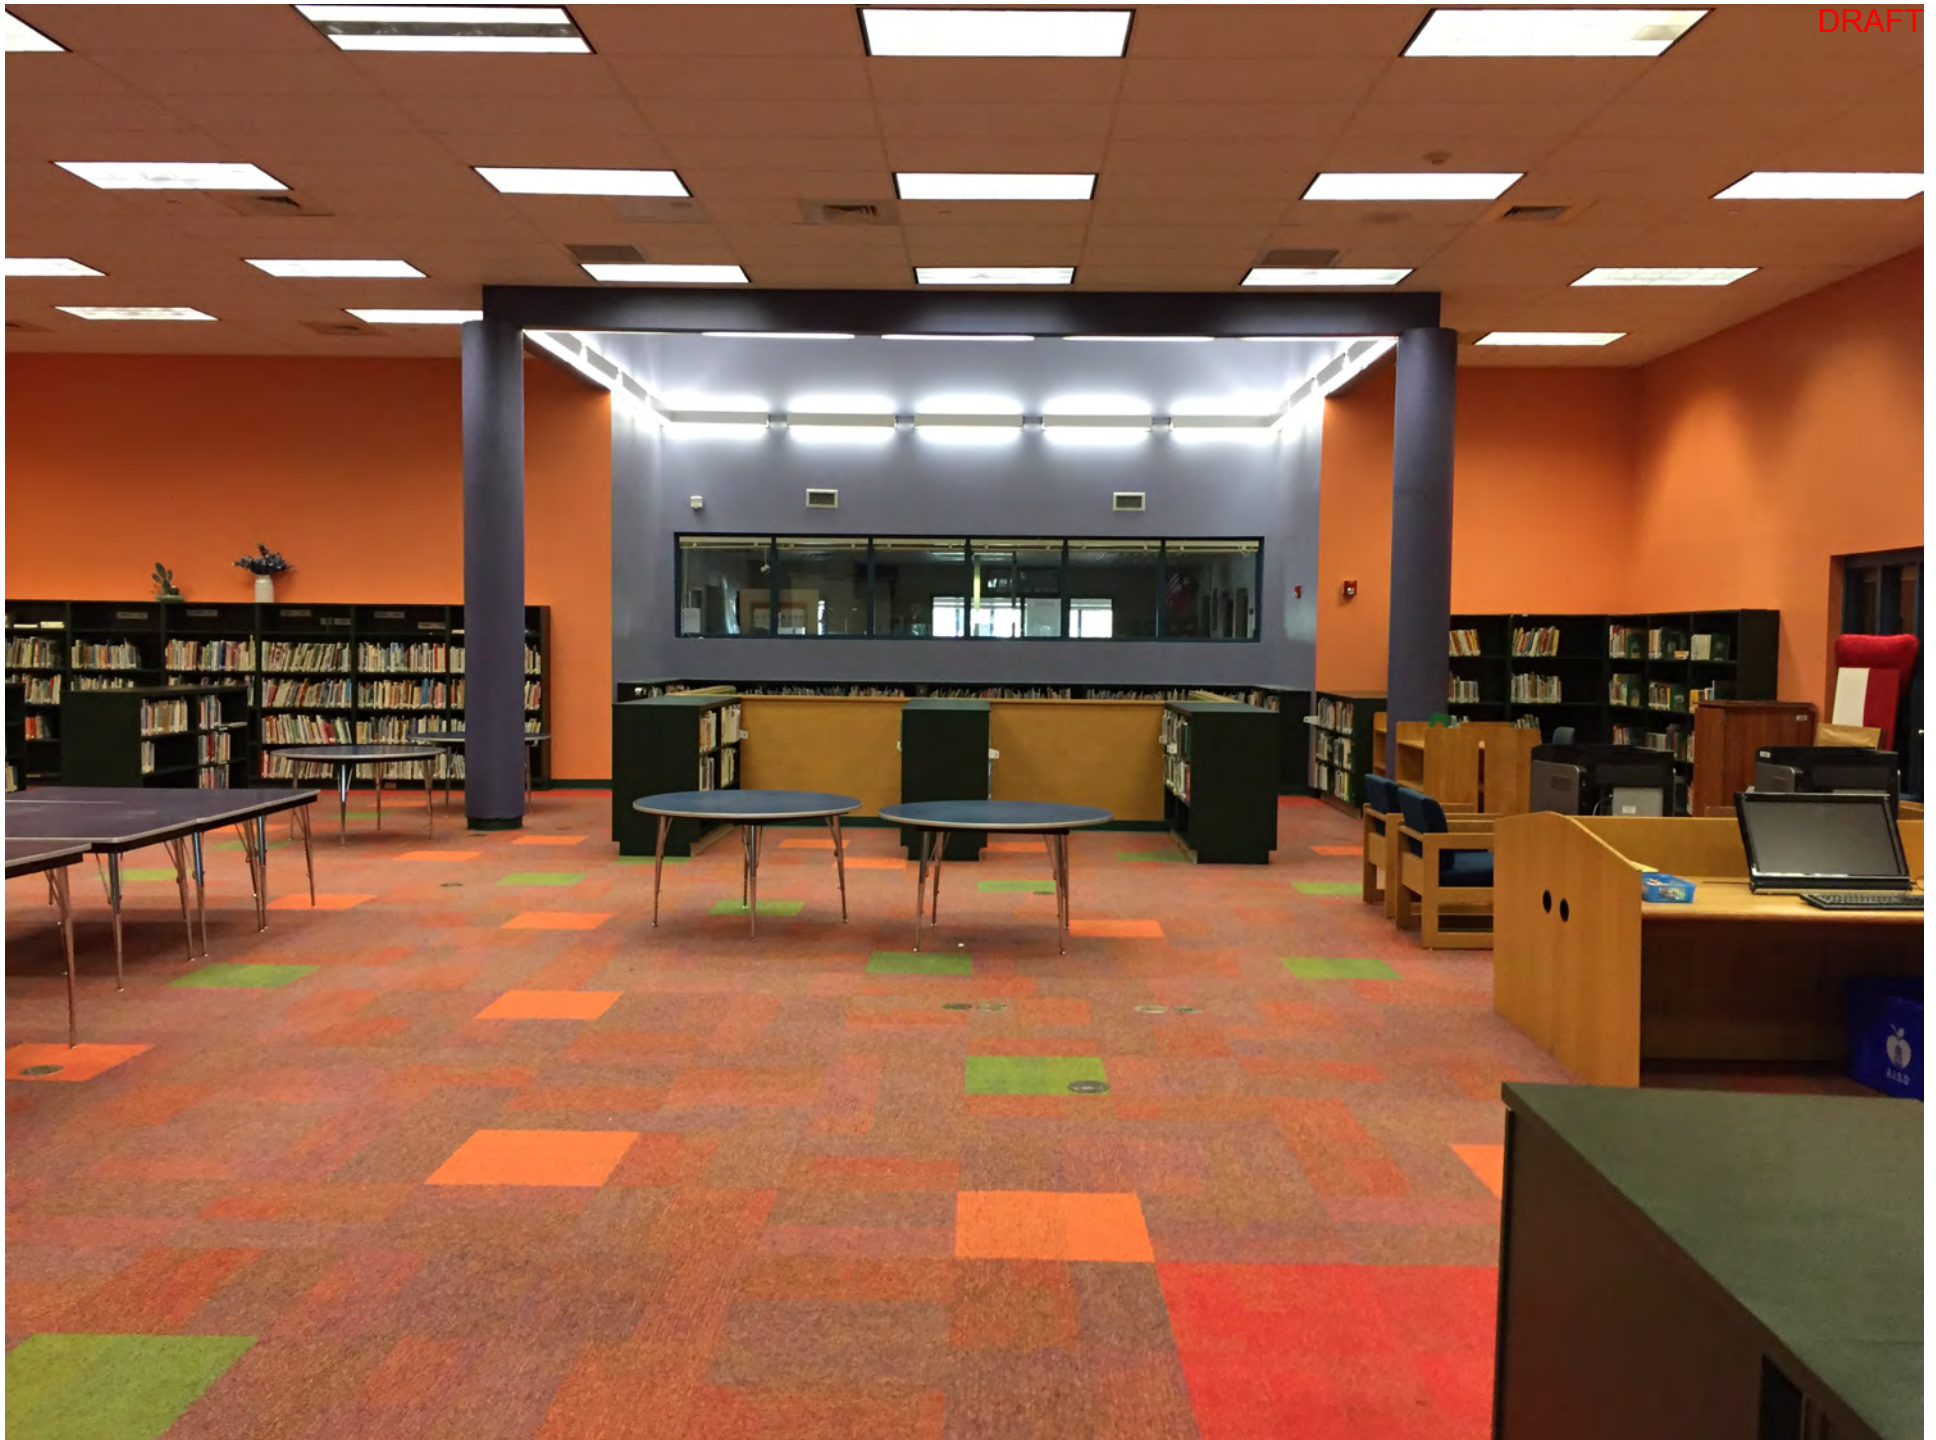
Photo 9.
5.3 Library

1) Very unsatisfactory 2) Unsatisfactory 3) Average 4) Good 5) Very good N/A) Does not apply.								see photo 9	
5.4	How well does the Library/Media Center support collaborative work in small groups (4-8 students)?			3				Comments	1.003.00

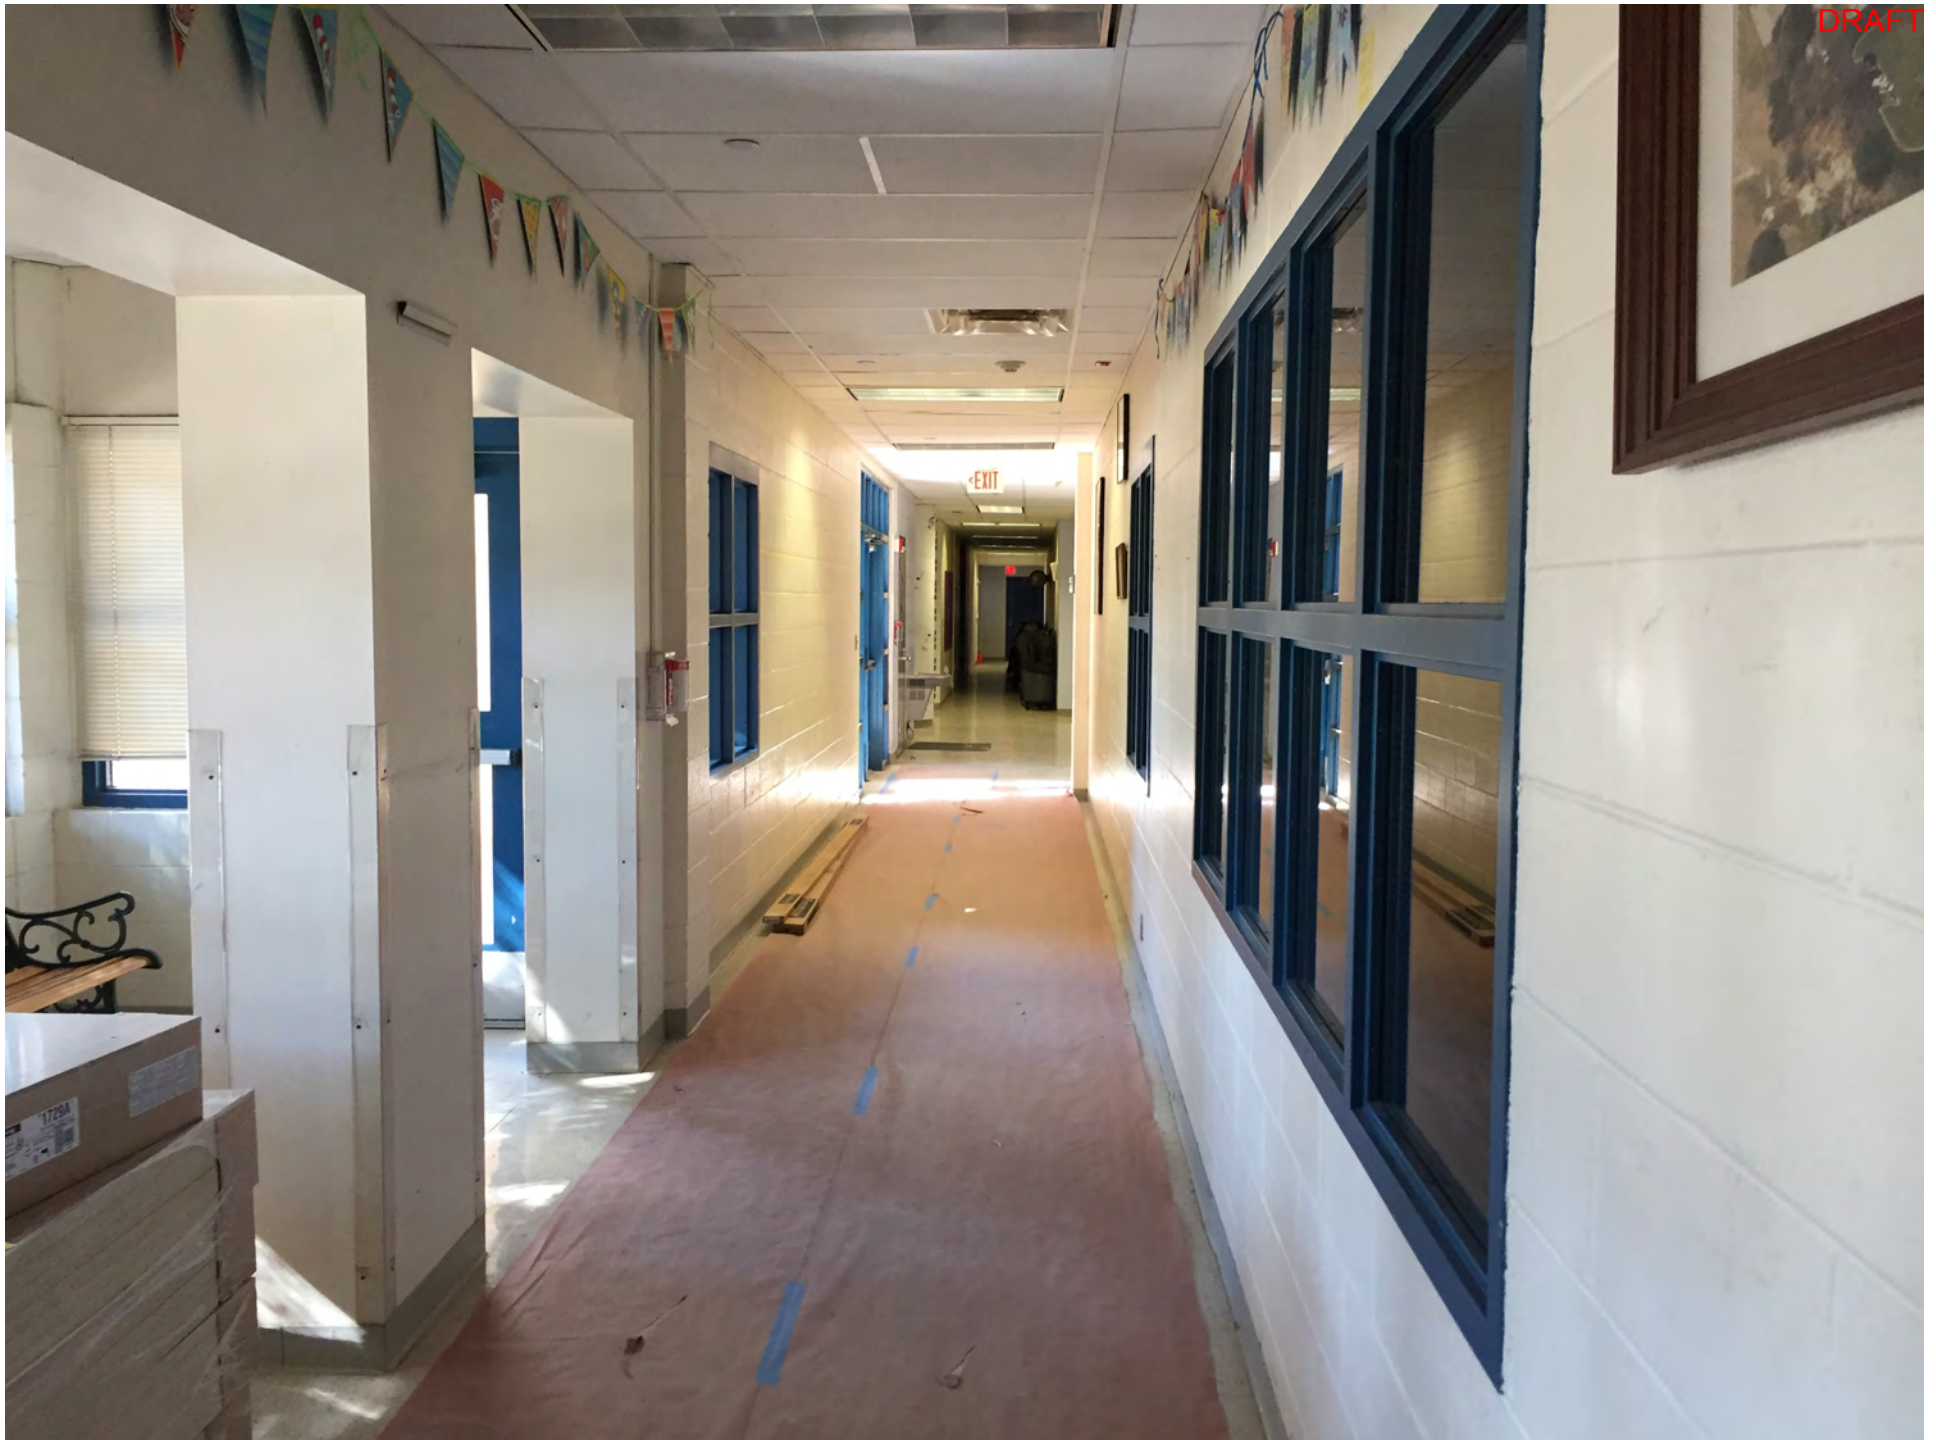
Photo 10.
6.3 Main Office

The location of the central office is located close to the entry to the school but no secure vestibule and views are obscured by walls. Additional lighting needed as well as additional cameras and camera upgrades.

6.3	Is the main office properly located and configured with a secure vestibule to the main corridor?		2					Comments	1.00 2.00
1) Very unsatisfactory - No secure vestibule, office located far from main entry. Allows visitors access to school unsupervised. 2) Unsatisfactory - No secure vestibule, office located somewhat far from main entry, minimal supervision of visitors. 3) Average - Office close to entry, views of front door, but no secure vestibule 4) Good - Office is well-located with a secure vestibule, but needs updates 5) Very good - Office well-located with secure vestibule and all appropriate security features. N/A) Does not apply.								The main office has no view of visitors at main entry.	
								see photo 10

The most critical issues for the campus is the appearance of the campus to appeal to the community and security concerns. Security priorities including a secure vestibule, updates as well as additional cameras, exterior lighting. The campus also needs technology upgrades.
