## Educational Suitability Summary Report

Langford Elementary School

Date: 08/23/2016

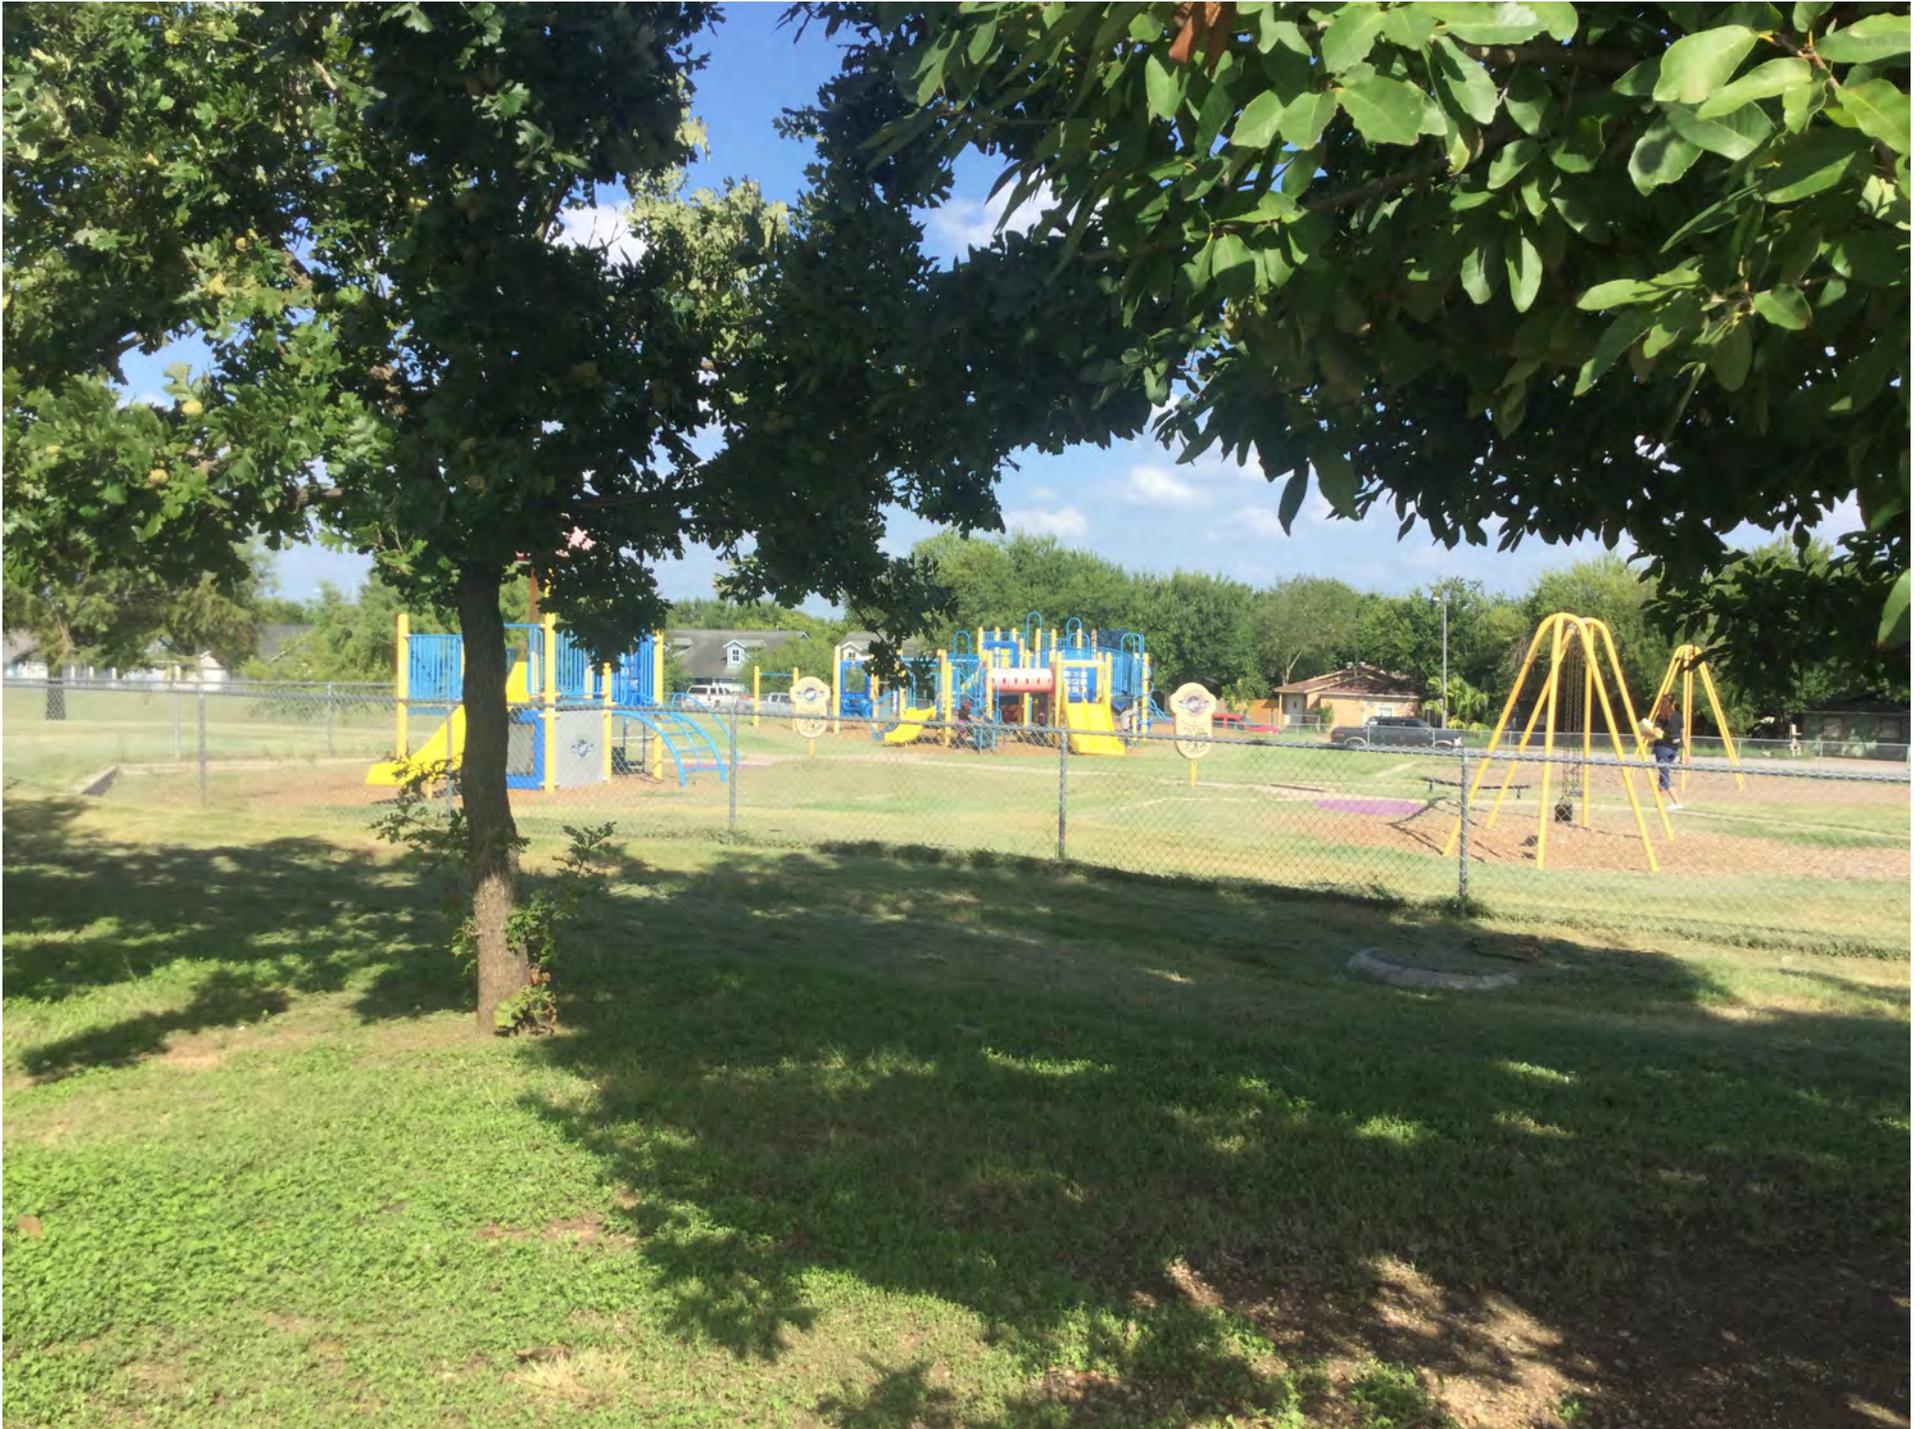
1.3 Playground

1.3	Are outdoor play spaces and playfields adequate in size and configuration?			3				Comments	1.00	3.00
1) Outdoor play space exists, not developed 2)Outdoor play space exists but is not connected to gym or other athletic support areas or is too small. 3. Outdoor play spaces exist, are connected to other athletic areas, are the right size, but are not in good condition. 4. Outdoor play spaces need minor improvements to function well. 5. Outdoor play spaces are in excellent condition. N/A) Does not apply.

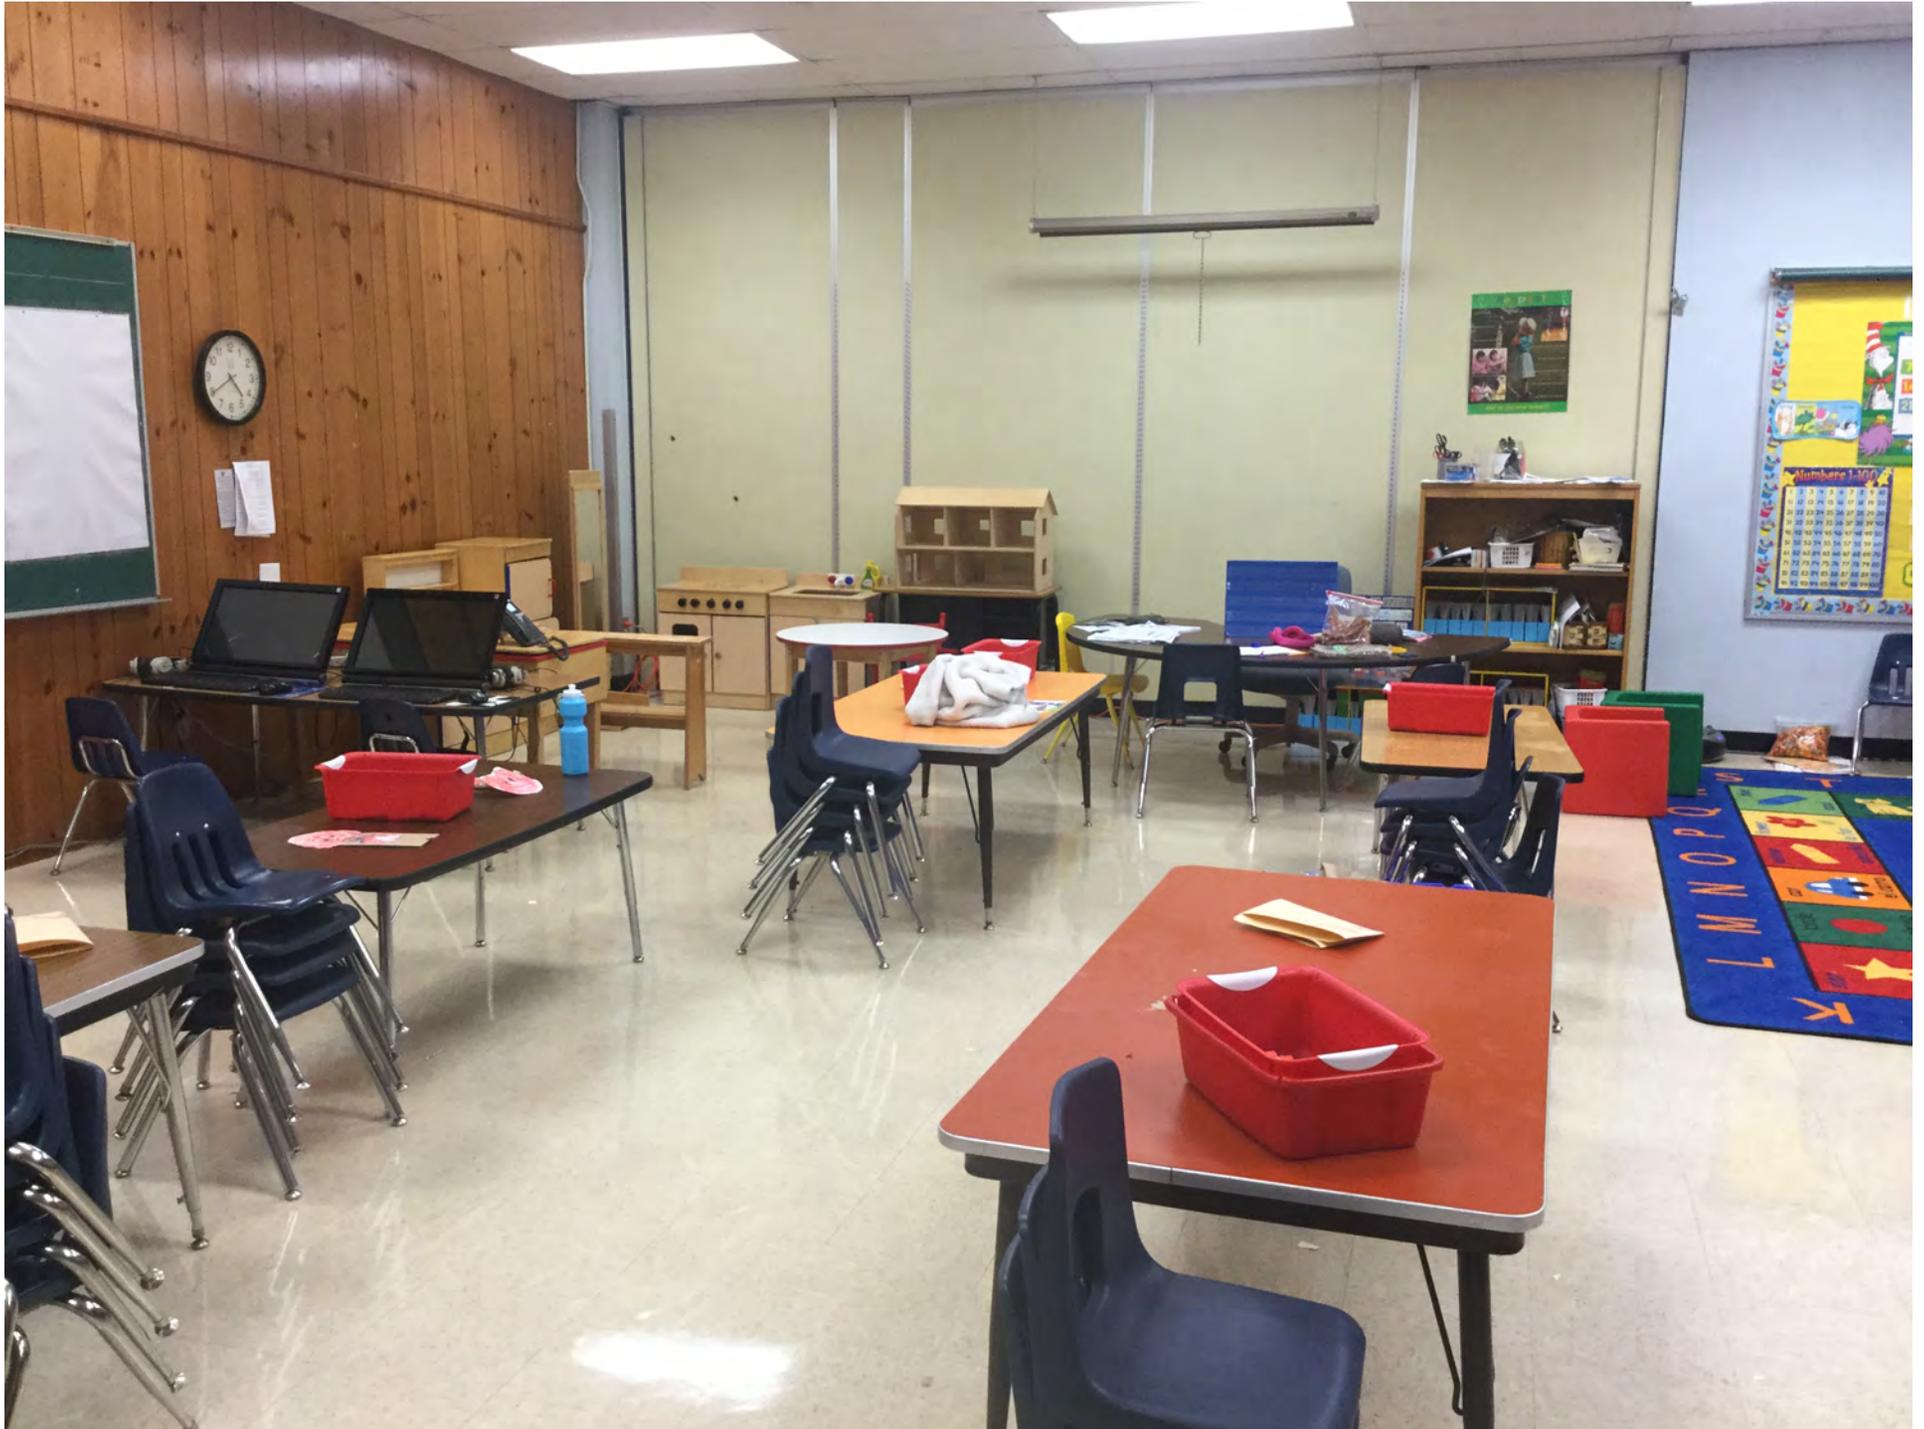
3.2 Kinder Room

3 - Academic & Co-Curricular Support		1	2	3	4	5	N/A			31.00
3.2	Are Pre-K and Kinder classrooms appropriately configured per the ed spec? (elementary school only)			3				Comments	1.00	3.00

1) Very unsatisfactory - Too small, awkward layout, does not meet needs 2) Unsatisfactory - Too small, only one area for all teaching methods, limited flexibility 3) Neutral - Moderate size, two areas for different teaching methods, some flexibility, access to student storage/casework 4) Satisfactory - Good size, at least two zones for different teaching methods, flexibility and student storage, not new 5) Very Satisfactory - Good size, two zones for different teaching methods, flexibility and student storage/casework, adequate display area and visual teaching tools N/A) Does not apply.

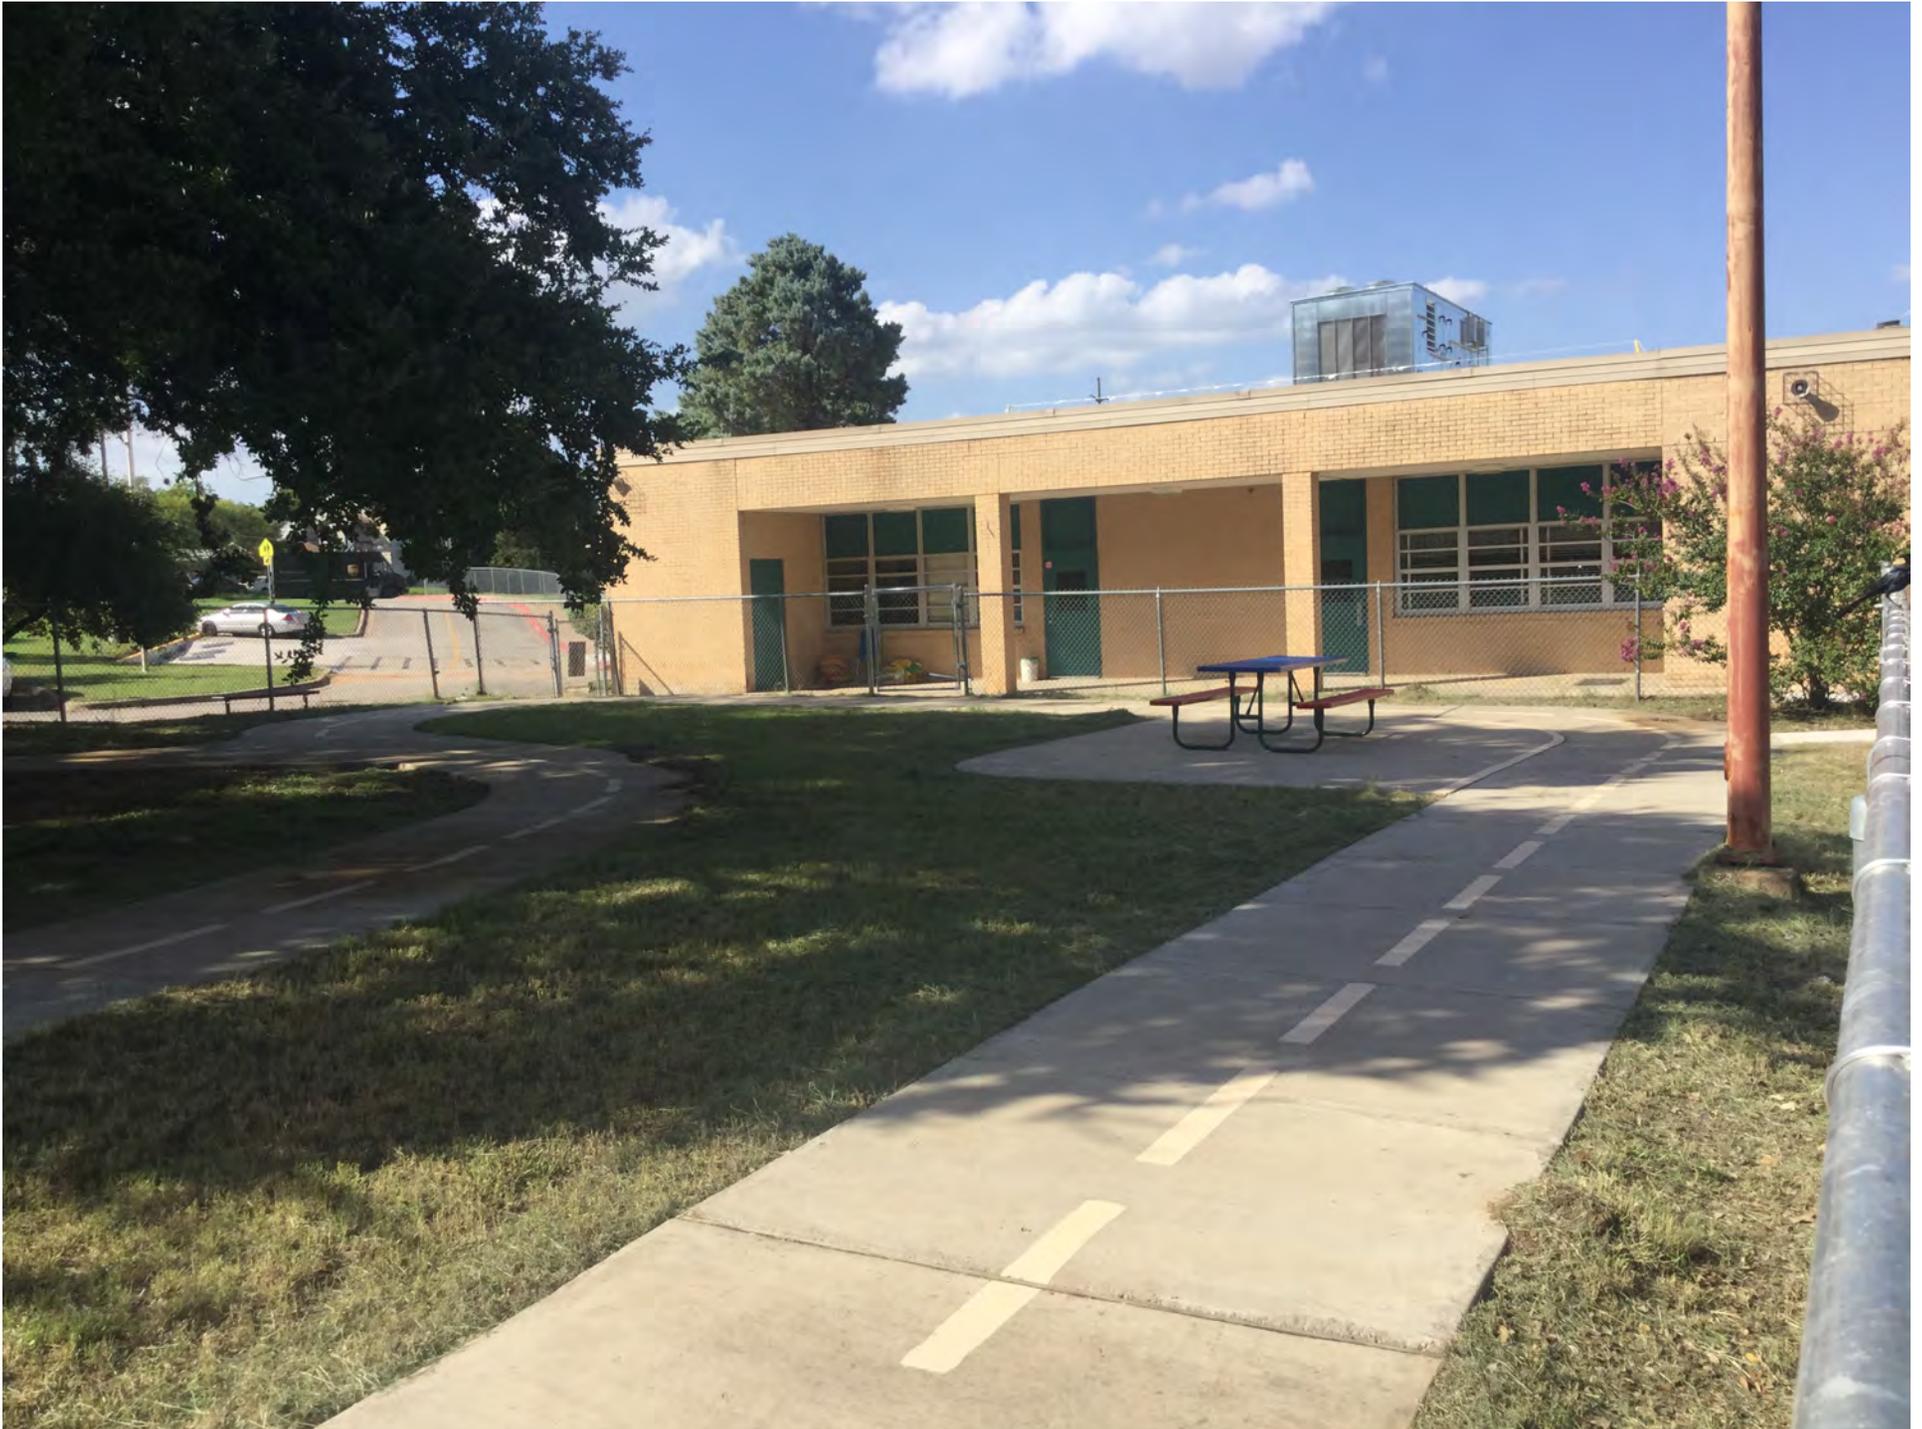
3.3 Pre-K Kinder  
Playground

The Pre-K and kindergarten areas adequate in size and condition, but the restrooms are dated and small. The casework is older and not configured appropriately for the young students. Additionally, the fenced Pre-K and Kinder play area is extremely underwhelming with only a

3.3	Do Pre-K and Kinder have appropriate support spaces such as restrooms and storage per the ed spec? (elementary only)		2					Comments	1.00	2.00
1) Very unsatisfactory - No storage, casework, or restrooms 2) Unsatisfactory - unsatisfactory size or condition of storage, casework, or restrooms 3) Neutral - Moderate size or moderate condition storage, casework, and restrooms 4) Satisfactory - Satisfies ed spec for storage, casework, and restrooms 5) Very Satisfactory - exceeds ed spec for storage, casework, and restrooms N/A) Does not apply.		Restrooms are present but they are undersized and dated. The casework is not appropriately sized and configured for young children.

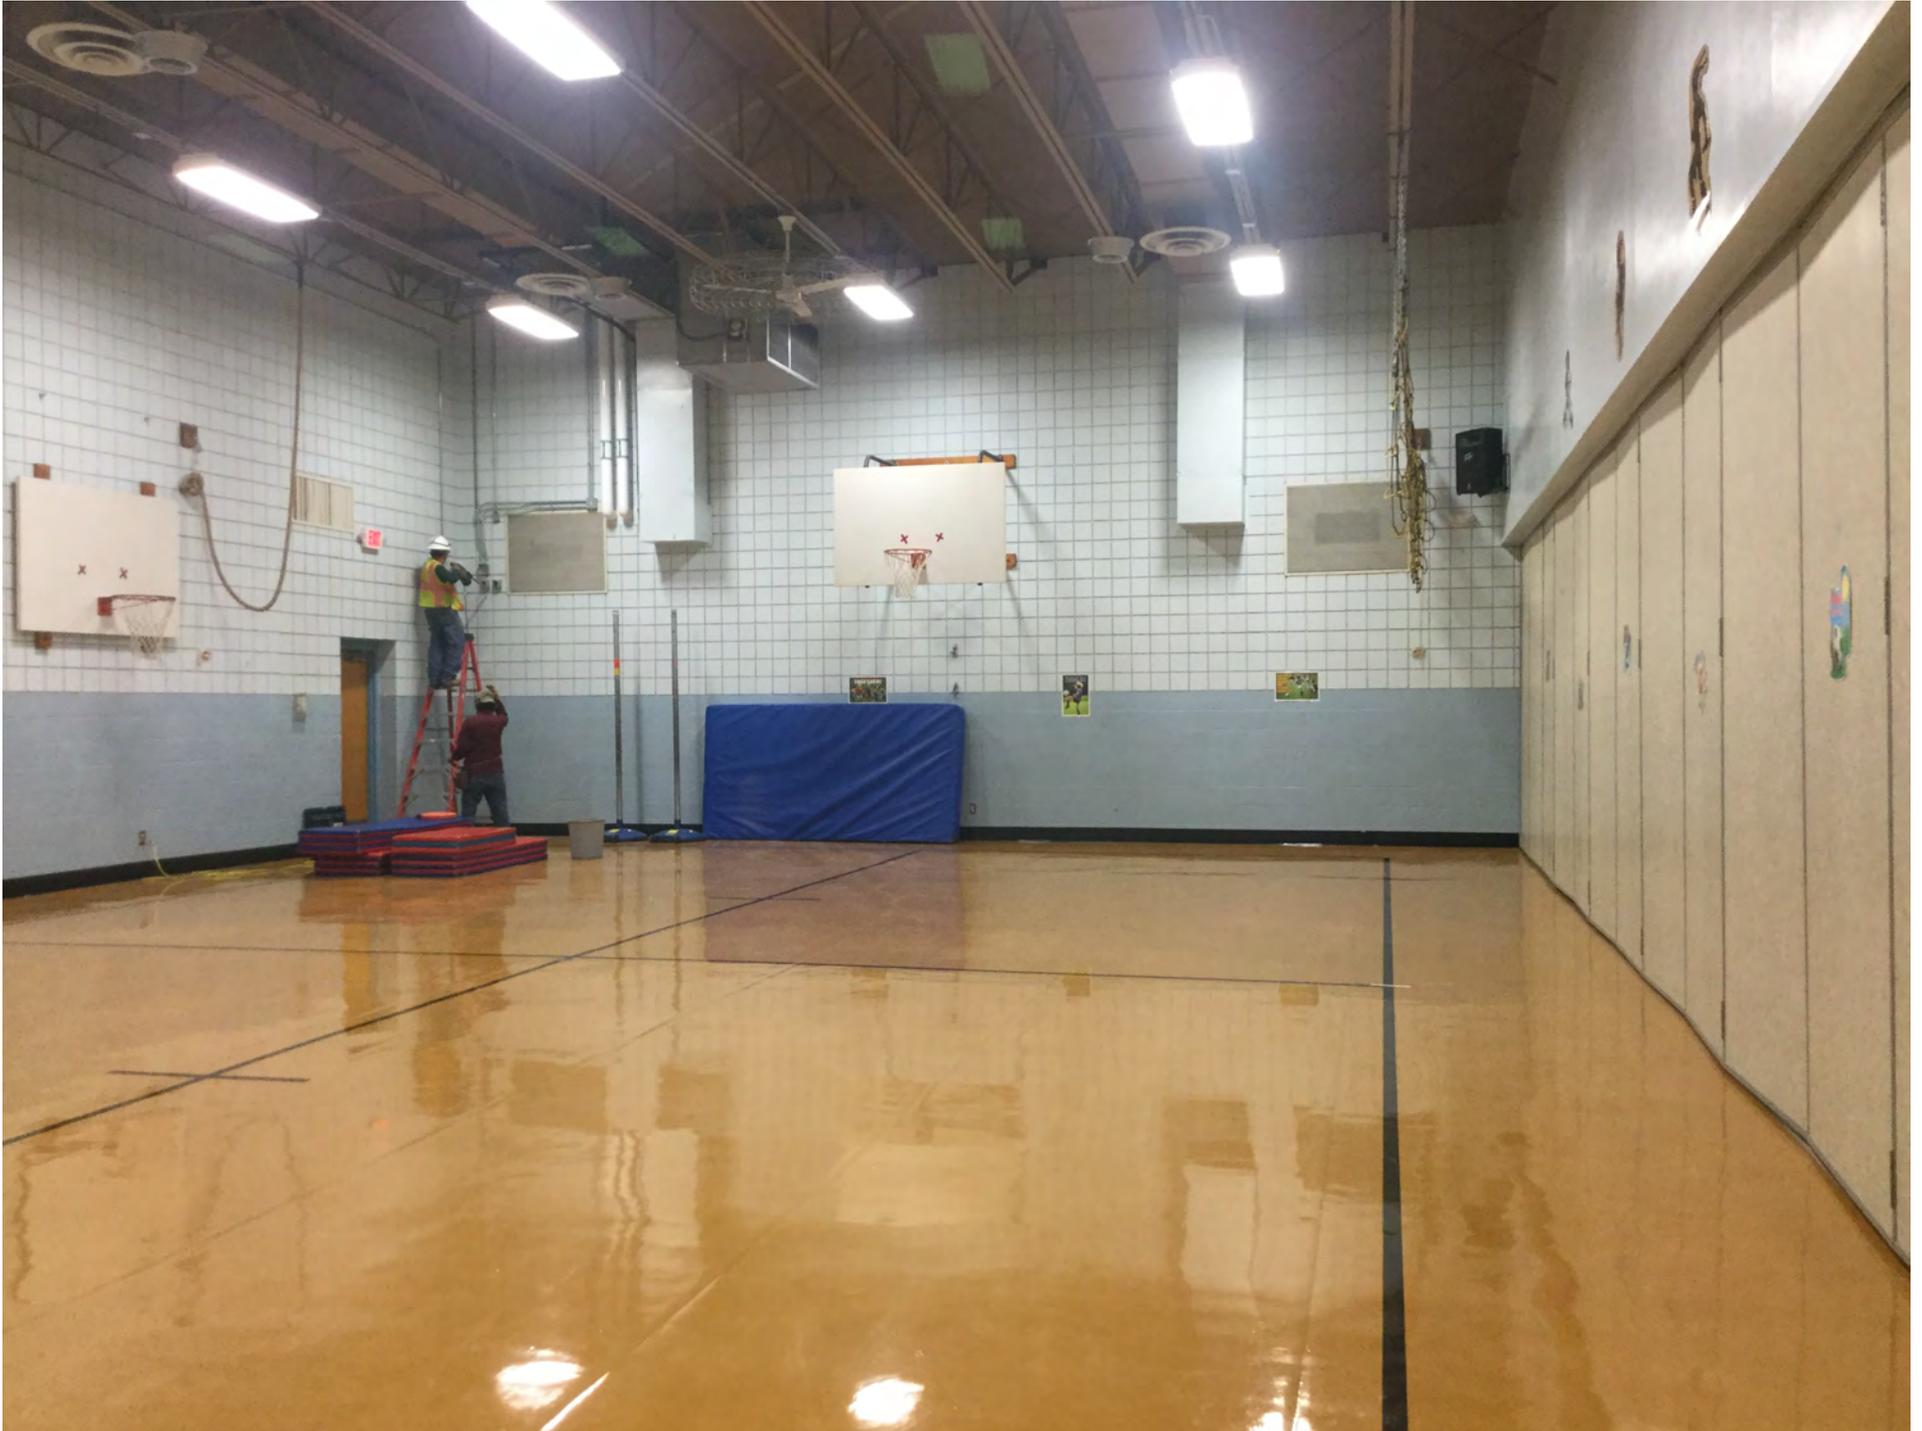
3.6 Gymnasium

3 - Academic & Co-Curricular Support - Continued		1	2	3	4	5	N/A			
3.6	Are Physical Education and Athletic spaces appropriately configured per the ed spec?			3				Comments	1.00	3.00

1) Very unsatisfactory 2) Unsatisfactory 3) Average 4) Good 5) Very good N/A) Does not apply.		The gym is a moderate size, but it is undersized for the number of students.

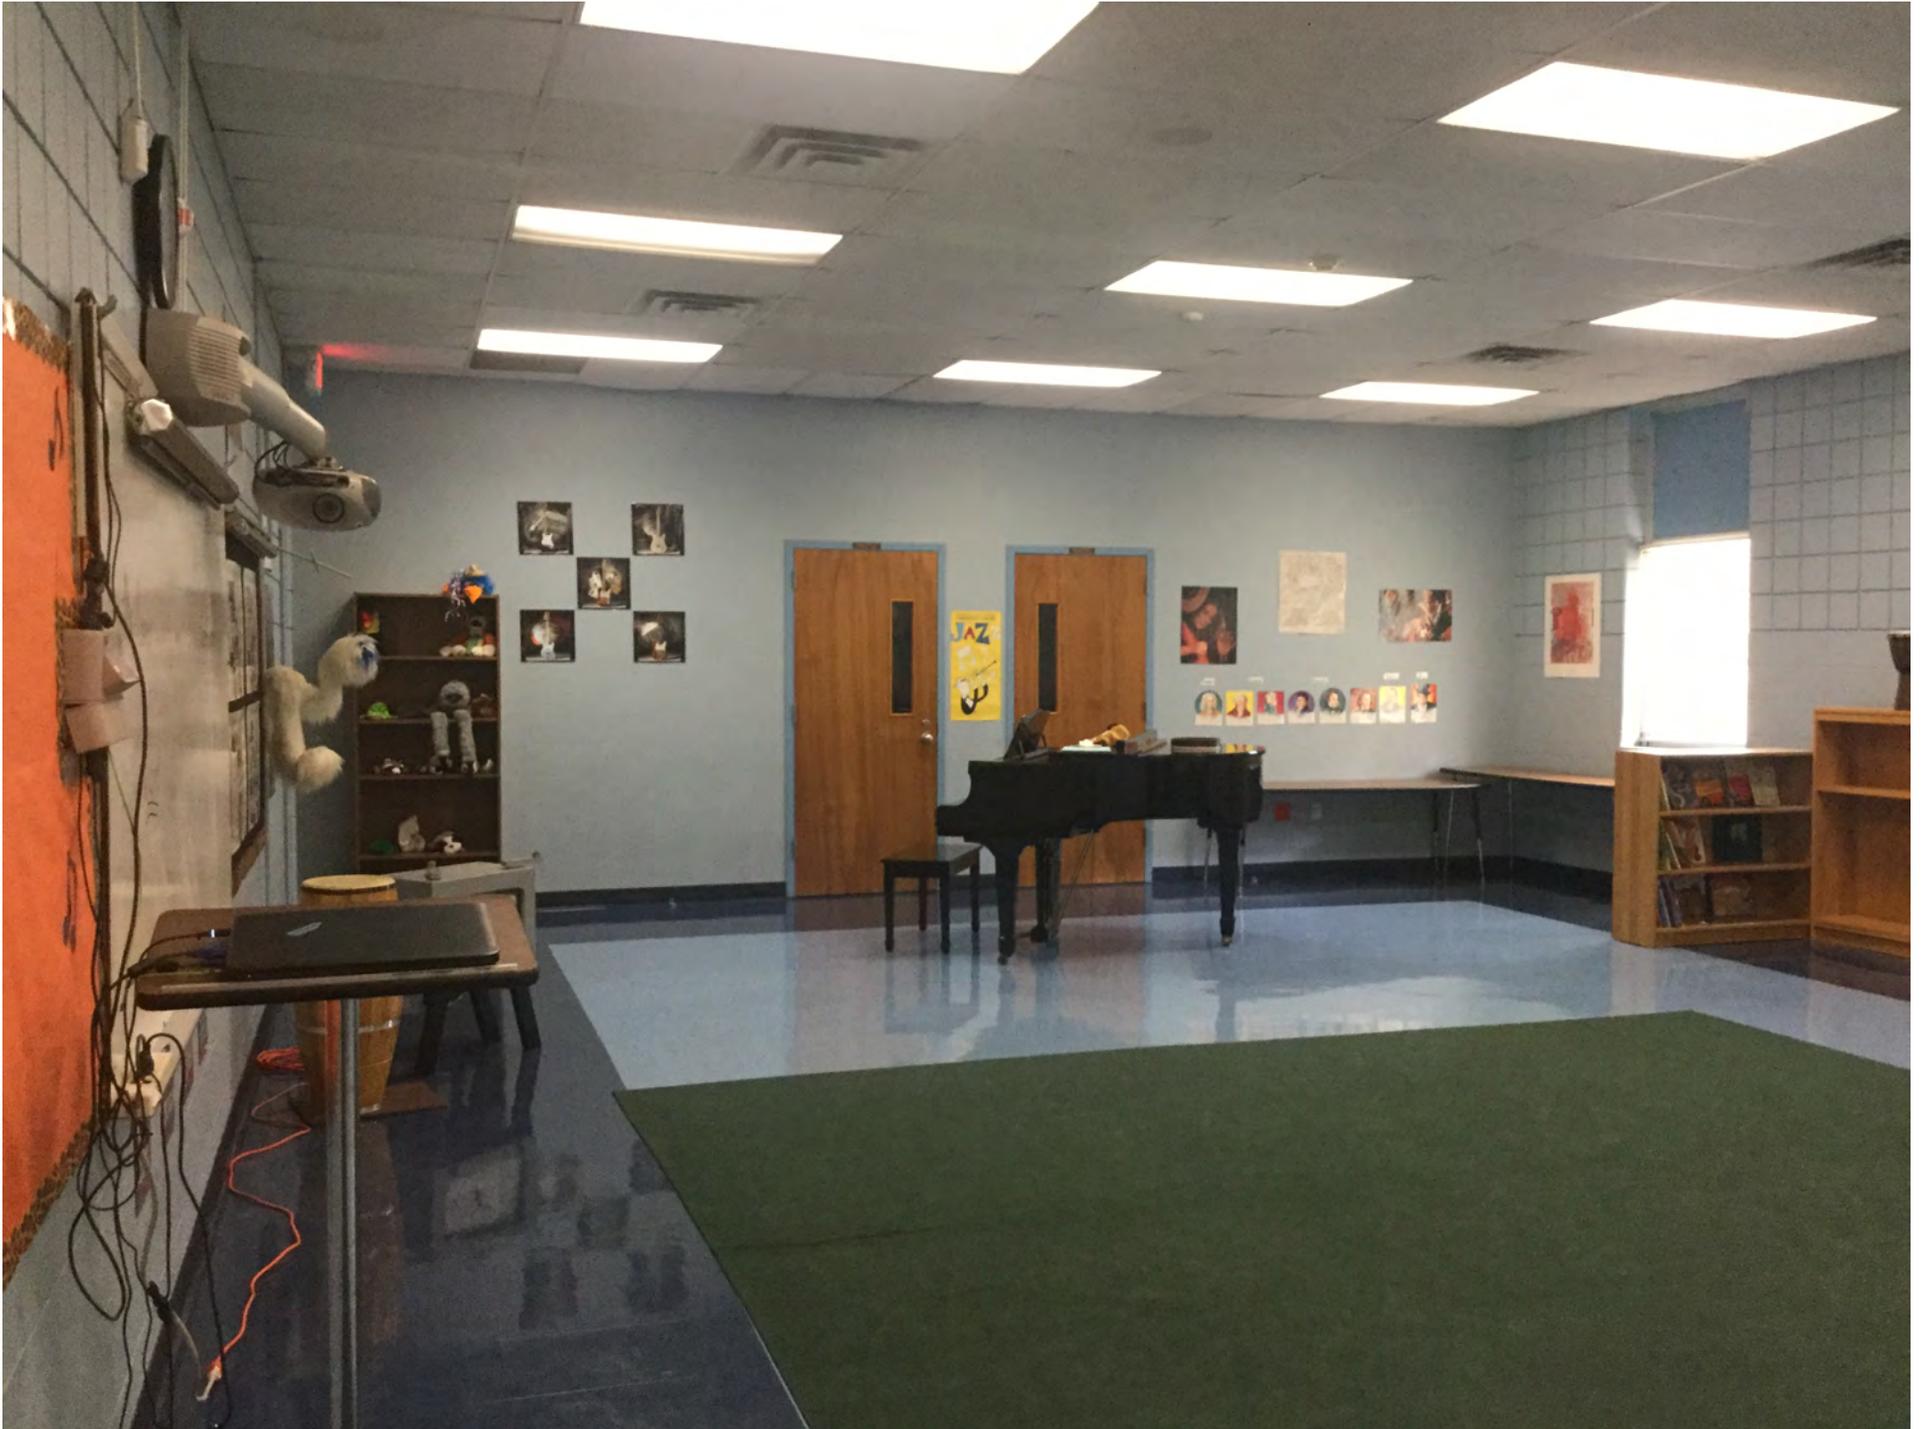
3.8 Music Room

3.8	Are music, drama, or performance spaces appropriately configured per the ed spec?			3				Comments	1.00	3.00
1) Very unsatisfactory 2) Unsatisfactory 3) Average 4) Good 5) Very good N/A) Does not apply.		The stage area needs updates for performances. The music room is a good size.

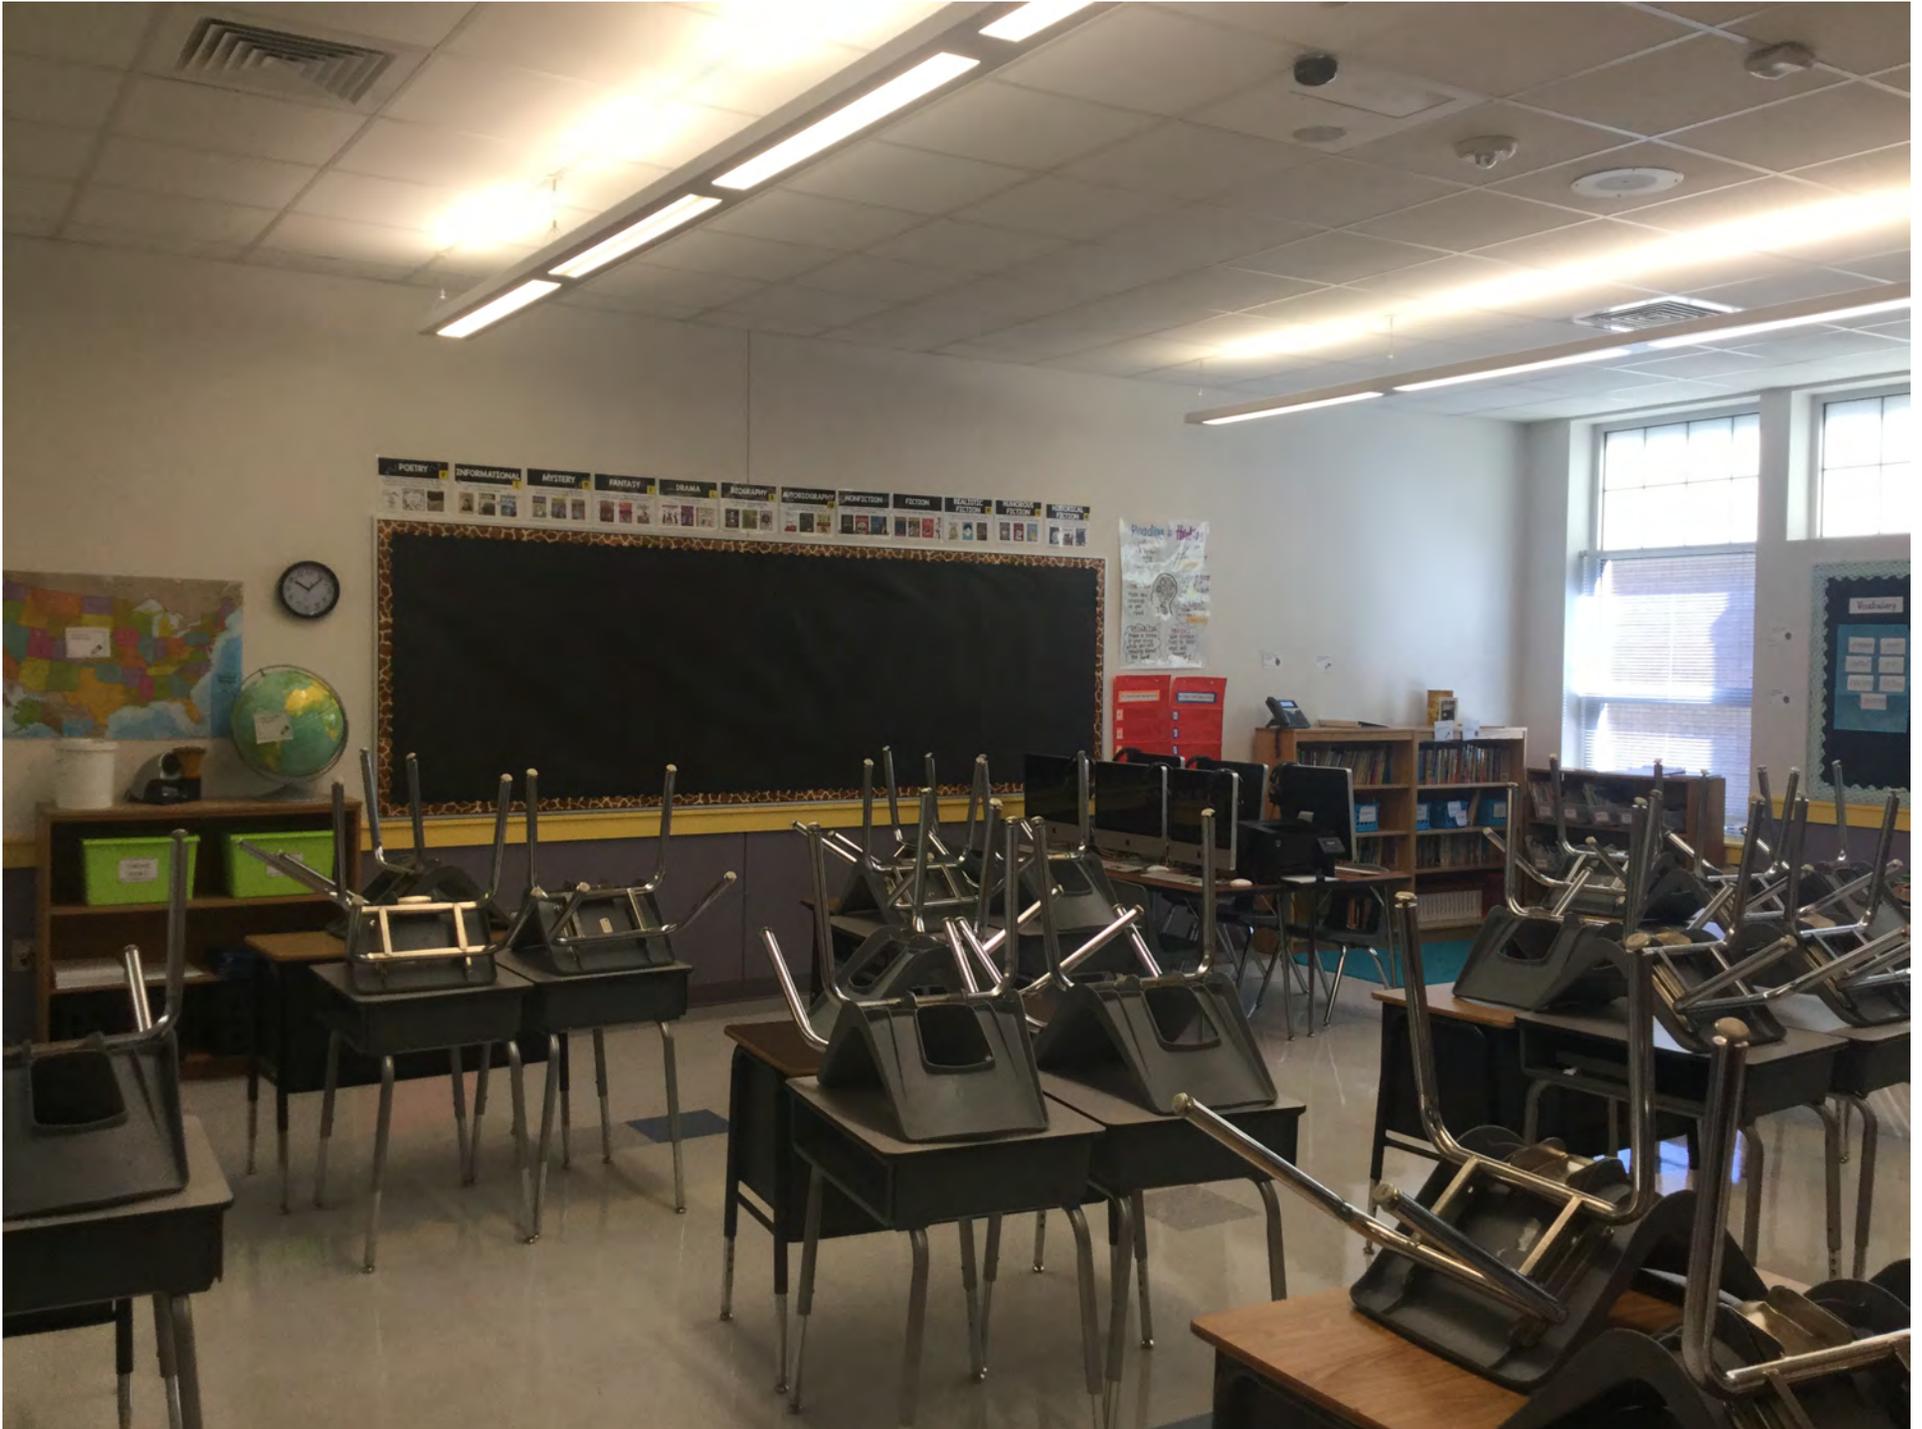
4.2 Classroom - Newer

4.2	Are general classrooms large enough to support project-based learning and multiple teaching modalities?		2					Comments	1.00	2.00
1) Very unsatisfactory -too small to move, set for lecture only, no connectivity, no flexibility 2) Unsatisfactory - adequate size but set for lecture only, no connectivity, no flexibility 3) Neutral - have flexibility and space for hands on or project based learning 4) Satisfactory - have flexibility and space for hands on or project based learning and connectivity for global learning 5) Very Satisfactory - space for hands on learning, flexibility for different groupings, and connectivity for global classrooms N/A) Does not apply.		Classrooms in the main building are undersized for large projects. The newest addition is more generous.

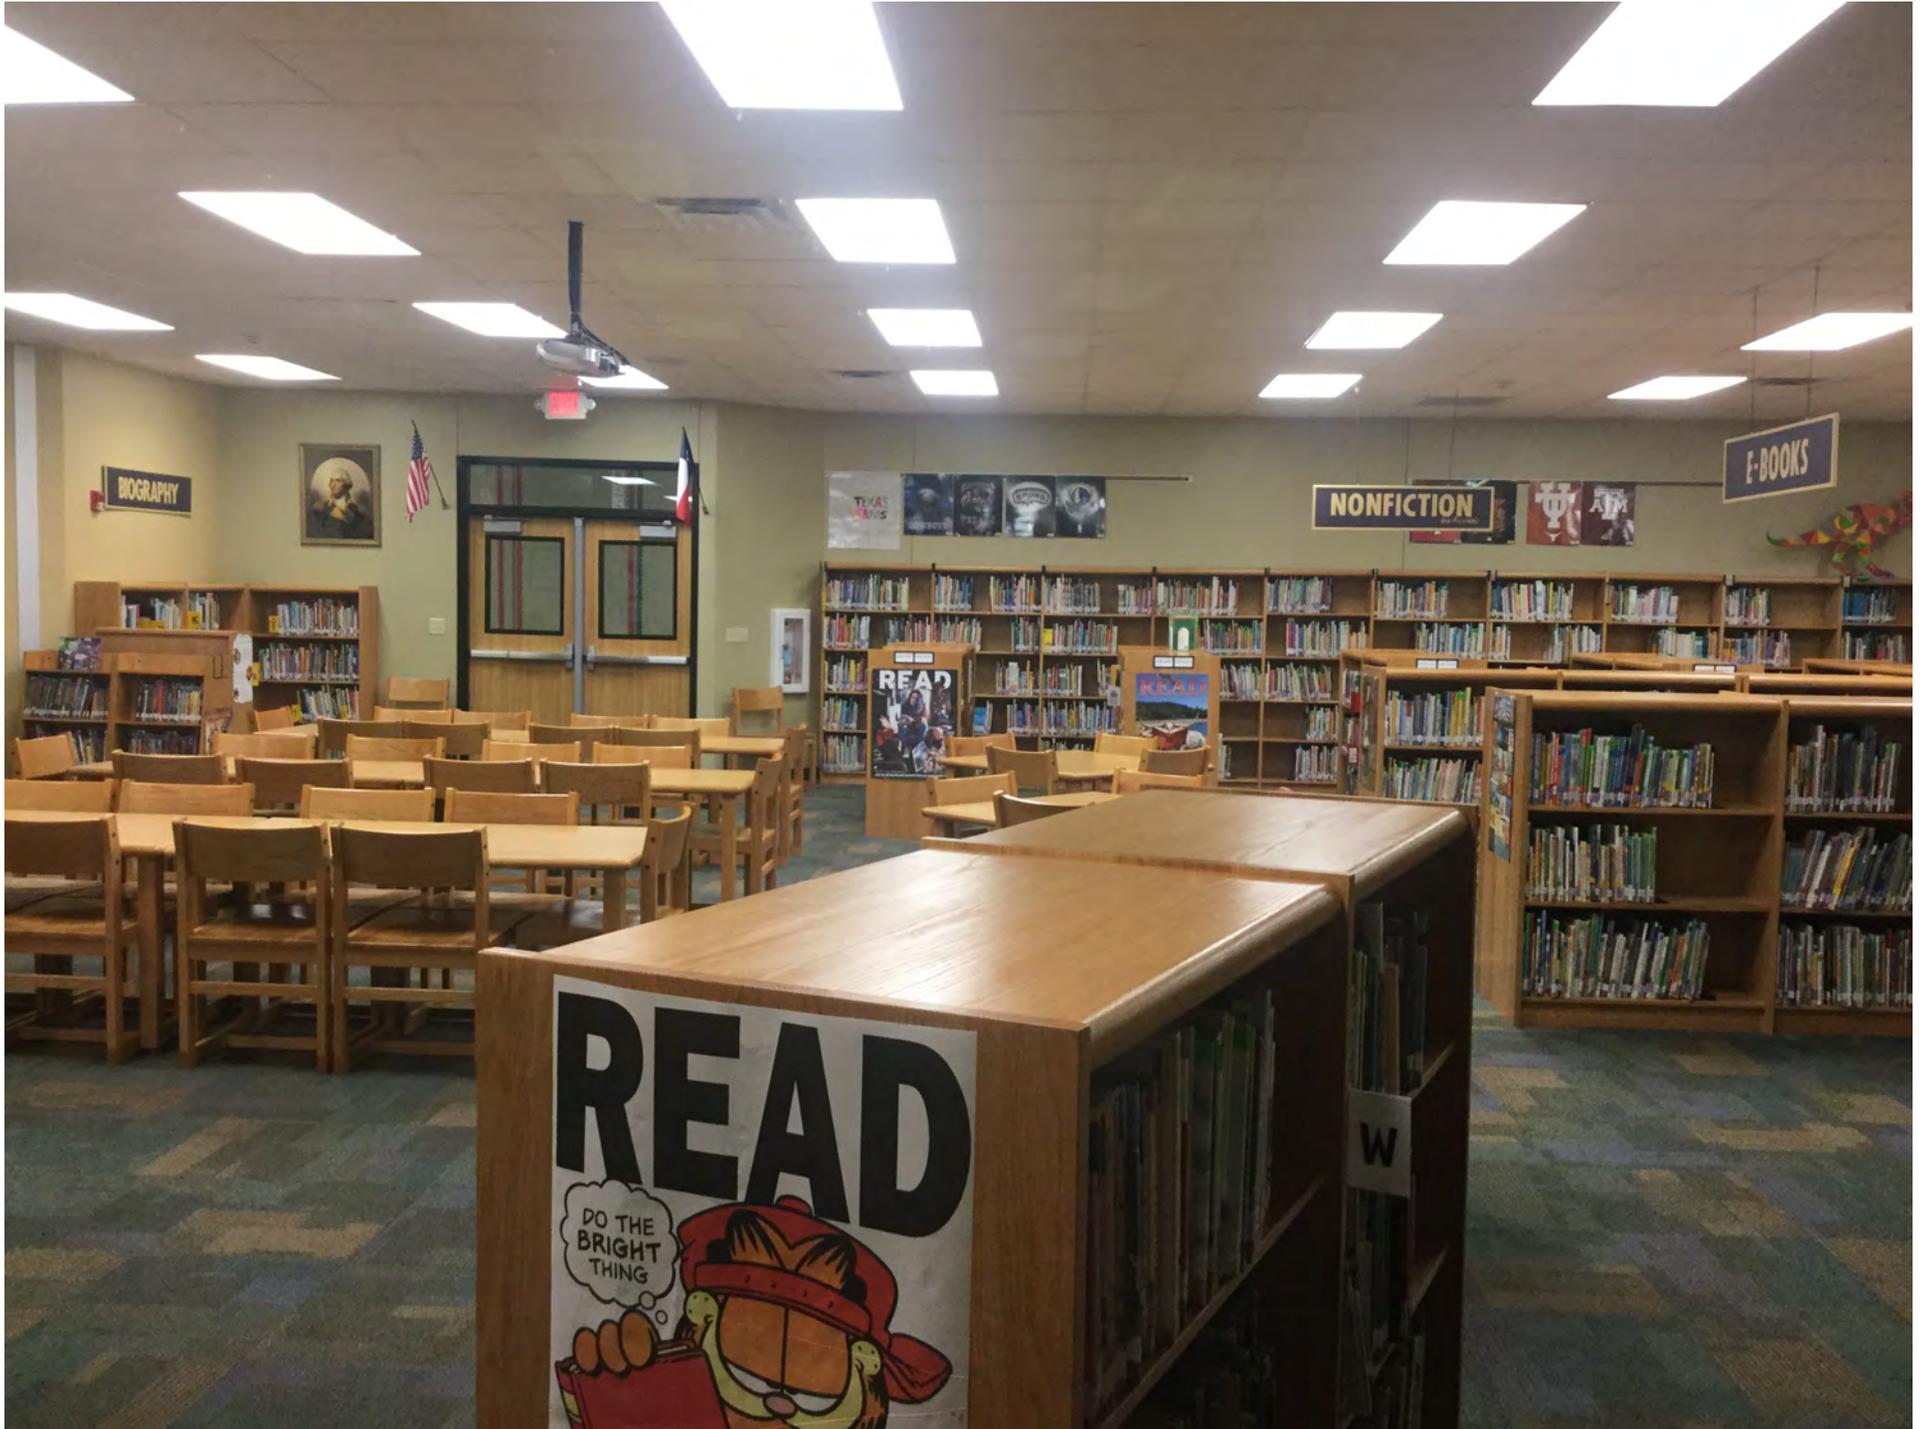
5.4 Library

5.4	How well does the Library/Media Center support collaborative work in small groups (4-8 students)?				4			Comments	1.00	4.00
1) Very unsatisfactory 2) Unsatisfactory 3) Average 4) Good 5) Very good N/A) Does not apply.
