## Educational Suitability Summary Report

Russell Lee Elementary School

Date: 07/28/2016

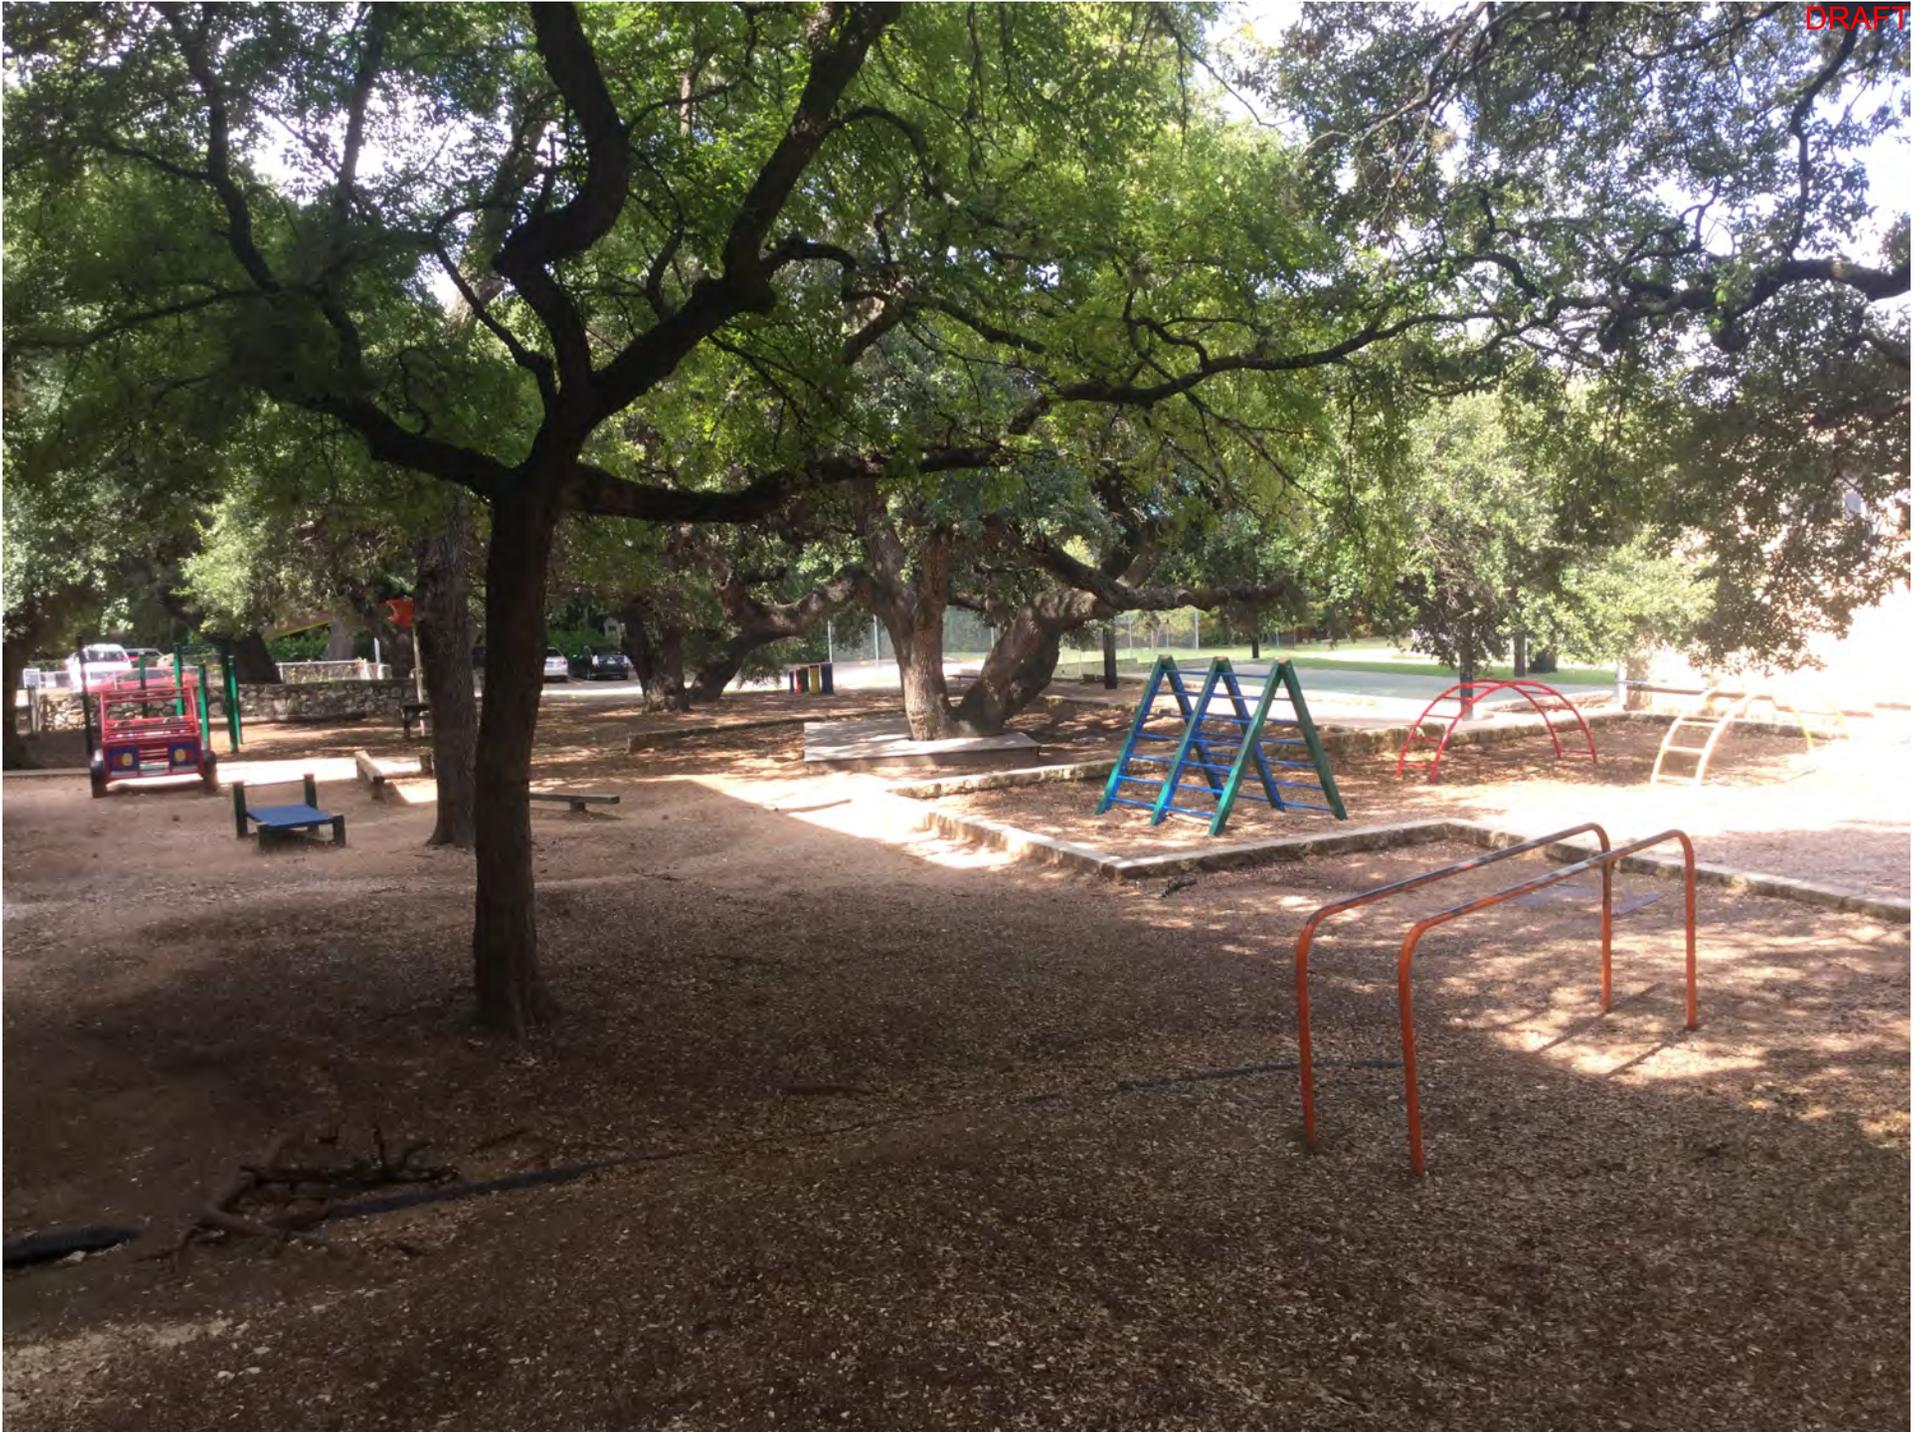
Photo 1.  
1.2 Outdoor Play Spaces

| 1 - Exterior | | 1 | 2 | 3 | 4 | 5 | N/A | | | 10.50 |
|---|--|---|---|---|---|---|---|---|---|---|
| 1) Outdoor space exists is not developed<br>2)Outdoor space for learning exists but not connected to classroom learning areas.<br>3. Outdoor learning spaces exist and are accessible but not in good condition.<br>4. Outdoor learning spaces need minor improvements to function well.<br>5. Outdoor learning spaces are in excellent condition.<br>N/A) Does not apply. | | There are chicken coops and garden spaces available. These spaces need some improvements, including more furniture. | | | | | | | | |

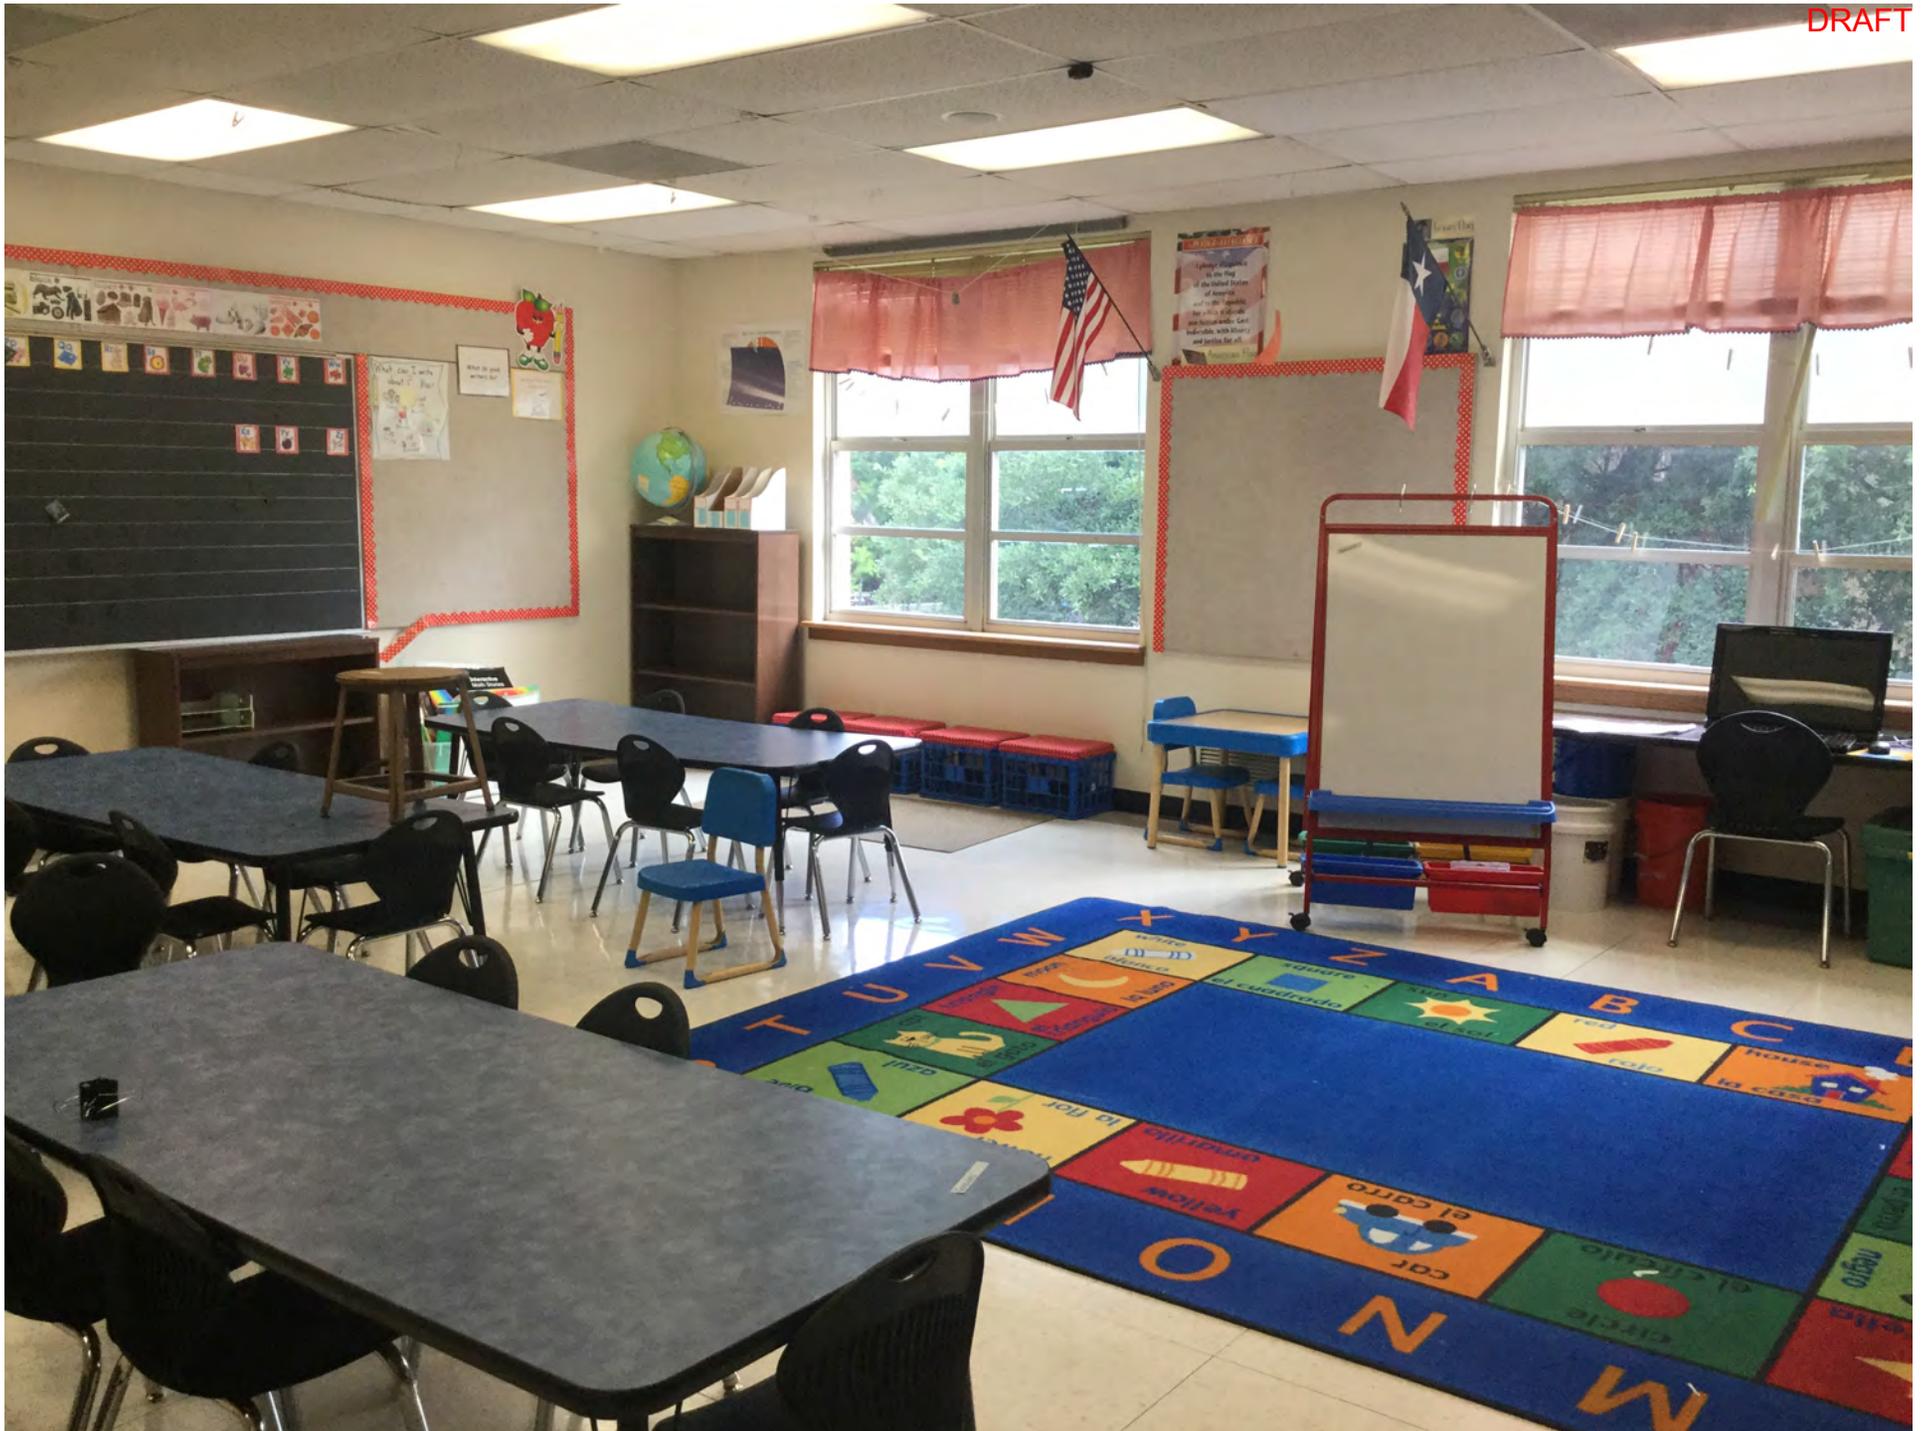
Photo 2.  
3.2 Pre-K Space

| 3 - Academic & Co-Curricular Support | | 1 | 2 | 3 | 4 | 5 | N/A | | | 21.00 |
|--|--|---|---|---|---|---|---|---|---|---|
| 1) Very unsatisfactory - Too small, awkward layout, does not meet needs<br>2) Unsatisfactory - Too small, only one area for all teaching methods, limited flexibility<br>3) Neutral - Moderate size, two areas for different teaching methods, some flexibility, access to student storage/casework<br>4) Satisfactory - Good size, at least two zones for different teaching methods, flexibility and student storage, not new<br>5) Very Satisfactory - Good size, two zones for different teaching methods, flexibility and student storage/casework, adequate display area and visual teaching tools<br>N/A) Does not apply. | | see photo 2 | | | | | | | | |
| 1) Very unsatisfactory - No storage, casework, or restrooms<br>2) Unsatisfactory - unsatisfactory size or condition of storage, casework, or restrooms<br>3) Neutral - Moderate size or moderate condition storage, casework, and restrooms<br>4) Satisfactory - Satisfies ed spec for storage, casework, and restrooms<br>5) Very Satisfactory - exceeds ed spec for storage, casework, and restrooms<br>N/A) Does not apply. | | The casework is in good condition, but the room needs more storage. The restrooms are not attached and are community based. | | | | | | | | |

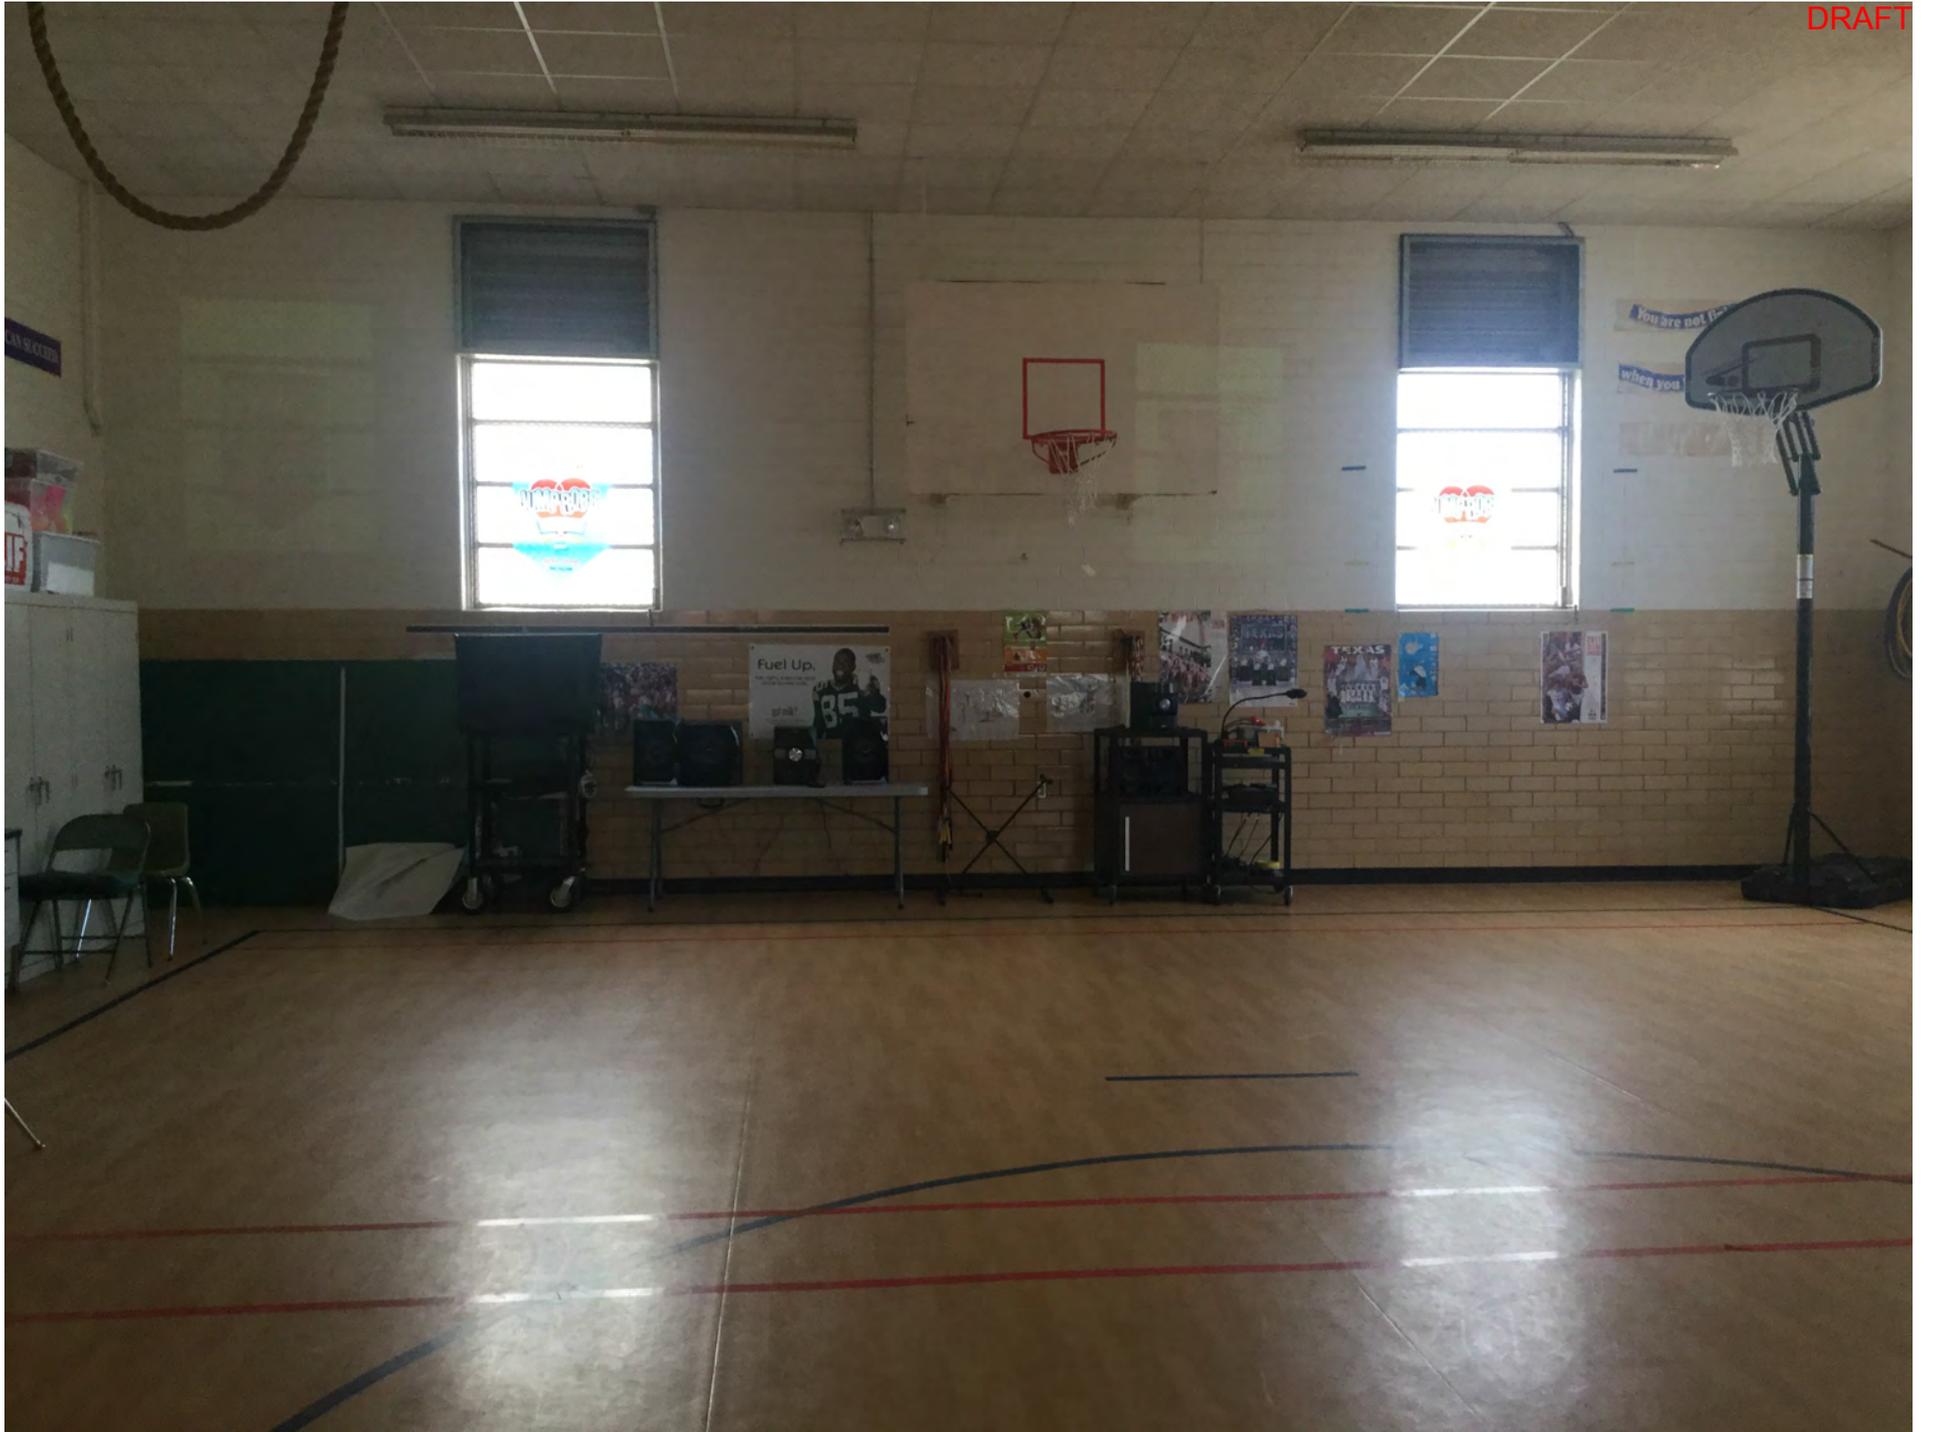
Photo 3.  
3.6 Gym

| 3 - Academic & Co-Curricular Support - Continued | | 1 | 2 | 3 | 4 | 5 | N/A | | | | |
|---|---|---|---|---|---|---|---|---|---|---|---|
| 1) Very unsatisfactory<br>2) Unsatisfactory<br>3) Average<br>4) Good<br>5) Very good<br>N/A) Does not apply. | | | | | | | | The gym is dated. | | | |

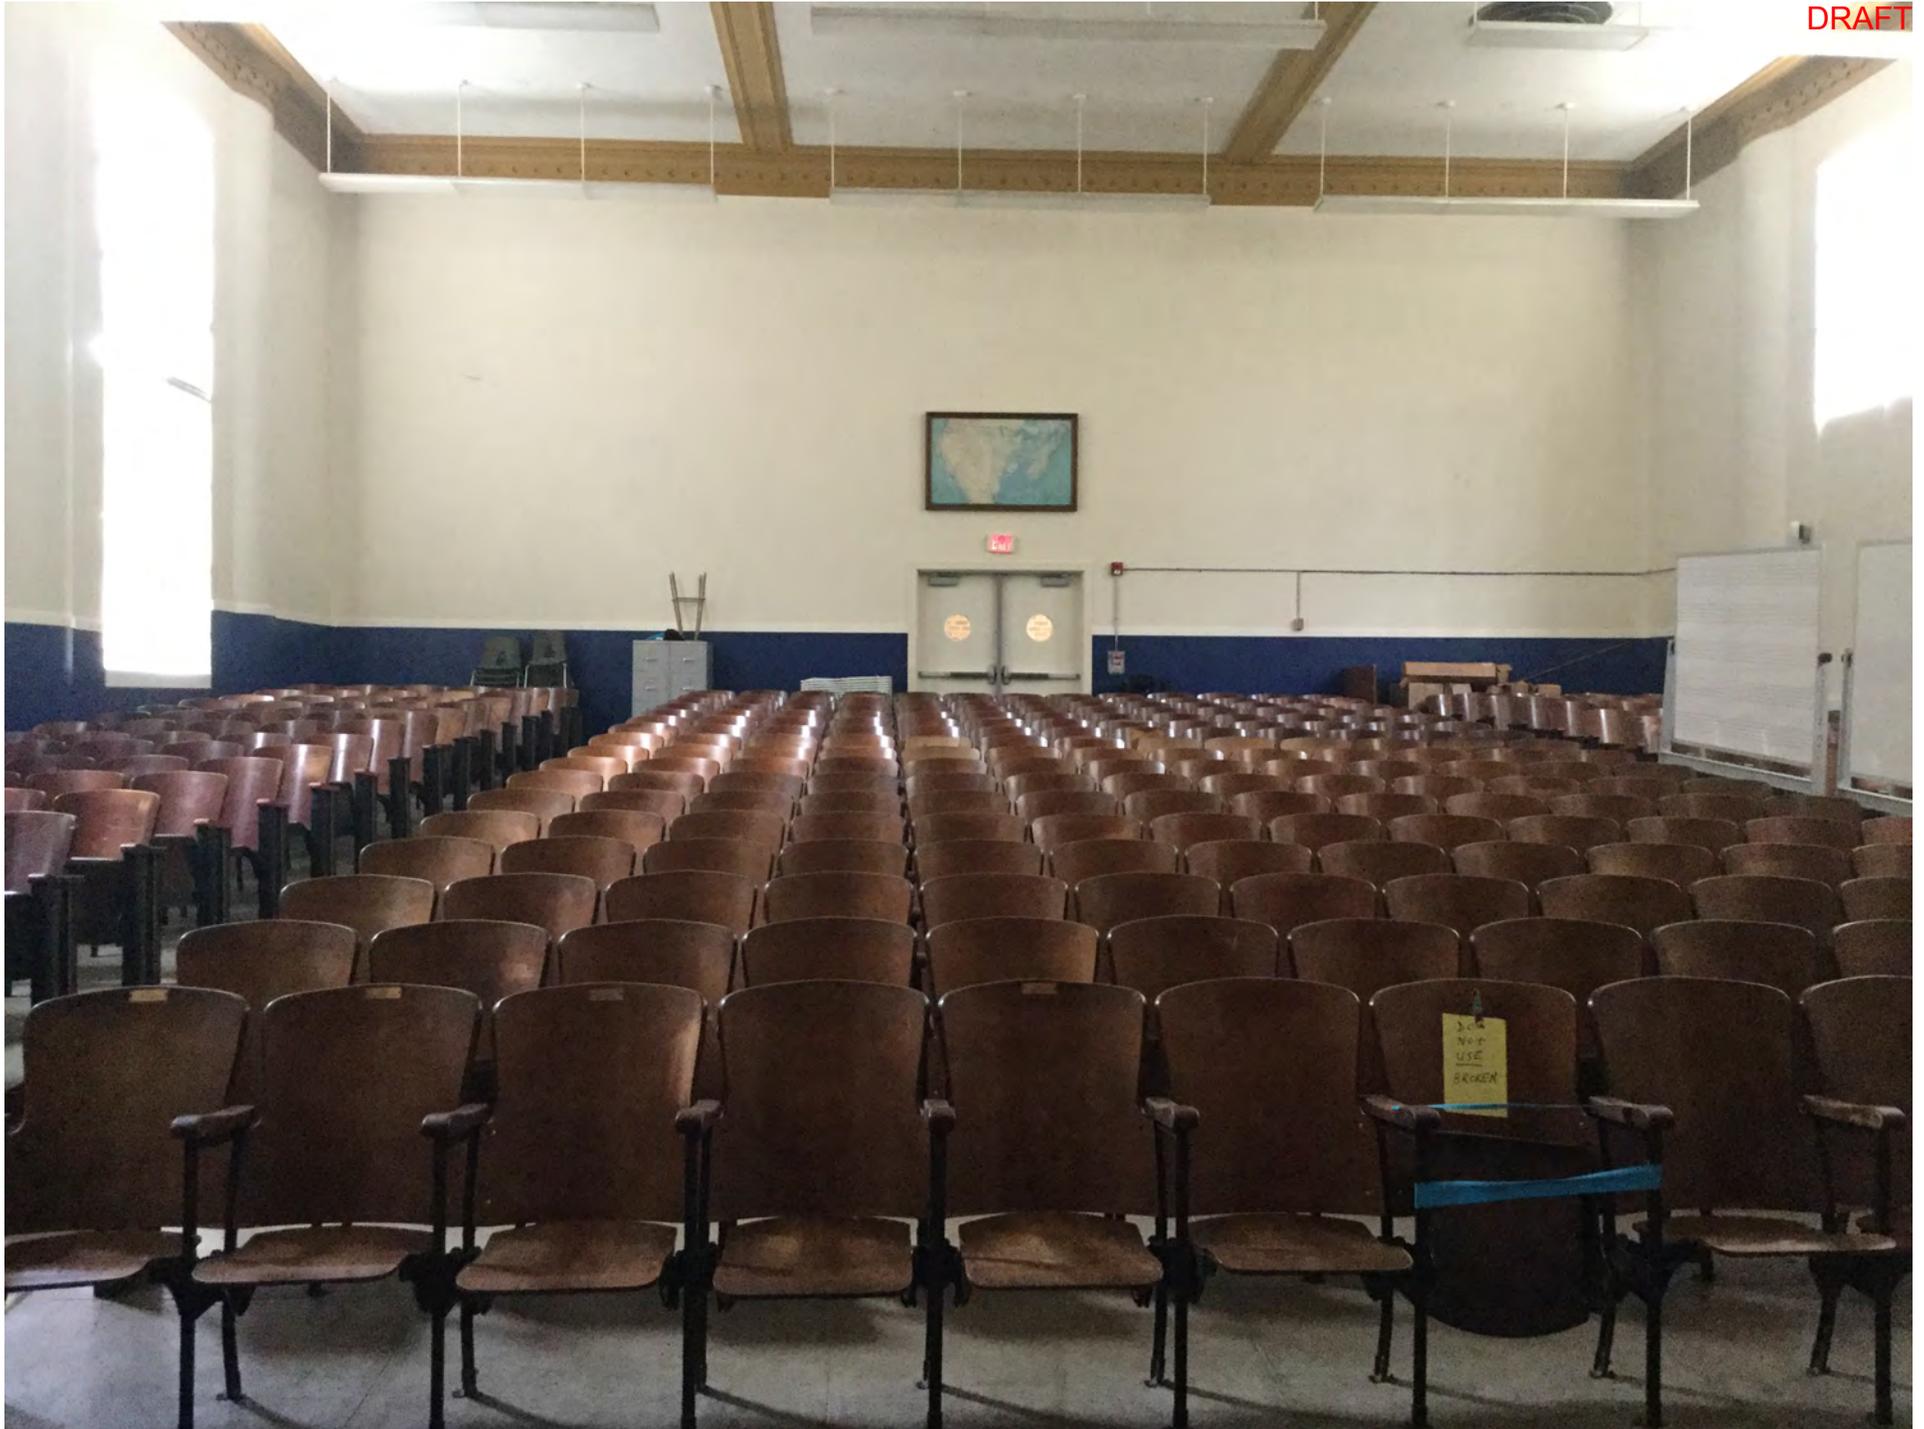
Photo 4  
3.8 Auditorium

| 3 - Academic & Co-Curricular Support - Continued | | 1 | 2 | 3 | 4 | 5 | N/A | | | | |
|---|---|---|---|---|---|---|---|---|---|---|---|
| 1) Very unsatisfactory<br>2) Unsatisfactory<br>3) Average<br>4) Good<br>5) Very good<br>N/A) Does not apply. | | | | | | | | The auditorium space is excellent, but there is no dedicated music/ band/ or orchestra space. These classes take place in the auditorium and cafeteria. The orchestra performs in the 6th grade classrooms. | | | |

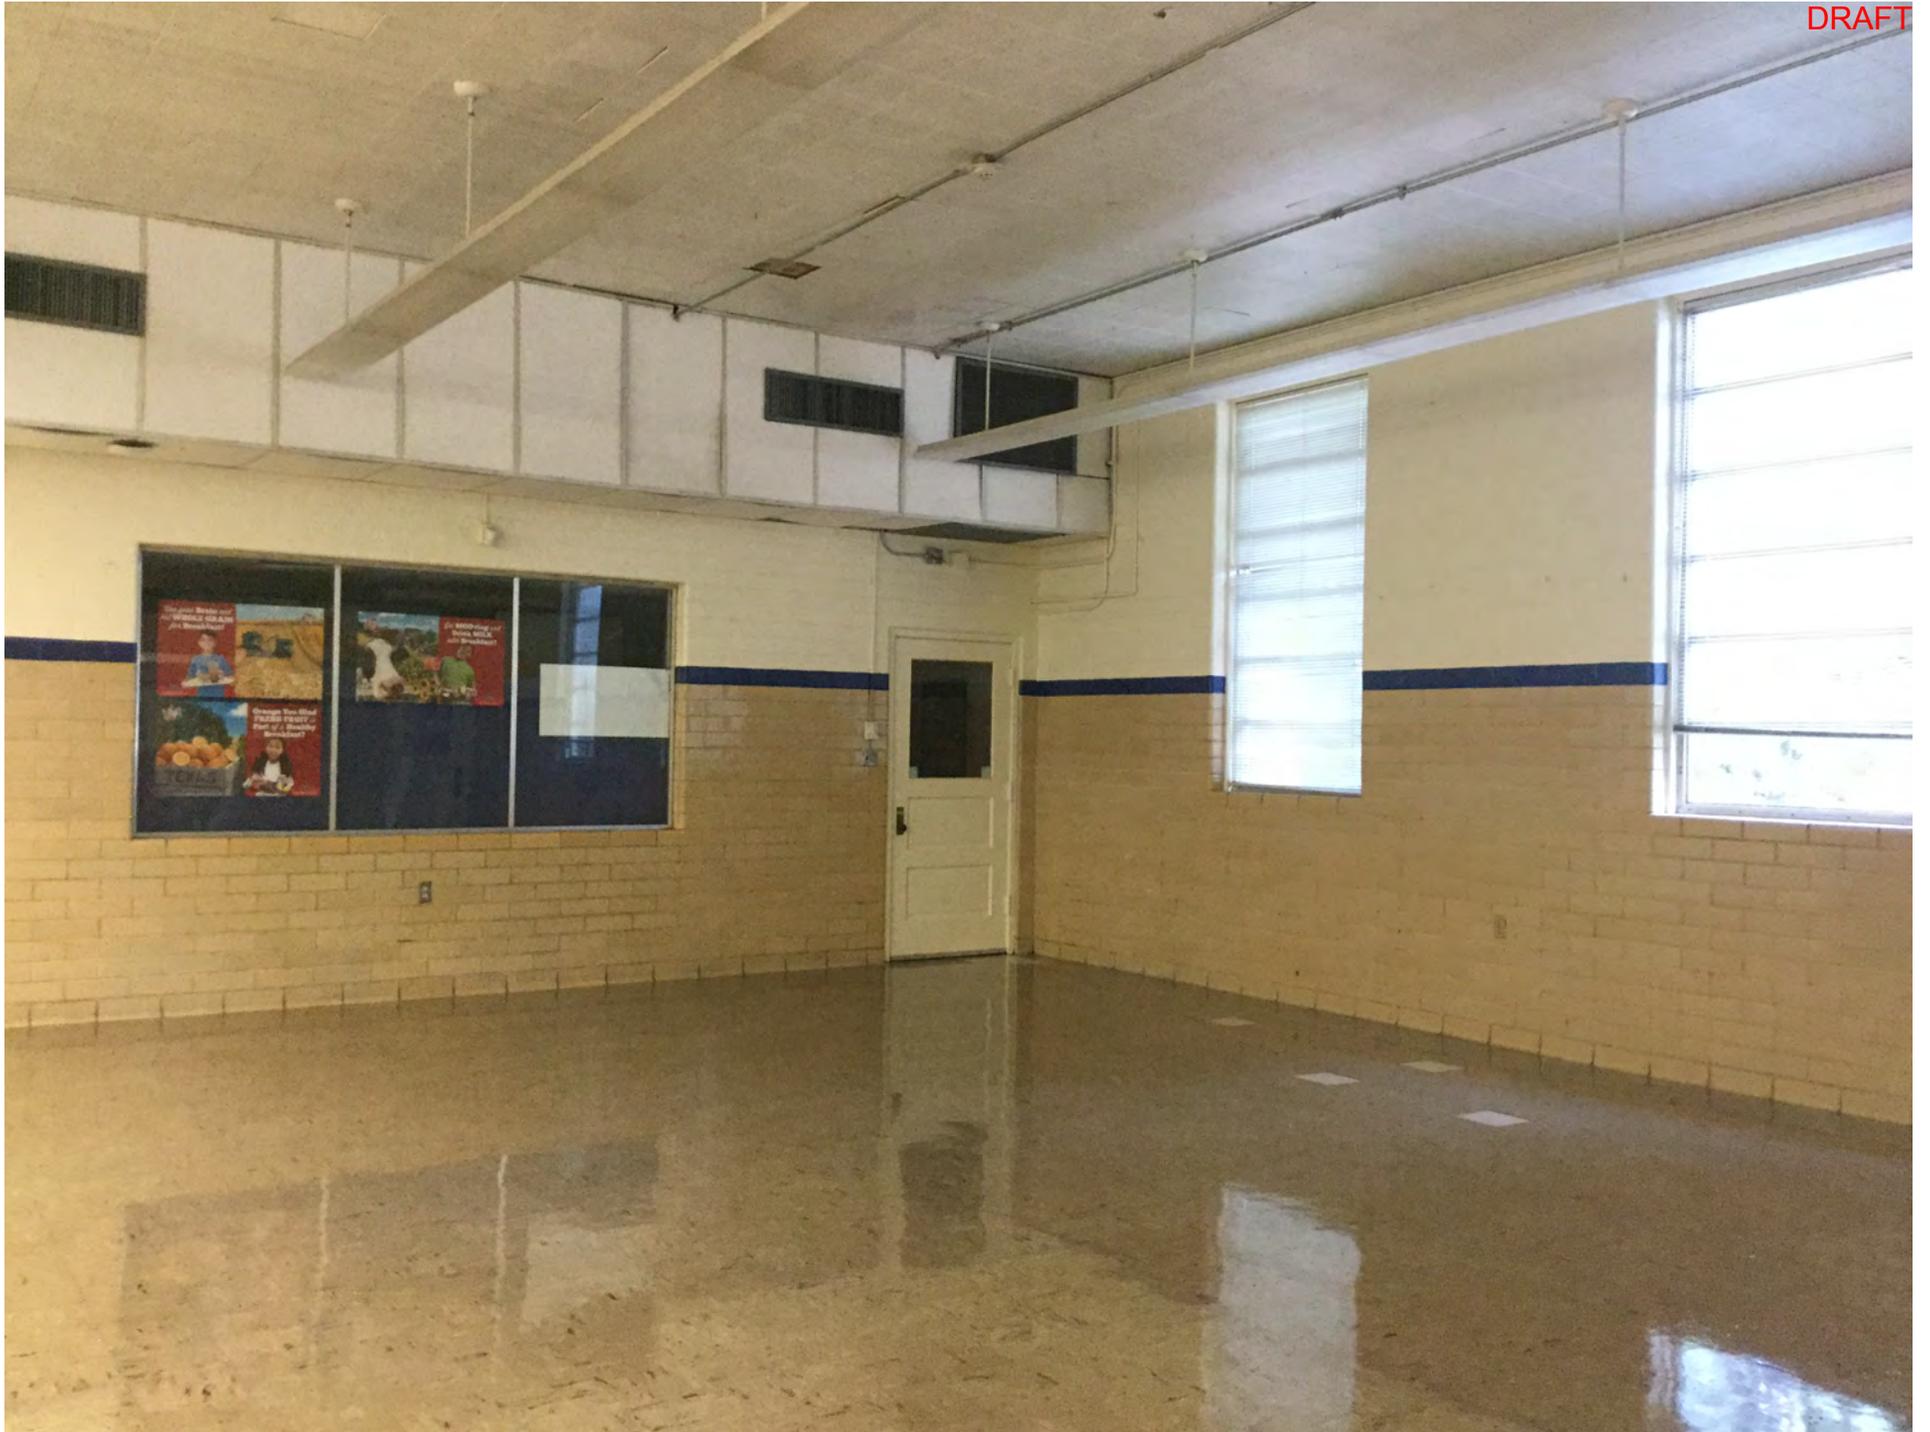
Photo 6.  
3.16 Cafeteria

| 3 - Academic & Co-Curricular Support - Continued | | 1 | 2 | 3 | 4 | 5 | N/A | | |
|---|---|---|---|---|---|---|---|---|--|
| <p>1) Very unsatisfactory - Too small, poor circulation, inflexible seating in poor condition</p> <p>2) Unsatisfactory - Too small or inadequate circulation, seating in poor condition</p> <p>3) Average - moderate size, with adequate circulation, seating in okay condition</p> <p>4) Good - good size, adequate circulation, seating in good condition</p> <p>5) Very good - good size, adequate circulation, seating in good condition, with more than one option for eating space (ex: connection to outdoor eating space)</p> <p>N/A) Does not apply.</p> | | | | | | | | <p>The cafeteria is small and dated.</p> <p style="text-align: right;">see photo 6</p> | |

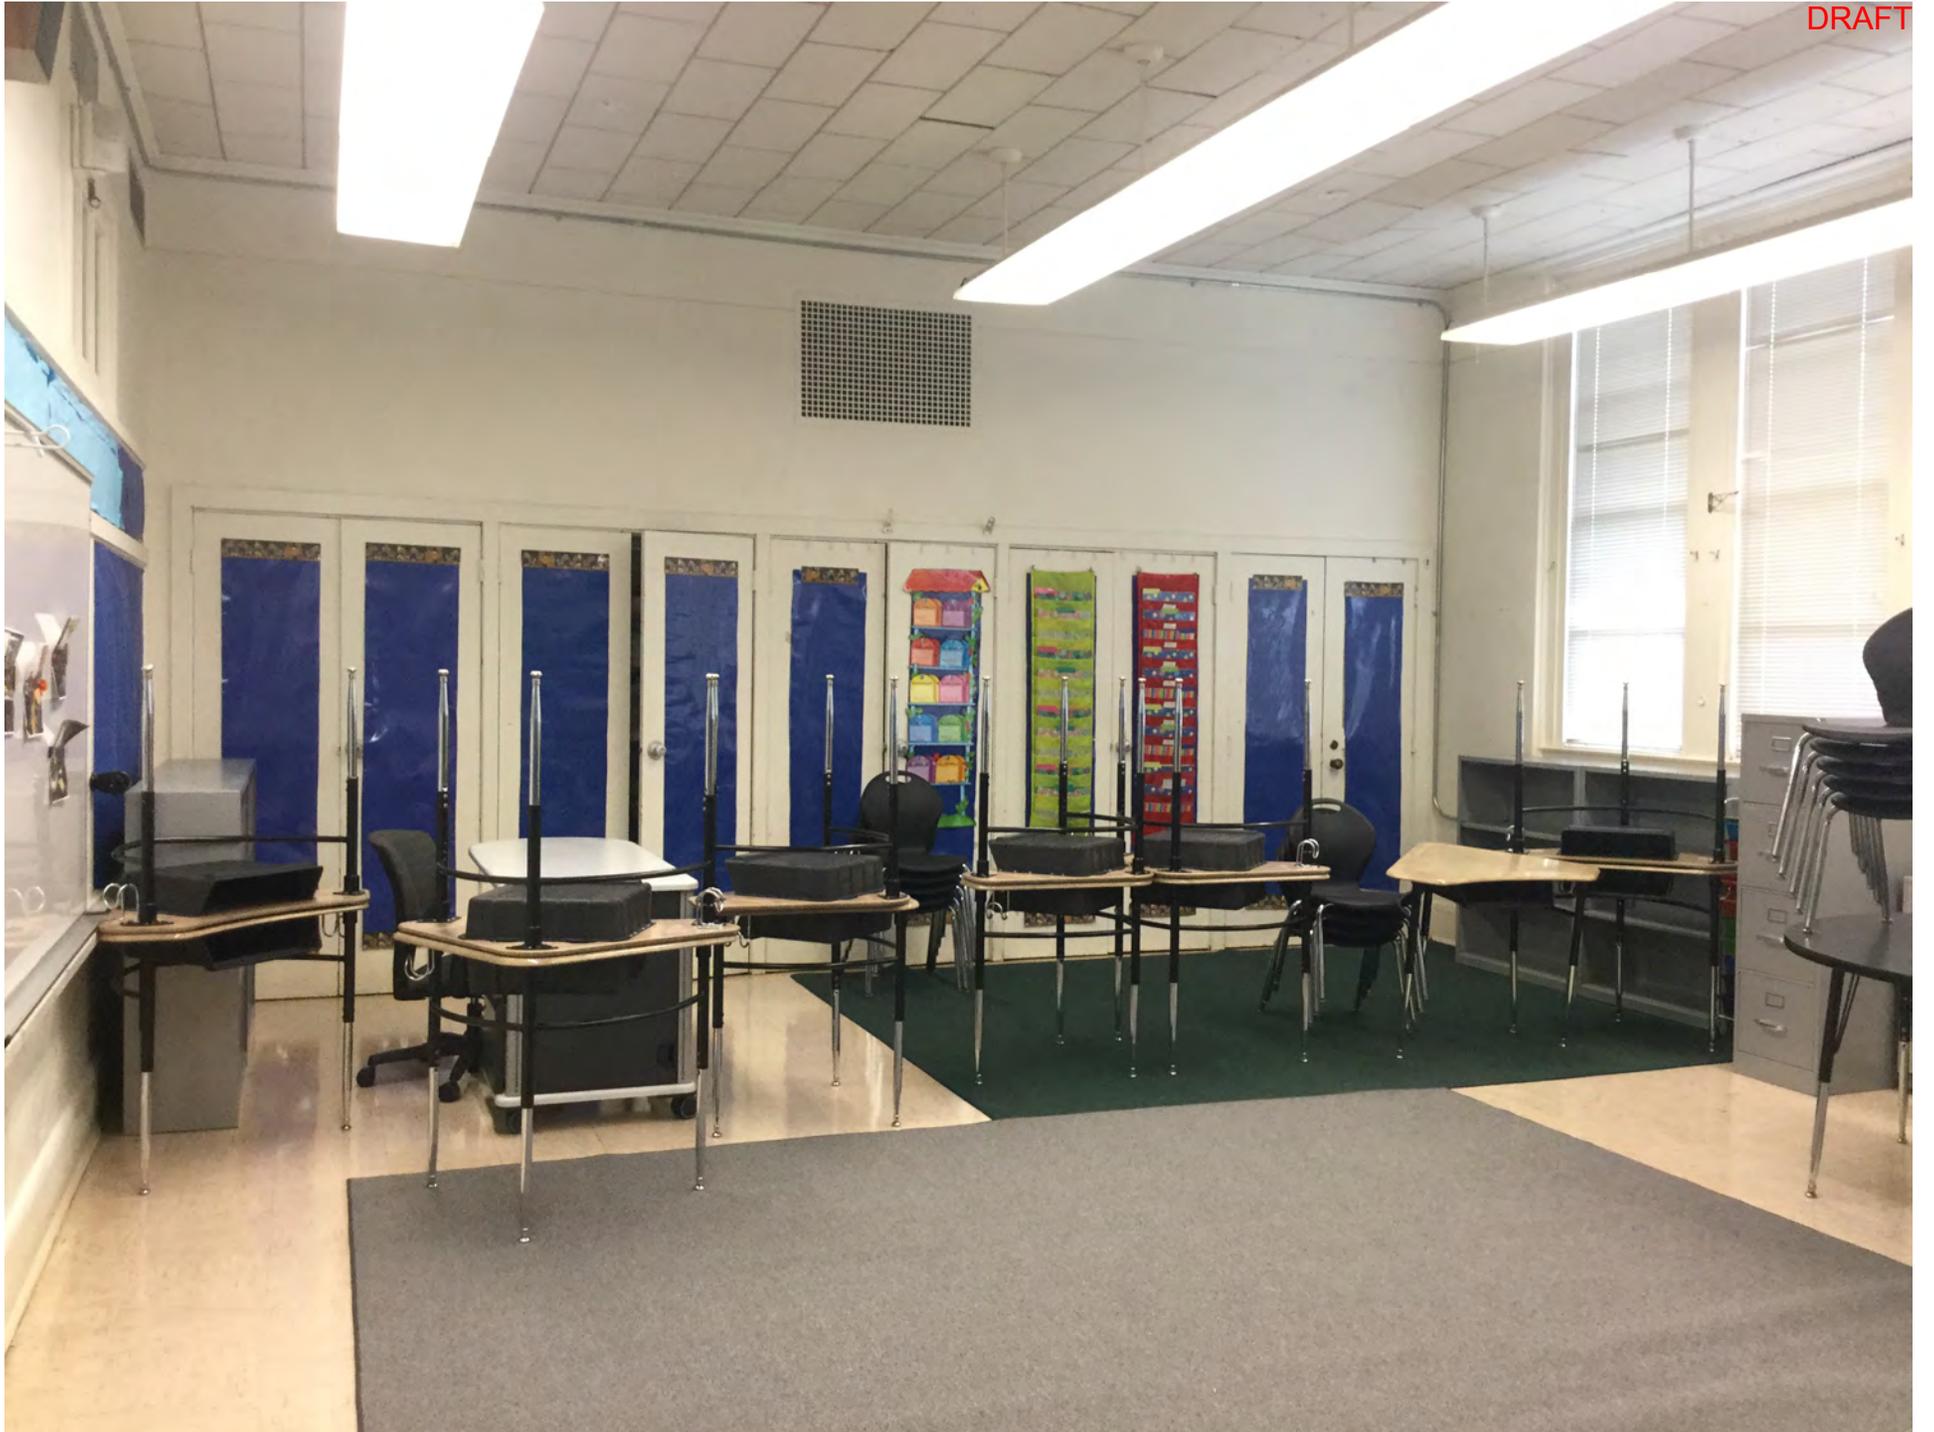
Photo 7.  
4.2 Standard Classroom

| 4 - Future Ready Student Development | | 1 | 2 | 3 | 4 | 5 | N/A | | | 17.00 |
|--|---|---|---|---|---|---|---|---|---|---|
| 1) Very unsatisfactory -too small to move, set for lecture only, no connectivity, no flexibility<br>2) Unsatisfactory - adequate size but set for lecture only, no connectivity, no flexibility<br>3) Neutral - have flexibility and space for hands on or project based learning<br>4) Satisfactory - have flexibility and space for hands on or project based learning and connectivity for global learning<br>5) Very Satisfactory - space for hands on learning, flexibility for different groupings, and connectivity for global classrooms<br>N/A) Does not apply. | | | | | | | | | | |

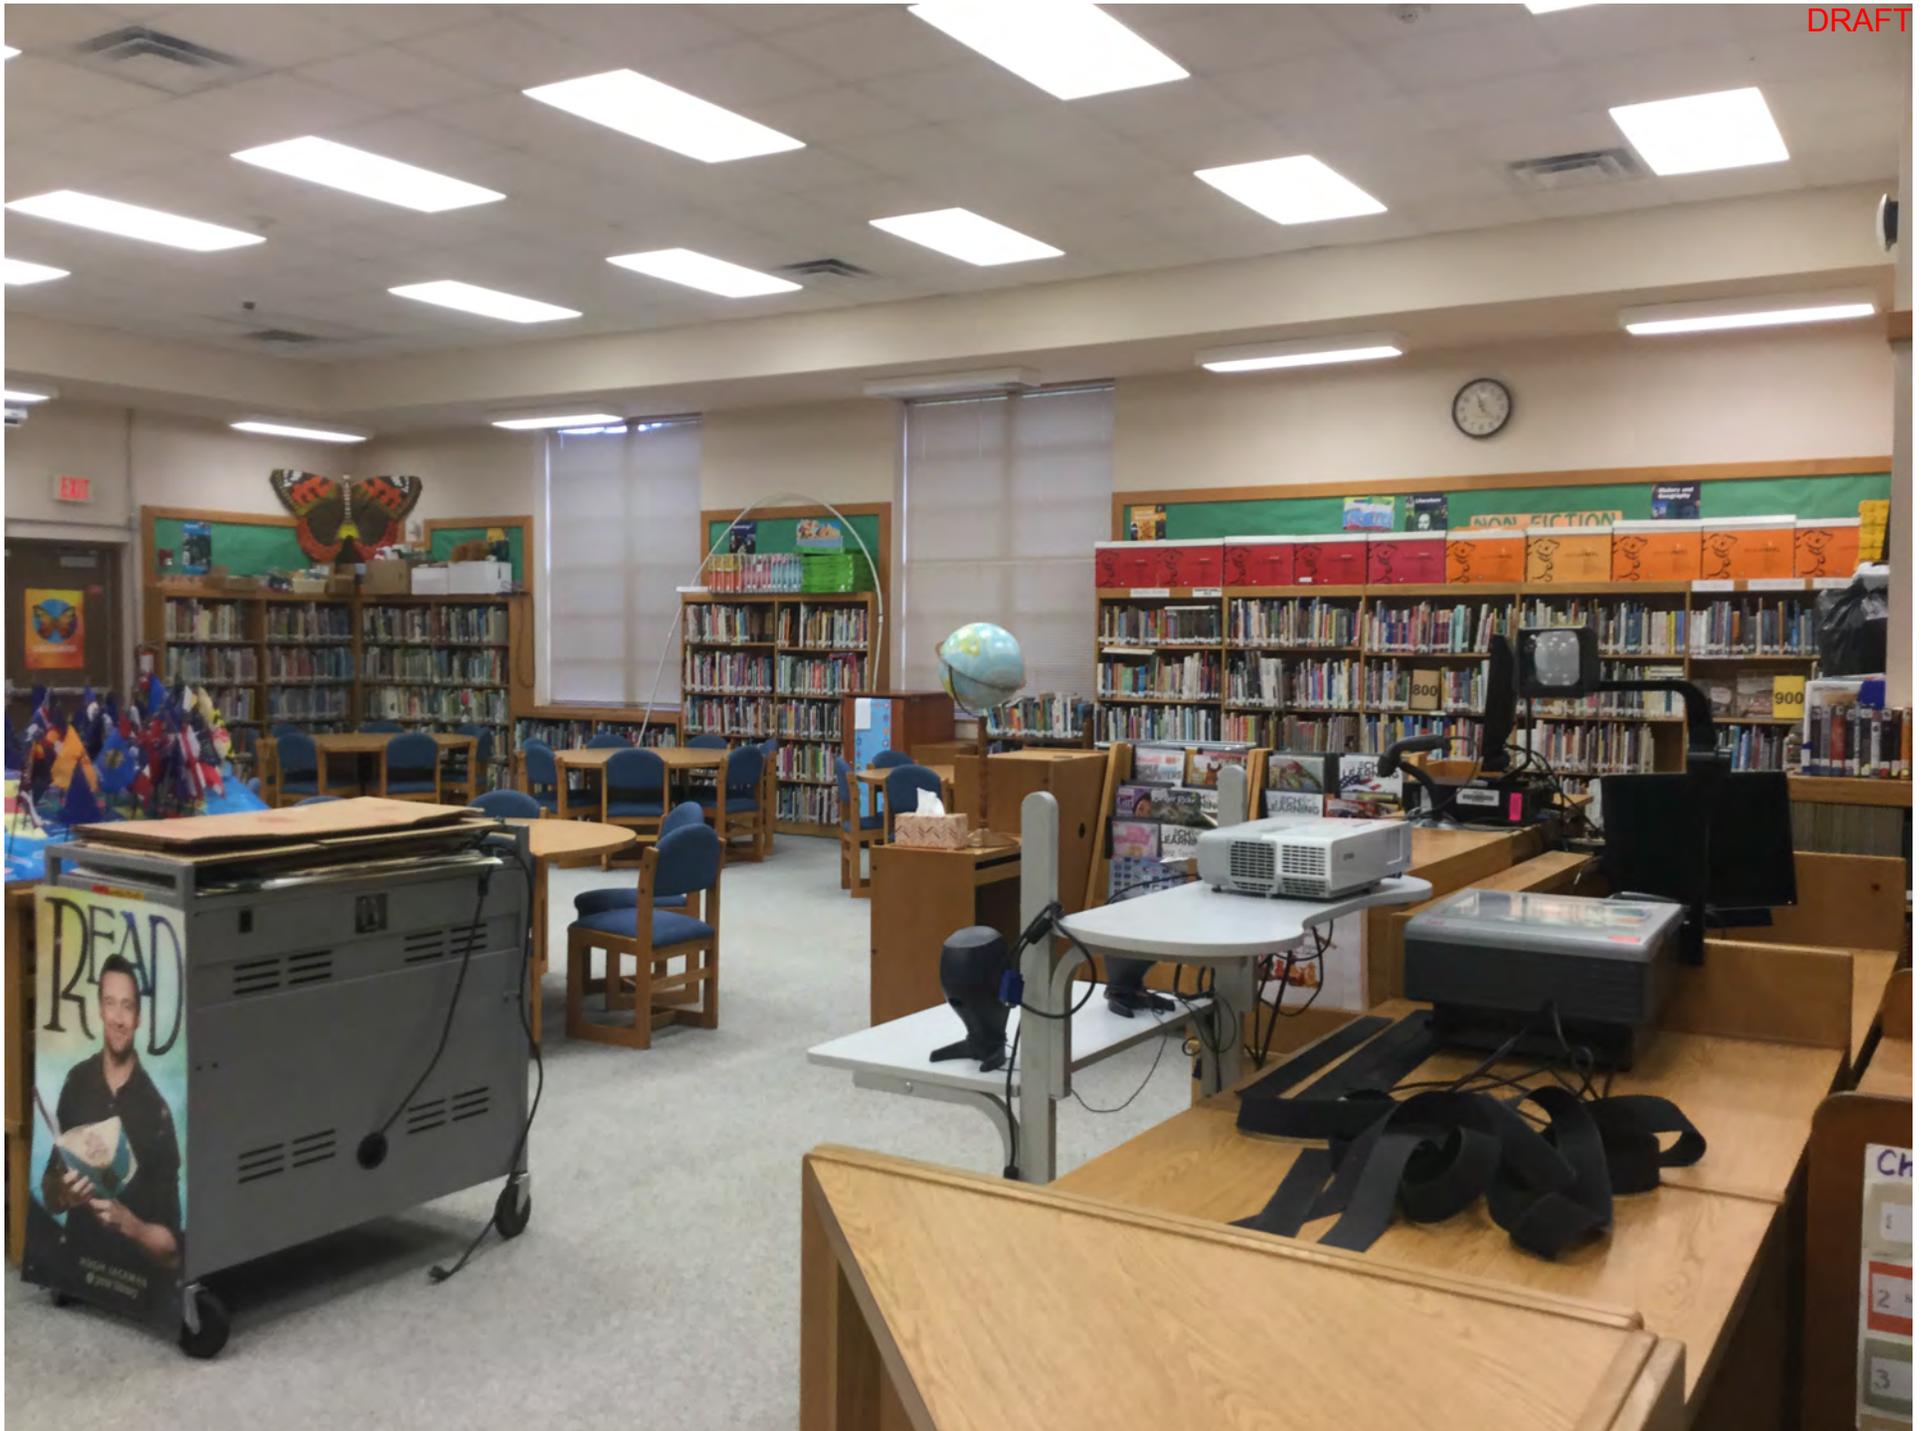
Photo 8.  
5.4 Library

| 5 - Library/Media Center | | 1 | 2 | 3 | 4 | 5 | N/A | | | 20.50 |
|--|---|--|---|---|---|---|---|---|---|---|
| 5.4 | How well does the Library/Media Center support collaborative work in small groups (4-8 students)? | | | | | 5 | | Comments | 1.00 | 5.00 |
