## Educational Suitability Summary Report

Russell Lee Elementary School

Date: 07/28/2016

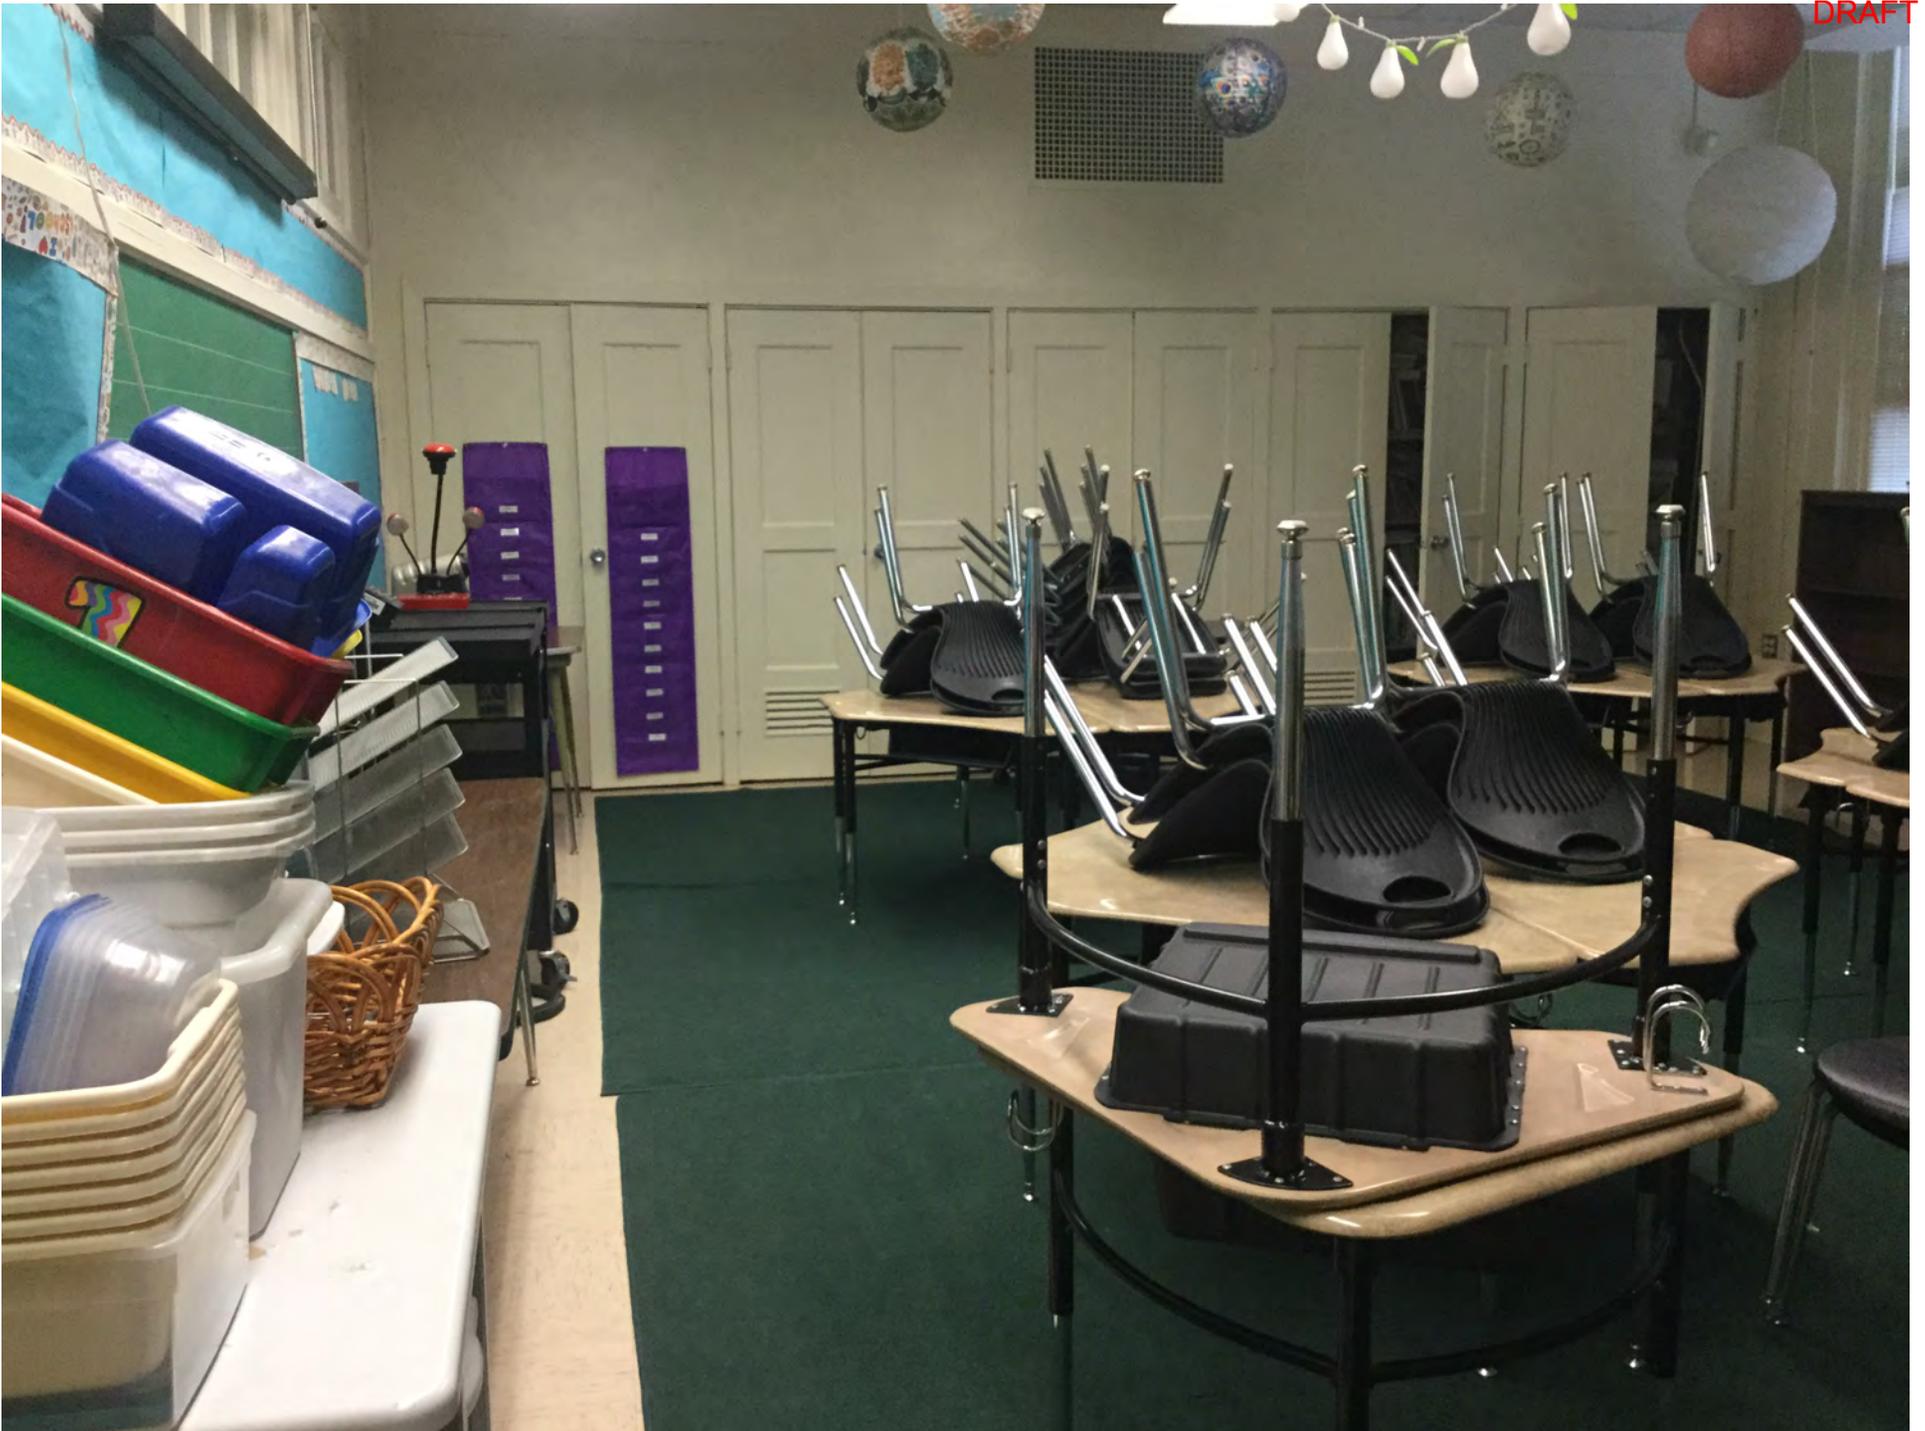
Photo 9.  
9.2 Furniture

| 9 - Furniture, Fixtures & Equipment | | 1 | 2 | 3 | 4 | 5 | N/A | | | 12.00 |
|---|---|---|---|---|---|---|---|---|---|---|
| 1) Very unsatisfactory - desk with attached chair combinations too small for grade level<br>2) Unsatisfactory -desk with attached chair combinations<br>3) Average - mix of classrooms with tables/loose chairs and desks with fixed seats<br>4) Good - tables with loose chairs<br>5) Very good - tables with loose chairs that allow students to bounce in seat<br>N/A) Does not apply. | | | | | | | | | | |
