Educational Suitability Summary Report

Linder Elementary School

Date: 08/15/2016

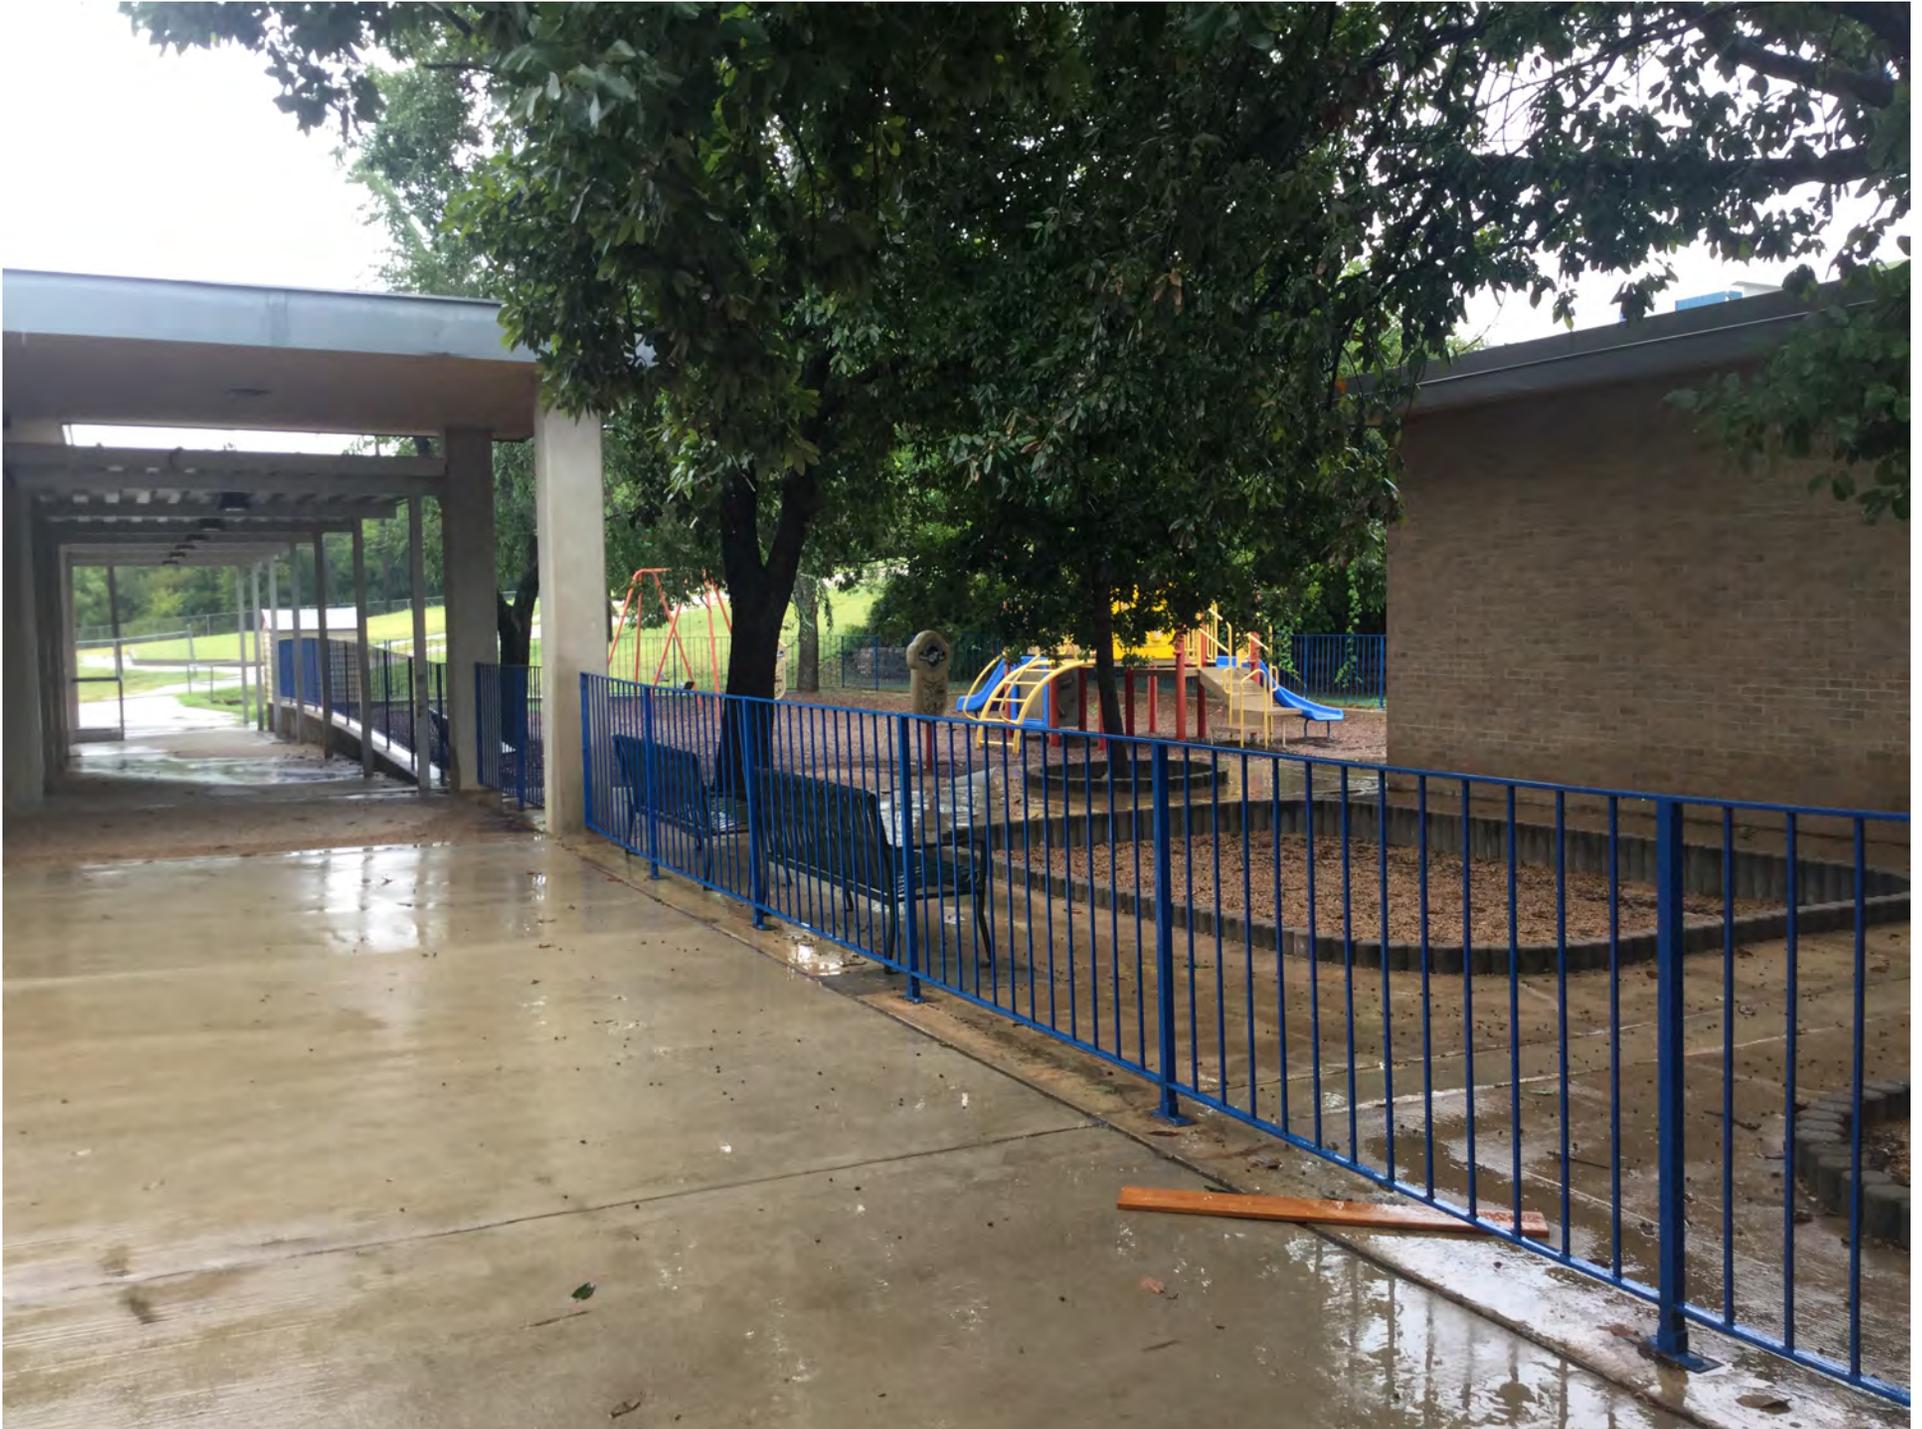
Photo 1. Outdoor play/
common areador
Playground

1.2	Are opportunities provided for outdoor learning (outdoor classrooms, gardens, etc.)?		2					Comments	1.00	2.00	
1) Outdoor space exists is not developed 2) Outdoor space for learning exists but not connected to classroom learning areas. 3. Outdoor learning spaces exist and are accessible but not in good condition. 4. Outdoor learning spaces need minor improvements to function well. 5. Outdoor learning spaces are in excellent condition. N/A) Does not apply.								Only connected outdoor learning space is a playground that was originally intended for Pre-K and Kinder students. Now used by 1st graders and Special Education students. See Photo 1

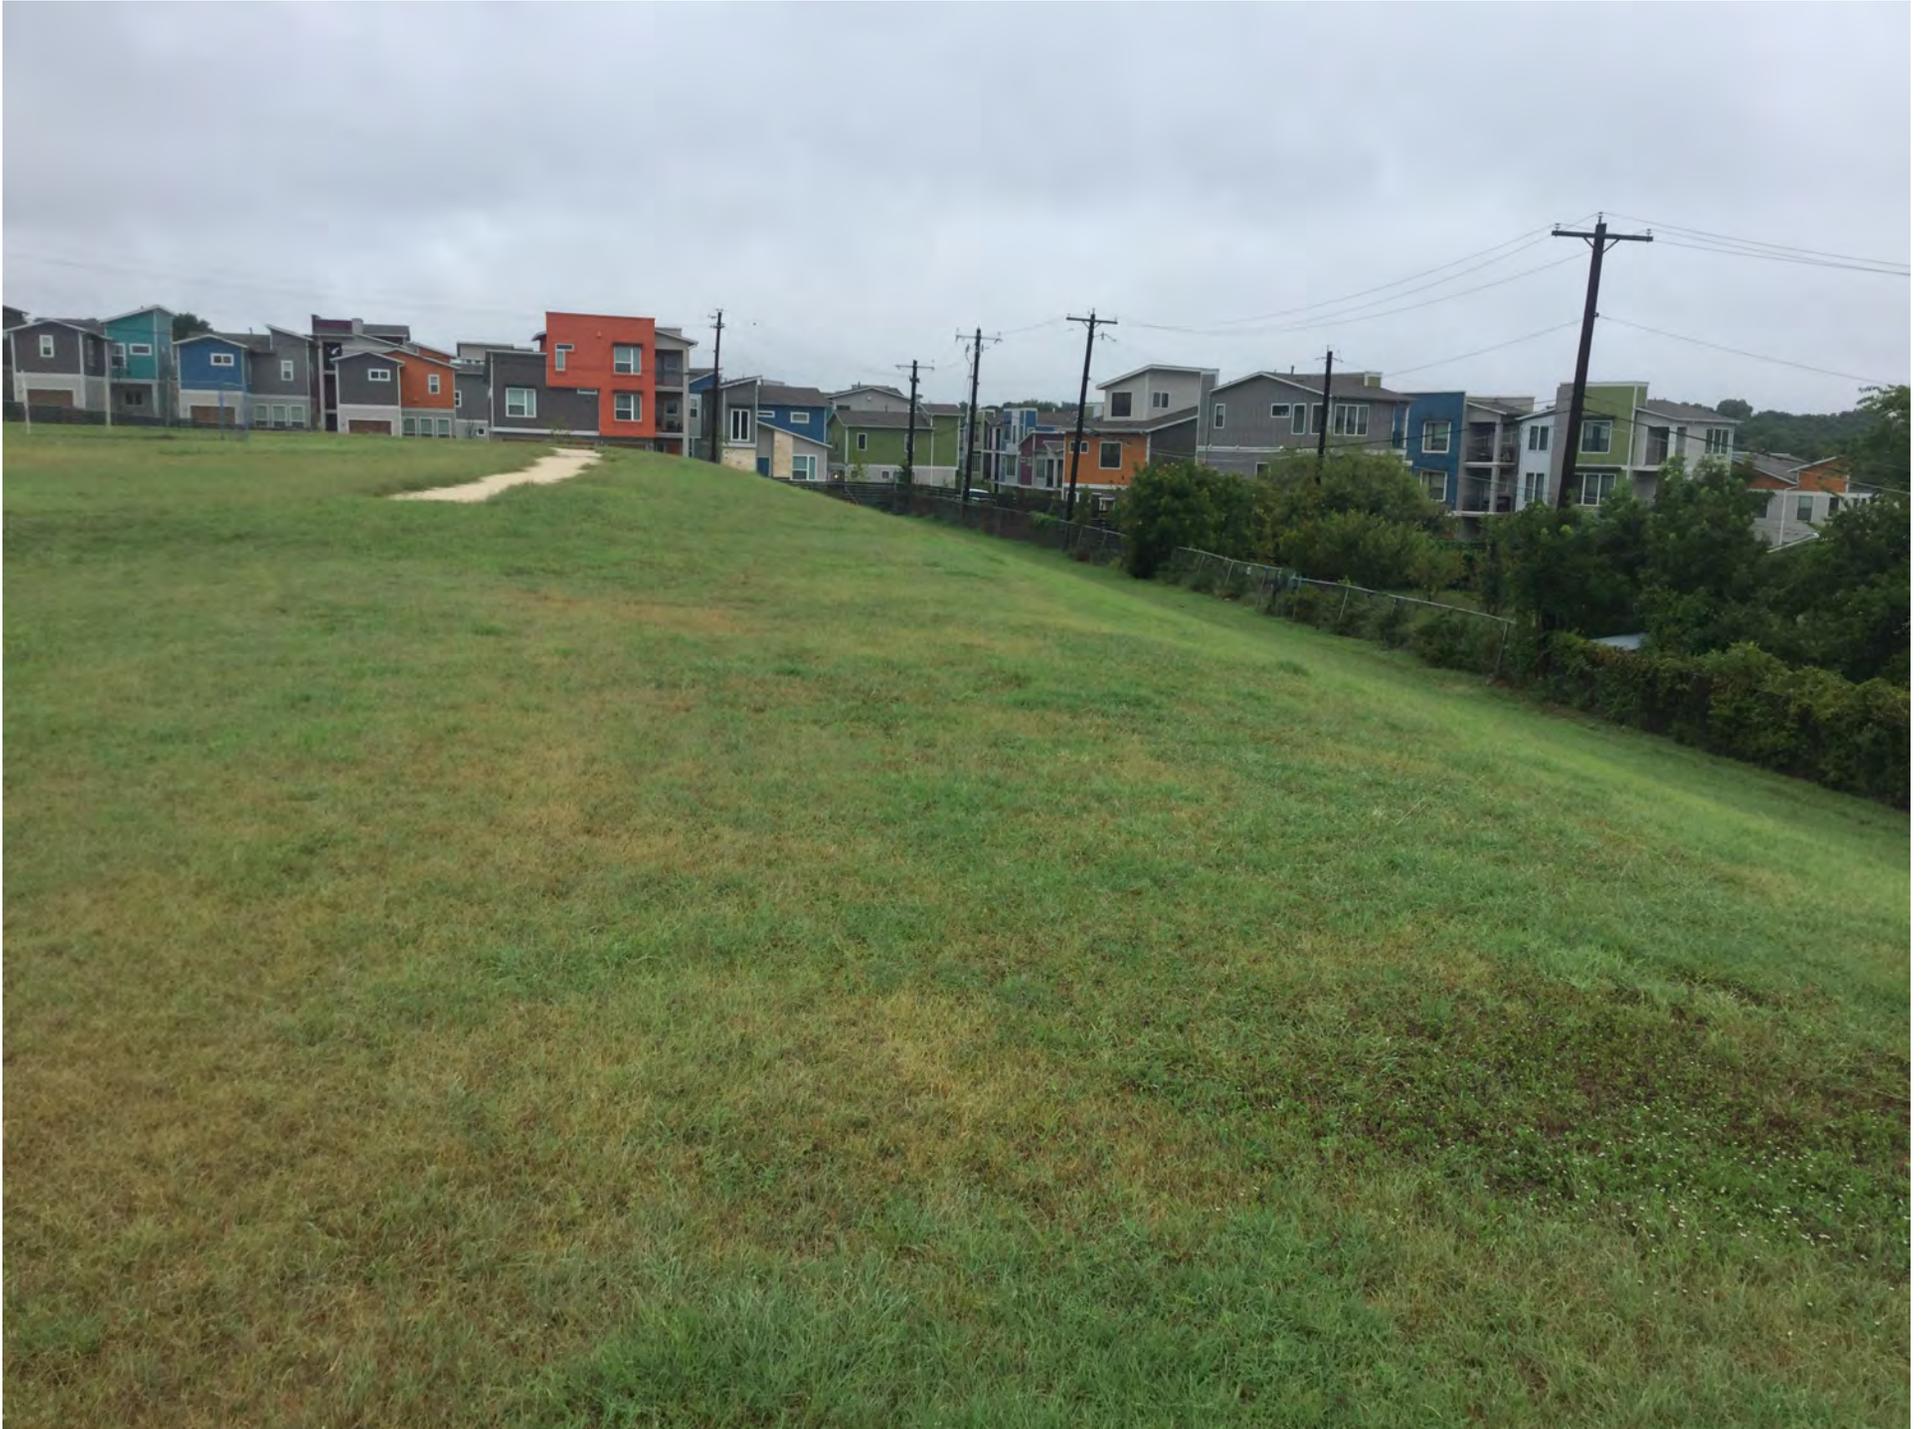
Photo 2. TPlayground/
trackrack/Playfield Area

1.3	Are outdoor play spaces and playfields adequate in size and configuration?		2					Comments	1.00	2.00	
1) Outdoor play space exists, not developed 2) Outdoor play space exists but is not connected to gym or other athletic support areas or is too small. 3. Outdoor play spaces exist, are connected to other athletic areas, are the right size, but are not in good condition. 4. Outdoor play spaces need minor improvements to function well. 5. Outdoor play spaces are in excellent condition. N/A) Does not apply.								Track is not level. The access to playground area is through a parking lot. Potential fall hazard and limited visibility with the sloped grounds near the play fields. Weeds growing through play area. Grounds maintenance needed. See Photo 2

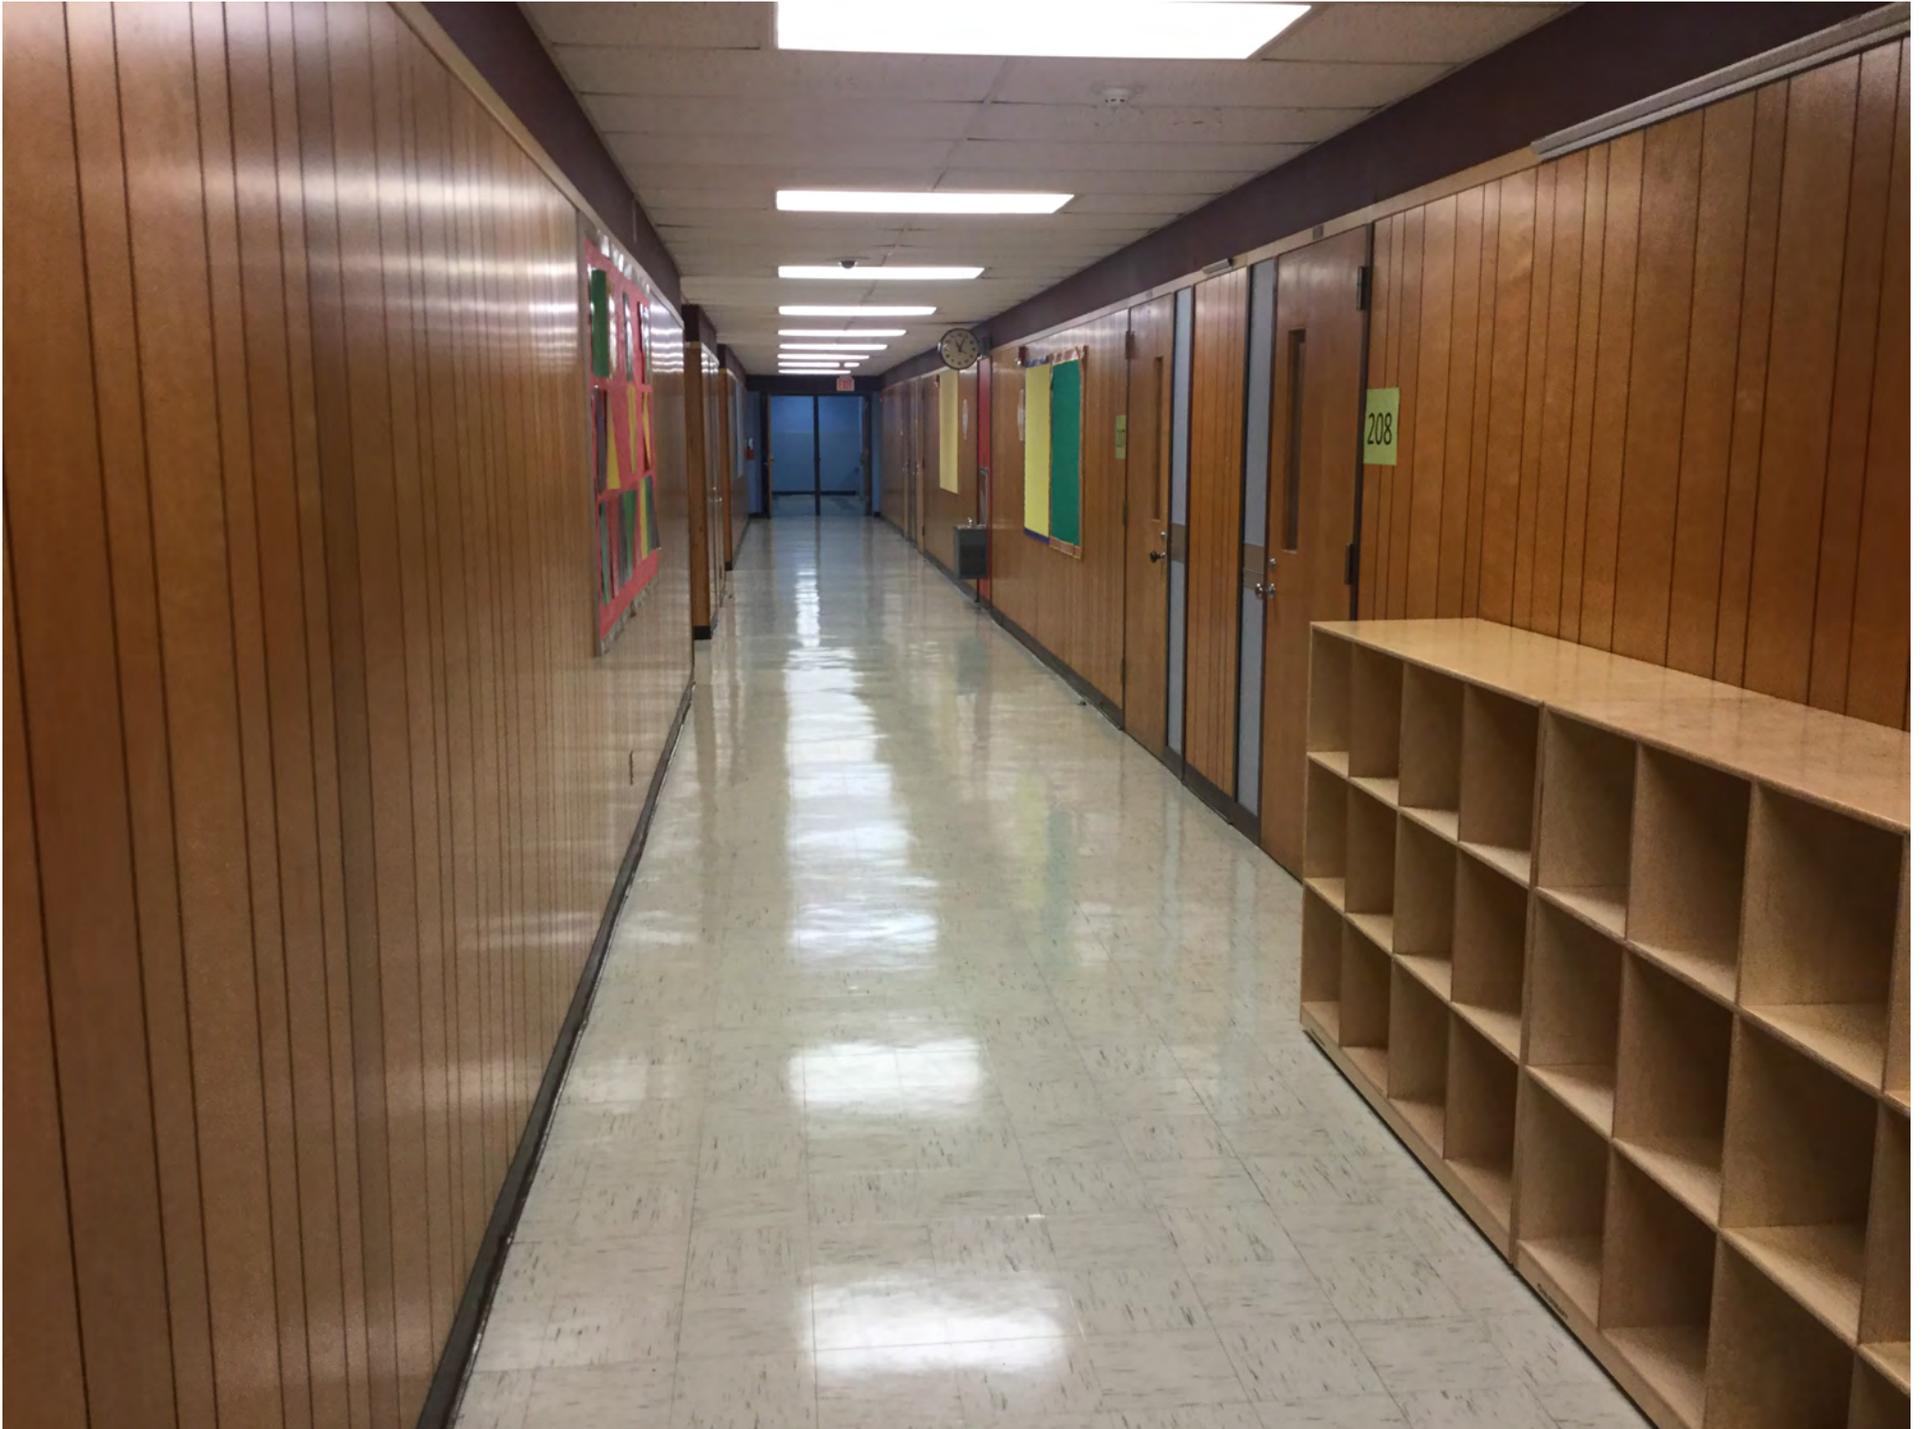
Photo 3. Classroom
corridor
classroom
corridor

1) Primary circulation is 5'-0" to 6'-0" wide. 2) Primary circulation is 6'-0" to 7'-0" wide 3) Primary circulation is 7'-0" to 8'-0" wide 4) Primary circulation is 8'-0"-10'-0" wide 5) Primary circulation is 10'-0"+ wide N/A) Does not apply.		Only the main corridors are 10 feet wide. Most corridors are 7'-8' wide.							See Photo 3

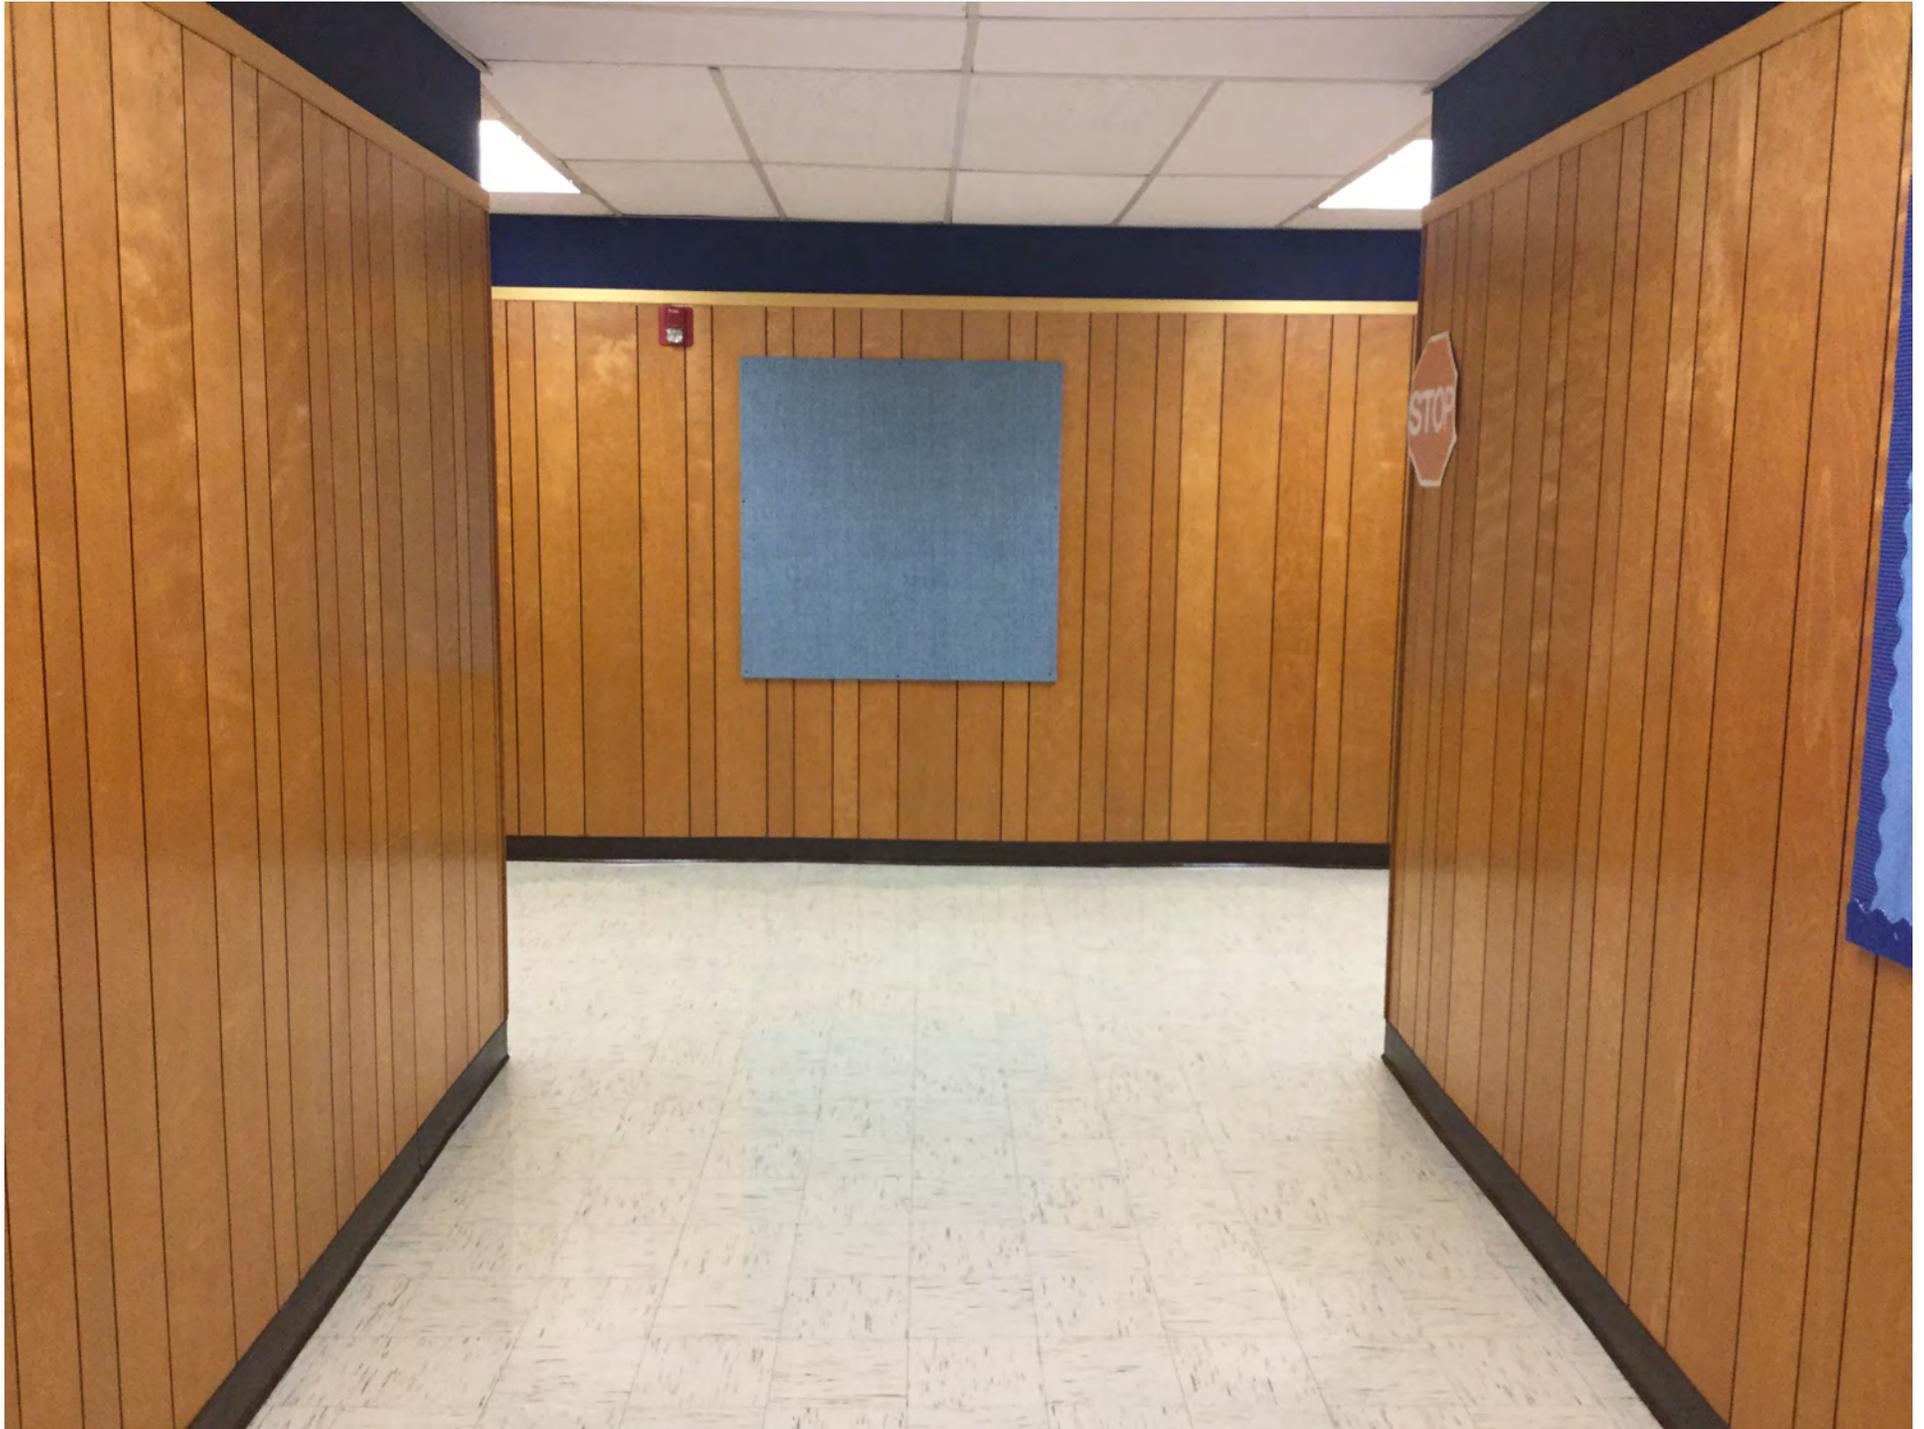
Photo 4. Corridors

2.3	Does the general appearance of the school evoke pride for the students and community?		2					0.25	0.50	
1) General appearance is poor. 2) General appearance is aged but ok. 3) General appearance is good. 4) General appearance shows pride in campus and student works. 5) General appearance shows pride in campus and student works and is welcoming to the community. N/A) Does not apply.		Does not look like an elementary campus. Although well maintained, interior wood panel in corridors give campus a dated feeling.							See Photo 4

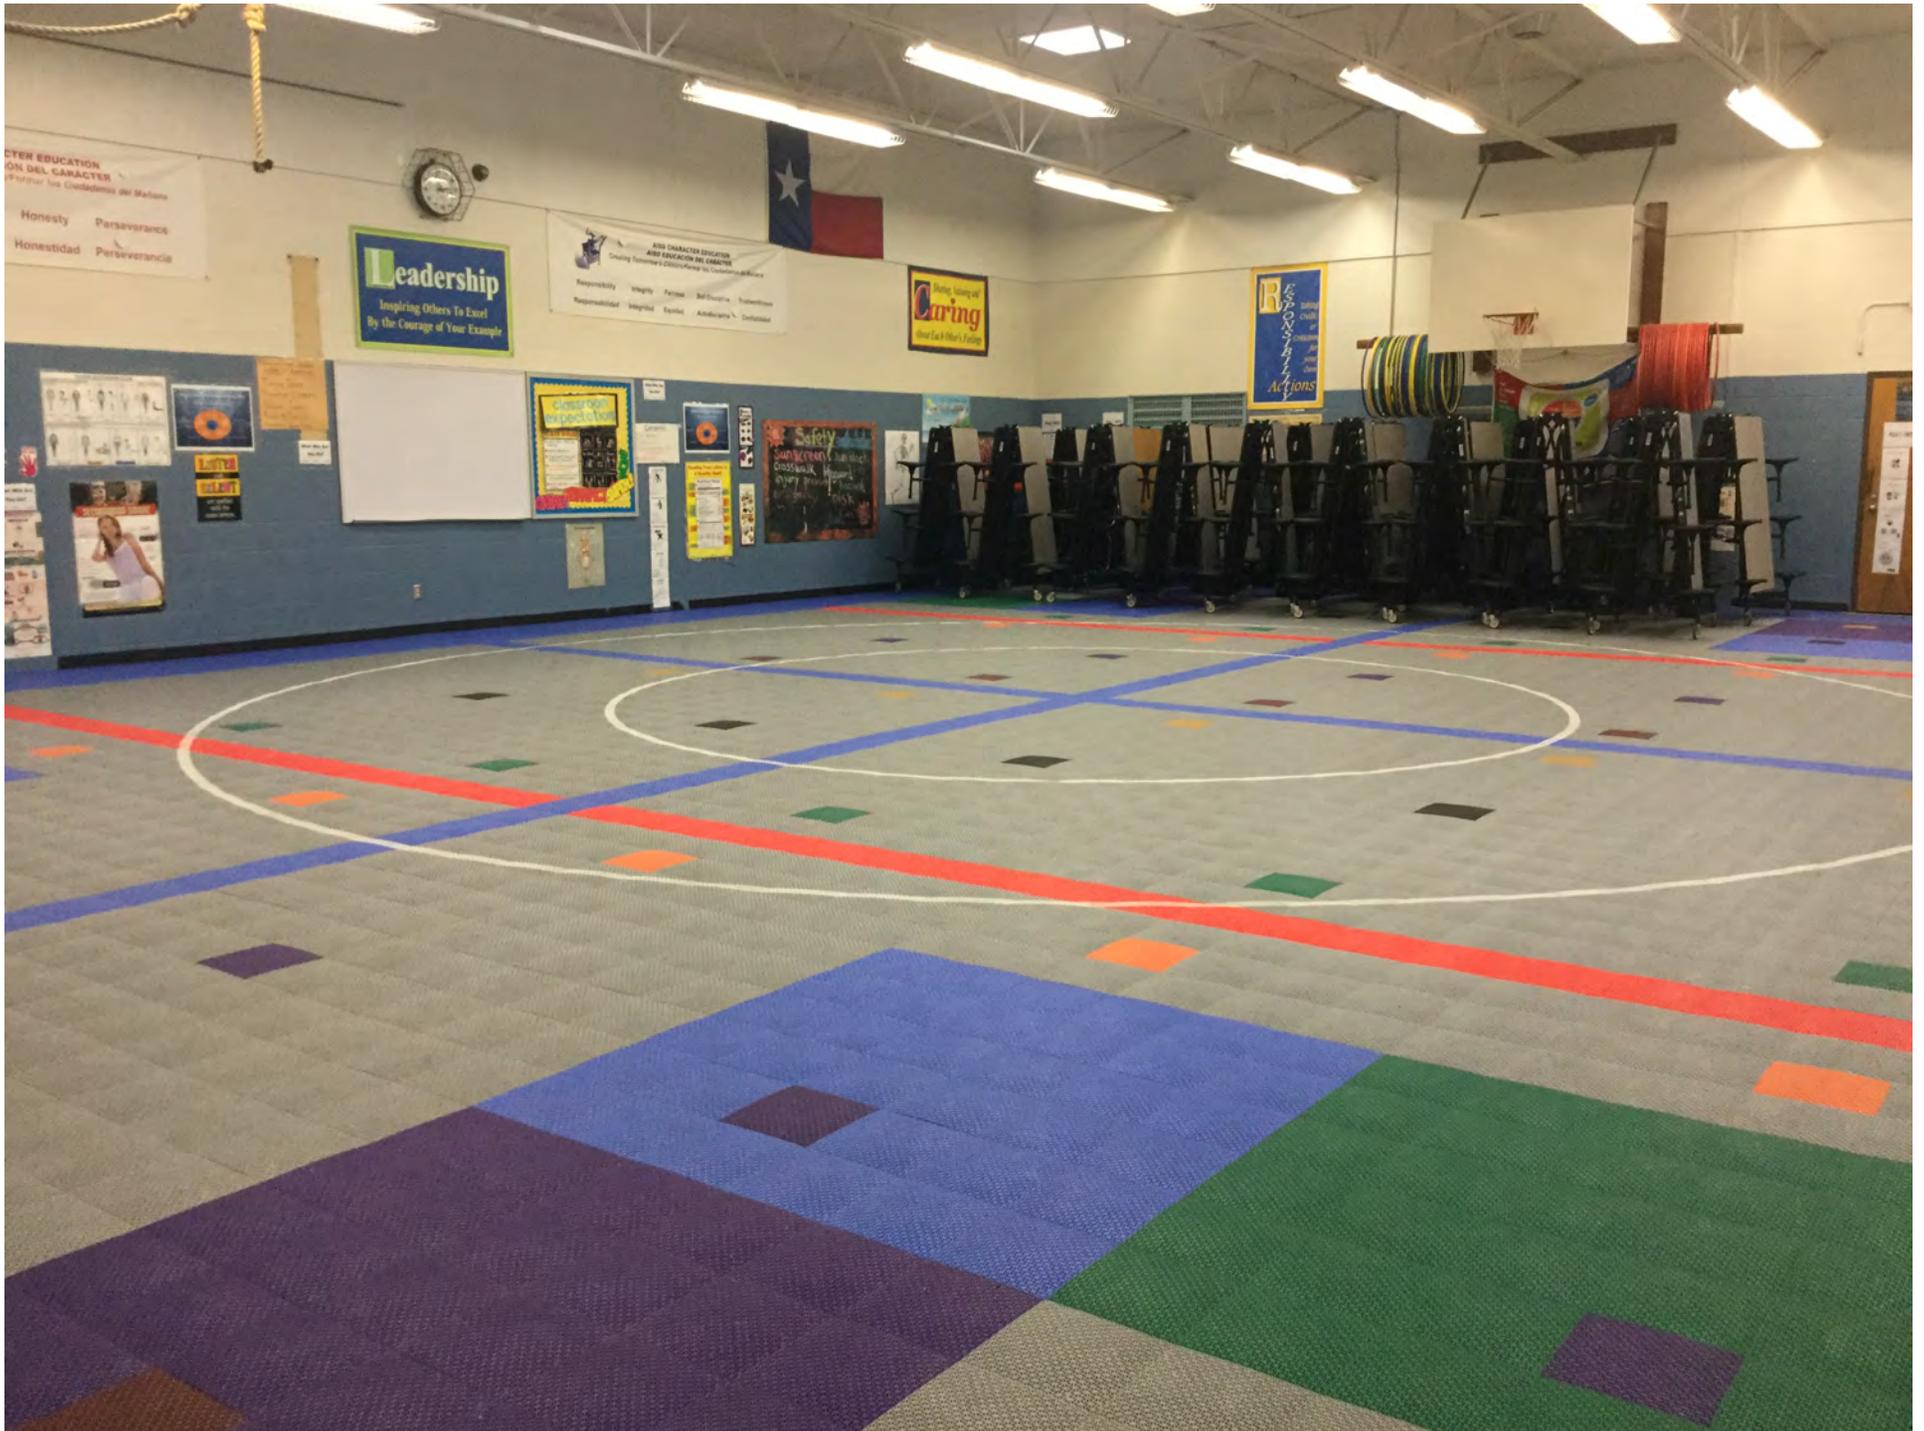
Photo 5. GyGymm

1) Very unsatisfactory 2) Unsatisfactory 3) Average 4) Good 5) Very good N/A) Does not apply.								Comments	1.00 3.00
								Flooring is new and size is appropriate. Small storage room attached. Equipment is dated.	
								See Photo 5

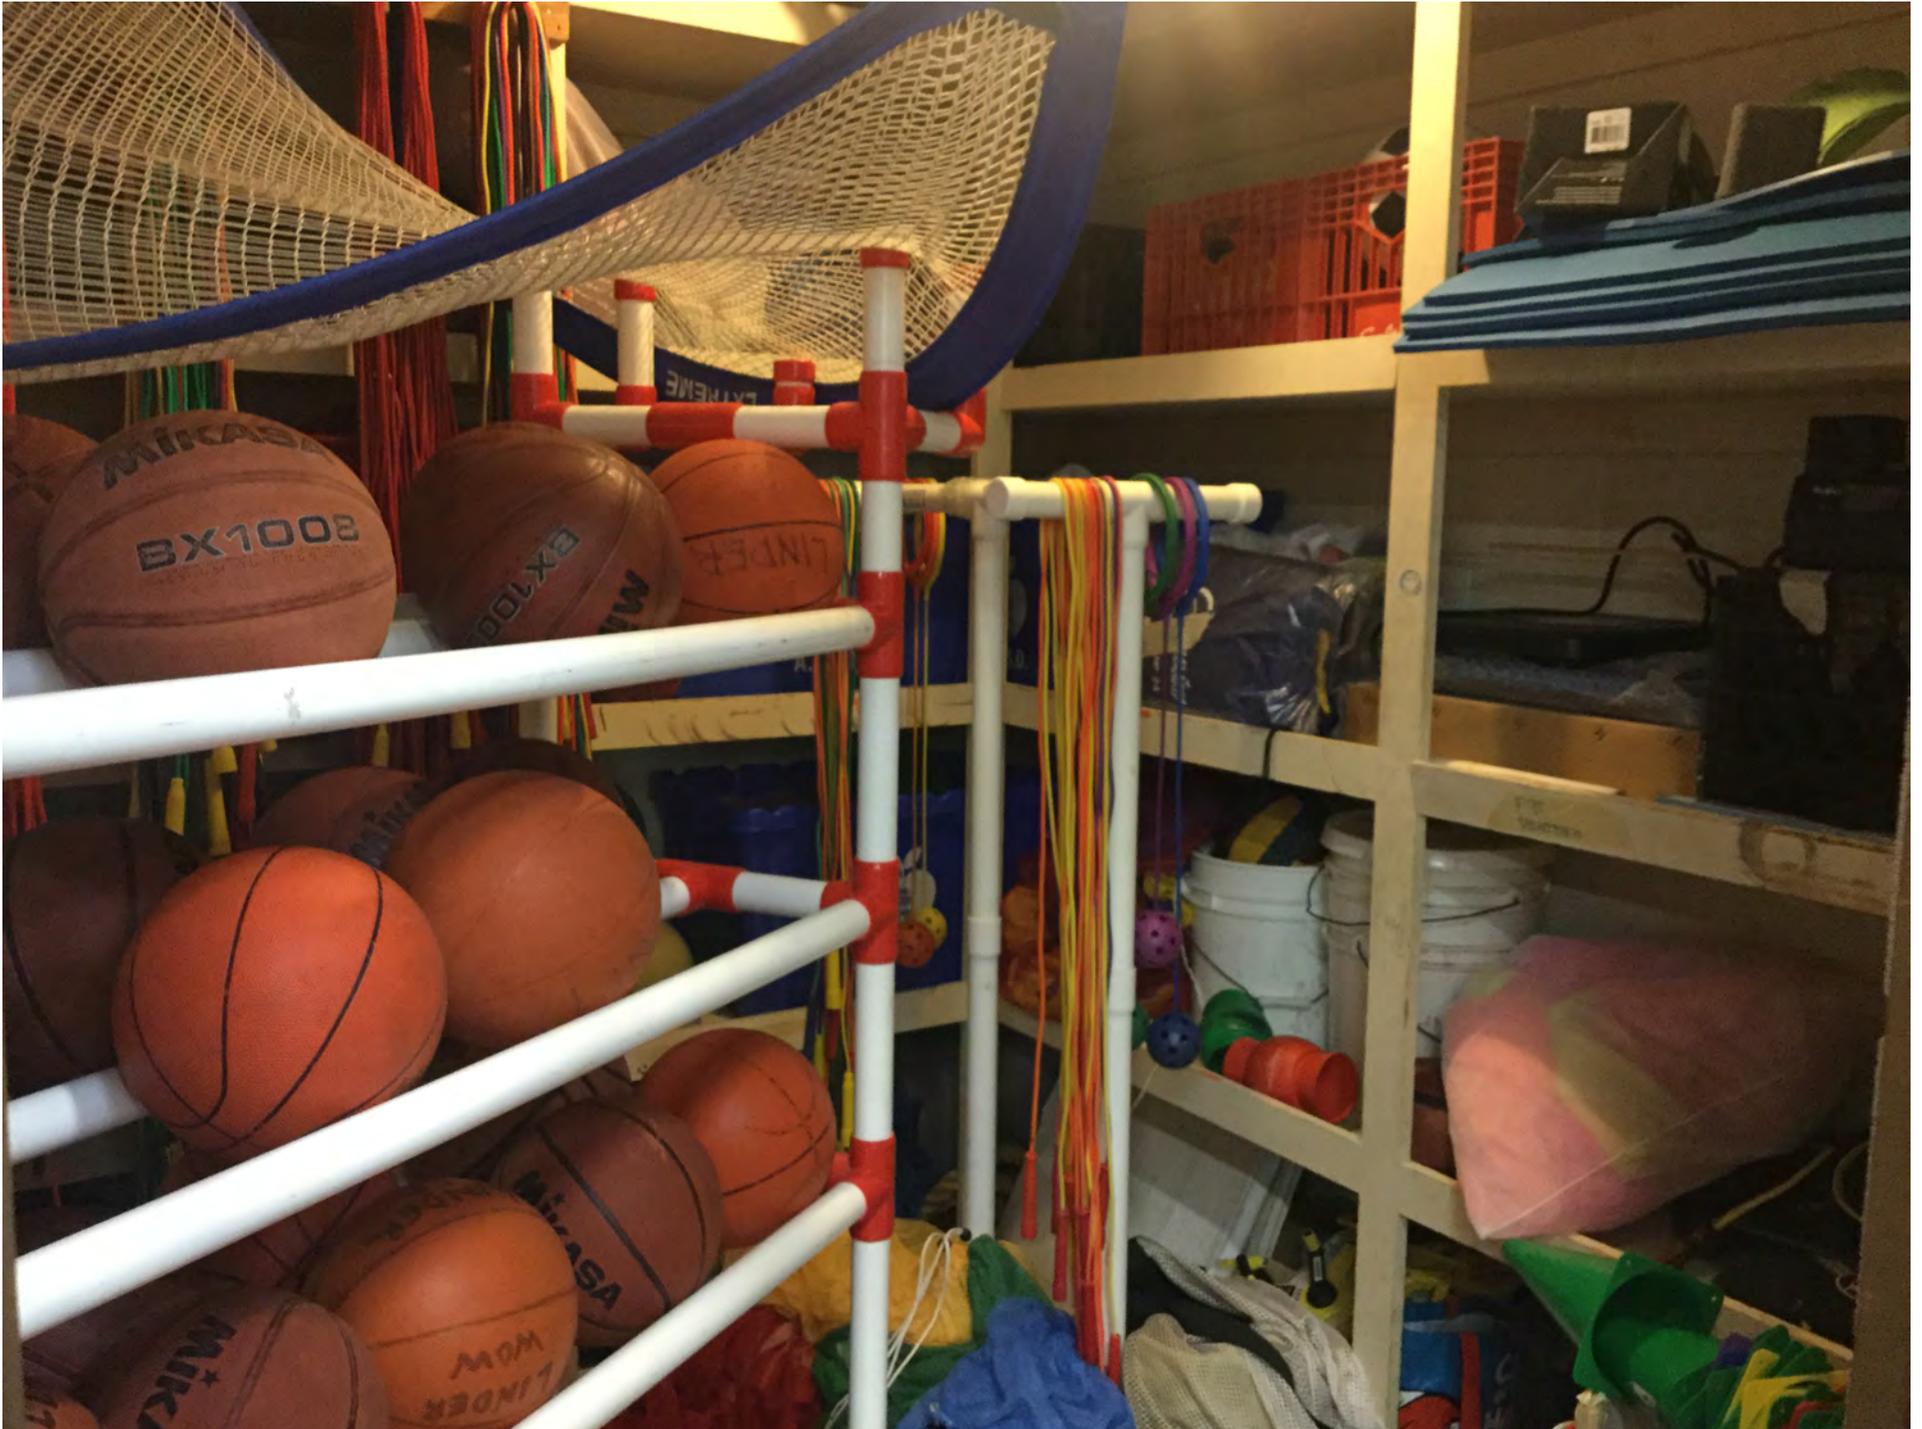
Photo 6. Gym Storage Storage

3.7	Are Physical Education and Athletic support spaces appropriately configured per the ed spec?		2						
1) Very unsatisfactory - Support spaces are disconnected from served spaces, too small, do not meet needs 2) Unsatisfactory - Support spaces are connected, but too small, inadequate for needs 3) Average - Connected, moderate size, but need some renovations or updates to function well 4) Good - Connected, good size/layout, meets needs/functions well 5) Very good - connected, generous size, nice condition, functions appropriately N/A) Does not apply.								Comments	1.00 2.00
								See Photo 6

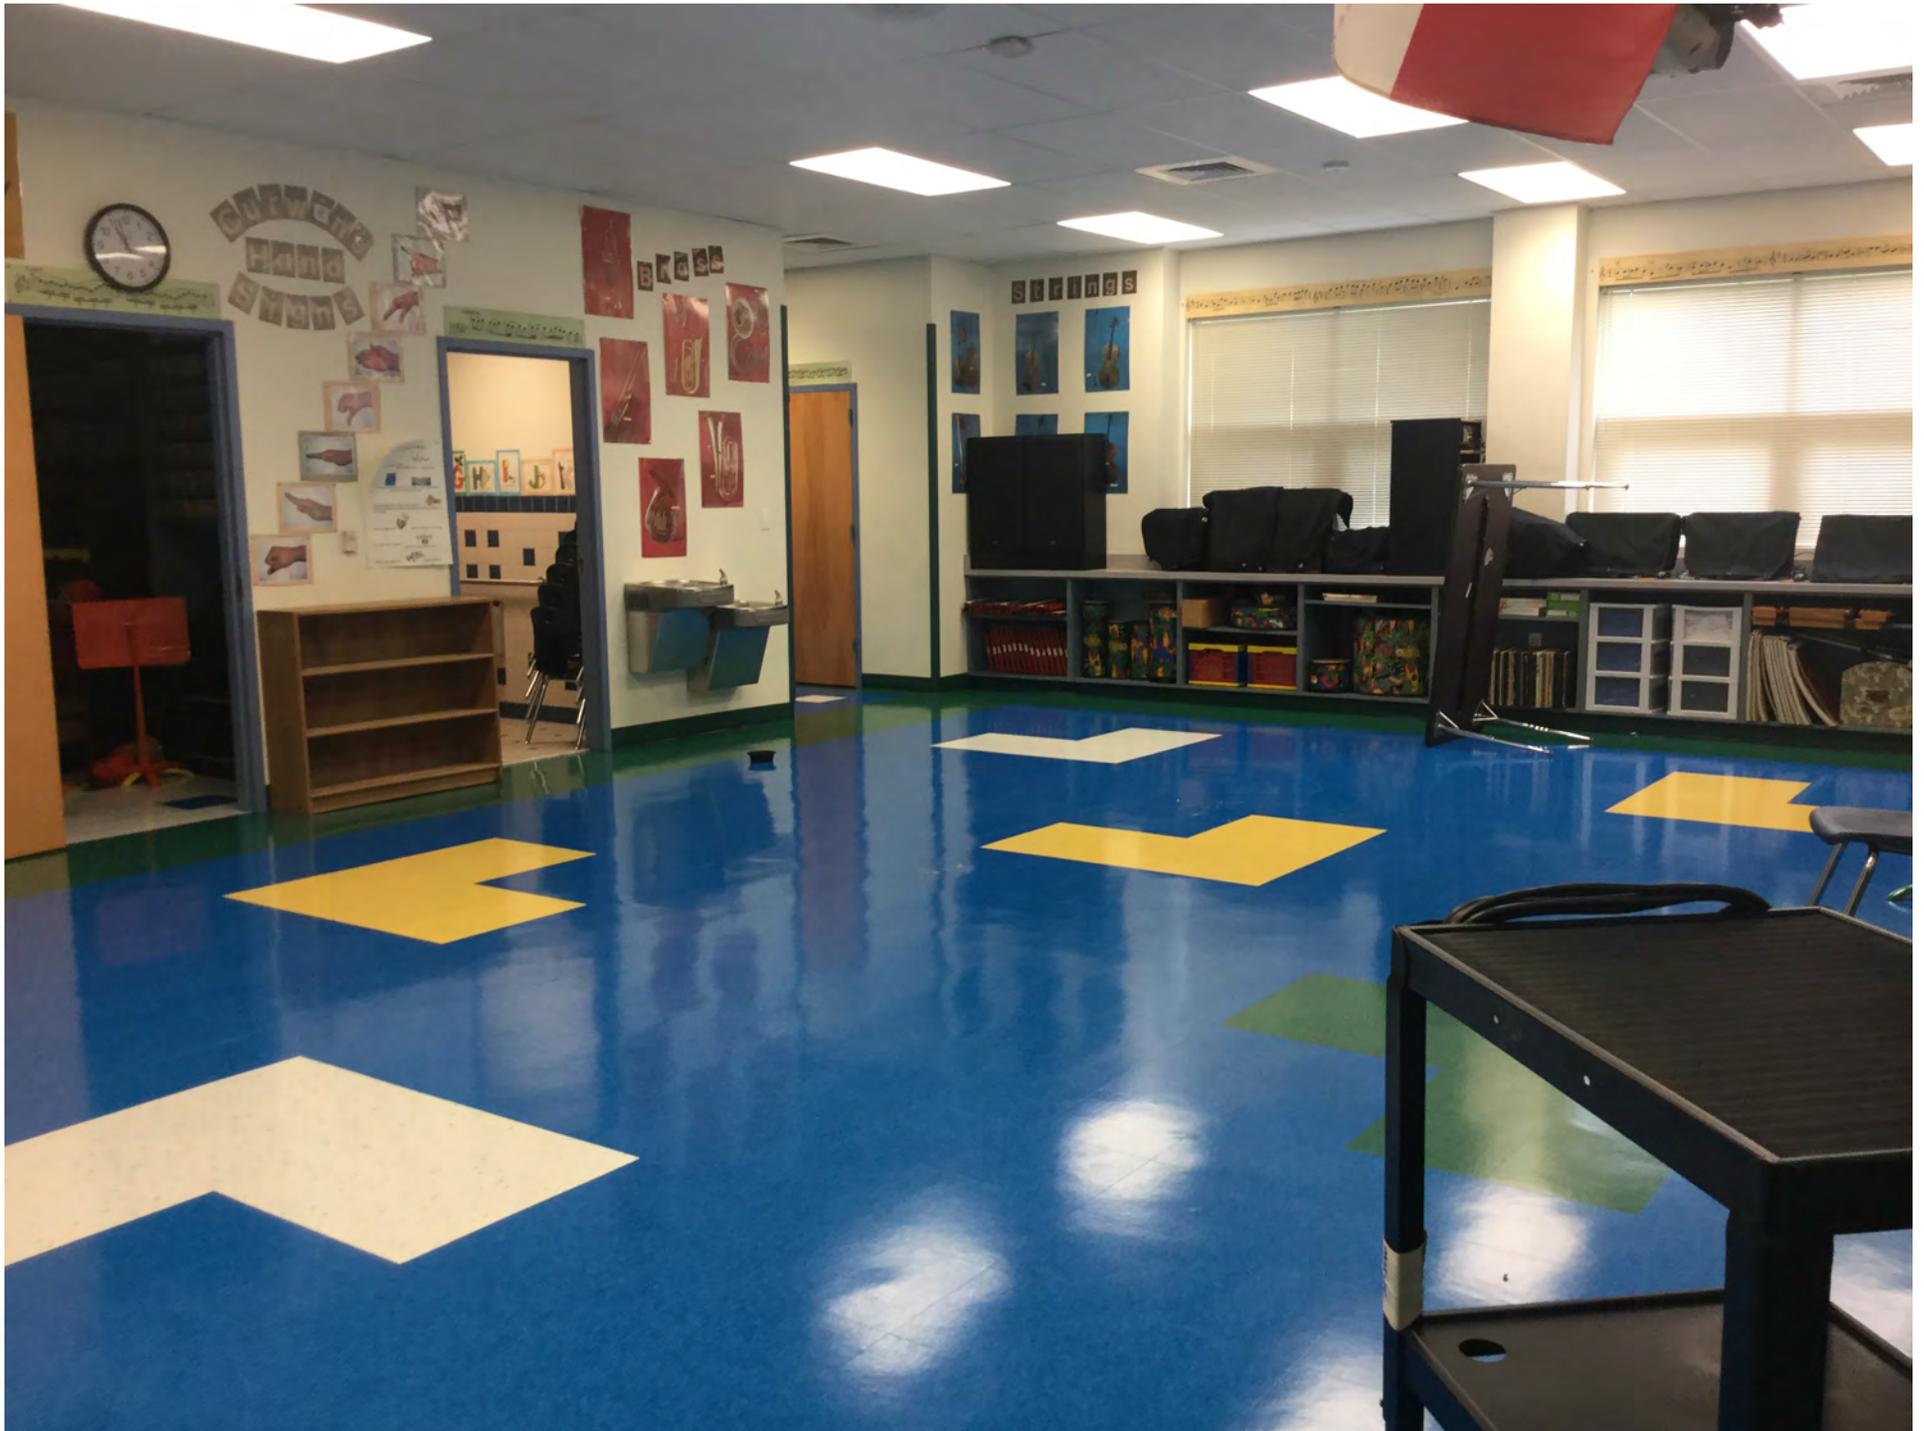
Photo 7. Music Room
music Room

3.8	Are music, drama, or performance spaces appropriately configured per the ed spec?				4				
1) Very unsatisfactory 2) Unsatisfactory 3) Average 4) Good 5) Very good N/A) Does not apply.								Comments	1.00 4.00
								In a new separate building but far from stage area of the cafeteria.	
								See Photo 7

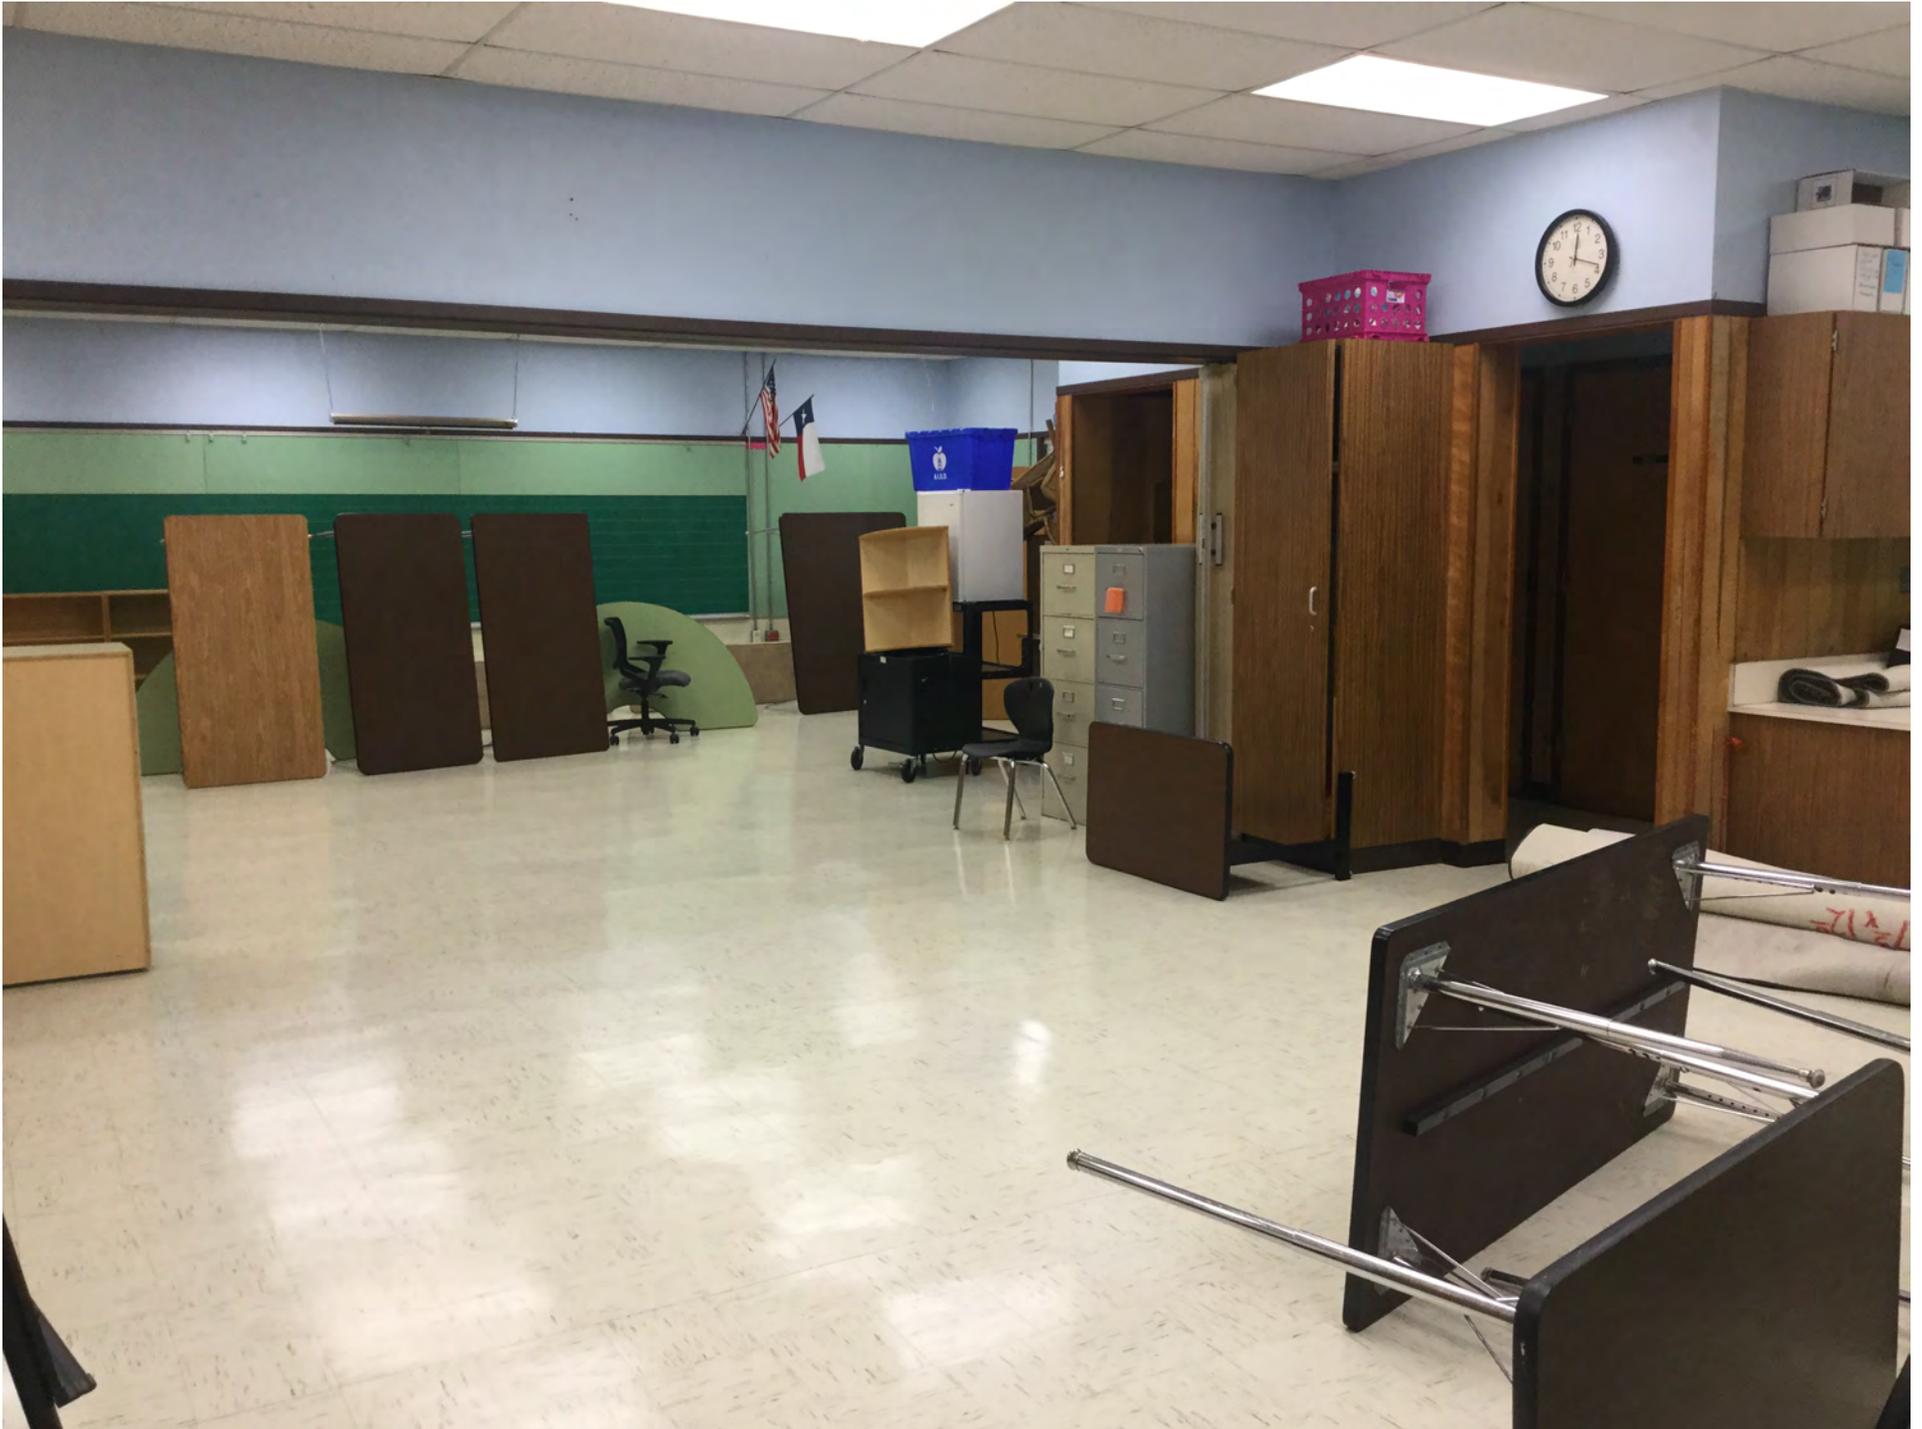
Photo 8. S
Special Education
Education Room

1) Very unsatisfactory 2) Unsatisfactory 3) Average 4) Good 5) Very good N/A) Does not apply.								Two typical classrooms in the older wing serving special education students and life skills. <i>SPED comments: Life Skills classroom in building. Restroom not wheelchair accessible. Sink in classroom.</i>	See Photo 8
