Educational Suitability Summary Report

Linder Elementary School

Date: 08/15/2016

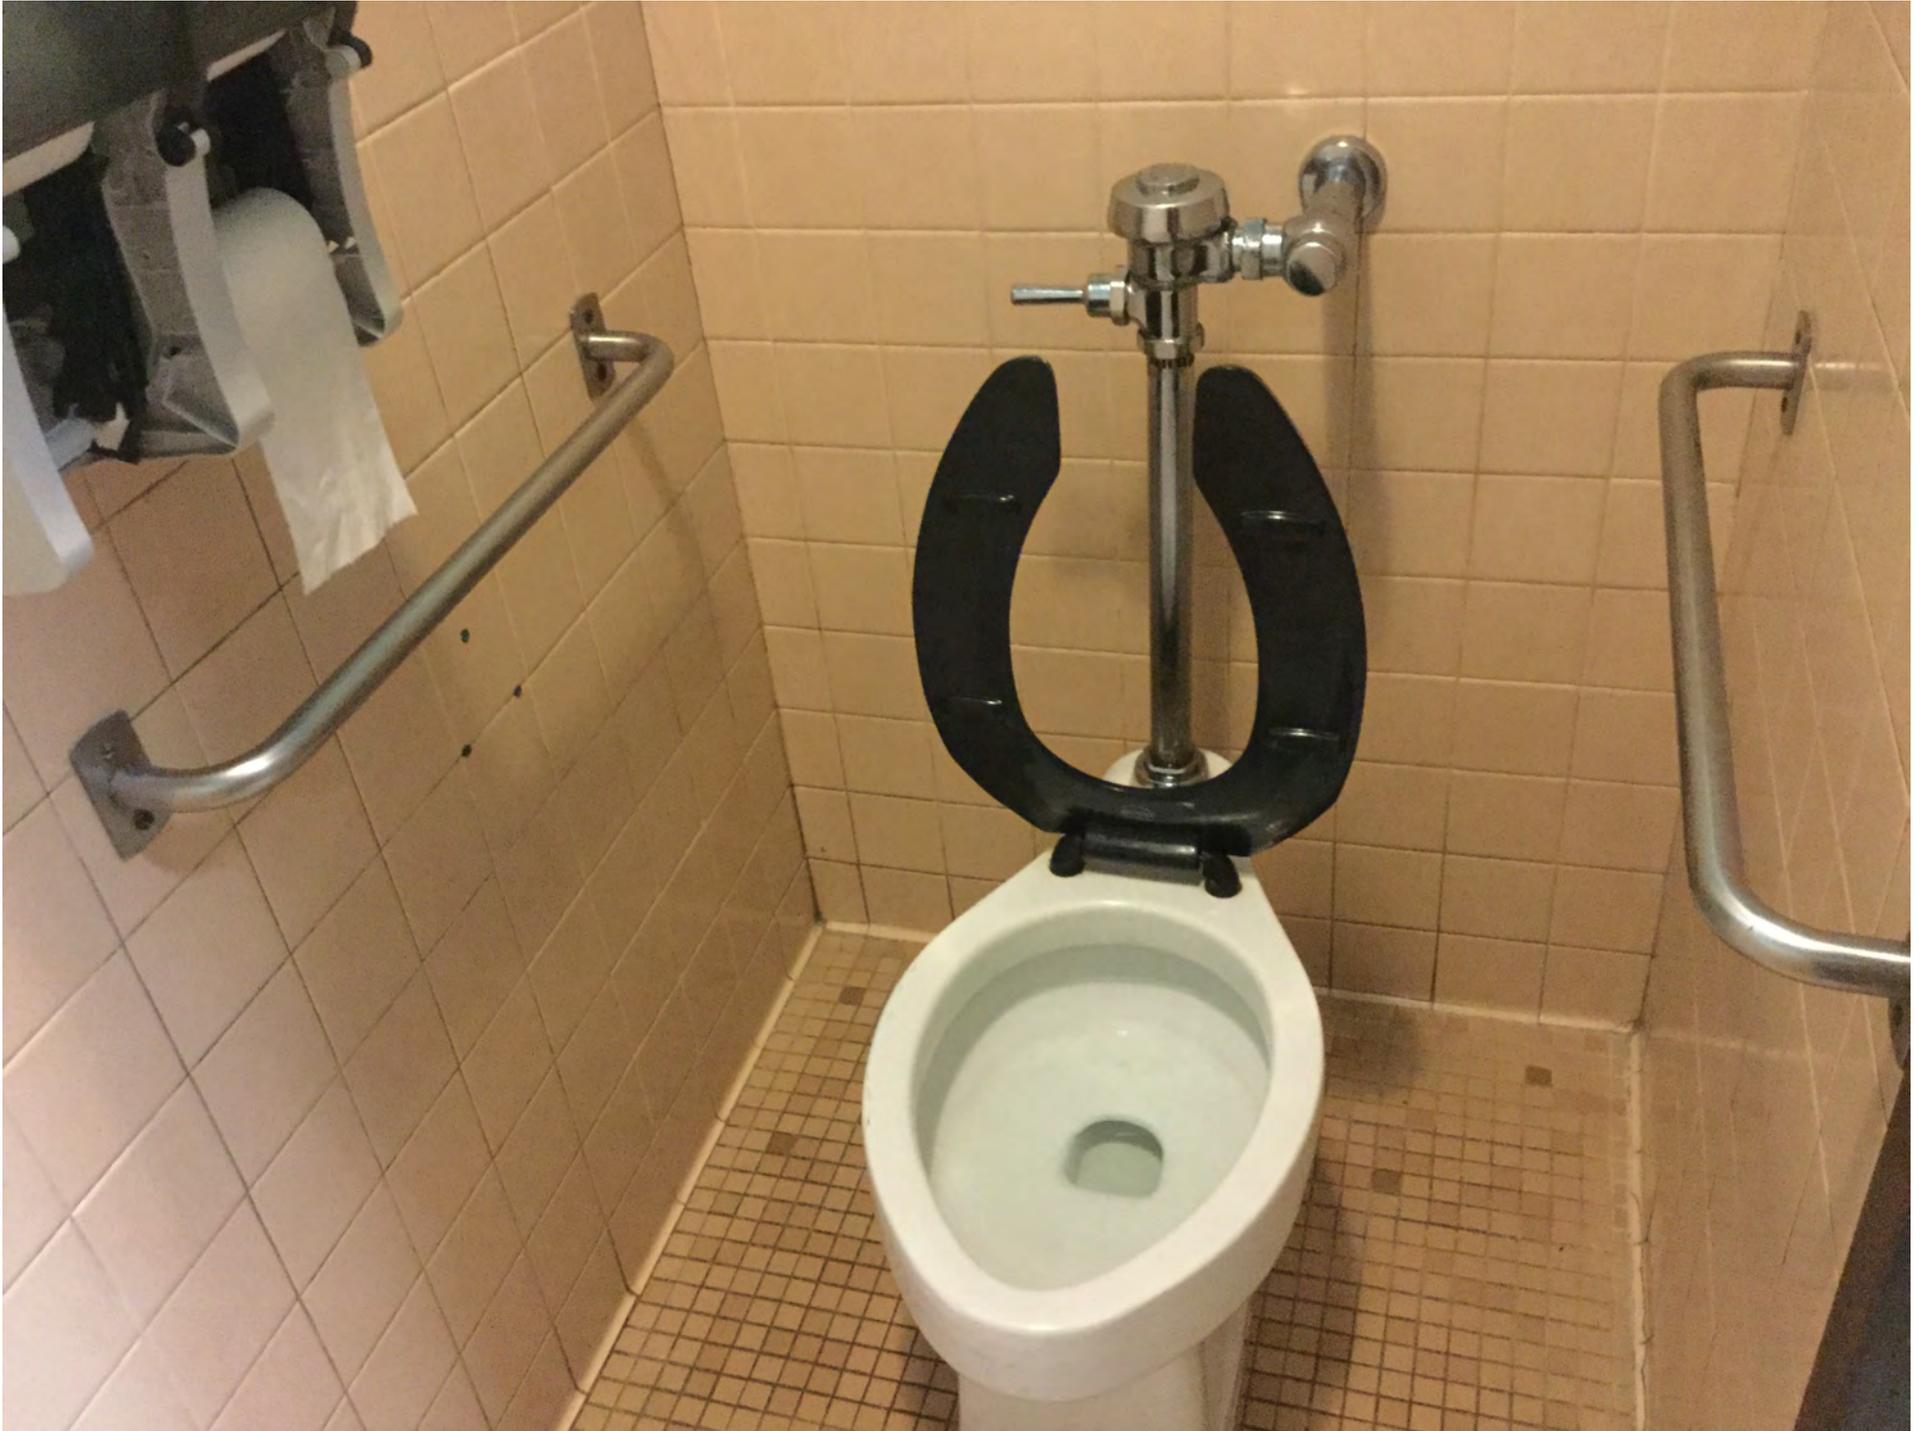
Photo 9. Special Education Restroom

3.15	Are Special Education support spaces appropriately configured per the ed spec?		2					Comments	1.00 2.00
1) Very unsatisfactory - Support spaces are disconnected from served spaces, too small, do not meet needs 2) Unsatisfactory - Support spaces are connected, but too small, inadequate for needs 3) Average - Connected, moderate size, but need some renovations or updates to function well 4) Good - Connected, good size/layout, meets needs/functions well 5) Very good - connected, generous size, nice condition, functions appropriately N/A) Does not apply.								Restrooms are too small to support life skills students. Restroom updated with only grab rails.	See Photo 9

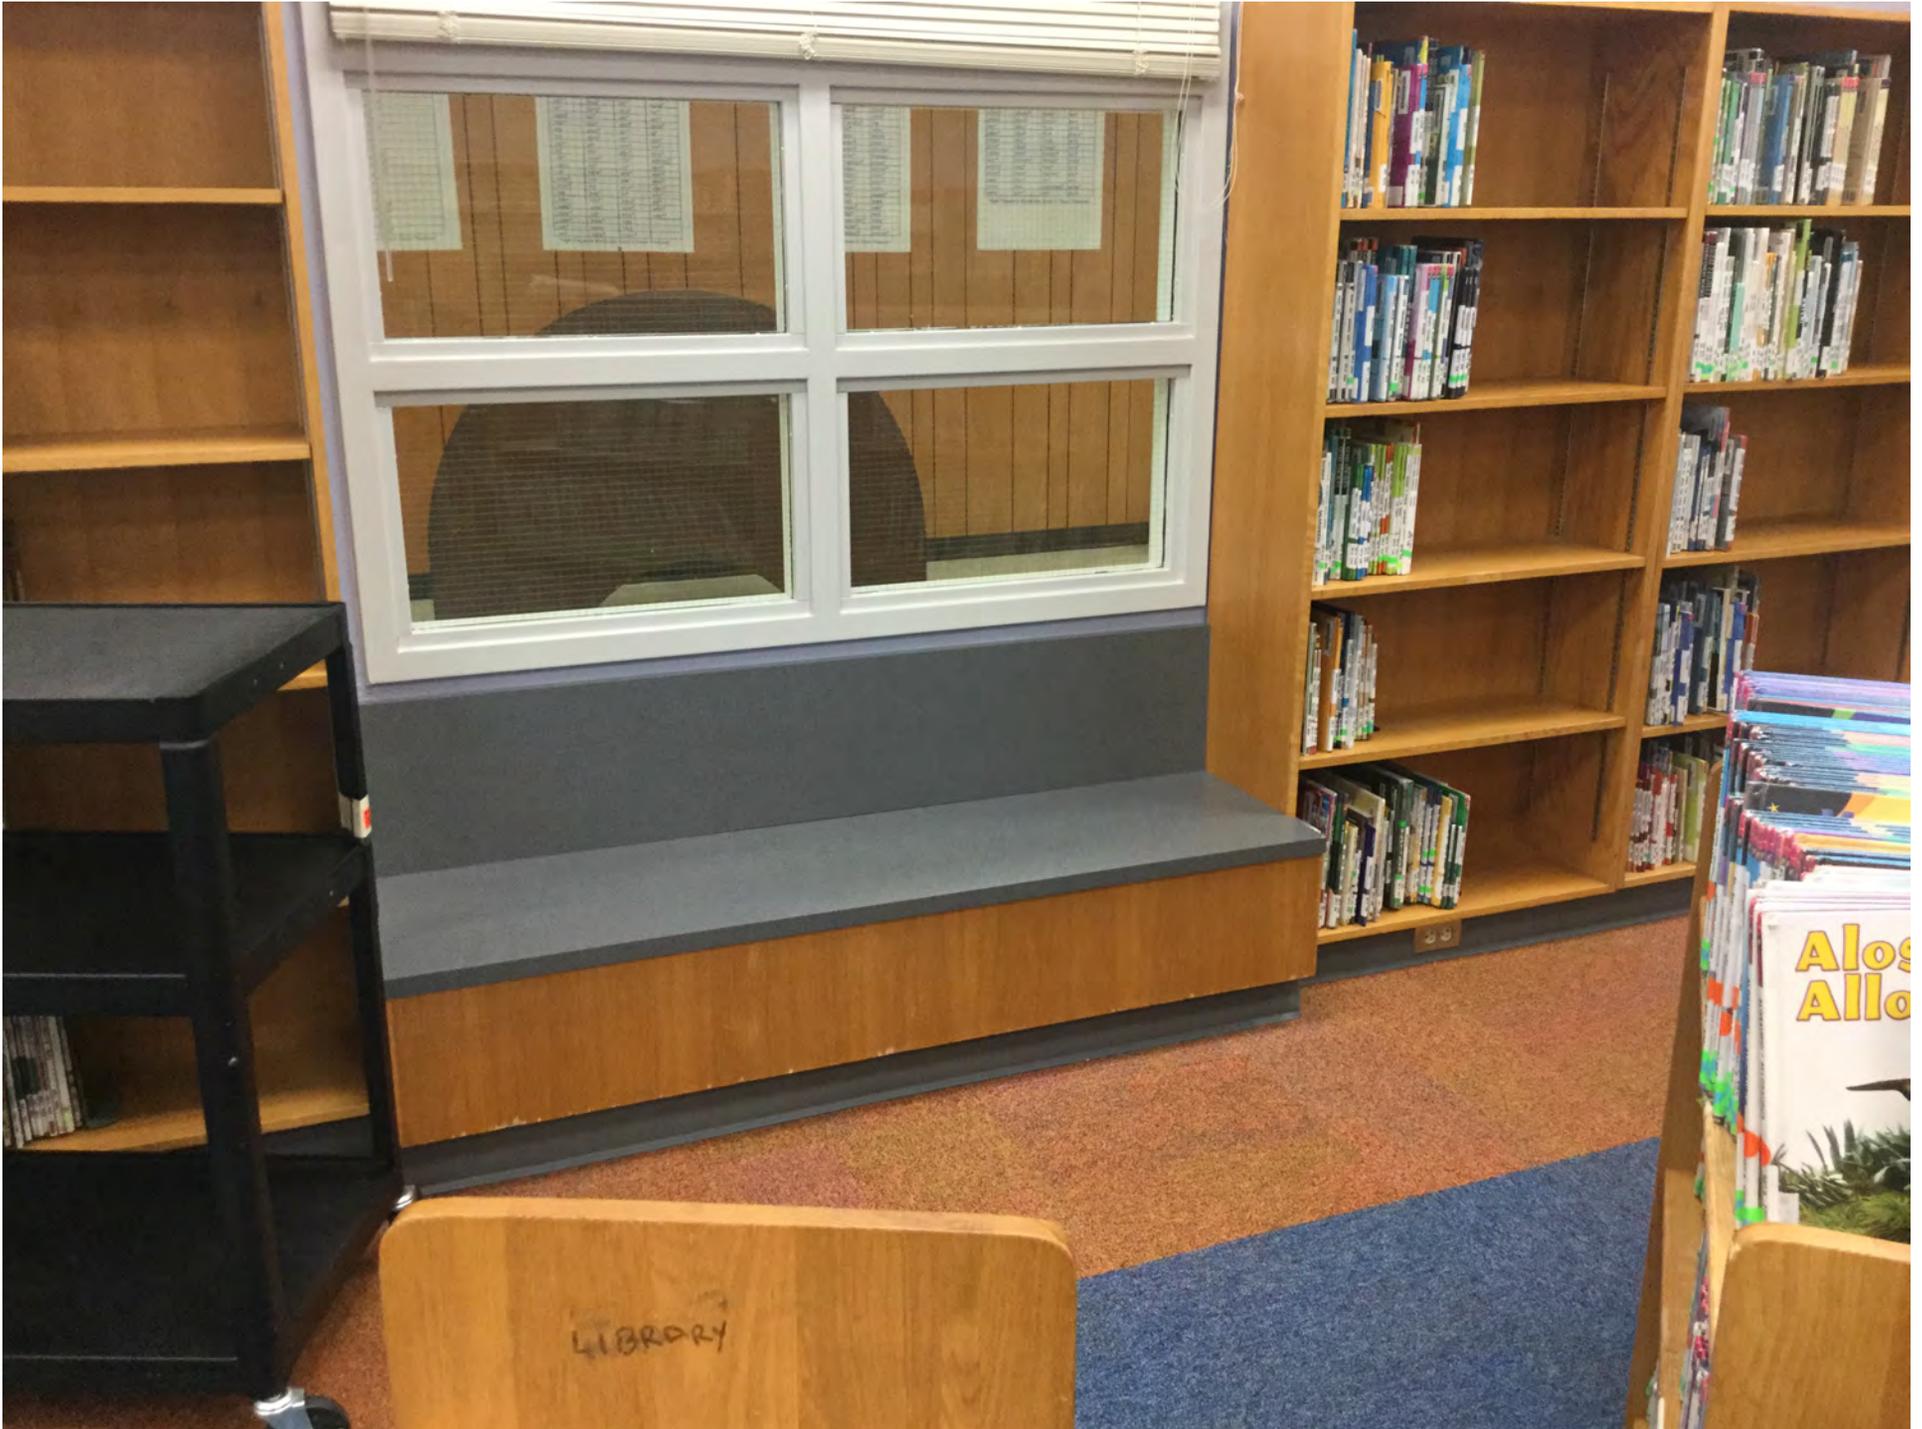
Photo 10. Library Window Seating
Seating by Window
Seating

1) Very unsatisfactory 2) Unsatisfactory 3) Average 4) Good 5) Very good N/A) Does not apply.								Some different built-in bench seating for individuals is provided for individual study.		
								See Photo 10

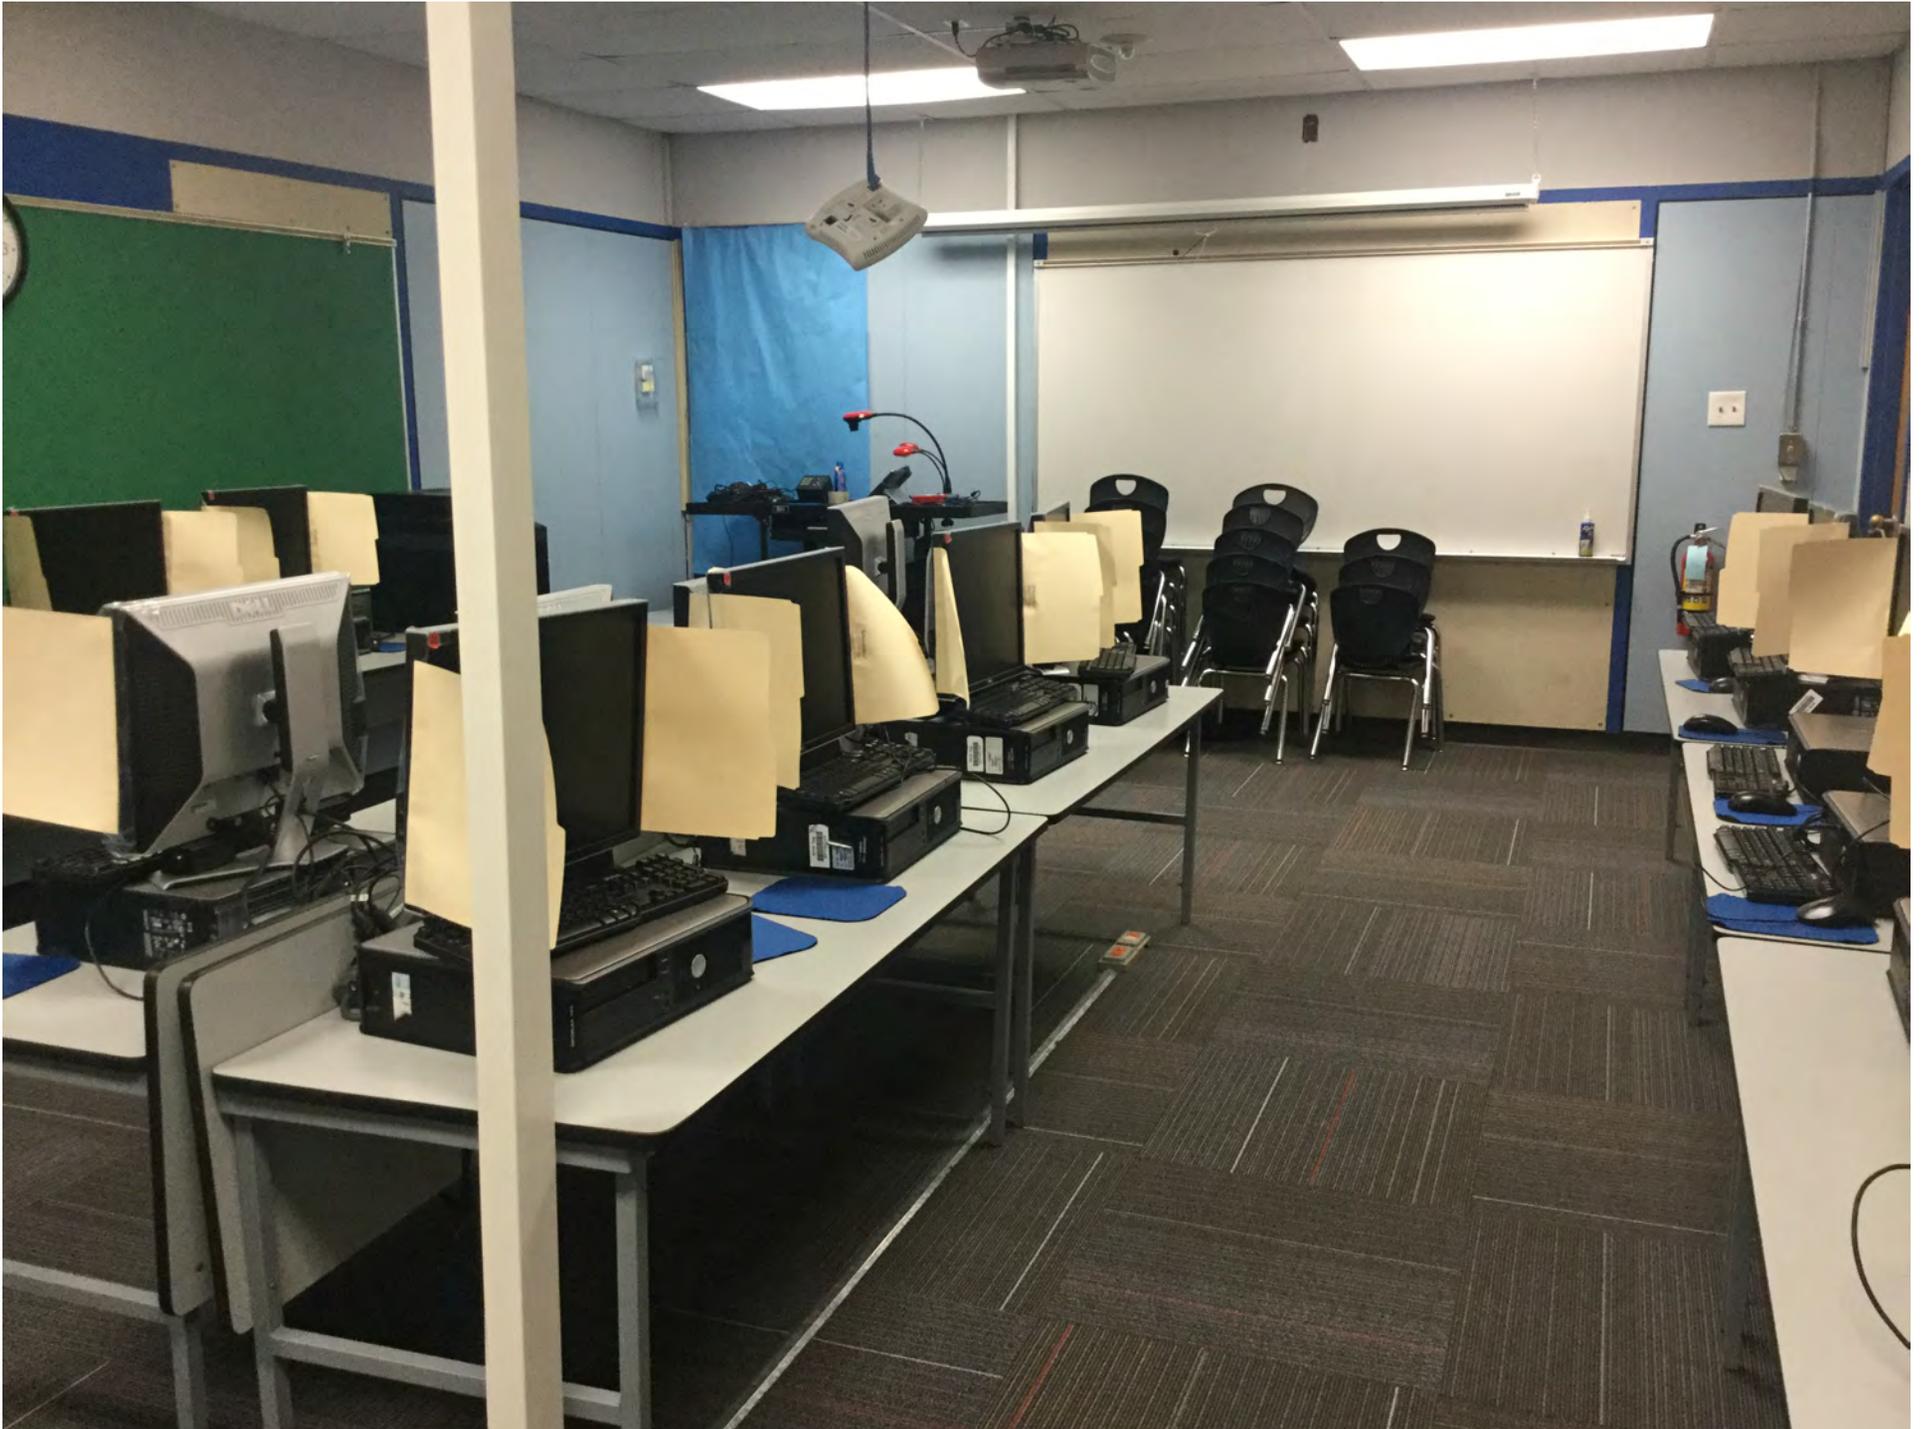
Photo 11.
Computer Roomcomputer
Lab

7 - Technology		1	2	3	4	5	N/A	6.00
7.1	How well equipped are the facilities with instructional technology?			3				3.00
<p>1) Very unsatisfactory - very few or no available computers or devices. Old/outdated technology</p> <p>2) Unsatisfactory- few computers/devices. Some outdated technology</p> <p>3) Average- A few computers/devices. A mix of new and outdated technology</p> <p>4) Good - multiple computers or devices per room. Mostly new technology.</p> <p>5) Very good - multiple computers and devices and new technology.</p> <p>N/A) Does not apply.</p>								<p>Comments</p> <p>Computer room needs updated computers.</p>

1.00
								3.00
								See Photo 11
7.2	Is there an adequate number of power and data outlets in learning spaces?			3				3.00
<p>1) Very unsatisfactory - none</p> <p>2) Unsatisfactory - only for teacher</p> <p>3) Average - for teacher and 1-2 students</p> <p>4) Good - 2-3 outlets per wall</p> <p>5) Very good - 3-4 per wall</p> <p>N/A) Does not apply.</p>								<p>Comments</p> <p>Better in newer wings but limited in the older wing.</p>

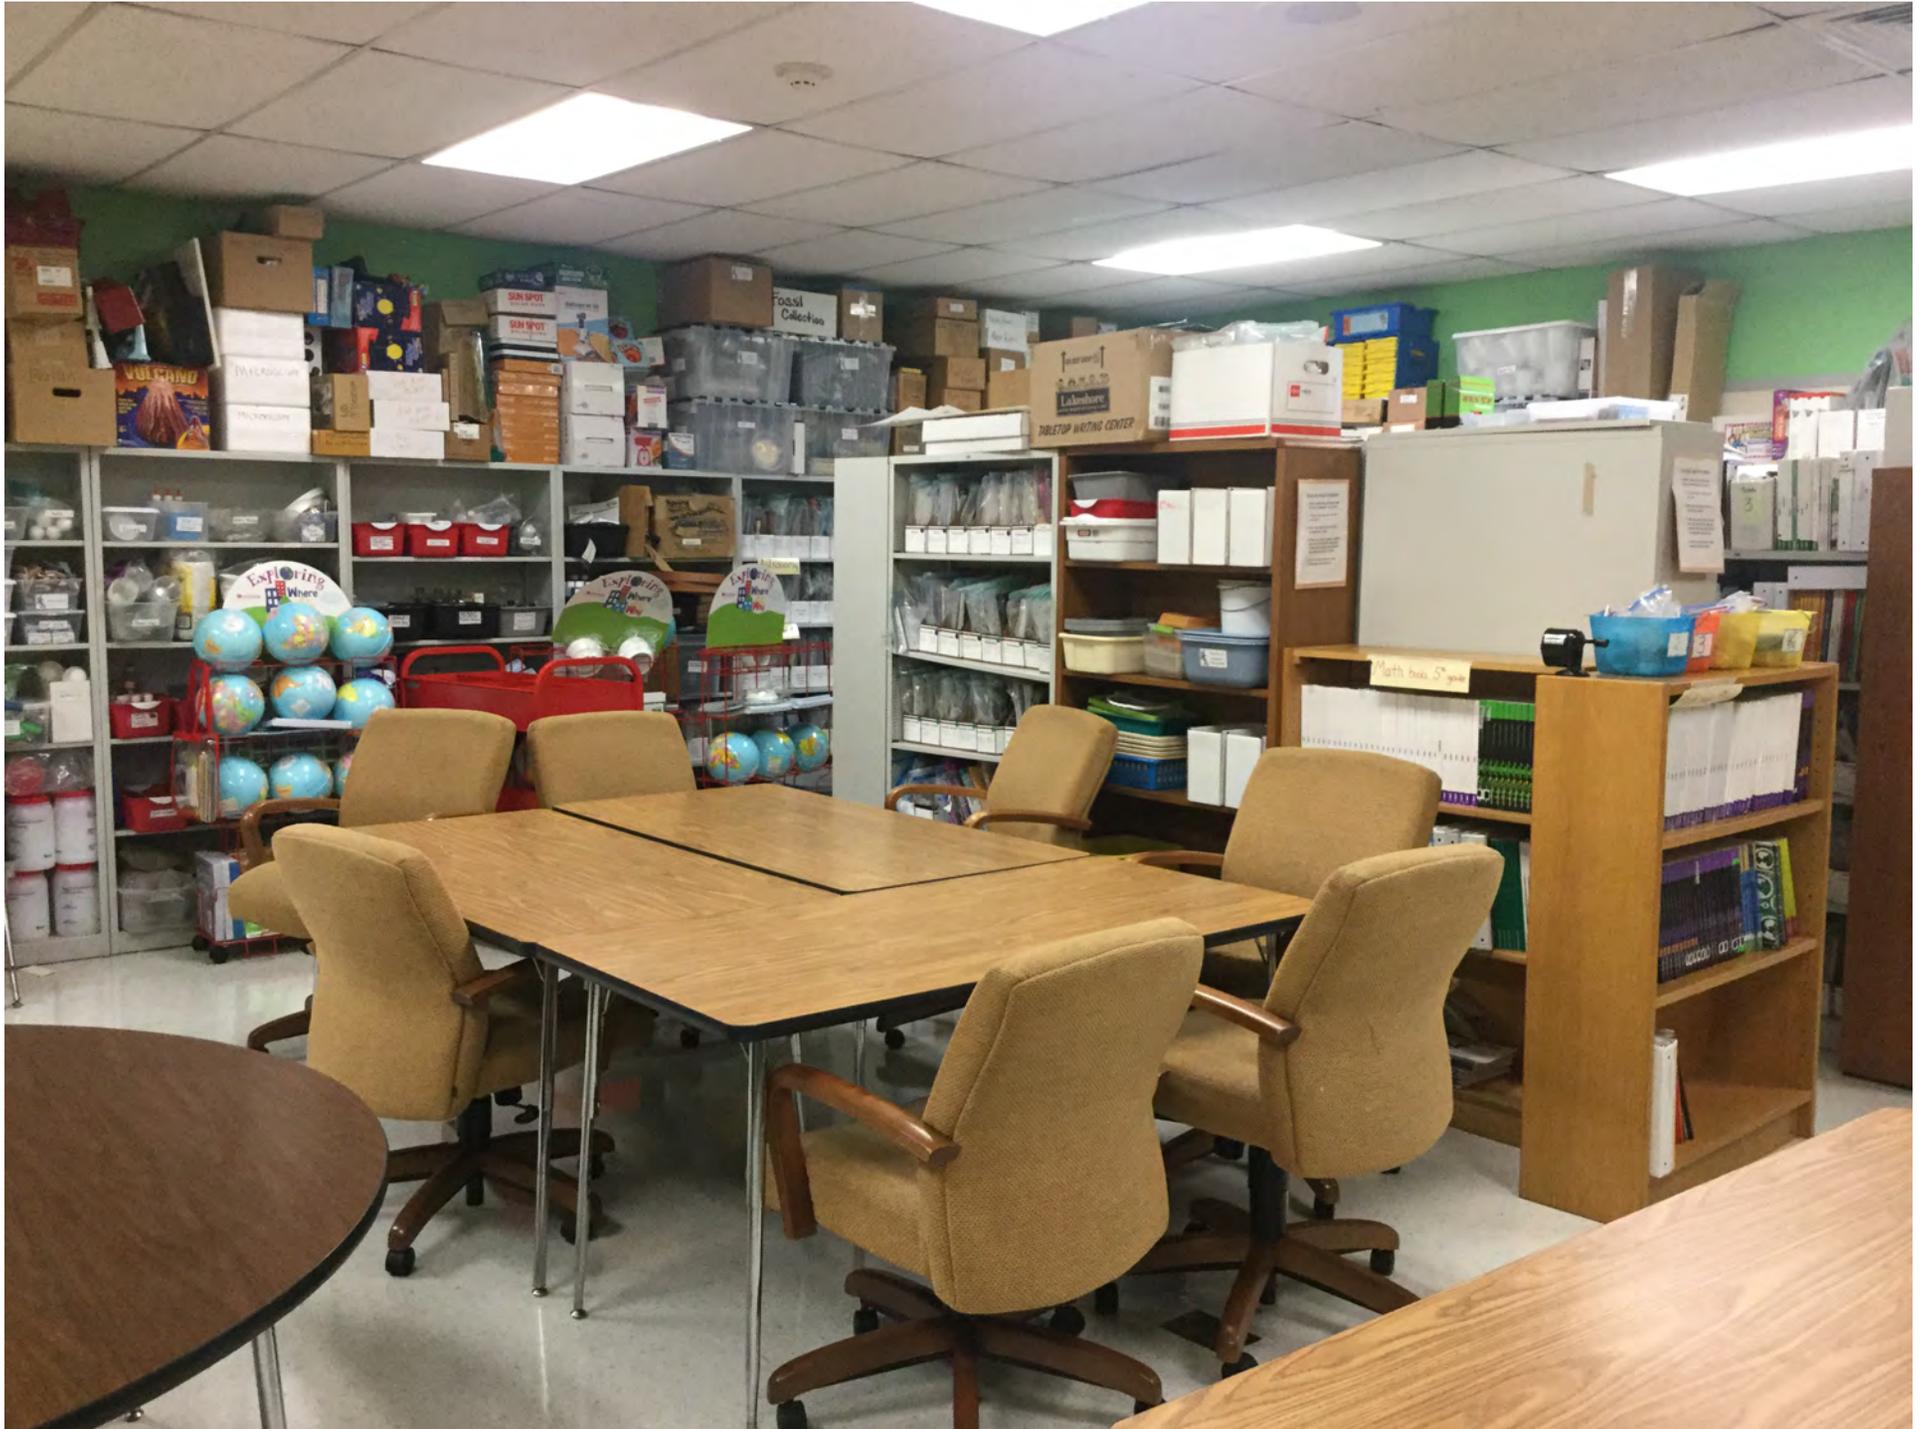
General building storage has sufficient storage with larger cabinets in classrooms and enough for students and overall on campus. One area for separate storage would be for curriculum materials in a shared room with a staff work room.

Photo 12. Curriculum Storage

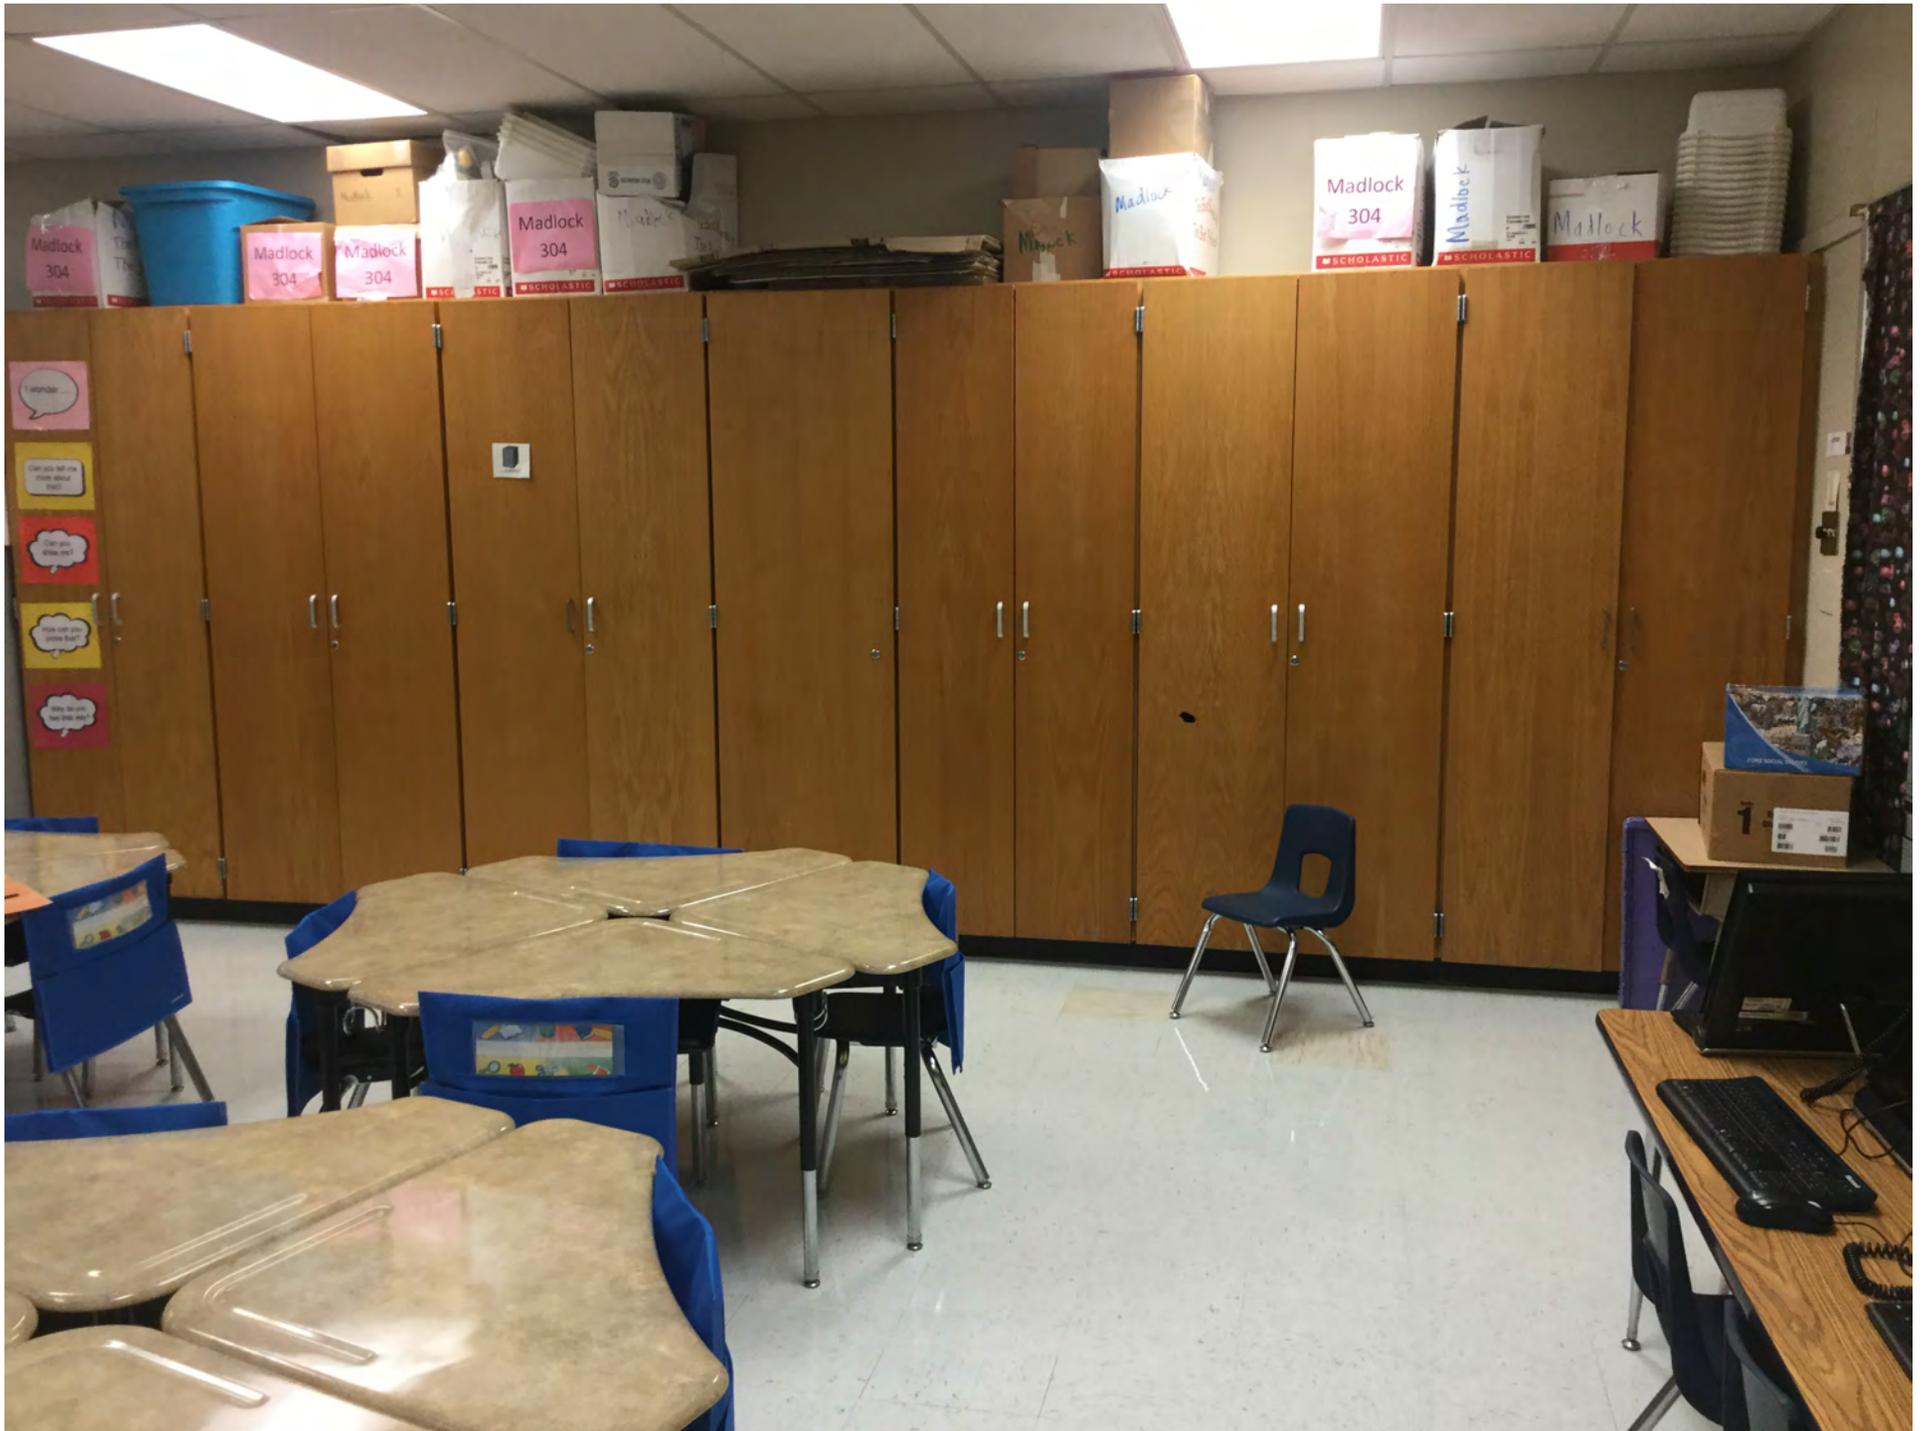
4.3	Is there adequate storage and or support space to support project-based learning?				4			Comments	1.00	4.00	
1) Very unsatisfactory - none 2) Unsatisfactory-minimal casework/storage 3) Average - moderately sized casework 4) Good - large casework/cabinets/support 5) Very good - walk-in storage/ample support space N/A) Does not apply.									There is sufficient storage in classrooms. Older wings have slightly worn cabinets, but are adequate.

Photo13. Classroom furniture and storage

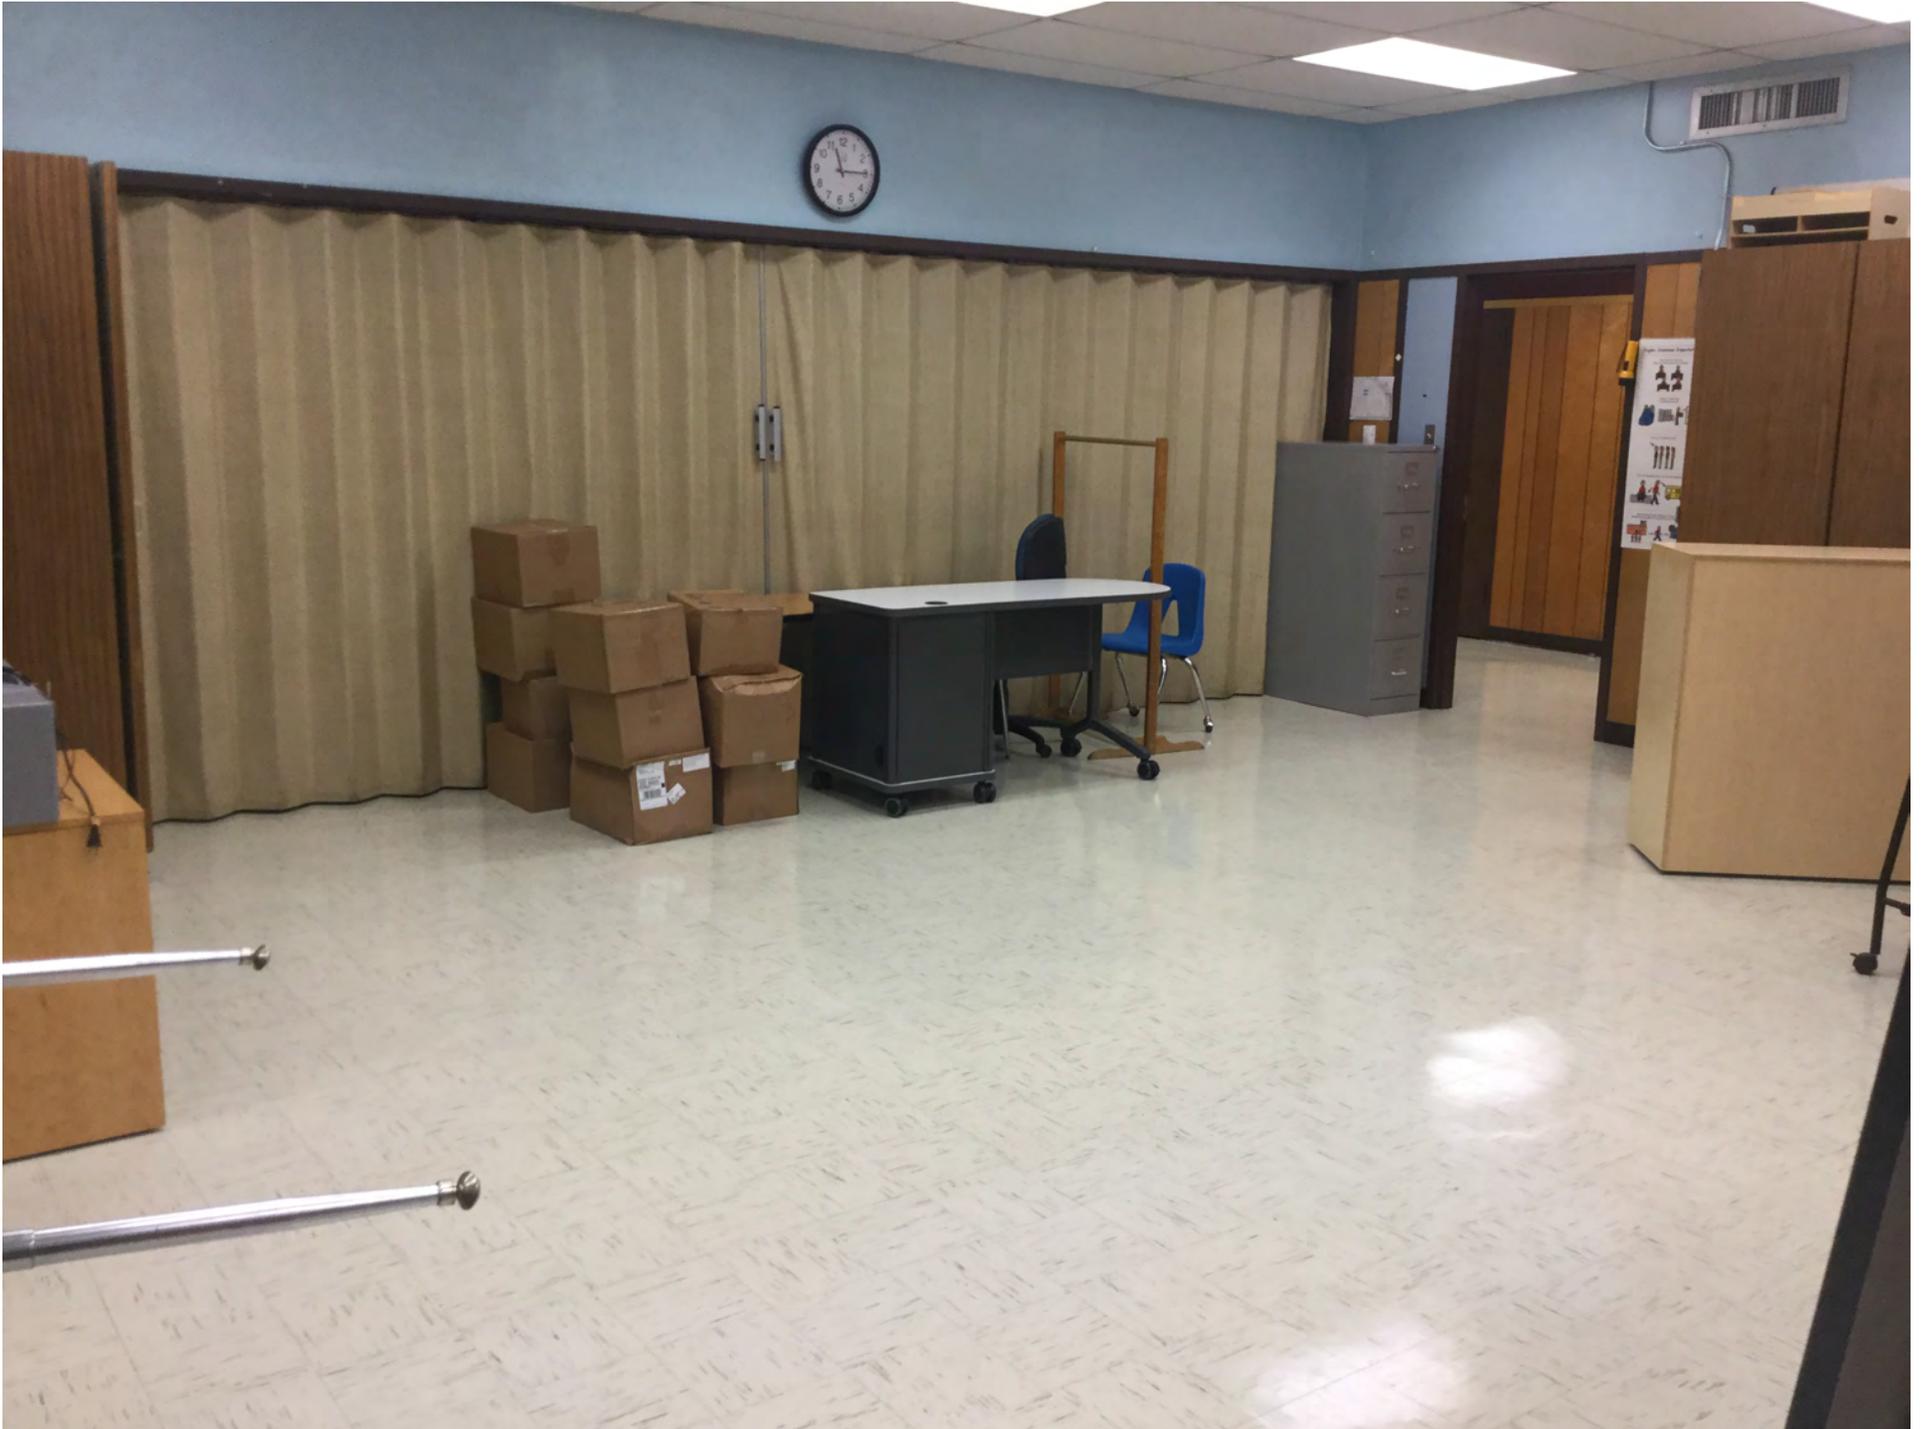
4.4	Are there adequate places to display the evidence and artifacts of learning (both 2D and 3D)?			3				Comments	1.00	3.00	
1) Very unsatisfactory - No display cases or wall space for display 2) Unsatisfactory - 1 wall in classrooms or very few spaces for display 3) Average - 2 walls in classrooms or some hallway spaces for display 4) Good - 3 walls in classrooms or multiple hallway spaces for display 5) Very good - ample classroom display space or many hallway spaces, including display cases N/A) Does not apply.									Some classrooms have accordian partition between classrooms.

Photo 14. Classroom folding partition
