Educational Suitability Summary Report

Lucy Read Pre-Kindergarten Demonstration School

Date: 08/04/2016 – (Rev.1 – 12/19/16- Survey Results and Const. Dept)

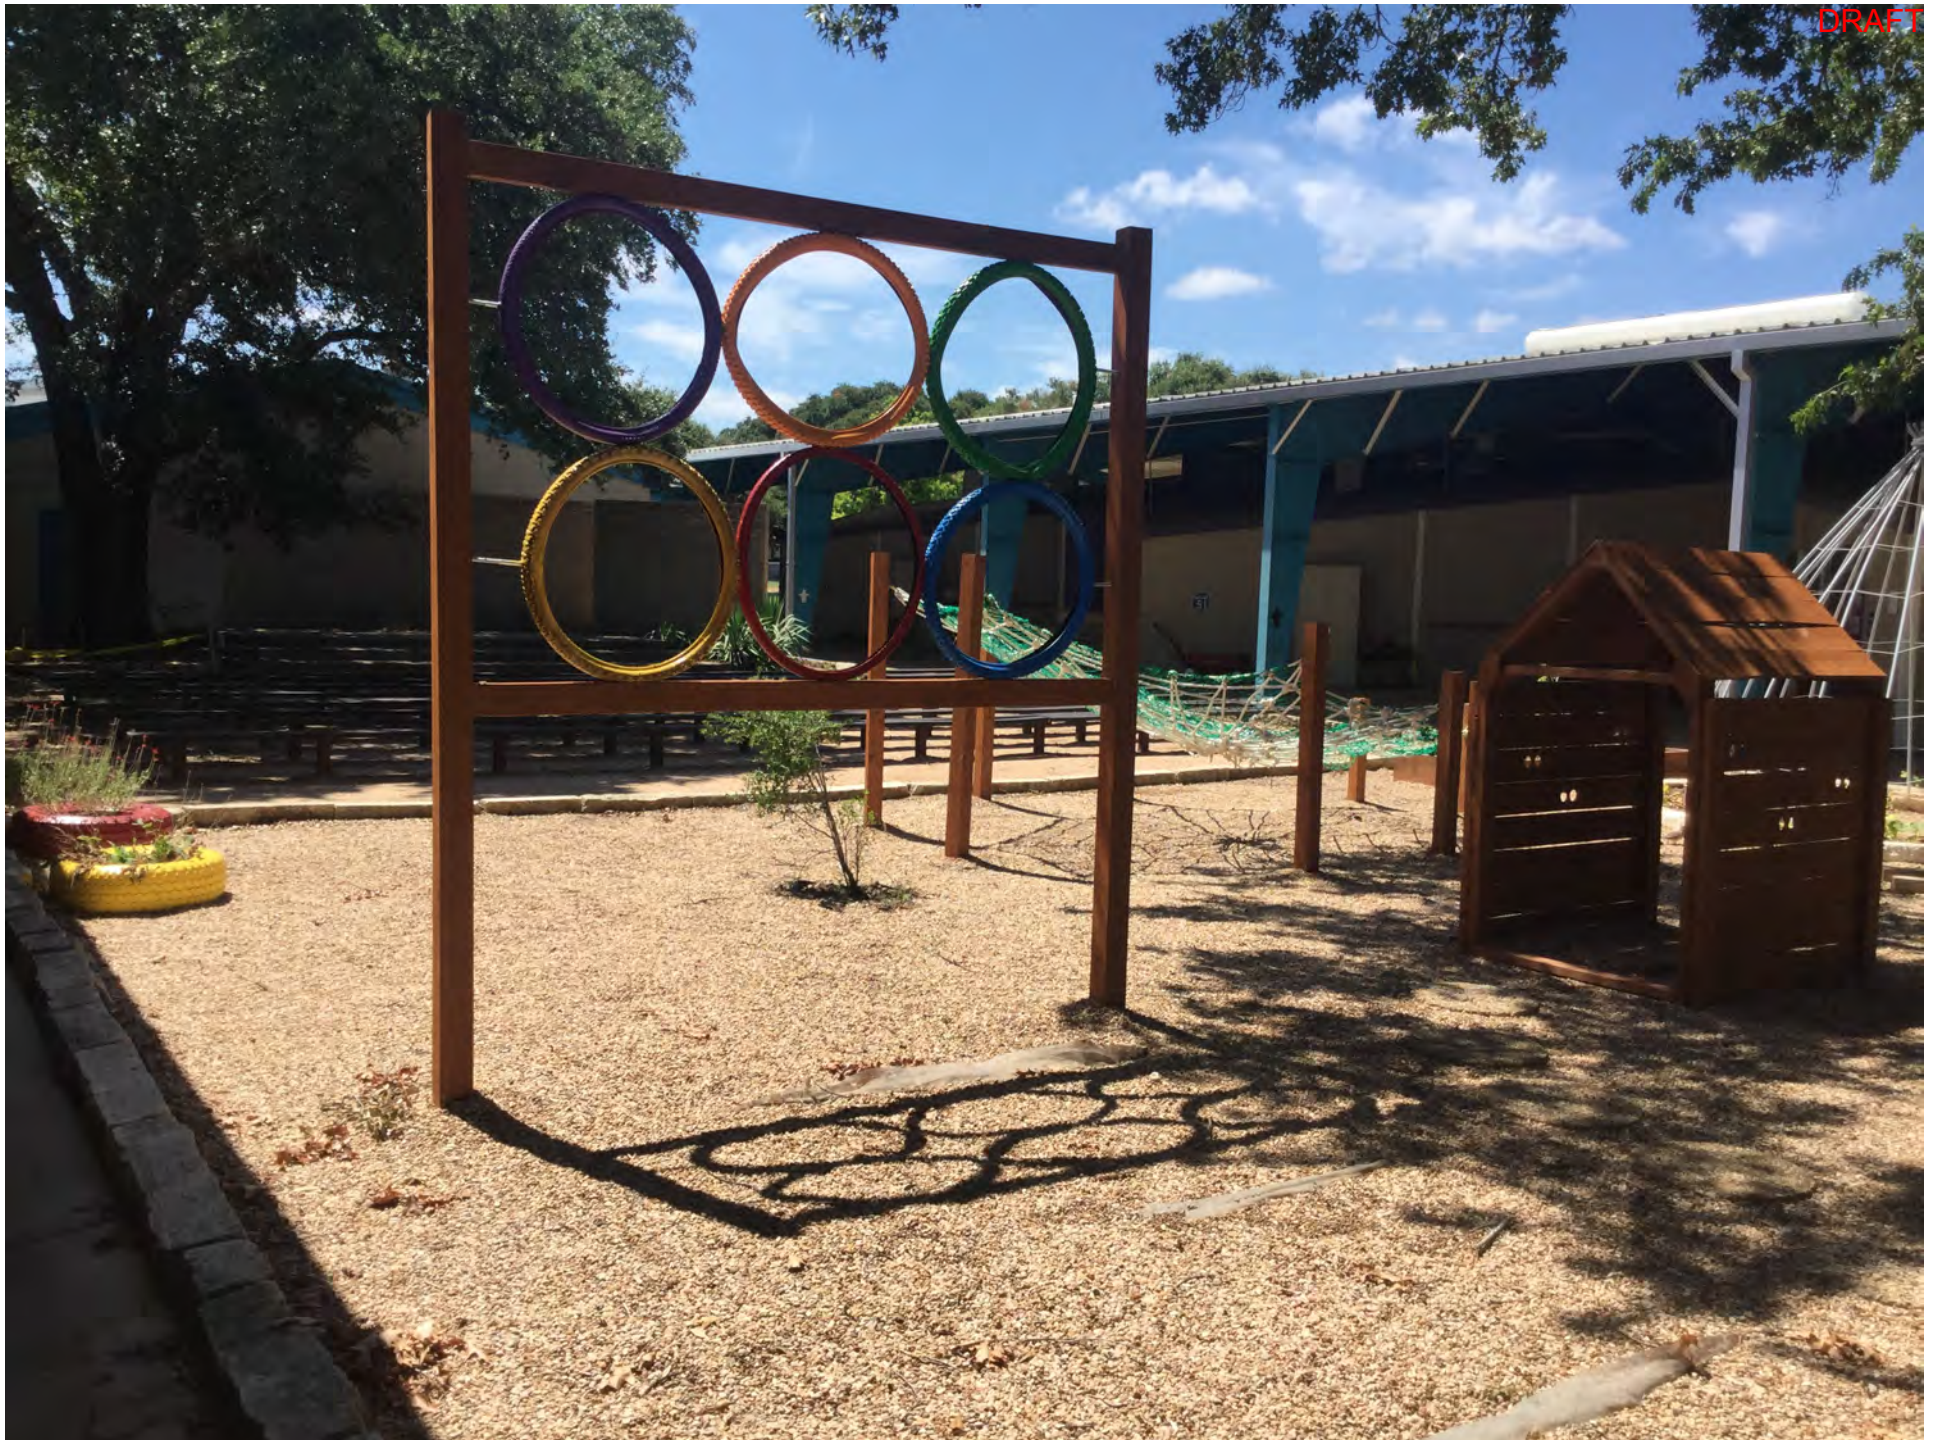
Photo 1.
1.2 Outdoor Learning Space

1.2	Are opportunities provided for outdoor learning (outdoor classrooms, gardens, etc.)?				4			Comments	1.00 4.00
	1) Outdoor space exists is not developed 2) Outdoor space for learning exists but not connected to classroom learning areas. 3. Outdoor learning spaces exist and are accessible but not in good condition. 4. Outdoor learning spaces need minor improvements to function well. 5. Outdoor learning spaces are in excellent condition. N/A) Does not apply.								see photo 1

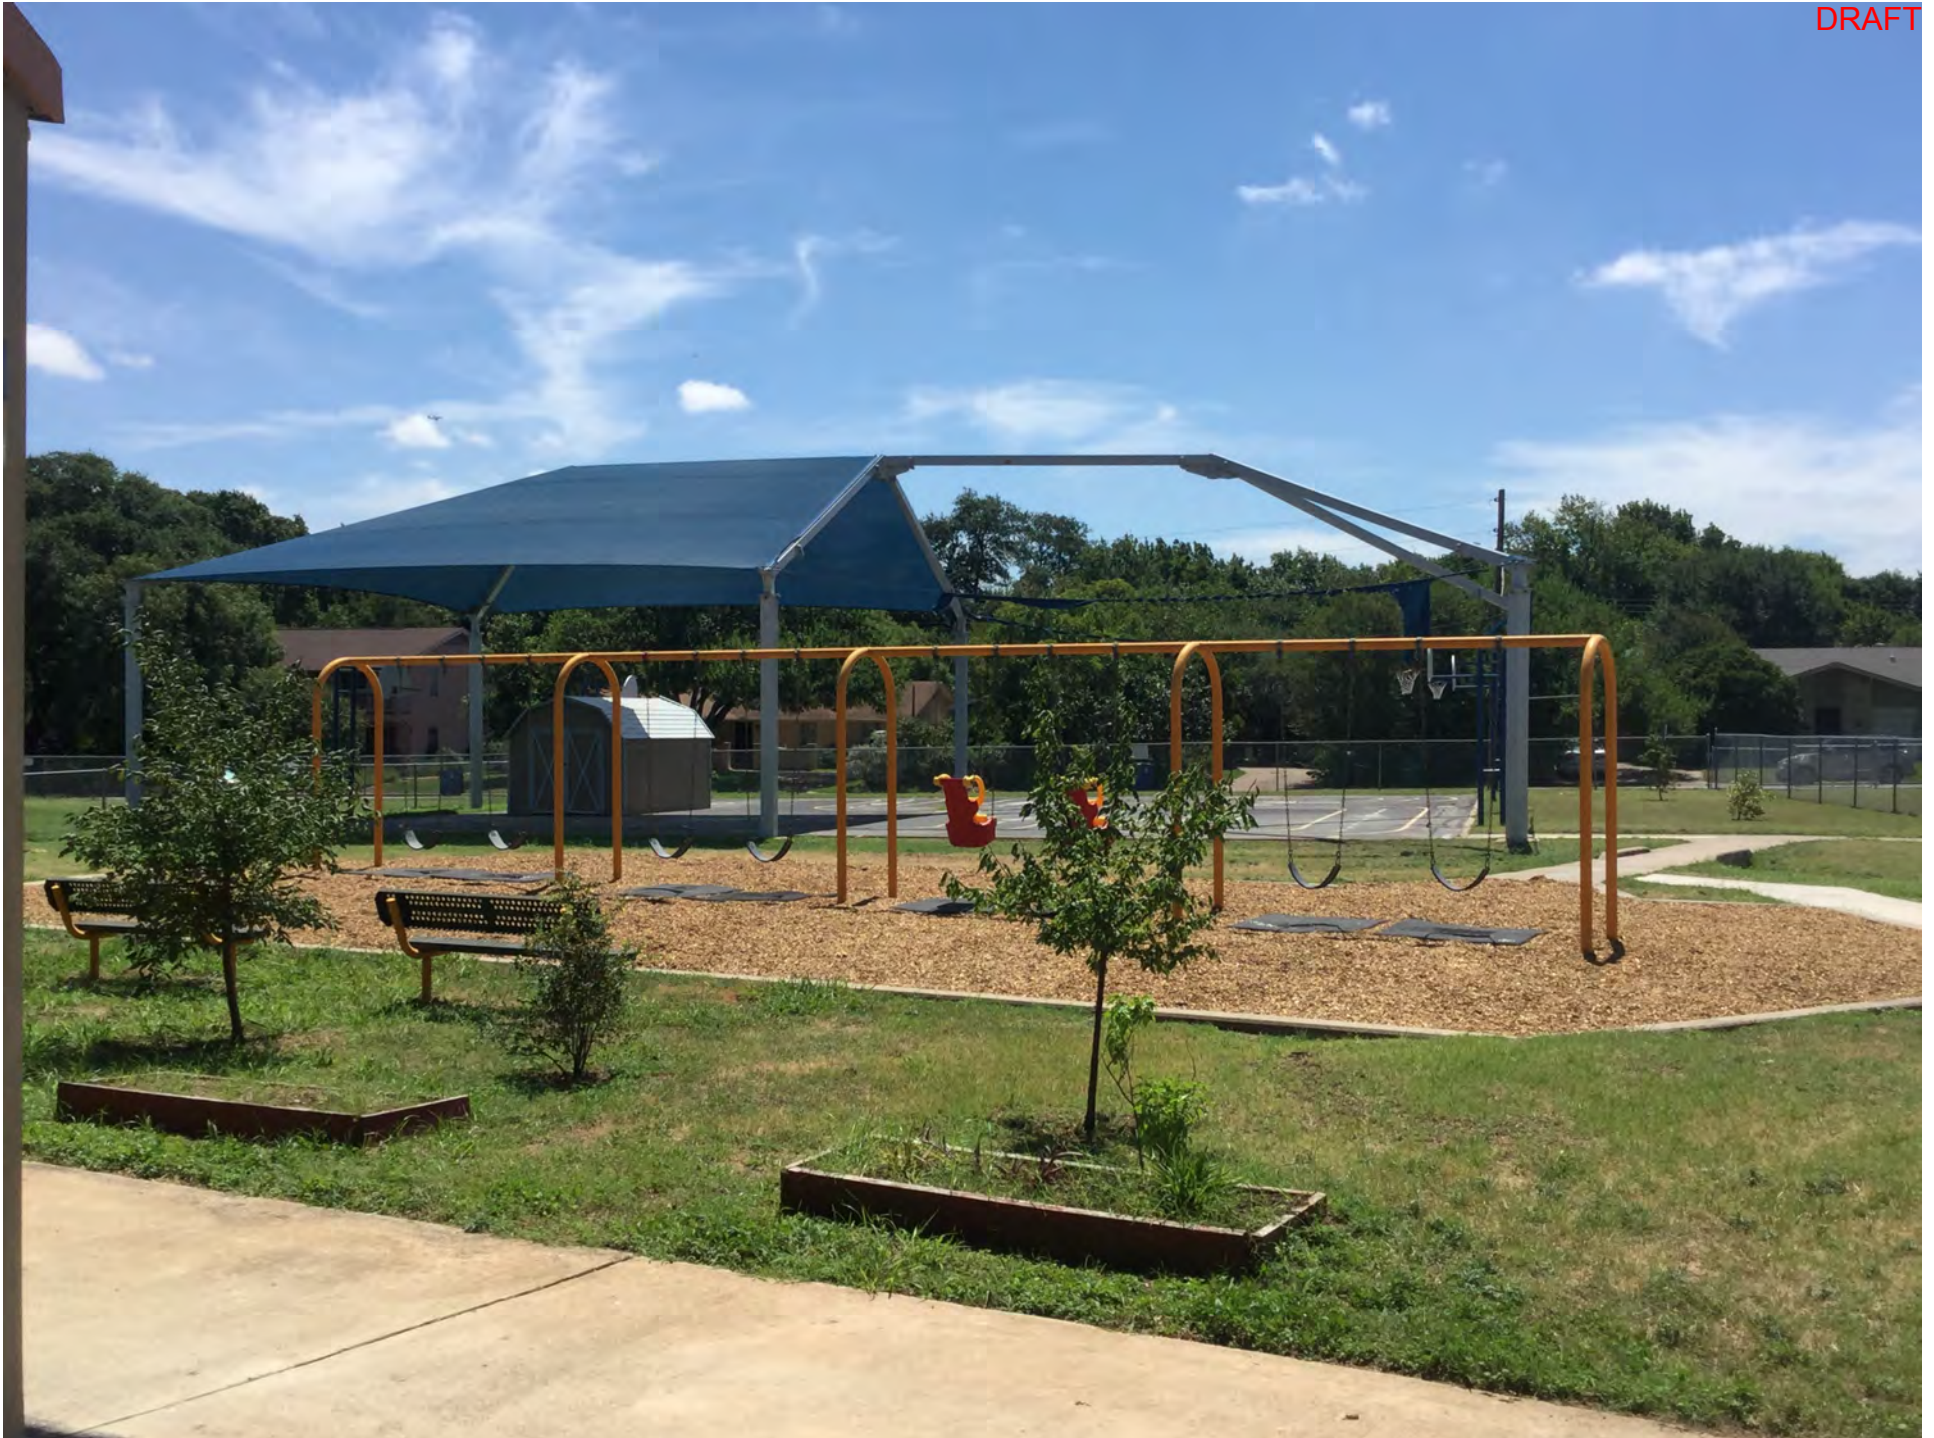
Photo 2.
1.3 Outdoor Play Space

1.3	Are outdoor play spaces and playfields adequate in size and configuration?				4			Comments	1.00 4.00
	1) Outdoor play space exists, not developed 2) Outdoor play space exists but is not connected to gym or other athletic support areas or is too small. 3. Outdoor play spaces exist, are connected to other athletic areas, are the right size, but are not in good condition. 4. Outdoor play spaces need minor improvements to function well. 5. Outdoor play spaces are in excellent condition. N/A) Does not apply.							Part of the playground is a public park. With such small children, this can be a hindrance.	see photo 2

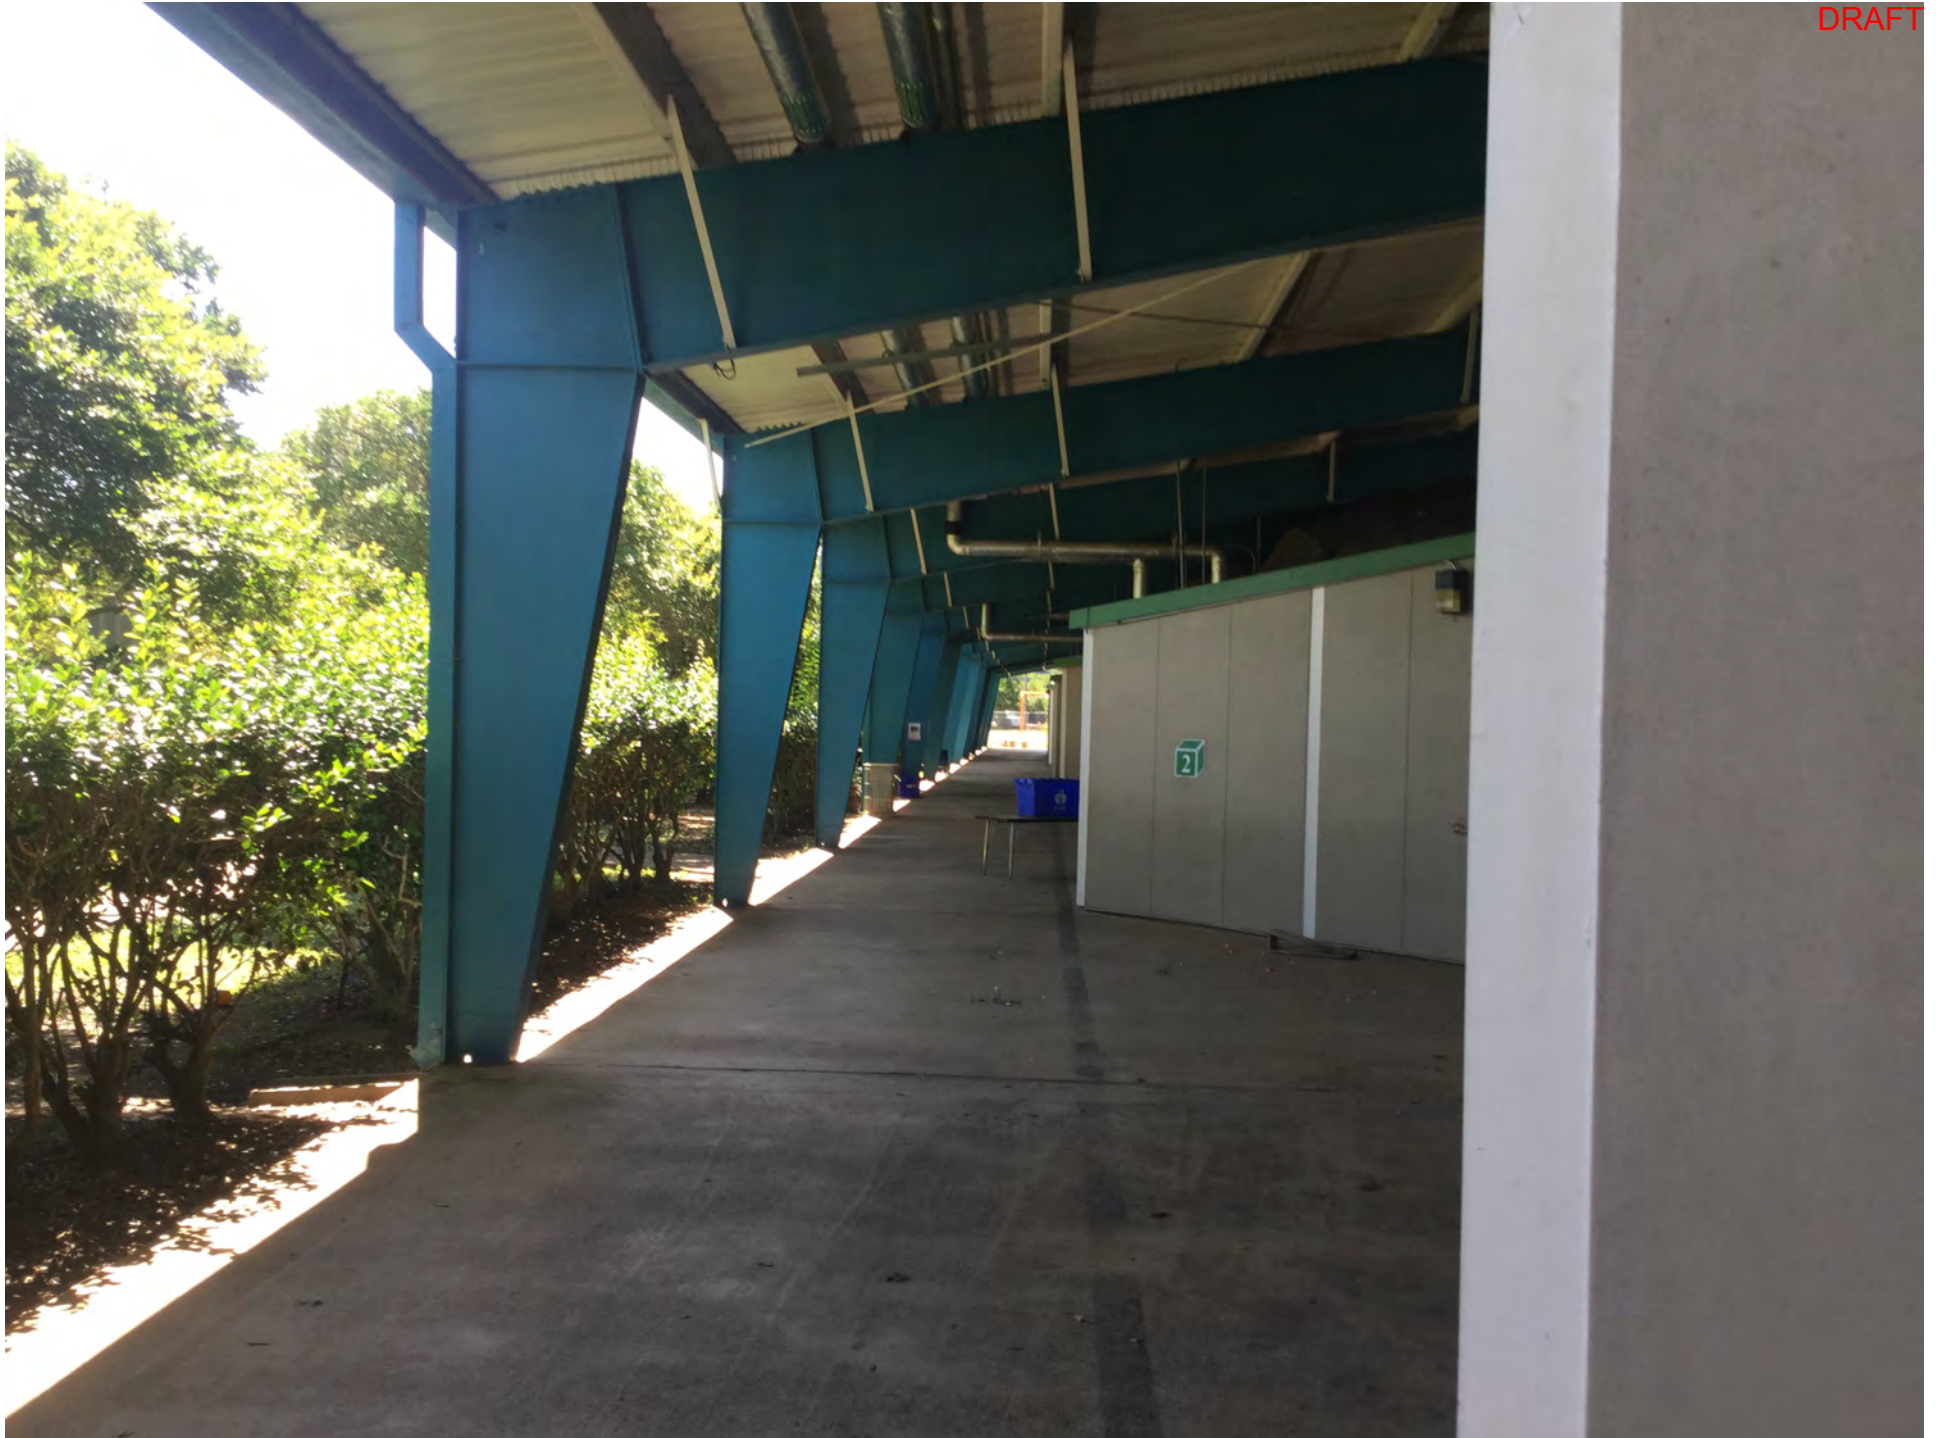
Photo 3.
2.1 Circulation

1) Primary circulation is 5'-0" to 6'-0" wide. 2) Primary circulation is 6'-0" to 7'-0" wide 3) Primary circulation is 7'-0" to 8'-0" wide 4) Primary circulation is 8'-0"-10'-0" wide 5) Primary circulation is 10'-0"+ wide N/A) Does not apply.							Most of the circulation between classrooms is exterior. This is a safety concern for the small children.	see photo 3

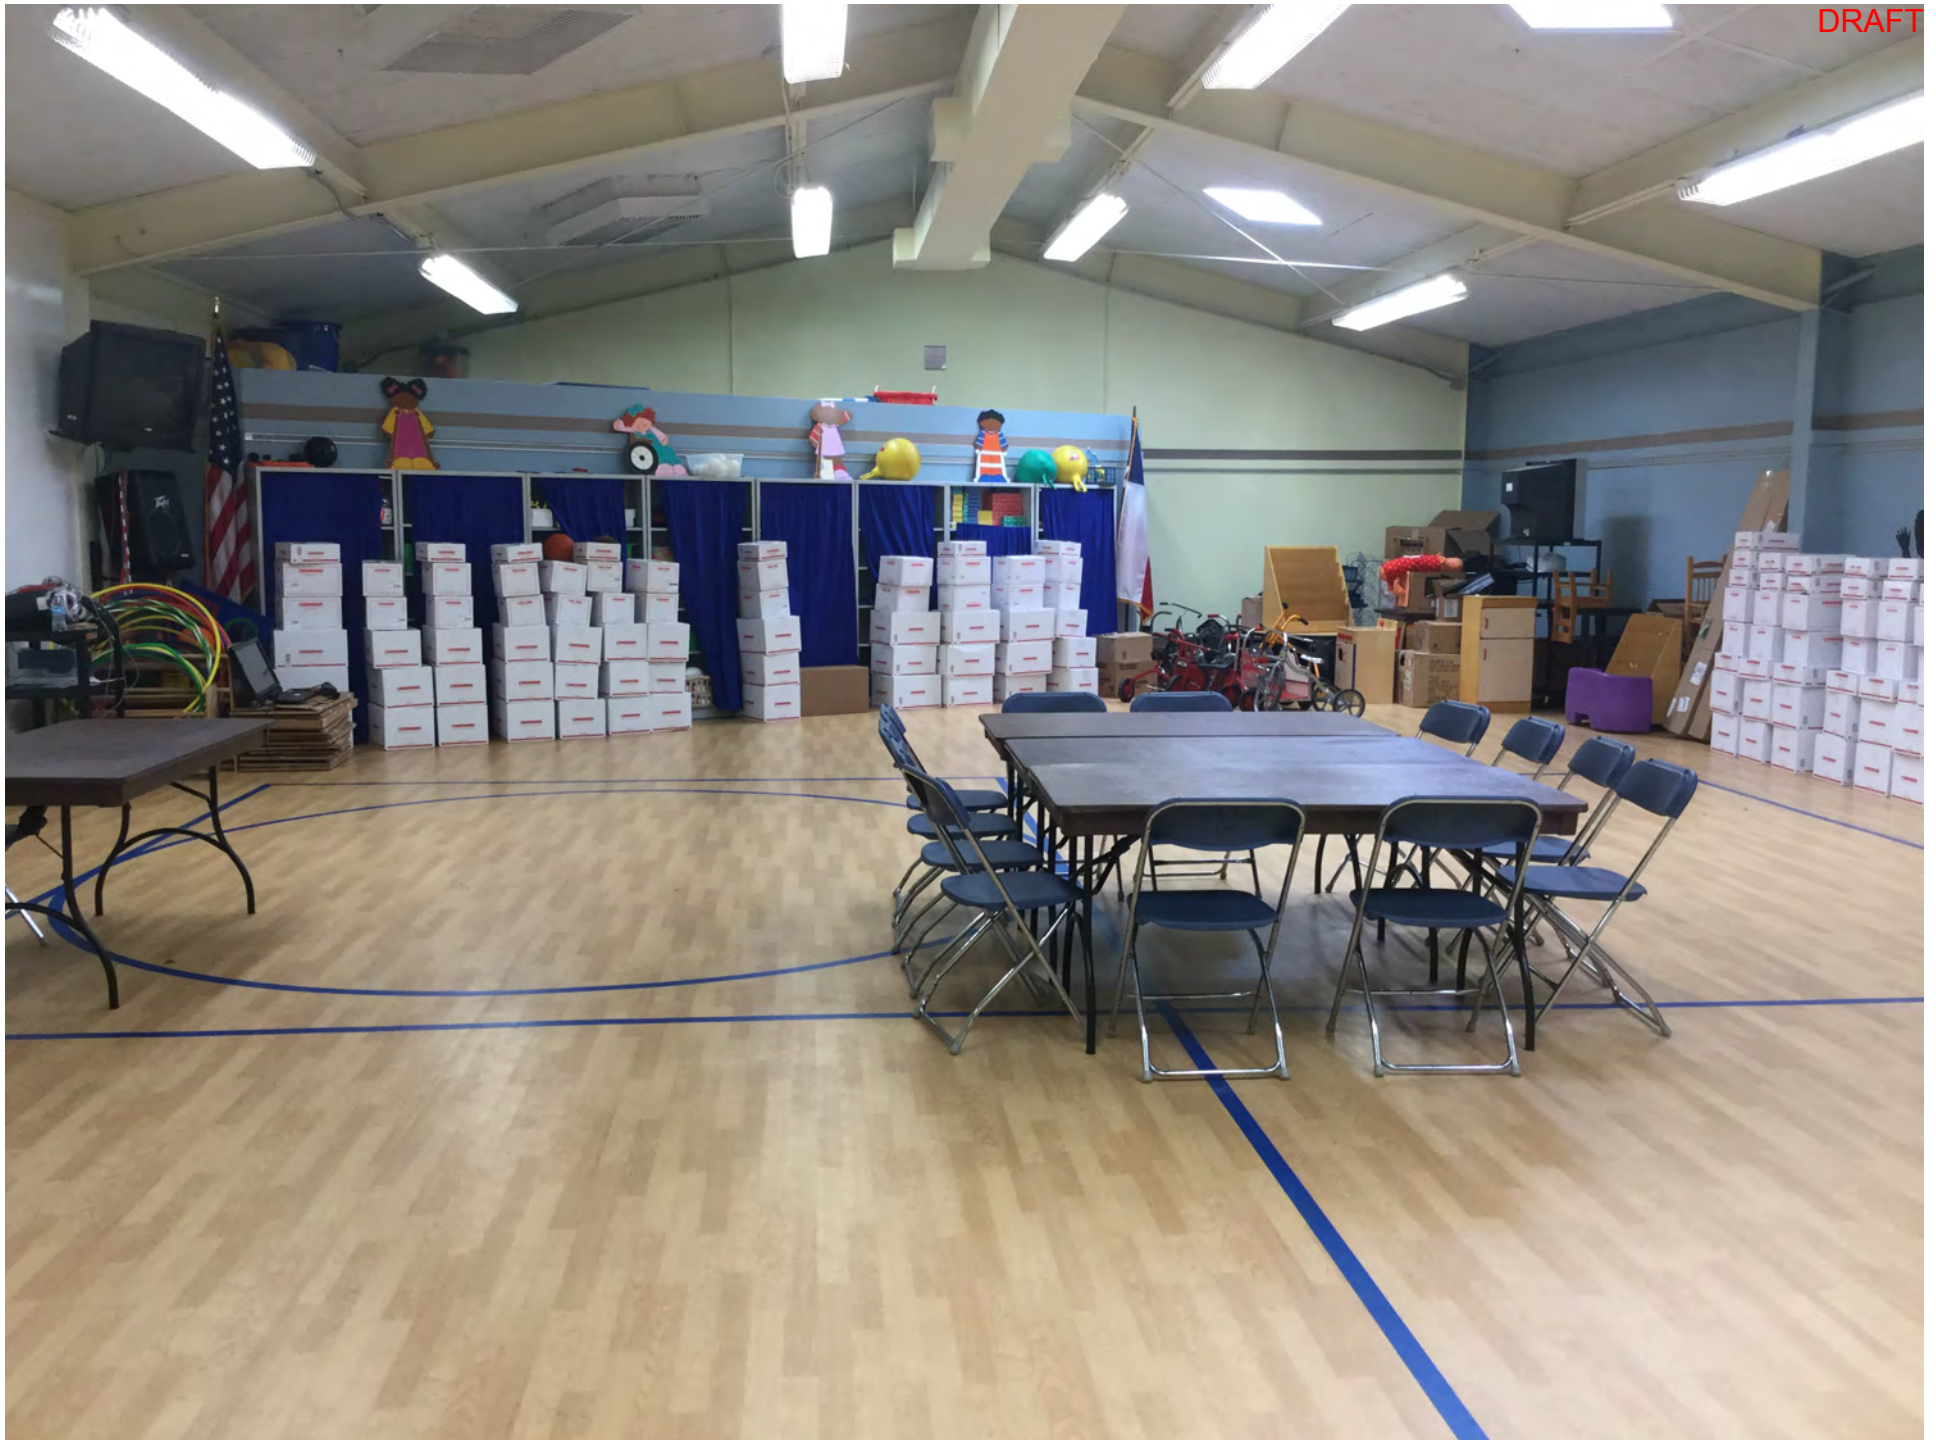
Photo 4.
3.6 Gym

1) Very unsatisfactory 2) Unsatisfactory 3) Average 4) Good 5) Very good N/A) Does not apply.								see photo 4	
3.7	Are Physical Education and Athletic support spaces appropriately configured per the ed spec?		2					Comments	1.002.00

1) Very unsatisfactory - Support spaces are disconnected from served spaces, too small, do not meet needs 2) Unsatisfactory - Support spaces are connected, but too small, inadequate for needs 3) Average - Connected, moderate size, but need some renovations or updates to function well 4) Good - Connected, good size/layout, meets needs/functions well 5) Very good - connected, generous size, nice condition, functions appropriately N/A) Does not apply.								The gym does not have any storage.

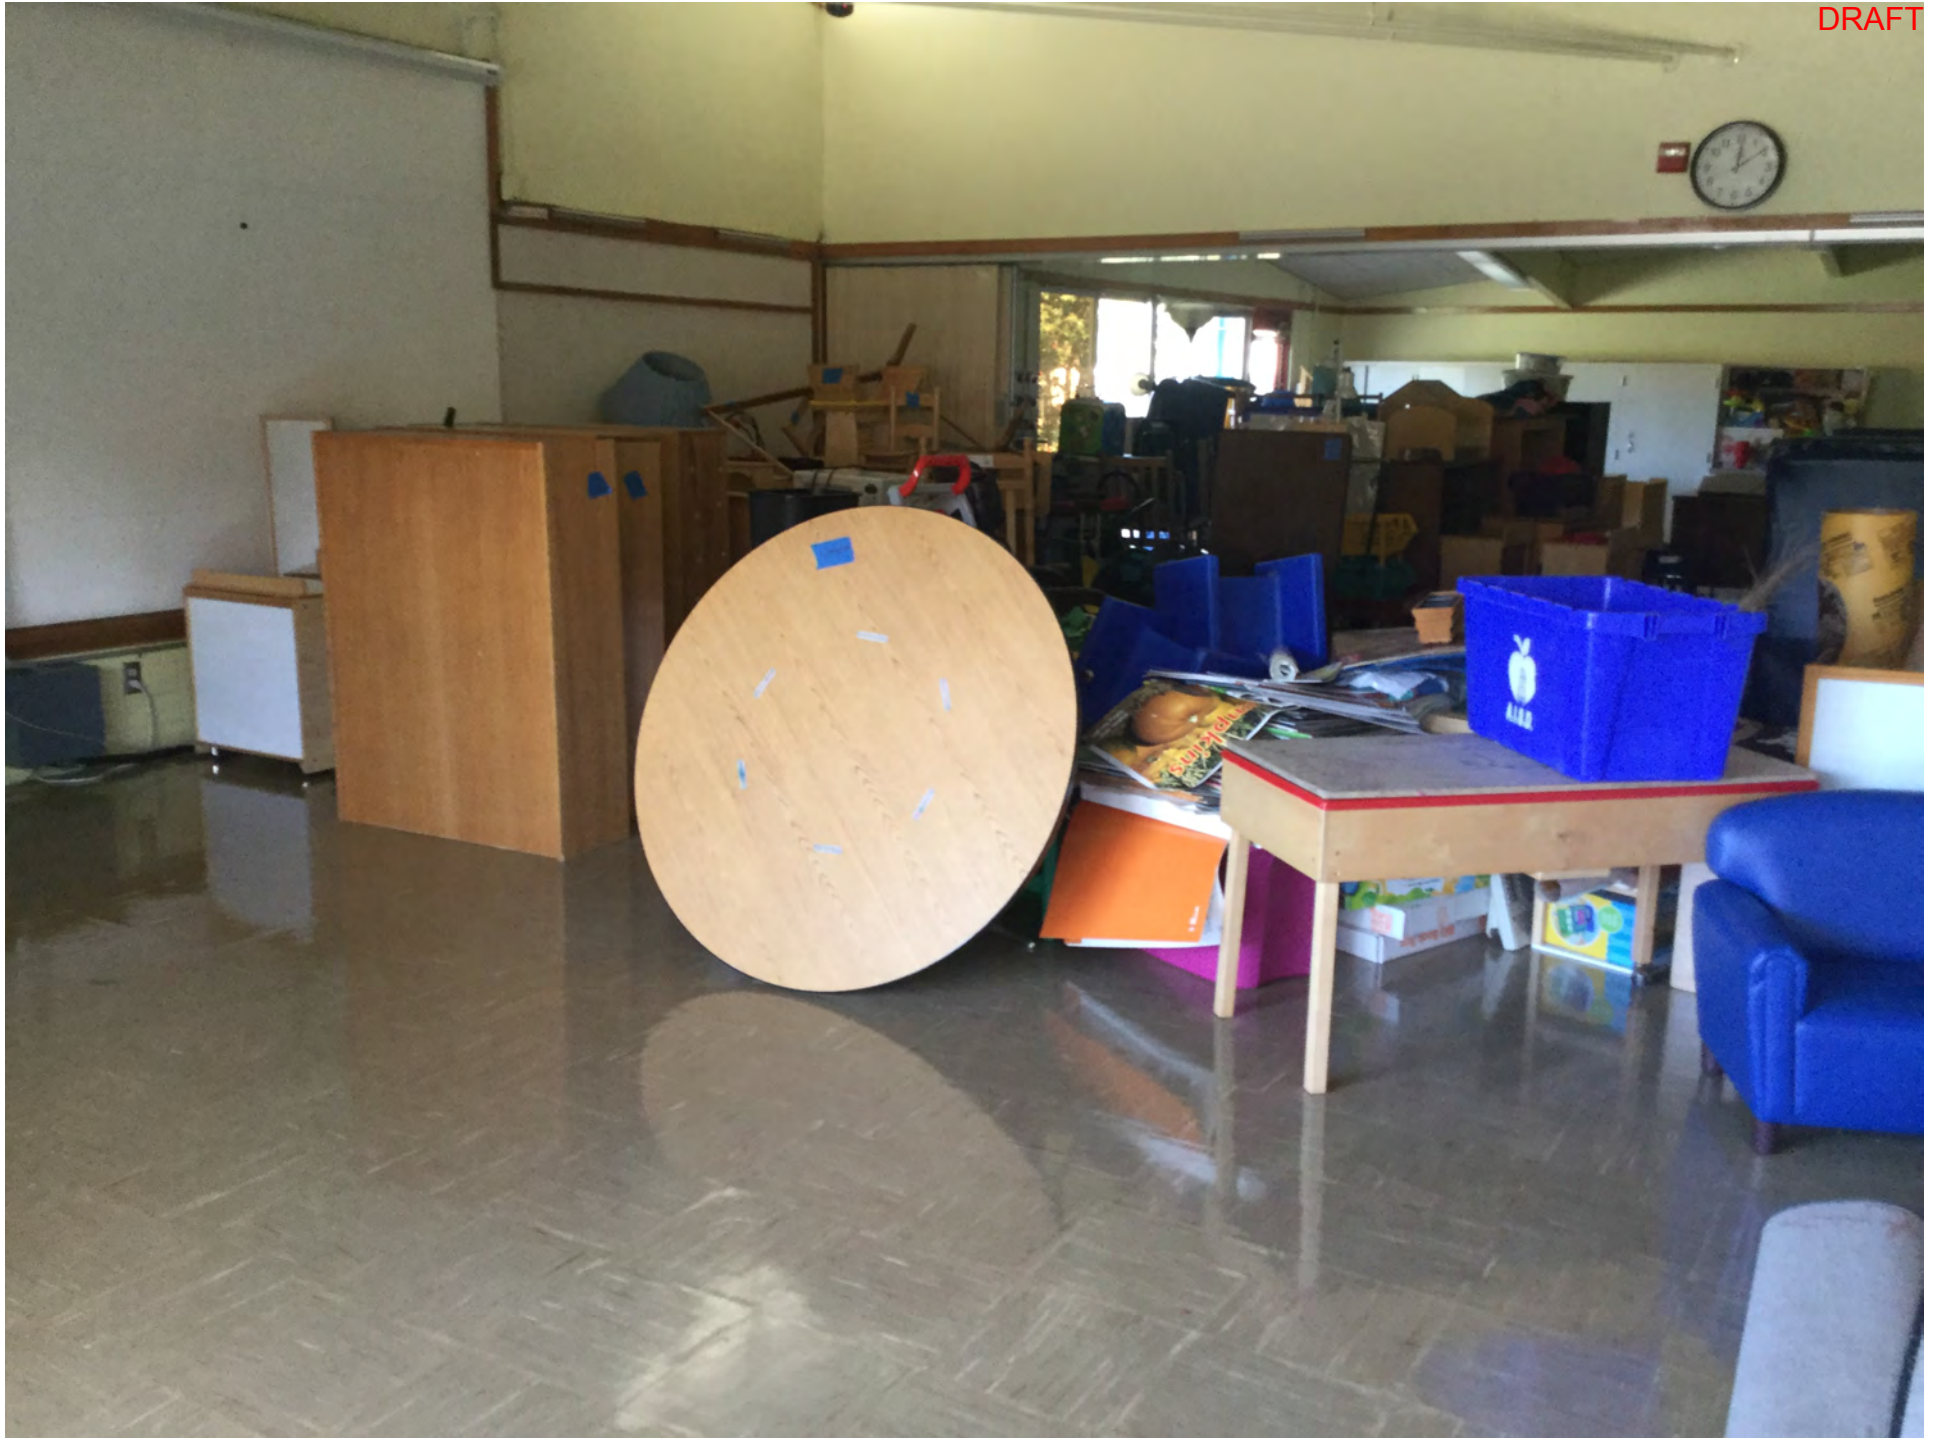
Photo 5.
3.14 PPCD Room

1) Very unsatisfactory 2) Unsatisfactory 3) Average 4) Good 5) Very good N/A) Does not apply.								The restrooms are not ADA accessible. The room sizes are small and not flexible.						see photo 5

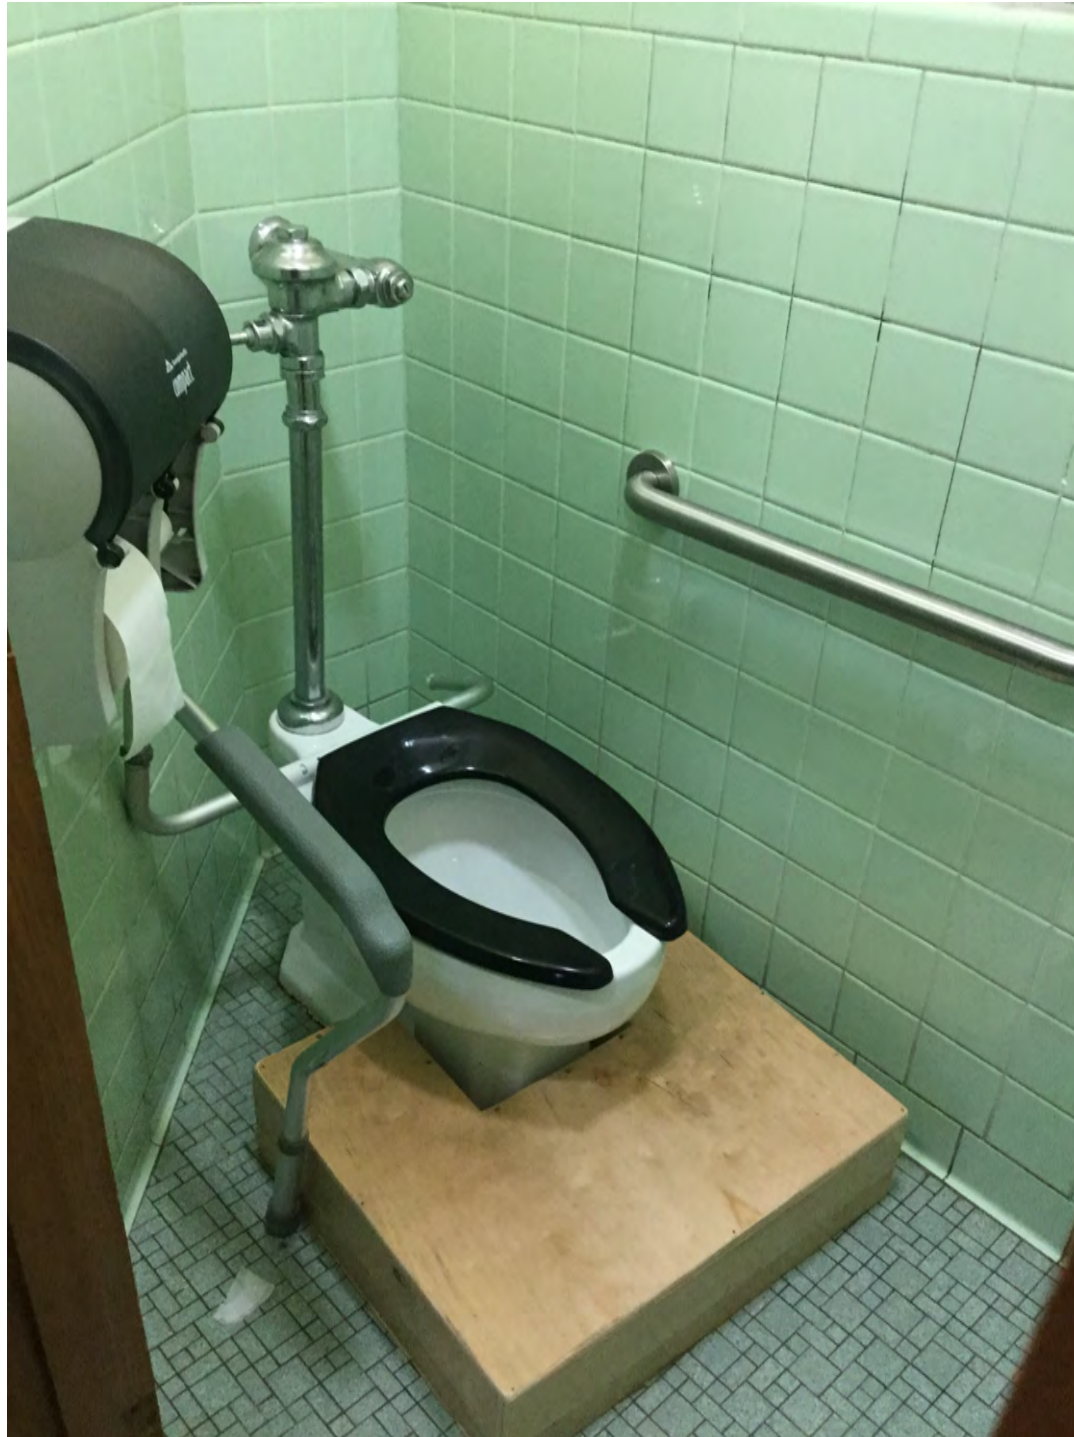
Photo 6.
PPCD Support

3.15	Are Special Education support spaces appropriately configured per the ed spec?		2					Comments						1.00	2.00
1) Very unsatisfactory - Support spaces are disconnected from served spaces, too small, do not meet needs 2) Unsatisfactory - Support spaces are connected, but too small, inadequate for needs 3) Average - Connected, moderate size, but need some renovations or updates to function well 4) Good - Connected, good size/layout, meets needs/functions well 5) Very good - connected, generous size, nice condition, functions appropriately N/A) Does not apply.								The restrooms are not ADA accessible.						see photo 6

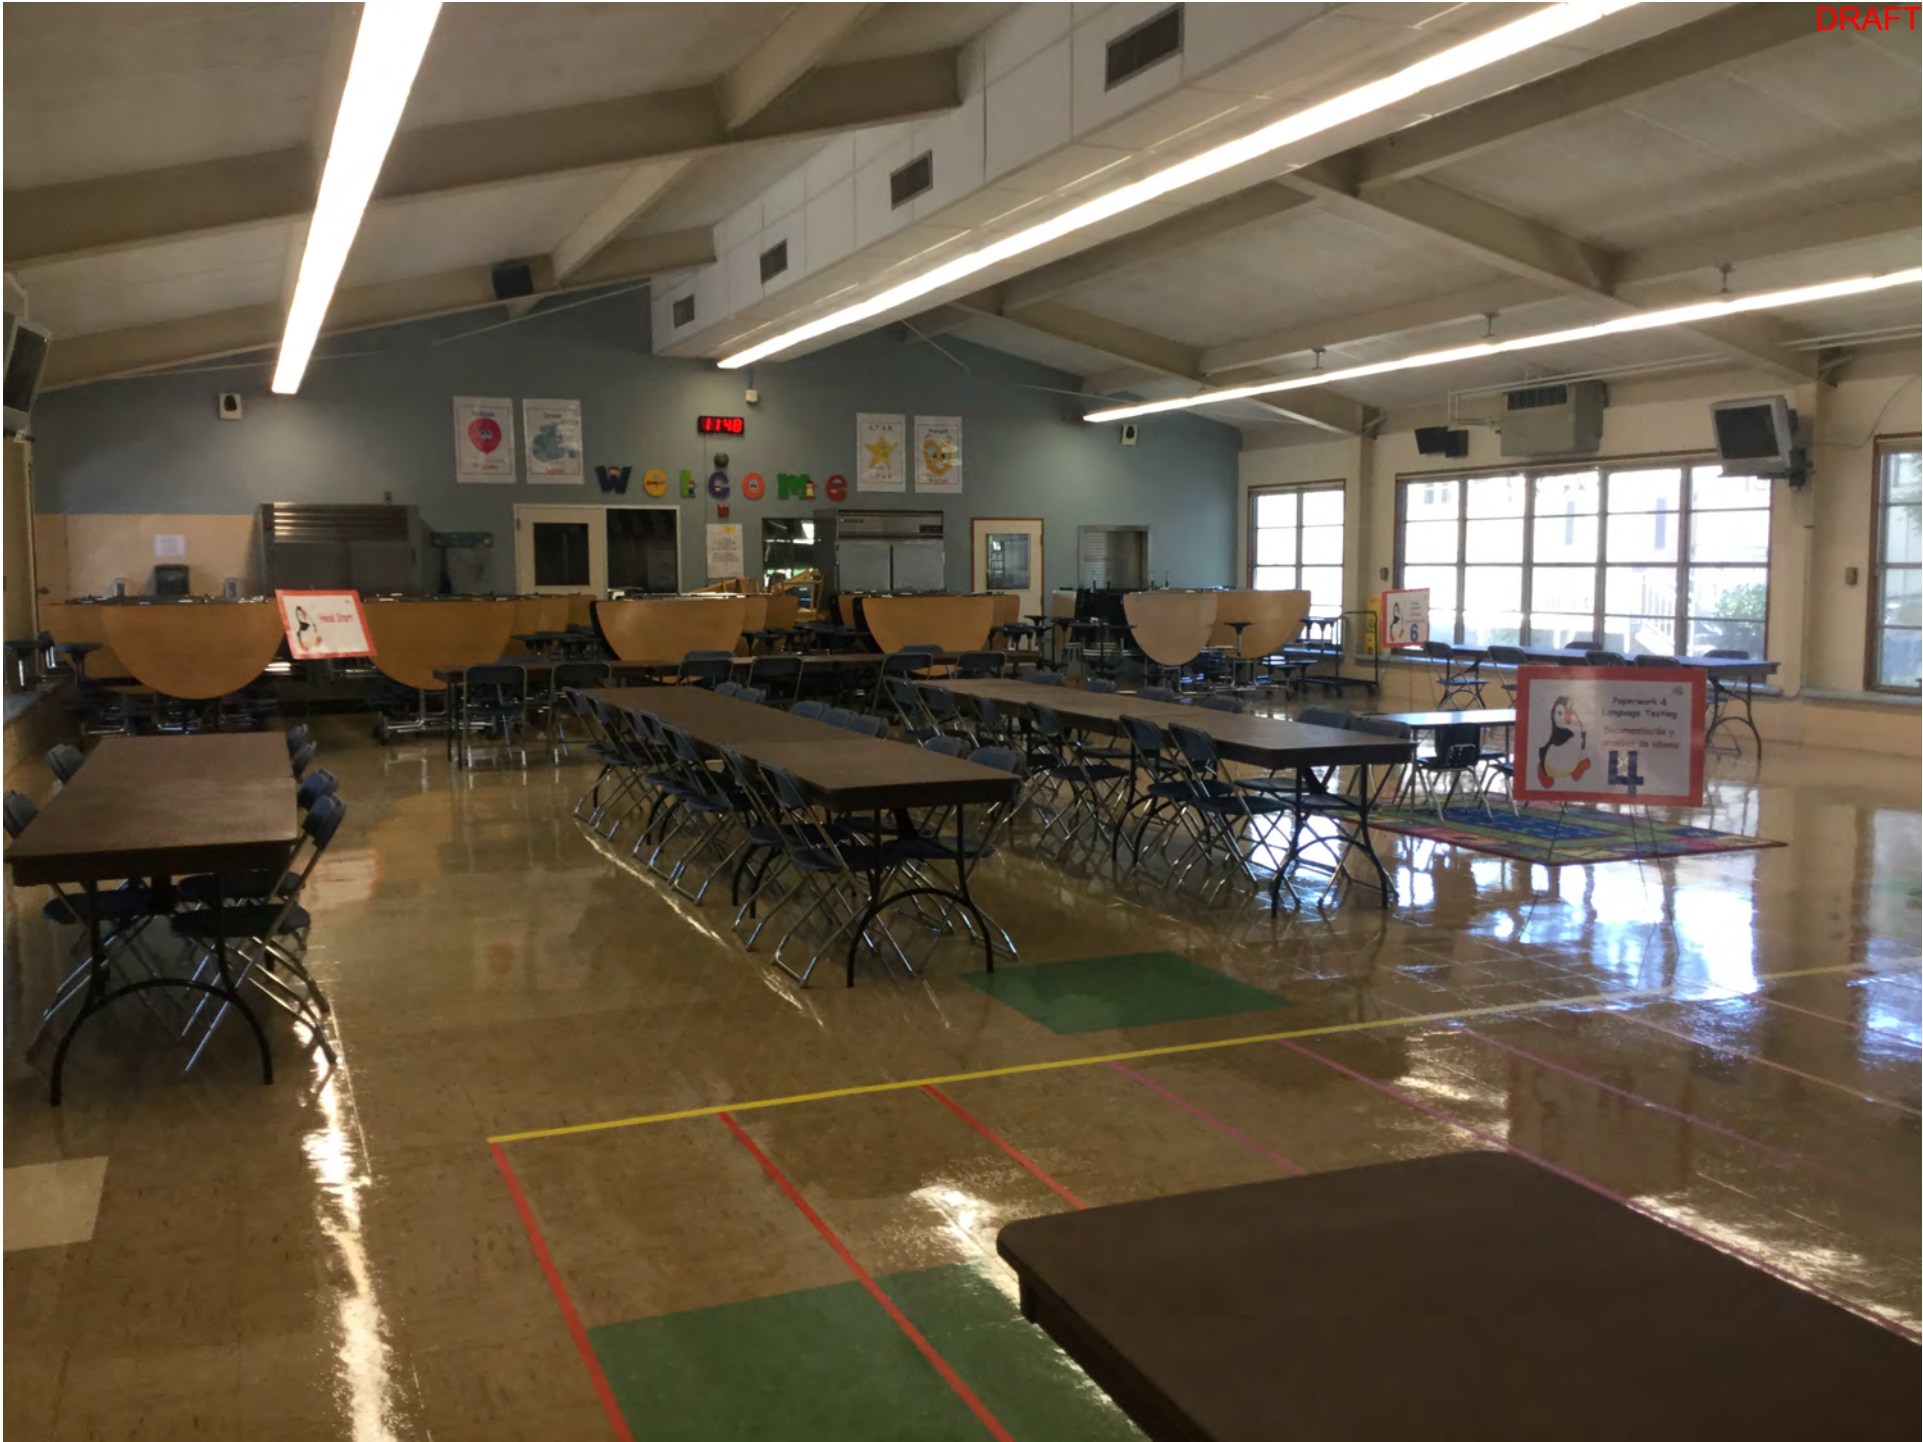
Photo 7.
Cafetorium

3.16	Are the student dining facilities appropriately configured?				4			Comments						1.00	4.00
1) Very unsatisfactory - Too small, poor circulation, inflexible seating in poor condition 2) Unsatisfactory - Too small or inadequate circulation, seating in poor condition 3) Average - moderate size, with adequate circulation, seating in okay condition 4) Good - good size, adequate circulation, seating in good condition 5) Very good - good size, adequate circulation, seating in good condition, with more than one option for eating space (ex: connection to outdoor eating space) N/A) Does not apply.														see photo 7

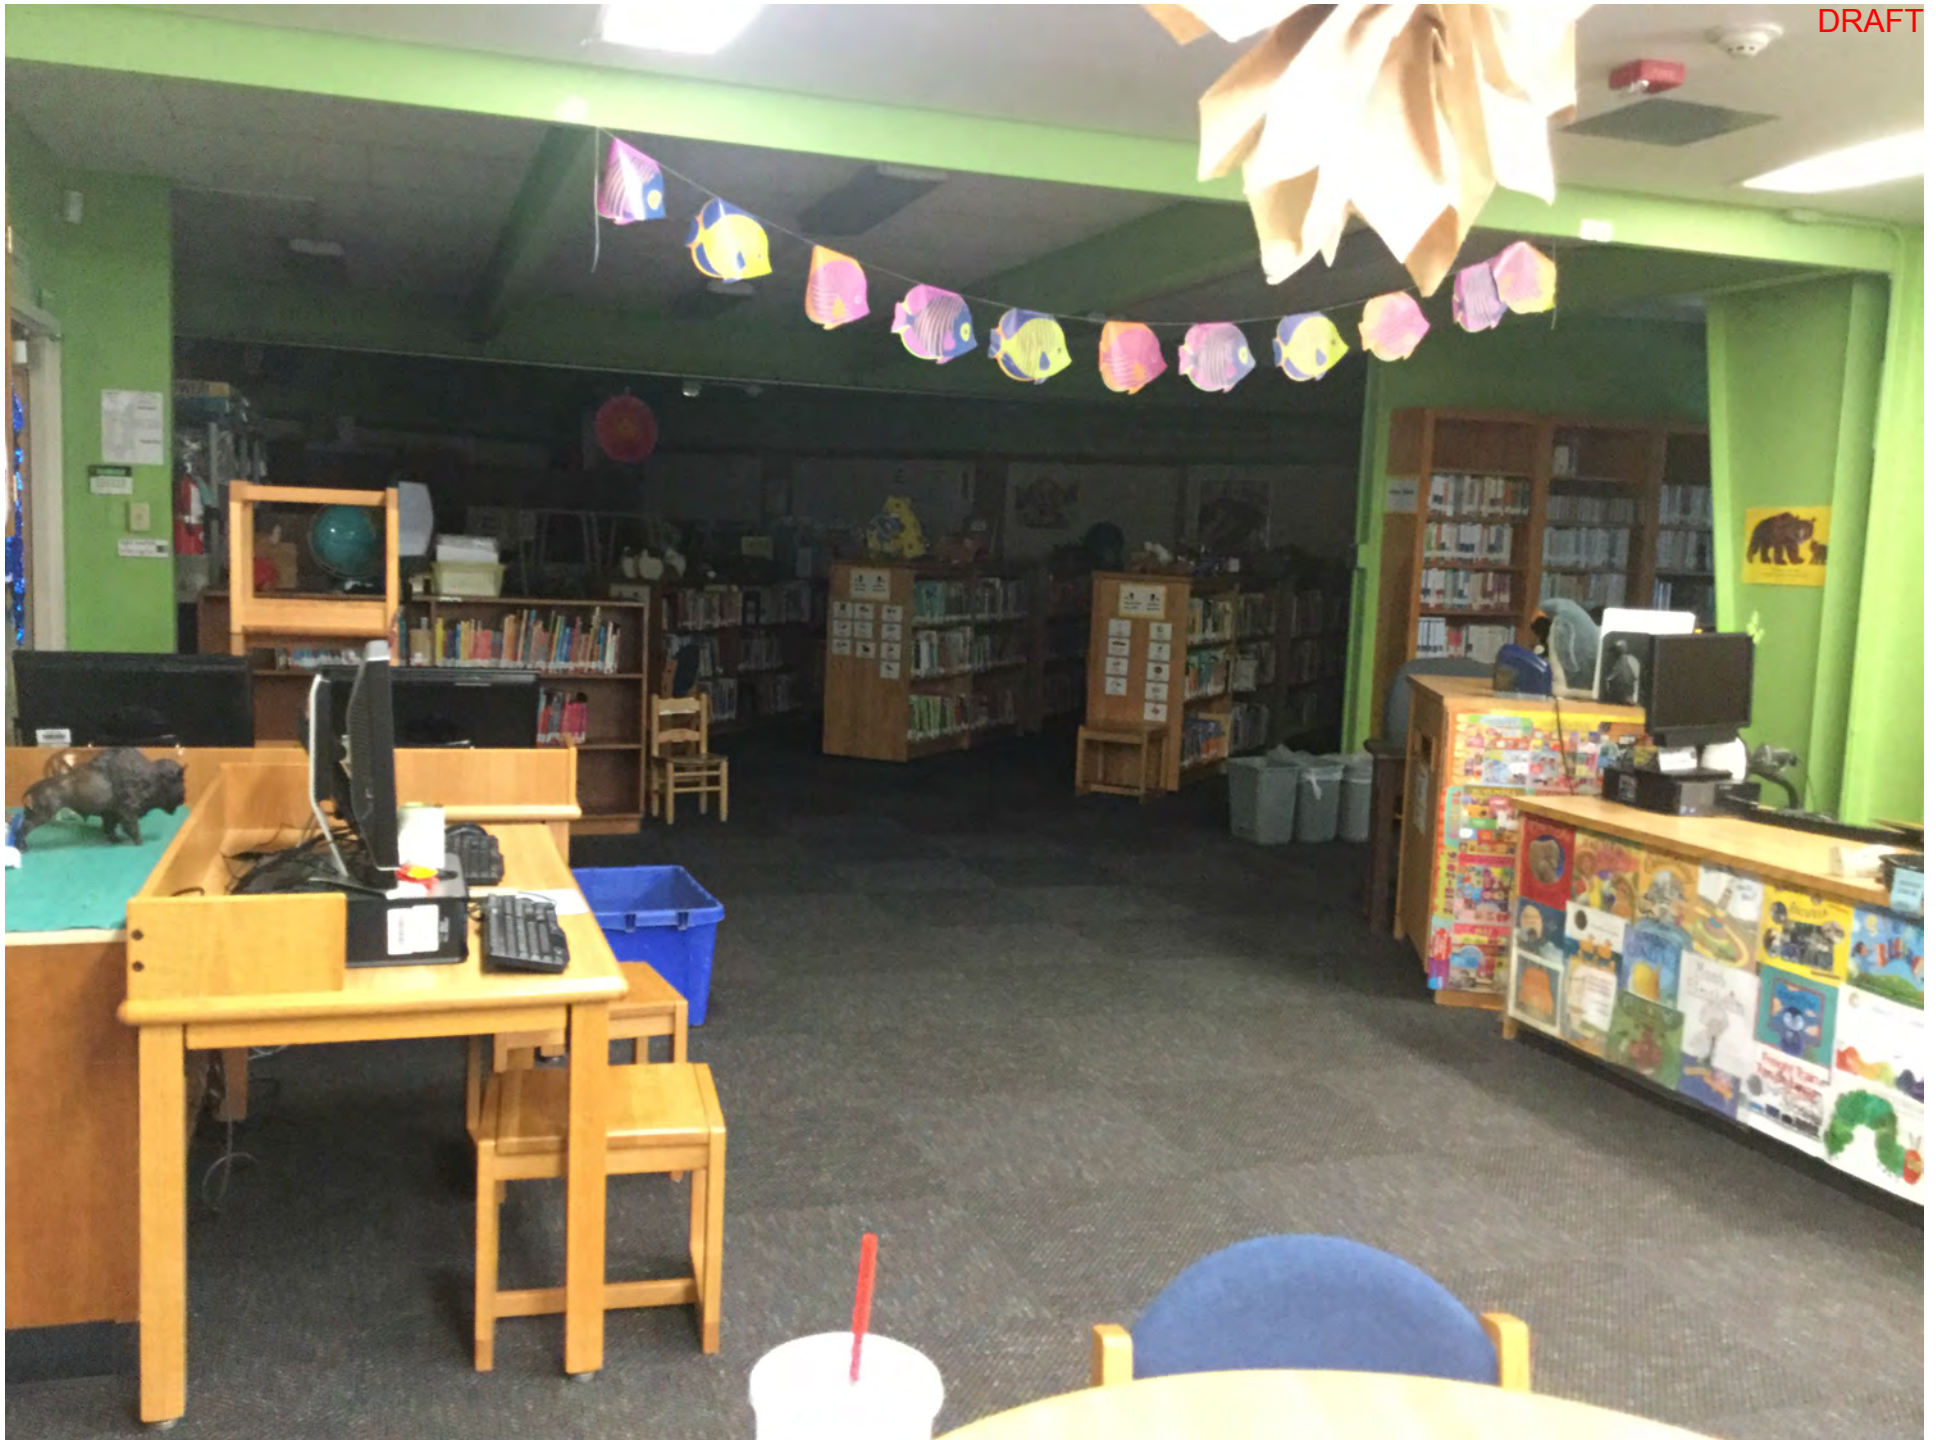
Photo 8.
5.3 Library

1) Very unsatisfactory 2) Unsatisfactory 3) Average 4) Good 5) Very good N/A) Does not apply.								see photo 8	
5.4	How well does the Library/Media Center support collaborative work in small groups (4-8 students)?				4			Comments	1.004.00
