Educational Suitability Summary Report

Lucy Read Pre-Kindergarten Demonstration School

Date: 08/04/2016 – (Rev.1 – 12/19/16- Survey Results and Const. Dept)

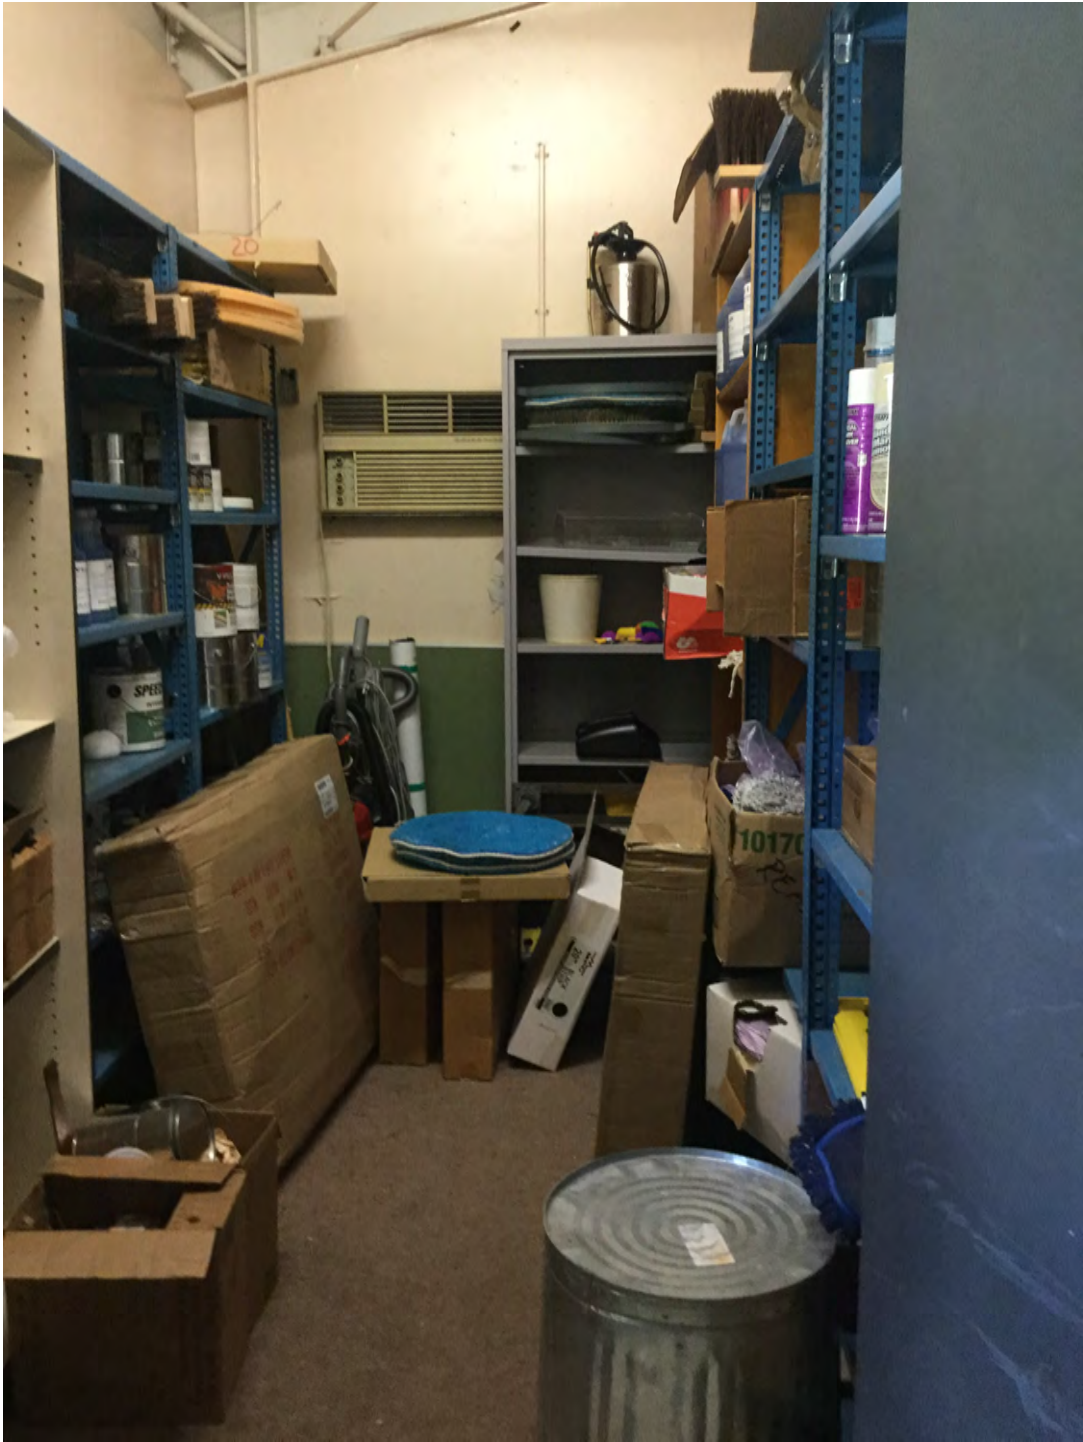
Photo 9.
8.1 Storage

General building storage is very inadequate. Additionally, classroom storage spaces are equipped with only minimal built-in cabinets.

8 - Storage		1	2	3	4	5	N/A	5.00	
8.1	Is there adequate general storage in the building?	1						Comments	1.00 1.00
1) Very unsatisfactory 2) Unsatisfactory 3) Average 4) Good 5) Very good N/A) Does not apply.								see photo 9	
8.2	Is there adequate classroom storage?	1						Comments	1.00 1.00
1) Very unsatisfactory 2) Unsatisfactory 3) Average 4) Good 5) Very good N/A) Does not apply.									
8.3	Is there adequate student storage?			3				Comments	1.00 3.00
1) Very unsatisfactory 2) Unsatisfactory 3) Average 4) Good 5) Very good N/A) Does not apply.								There are student hooks available, but they are outside of the classrooms.
