Educational Suitability Summary Report

Maplewood Elementary School – BLDG. 122

Date: 06/21/2016

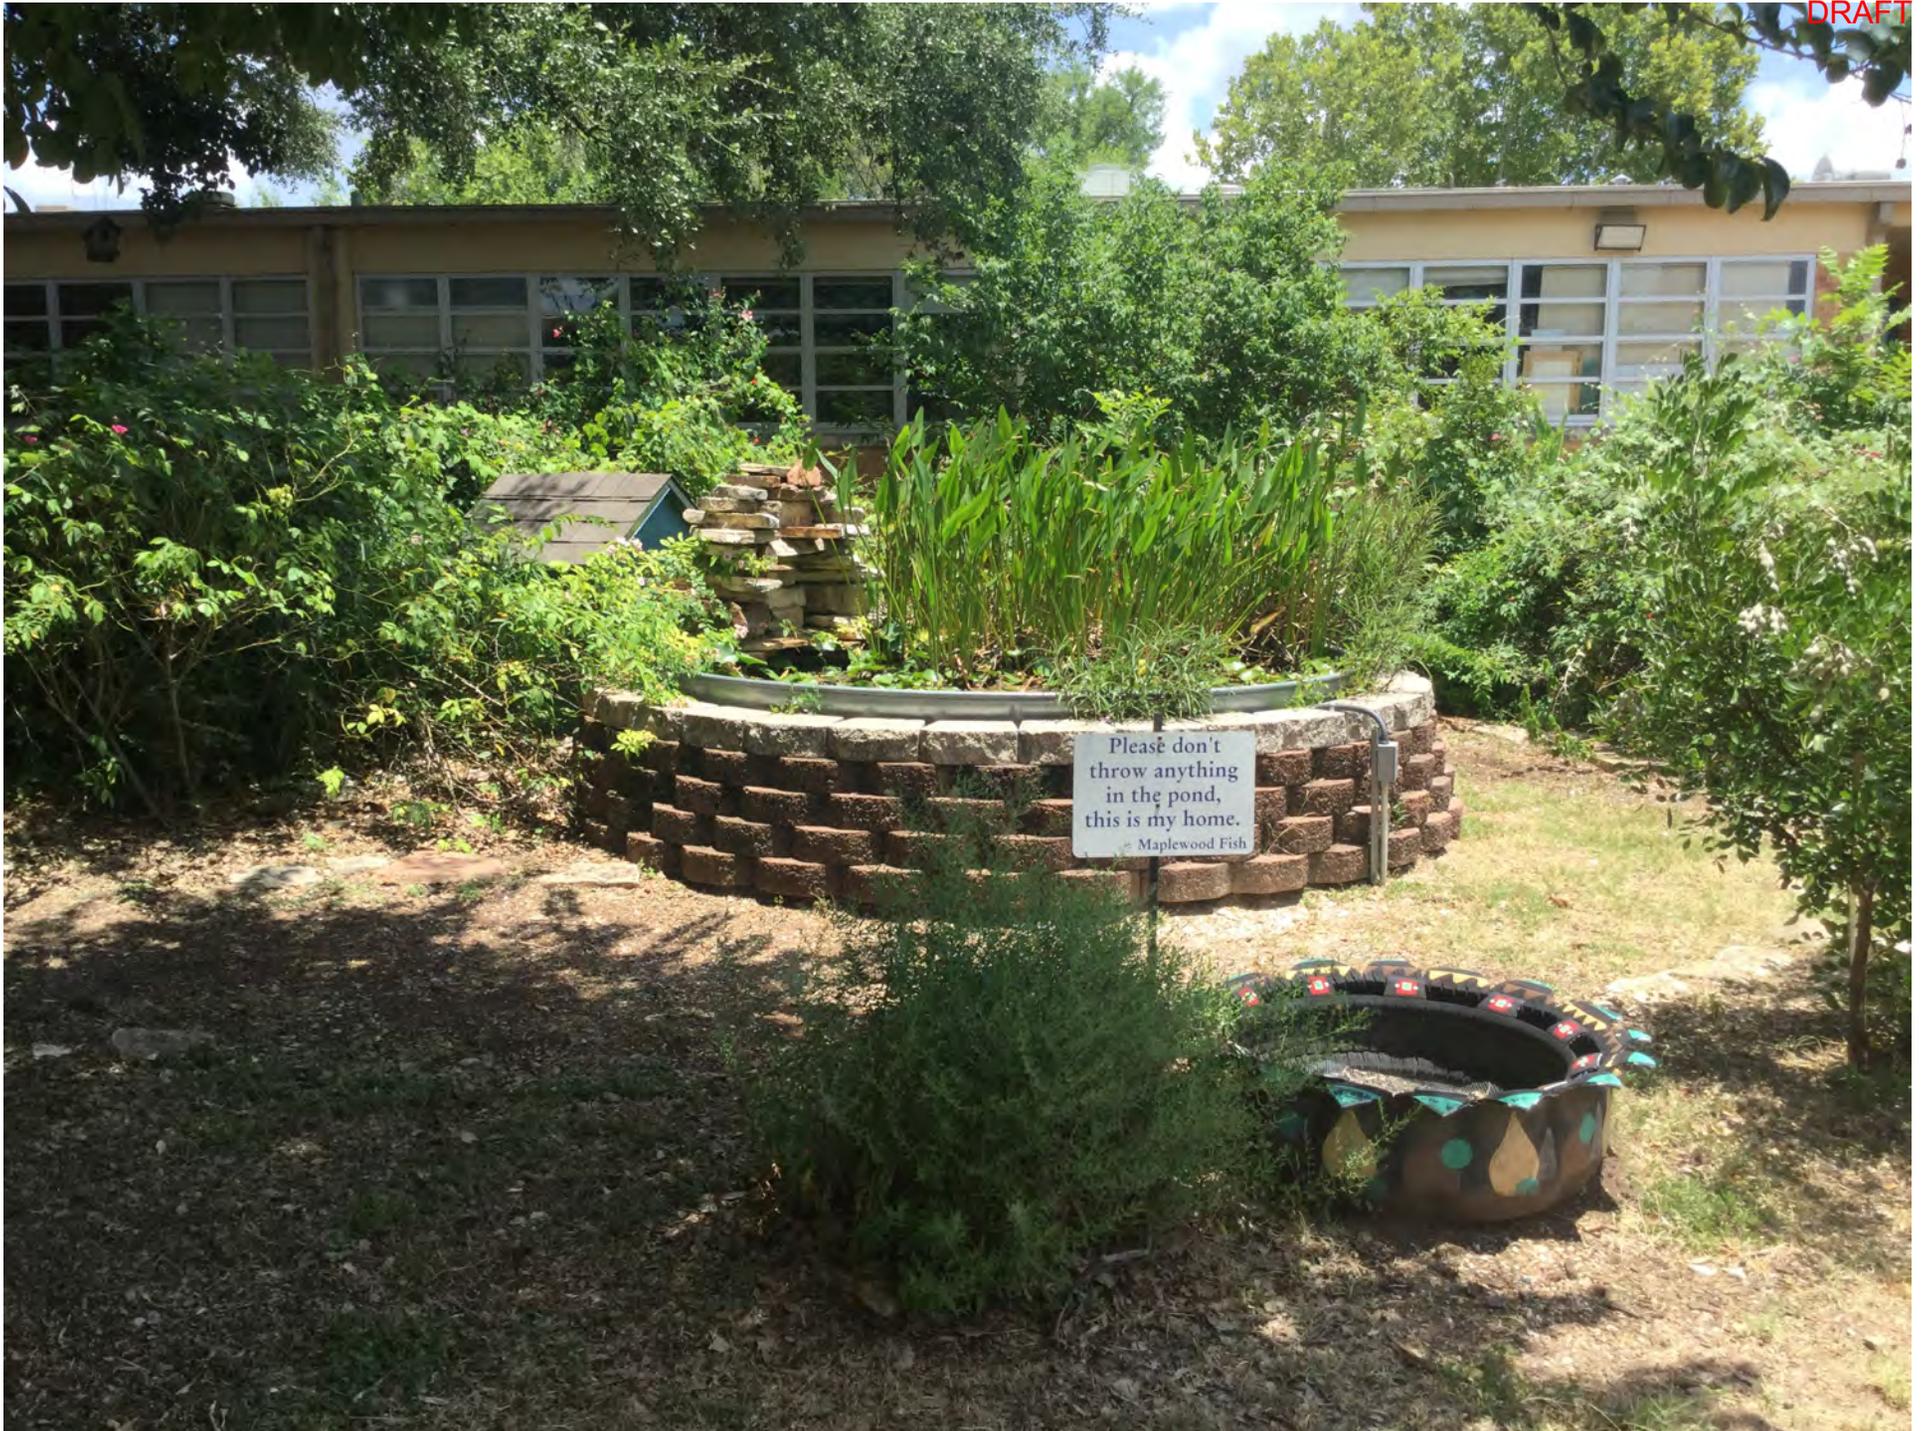
Photo 1.
1.2 Outdoor Space

1.2	Are opportunities provided for outdoor learning (outdoor classrooms, gardens, etc.)?				4			Comments	1.00	4.00	
1) Outdoor space exists is not developed 2) Outdoor space for learning exists but not connected to classroom learning areas. 3. Outdoor learning spaces exist and are accessible but not in good condition. 4. Outdoor learning spaces need minor improvements to function well. 5. Outdoor learning spaces are in excellent condition. N/A) Does not apply.								A sufficient amount of the outdoor spaces seemed well maintained. The courtyard areas are special to the school staff.			
								see photo 1

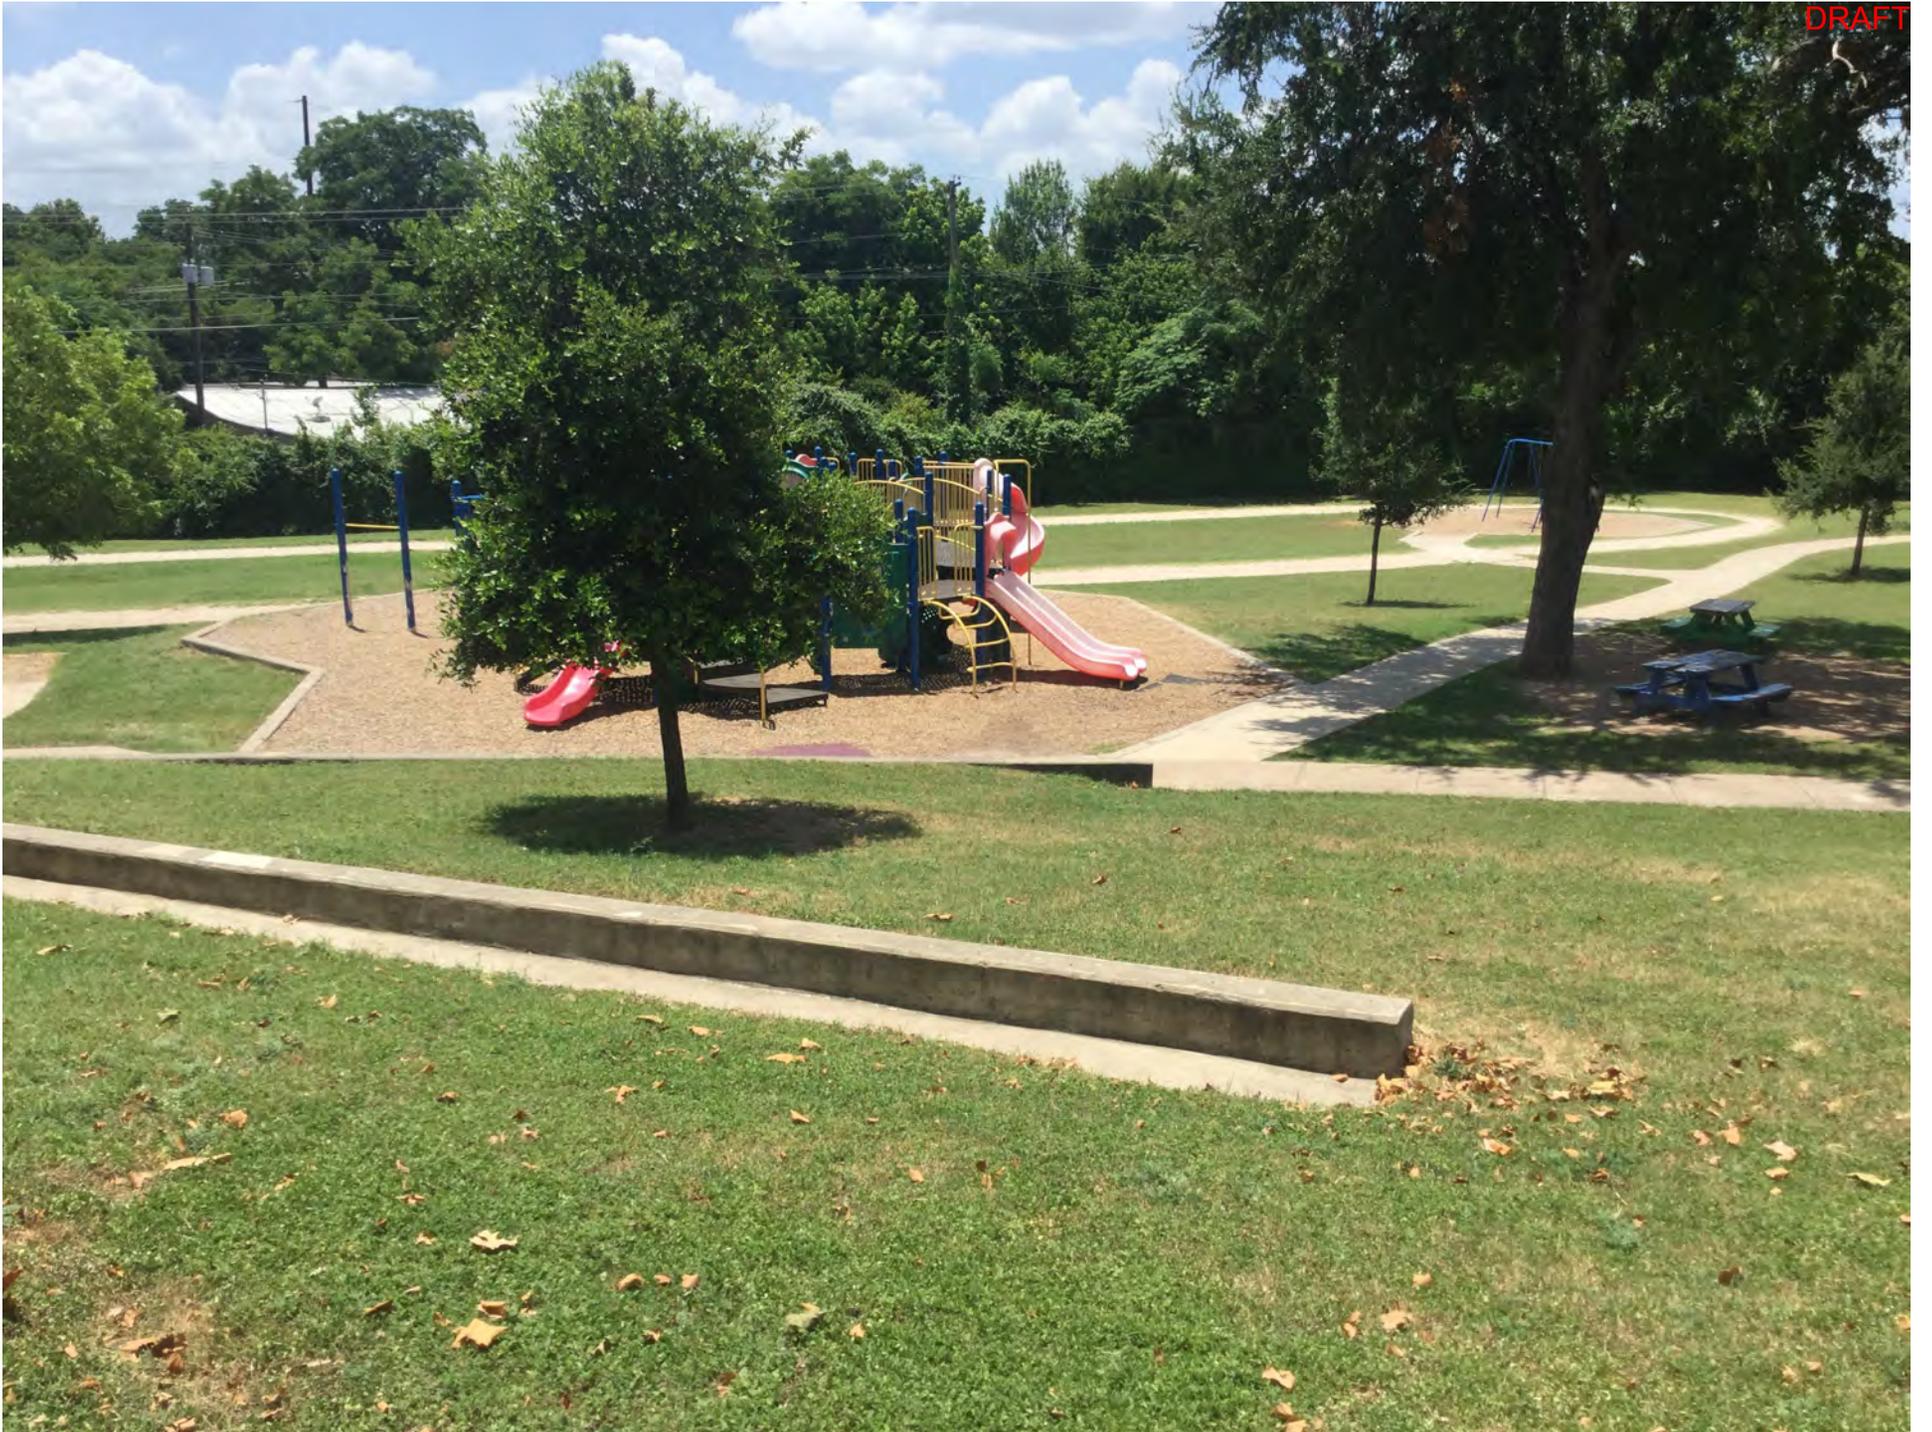
Photo 2.
1.3 Playfield

1.3	Are outdoor play spaces and playfields adequate in size and configuration?				4			Comments	1.00	4.00	
1) Outdoor play space exists, not developed 2) Outdoor play space exists but is not connected to gym or other athletic support areas or is too small. 3. Outdoor play spaces exist, are connected to other athletic areas, are the right size, but are not in good condition. 4. Outdoor play spaces need minor improvements to function well. 5. Outdoor play spaces are in excellent condition. N/A) Does not apply.								The playspaces are in great condition and spacious. However, the track is in poor condition and inadequate in size.			
								see photo 2

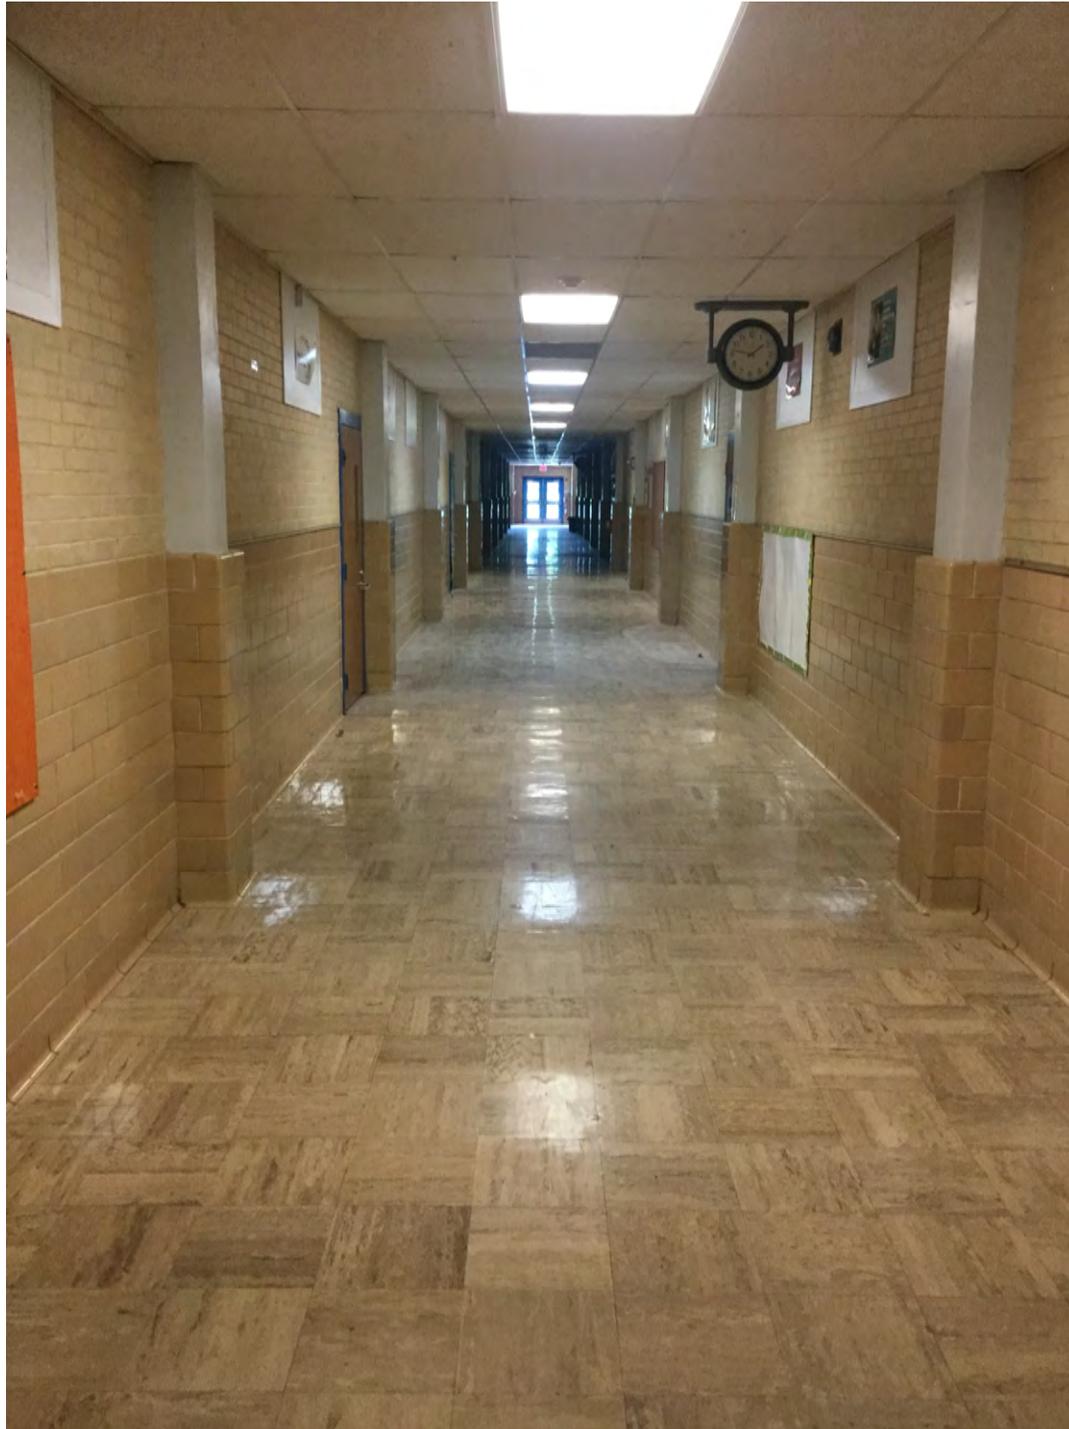
Photo 3.
2.1 Hallway Corridor

1) Primary circulation is 5'-0" to 6'-0" wide. 2) Primary circulation is 6'-0" to 7'-0" wide 3) Primary circulation is 7'-0" to 8'-0" wide 4) Primary circulation is 8'-0"-10'-0" wide 5) Primary circulation is 10'-0"+ wide N/A) Does not apply.		The hallways are very spacious and have lifts to help disabled children.						see photo 3

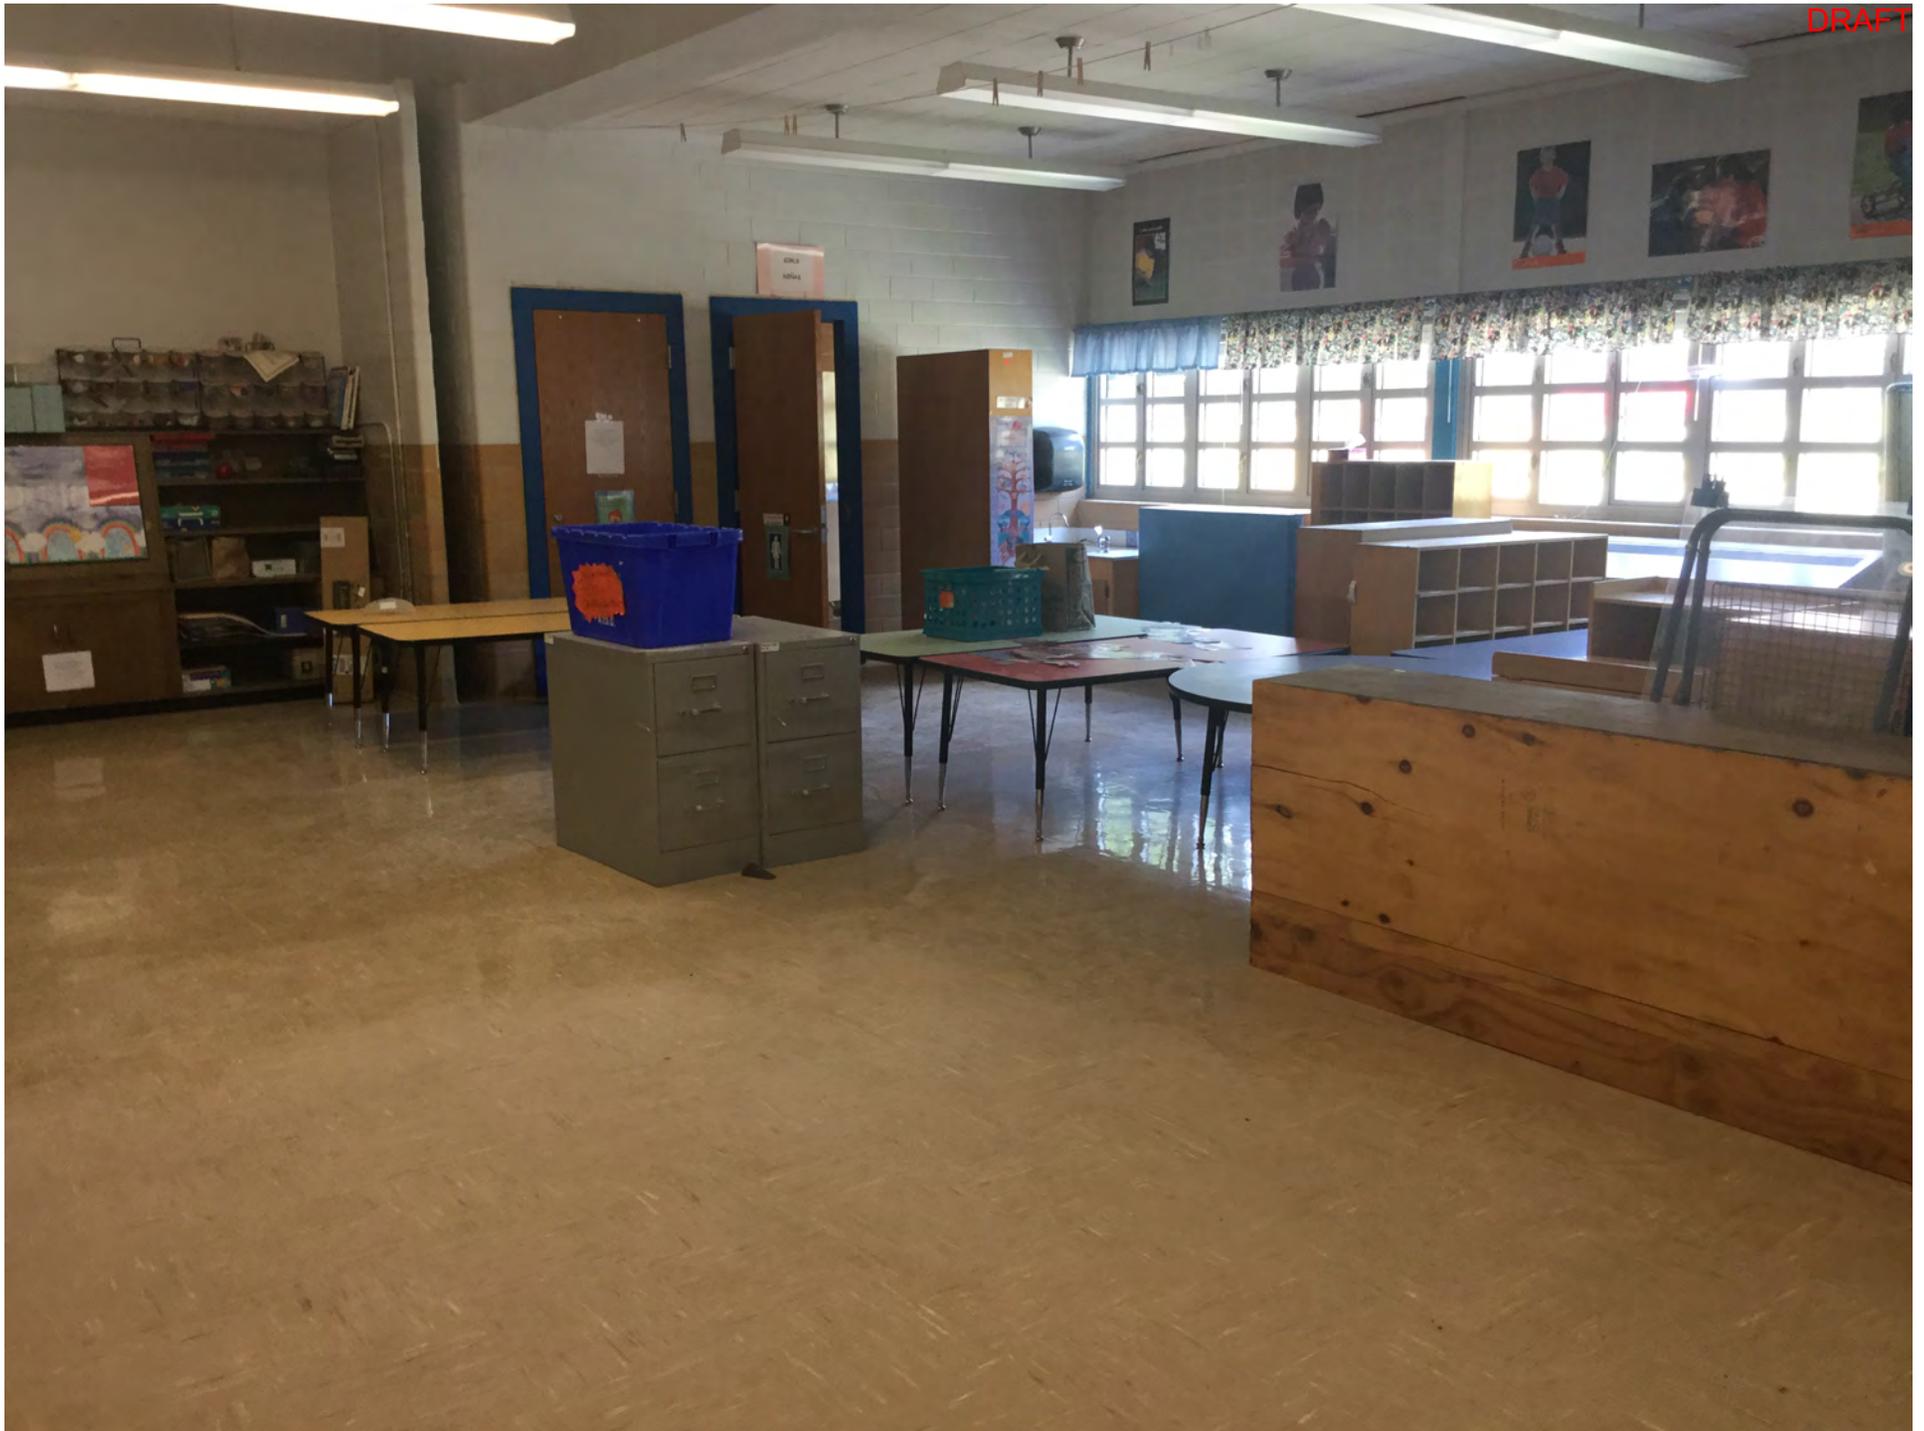
Photo 4.
3.2 Pre K Classrooms

1) Very unsatisfactory - Too small, awkward layout, does not meet needs 2) Unsatisfactory - Too small, only one area for all teaching methods, limited flexibility 3) Neutral - Moderate size, two areas for different teaching methods, some flexibility, access to student storage/casework 4) Satisfactory - Good size, at least two zones for different teaching methods, flexibility and student storage, not new 5) Very Satisfactory - Good size, two zones for different teaching methods, flexibility and student storage/casework, adequate display area and visual teaching tools N/A) Does not apply.									
								see photo 4

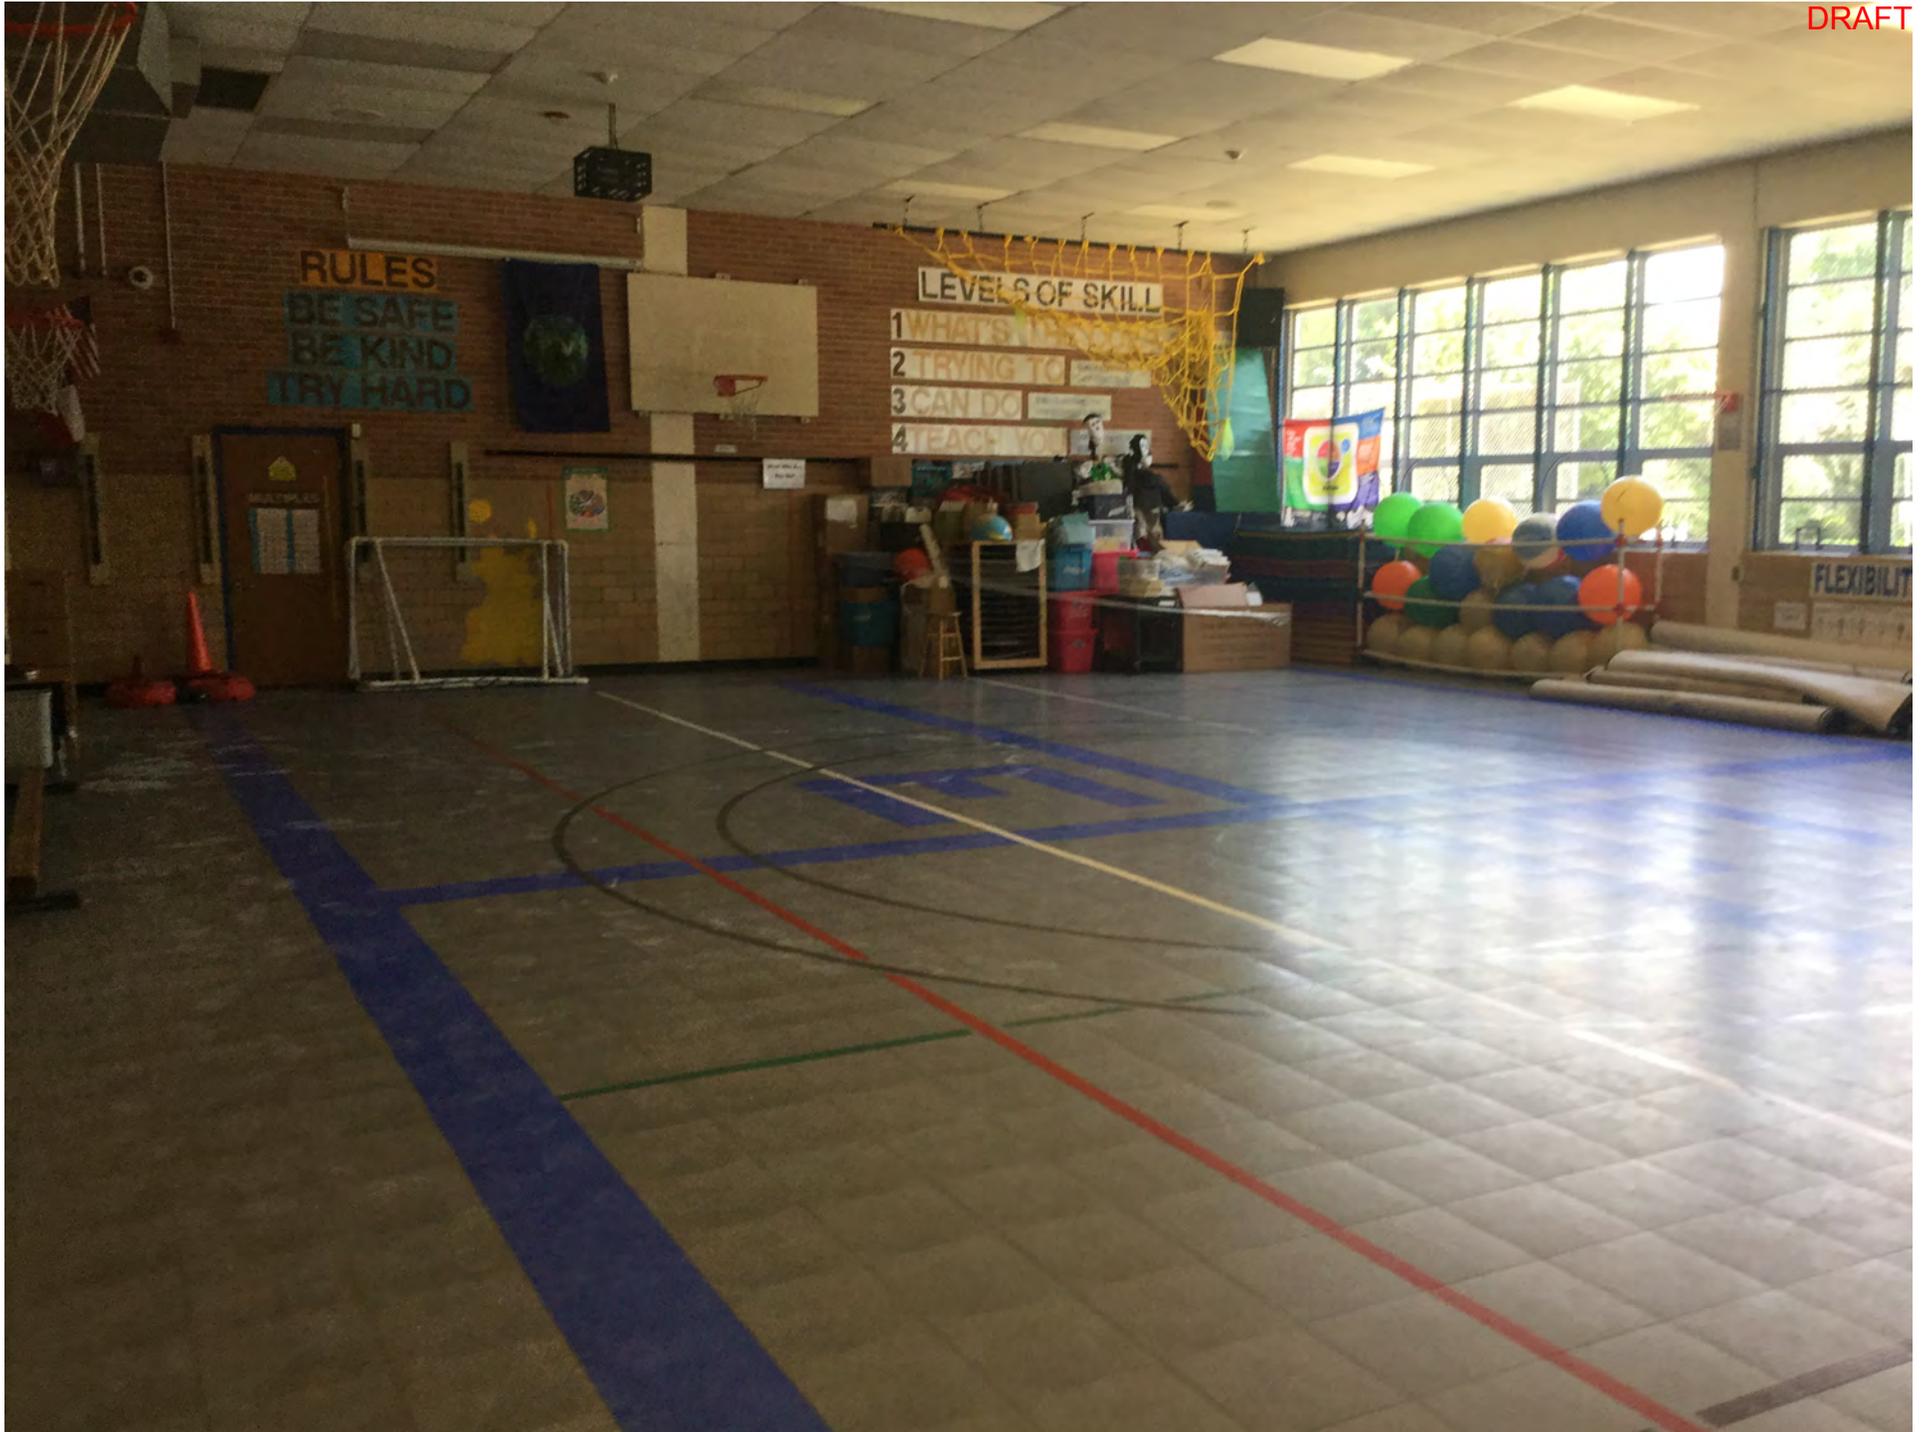
Photo 5.
3.6 Gym

3 - Academic & Co-Curricular Support - Continued		1	2	3	4	5	N/A		
3.6	Are Physical Education and Athletic spaces appropriately configured per the ed spec?					5			
<p>1) Very unsatisfactory</p> <p>2) Unsatisfactory</p> <p>3) Average</p> <p>4) Good</p> <p>5) Very good</p> <p>N/A) Does not apply.</p>								Comments	1.00 5.00
								The gym is very spacious with plenty of equipment and has an abundance of windows for natural light.	
see photo 5

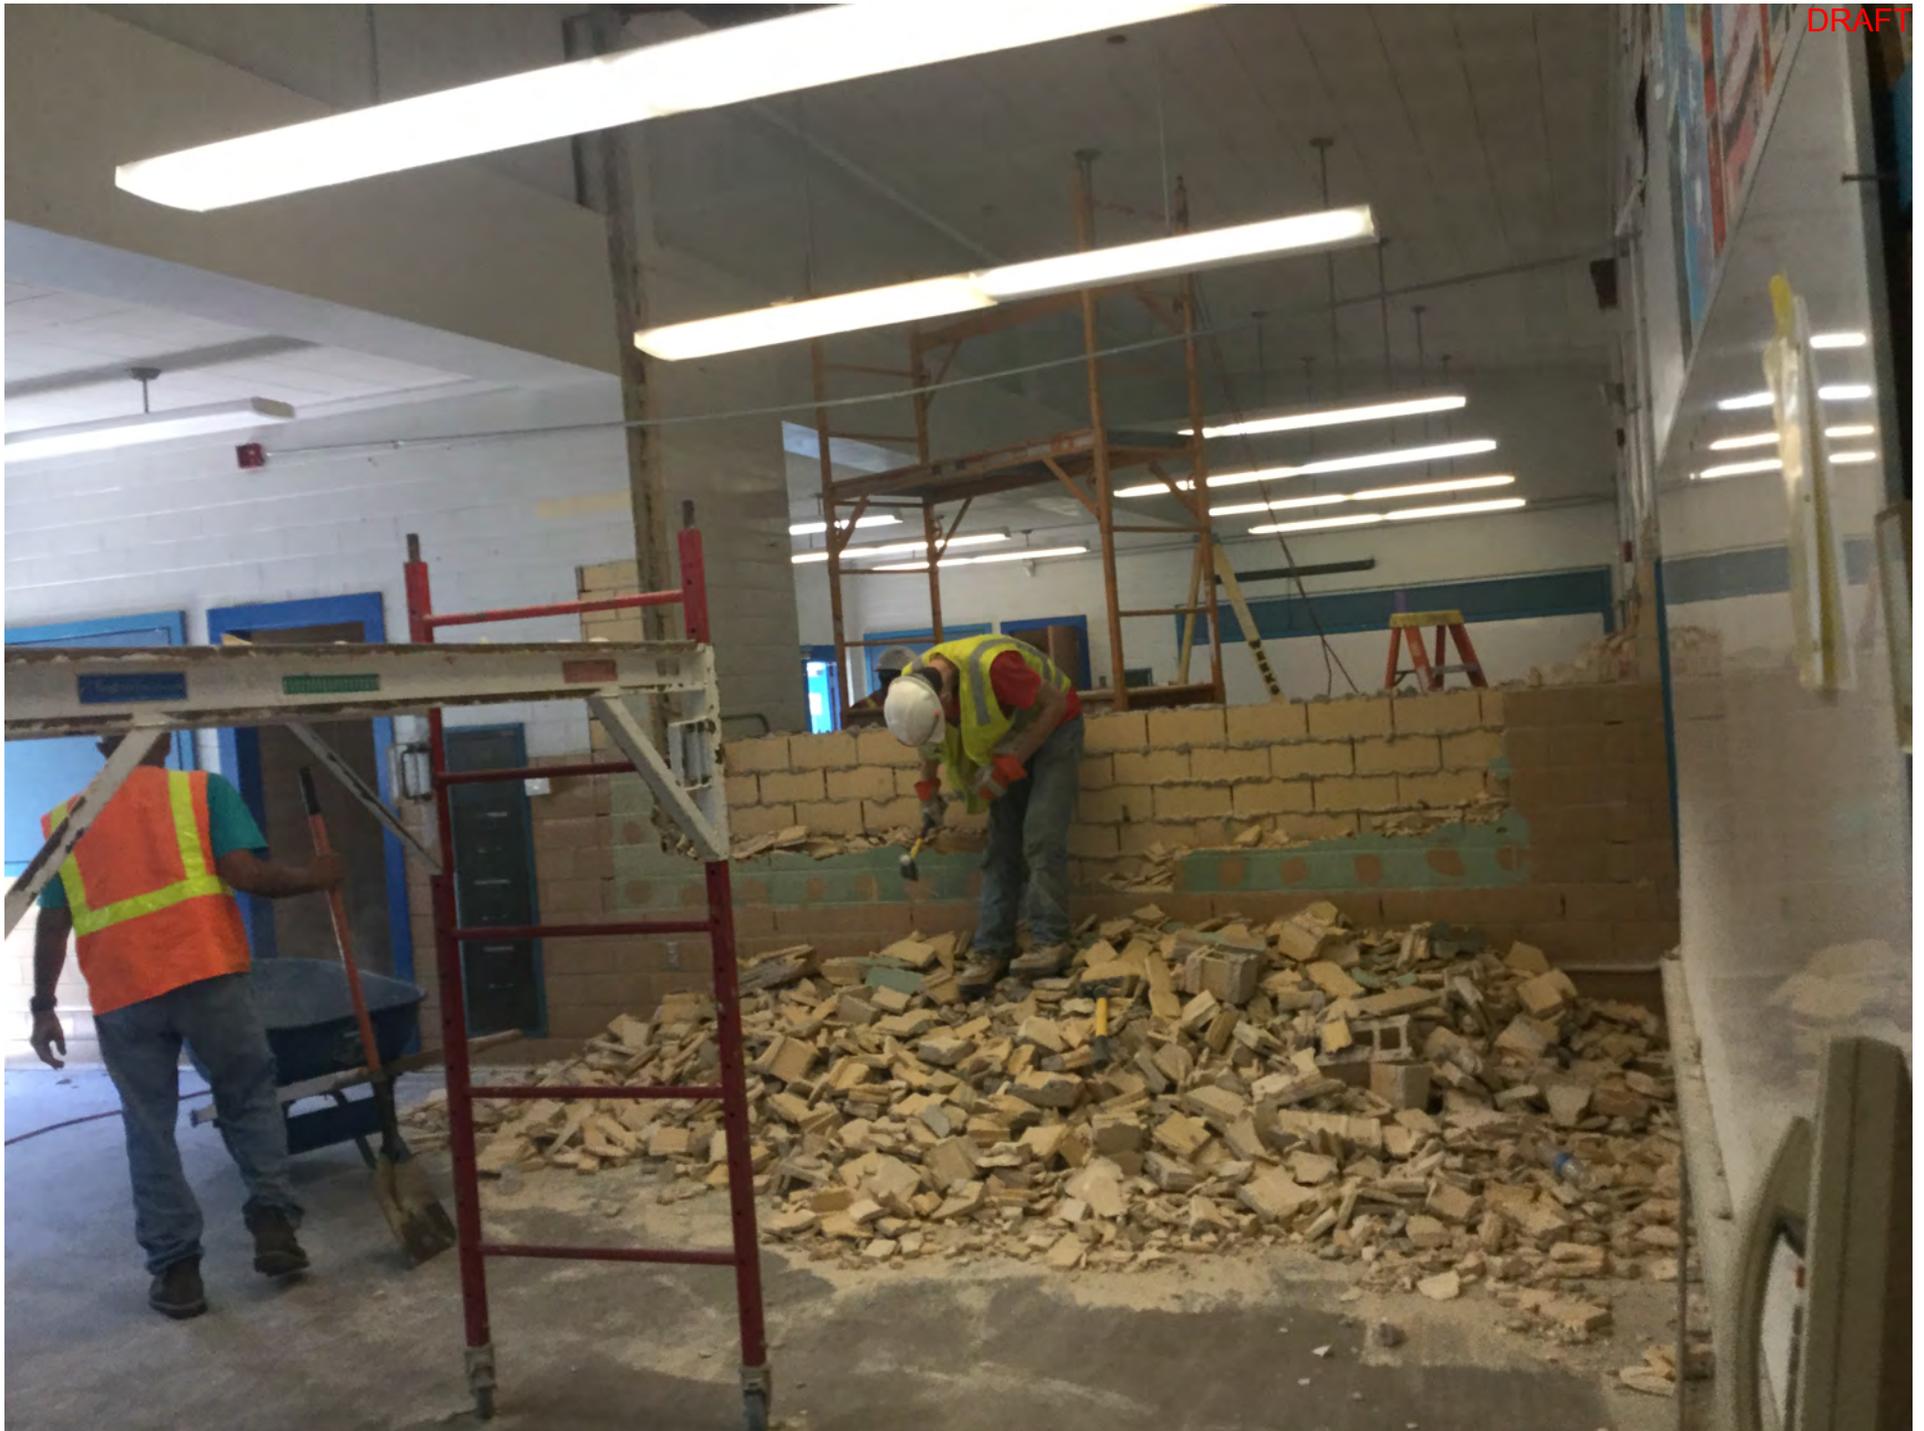
Photo 6.
3.10 Art Room

1) Very unsatisfactory 2) Unsatisfactory 3) Average 4) Good 5) Very good N/A) Does not apply.								The art room is currently under renovation to be expanded. The principal seems excited about the new plans.	see photo 6

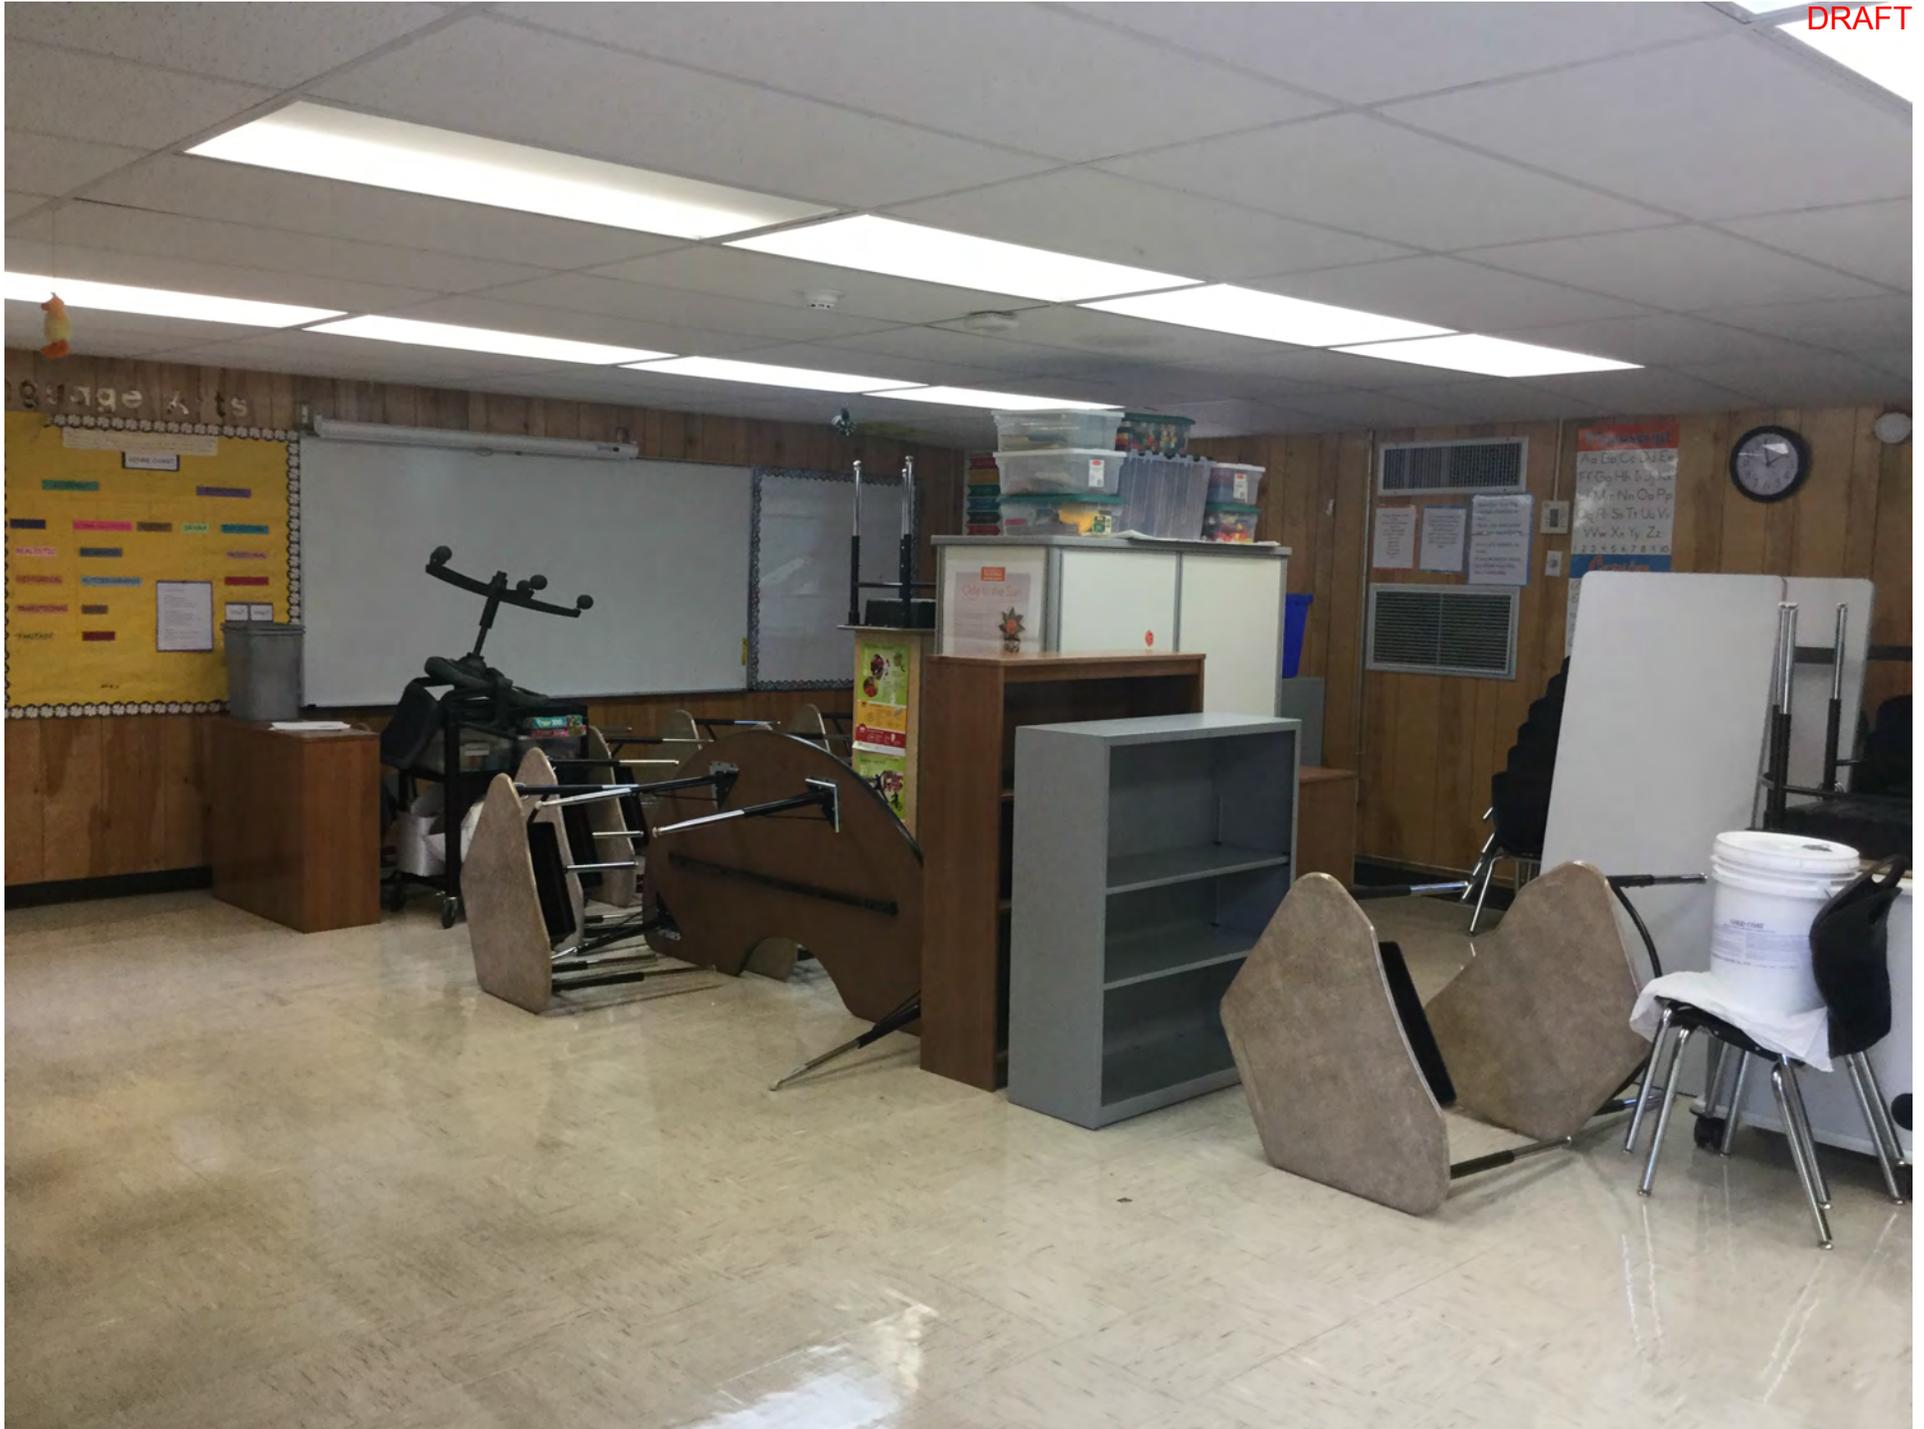
Photo 7.
3.12 Computer Lab

3.12	Are computer lab spaces appropriately configured?		2					Comments	1.00 2.00
1) Very unsatisfactory 2) Unsatisfactory 3) Average 4) Good 5) Very good N/A) Does not apply.								The computer Lab is in a portable and lacks security.	see photo 7

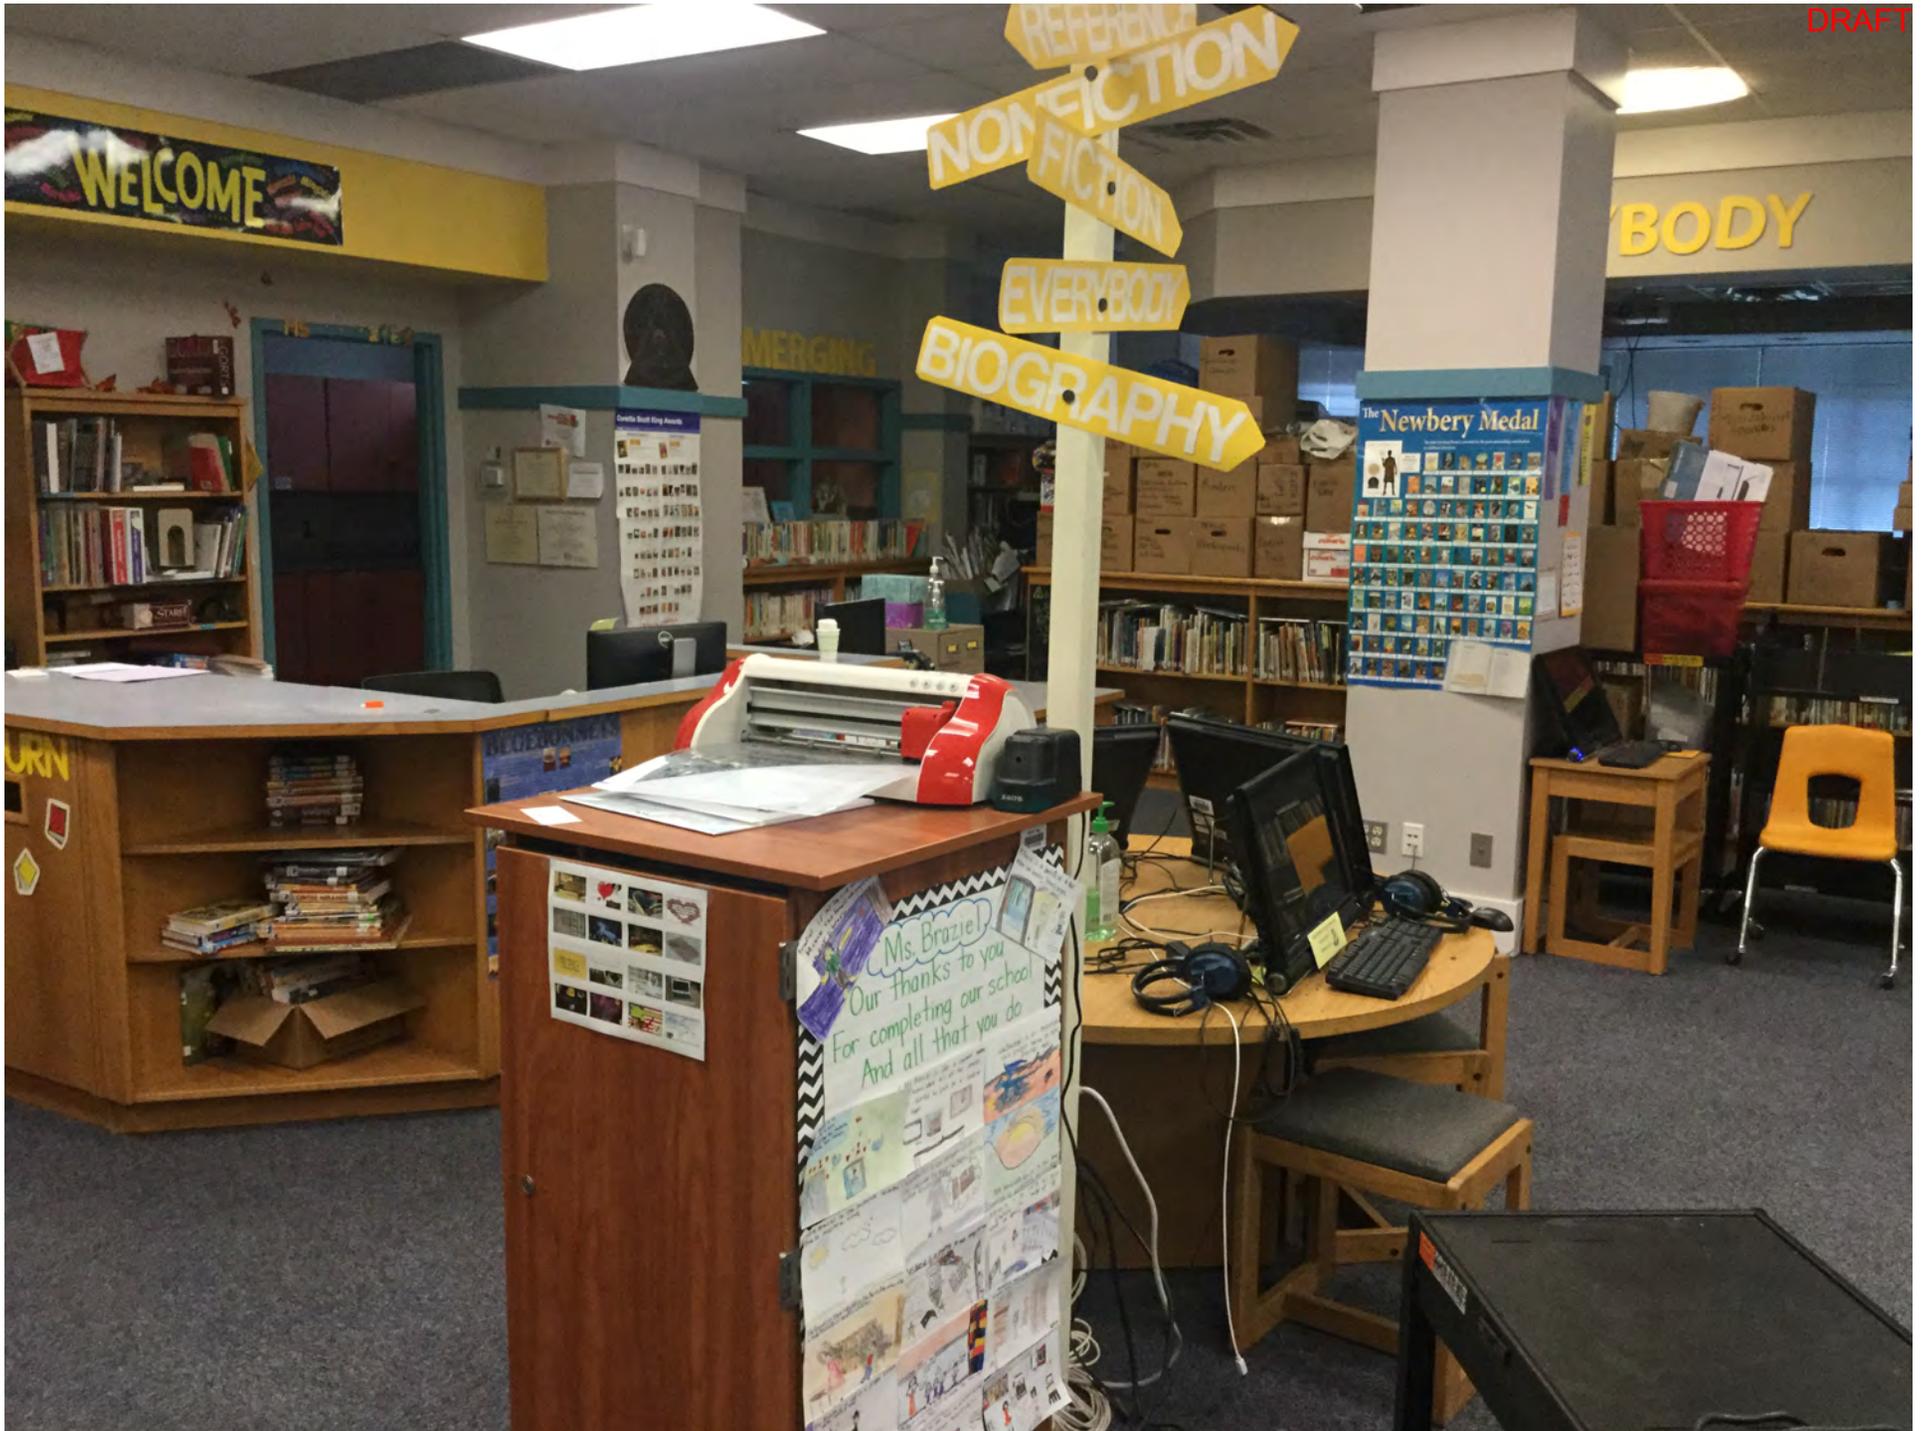
Photo 8.
5.2 Library

5.2	How well does the Library/Media Center support quiet study?			3				Comments	1.00	3.00
1) Very unsatisfactory 2) Unsatisfactory 3) Average 4) Good 5) Very good N/A) Does not apply.		No real specialized spaces for independent learning or reading.								
		see photo 8
