Educational Suitability Summary Report

Maplewood Elementary School – BLDG. 122

Date: 06/21/2016

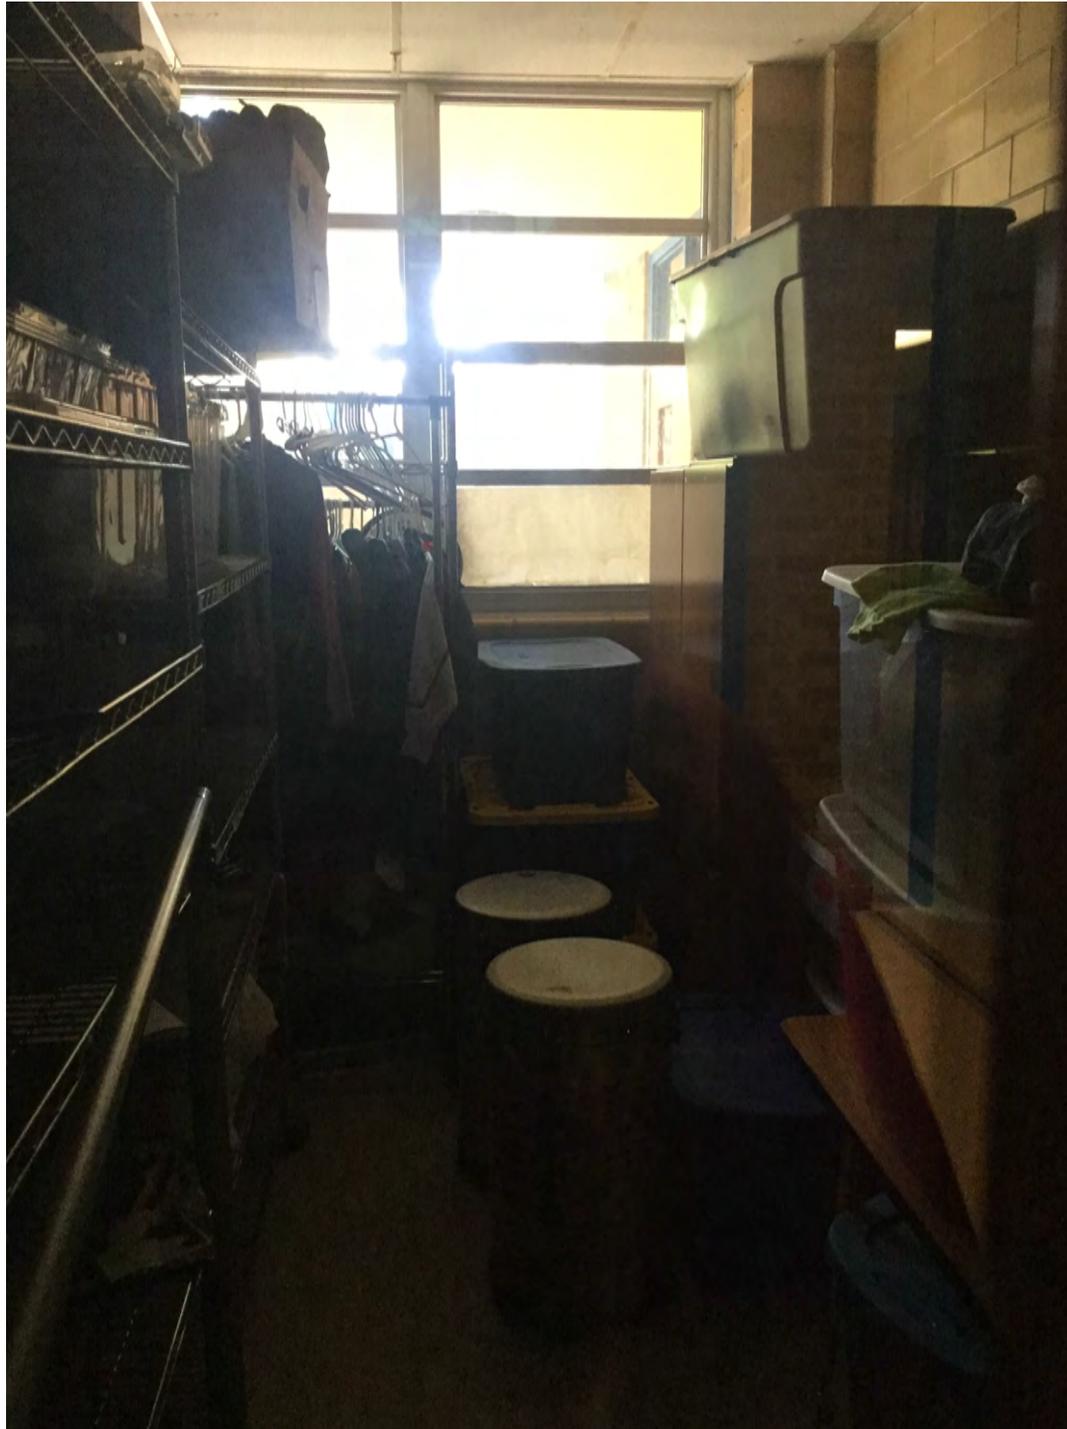
Photo 9.
Storage

General building storage is very inadequate. There is no book room and classroom storage spaces are equipped with dated built-in cabinets.

8 - Storage		1	2	3	4	5	N/A			6.00
8.1	Is there adequate general storage in the building?		2					Comments	1.00	2.00
1) Very unsatisfactory 2) Unsatisfactory 3) Average 4) Good 5) Very good N/A) Does not apply.								There is a evere lack of general storage throughout the building. Electrical rooms have also become converted to storage.		see photo 9
8.2	Is there adequate classroom storage?		2					Comments	1.00	2.00
1) Very unsatisfactory 2) Unsatisfactory 3) Average 4) Good 5) Very good N/A) Does not apply.								The teachers have complained about lack of classroom storage furniture.		
8.3	Is there adequate student storage?		2					Comments	1.00	2.00
1) Very unsatisfactory 2) Unsatisfactory 3) Average 4) Good 5) Very good N/A) Does not apply.								There is no student storage but there is space for it.
