Educational Suitability Summary Report

Mathews Elementary School

Date: 07/27/2016 – (Rev. 1 – 12/19/16 – Survey, CAC & FABPAC comments) **Score 57% Average**

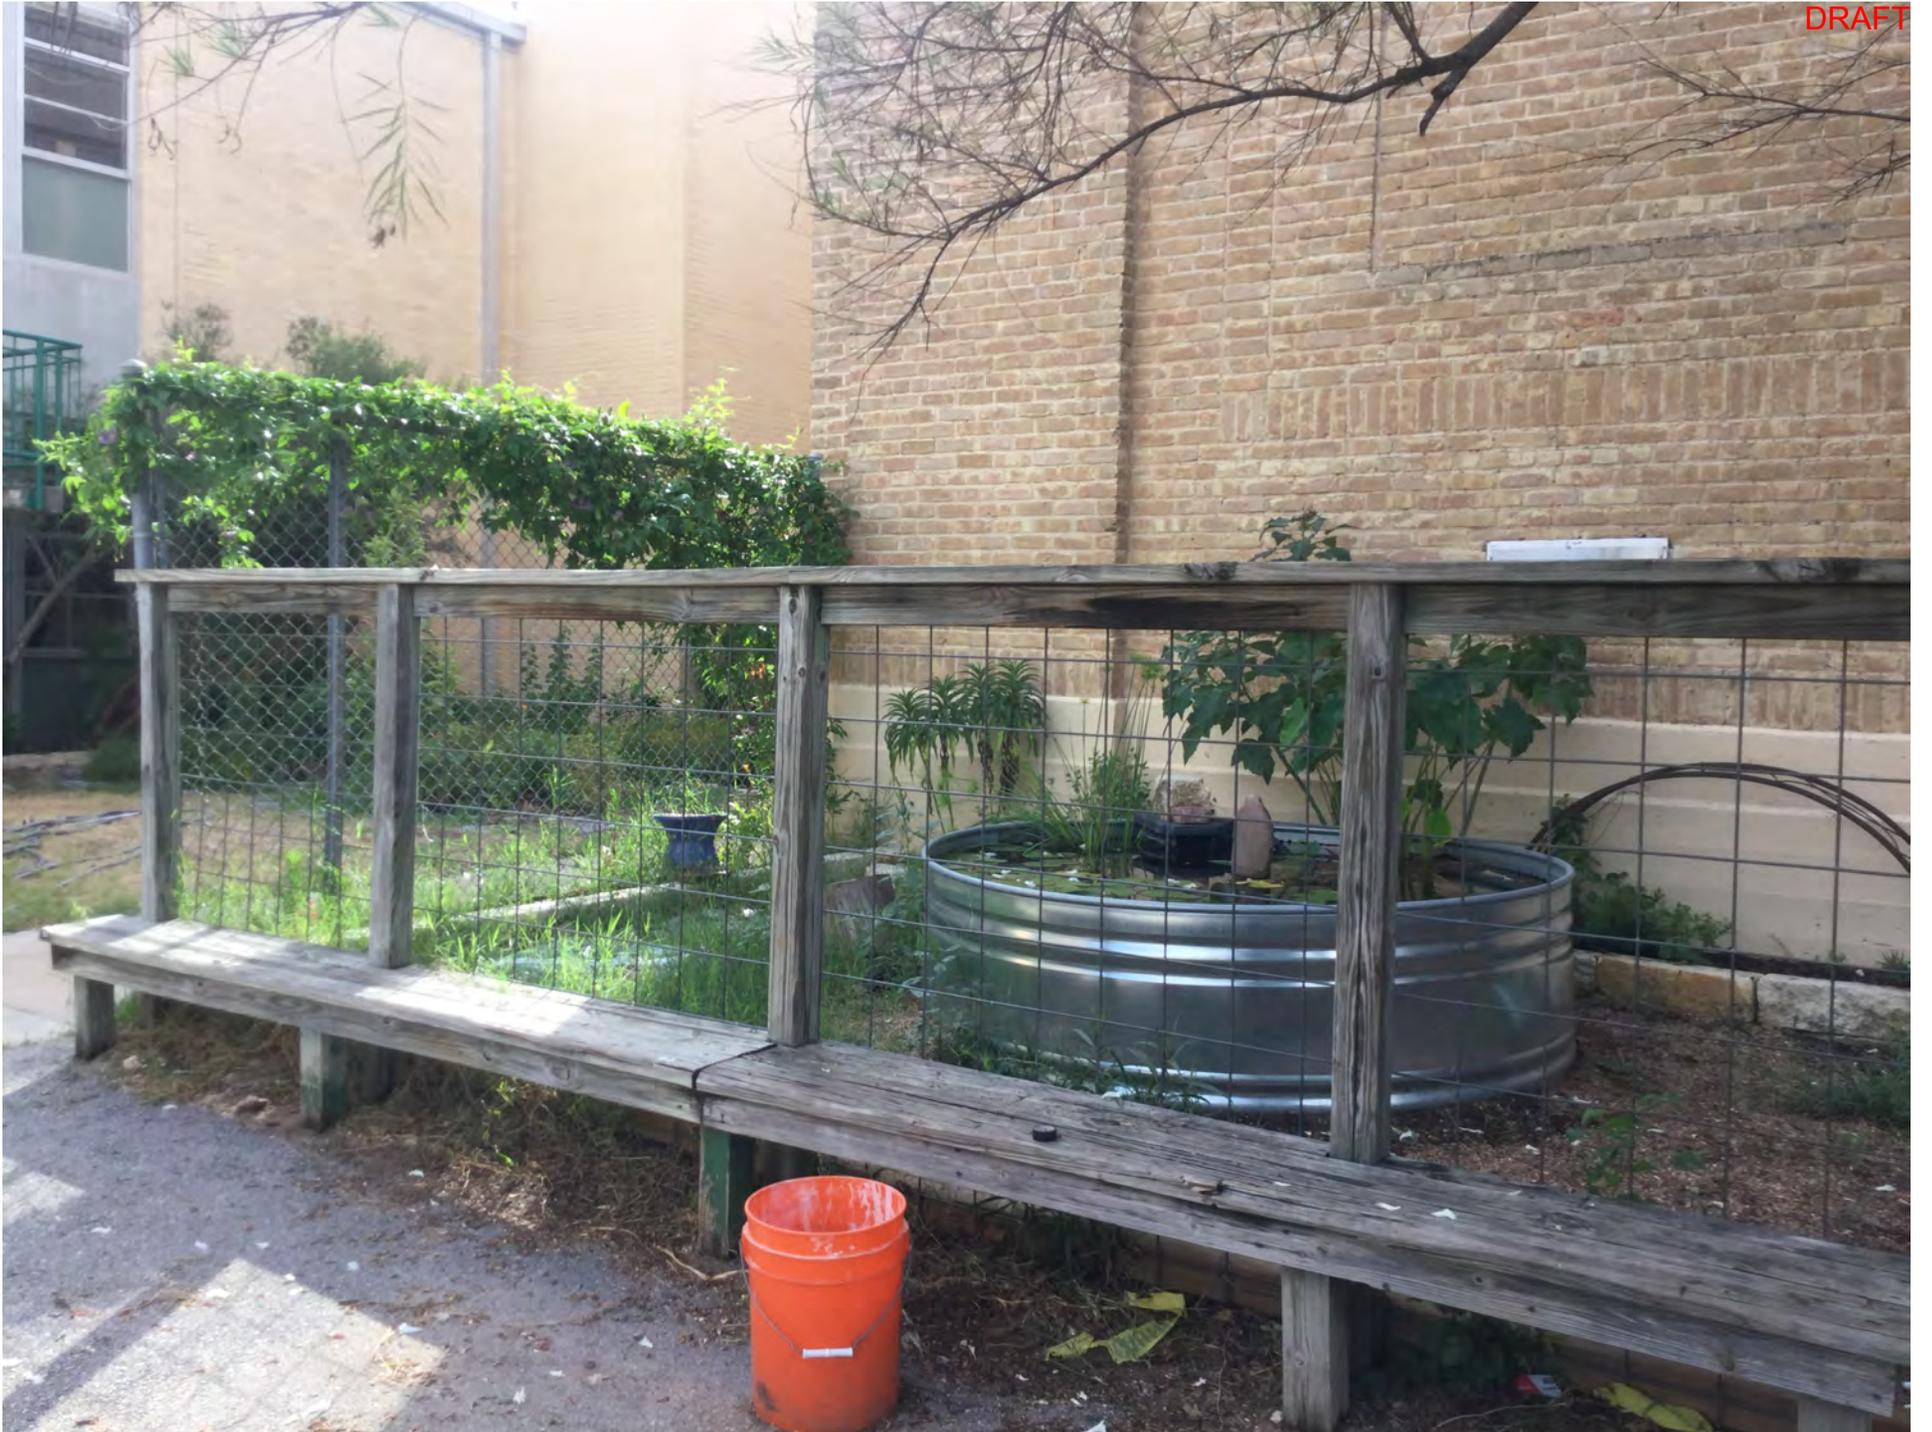
Photo 1.
1.2 Outdoor Learning

1.2	Are opportunities provided for outdoor learning (outdoor classrooms, gardens, etc.)?		2					Comments	1.00	2.00
1) Outdoor space exists is not developed 2)Outdoor space for learning exists but not connected to classroom learning areas. 3. Outdoor learning spaces exist and are accessible but not in good condition. 4. Outdoor learning spaces need minor improvements to function well. 5. Outdoor learning spaces are in excellent condition. N/A) Does not apply.										
		see photo 1

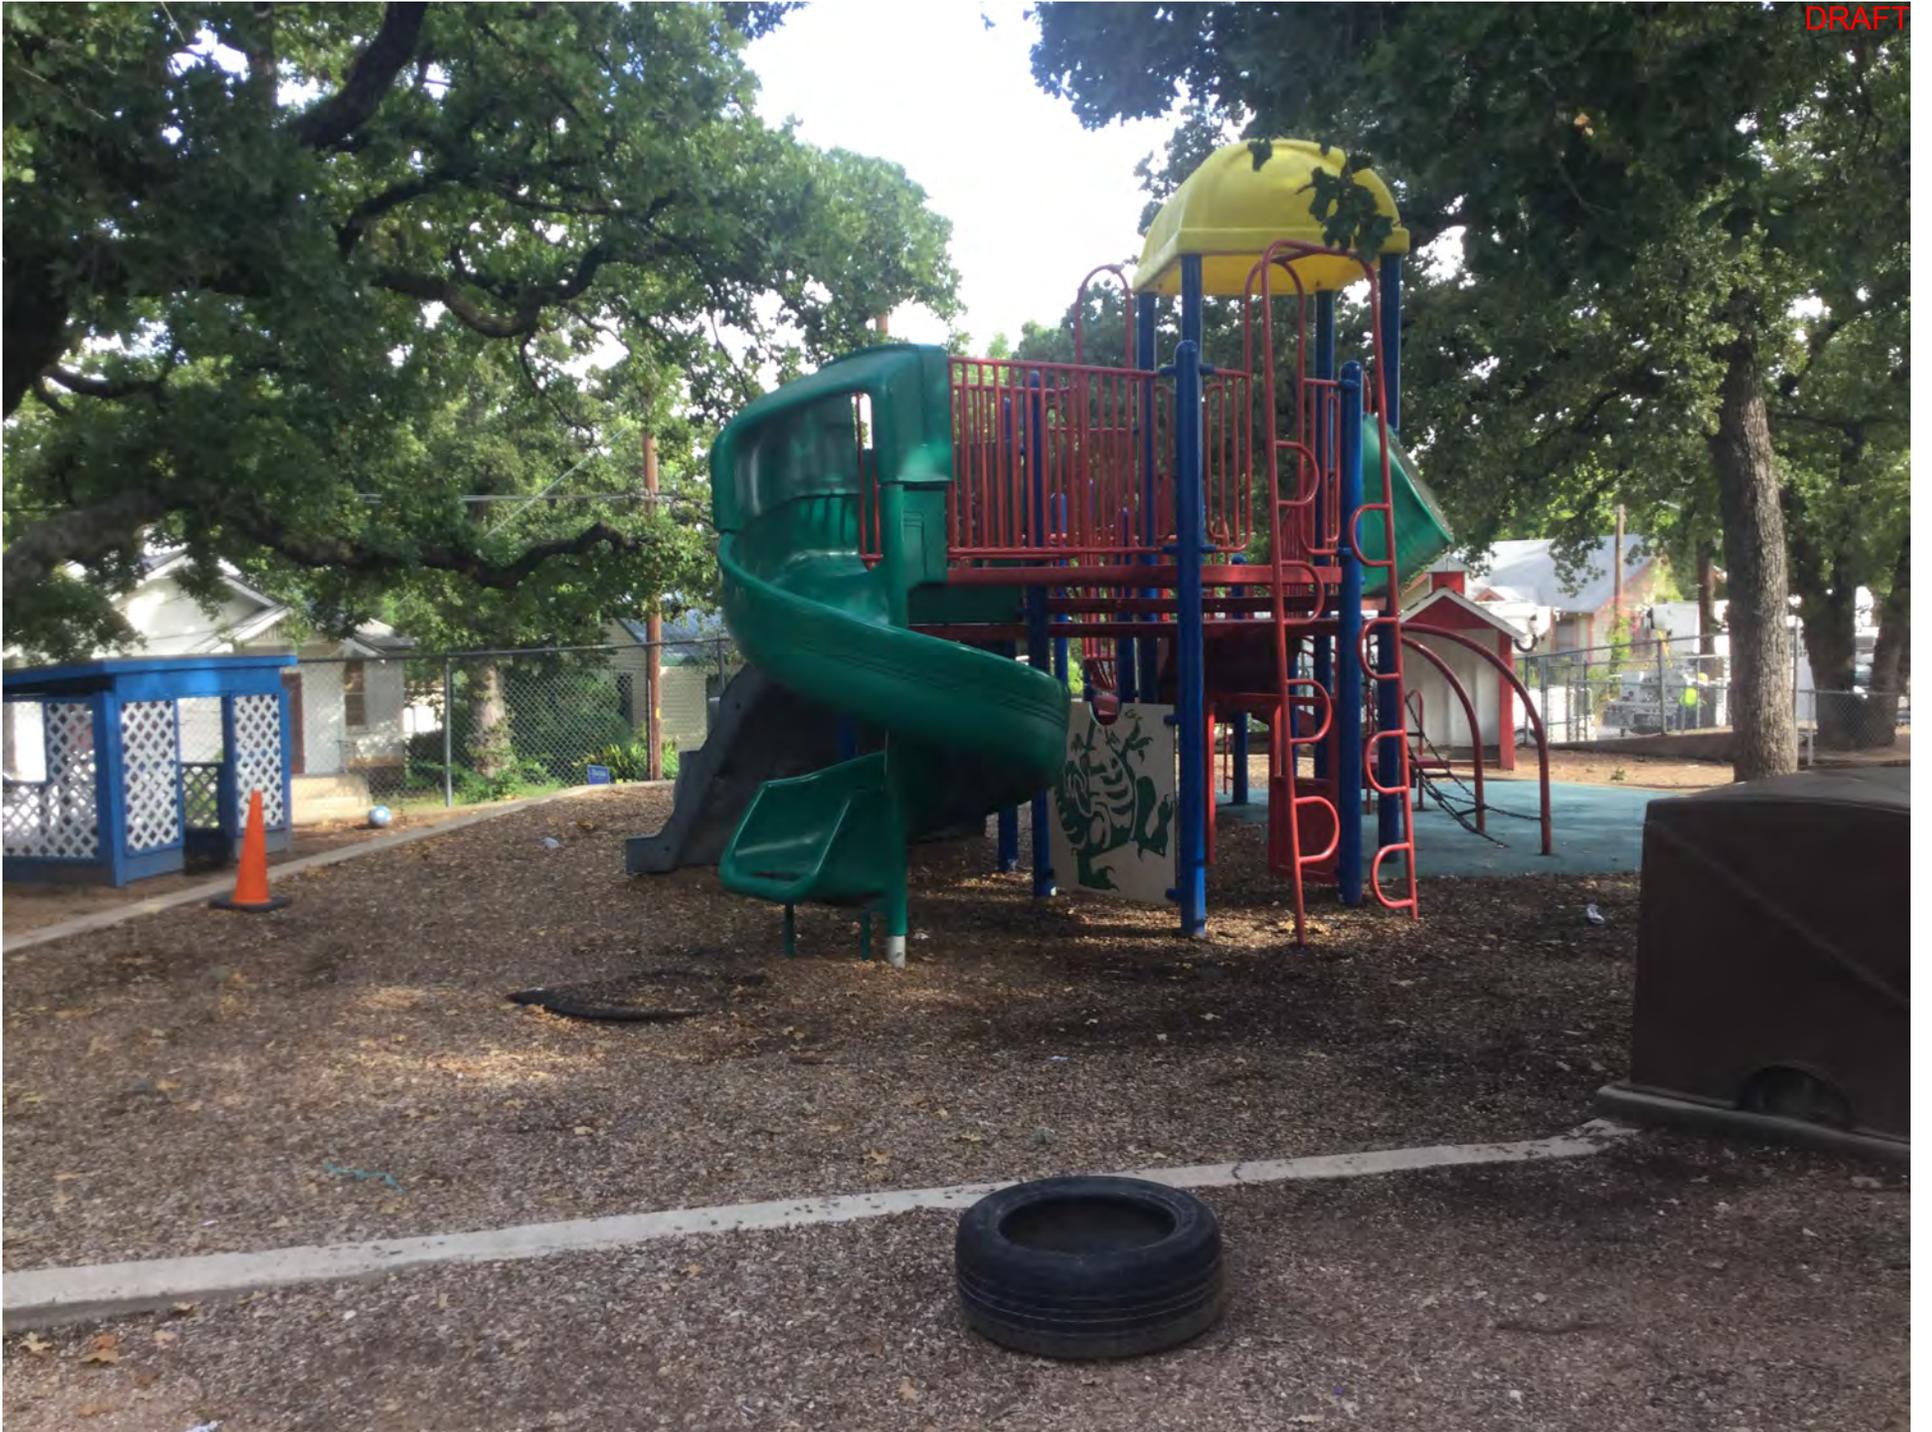
Photo 2.
1.3 Playground

1.3	Are outdoor play spaces and playfields adequate in size and configuration?		2					Comments	1.00	2.00
1) Outdoor play space exists, not developed 2)Outdoor play space exists but is not connected to gym or other athletic support areas or is too small. 3. Outdoor play spaces exist, are connected to other athletic areas, are the right size, but are not in good condition. 4. Outdoor play spaces need minor improvements to function well. 5. Outdoor play spaces are in excellent condition. N/A) Does not apply.		There is very limited green space.								
		see photo 2

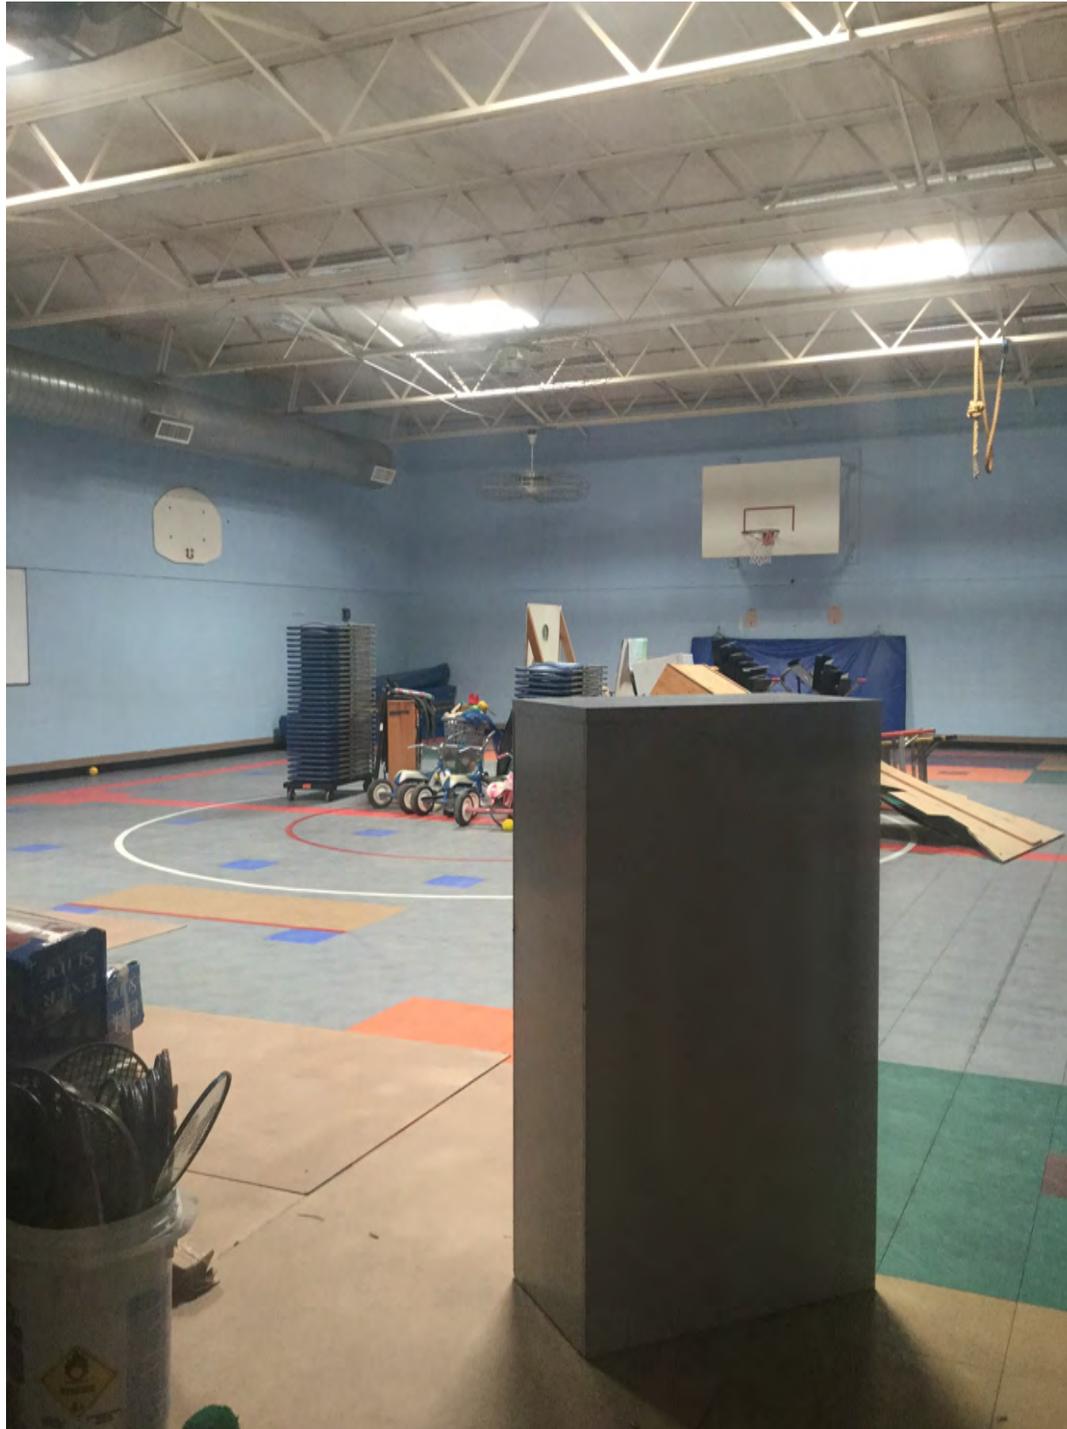
Photo 3.
3.6 Gym

1) Very unsatisfactory 2) Unsatisfactory 3) Average 4) Good 5) Very good N/A) Does not apply.								The equipment is very outdated. Some of the basketball rims are completely missing.		
								see photo 3

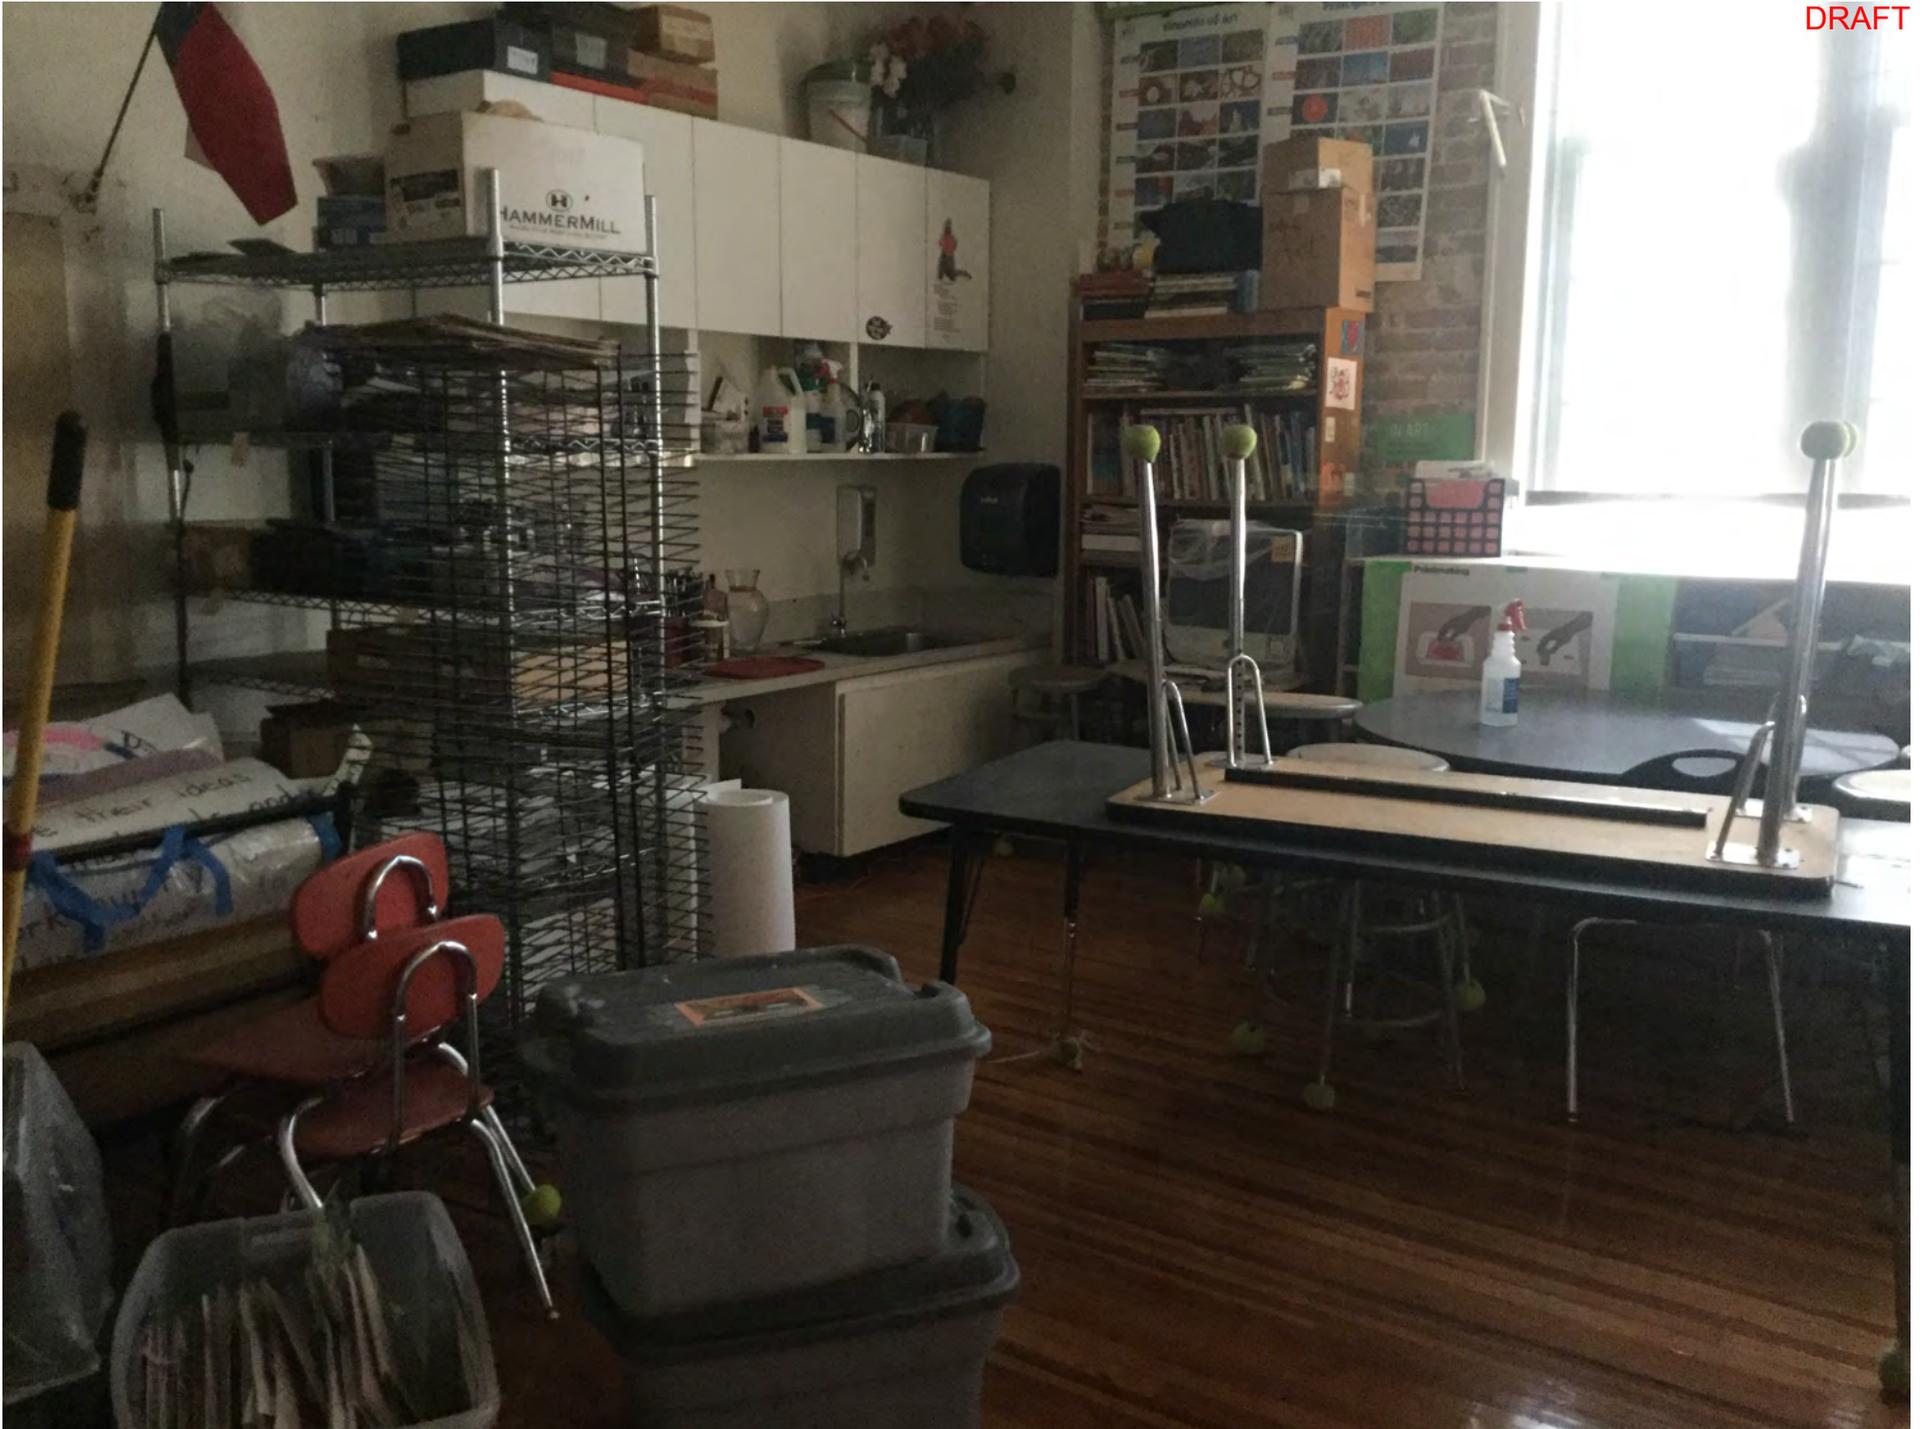
Photo 4.
3.10 Art Room

1) Very unsatisfactory 2) Unsatisfactory 3) Average 4) Good 5) Very good N/A) Does not apply.								There are missing sinks in the art room.	see photo 4

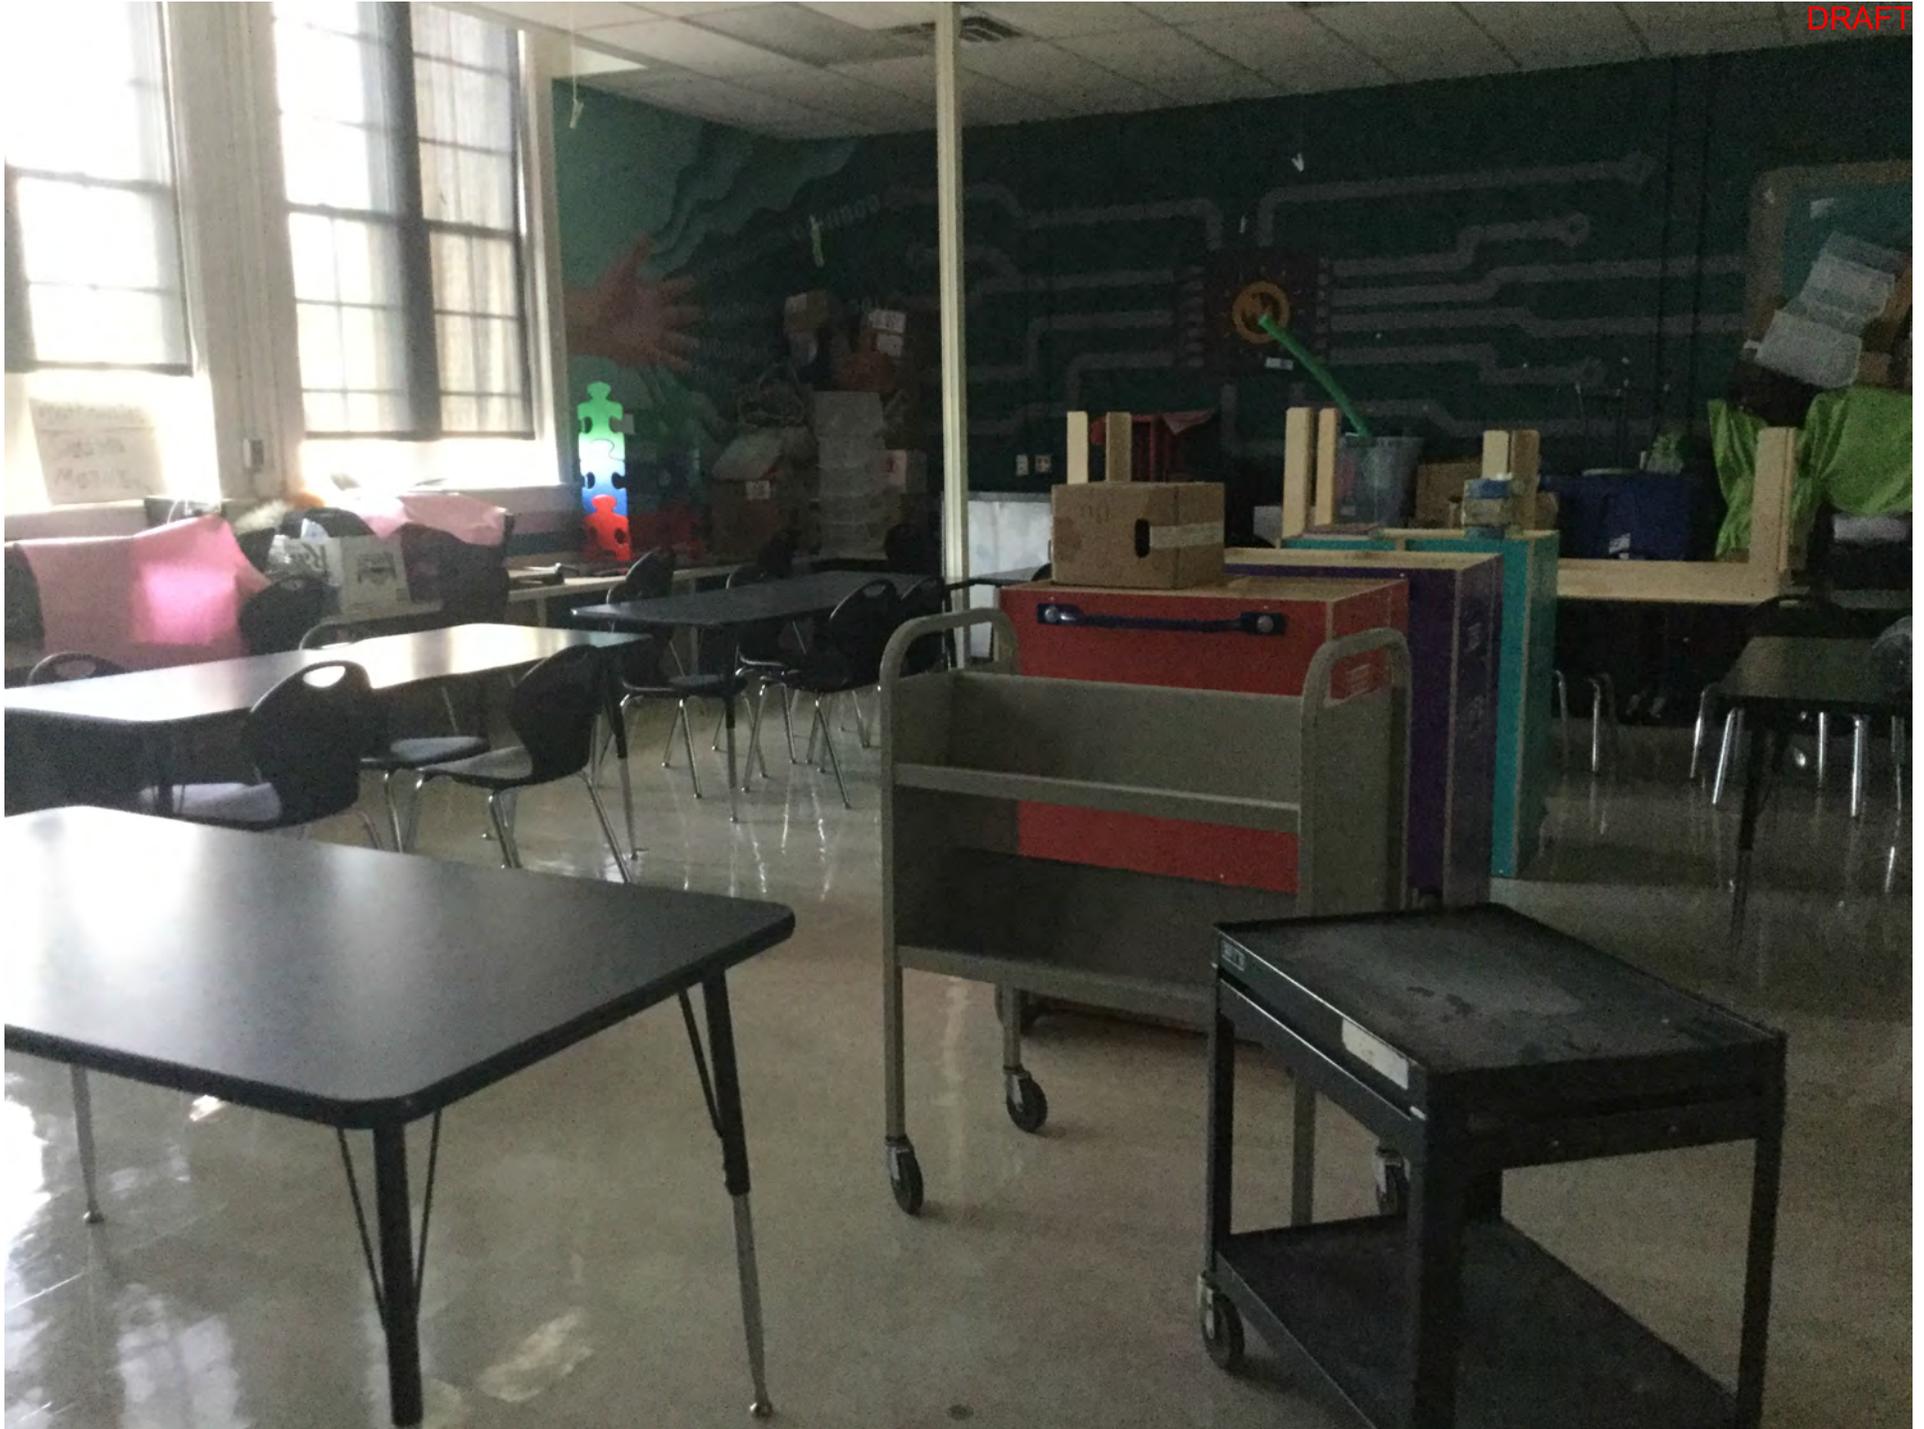
Photo 5.
3.13 Computer Lab and Makerspace

3.12	Are computer lab spaces appropriately configured?			3				Comments	1.00 3.00
1) Very unsatisfactory 2) Unsatisfactory 3) Average 4) Good 5) Very good N/A) Does not apply.								The computer lab is functioning as a makerspace.

3.13	Are computer lab support spaces appropriately configured?			3				Comments	1.00 3.00
1) Very unsatisfactory - Support spaces are disconnected from served spaces, too small, do not meet needs 2) Unsatisfactory - Support spaces are connected, but too small, inadequate for needs 3) Average - Connected, moderate size, but need some renovations or updates to function well 4) Good - Connected, good size/layout, meets needs/functions well 5) Very good - connected, generous size, nice condition, functions appropriately N/A) Does not apply.									see photo 5

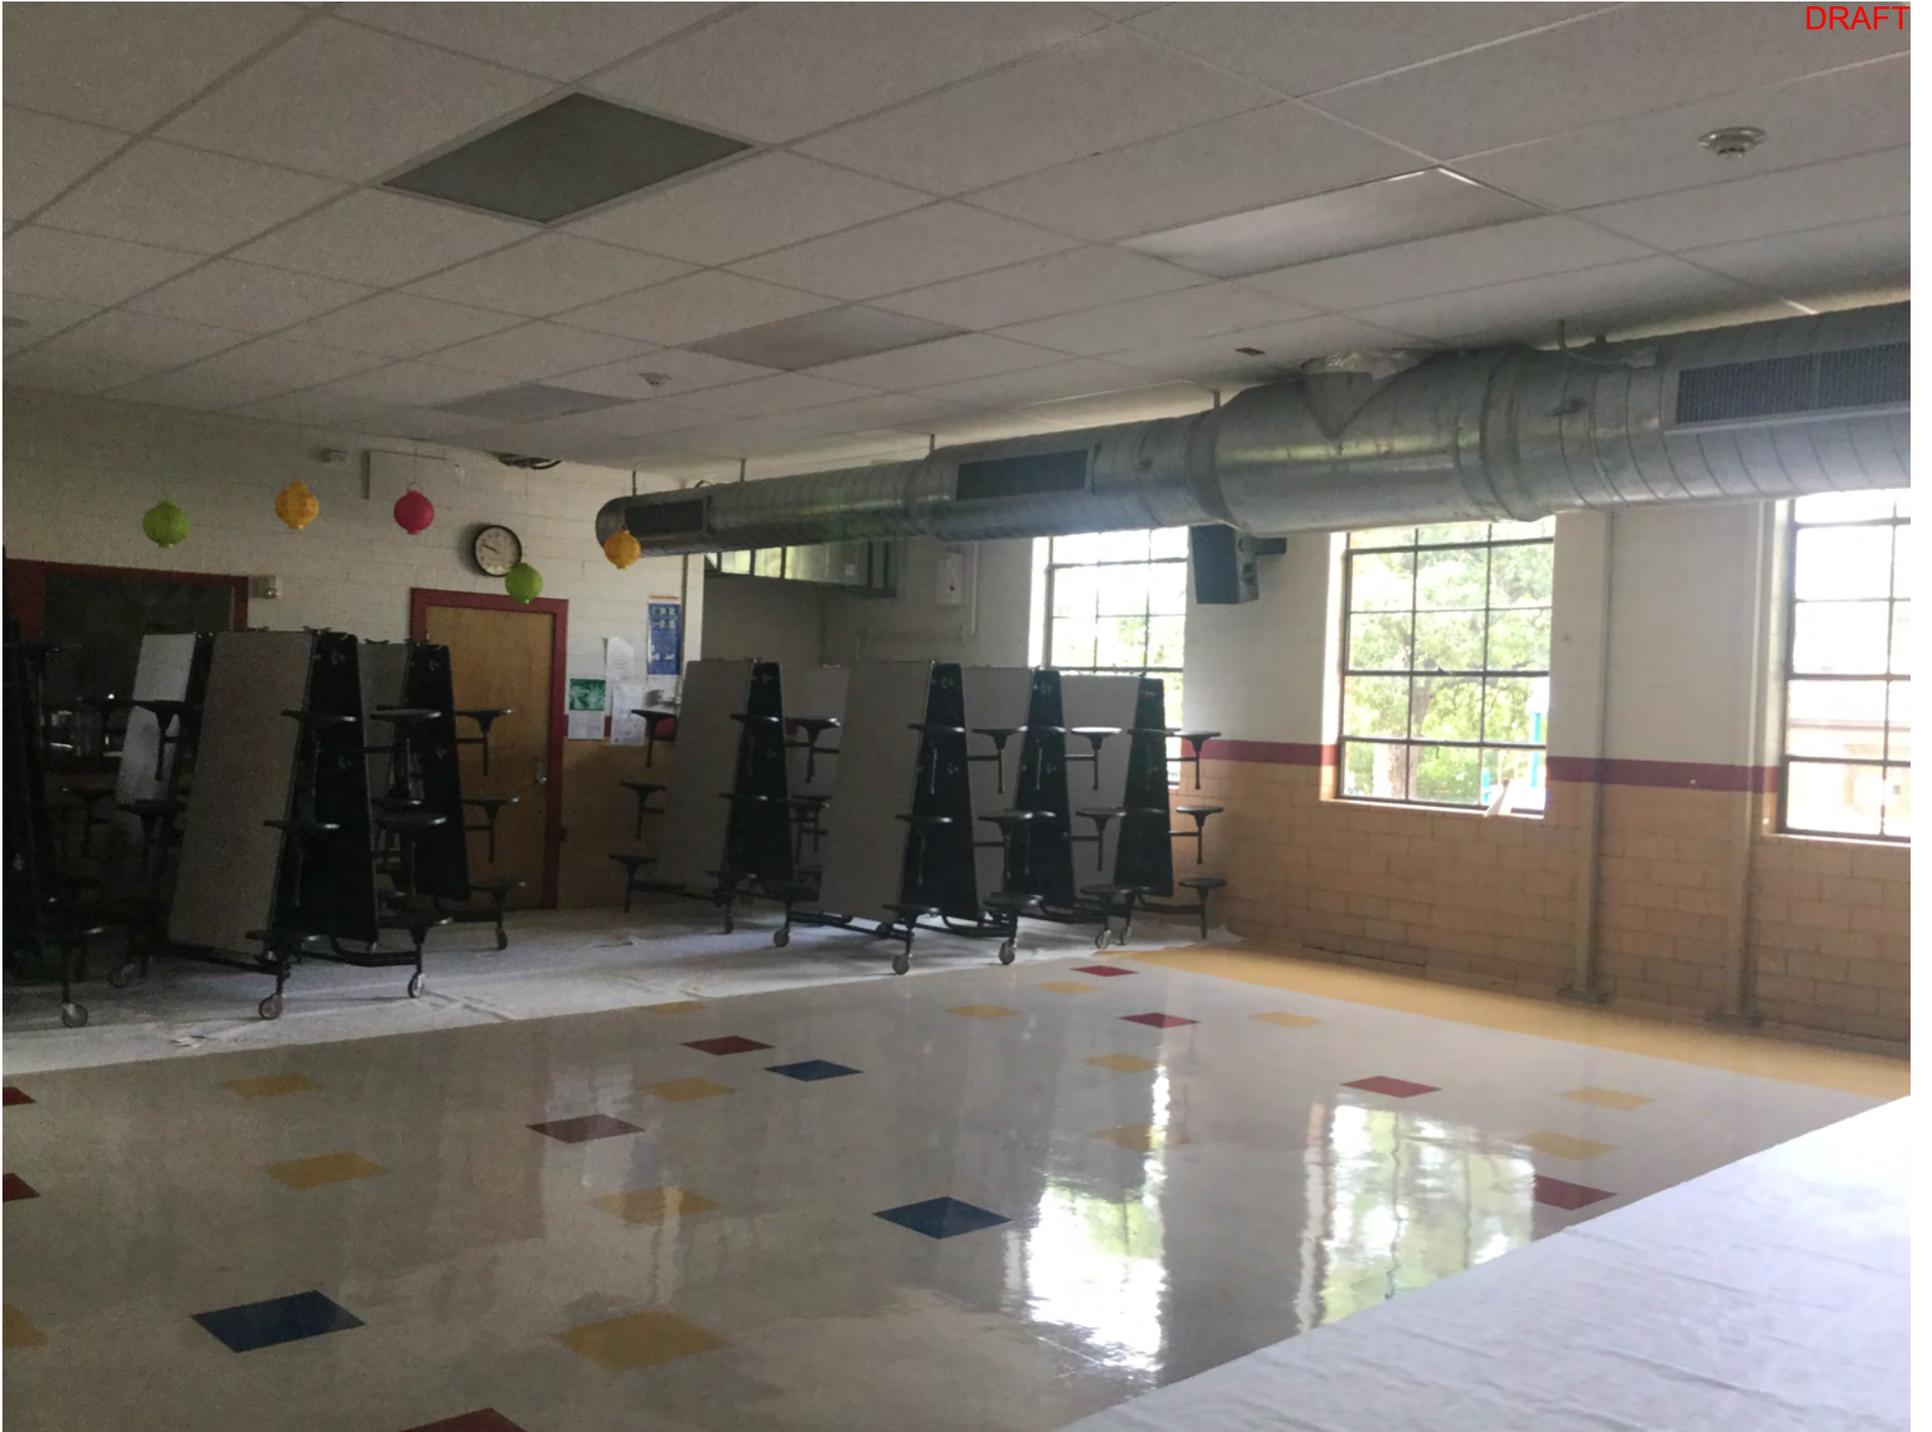
Photo 6.
3.16 Cafetorium

3.16	Are the student dining facilities appropriately configured?		2										Comments	1.00	2.00
1) Very unsatisfactory - Too small, poor circulation, inflexible seating in poor condition 2) Unsatisfactory - Too small or inadequate circulation, seating in poor condition 3) Average - moderate size, with adequate circulation, seating in okay condition 4) Good - good size, adequate circulation, seating in good condition 5) Very good - good size, adequate circulation, seating in good condition, with more than one option for eating space (ex: connection to outdoor eating space) N/A) Does not apply.													The cafeteria space is very undersized.	see photo 6

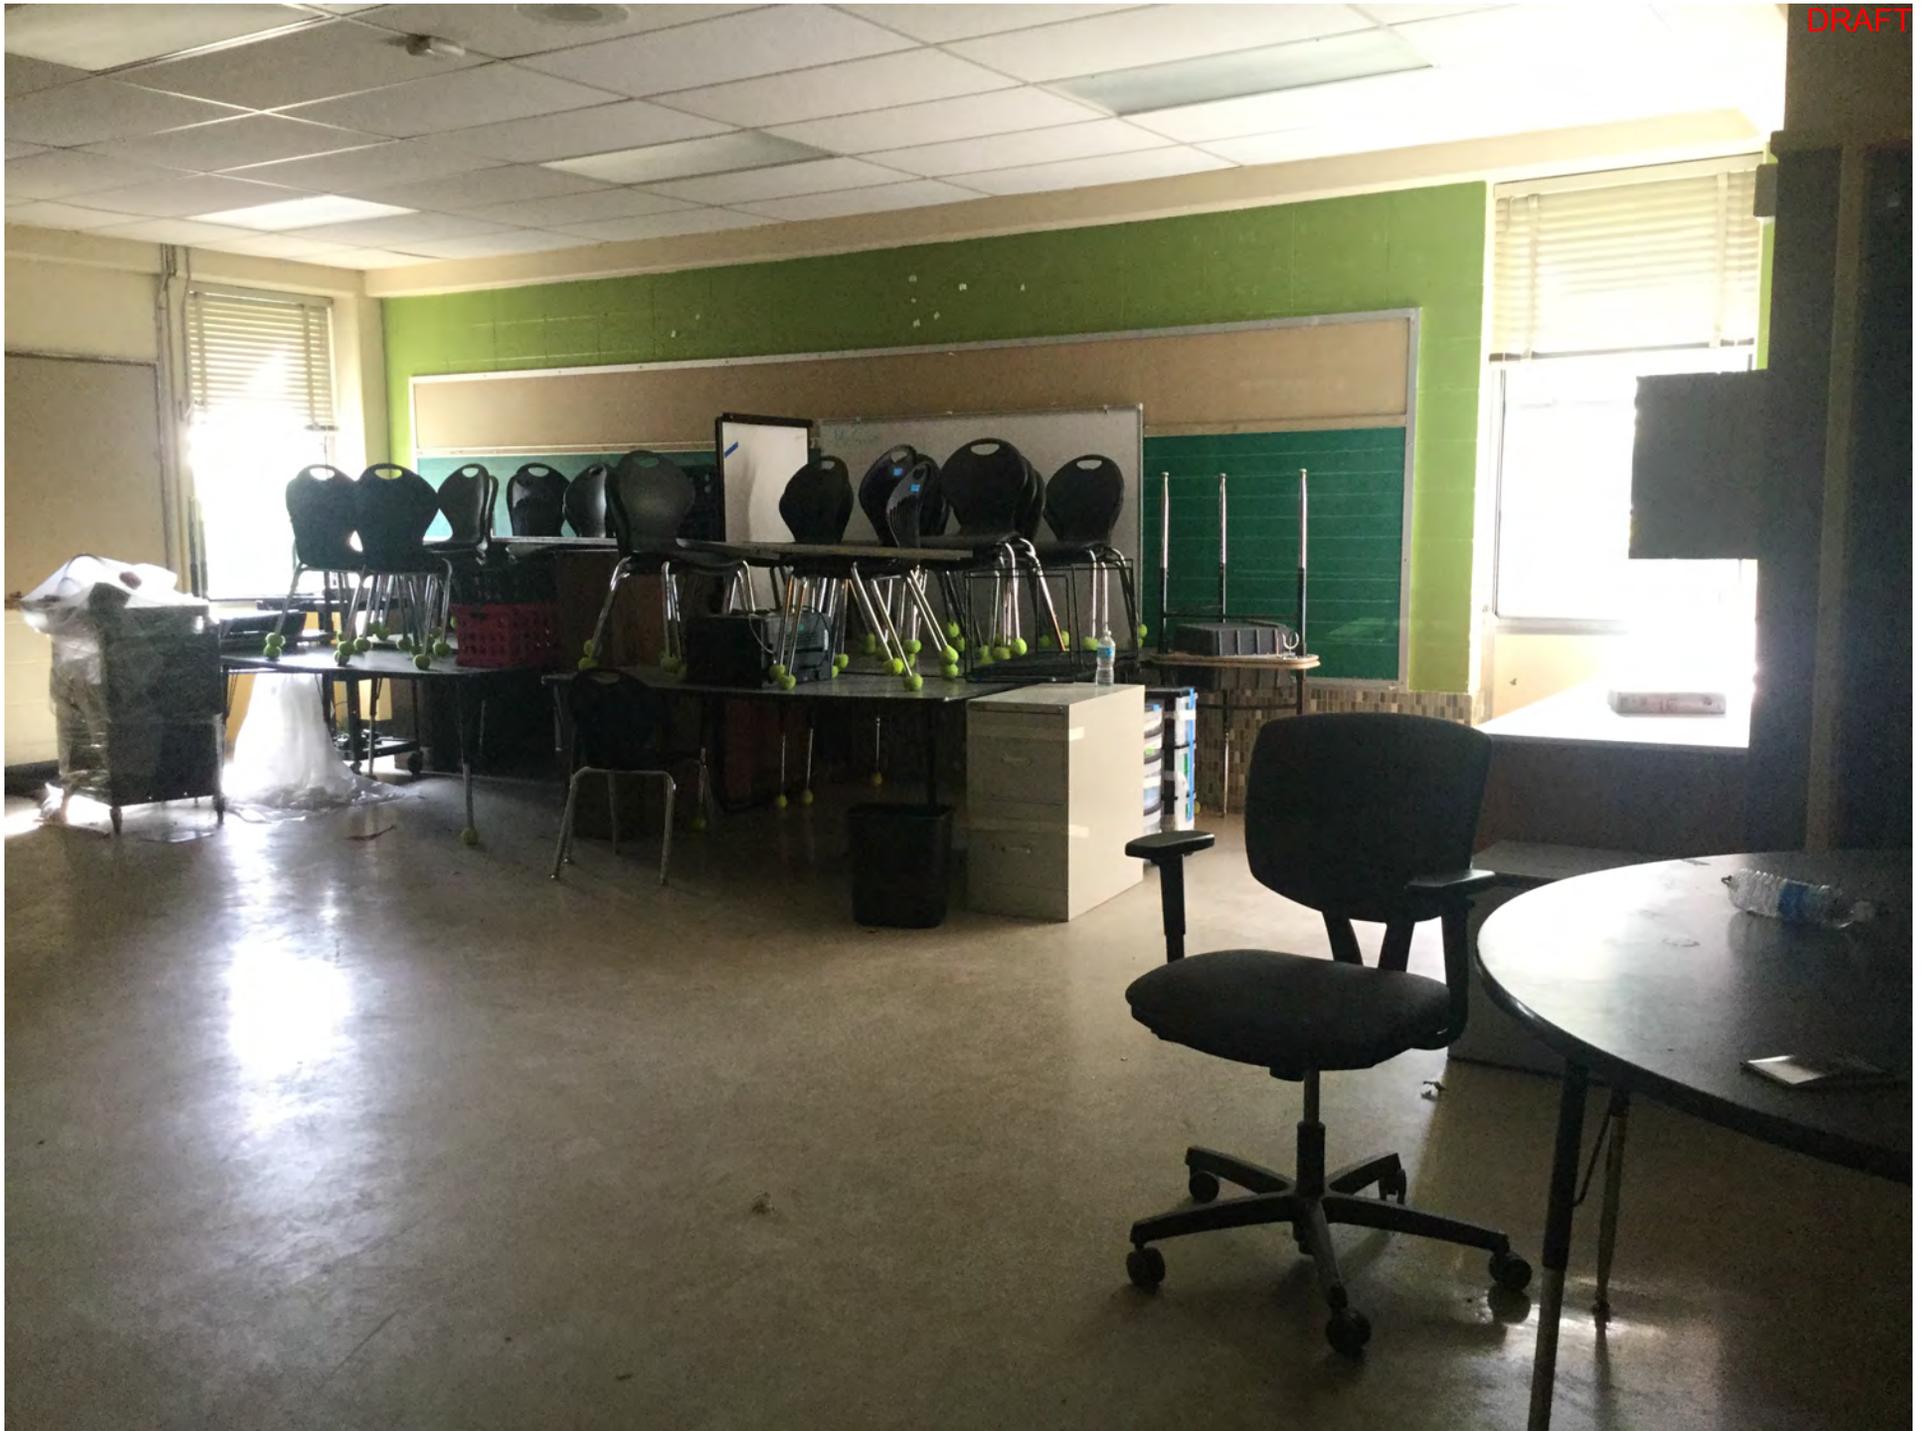
Photo 7.
4.2 Standard Classroom

4.2	Are general classrooms large enough to support project-based learning and multiple teaching modalities?				4			Comments	1.00	4.00
1) Very unsatisfactory -too small to move, set for lecture only, no connectivity, no flexibility 2) Unsatisfactory - adequate size but set for lecture only, no connectivity, no flexibility 3) Neutral - have flexibility and space for hands on or project based learning 4) Satisfactory - have flexibility and space for hands on or project based learning and connectivity for global learning 5) Very Satisfactory - space for hands on learning, flexibility for different groupings, and connectivity for global classrooms N/A) Does not apply.		see photo 7

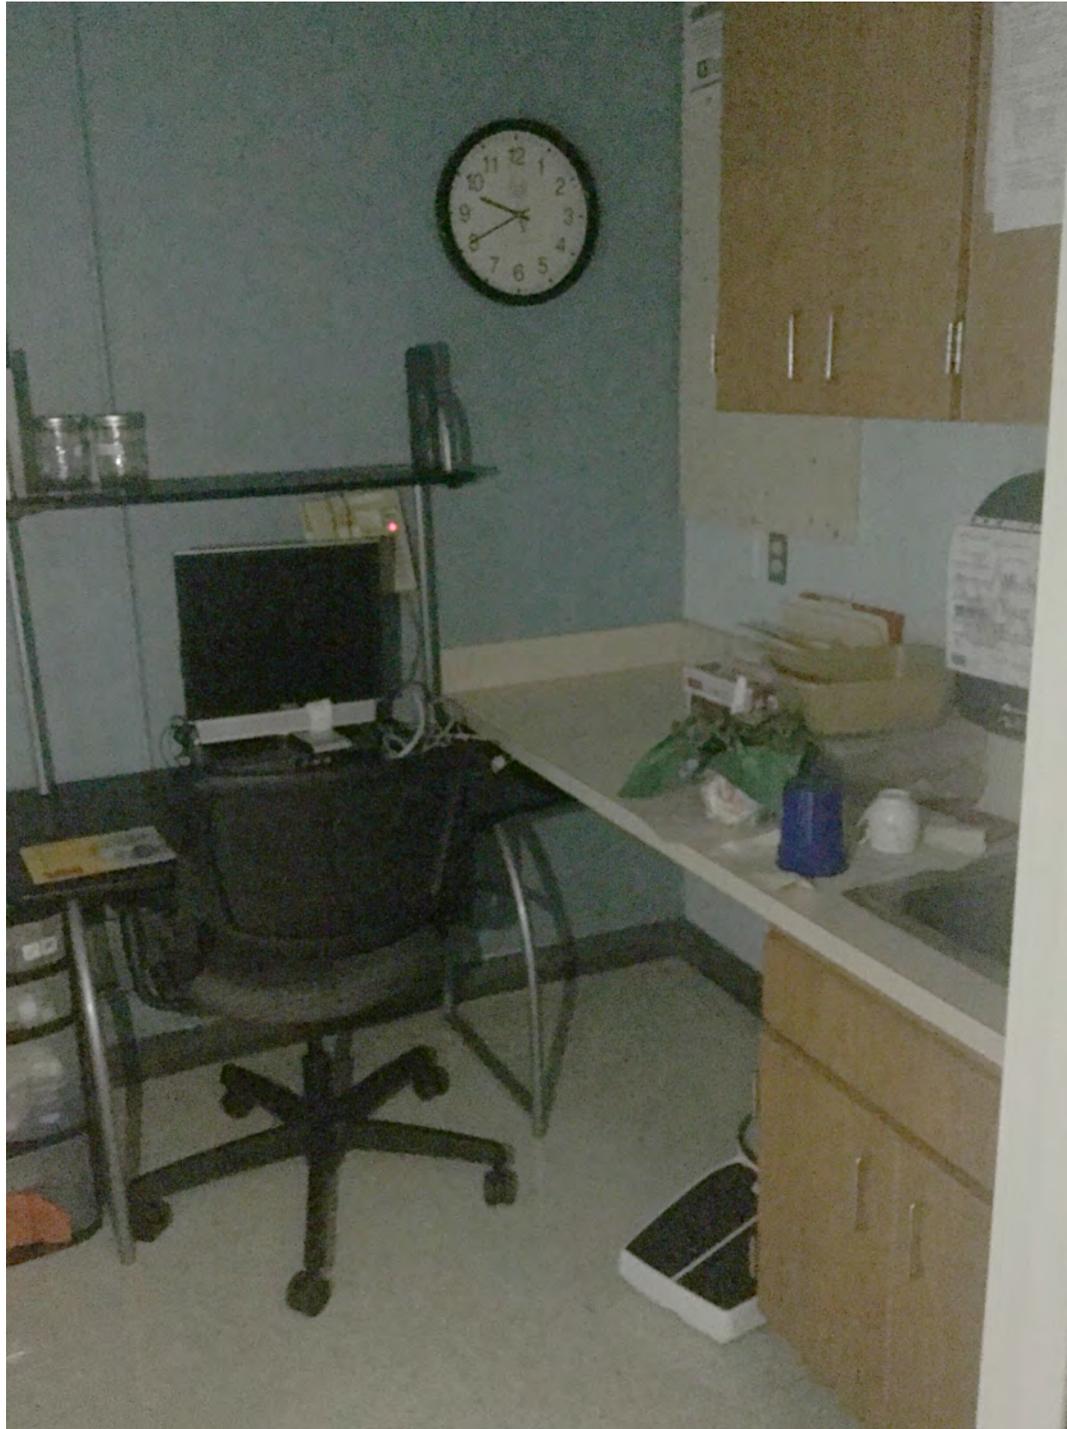
Photo 8.
6.2 Nurse's Room

6.2	How adequate is site lighting and security for the campus overall?		2					Comments	1.00	2.00
1) No exterior lighting, no secure perimeter 2) Lighting is limited to front entry only, parking lot lighting poor, security is minimal 3) Lighting at all night-use entries and parking lot, but poor condition. Security is moderate 4) Lighting at all night-use entries and parking lots, good condition, signage less visible. Perimeter is well secured, but needs updates. 5) Signage, parking lots, and entries are well lit, visible and easy to use. Perimeter is very secure. N/A) Does not apply.		One health and safety issue is the significantly undersized nurse's room. This is a concern for the well-being of the students, many of whom have significant health issues and need lunch checks. There are holes in the fencing that are also a security concern.								
		See photo 8
