Educational Suitability Summary Report

McBee Elementary School – BLDG # 165

Date: 7/25/2016

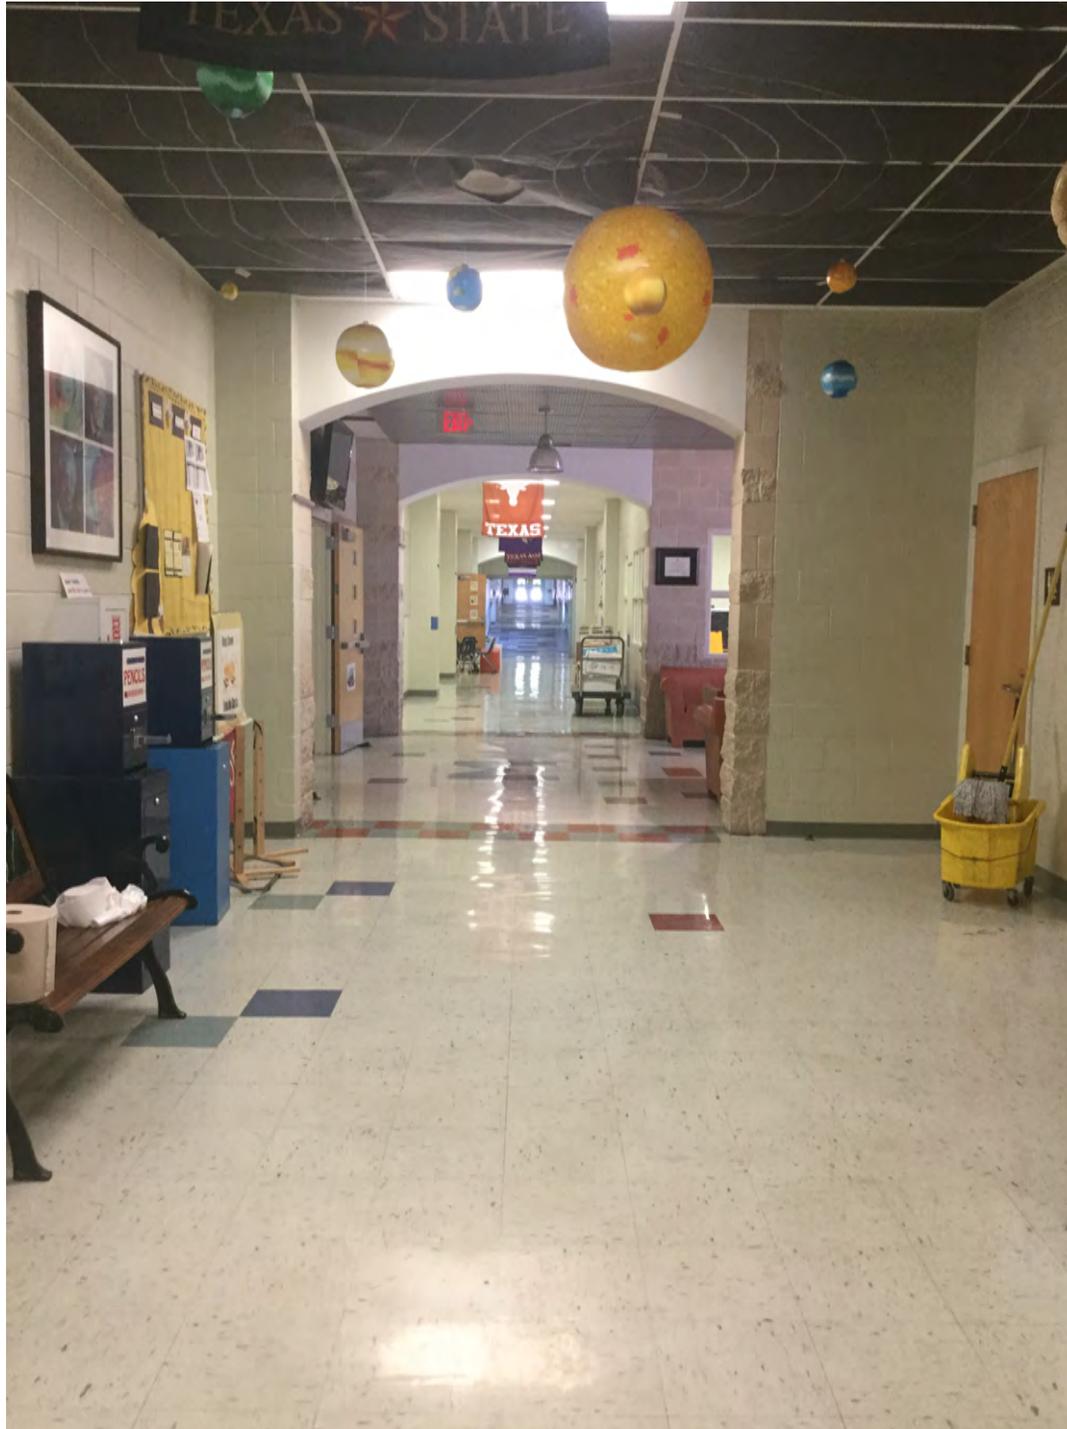
2.1 Corridor

1) Primary circulation is 5'-0" to 6'-0" wide. 2) Primary circulation is 6'-0" to 7'-0" wide 3) Primary circulation is 7'-0" to 8'-0" wide 4) Primary circulation is 8'-0"-10'-0" wide 5) Primary circulation is 10'-0"+ wide N/A) Does not apply.

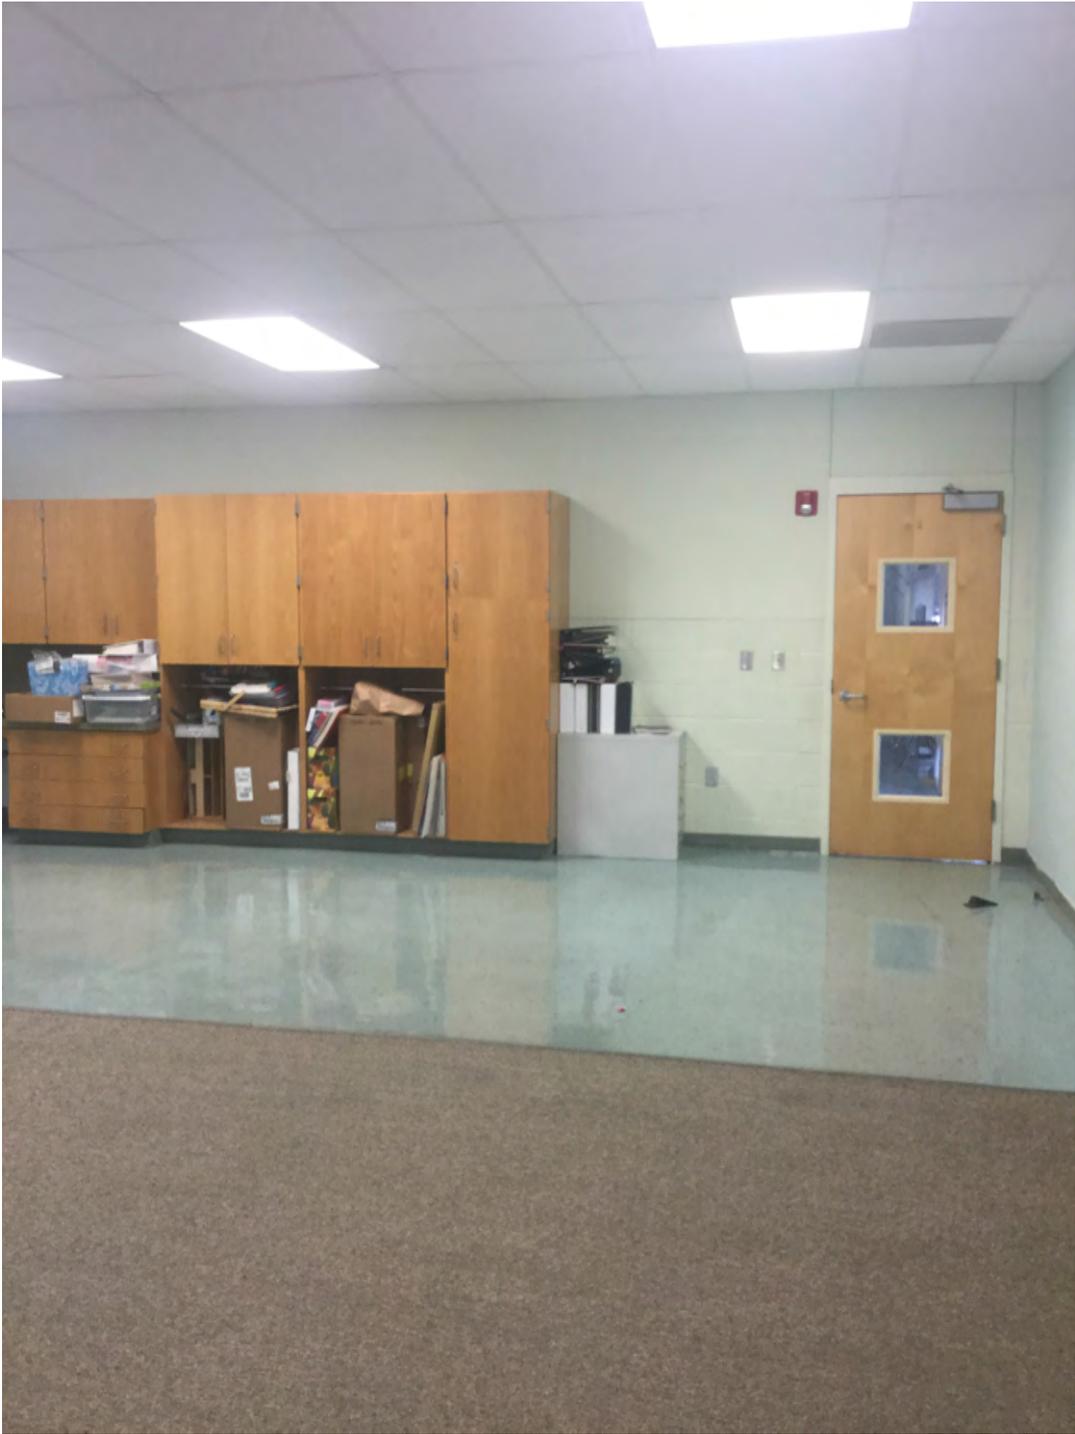
4.2 Classroom

4.2	Are general classrooms large enough to support project-based learning and multiple teaching modalities?					5		Comments	1.00	5.00
1) Very unsatisfactory -too small to move, set for lecture only, no connectivity, no flexibility 2) Unsatisfactory - adequate size but set for lecture only, no connectivity, no flexibility 3) Neutral - have flexibility and space for hands on or project based learning 4) Satisfactory - have flexibility and space for hands on or project based learning and connectivity for global learning 5) Very Satisfactory - space for hands on learning, flexibility for different groupings, and connectivity for global classrooms N/A) Does not apply.

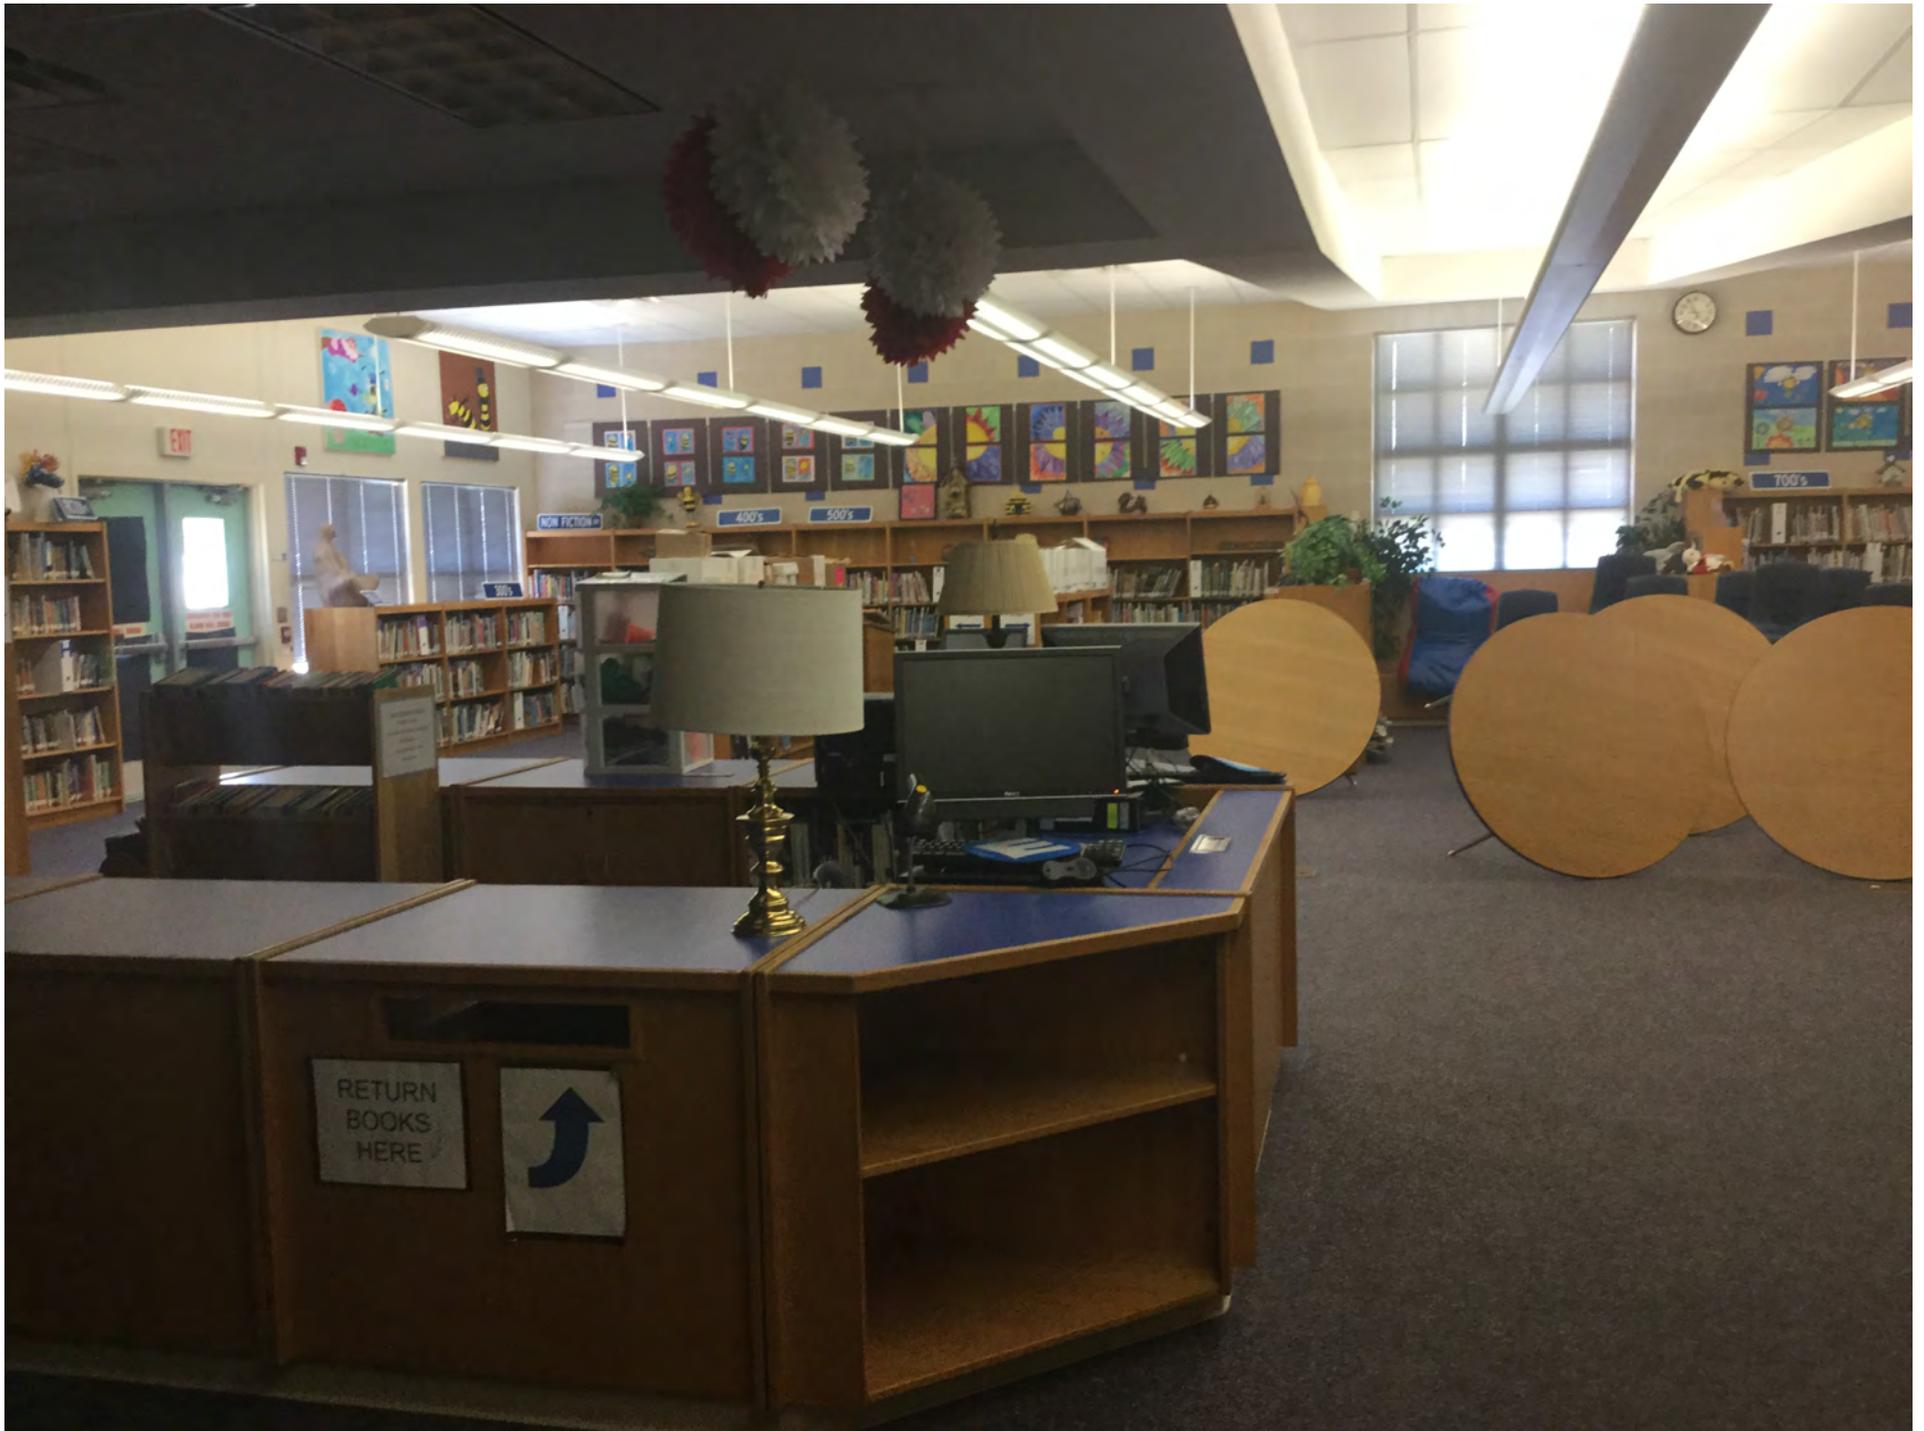
5.4 Library

The library has adequate space and flexibility for collaborative work of different group sizes. Casual seating supports social interaction and areas for individual study. The library has satisfactory technological support, but would benefit from additional computers.
