Educational Suitability Summary Report

Menchaca Elementary School BLDG-147

Date: 06/28/2016 (Rev 1 – 12/12/16 – Added Survey Responses)

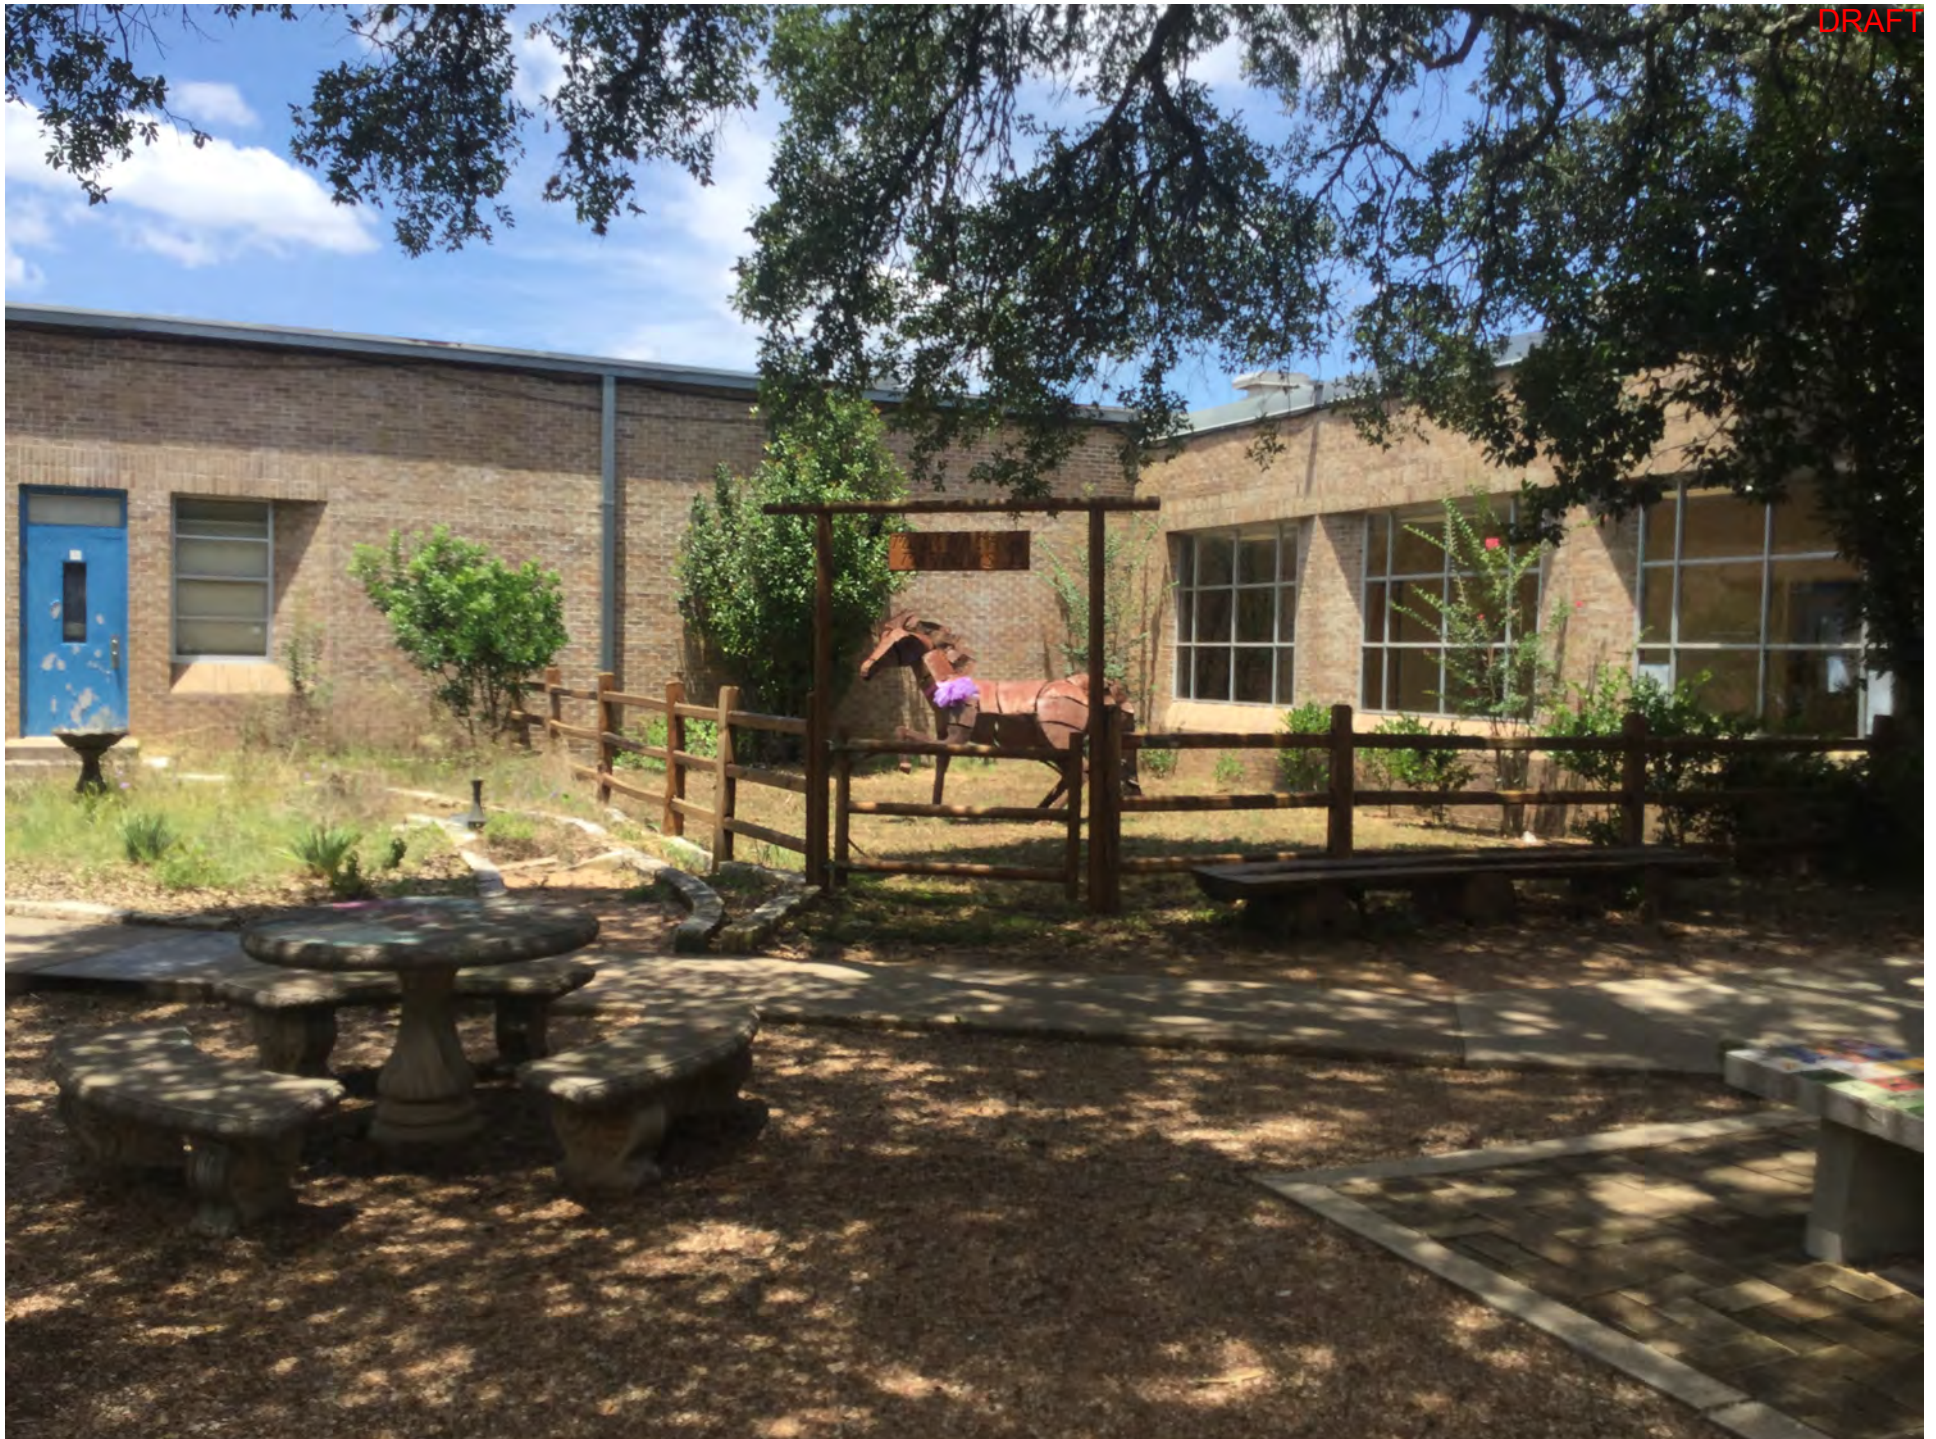
Photo 1.
1.2 Outdoor Space

1.2	Are opportunities provided for outdoor learning (outdoor classrooms, gardens, etc.)?										4			Comments	1.00	4.00
1) Outdoor space exists is not developed 2)Outdoor space for learning exists but not connected to classroom learning areas. 3. Outdoor learning spaces exist and are accessible but not in good condition. 4. Outdoor learning spaces need minor improvements to function well. 5. Outdoor learning spaces are in excellent condition. N/A) Does not apply.								There are plenty of exterior seating and garden spaces.

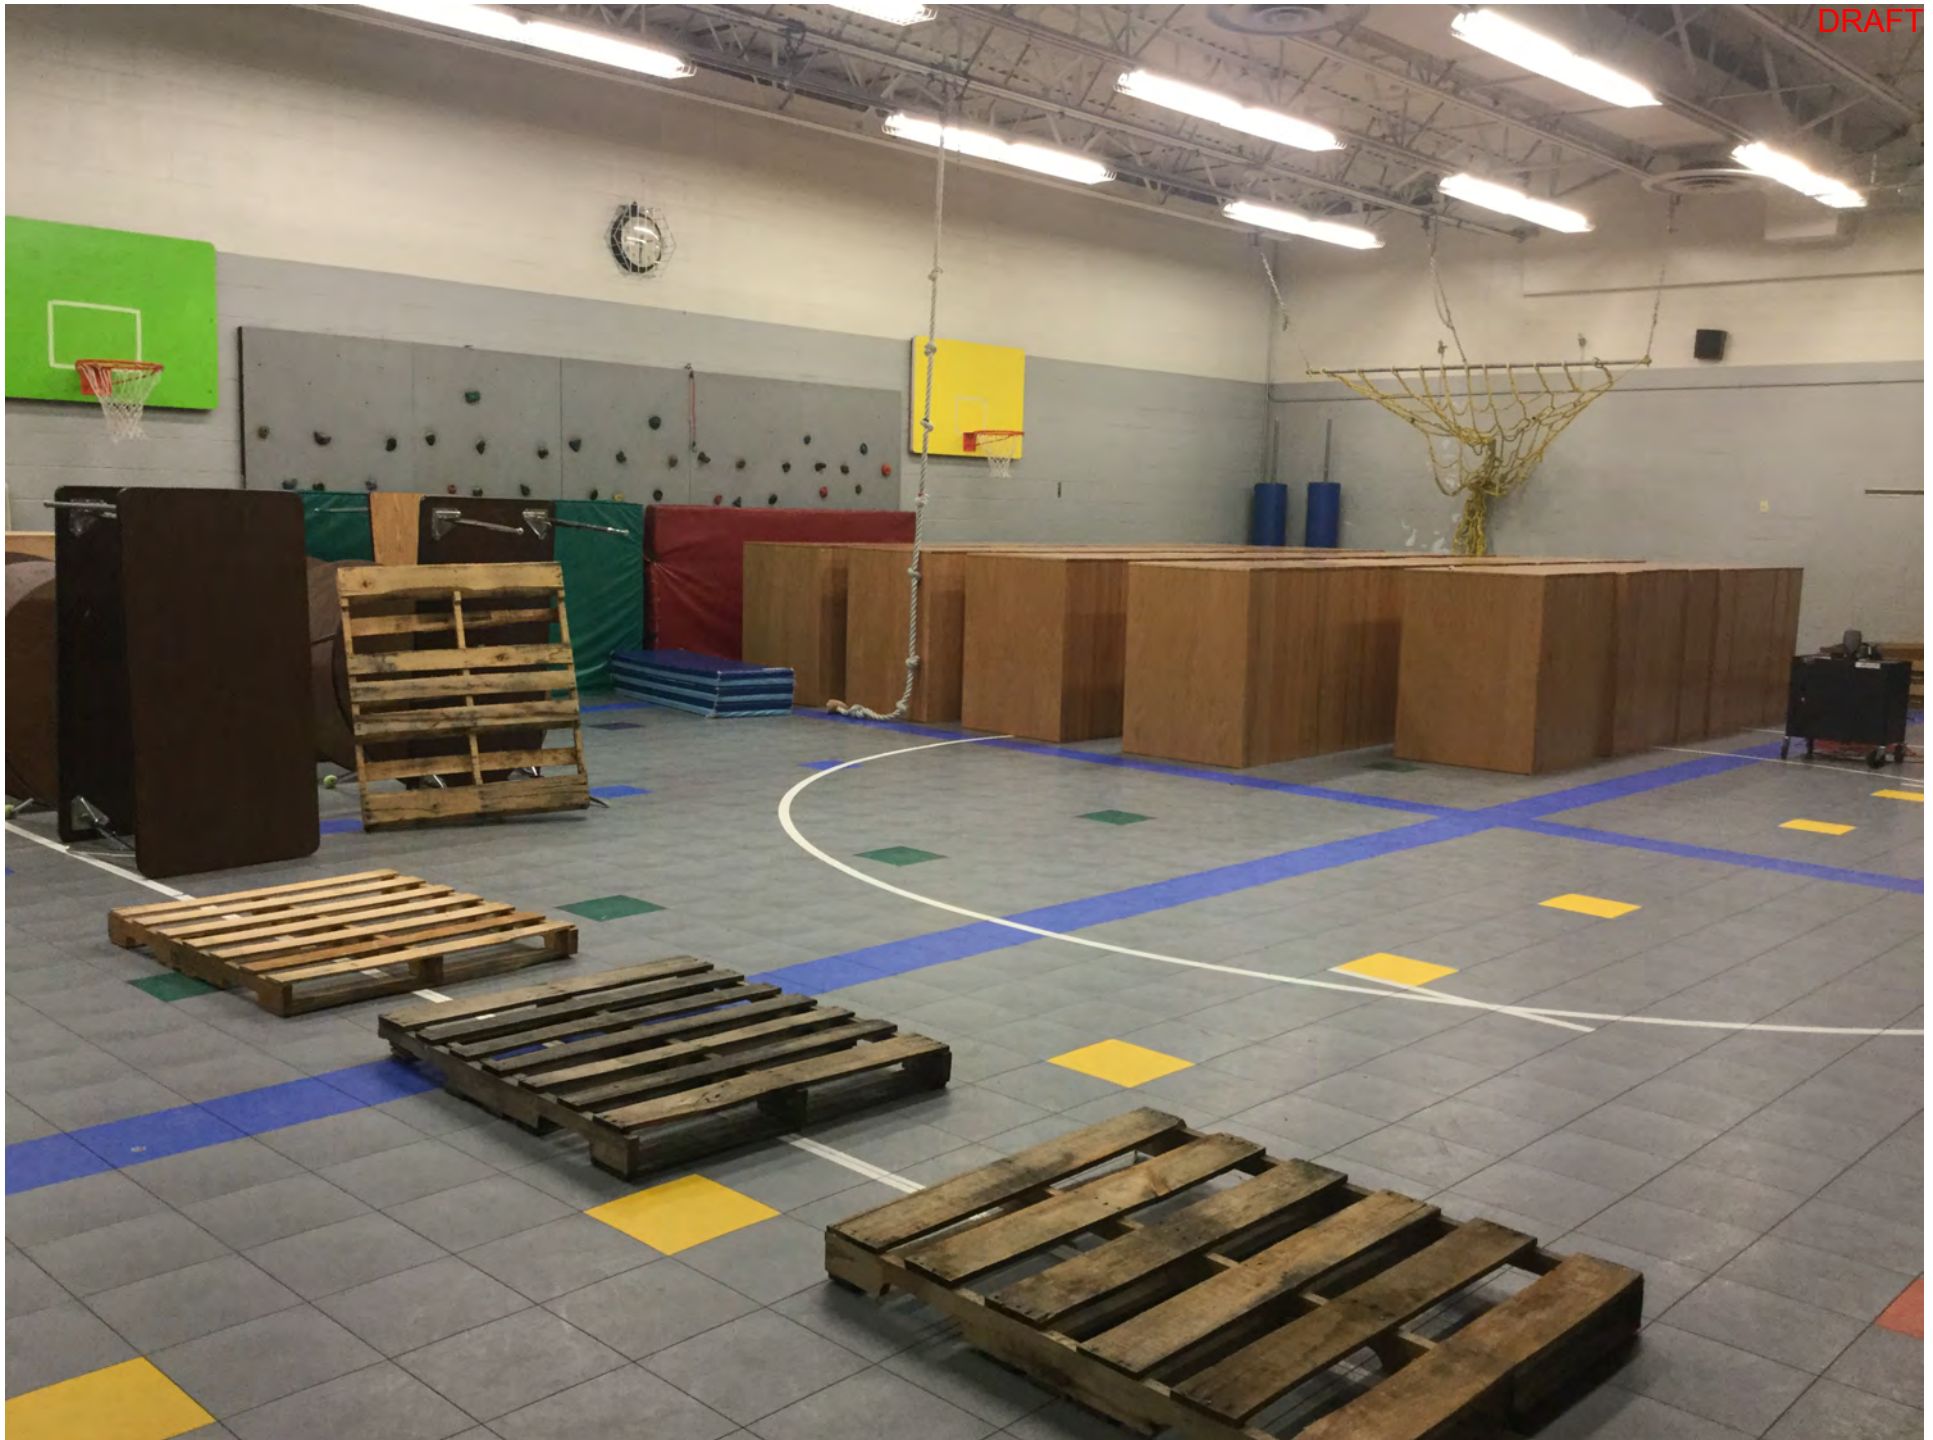
Photo 2.
3.7 Gym

1.00 4.00
3.7	Are Physical Education and Athletic support spaces appropriately configured per the ed spec?			3			
	1) Very unsatisfactory - Support spaces are disconnected from served spaces, too small, do not meet needs 2) Unsatisfactory - Support spaces are connected, but too small, inadequate for needs 3) Average - Connected, moderate size, but need some renovations or updates to function well 4) Good - Connected, good size/layout, meets needs/functions well 5) Very good - connected, generous size, nice condition, functions appropriately N/A) Does not apply.						Comments The gym storage, offices, and restrooms are adequate in size but are separate from the gym.

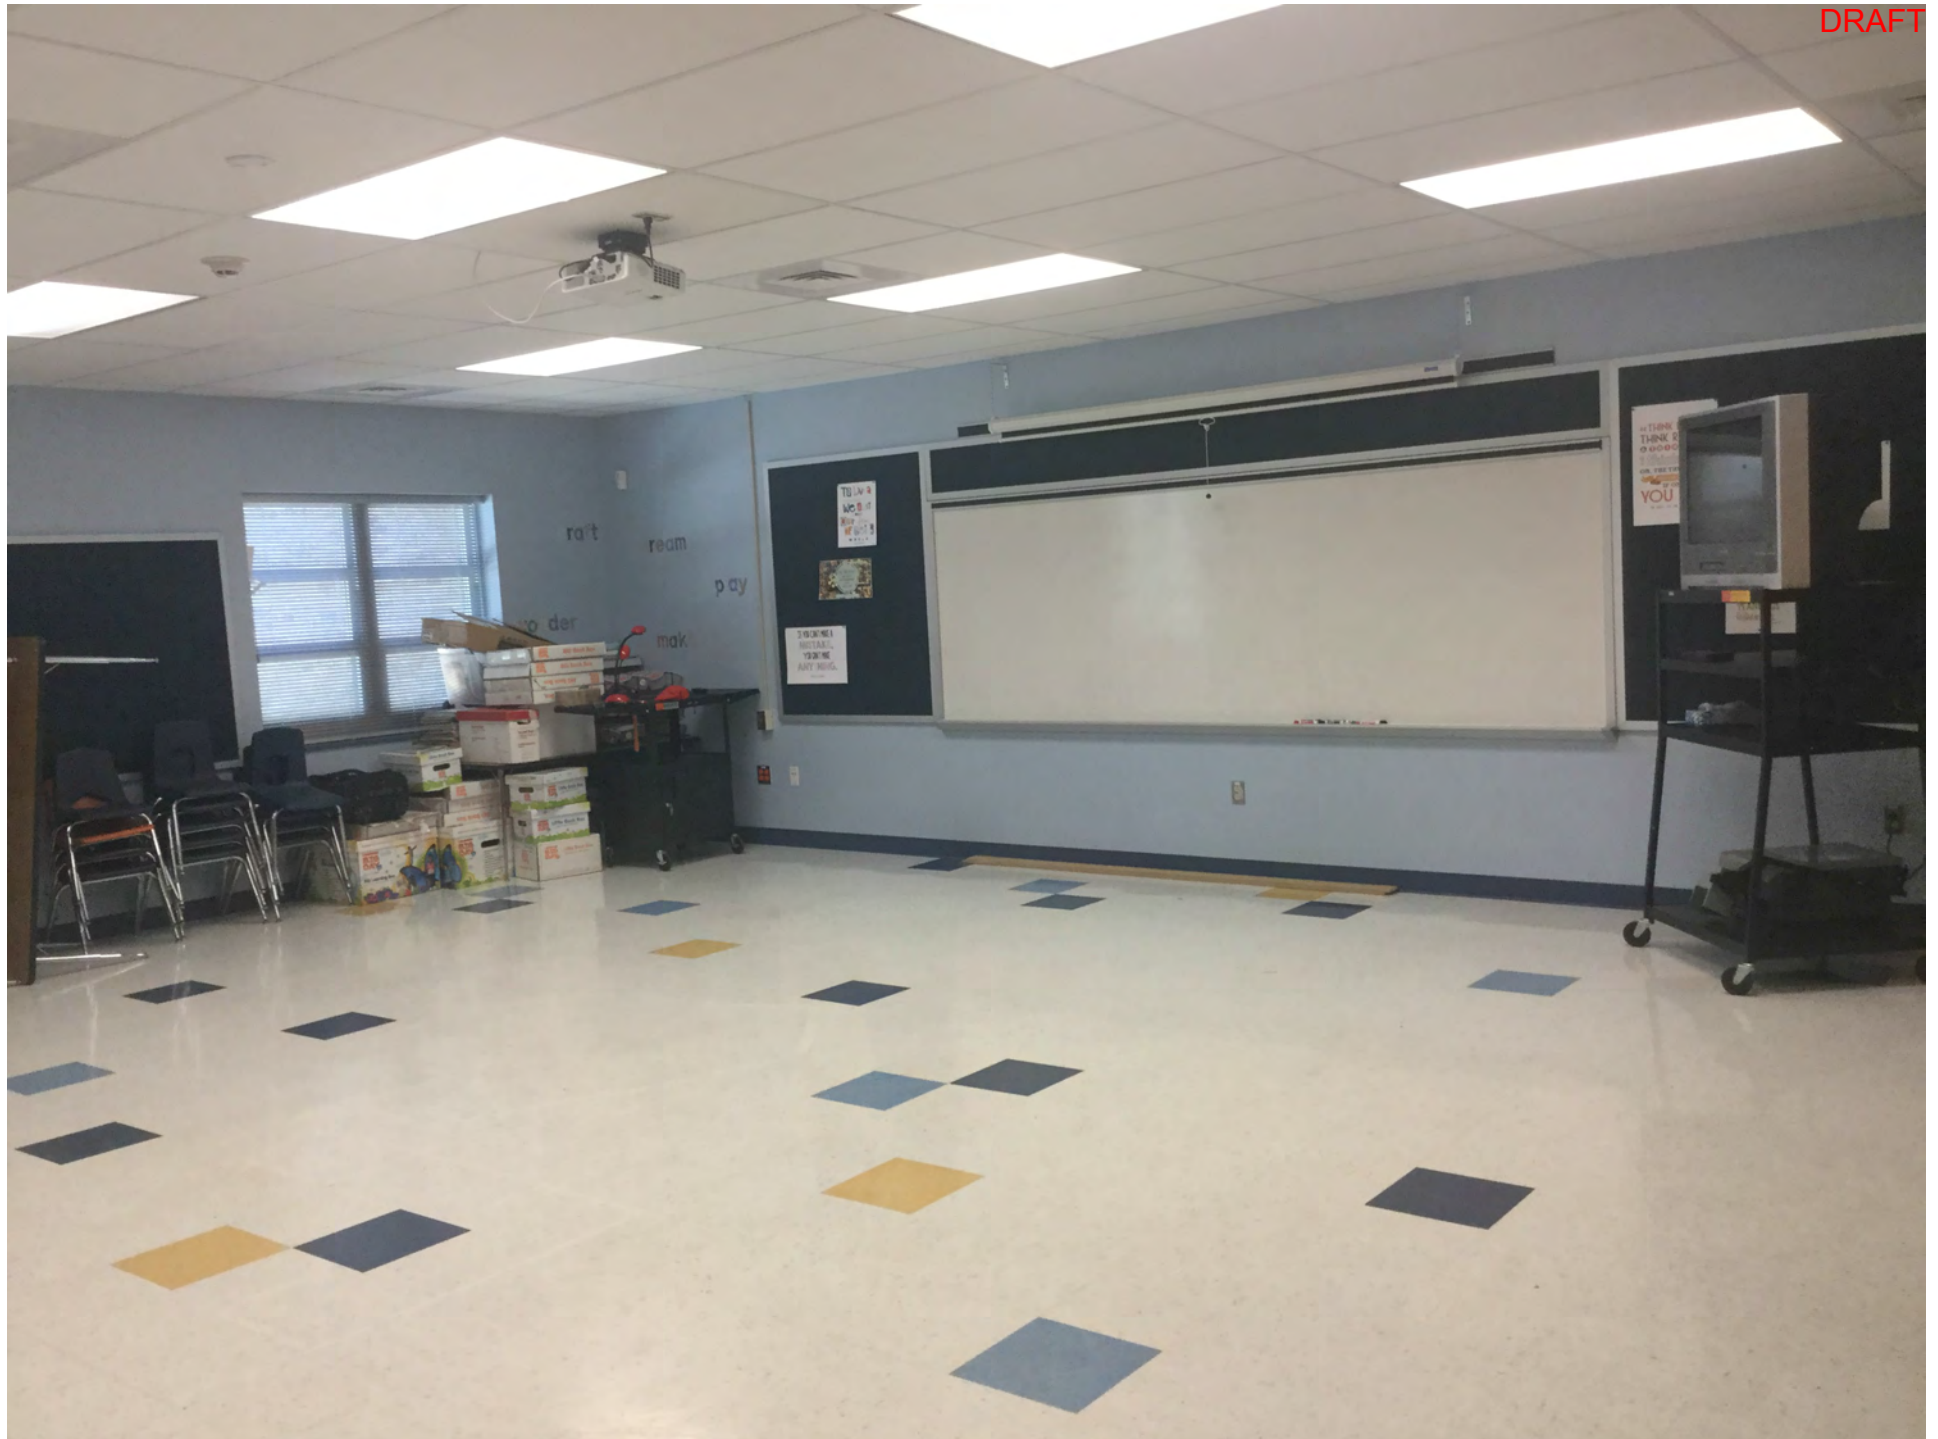
Photo 3.
3.11 Makers Space

3.11	Are Visual Arts support spaces appropriately configured per the ed spec?				4			Comments	1.00 4.00
1) Very unsatisfactory - Support spaces are disconnected from served spaces, too small, do not meet needs 2) Unsatisfactory - Support spaces are connected, but too small, inadequate for needs 3) Average - Connected, moderate size, but need some renovations or updates to function well 4) Good - Connected, good size/layout, meets needs/functions well 5) Very good - connected, generous size, nice condition, functions appropriately N/A) Does not apply.								There is a separate kiln room and a new maker space.

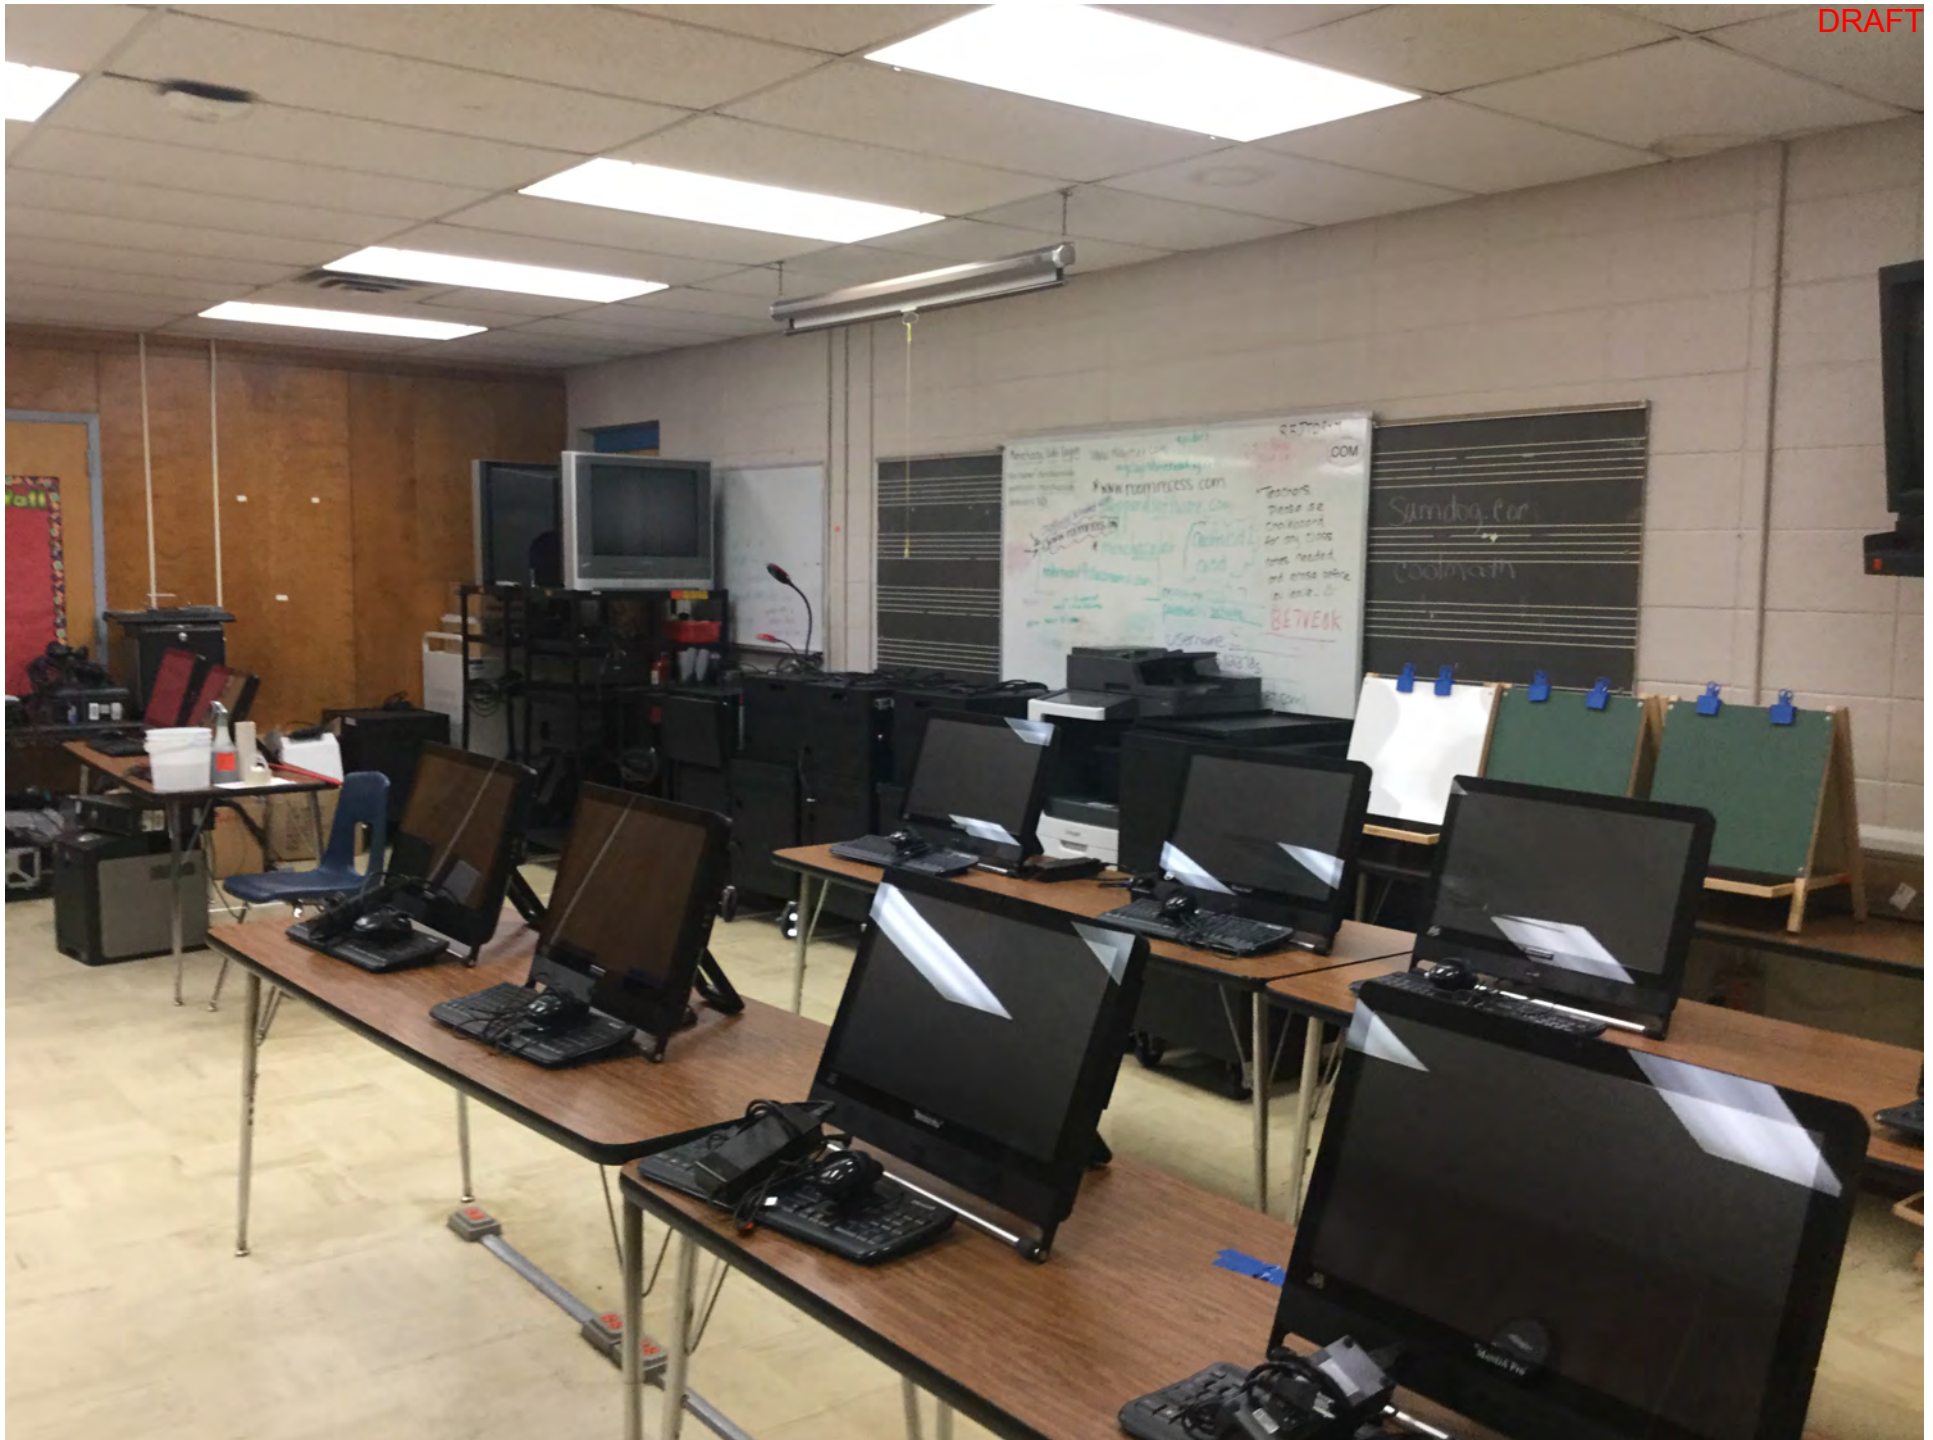
Photo 4.
3.12 Computer Lab

3.12	Are computer lab spaces appropriately configured?				4			Comments	1.00 4.00
1) Very unsatisfactory 2) Unsatisfactory 3) Average 4) Good 5) Very good N/A) Does not apply.								The new computer lab was dedicated by the PTA two years ago. However, technology in the lab is becoming outdated.

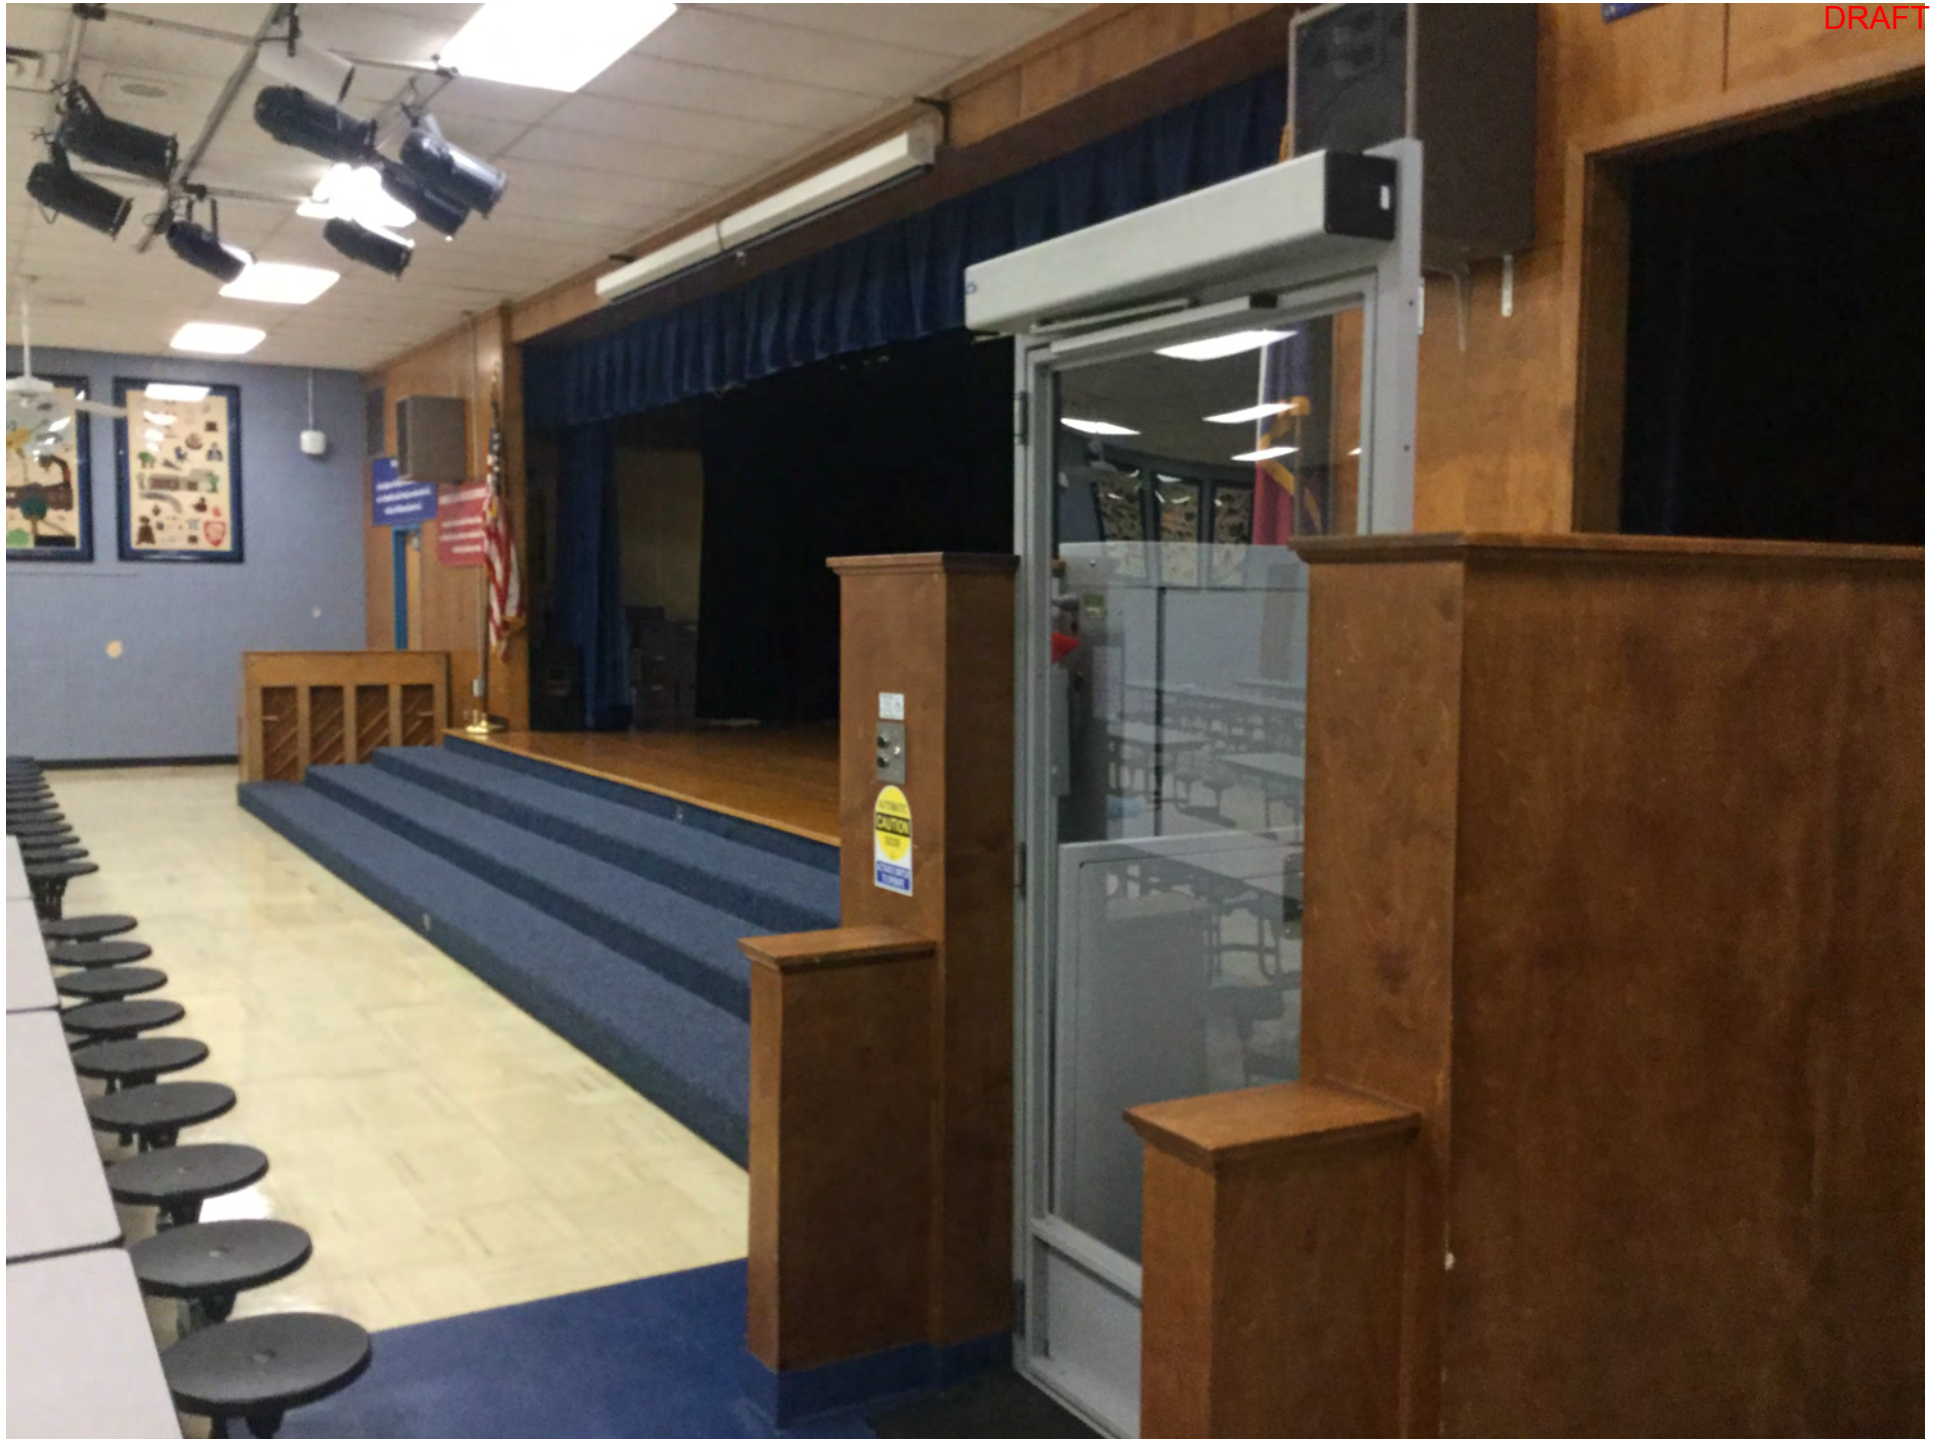
Photo 5.
3.16 Cafetorium

3.16	Are the student dining facilities appropriately configured?				4			Comments	1.00 4.00
	1) Very unsatisfactory - Too small, poor circulation, inflexible seating in poor condition 2) Unsatisfactory - Too small or inadequate circulation, seating in poor condition 3) Average - moderate size, with adequate circulation, seating in okay condition 4) Good - good size, adequate circulation, seating in good condition 5) Very good - good size, adequate circulation, seating in good condition, with more than one option for eating space (ex: connection to outdoor eating space) N/A) Does not apply.

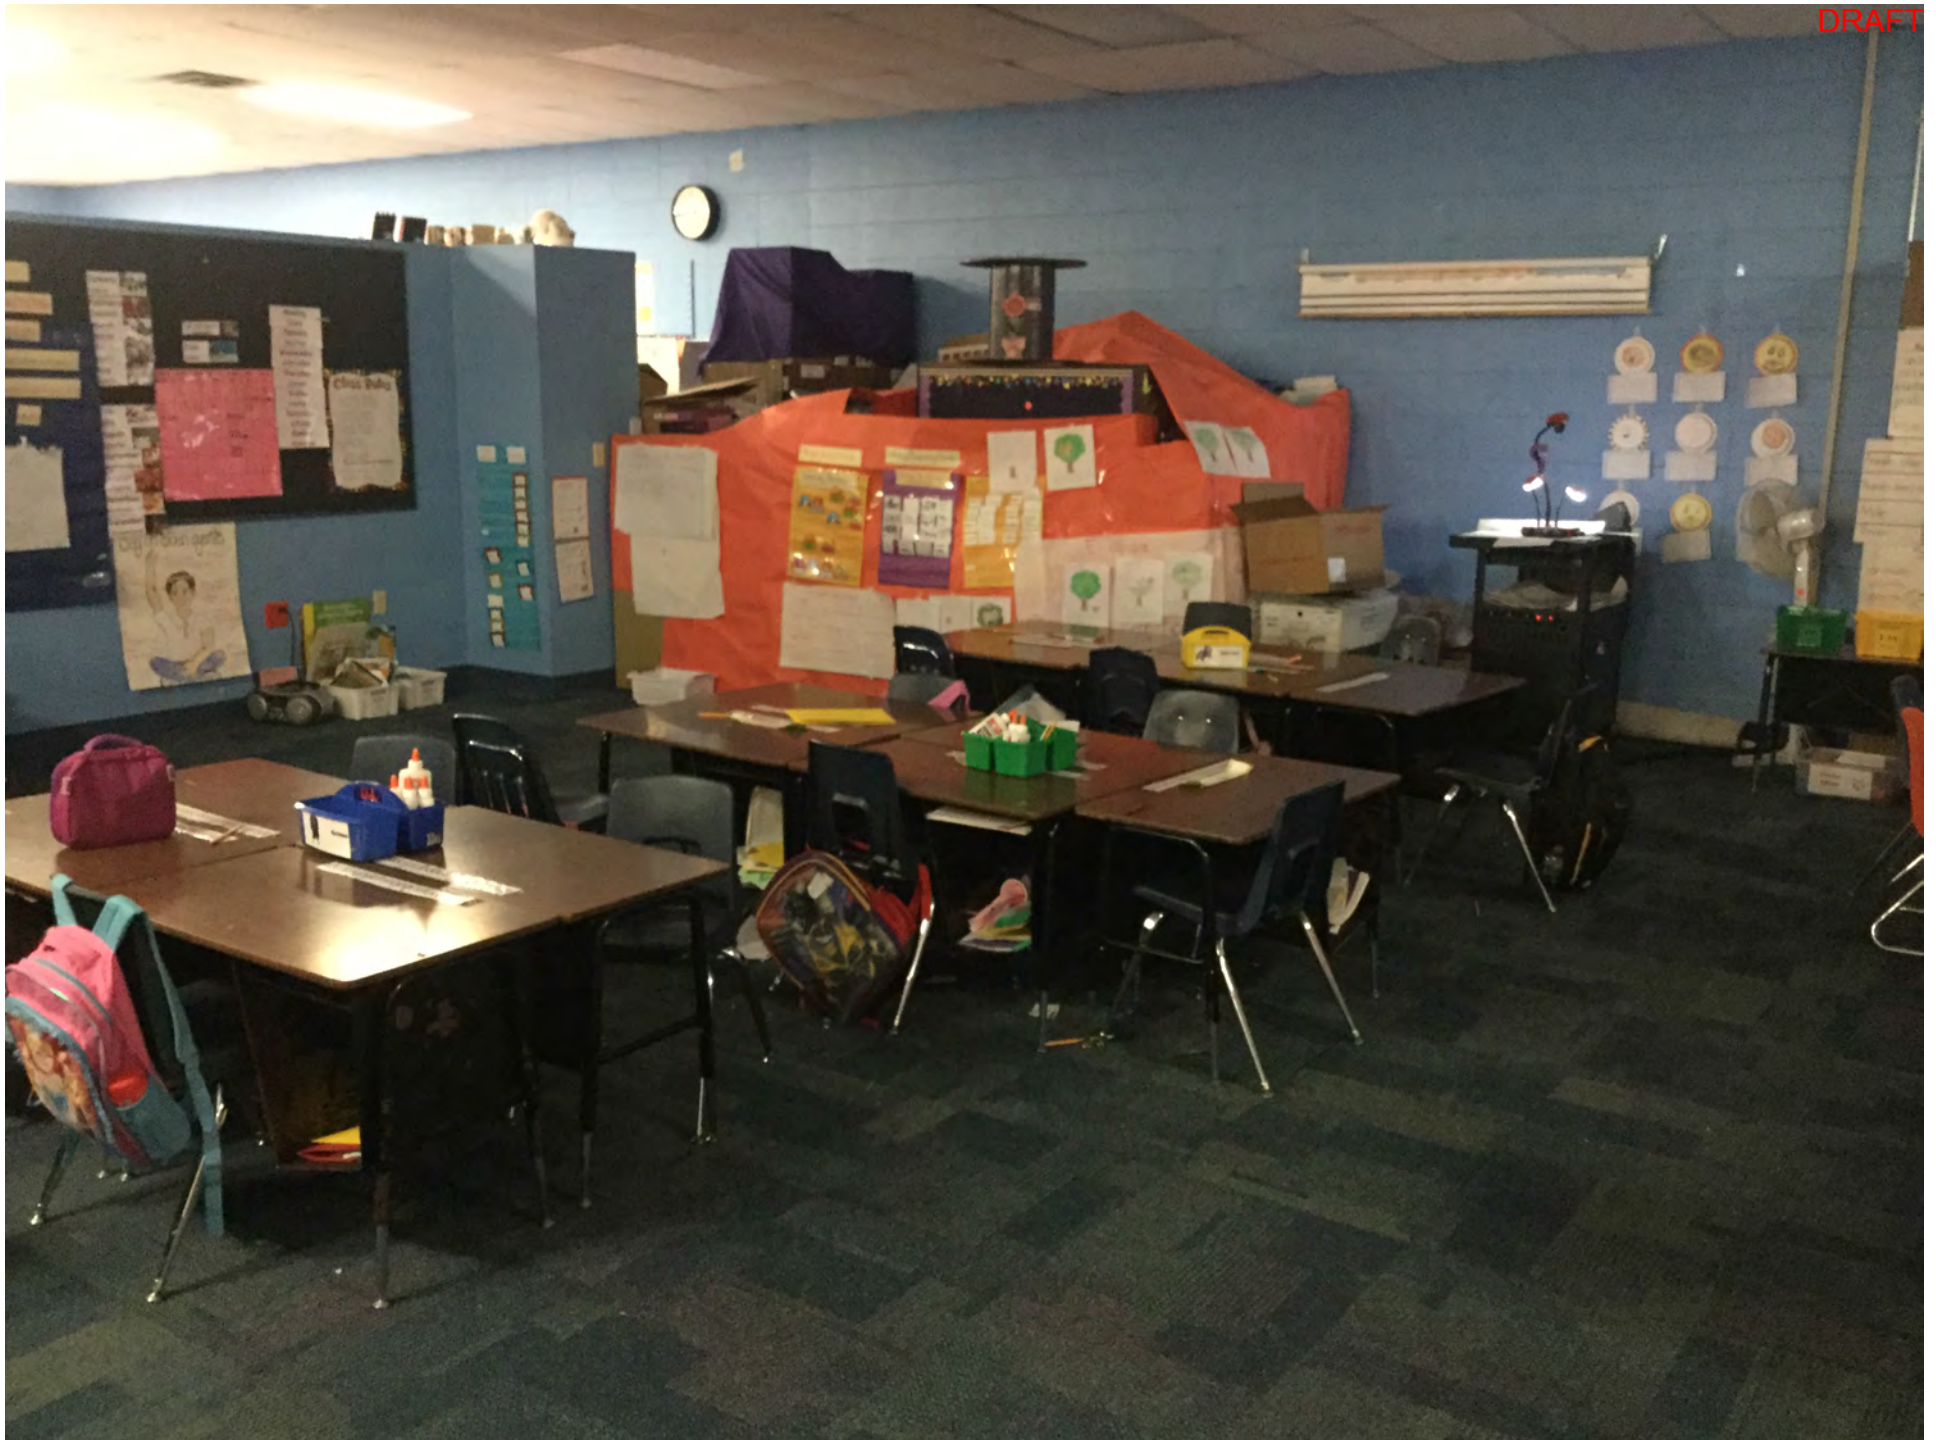
Photo 6.
4.2 General Classroom

4.2	Are general classrooms large enough to support project-based learning and multiple teaching modalities?		2					Comments	1.00 2.00
1) Very unsatisfactory -too small to move, set for lecture only, no connectivity, no flexibility 2) Unsatisfactory - adequate size but set for lecture only, no connectivity, no flexibility 3) Neutral - have flexibility and space for hands on or project based learning 4) Satisfactory - have flexibility and space for hands on or project based learning and connectivity for global learning 5) Very Satisfactory - space for hands on learning, flexibility for different groupings, and connectivity for global classrooms N/A) Does not apply.								The classrooms are generally inadequate in size, especially those in the open classroom plan. There are a couple of instances of teachers sharing one class room.

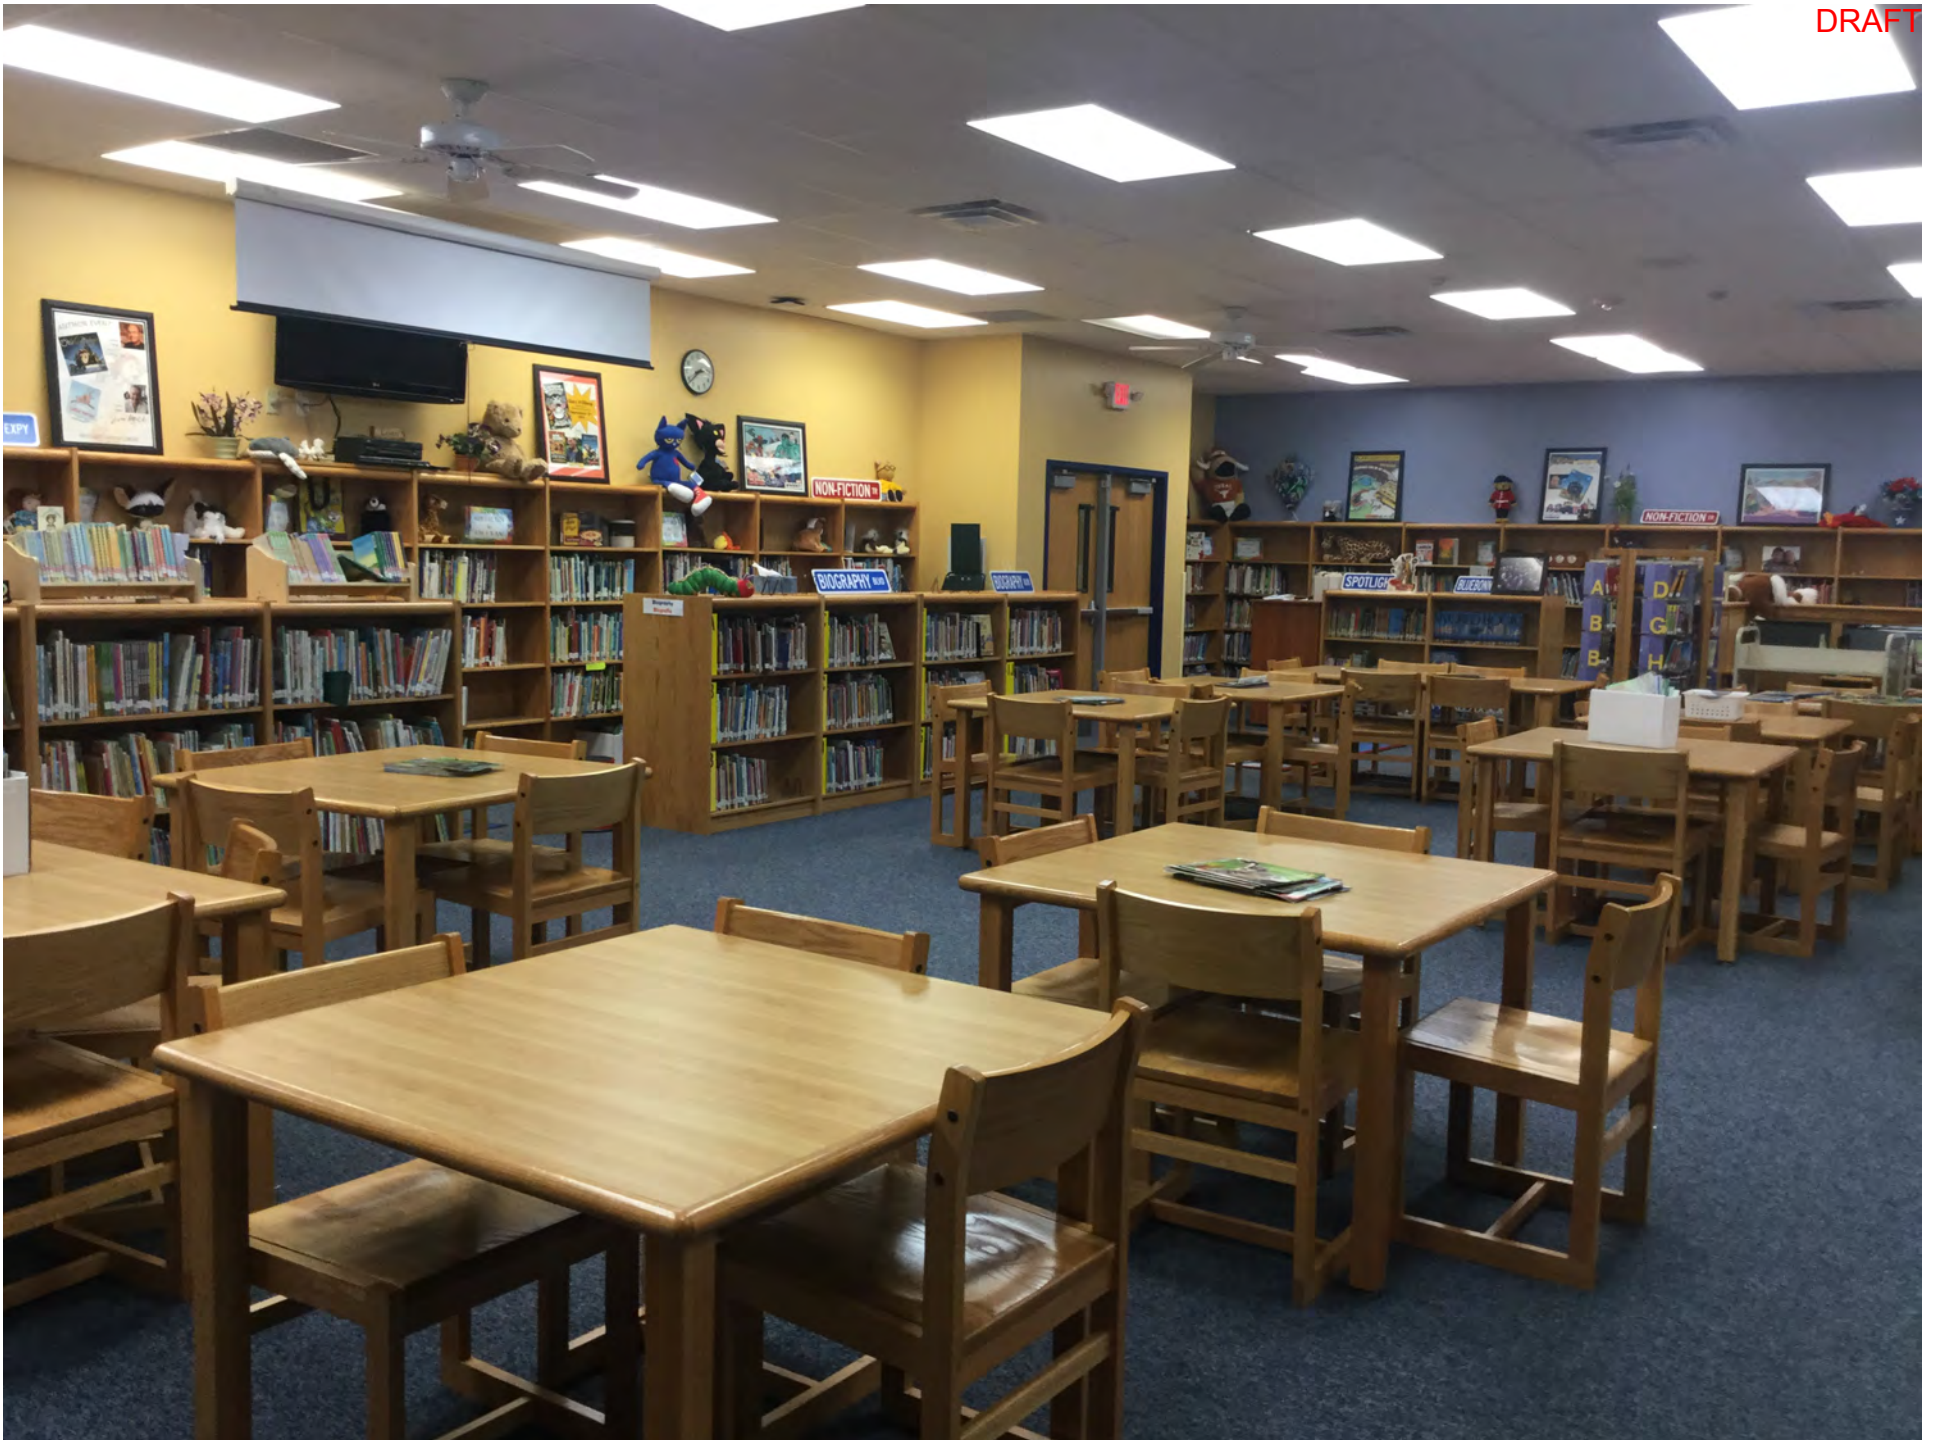
Photo 9.
5.3 Library

5.3	How well does the Library/Media Center support social interaction?		2					Comments	1.00 2.00
1) Very unsatisfactory 2) Unsatisfactory 3) Average 4) Good 5) Very good N/A) Does not apply.								There is no designated space that aids social interaction.
