Educational Suitability Summary Report

Mills Elementary School

Date: 7/18/2016 Score 81% Excellent

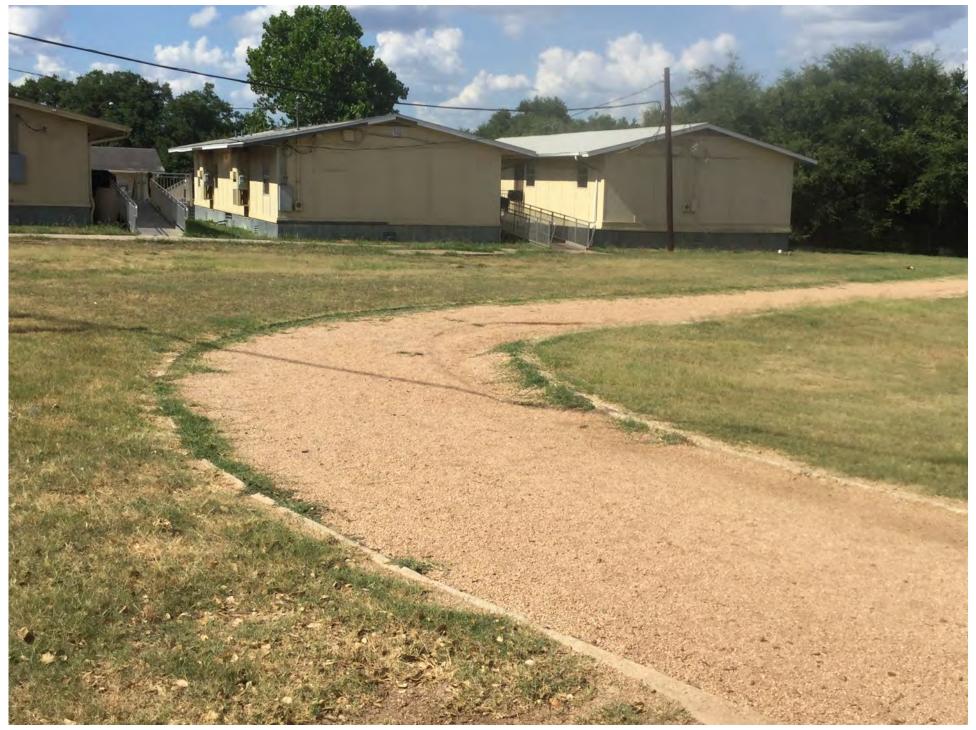
Photo 1. 1.3 Track

1) Outdoor play space exists, not developed							Track is in poor condition and students hurt themselves on it.		
Outdoor play space exists but is not connected to gym or other athletic support areas or is too small.									
 Outdoor play spaces exist, are connected to other athletic areas, are the right size, but are not in good condition. Outdoor play spaces need minor improvements to function well.

5. Outdoor play spaces are in excellent condition.									
N/A) Does not apply.								see	photo 1
1.4 Is the building easily identified with appropriate signage and community wayfinding?			3				Comments	0.25	0.7

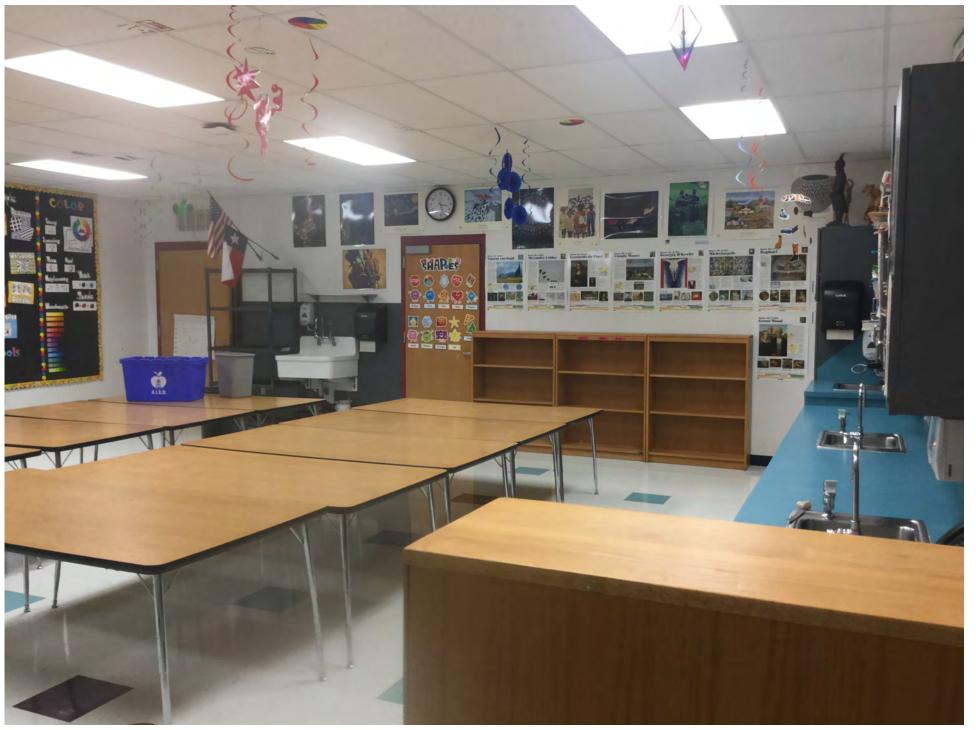
Photo 3. 3.10 Art Room

3 - Academic & Co-Curricular Support - Continued	1	2	3	4	4	5	N/A			
3.10 Are Visual Arts spaces appropriately configured per the ed spec?				4	4			Comments	1.00	4.00

1) Very unsatisfactory				-				One of the art rooms are in a portable with inadequate space.		
2) Unsatisfactory										
3) Average										
4) Good

5) Very good N/A) Does not apply.									500	nhoto 2
Are Visual Arts support spaces appropriately configured per the ed		T		Т	Т				366	photo 3
3.11 spec?				4	4			Comments	1.00	4.00
 Very unsatisfactory - Support spaces are disconnected from served spaces, too small, do not meet needs 								Kiln room shares space with storage.		
Unsatisfactory - Support spaces are connected, but too small, inadequate for needs

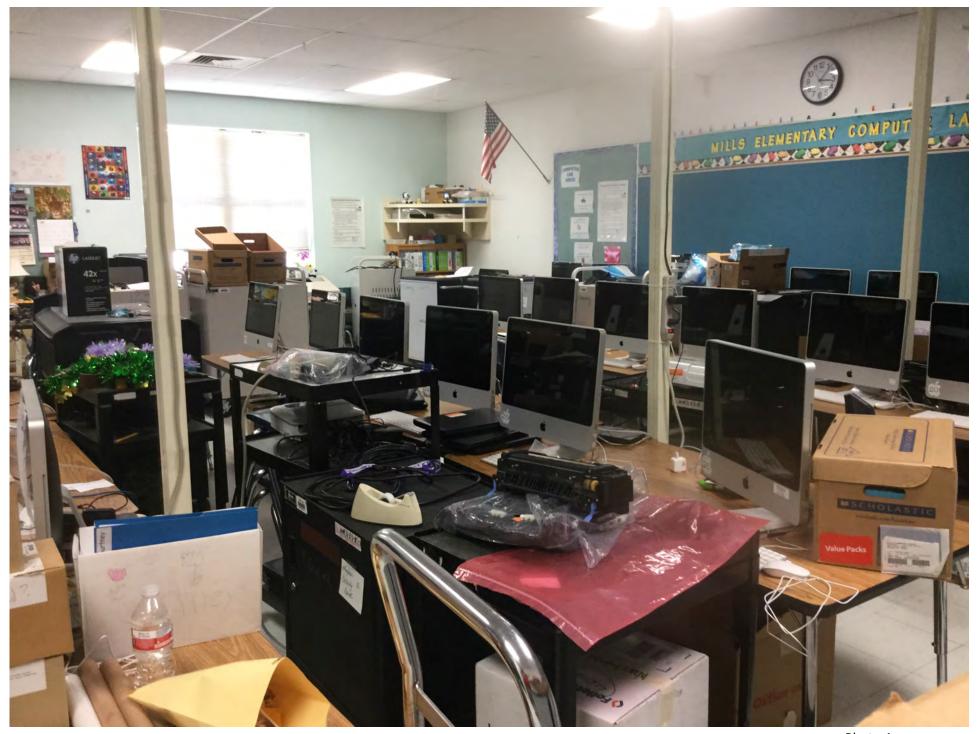
Photo 4. 3.12 Computer Lab

3.12 Are computer lab spaces appropriately configured?				Τ	Т	5		Comments	1.00	5.00
1) Very unsatisfactory			•		•			'		
2) Unsatisfactory										
3) Average

4) Good										
5) Very good										
N/A) Does not apply.										
		Т	Ι	Т	Т				see	photo 4
3.13 Are computer lab support spaces appropriately configured?				4	4			Comments	1.00	4.00
Very unsatisfactory - Support spaces are disconnected from served spaces, too small, do not meet needs				•	•			Storage needs to be improved upon.		
Unsatisfactory - Support spaces are connected, but too small, inadequate for needs

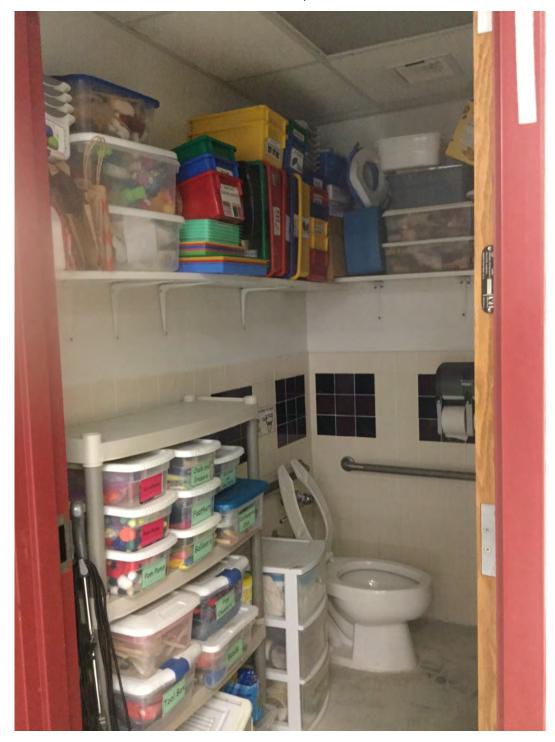
Photo 5. 3.15 Special Education Support

4) Good									
5) Very good									
N/A) Does not apply.									
Are Special Education support spaces appropriately configured per the ed spec?			3				Comments	1.00	3.0
Very unsatisfactory - Support spaces are disconnected from served spaces, too small, do not meet needs							Bathrooms are spacious with correct equipment but one is a storage. Special Ed Dept Comments: PPCD classrooms are in in close proximity.

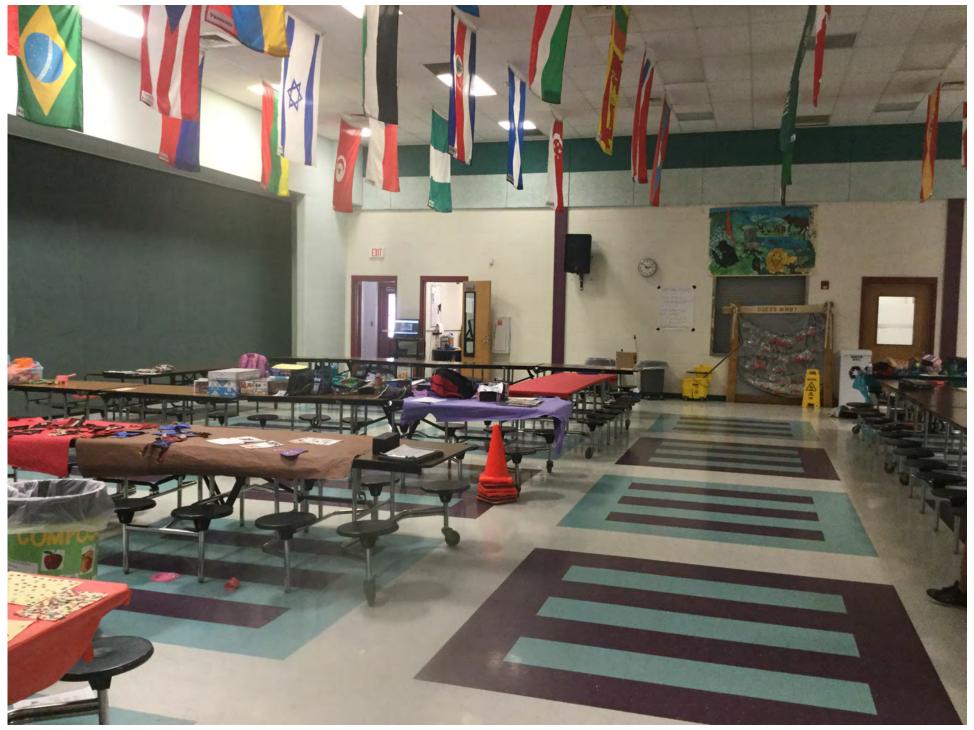
Photo 6. 3.16 Dining Facility

3.16 Are the student dining facilities appropriately configured?					5		Comments	1.00	5.0
 Very unsatisfactory - Too small, poor circulation, inflexible seating in poor condition Unsatisfactory - Too small or inadequate circulation, seating in poor condition Average - moderate size, with adequate circulation, seating in okay condition Good - good size, adequate circulation, seating in good condition Very good - good size, adequate circulation, seating in good condition, with more than one option for eating space (ex: connection to outdoor eating space) N/A) Does not apply. 									photo

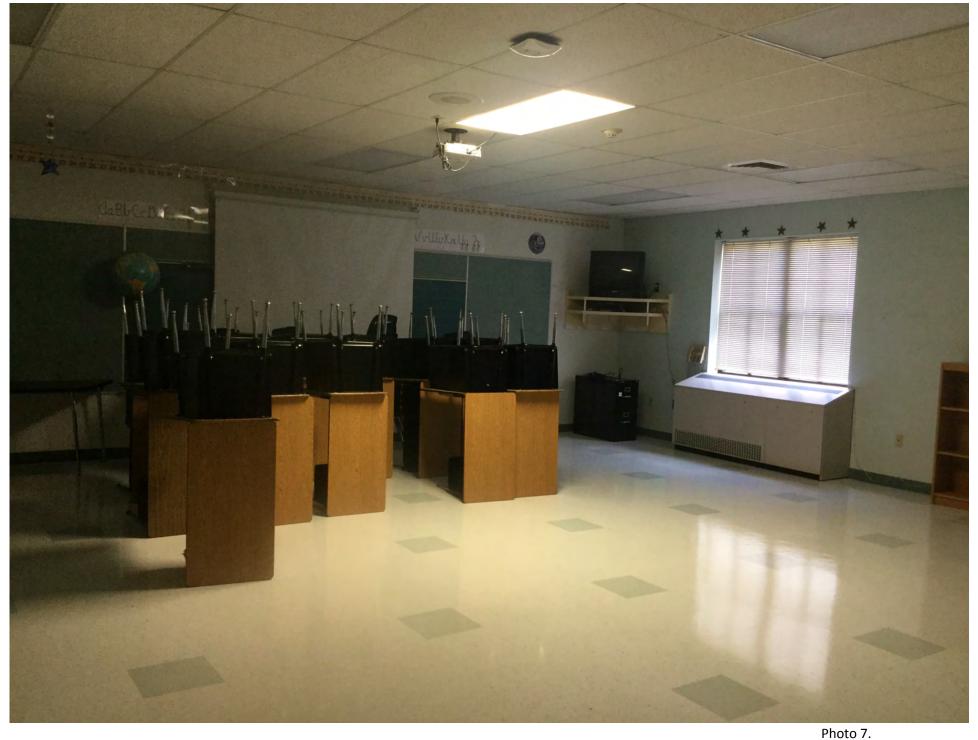
4.2 Standard Classroom

4.2 Are general classrooms large enough to support project-based learning and multiple teaching modalities?				Γ	ĩ	5		Comments	1.00	5.00
1) Very unsatisfactory -too small to move, set for lecture only, no connectivity, no flexibility 2) Unsatisfactory - adequate size but set for lecture only, no connectivity, no flexibility 3) Neutral - have flexibility and space for hands on or project based learning 4) Satisfactory - have flexibility and space for hands on or project based learning and connectivity for global learning 5) Very Satisfactory - space for hands on learning, flexibility for different groupings, and connectivity for global classrooms										
N/A) Does not apply.				,					see	photo 7

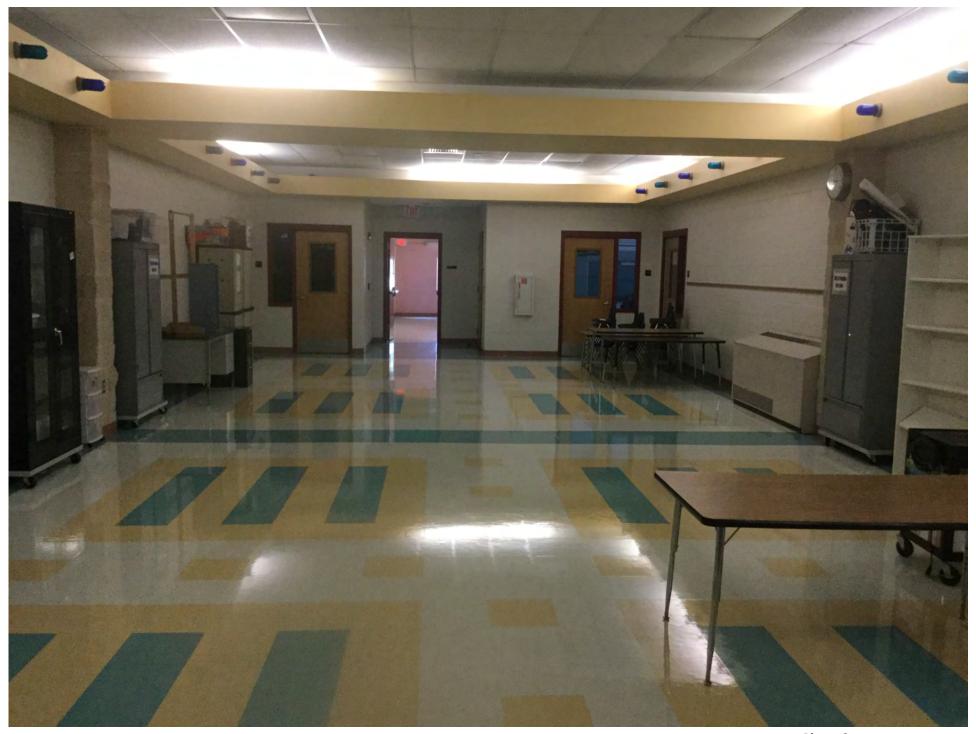
Photo 8. 4.5 Collaborative Space

_	115 E5_11CV I		
4 - Future Ready Student Development - Continued	1	2	3	4	5	N/A			
Does the building provide adequate opportunities for students/teachers to collaborate in varying group sizes?				4			Comments	1.00	4.
 Very unsatisfactory - no common spaces or meeting rooms or in very poor condition Unsatisfactory - a few common spaces or meeting rooms in unsatisfactory condition Average - a few common spaces and meeting areas needing updates Good - multiple common spaces and meeting rooms in good condition Very good - adequate common spaces and meeting rooms of excellent quality 									
N/A) Does not apply.					ı	1		see	phot

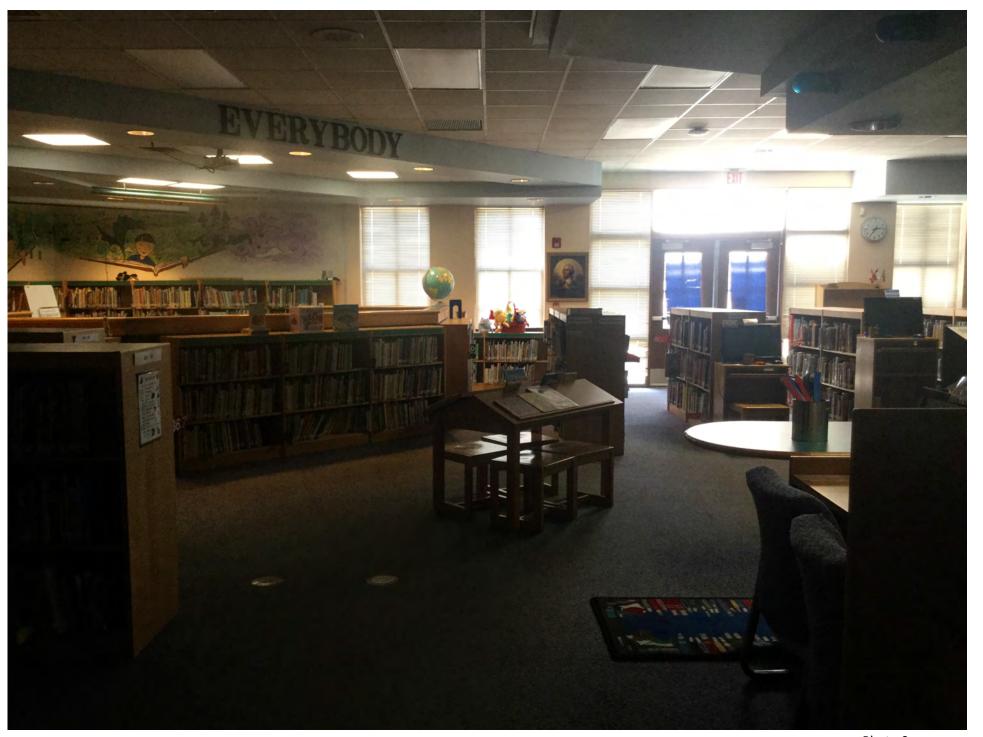
Photo 9. 5.4 Library

1) Very unsatisfactory									
2) Unsatisfactory									
3) Average									
4) Good									
5) Very good									
N/A) Does not apply.									
5.4 How well does the Library/Media Center support collaborative work in small groups (4-8 students)?					5		Comments	1.00	5.00

1) Very unsatisfactory									
2) Unsatisfactory									
3) Average									
4) Good									
5) Very good									
N/A) Does not apply.								see	photo 9
