## Educational Suitability Summary Report

Norman Elementary School – BLDG # 150

Date: 06/07/2016

**Score 56% Average**

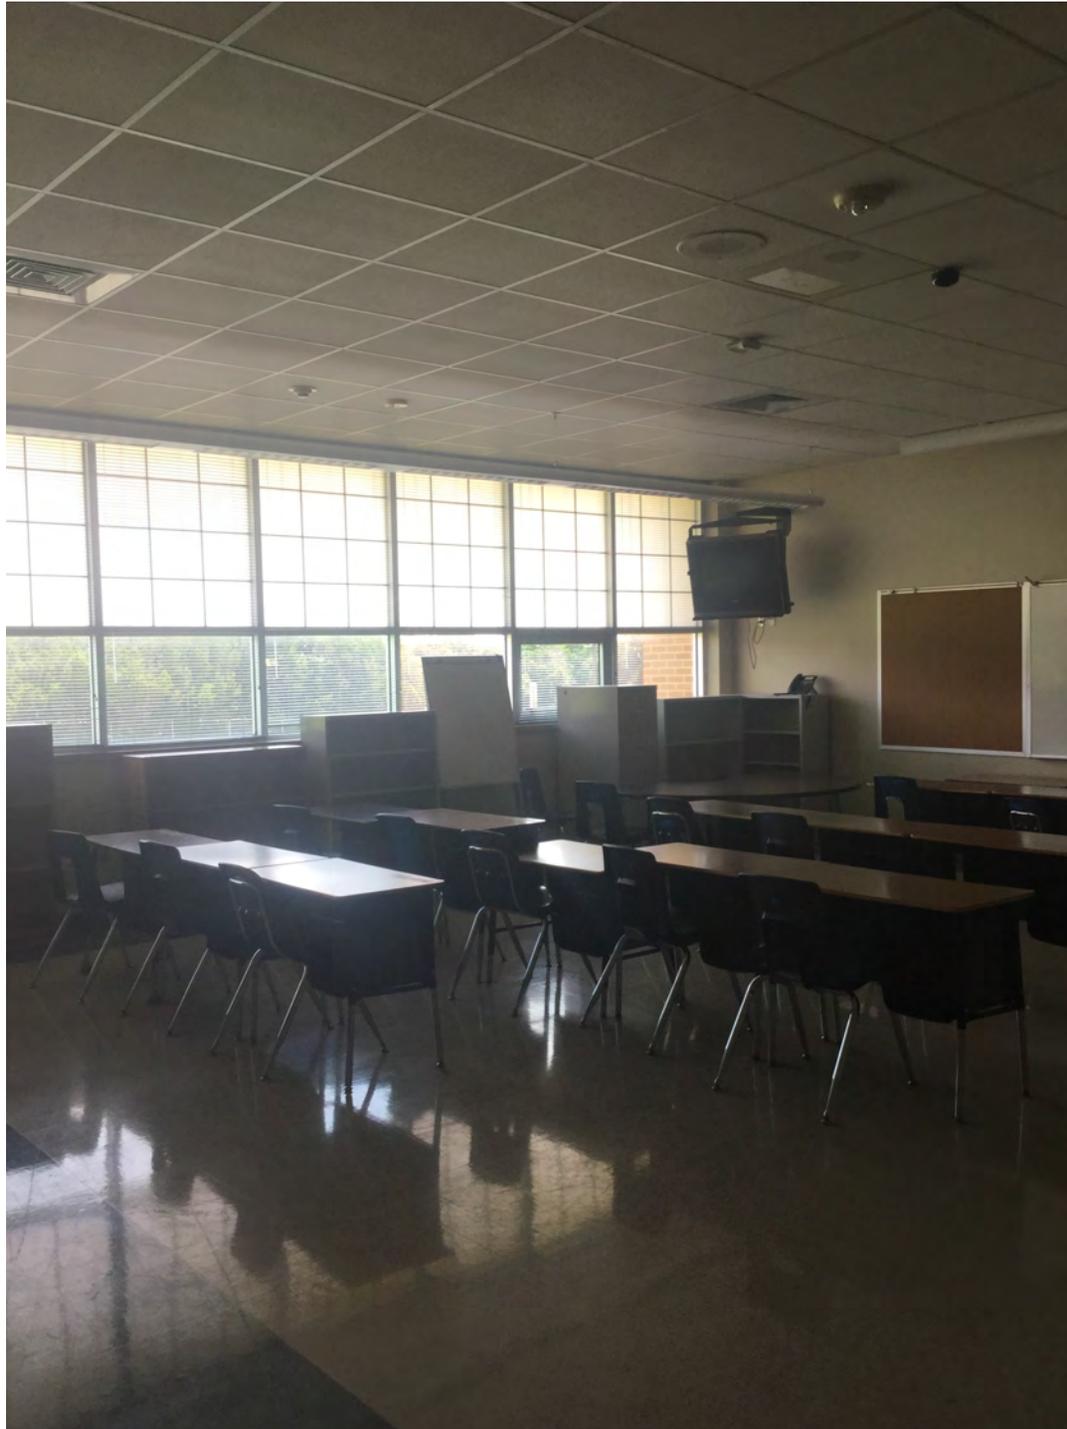
Photo 4. Classroom

The classroom spaces in the 100 wing are grossly undersized and lack appropriate storage space. Additionally, these classrooms lack adequate display space for student work as well as adequate visual communication and teaching tools. This is predominately due to irregularly shaped classrooms and accordion partitions that lack tackable/writable surfaces. The 200 wing classrooms are also slightly undersized per the interim Principal. The 300 wing however, is exempt from these concerns. Overall, the facility's chairs and desks are not flexible to allow for different group sizes and teaching methods. Athletic support spaces are insufficient in size while the gym itself lacks circulation and breakout space around the basketball court.

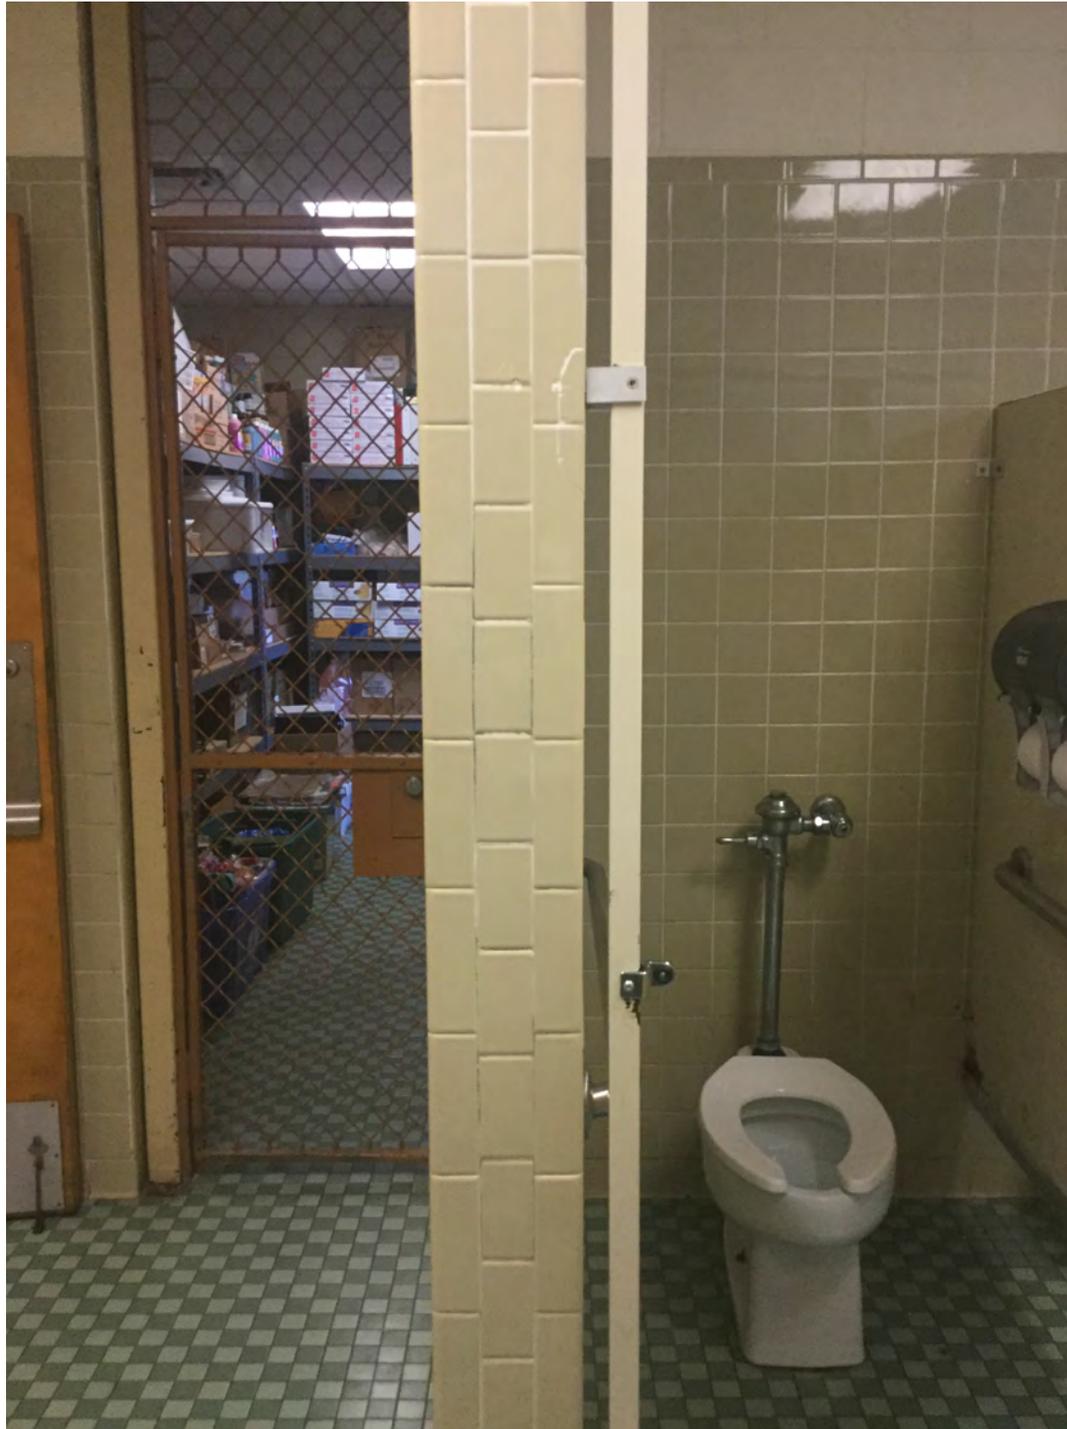
Photo 5. Storage

General building storage is very spacious in the 300 and 200 wings, but suffers from an inappropriate access method in a few instances. Some of the general storage spaces are only accessible from inside student restrooms. This is easily fixed by adding a door in the corridor

side wall. Storage in the 100 wing however, would score *very unsatisfactory* on its own. Some classrooms are provided with storage cabinets in the classroom while other classrooms only have storage accessible from the corridor outside the classroom.

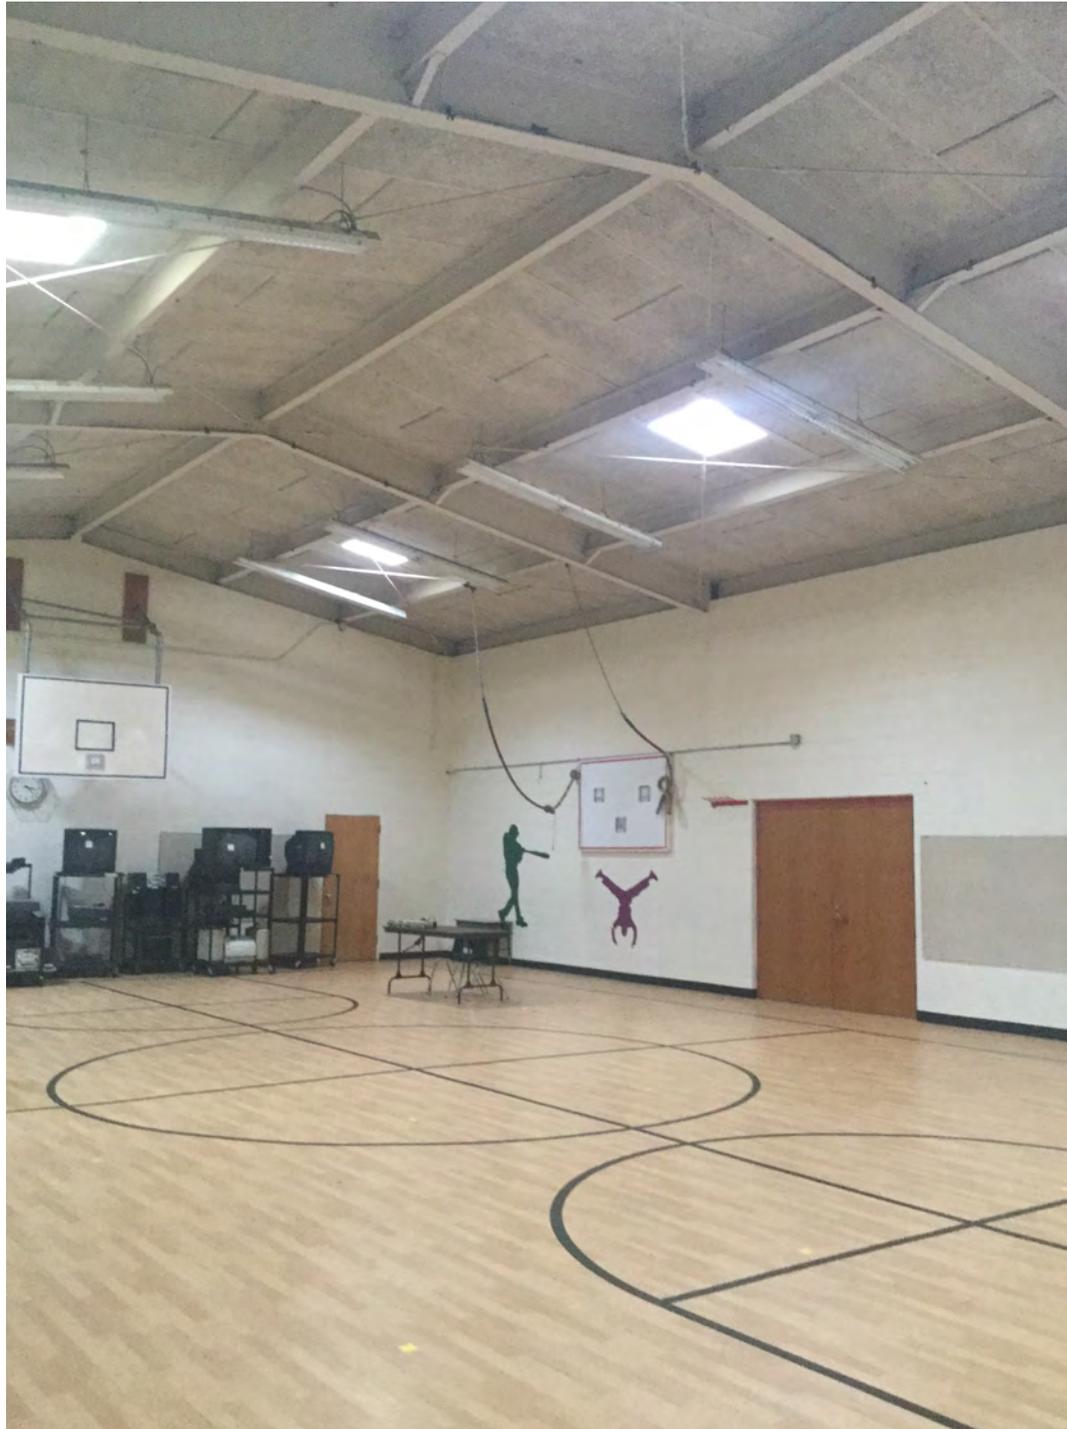
Photo 6. Gym

1) Very unsatisfactory 2) Unsatisfactory 3) Average 4) Good 5) Very good N/A) Does not apply.		The gym is tight and needs additional wall padding to further protect students in such a cramped space.

3.7	Are Physical Education and Athletic <b>support</b> spaces appropriately configured per the ed spec?			3				Comments	1.00	3.00
1) Very unsatisfactory - Support spaces are disconnected from served spaces, too small, do not meet needs 2) Unsatisfactory - Support spaces are connected, but too small, inadequate for needs 3) Average - Connected, moderate size, but need some renovations or updates to function well 4) Good - Connected, good size/layout, meets needs/functions well 5) Very good - connected, generous size, nice condition, functions appropriately N/A) Does not apply.		The gym storage is entirely insufficient.

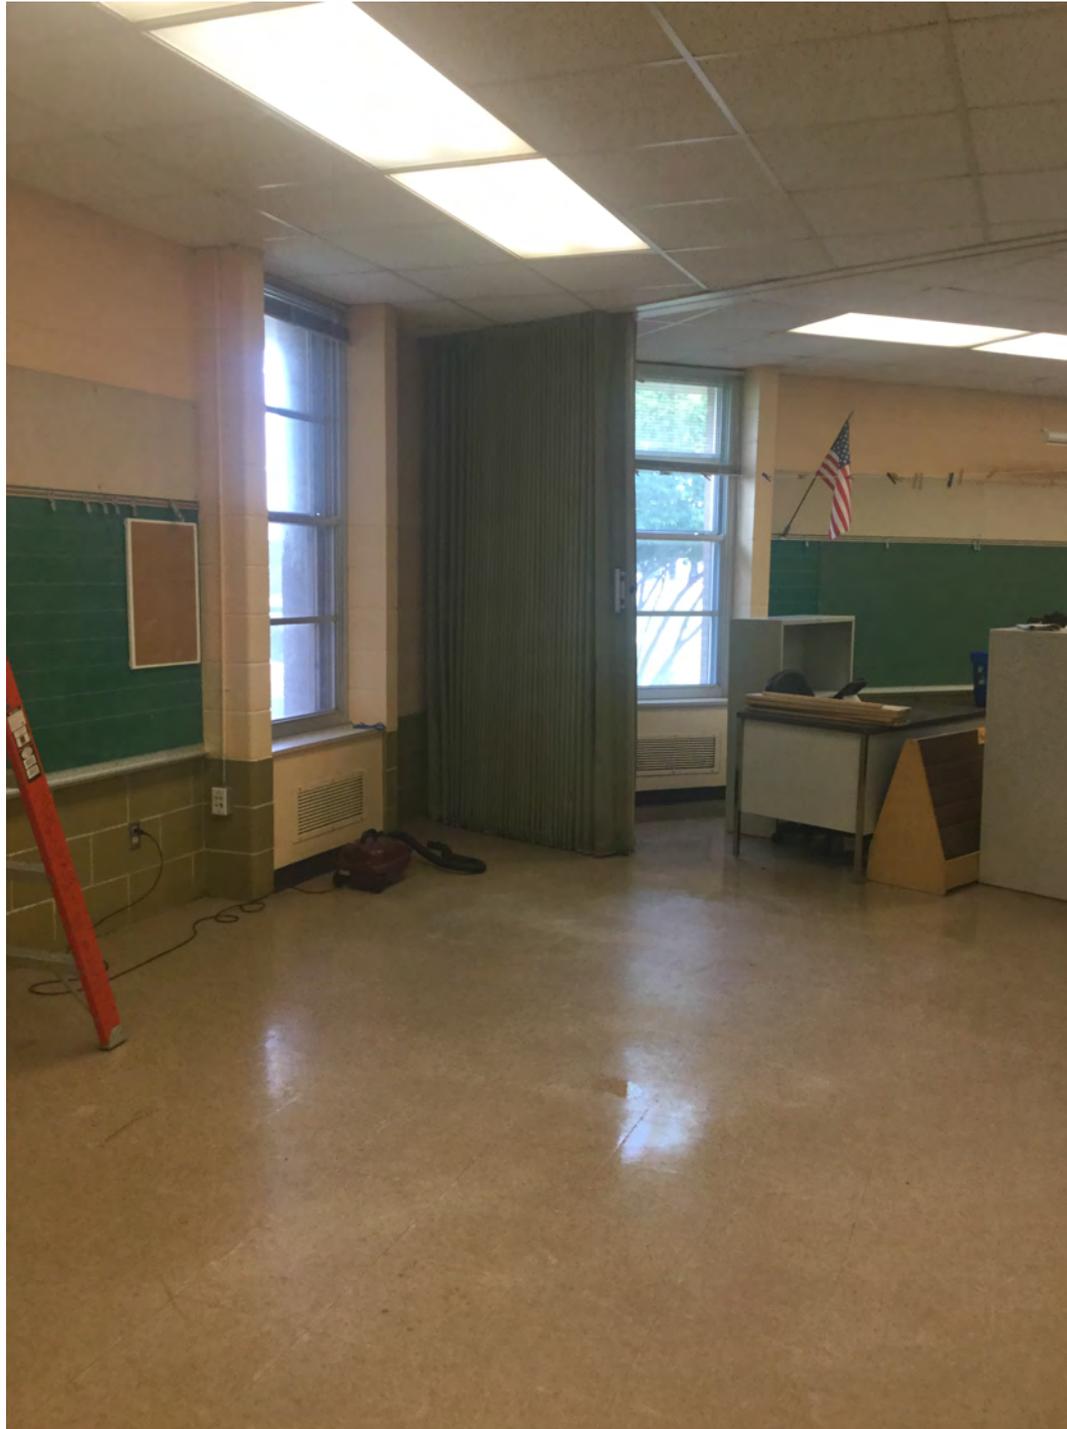
Photo 7. Accordion Wall

The majority of environmental issues occur in the 100 wing. Dated accordion walls offer virtually no acoustical value, there is an odor emanating from existing restrooms, and there is a rat infestation problem. Aside from this area of the school, the remaining spaces across campus have good access to natural daylight and views, the quality of the artificial lighting is appropriate for classroom functions, and acoustics are adequate in isolating sound from one classroom to another.

10 - Environmental Quality		1	2	3	4	5	N/A			15.00
10.1	How are acoustics in classrooms in general?		2					Comments	1.00	2.00
1) Recognized word/sound from adjacent classroom/corridor 2) audible sound from adjacent classroom/corridor 3) slight sound from outside room 4) walls to deck insulated only white noise from mechanical system 5) Able to hear quiet speaking from across the room N/A) Does not apply.		The 100 wing has very poor acoustics due to accordion partitions that have minimal acoustical value.
