## Educational Suitability Summary Report

Oak Springs Elementary School – BLDG #125

Date: 8/11/2016

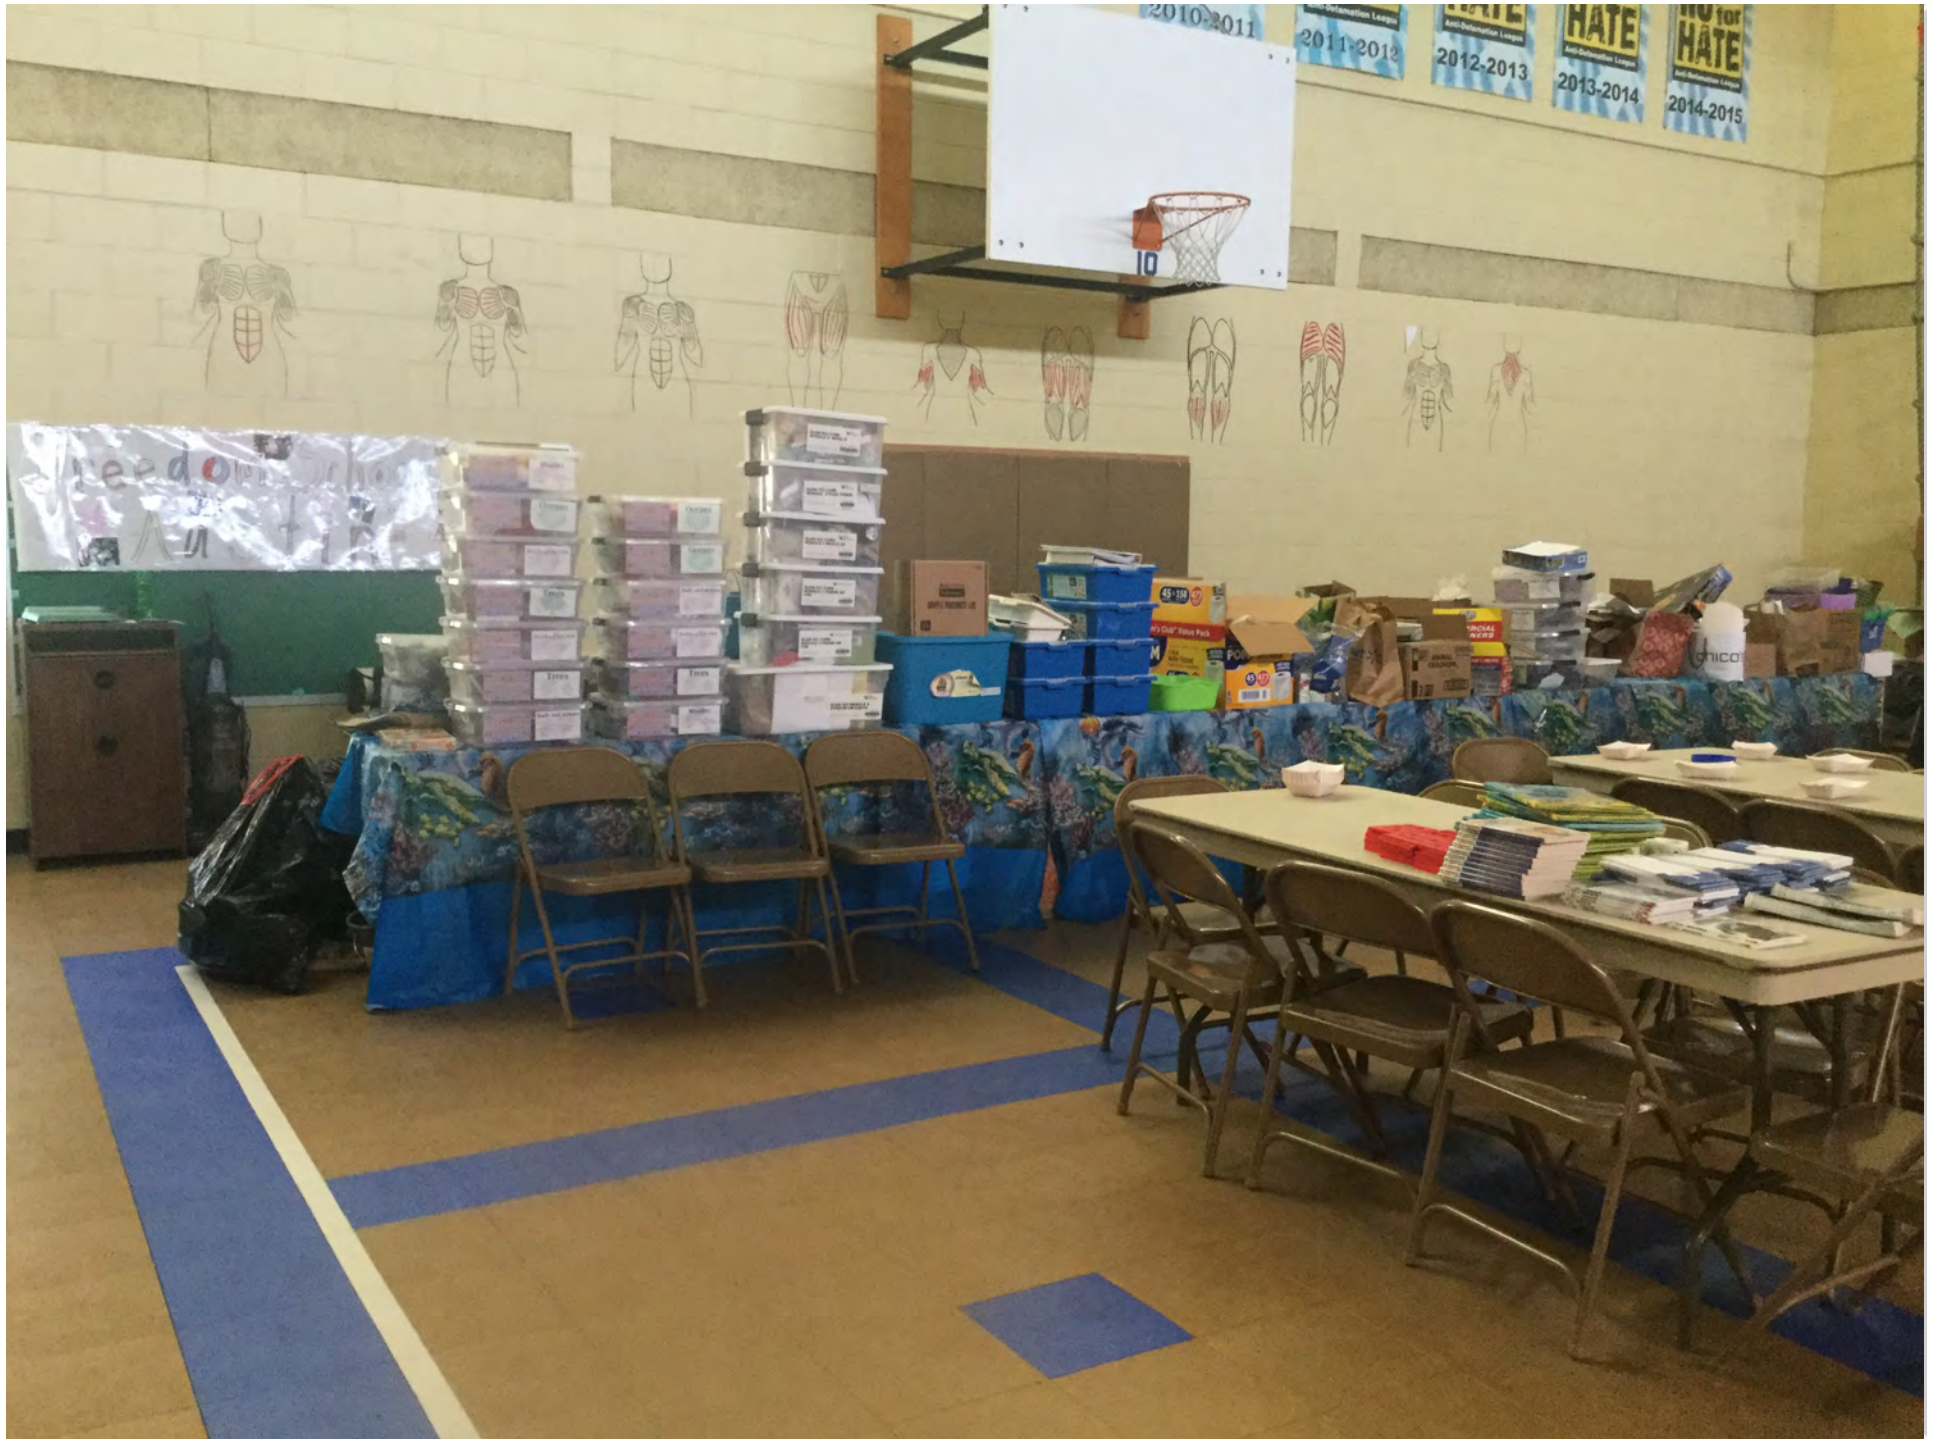
Photo 2. Gym

The gym is appropriately sized and equipped. The only issues present are paint peeling off the walls and lighting quality. The principal reports that the lighting takes a long time to power up. Existing lights also generate a very loud buzzing noise which causes staff to turn lights off for most functions.

1) Very unsatisfactory 2) Unsatisfactory 3) Average 4) Good 5) Very good N/A) Does not apply.	The gym is small and not very flexible. The lighting makes an extremely loud buzzing noise.

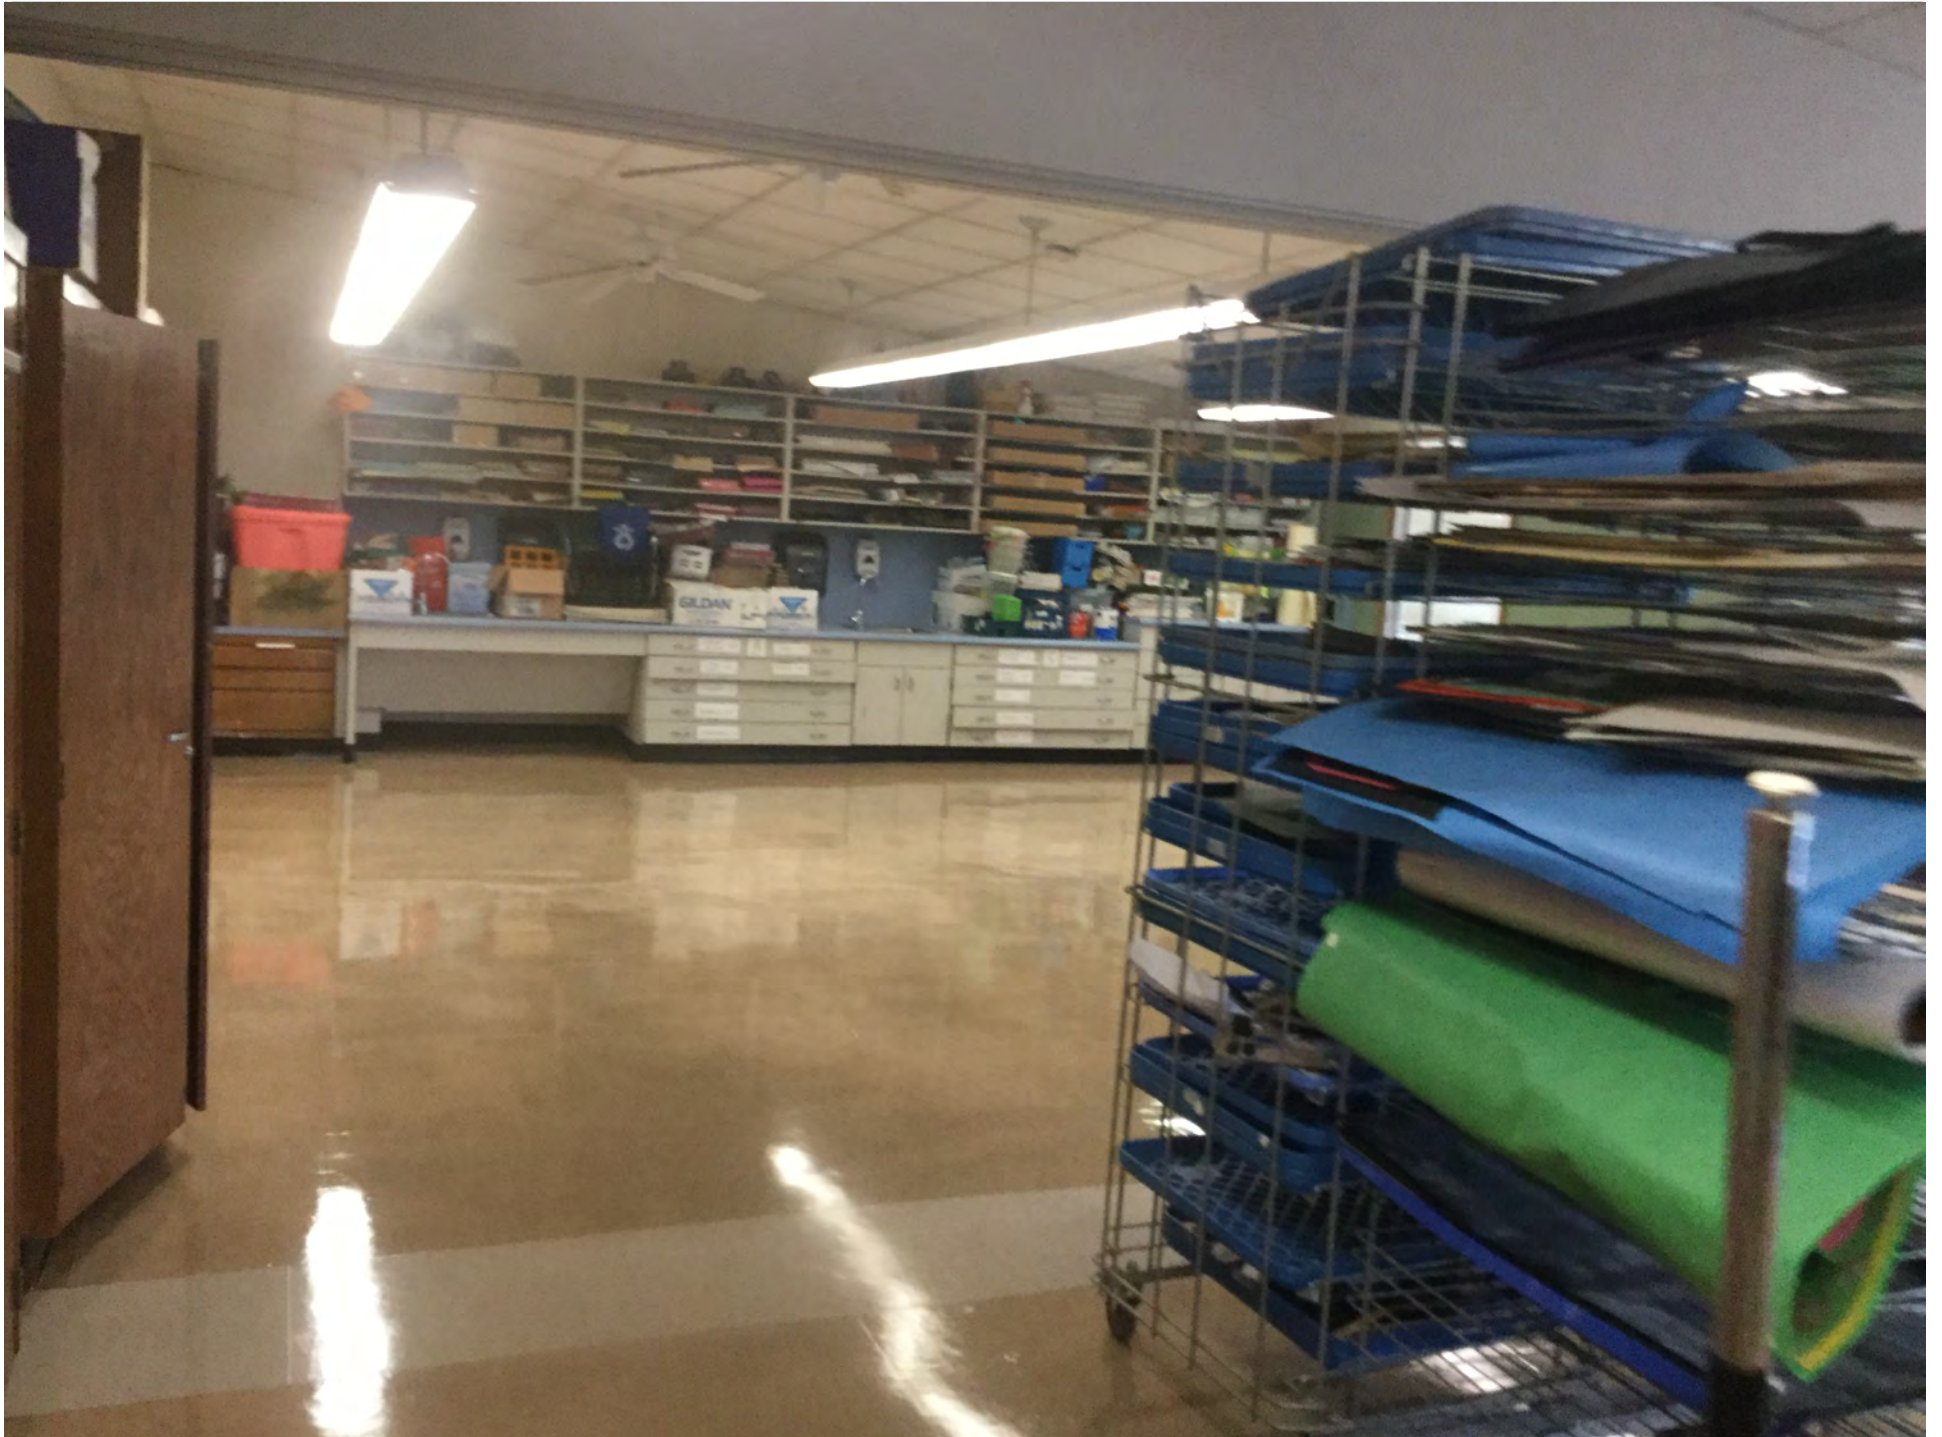
Photo 3. Art room

3 - Academic & Co-Curricular Support - Continued		1	2	3	4	5	N/A		
3.10	Are Visual Arts spaces appropriately configured per the ed spec?				4				<div>Comments</div> <div>1.00 4.00</div>
<div> 1) Very unsatisfactory  2) Unsatisfactory  3) Average  4) Good  5) Very good  N/A) Does not apply. </div>								The art room is very spacious but needs more sinks and available display space.

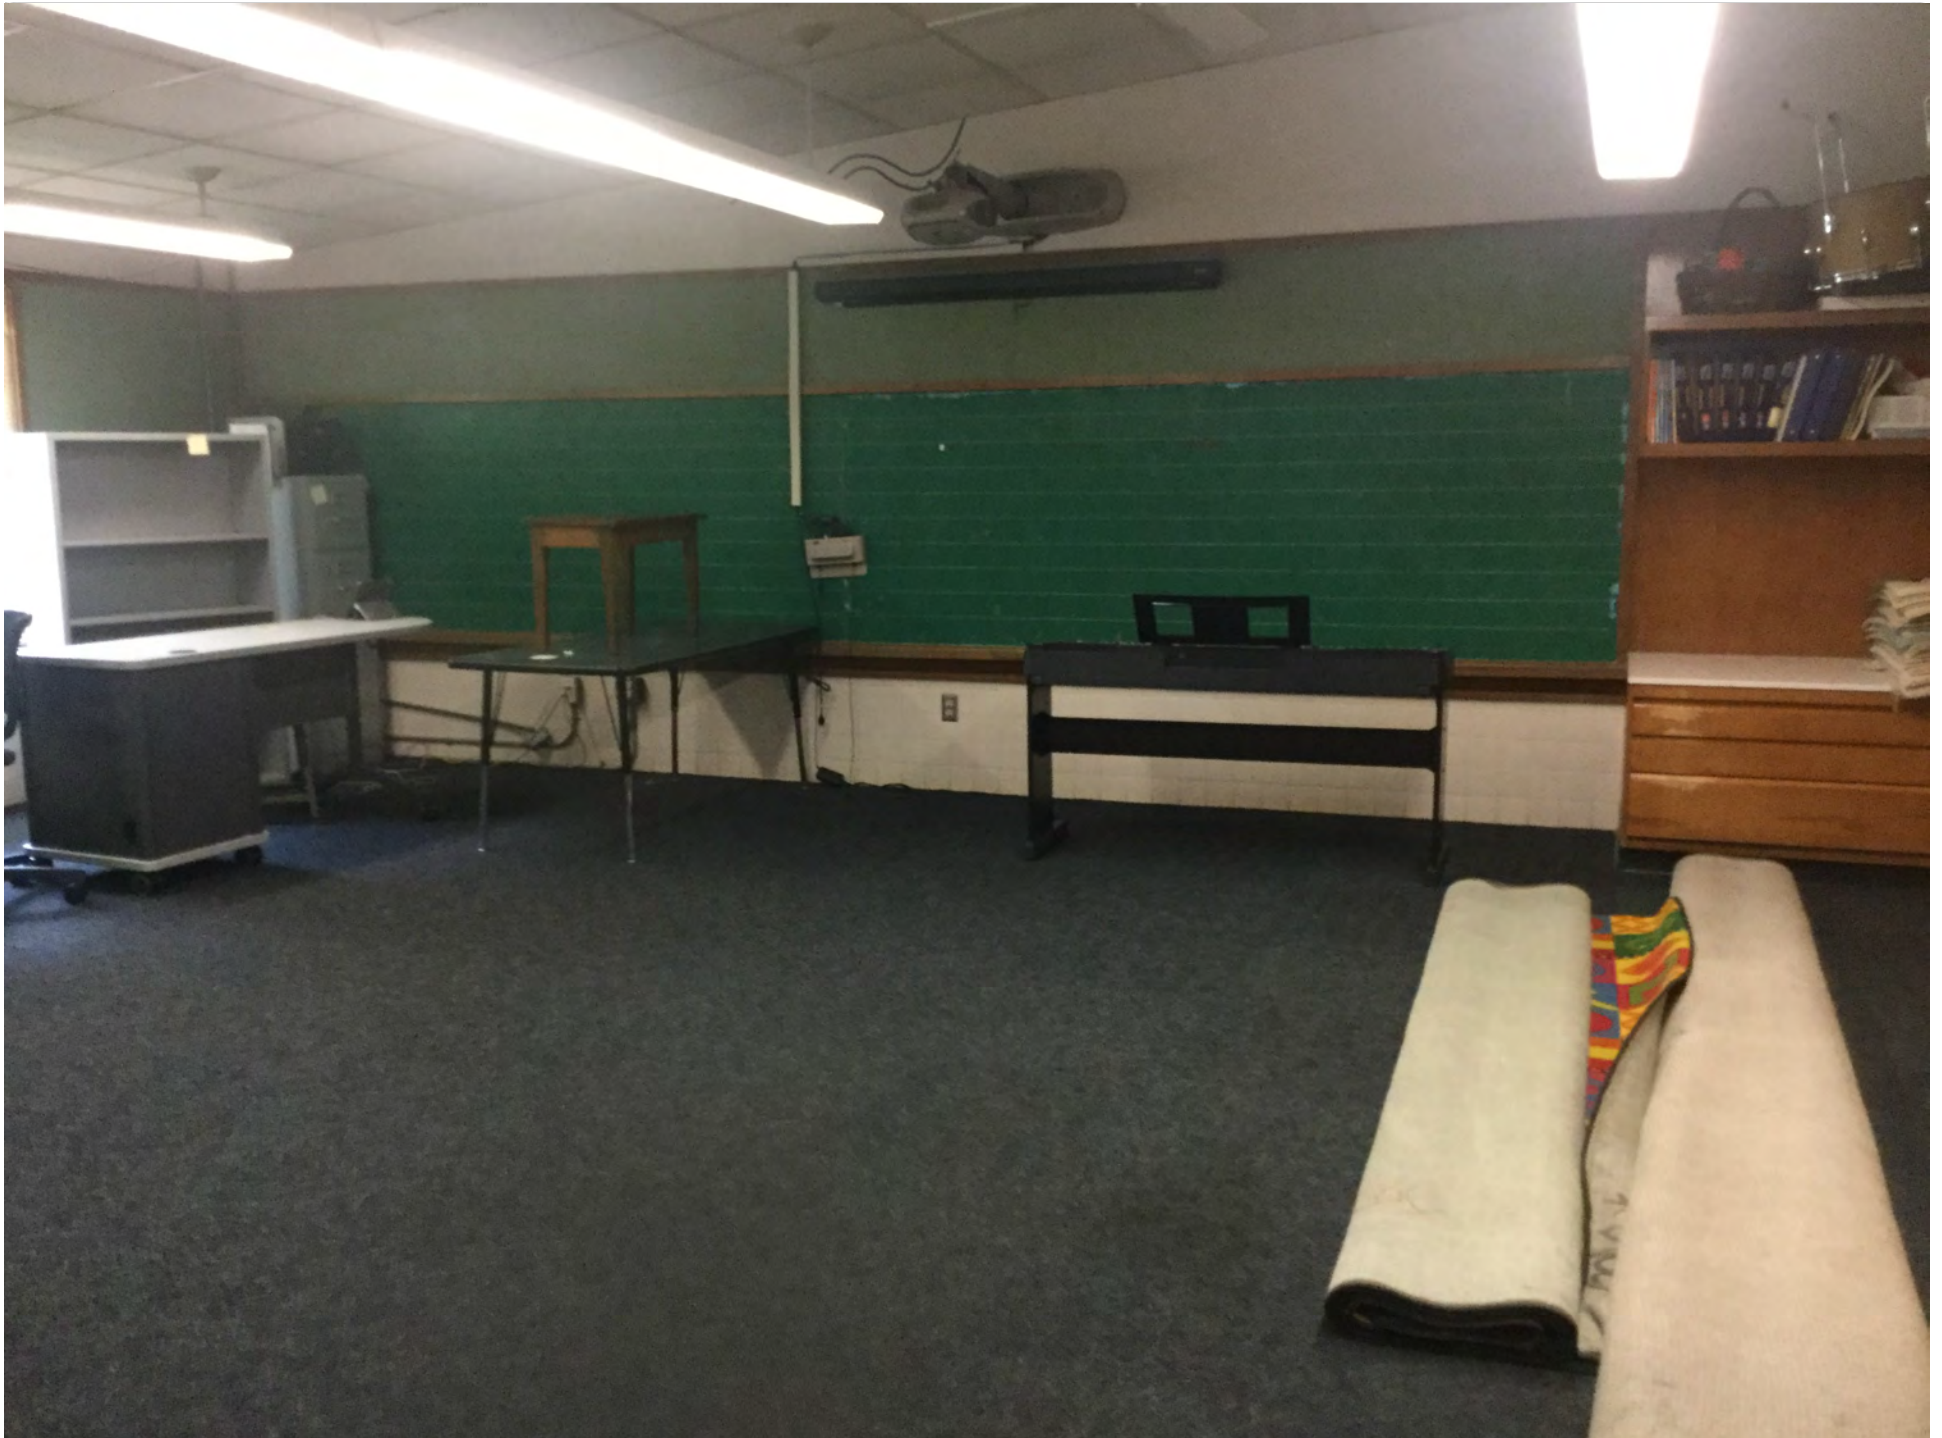
Photo 4.Music Room

The music and art programs occur in standard classrooms that do not meet ed specs. Choir risers are requested to serve the programs needs.

3.8	Are music, drama, or performance spaces appropriately configured per the ed spec?		2										Comments	1.00 <b>2.00</b>
	1) Very unsatisfactory 2) Unsatisfactory 3) Average 4) Good 5) Very good N/A) Does not apply.	Music is held in a standard classroom and does not have adequate equipment.

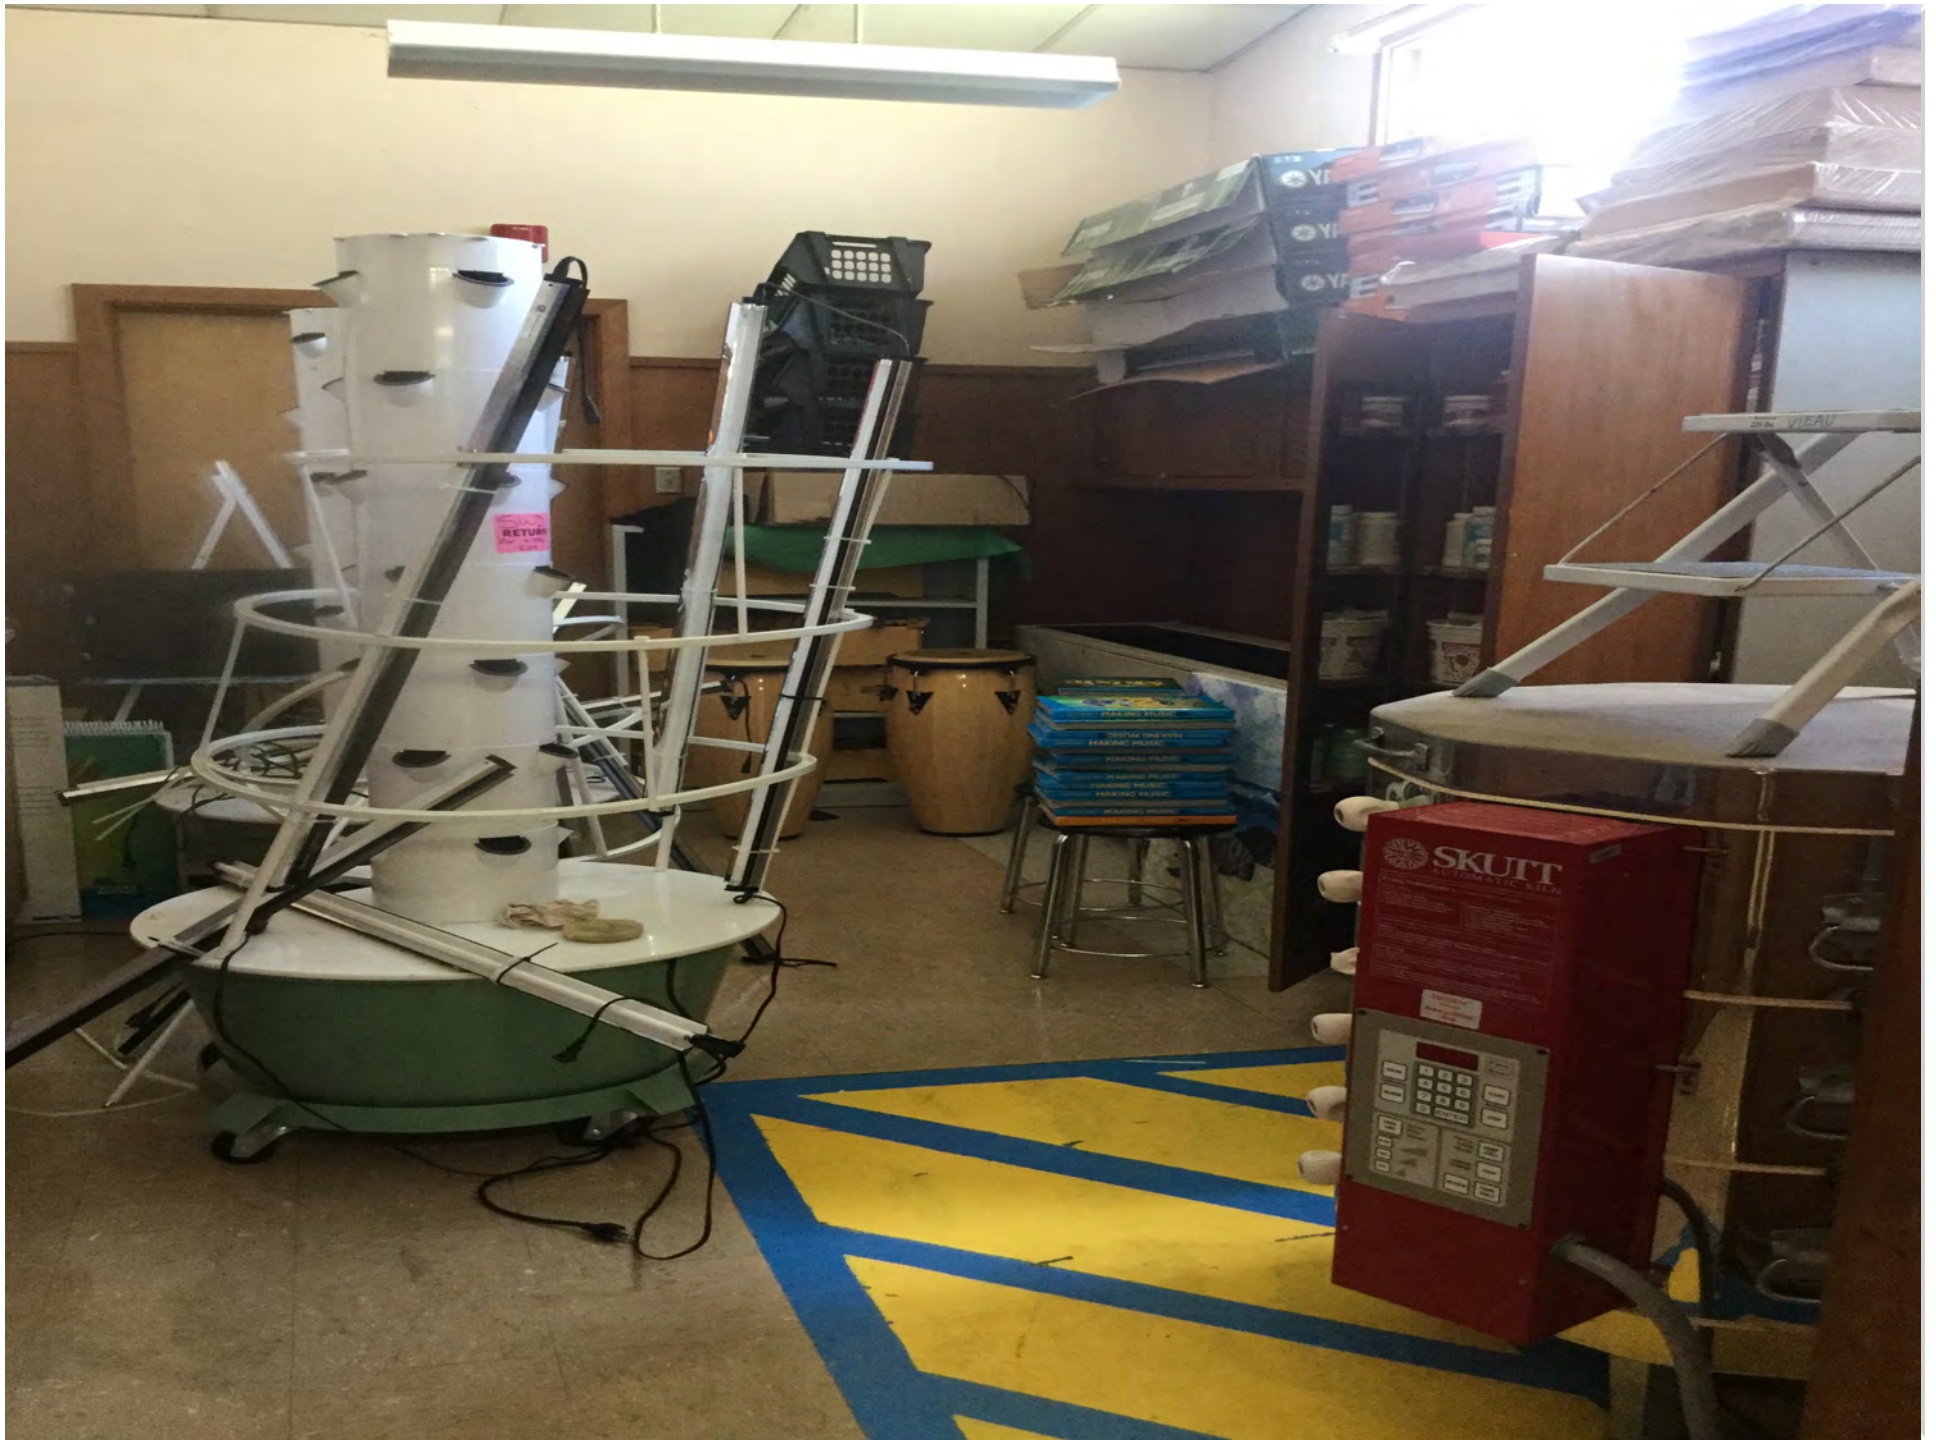
Photo 5. Music and art storage

3.9	Are music, drama, or performance <b>support</b> spaces appropriately configured per the ed spec?		2										Comments	1.00 <b>2.00</b>
	1) Very unsatisfactory - Support spaces are disconnected from served spaces, too small, do not meet needs 2) Unsatisfactory - Support spaces are connected, but too small, inadequate 3) Average - Connected, moderate size, but need some renovations or updates to function well 4) Good - Connected, good size/layout, meets needs/functions well 5) Very good - connected, generous size, nice condition, functions appropriately N/A) Does not apply.	Music room storage shares space with the art kiln room.

3.11	Are Visual Arts <b>support</b> spaces appropriately configured per the ed spec?		2						<div>Comments</div> <div>1.00 2.00</div>
<div> 1) Very unsatisfactory - Support spaces are disconnected from served spaces, too small, do not meet needs  2) Unsatisfactory - Support spaces are connected, but too small, inadequate  3) Average - Connected, moderate size, but need some renovations or updates to function well  4) Good - Connected, good size/layout, meets needs/functions well  5) Very good - connected, generous size, nice condition, functions appropriately  N/A) Does not apply. </div>								Music room storage shares space with the art kiln room.

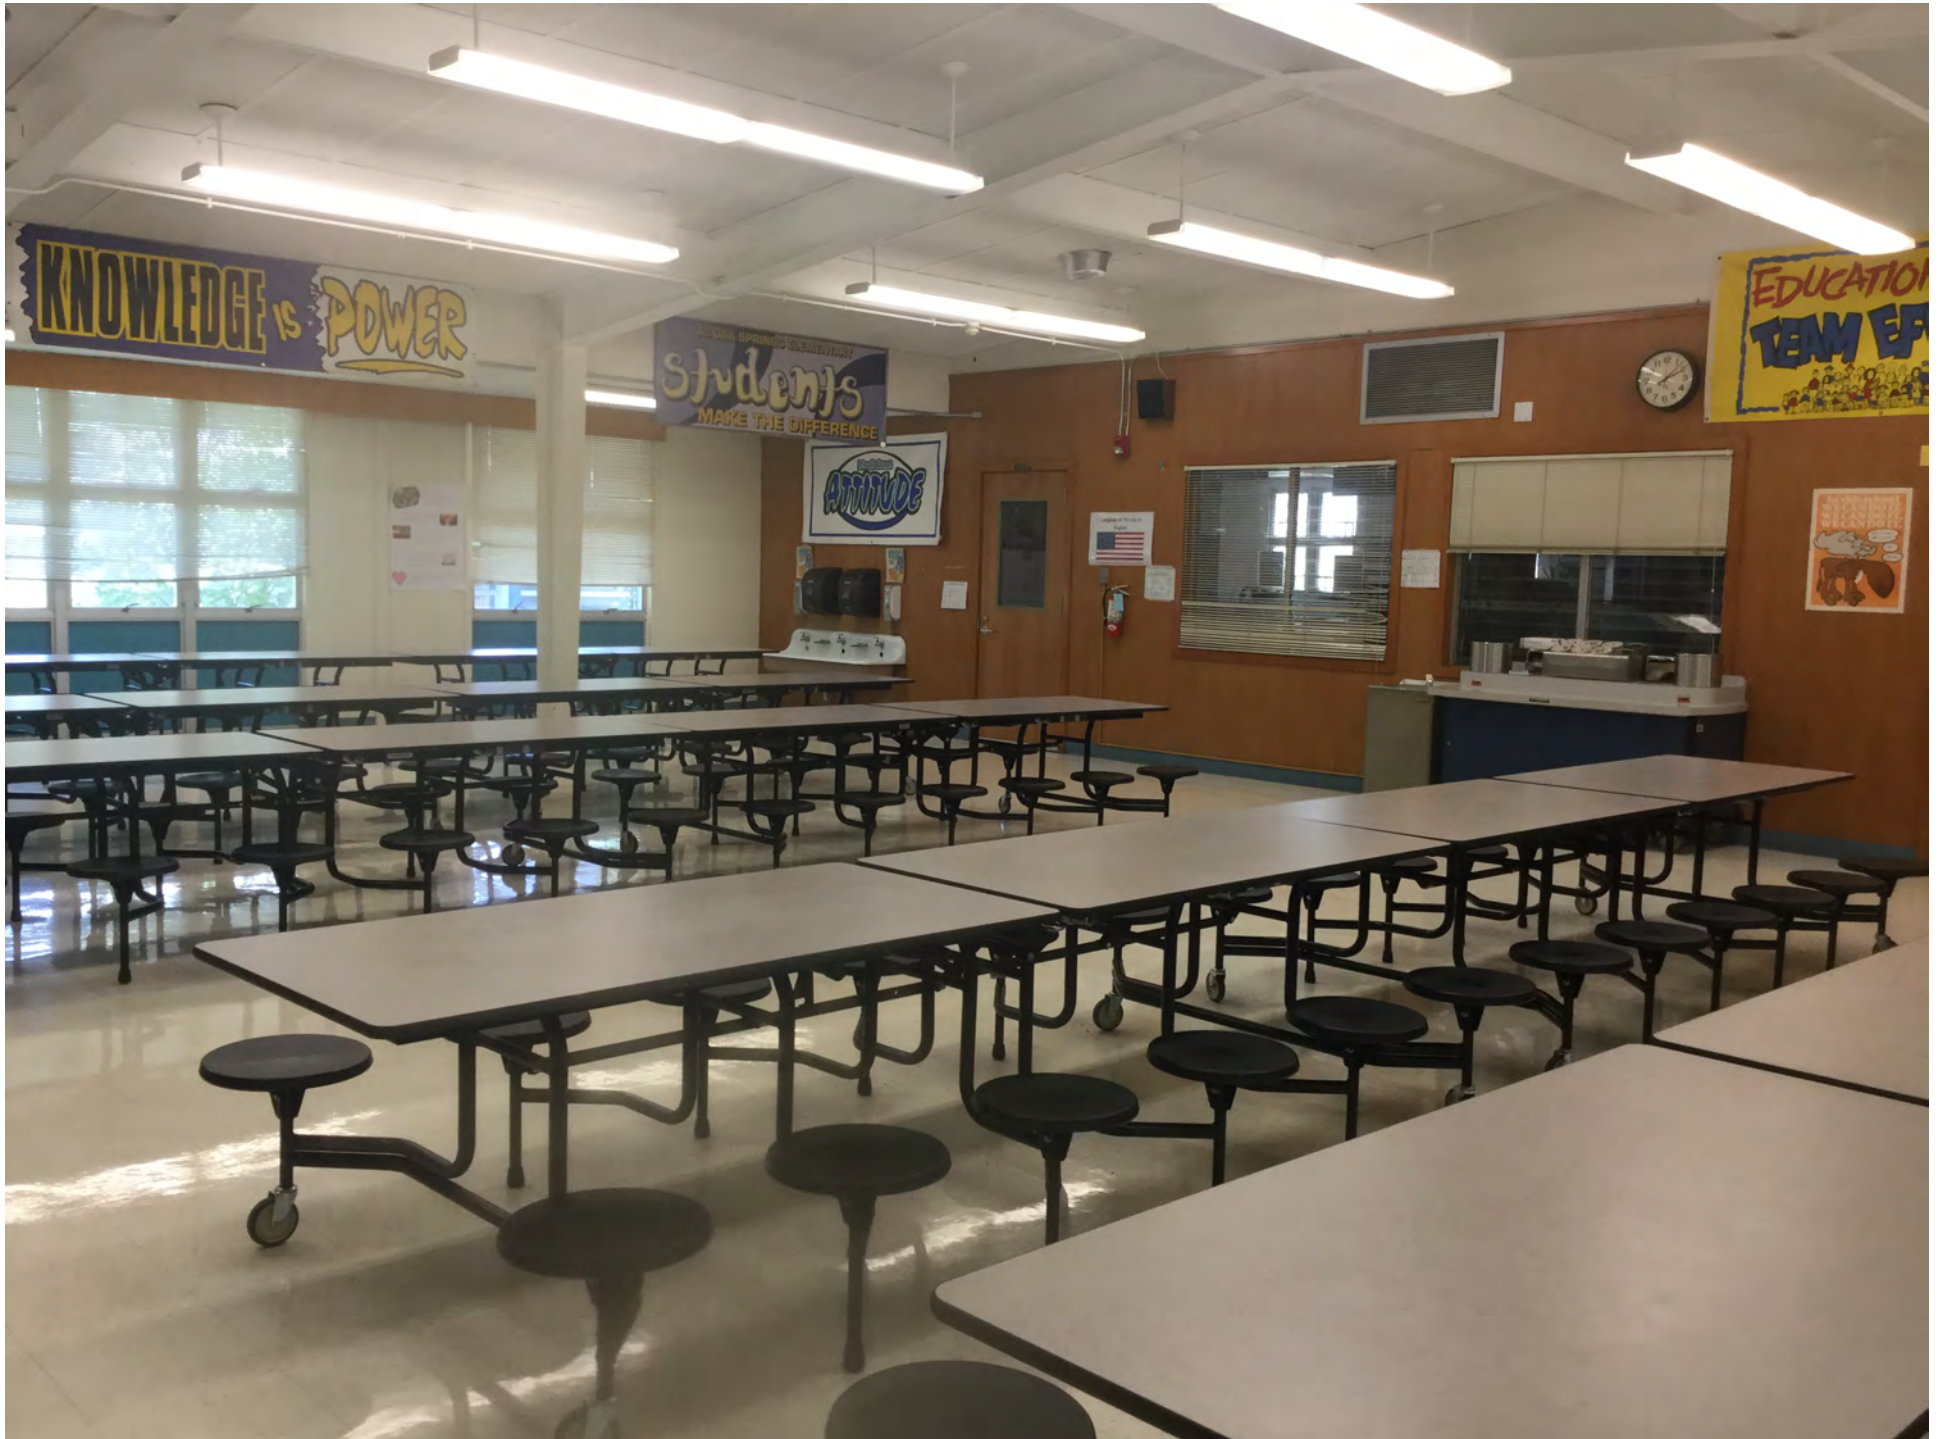
Photo 6. Cafeterium

The cafeteria is currently sized to accommodate student lunch periods, but it is very tight. The space is undersized when considering assembly purposes. The promotion ceremony is currently held at ACC. The stage is missing a lift and is not ADA compliant. Flooring in the cafeteria should also be improved and made to more appropriately accommodate the ballet program that operates out of the space. Lastly, the kitchen needs equipment and space updates in order to function properly.

3.16	Are the student dining facilities appropriately configured?		2					Comments	1.00 <b>2.00</b>
1) Very unsatisfactory - Too small, poor circulation, inflexible seating in poor condition 2) Unsatisfactory - Too small or inadequate circulation, seating in poor condition 3) Average - moderate size, with adequate circulation, seating in okay condition 4) Good - good size, adequate circulation, seating in good condition 5) Very good - good size, adequate circulation, seating in good condition, with more than one option for eating space (ex: connection to outdoor eating space) N/A) Does not apply.								The seating is inadequate. Student capacity is maxed out. Space does not function well for assembly uses.

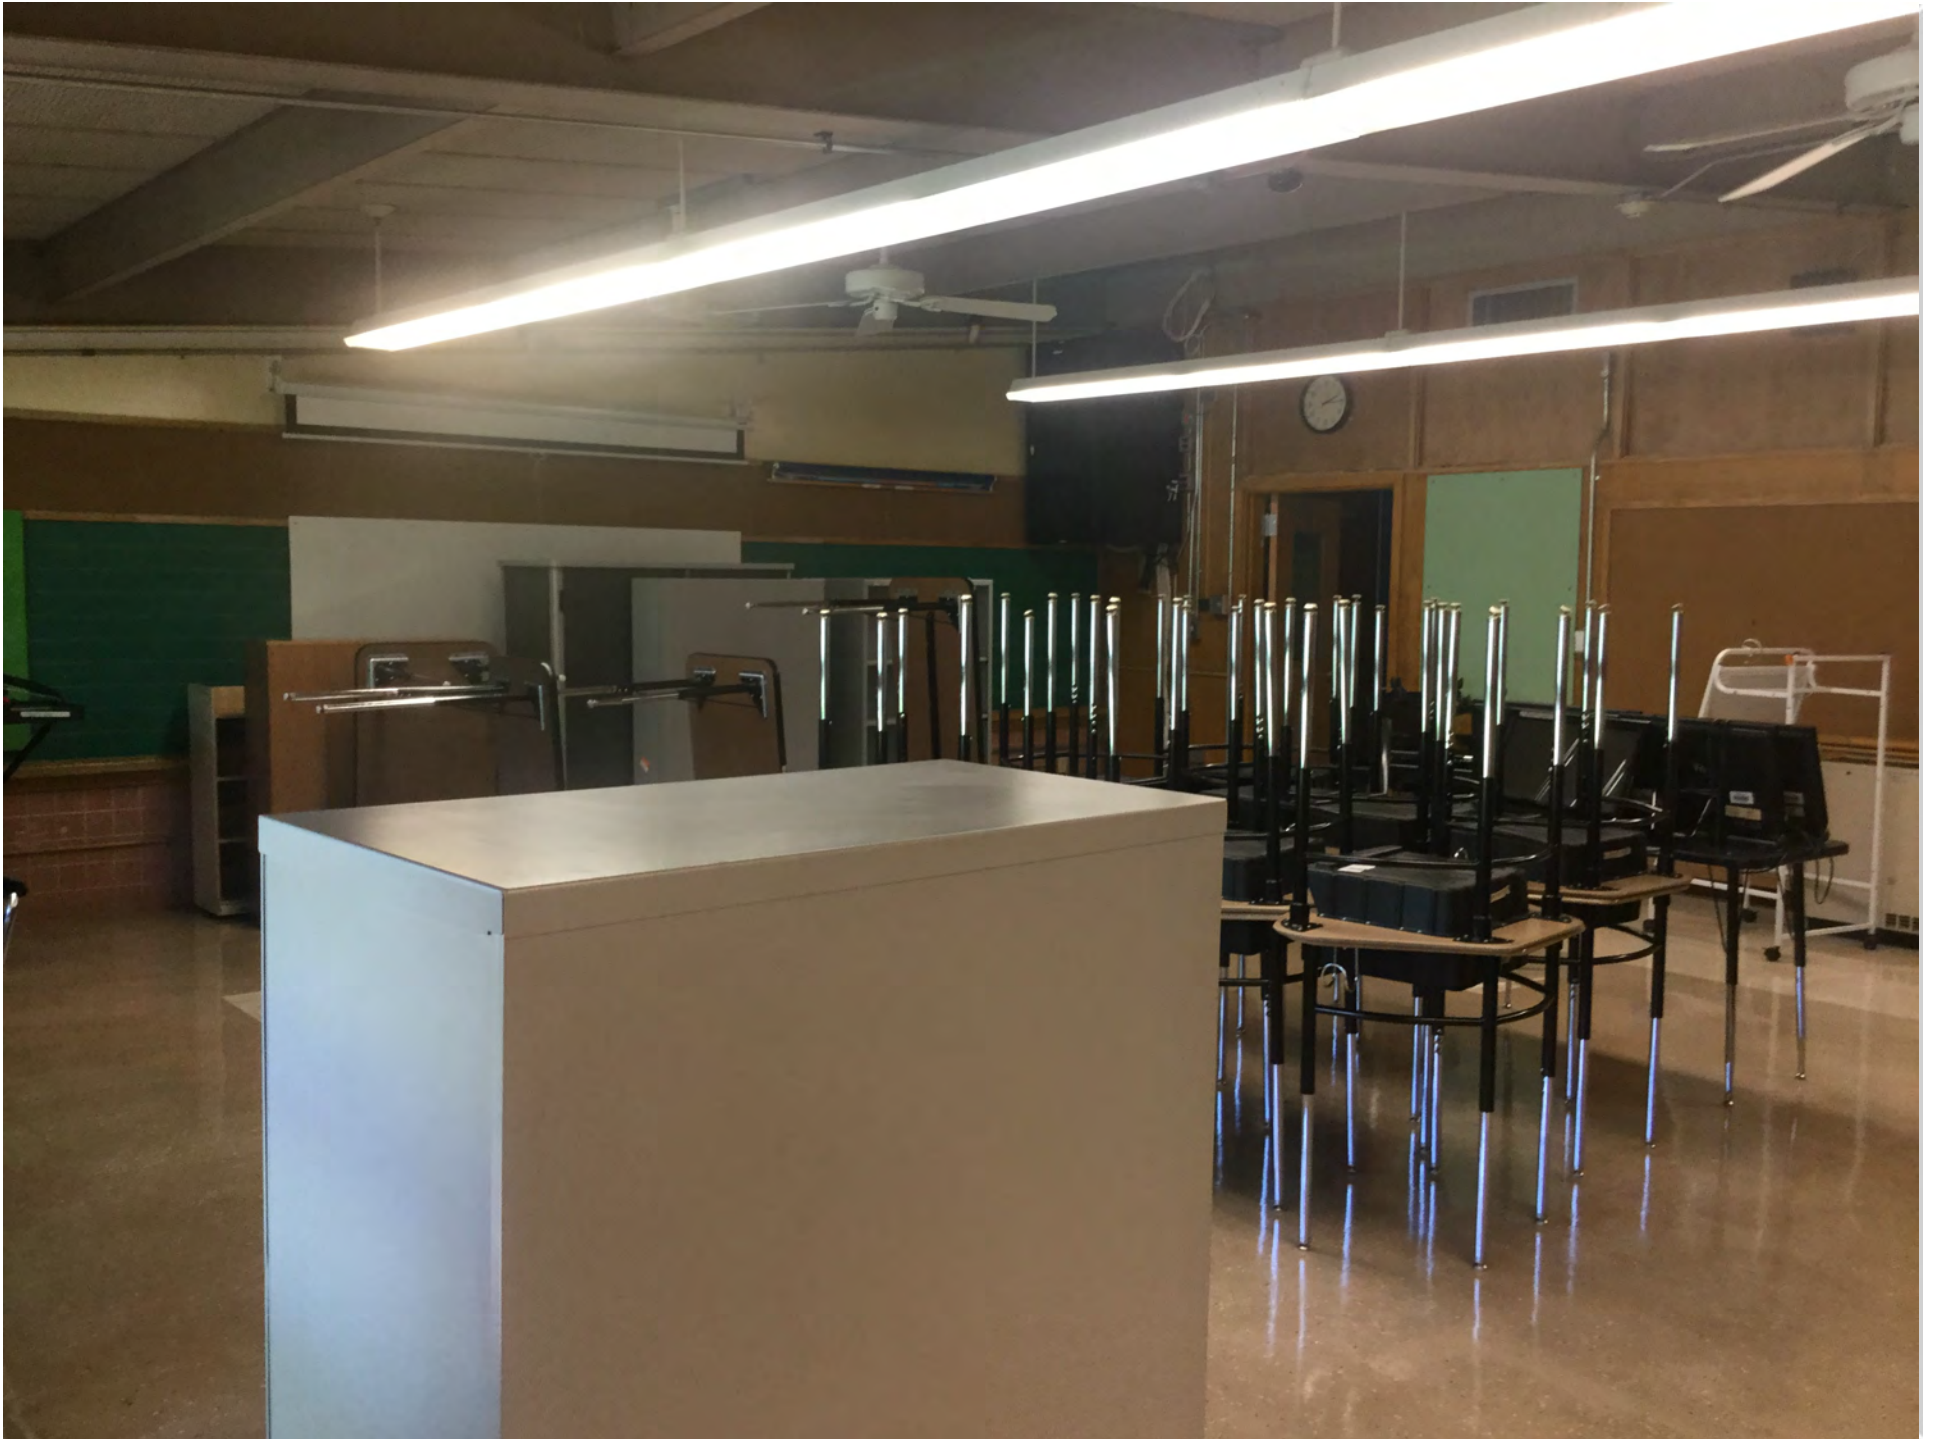
Photo 7. Standard Classroom

Core classrooms are adequate in size, but would benefit from cosmetic upgrades. Technologies are also lacking in classrooms. Newer projectors or innovation stations (smart boards preferred) are needed. Pre-k sinks are not at optimal heights for student use. The ACE program is currently housed in a standard classroom. First graders and PPCD are housed in portables, which is not ideal. Lastly, there are not enough spaces for after school programs, tutorials, and off-hours classes.

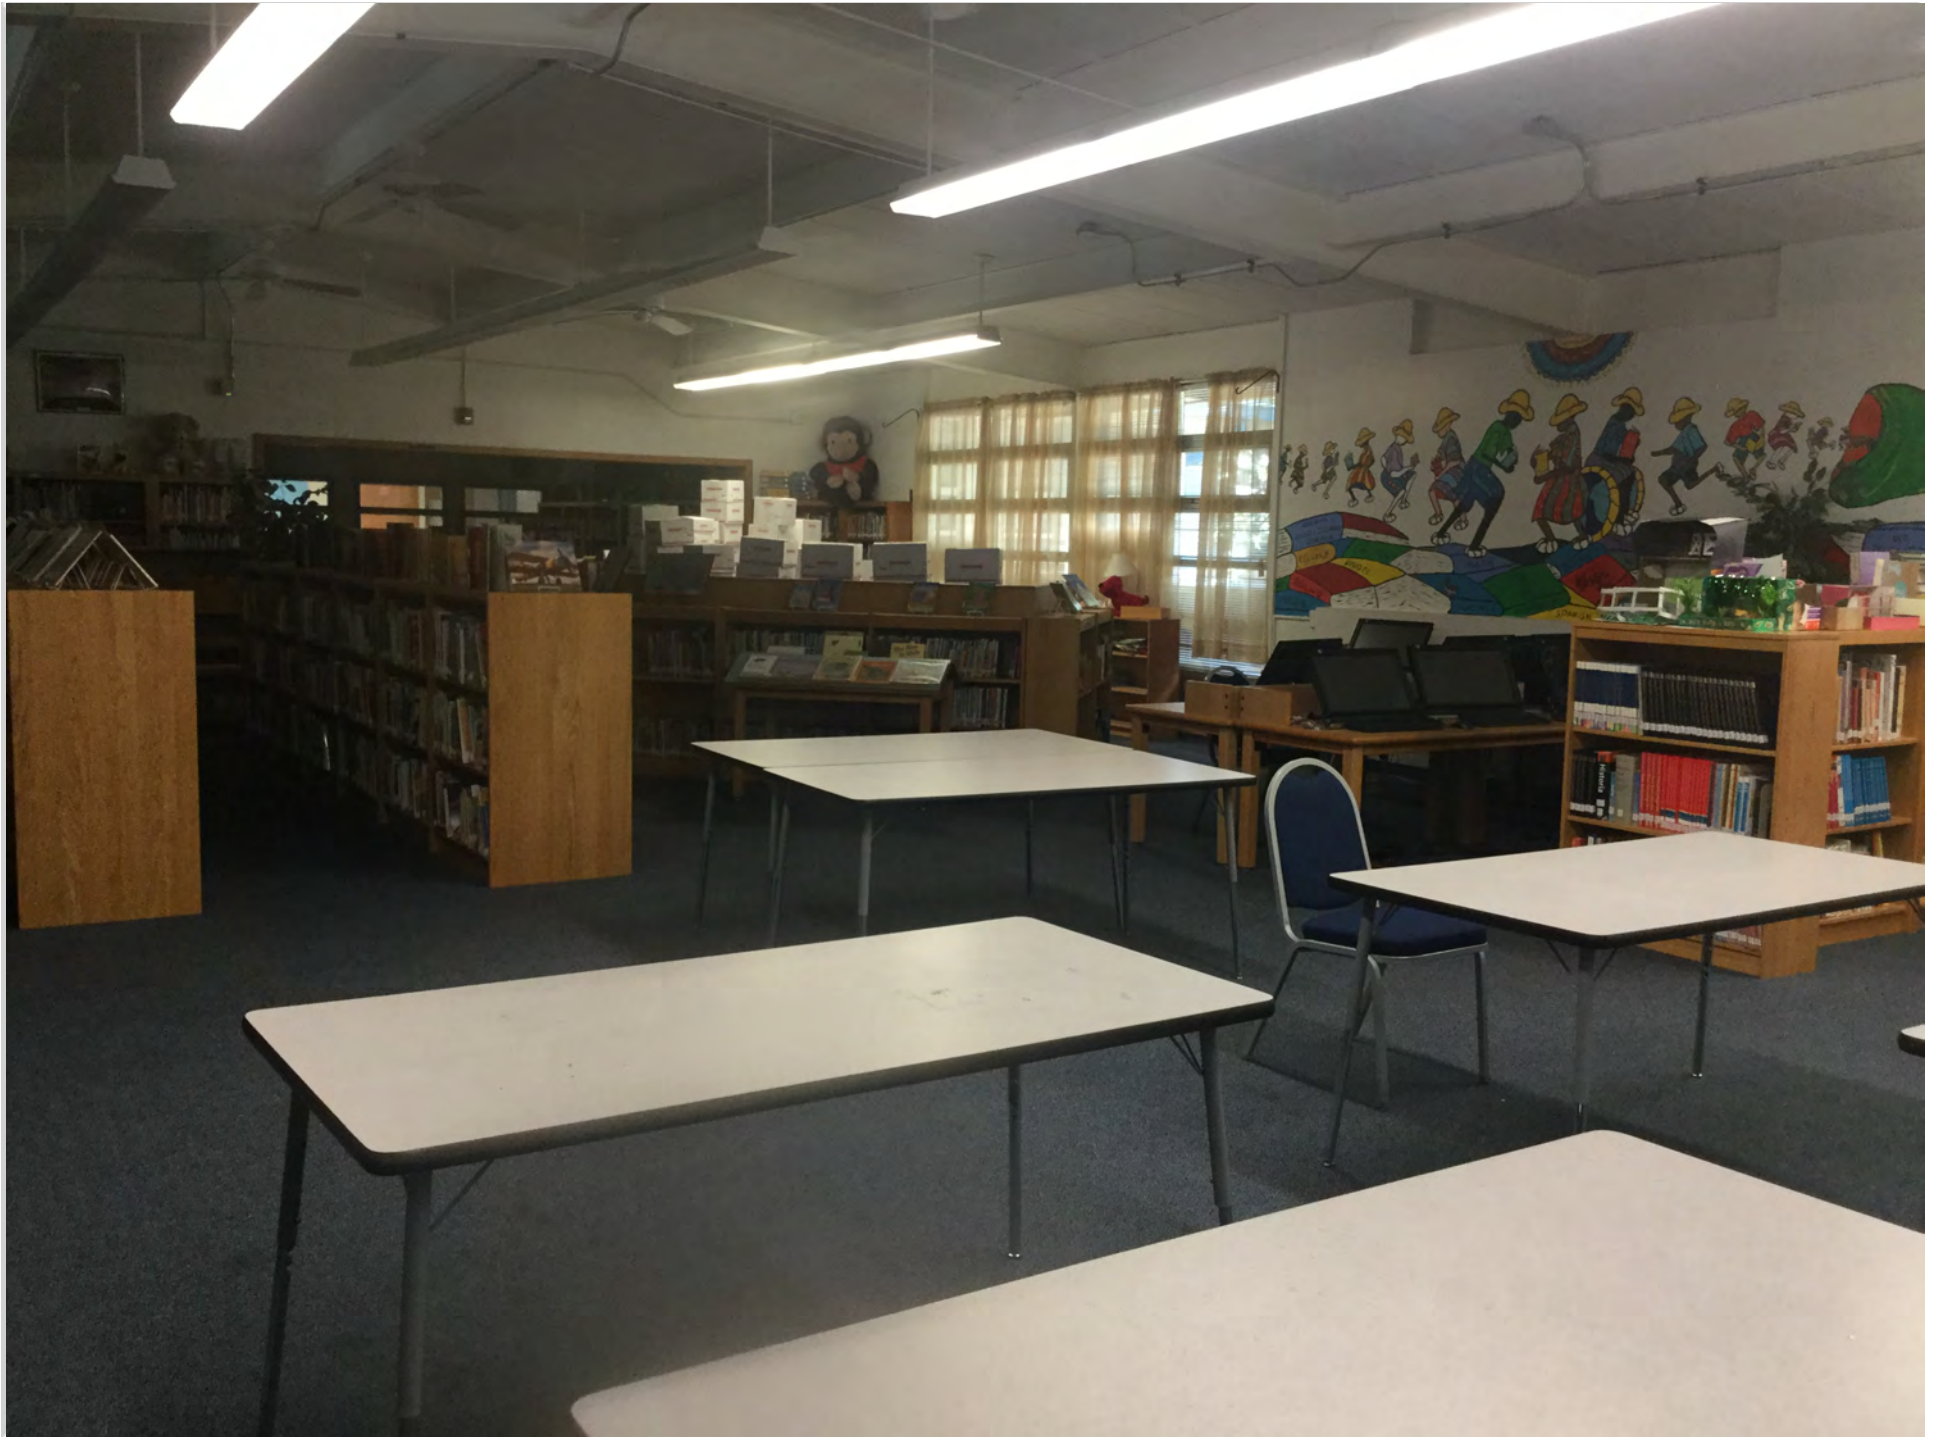
Photo 9. Library

The library was recently expanded to absorb the adjacent music room. As such, space is not a primary concern. The condition and flexibility of furniture is not adequate. It is also noted that there is no dedicated literacy library as this function shares space with the computer lab. A dedicated conference room is also needed as meetings in the library regularly take priority and limit student access throughout the day. Lastly, a media room is needed to support several functions.

1) Very unsatisfactory 2) Unsatisfactory 3) Average 4) Good 5) Very good N/A) Does not apply.								The library is very small and congested. It would be hard to maintain large groups in the room comfortably.
