## Educational Suitability Summary Report

Oak Springs Elementary School – BLDG #125

Date: 8/11/2016

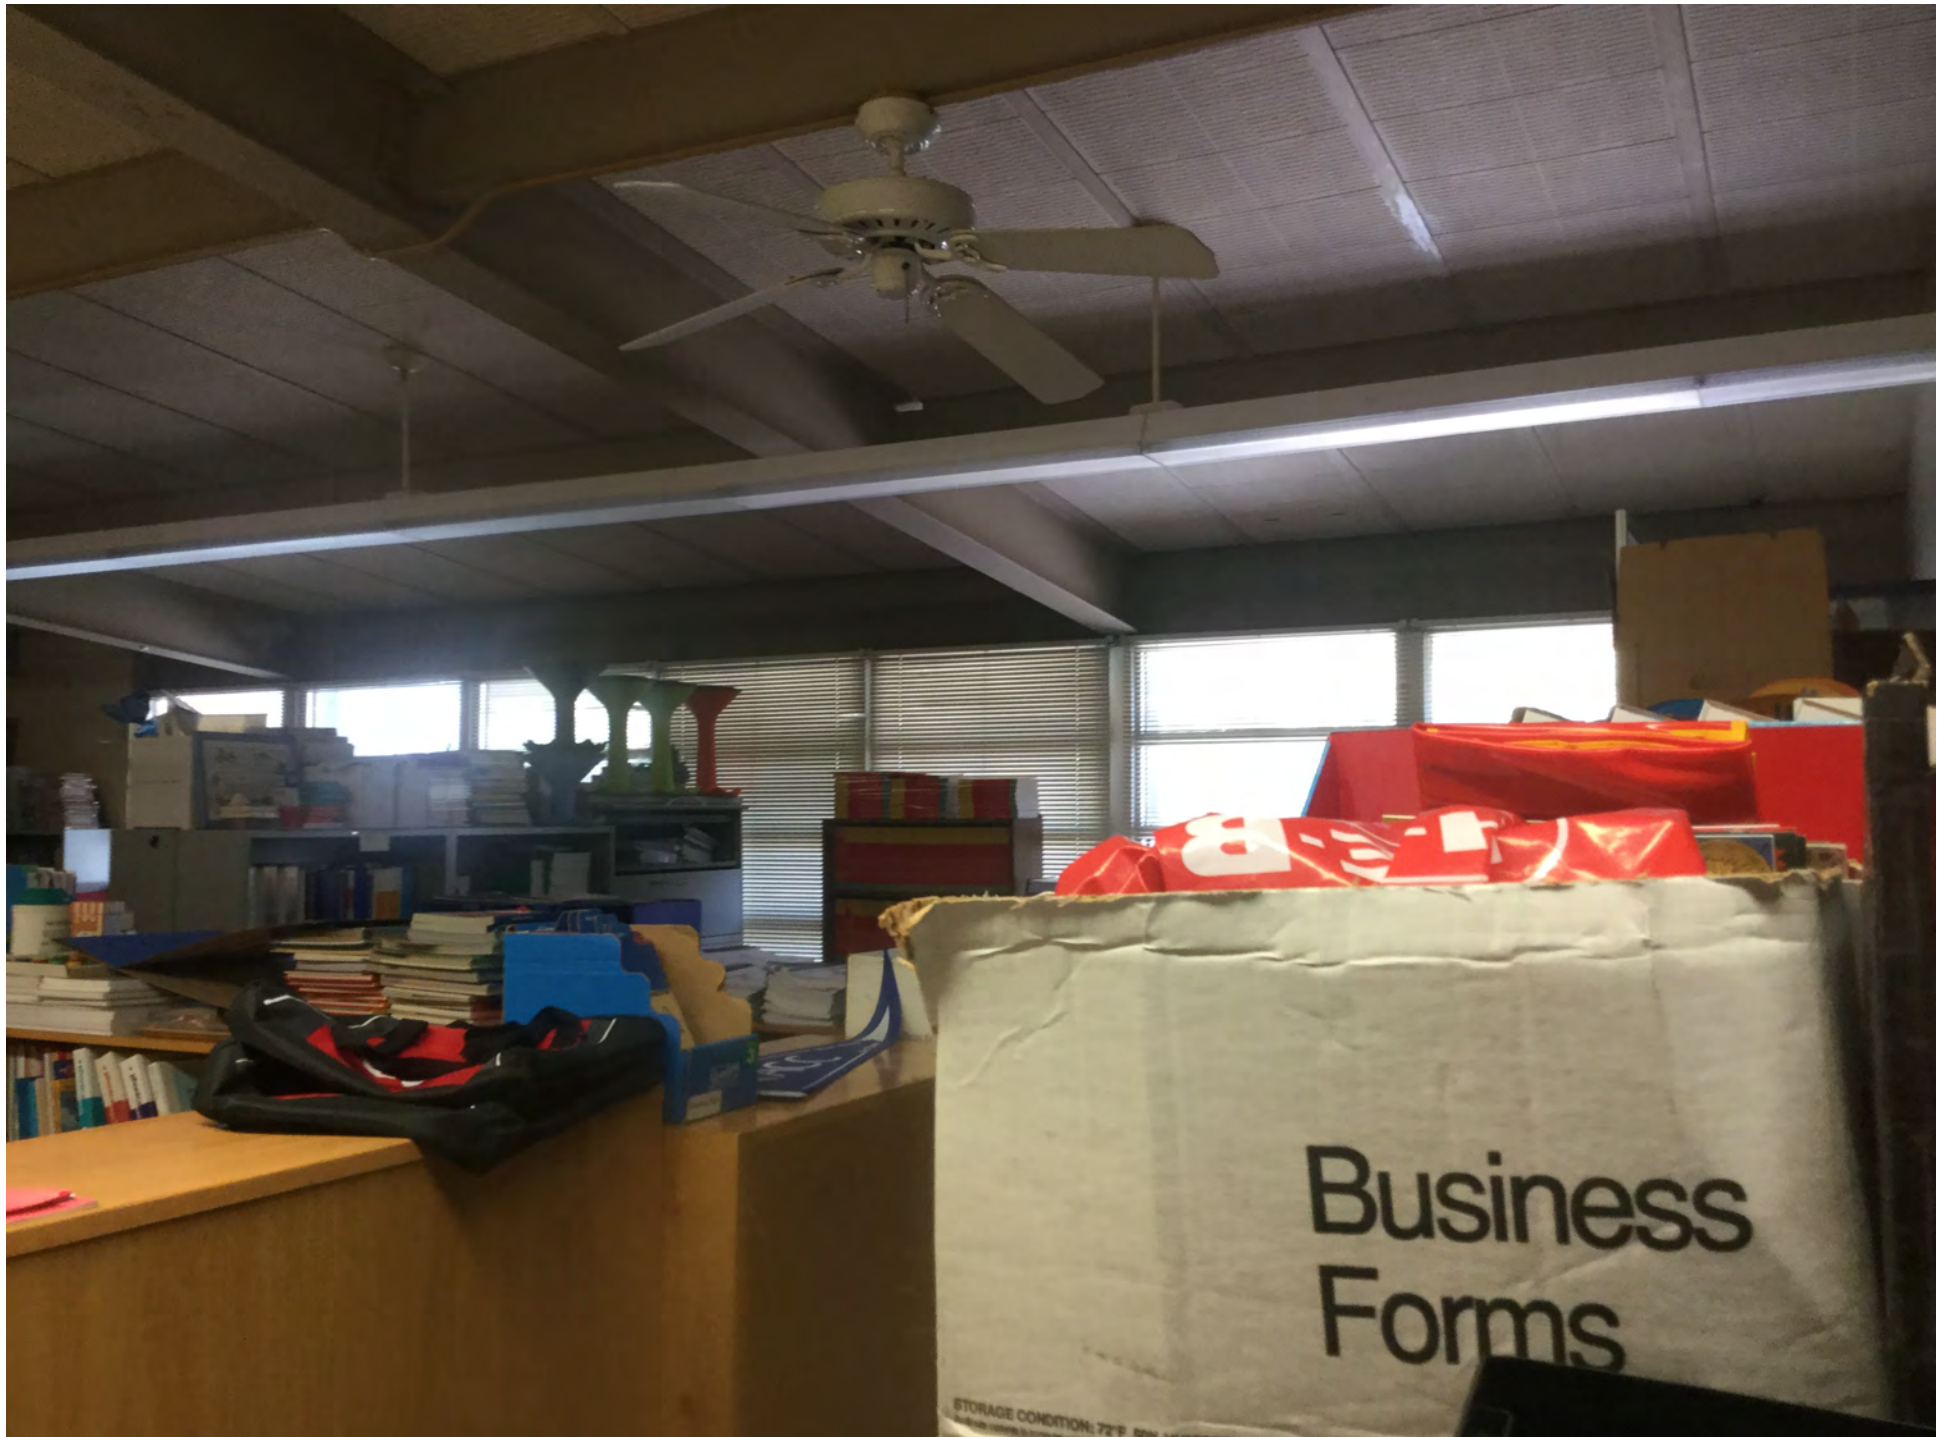
Photo 10. storage Lit  
Library

Technology quality and quantity are inadequate. Classroom technologies (projectors, innovation stations, etc.) are dated, limited in number, or poorly functioning. The existing computer room is cramped and doubles as a literacy storage.
