Educational Suitability Summary Report

Padron Elementary School

Date: 07/25/2016

School	Padron ES	BLDG - 188
Name	John Eldred + Ellen Saathoff	
Date	7/25/2016

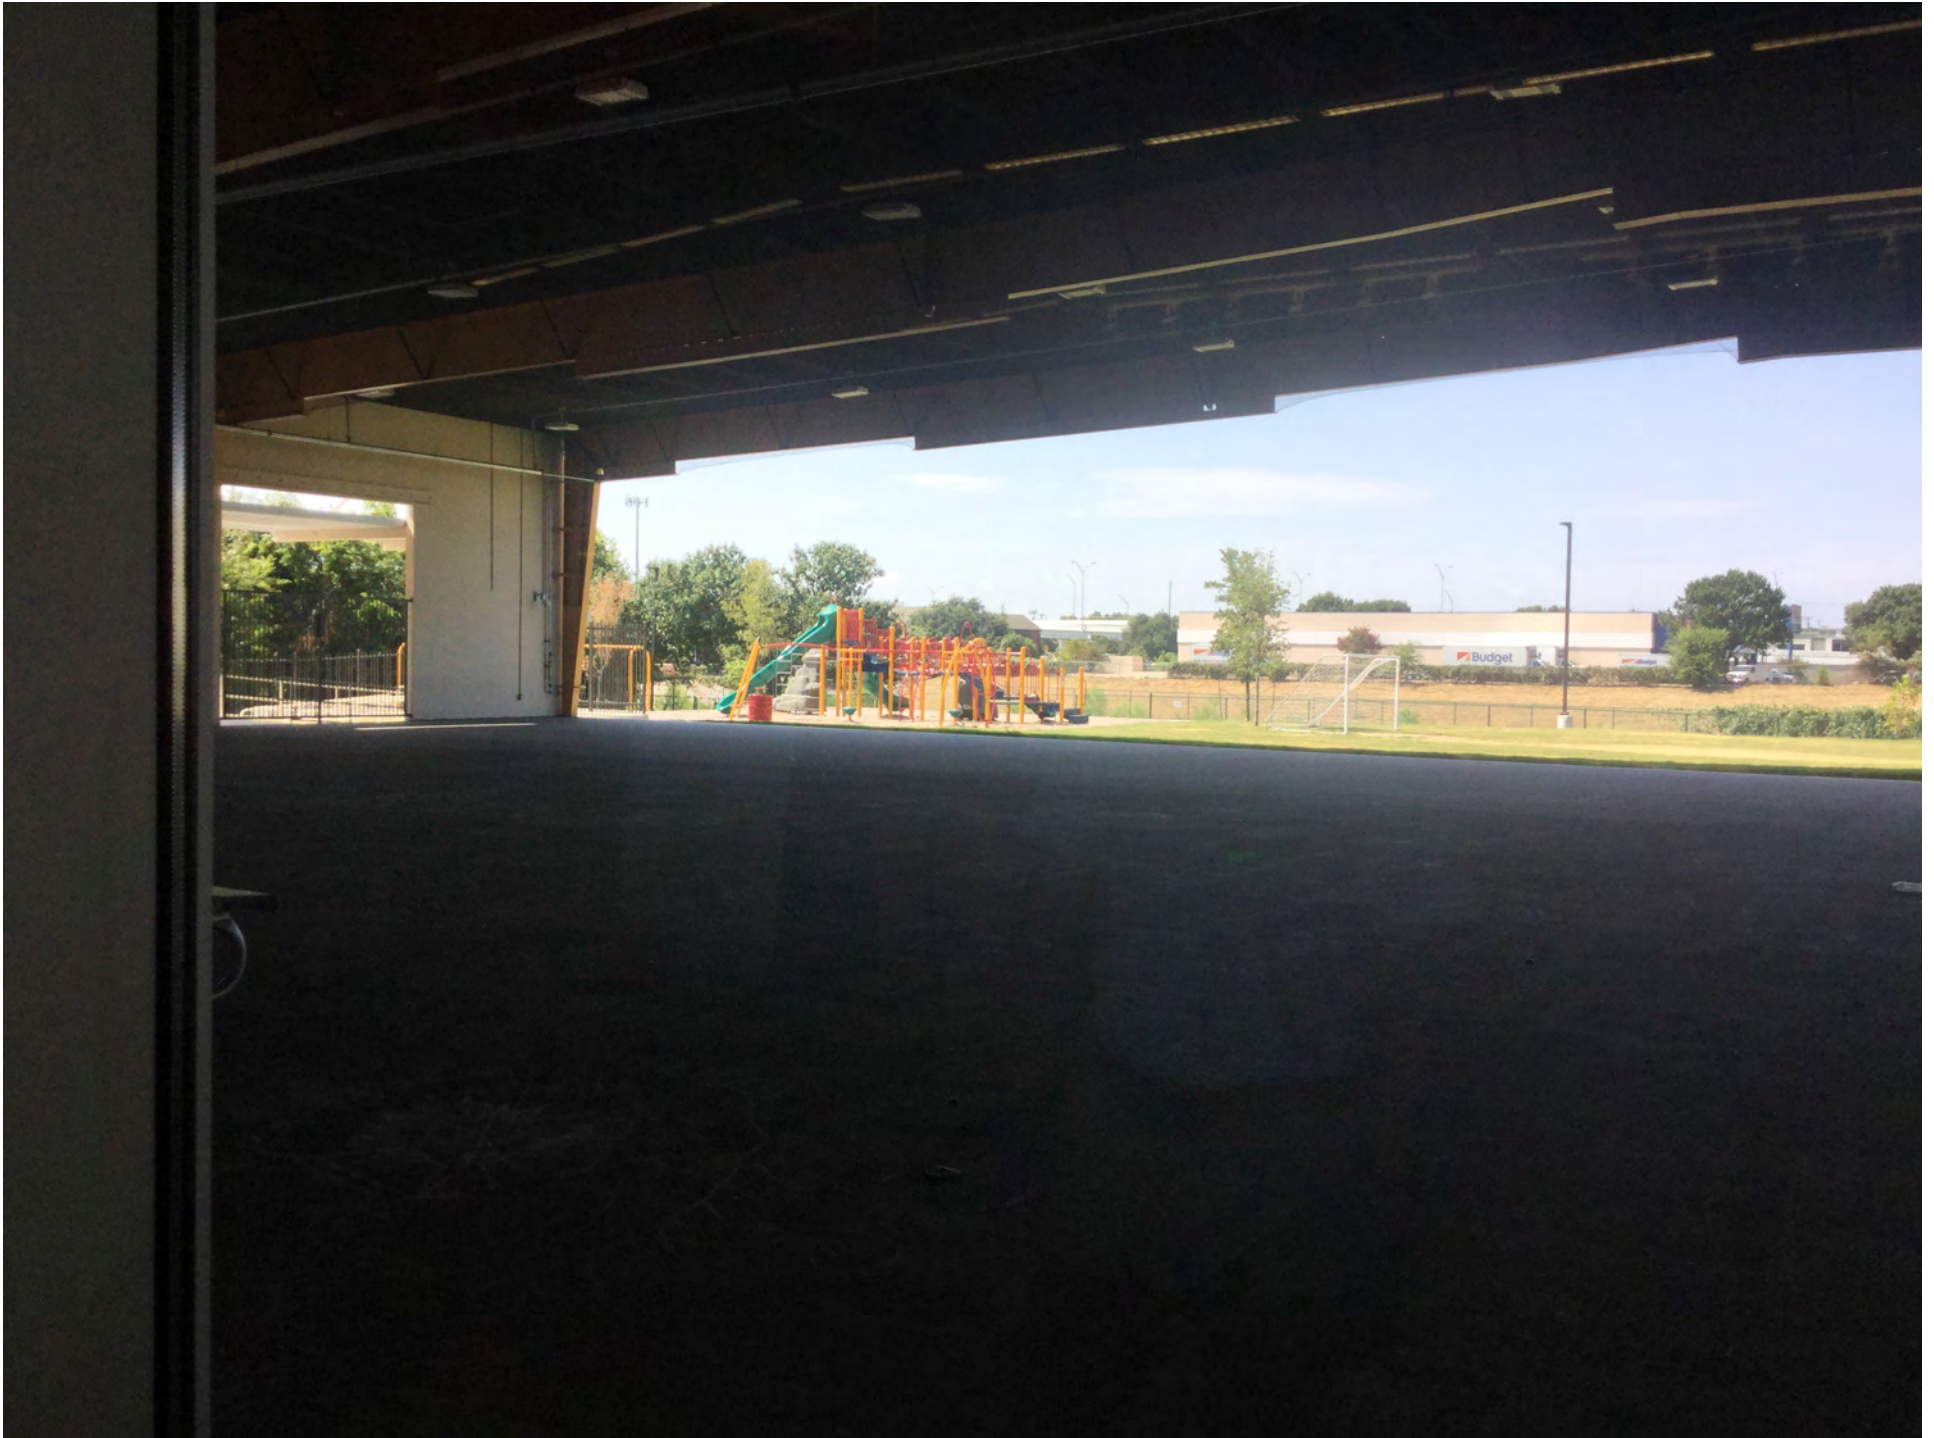
Photo 1.
1.3 Outdoor Playfields

1.3	Are outdoor play spaces and playfields adequate in size and configuration?				4			Comments	1.00 4.00
	1) Outdoor play space exists, not developed 2) Outdoor play space exists but is not connected to gym or other athletic support areas or is too small. 3. Outdoor play spaces exist, are connected to other athletic areas, are the right size, but are not in good condition. 4. Outdoor play spaces need minor improvements to function well. 5. Outdoor play spaces are in excellent condition. N/A) Does not apply.							The school needs more play space as well as a track. There is only one playground space and a large shaded gym area. Both of them are in excellent condition.	
									see photo 1

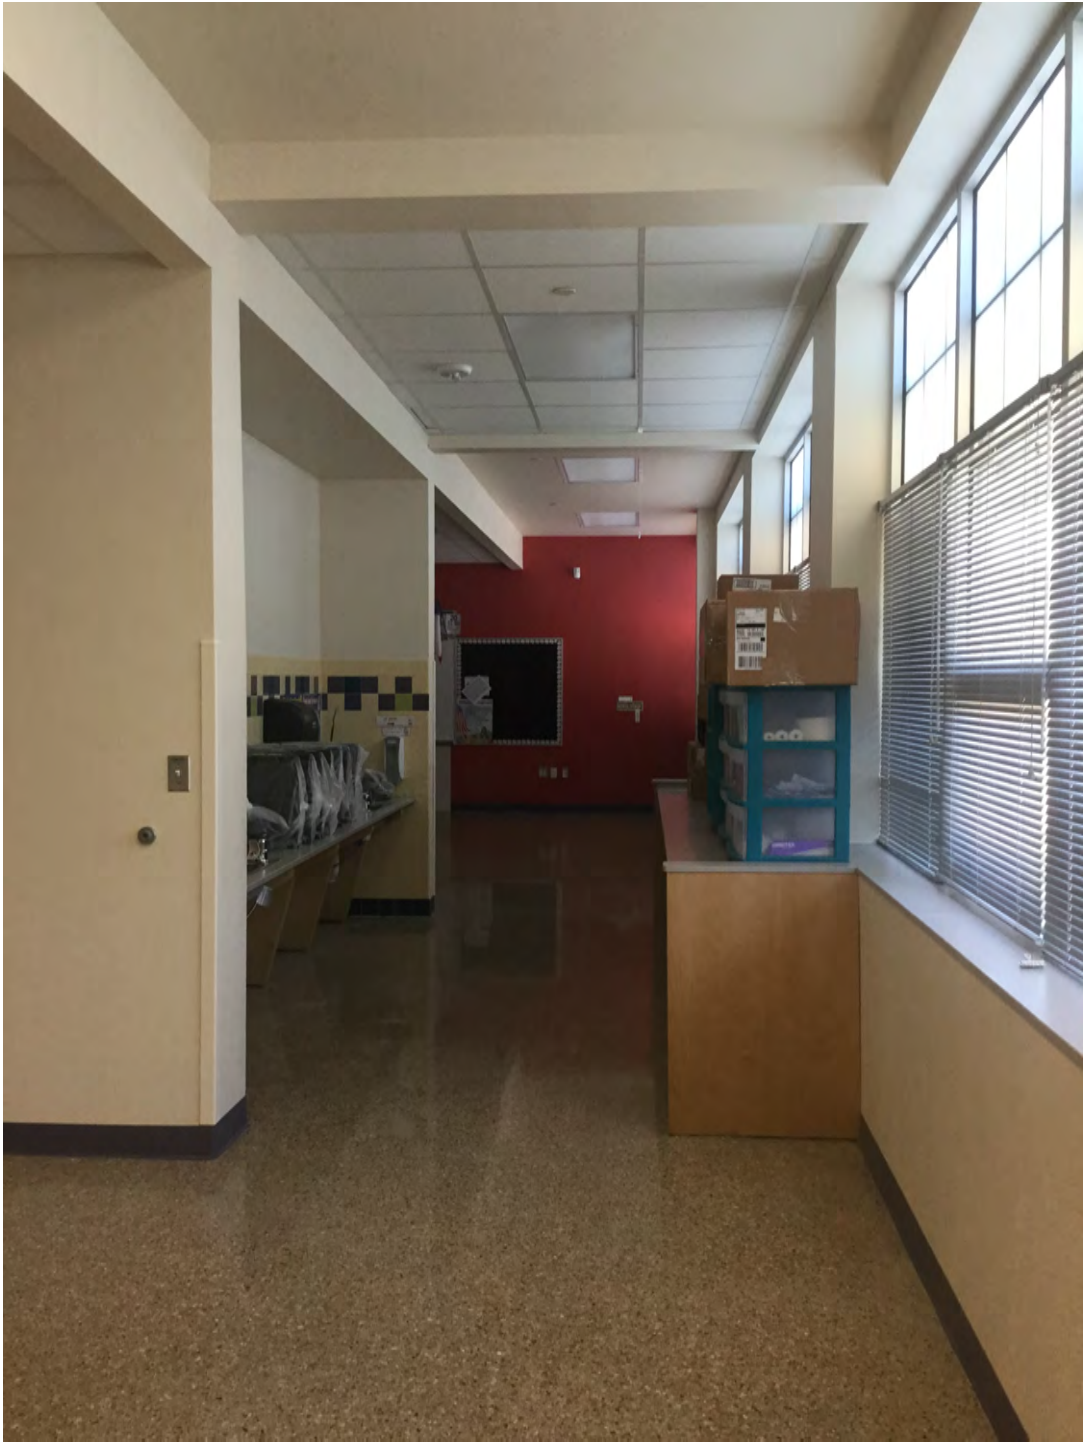
Photo 2.
3.2 Adjoining Pre-K Spaces

There are reported acoustic issues especially in the Pre-K classrooms due to the large openings between classrooms. The majority of classrooms have nice exterior views, although some have higher windows that just allow natural light.

1) Very unsatisfactory - Too small, awkward layout, does not meet needs 2) Unsatisfactory - Too small, only one area for all teaching methods, limited flexibility 3) Neutral - Moderate size, two areas for different teaching methods, some flexibility, access to student storage/casework 4) Satisfactory - Good size, at least two zones for different teaching methods, flexibility and student storage, not new 5) Very Satisfactory - Good size, two zones for different teaching methods, flexibility and student storage/casework, adequate display area and visual teaching tools N/A) Does not apply.								The sound transmission is an issue between classrooms due to a large connecting corridor.	see photo 2

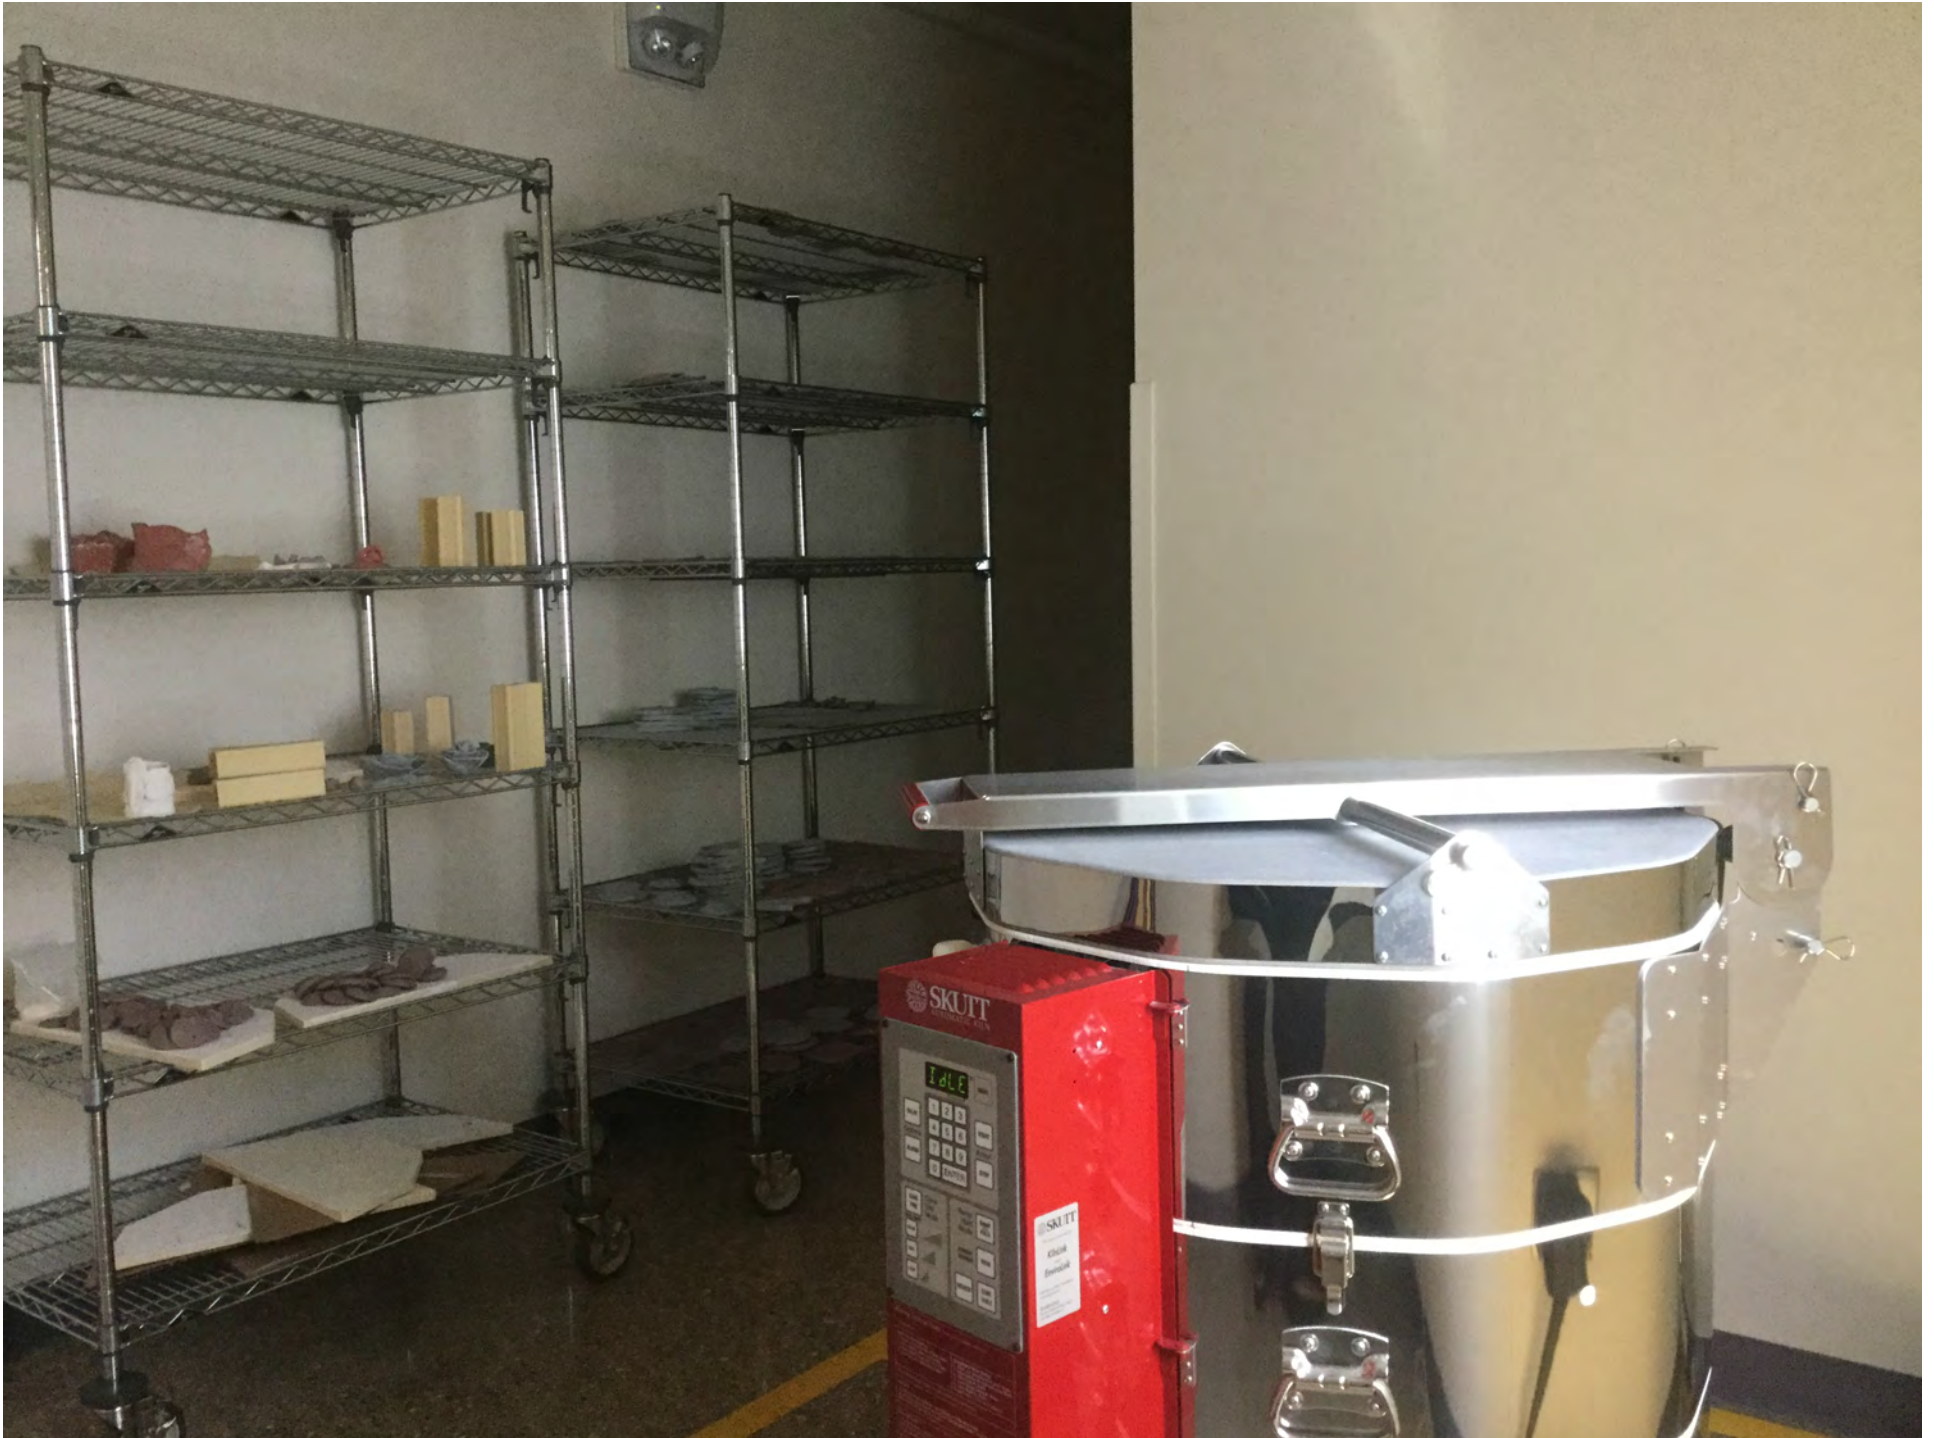
Photo 3.
3.11 Kiln Room

3.11	Are Visual Arts support spaces appropriately configured per the ed spec?					5							Comments	1.00	5.00
<div>1) Very unsatisfactory - Support spaces are disconnected from served spaces, too small, do not meet needs</div> <div>2) Unsatisfactory - Support spaces are connected, but too small, inadequate for needs</div> <div>3) Average - Connected, moderate size, but need some renovations or updates to function well</div> <div>4) Good - Connected, good size/layout, meets needs/functions well</div> <div>5) Very good - connected, generous size, nice condition, functions appropriately</div> <div>N/A) Does not apply.</div>													There is plenty of storage space, and the kiln rooms are in excellent condition.		
													see photo 3

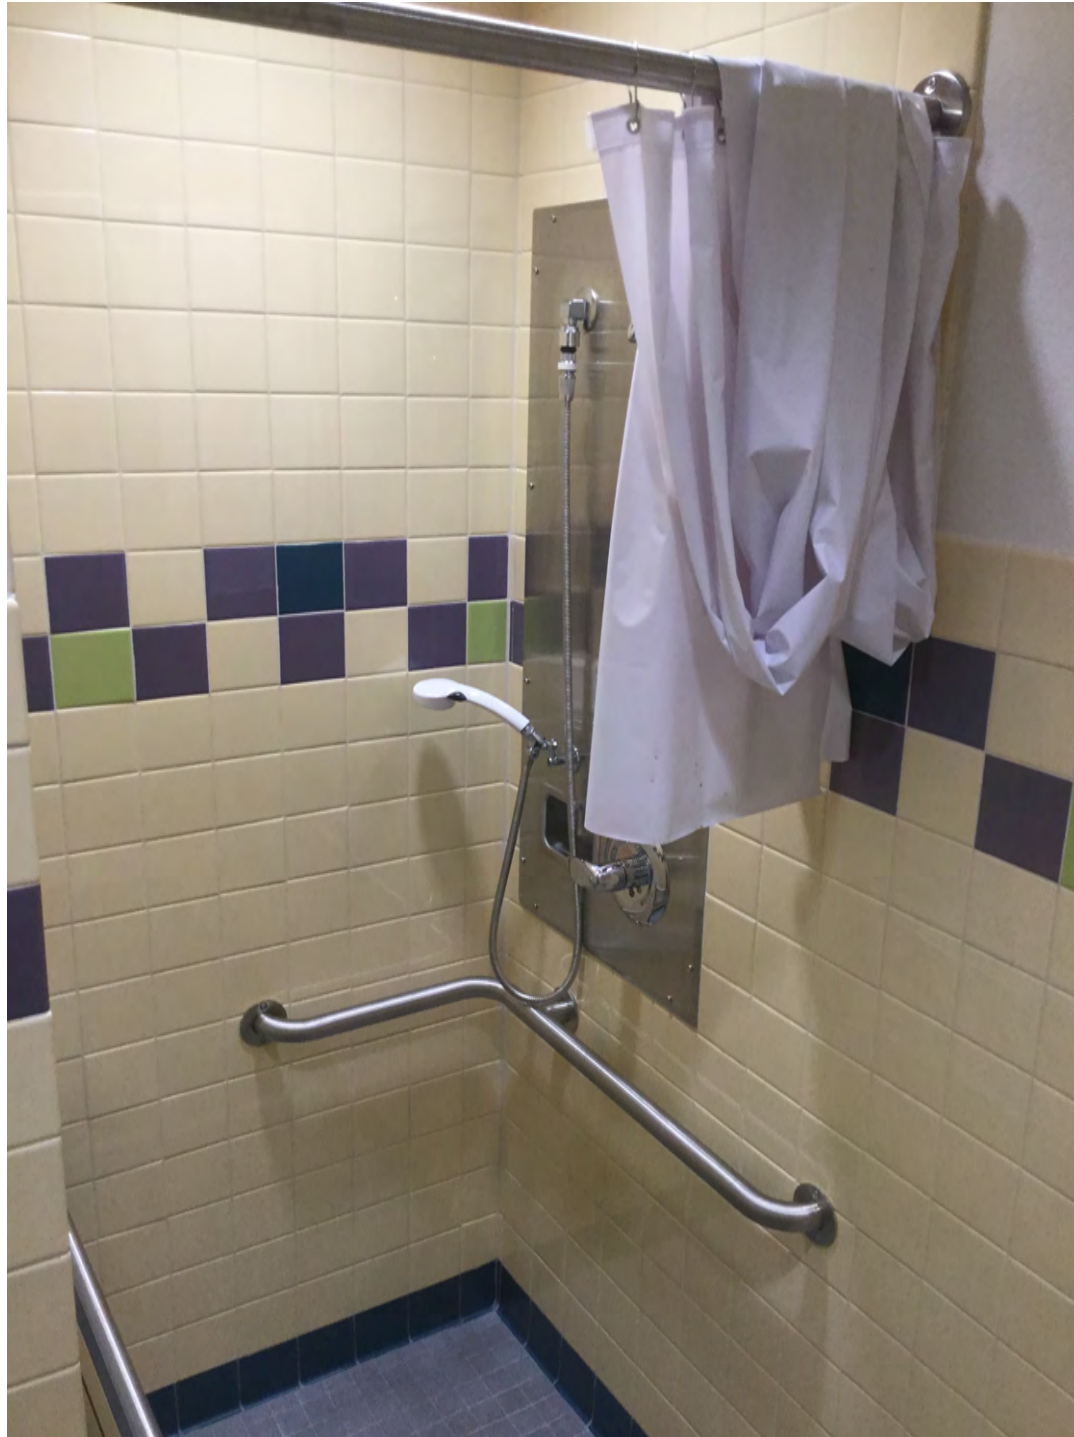
Photo 4.
3.15 Special Ed Shower

1) Very unsatisfactory - Support spaces are disconnected from served spaces, too small, do not meet needs 2) Unsatisfactory - Support spaces are connected, but too small, inadequate for needs 3) Average - Connected, moderate size, but need some renovations or updates to function well 4) Good - Connected, good size/layout, meets needs/functions well 5) Very good - connected, generous size, nice condition, functions appropriately N/A) Does not apply.									see photo 4

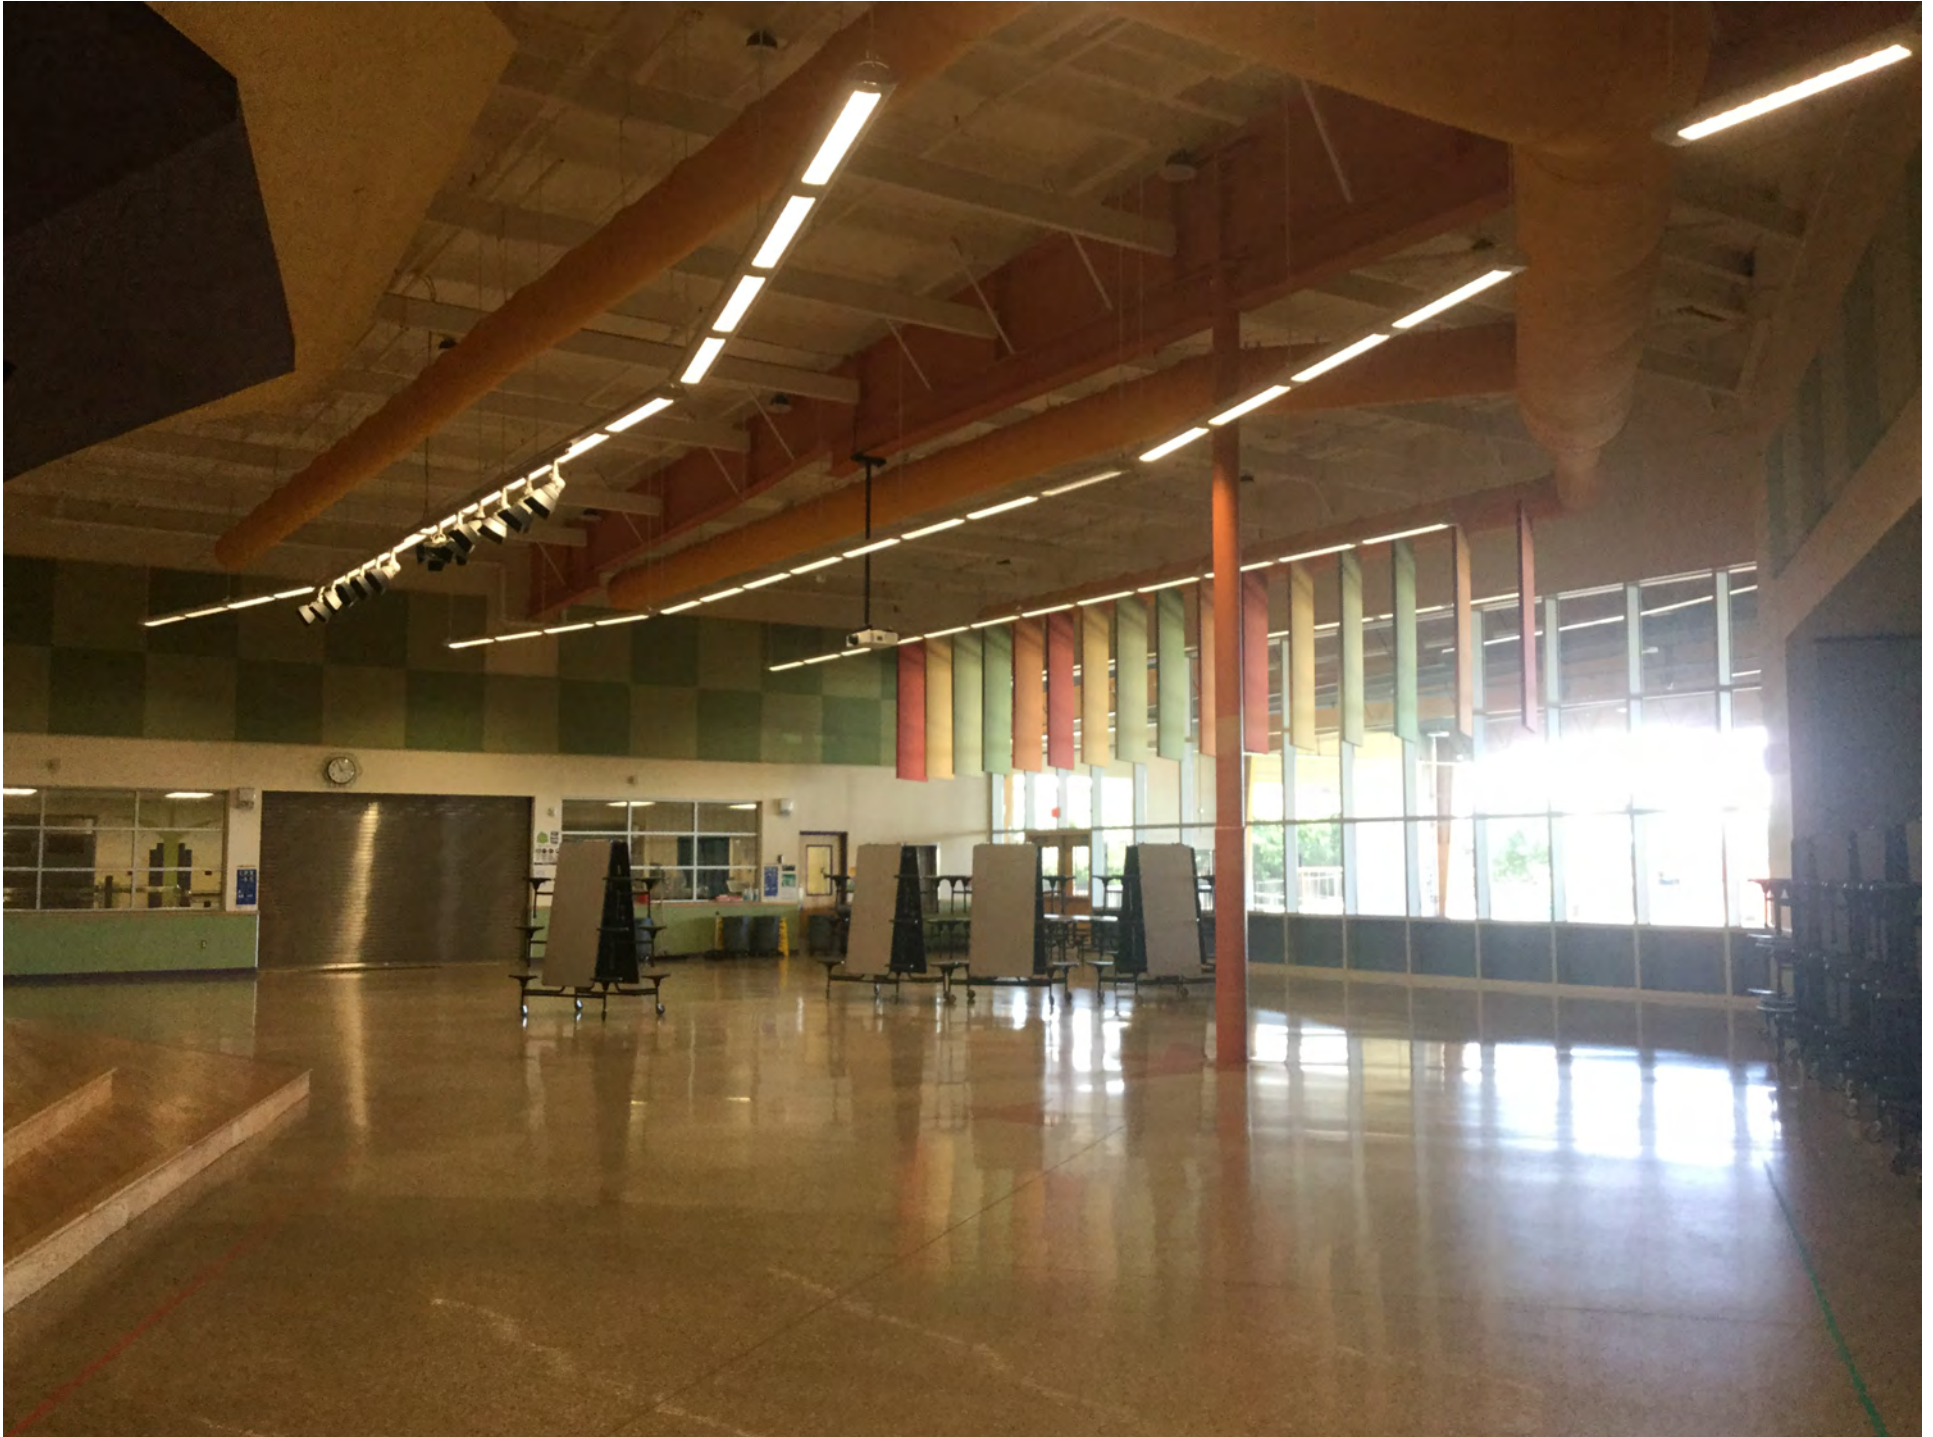
Photo 5.
3.16 Cafetorium

3.16	Are the student dining facilities appropriately configured?					5		Comments	1.00 5.00
1) Very unsatisfactory - Too small, poor circulation, inflexible seating in poor condition 2) Unsatisfactory - Too small or inadequate circulation, seating in poor condition 3) Average - moderate size, with adequate circulation, seating in okay condition 4) Good - good size, adequate circulation, seating in good condition 5) Very good - good size, adequate circulation, seating in good condition, with more than one option for eating space (ex: connection to outdoor eating space) N/A) Does not apply.									see photo 5

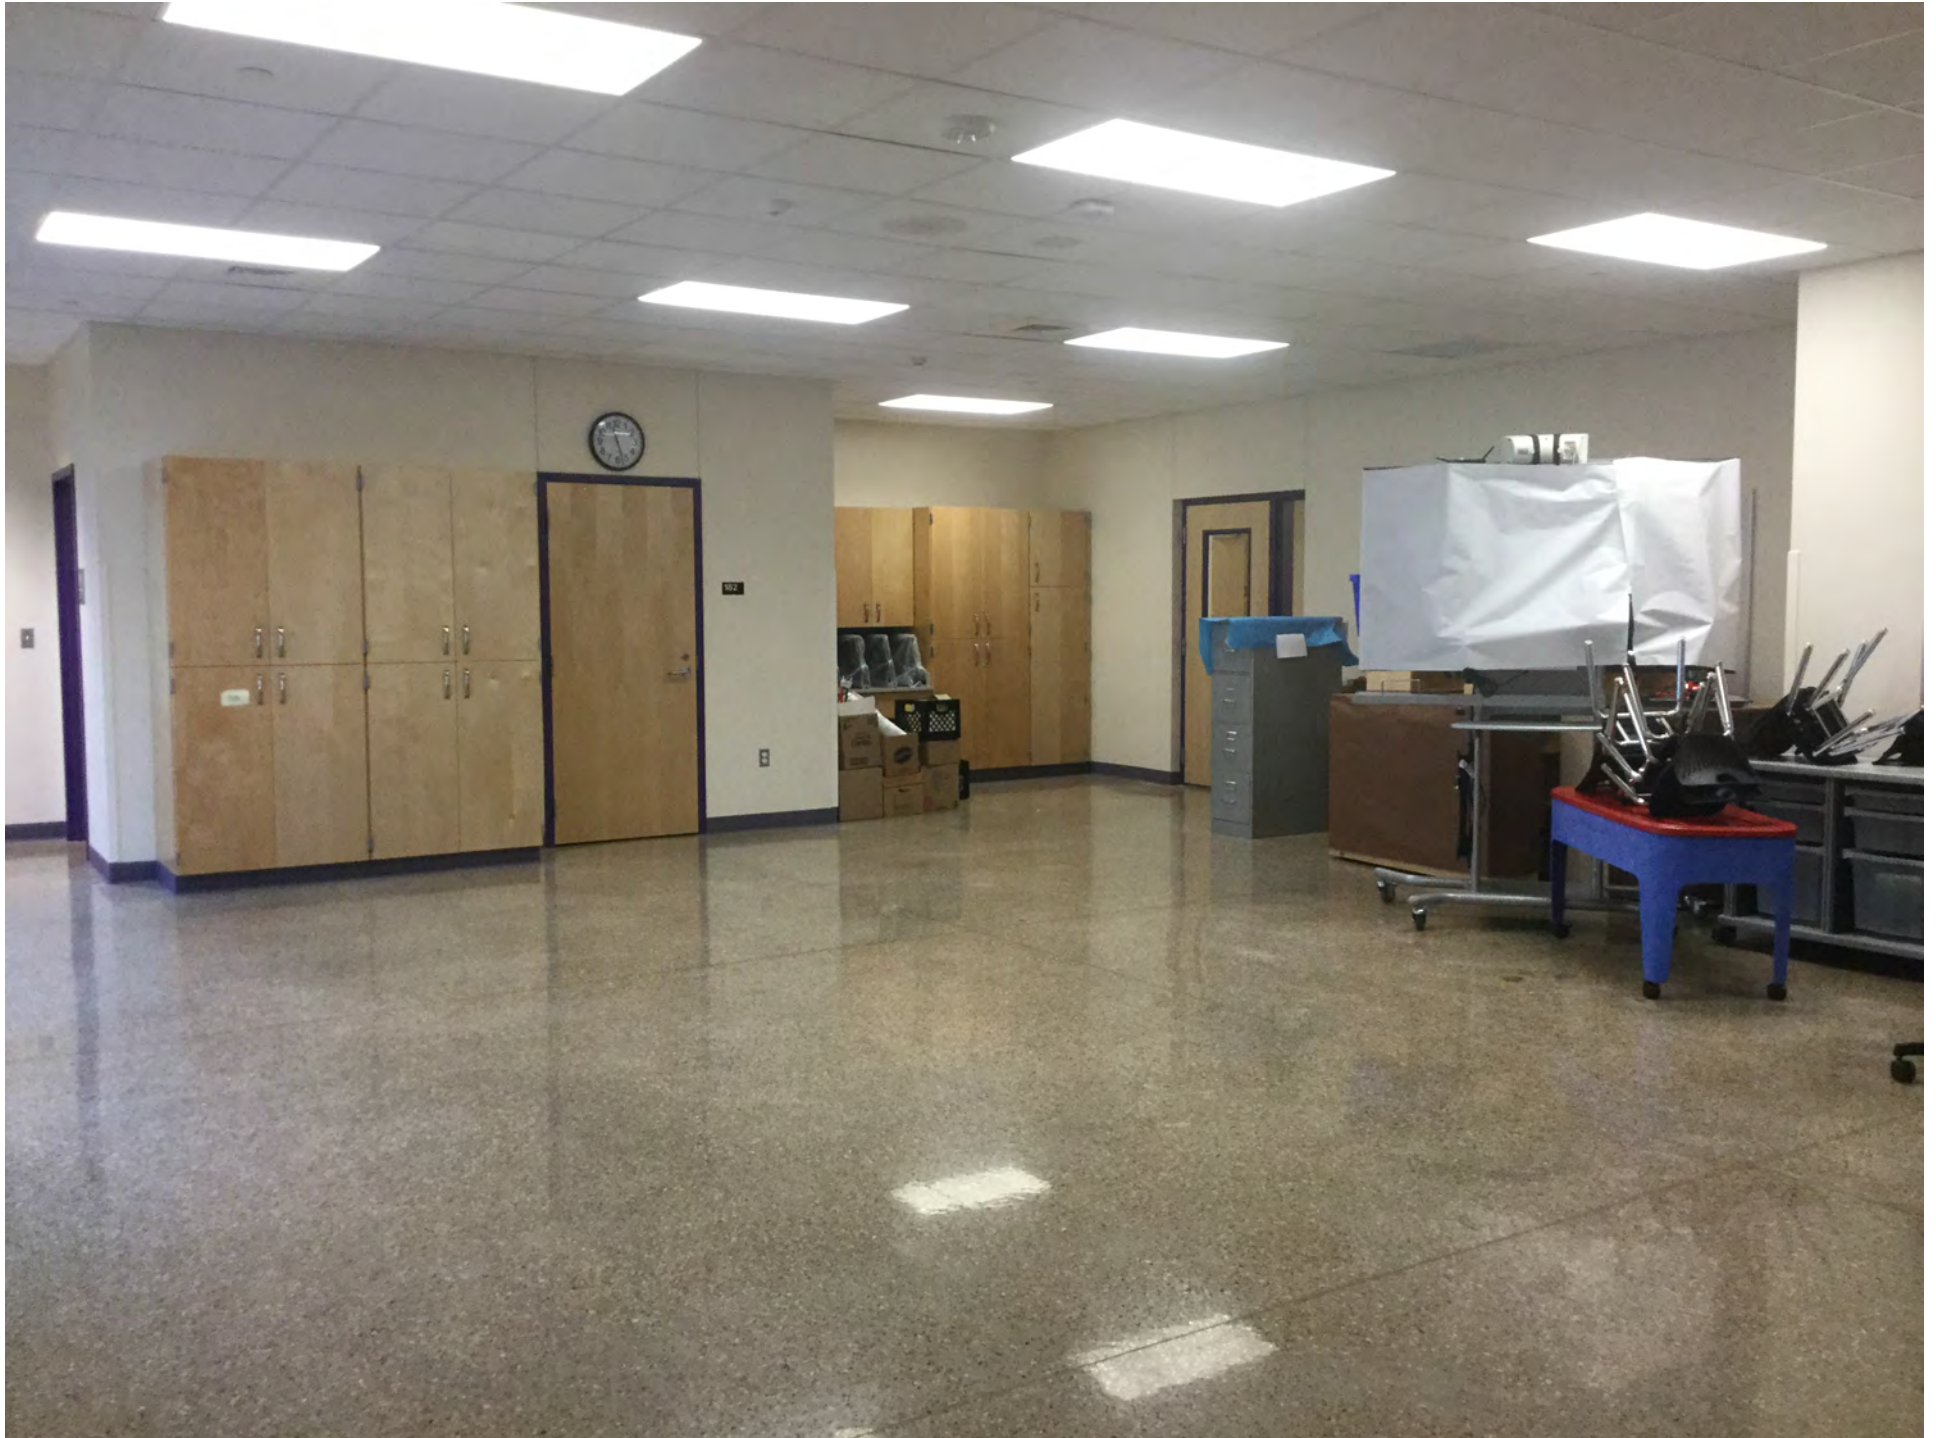
Photo 6.
4.2 Standard Classroom

4.2	Are general classrooms large enough to support project-based learning and multiple teaching modalities?					5		Comments	1.00 5.00
1) Very unsatisfactory -too small to move, set for lecture only, no connectivity, no flexibility 2) Unsatisfactory - adequate size but set for lecture only, no connectivity, no flexibility 3) Neutral - have flexibility and space for hands on or project based learning 4) Satisfactory - have flexibility and space for hands on or project based learning and connectivity for global learning 5) Very Satisfactory - space for hands on learning, flexibility for different groupings, and connectivity for global classrooms N/A) Does not apply.									see photo 6

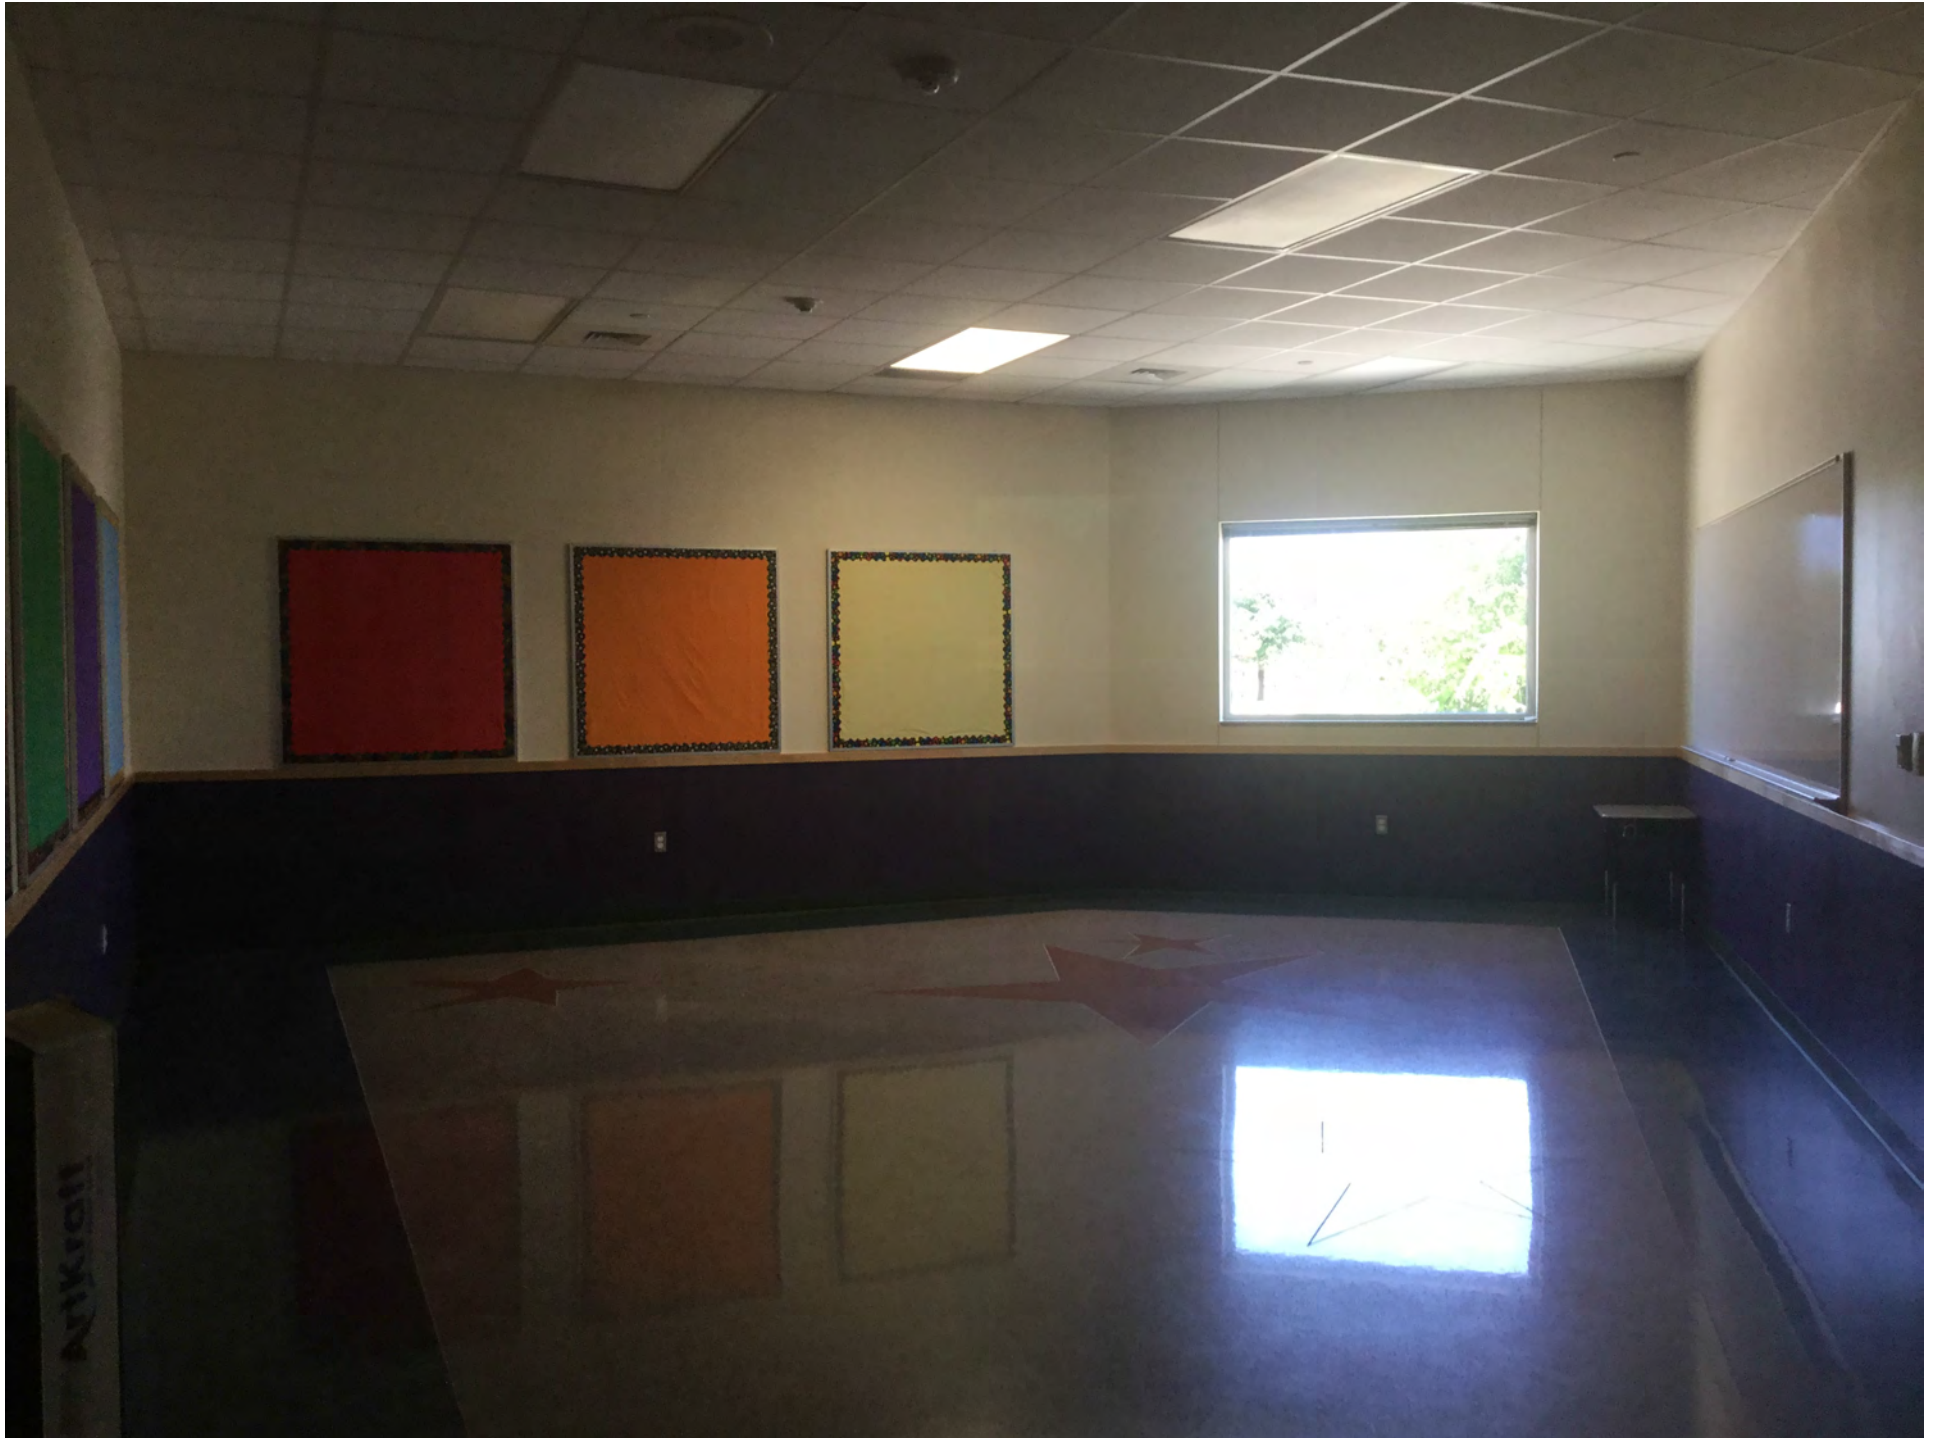
Photo 7.
4.5 Collaborative Space

1) Very unsatisfactory - no common spaces or meeting rooms or in very poor condition 2) Unsatisfactory - a few common spaces or meeting rooms in unsatisfactory condition 3) Average - a few common spaces and meeting areas needing updates 4) Good - multiple common spaces and meeting rooms in good condition 5) Very good - adequate common spaces and meeting rooms of excellent quality N/A) Does not apply.								see photo 7

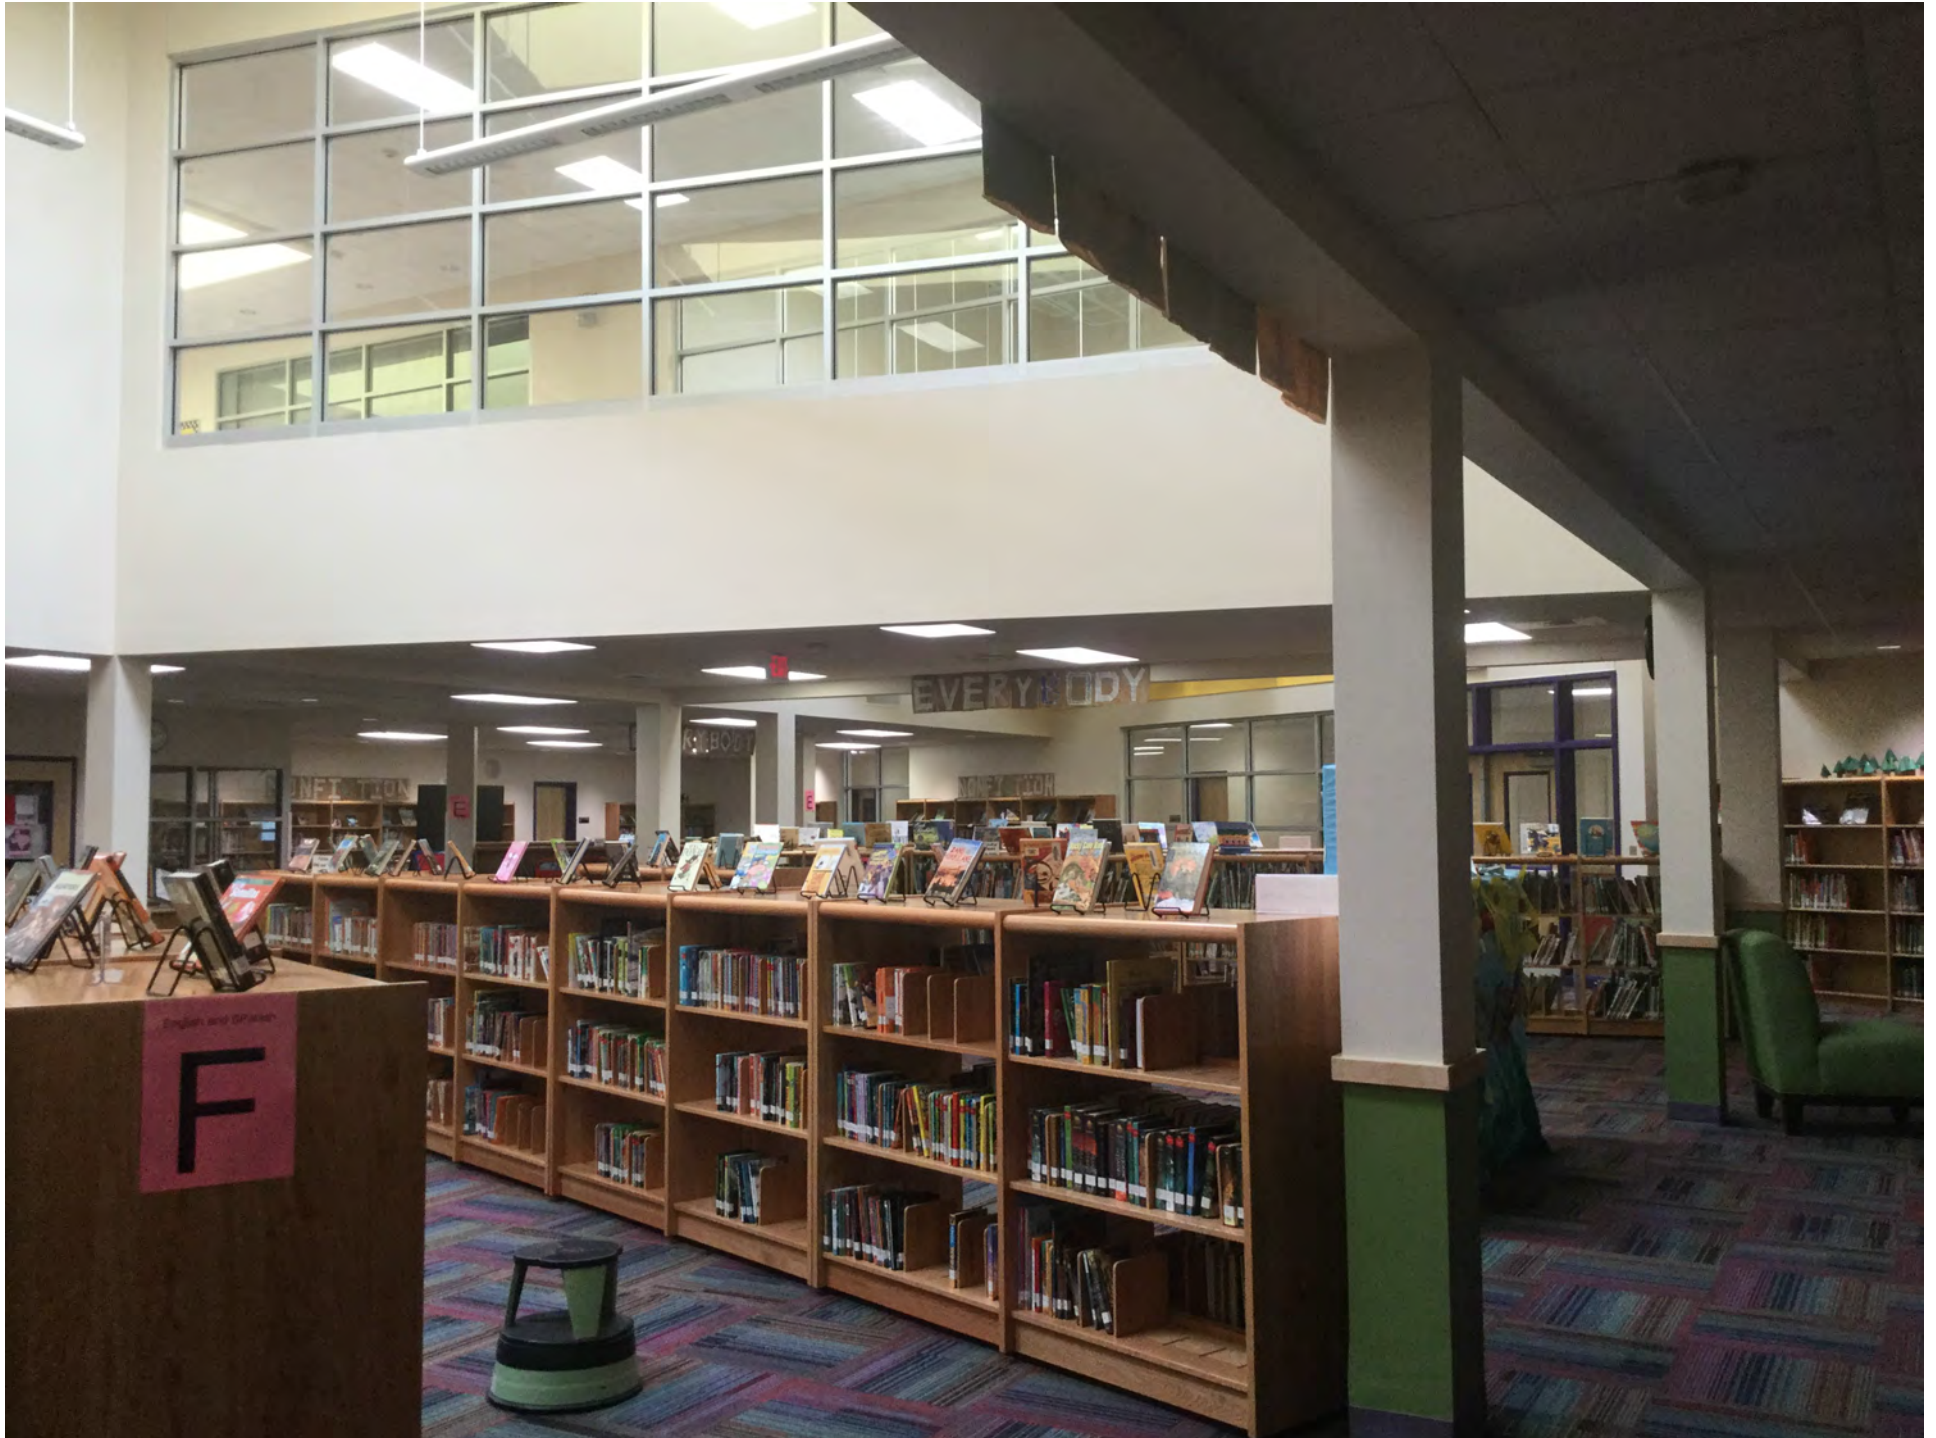
Photo 8.
5.3 Library

1) Very unsatisfactory 2) Unsatisfactory 3) Average 4) Good 5) Very good N/A) Does not apply.								see photo 8	
5.4	How well does the Library/Media Center support collaborative work in small groups (4-8 students)?					5		Comments	1.005.00
