Educational Suitability Summary Report

Padron Elementary School

Date: 07/25/2016

School	Padron ES	BLDG - 188
Name	John Eldred + Ellen Saathoff	
Date	7/25/2016

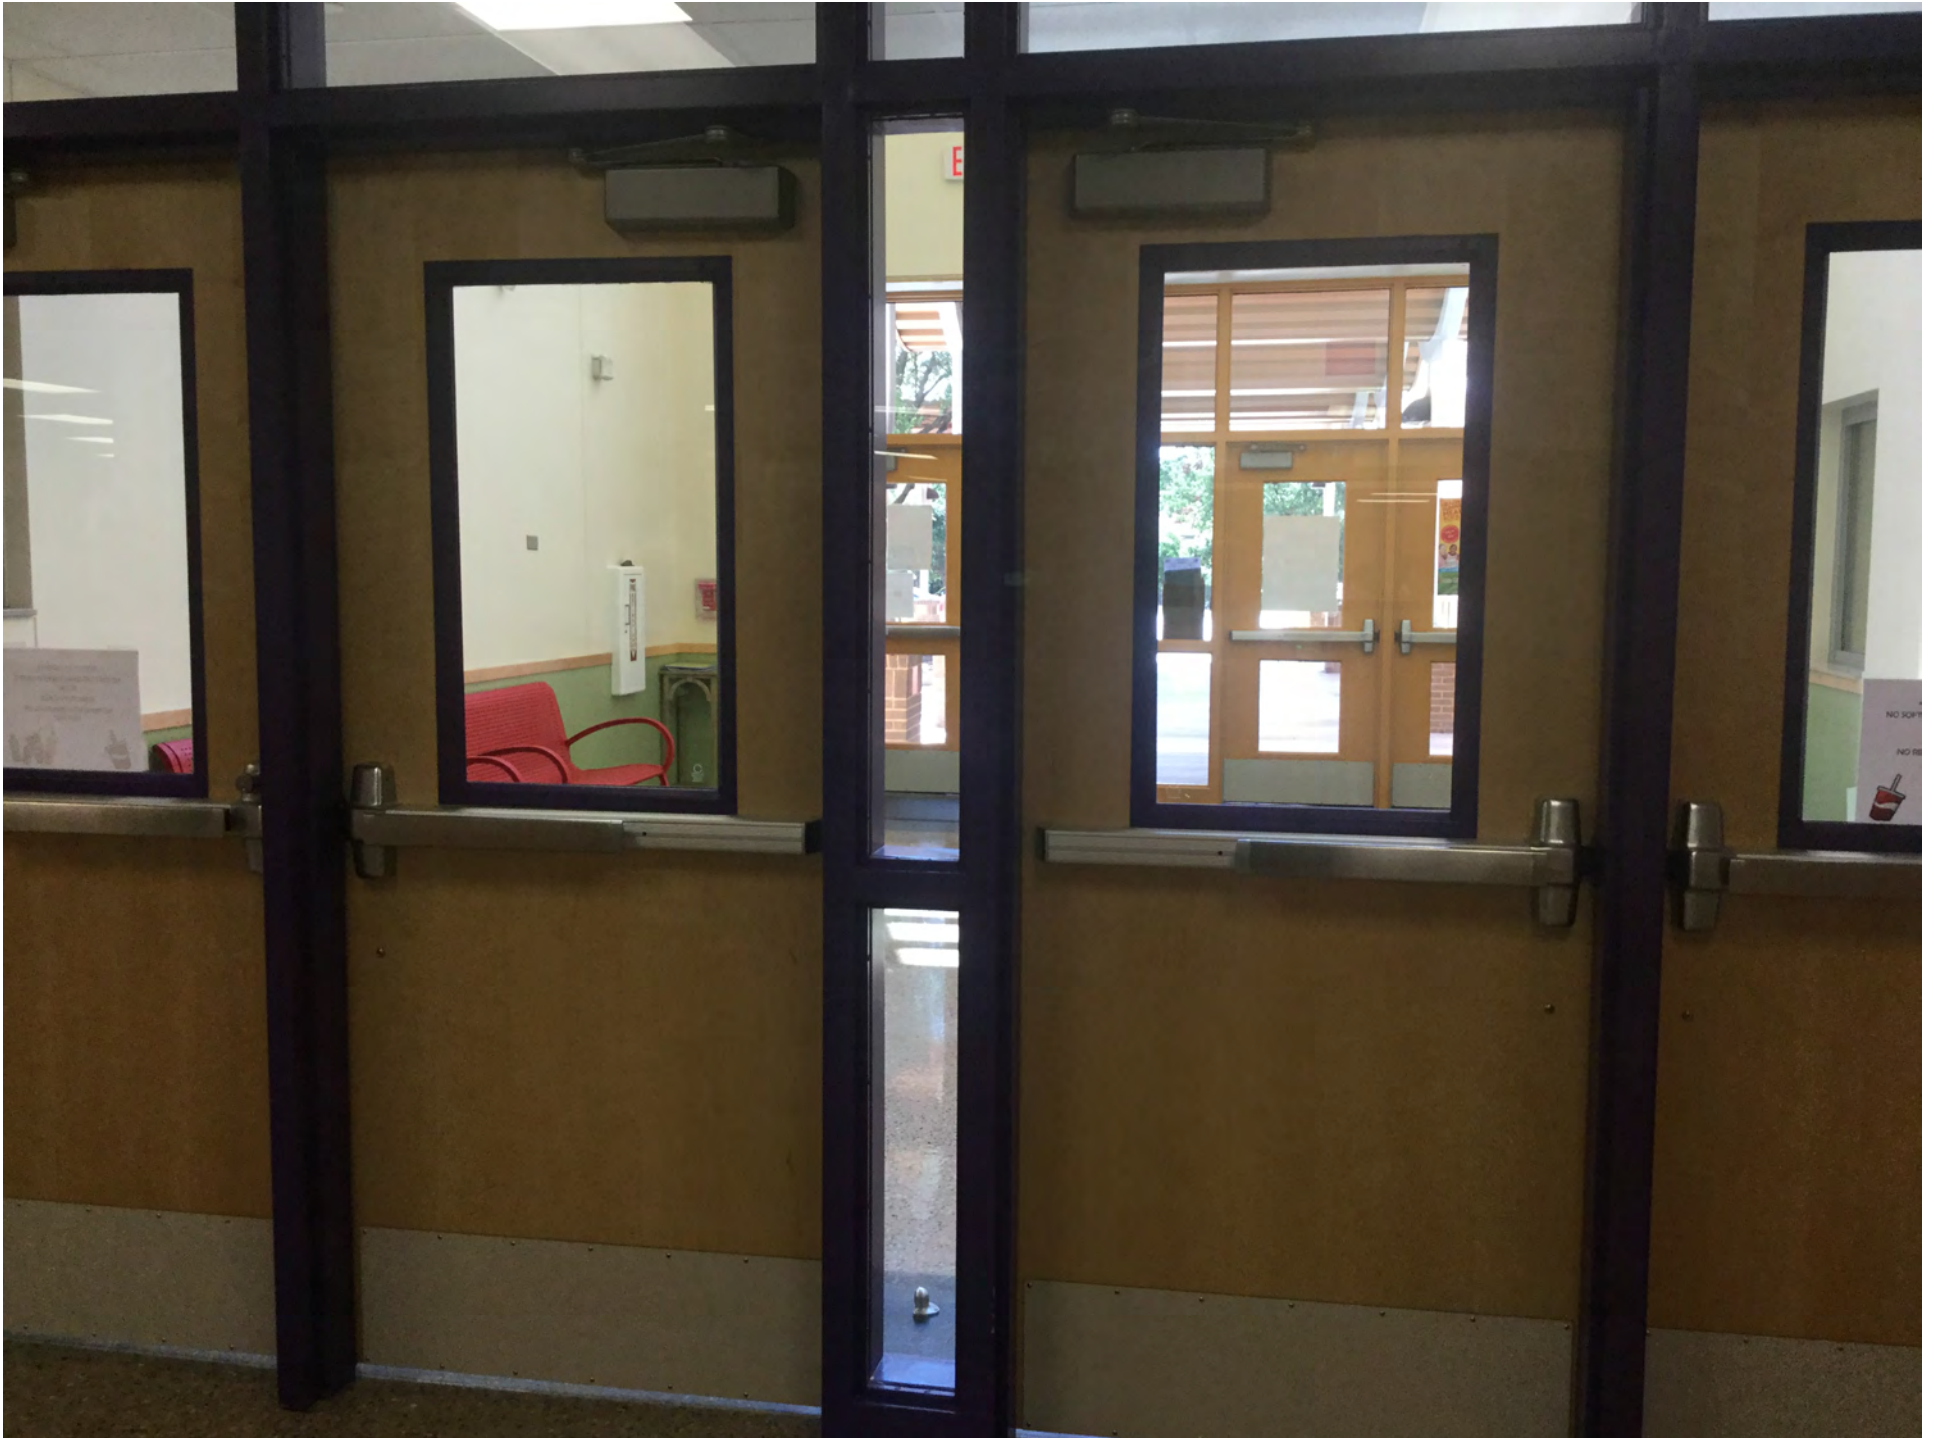
Photo 9.
6.3 Main Office Entry

6.3	Is the main office properly located and configured with a secure vestibule to the main corridor?					5		Comments	1.00 5.00
1) Very unsatisfactory - No secure vestibule, office located far from main entry. Allows visitors access to school unsupervised. 2) Unsatisfactory - No secure vestibule, office located somewhat far from main entry, minimal supervision of visitors. 3) Average - Office close to entry, views of front door, but no secure vestibule 4) Good - Office is well-located with a secure vestibule, but needs updates 5) Very good - Office well-located with secure vestibule and all appropriate security features. N/A) Does not apply.								see photo 9

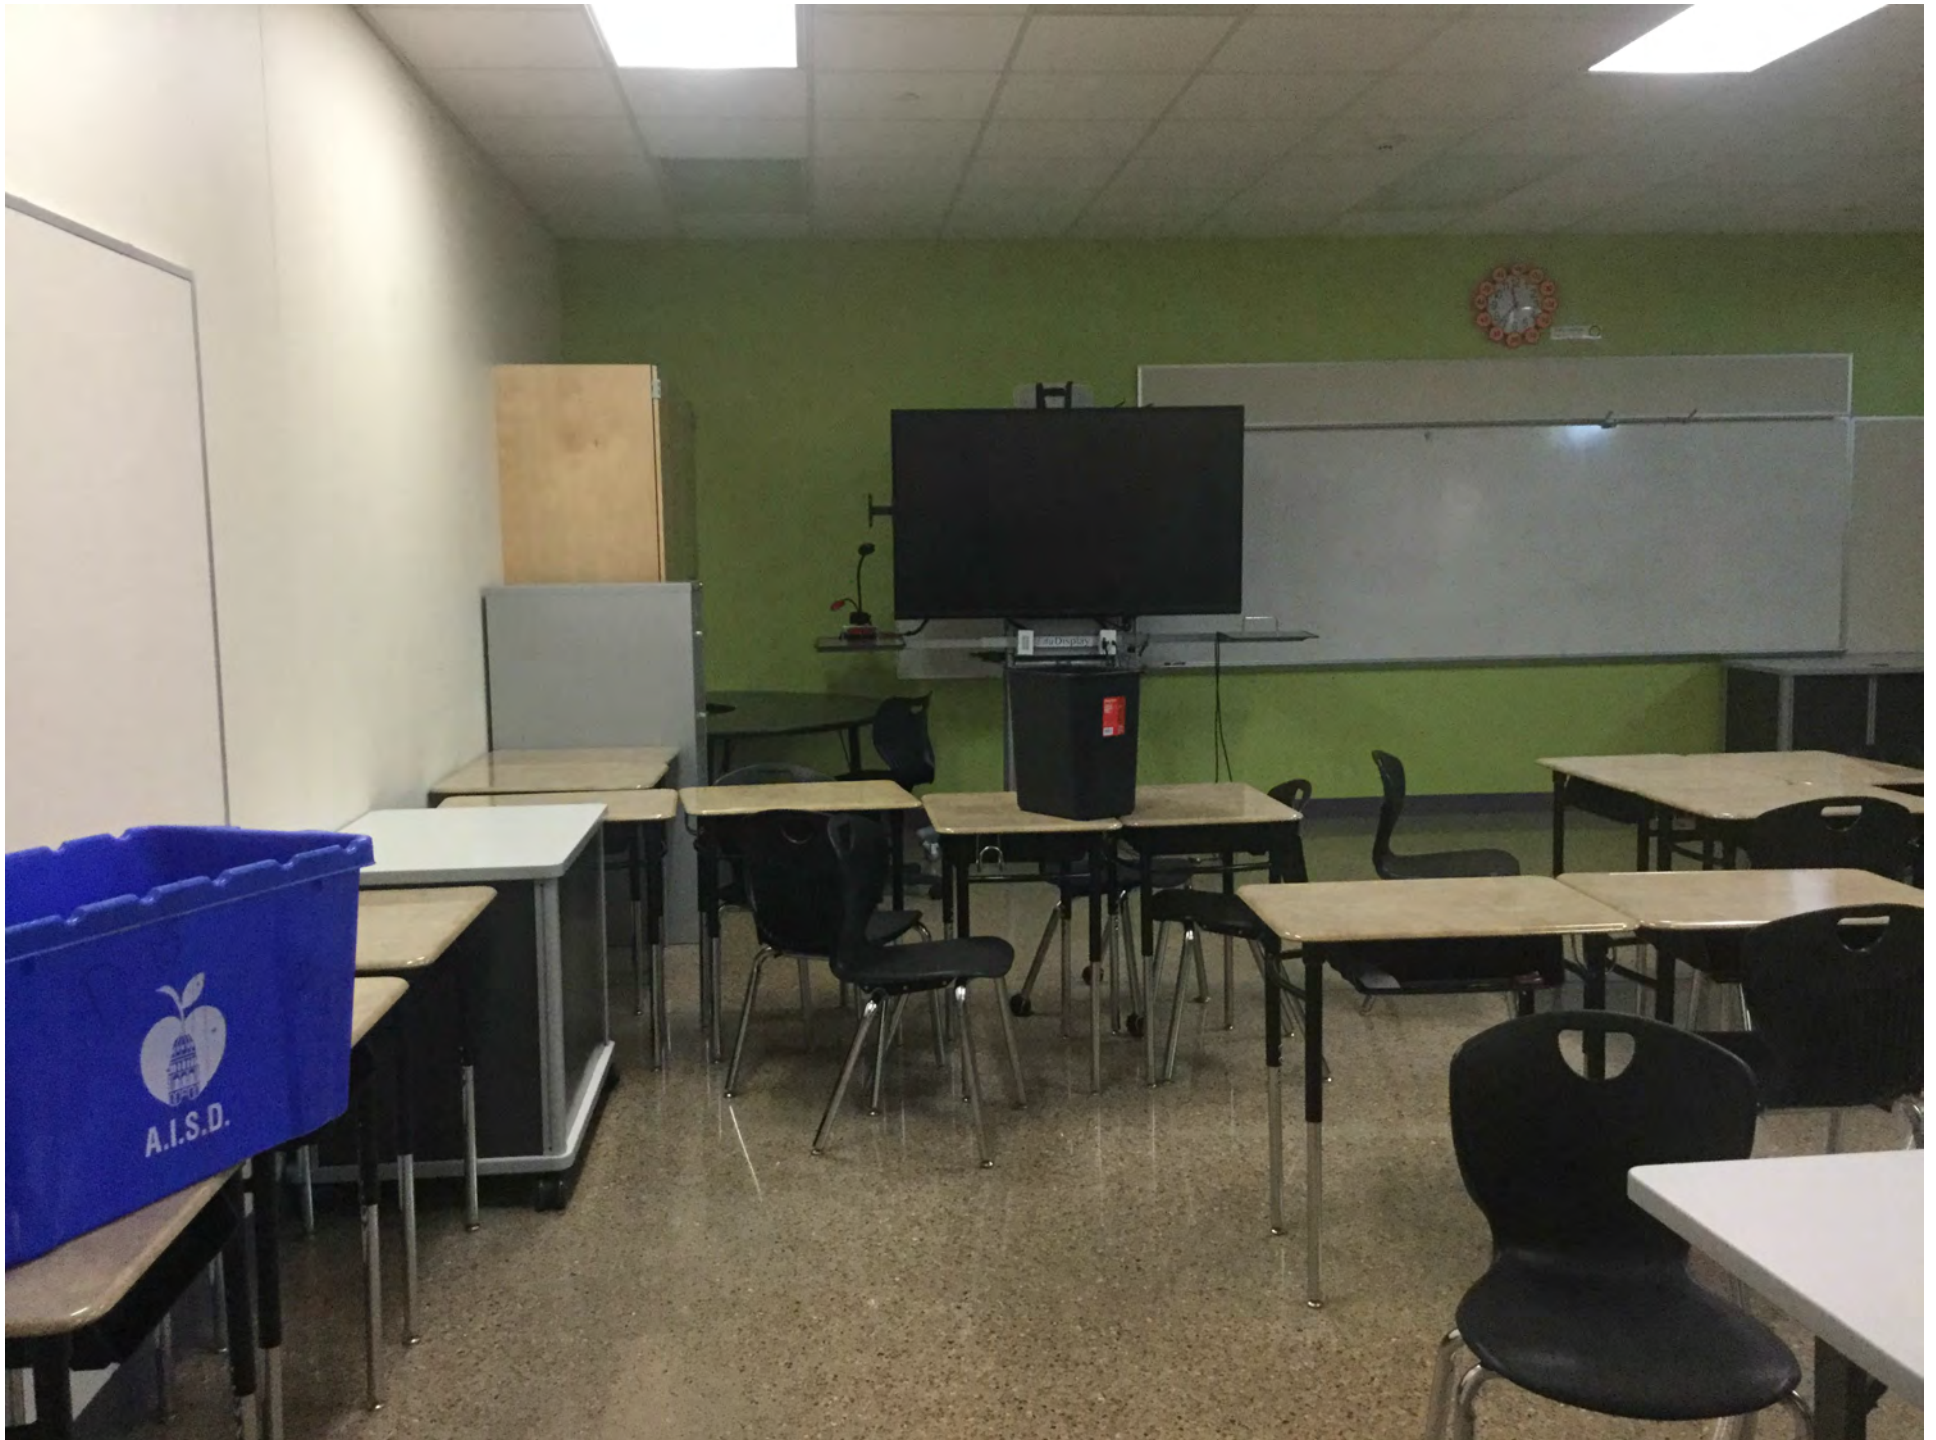
Photo 10.
9.1 Furniture

9 - Furniture, Fixtures & Equipment		1	2	3	4	5	N/A	13.75	
9.1	What is the current condition of the furniture?					5		Comments	0.75 3.75
1) Very unsatisfactory - damaged/non-functioning 2) Unsatisfactory - torn, bent, wrong size 3) Average - scratched/dented/marked 4) Good - not new but sturdy and clean 5) Very good - new N/A) Does not apply.								see photo 10
