Educational Suitability Summary Report

Palm Elementary School

Date: 08/04/2016

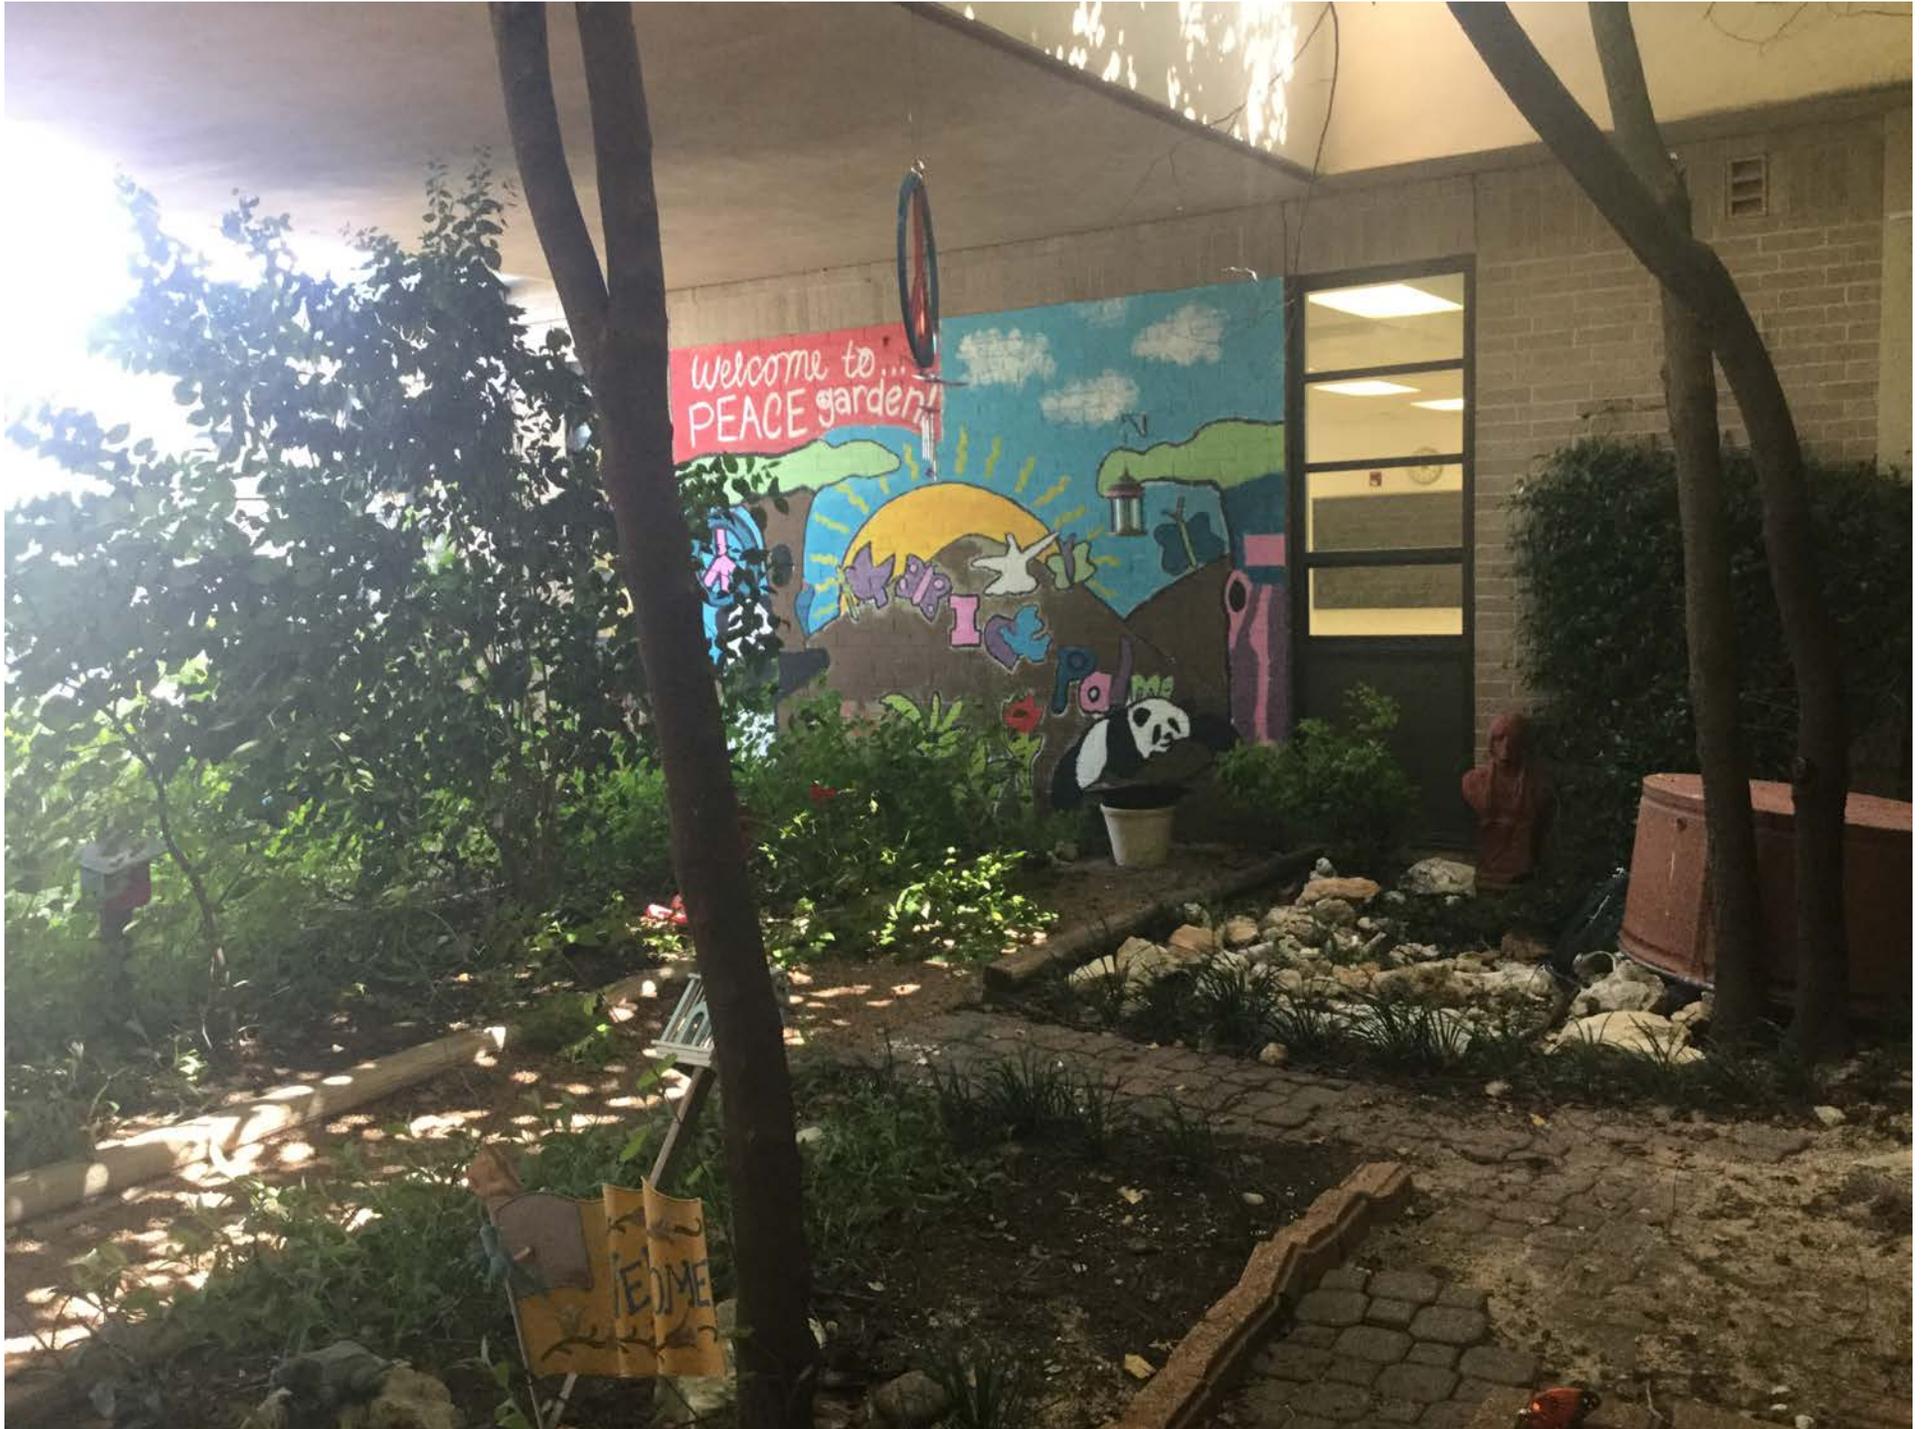
Photo 1. Outdoor learning space

1.2	Are opportunities provided for outdoor learning (outdoor classrooms, gardens, etc.)?			3				Comments	1.00	3.00
1) Outdoor space exists is not developed 2)Outdoor space for learning exists but not connected to classroom learning areas. 3. Outdoor learning spaces exist and are accessible but not in good condition. 4. Outdoor learning spaces need minor improvements to function well. 5. Outdoor learning spaces are in excellent condition. N/A) Does not apply.		See Photo 1

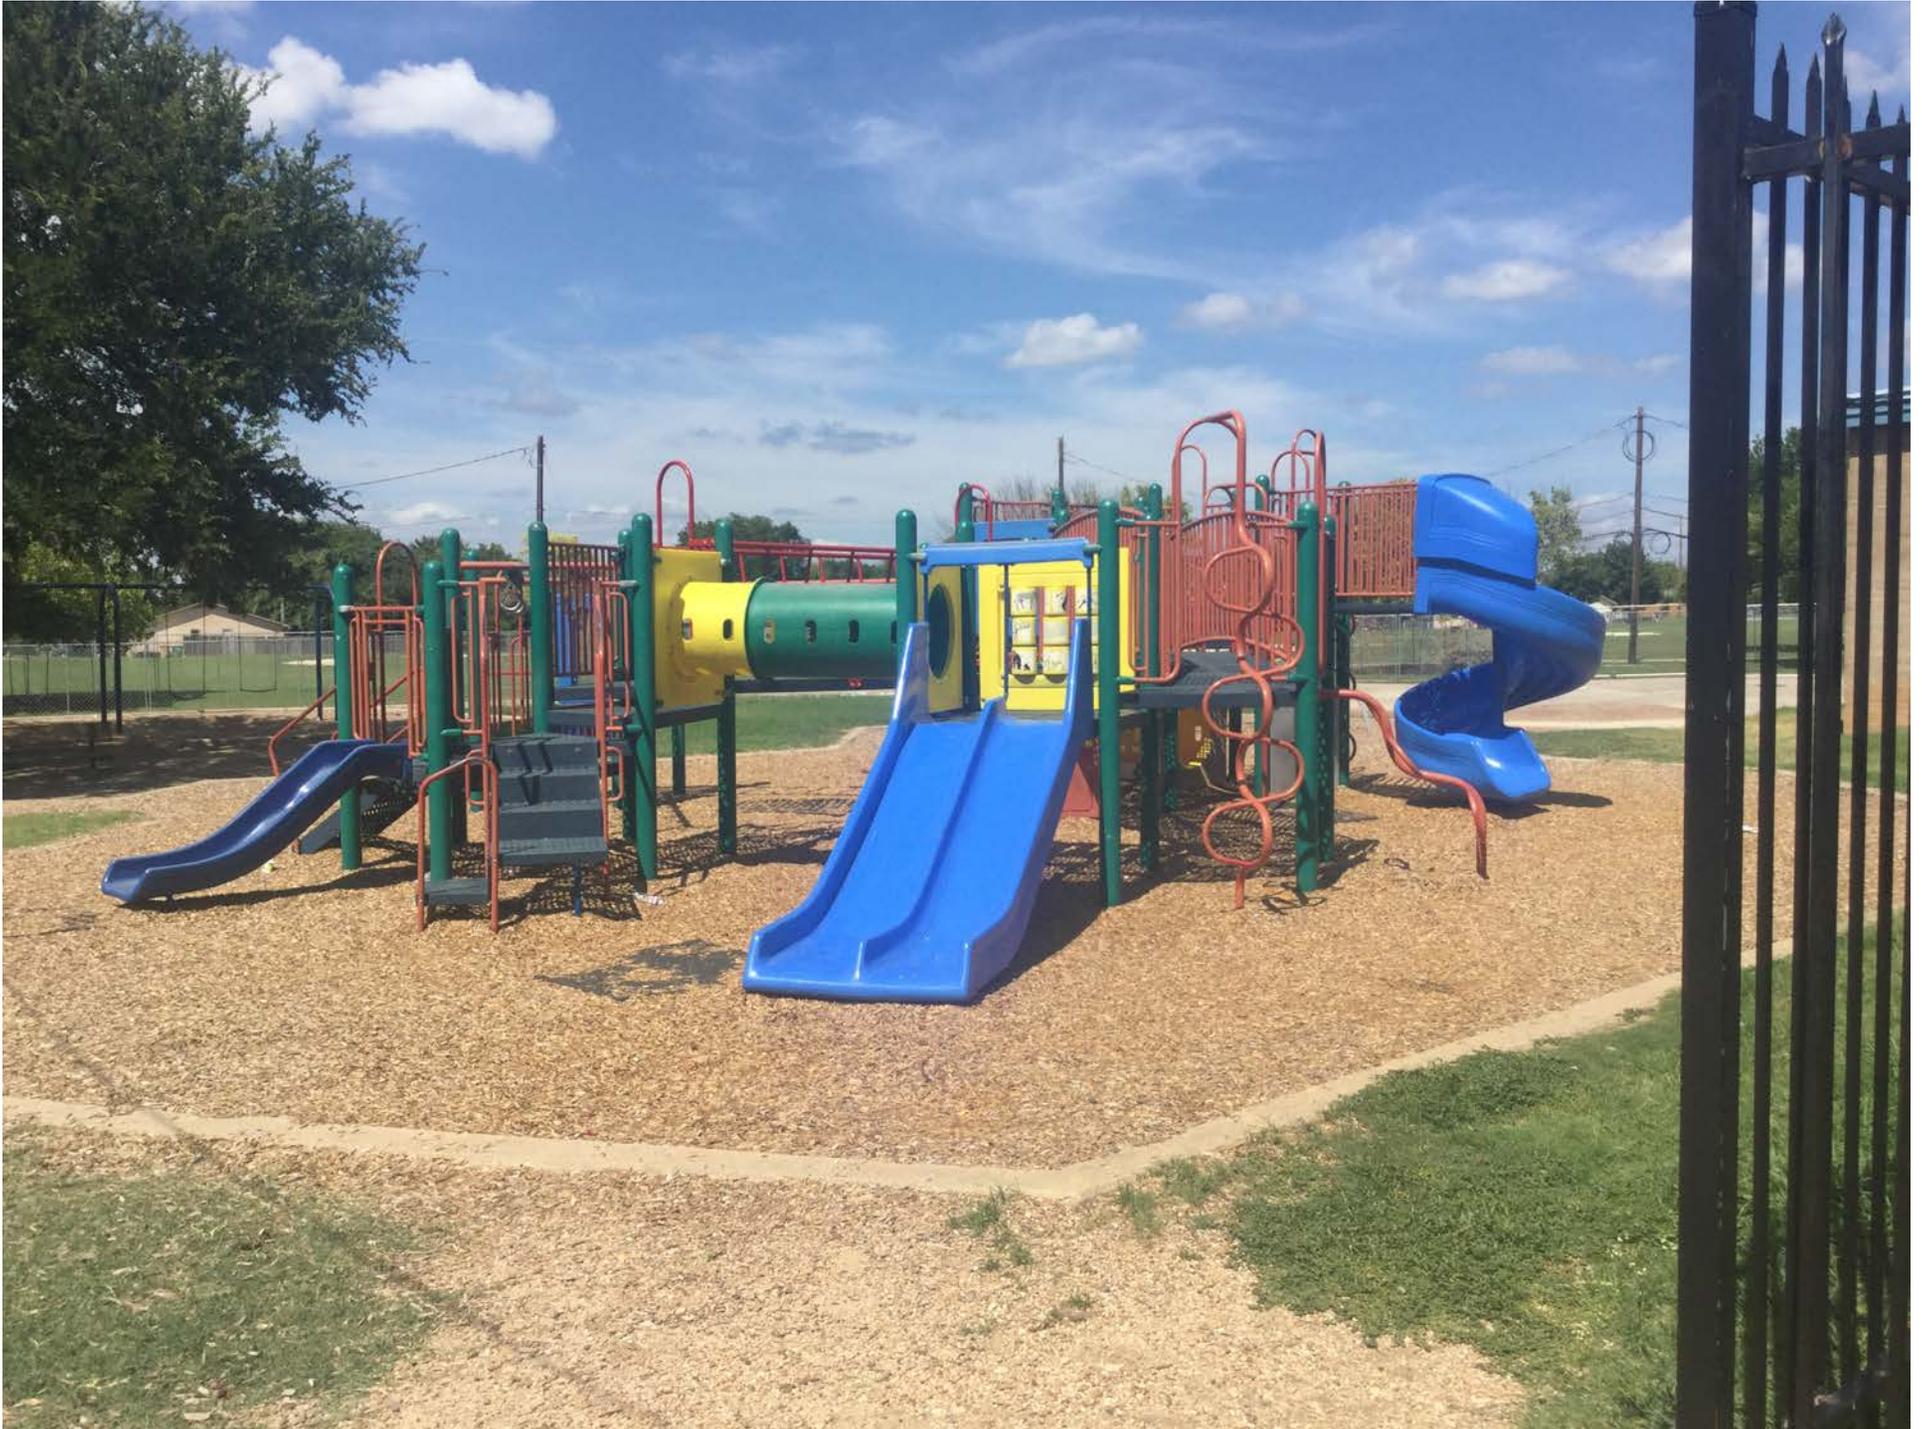
Photo 2. Playground

1.3	Are outdoor play spaces and playfields adequate in size and configuration?				4			Comments	1.00	4.00
1) Outdoor play space exists, not developed 2)Outdoor play space exists but is not connected to gym or other athletic support areas or is too small. 3. Outdoor play spaces exist, are connected to other athletic areas, are the right size, but are not in good condition. 4. Outdoor play spaces need minor improvements to function well. 5. Outdoor play spaces are in excellent condition. N/A) Does not apply.		See Photo 2

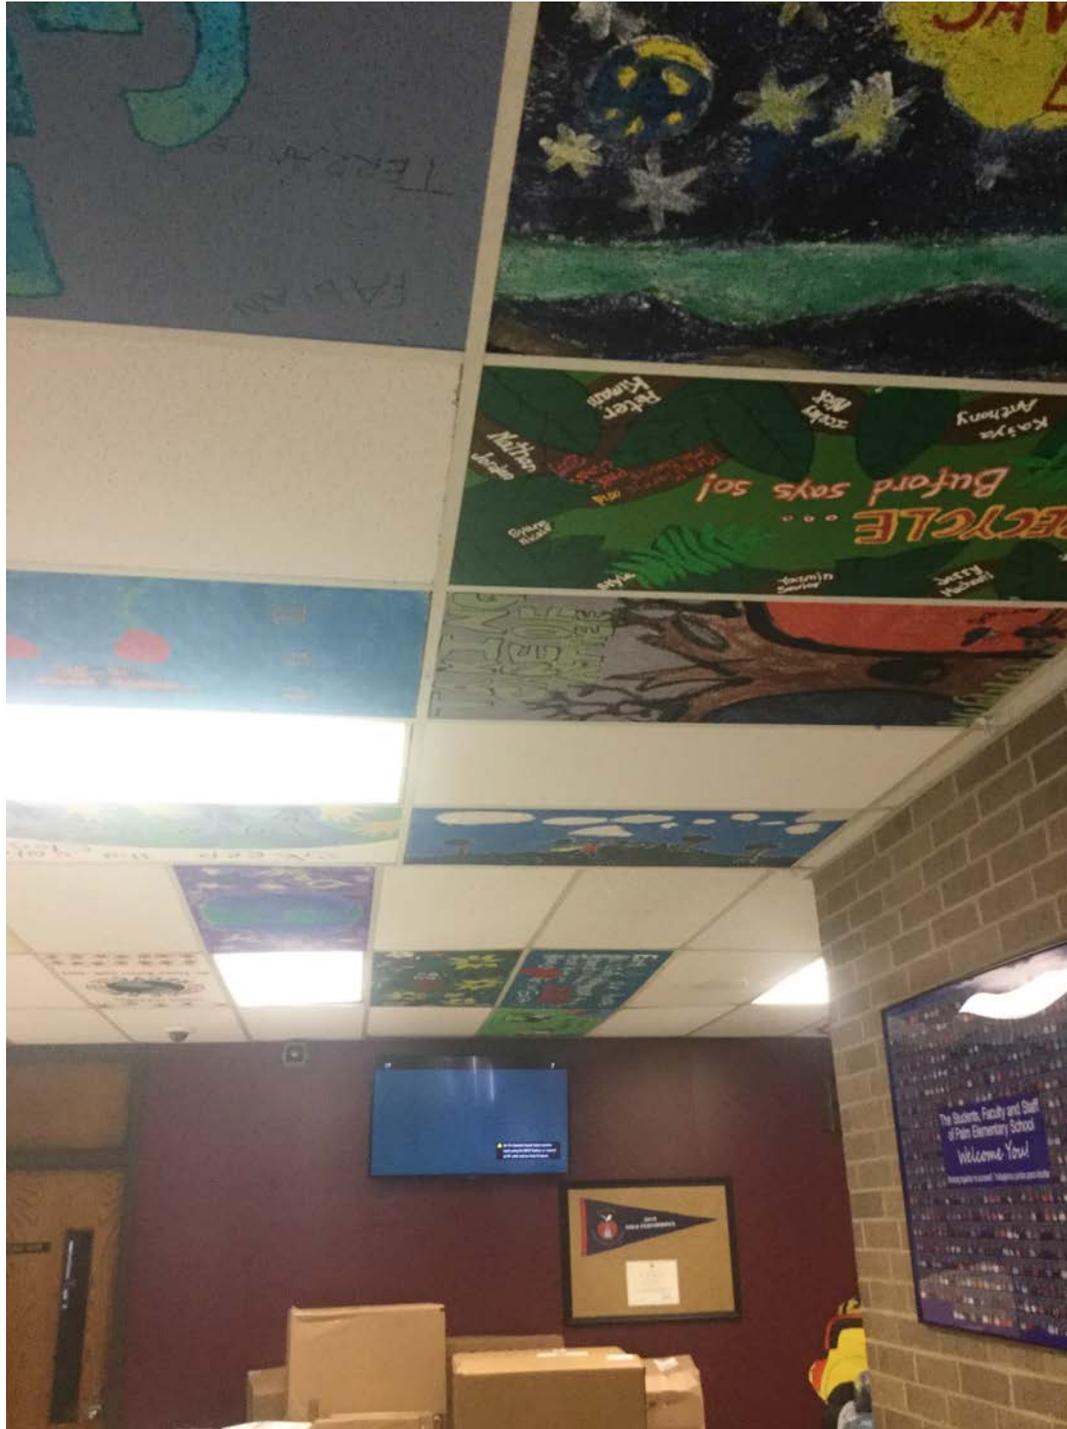
Photo 3. Ceiling Art

The murals and ceiling tile art work throughout the campus are important to the staff and community.

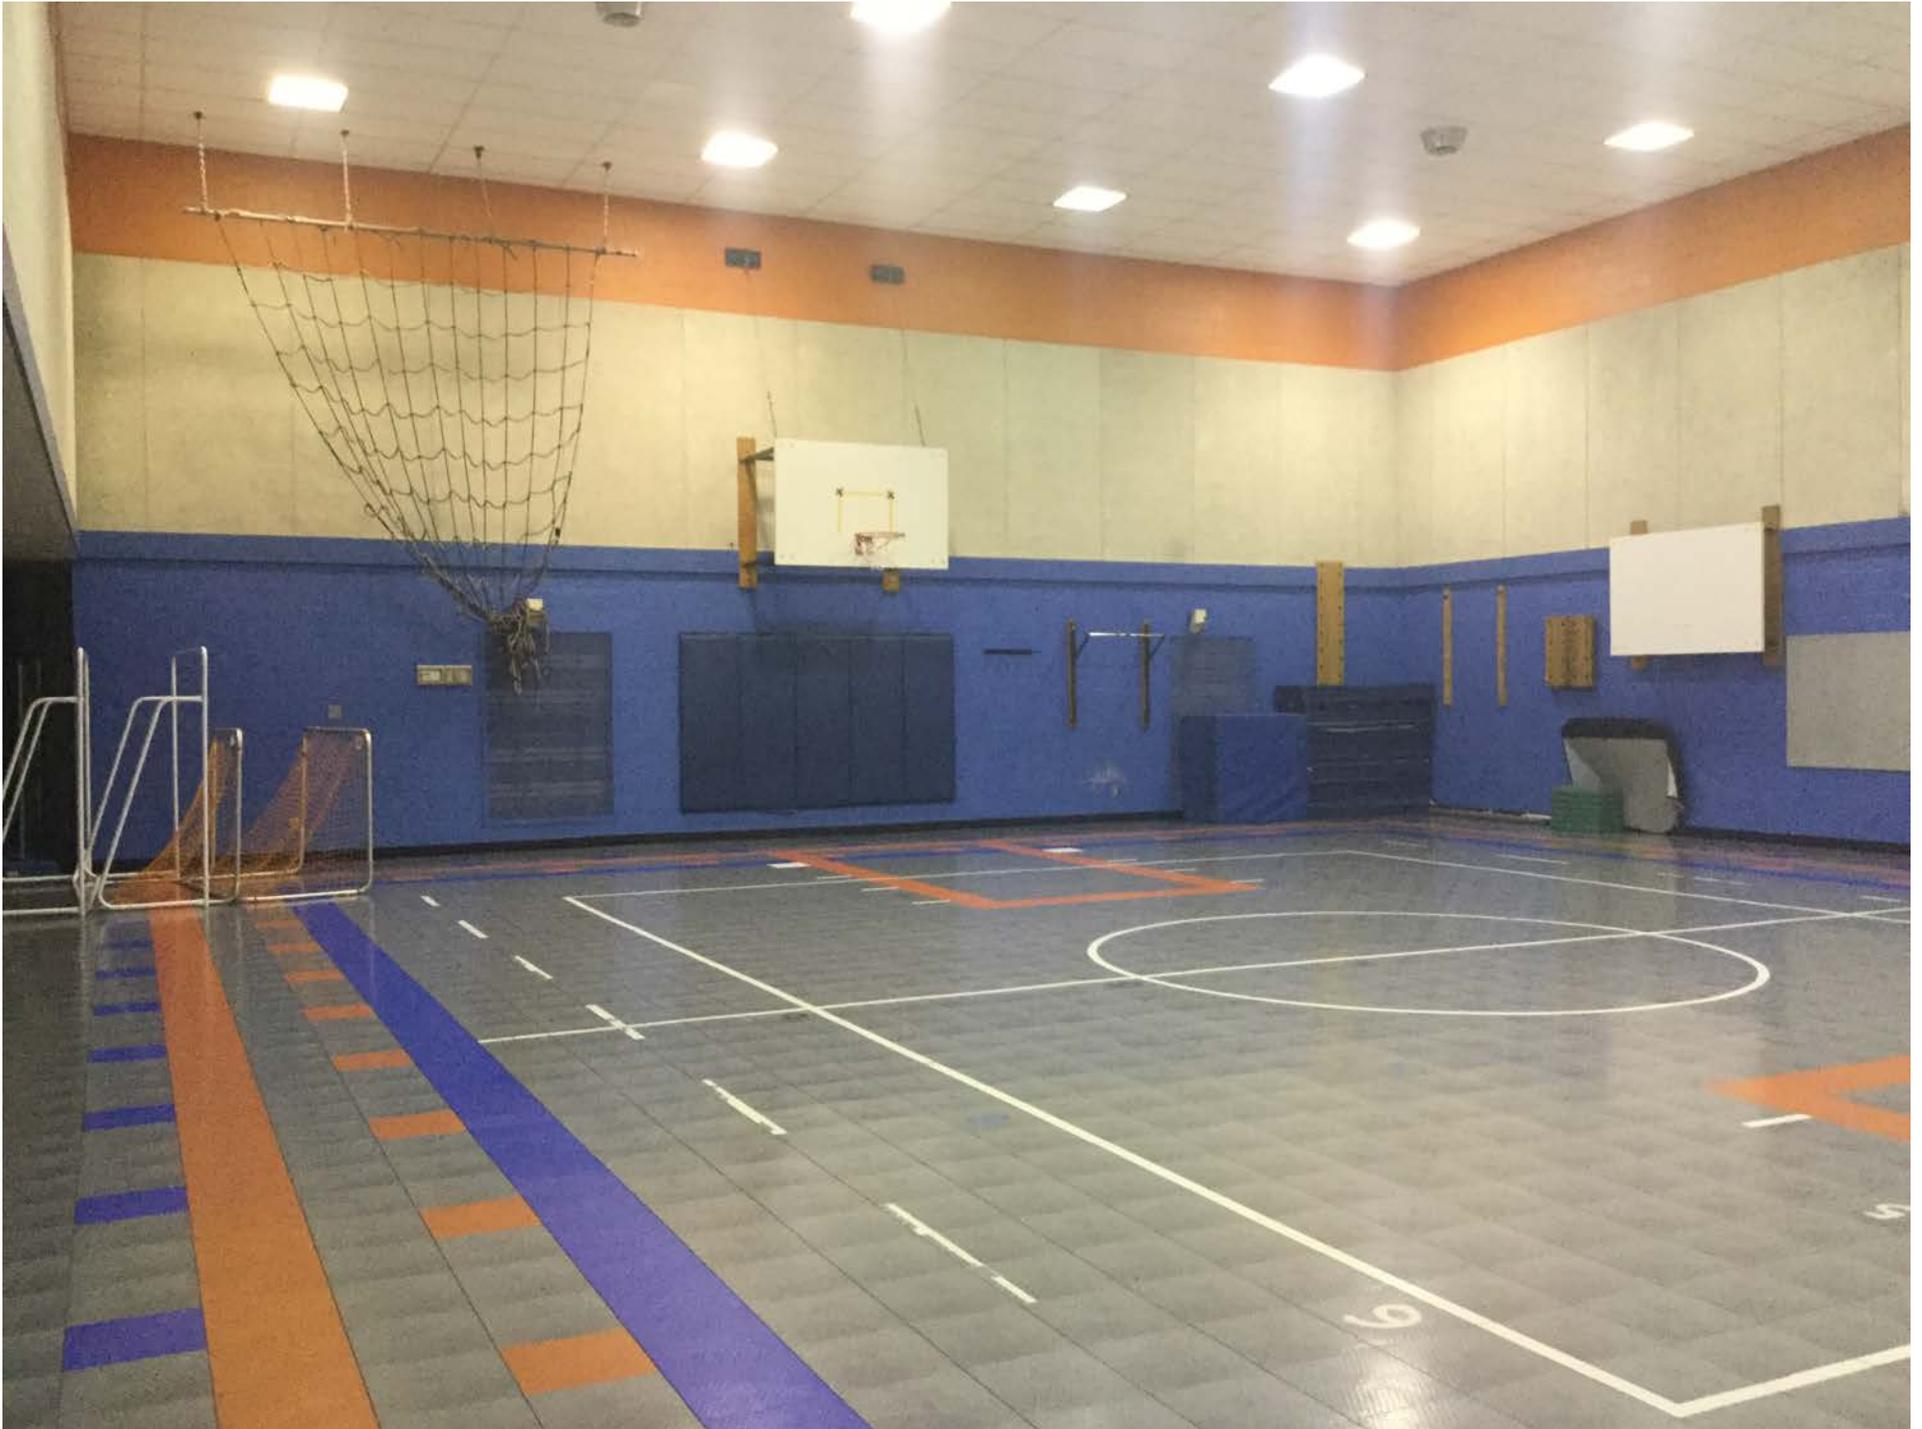
Photo 4. Gym

3 - Academic & Co-Curricular Support - Continued		1	2	3	4	5	N/A		
3.6	Are Physical Education and Athletic spaces appropriately configured per the ed spec?				4			Comments	1.00 4.00

1) Very unsatisfactory 2) Unsatisfactory 3) Average 4) Good 5) Very good N/A) Does not apply.		See Photo 4							
3.7	Are Physical Education and Athletic support spaces appropriately configured per the ed spec?			3				Comments	1.00 3.00

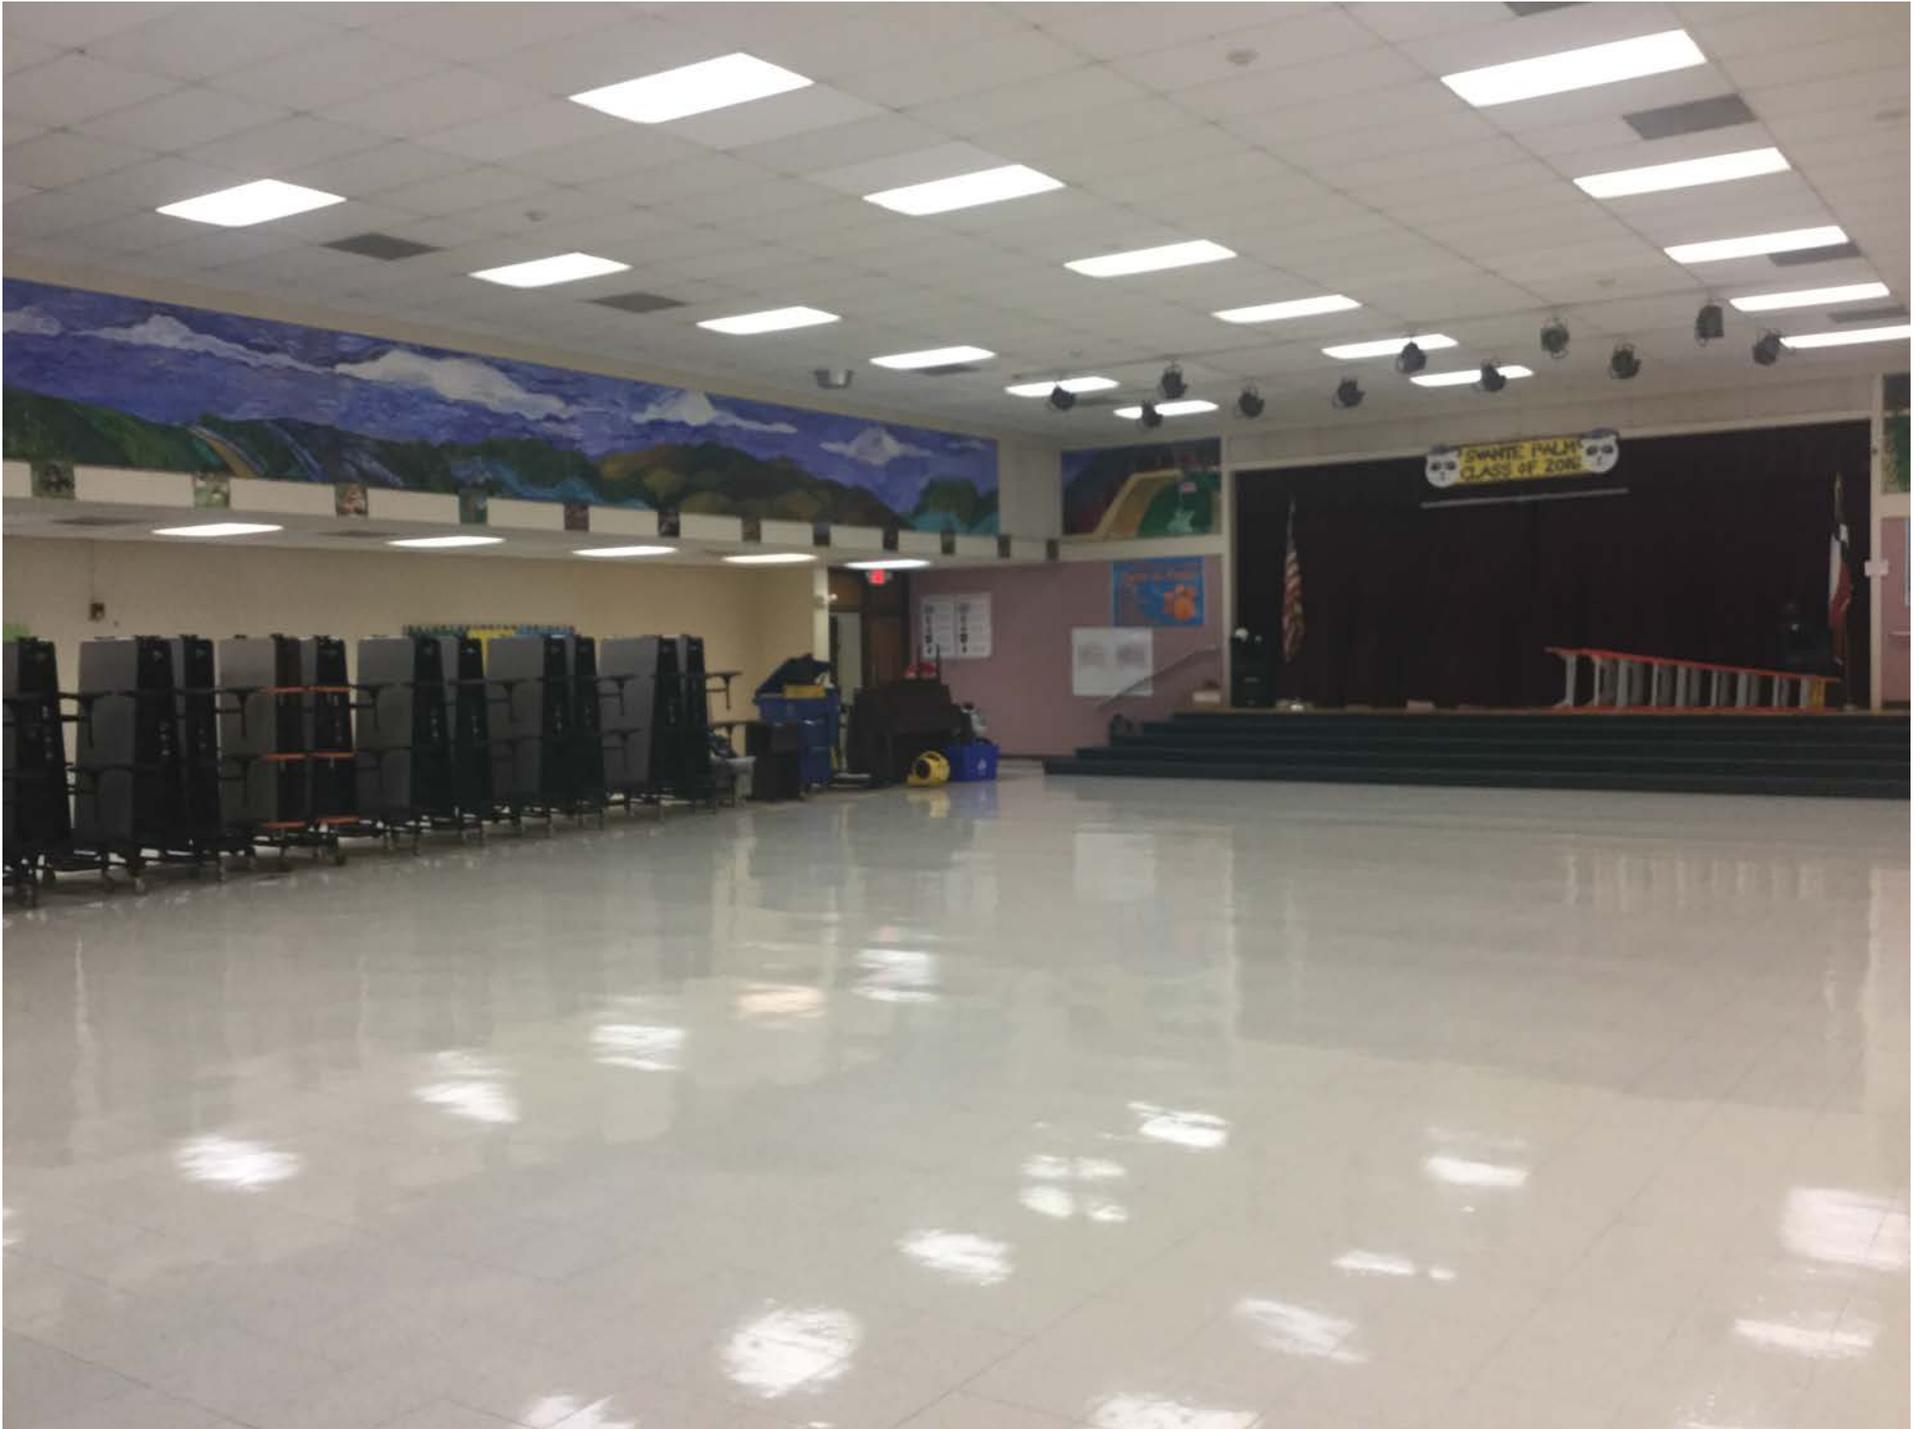
Photo 6. Cafeteria

3.16	Are the student dining facilities appropriately configured?				4			Comments	1.00 4.00
1) Very unsatisfactory - Too small, poor circulation, inflexible seating in poor condition 2) Unsatisfactory - Too small or inadequate circulation, seating in poor condition 3) Average - moderate size, with adequate circulation, seating in okay condition 4) Good - good size, adequate circulation, seating in good condition 5) Very good - good size, adequate circulation, seating in good condition, with more than one option for eating space (ex: connection to outdoor eating space) N/A) Does not apply.								See Photo 6

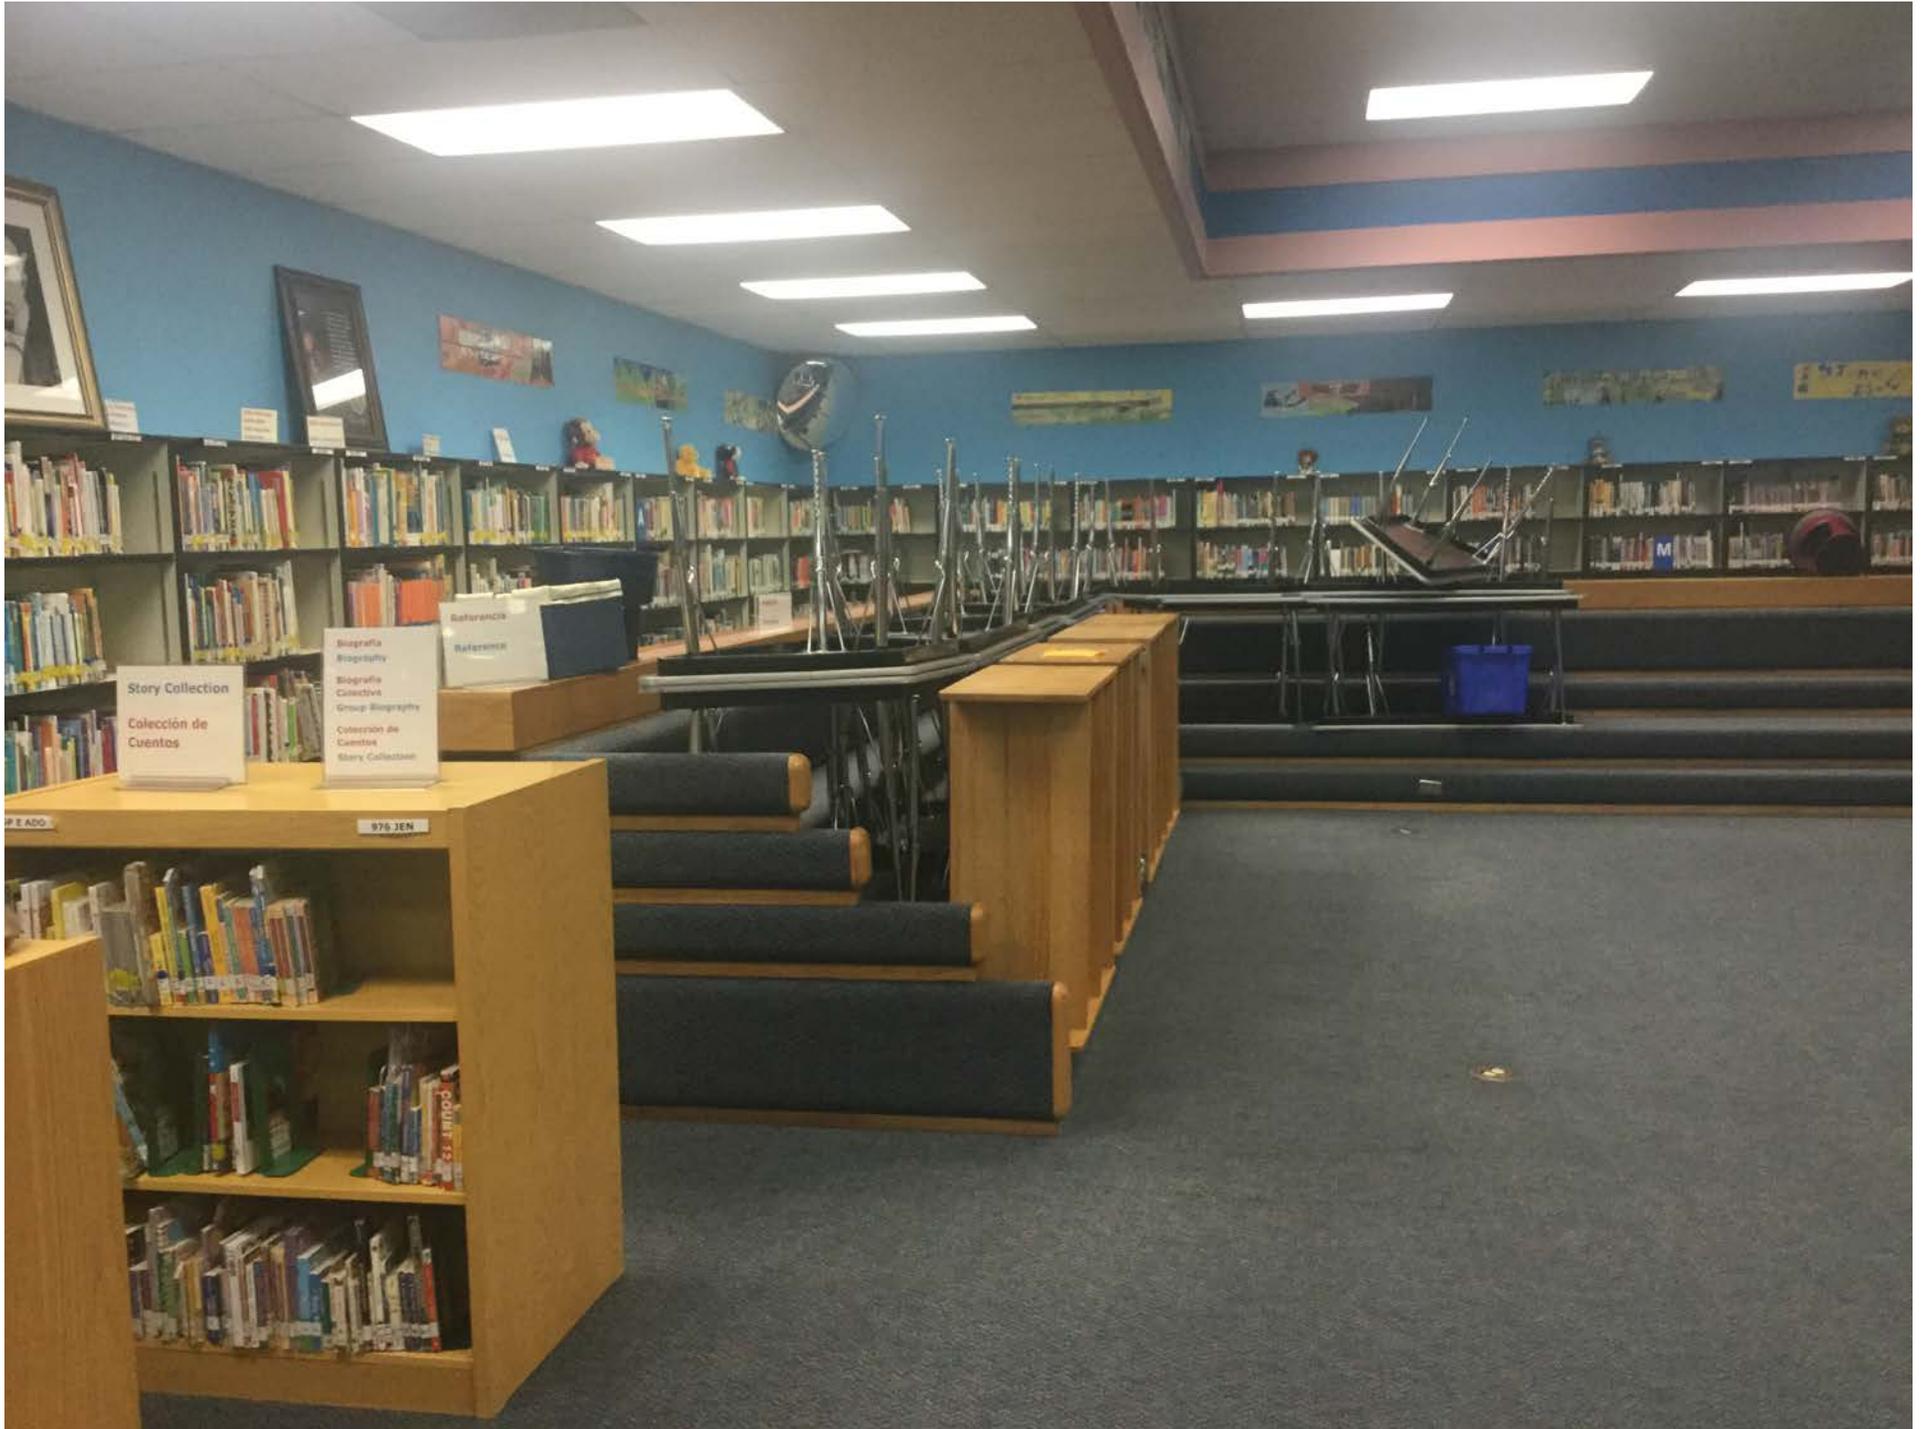
Photo 7. Library

1) Very unsatisfactory 2) Unsatisfactory 3) Average 4) Good 5) Very good N/A) Does not apply.								There is no direct access to the library from the entrance as the space is located centrally in the building.		
								See Photo 7

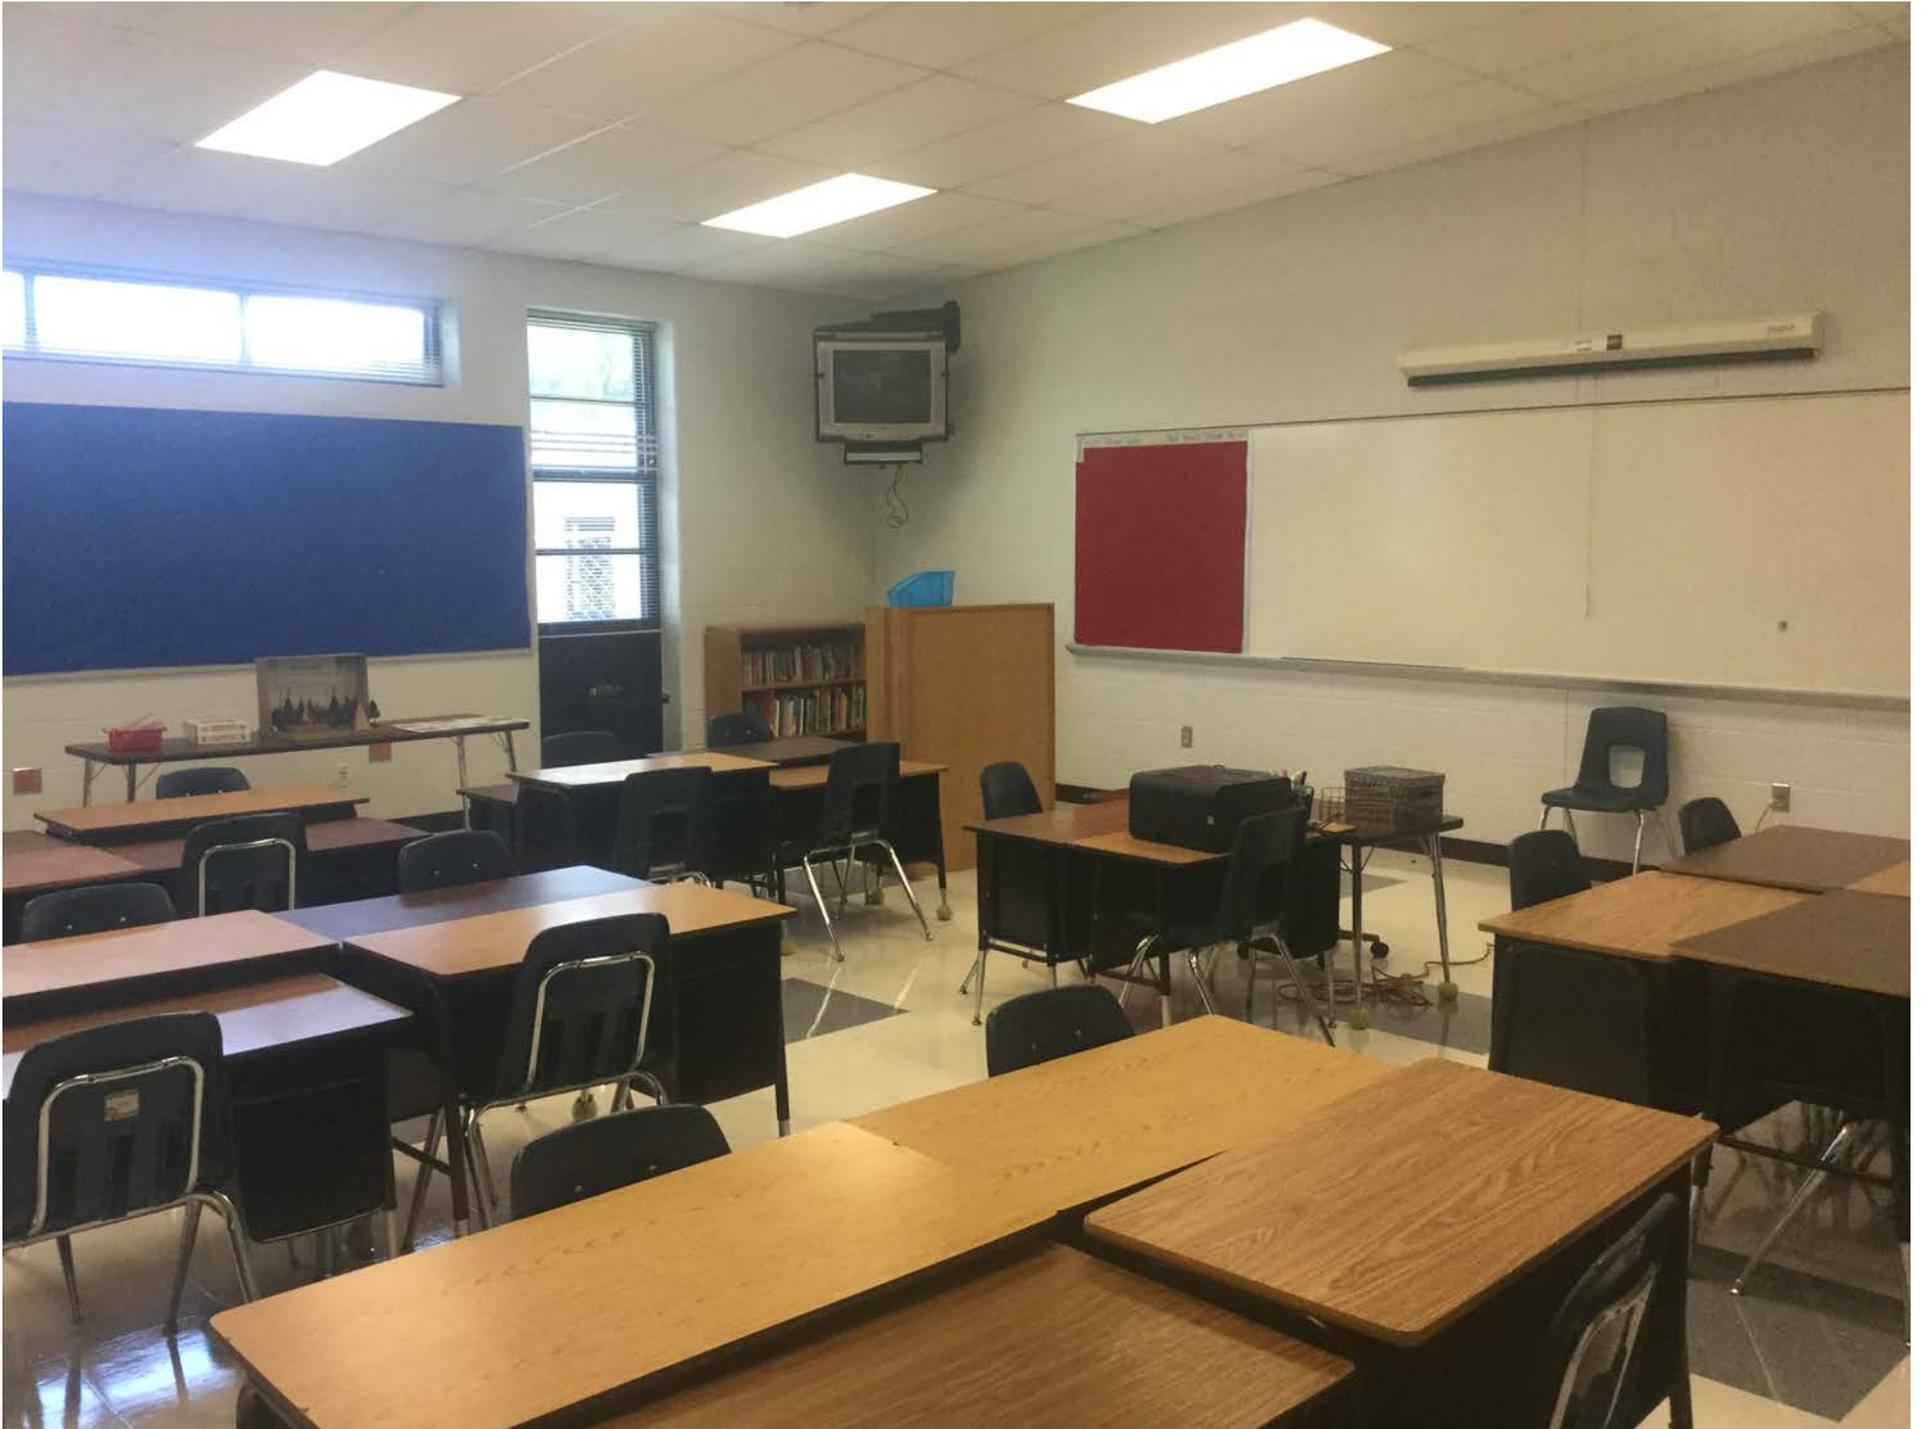
Photo 8. Classroom Furniture

Furniture is unsatisfactory in condition and size, and does not allow for easy reconfiguration of the space for different learning groups. Desks and chairs are in poor condition and break often. This is an ongoing issue for the campus.

9 - Furniture, Fixtures & Equipment		1	2	3	4	5	N/A	Comments	0.75	5.75
9.1	What is the current condition of the furniture?	1						Comments	0.75	0.75
1) Very unsatisfactory - damaged/non-functioning 2) Unsatisfactory - torn, bent, wrong size 3) Average - scratched/dented/marked 4) Good - not new but sturdy and clean 5) Very good - new N/A) Does not apply.								The furniture is dated and requires constant maintenance.		
								See Photo 8
