## Educational Suitability Summary Report

Patton Elementary School

Date: 07/25/2016

## Austin ISD Educational Suitability Assessment Criteria

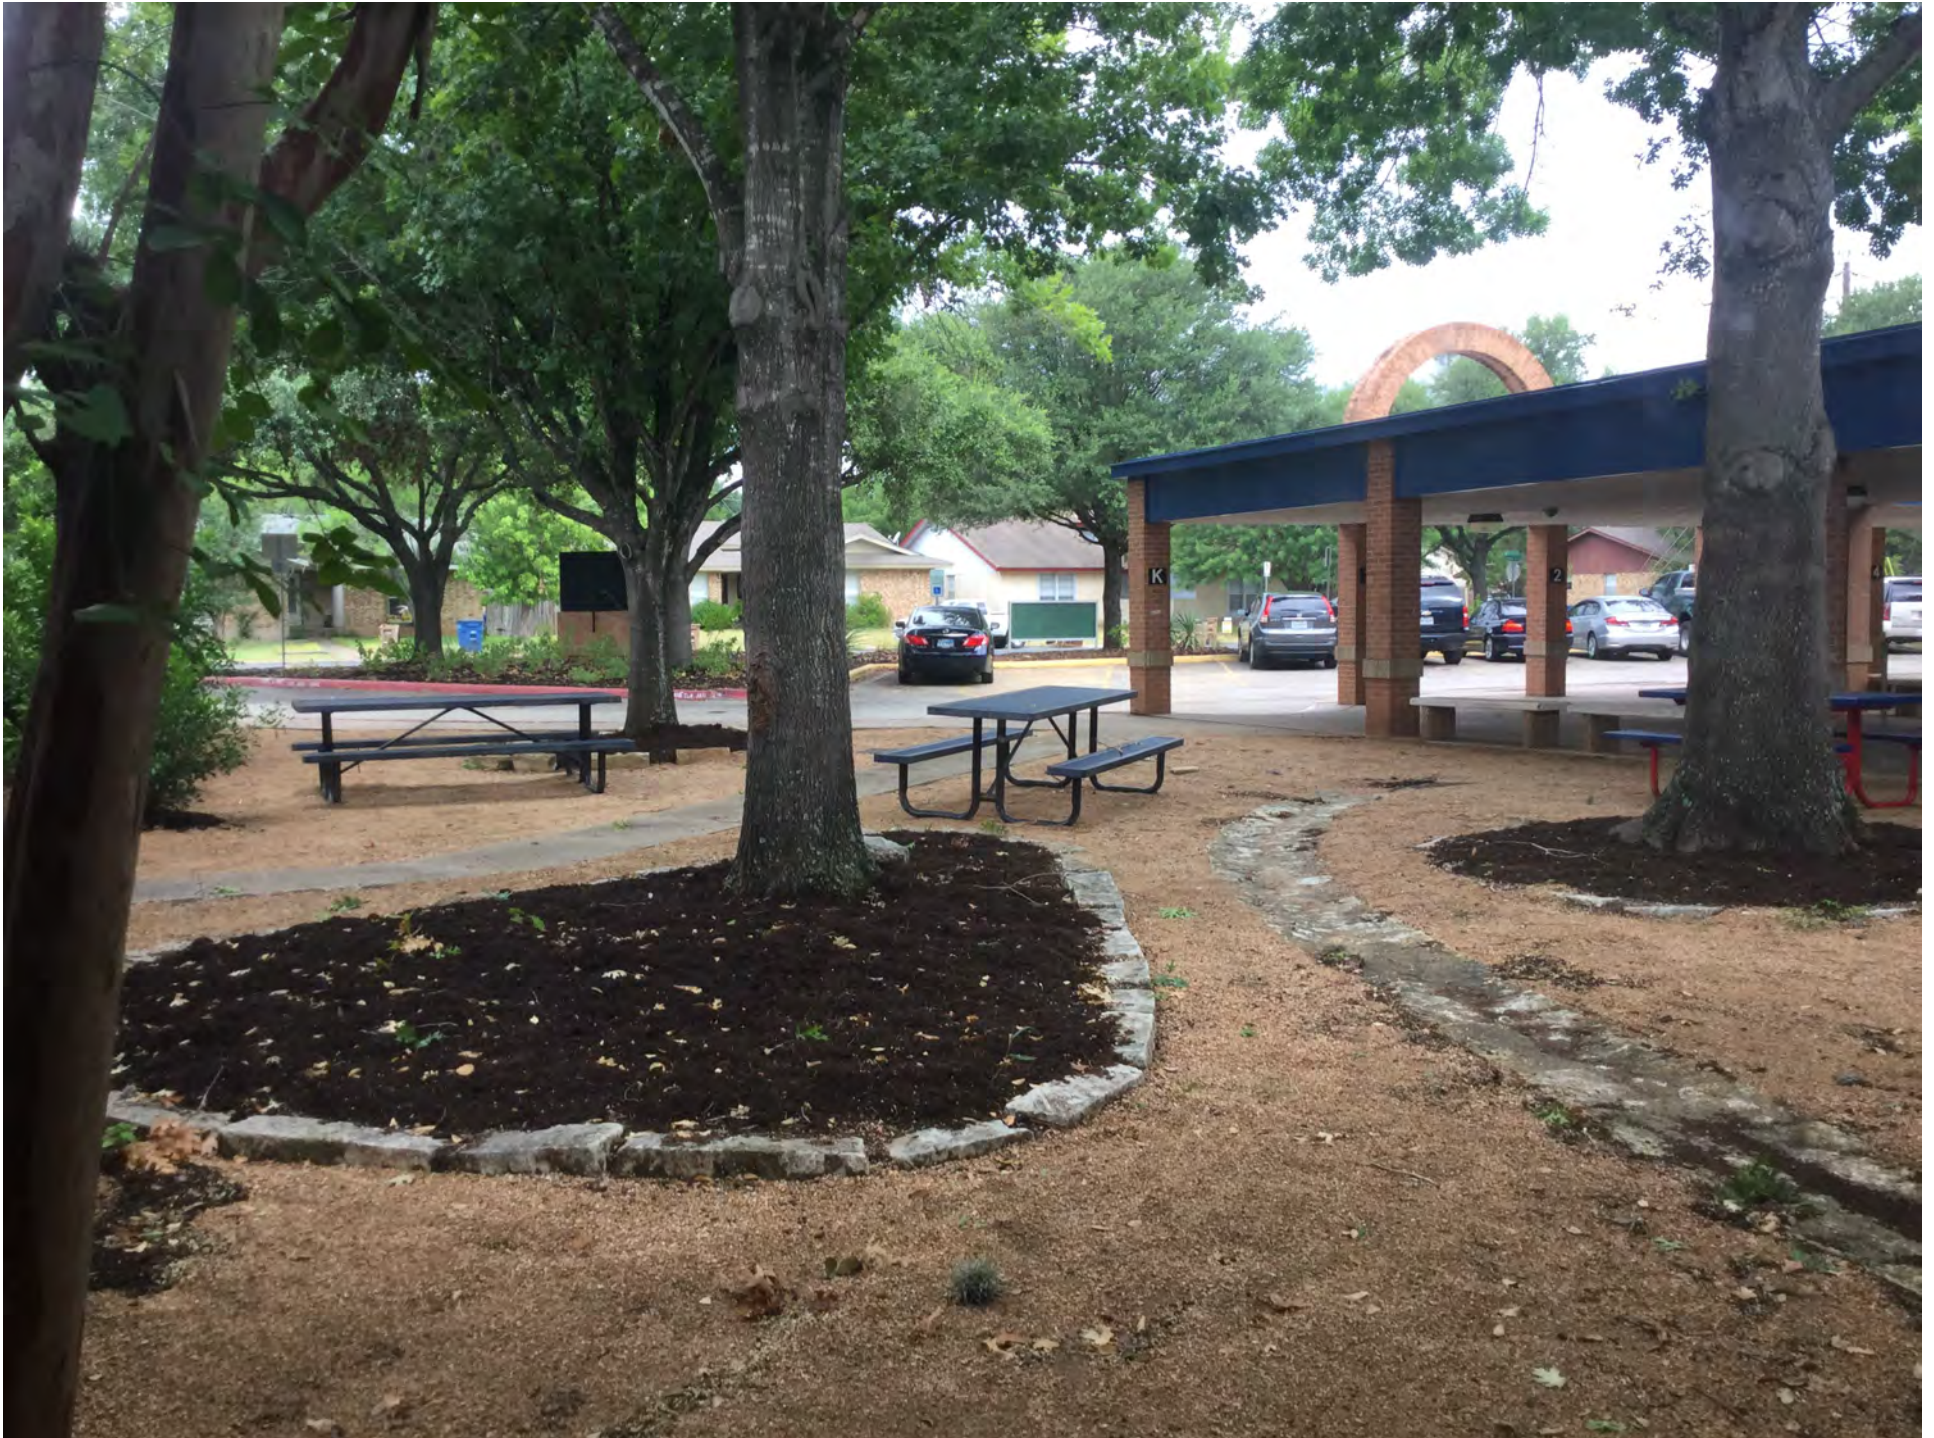
Photo 1.  
1.2 Outdoor Learning Space

1.2	Are opportunities provided for outdoor learning (outdoor classrooms, gardens, etc.)?			3				Comments 1.00 3.00
	1) Outdoor space exists is not developed 2) Outdoor space for learning exists but not connected to classroom learning areas. 3. Outdoor learning spaces exist and are accessible but not in good condition. 4. Outdoor learning spaces need minor improvements to function well. 5. Outdoor learning spaces are in excellent condition. N/A) Does not apply.							see photo 1

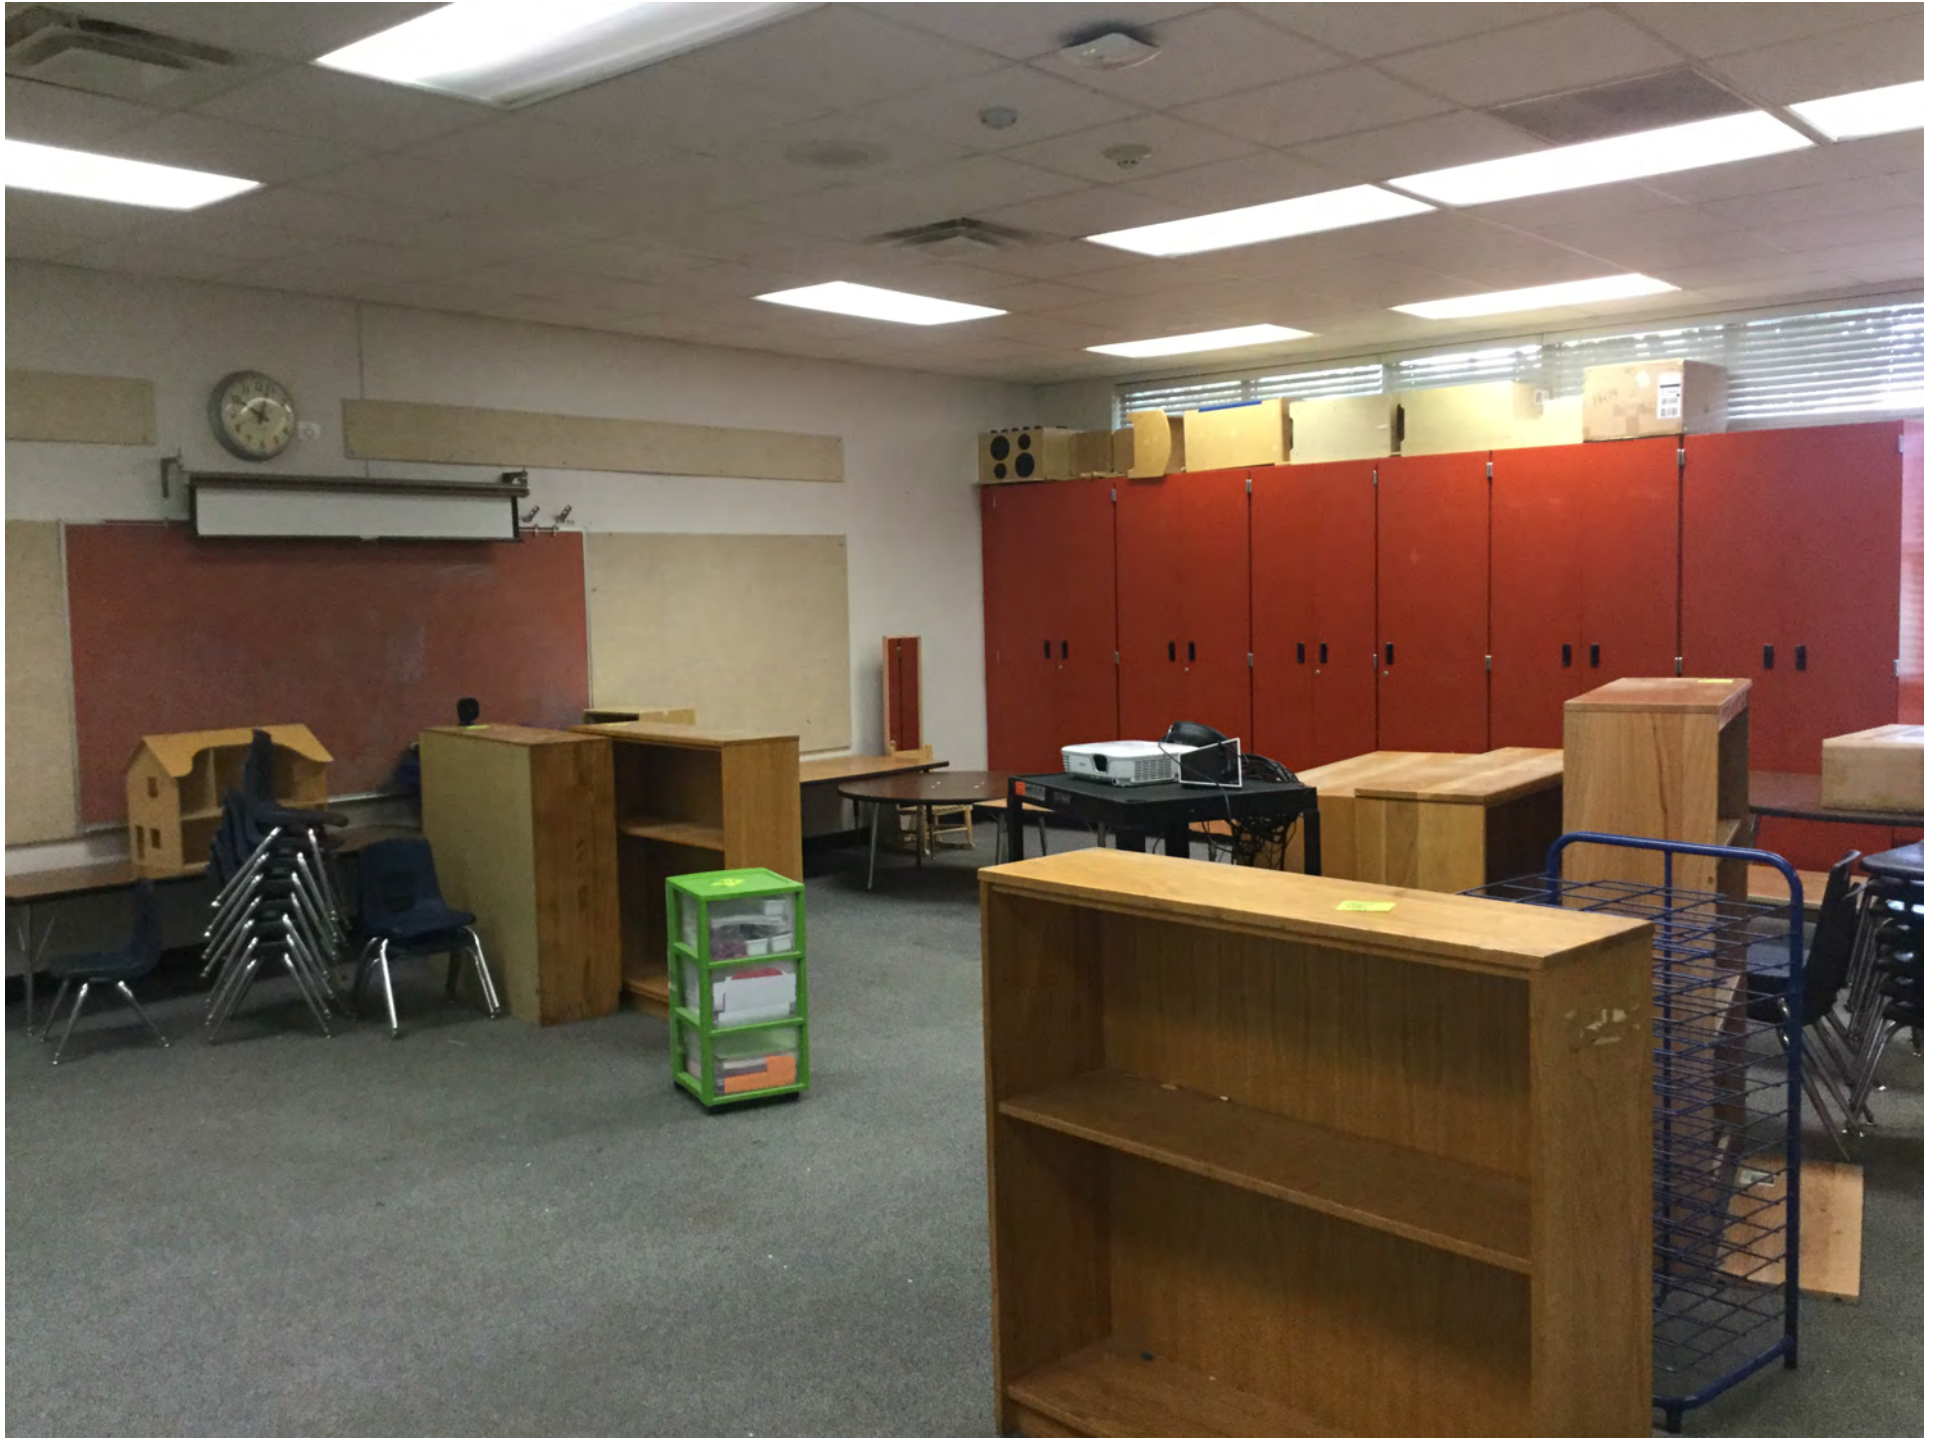
Photo 2.  
3.2 Pre-K Classroom

3 - Academic & Co-Curricular Support		1	2	3	4	5	N/A	40.00	
3.2	Are Pre-K and Kinder classrooms appropriately configured per the ed spec? (elementary school only)				4			Comments	1.004.00

1) Very unsatisfactory - Too small, awkward layout, does not meet needs 2) Unsatisfactory - Too small, only one area for all teaching methods, limited flexibility 3) Neutral - Moderate size, two areas for different teaching methods, some flexibility, access to student storage/casework 4) Satisfactory - Good size, at least two zones for different teaching methods, flexibility and student storage, not new 5) Very Satisfactory - Good size, two zones for different teaching methods, flexibility and student storage/casework, adequate display area and visual teaching tools N/A) Does not apply.									see photo 2

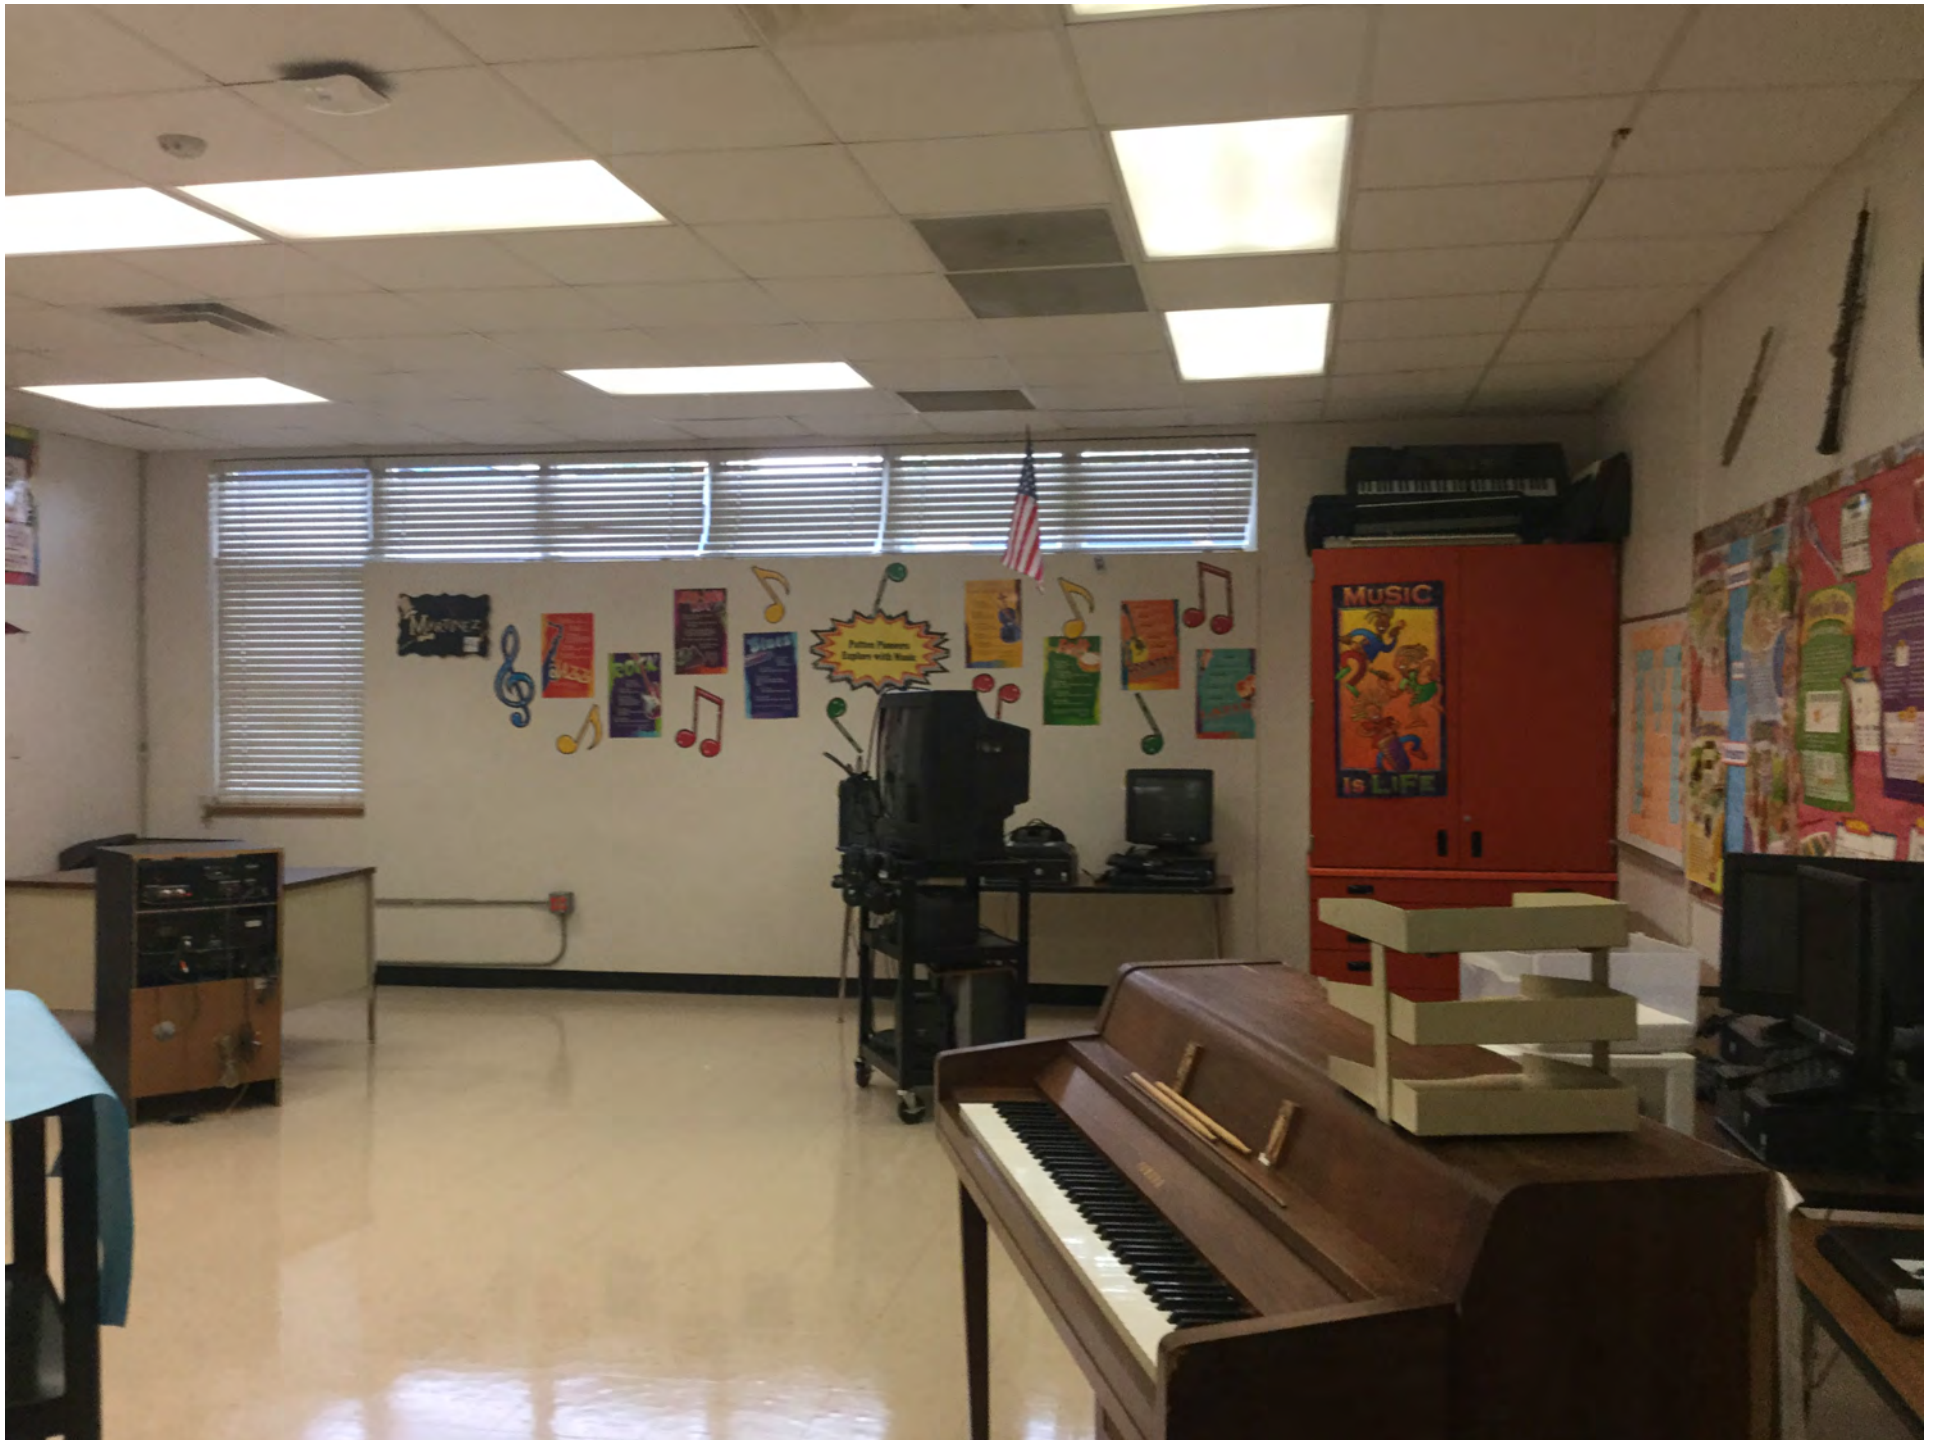
Photo 3.  
3.8 Music Room

3.8	Are music, drama, or performance spaces appropriately configured per the ed spec?			3				Comments	1.00 3.00
1) Very unsatisfactory 2) Unsatisfactory 3) Average 4) Good 5) Very good N/A) Does not apply.								The classrooms are small, but the stage is in good condition.

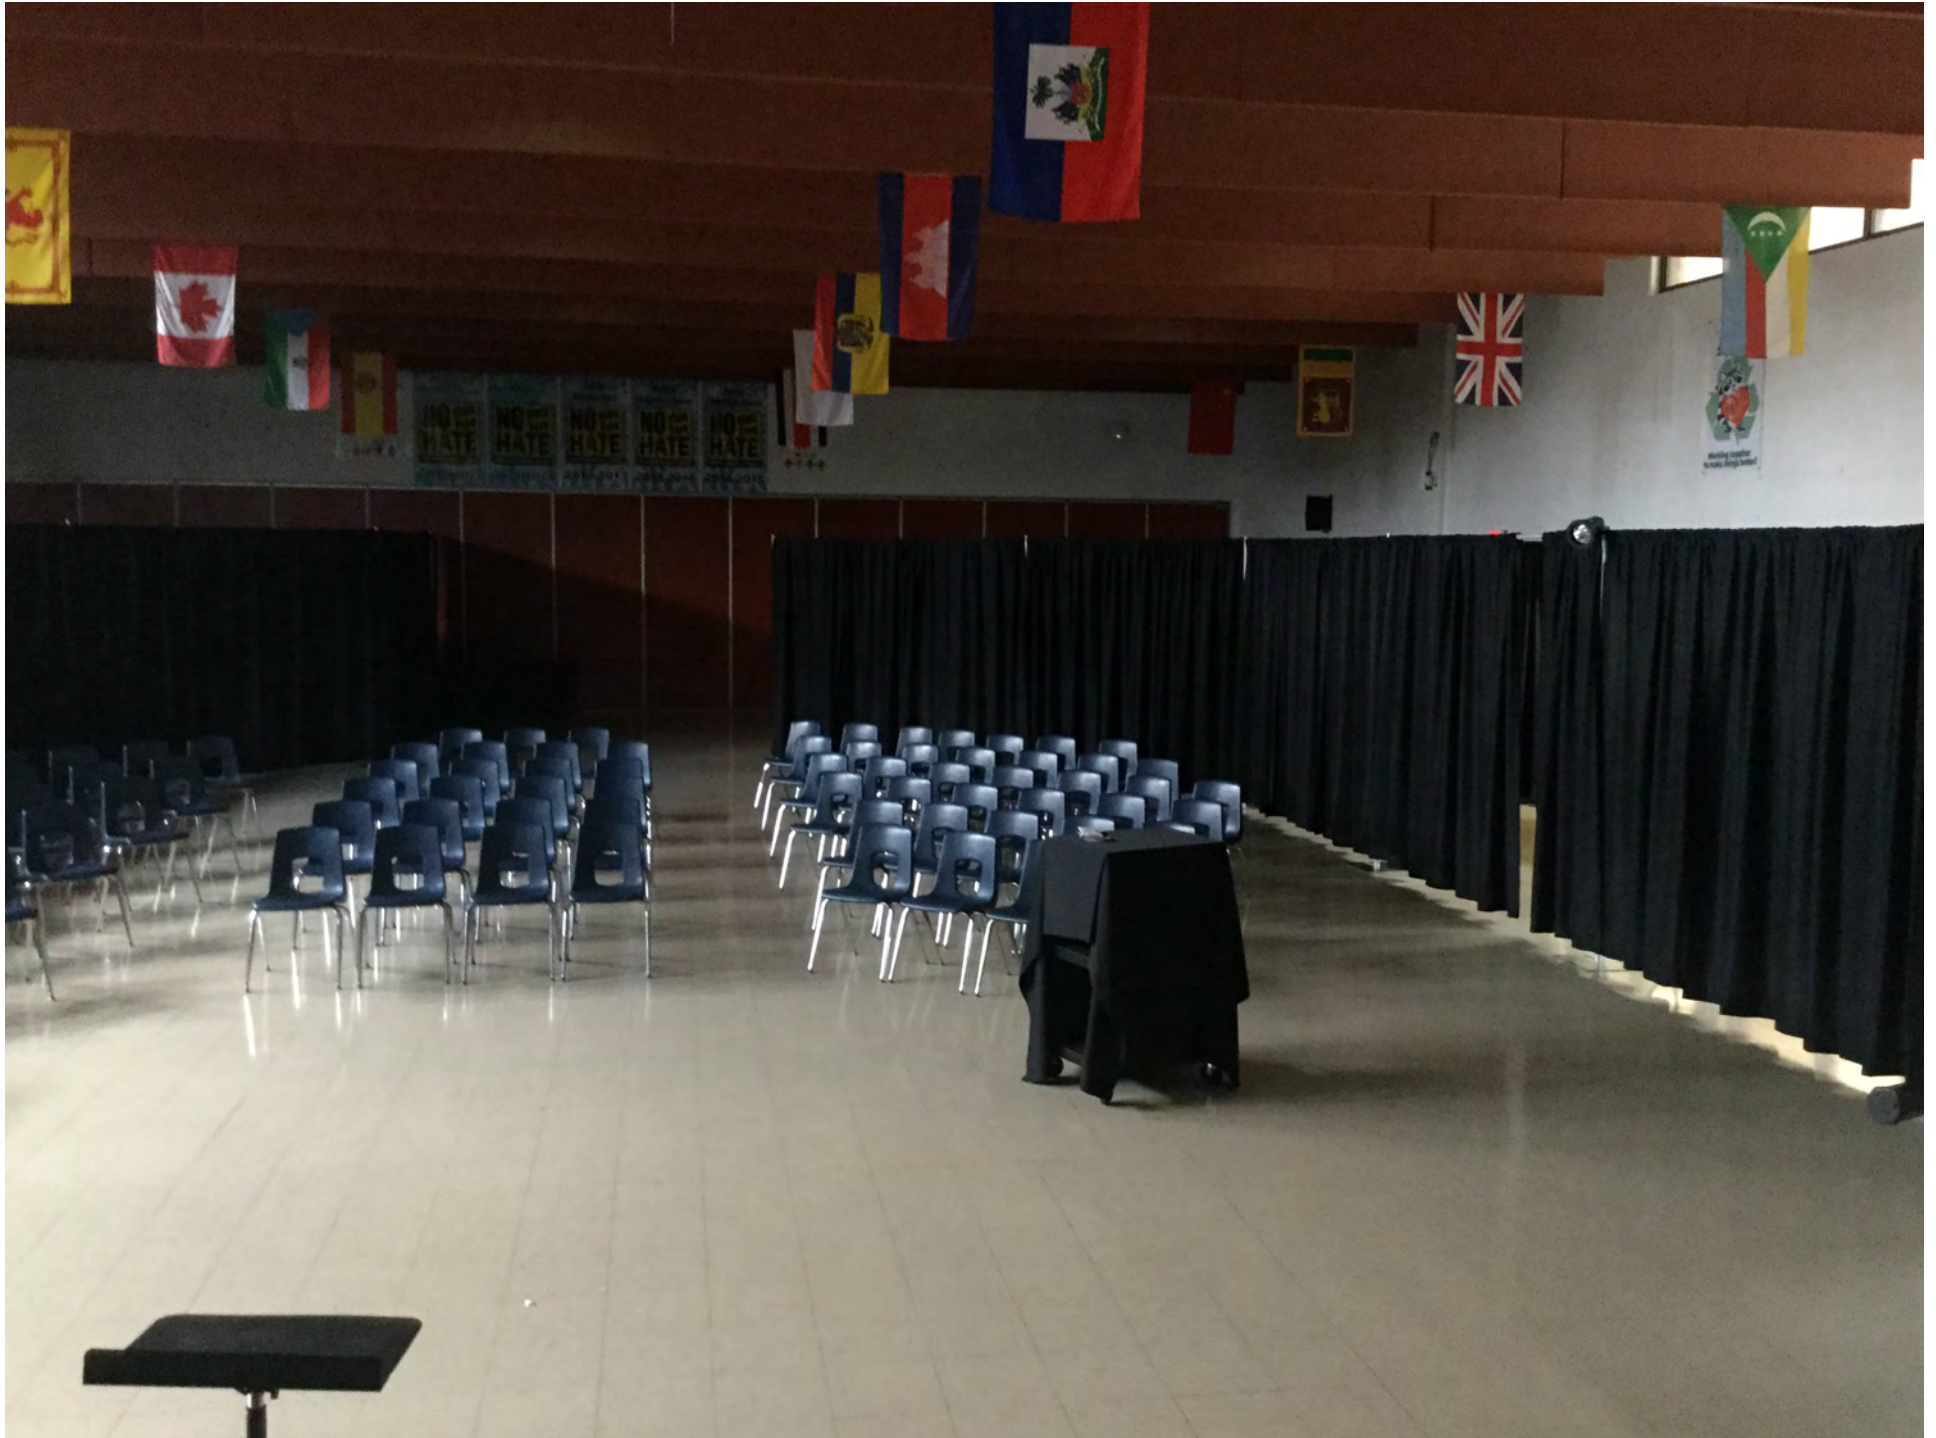
Photo 5.  
3.16 Cafetorium

3.16	Are the student dining facilities appropriately configured?			3				Comments	1.00 <b>3.00</b>
1) Very unsatisfactory - Too small, poor circulation, inflexible seating in poor condition 2) Unsatisfactory - Too small or inadequate circulation, seating in poor condition 3) Average - moderate size, with adequate circulation, seating in okay condition 4) Good - good size, adequate circulation, seating in good condition 5) Very good - good size, adequate circulation, seating in good condition, with more than one option for eating space (ex: connection to outdoor eating space) N/A) Does not apply.								The overcrowding at the school is making this space somewhat crowded.	<b>see photo 5</b>

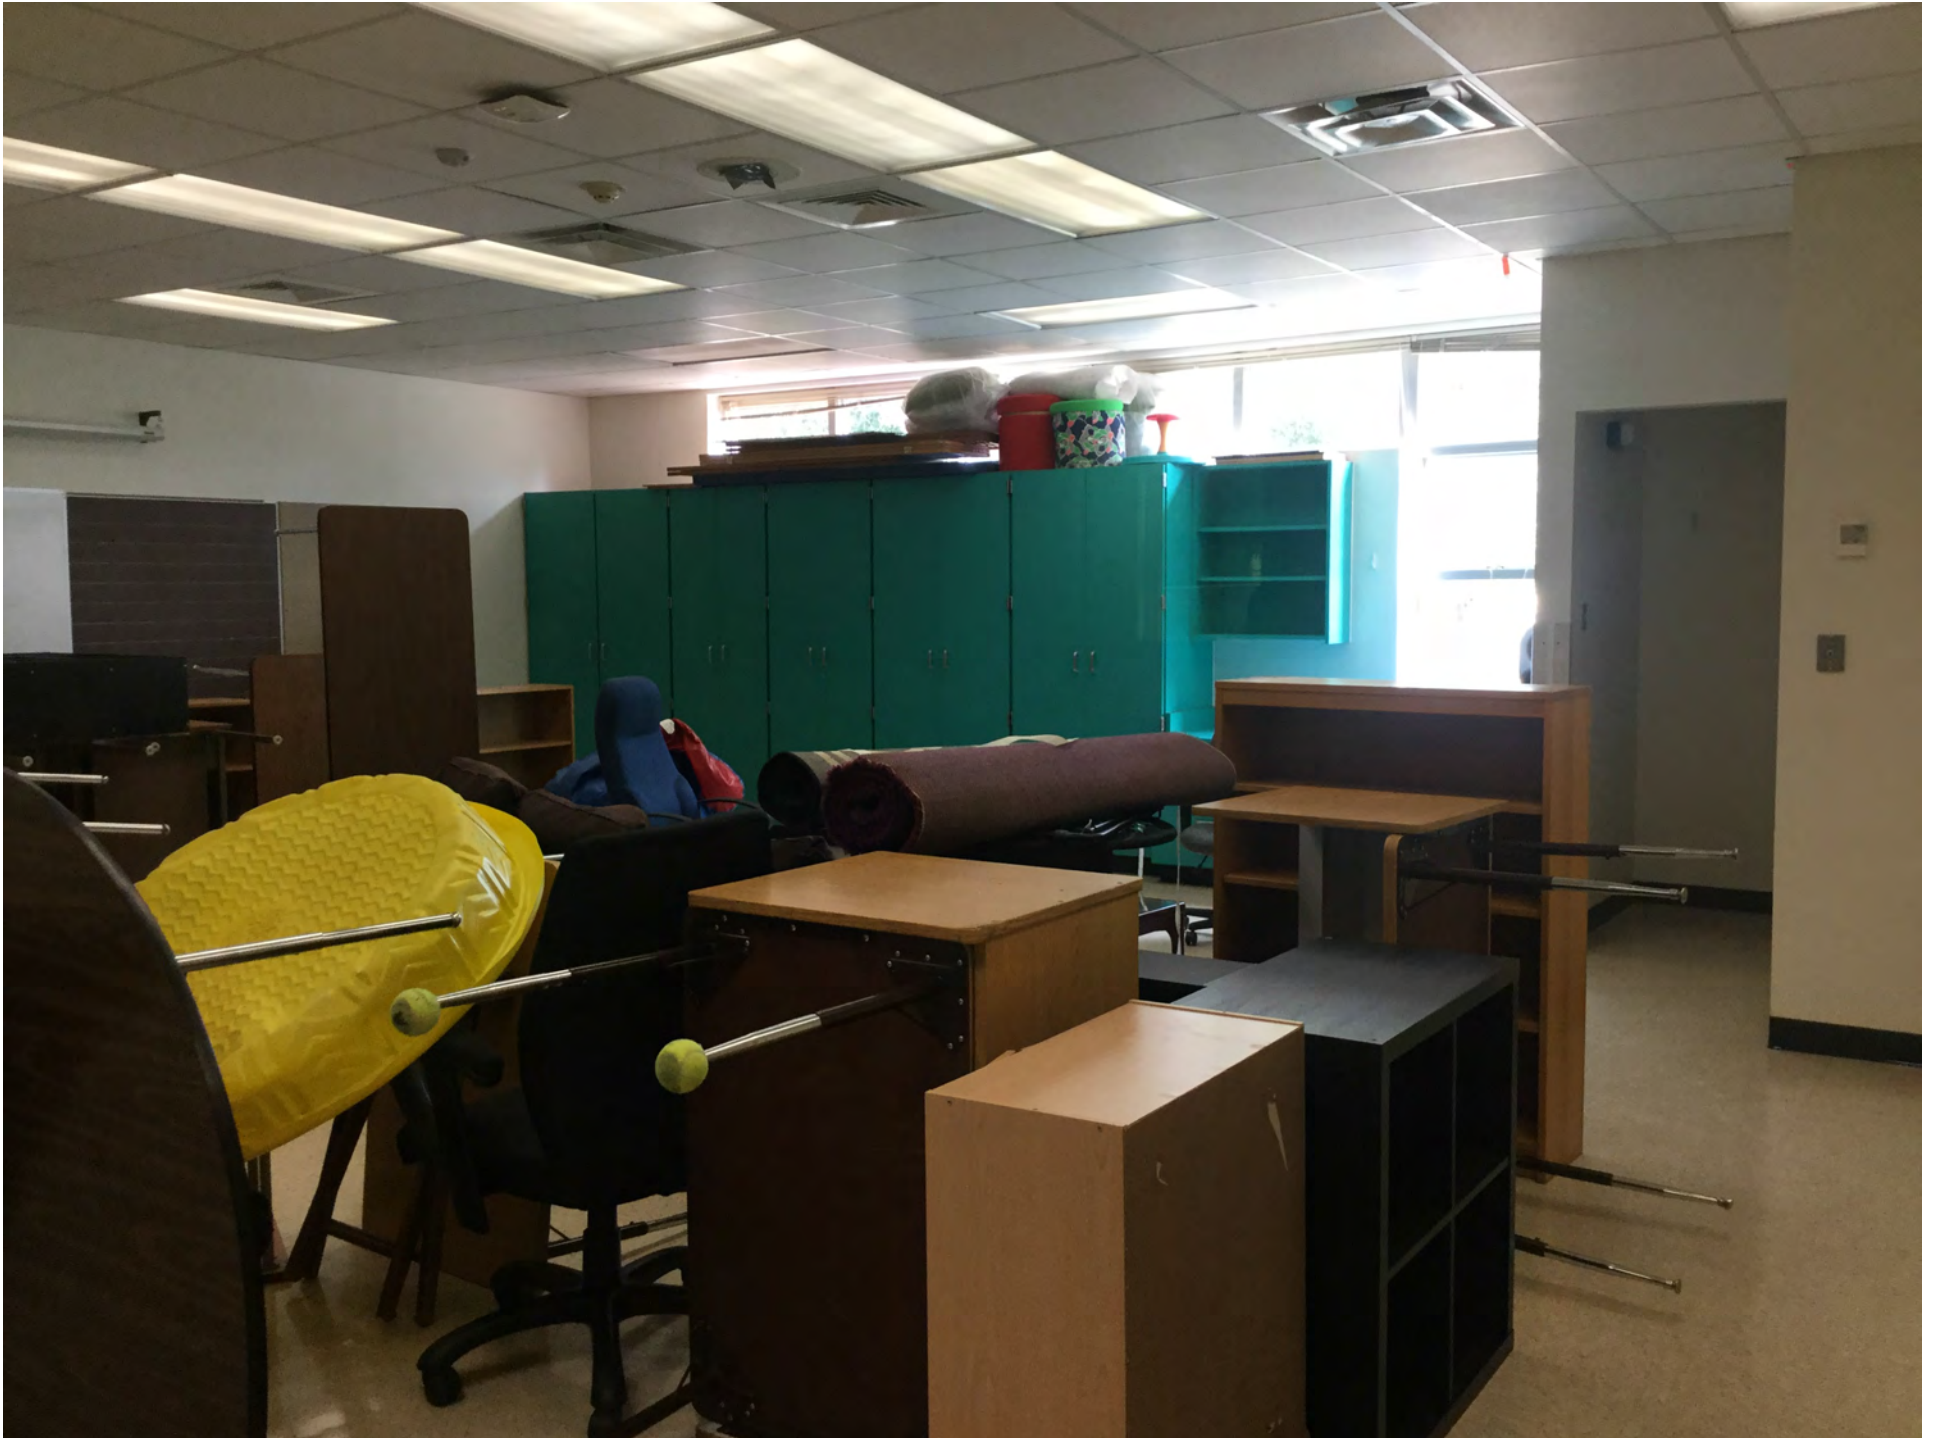
Photo 6.  
4.2 Standard Classroom

4.2	Are general classrooms large enough to support project-based learning and multiple teaching modalities?				4			Comments	1.00 4.00
1) Very unsatisfactory -too small to move, set for lecture only, no connectivity, no flexibility 2) Unsatisfactory - adequate size but set for lecture only, no connectivity, no flexibility 3) Neutral - have flexibility and space for hands on or project based learning 4) Satisfactory - have flexibility and space for hands on or project based learning and connectivity for global learning 5) Very Satisfactory - space for hands on learning, flexibility for different groupings, and connectivity for global classrooms N/A) Does not apply.

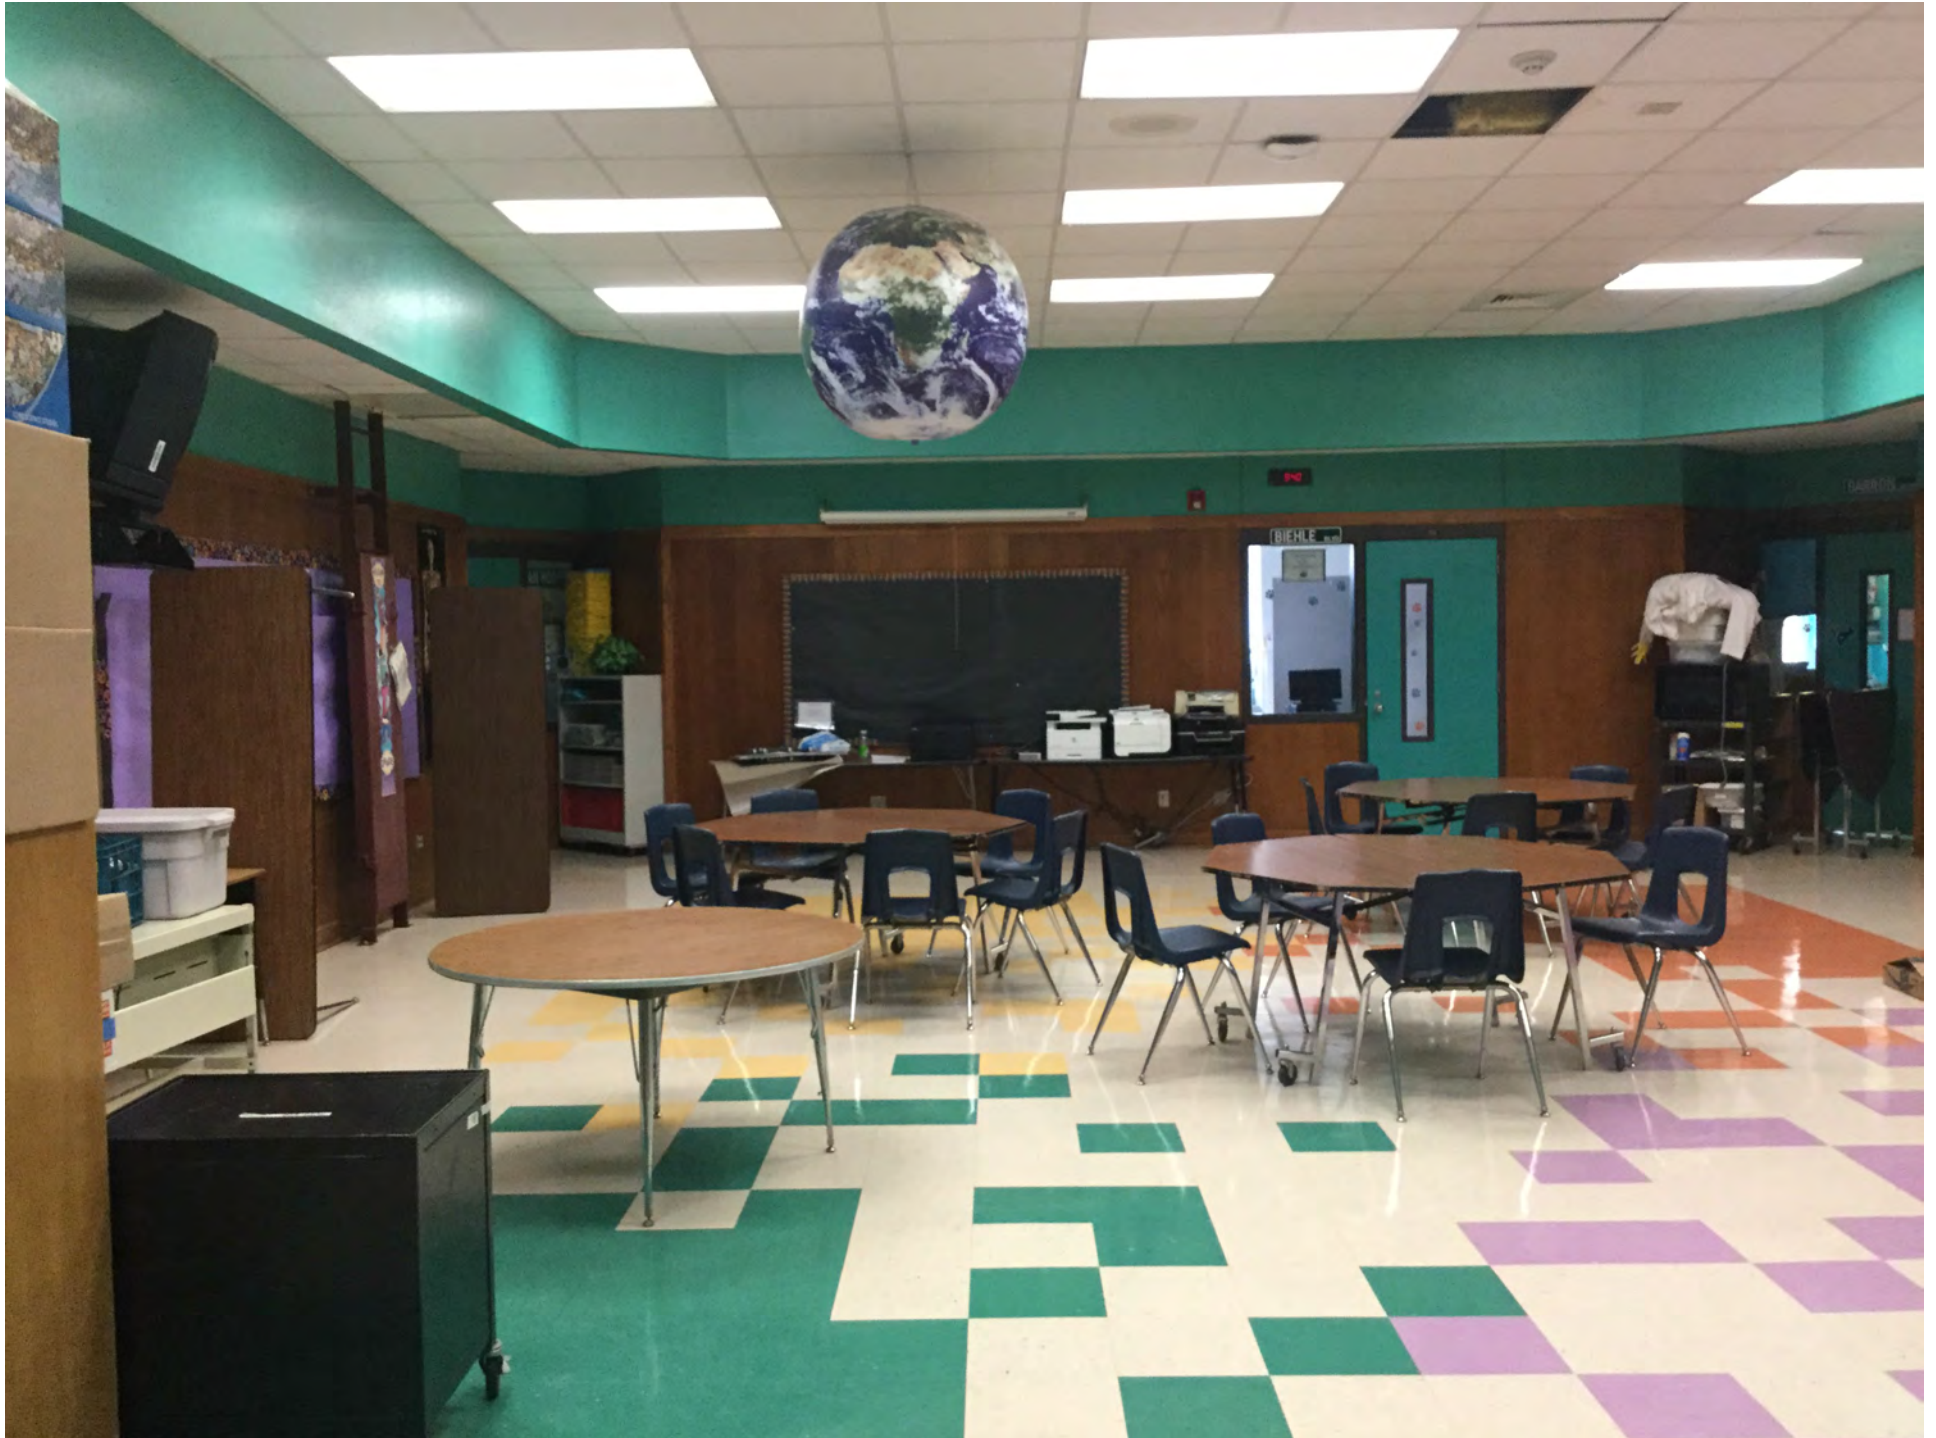
Photo 7.  
4.5 Collaborative Space

4 - Future Ready Student Development - Continued							1	2	3	4	5	N/A		
4.5	Does the building provide adequate opportunities for students/teachers to collaborate in varying group sizes?				4								Comments	1.00 4.00

1) Very unsatisfactory - no common spaces or meeting rooms or in very poor condition 2) Unsatisfactory - a few common spaces or meeting rooms in unsatisfactory condition 3) Average - a few common spaces and meeting areas needing updates 4) Good - multiple common spaces and meeting rooms in good condition 5) Very good - adequate common spaces and meeting rooms of excellent quality N/A) Does not apply.													The common spaces between classrooms are working well. The meeting and office space is limited in the administration area. <i>CAC comments that they desire additional learning spaces for reading specialists.</i>	
													see photo 7

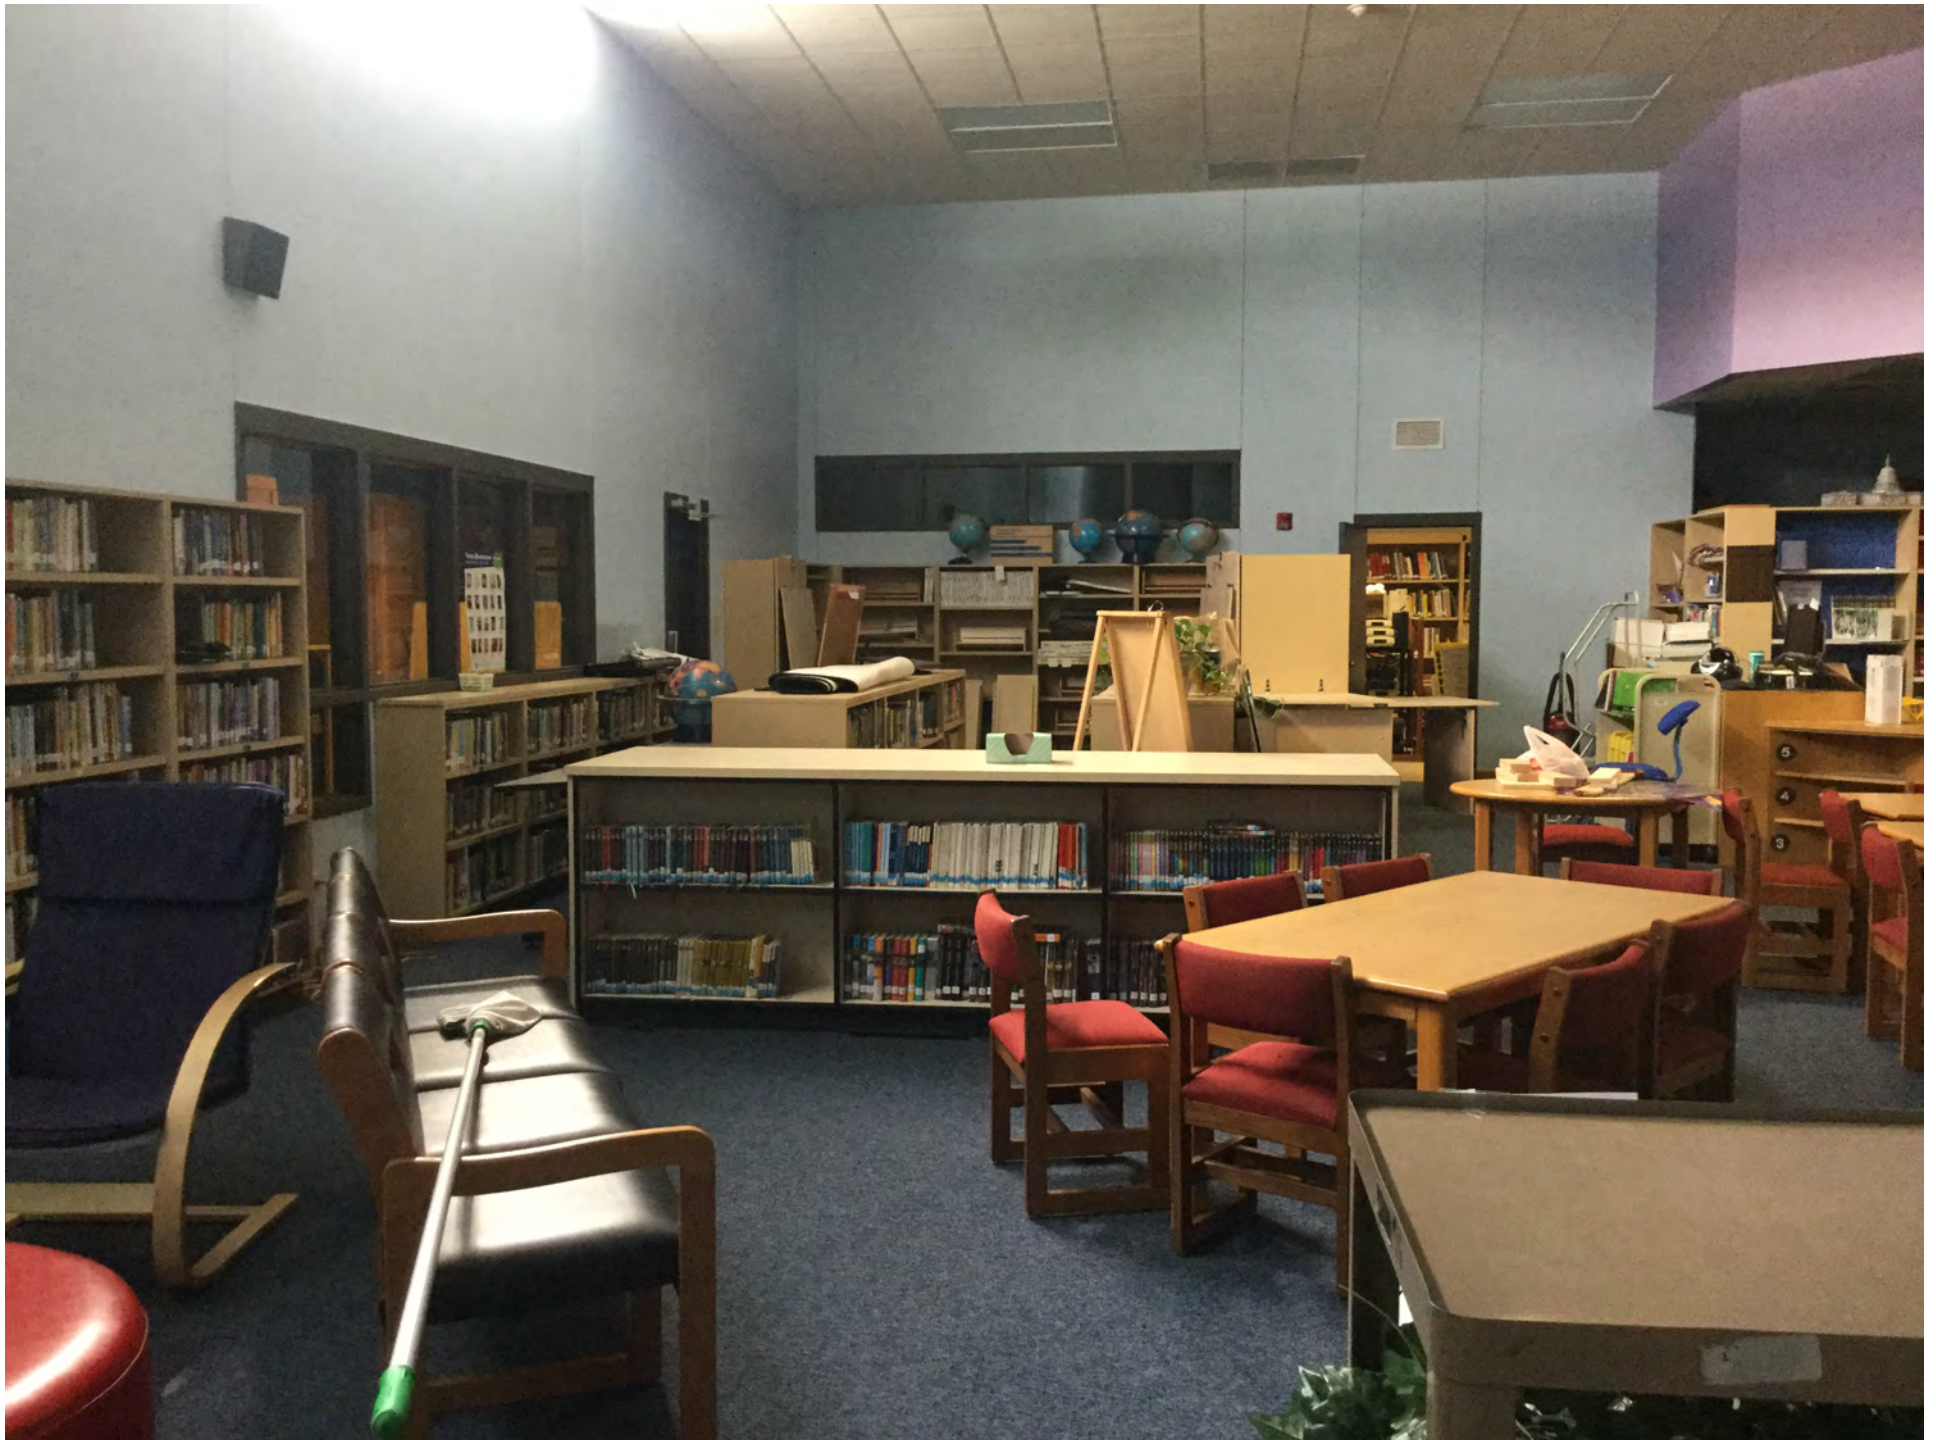
Photo 8.  
5.2 Library

1) Very unsatisfactory 2) Unsatisfactory 3) Average 4) Good 5) Very good N/A) Does not apply.										
5.2	How well does the Library/Media Center support quiet study?			3				Comments	1.00	3.00

1) Very unsatisfactory 2) Unsatisfactory 3) Average 4) Good 5) Very good N/A) Does not apply.								There are some smaller seating areas for quiet study, but the size is limited.		
								see photo 8
