Educational Suitability Summary Report

Pecan Springs Elementary – BLDG 129

Date: 06/21/2016

Austin ISD Educational Suitability Assessment Criteria

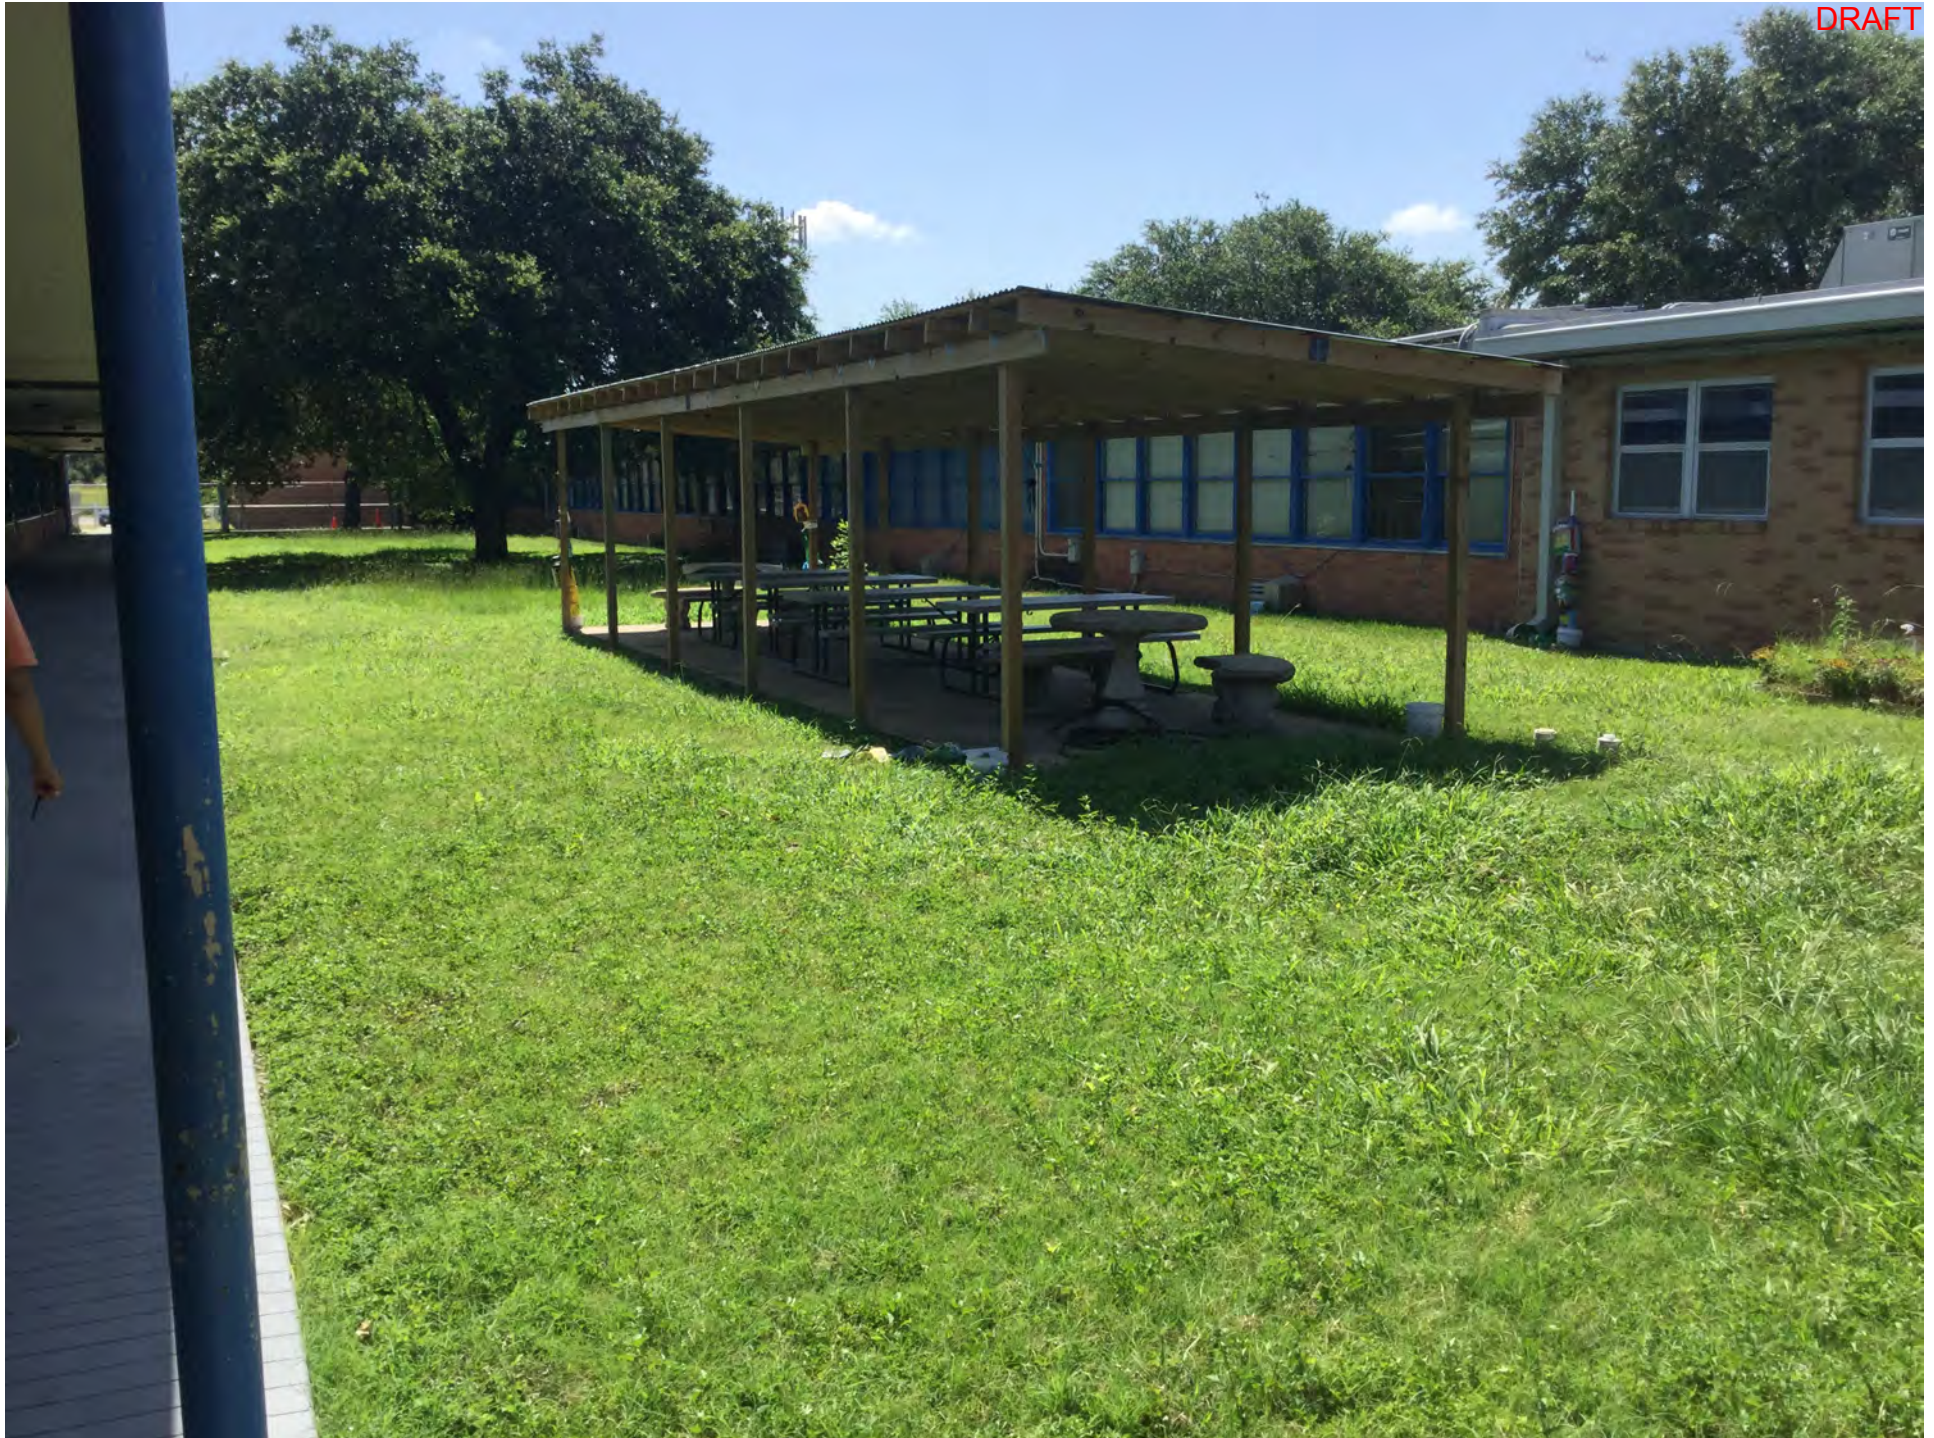
Photo 1.
1.2 Outdoor Spaces

1.2	Are opportunities provided for outdoor learning (outdoor classrooms, gardens, etc.)?				4			Comments	1.00 4.00
	1) Outdoor space exists is not developed 2) Outdoor space for learning exists but not connected to classroom learning areas. 3. Outdoor learning spaces exist and are accessible but not in good condition. 4. Outdoor learning spaces need minor improvements to function well. 5. Outdoor learning spaces are in excellent condition. N/A) Does not apply.								see photo 1

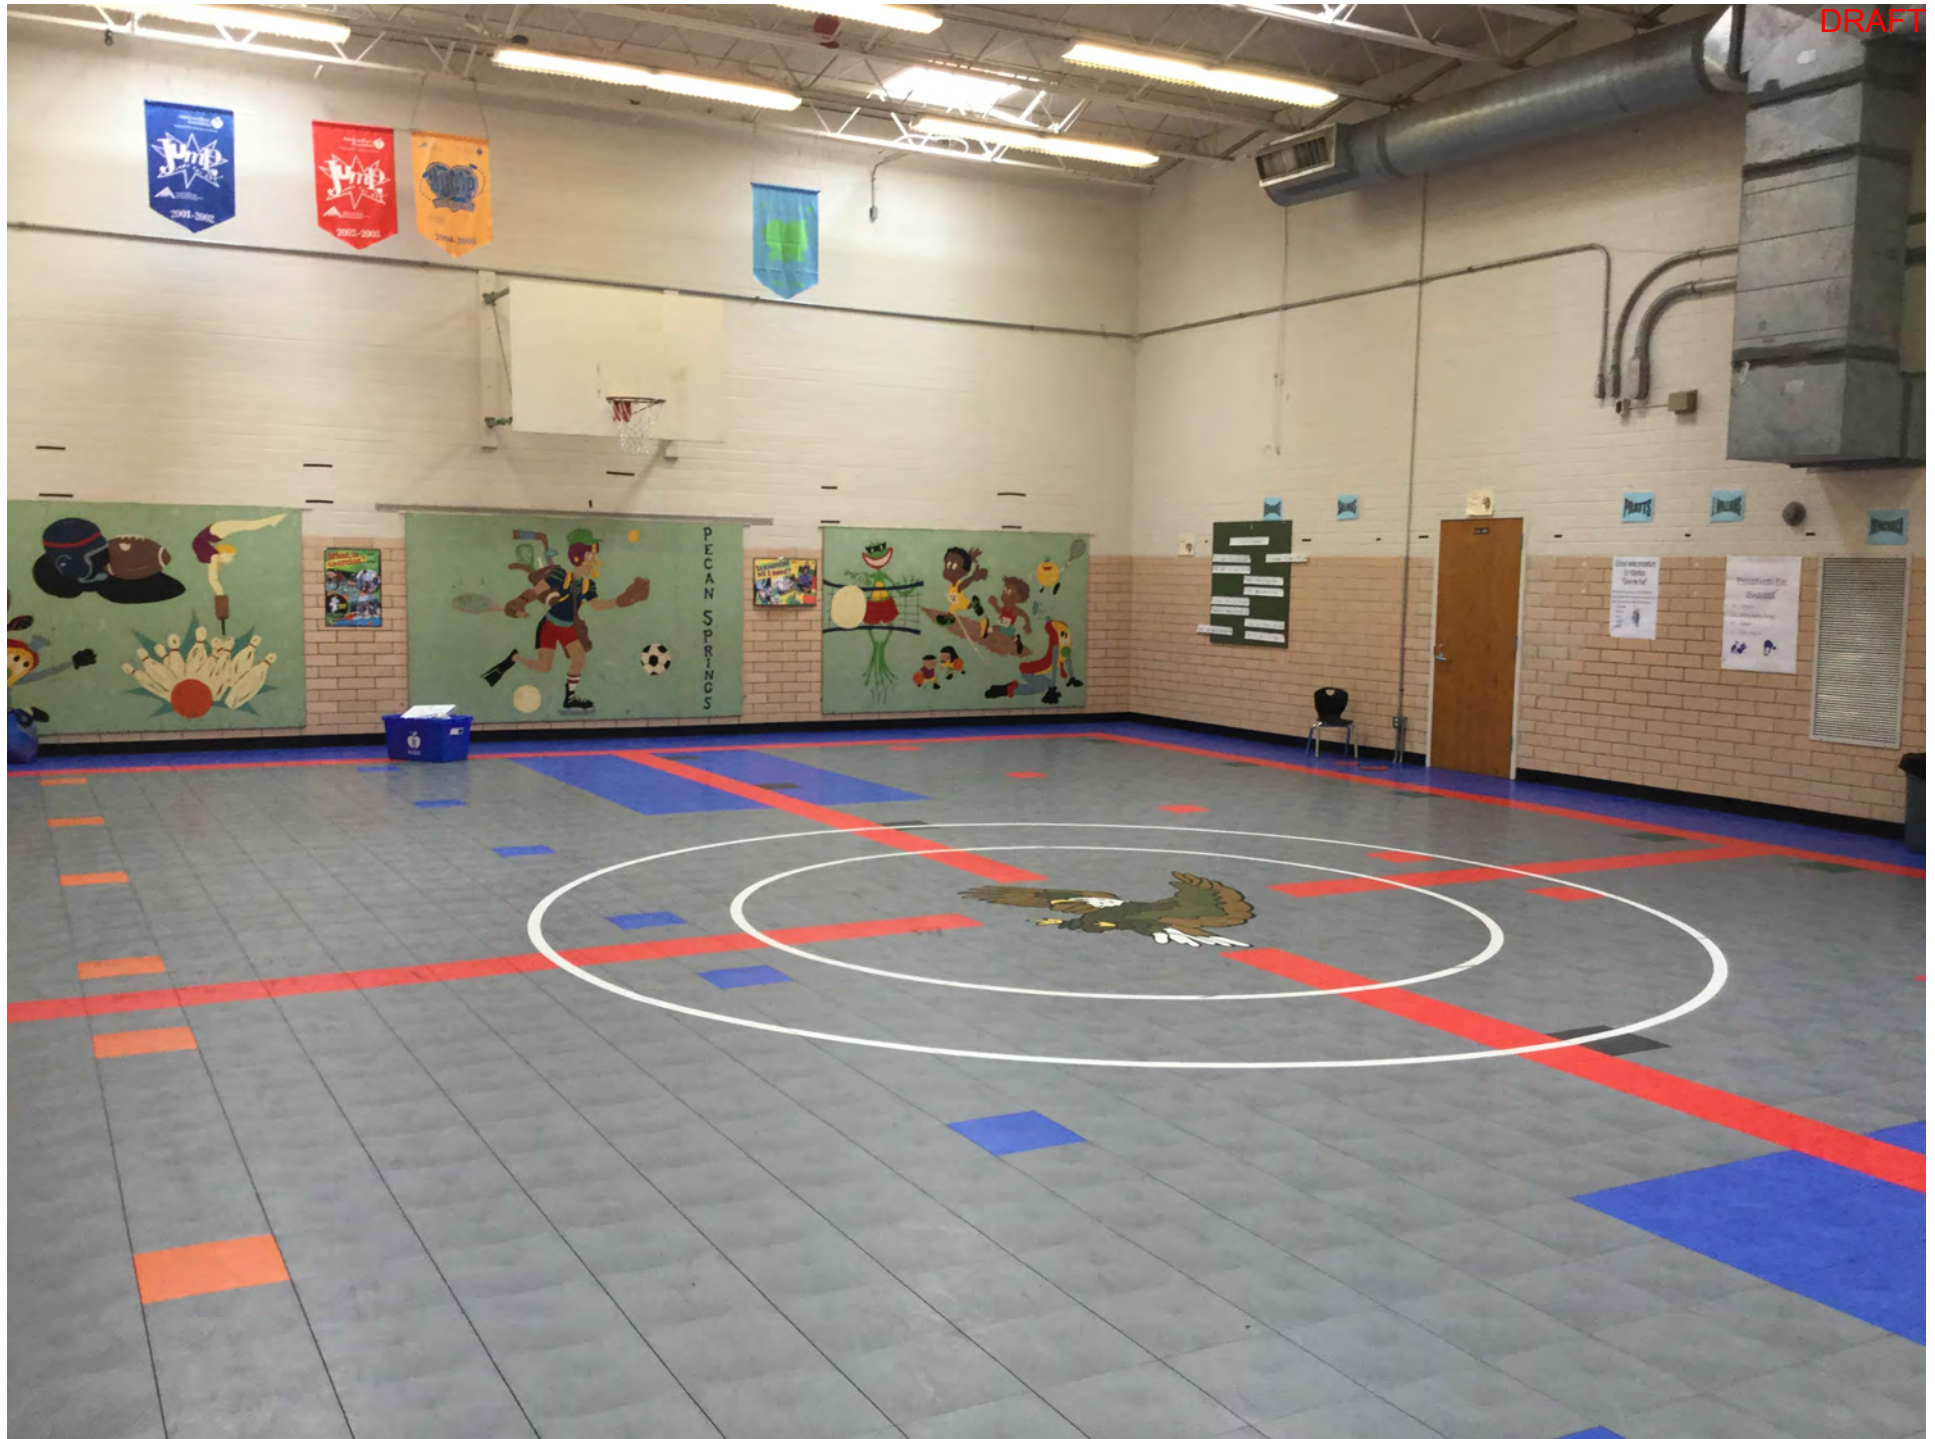
Photo 2.
3.6 Gym

1) Very unsatisfactory 2) Unsatisfactory 3) Average 4) Good 5) Very good N/A) Does not apply.								The gym is not very flexible and is missing windows for natural light.	see photo 2

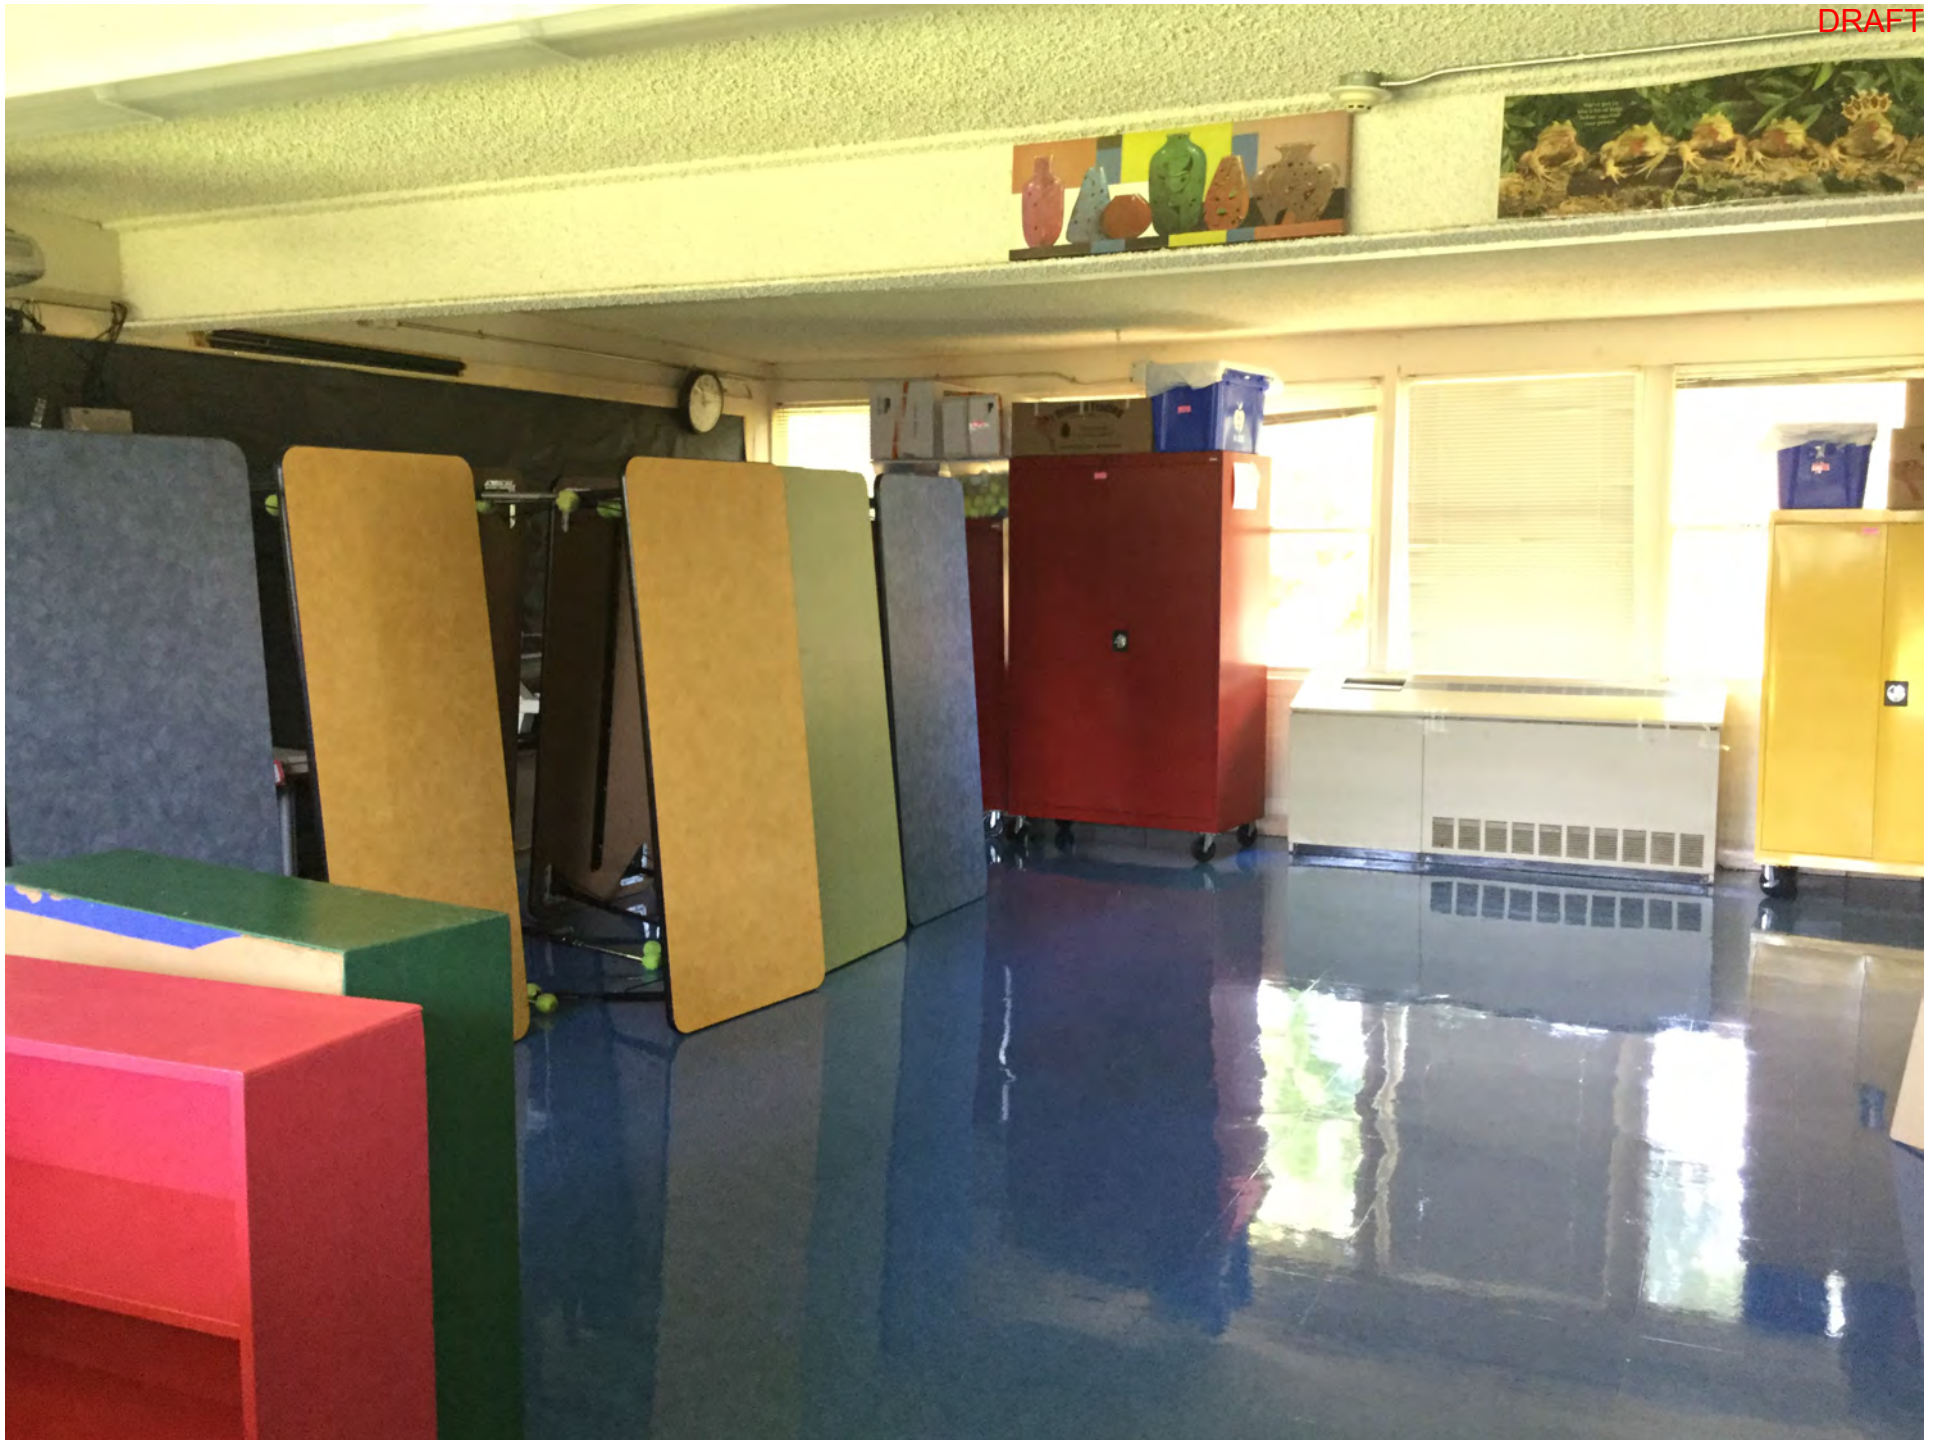
Photo 3.
3.10 Art Room

1) Very unsatisfactory 2) Unsatisfactory 3) Average 4) Good 5) Very good N/A) Does not apply.										Room is not adequate in size and is missing proper equipment such as sink basins.				see photo 3

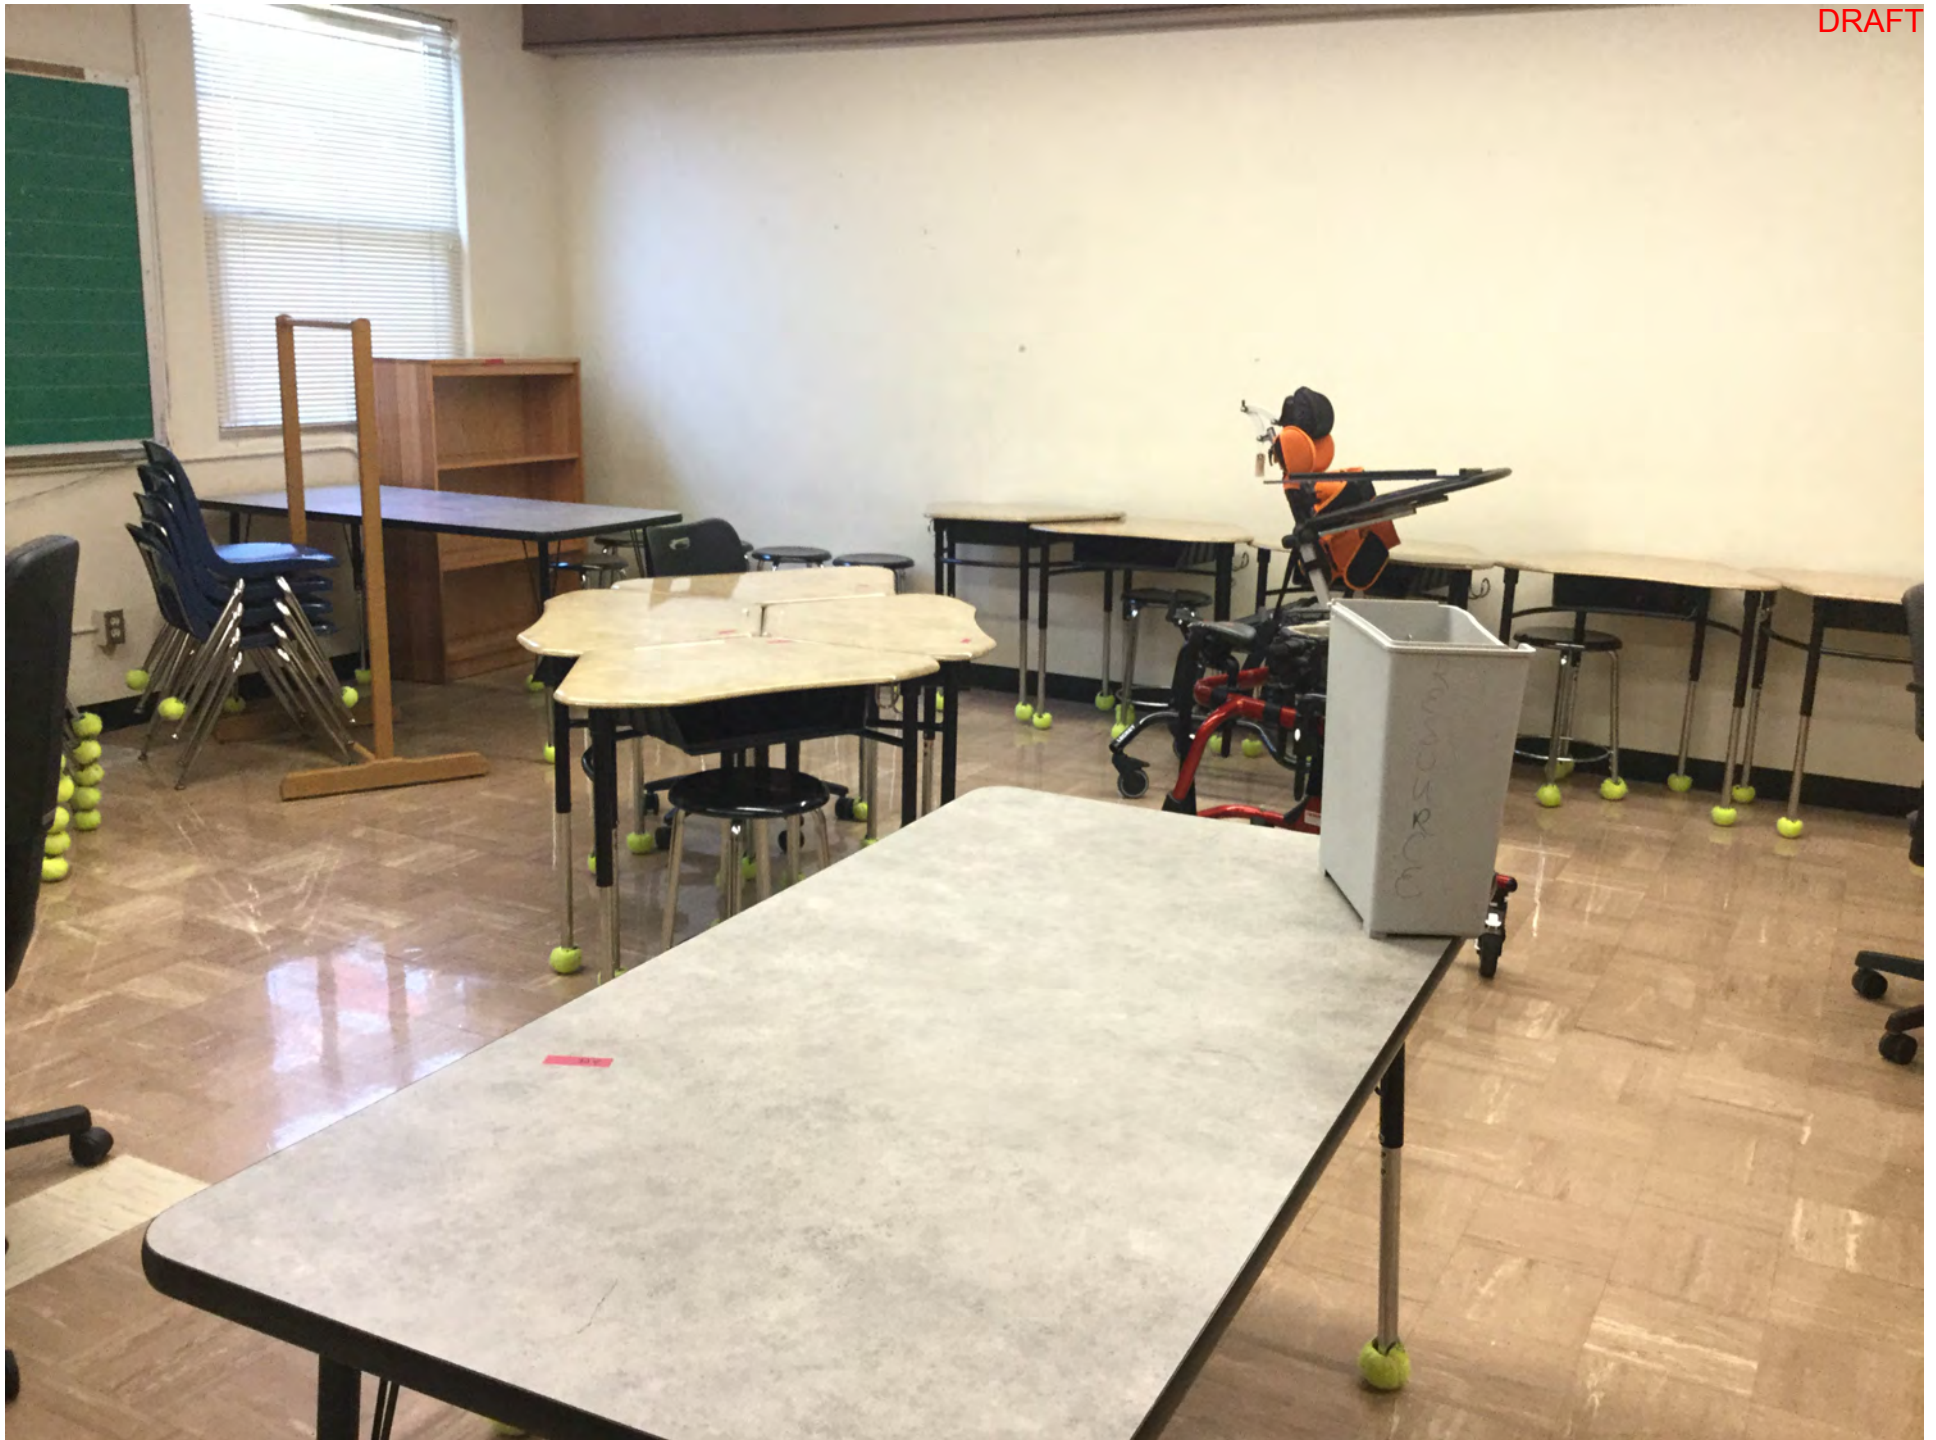
Photo 4.
3.14 Special Education Space

1) Very unsatisfactory 2) Unsatisfactory 3) Average 4) Good 5) Very good N/A) Does not apply.													Special Ed space is an appropriated standard classroom that is inadequate in size. <i>SPED comment: resource class too small for # of students.</i>			
													see photo 4

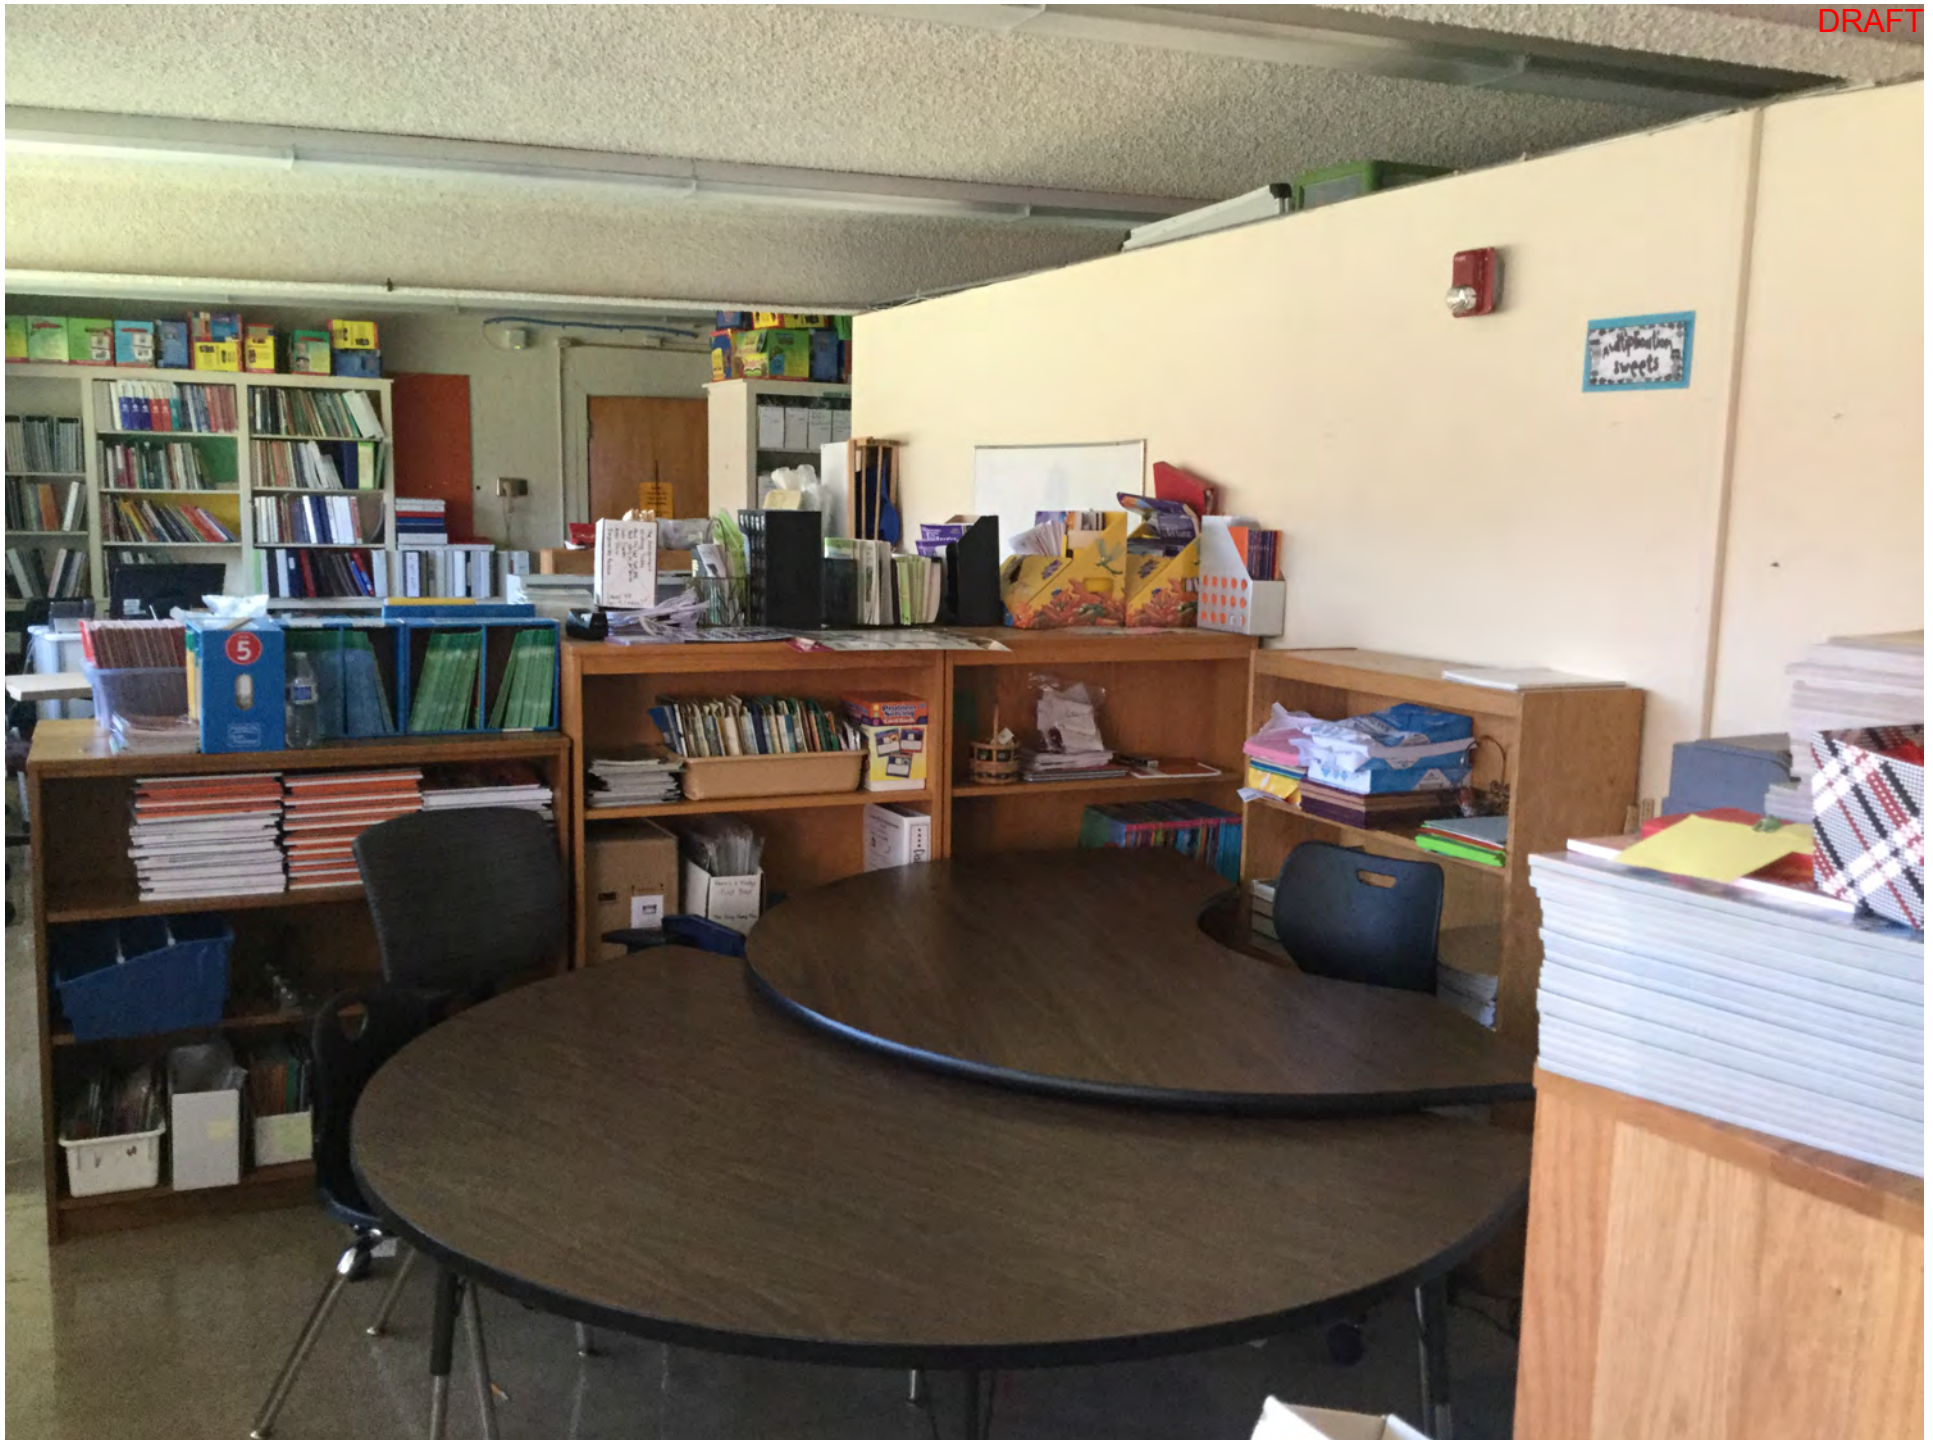
Photo 5.
4.1 Specialized Learning Space

1) Very unsatisfactory - No project space 2) Unsatisfactory - Non-dedicated, undersized or otherwise inadequate 3) Average - Limited dedicated spaces of moderate size and layout, equipment and furniture appropriate but need updates 4) Good - Dedicated spaces of adequate size and layout, most of the equipment and furniture is appropriate for program 5) Very good - Dedicated spaces of adequate size and layout, equipment and furniture appropriate for program N/A) Does not apply.							The specialized learning space also share an area with storage and offices.	see photo 5

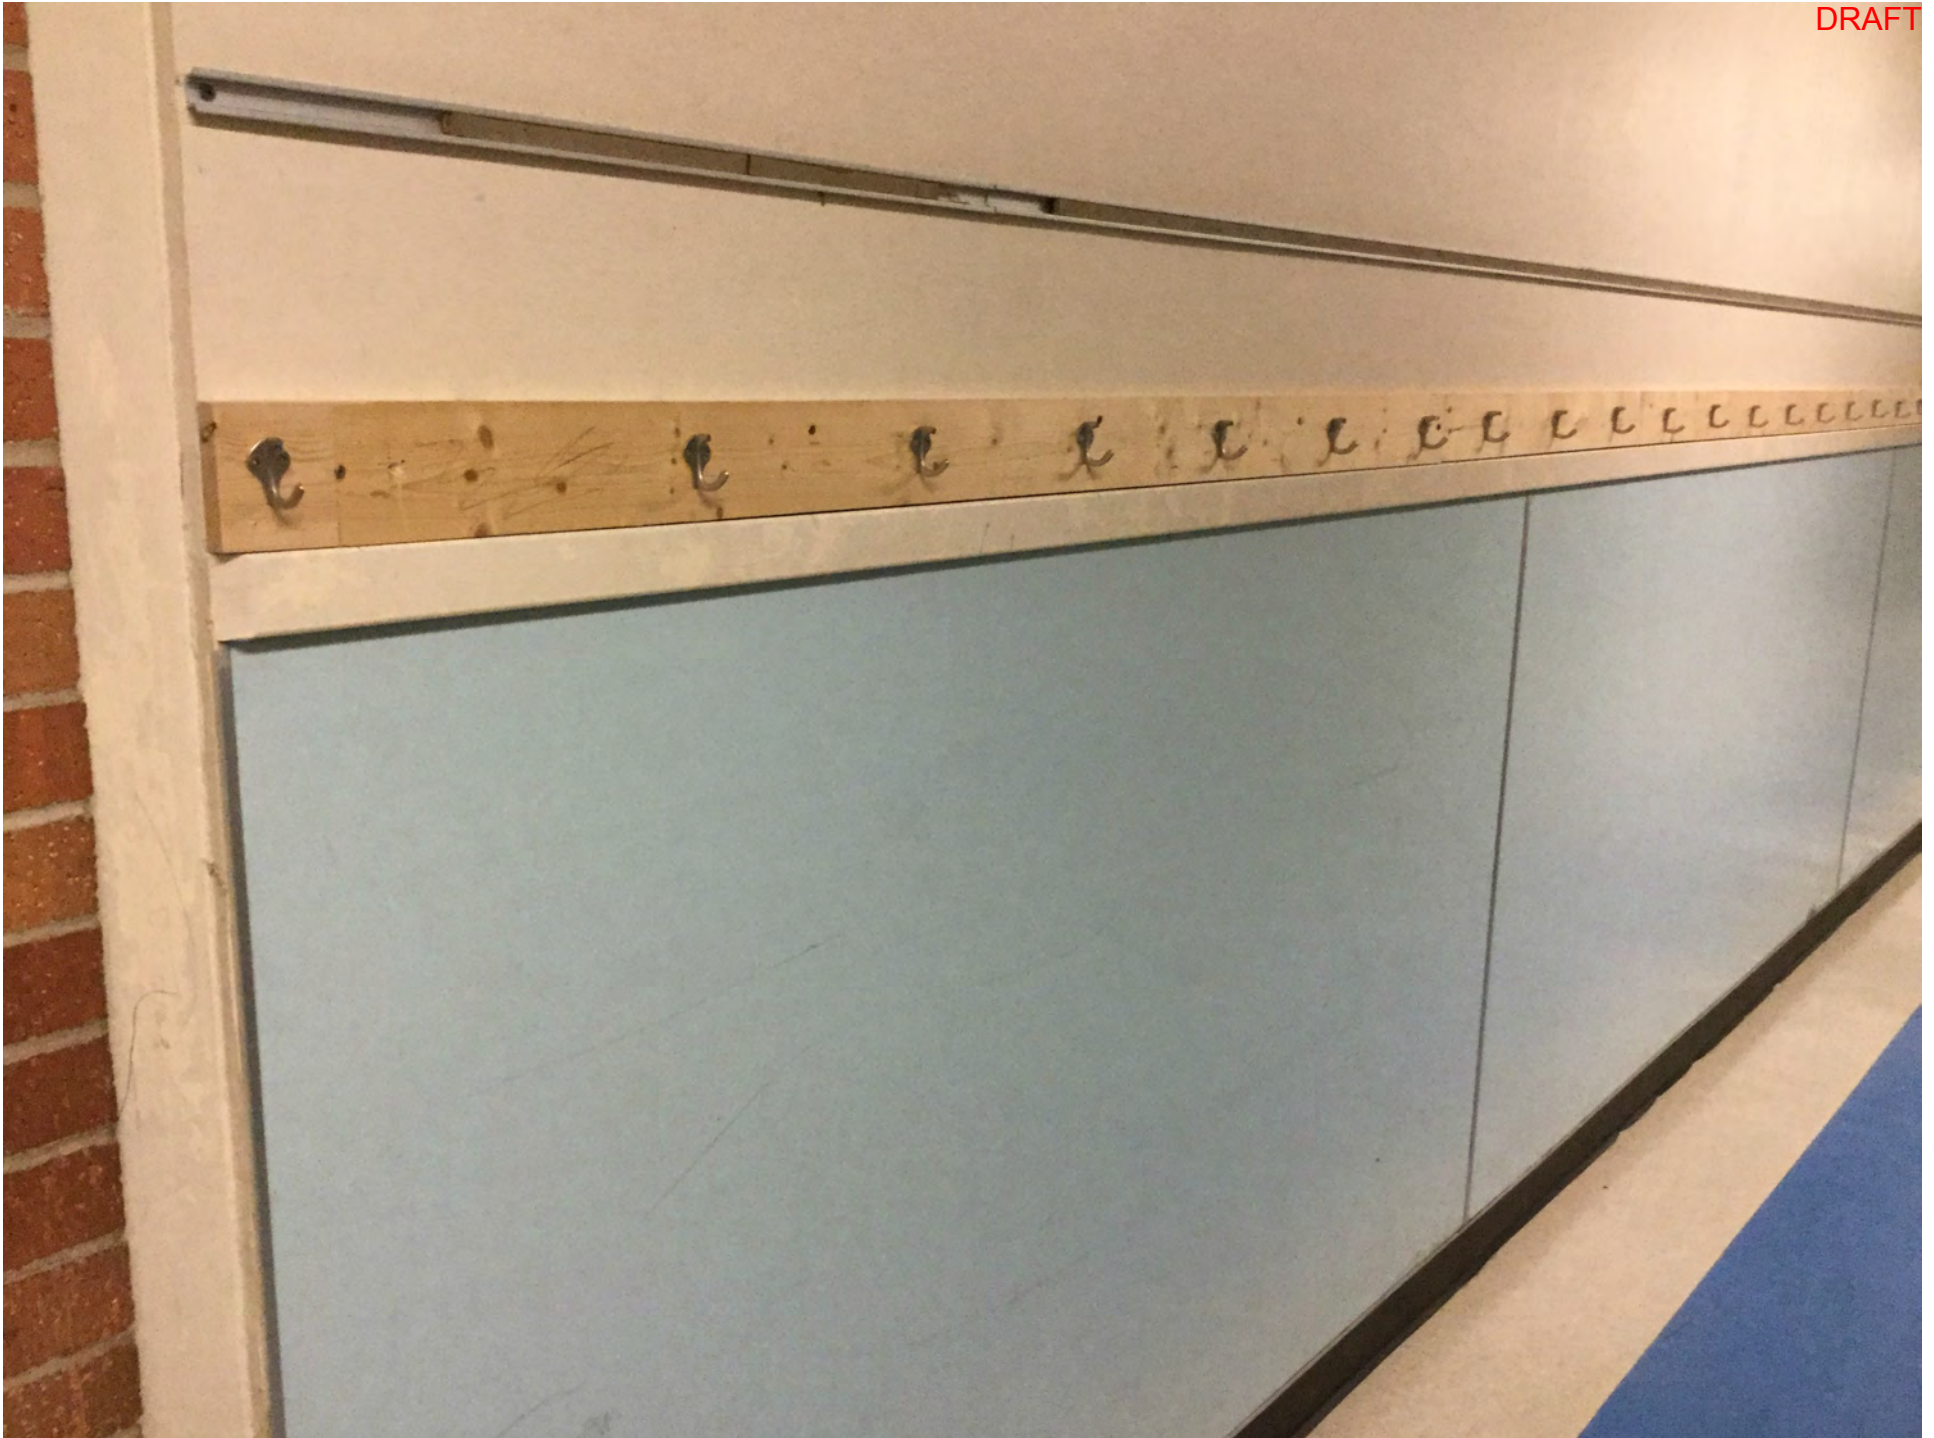
Photo 6.
4.4 Visual Space

4.4	Are there adequate places to display the evidence and artifacts of learning (both 2D and 3D)?		2					Comments	1.00 2.00
	1) Very unsatisfactory - No display cases or wall space for display 2) Unsatisfactory - 1 wall in classrooms or very few spaces for display 3) Average - 2 walls in classrooms or some hallway spaces for display 4) Good - 3 walls in classrooms or multiple hallway spaces for display 5) Very good - ample classroom display space or many hallway spaces, including display cases N/A) Does not apply.							The backpack hangars in the hallways for student storage limit use of the hallways.	see photo 6

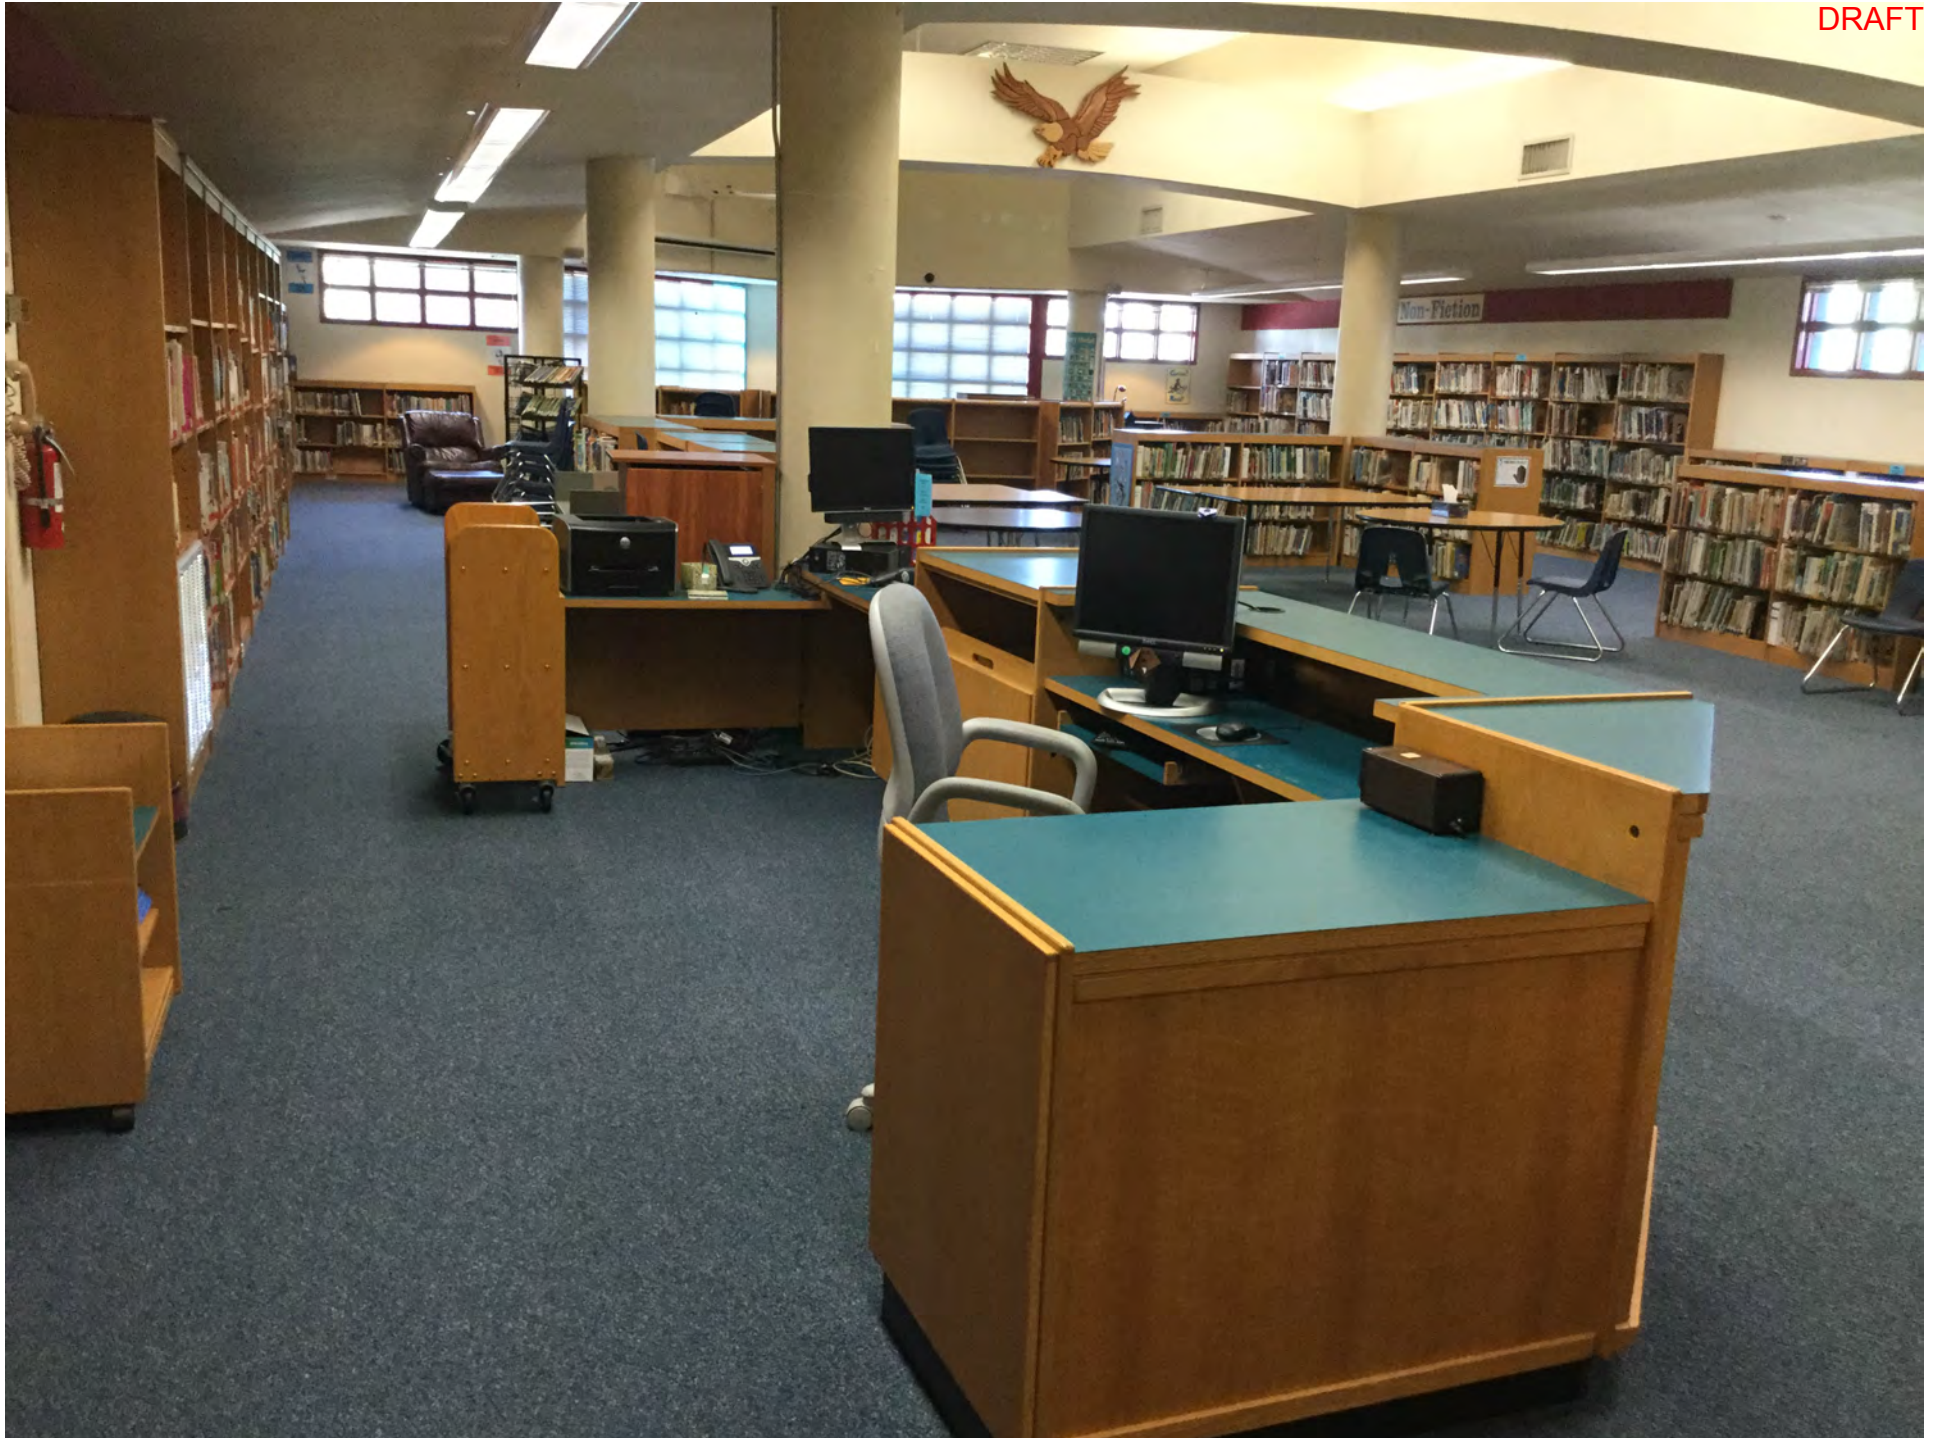
Photo 7.
5.4 Library

5.4	How well does the Library/Media Center support collaborative work in small groups (4-8 students)?					5		Comments	1.00 5.00
1) Very unsatisfactory 2) Unsatisfactory 3) Average 4) Good 5) Very good N/A) Does not apply.								see photo 7

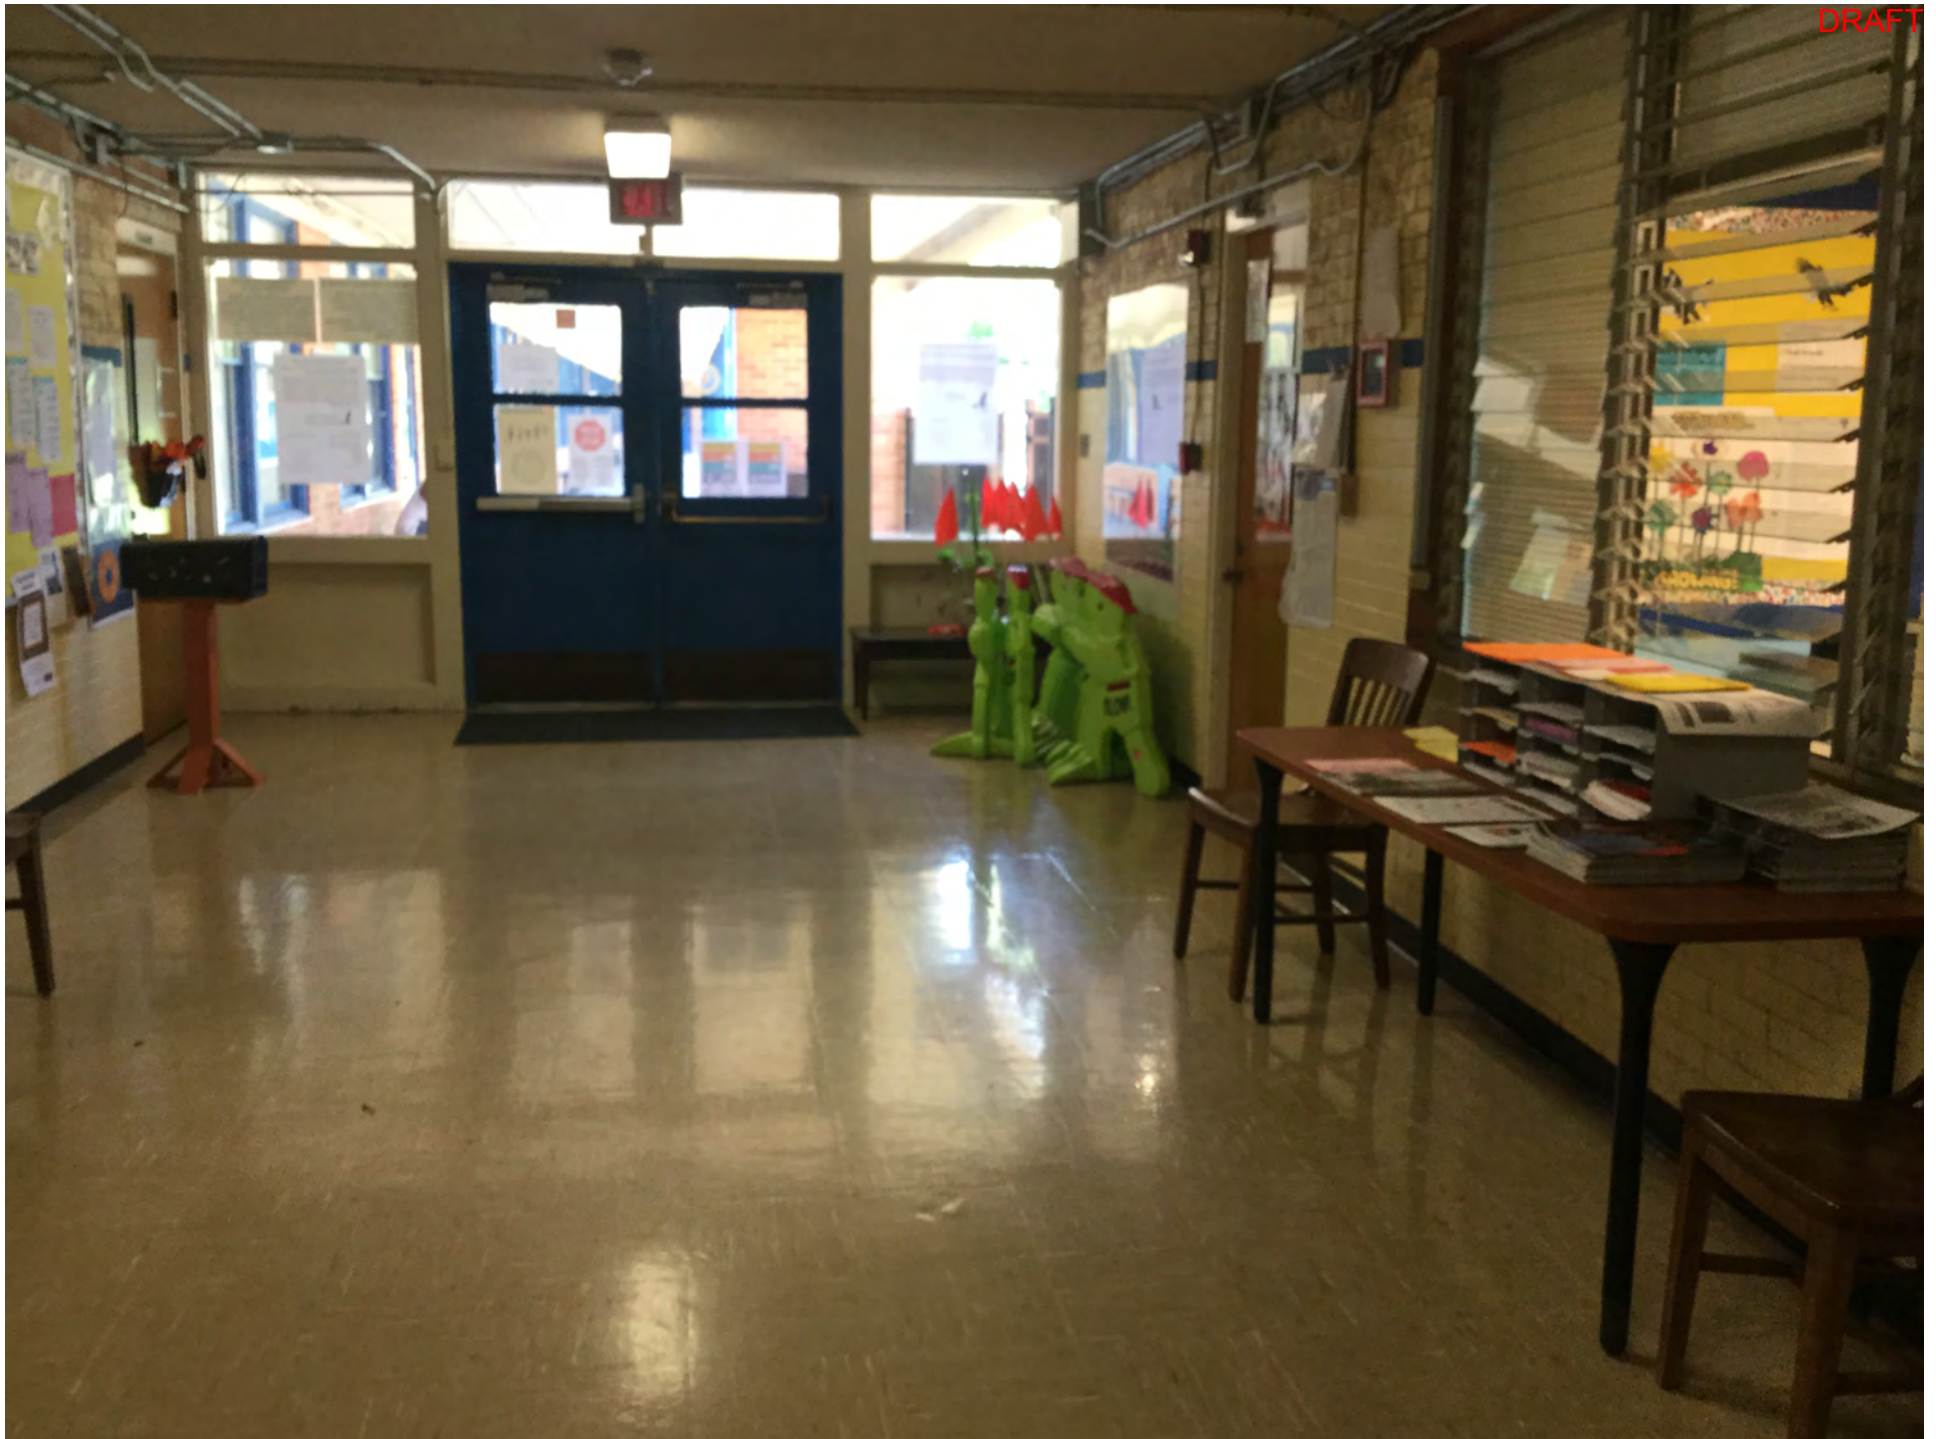
Photo 8.
6.3 Main Entrance

6.3	Is the main office properly located and configured with a secure vestibule to the main corridor?			3				Comments	1.00 3.00
1) Very unsatisfactory - No secure vestibule, office located far from main entry. Allows visitors access to school unsupervised. 2) Unsatisfactory - No secure vestibule, office located somewhat far from main entry, minimal supervision of visitors. 3) Average - Office close to entry, views of front door, but no secure vestibule 4) Good - Office is well-located with a secure vestibule, but needs updates 5) Very good - Office well-located with secure vestibule and all appropriate security features. N/A) Does not apply.								The principal has expressed concern that there was no vestibule and that parents were able to enter the school as they pleased.	
									see photo 8
