Educational Suitability Summary Report

Pecan Springs Elementary – BLDG 129

Date: 06/21/2016

Austin ISD Educational Suitability Assessment Criteria

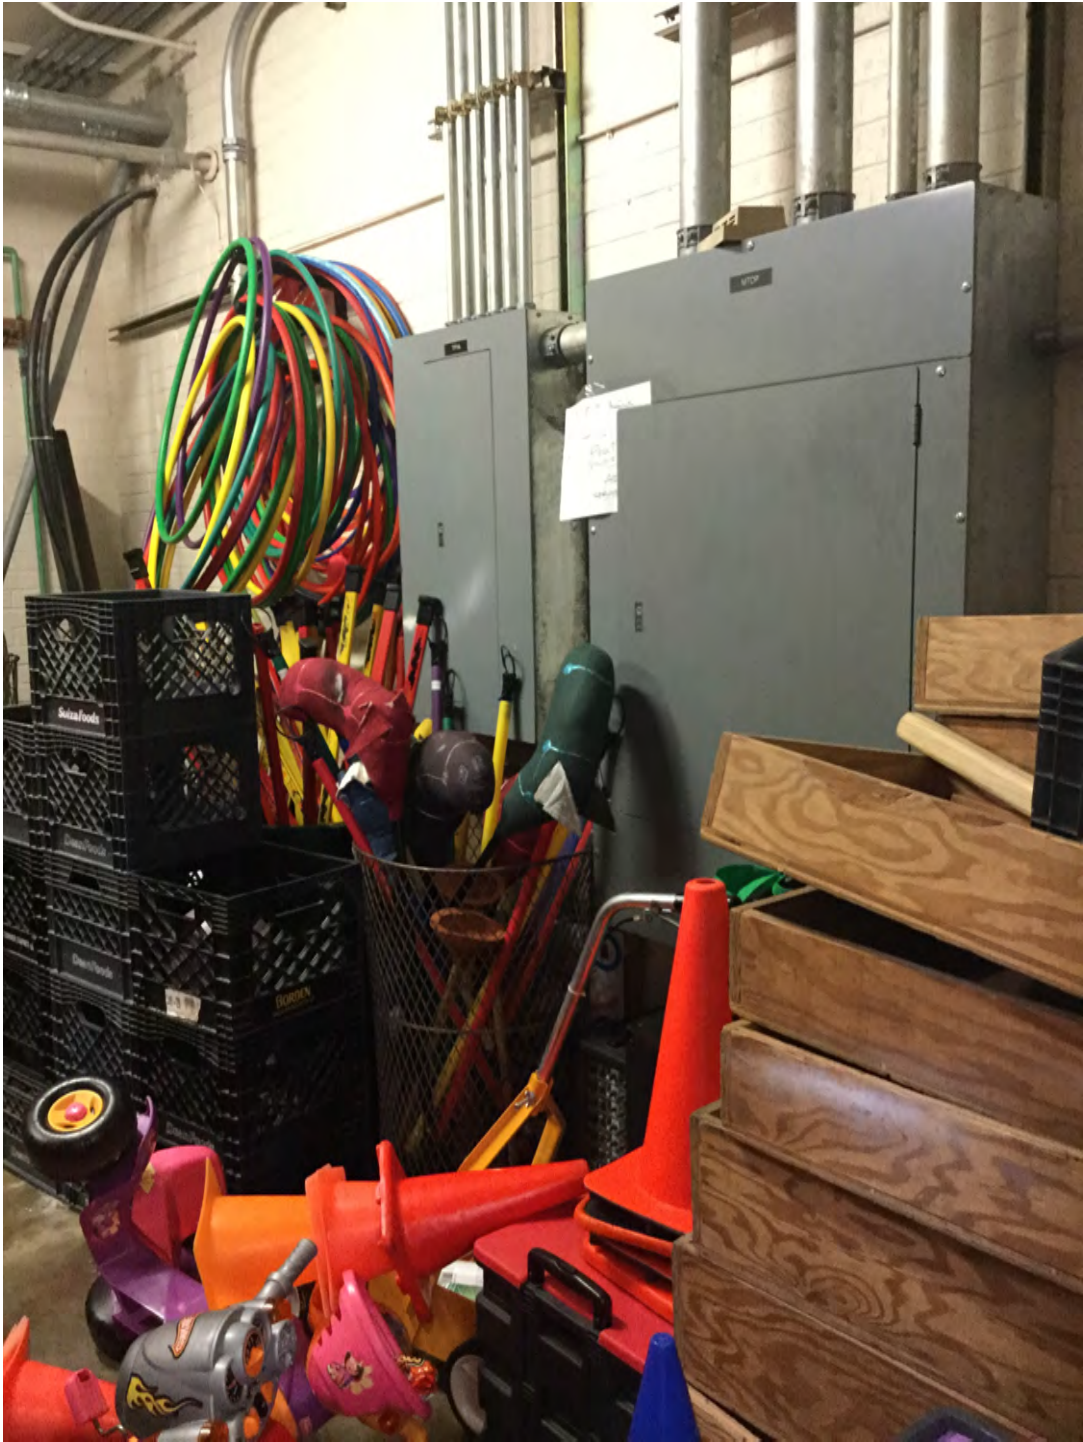
Photo 9.
8.1 Storage

8 - Storage		1	2	3	4	5	N/A	6.00	
8.1	Is there adequate general storage in the building?		2					Comments	1.00 2.00
1) Very unsatisfactory 2) Unsatisfactory 3) Average 4) Good 5) Very good N/A) Does not apply.								The faculty and staff express that the storage throughout the building is a huge issue.	see photo 9
8.2	Is there adequate classroom storage?		2					Comments	1.00 2.00
1) Very unsatisfactory 2) Unsatisfactory 3) Average 4) Good 5) Very good N/A) Does not apply.								There is a lack of cabinets and storage in the classroom.	
8.3	Is there adequate student storage?		2					Comments	1.00 2.00
1) Very unsatisfactory 2) Unsatisfactory 3) Average 4) Good 5) Very good N/A) Does not apply.								There are no student lockers or places in the classroom for students to place their backpacks.

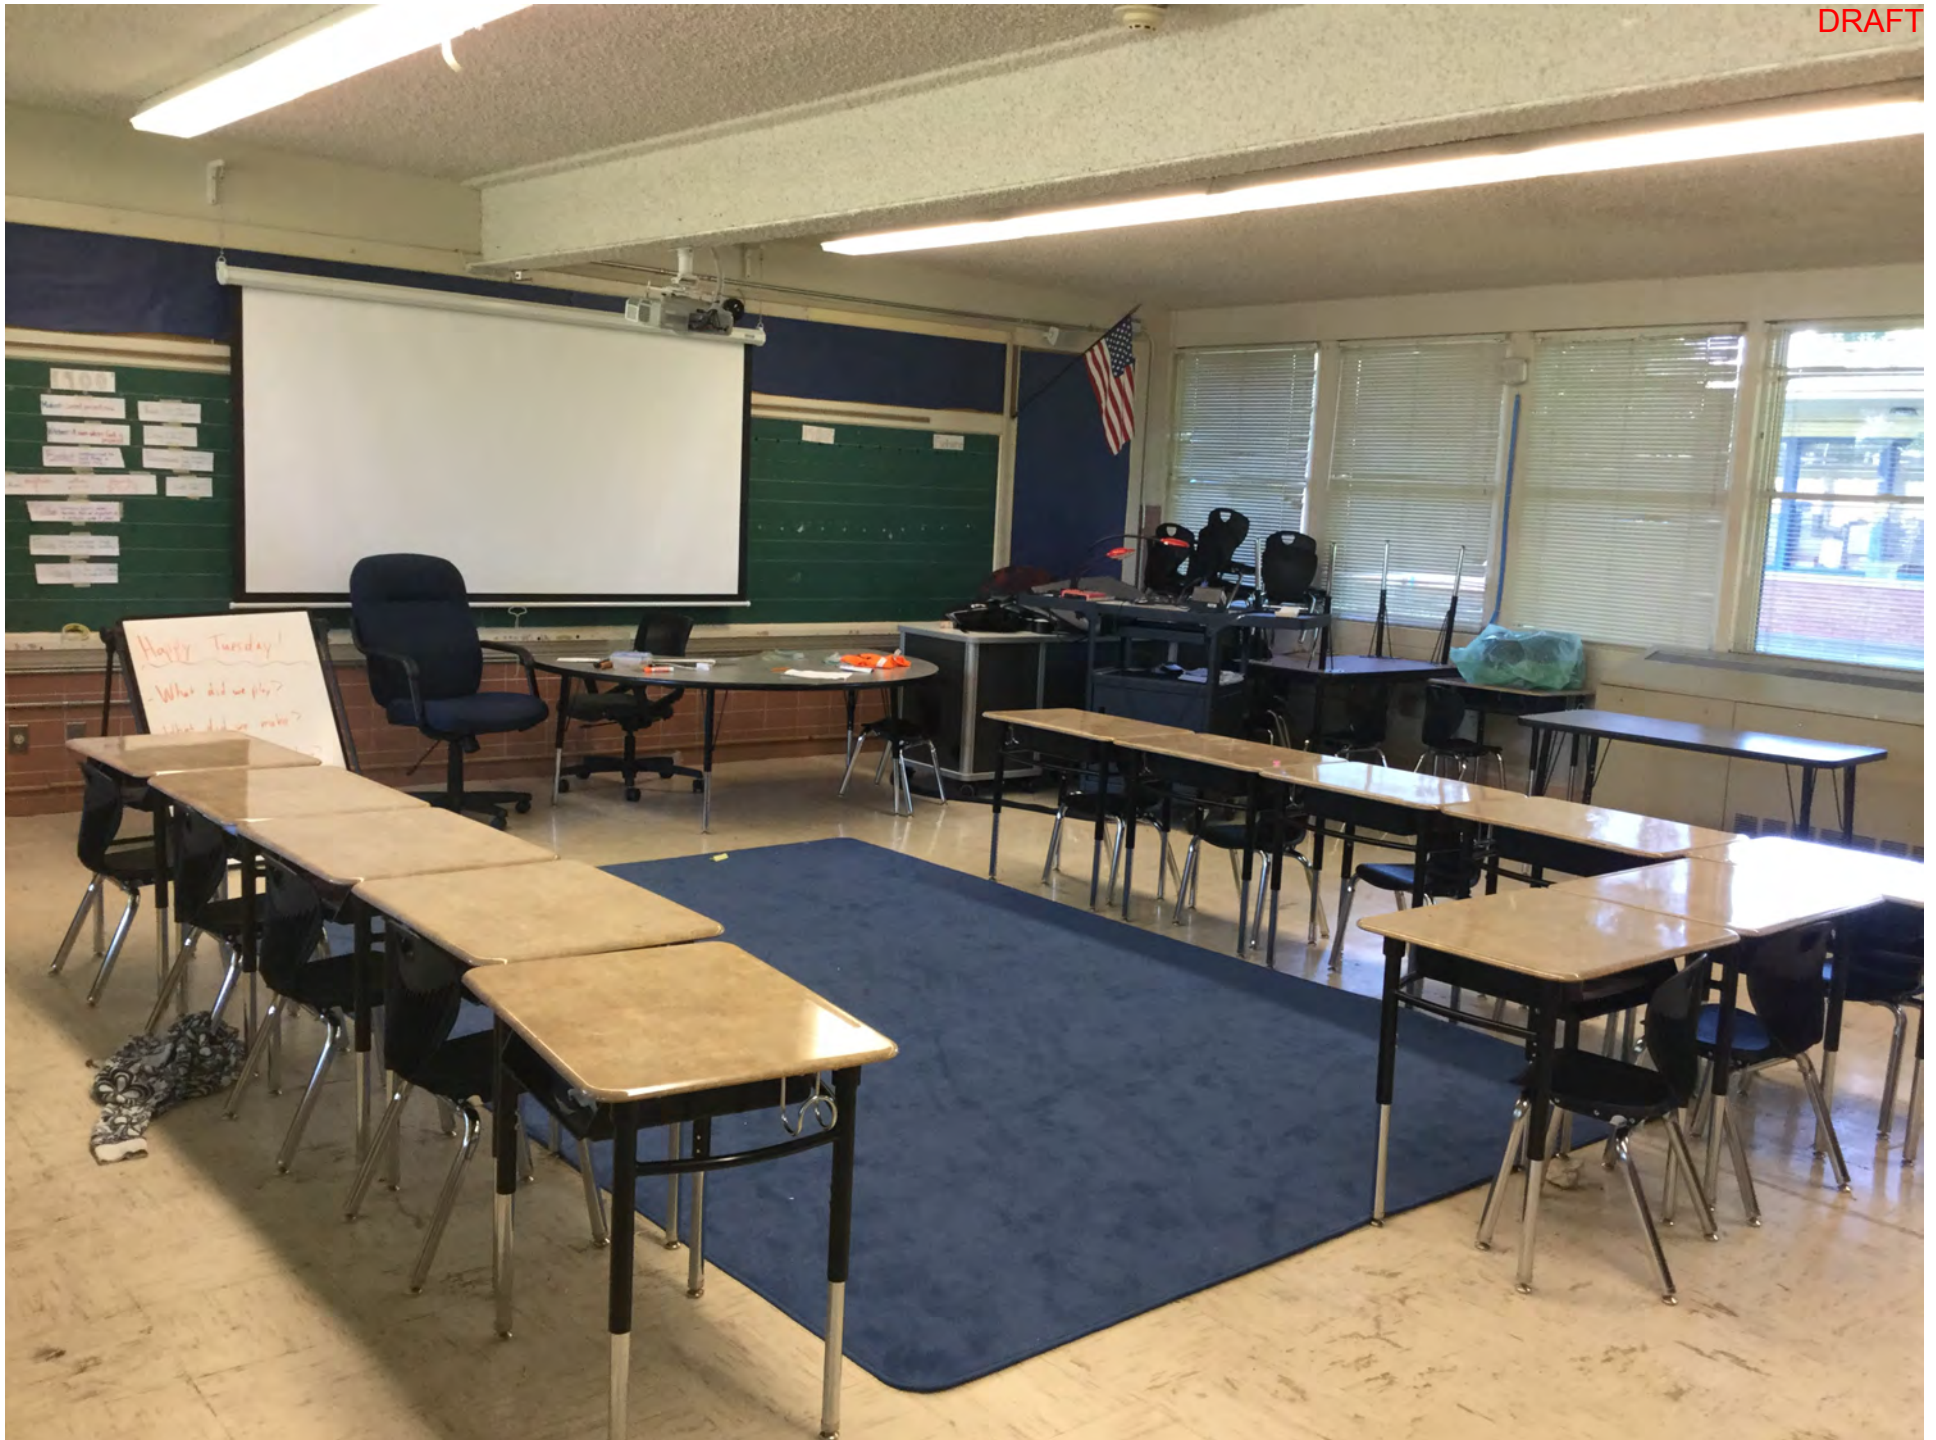
Photo 10.
9.1 Furniture

9 - Furniture, Fixtures & Equipment						1	2	3	4	5	N/A		11.75
9.1	What is the current condition of the furniture?					5		Comments				0.75	3.75
								The furniture in the library is dated, but the student desks and chairs seem new.
