## Educational Suitability Summary Report

Pickle Elementary School

Date: 08/01/2016

## Austin ISD Educational Suitability Assessment Criteria

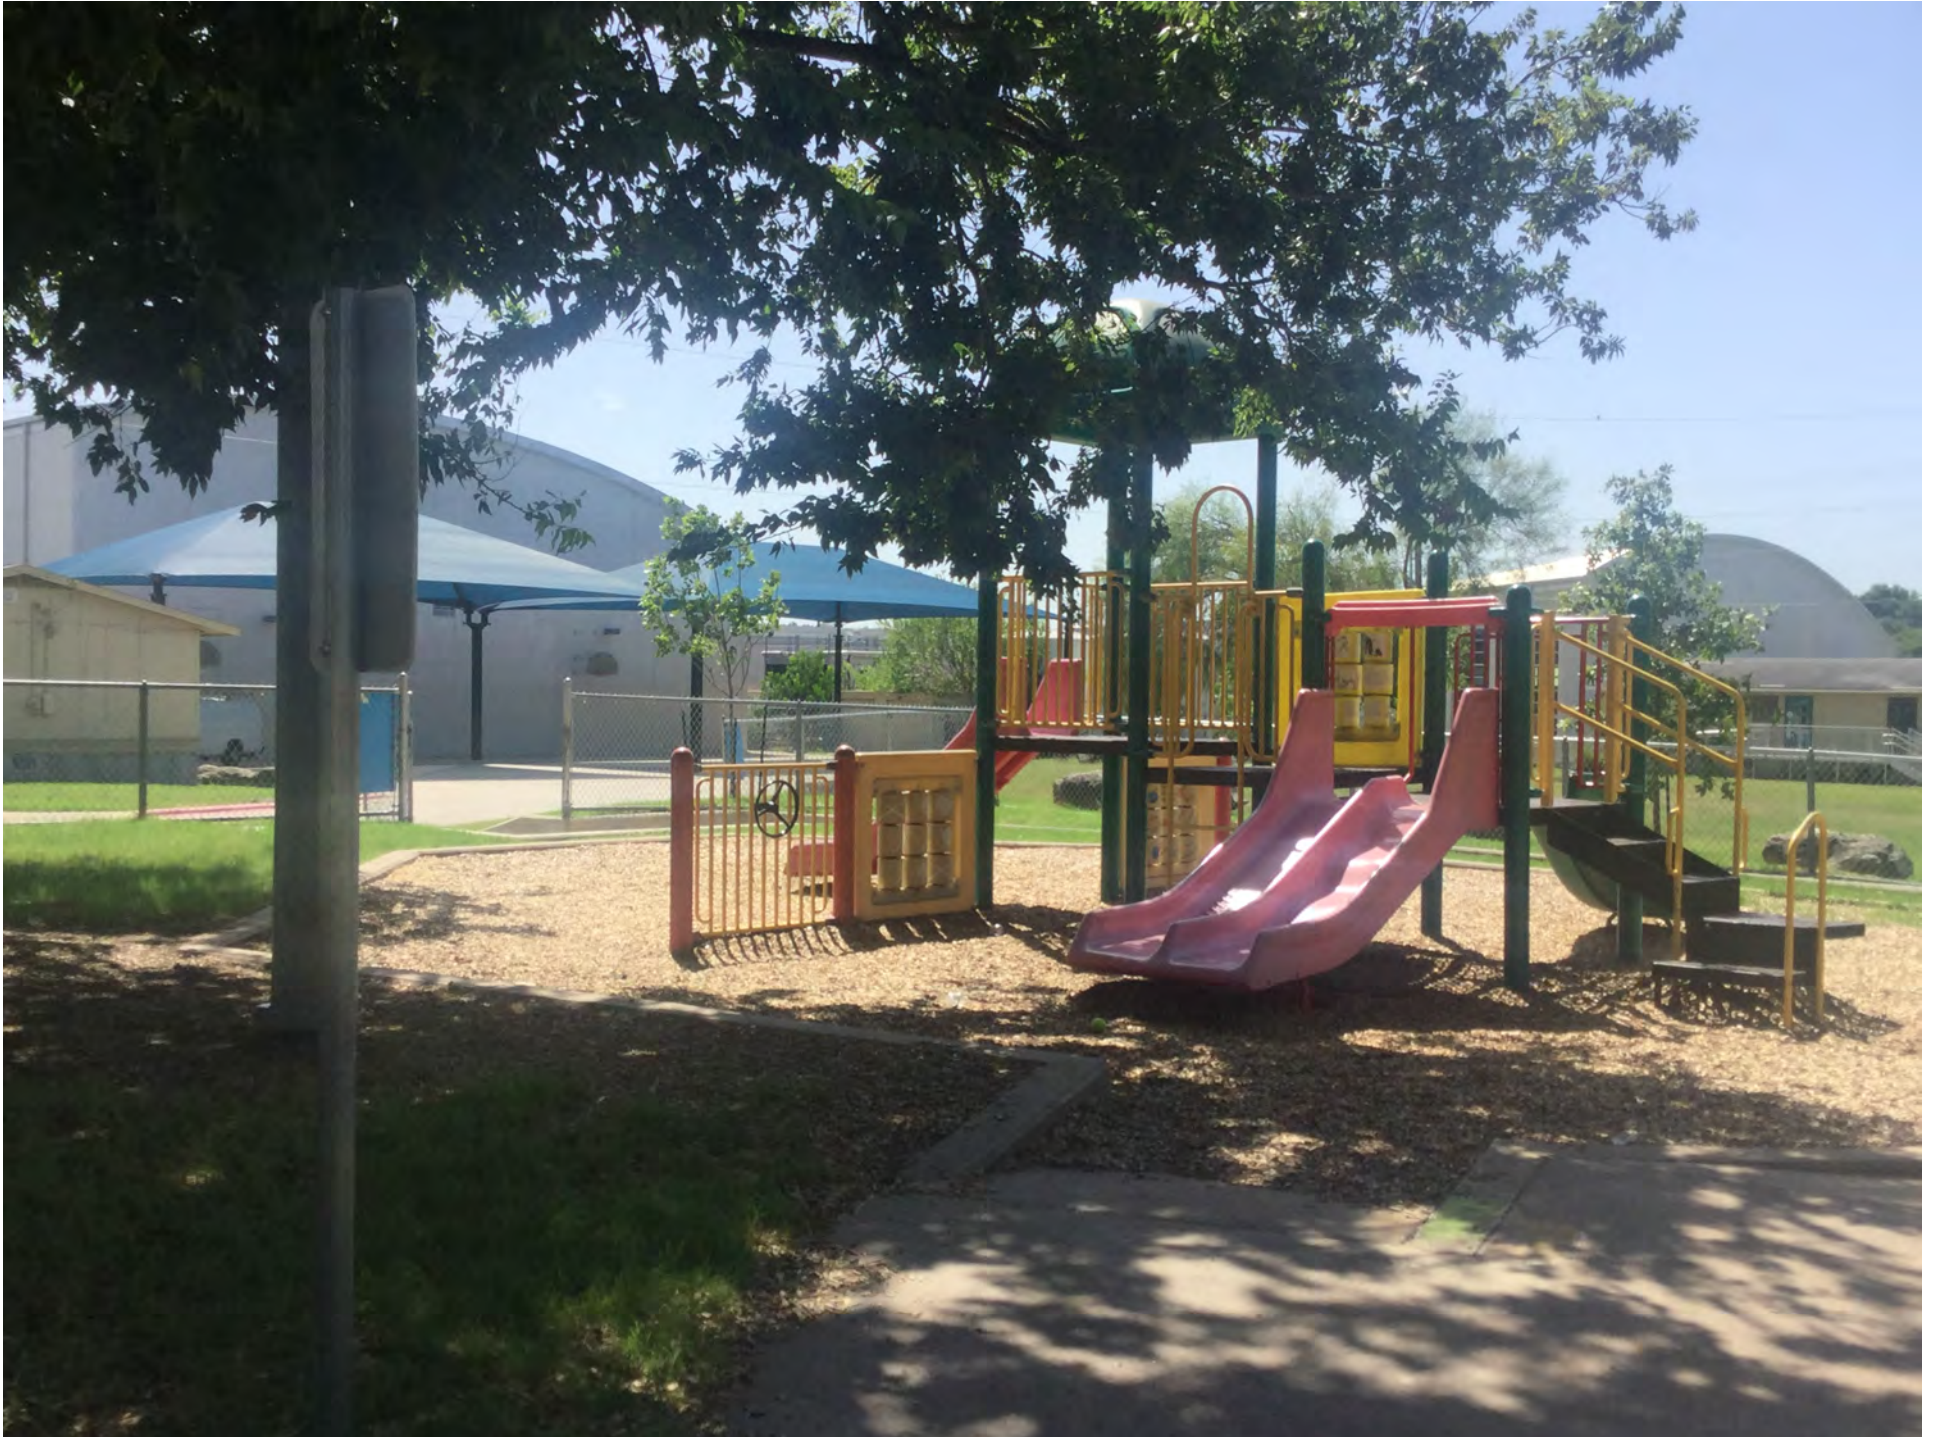
Photo 1. Outdoor Area

1.3	Are outdoor play spaces and playfields adequate in size and configuration?		2					Comments	1.00 2.00
	1) Outdoor play space exists, not developed 2) Outdoor play space exists but is not connected to gym or other athletic support areas or is too small. 3. Outdoor play spaces exist, are connected to other athletic areas, are the right size, but are not in good condition. 4. Outdoor play spaces need minor improvements to function well. 5. Outdoor play spaces are in excellent condition. N/A) Does not apply.							The playground needs additional shade and more equipment.	
									See Image 1

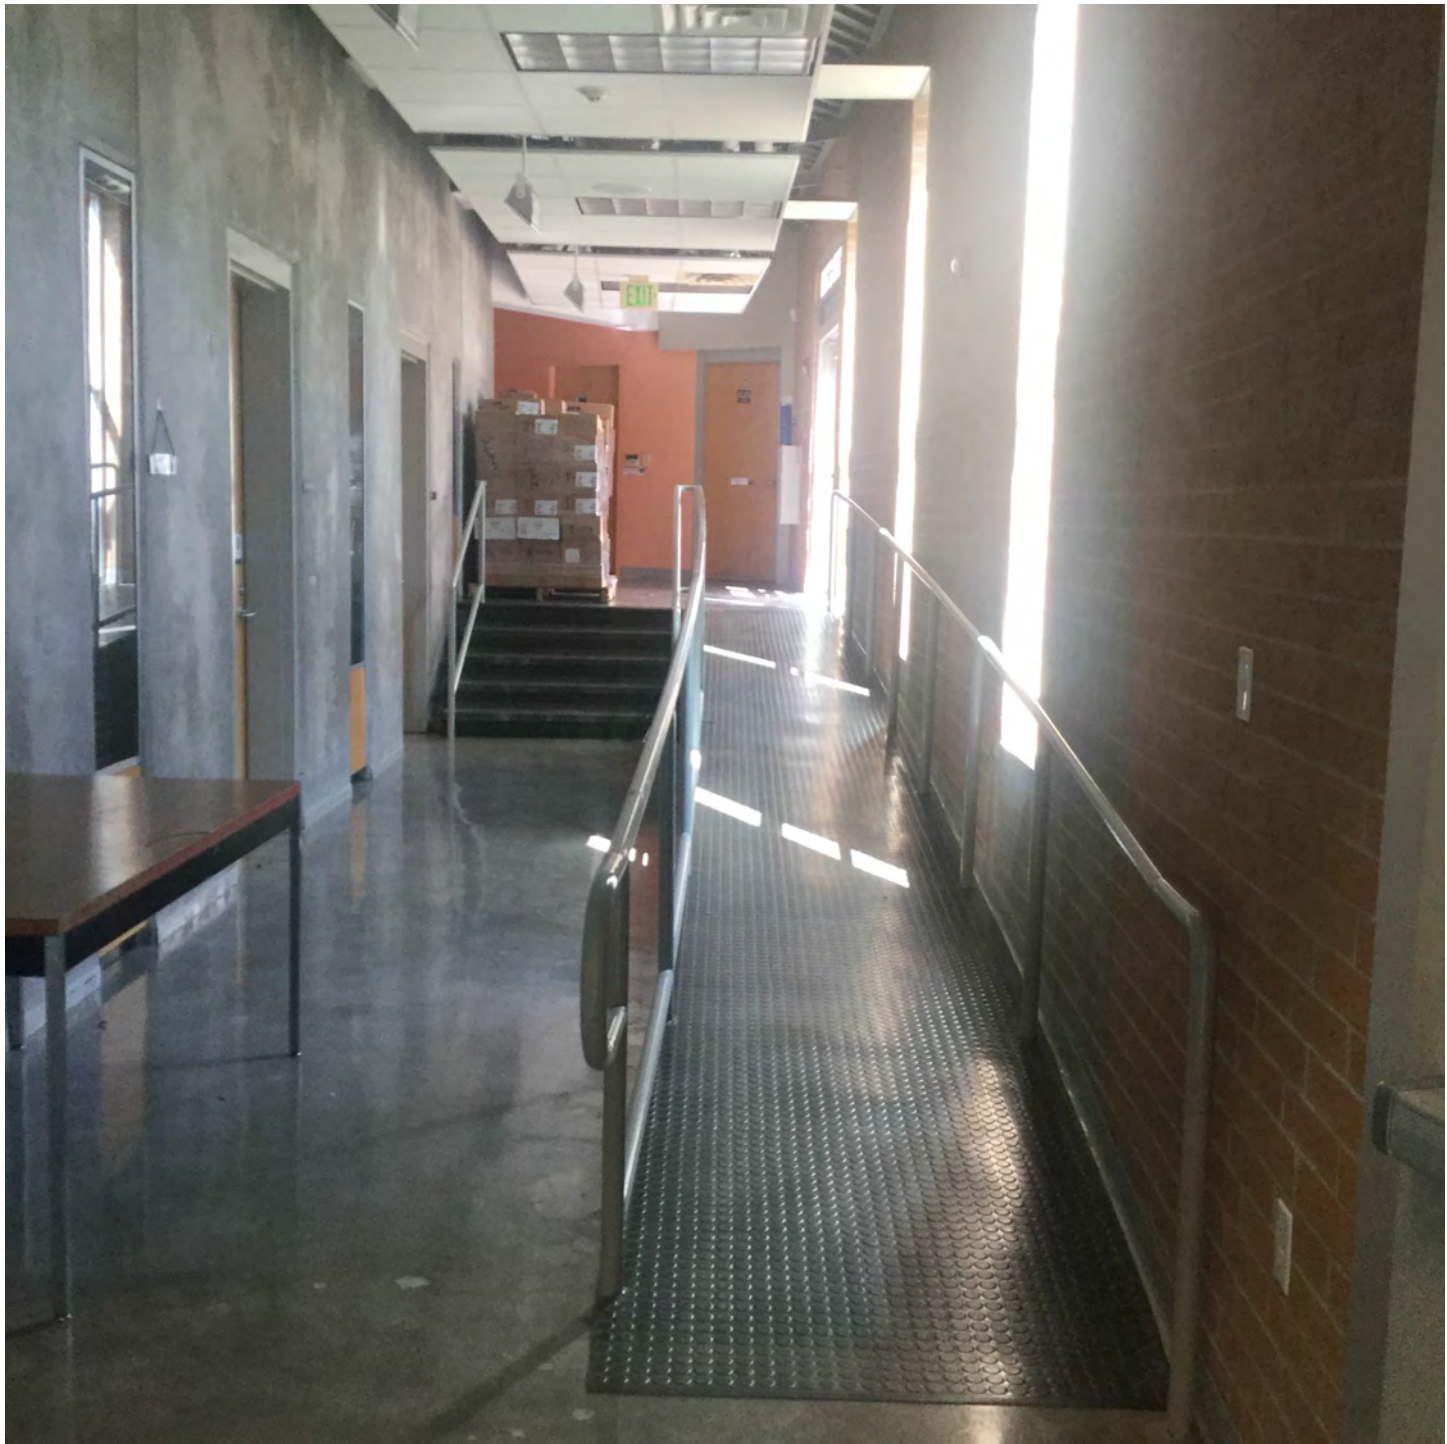
Photo 2. Hallways

1) Primary circulation is 5'-0" to 6'-0" wide. 2) Primary circulation is 6'-0" to 7'-0" wide 3) Primary circulation is 7'-0" to 8'-0" wide 4) Primary circulation is 8'-0"-10'-0" wide 5) Primary circulation is 10'-0"+ wide N/A) Does not apply.							There is a combination of steps and ramps in the main hallway. The classroom corridors are 8'-0" wide.	See Image 2

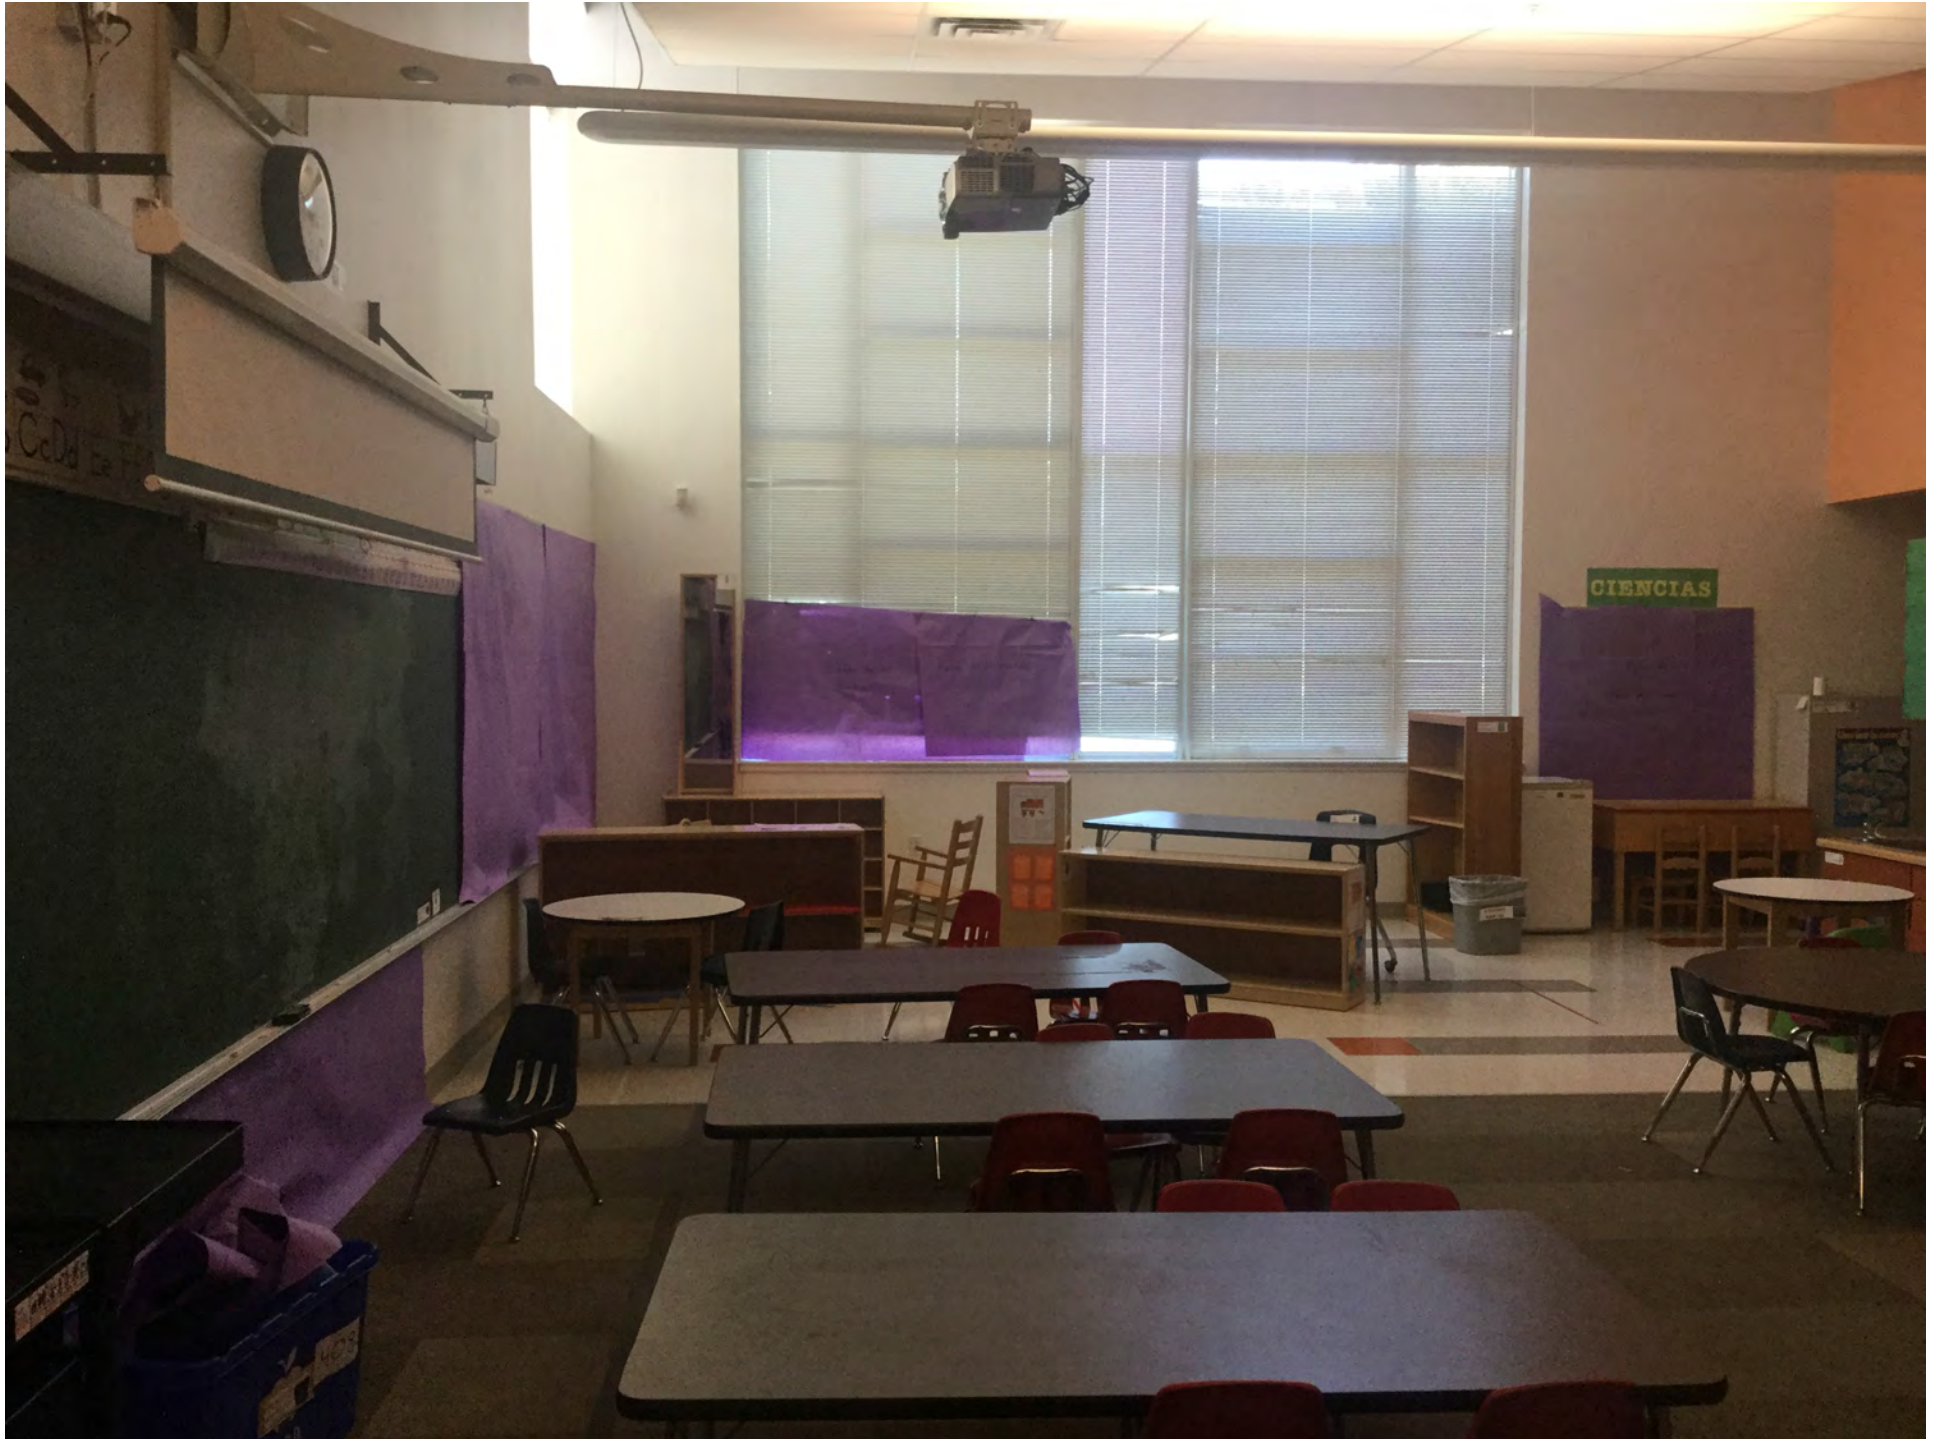
Photo 3. Classroom

1) Very unsatisfactory - Too small, awkward layout, does not meet needs 2) Unsatisfactory - Too small, only one area for all teaching methods, limited flexibility 3) Neutral - Moderate size, two areas for different teaching methods, some flexibility, access to student storage/casework 4) Satisfactory - Good size, at least two zones for different teaching methods, flexibility and student storage, not new 5) Very Satisfactory - Good size, two zones for different teaching methods, flexibility and student storage/casework, adequate display area and visual teaching tools N/A) Does not apply.								See Image 3

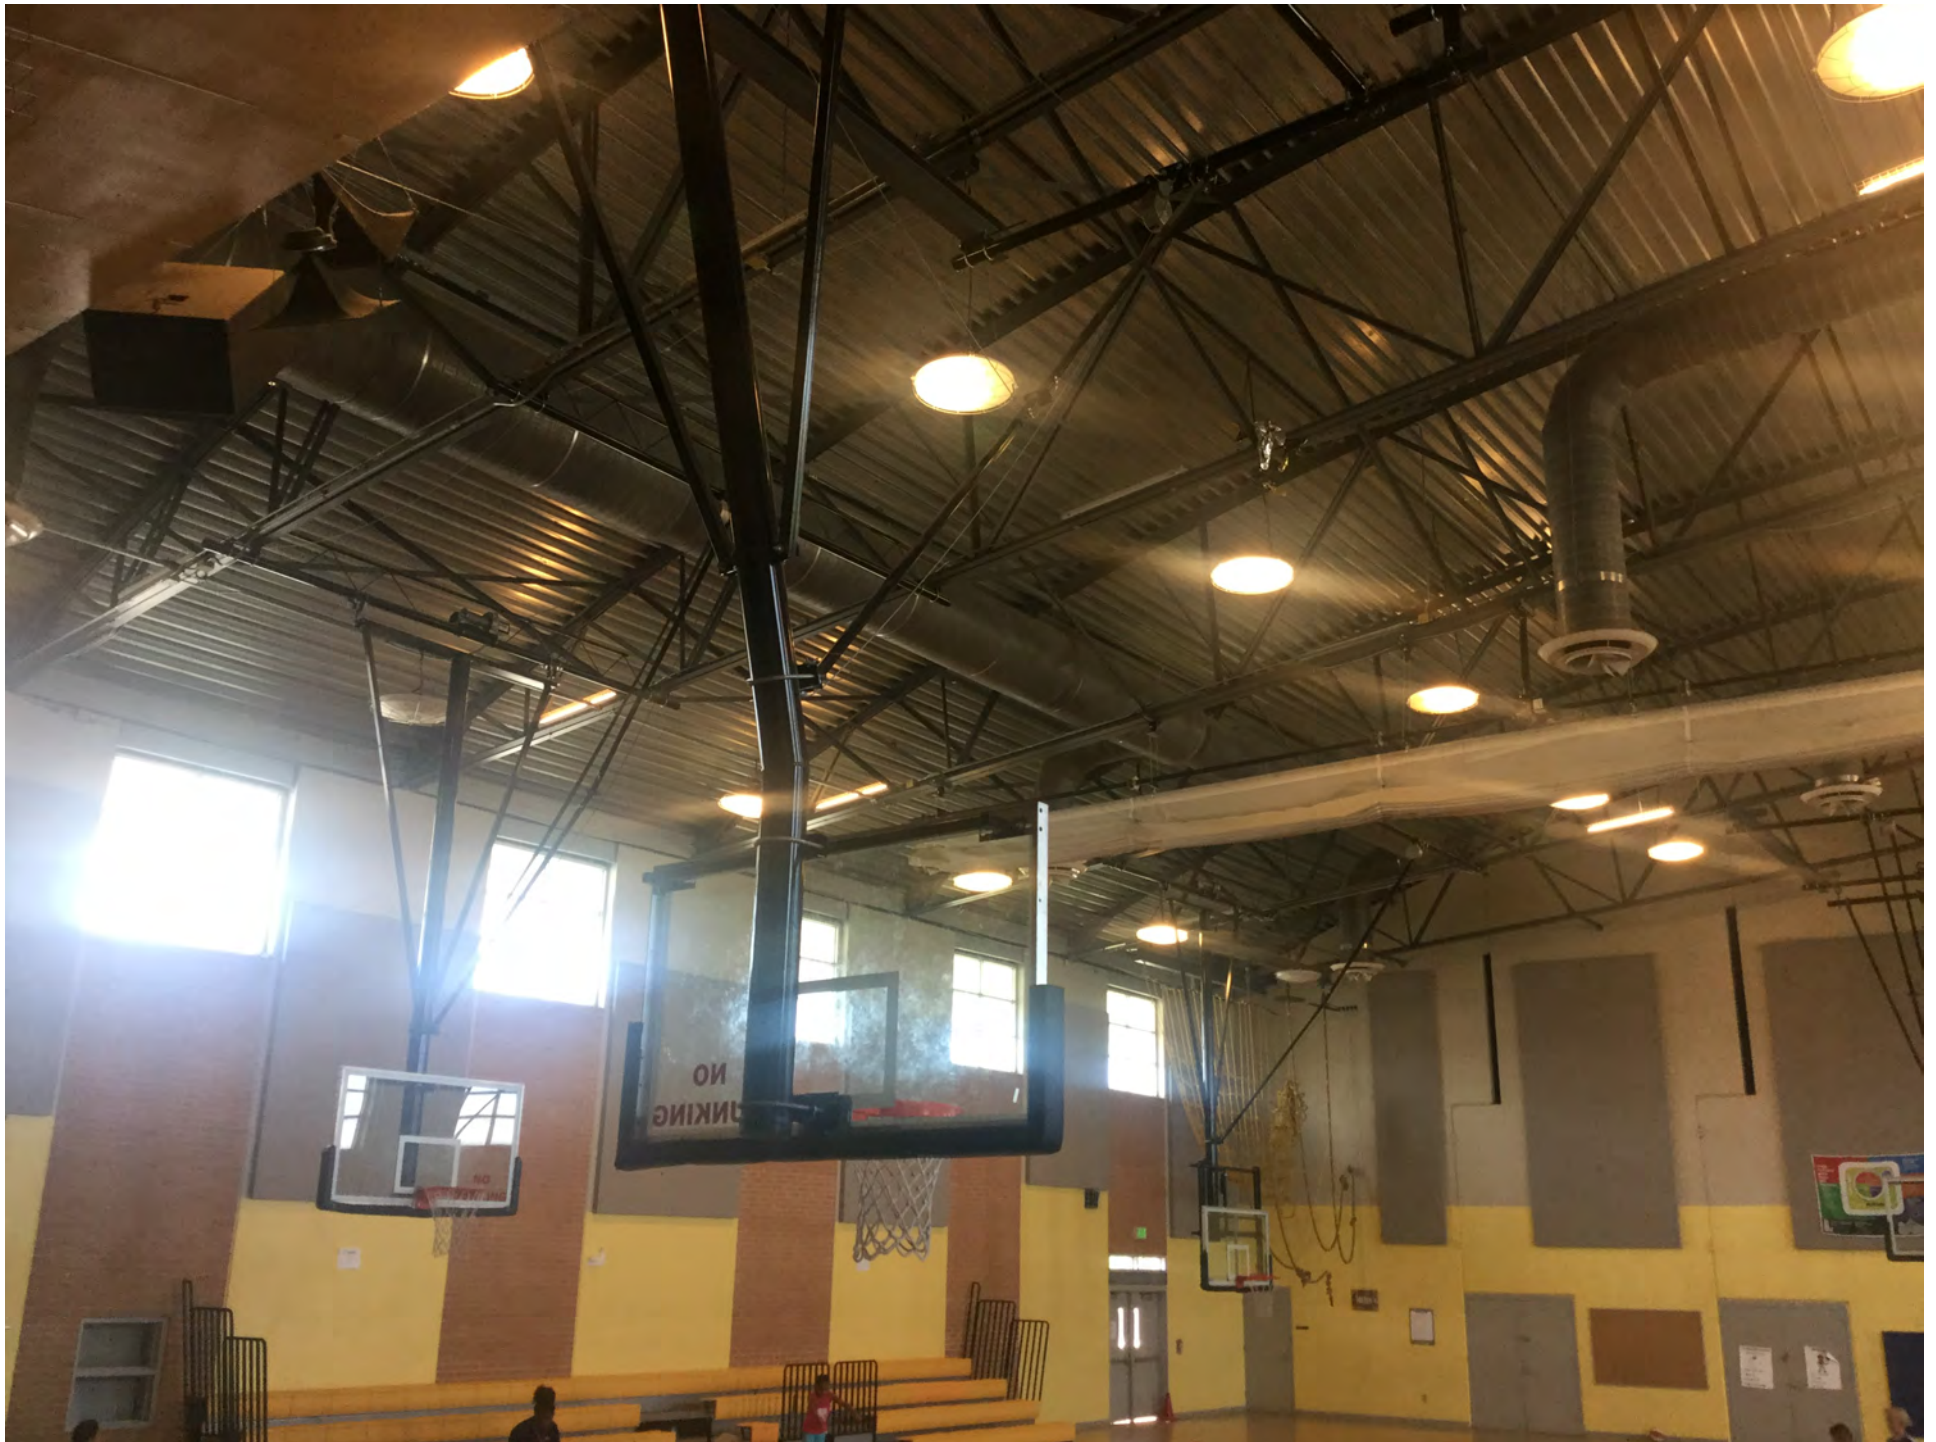
Photo 4. Gymnasium

1) Very unsatisfactory 2) Unsatisfactory 3) Average 4) Good 5) Very good N/A) Does not apply.								See Image 4	
3.7	Are Physical Education and Athletic <b>support</b> spaces appropriately configured per the ed spec?				4			Comments	1.004.00

1) Very unsatisfactory - Support spaces are disconnected from served spaces, too small, do not meet needs 2) Unsatisfactory - Support spaces are connected, but too small, inadequate for needs 3) Average - Connected, moderate size, but need some renovations or updates to function well 4) Good - Connected, good size/layout, meets needs/functions well 5) Very good - connected, generous size, nice condition, functions appropriately N/A) Does not apply.								The gym acoustics need improving.

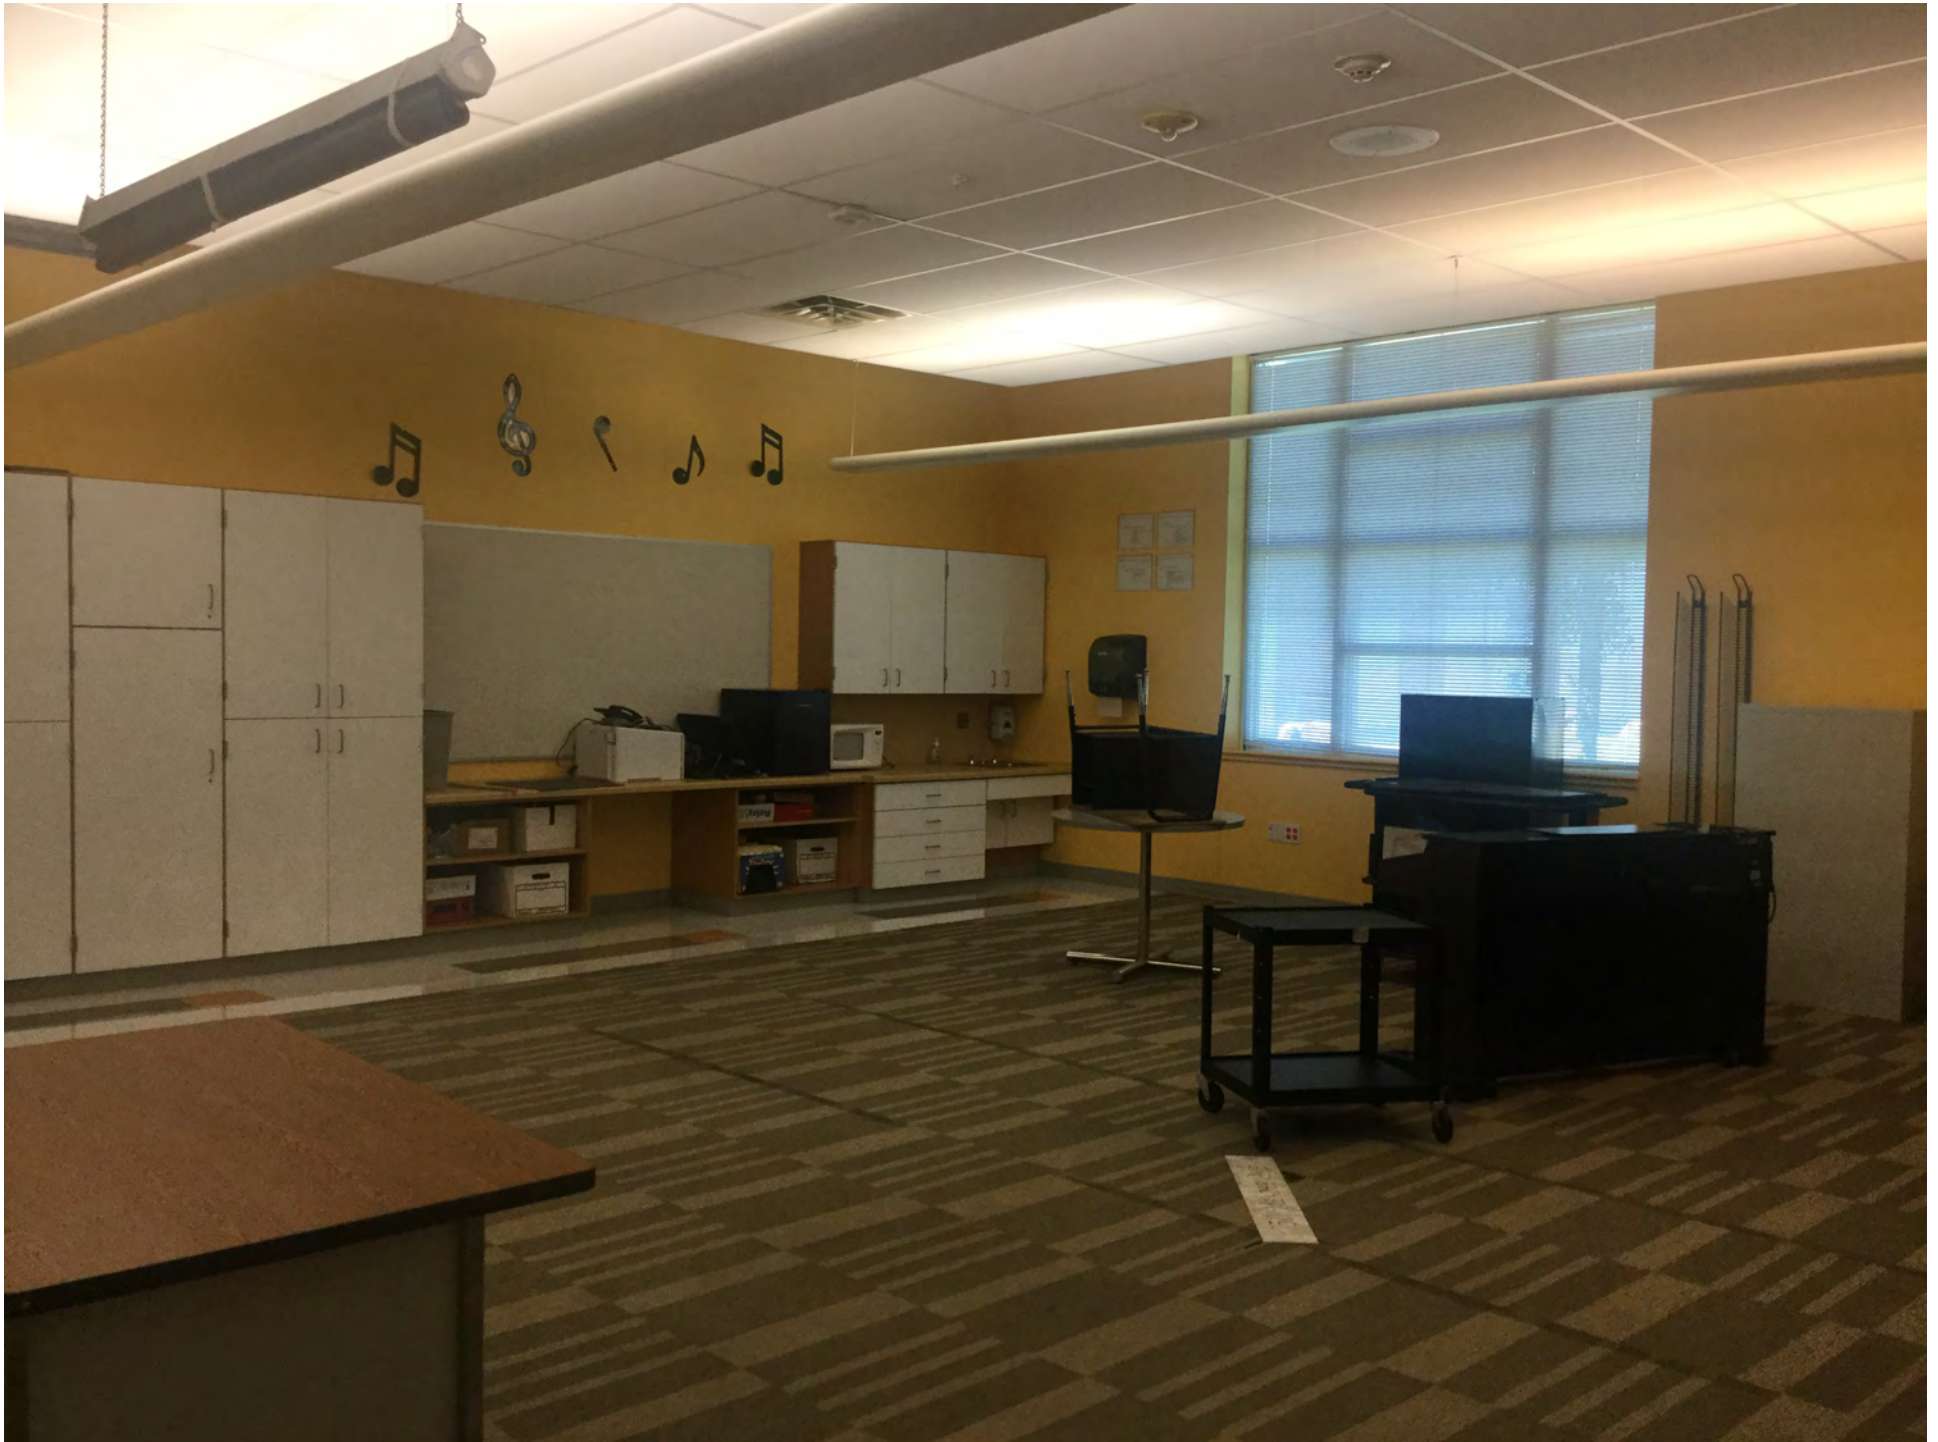
Photo 5. Music

3.8	Are music, drama, or performance spaces appropriately configured per the ed spec?				4			Comments	1.004.00
1) Very unsatisfactory 2) Unsatisfactory 3) Average 4) Good 5) Very good N/A) Does not apply.								There is one music room in the building that is well configured, and the stage is in excellent condition. However there is one music room in a portable which is not ideal.	
								See Image 5

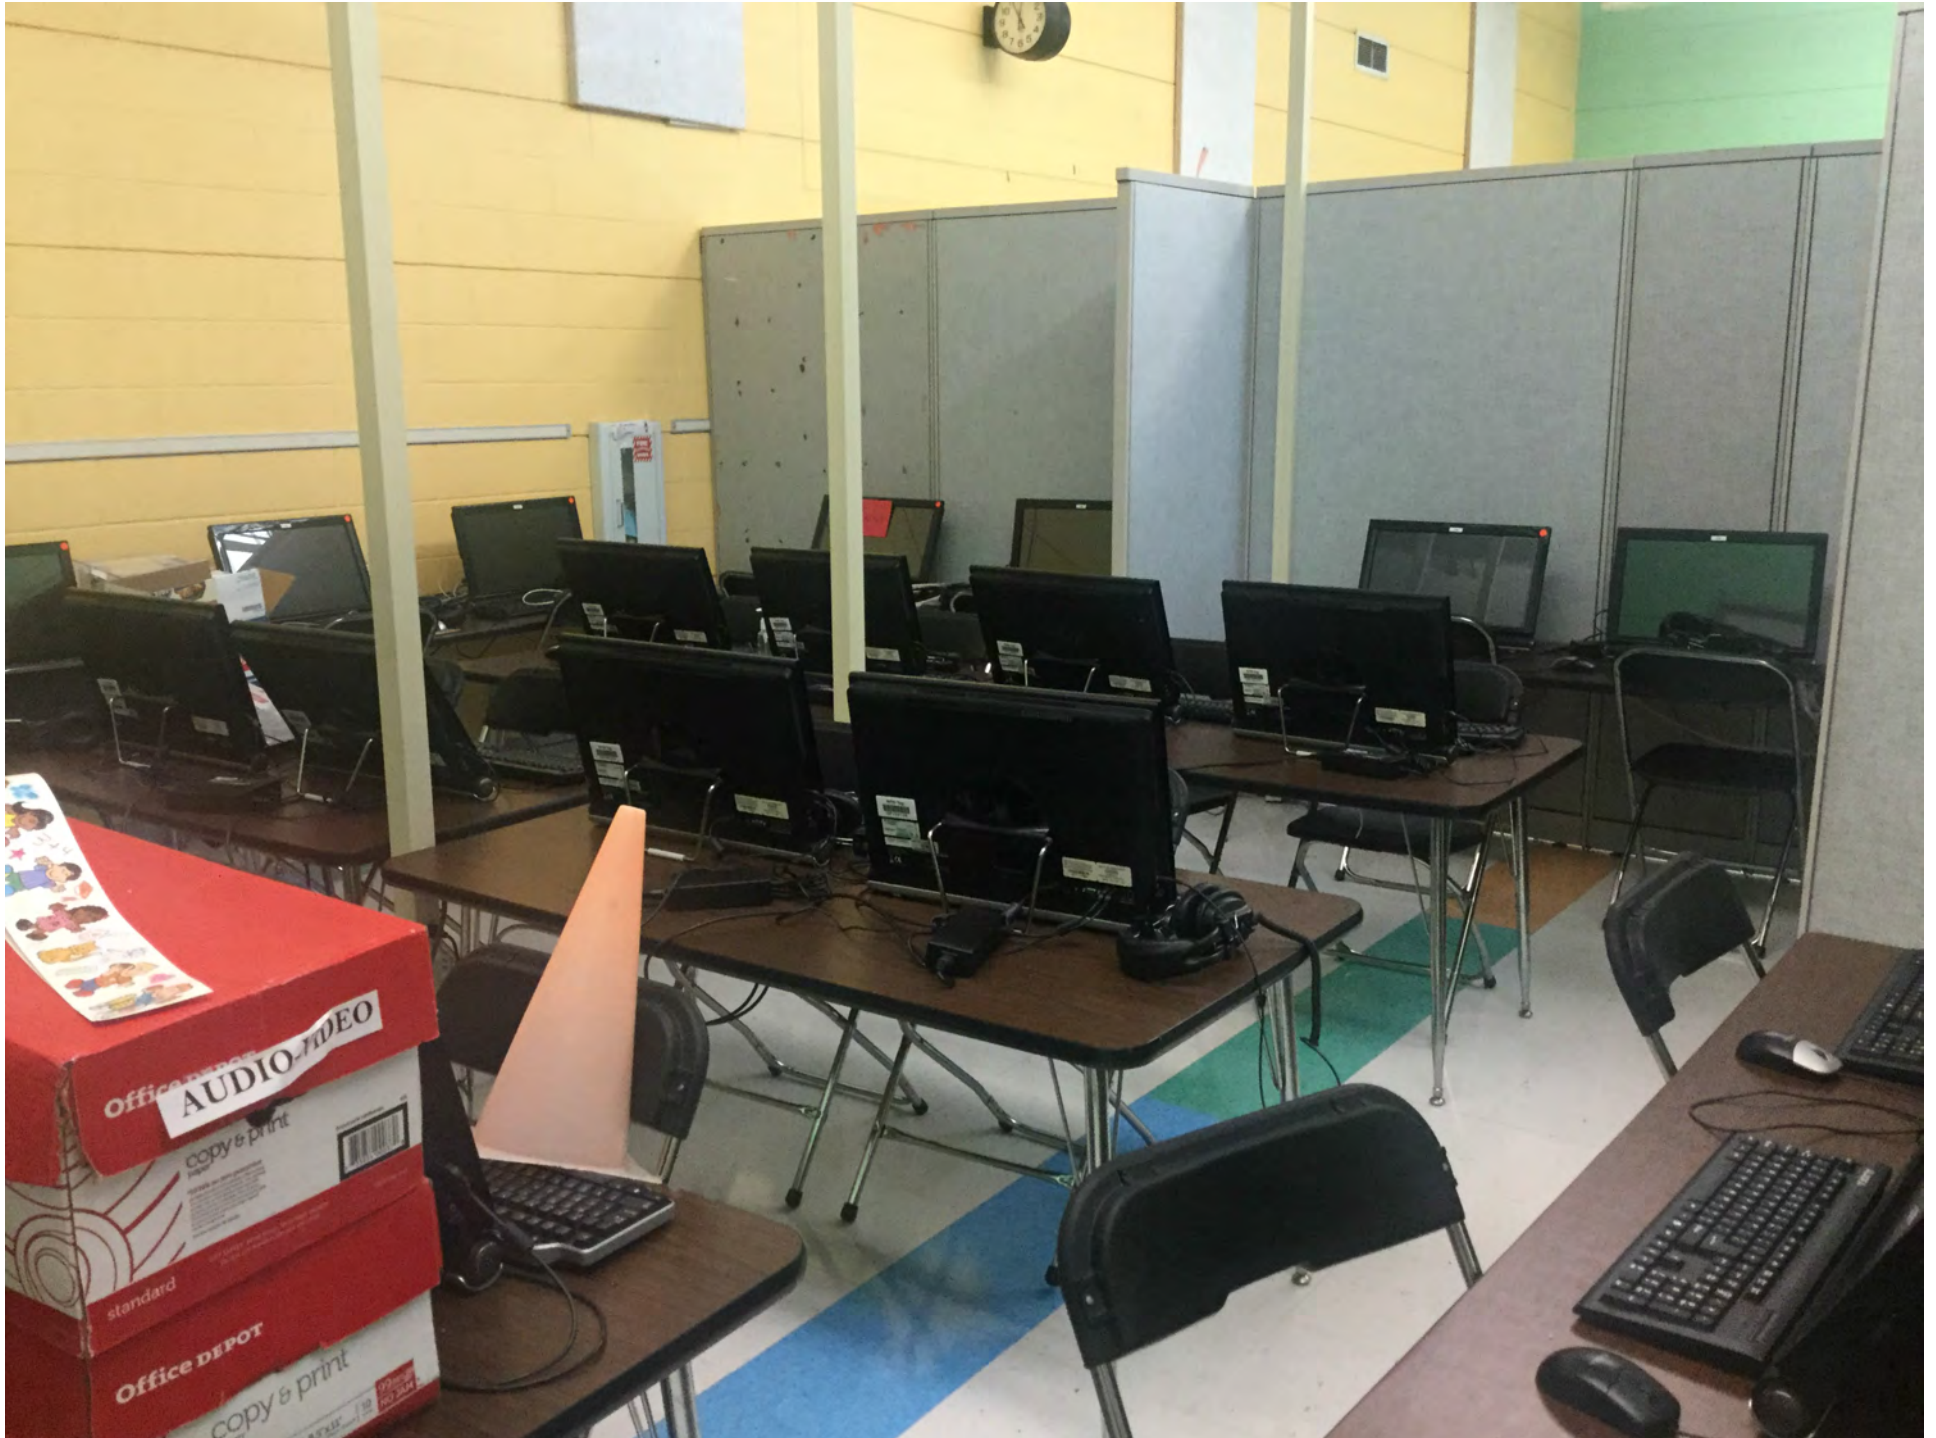
Photo 6. Computer Lab

3.12	Are computer lab spaces appropriately configured?										2						Comments		1.00	2.00
1) Very unsatisfactory 2) Unsatisfactory 3) Average 4) Good 5) Very good N/A) Does not apply.										The computer lab is set up in a temporary space.										
										See Image 6

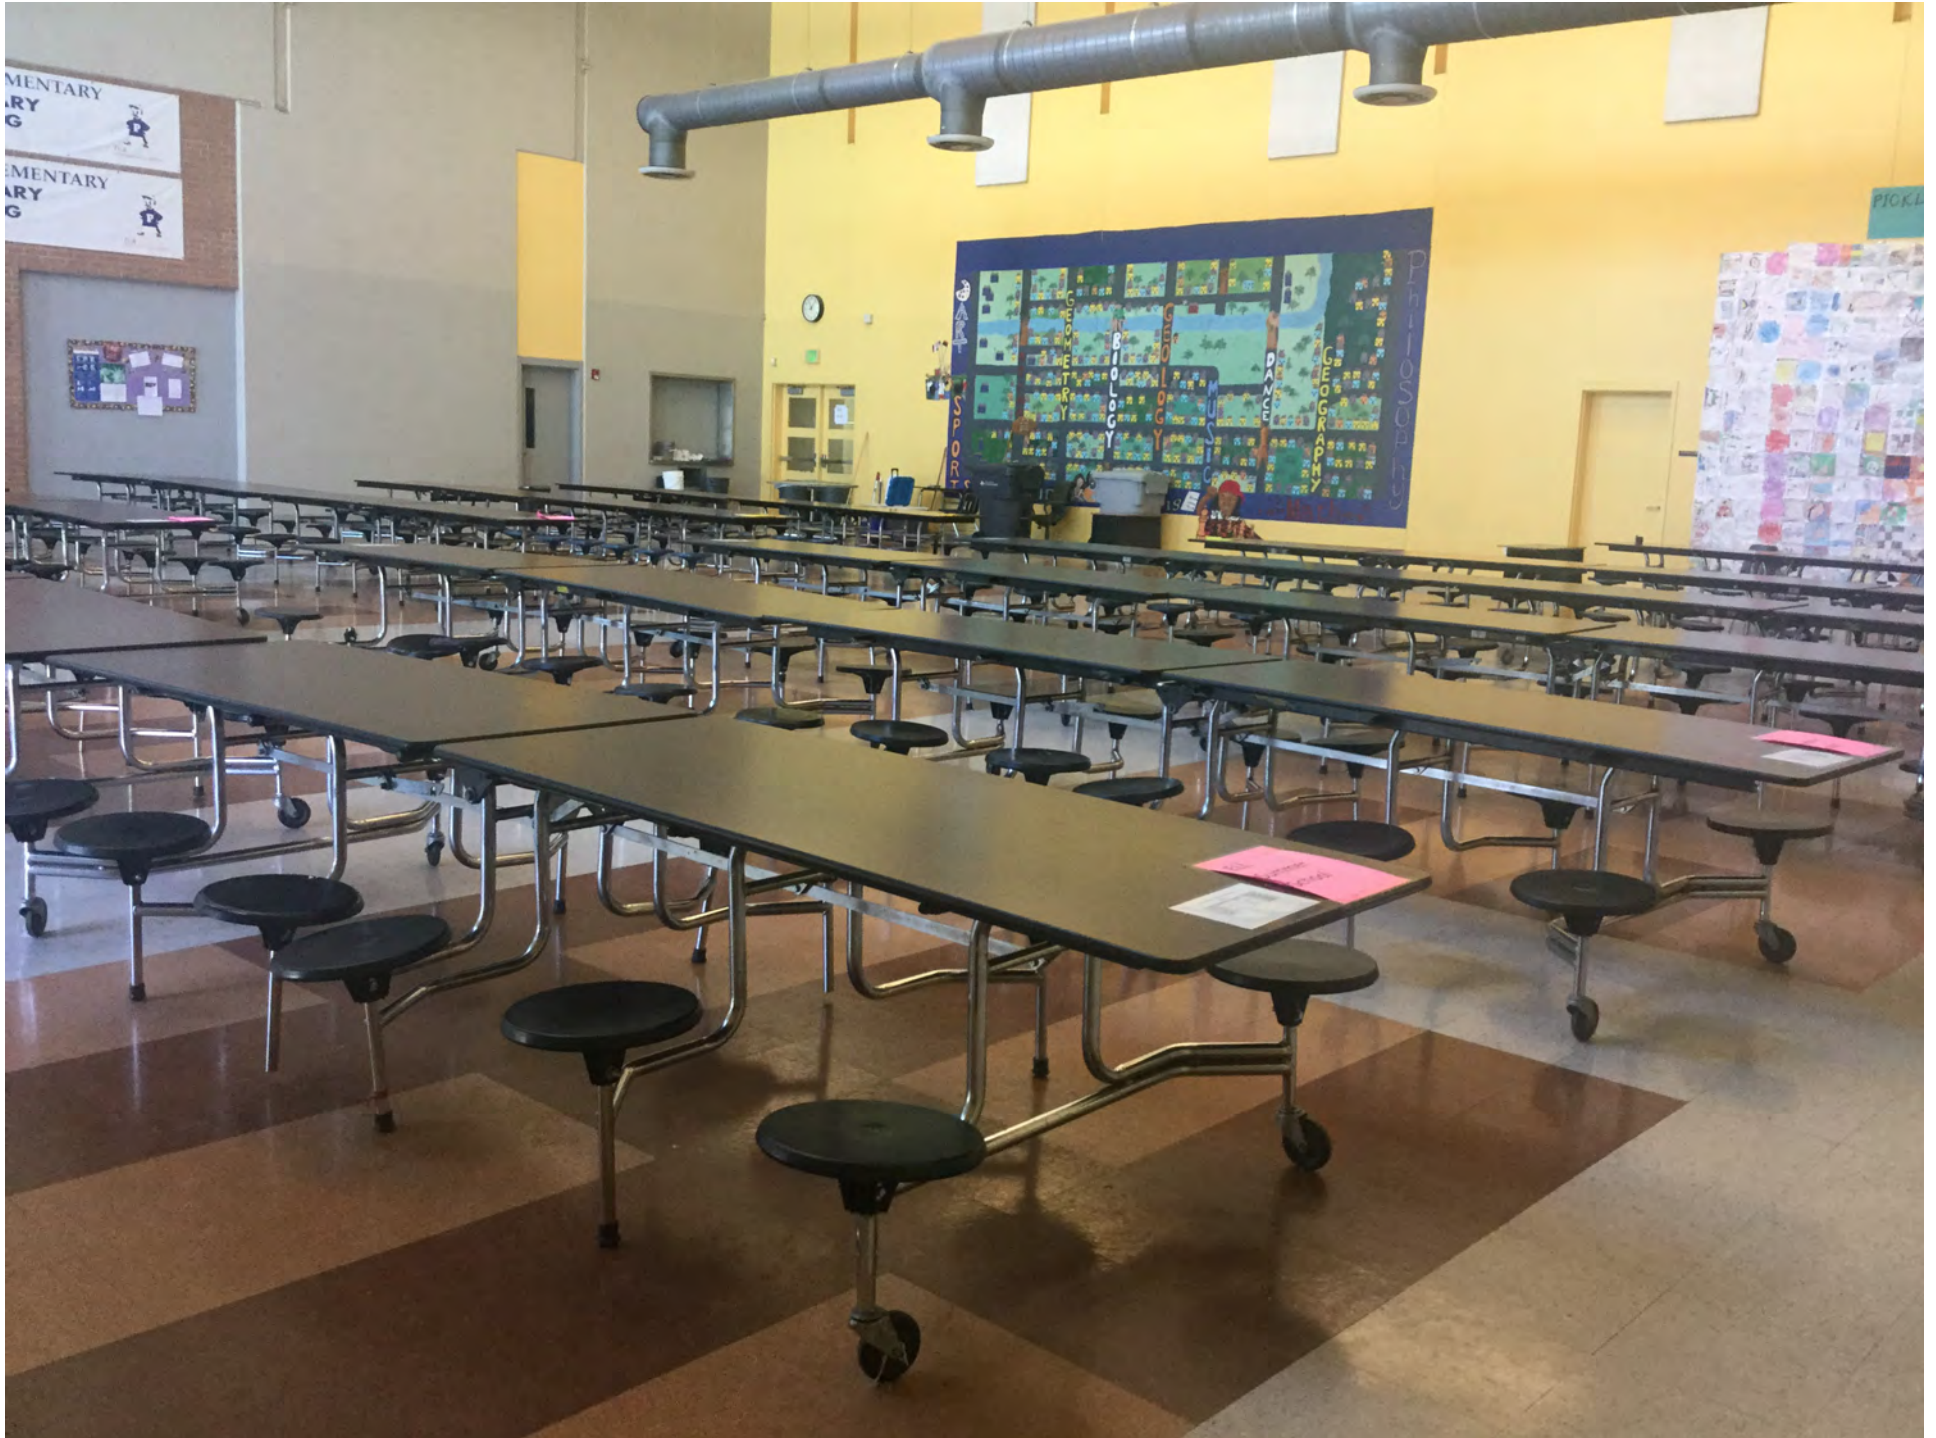
Photo 7. Cafeteria

3.16	Are the student dining facilities appropriately configured?			3				Comments	1.00 <b>3.00</b>
							1) Very unsatisfactory - Too small, poor circulation, inflexible seating in poor condition 2) Unsatisfactory - Too small or inadequate circulation, seating in poor condition 3) Average - moderate size, with adequate circulation, seating in okay condition 4) Good - good size, adequate circulation, seating in good condition 5) Very good - good size, adequate circulation, seating in good condition, with more than one option for eating space (ex: connection to outdoor eating space) N/A) Does not apply.	The cafeteria is large, but the acoustics are poor. The furniture is damaged.

See Image 7

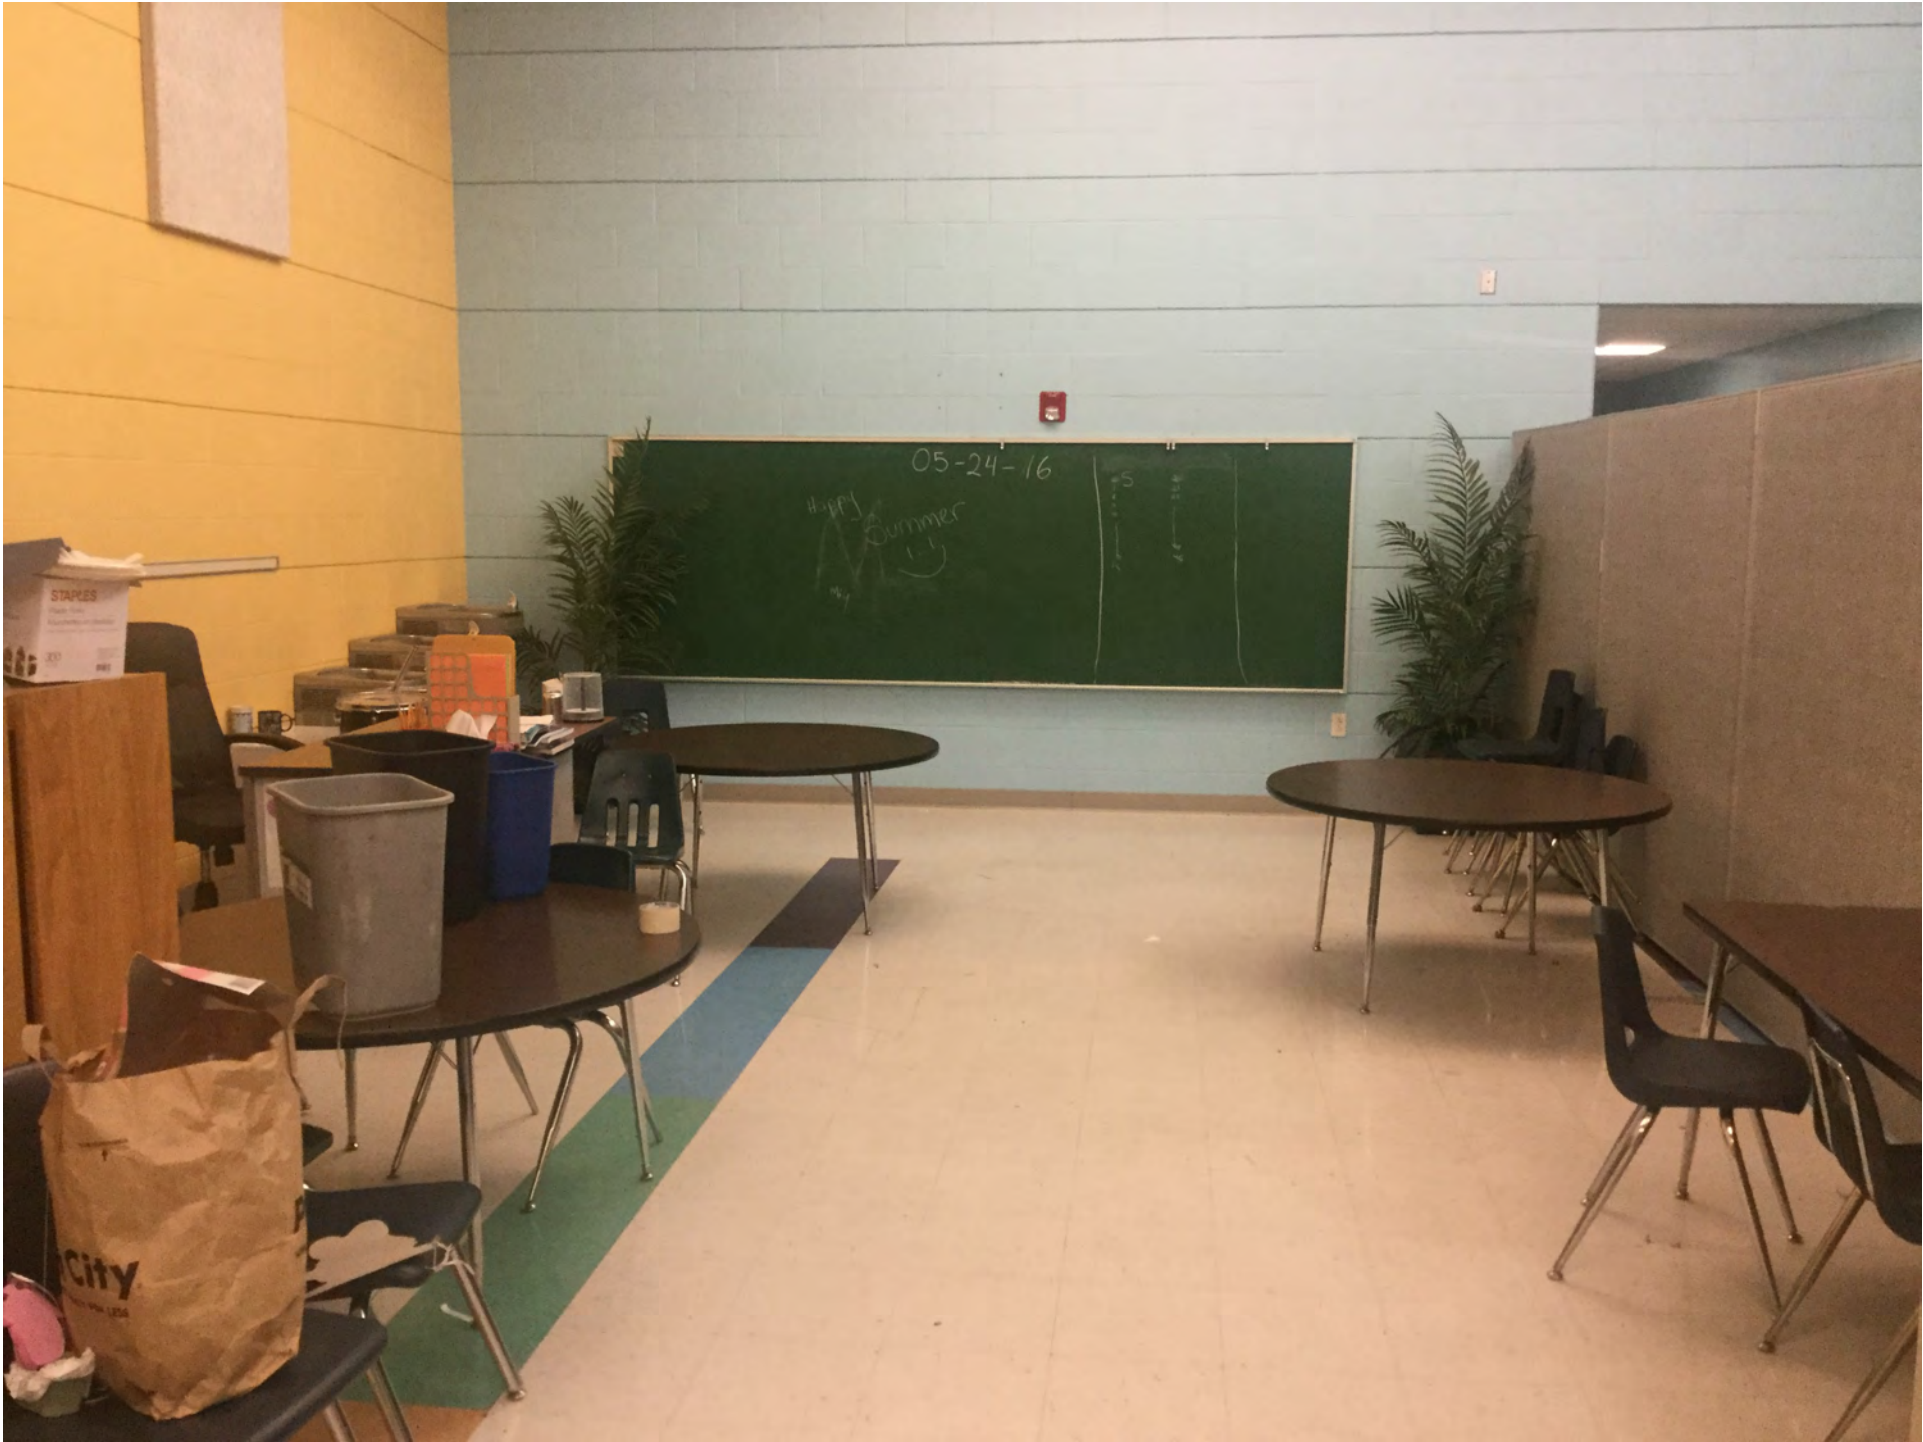
Photo 8. Flex Space

1) Very unsatisfactory - no common spaces or meeting rooms or in very poor condition 2) Unsatisfactory - a few common spaces or meeting rooms in unsatisfactory condition 3) Average - a few common spaces and meeting areas needing updates 4) Good - multiple common spaces and meeting rooms in good condition 5) Very good - adequate common spaces and meeting rooms of excellent quality N/A) Does not apply.								See Image 8
