## Educational Suitability Summary Report

Pickle Elementary School

Date: 08/01/2016

## Austin ISD Educational Suitability Assessment Criteria

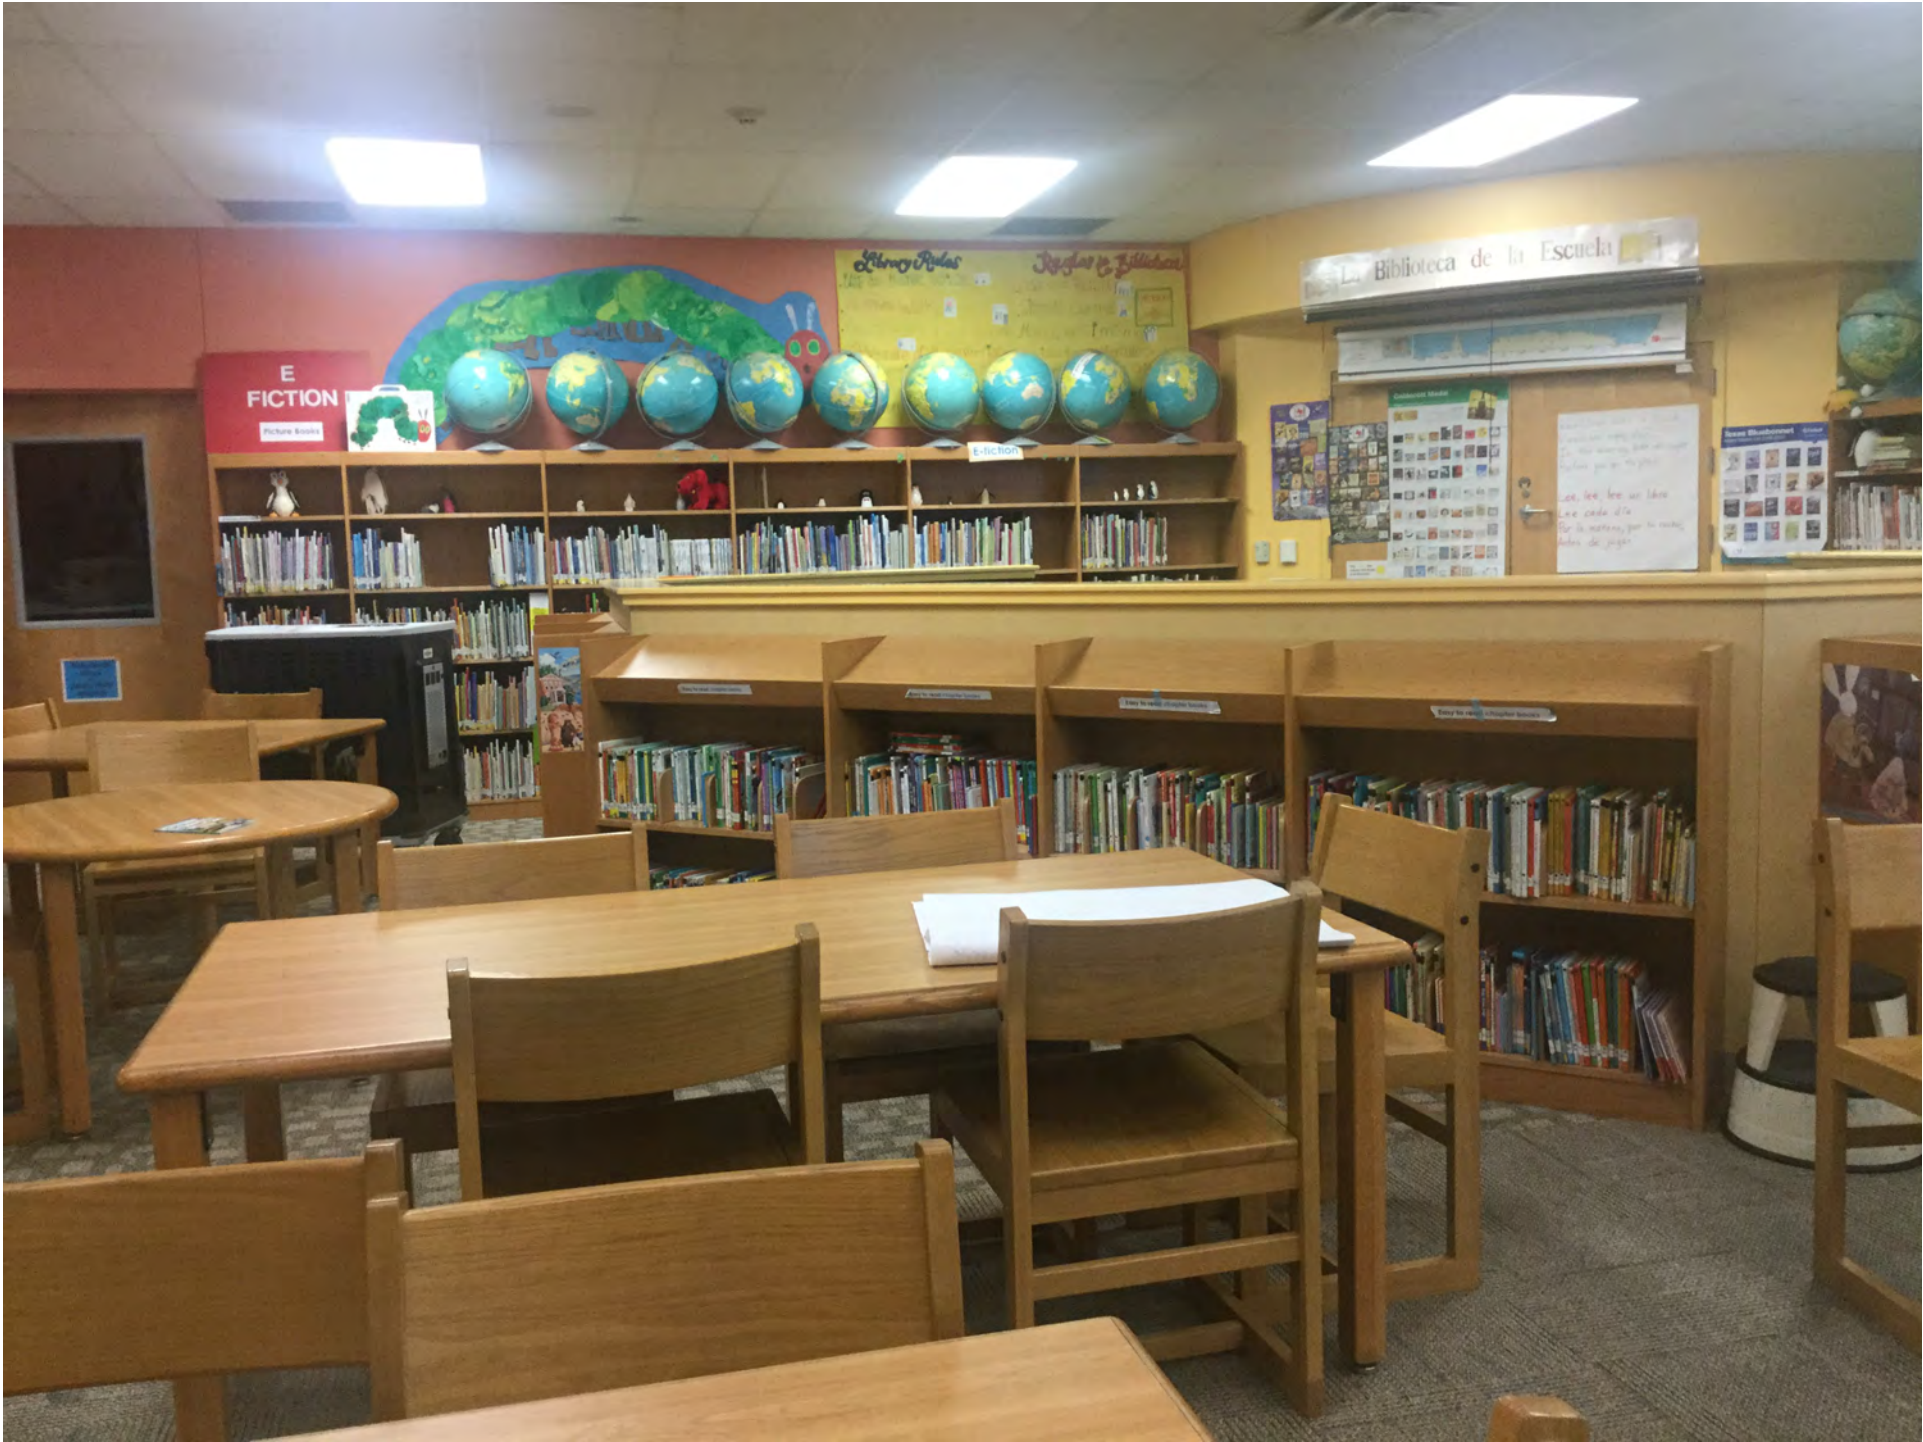
Photo 9. Library

5.3	How well does the Library/Media Center support social interaction?			3				Comments	1.003.00
1) Very unsatisfactory 2) Unsatisfactory 3) Average 4) Good 5) Very good N/A) Does not apply.								There is a learning stair, but there are limited areas for social interaction.	
								See Image 9

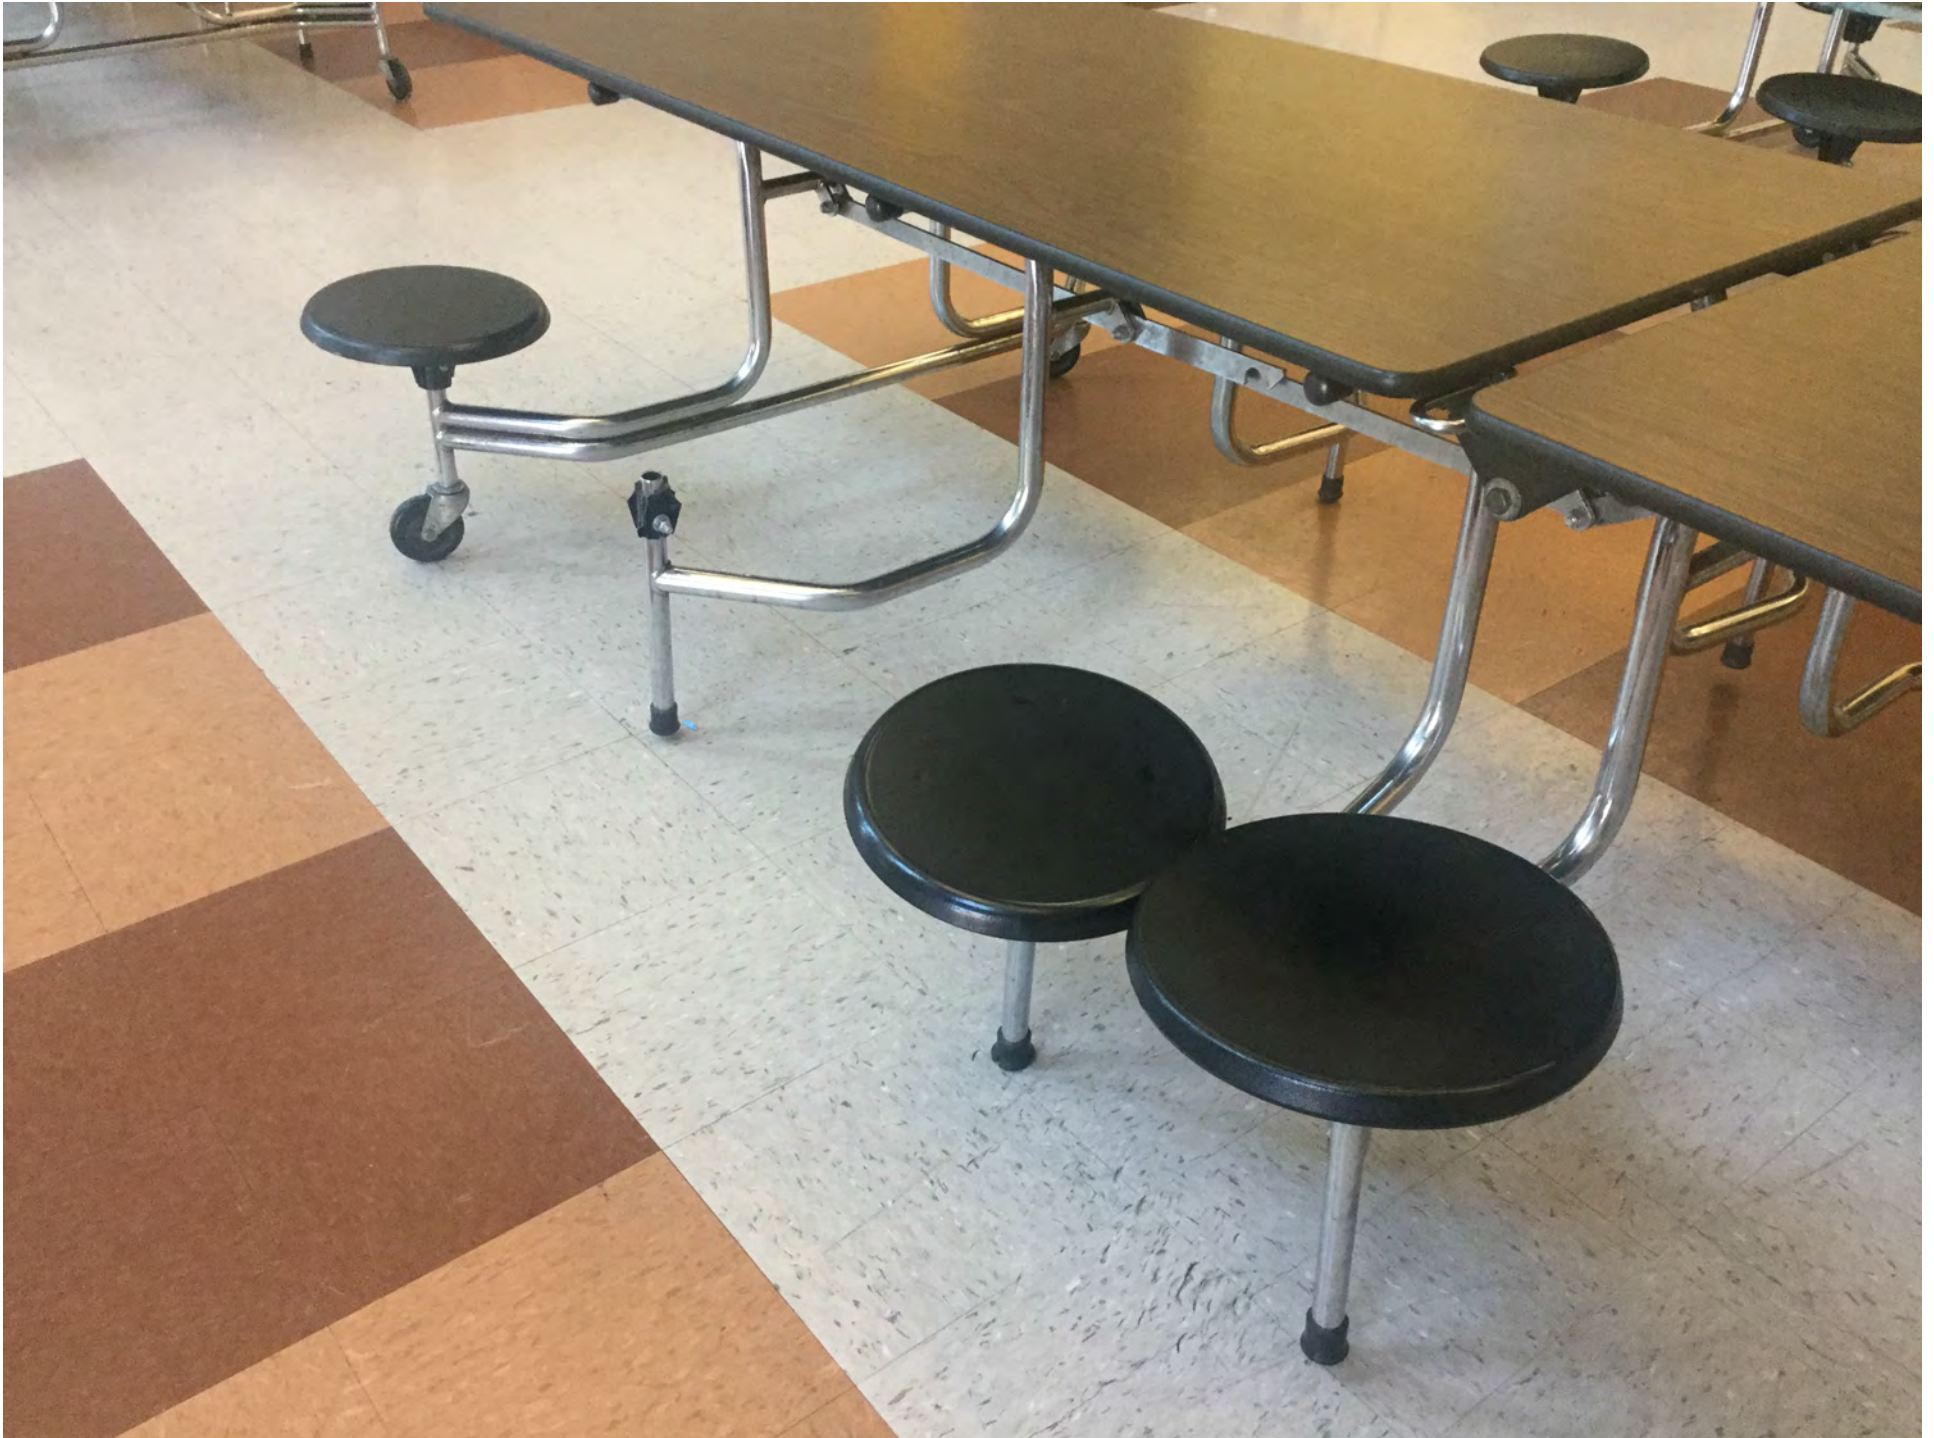
Photo 10. Furniture

9 - Furniture, Fixtures & Equipment		1	2	3	4	5	N/A	12.00	
9.1	What is the current condition of the furniture?				4			Comments	0.75 3.00
<div>1) Very unsatisfactory - damaged/non-functioning</div> <div>2) Unsatisfactory - torn, bent, wrong size</div> <div>3) Average - scratched/dented/marked</div> <div>4) Good - not new but sturdy and clean</div> <div>5) Very good - new</div> <div>N/A) Does not apply.</div>								Some older furniture is still used on the campus. The tables and attached seats in the cafeteria are in poor condition.	
								See Image 10
