Educational Suitability Summary Report

Pillow Elementary School – BLDG #151

Date: 8/1/2016 (REV 1 - 12/09/16 CAC Comments)

Score 49% Unsatisfactory

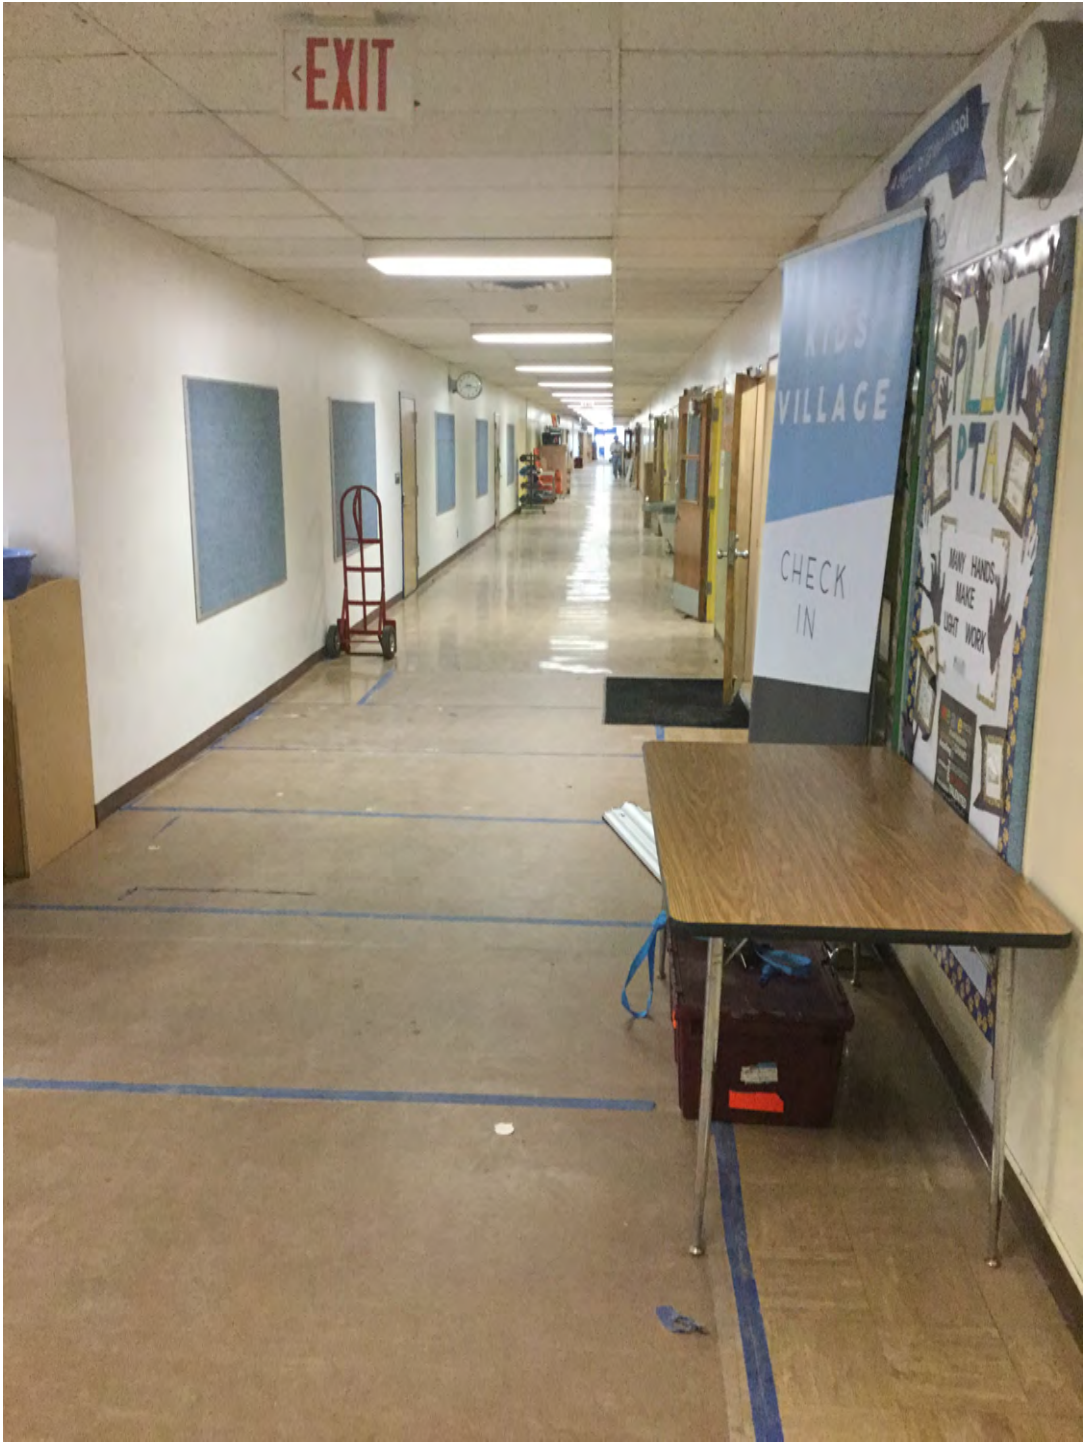
Photo 1. Corridor

The corridors are generally crowded with supplementary storage, are yellowed from age, and are poorly lit. The Principal suggests LED lighting be installed throughout the campus to improve environmental conditions and lower energy consumption.

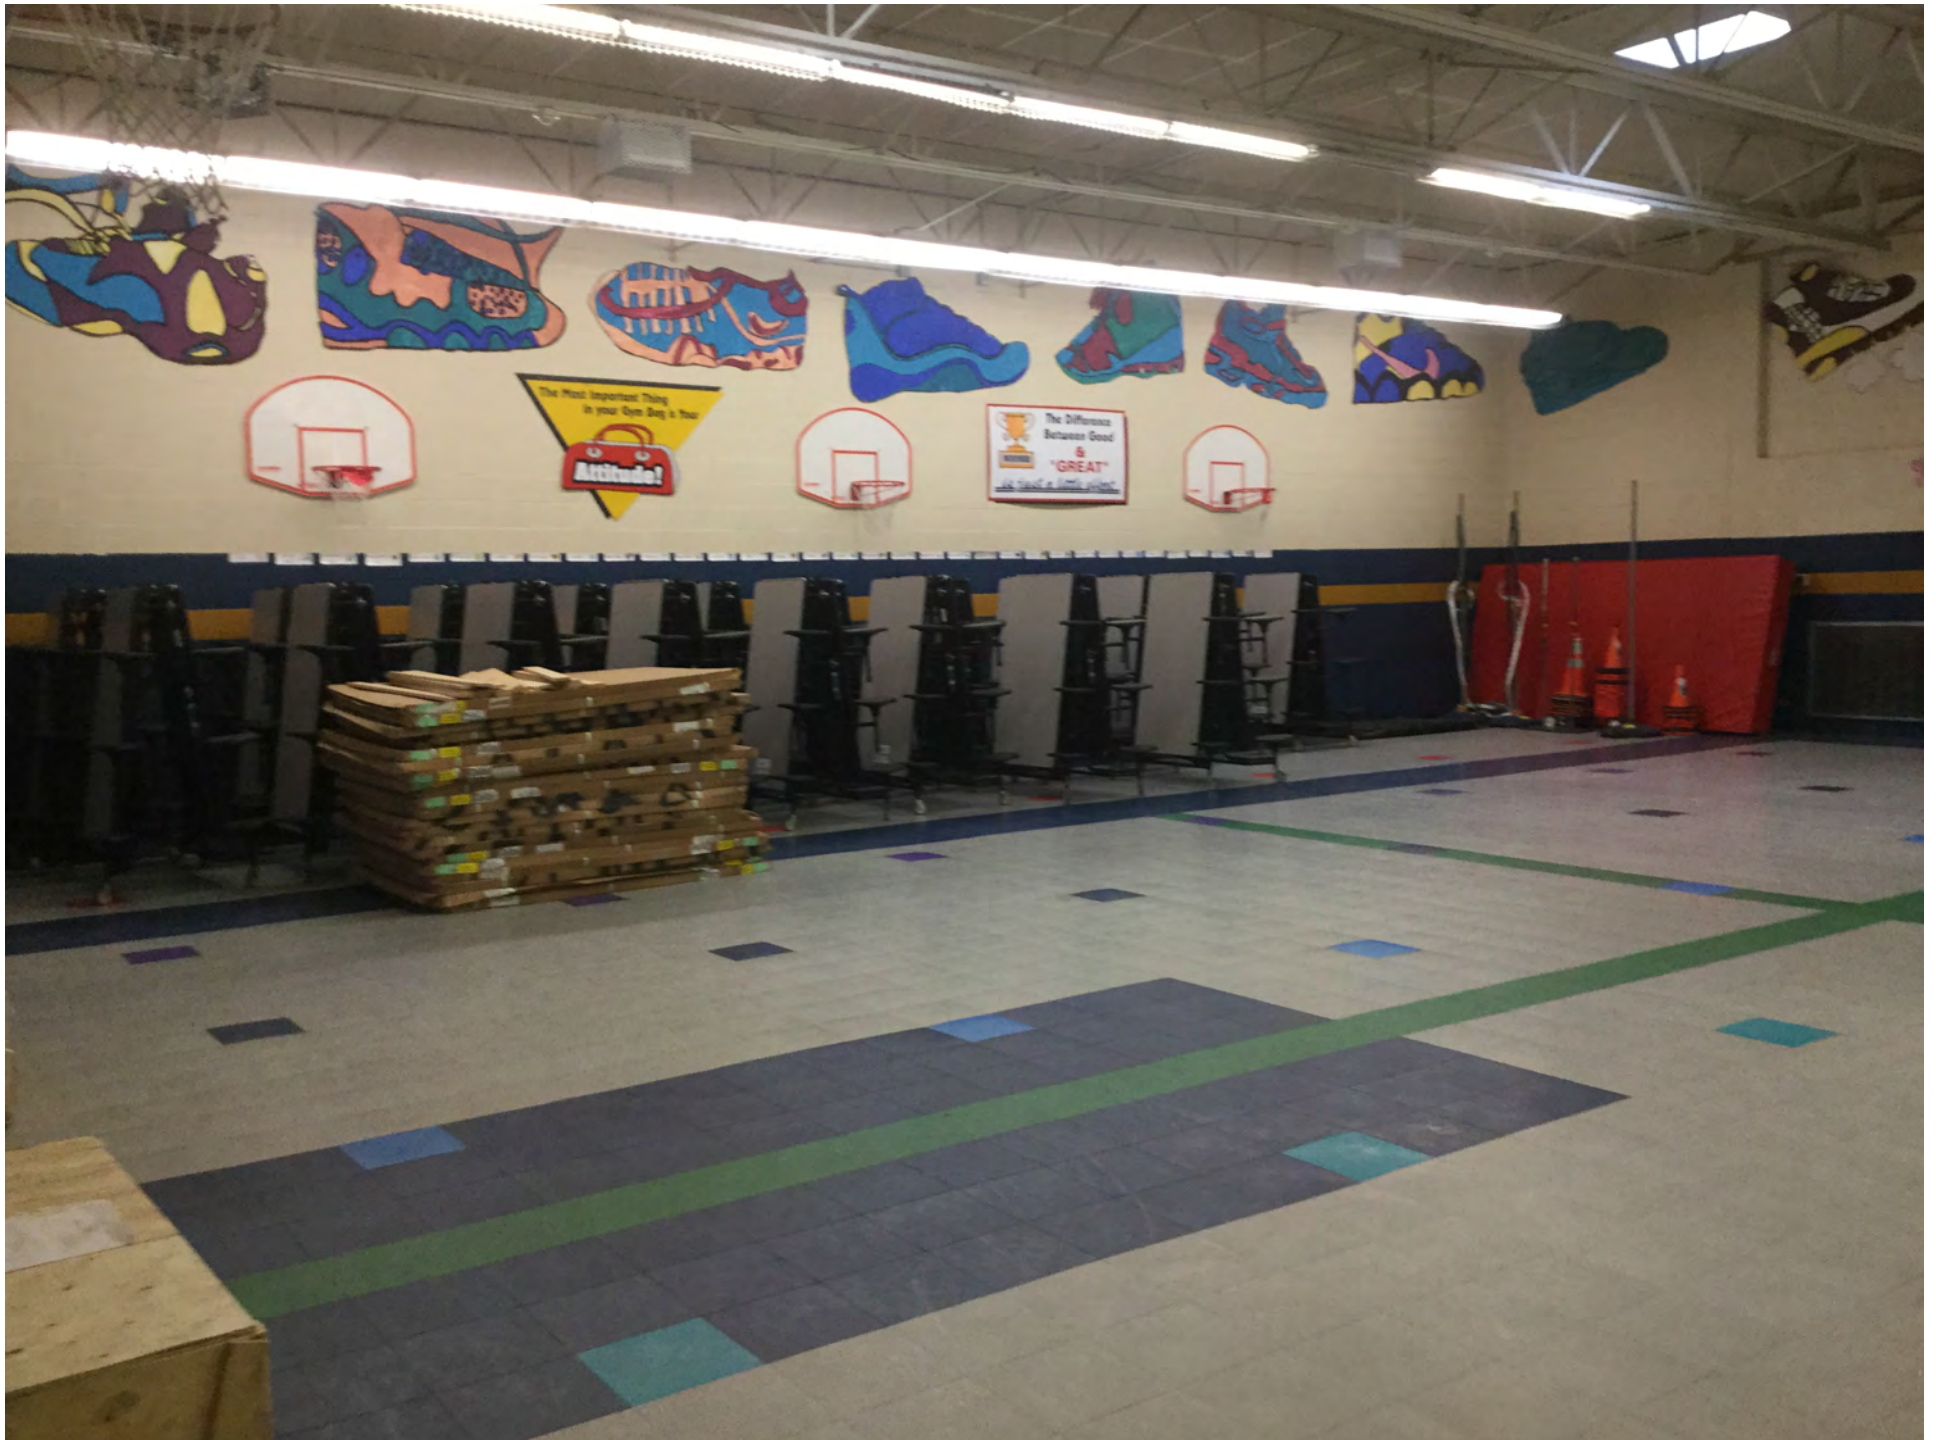
Photo 2. gym and cafeteria
accordion partition

1) Very unsatisfactory 2) Unsatisfactory 3) Average 4) Good 5) Very good N/A) Does not apply.								The gym is undersized, has an uneven floor, there is evidence of roof leaks, and a poorly functioning accordion partition. The floor must be pulled up in order to close or open said partition.

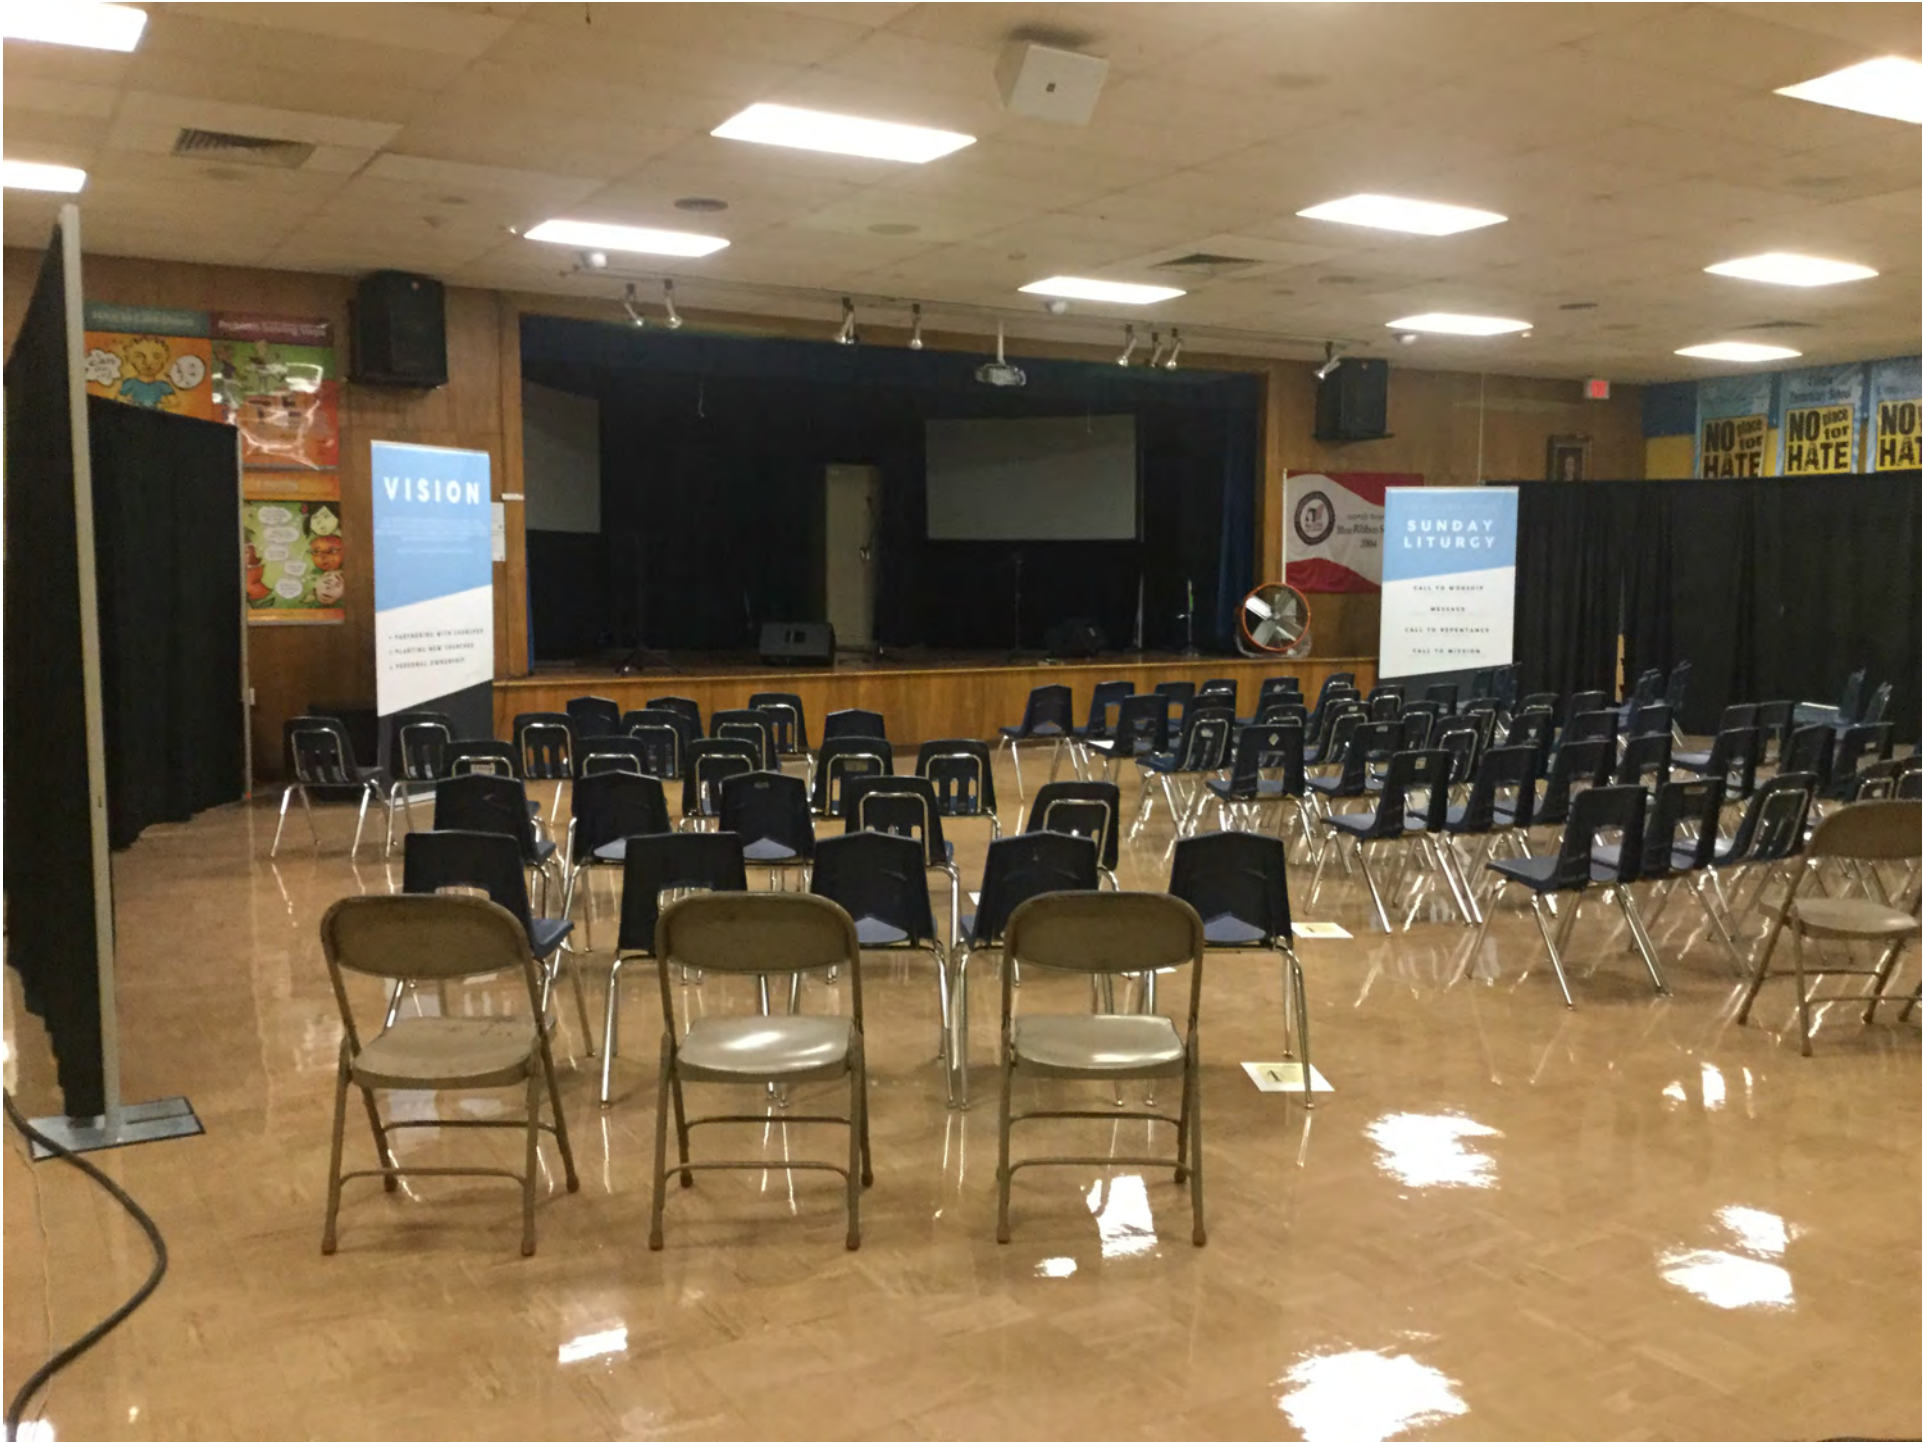
Photo 4. cafetorium

cafetorium (see additional storage information in the interview summary above). The cafetorium is very undersized and inadequate in all aspects; seating capacity, serving line size, kitchen space, stage space and accessibility, etc. The computer lab is located far from the library in a shared area intended for classroom collaborative break out space. While the equipment is adequate, there is no dedicated storage space for this function.

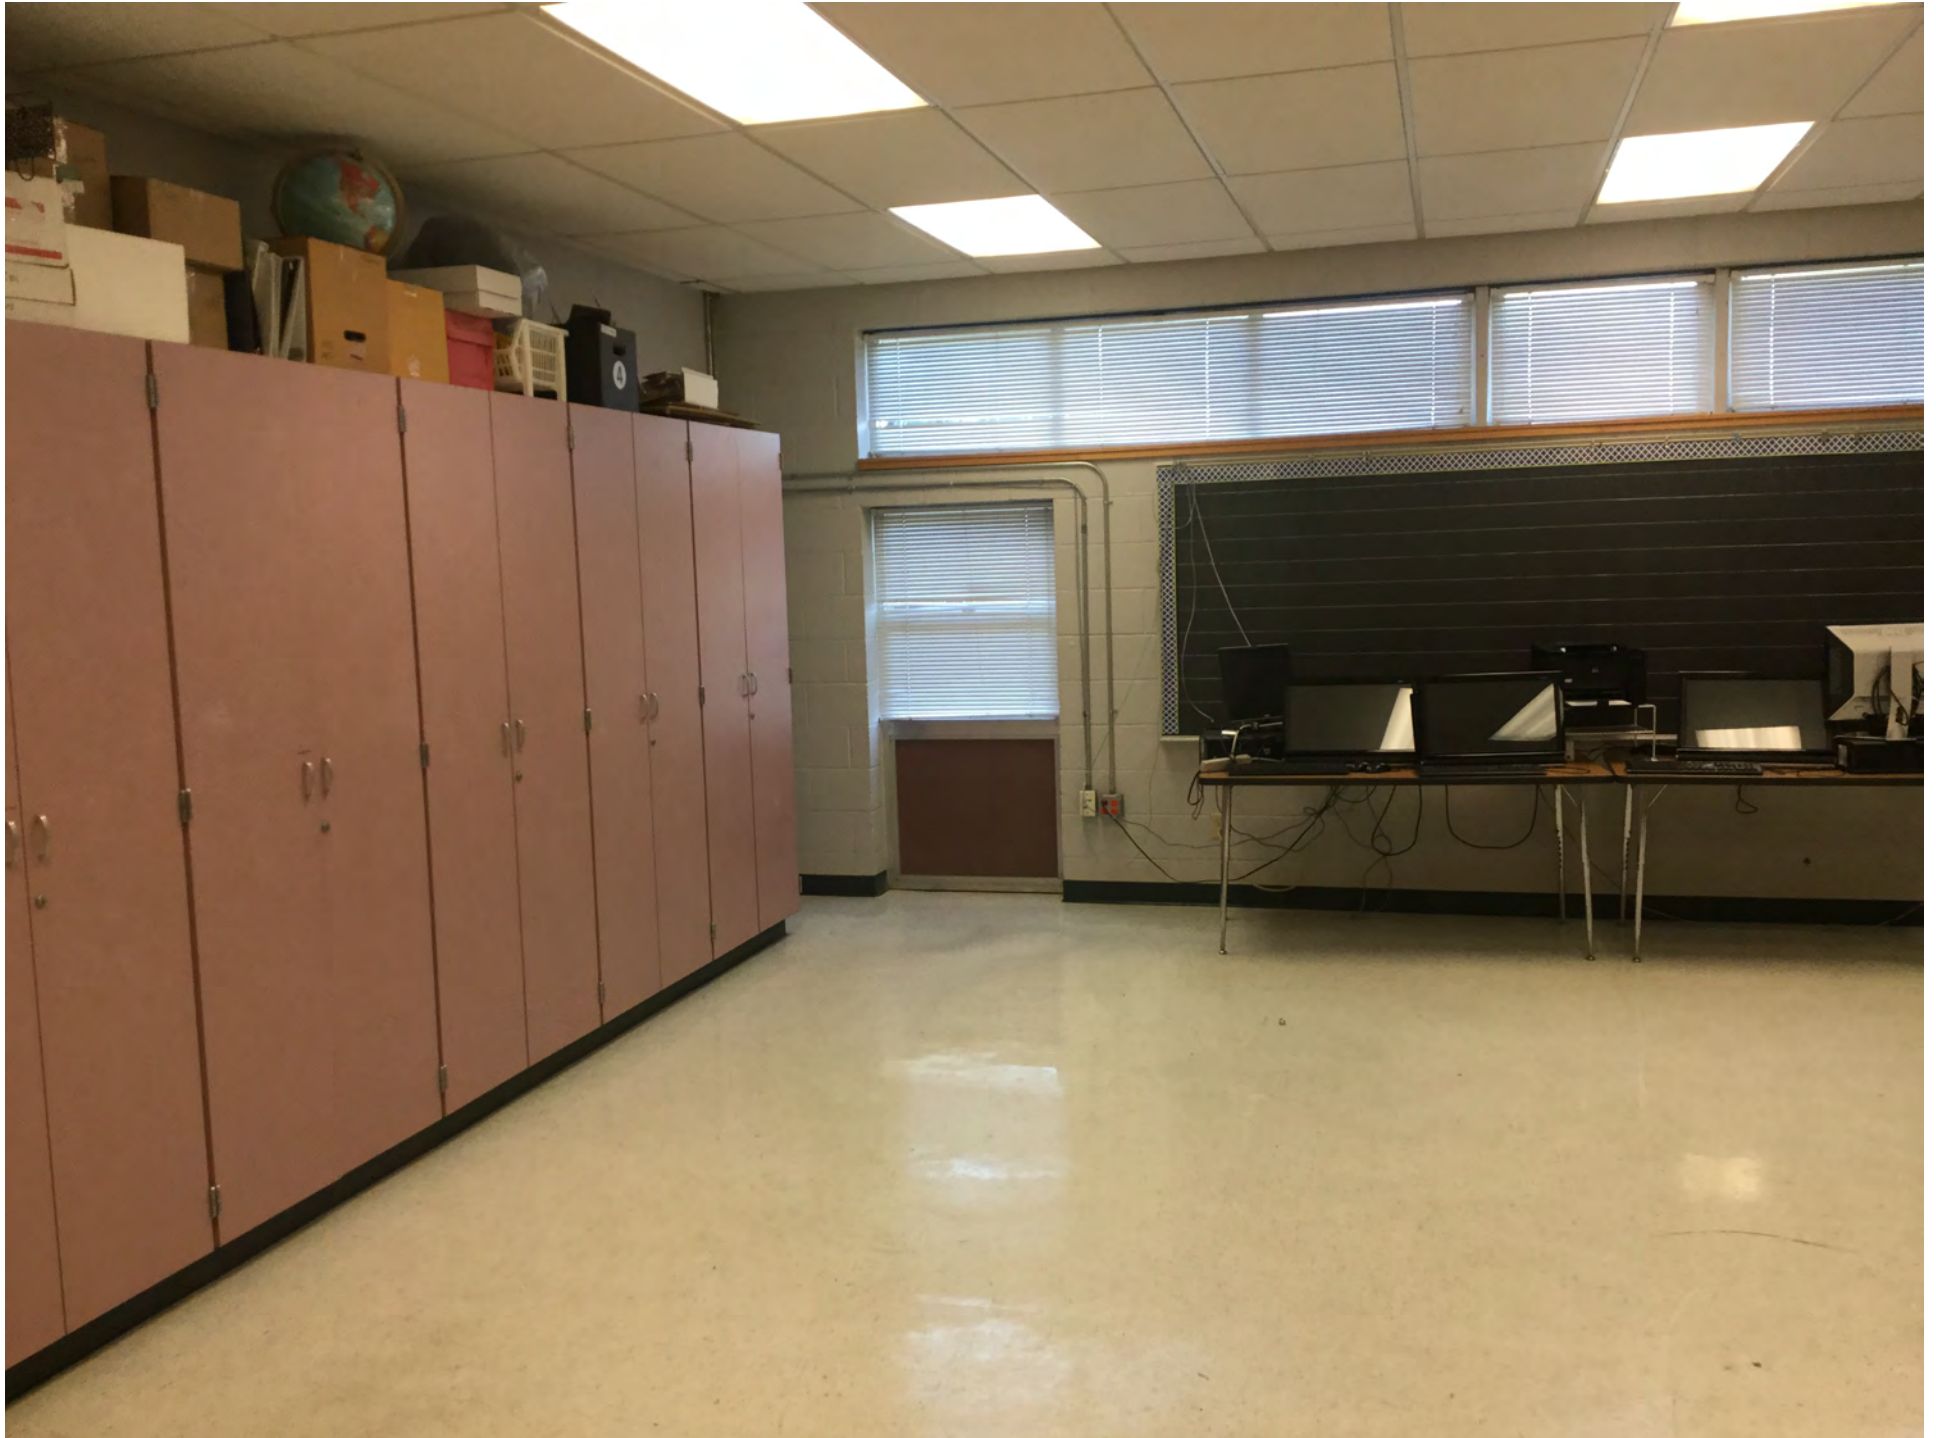
Photo 5. Classroom storage and Chalk Board

General building storage is inadequate and a primary concern of the faculty. Classroom storage spaces have limited built-in cabinets and rely heavily on storage in shared spaces and corridors. Additional loose cabinetry is placed in corridors, creating egress concerns. Teacher and student storage options are limited to personal desk storage and corridor coat hooks.

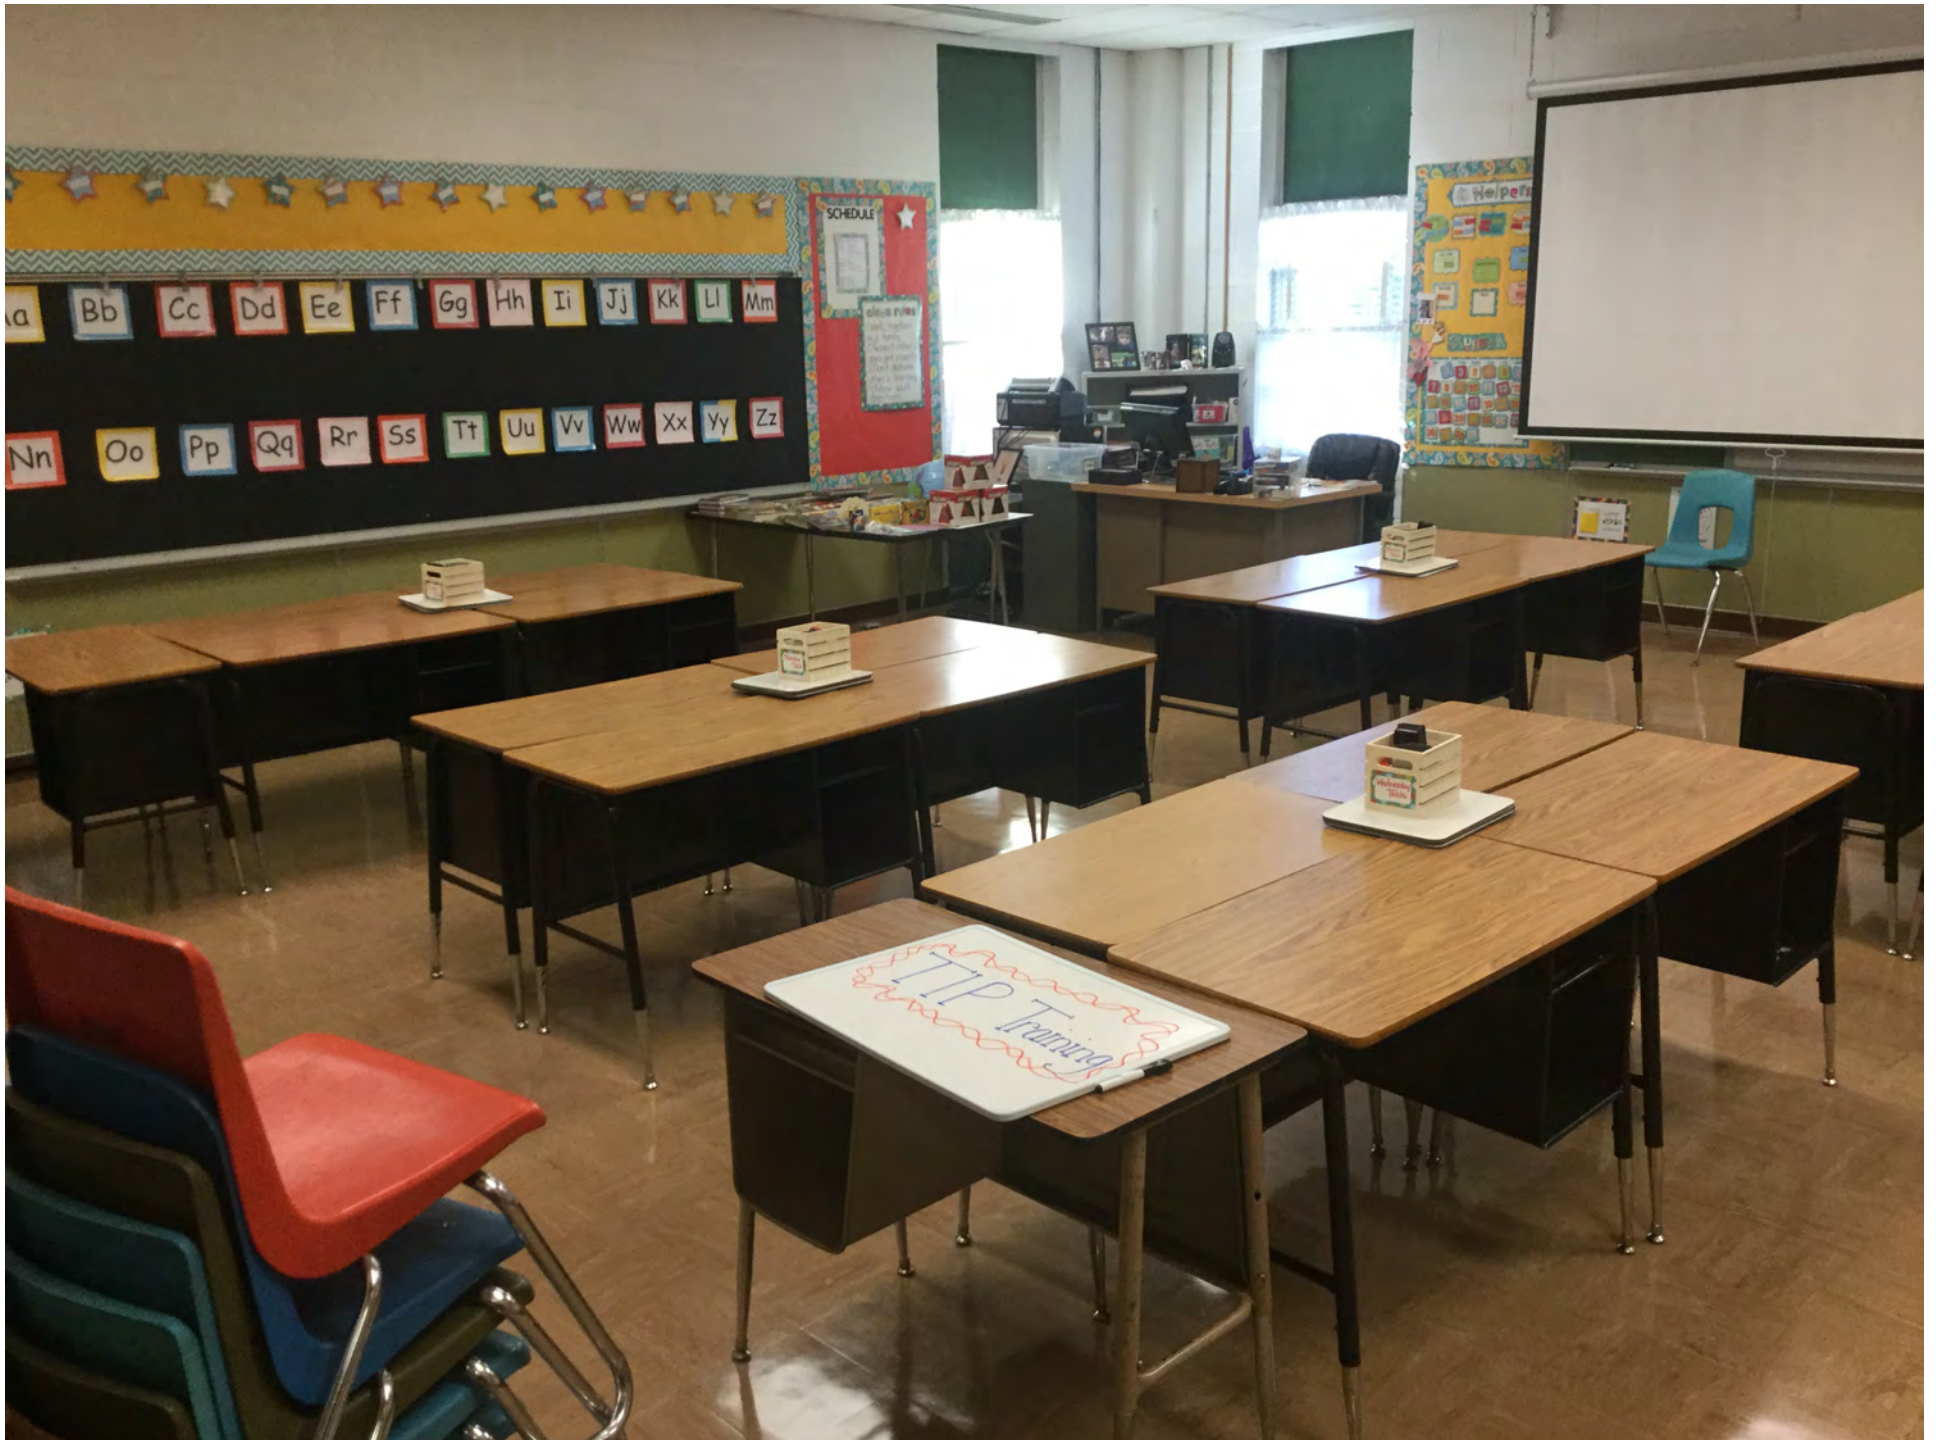
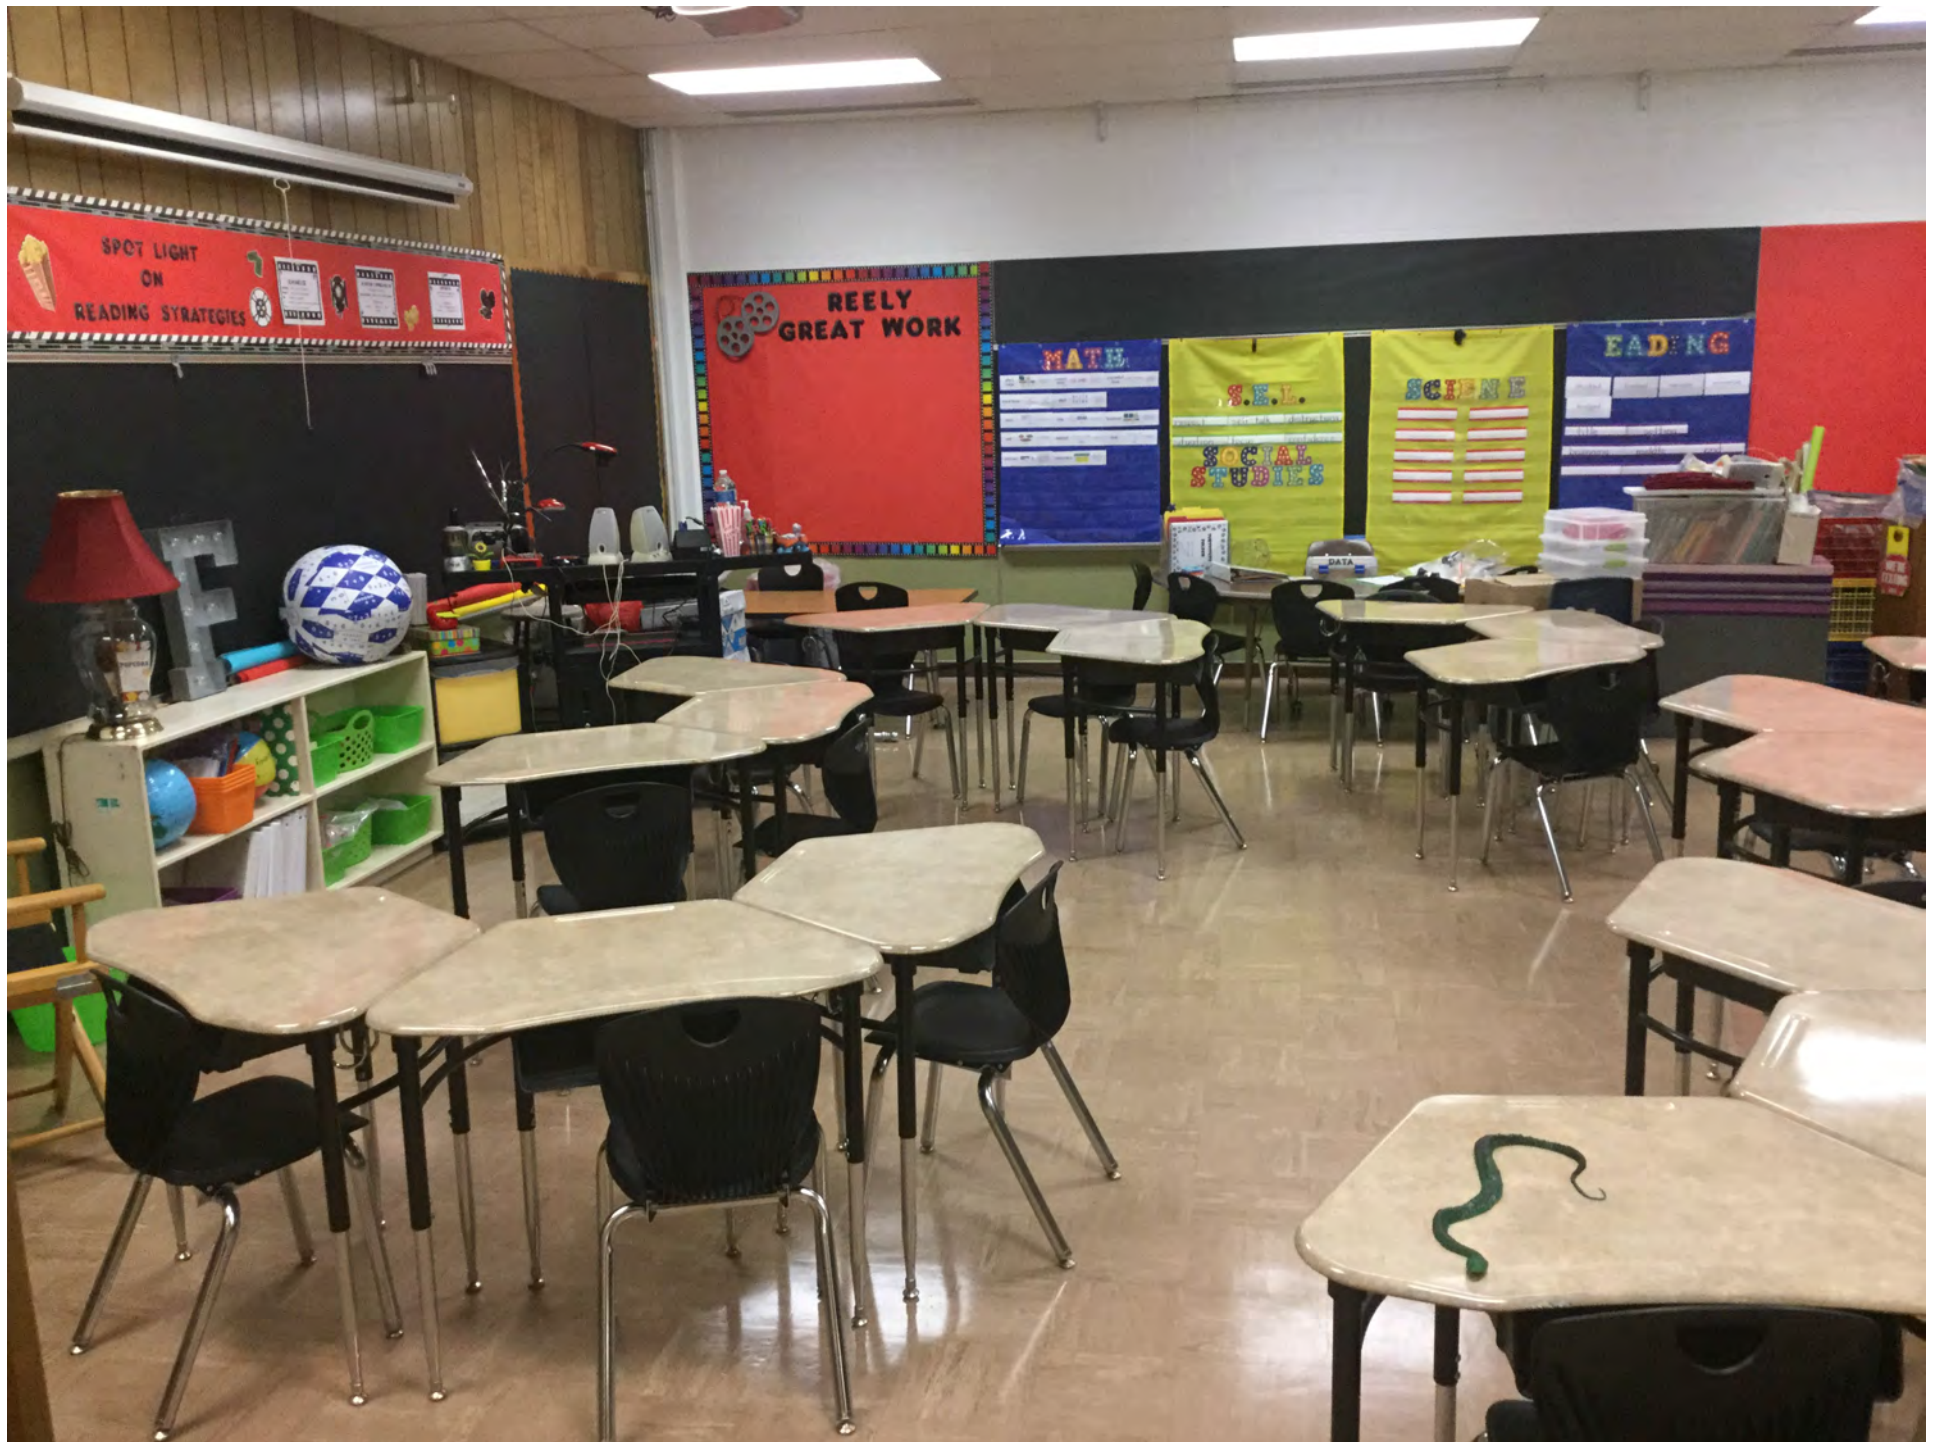
Photo 6. Classroom furniture

There is a mix of new and dated furniture throughout the building. While most furniture types appear appropriate for student age groups, some furniture is top-heavy and have been known to topple over and injure students. Staff request more flexible furniture types to better promote collaborative working environments.

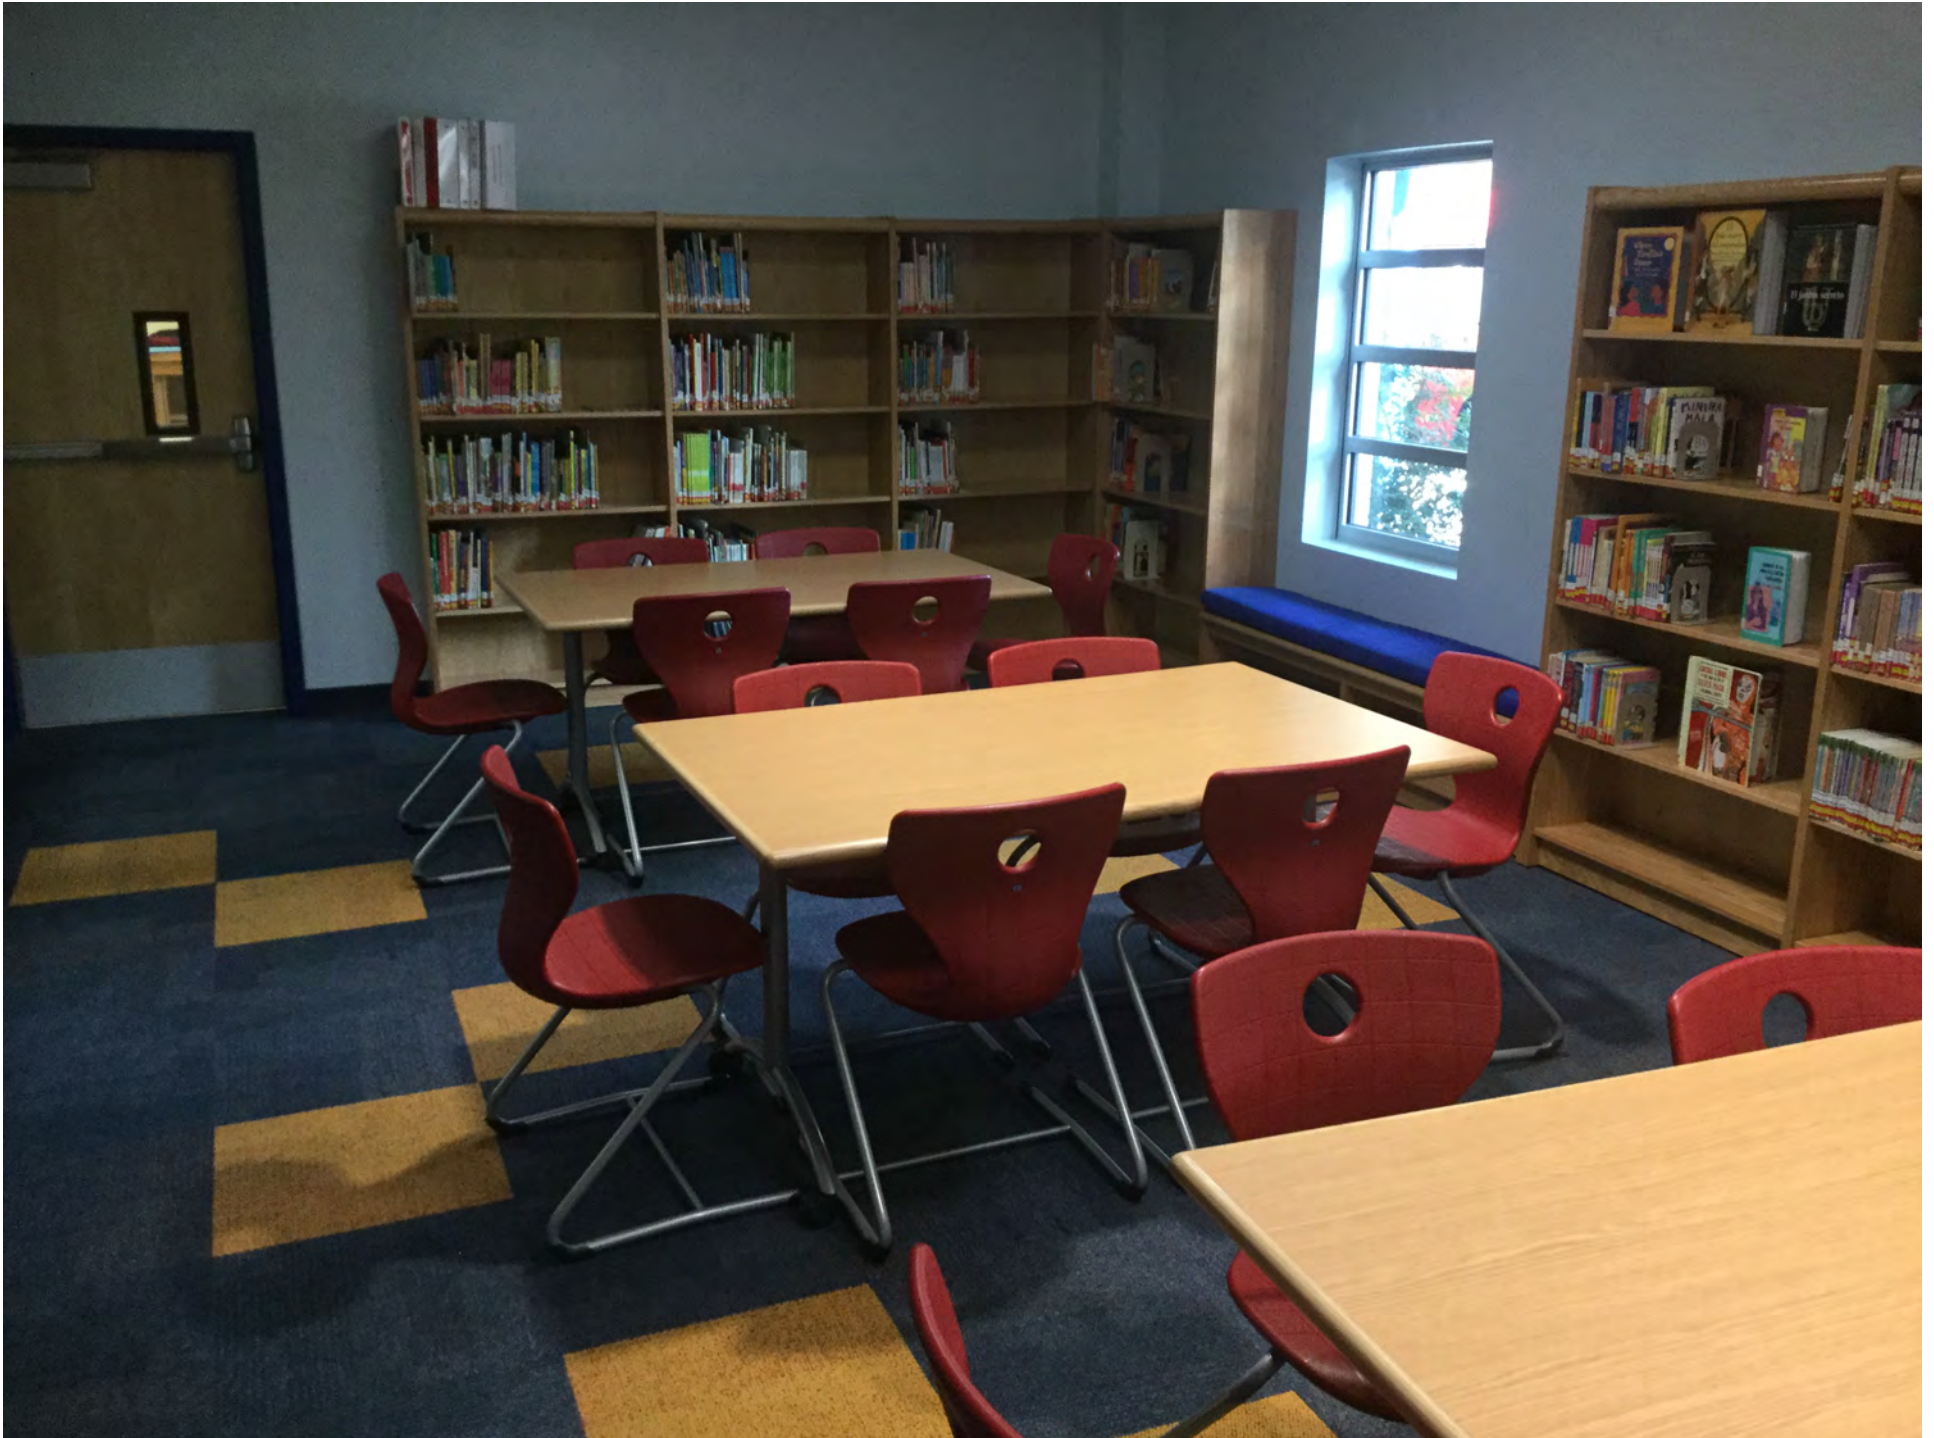
Photo 9. Library collaboration space

The library is located central to the building, but is far from the newest classrooms pod. In general, it is easily accessible to daily and nighttime users. Flexible furniture types offer different areas for collaboration and independent study. The reading amphitheater accommodates larger groups and was constructed after the community member the library is named after. Technologies are adequate, but not readily accessible as the remote computer lab is located on the opposite end of the building.

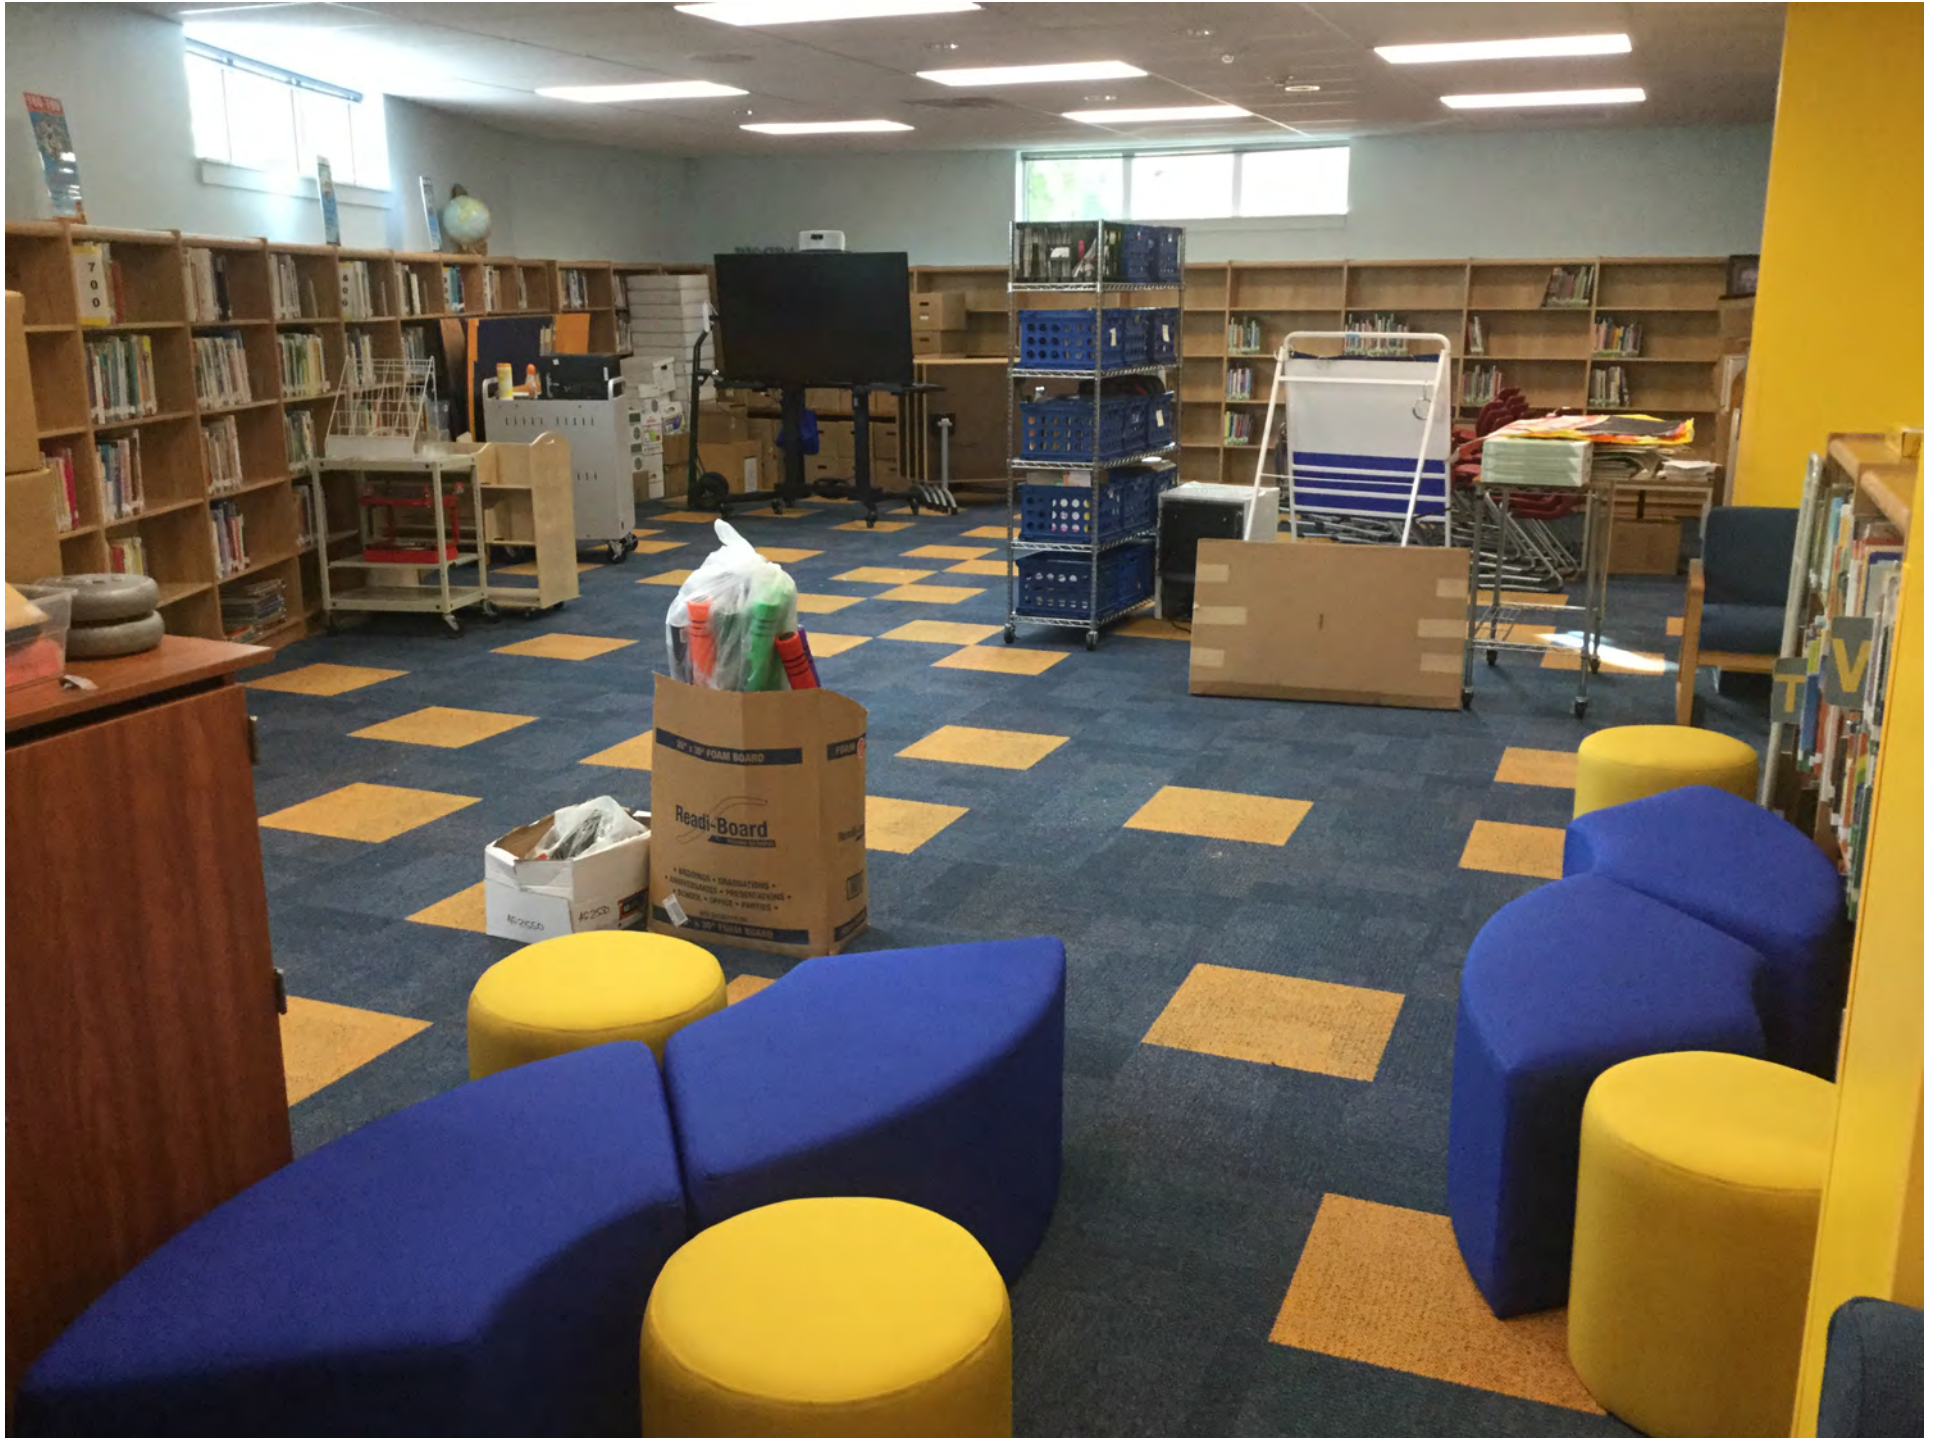
Photo 10. Library

1) Very unsatisfactory 2) Unsatisfactory 3) Average 4) Good 5) Very good N/A) Does not apply.								The library is newly renovated and recently opened.
