Educational Suitability Summary Report

Reilly Elementary School – BLDG # 132

Date: 7/20/2016

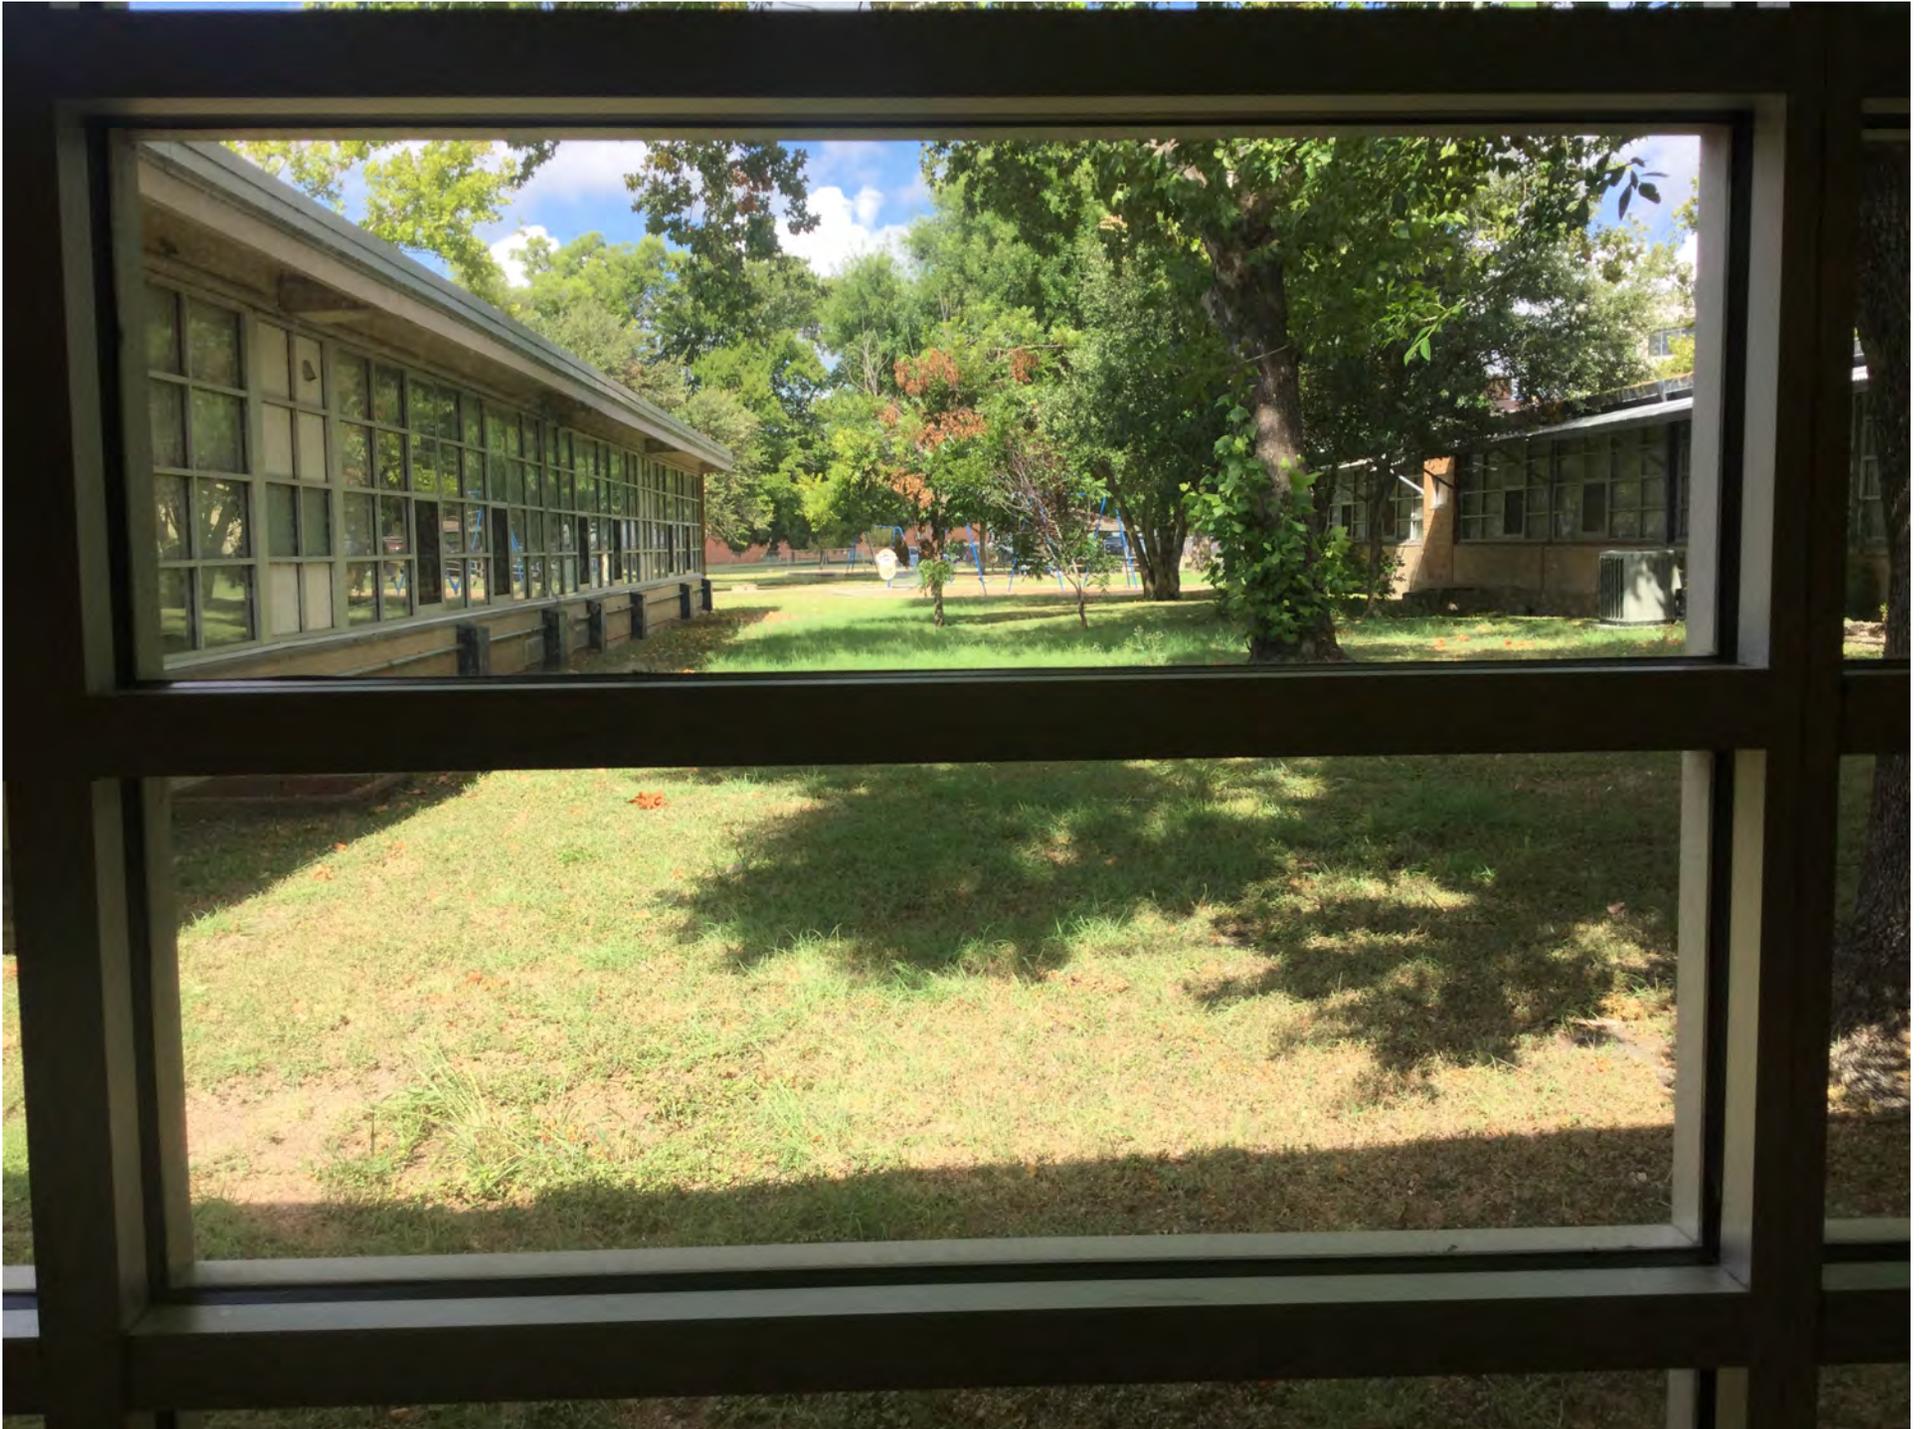
Photo 1. Garden

1.2	Are opportunities provided for outdoor learning (outdoor classrooms, gardens, etc.)?			3				Comments	1.00	3.00
1) Outdoor space exists is not developed 2)Outdoor space for learning exists but not connected to classroom learning areas. 3. Outdoor learning spaces exist and are accessible but not in good condition. 4. Outdoor learning spaces need minor improvements to function well. 5. Outdoor learning spaces are in excellent condition. N/A) Does not apply.		There is a large garden space that is poorly maintained but with various spaces to promote learning. The principal states that much of the school grounds are already scheduled for work through grant and community programs.								
		See Image 1

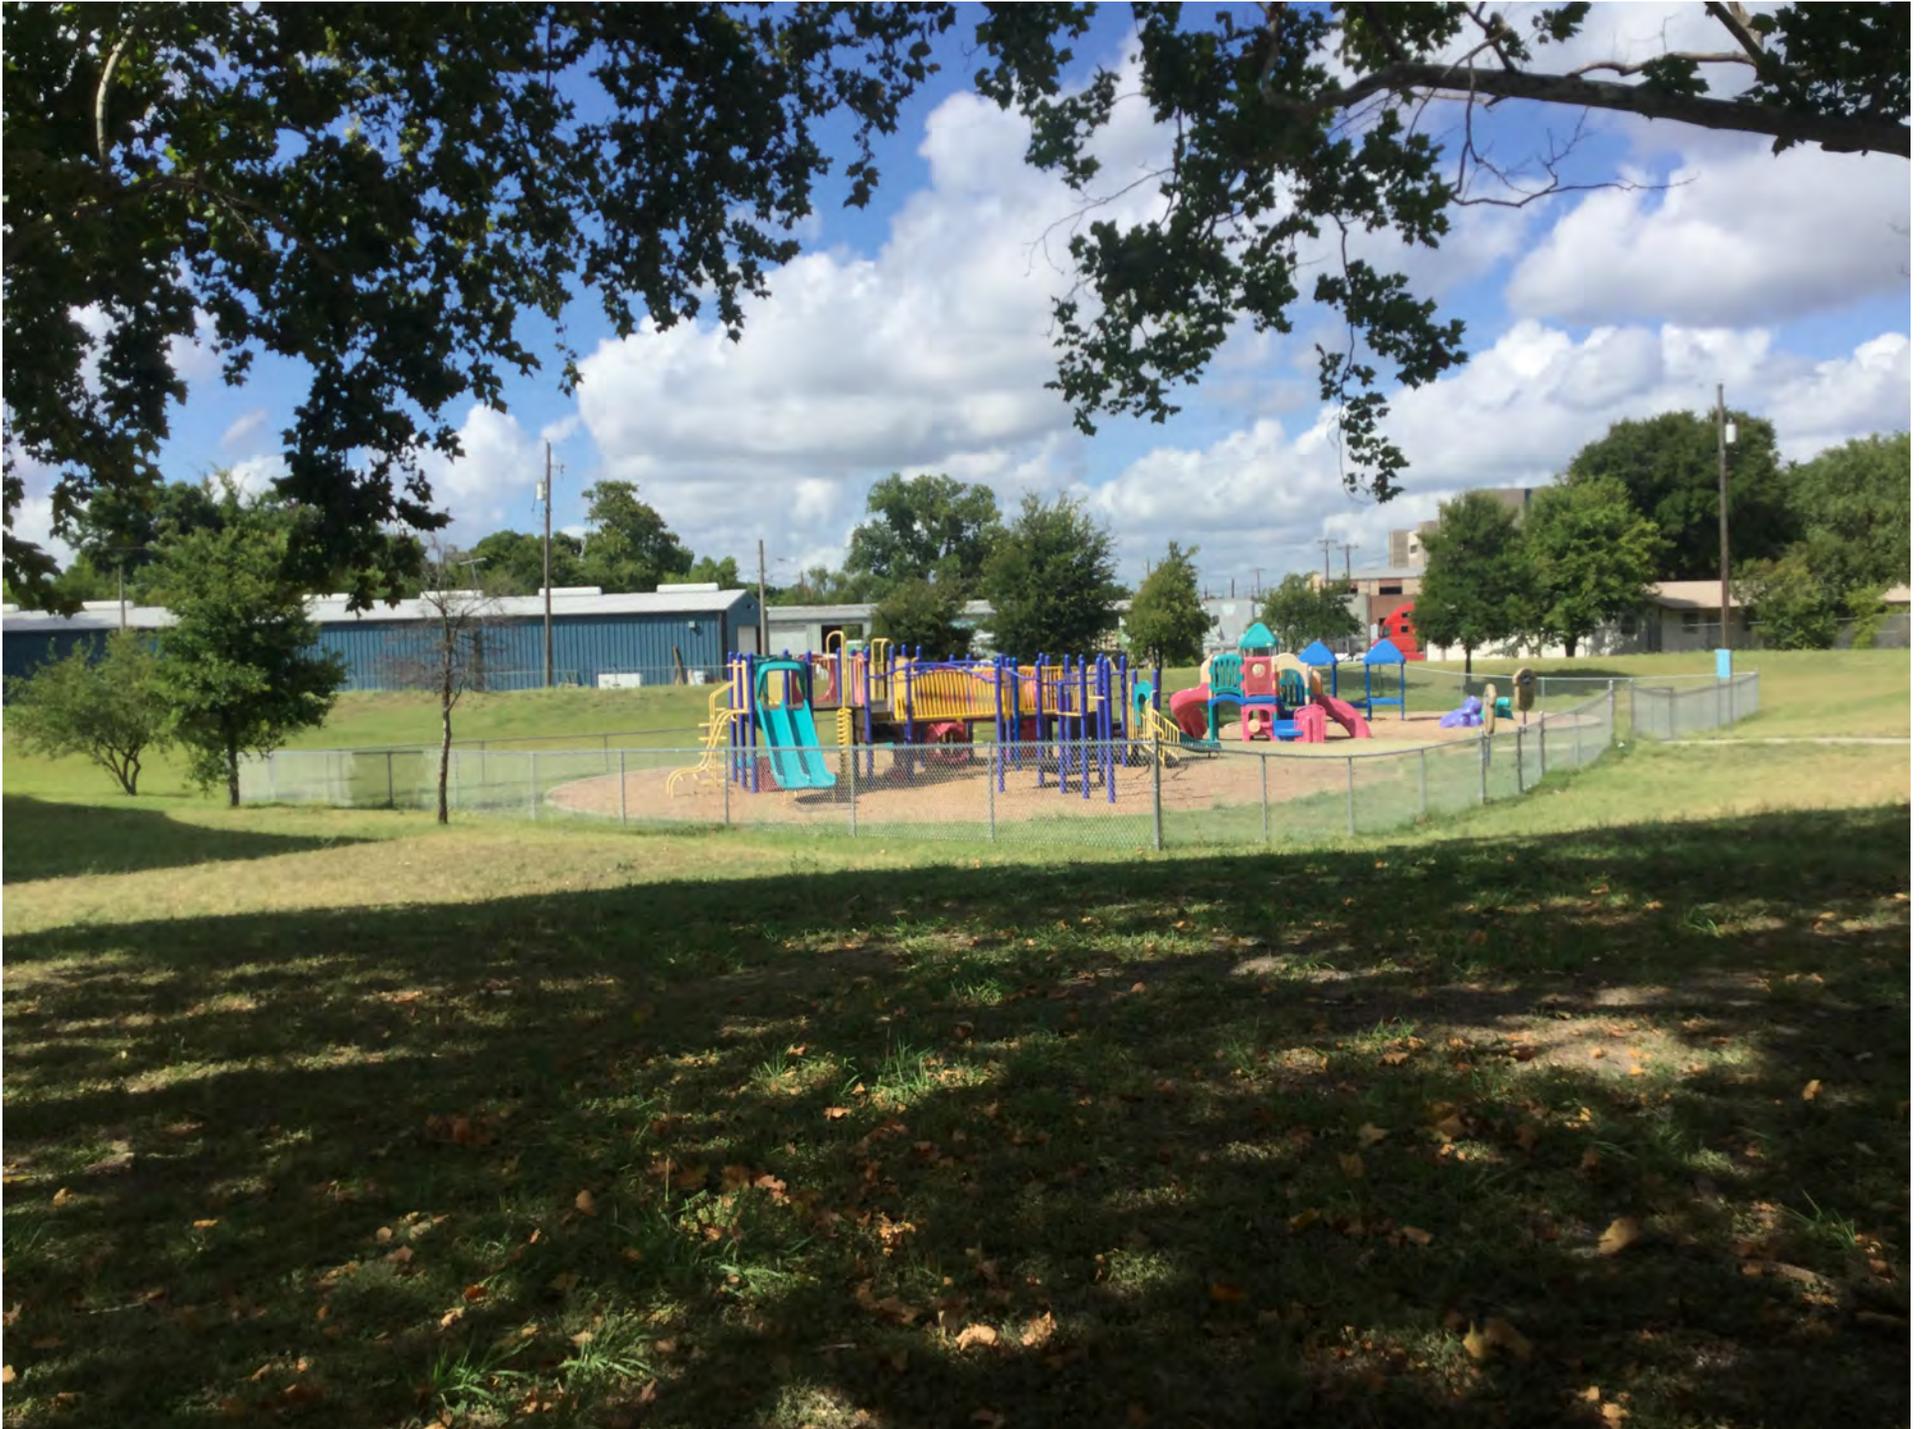
Photo 2. Play space

1.3	Are outdoor play spaces and playfields adequate in size and configuration?					5		Comments	1.00	5.00
1) Outdoor play space exists, not developed 2)Outdoor play space exists but is not connected to gym or other athletic support areas or is too small. 3. Outdoor play spaces exist, are connected to other athletic areas, are the right size, but are not in good condition. 4. Outdoor play spaces need minor improvements to function well. 5. Outdoor play spaces are in excellent condition. N/A) Does not apply.		The playground and track area doubles as a public park.								
		See image 2

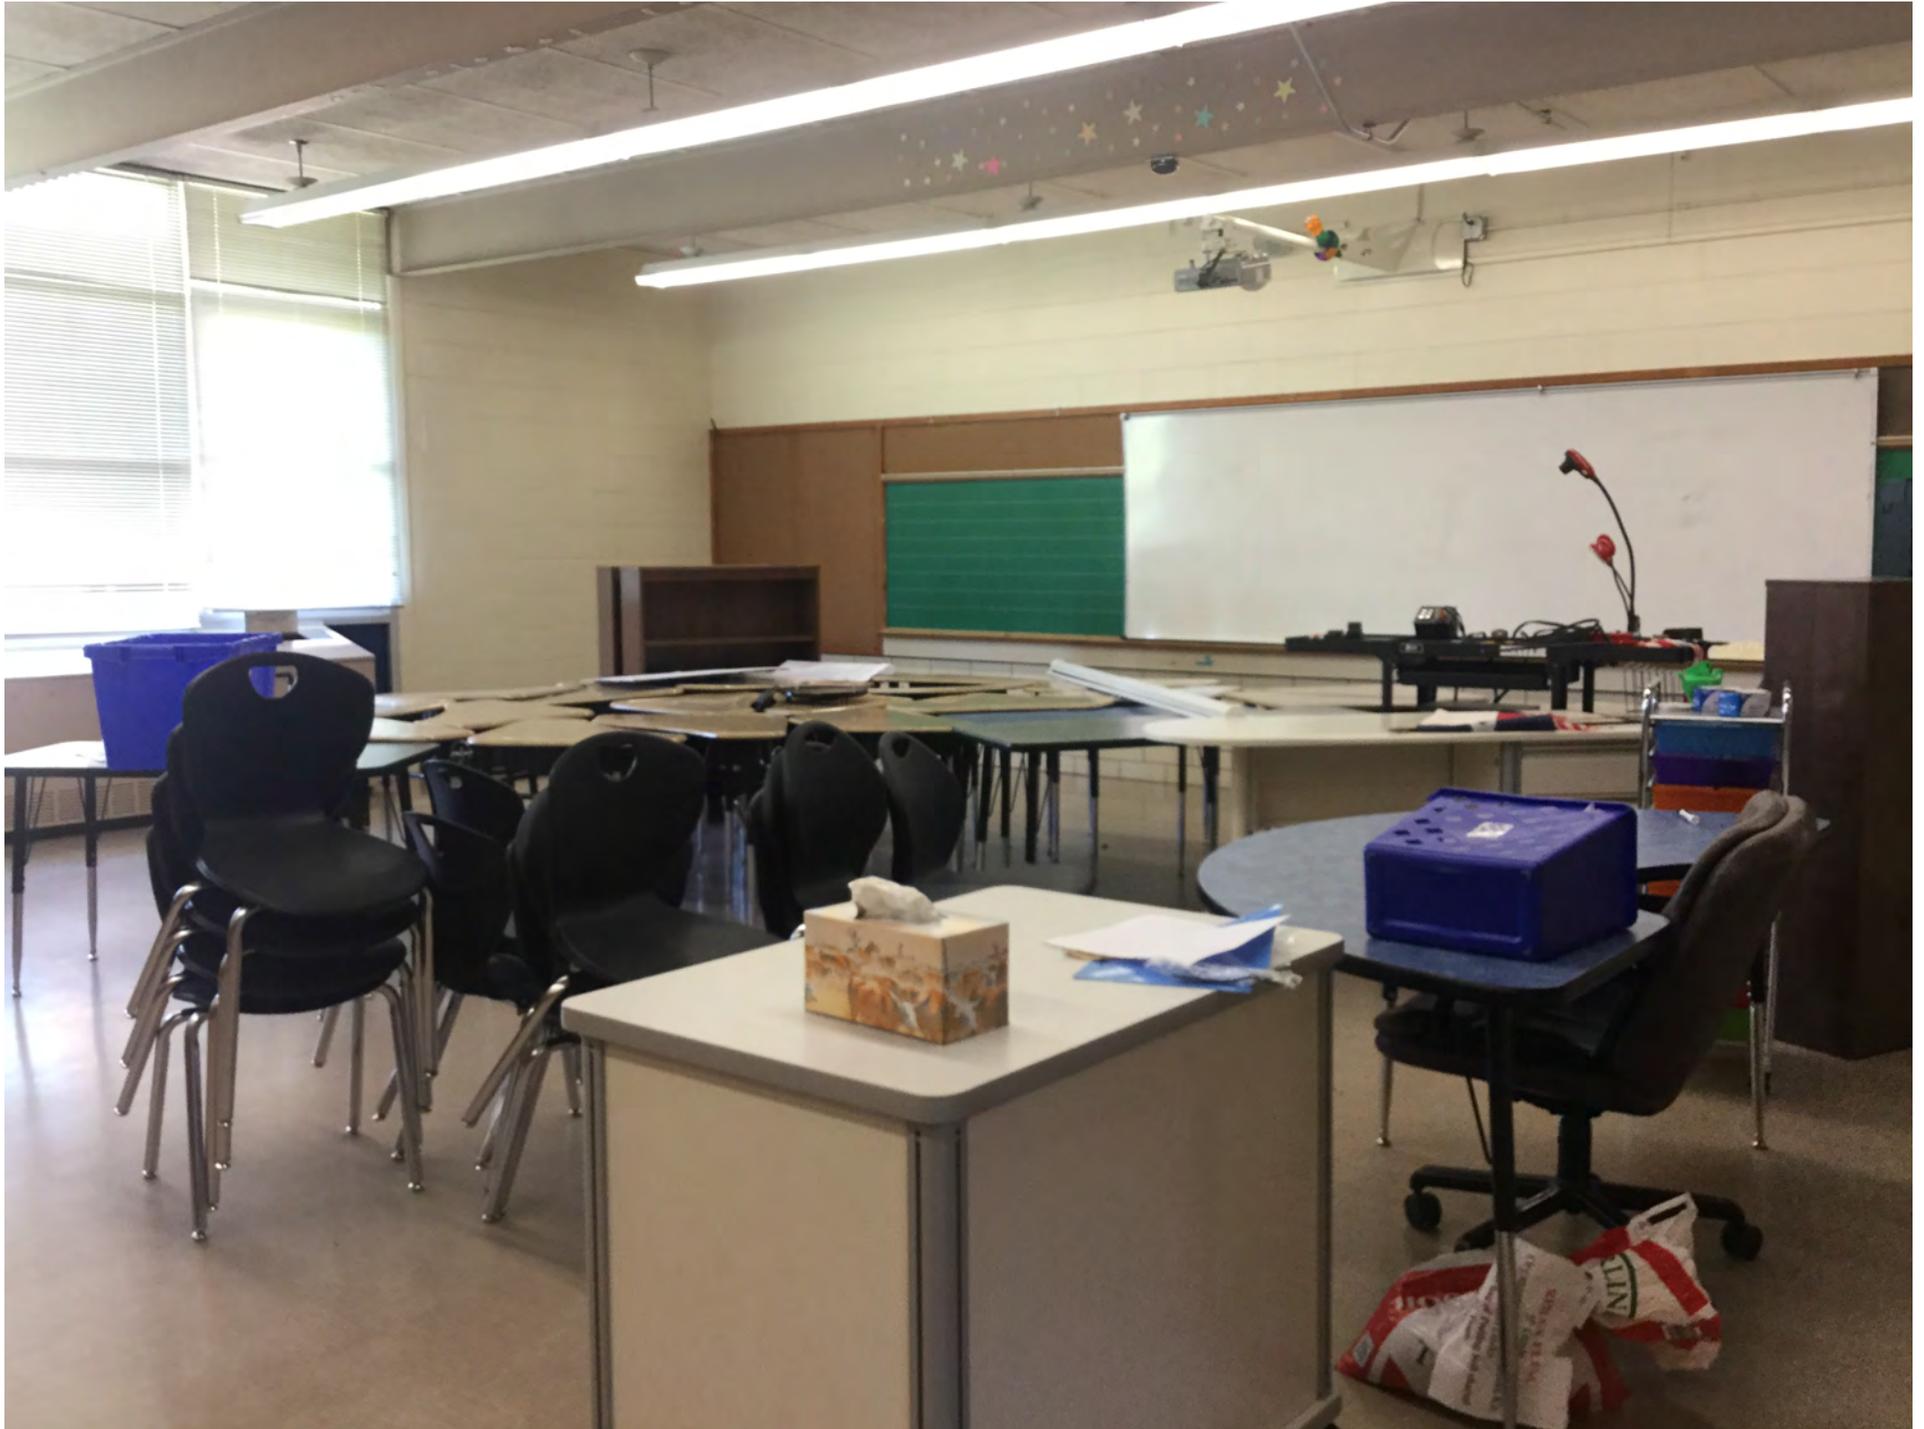
Photo 3. Classroom

1) Very unsatisfactory - Too small, awkward layout, does not meet needs 2) Unsatisfactory - Too small, only one area for all teaching methods, limited flexibility 3) Neutral - Moderate size, two areas for different teaching methods, some flexibility, access to student storage/casework 4) Satisfactory - Good size, at least two zones for different teaching methods, flexibility and student storage, not new 5) Very Satisfactory - Good size, two zones for different teaching methods, flexibility and student storage/casework, adequate display area and visual teaching tools N/A) Does not apply.				The classrooms are of adequate size as the school is under enrolled.						
See image 3

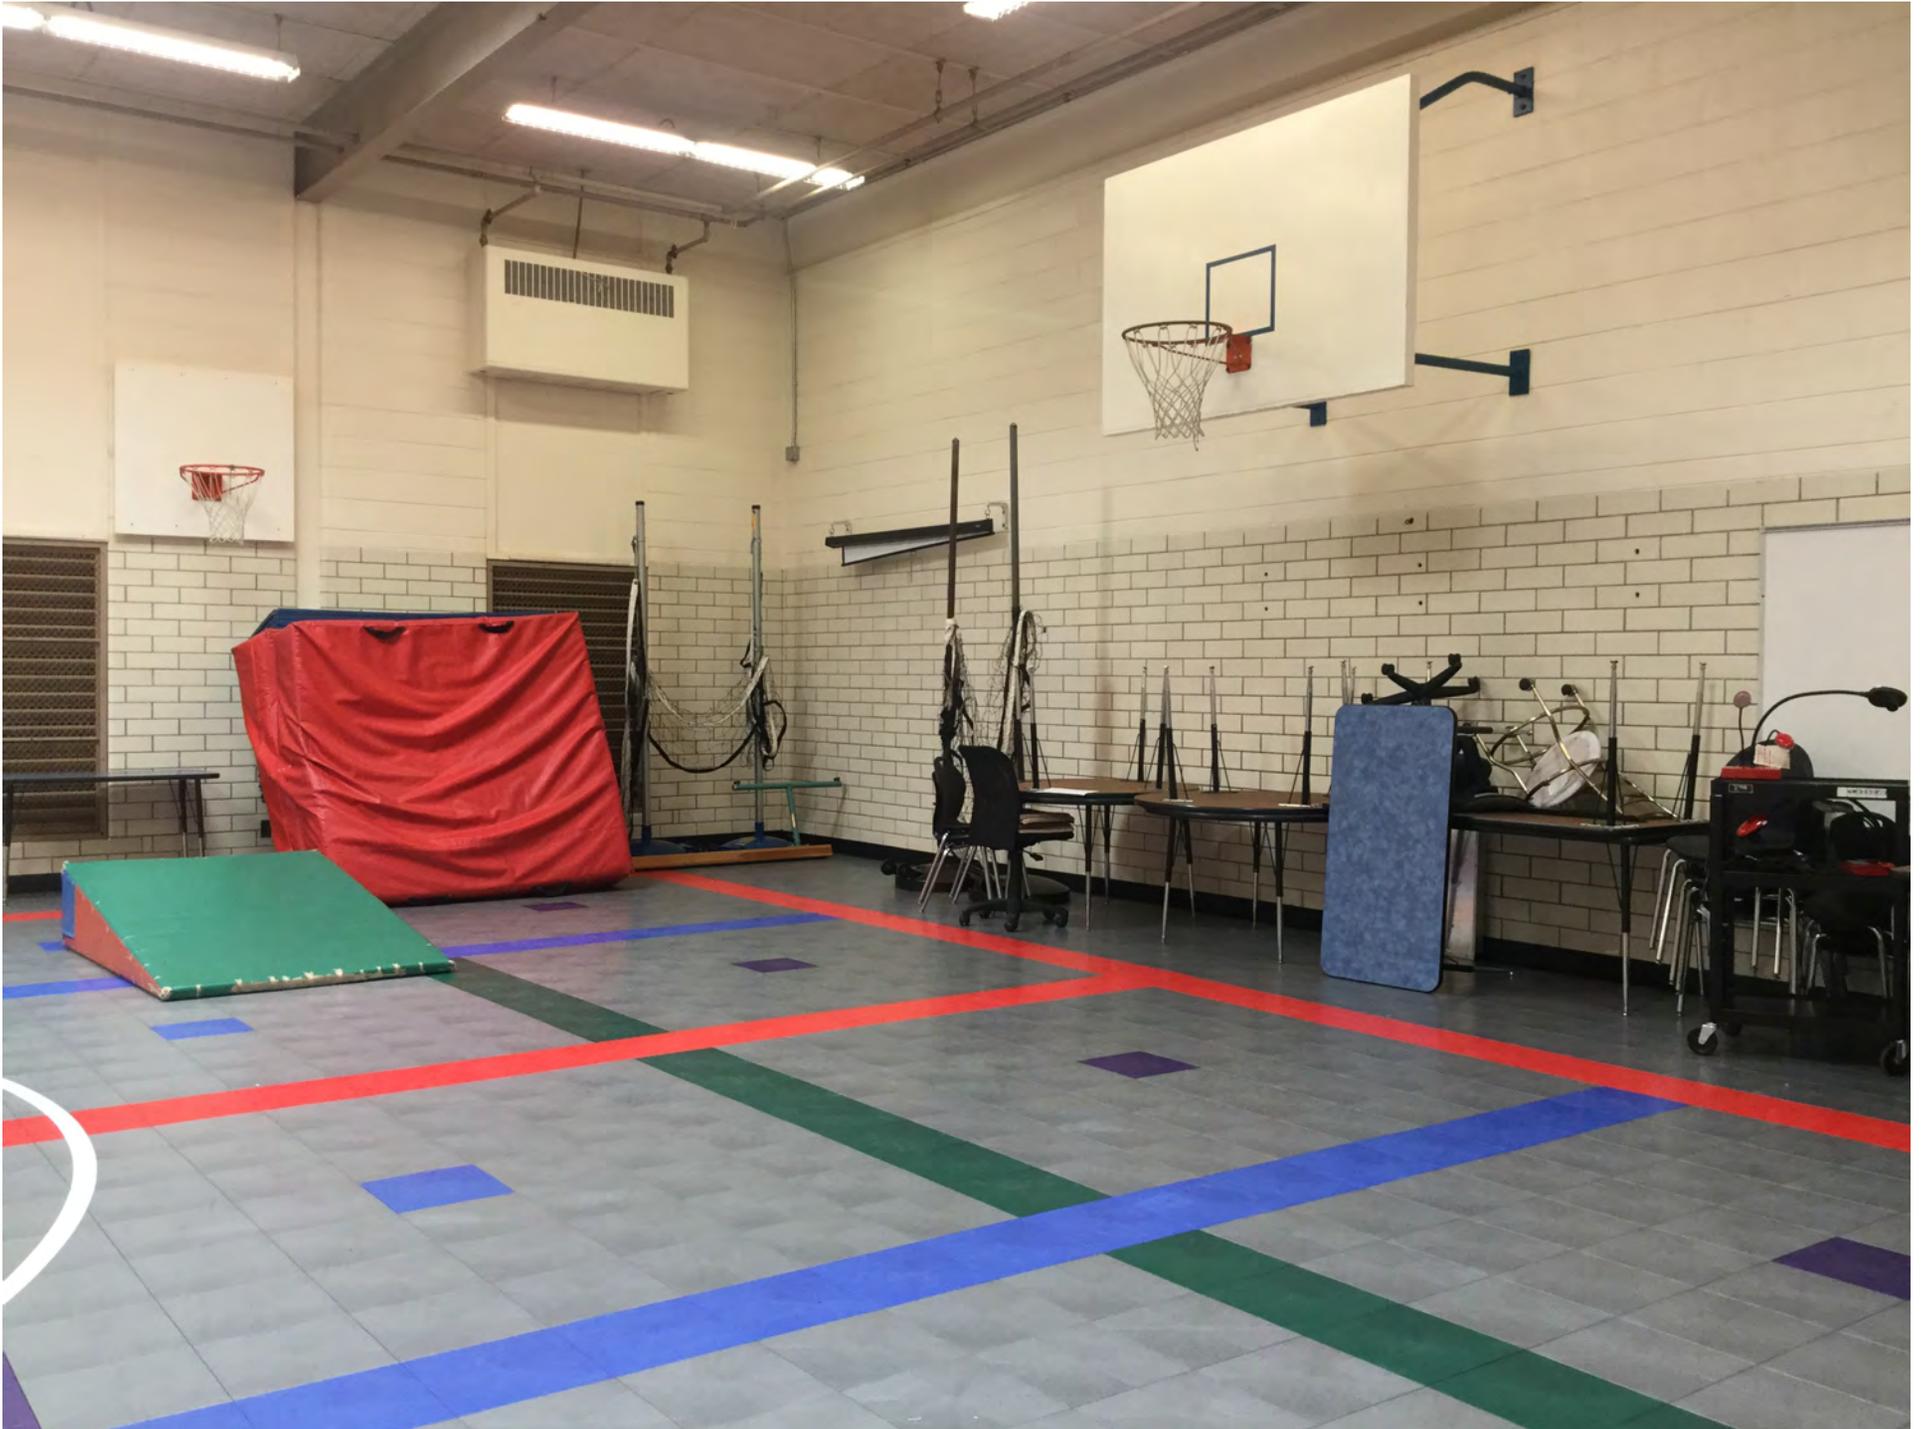
Photo 4. Gymnasium

1) Very unsatisfactory 2) Unsatisfactory 3) Average 4) Good 5) Very good N/A) Does not apply.								The gymnasium is adequate and provides limited natural light.	See image 4

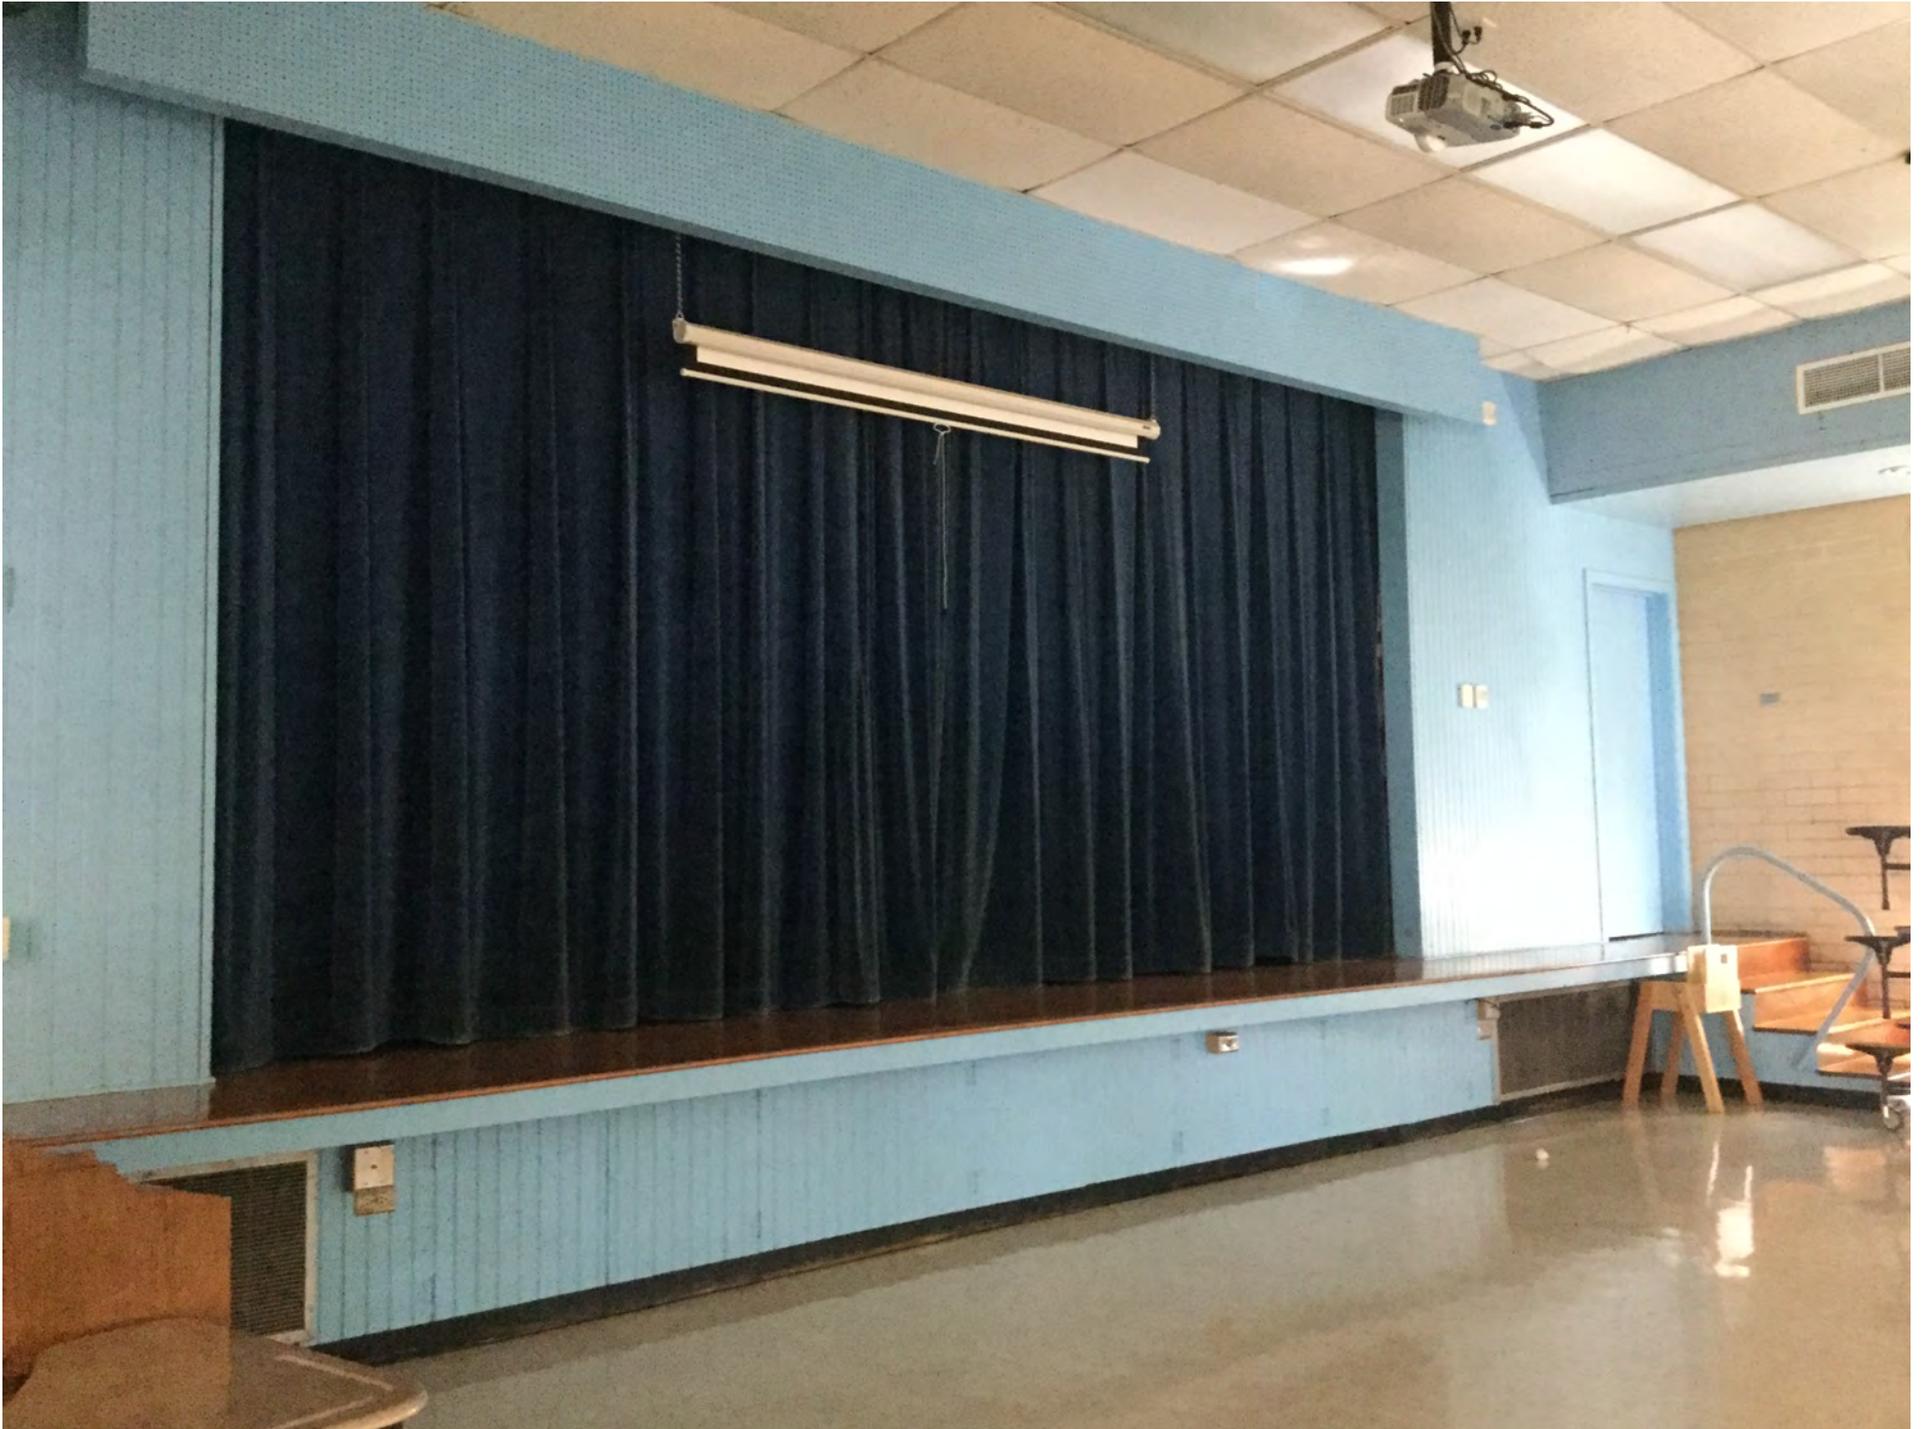
Photo 5. Stage

3.8	Are music, drama, or performance spaces appropriately configured per the ed spec?				4			Comments	1.00 4.00
1) Very unsatisfactory 2) Unsatisfactory 3) Average 4) Good 5) Very good N/A) Does not apply.								The cafetorium is adequate given the student population.	See image 5

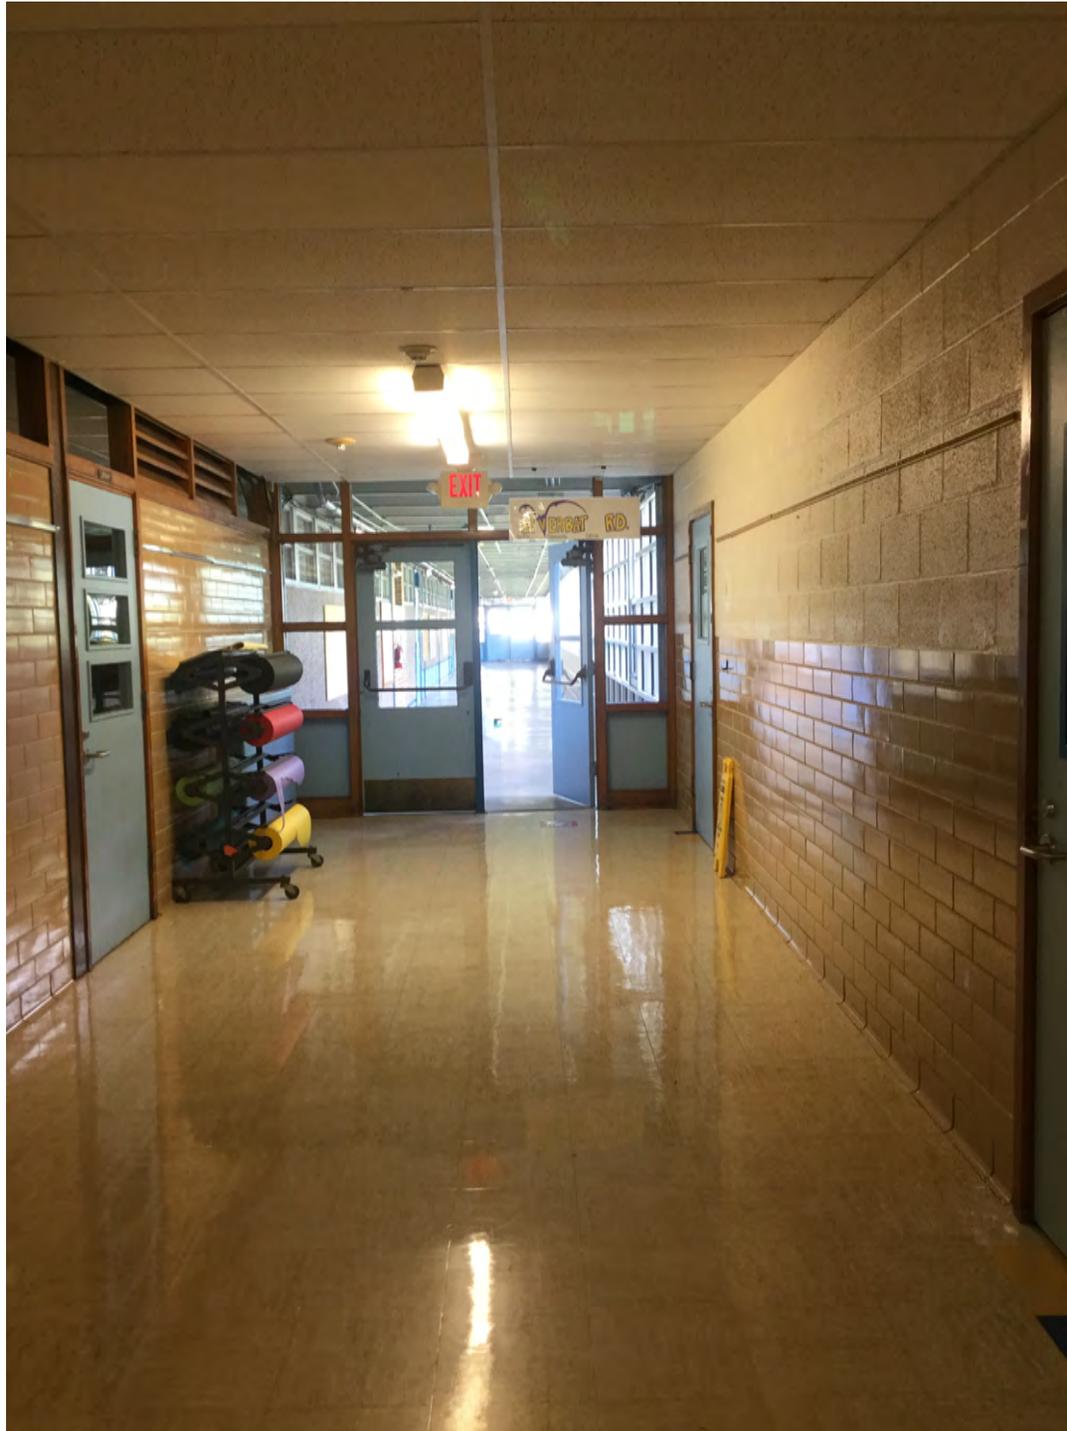
Photo 6. Hallway

1) Very unsatisfactory - No project space 2) Unsatisfactory - Non-dedicated, undersized or otherwise inadequate 3) Average - Limited dedicated spaces of moderate size and layout, equipment and furniture appropriate but need updates 4) Good - Dedicated spaces of adequate size and layout, most of the equipment and furniture is appropriate for program 5) Very good - Dedicated spaces of adequate size and layout, equipment and furniture appropriate for program N/A) Does not apply.								The corridors are not easily monitored from the classrooms.	See image 6

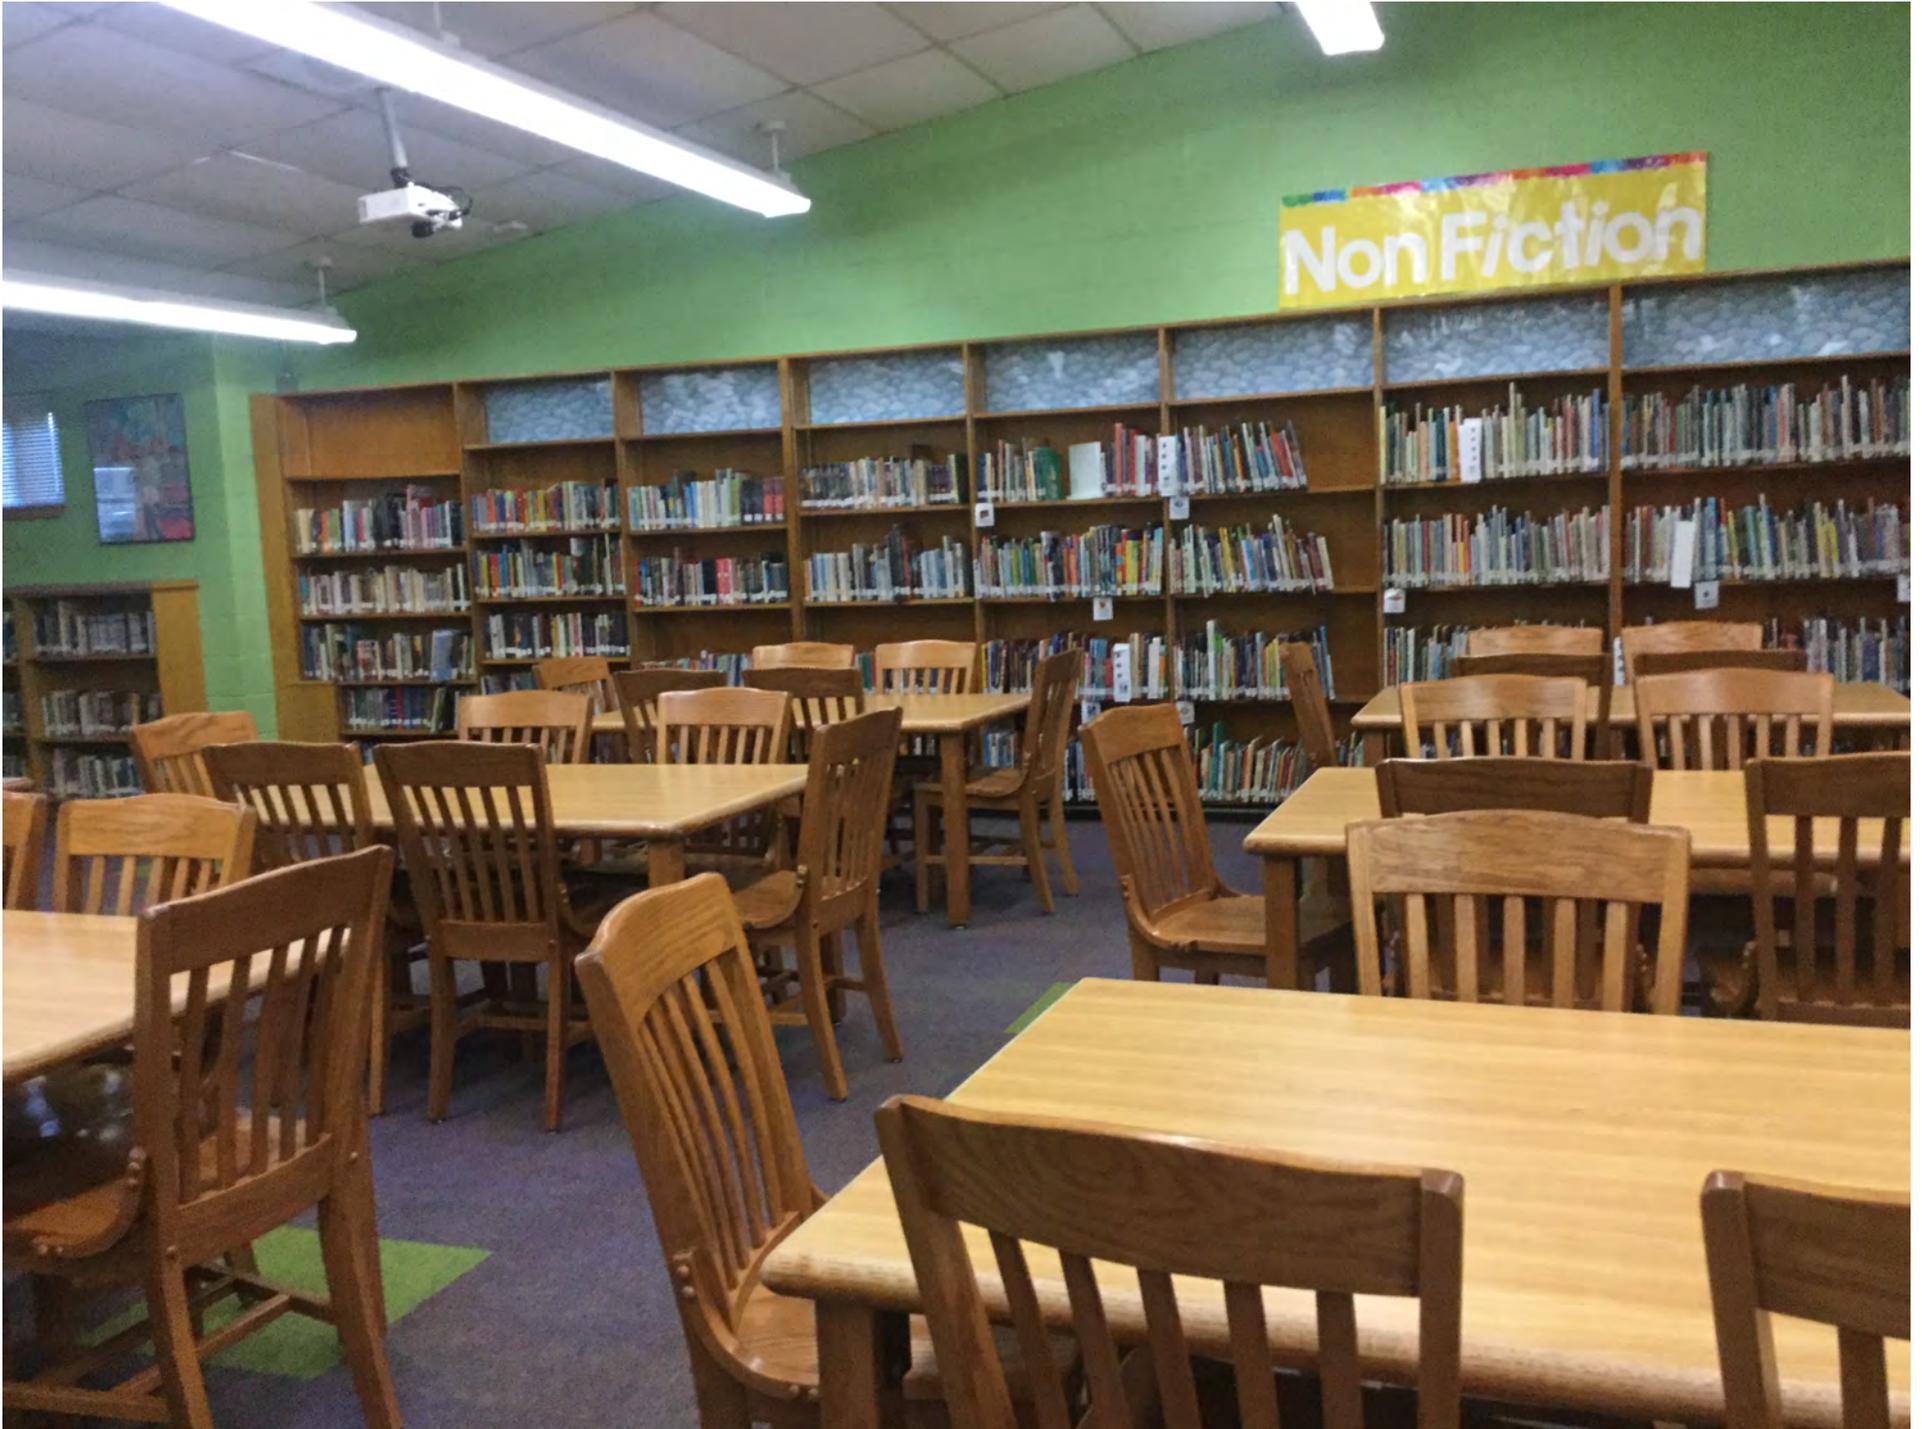
Photo 7. Library

The library has an adequate amount of space for collaborative work of different group sizes, but is not well suited for social interaction. The technologies housed in the library are unsatisfactory in both quantity and quality. The furniture is generally inflexible and does not support larger groups (10-25 people). The principal notes that they would like to remove the carpet and install a tile that is easier to maintain and will not hold odors.

5.3	How well does the Library/Media Center support social interaction?		2					Comments	1.00	2.00
1) Very unsatisfactory 2) Unsatisfactory 3) Average 4) Good 5) Very good N/A) Does not apply.								The furniture is not flexible enough and the library carpet has an odor.		
								See image 7

Final comments made involved replacing the old, odor filled carpet in the library with tile, which can be more easily maintained.

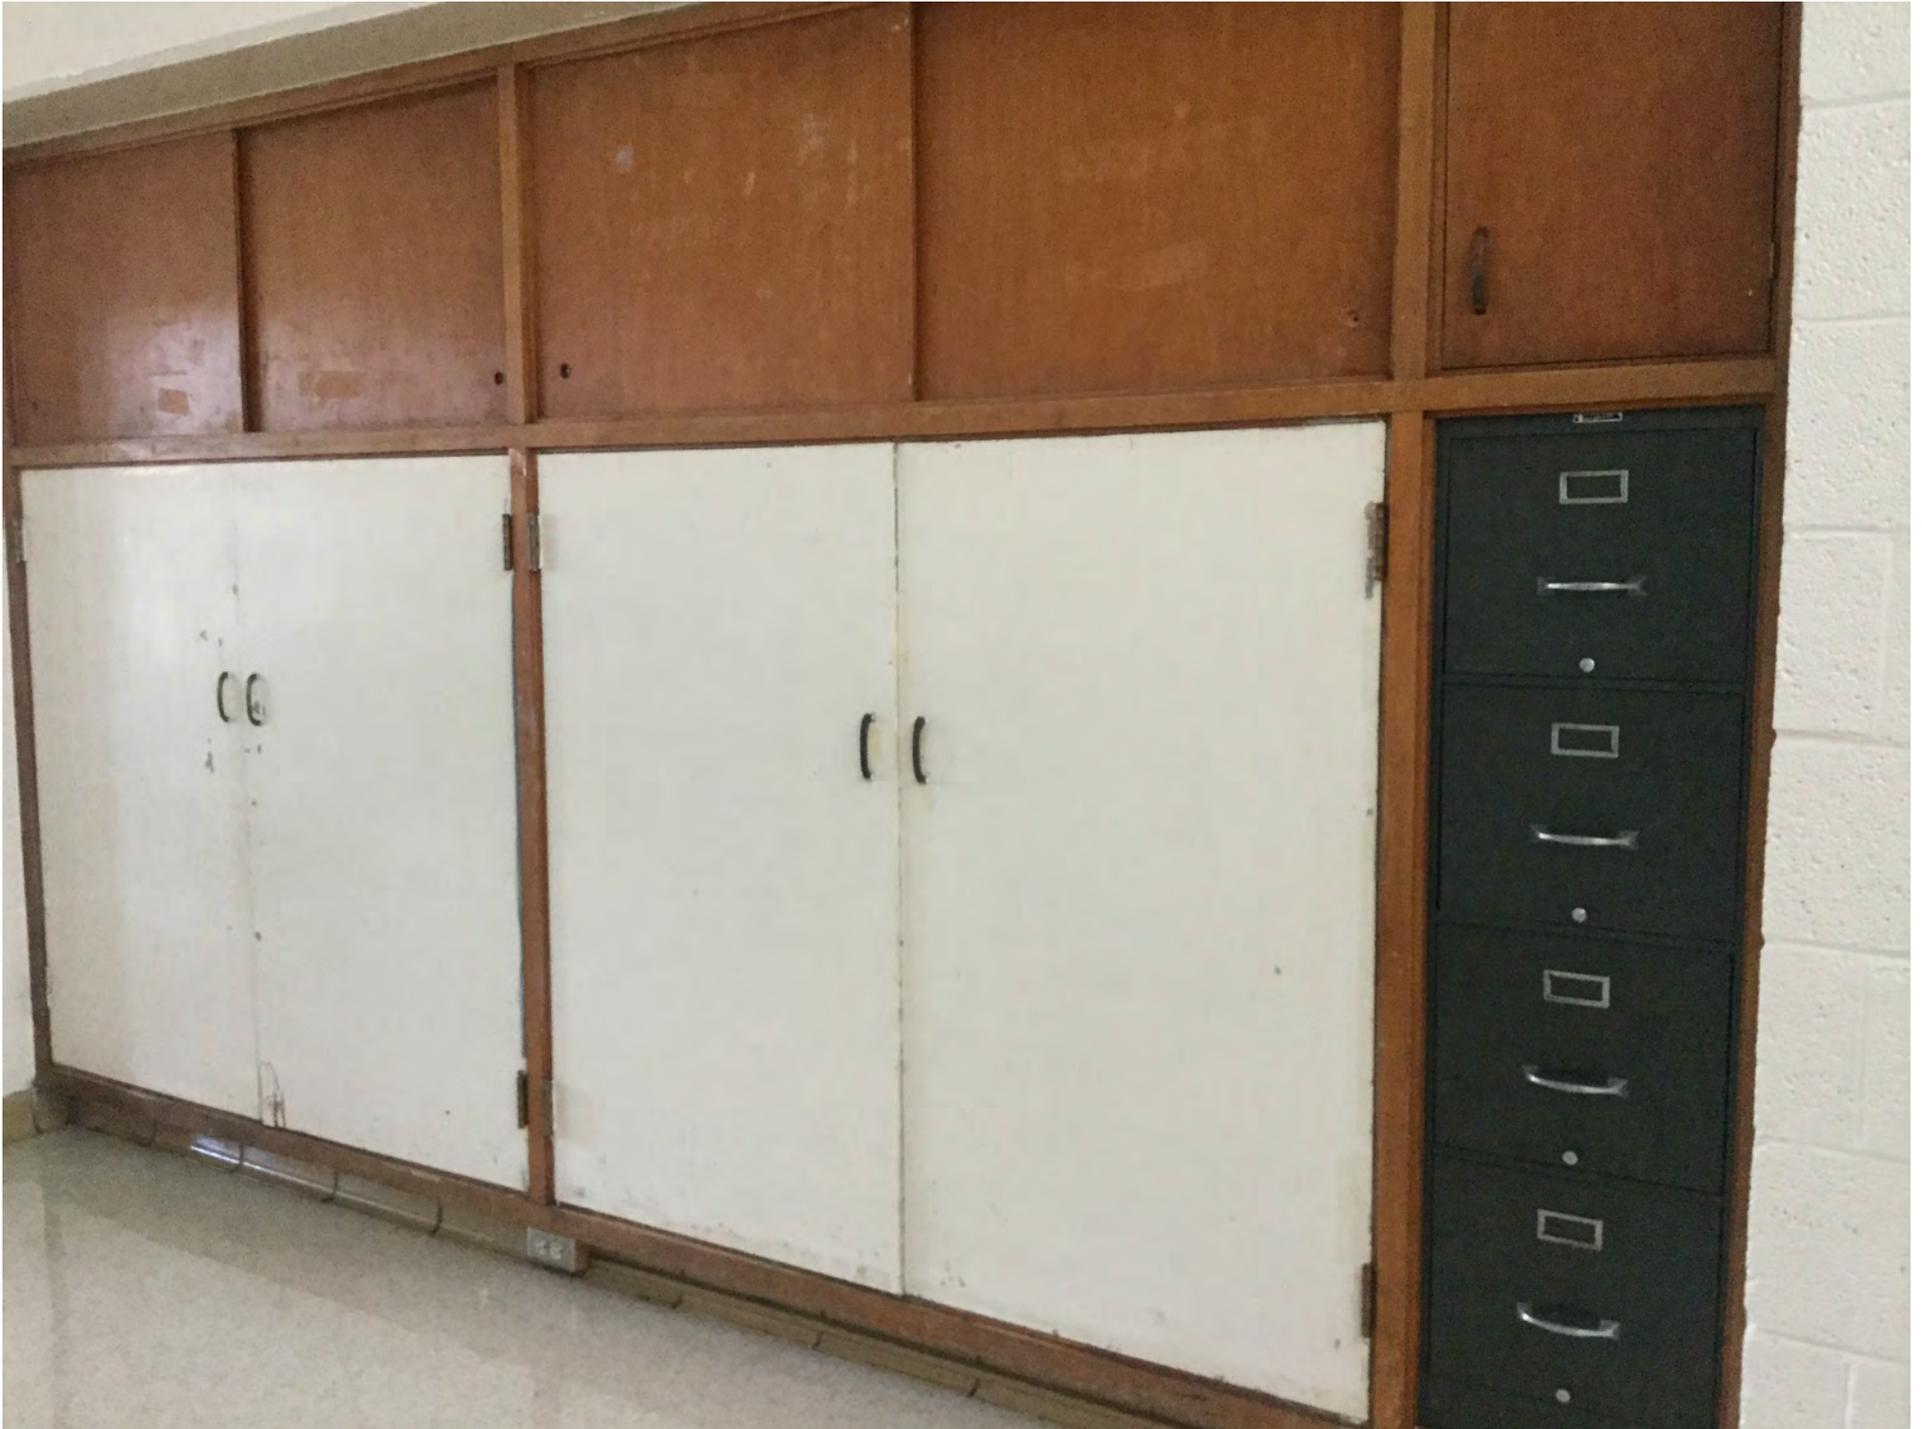
Photo 8. Storage

8 - Storage		1	2	3	4	5	N/A			14.00
8.1	Is there adequate general storage in the building?				4			Comments	1.00	4.00
1) Very unsatisfactory 2) Unsatisfactory 3) Average 4) Good 5) Very good N/A) Does not apply.								The storage is not an issue as the school is highly under enrolled. The storage is kept in casework that is very old.		
								See image 8		
8.2	Is there adequate classroom storage?					5		Comments	1.00	5.00
1) Very unsatisfactory 2) Unsatisfactory 3) Average 4) Good 5) Very good N/A) Does not apply.								The casework is very old.		
8.3	Is there adequate student storage?					5		Comments	1.00	5.00
1) Very unsatisfactory 2) Unsatisfactory 3) Average 4) Good 5) Very good N/A) Does not apply.								The casework is very old.
