## Educational Suitability Summary Report

Ridgetop Elementary School – BLDG #133

Date: 8/11/2016 (Rev 1 – 11/8/16 – Added Survey Responses)

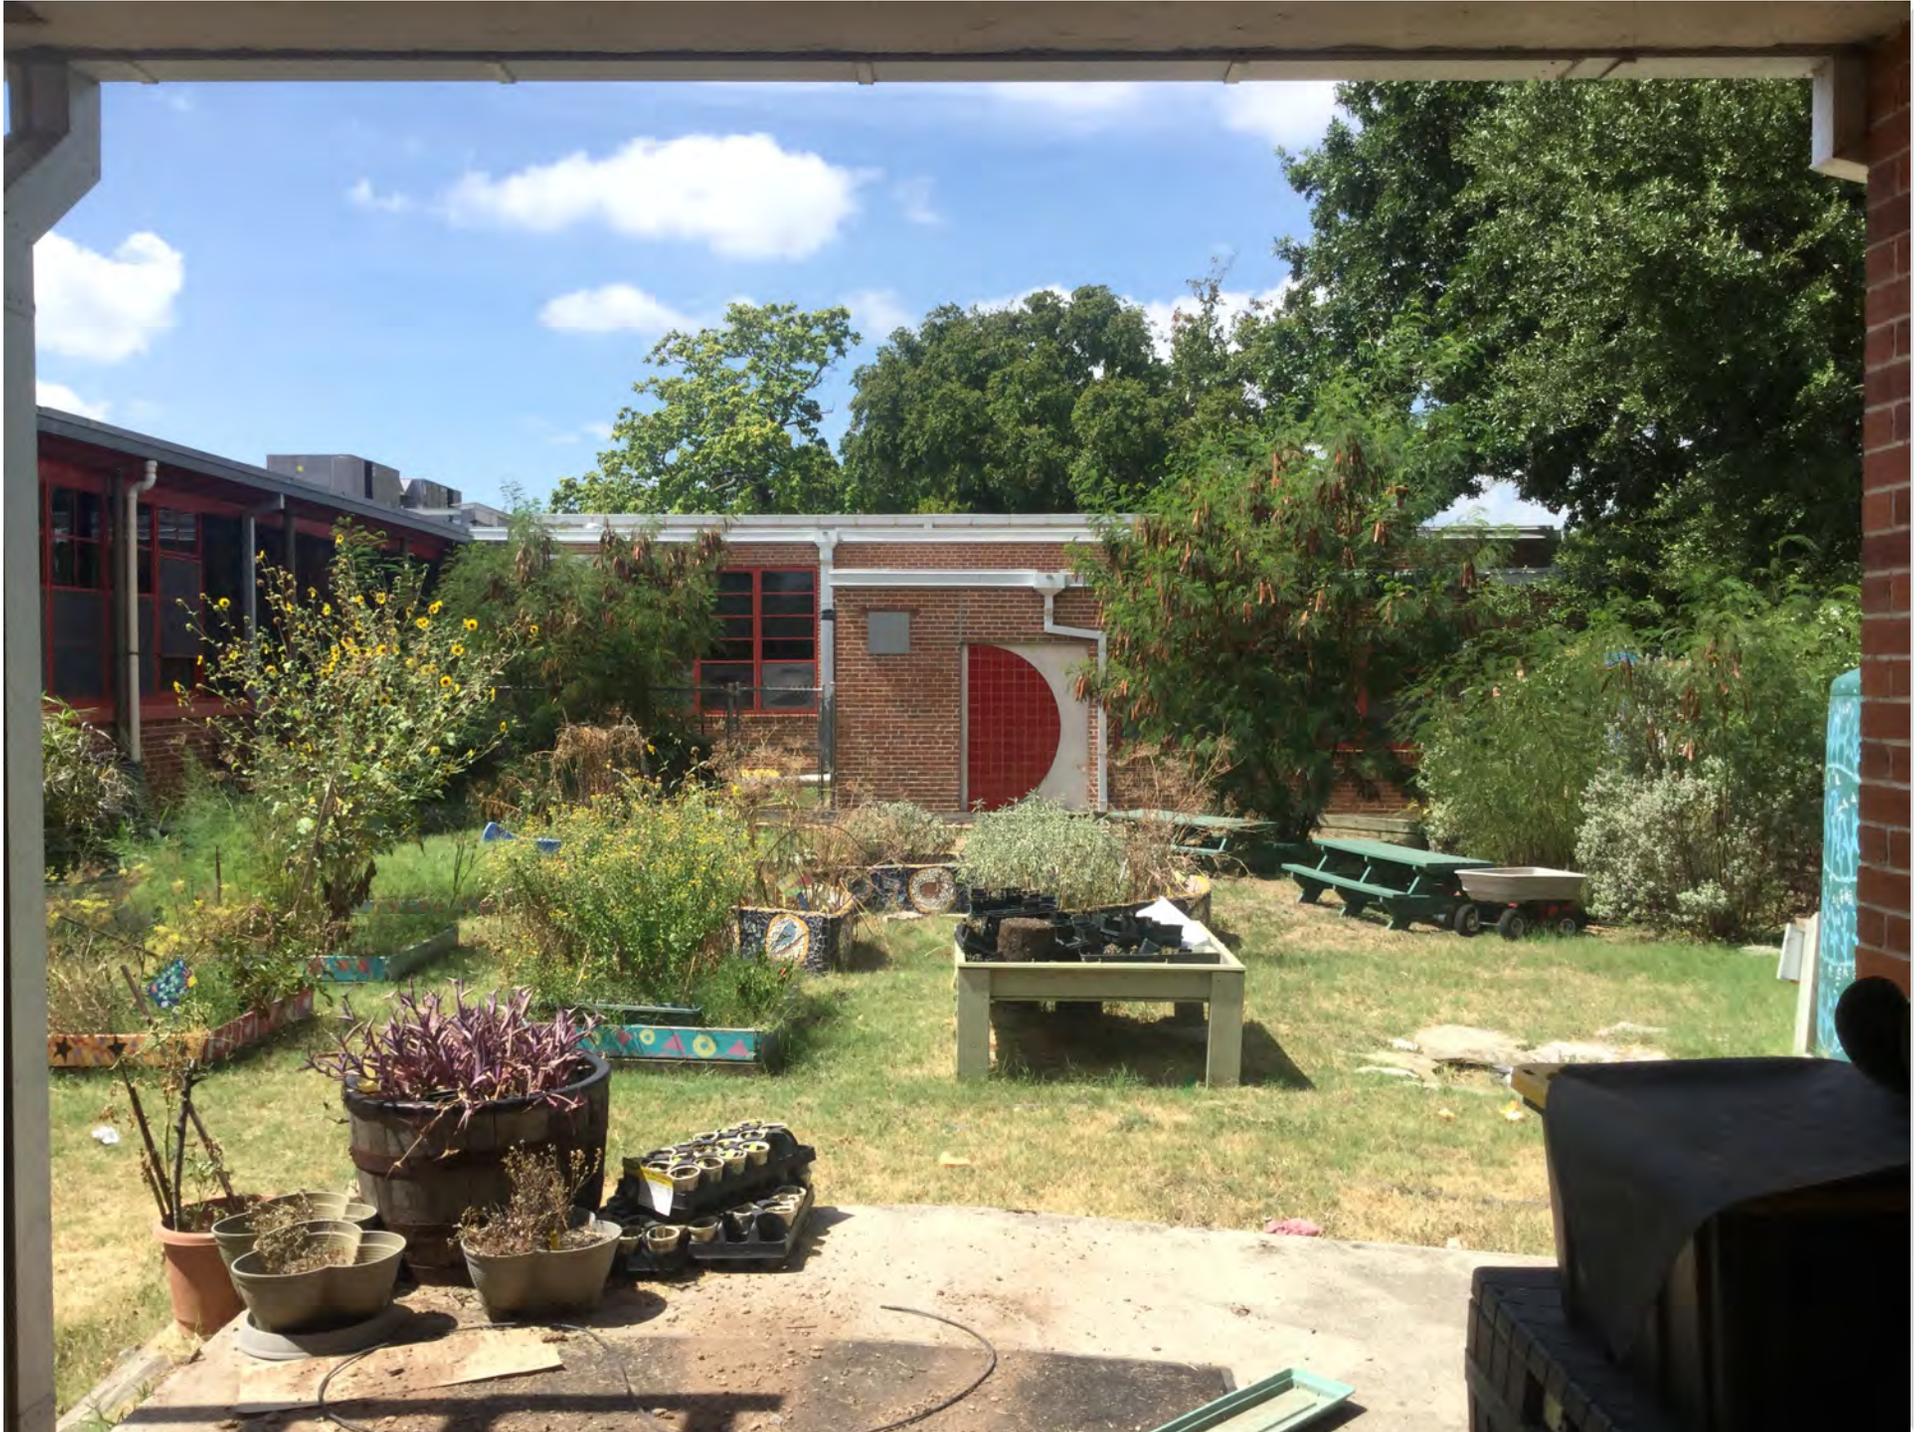
Photo 1. Garden Space

1.2	Are opportunities provided for outdoor learning (outdoor classrooms, gardens, etc.)?			3				Comments	1.00	3.00
1) Outdoor space exists is not developed 2)Outdoor space for learning exists but not connected to classroom learning areas. 3. Outdoor learning spaces exist and are accessible but not in good condition. 4. Outdoor learning spaces need minor improvements to function well. 5. Outdoor learning spaces are in excellent condition. N/A) Does not apply.										
		see photo 1

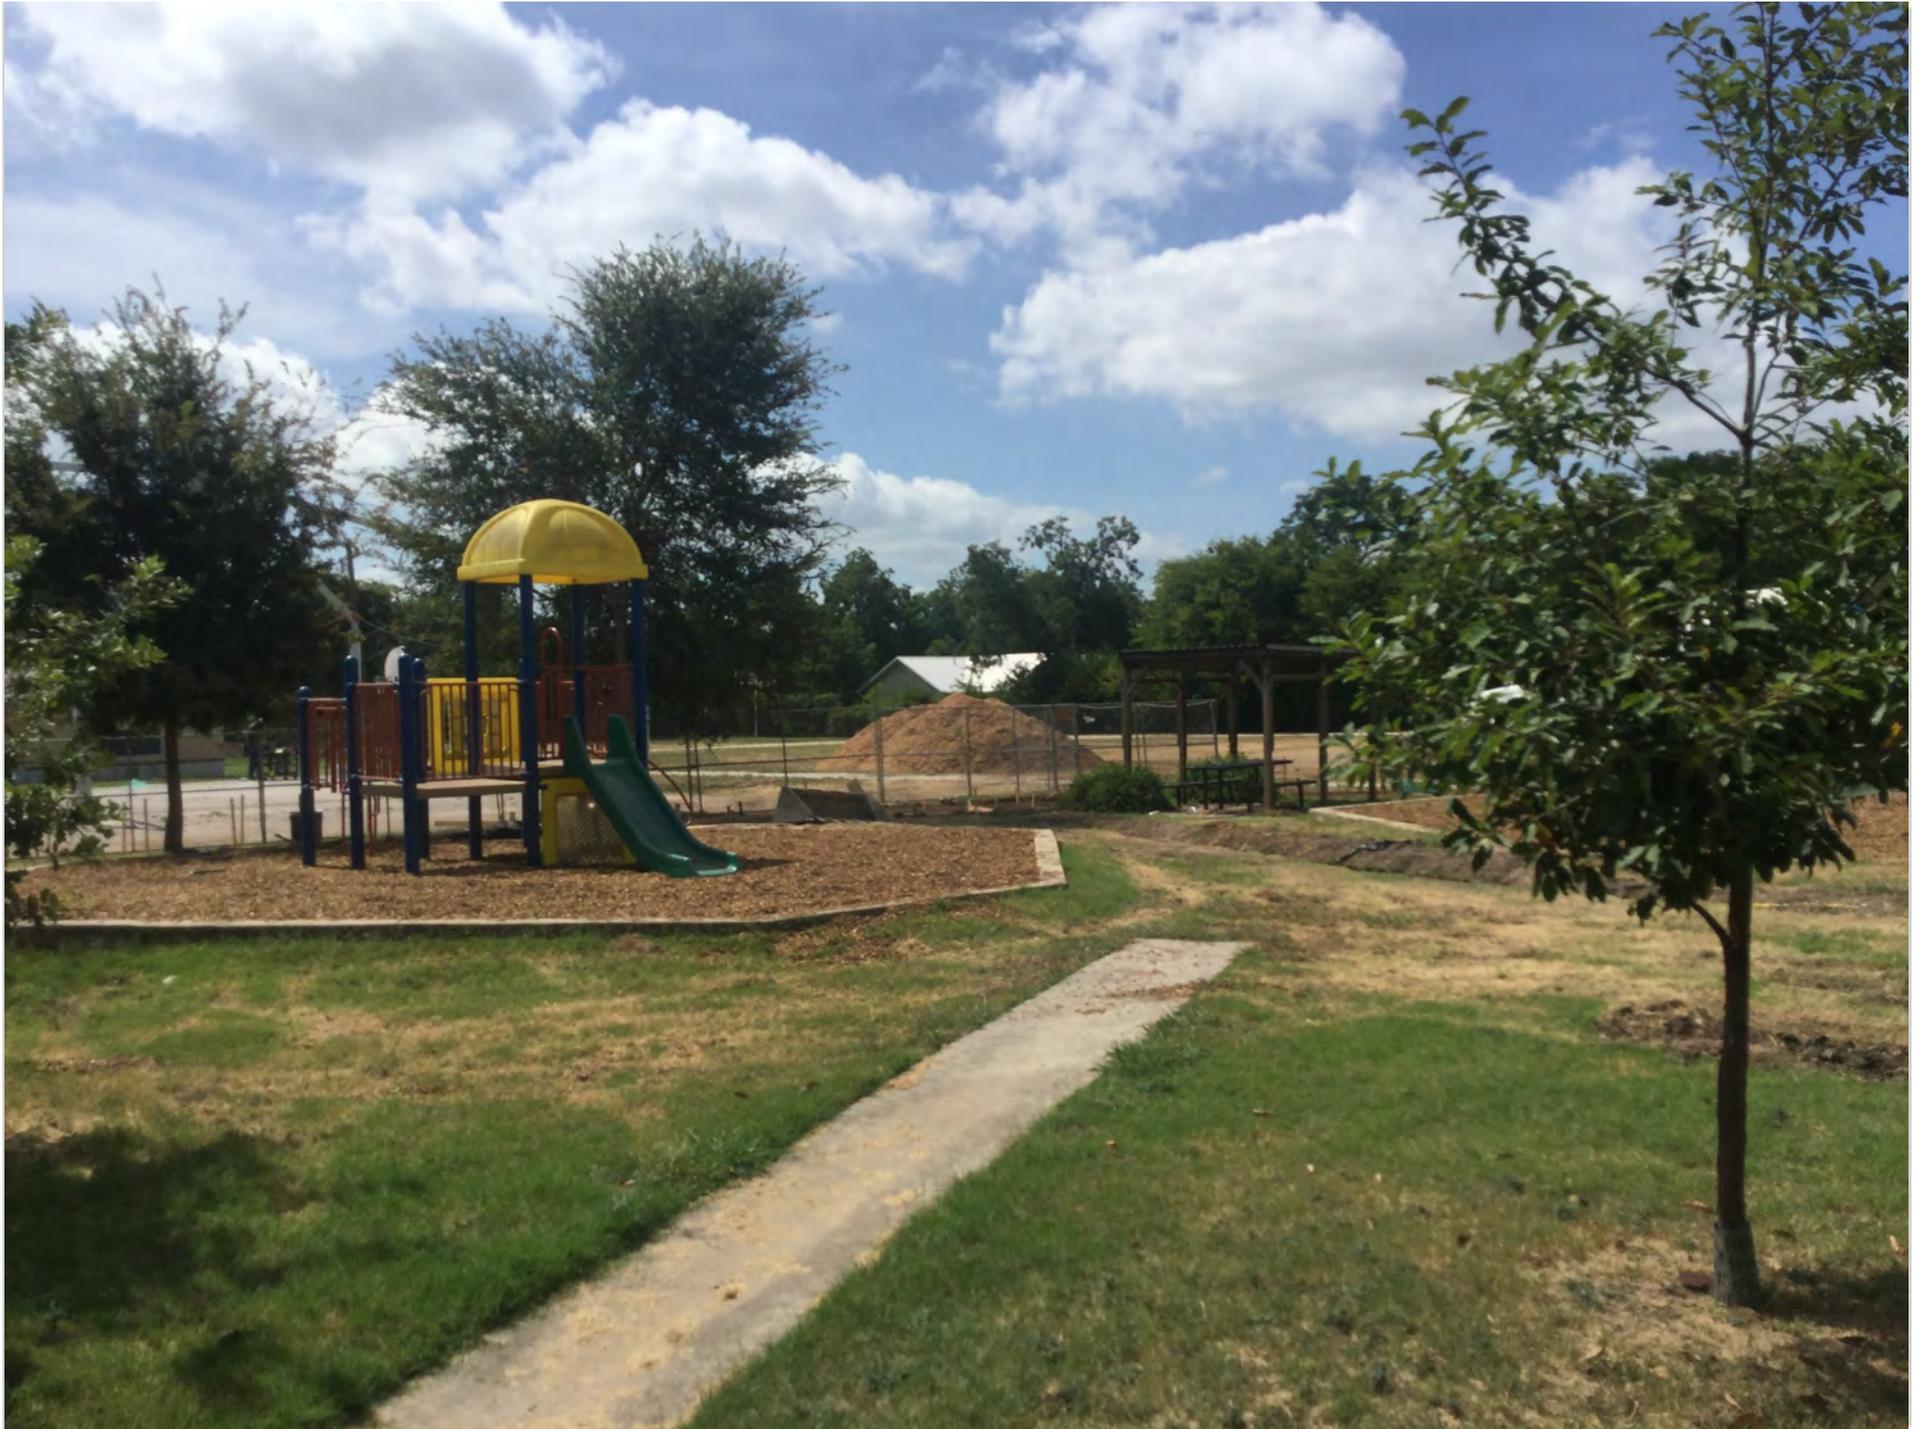
Photo 2. Outdoor Space

1.3	Are outdoor play spaces and playfields adequate in size and configuration?				4			Comments	1.00	4.00
1) Outdoor play space exists, not developed 2)Outdoor play space exists but is not connected to gym or other athletic support areas or is too small. 3. Outdoor play spaces exist, are connected to other athletic areas, are the right size, but are not in good condition. 4. Outdoor play spaces need minor improvements to function well. 5. Outdoor play spaces are in excellent condition. N/A) Does not apply.										
		see photo 2

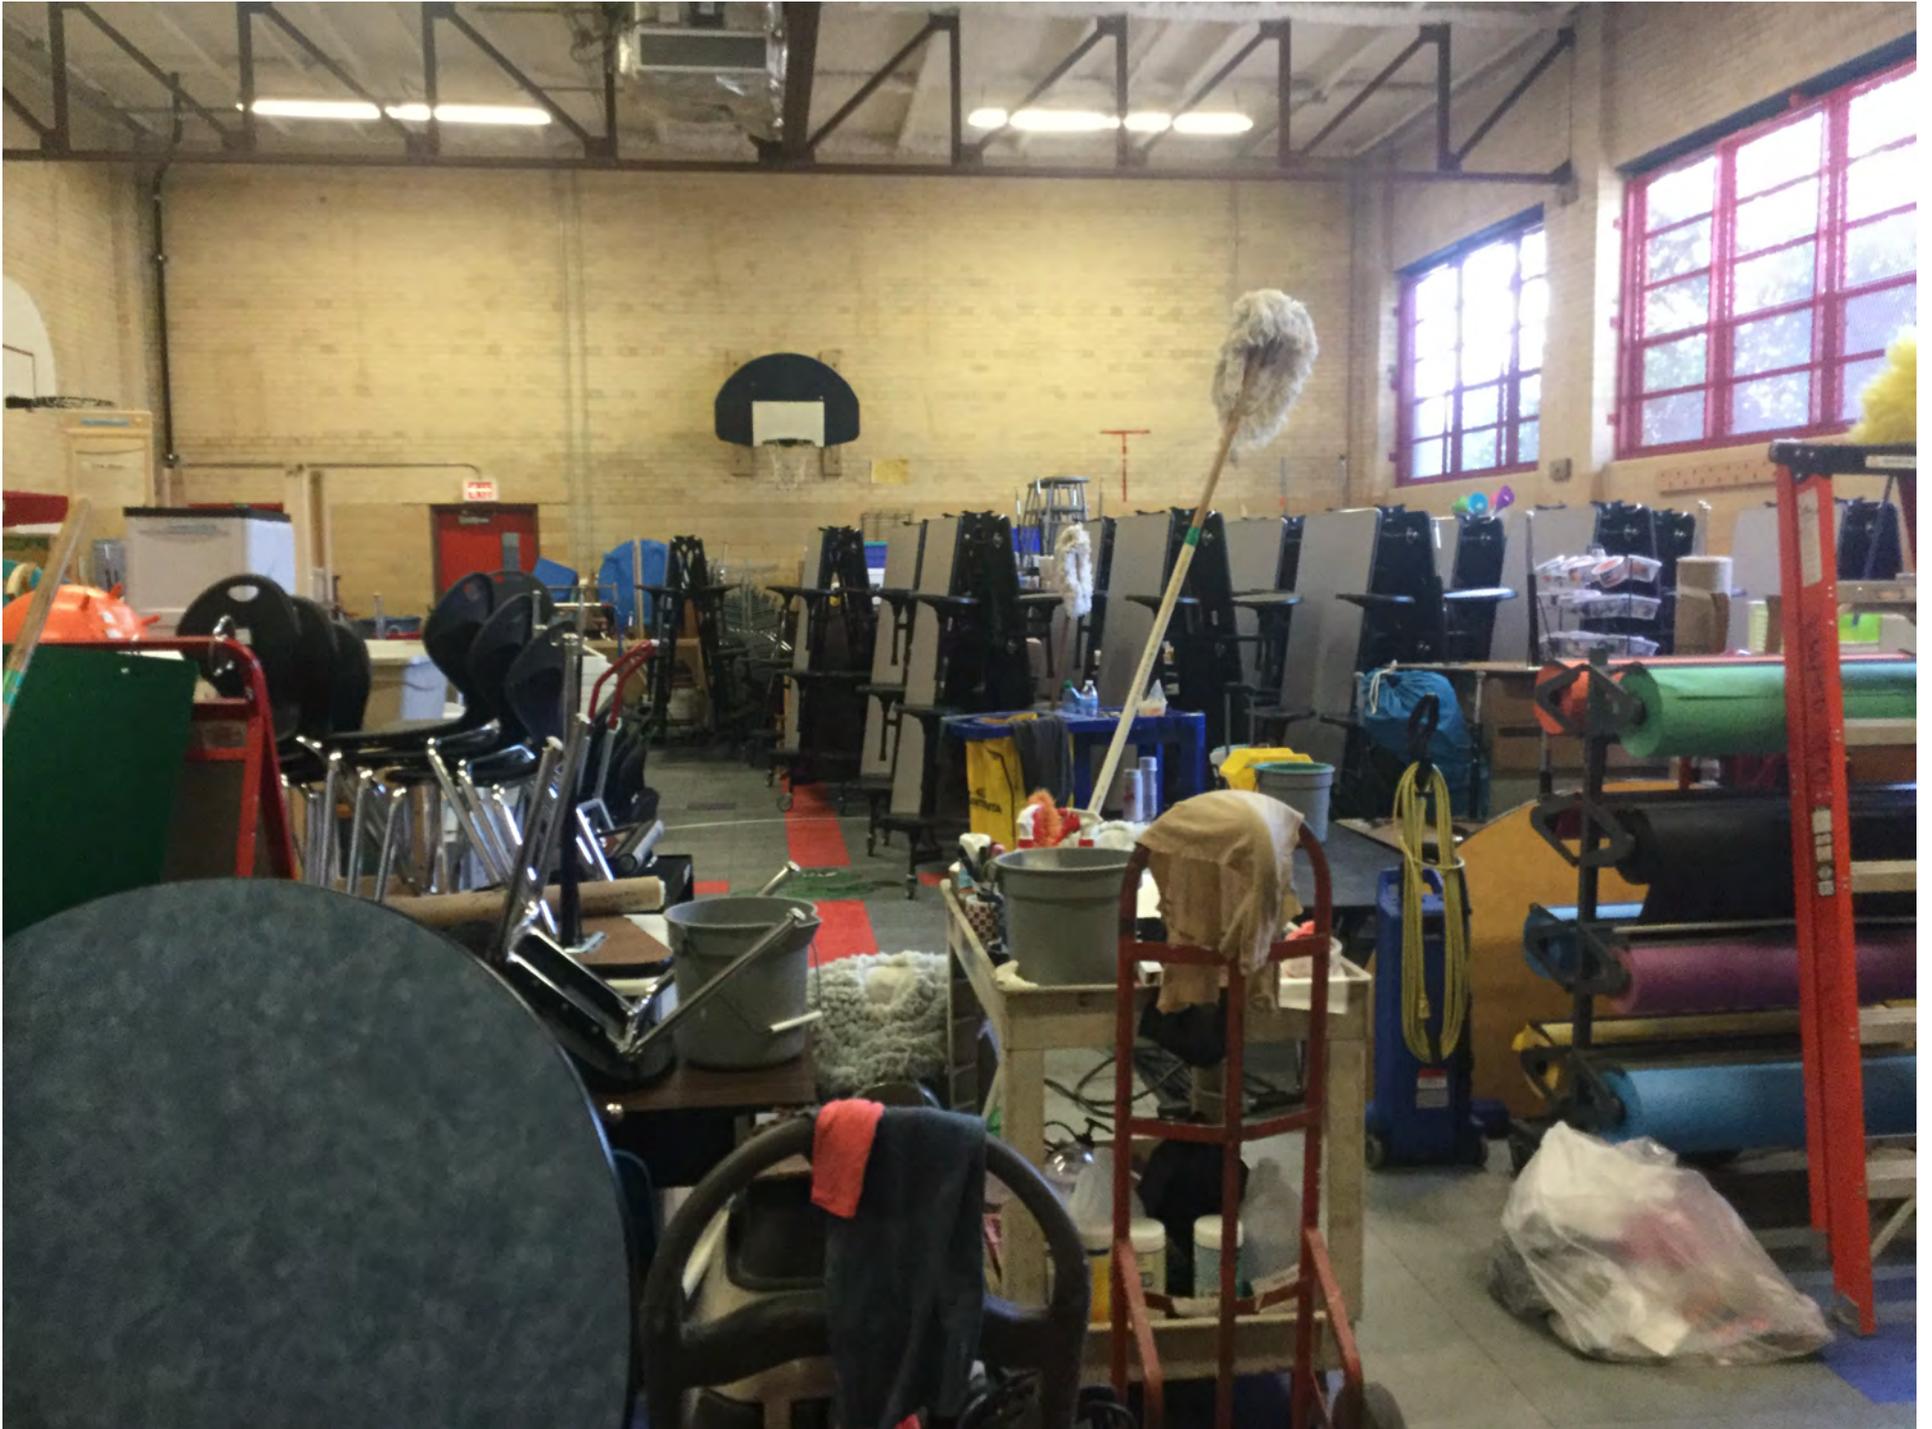
Photo 3. Gym

1) Very unsatisfactory 2) Unsatisfactory 3) Average 4) Good 5) Very good N/A) Does not apply.								the gym is outdated and the equipment is poor. However, it is a nice size for the student body.	see photo 3

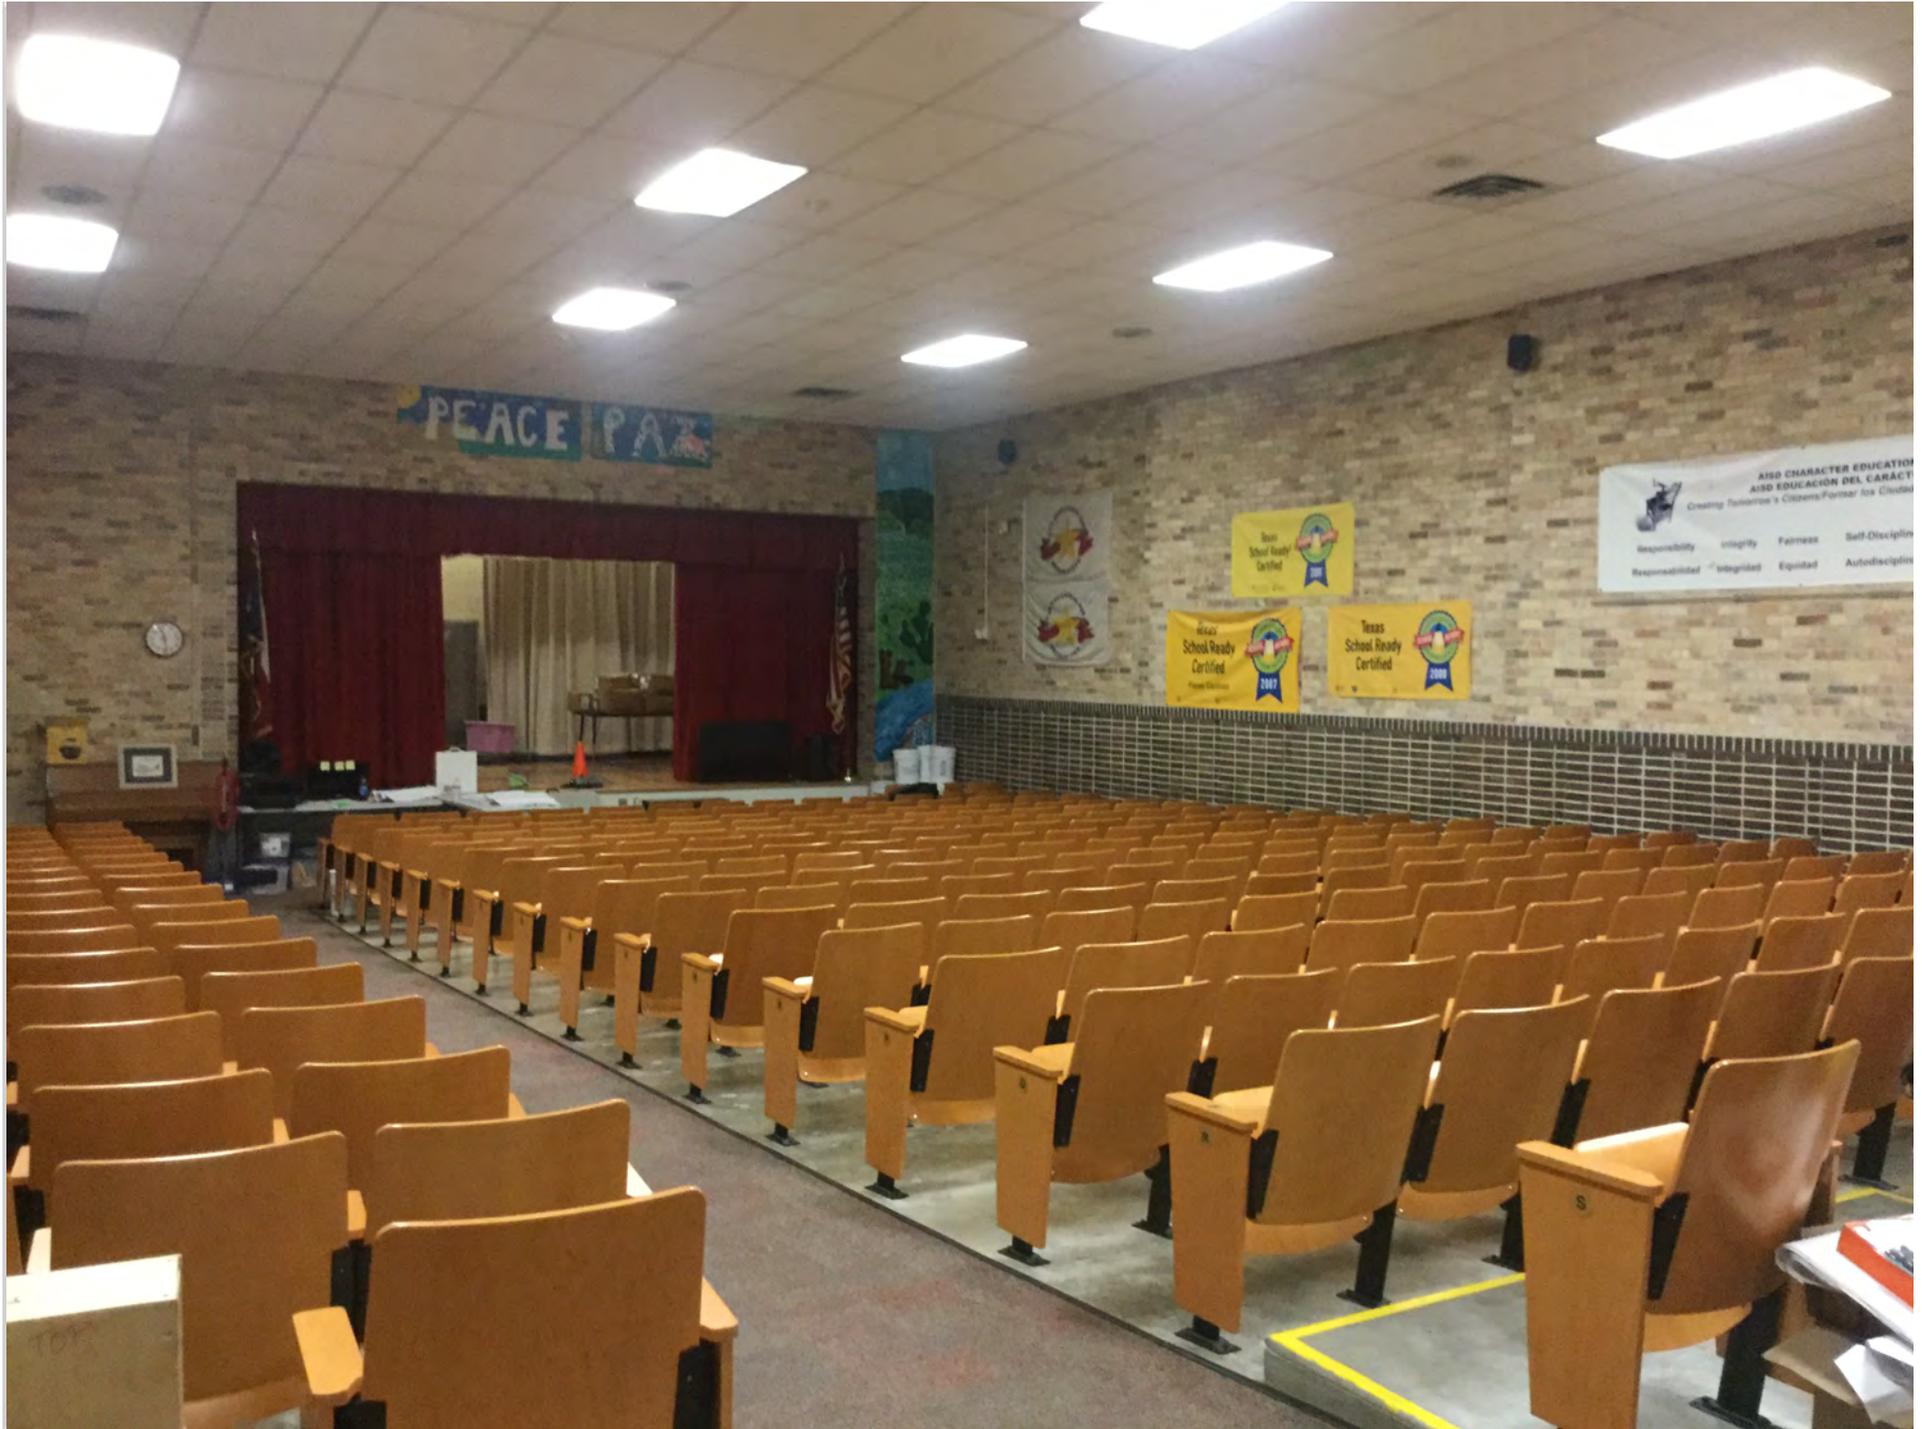
Photo 4. Auditorium

Music is taught out of a portable with very little acoustical insulation between adjacent classrooms. The art room is insufficiently sized for a class of twenty students. Storage is limited for equipment and there is no space for drying art work. The kiln is housed on the front lawn along with central plant equipment. The auditorium is adequate, but has poorly functioning audiovisual systems. Stage curtains are also in very poor condition.

3.8	Are music, drama, or performance spaces appropriately configured per the ed spec?			3				Comments	1.00 3.00
1) Very unsatisfactory 2) Unsatisfactory 3) Average 4) Good 5) Very good N/A) Does not apply.								The music Room is in portable but the school has its own auditorium space with good condition seating. Auditorium support such as storage, lighting, and curtains are in very poor condition.	see photo 4

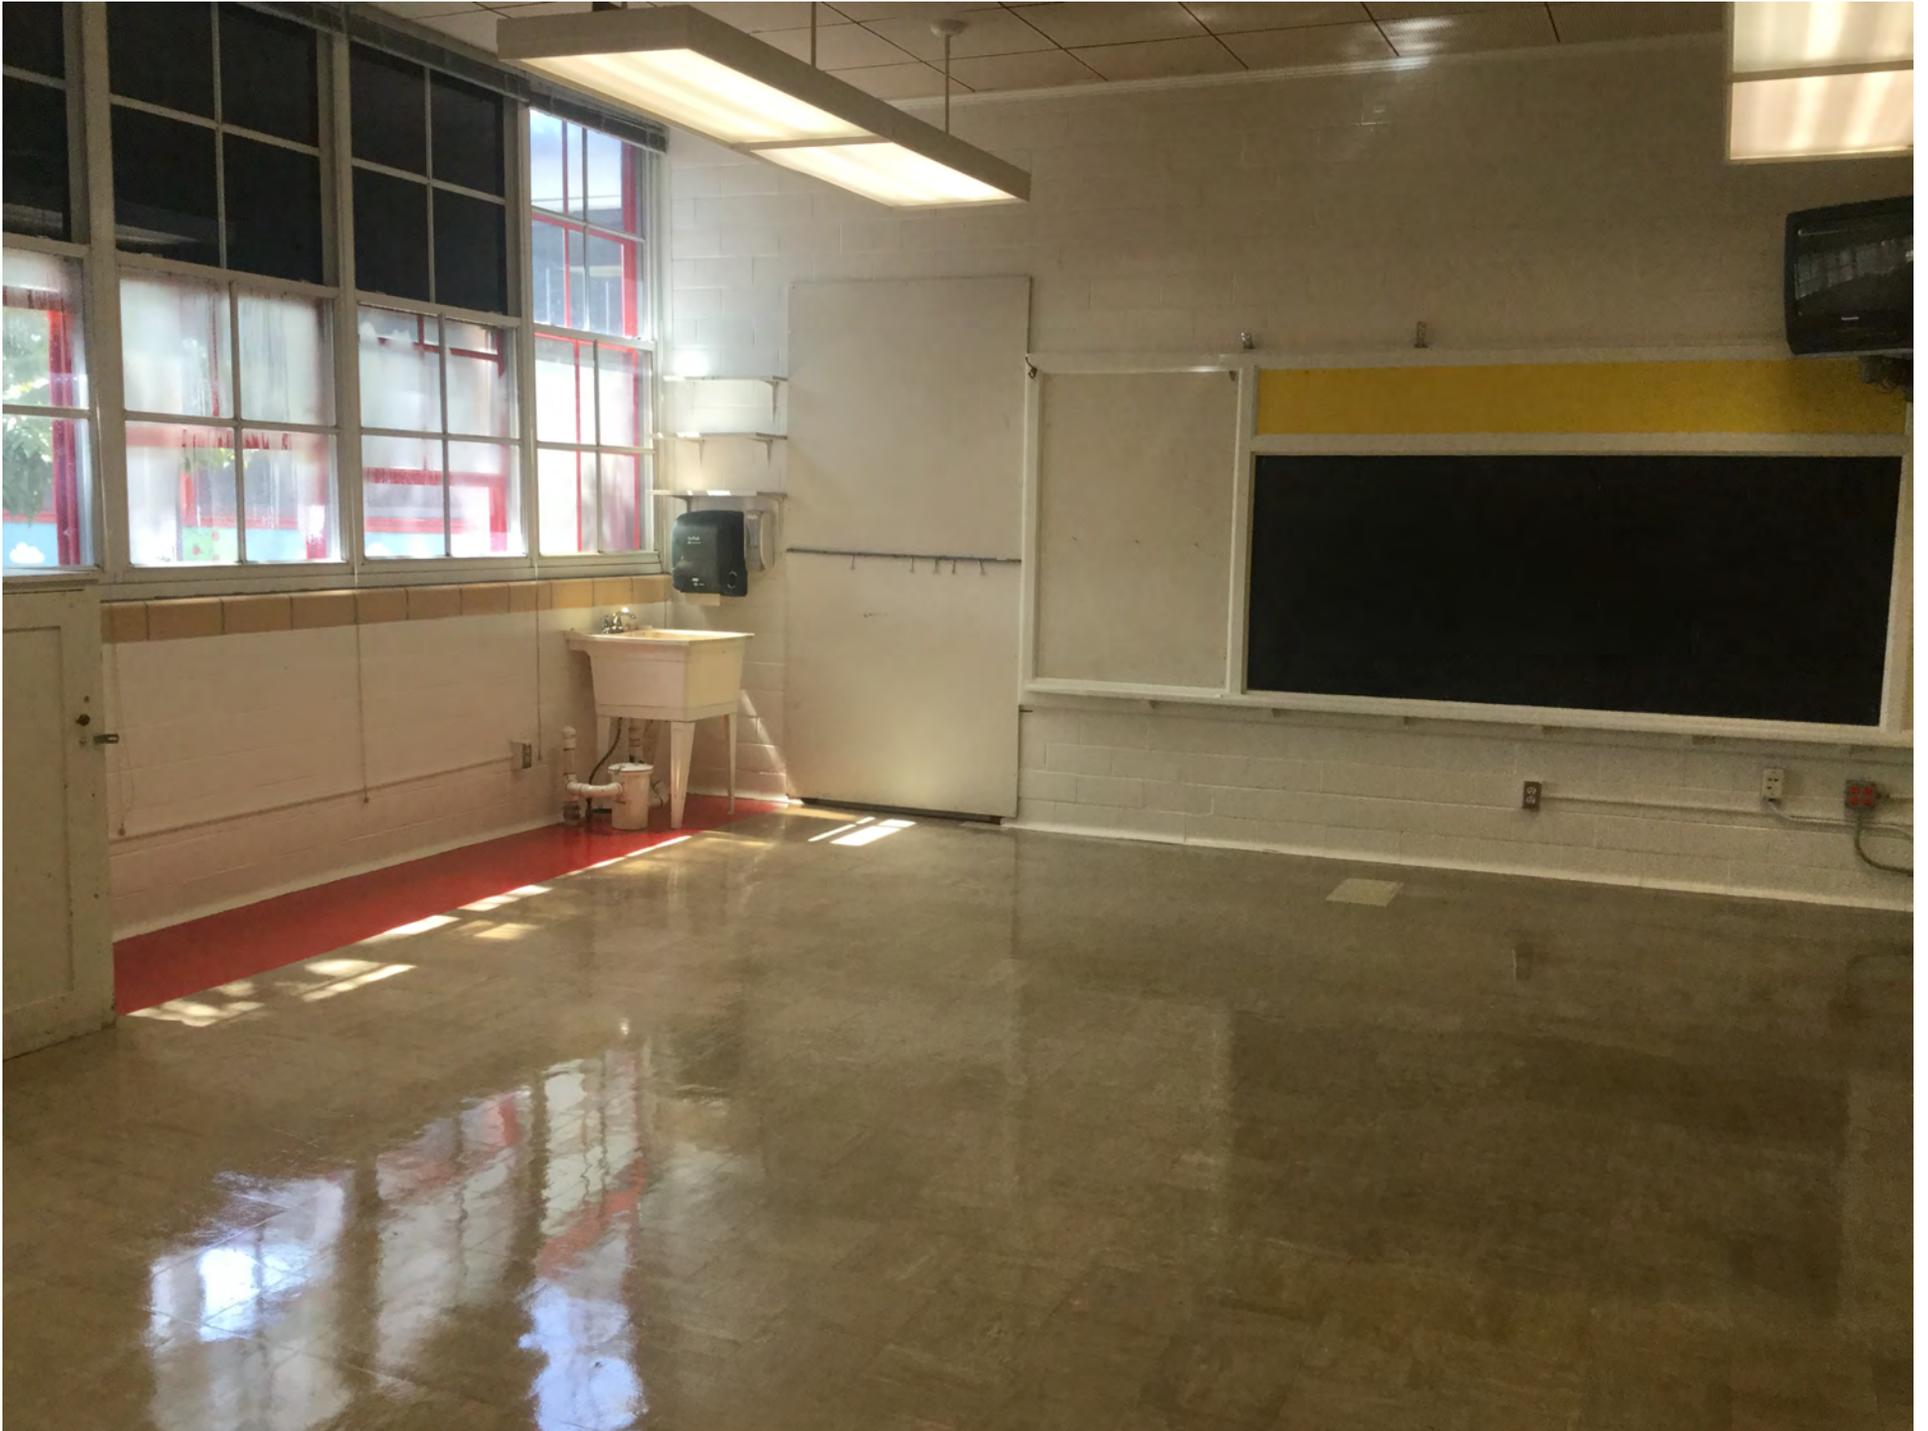
Photo 5. Art Room

1) Very unsatisfactory 2) Unsatisfactory 3) Average 4) Good 5) Very good N/A) Does not apply.								The art room is appropriated from a standard classroom and is inadequate in size. The room is not properly configured with the appropriate sinks and equipment.  see photo 5

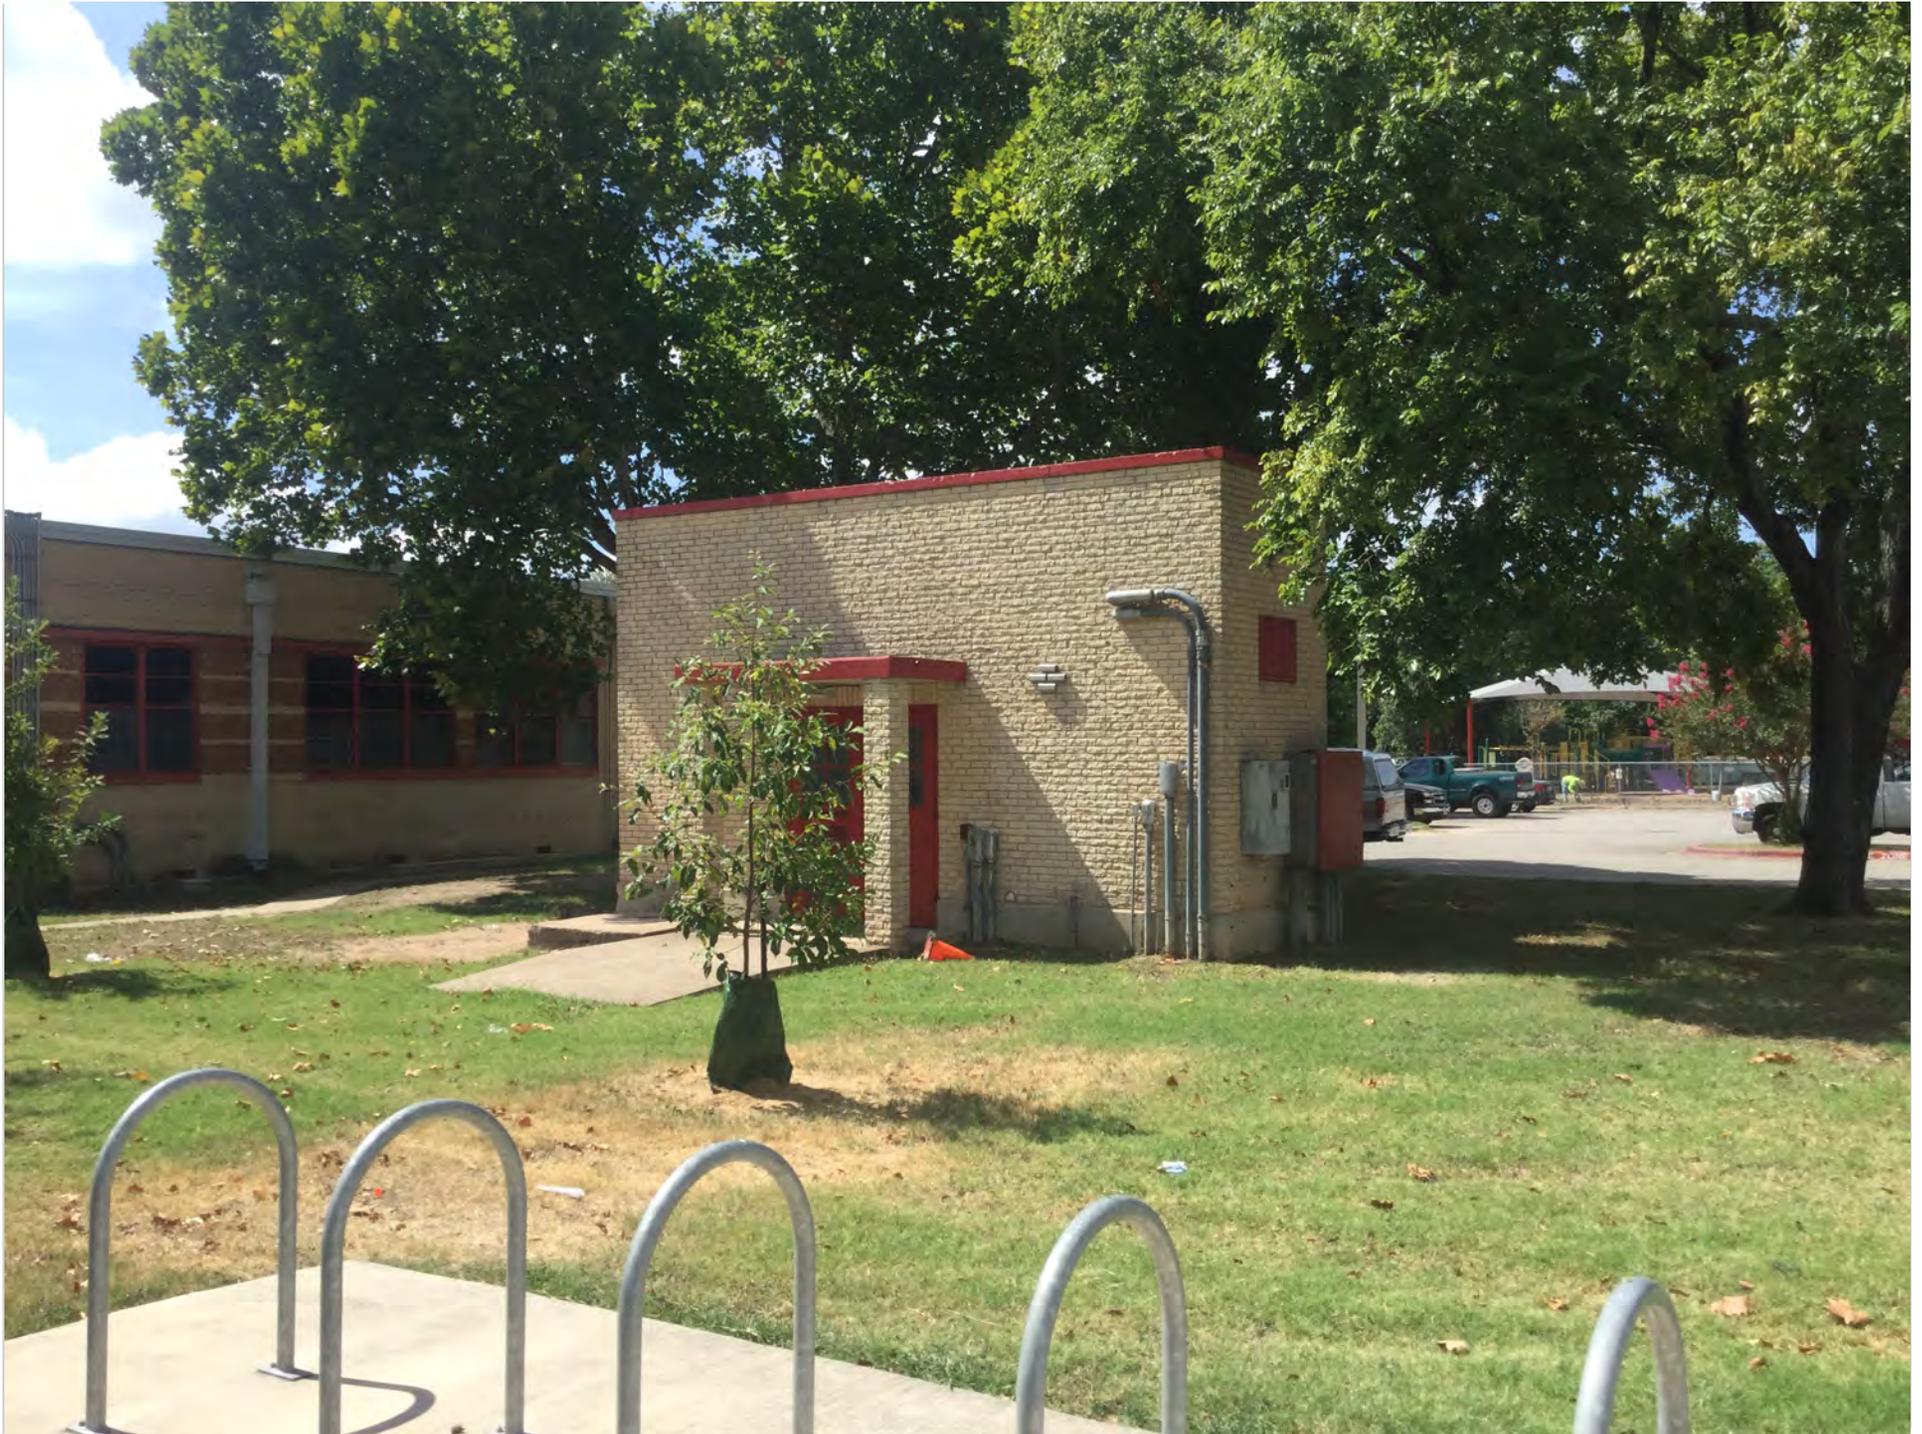
Photo 6. Kiln Room

3.11	Are Visual Arts <b>support</b> spaces appropriately configured per the ed spec?	1							Comments	1.00	1.00
1) Very unsatisfactory - Support spaces are disconnected from served spaces, too small, do not meet needs 2) Unsatisfactory - Support spaces are connected, but too small, inadequate for needs 3) Average - Connected, moderate size, but need some renovations or updates to function well 4) Good - Connected, good size/layout, meets needs/functions well 5) Very good - connected, generous size, nice condition, functions appropriately N/A) Does not apply.								The kiln is in its own separate building on the other side of campus.  see photo 6

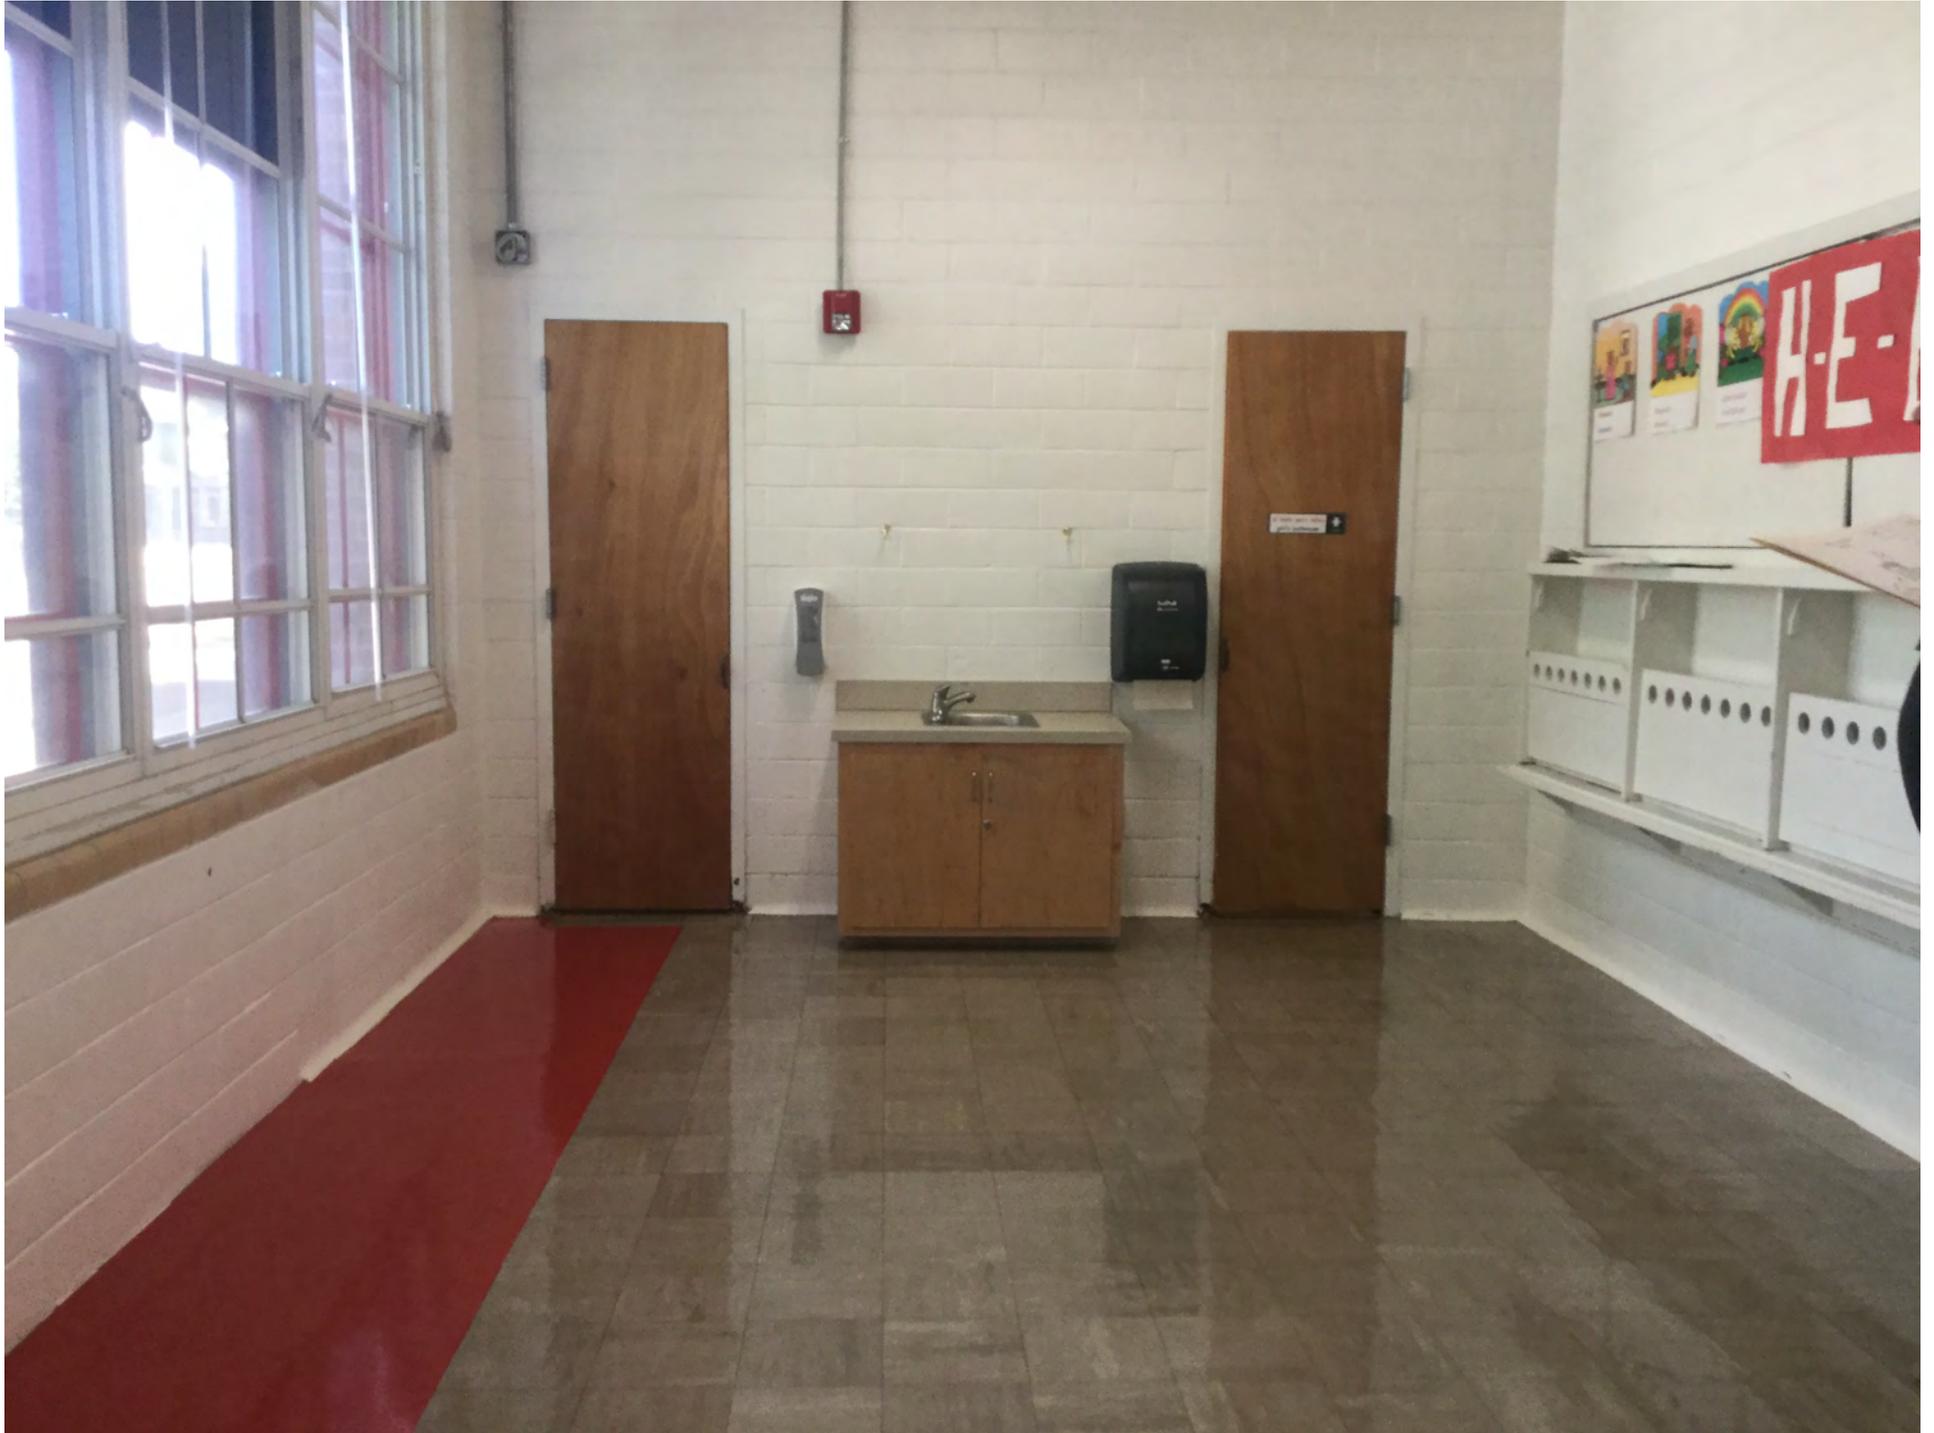
Photo 7. Special Education Space

3.15	Are Special Education <b>support</b> spaces appropriately configured per the ed spec?	1						Comments	1.00 1.00
1) Very unsatisfactory - Support spaces are disconnected from served spaces, too small, do not meet needs 2) Unsatisfactory - Support spaces are connected, but too small, inadequate for needs 3) Average - Connected, moderate size, but need some renovations or updates to function well 4) Good - Connected, good size/layout, meets needs/functions well 5) Very good - connected, generous size, nice condition, functions appropriately N/A) Does not apply.								The restrooms are not ADA accessible and there are no shower/changing tables.	see photo 7

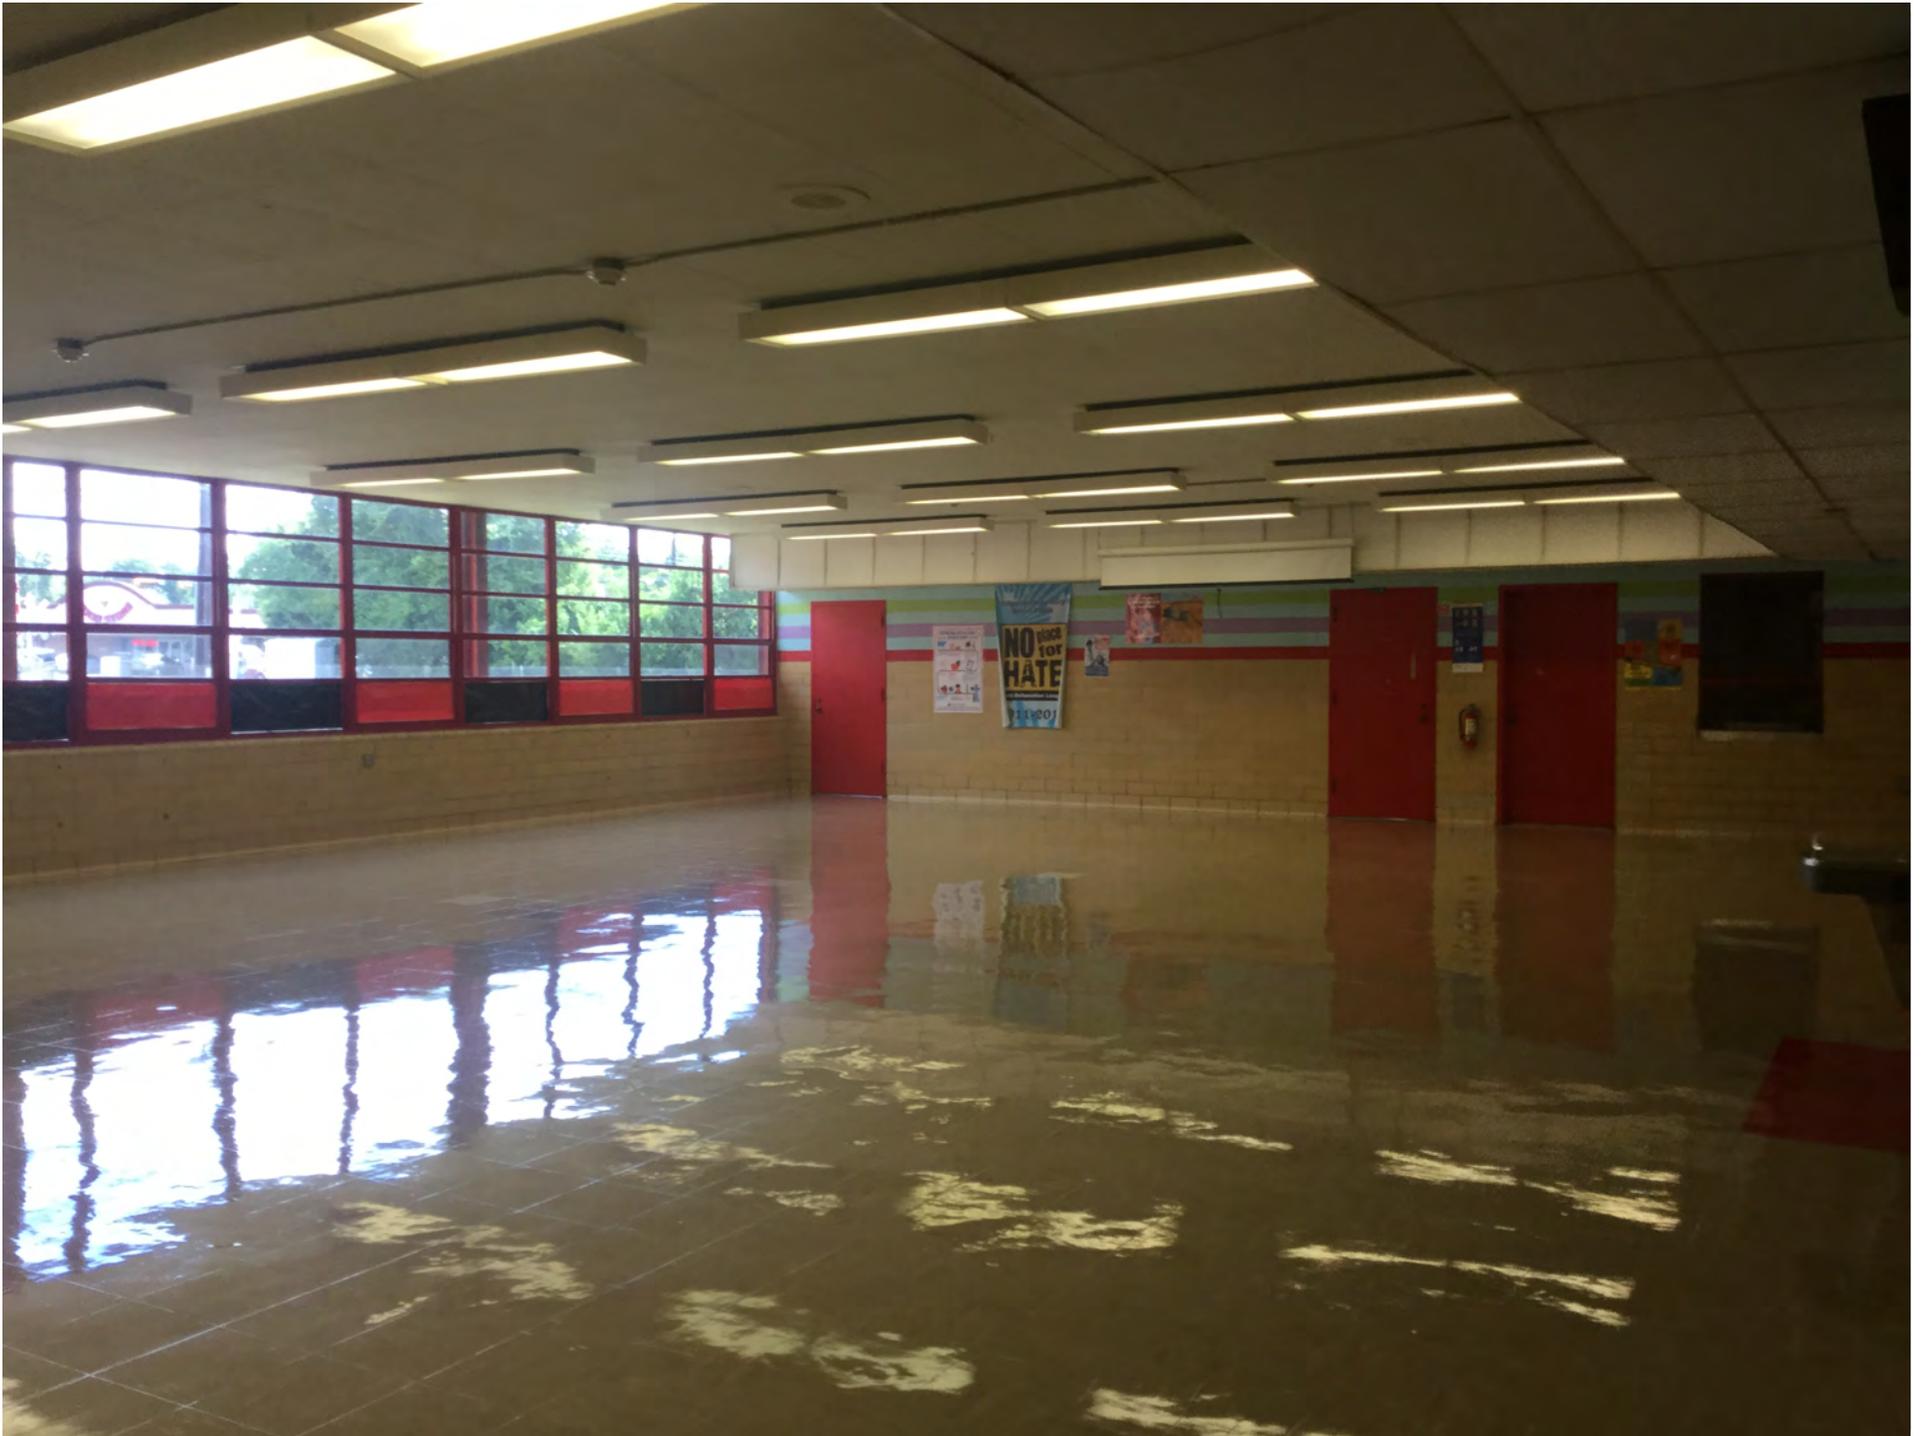
Photo 8. Cafeteria

3.16	Are the student dining facilities appropriately configured?				4			Comments	1.00 4.00
1) Very unsatisfactory - Too small, poor circulation, inflexible seating in poor condition 2) Unsatisfactory - Too small or inadequate circulation, seating in poor condition 3) Average - moderate size, with adequate circulation, seating in okay condition 4) Good - good size, adequate circulation, seating in good condition 5) Very good - good size, adequate circulation, seating in good condition, with more than one option for eating space (ex: connection to outdoor eating space) N/A) Does not apply.									see photo 8
