## Educational Suitability Summary Report

Ridgetop Elementary School – BLDG #133

Date: 8/11/2016 (Rev 1 – 11/8/16 – Added Survey Responses)

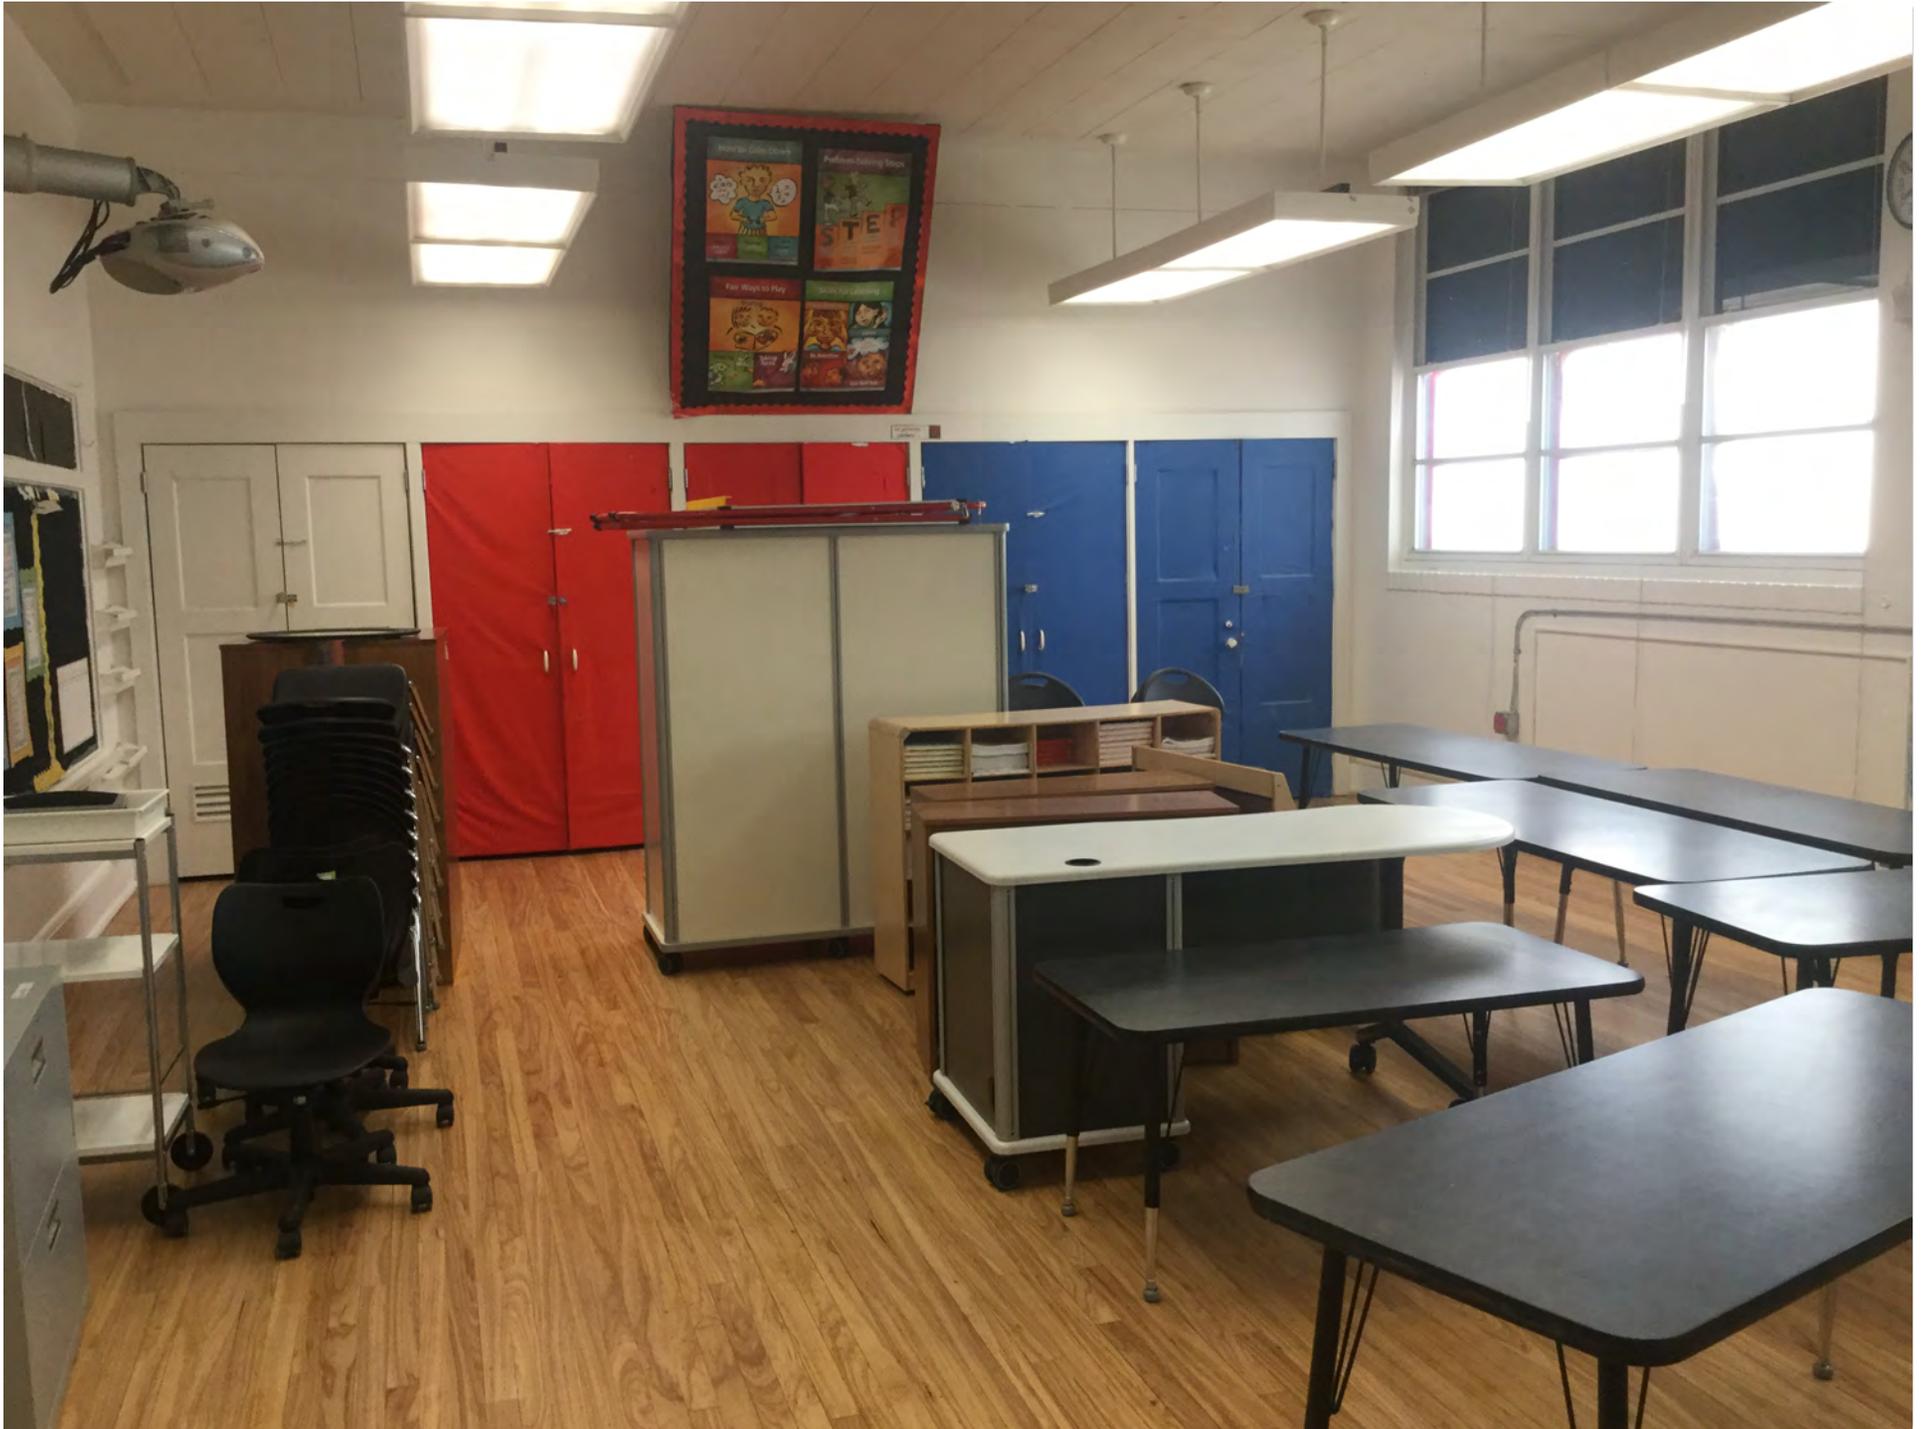
Photo 9. Standard Classroom

4.4	Are there adequate places to display the evidence and artifacts of learning (both 2D and 3D)?			3				Comments	1.00	3.00
1) Very unsatisfactory - No display cases or wall space for display 2) Unsatisfactory - 1 wall in classrooms or very few spaces for display 3) Average - 2 walls in classrooms or some hallway spaces for display 4) Good - 3 walls in classrooms or multiple hallway spaces for display 5) Very good - ample classroom display space or many hallway spaces, including display cases N/A) Does not apply.

see photo 9

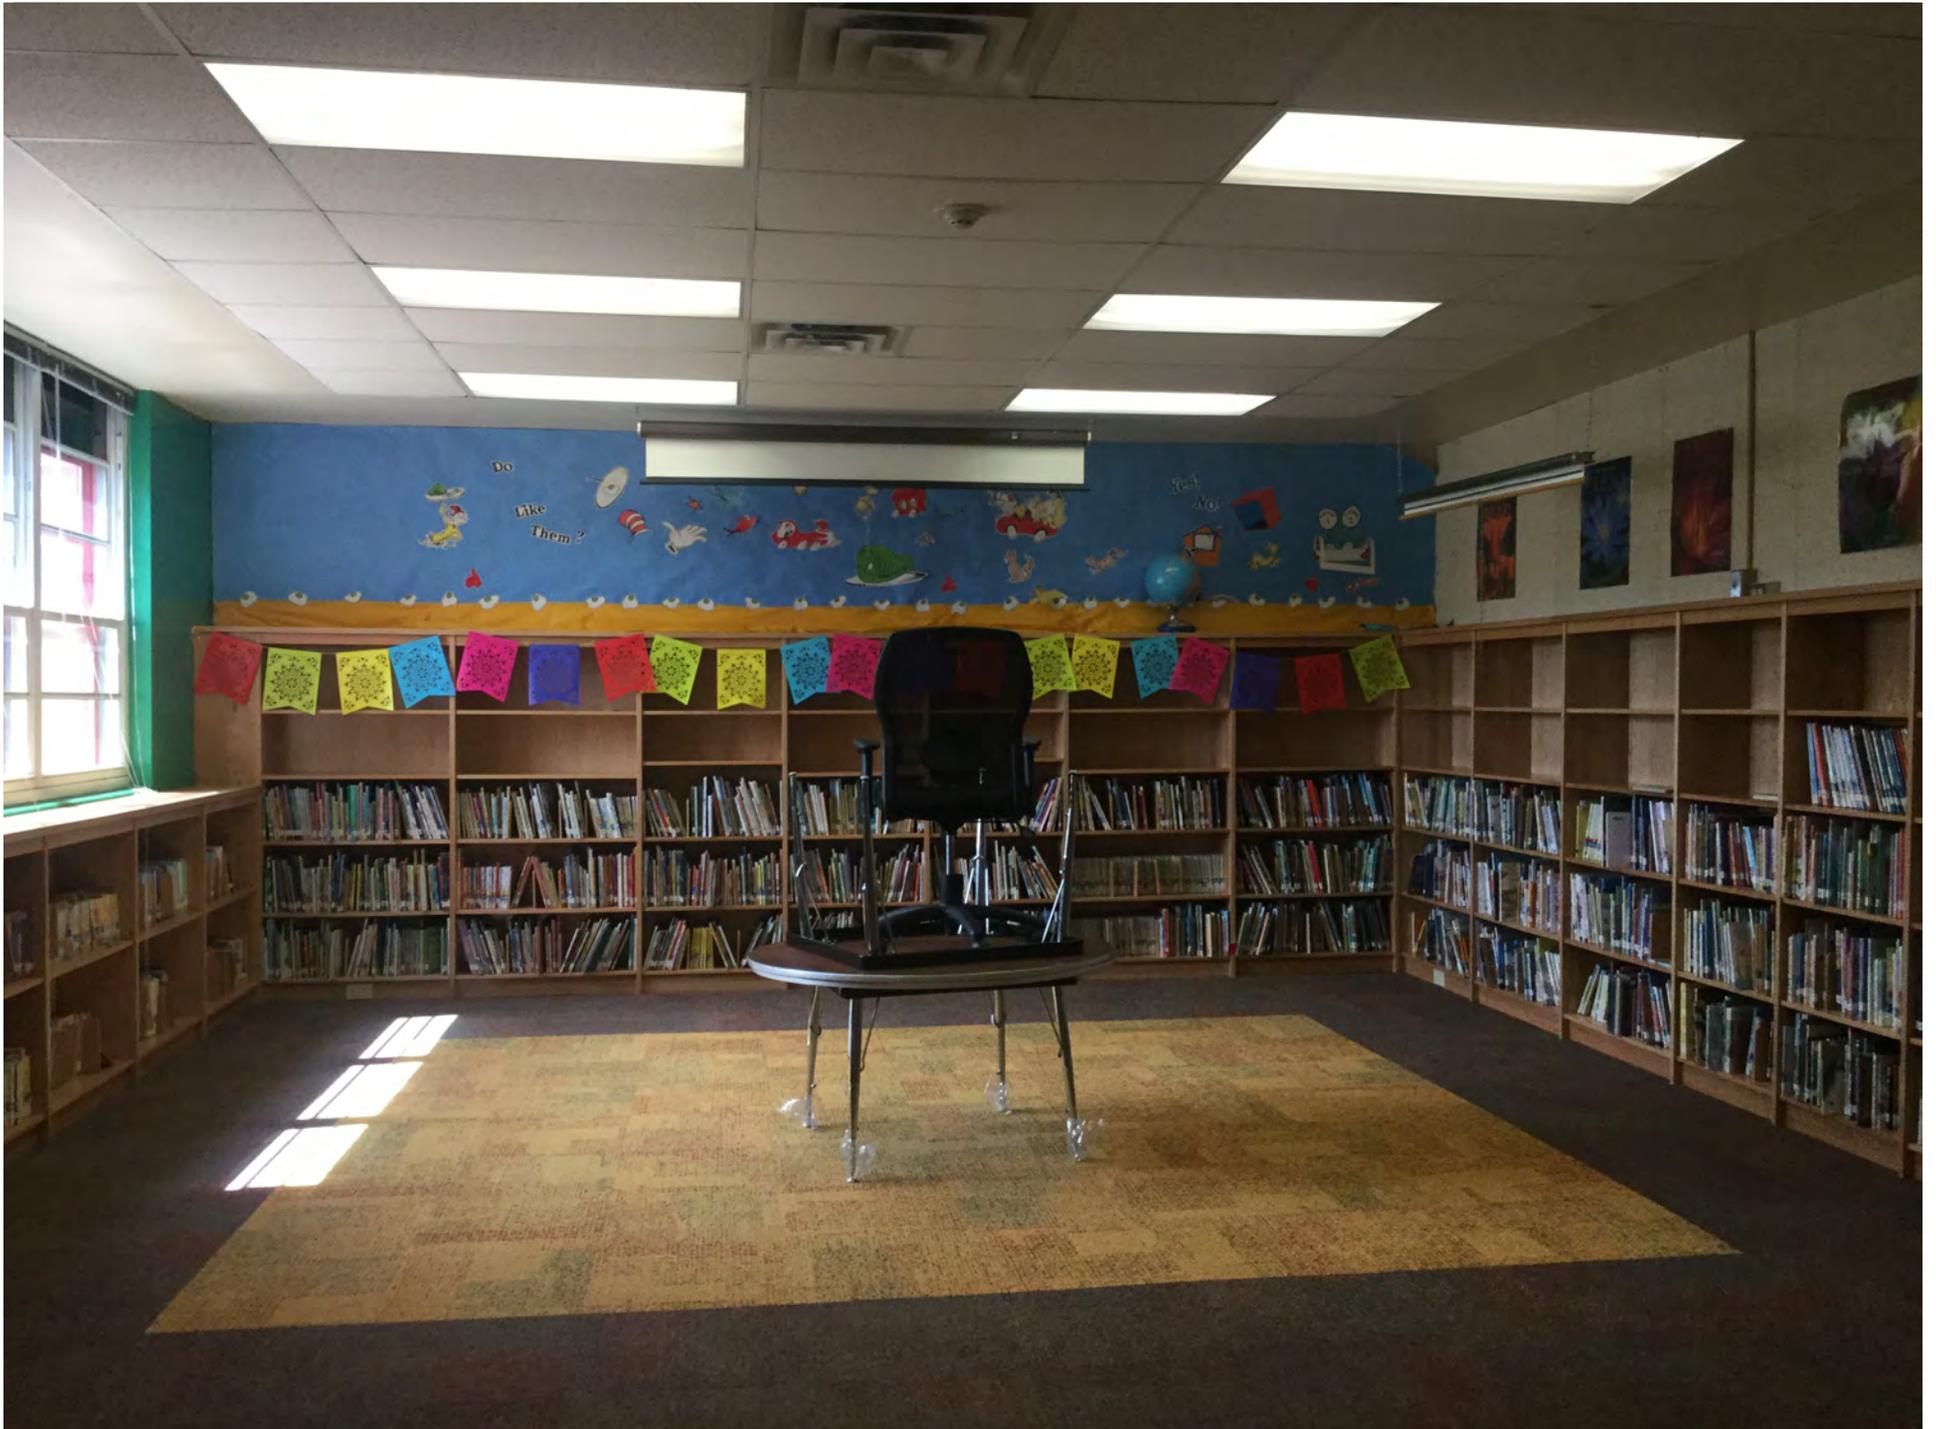
Photo 10. Library

5.3	How well does the Library/Media Center support social interaction?			3				Comments	1.00	3.00
1) Very unsatisfactory 2) Unsatisfactory 3) Average 4) Good 5) Very good N/A) Does not apply.		There are no social stairs but instead a large open area.								
		<b>see photo 10</b>
