Educational Suitability Summary Report

Sims Elementary School – BLDG 139

Date: 06/07/2016 (REV1 – 11/15/2016 – AISD Construction Dept. Comments) **Score 62% Average**

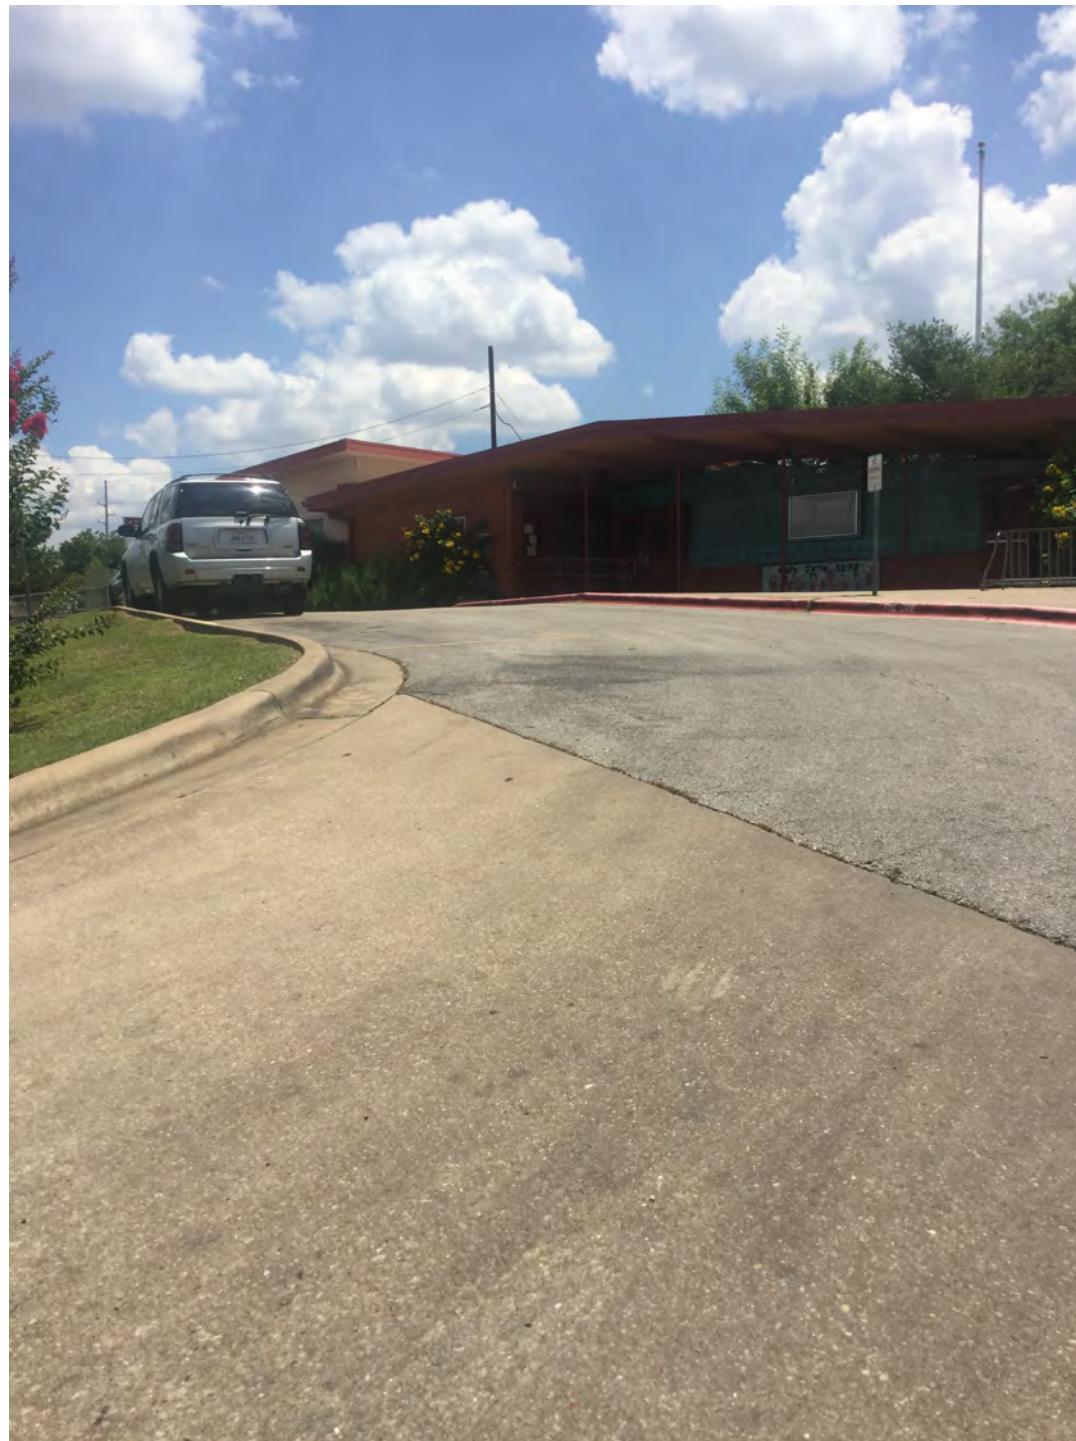
Photo 1.
1.1 Traffic

1 - Exterior	1	2	3	4	5	N/A		5.50
1.1 Does the site permit desirable separation of vehicular, bus and pedestrian traffic?	1						Comments	1.00 1.00
1) Bus , car and pedestrian all happen at the same location. 2) Cars and buses mix, pedestrians are separated. 3) Buses, cars, and pedestrians are separate but stack space is small. 4) Buses, cars, and pedestrians are separate but drop off does not have a canopy or a holding place like a commons or cafeteria. 5) Buses, cars, and pedestrians are separate and drop off area has a canopy and destination.							All drop-off and pick up has to occur in the same place for pedestrians, buses and vehicles. The singular location for all traffic is very inadequate. The accessible parking is inadequate. The drive width is too small for parked cars in accessible spaces and buses to pass. The campus has a very large student population who walk, so a crosswalk across street desired. <i>AISD Construction Department Comment: There is a crosswalk and crossing guard at 12th and Springdale.</i>

N/A) Does not apply.								see photo 1
1.2 Are opportunities provided for outdoor learning (outdoor classrooms, gardens, etc.)?		2					Comments	1.00 2.00

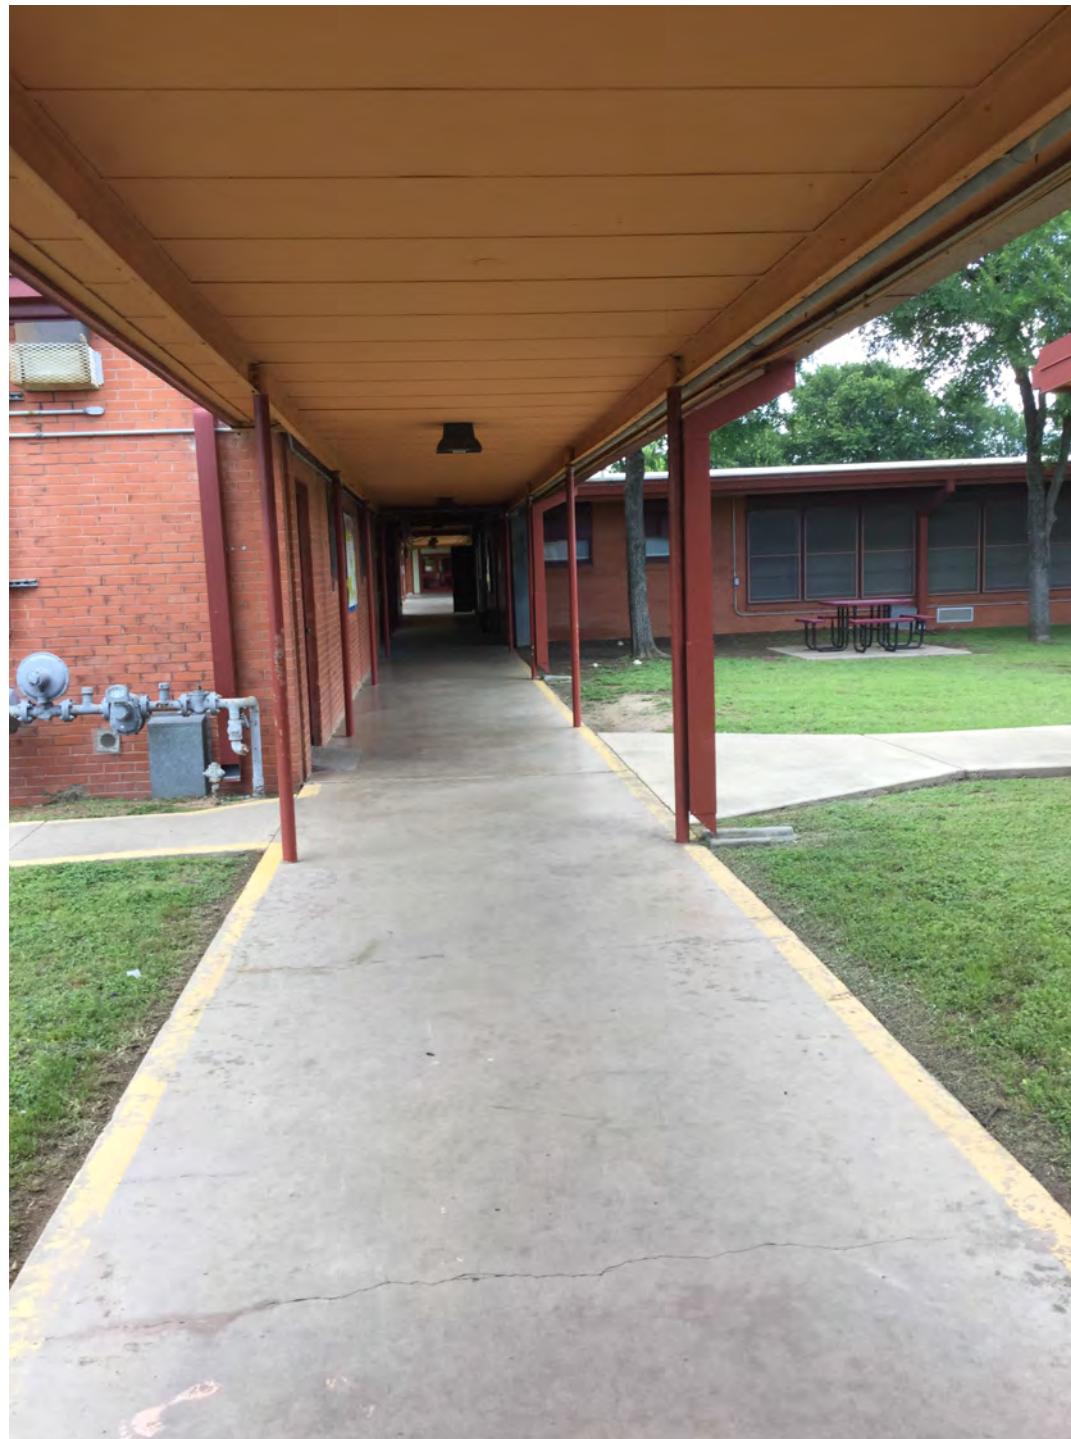
Photo 2.
2.2 General Building Circulation

2.2 Are community use areas arranged so that the school can allow night functions without full school access?	1						Comments 0.75 0.75
	1) Cafeteria, gym, and library cannot be accessed from parking area or secured from the rest of campus.	2) Only one of the public spaces (Cafeteria, Gym and Library) can be accessed from parking and secured from the rest of the building.	3) Only two of the public spaces (Cafeteria, Gym and Library) can be accessed from parking and secured from the rest of the building.	4) All of the public spaces (Cafeteria, Gym and Library) can be accessed from parking and secured from the rest of the building but do not have individual entrances.	5) Cafeteria, gym, and library can be accessed from parking and locked off from rest of campus for night/evening use with their own entrance.		There is no way to secure entry into public spaces without also allowing access to general campus and other classroom wings.

N/A) Does not apply.						see photo 2
2.3 Does the general appearance of the school evoke pride for the students and community?			3				Comments 0.25 0.75

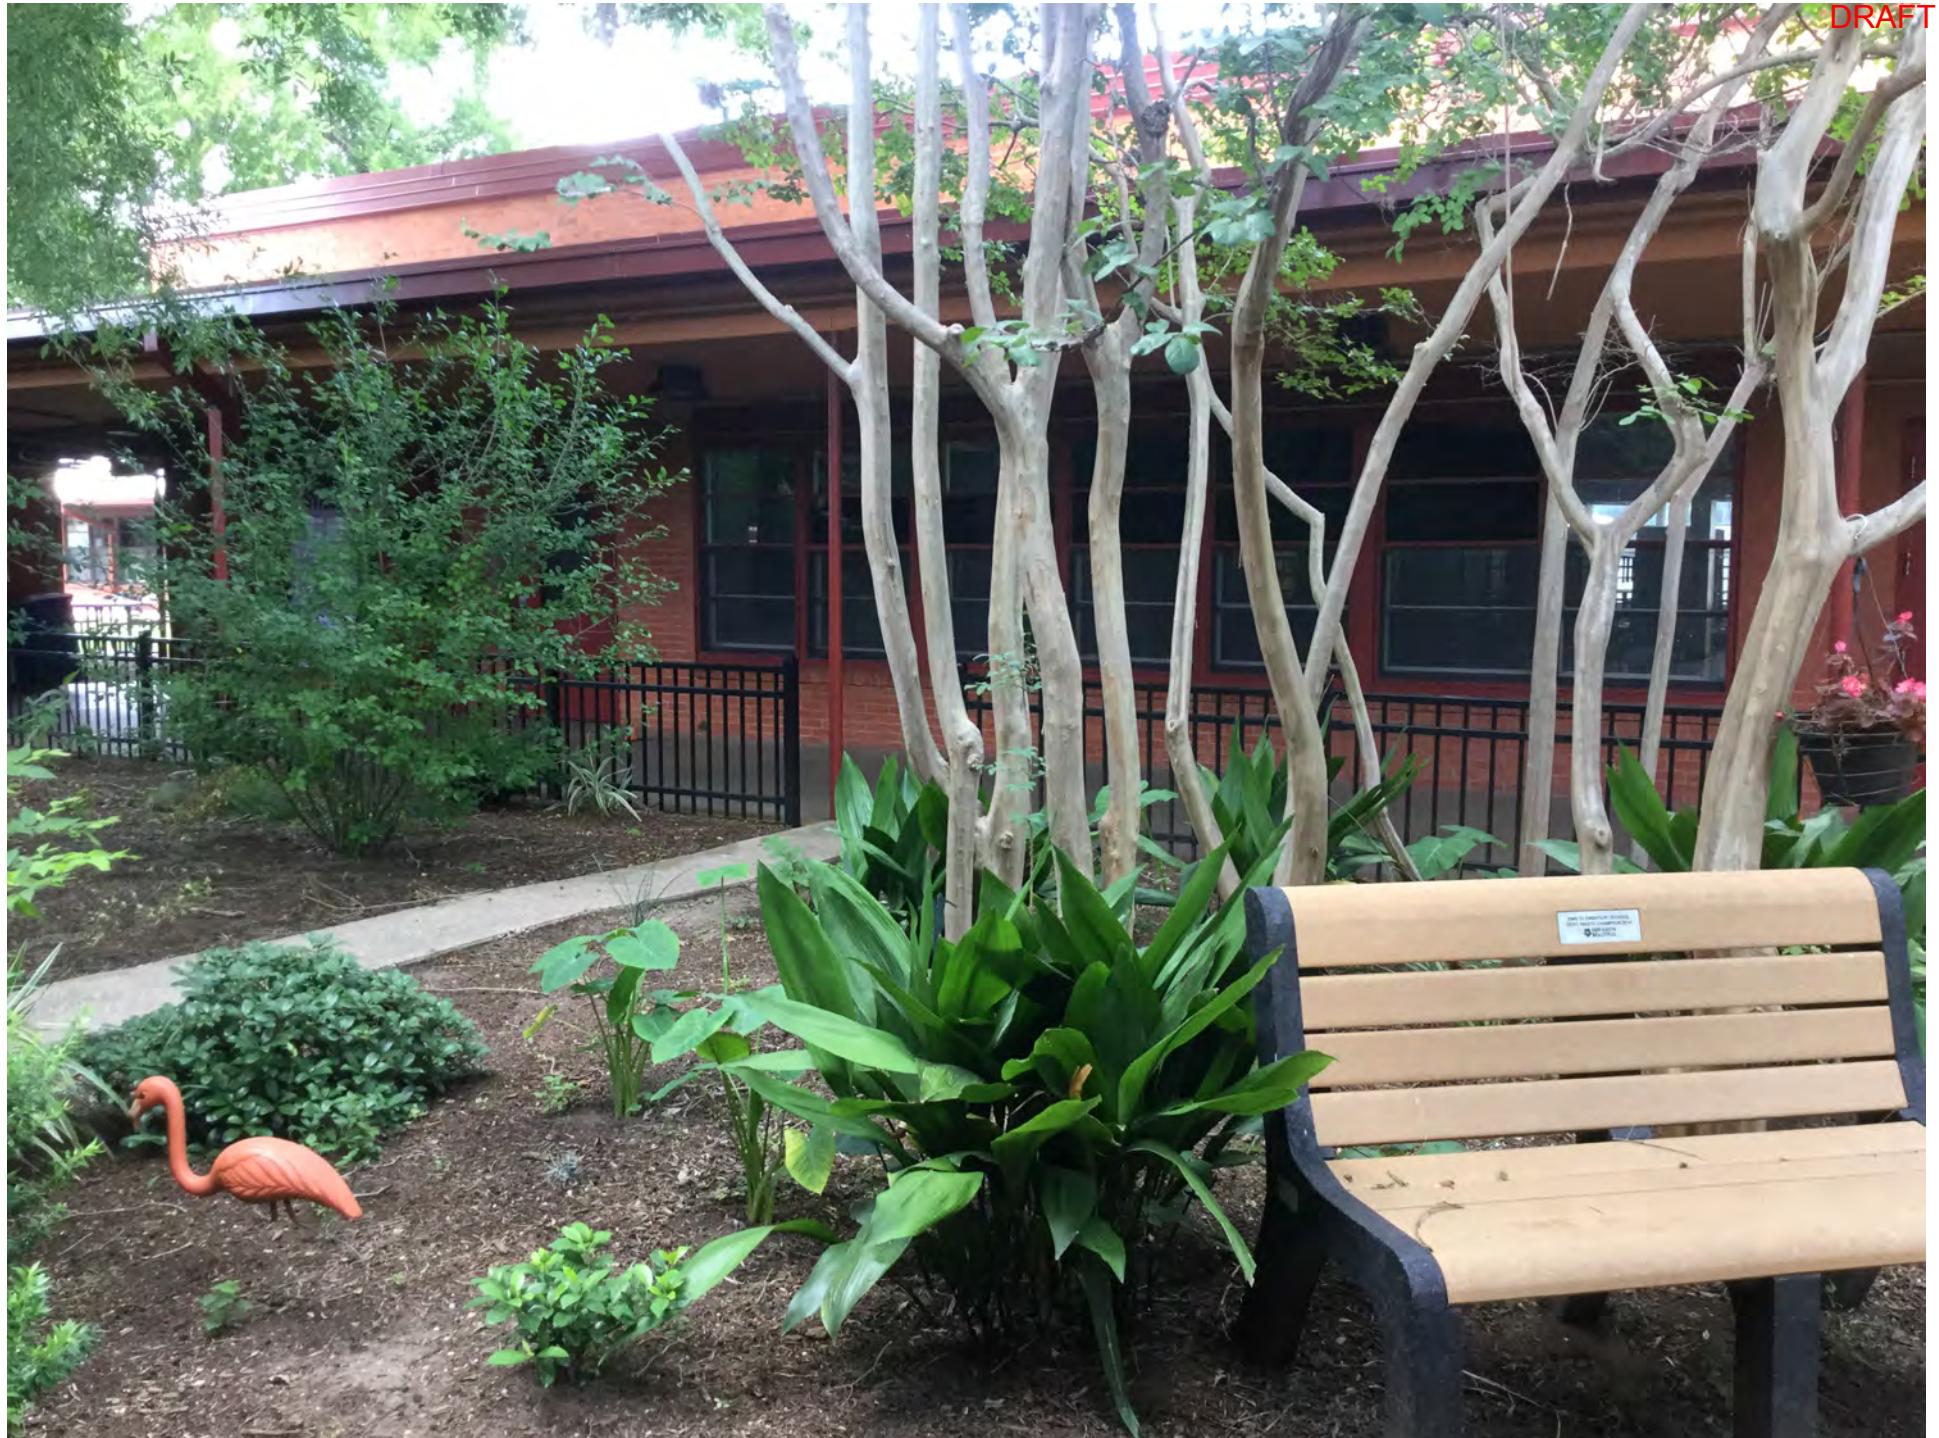
Photo 3.
2.3 Appearance

1) General appearance is poor.	2) General appearance is aged but ok.	3) General appearance is good.	4) General appearance shows pride in campus and student works.	5) General appearance shows pride in campus and student works and is welcoming to the community.		The front entry is simple and screens the school from view. Beyond the main entry screen is a very nicely maintained courtyard around which the school is organized. The school condition is older, but it is undergoing significant classroom renovations.
	N/A) Does not apply.						see photo 3

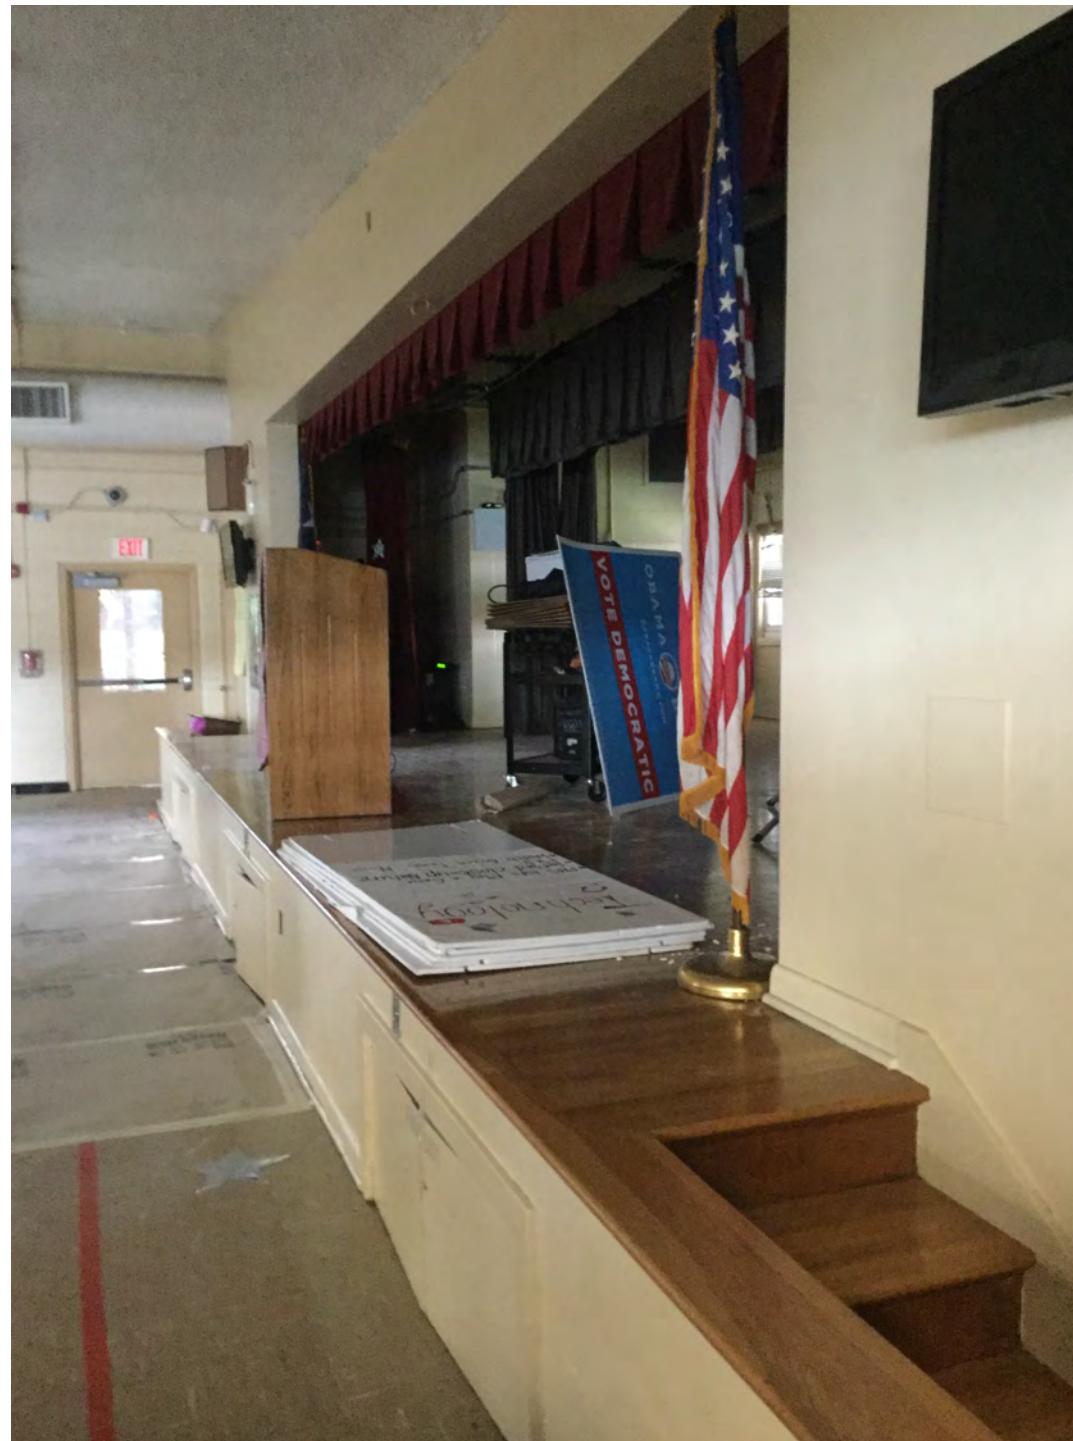
Photo 4.
3.8 Performing Arts Space

Performance space for students is unsatisfactory. The equipment at the stage is non-functioning and the curtains are ripped. There is no storage or lighting equipment for performances. The dining facility's serving line is too narrow for the school's needs and is inaccessible for students with special needs.

3.8 Are music, drama, or performance spaces appropriately configured per the ed spec?								3				
1) Very unsatisfactory 2) Unsatisfactory 3) Average 4) Good 5) Very good N/A) Does not apply.							The music room is well equipped and large. The stage in the cafeteria is not handicap accessible. The existing sound system, at the stage, does not function. The sound is supplemented by a sound cart. There is no performance lighting. The curtains are ripped. <i>AISD Construction Department Comment: Lift was added Summer 2016.</i>

3.9 Are music, drama, or performance support spaces appropriately configured per the ed spec?								3				
1) Very unsatisfactory - Support spaces are disconnected from served spaces, too small, do not meet needs 2) Unsatisfactory - Support spaces are connected, but too small, inadequate for needs 3) Average - Connected, moderate size, but need some renovations or updates to function well 4) Good - Connected, good size/layout, meets needs/functions well 5) Very good - connected, generous size, nice condition, functions appropriately N/A) Does not apply.							Storage for the music classroom is updated and sufficient. There is no storage area for cafeteria stage. There is no dedicated performing arts and support spaces.

see photo 4

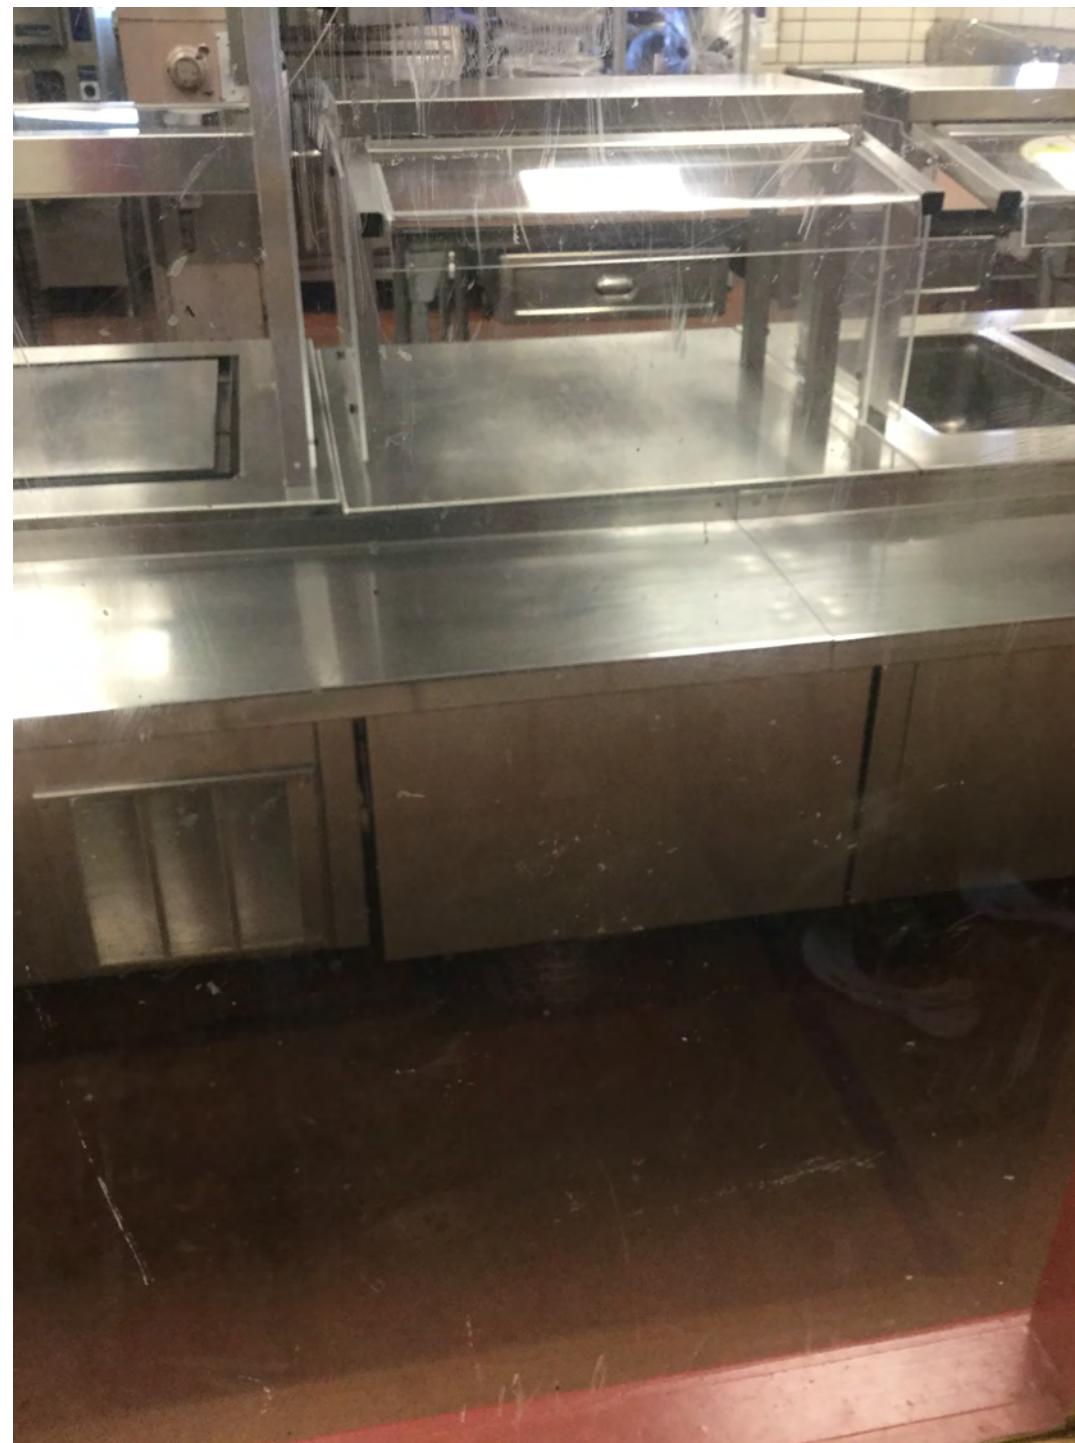
Photo 5.
3.16 Dining Facility

3.16 Are the student dining facilities appropriately configured?							Comments				1.00	3.00
1) Very unsatisfactory - Too small, poor circulation, inflexible seating in poor condition 2) Unsatisfactory - Too small or inadequate circulation, seating in poor condition 3) Average - moderate size, with adequate circulation, seating in okay condition 4) Good - good size, adequate circulation, seating in good condition 5) Very good - good size, adequate circulation, seating in good condition, with more than one option for eating space (ex: connection to outdoor eating space) N/A) Does not apply.							The dining facility is an adequate size. The serving line is extremely narrow and is not handicapped accessible.

see photo 5

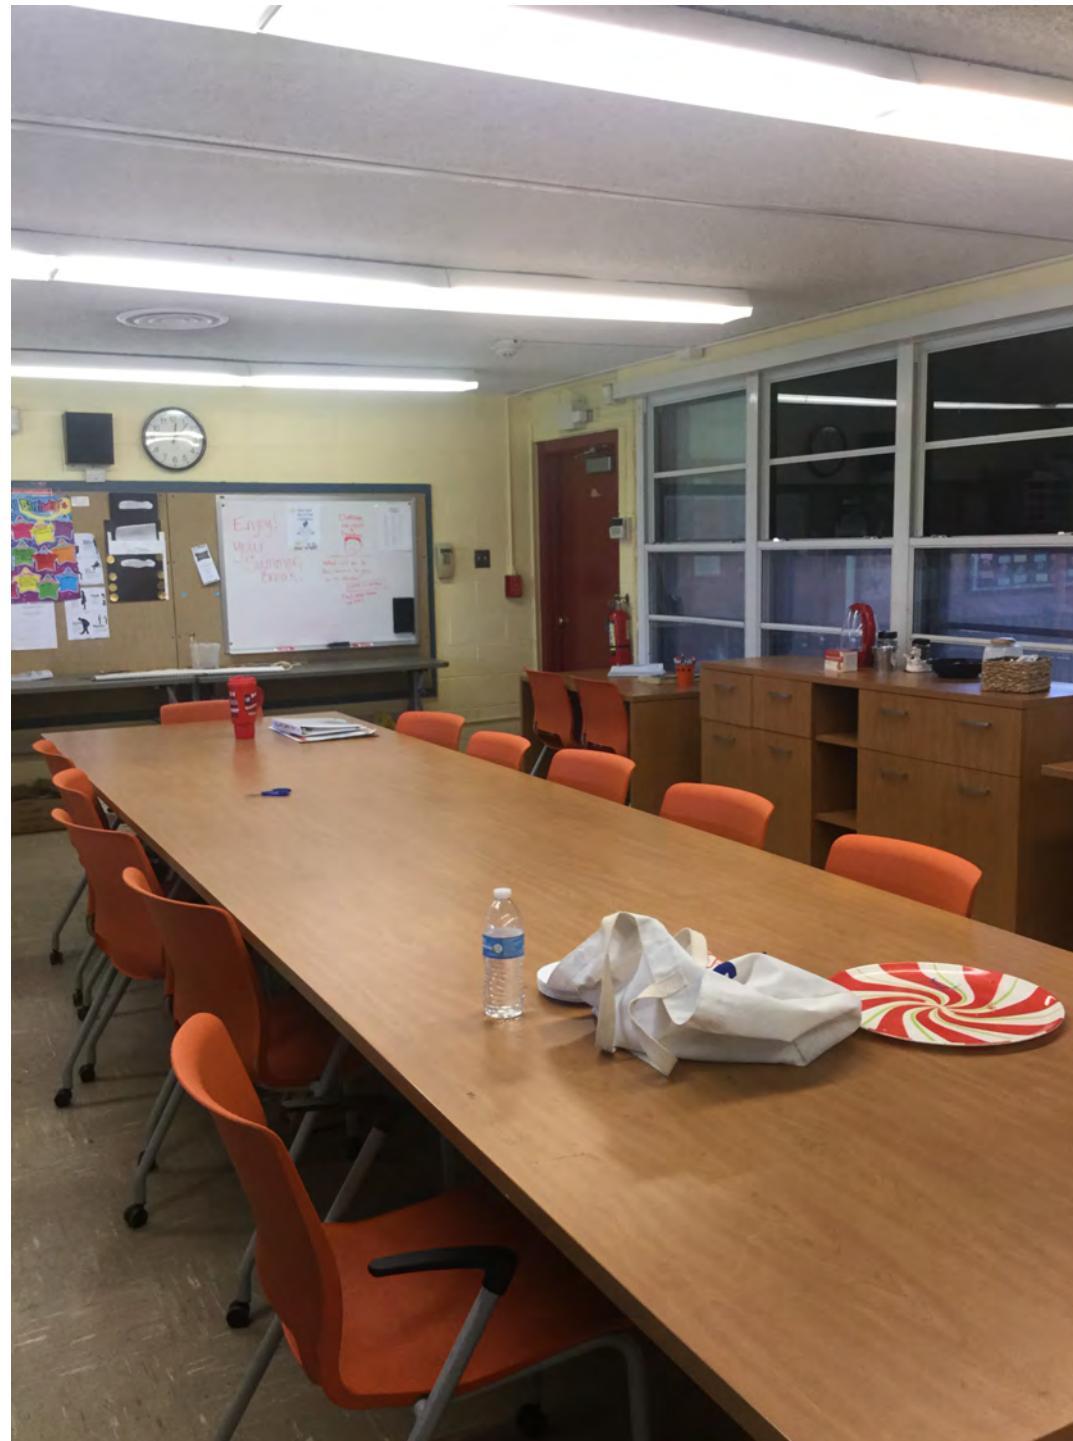
Photo 6.
4.5Collaborative Spaces

4 - Future Ready Student Development - Continued							1	2	3	4	5	N/A
							Comments				1.00	1.00
4.5 Does the building provide adequate opportunities for students/teachers to collaborate in varying group sizes?											1.00	1.00

1) Very unsatisfactory - no common spaces or meeting rooms or in very poor condition 2) Unsatisfactory - a few common spaces or meeting rooms in unsatisfactory condition 3) Average - a few common spaces and meeting areas needing updates 4) Good - multiple common spaces and meeting rooms in good condition 5) Very good - adequate common spaces and meeting rooms of excellent quality N/A) Does not apply.							The building does not have collaborative areas for separate student/teacher interactions.				see photo 6

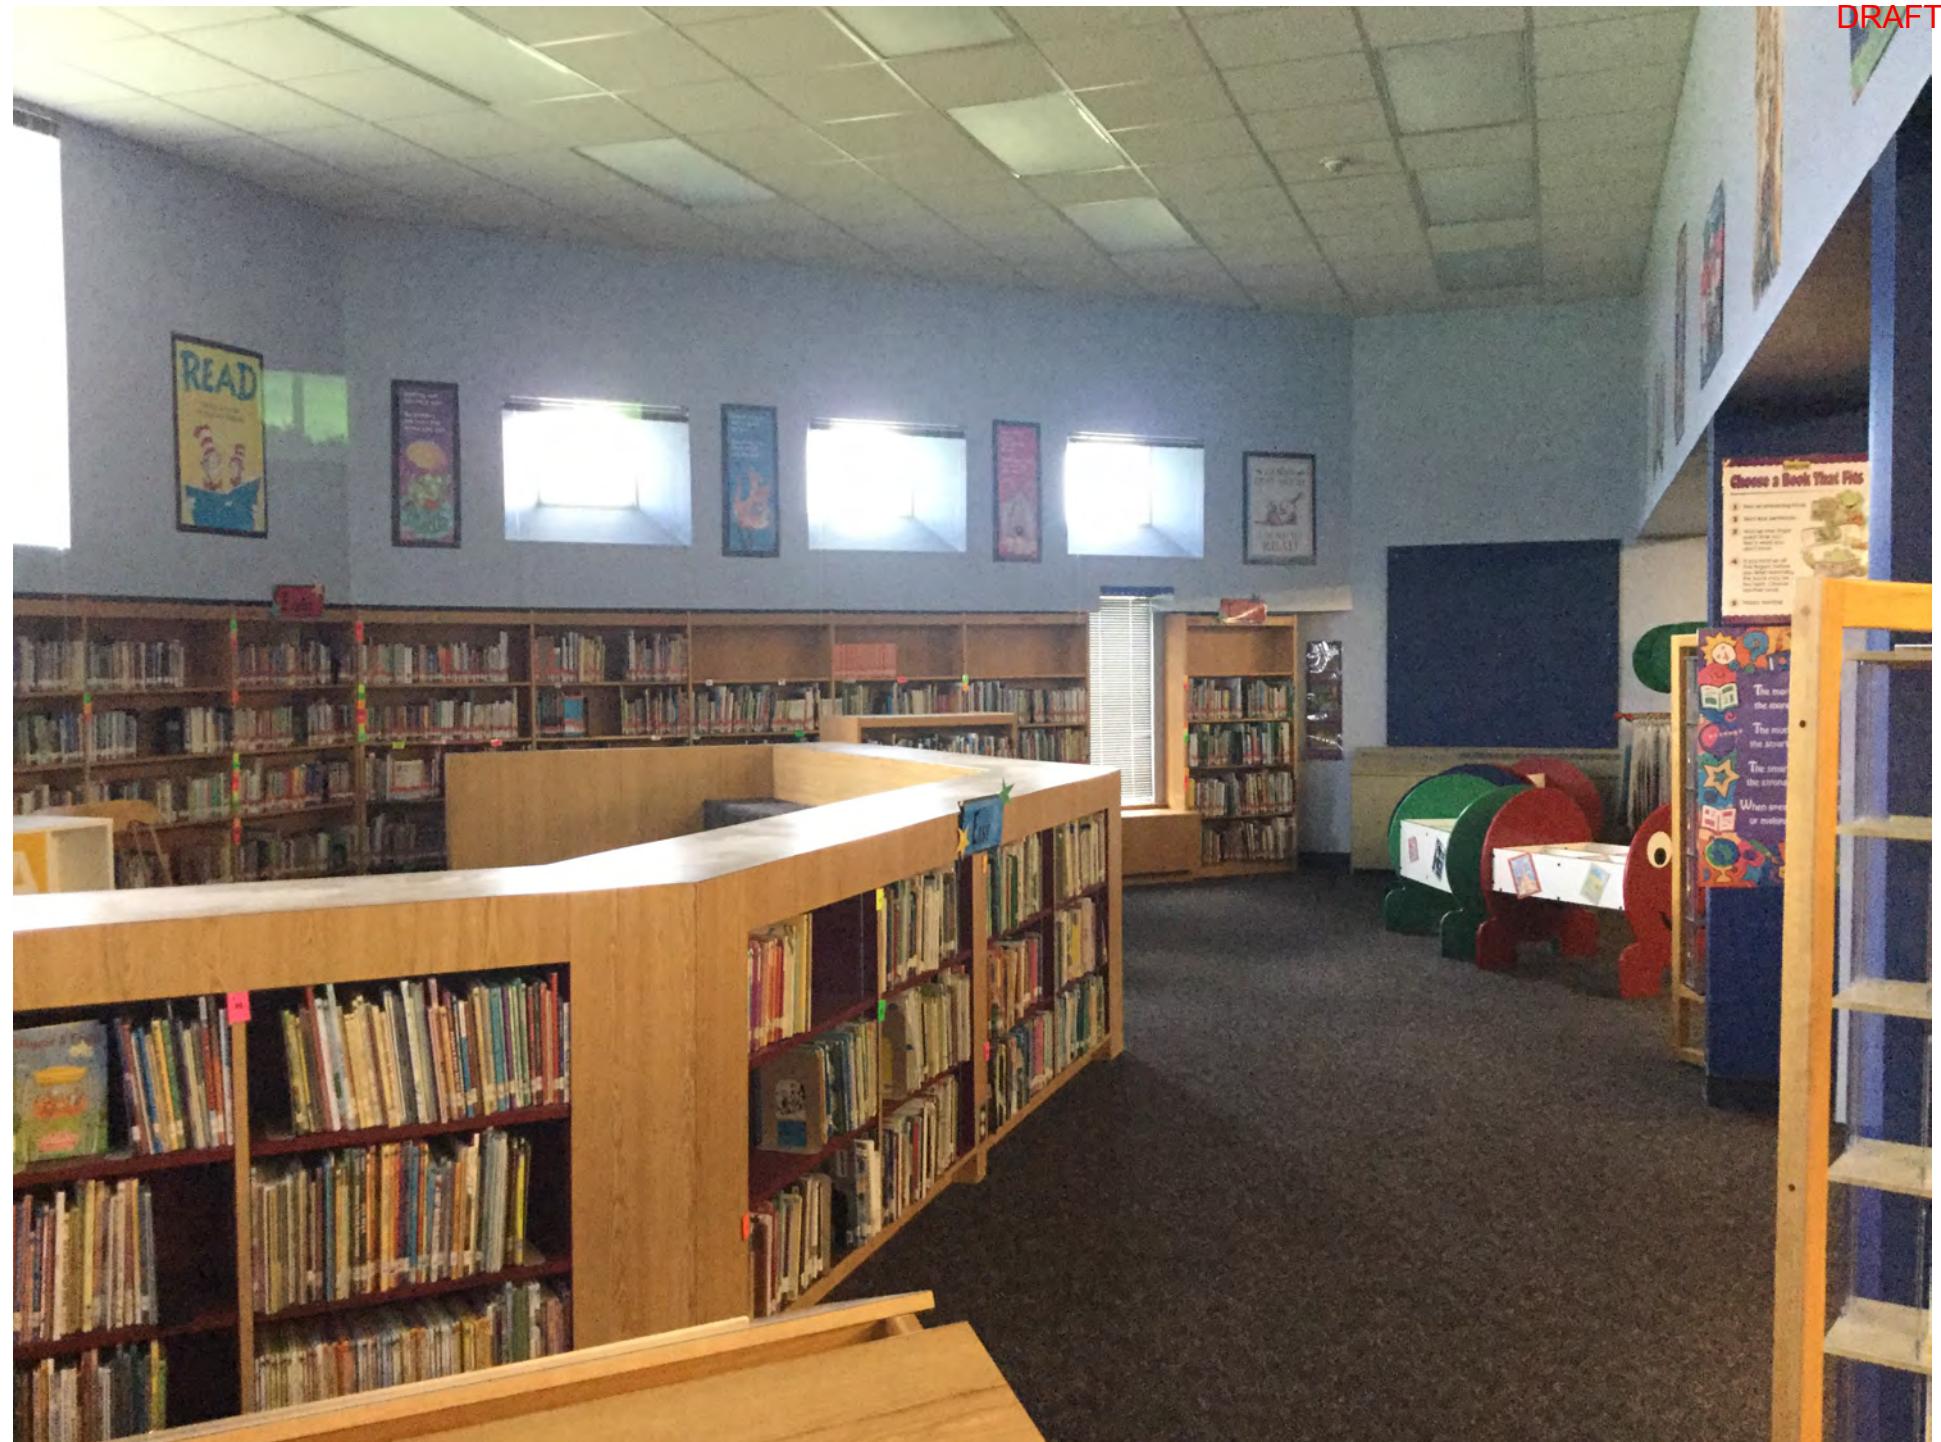
Photo 7.
5.3 Library

5.3 How well does the Library/Media Center support social interaction?			4				Comments	1.00 4.00
1) Very unsatisfactory 2) Unsatisfactory 3) Average 4) Good 5) Very good N/A) Does not apply.							There are several different areas for different types of interactions are currently provided in the library.

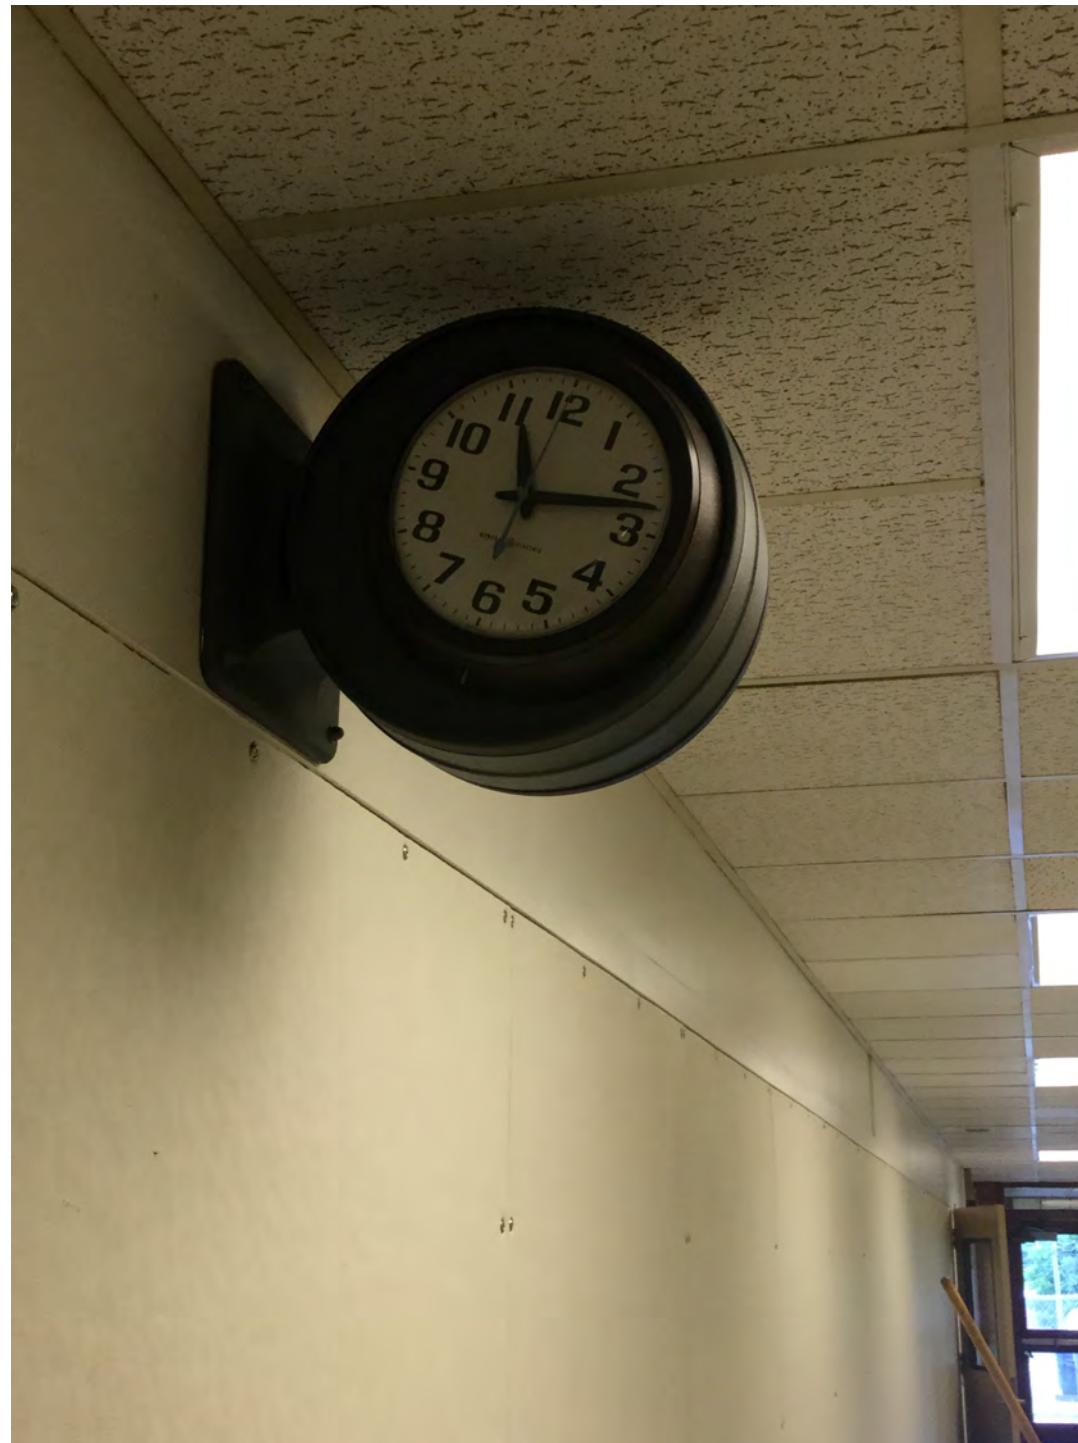
Photo 8.
7.1 Technology

7 - Technology	1	2	3	4	5	N/A		3.00
7.1 How well equipped are the facilities with instructional technology?	1						Comments	1.00 1.00
1) Very unsatisfactory - very few or no available computers or devices. Old/outdated technology 2) Unsatisfactory- few computers/devices. Some outdated technology 3) Average- 5-7 computers/devices. A mix of new and outdated technology 4) Good - 7-10 computers or devices. Mostly new technology. 5) Very good - 10+ computers or devices and new technology. N/A) Does not apply.							The facility has very little technology. There is no campus-wide system for keeping time. Currently the campus is only operating with several battery-run clocks. Campus-wide announcement system is hard to hear at most building wings--does not serve purpose properly.	
								see photo 8

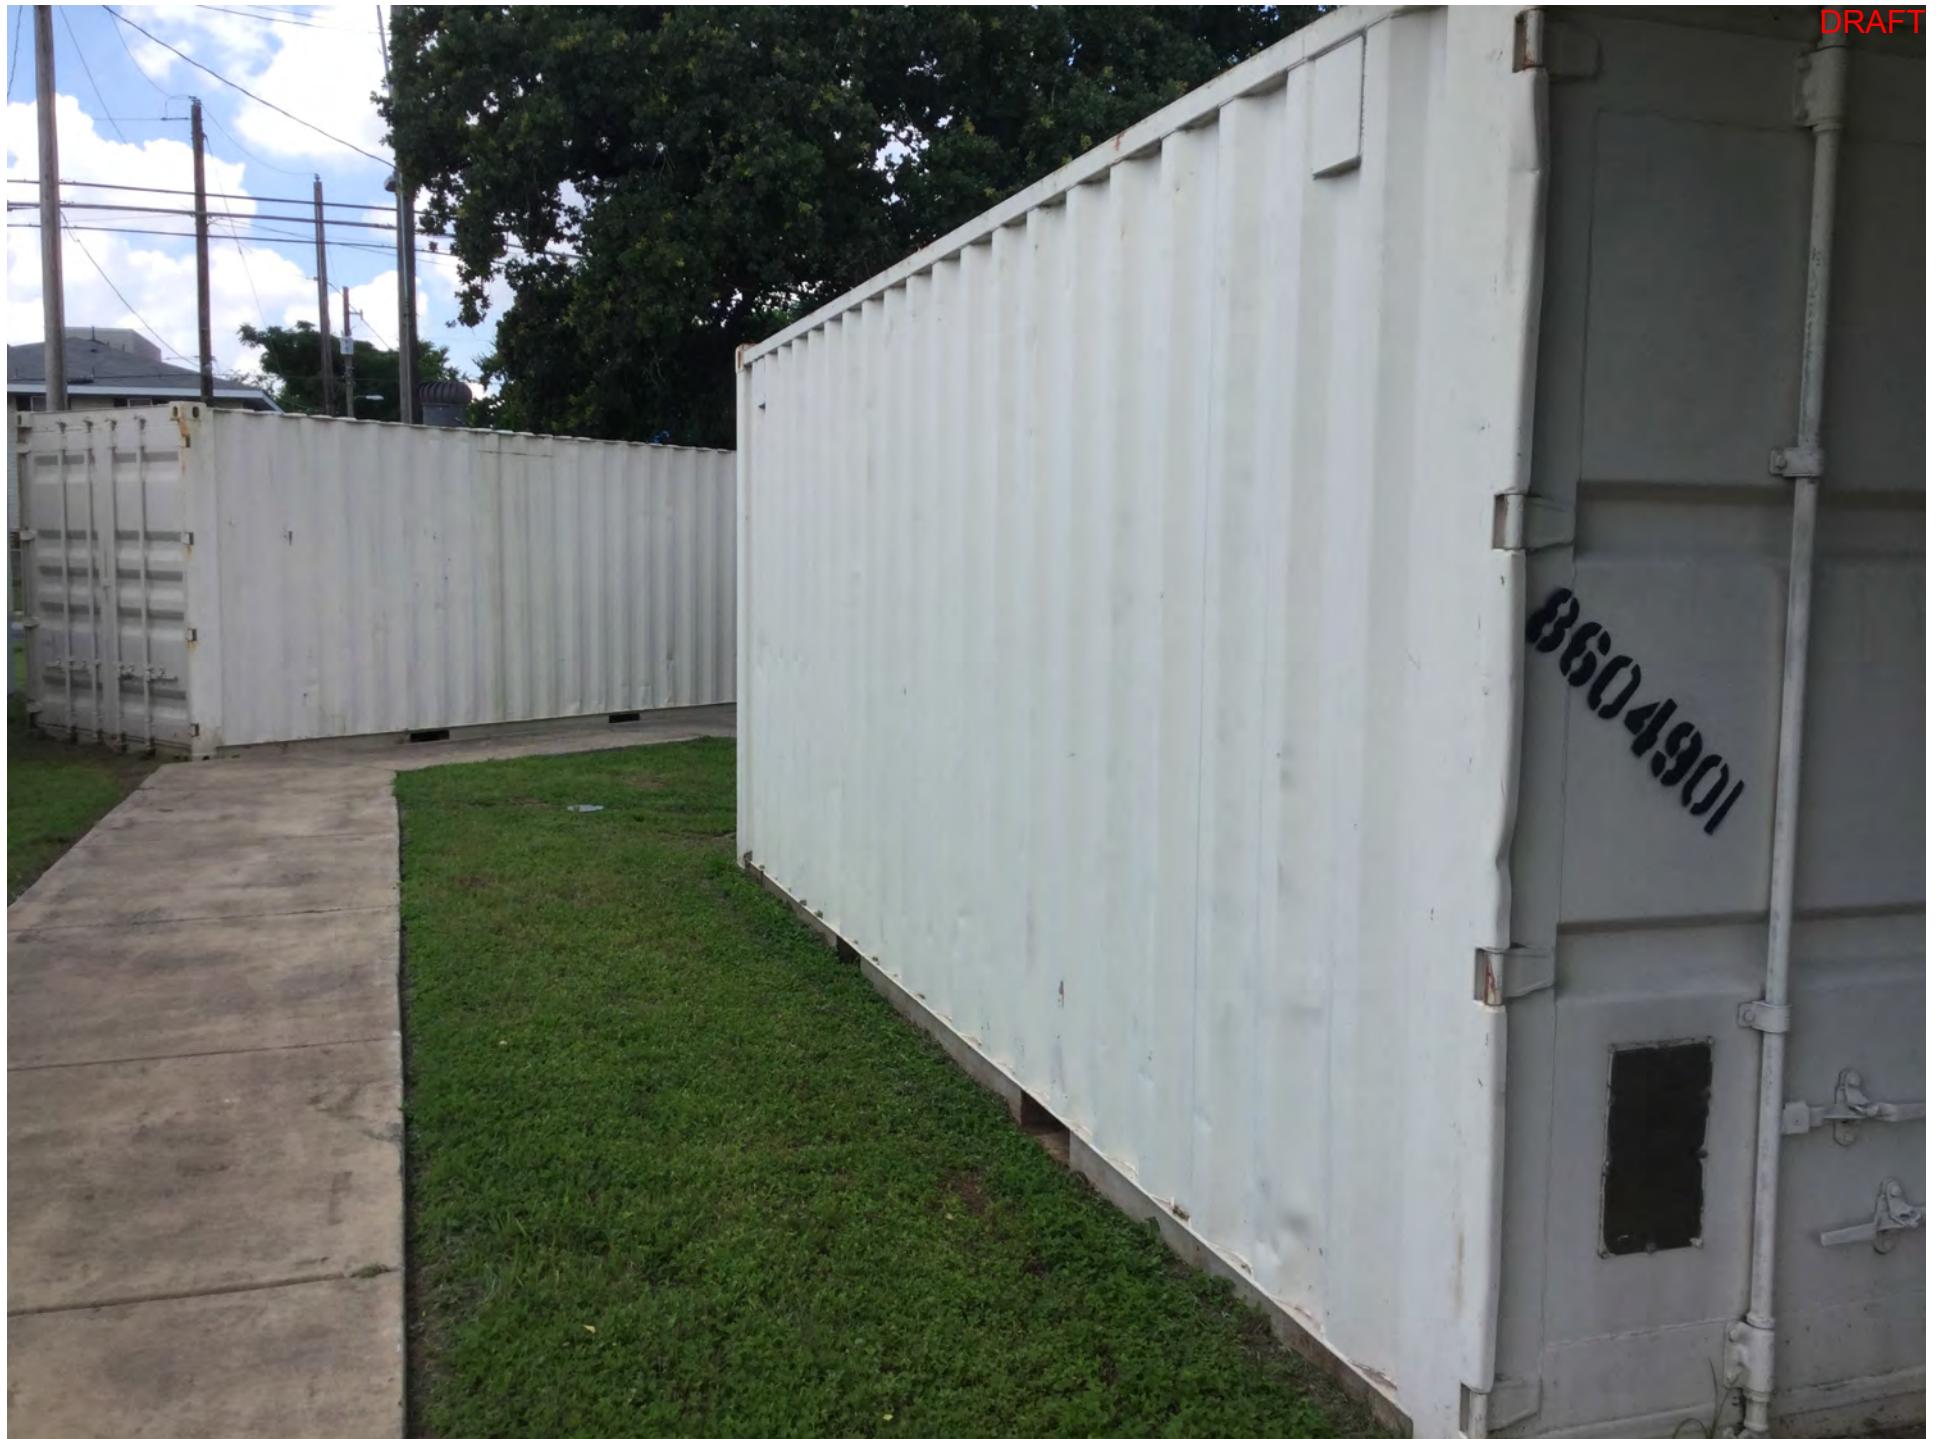
Photo 9.
8.1 Storage

General building storage is very inadequate and is being supplemented by three large shipping containers outside the school (*AISD construction department indicates unused furniture is*

(located in the shipping containers). Storage is one of the most critical needs at Sims Elementary. While the general building storage is very inadequate and undersized, the classroom and student storage is being upgraded during summer renovations (*recently completed construction*) to a satisfactory condition.

8 - Storage	1	2	3	4	5	N/A		9.00
8.1 Is there adequate general storage in the building?	1						Comments	1.00 1.00
1) Very unsatisfactory 2) Unsatisfactory 3) Average 4) Good 5) Very good N/A) Does not apply.							No, there is not adequate storage. There are three large metal storage containers in the back of the school for storage. The campus has no storage rooms. <i>AISD Construction Department Comment: Storage containers have unused furniture.</i>	
								see photo 9
