## Educational Suitability Summary Report

St. Elmo Elementary School

Date: 07/22/2016 (Rev 1 – 11/14/2016 : CAC Comments)

## Austin ISD Educational Suitability Assessment Criteria

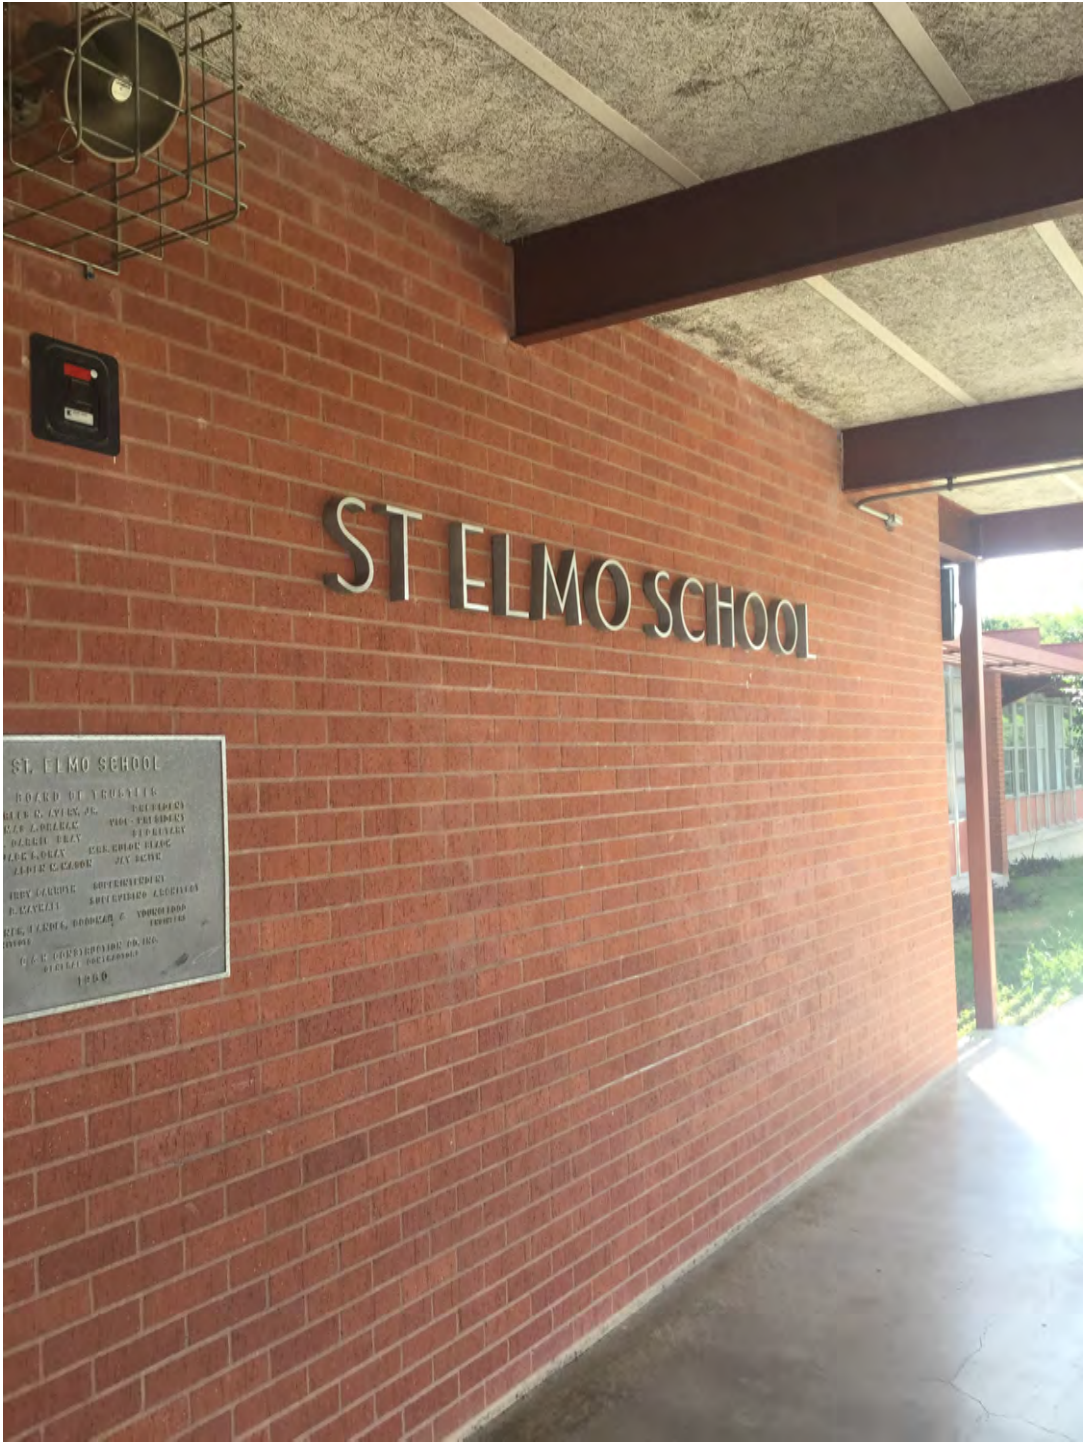
1.4 Signage

1.4	Is the building easily identified with appropriate signage and community wayfinding?			3				Comments	0.25 0.75
	1) Campus has no signage and no striping. 2) Signage is faded/hidden. 3) Signage & striping visible but not apparent. 4) Signage is visible but not good condition. 5. Signage and wayfinding is visible and easy to use. N/A) Does not apply.							The signage could be more clear.

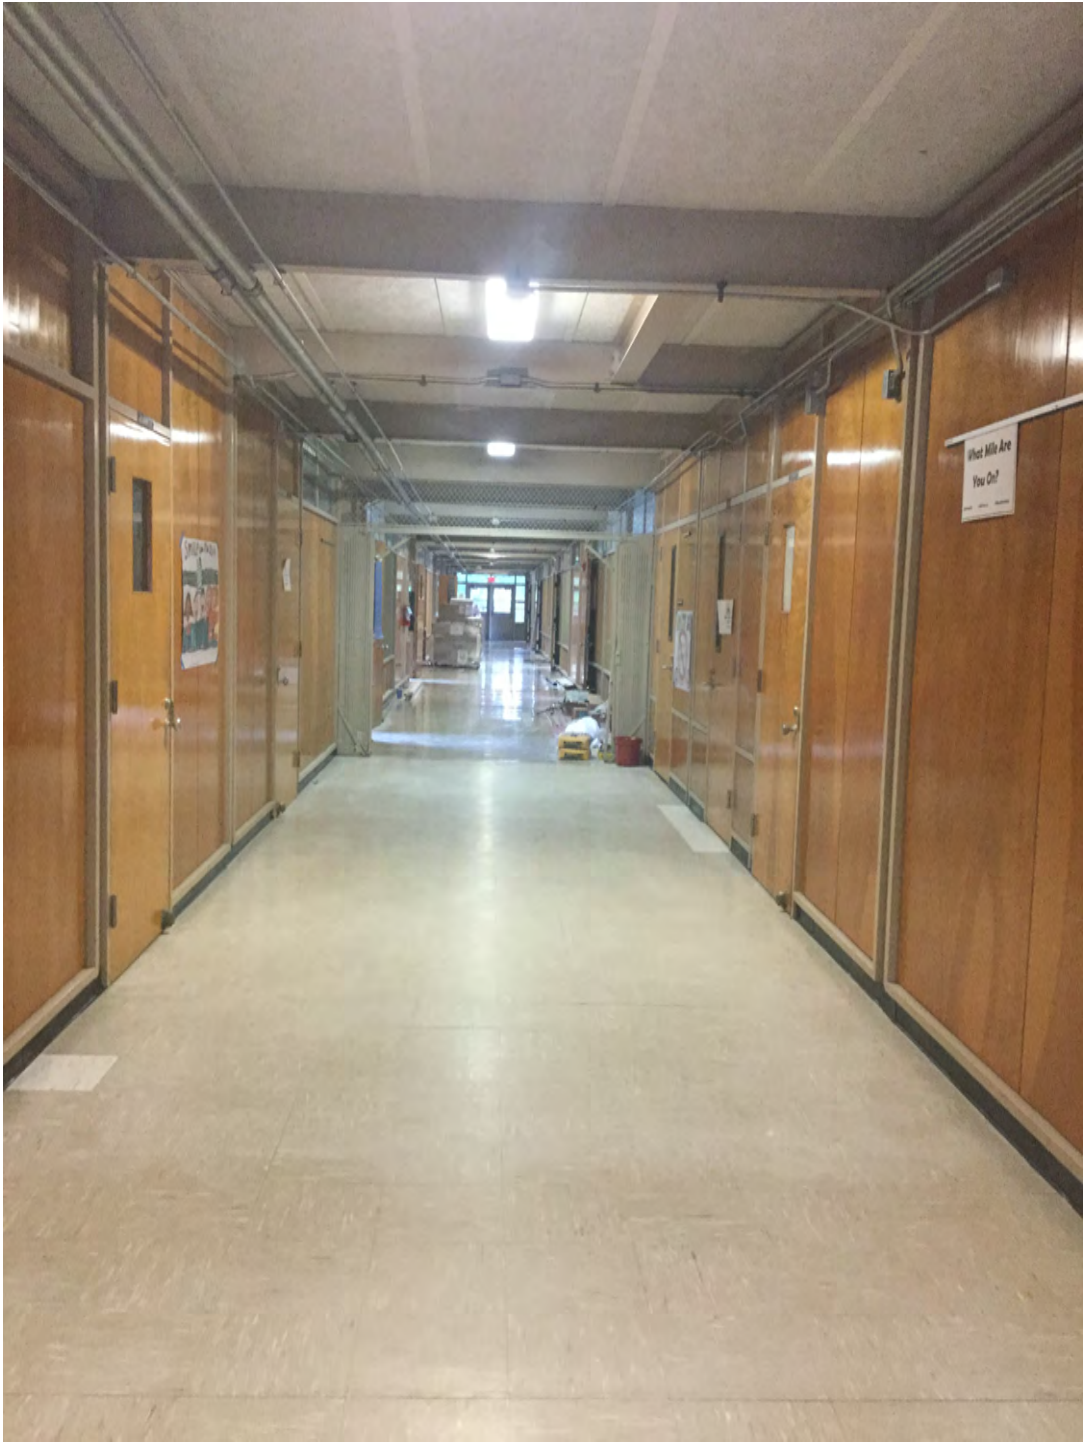
2.1 Corridors

1) Primary circulation is 5'-0" to 6'-0" wide. 2) Primary circulation is 6'-0" to 7'-0" wide 3) Primary circulation is 7'-0" to 8'-0" wide 4) Primary circulation is 8'-0"-10'-0" wide 5) Primary circulation is 10'-0"+ wide N/A) Does not apply.							The interior circulation is sufficient, but the acoustics are unsatisfactory in the hallways due to louvers to the classrooms. The wood paneling also makes some corridors appear dark.

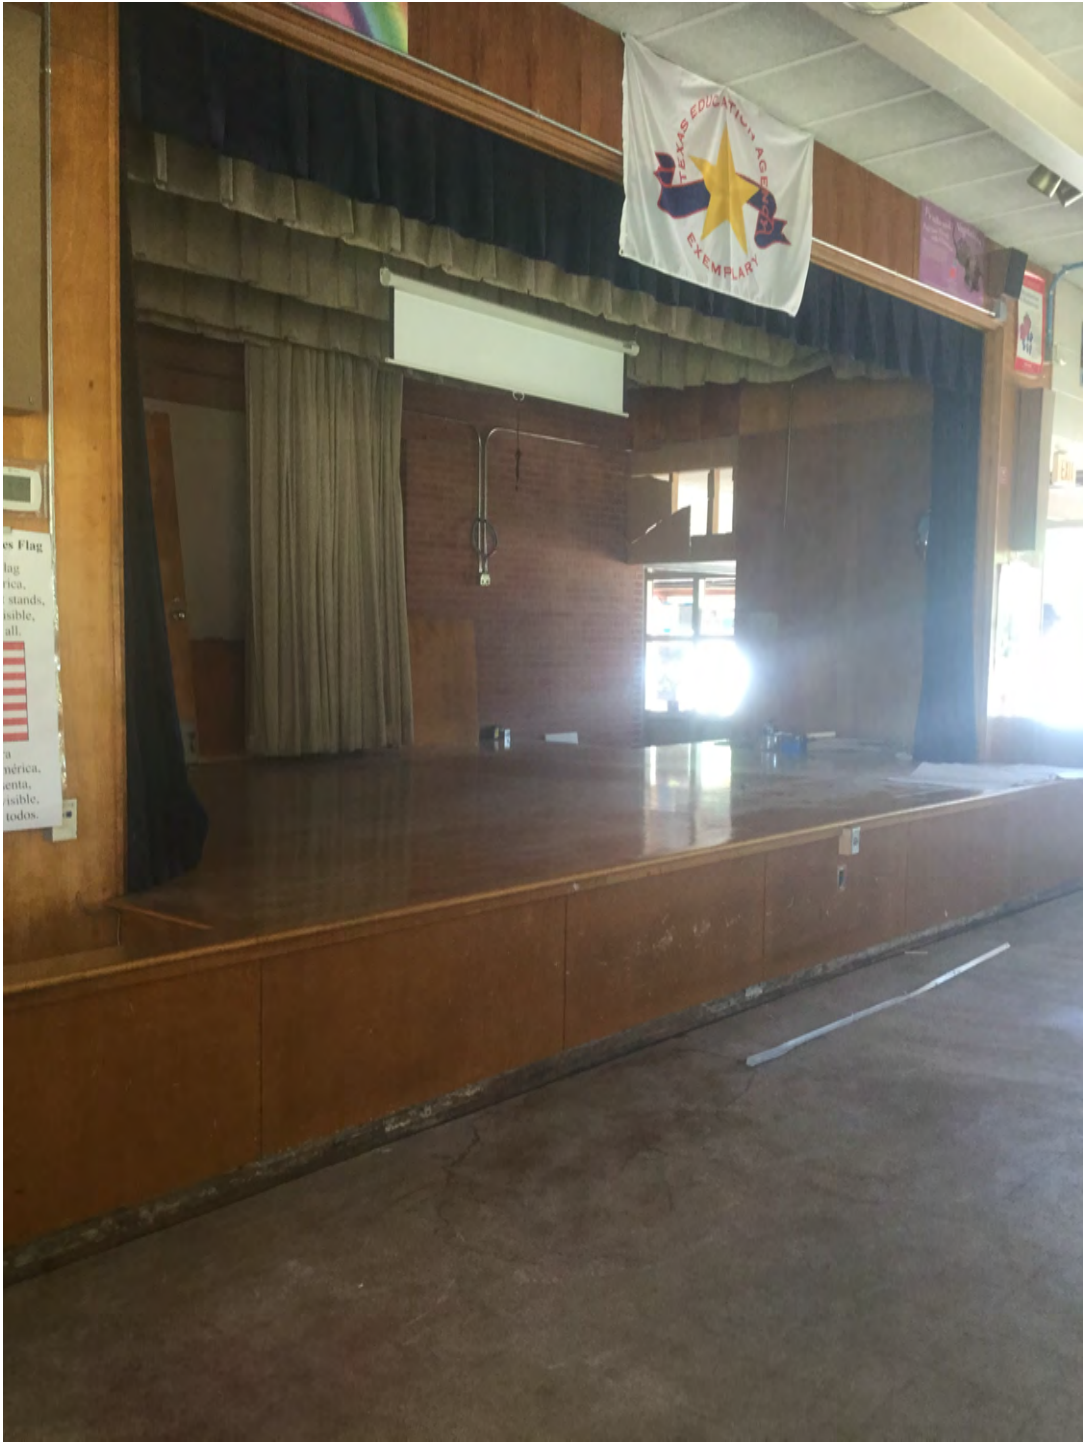
3.8 Stage

3.8	Are music, drama, or performance spaces appropriately configured per the ed spec?		2					Comments	1.00 2.00
1) Very unsatisfactory 2) Unsatisfactory 3) Average 4) Good 5) Very good N/A) Does not apply.								The music classroom is in a portable. The stage is showing signs of wear and has no usable storage.

3.9	Are music, drama, or performance <b>support</b> spaces appropriately configured per the ed spec?	1						Comments	1.00 1.00
1) Very unsatisfactory - Support spaces are disconnected from served spaces, too small, do not meet needs 2) Unsatisfactory - Support spaces are connected, but too small, inadequate for needs 3) Average - Connected, moderate size, but need some renovations or updates to function well 4) Good - Connected, good size/layout, meets needs/functions well 5) Very good - connected, generous size, nice condition, functions appropriately N/A) Does not apply.								There is no stage storage and no ADA access to the stage. <i>CAC/Principal Comment: ADA access to the stage has been added as a result of the 2013 bond program.</i>
