## Educational Suitability Summary Report

Widen Elementary School – BLDG # 175

Date: 7/19/2016

**Austin ISD Educational Suitability Assessment Criteria**

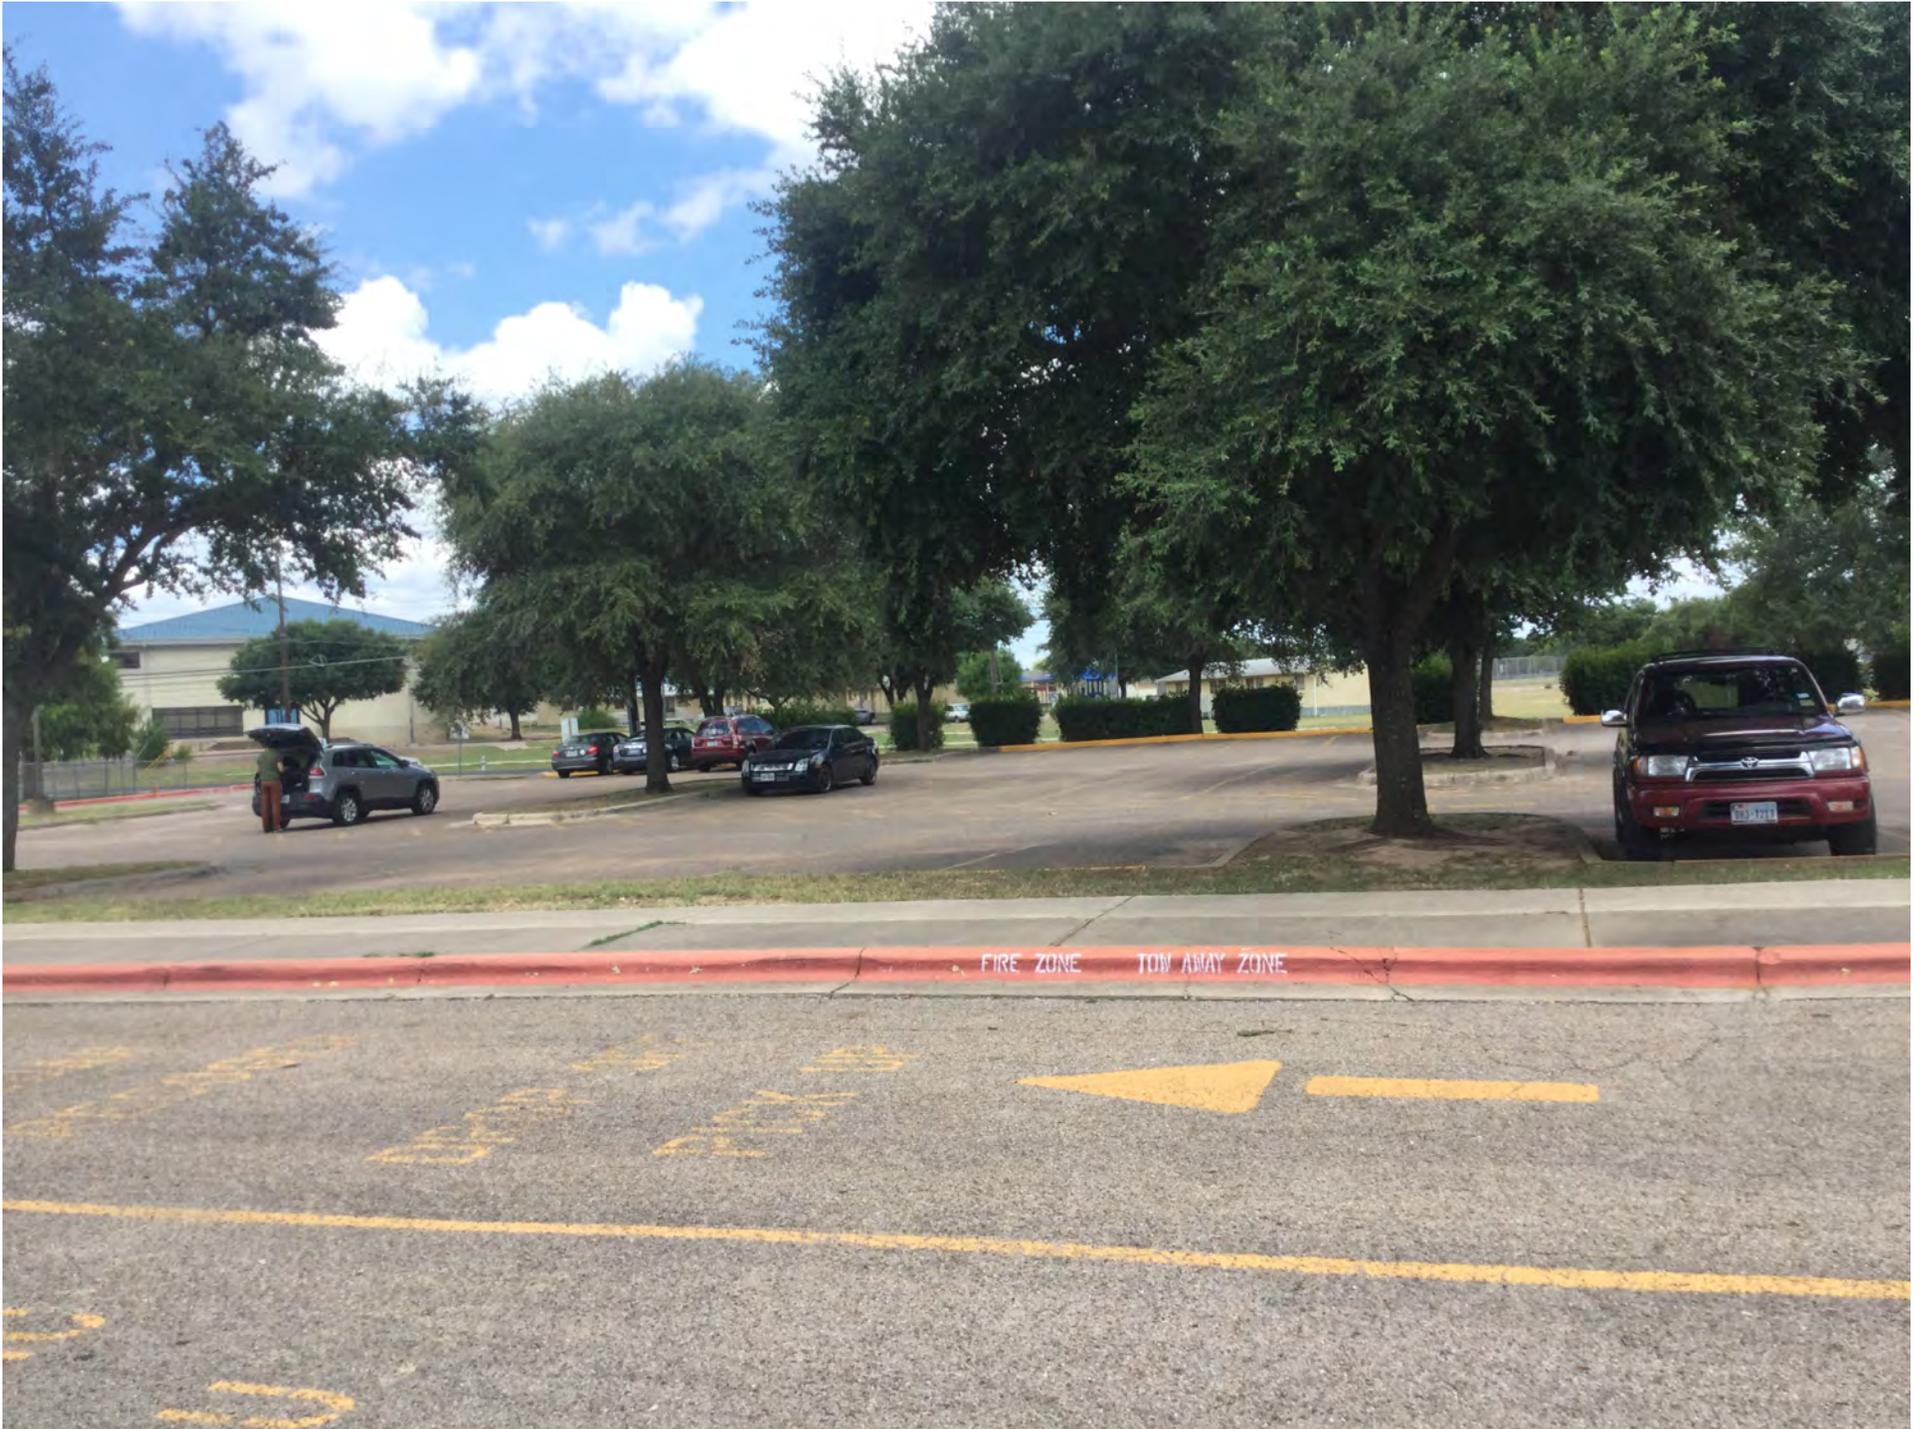
Photo 1. Parking

1 - Exterior		1	2	3	4	5	N/A			9.75
1.1	Does the site permit desirable separation of vehicular, bus and pedestrian traffic?				4			Comments	1.00	4.00
1) Bus , car and pedestrian all happen at the same location. 2) Cars and buses mix, pedestrians are separated. 3) Buses, cars, and pedestrians are separate but stack space is small. 4) Buses, cars, and pedestrians are separate but drop off does not have a canopy or a holding place like a commons or cafeteria. 5) Buses, cars, and pedestrians are separate and drop off area has a canopy and destination. N/A) Does not apply.								There needs to be a secured vestibule for parent pickup and drop off. There is ample parking space.	see image 1

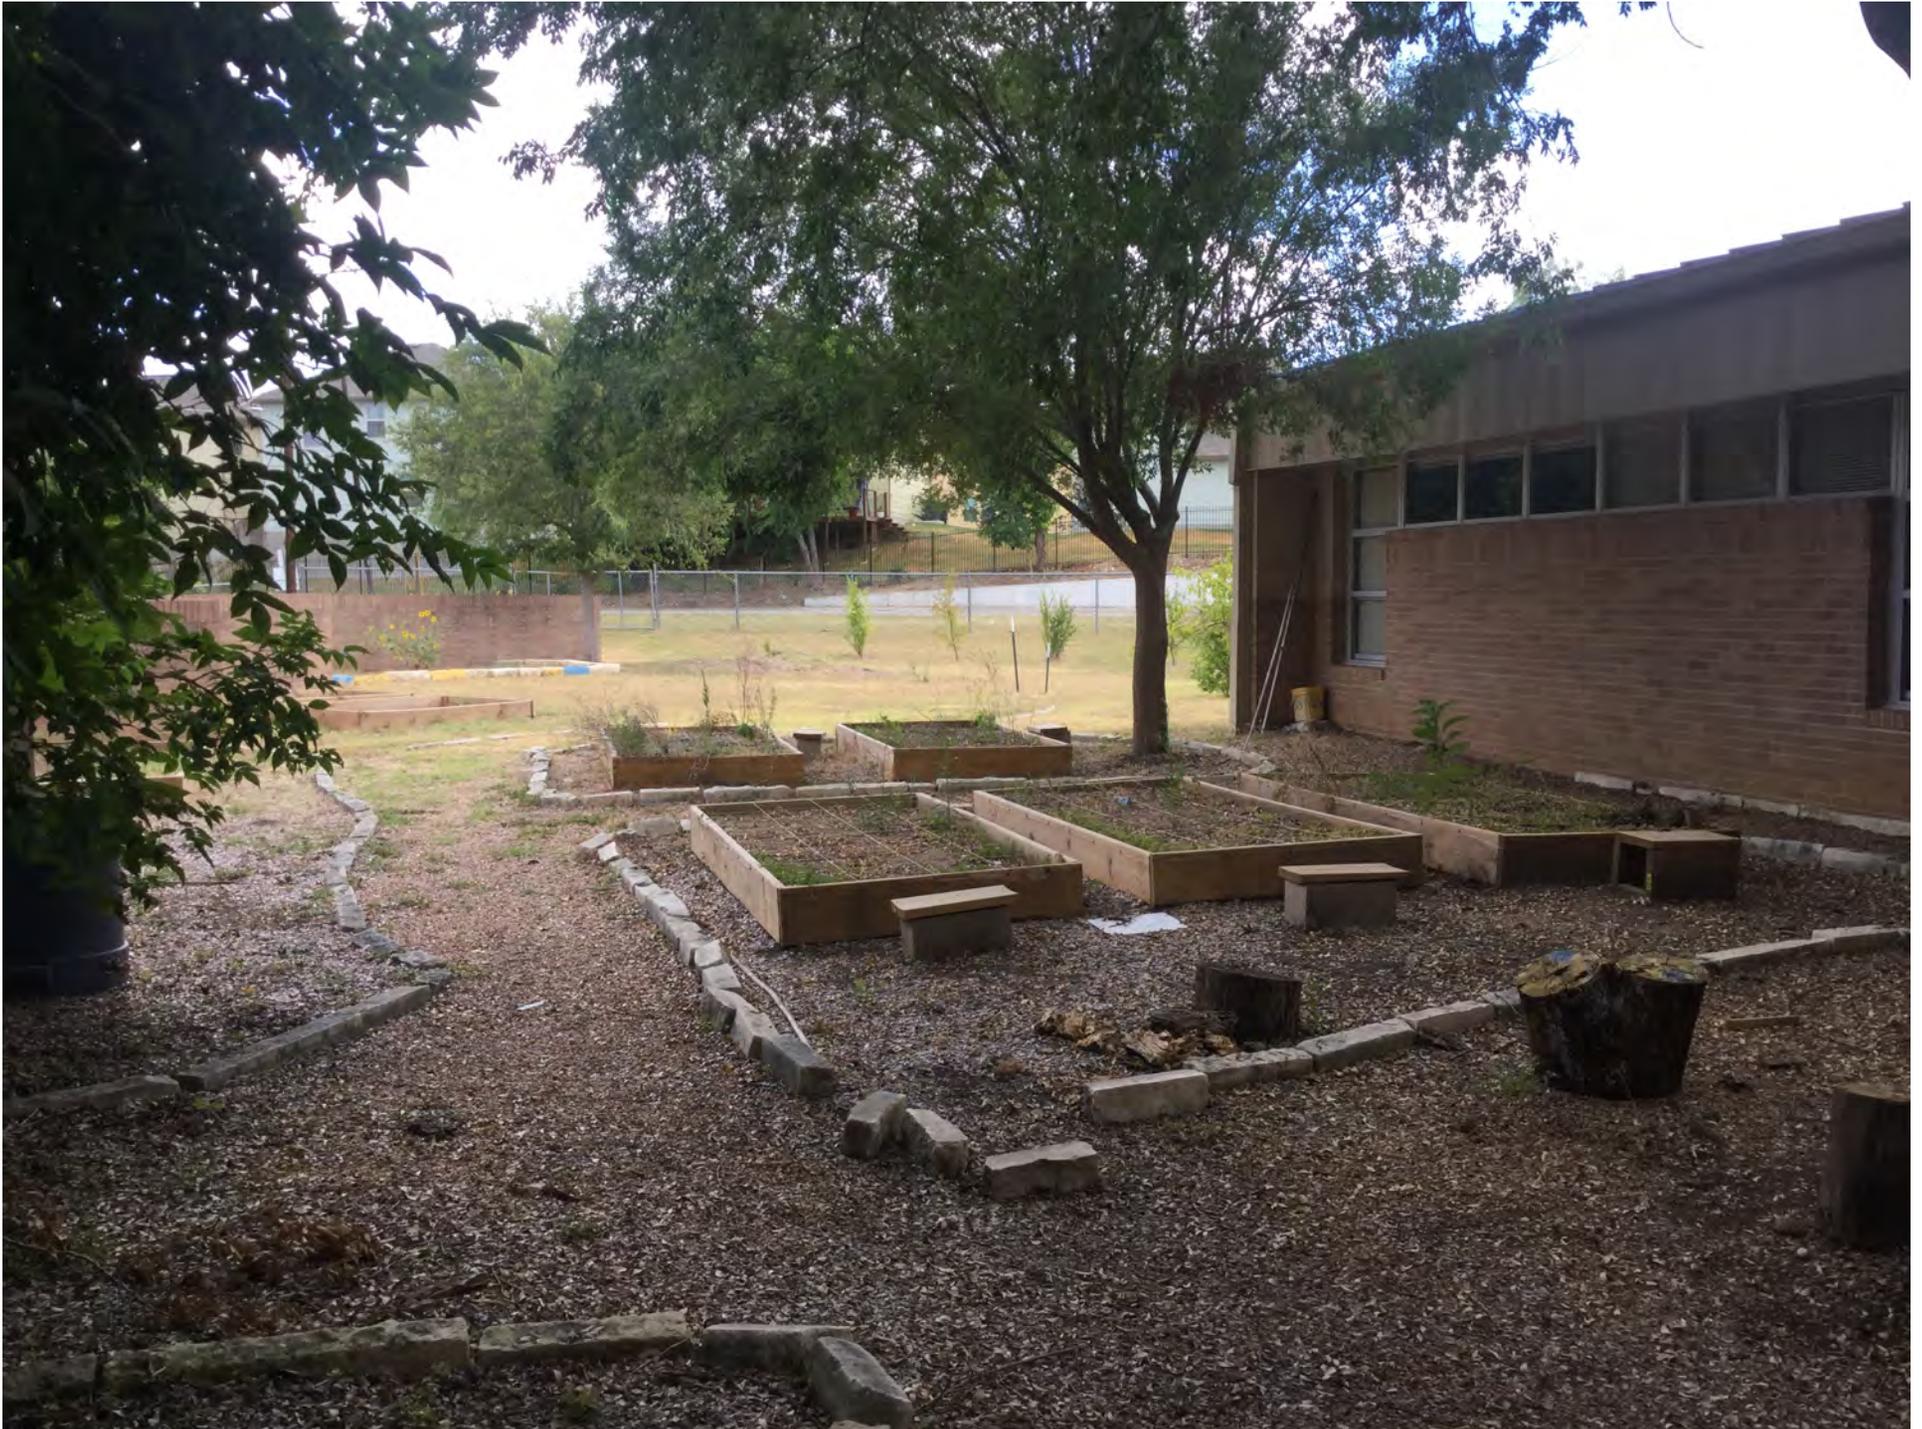
Photo 2. Garden

1.2	Are opportunities provided for outdoor learning (outdoor classrooms, gardens, etc.)?			3				Comments	1.00	3.00
1) Outdoor space exists is not developed 2)Outdoor space for learning exists but not connected to classroom learning areas. 3. Outdoor learning spaces exist and are accessible but not in good condition. 4. Outdoor learning spaces need minor improvements to function well. 5. Outdoor learning spaces are in excellent condition. N/A) Does not apply.								There are opportunities present for outdoor learning but they need to be developed and connected.	see image 2

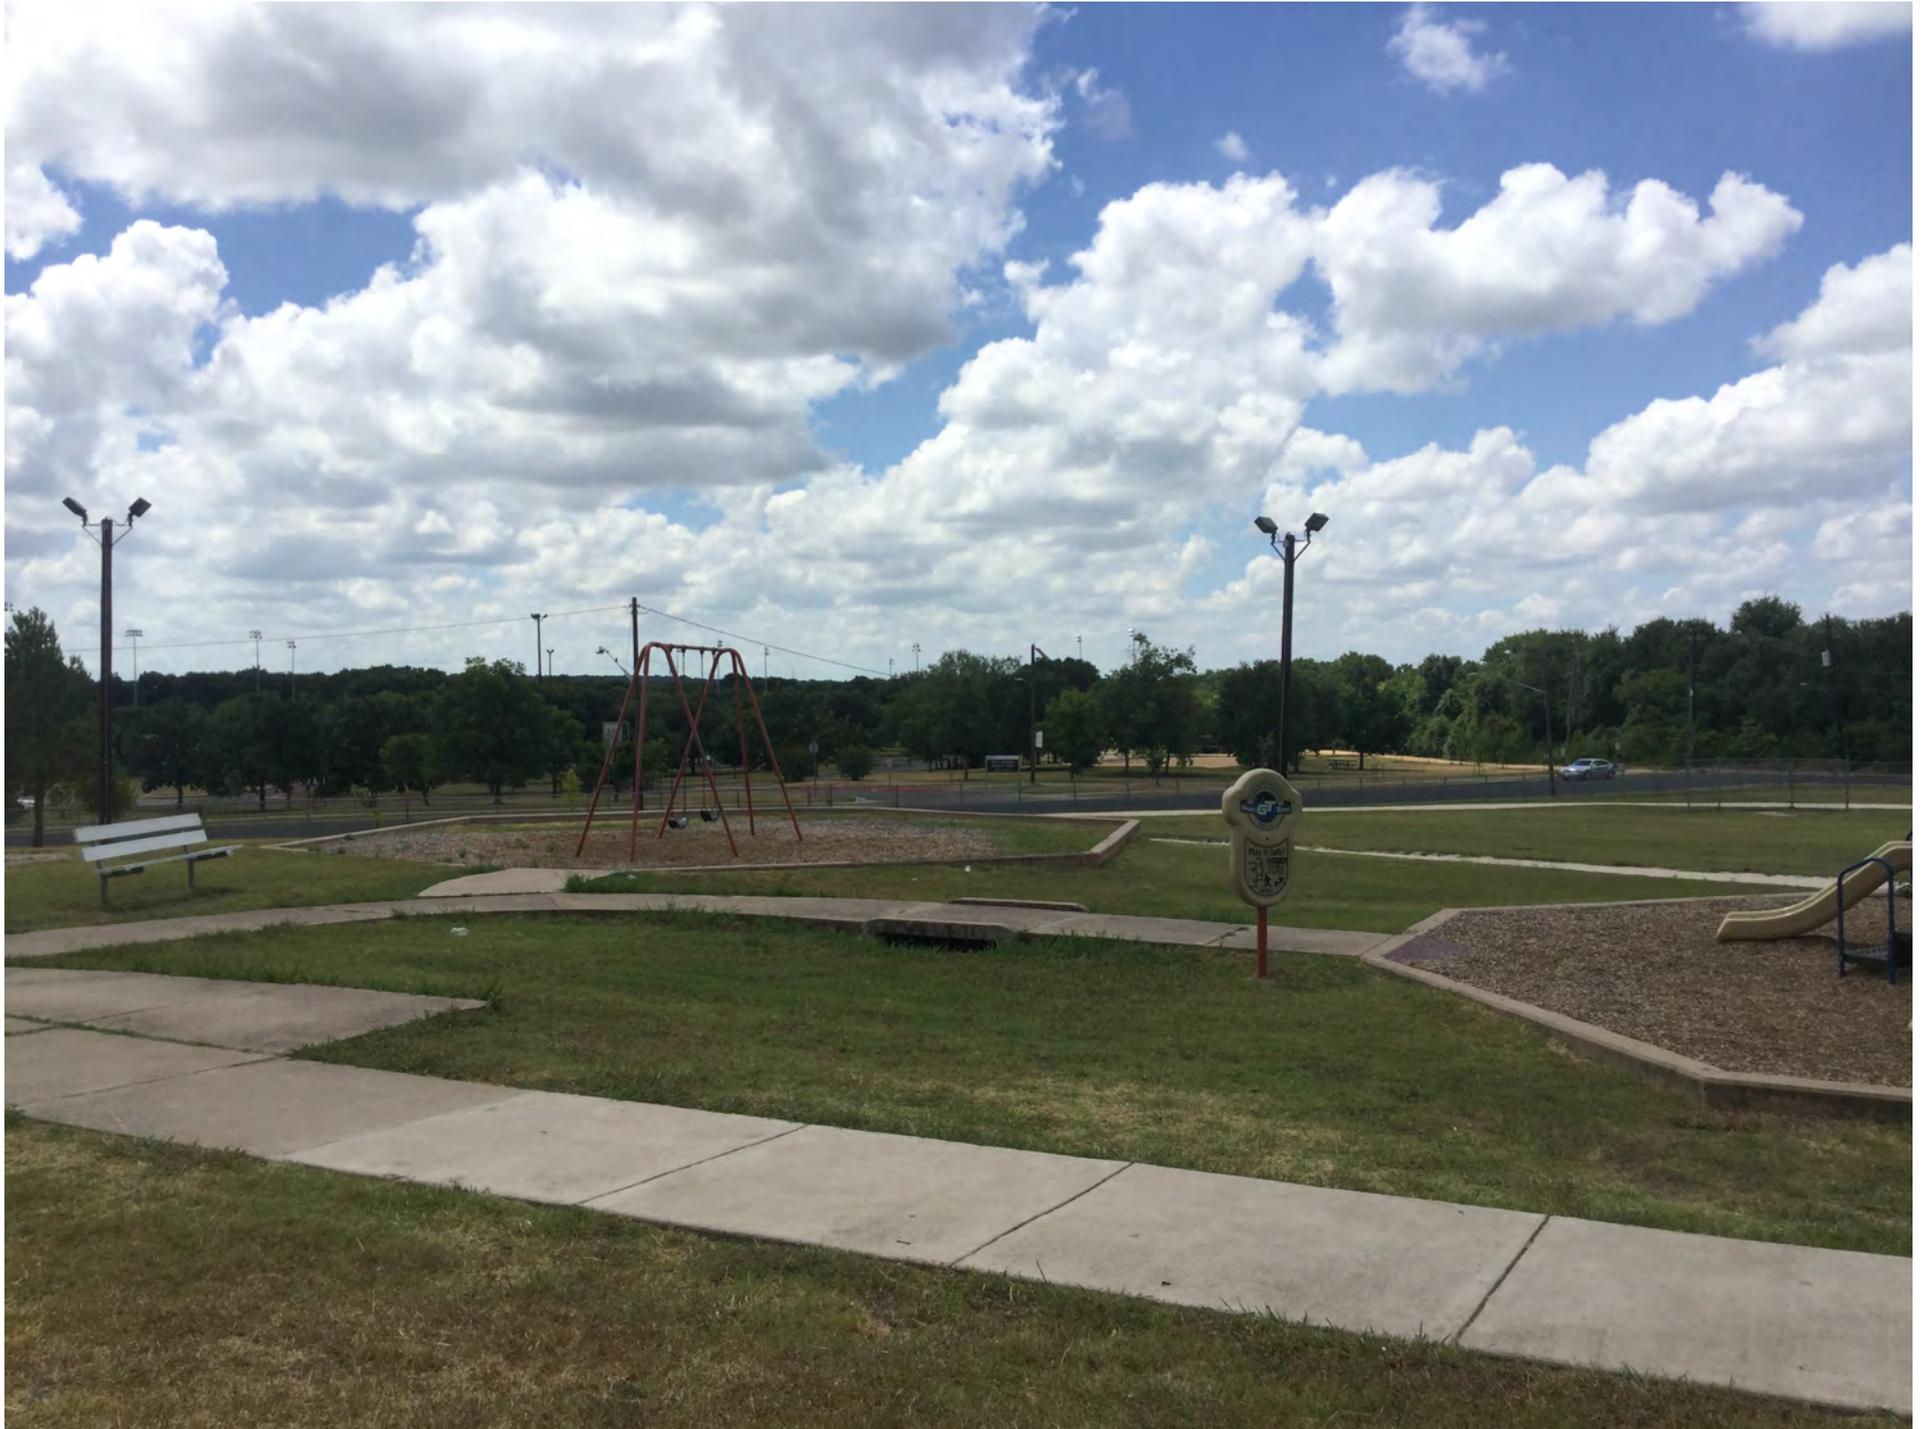
Photo 3. playfield

1.3	Are outdoor play spaces and playfields adequate in size and configuration?		2					Comments	1.00	2.00
1) Outdoor play space exists, not developed 2)Outdoor play space exists but is not connected to gym or other athletic support areas or is too small. 3. Outdoor play spaces exist, are connected to other athletic areas, are the right size, but are not in good condition. 4. Outdoor play spaces need minor improvements to function well. 5. Outdoor play spaces are in excellent condition. N/A) Does not apply.								The campus does not have a proper sports field. The track needs to be upgraded as it becomes uneven during the rain. The play area needs fencing around it.	see image 3

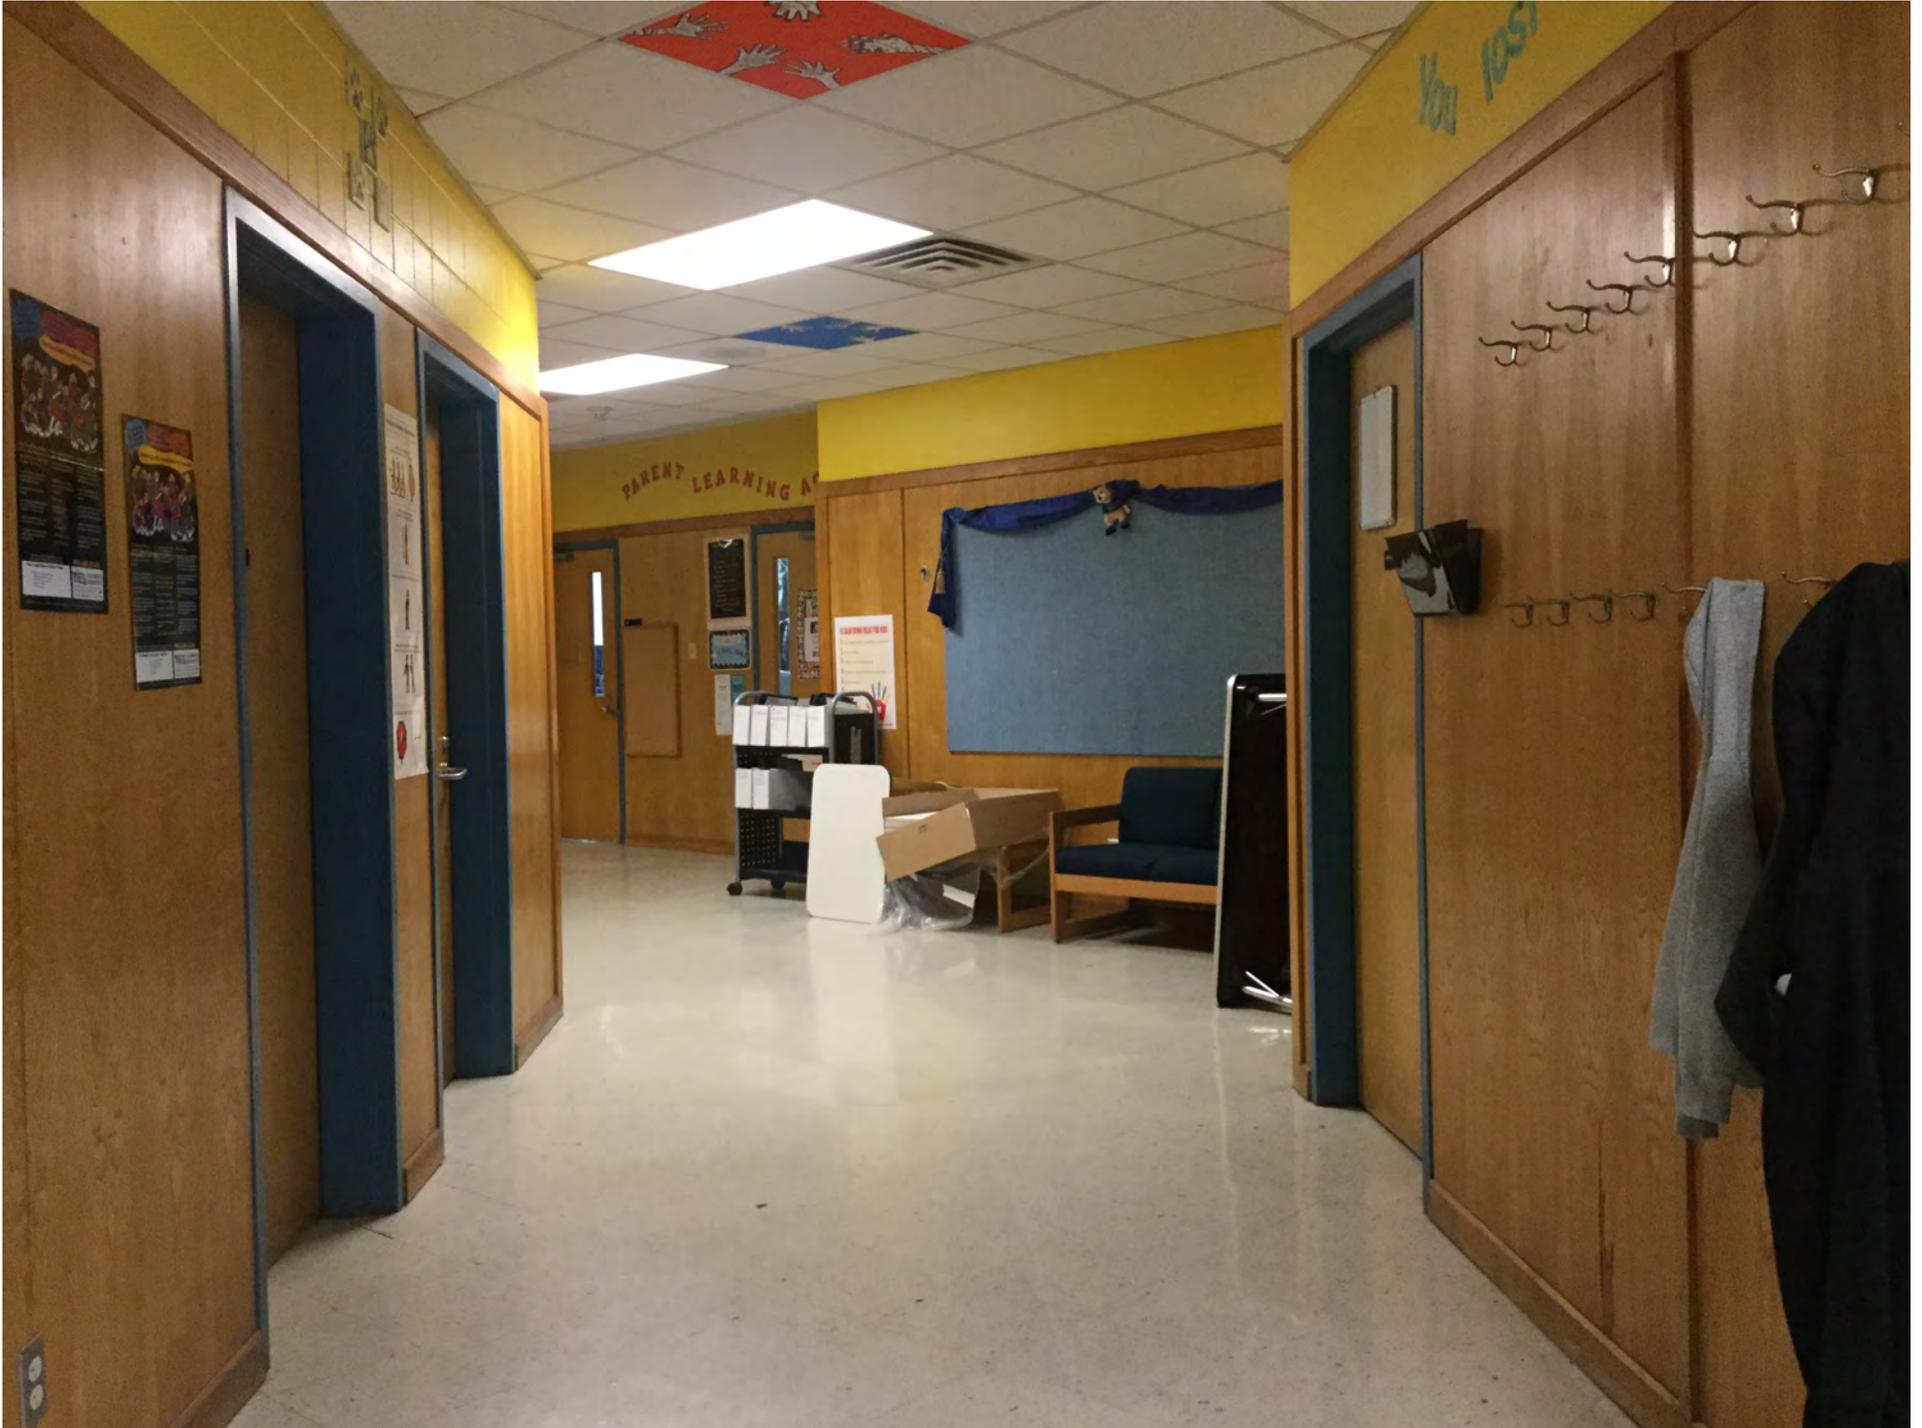
Photo 4. Hallway

2 - General Building		1	2	3	4	5	N/A	4.00		
2.1	Are interior circulation routes wide enough to safely and effectively accommodate student movement?				4			Comments	0.50	2.00

1) Primary circulation is 5'-0" to 6'-0" wide. 2) Primary circulation is 6'-0" to 7'-0" wide 3) Primary circulation is 7'-0" to 8'-0" wide 4) Primary circulation is 8'-0"-10'-0" wide 5) Primary circulation is 10'-0"+ wide N/A) Does not apply.								see image 4

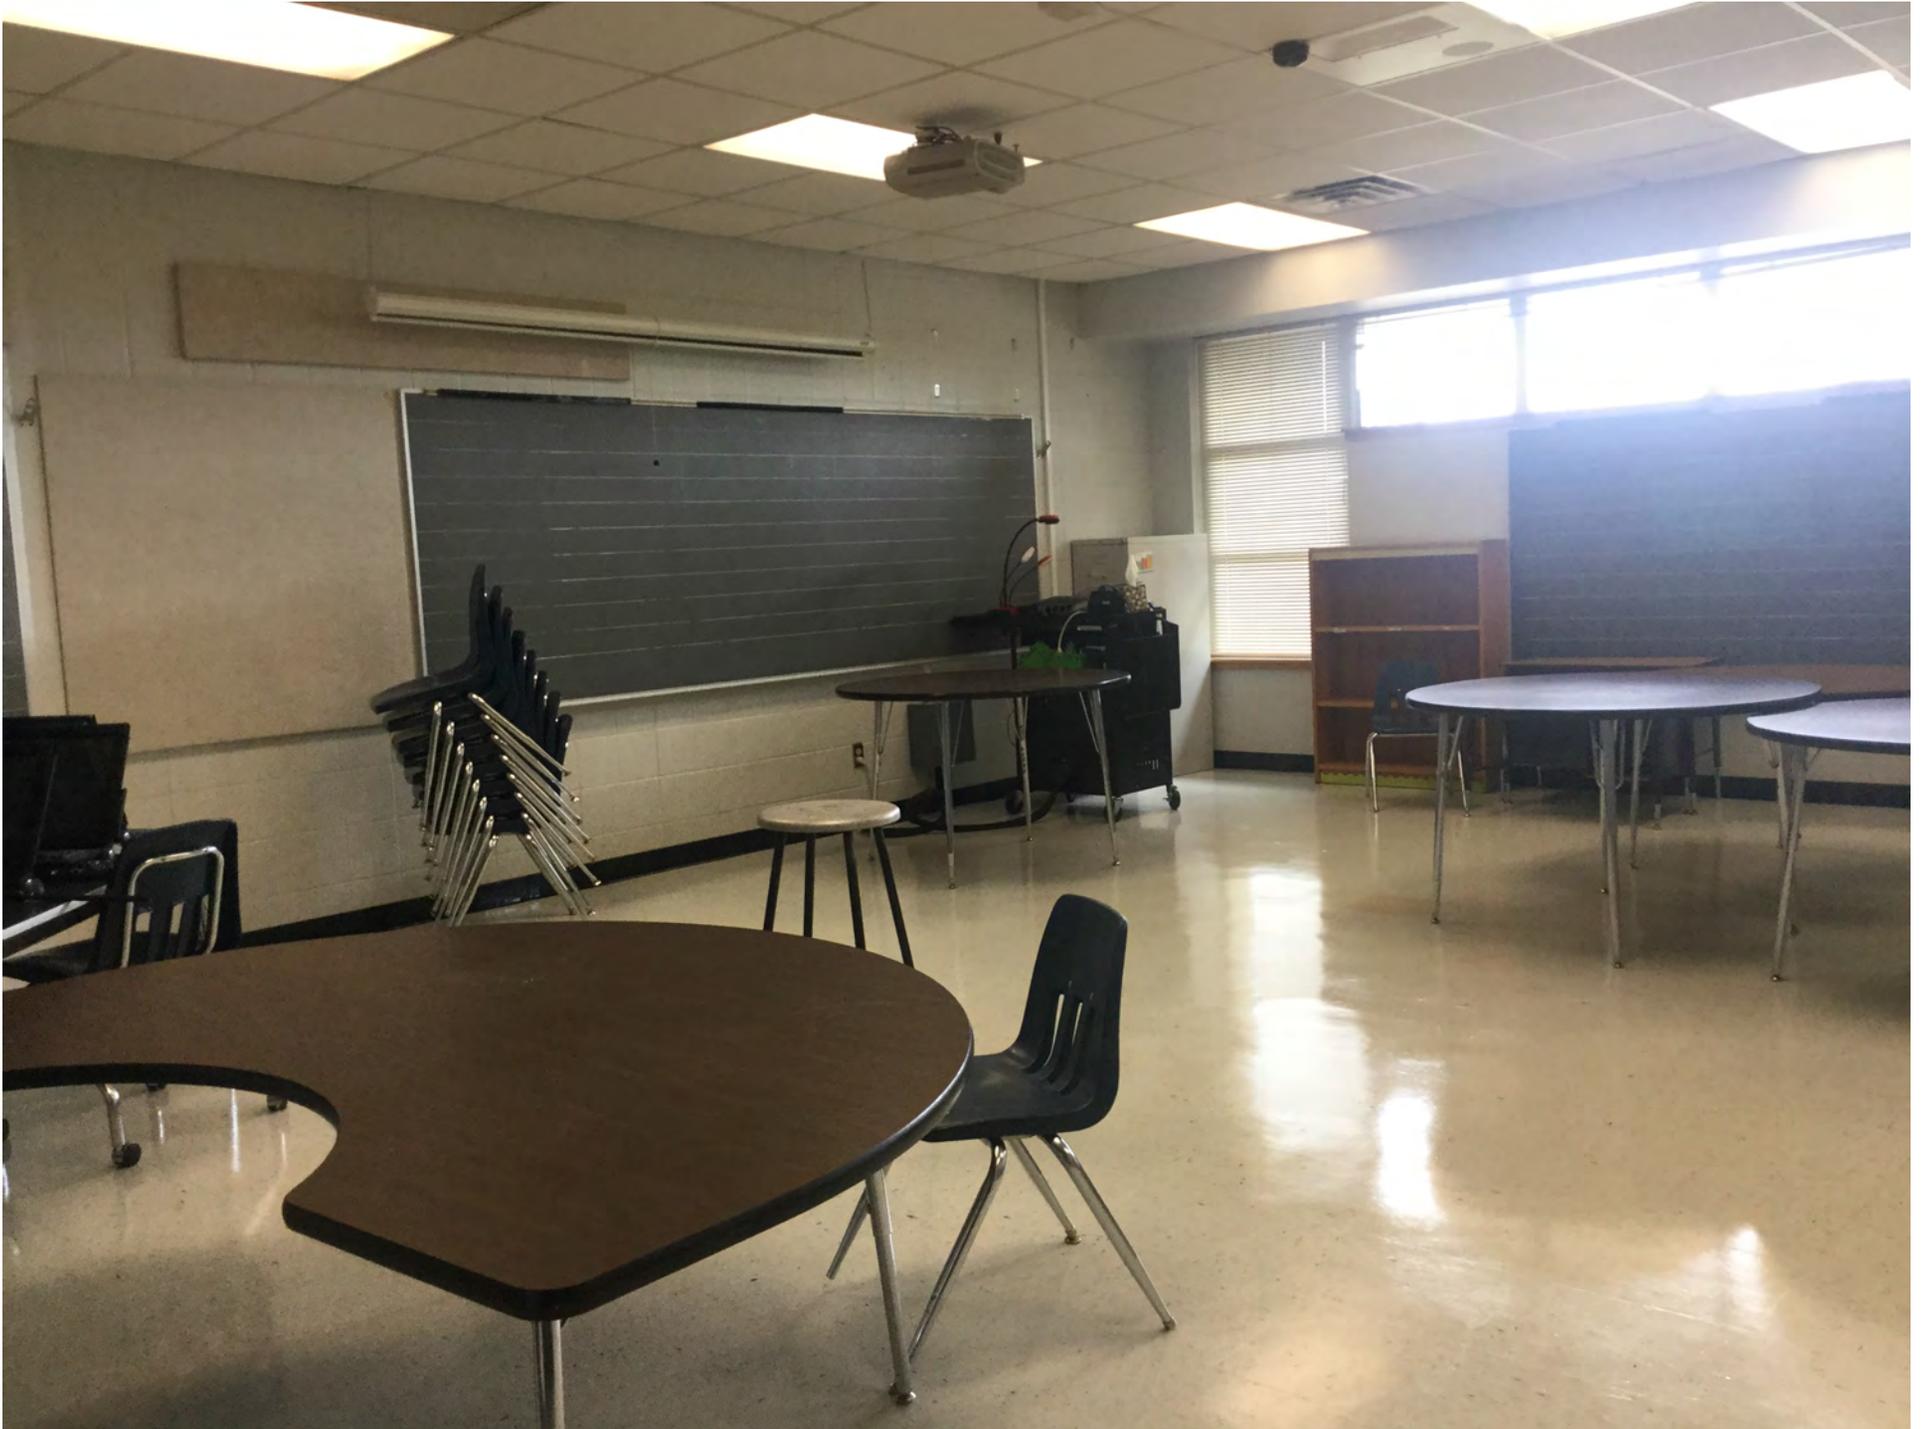
Photo 5. pre-k classroom

3 - Academic & Co-Curricular Support		1	2	3	4	5	N/A			32.00
3.2	Are Pre-K and Kinder classrooms appropriately configured per the ed spec? (elementary school only)			3				Comments	1.00	3.00

1) Very unsatisfactory - Too small, awkward layout, does not meet needs 2) Unsatisfactory - Too small, only one area for all teaching methods, limited flexibility 3) Neutral - Moderate size, two areas for different teaching methods, some flexibility, access to student storage/casework 4) Satisfactory - Good size, at least two zones for different teaching methods, flexibility and student storage, not new 5) Very Satisfactory - Good size, two zones for different teaching methods, flexibility and student storage/casework, adequate display area and visual teaching tools N/A) Does not apply.								see image 5

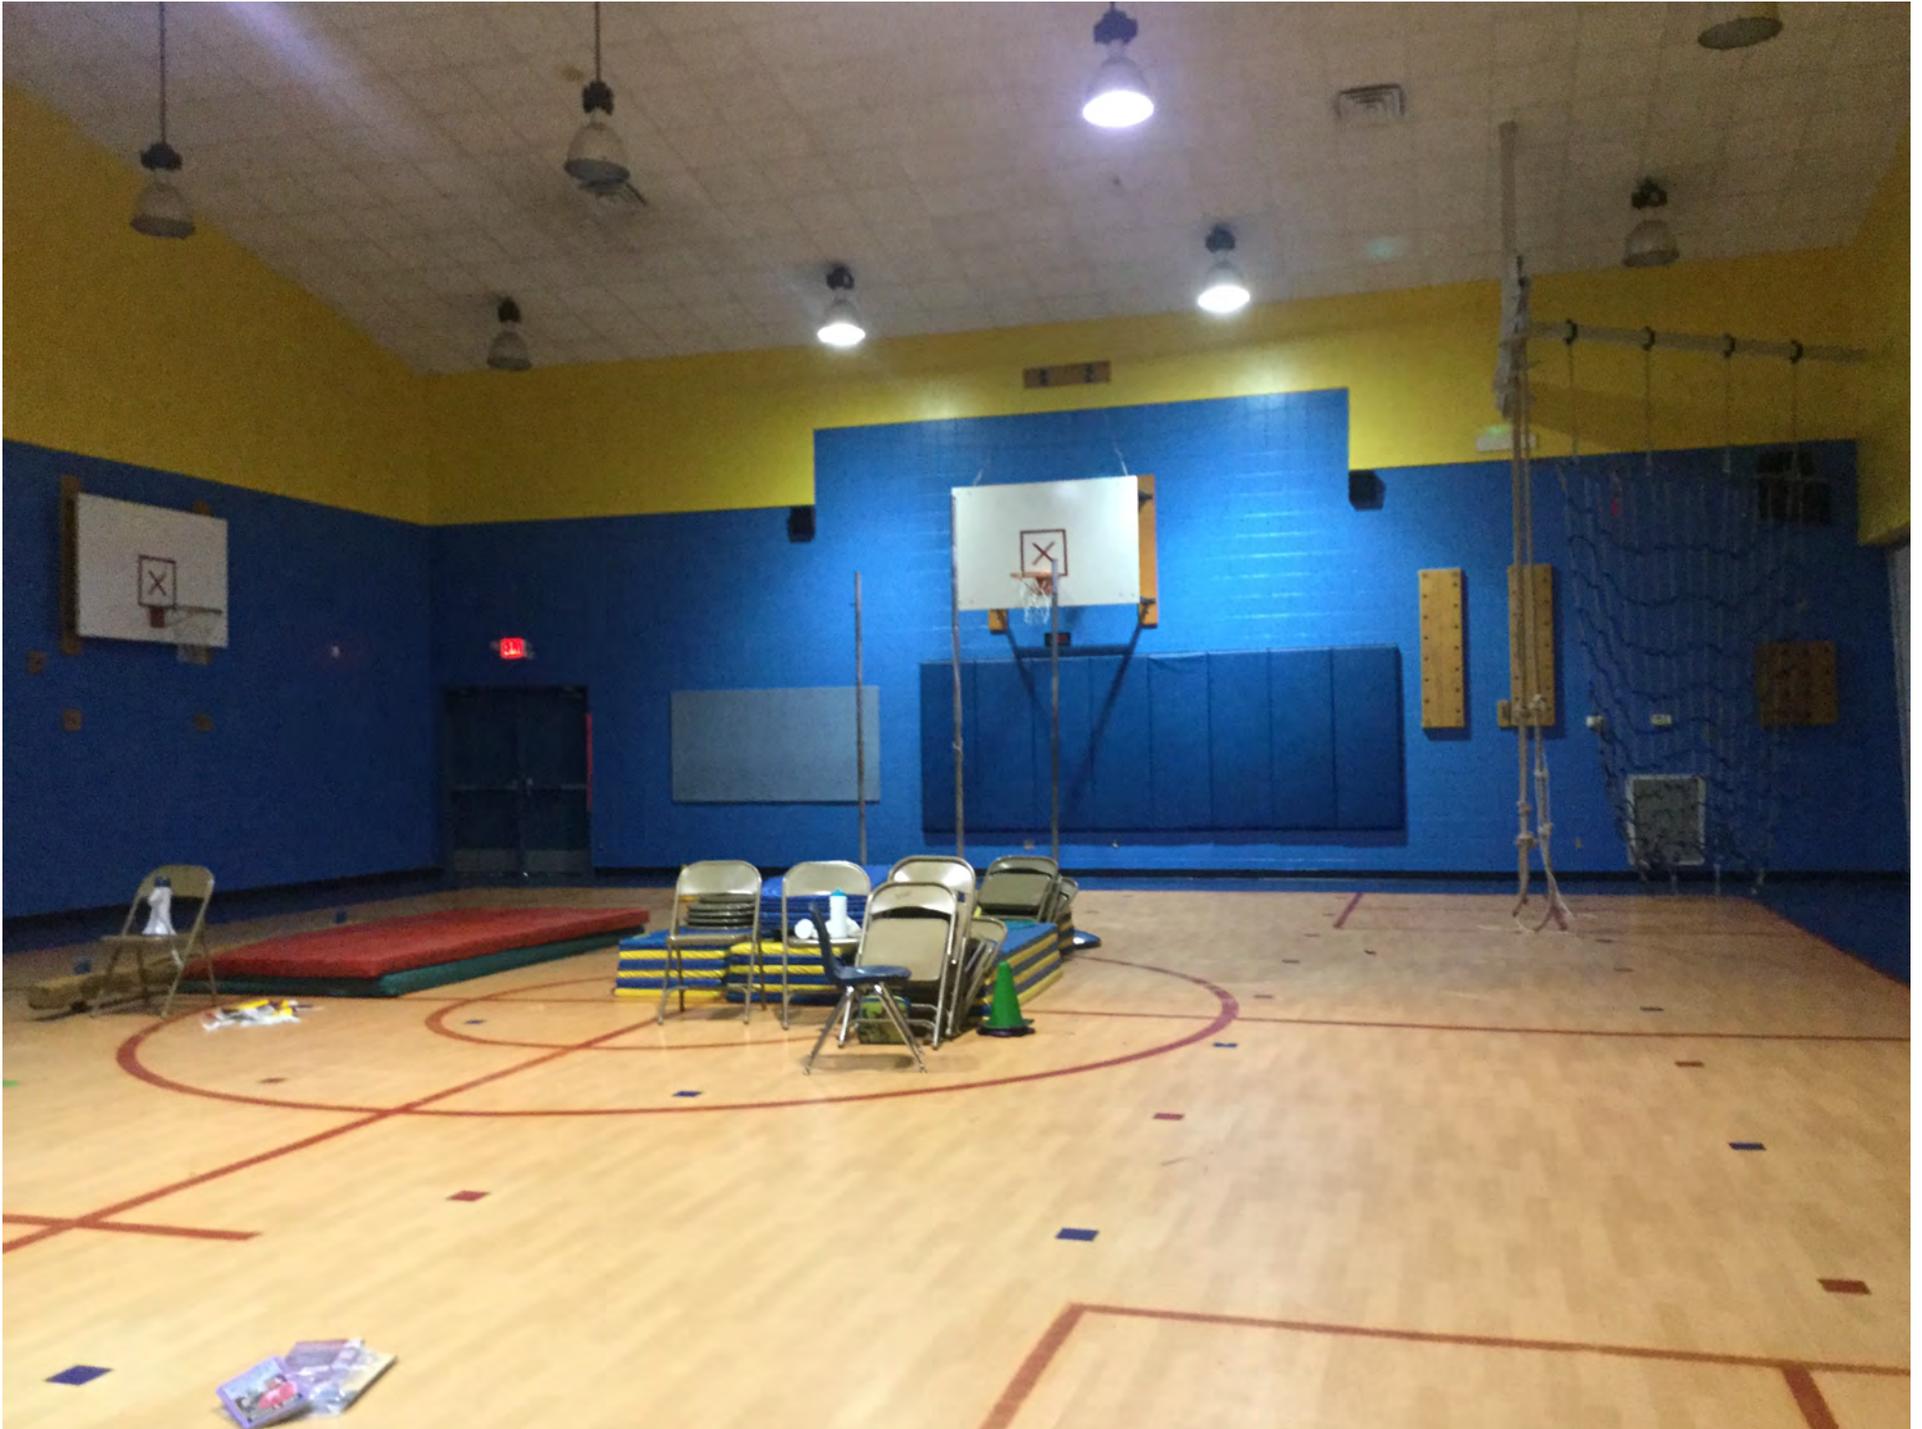
Photo 6. Gym

3 - Academic & Co-Curricular Support - Continued		1	2	3	4	5	N/A	Comments	1.00	3.00
3.6	Are Physical Education and Athletic spaces appropriately configured per the ed spec?			3

1) Very unsatisfactory 2) Unsatisfactory 3) Average 4) Good 5) Very good N/A) Does not apply.								The gym is inadequate in size and does not have access to natural light. <i>CAC comment: very small.</i>		
<b>see image 6</b>

3.7	Are Physical Education and Athletic <b>support</b> spaces appropriately configured per the ed spec?		2							
1) Very unsatisfactory - Support spaces are disconnected from served spaces, too small, do not meet needs 2) Unsatisfactory - Support spaces are connected, but too small, inadequate for needs 3) Average - Connected, moderate size, but need some renovations or updates to function well 4) Good - Connected, good size/layout, meets needs/functions well 5) Very good - connected, generous size, nice condition, functions appropriately N/A) Does not apply.								The gym has very insufficient storage. <i>CAC comments: Remodel classrooms and bathrooms.</i>		
<b>see image 6</b>

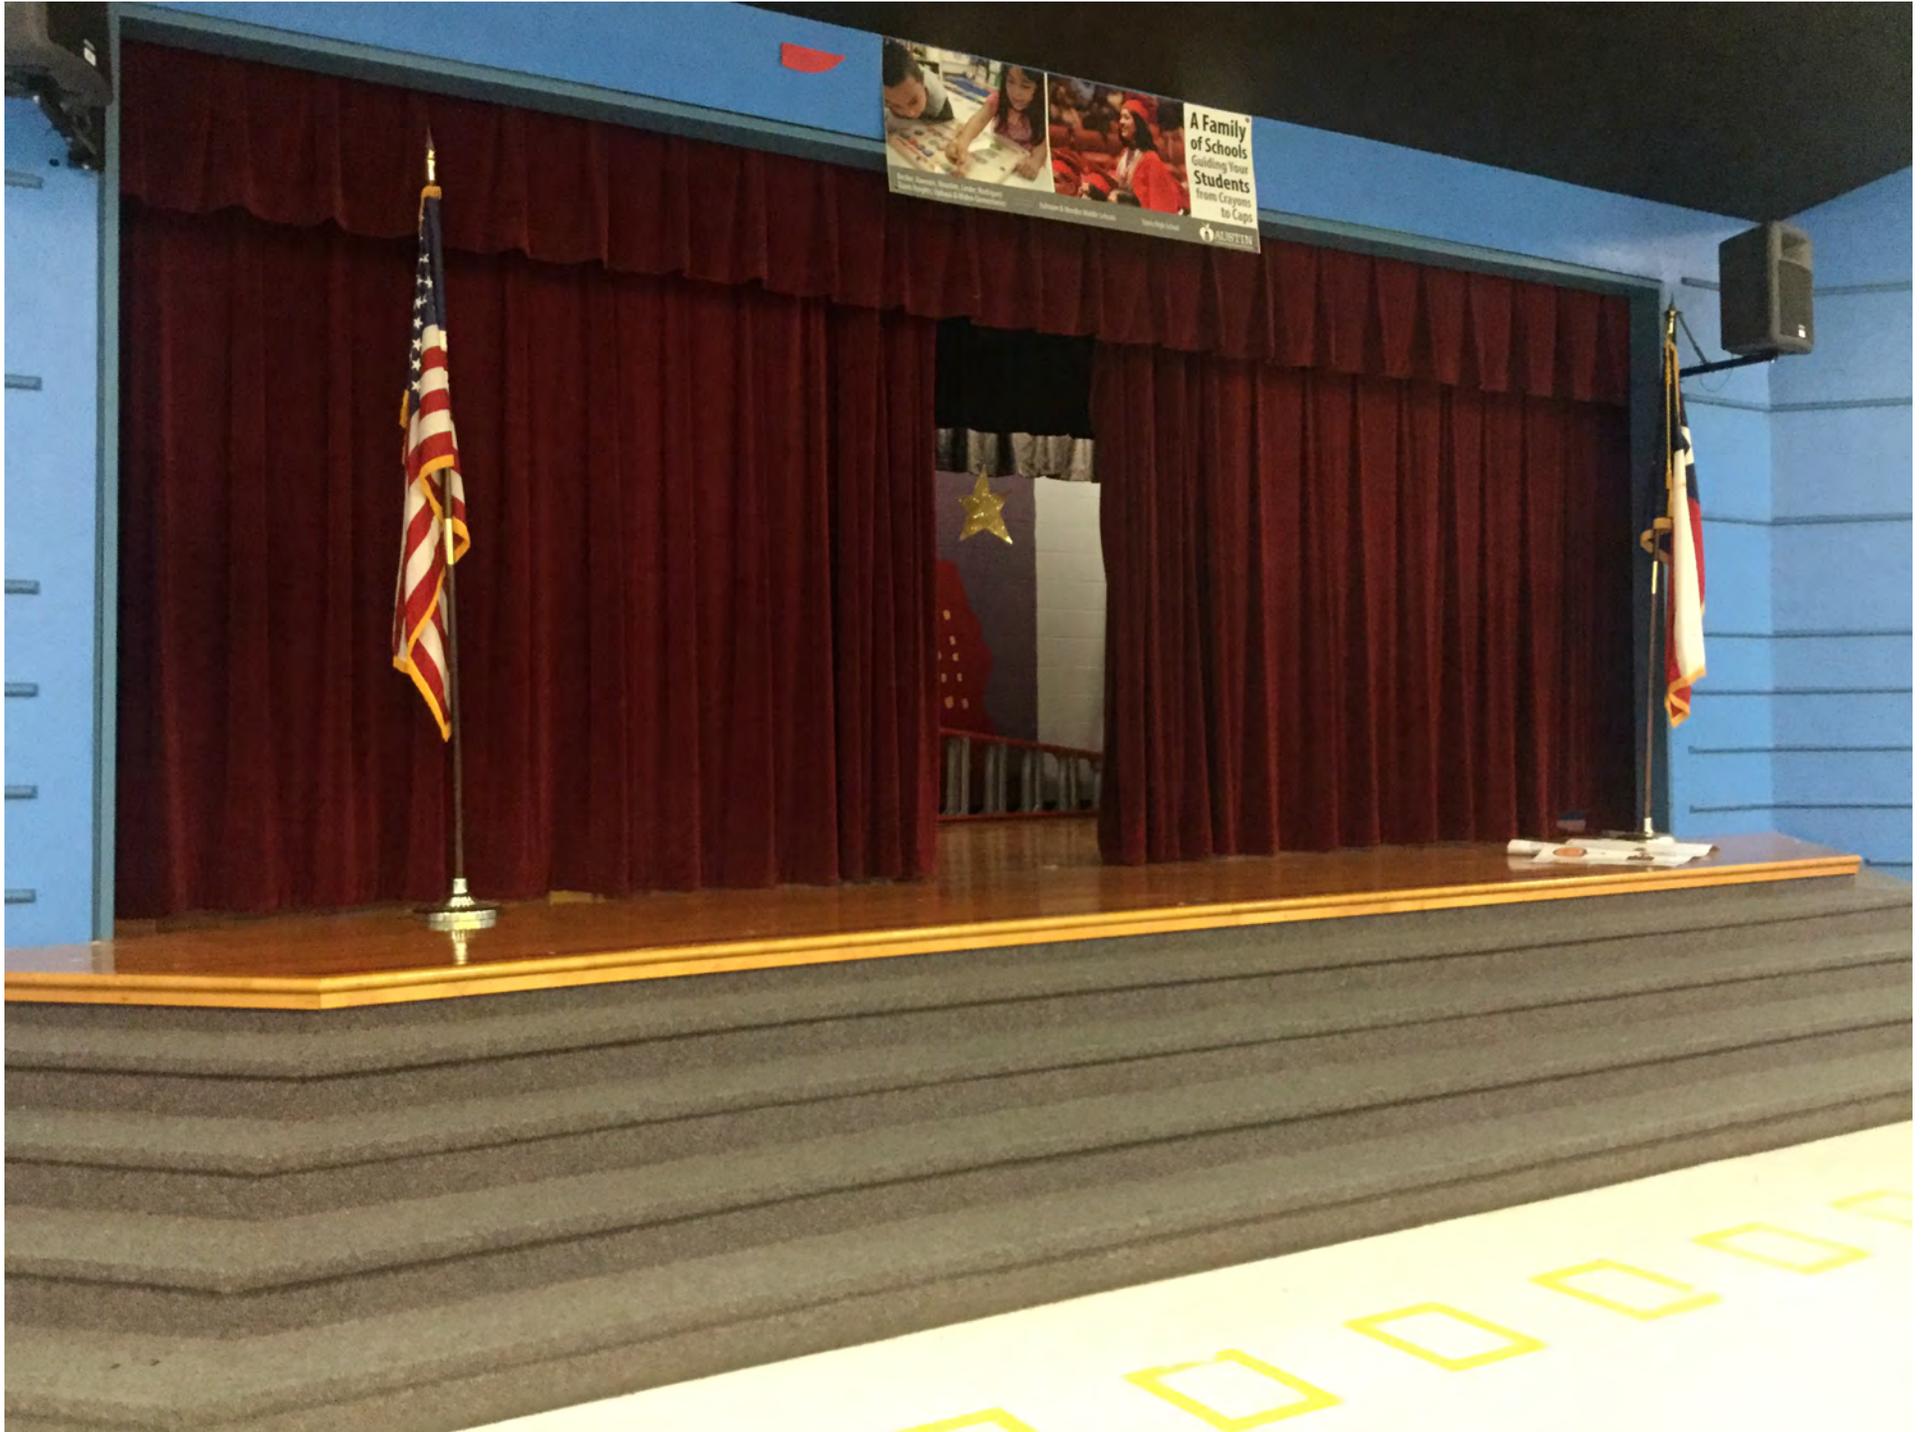
Photo 7. stage

3.8	Are music, drama, or performance spaces appropriately configured per the ed spec?		2							
1) Very unsatisfactory 2) Unsatisfactory 3) Average 4) Good 5) Very good N/A) Does not apply.								Spaces are not ideal in size, storage, or support spaces. The size of the art room is sufficient. <i>CAC comment: The room is very small.</i>		
<b>see image 7</b>
