## Educational Suitability Summary Report

Widen Elementary School – BLDG # 175

Date: 7/19/2016

**Austin ISD Educational Suitability Assessment Criteria**

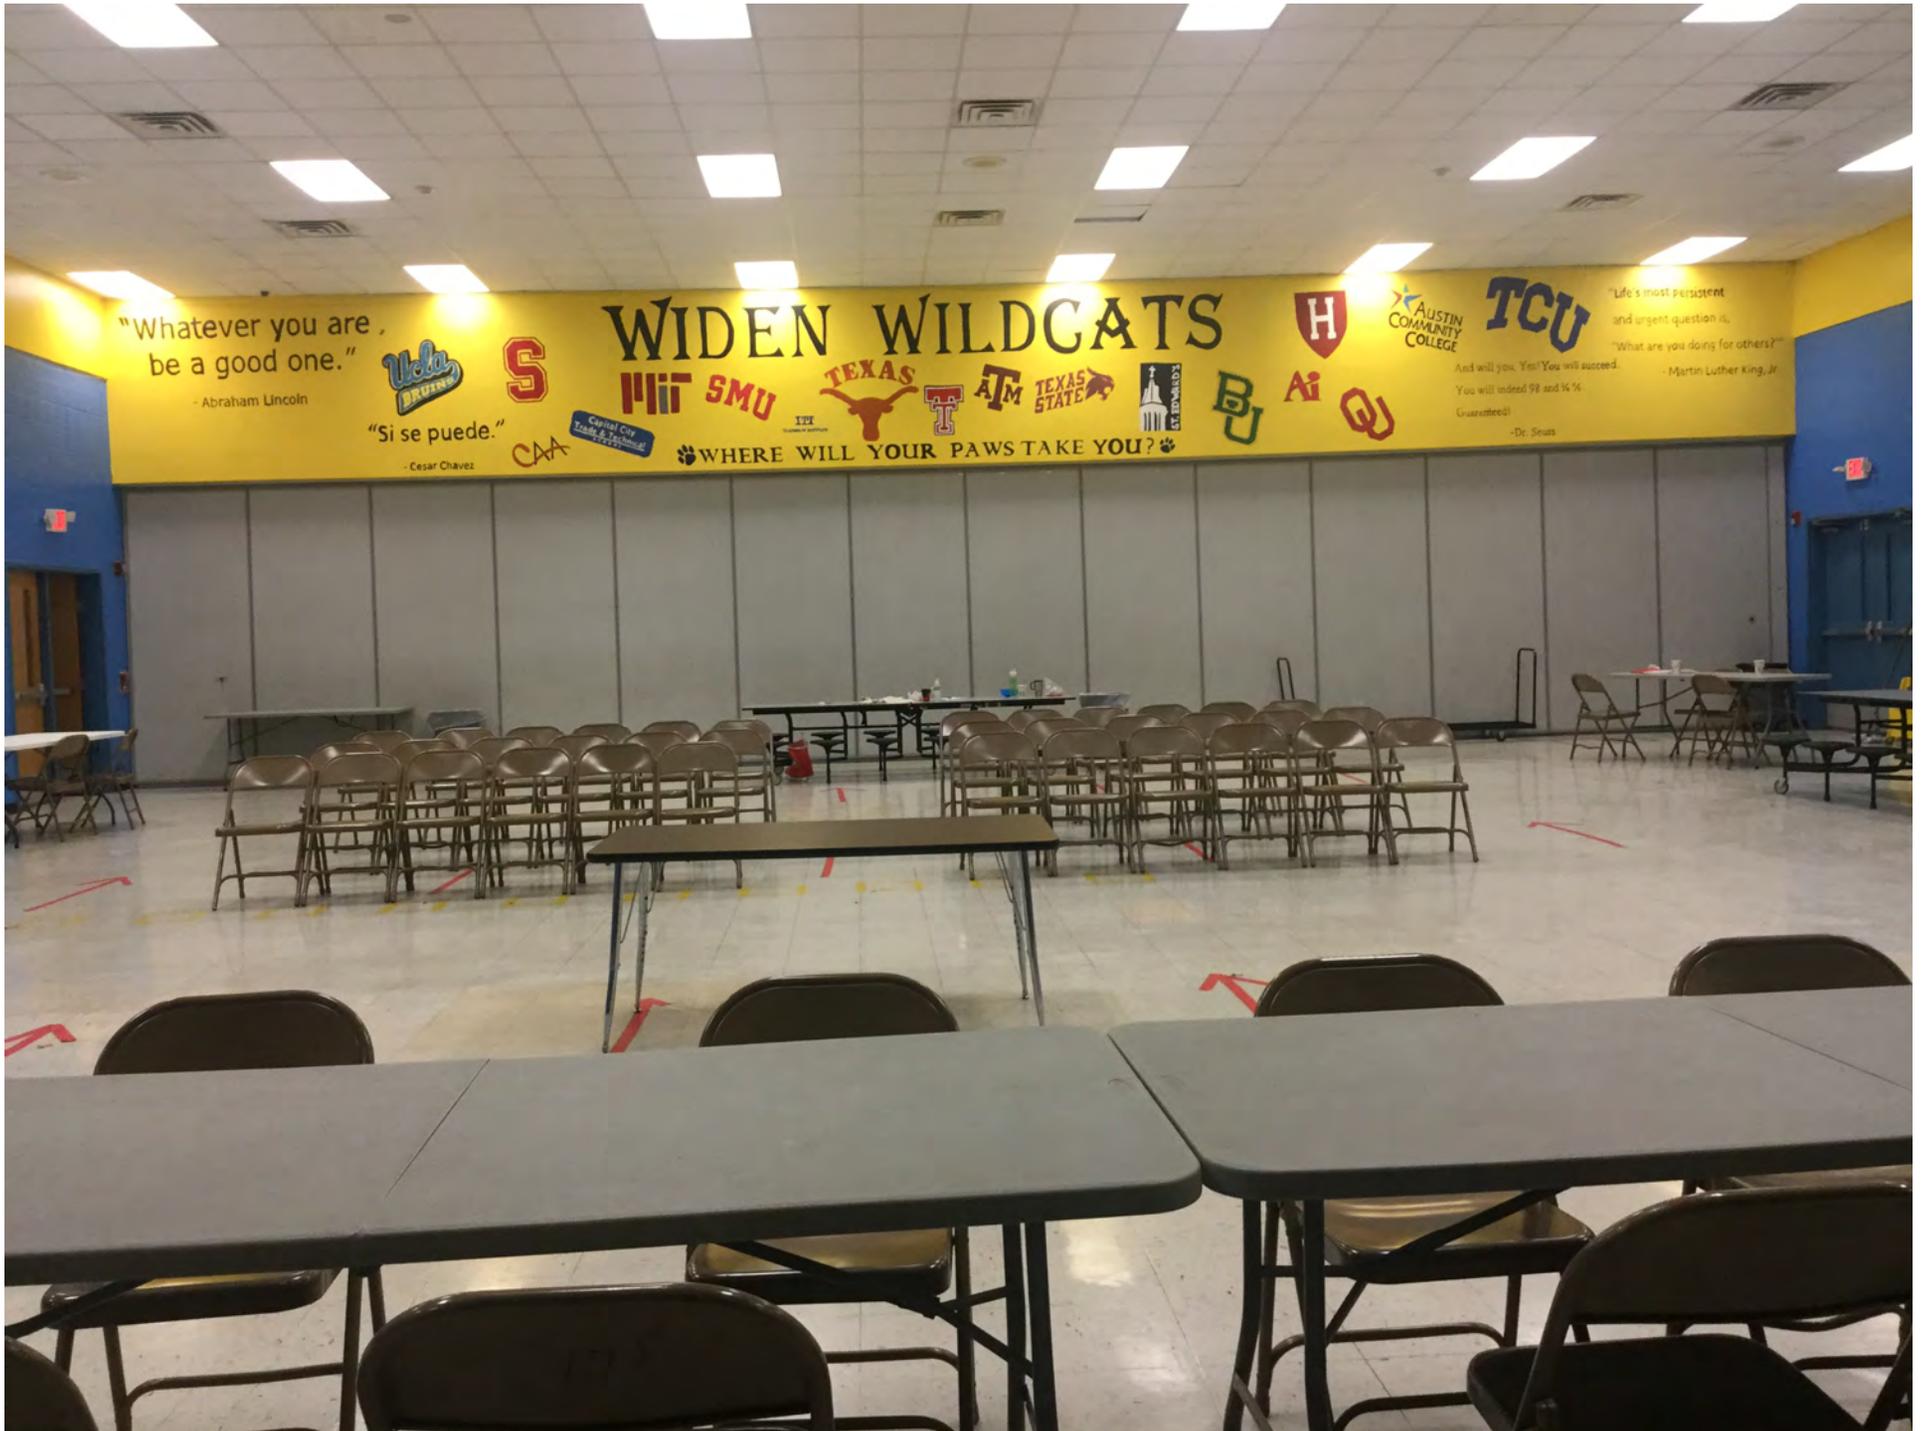
Photo 8. cafeteria

3.16	Are the student dining facilities appropriately configured?		2							
<p>1) Very unsatisfactory - Too small, poor circulation, inflexible seating in poor condition</p> <p>2) Unsatisfactory - Too small or inadequate circulation, seating in poor condition</p> <p>3) Average - moderate size, with adequate circulation, seating in okay condition</p> <p>4) Good - good size, adequate circulation, seating in good condition</p> <p>5) Very good - good size, adequate circulation, seating in good condition, with more than one option for eating space (ex: connection to outdoor eating space)</p> <p>N/A) Does not apply.</p>								The students have to stand in long lines during lunch, and would like to add a separate line for the salad bar. There is no outdoor eating space.

see image 8

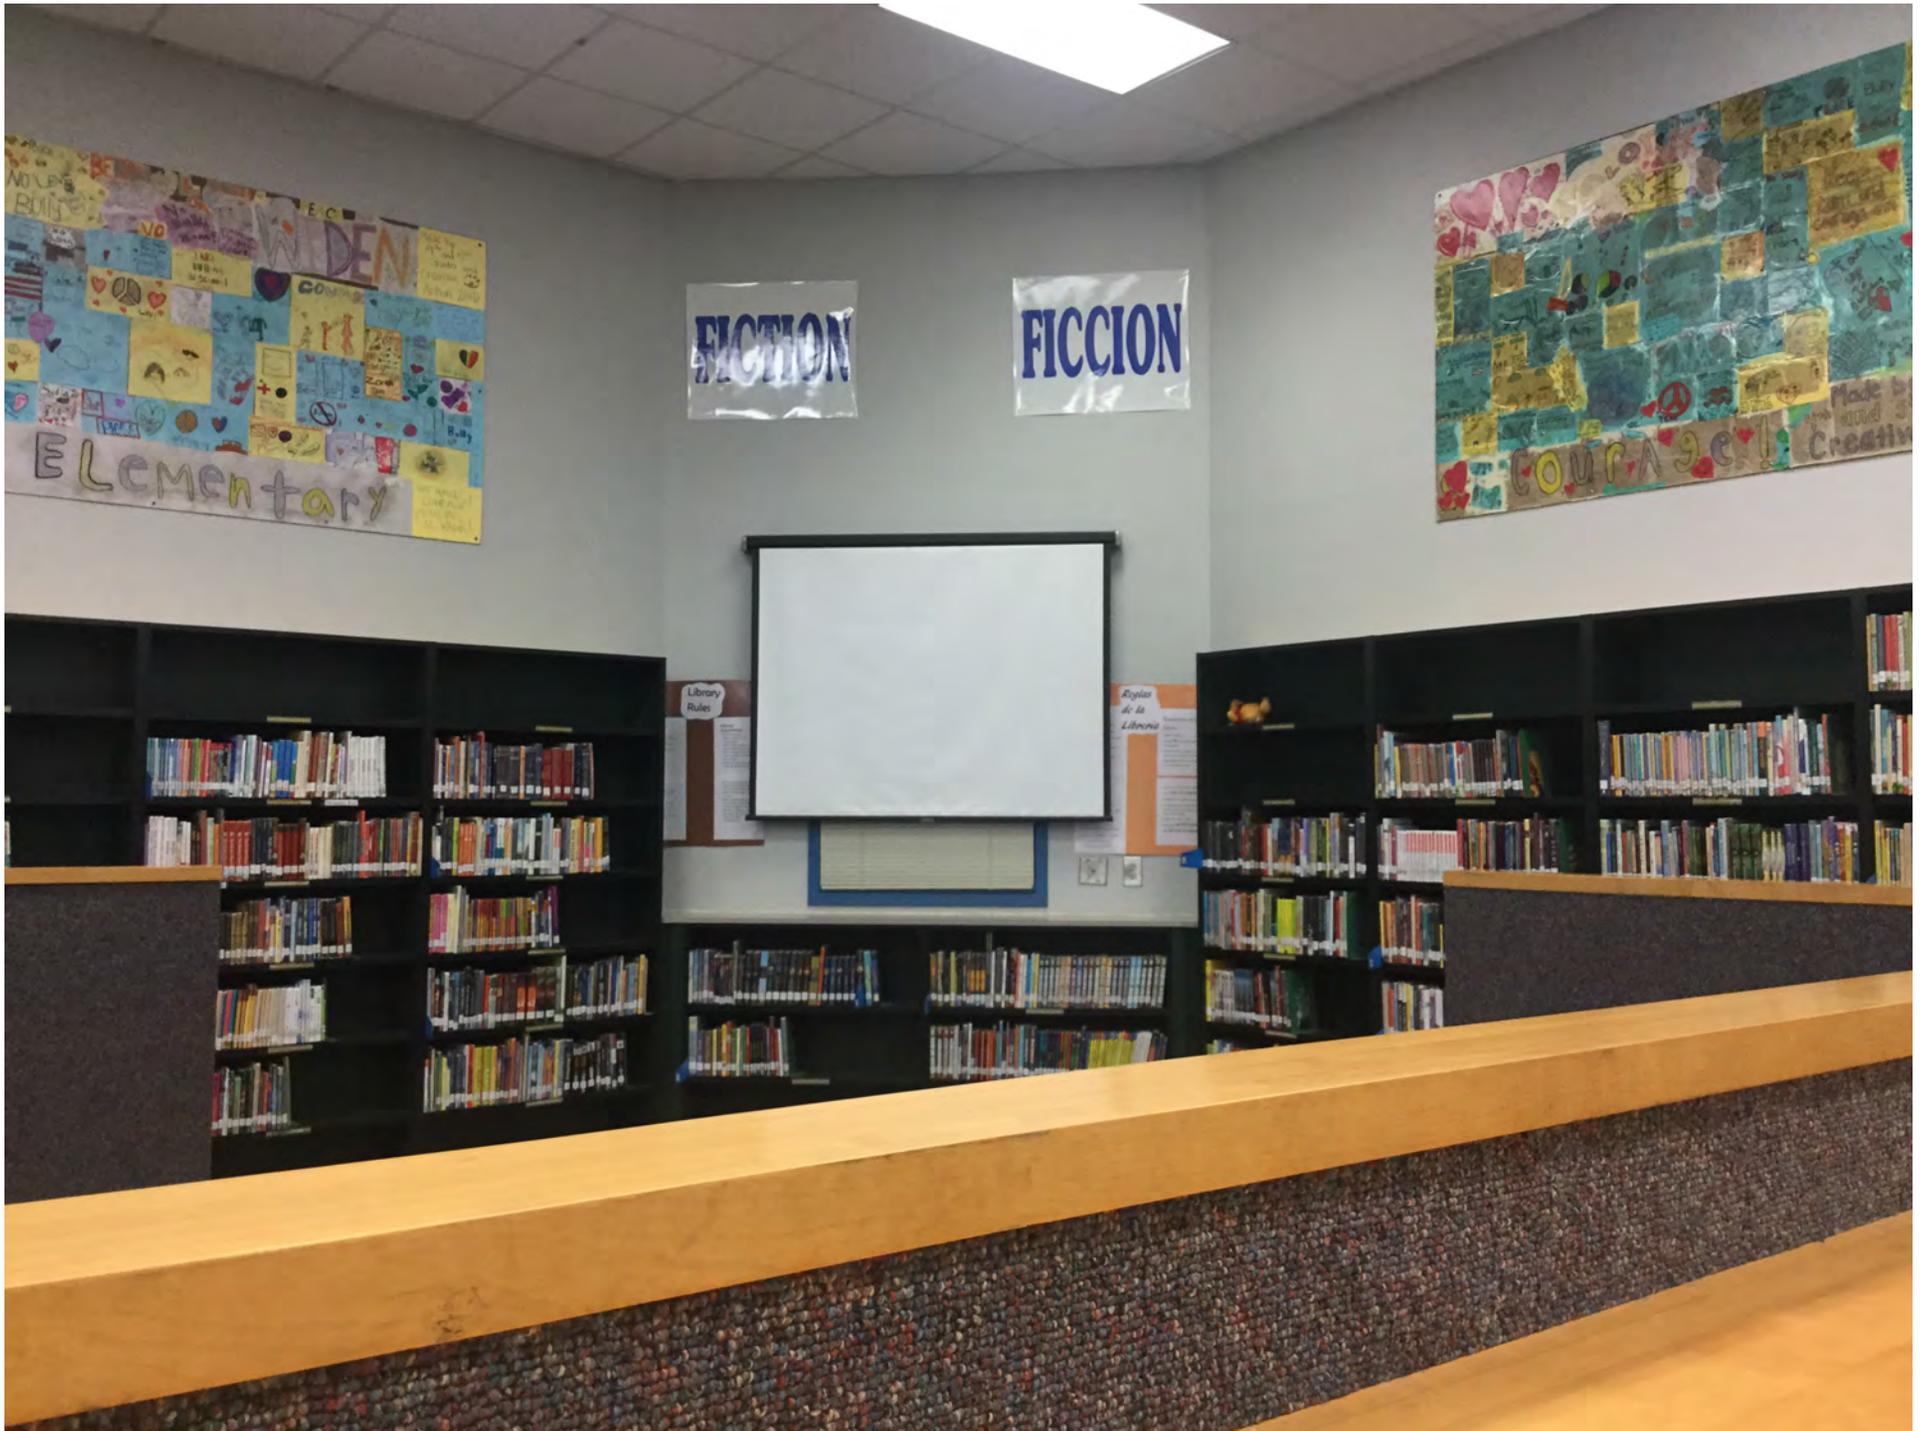
Photo 10. Library

5.3	How well does the Library/Media Center support social interaction?				4			Comments	1.00	4.00
1) Very unsatisfactory 2) Unsatisfactory 3) Average 4) Good 5) Very good N/A) Does not apply.								The library has a good furniture layout for social interactions. <i>CAC comments: Because it is not good. Smells bad.</i>		
								<b>see image 10</b>
