## Educational Suitability Summary Report

Williams Elementary School

Date: 08/03/2016

**Score 47% Unsatisfactory**

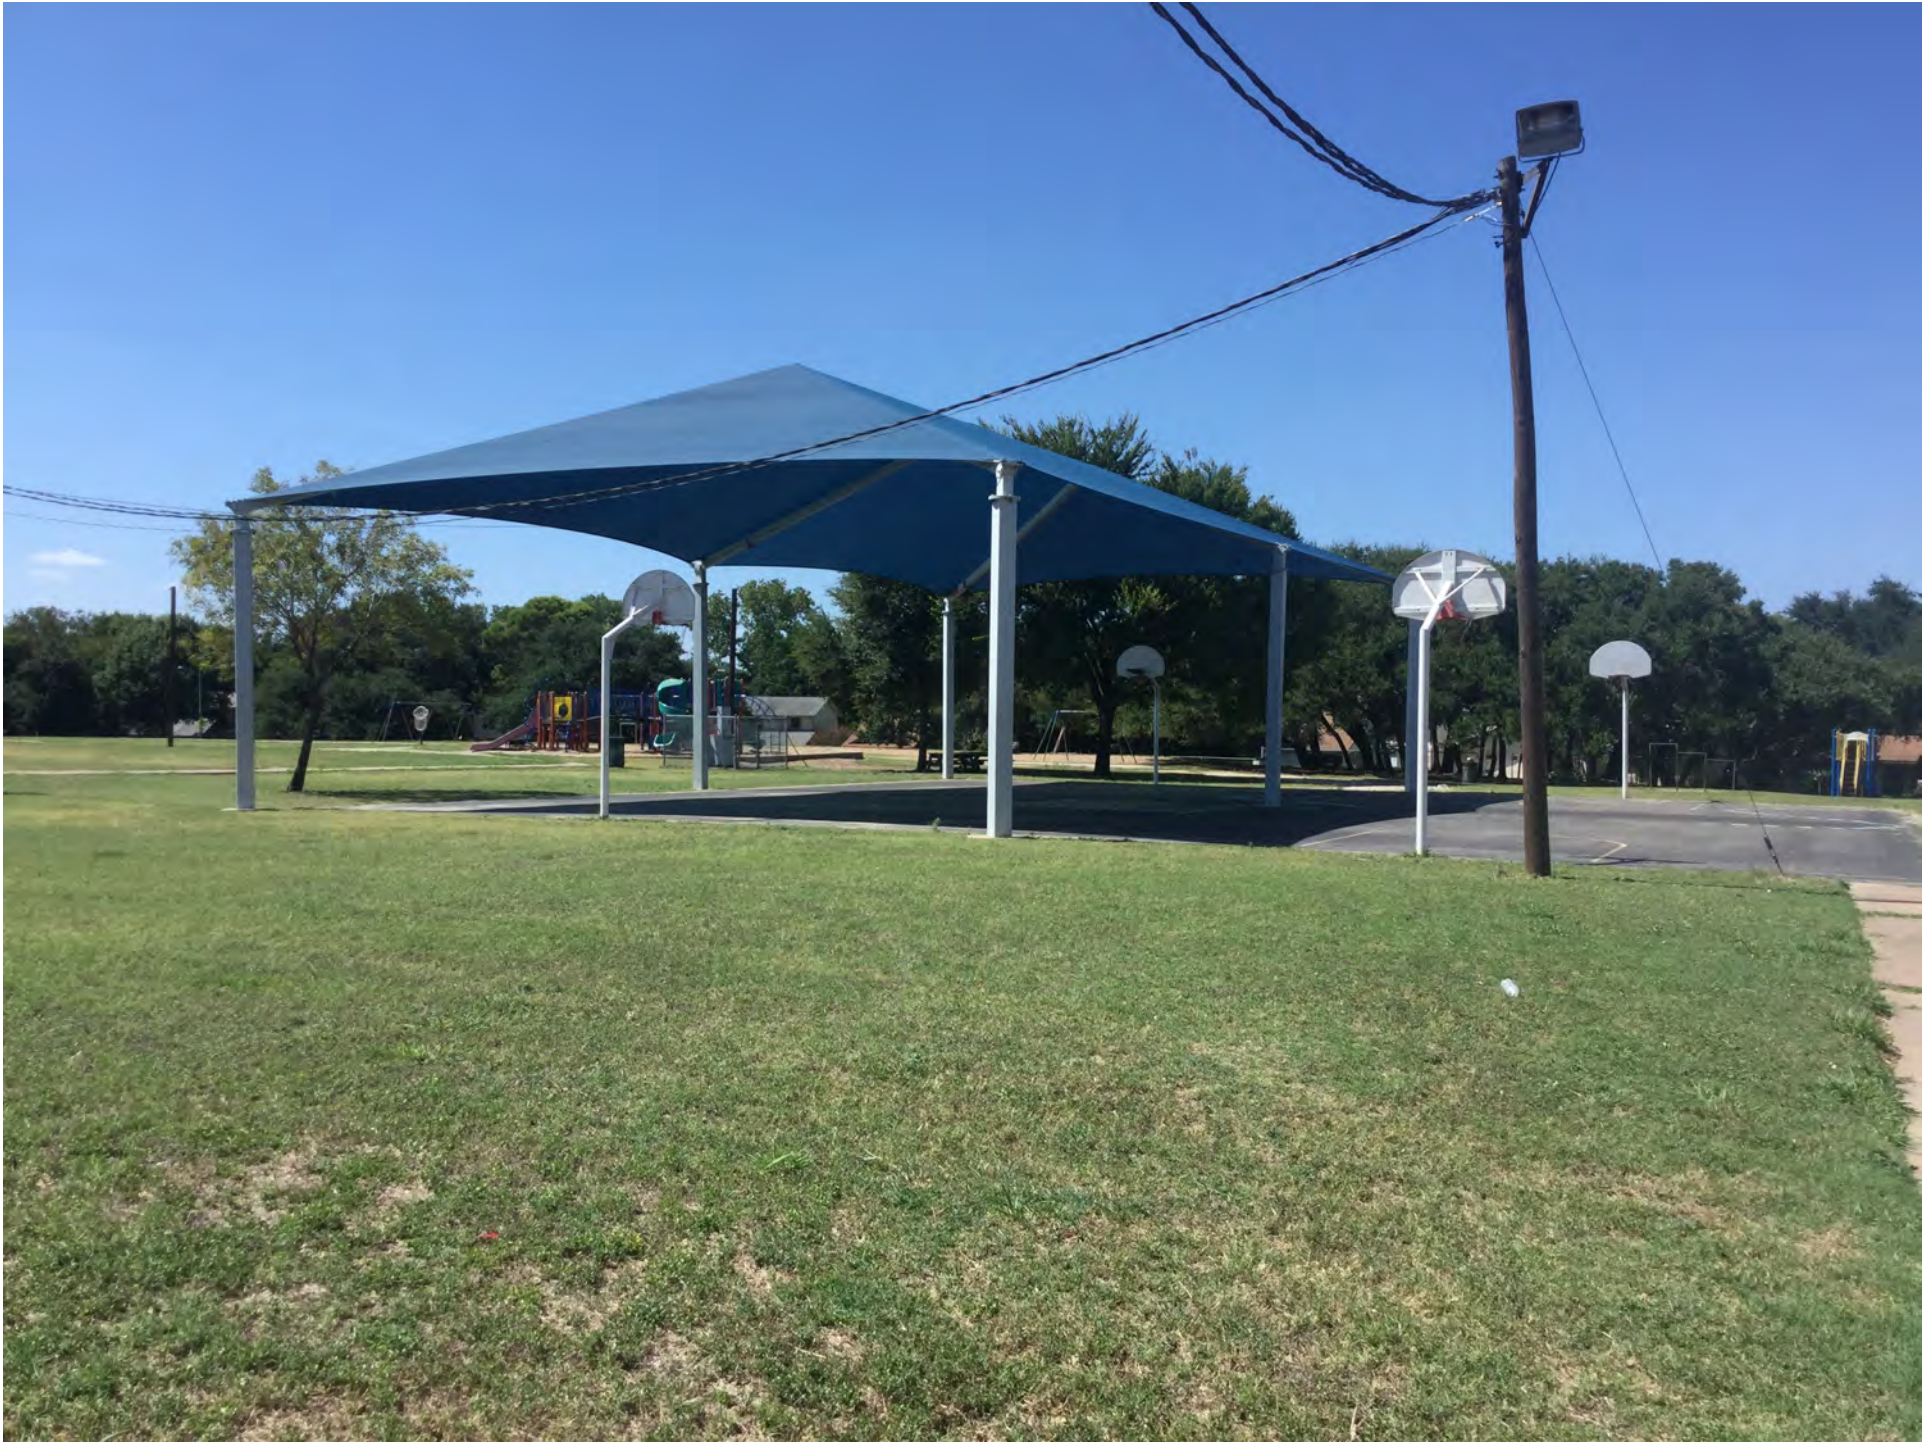
1.3 Exterior Play Space

1.3	Are outdoor play spaces and playfields adequate in size and configuration?		2					Comments	1.00 2.00
1) Outdoor play space exists, not developed 2) Outdoor play space exists but is not connected to gym or other athletic support areas or is too small. 3. Outdoor play spaces exist, are connected to other athletic areas, are the right size, but are not in good condition. 4. Outdoor play spaces need minor improvements to function well. 5. Outdoor play spaces are in excellent condition. N/A) Does not apply.									
									See Photo 1

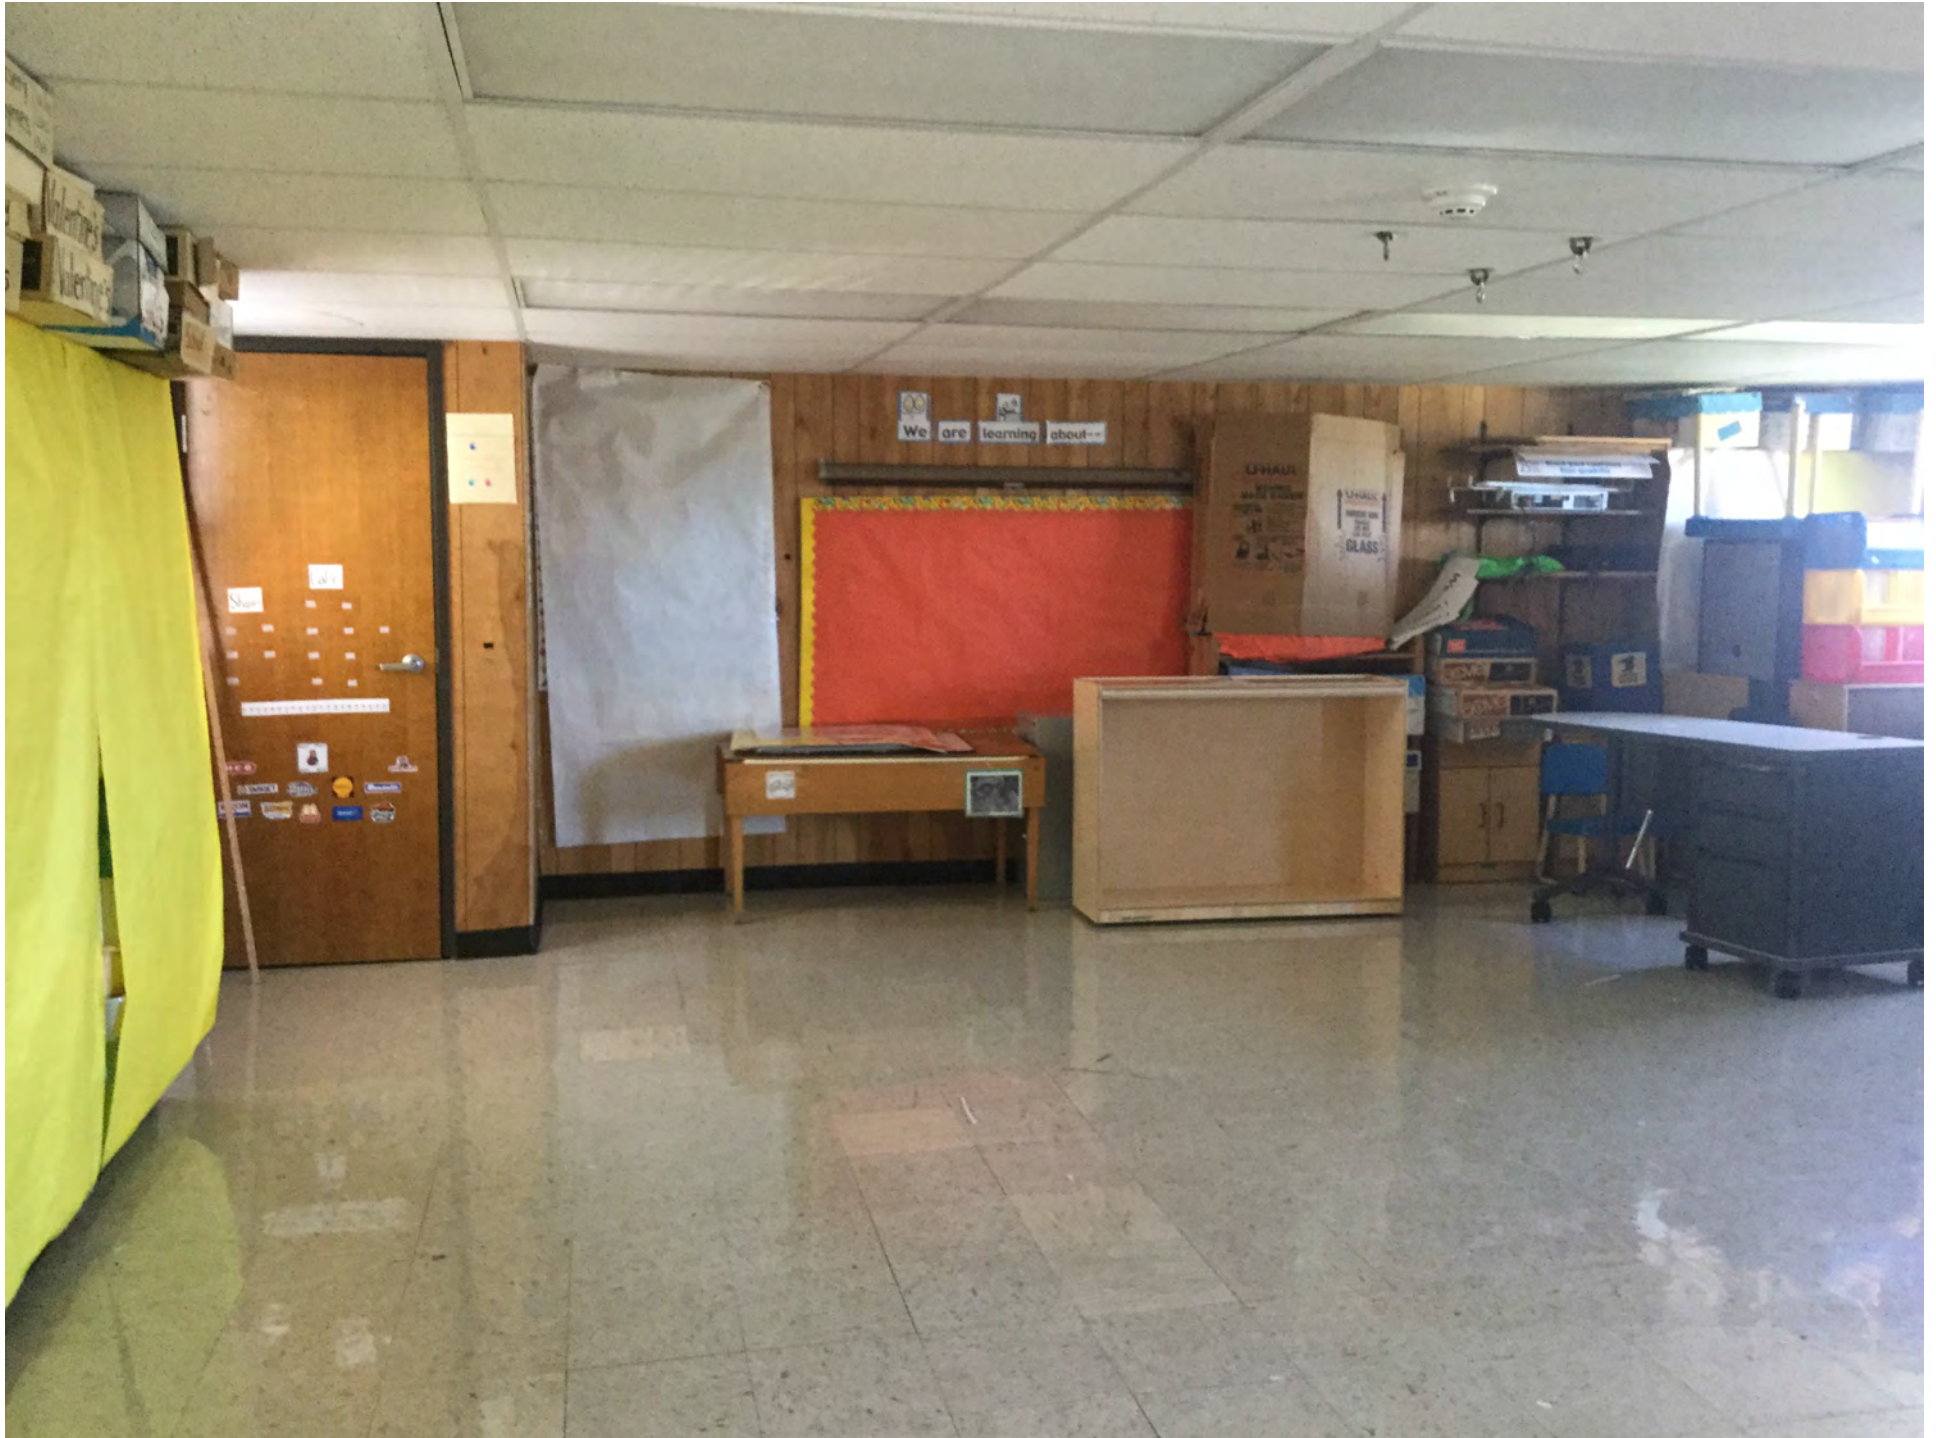
3.2 Classroom

1) Very unsatisfactory - Too small, awkward layout, does not meet needs 2) Unsatisfactory - Too small, only one area for all teaching methods, limited flexibility 3) Neutral - Moderate size, two areas for different teaching methods, some flexibility, access to student storage/casework 4) Satisfactory - Good size, at least two zones for different teaching methods, flexibility and student storage, not new 5) Very Satisfactory - Good size, two zones for different teaching methods, flexibility and student storage/casework, adequate display area and visual teaching tools N/A) Does not apply.								The Pre-K classes are currently in portables which are undersized. There are security concerns with the small gate to the parking lot next to the portables.							
See Photo 2

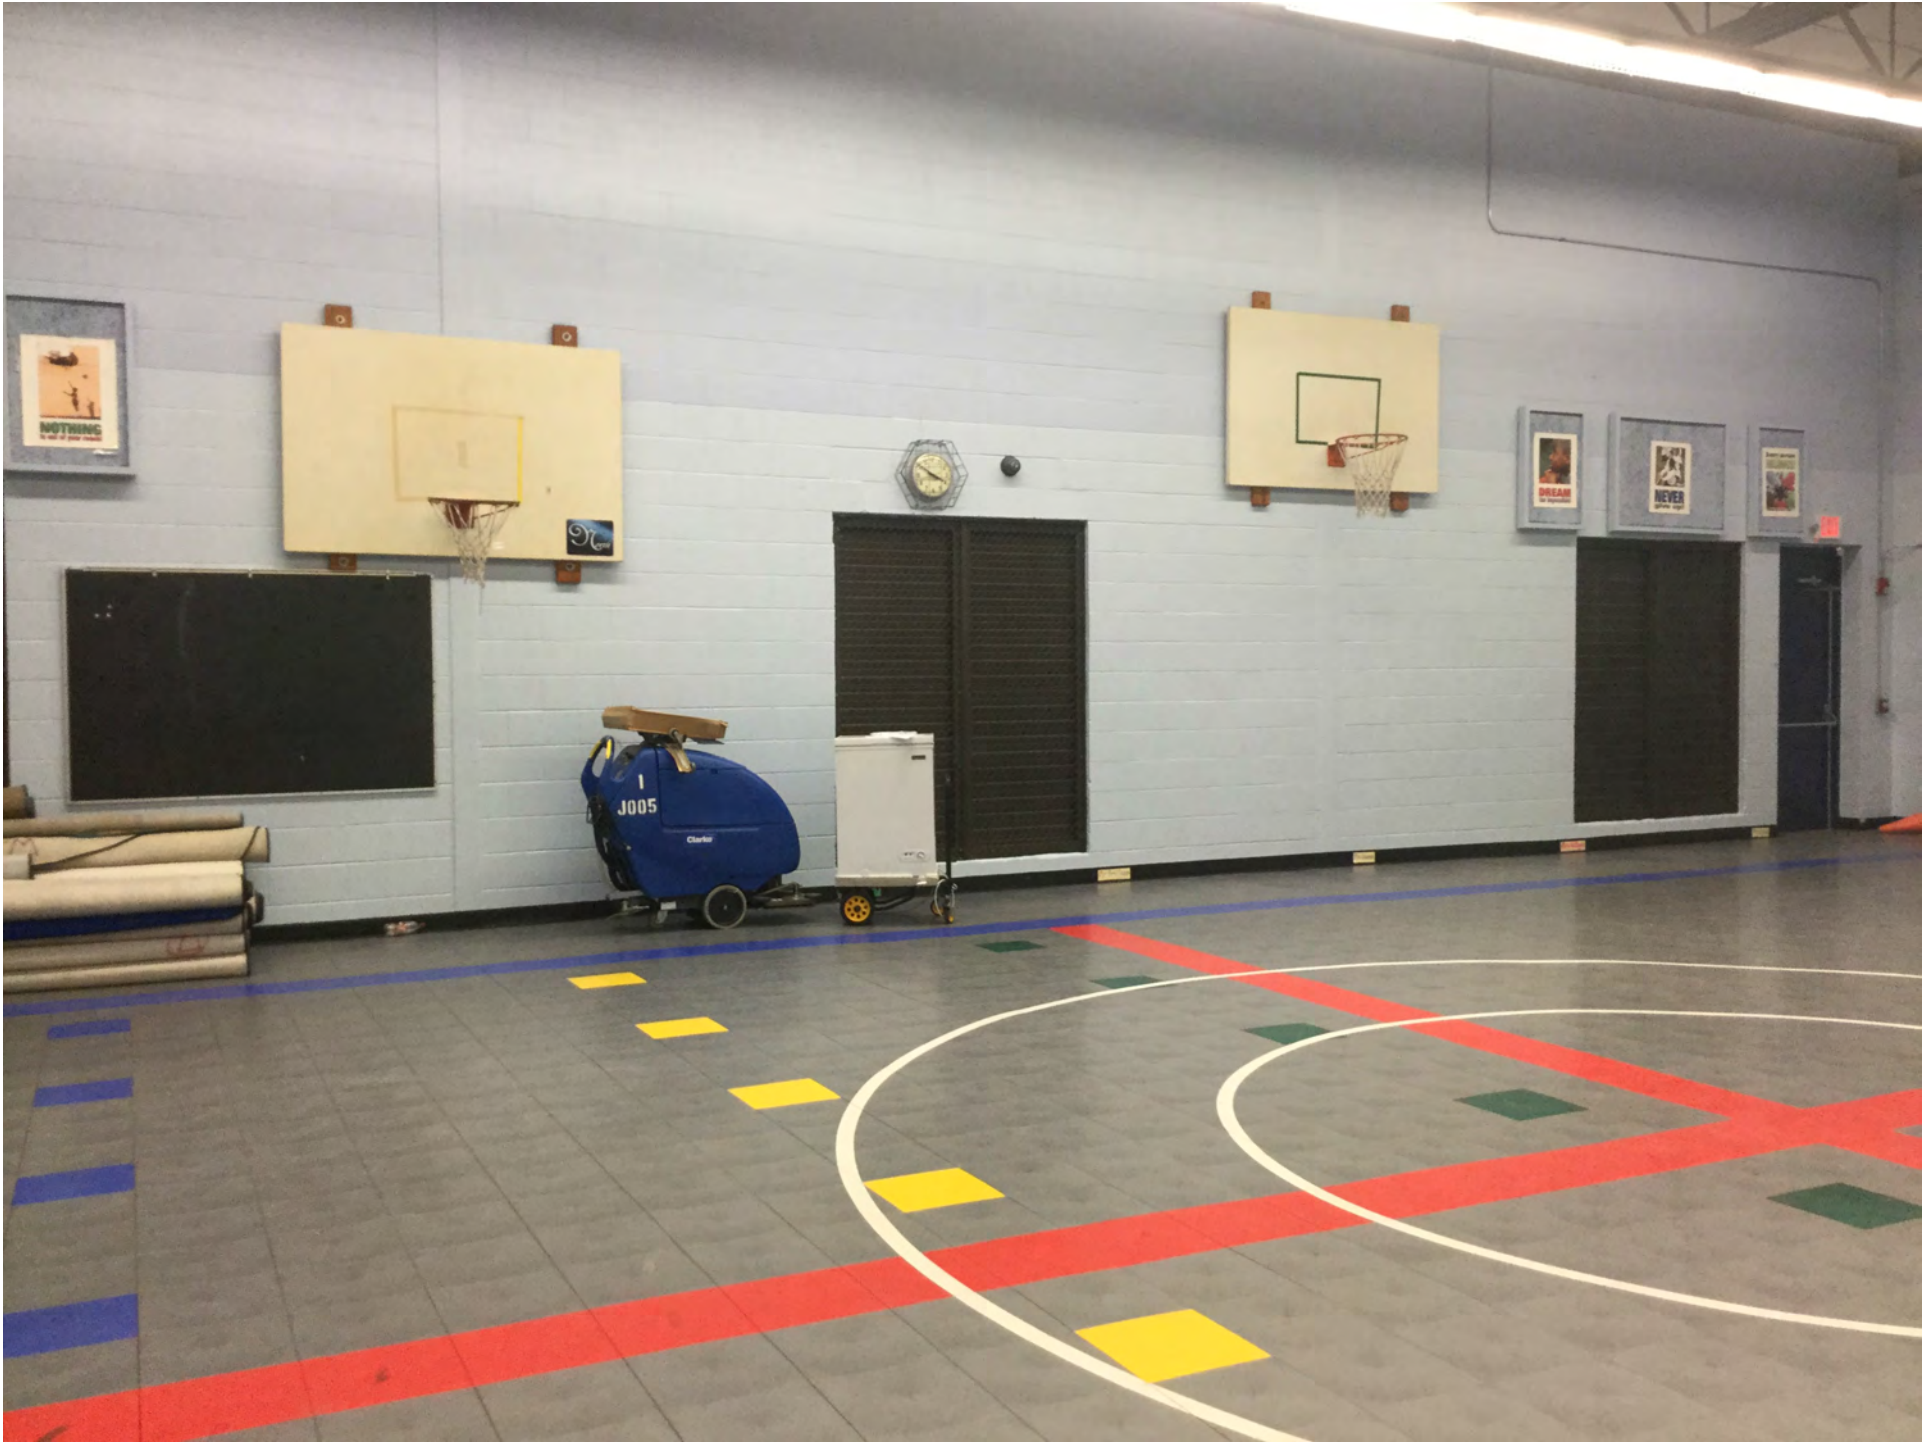
3.6 Gymnasium

1) Very unsatisfactory 2) Unsatisfactory 3) Average 4) Good 5) Very good N/A) Does not apply.								The gym is moderately sized, and in average condition.							
														See Photo 3

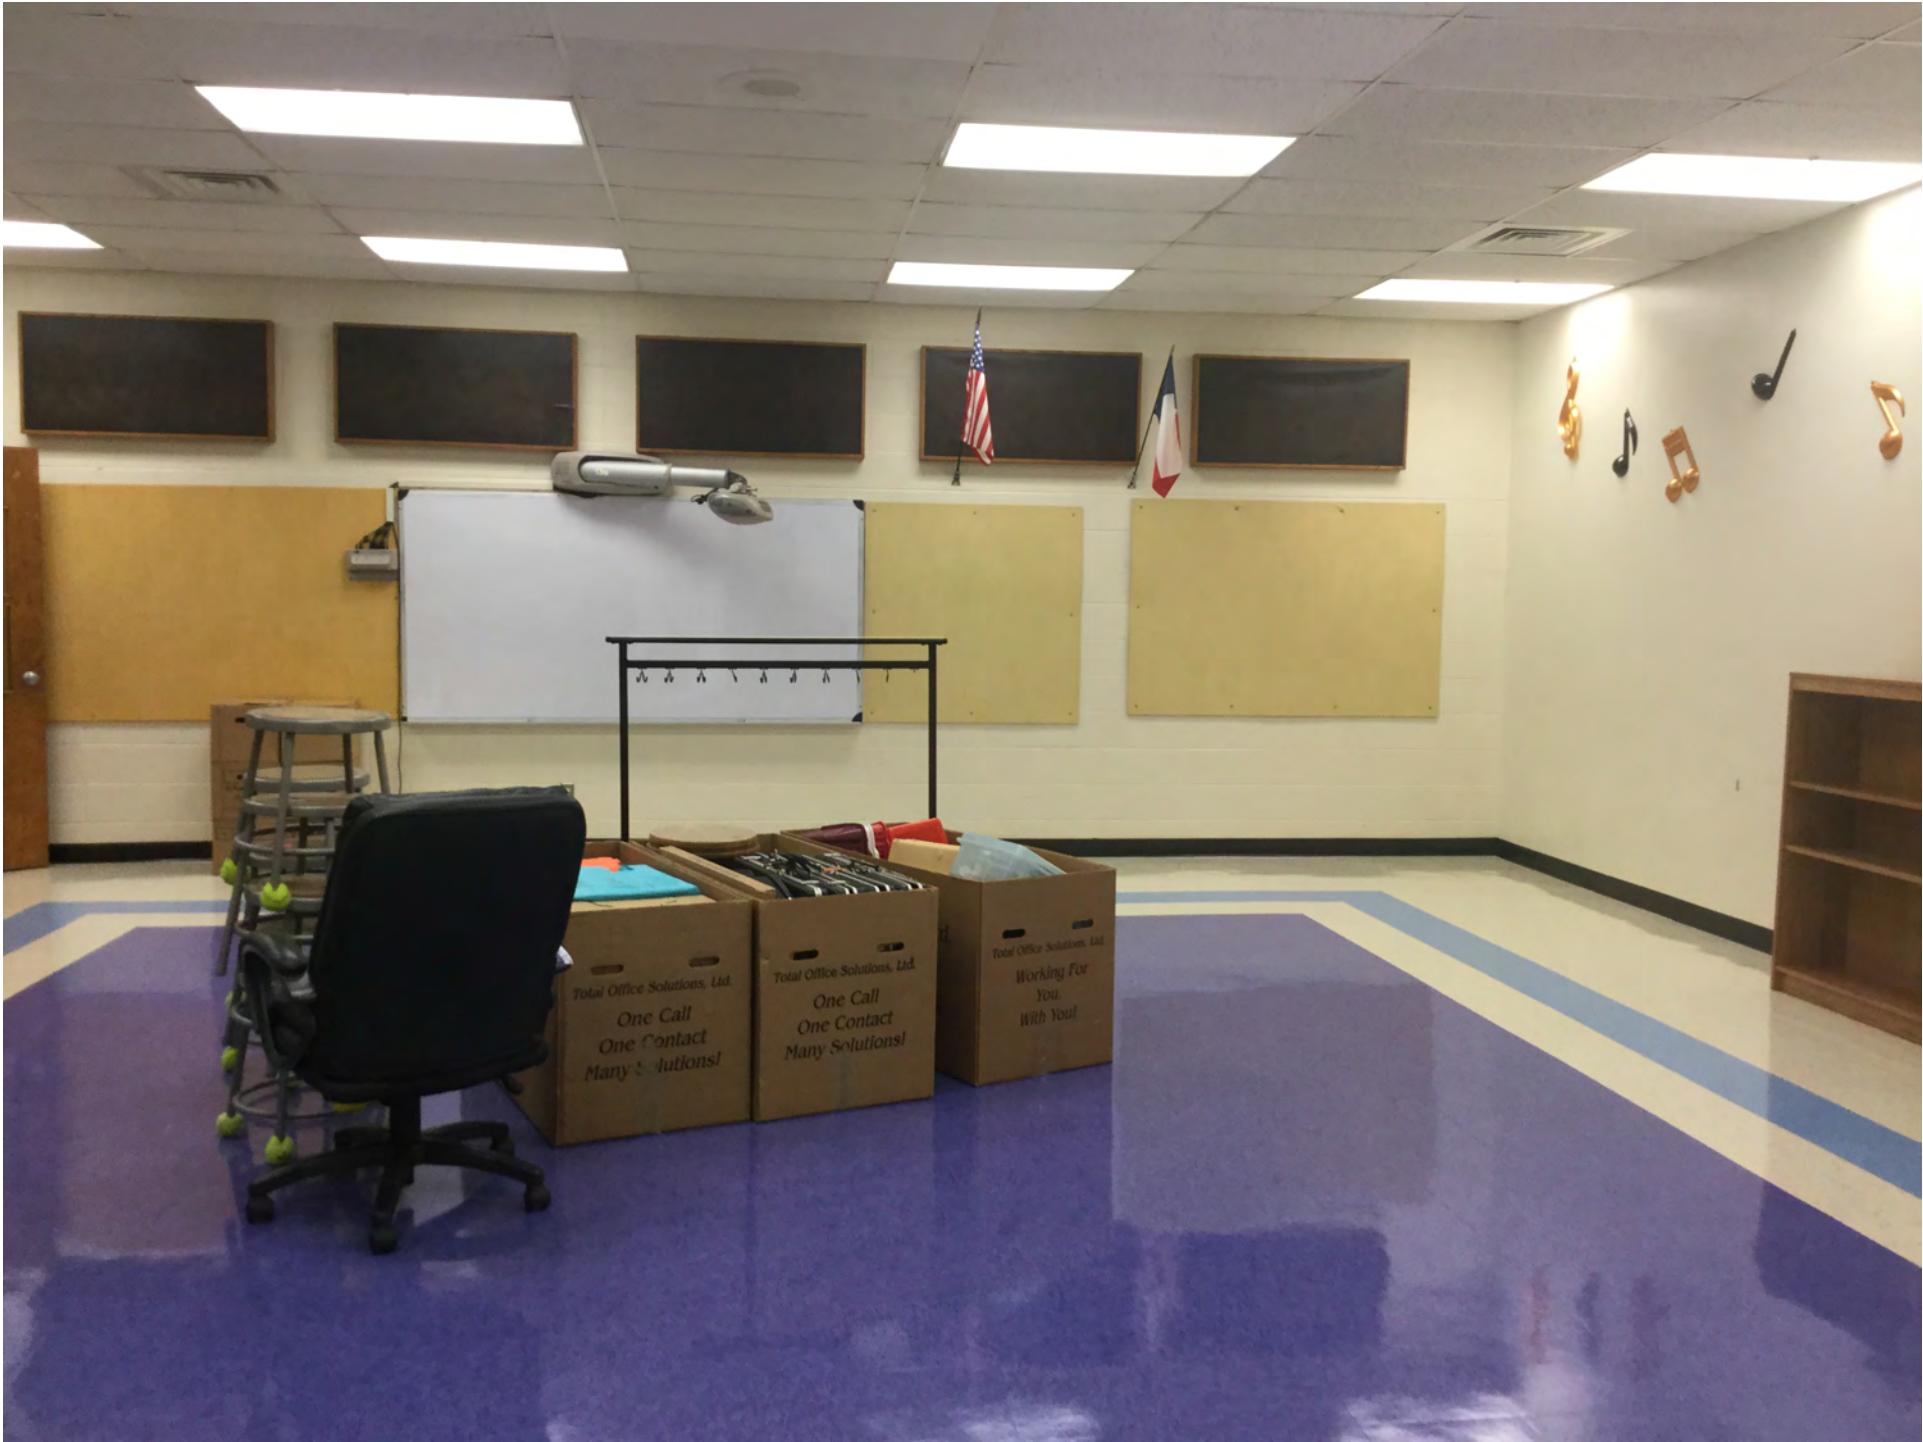
3.8	Are music, drama, or performance spaces appropriately configured per the ed spec?			3				Comments				1.00	3.00		
1) Very unsatisfactory 2) Unsatisfactory 3) Average 4) Good 5) Very good N/A) Does not apply.															
														See Photo 4

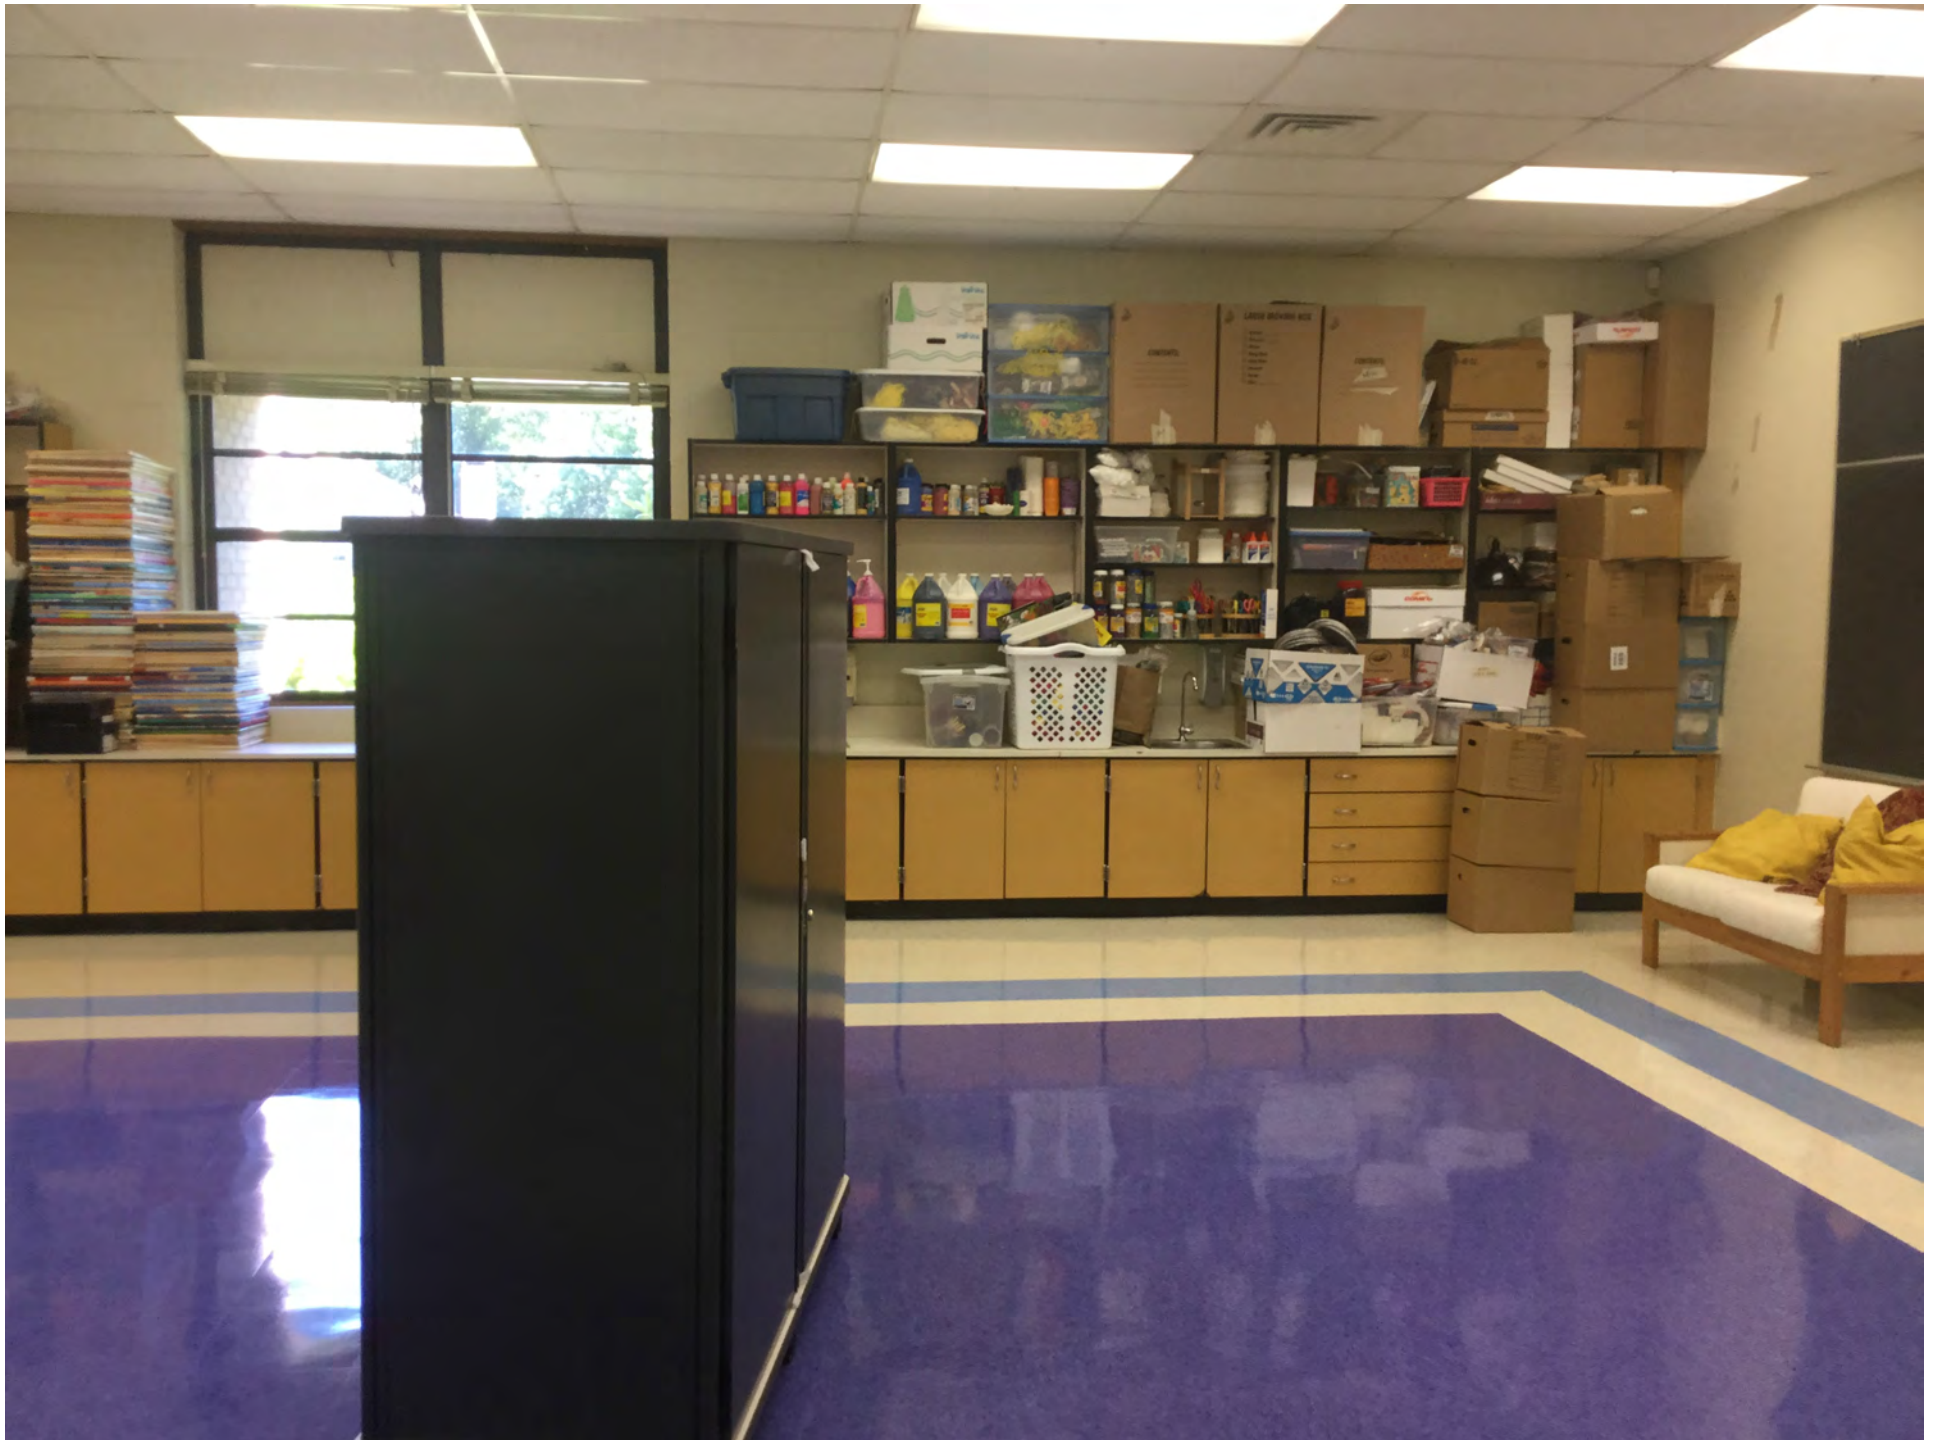
3.10 Art Classroom

1) Very unsatisfactory 2) Unsatisfactory 3) Average 4) Good 5) Very good N/A) Does not apply.								See Photo 5	
3.11	Are Visual Arts <b>support</b> spaces appropriately configured per the ed spec?		2					Comments	1.00 2.00

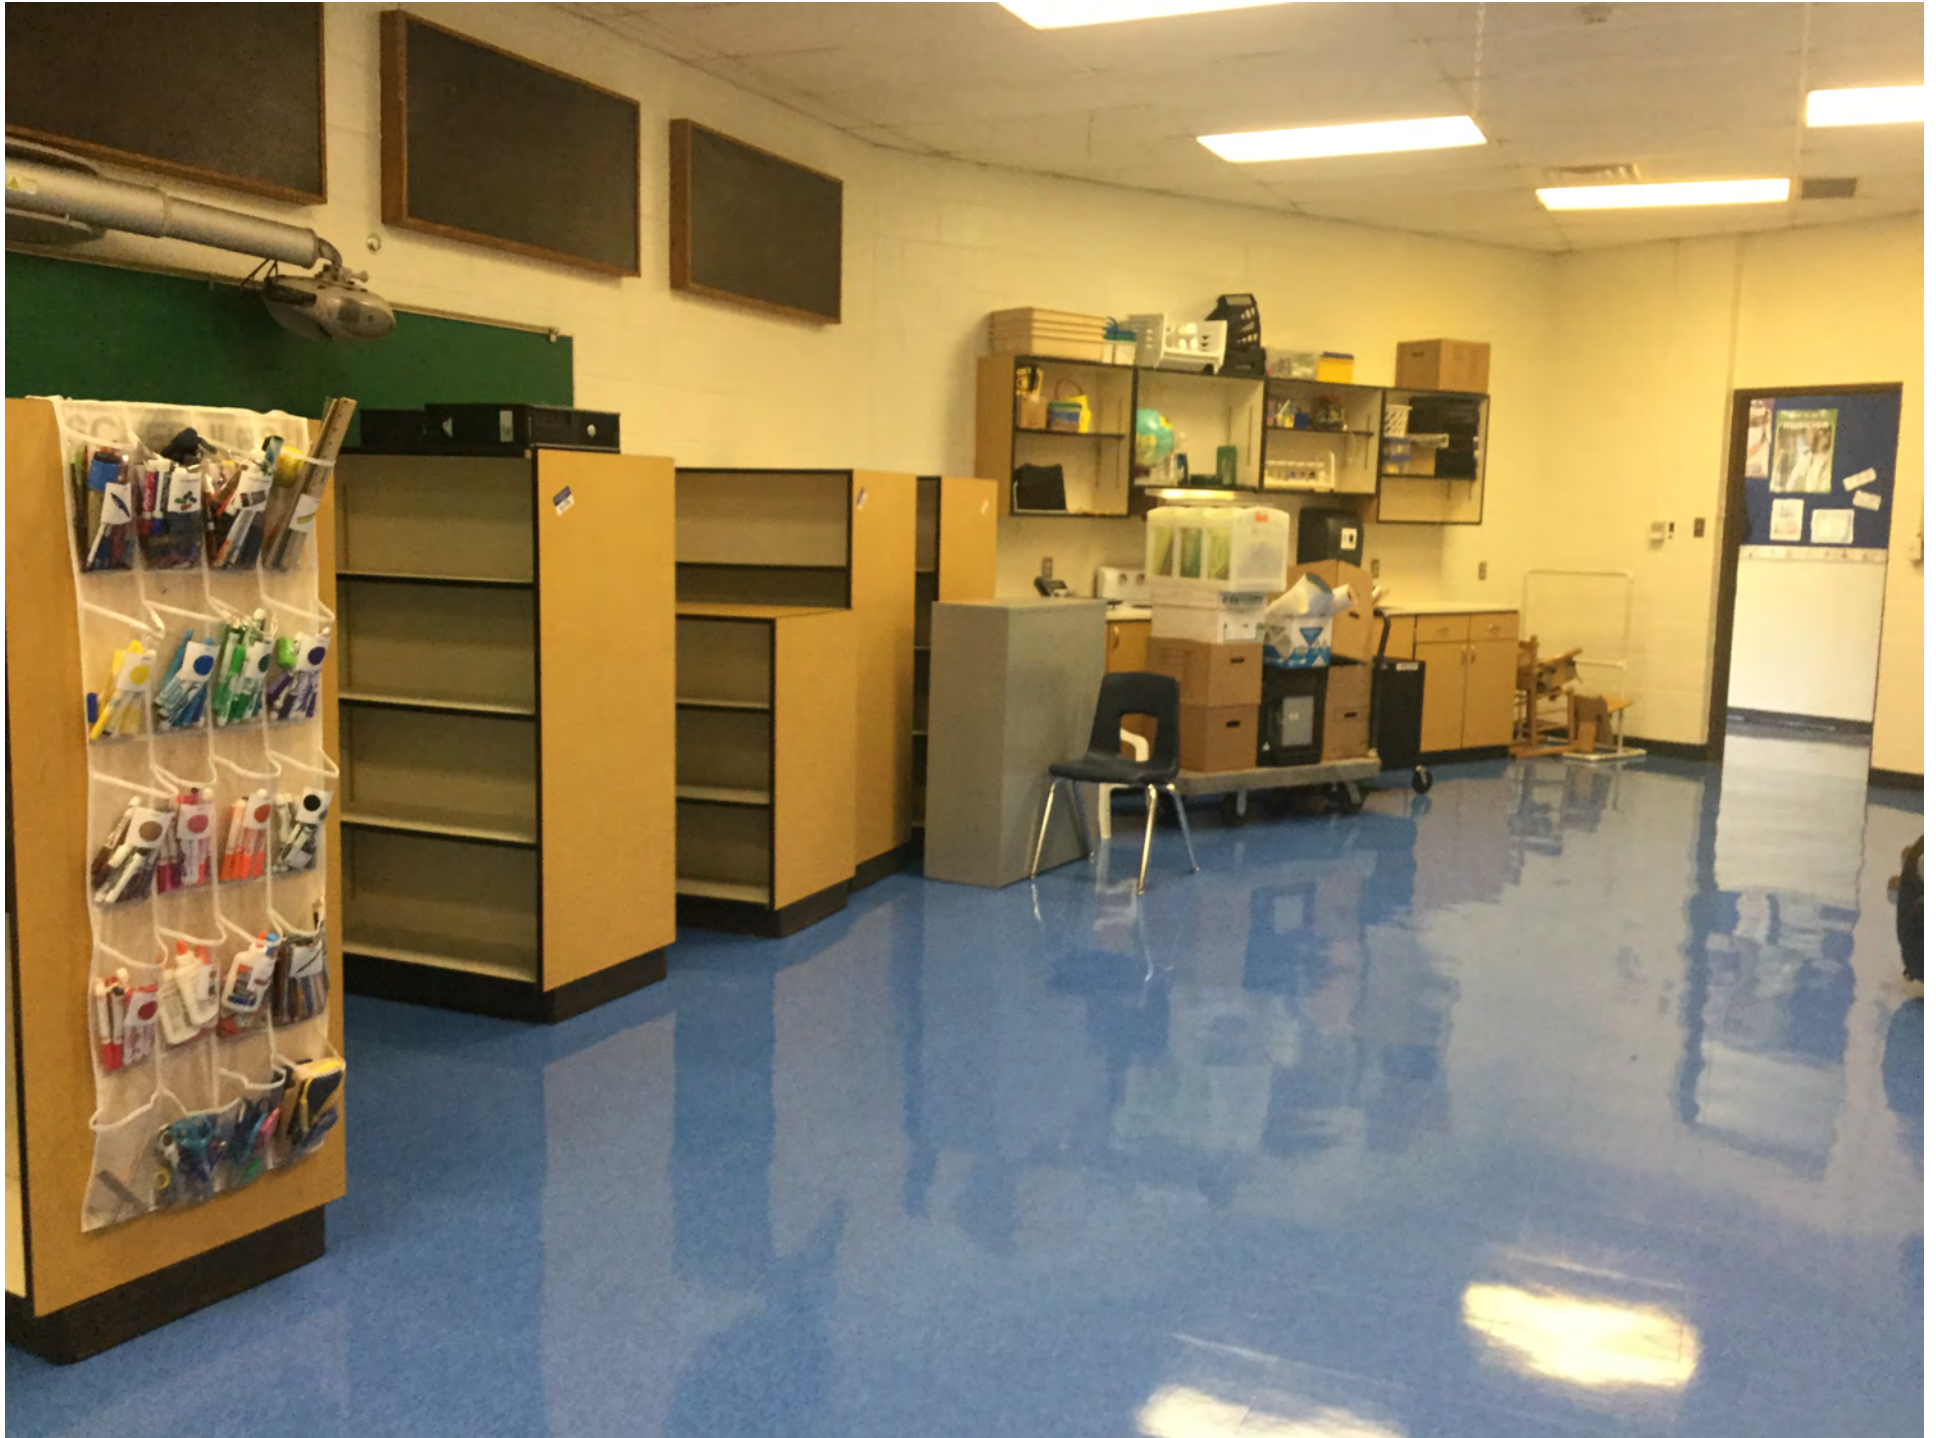
1) Very unsatisfactory 2) Unsatisfactory 3) Average 4) Good 5) Very good N/A) Does not apply.								The classroom is long and narrow and lacks any natural light. It has outdated visual communication tools. <i>Principal Comments: The open plan floorplan is not appropriate for the higher number of special education students on this campus. Principal explained that they have converted office space to be the life skills and the SBS classroom. The SBS classroom is adjacent to the principal's office which creates acoustic issues for meetings. Score has been lowered from a 2 to a 1 to reflect new information.</i>	See Photo 6

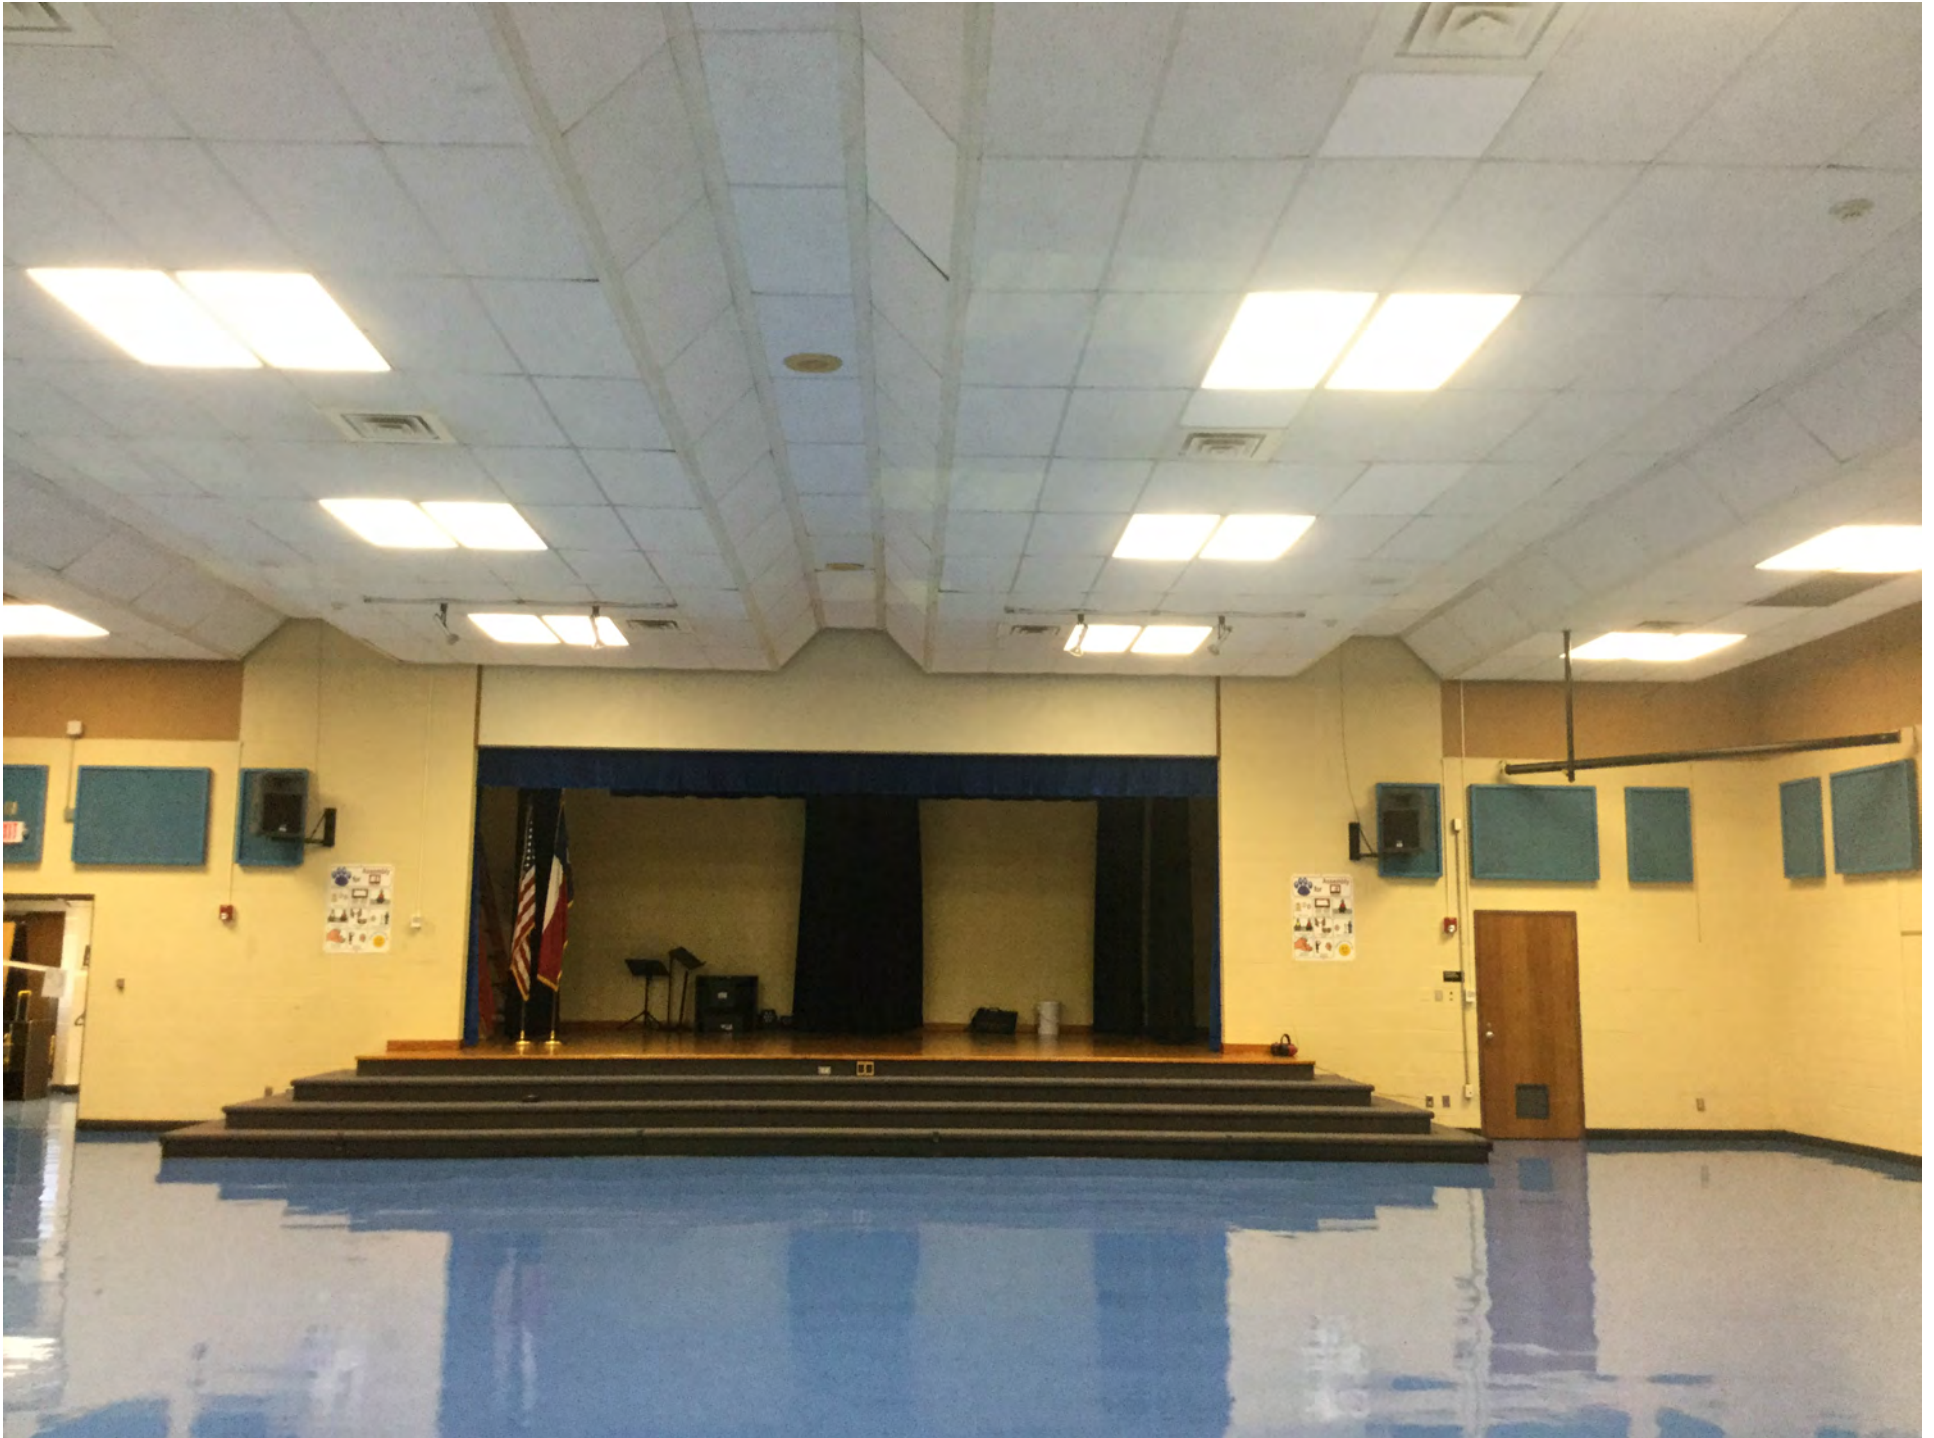
3.16 Cafeteria

3.16	Are the student dining facilities appropriately configured?		2					Comments	1.00 <b>2.00</b>
1) Very unsatisfactory - Too small, poor circulation, inflexible seating in poor condition 2) Unsatisfactory - Too small or inadequate circulation, seating in poor condition 3) Average - moderate size, with adequate circulation, seating in okay condition 4) Good - good size, adequate circulation, seating in good condition 5) Very good - good size, adequate circulation, seating in good condition, with more than one option for eating space (ex: connection to outdoor eating space) N/A) Does not apply.								The cafeteria is undersized for the number of students.	See Photo 7
