## Educational Suitability Summary Report

Williams Elementary School

Date: 08/03/2016

**Score 47% Unsatisfactory**

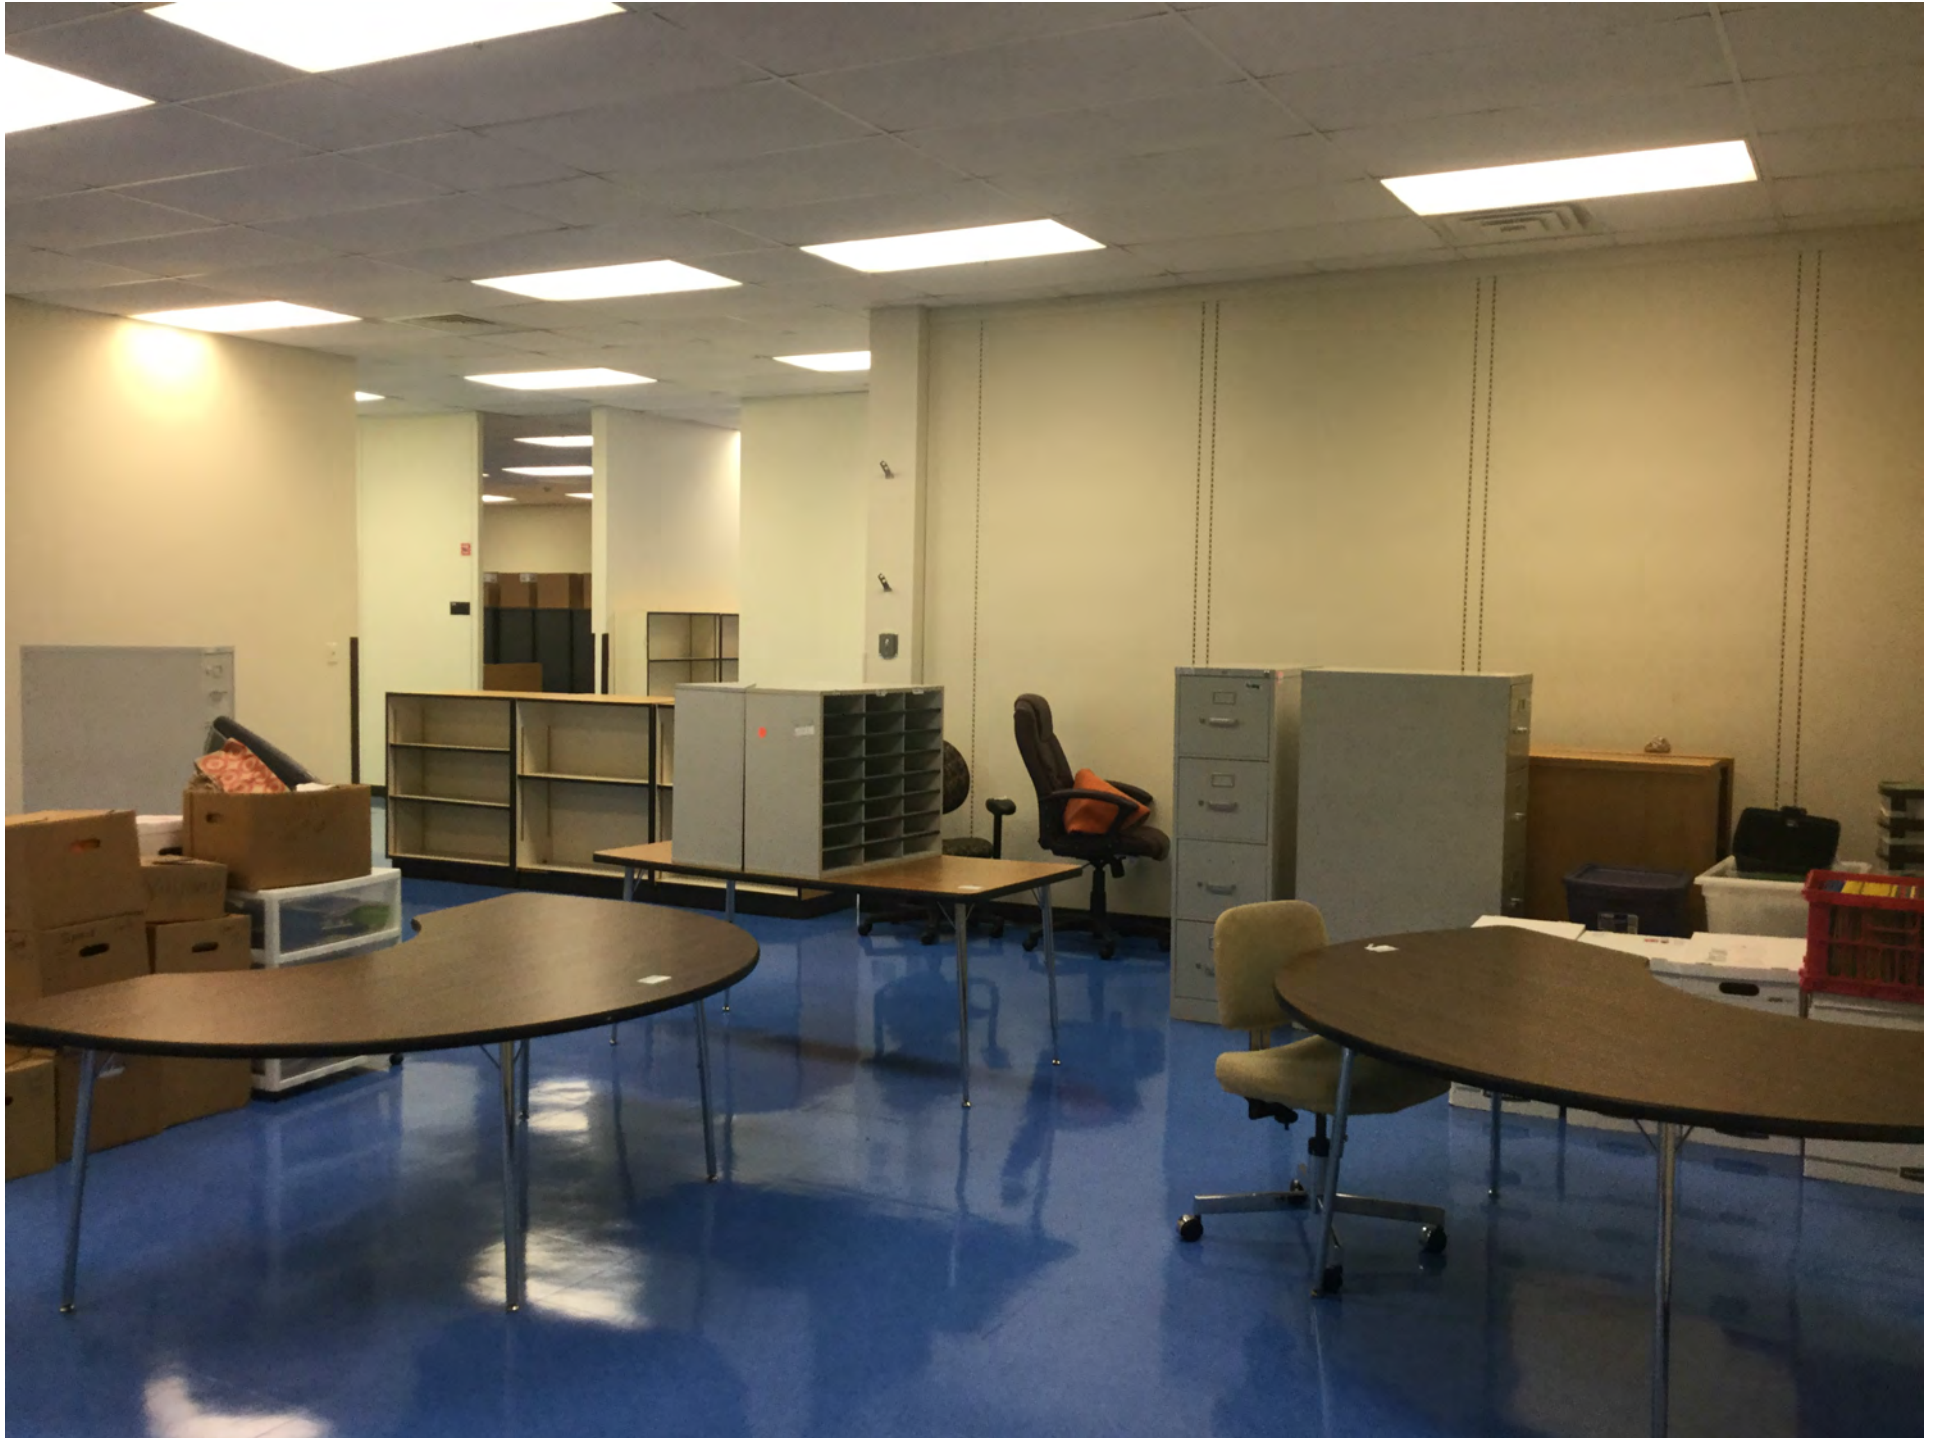
4.2 Classroom

4.2	Are general classrooms large enough to support project-based learning and multiple teaching modalities?			3				Comments	1.00 3.00
1) Very unsatisfactory -too small to move, set for lecture only, no connectivity, no flexibility 2) Unsatisfactory - adequate size but set for lecture only, no connectivity, no flexibility 3) Neutral - have flexibility and space for hands on or project based learning 4) Satisfactory - have flexibility and space for hands on or project based learning and connectivity for global learning 5) Very Satisfactory - space for hands on learning, flexibility for different groupings, and connectivity for global classrooms N/A) Does not apply.

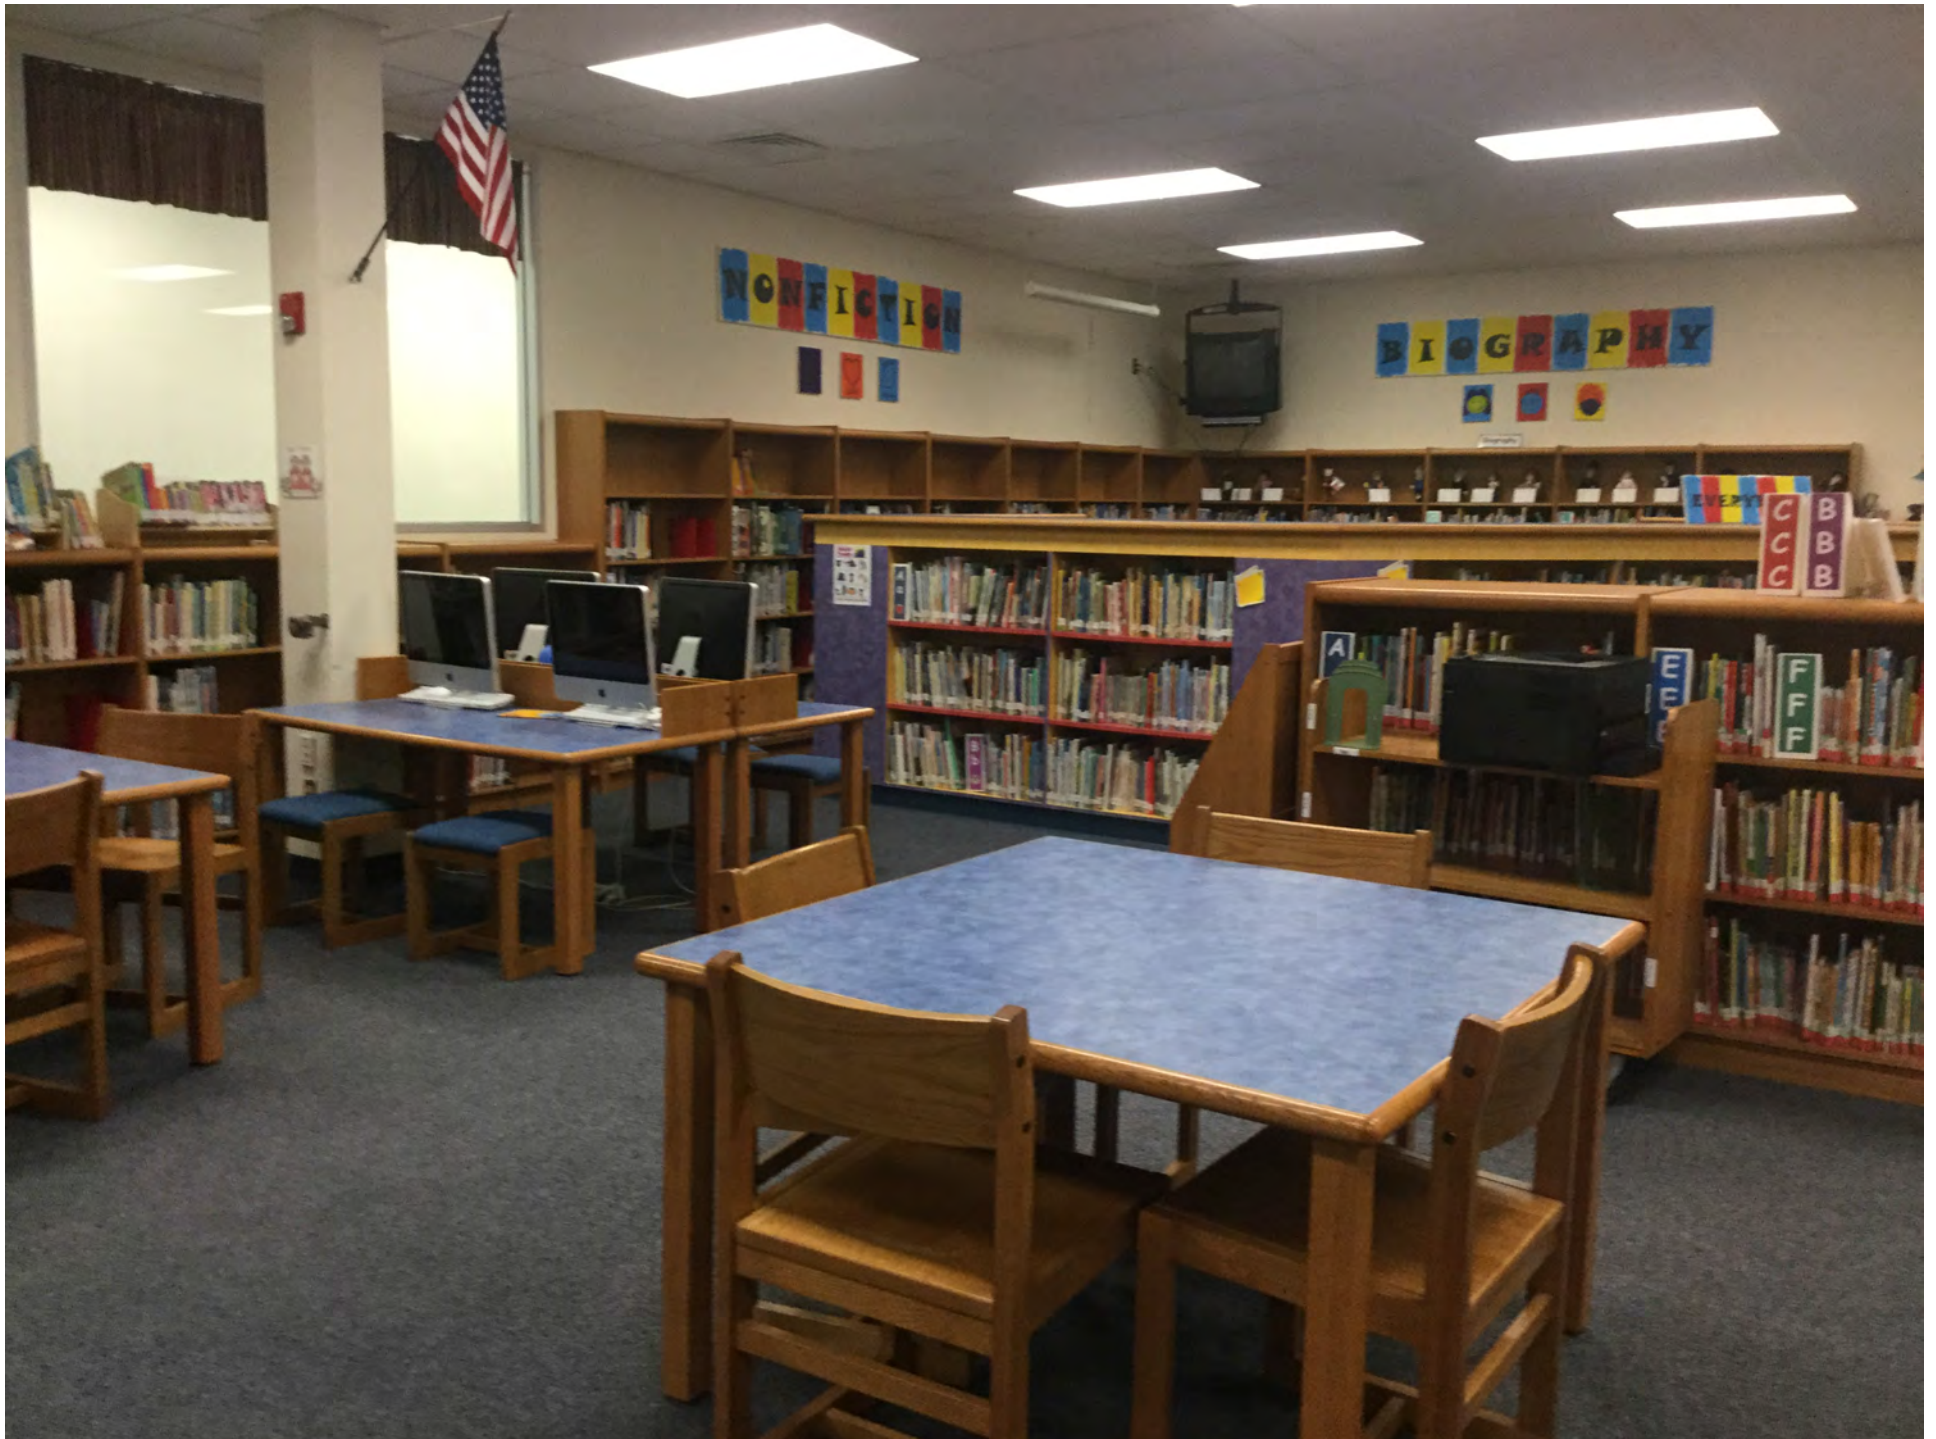
5.4 Library

See Photo 8

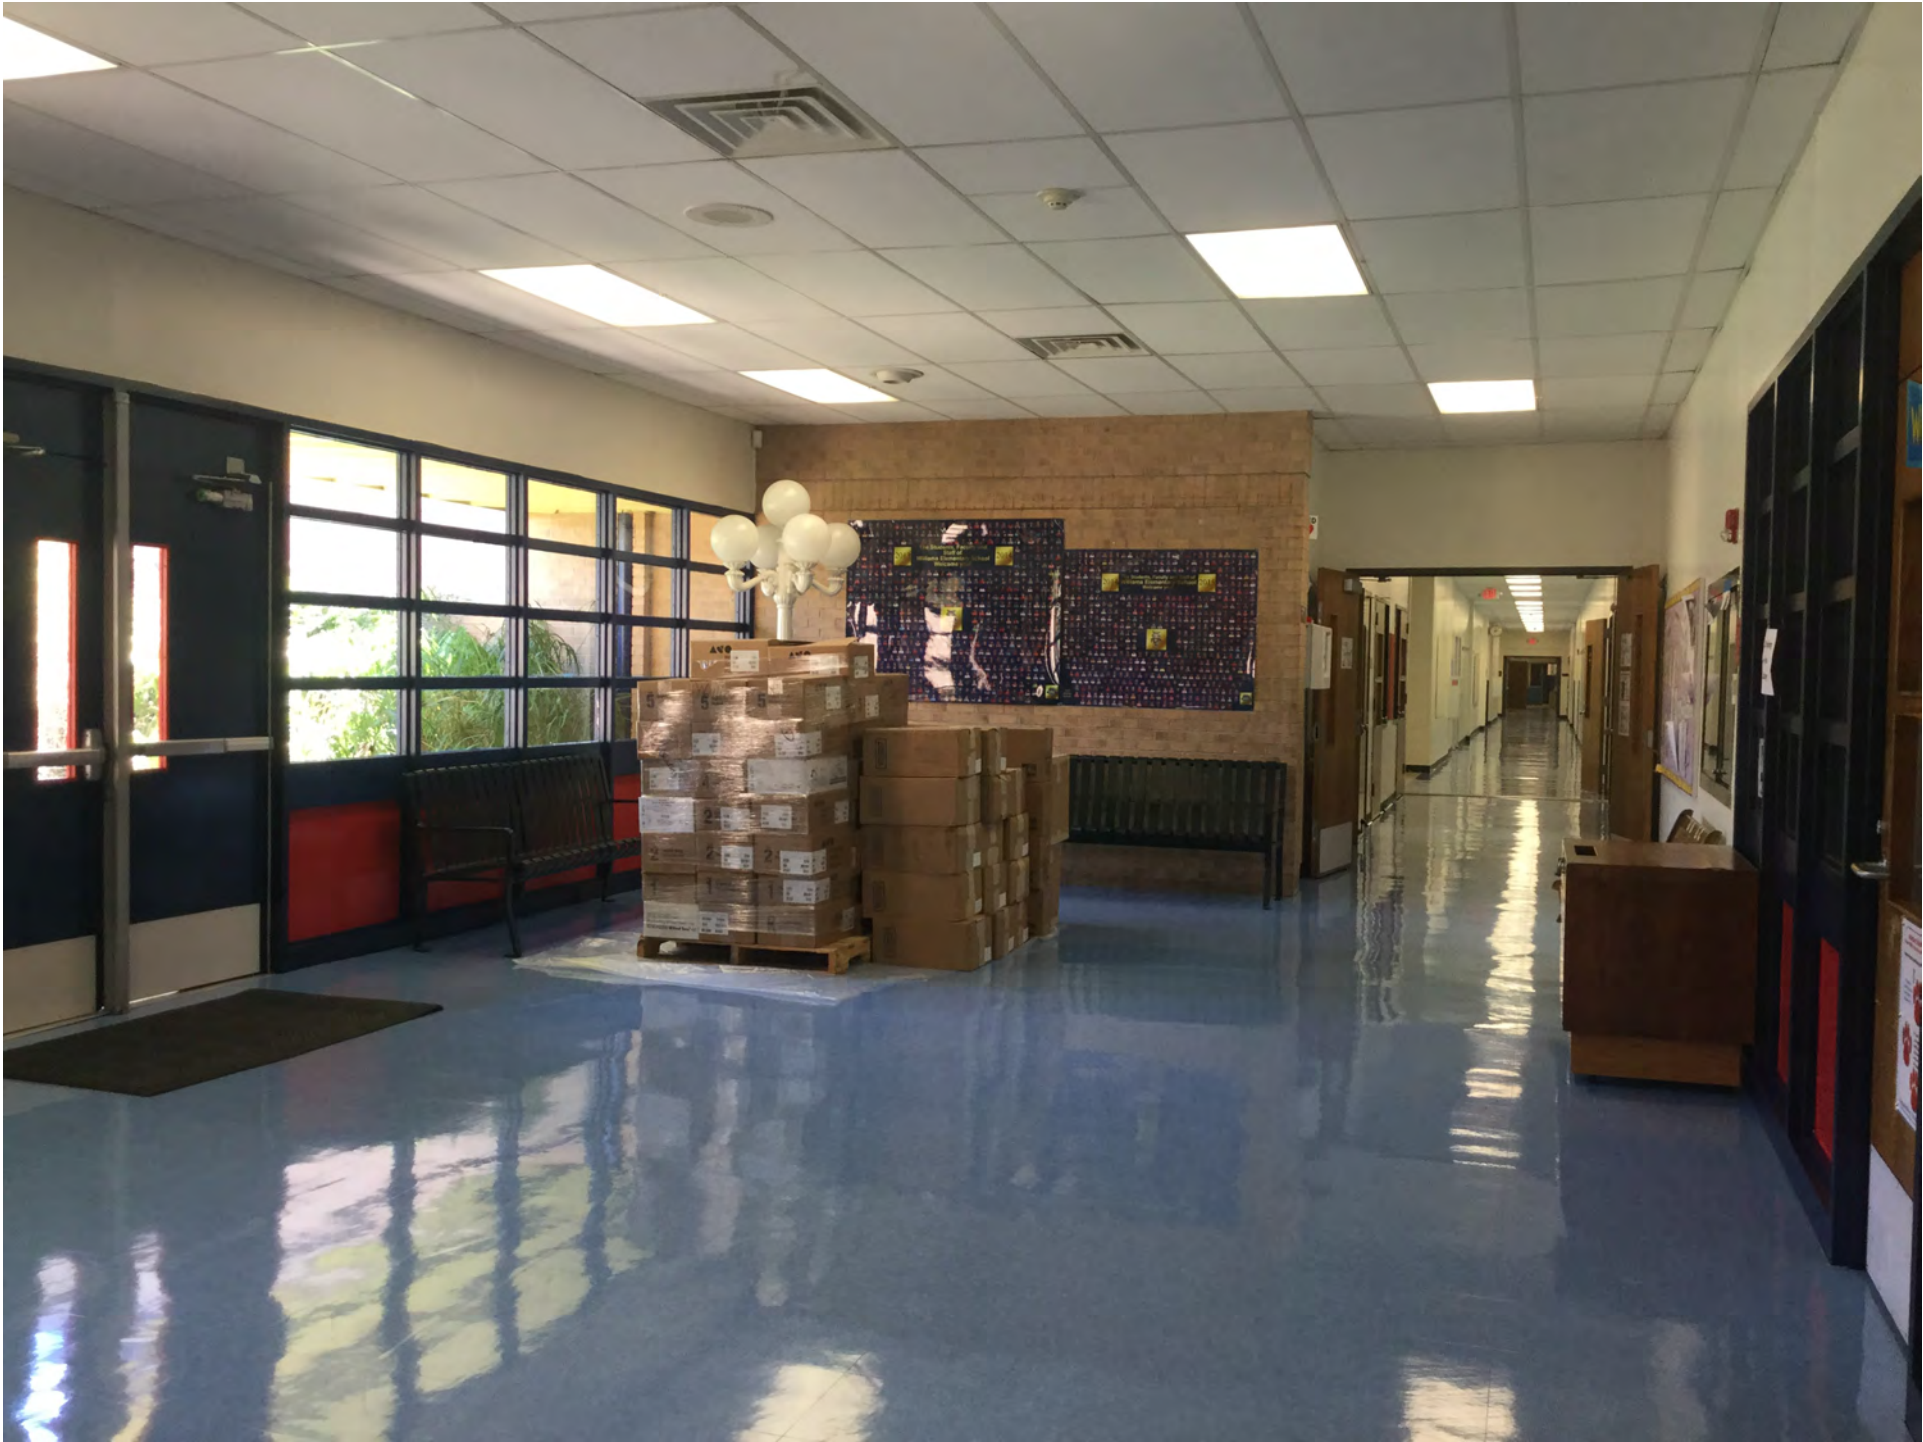
6.3 Entry Security

The location of the central office does not create a secure vestibule for the campus; however, it is located at the front entry for supervision of those entering the school. Key card access is at major entries, and the interior transparency is good for faculty supervision within the school. The principal reports concern about the open floor plan in the event of a lock-down scenario. She also is concerned with the small gate near the Pre-K area to the parking lot. *The fence currently has openings; there is not a continuous fenced perimeter around the campus. The principal provided new feedback that interior camera coverage is extremely limited and creates a surveillance concern for elopers.*
