Educational Suitability Summary Report

Winn Elementary School – BLDG 157

Date: 05/18/2016

Score 45% Unsatisfactory

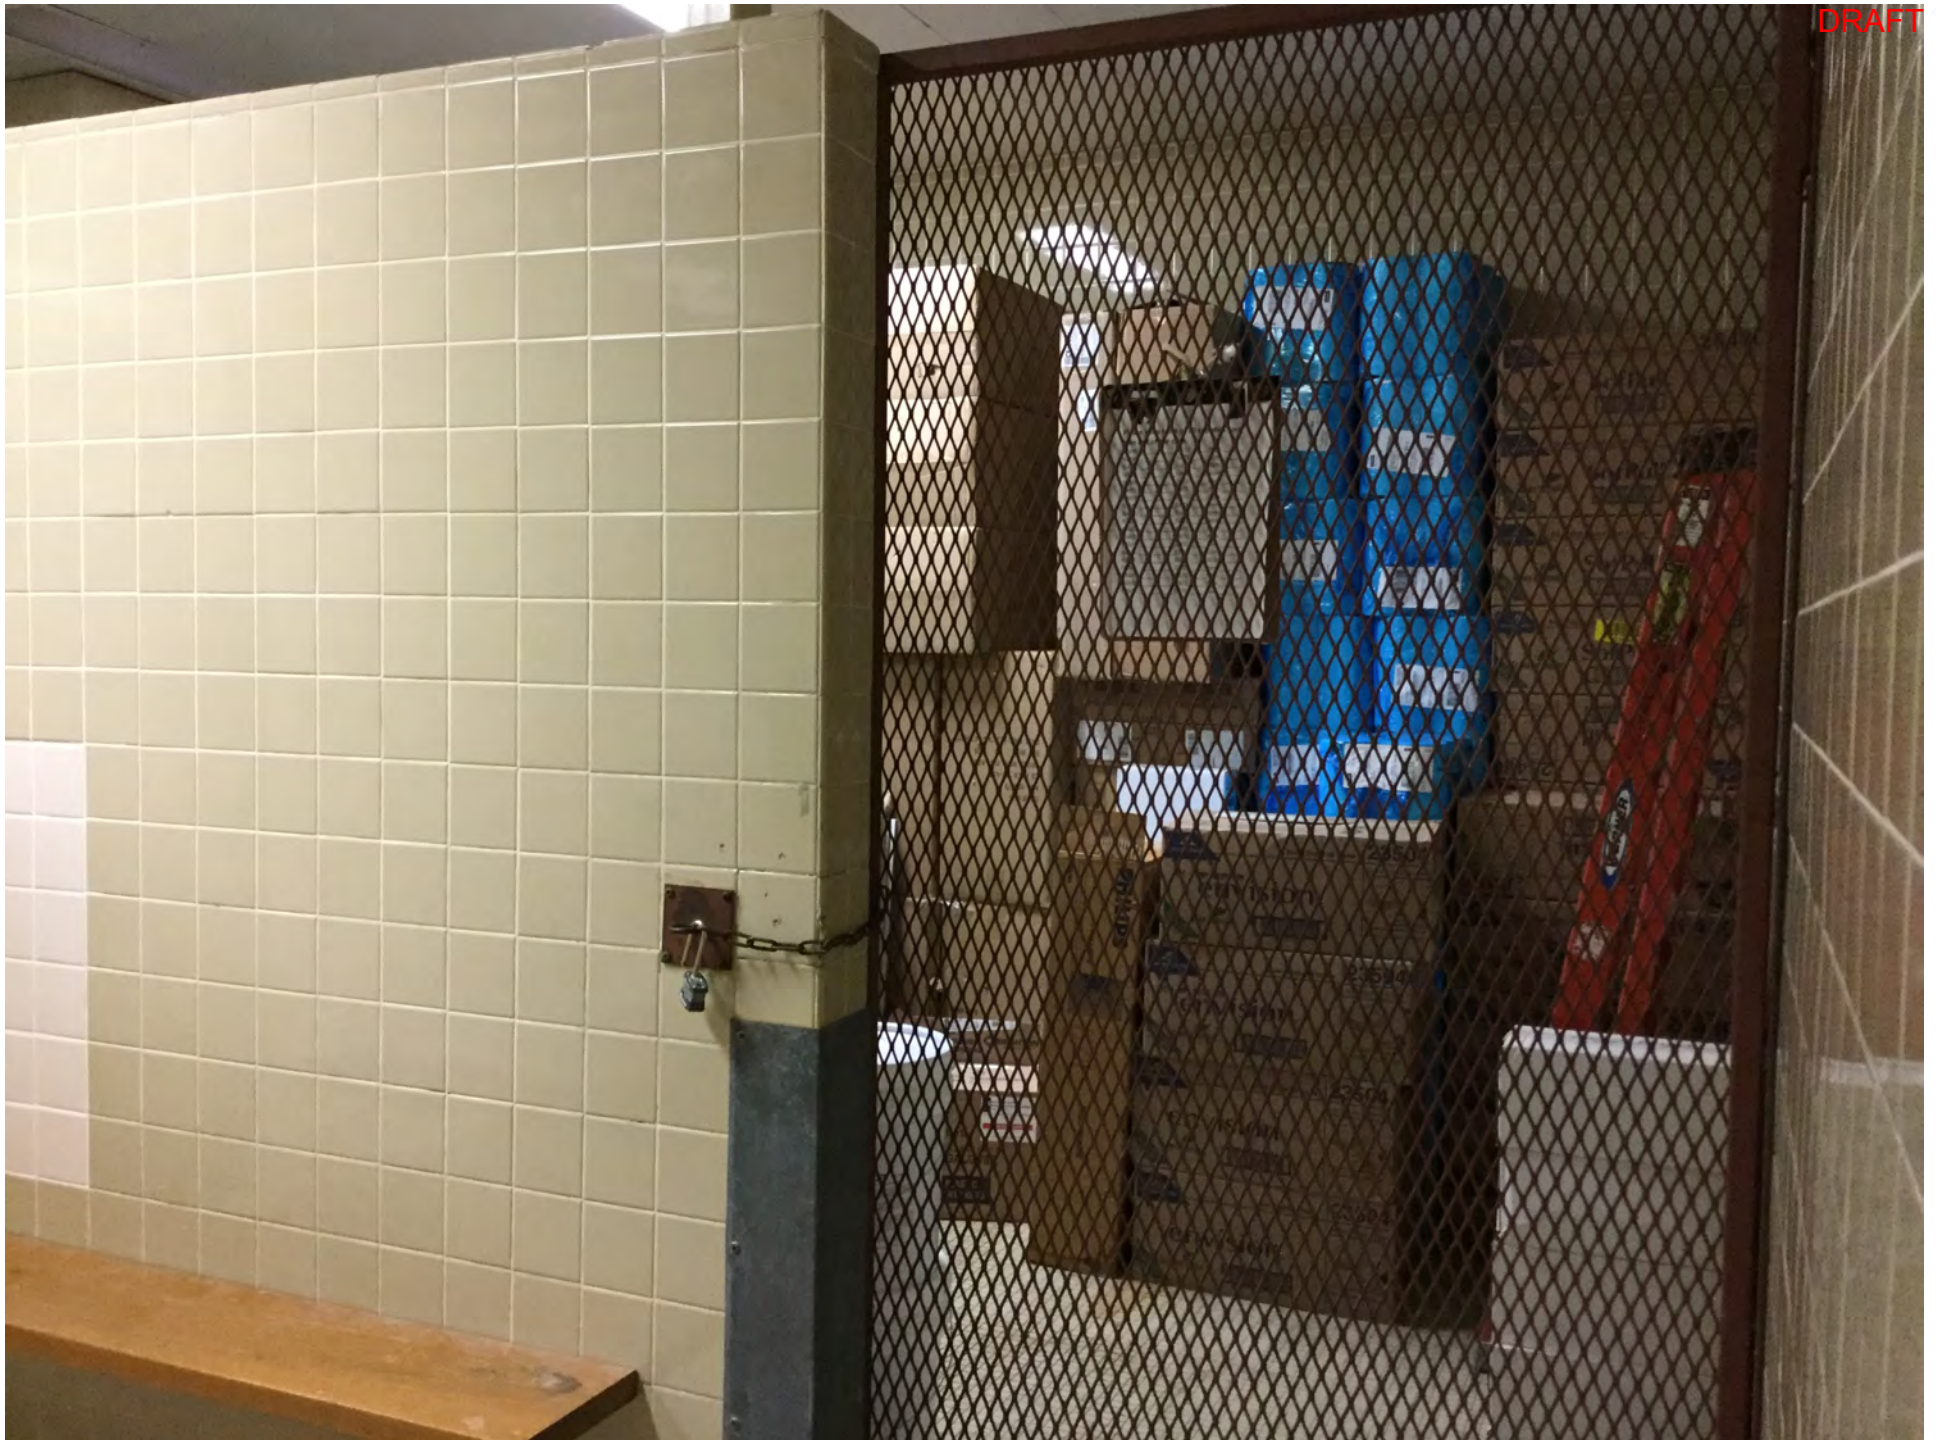
Photo 6. Storage
connected to restroom

3.7	Are Physical Education and Athletic support spaces appropriately configured per the ed spec?			2									Comments	1.00	2.00
1) Very unsatisfactory - Support spaces are disconnected from served spaces, too small, do not meet needs 2) Unsatisfactory - Support spaces are connected, but too small, inadequate for needs 3) Average - Connected, moderate size, but need some renovations or updates to function well 4) Good - Connected, good size/layout, meets needs/functions well 5) Very good - connected, generous size, nice condition, functions appropriately N/A) Does not apply.													Very small storage. Storage has no lighting. Water fountain across corridor. Storage is located in girls restroom.

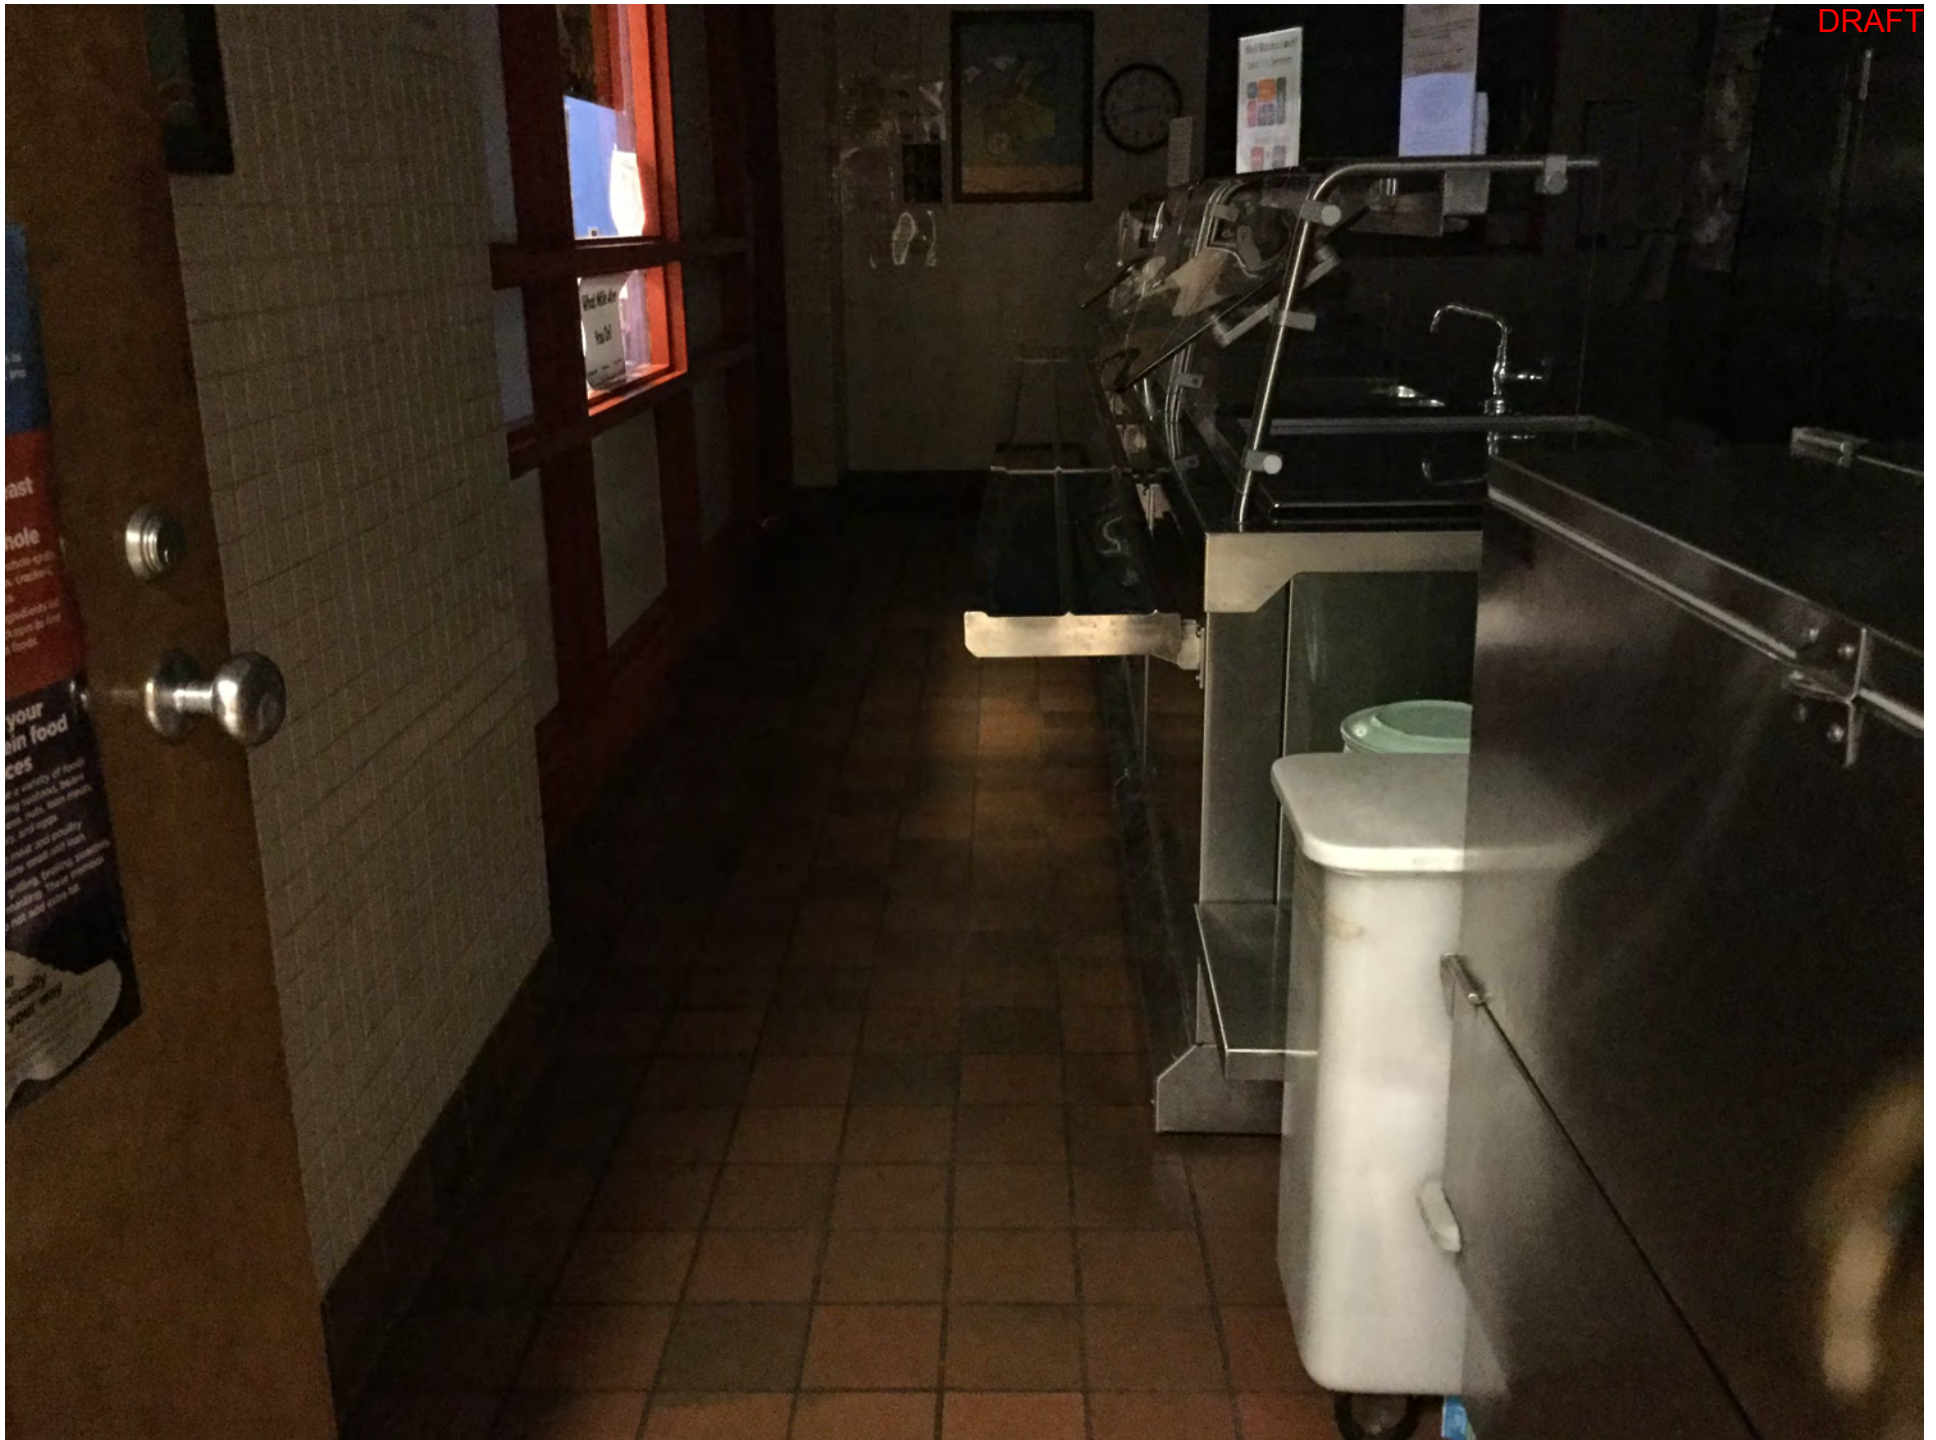
Photo 9. Cafeteria
serving line

3.16 Are the student dining facilities appropriately configured?			3				Comments 1.00 3.00
1) Very unsatisfactory - Too small, poor circulation, inflexible seating in poor condition 2) Unsatisfactory - Too small or inadequate circulation, seating in poor condition 3) Average - moderate size, with adequate circulation, seating in okay condition 4) Good - good size, adequate circulation, seating in good condition 5) Very good - good size, adequate circulation, seating in good condition, with more than one option for eating space (ex: connection to outdoor eating space) N/A) Does not apply.							Serving line is too narrow, and impedes efficiency.

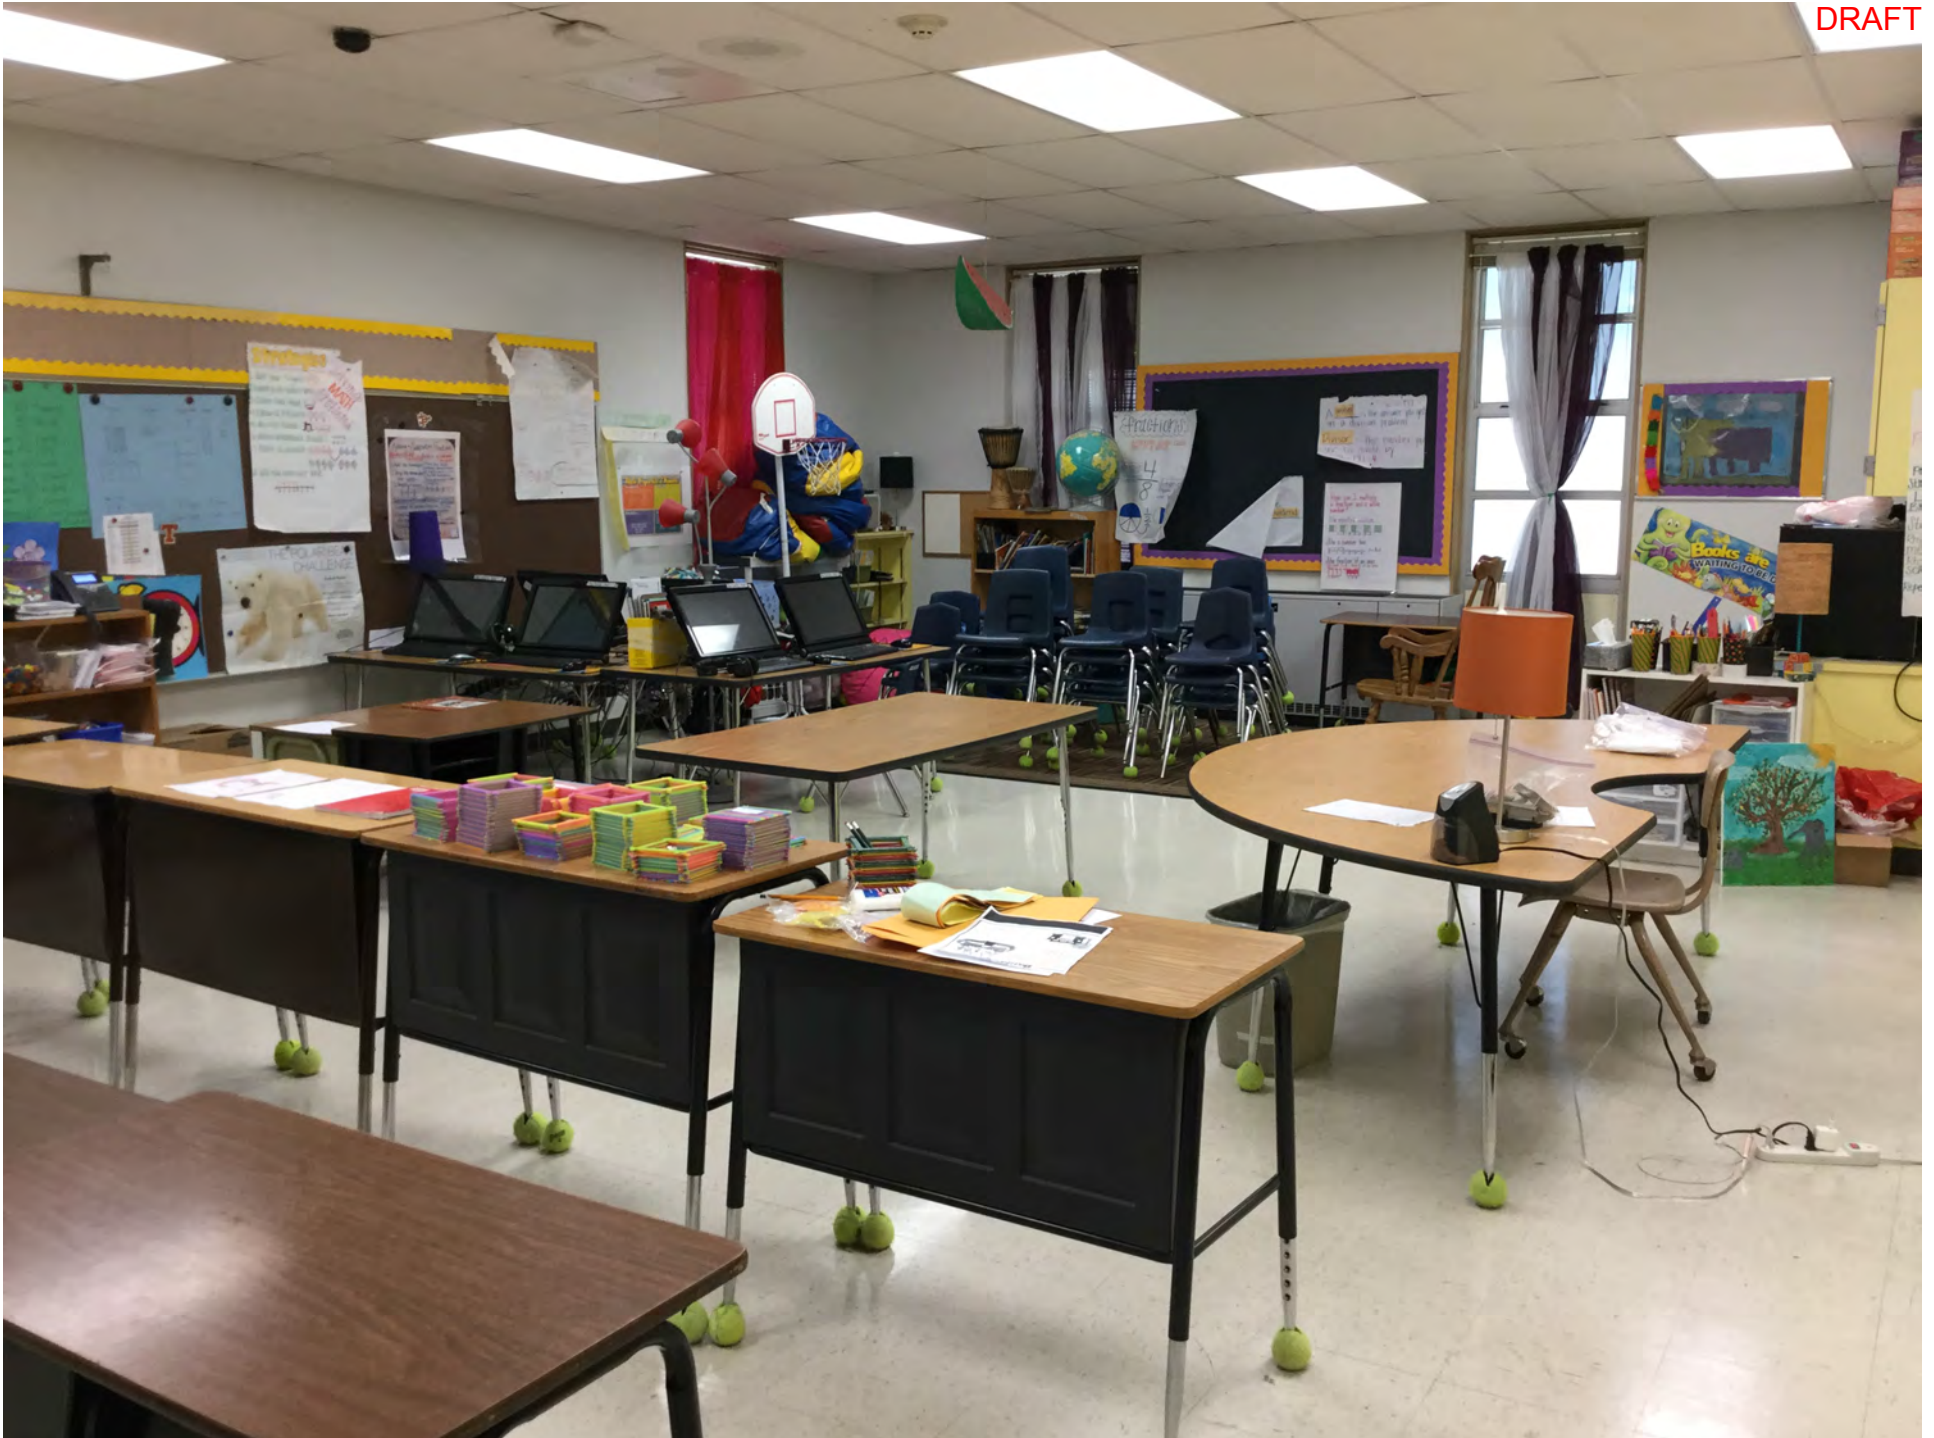
Photo 10. Classroom furniture

Furniture is unsatisfactory in condition and size, and does not allow for easy reconfiguration of the space for different learning groups.

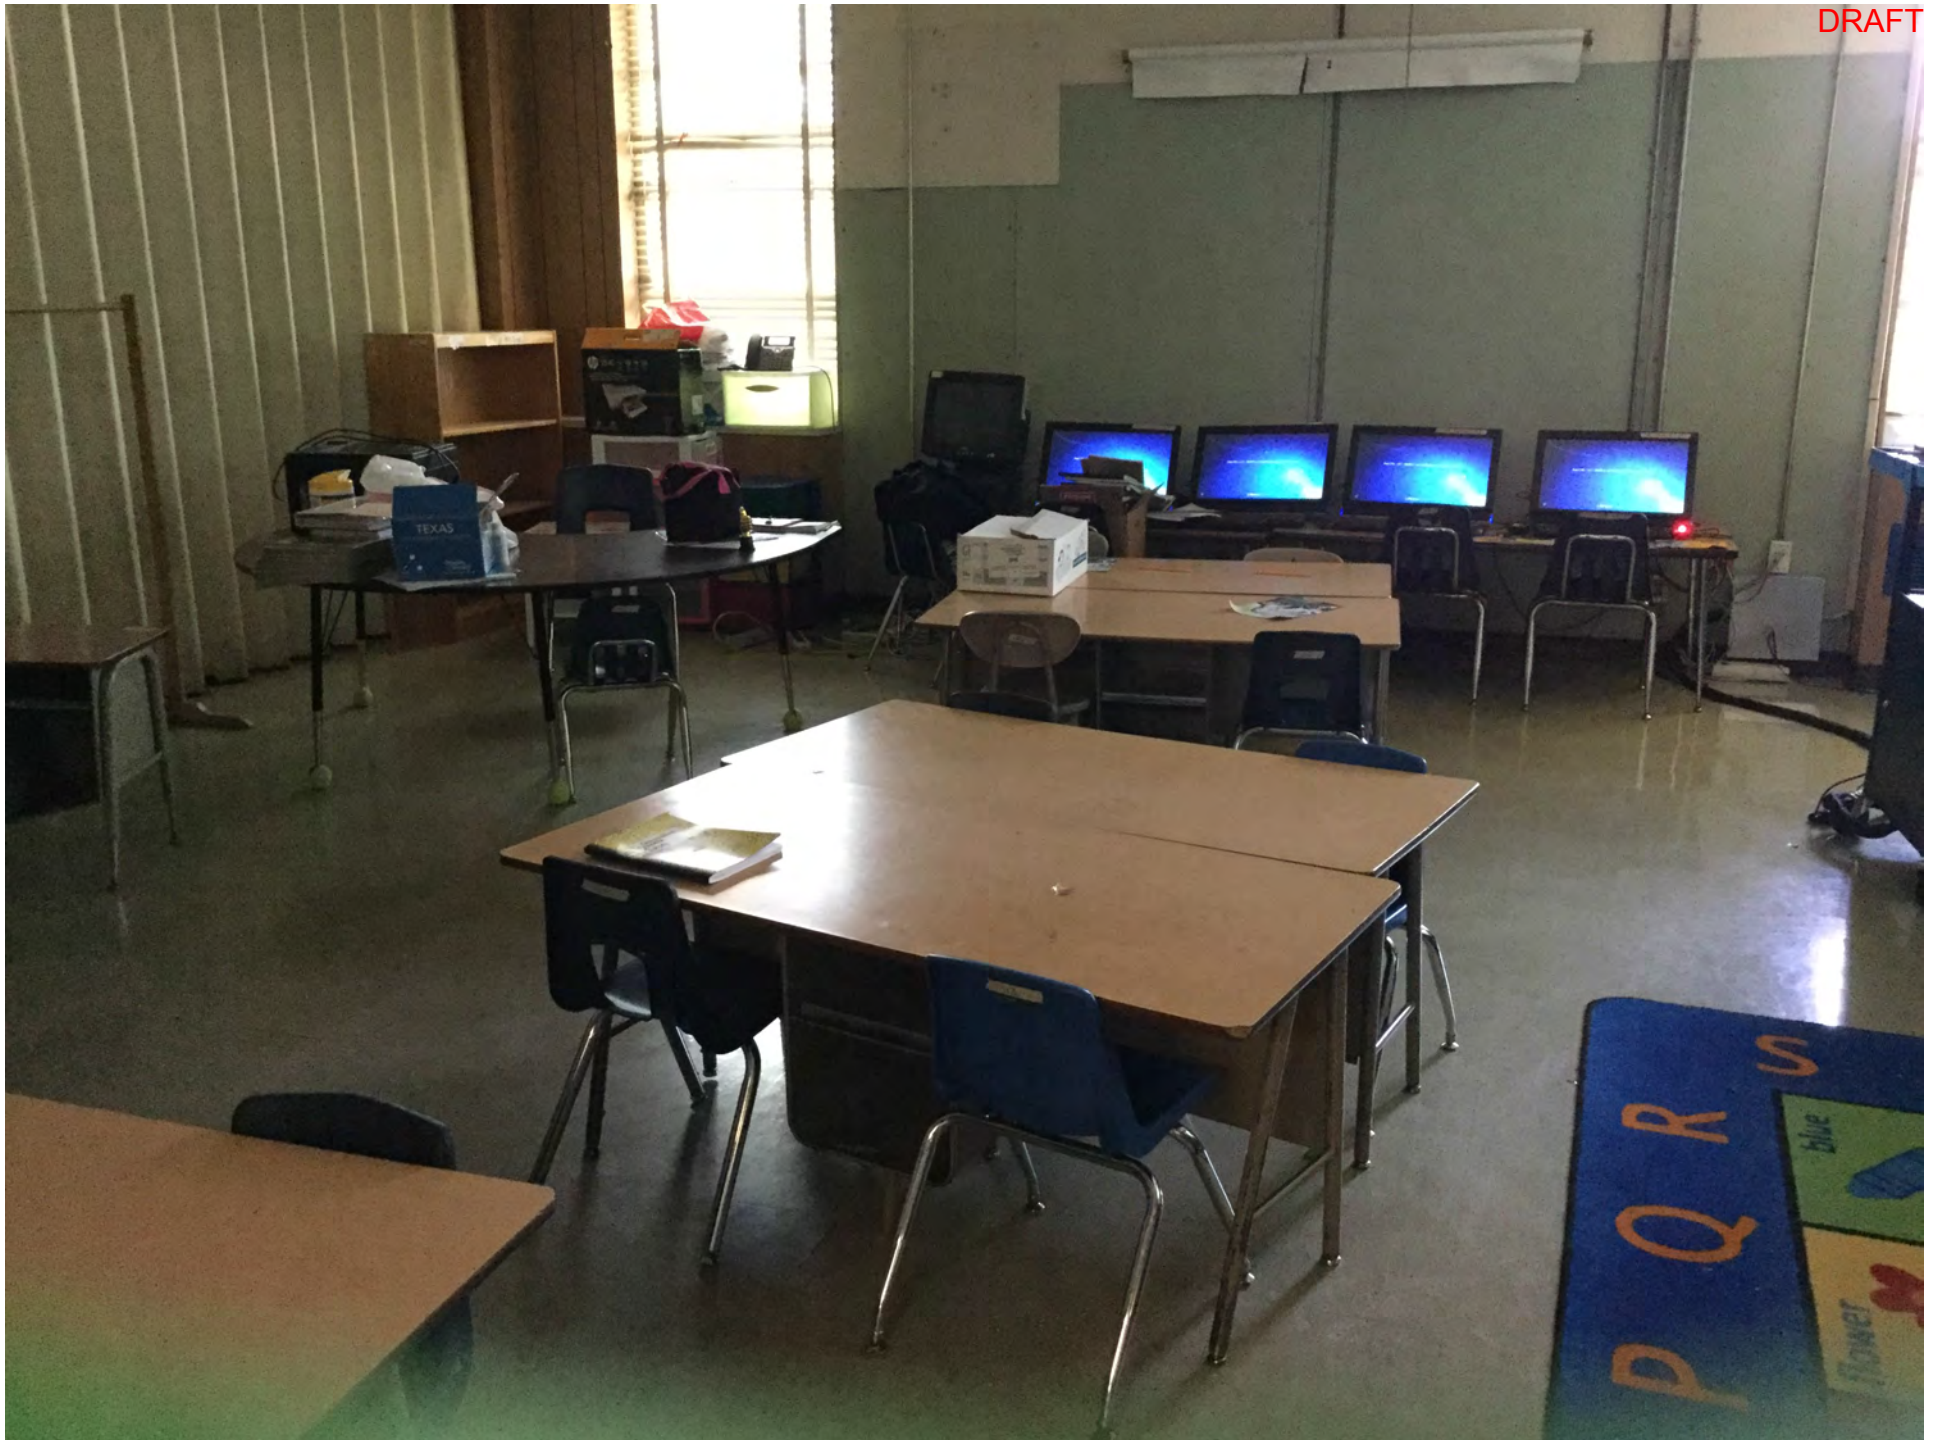
Photo 11. Classroom furniture and layout

Need spaces and items were discussed. Storage of furniture is placed at the ends of corridors. Classrooms are too small to organize and accommodate desks, carpet area, computer center and reading area. Paneling in classrooms does not allow for quality display space and reduces light quality. The campus does not have dyslexia space with whiteboard per the new district requirement. Science lab is just a classroom without science casework, sinks, and storage. Students' desks are heavy and rusted and are not easily reconfigured. The school needs a new marquee. Staff would like to have dedicated classrooms for dyslexic students, STEAM lab, Maker Space, Robotics lab. Student commons and break out space in each pod would be used regularly. Multipurpose rooms for drama, science fair,

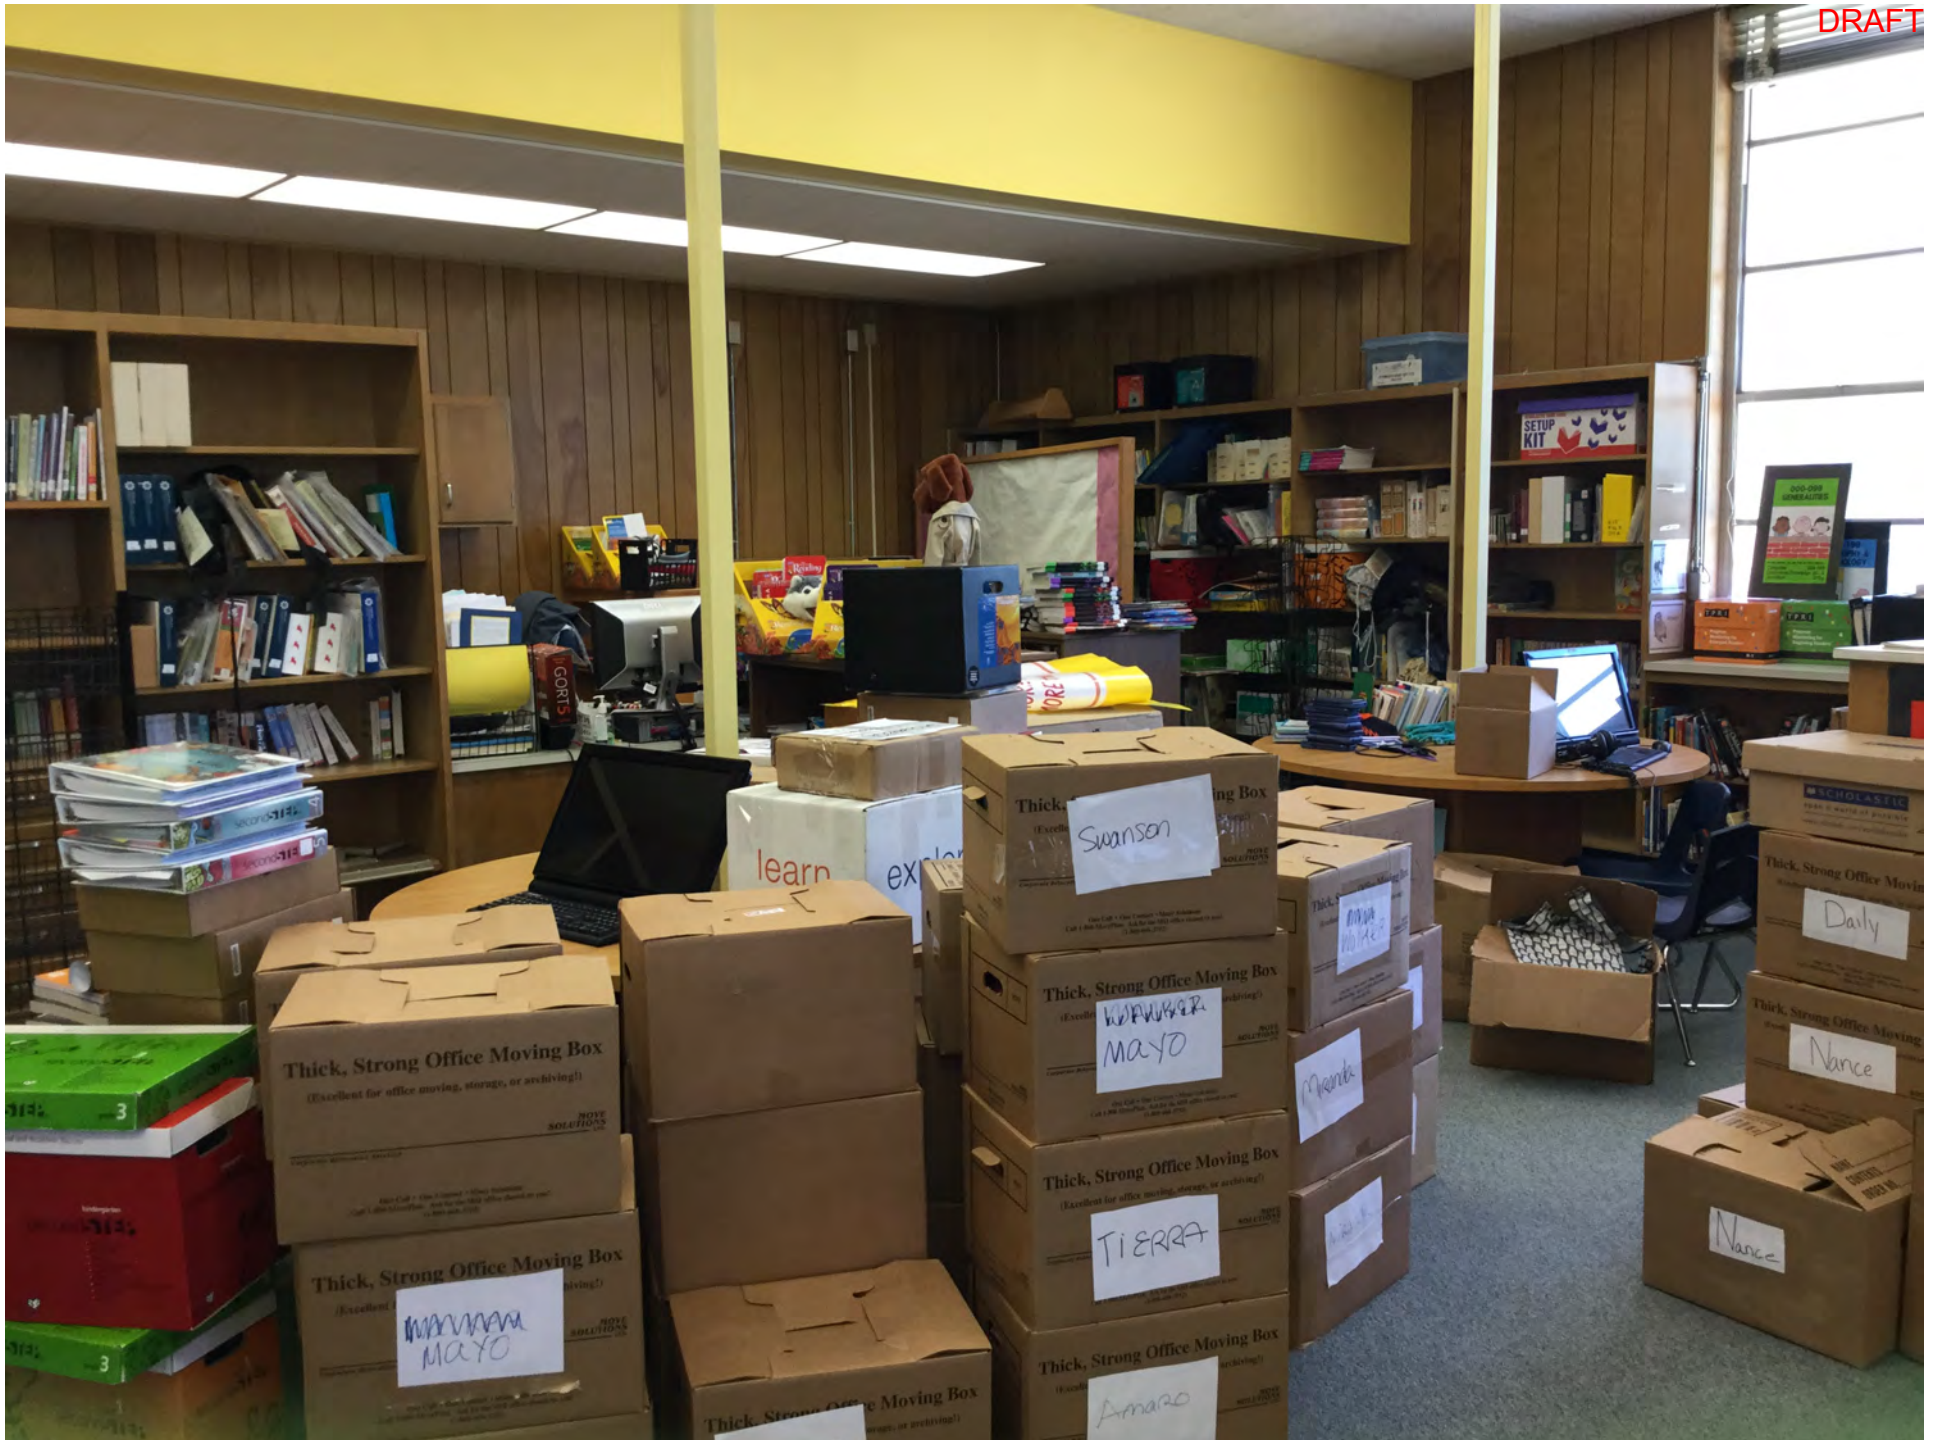
Photo 12. Library

5.4	How well does the Library/Media Center support collaborative work in small groups (4-8 students)?	1						Comments	1.00 1.00
1) Very unsatisfactory 2) Unsatisfactory 3) Average 4) Good 5) Very good N/A) Does not apply.								Fixed furniture is currently used in the library.

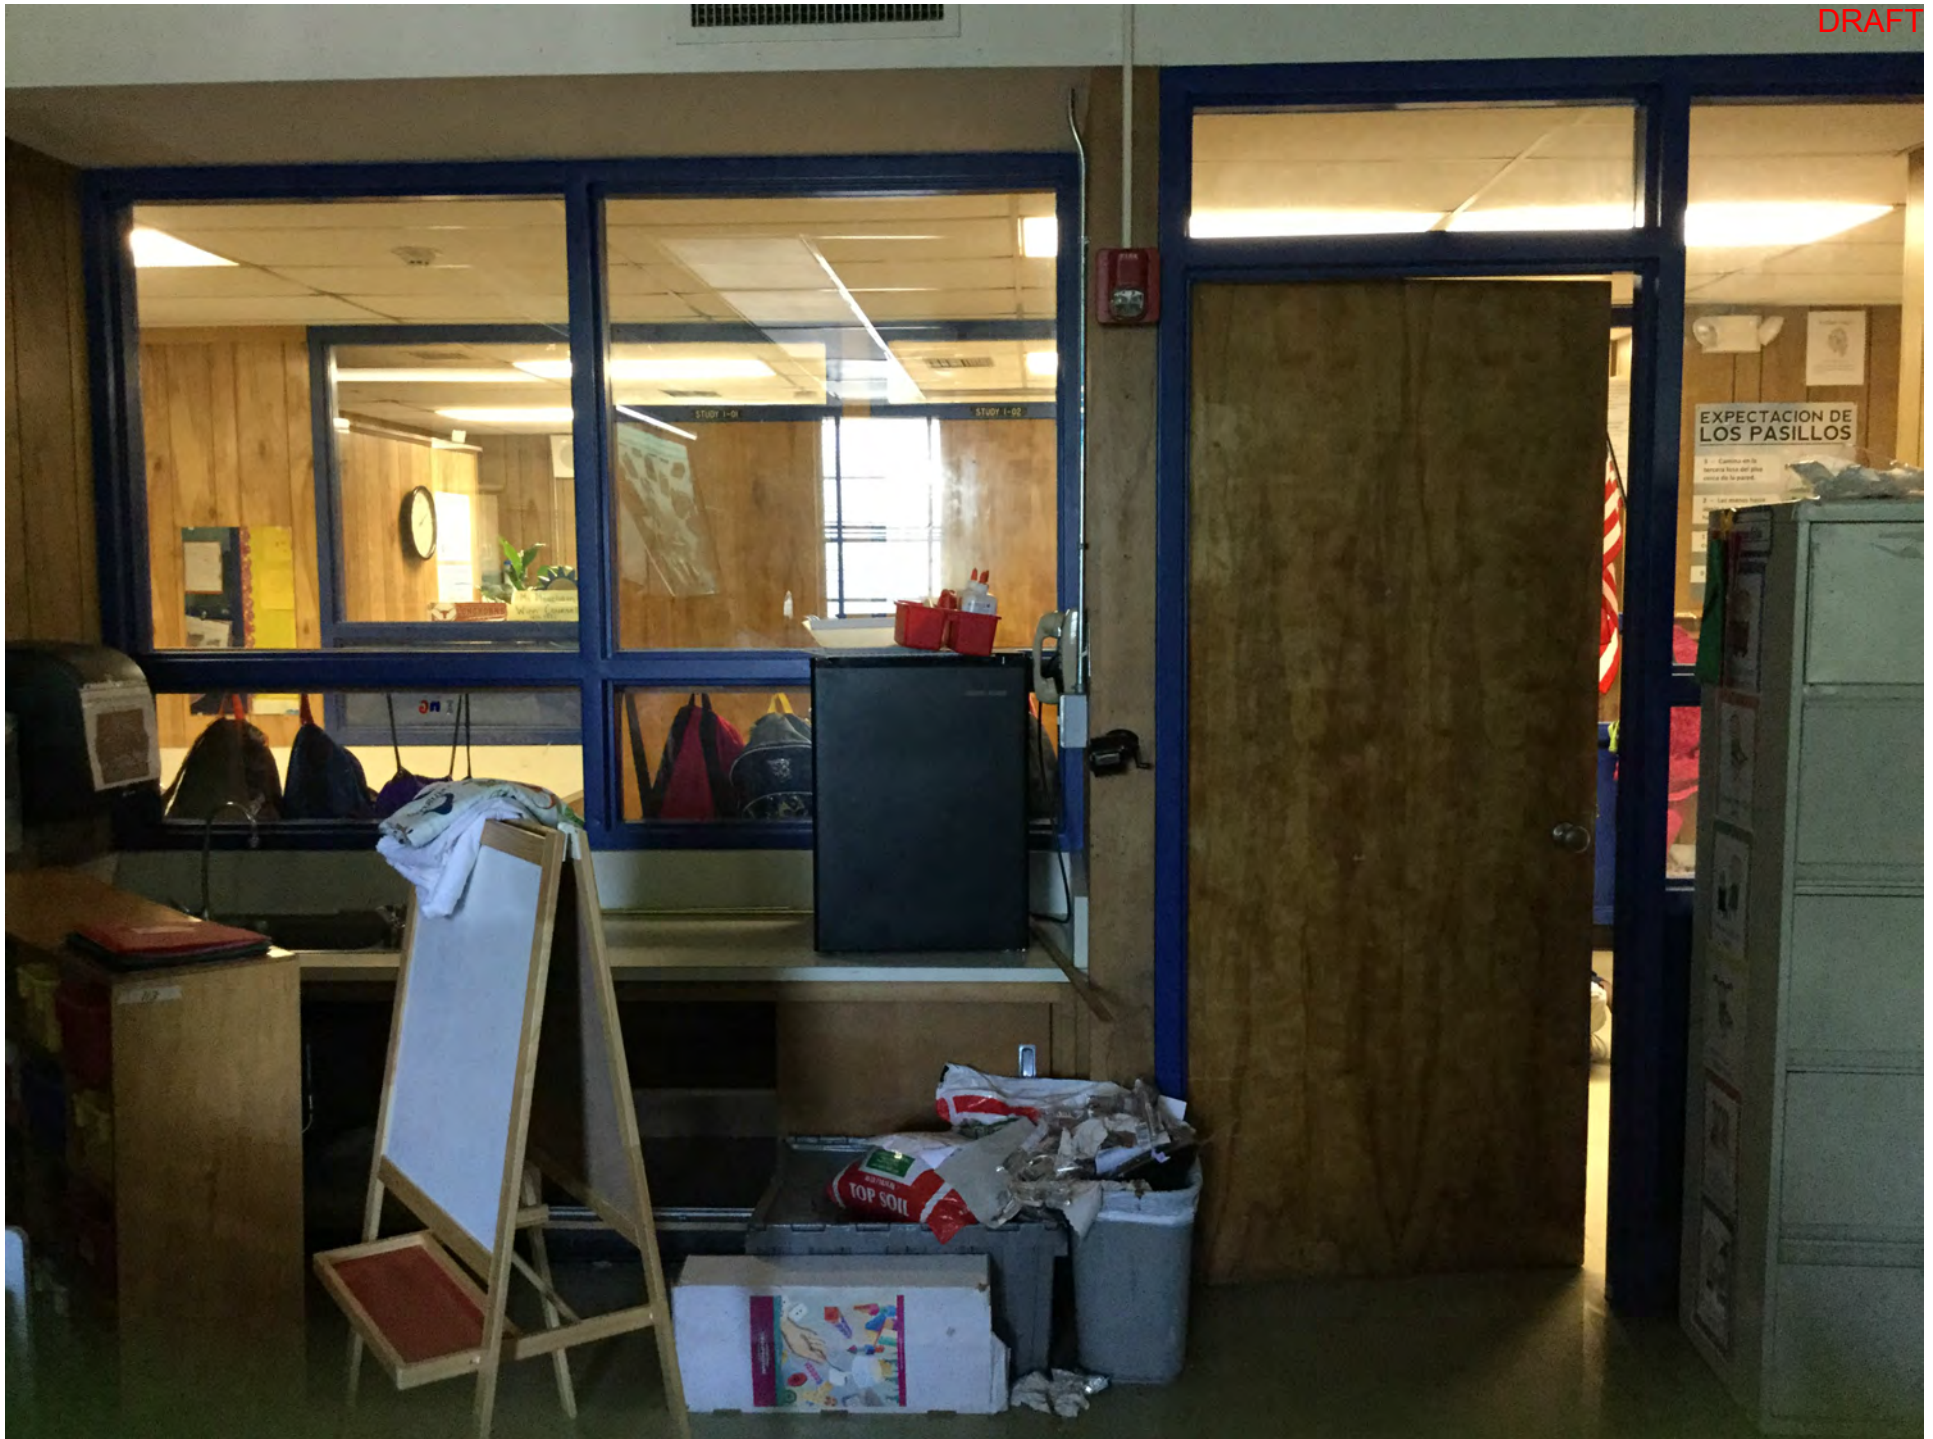
Photo 13. Classroom
view into corridor

6.4	Is there enough interior transparency for faculty to affectively supervise students who are not in classrooms?					5		Comments	1.00 5.00
	1) Very unsatisfactory 2) Unsatisfactory 3) Average 4) Good 5) Very good N/A) Does not apply.							Windows out to corridor for supervision and transparency.

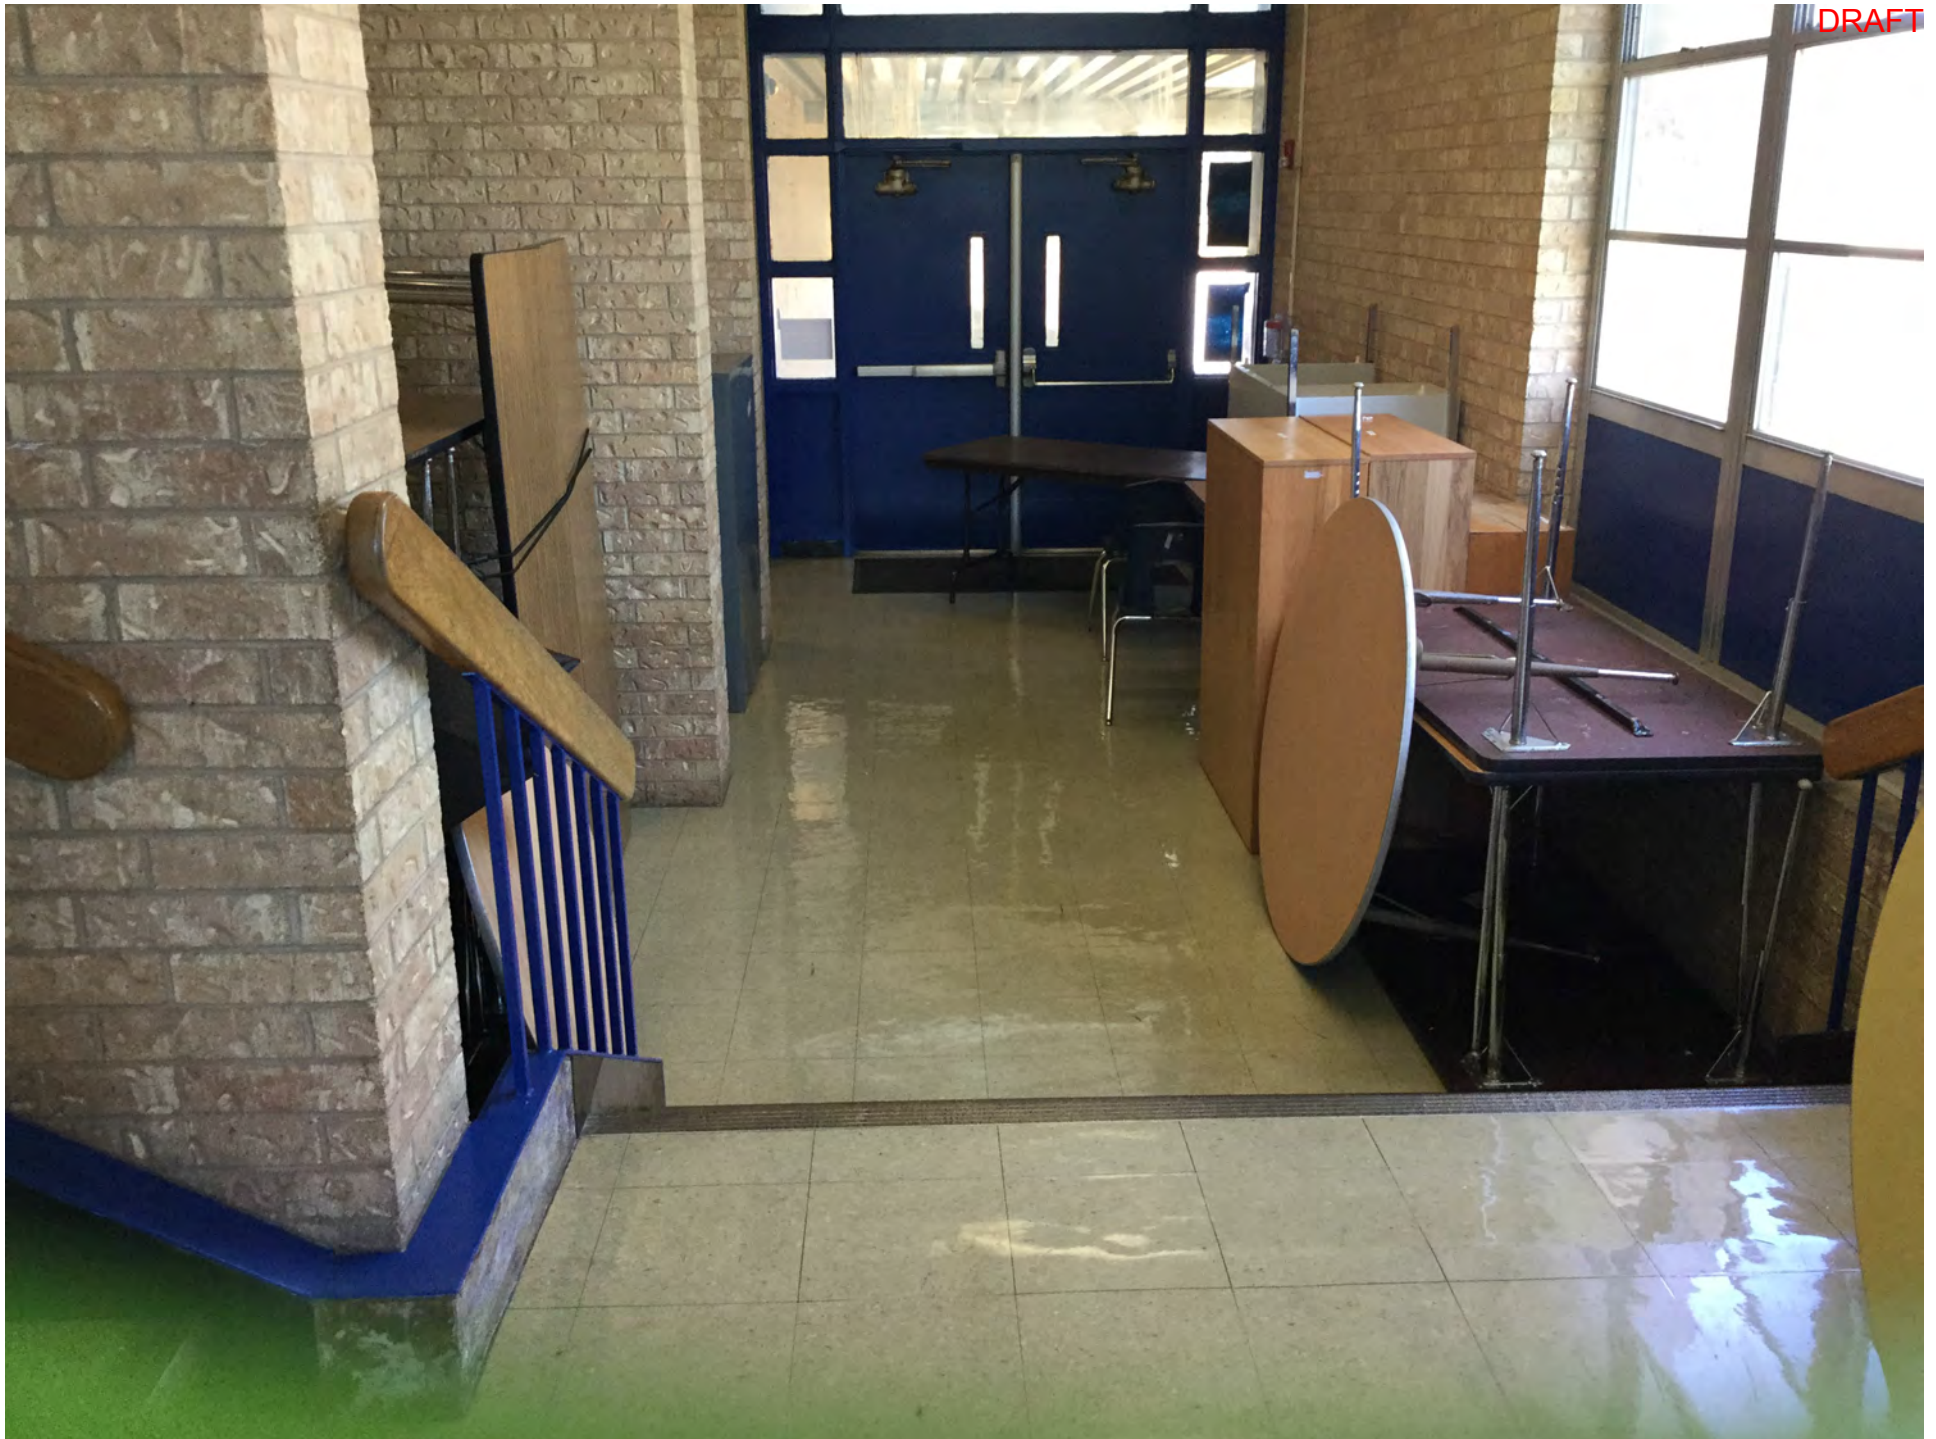
Photo 14. Furniture storage in corridor

General building storage was observed to be very inadequate and allocated to the corridors. Additionally, classroom storage spaces were equipped with only minimal built-in cabinets.
