Educational Suitability Summary Report

Wooten Elementary School

Date: 08/08/2016

Score 50% Unsatisfactory

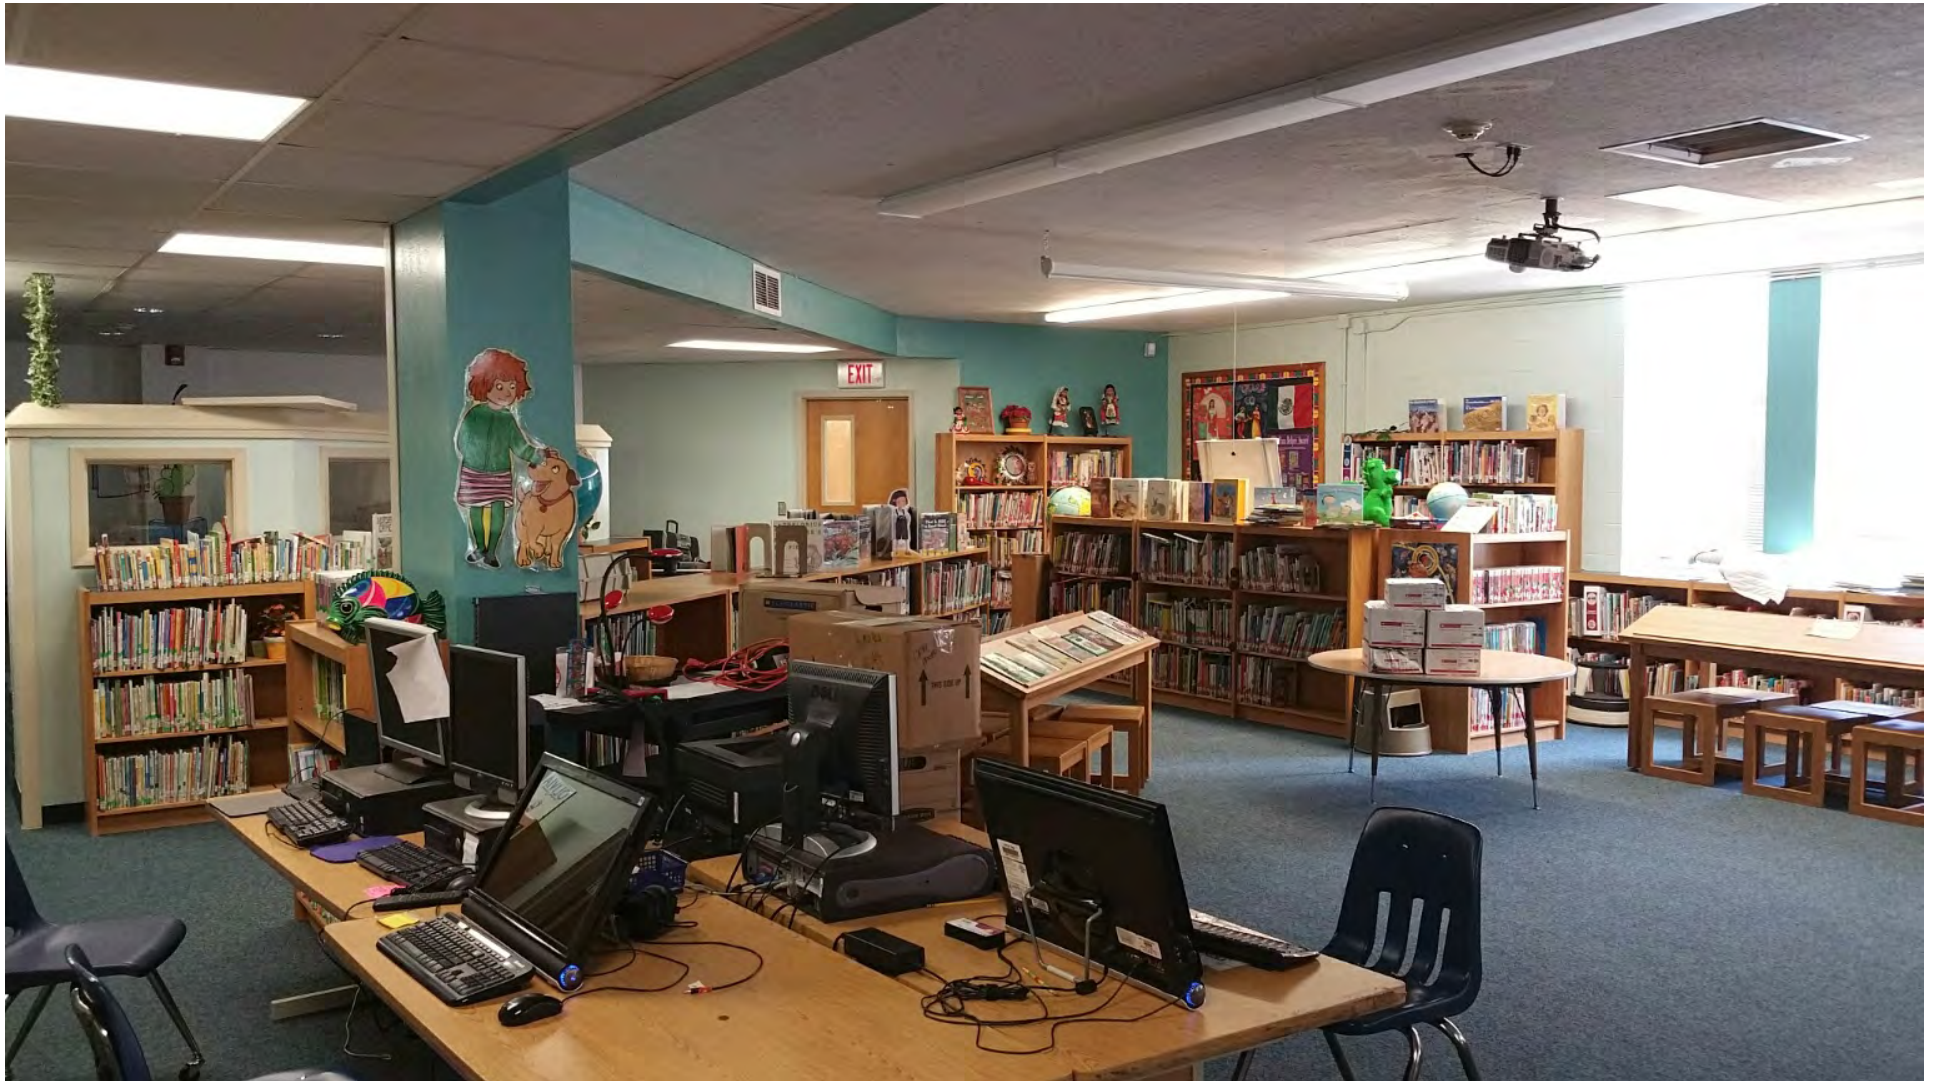
Photo 3. Library

The library has different types of spaces for flexibility of collaborative work with different group sizes. There is a need for other casual seating to support social interaction. Although the library

is dark and the ceiling height is low, there are separate areas for small group study.

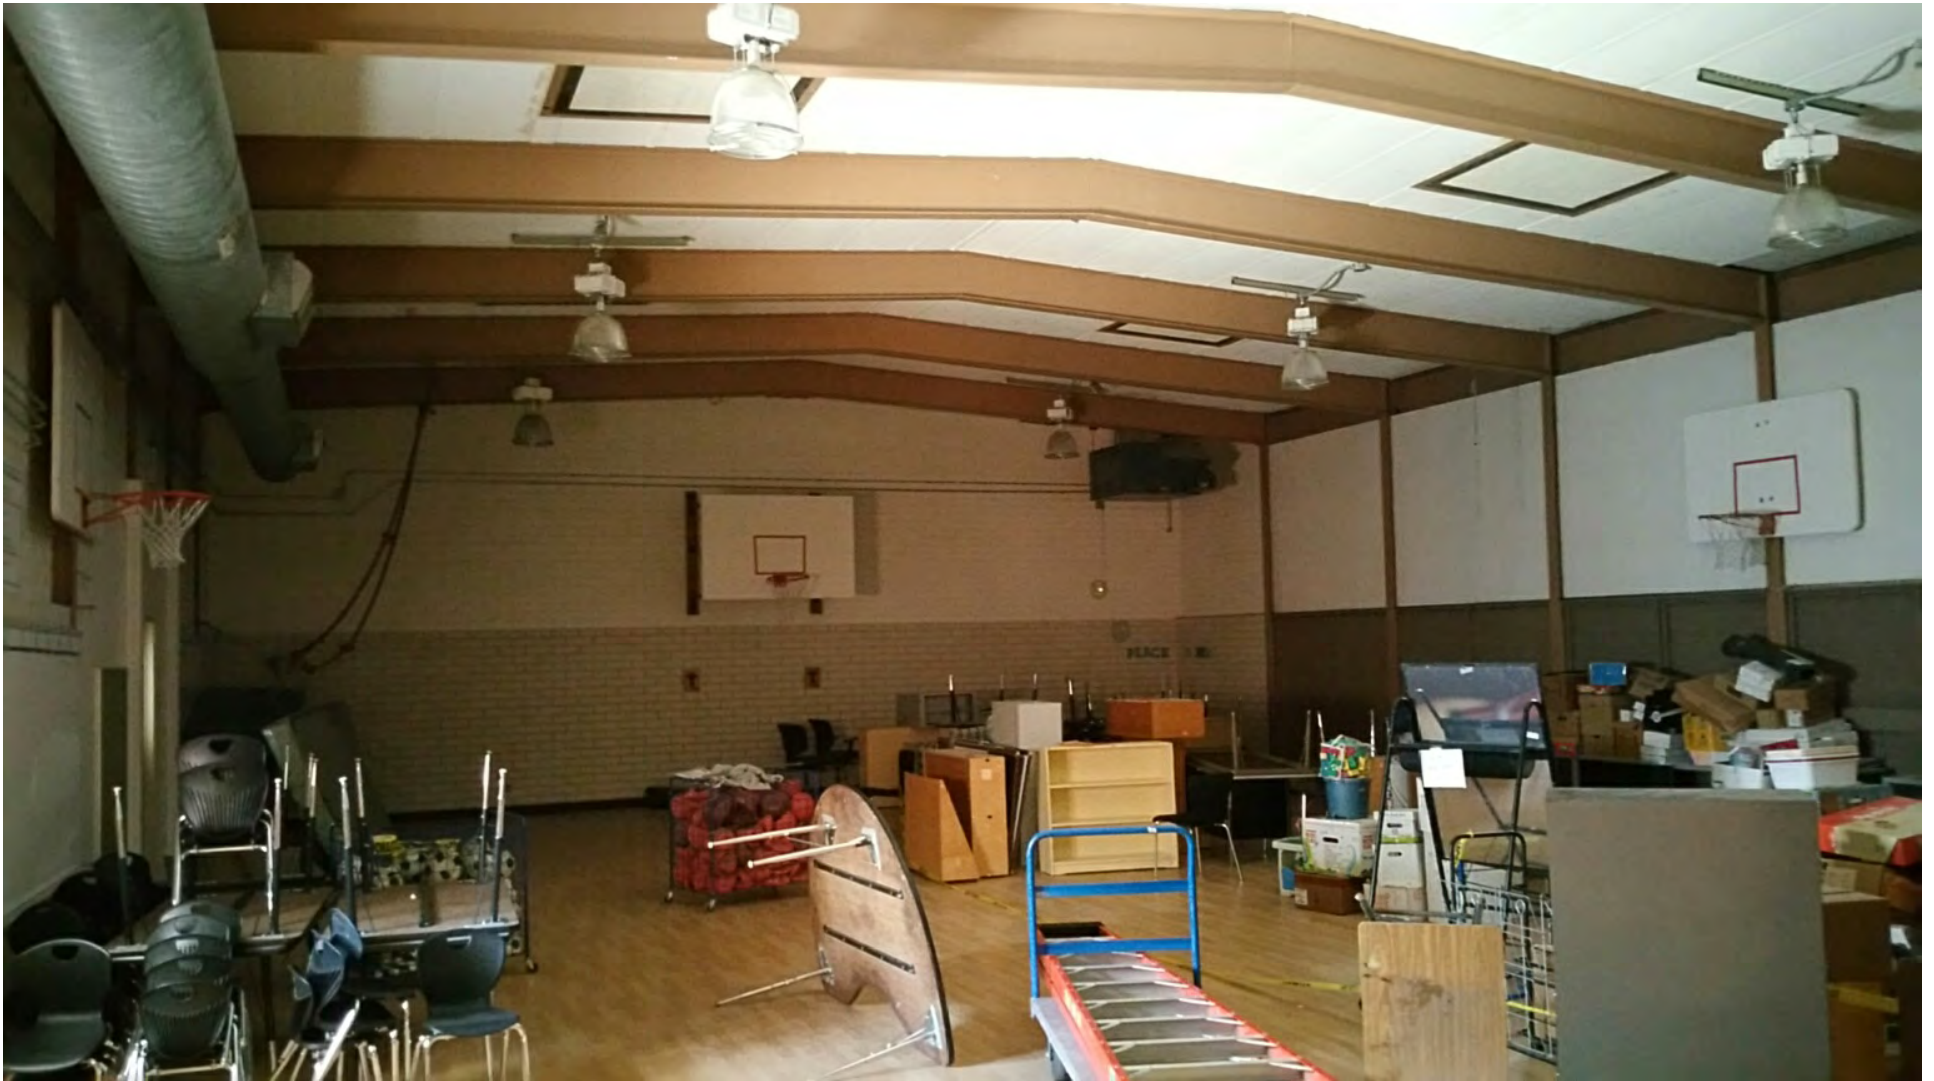
Photo 4. Gym

1) Very unsatisfactory 2) Unsatisfactory 3) Average 4) Good 5) Very good N/A) Does not apply.								The appropriate storage is not located adjacent to the gym, and is insufficient in size. The gym is too small to accommodate more than one class.

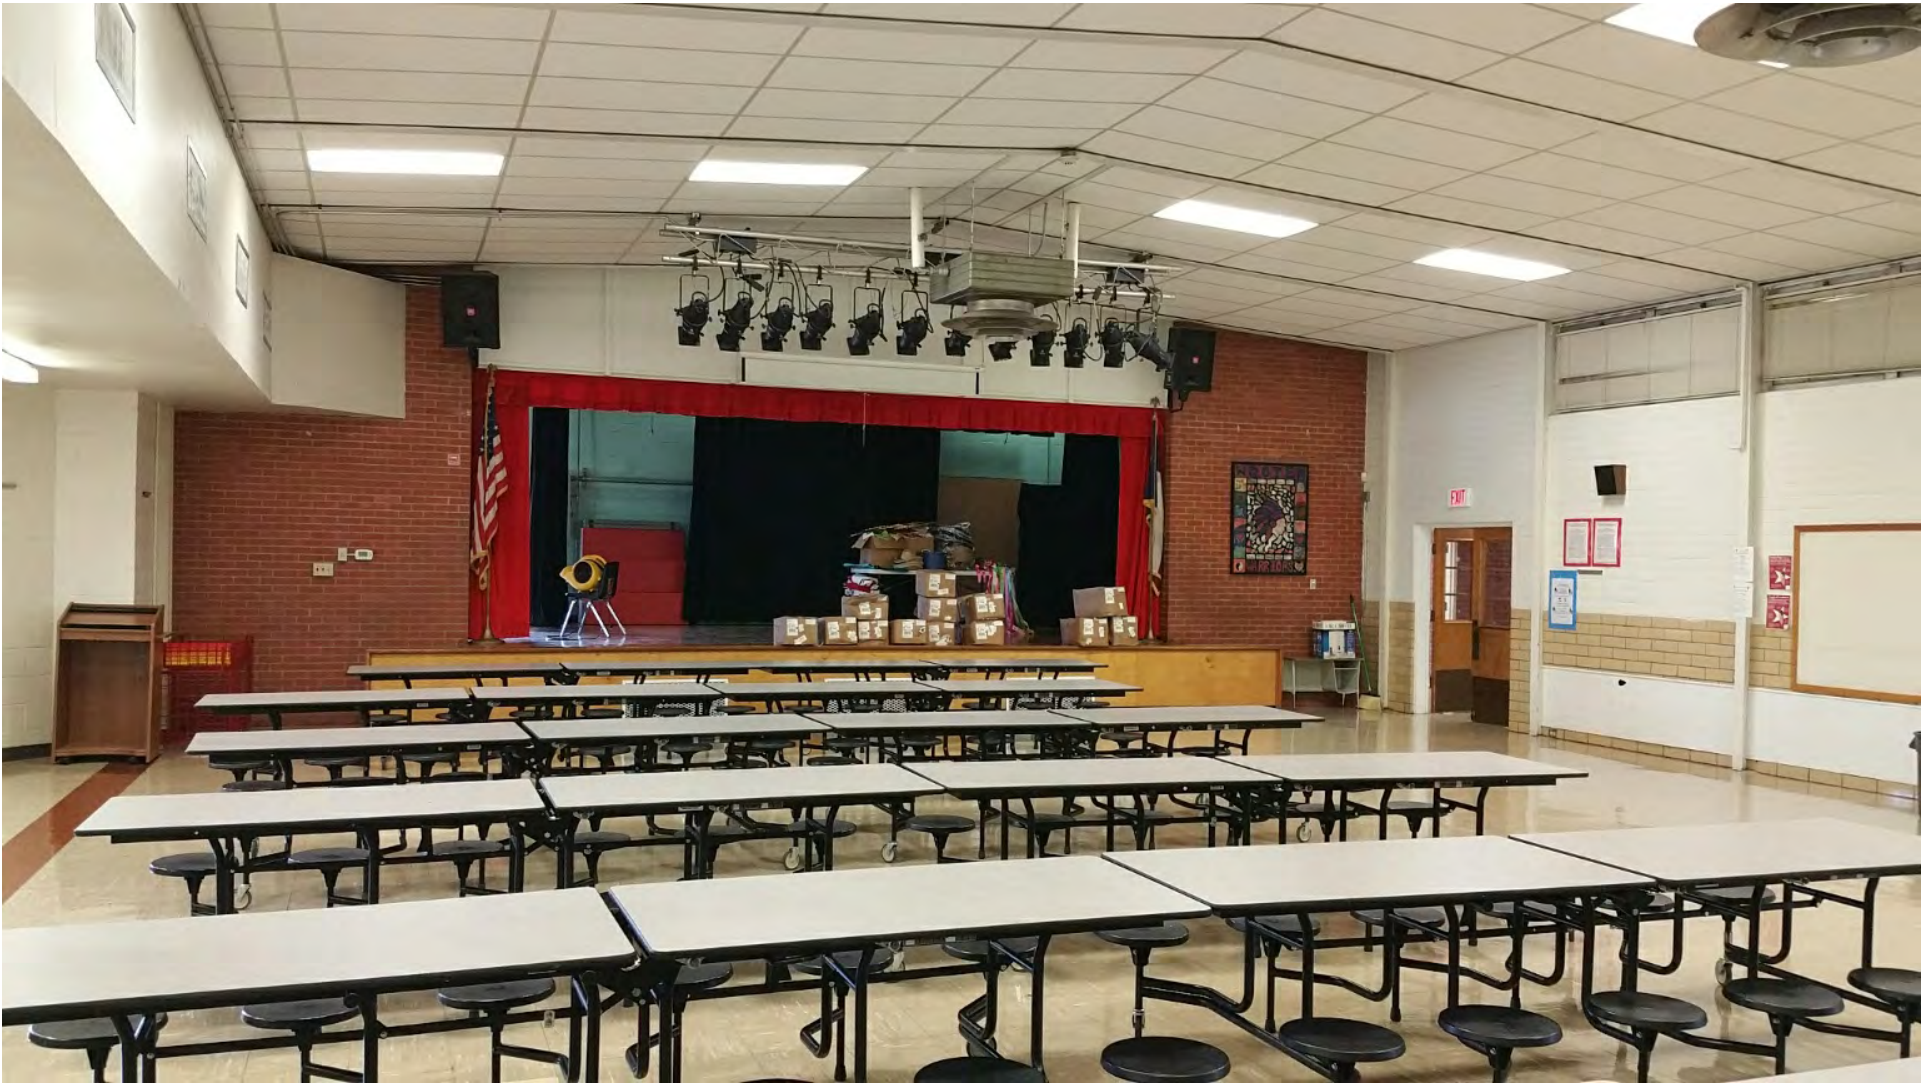
Photo 5. Cafeteria

3.16	Are the student dining facilities appropriately configured?		2					Comments					1.00	2.00
1) Very unsatisfactory - Too small, poor circulation, inflexible seating in poor condition 2) Unsatisfactory - Too small or inadequate circulation, seating in poor condition 3) Average - moderate size, with adequate circulation, seating in okay condition 4) Good - good size, adequate circulation, seating in good condition 5) Very good - good size, adequate circulation, seating in good condition, with more than one option for eating space (ex: connection to outdoor eating space) N/A) Does not apply.								The cafeteria is too small for the current enrollment. The expansion does not allow the audience in this section to see the stage.

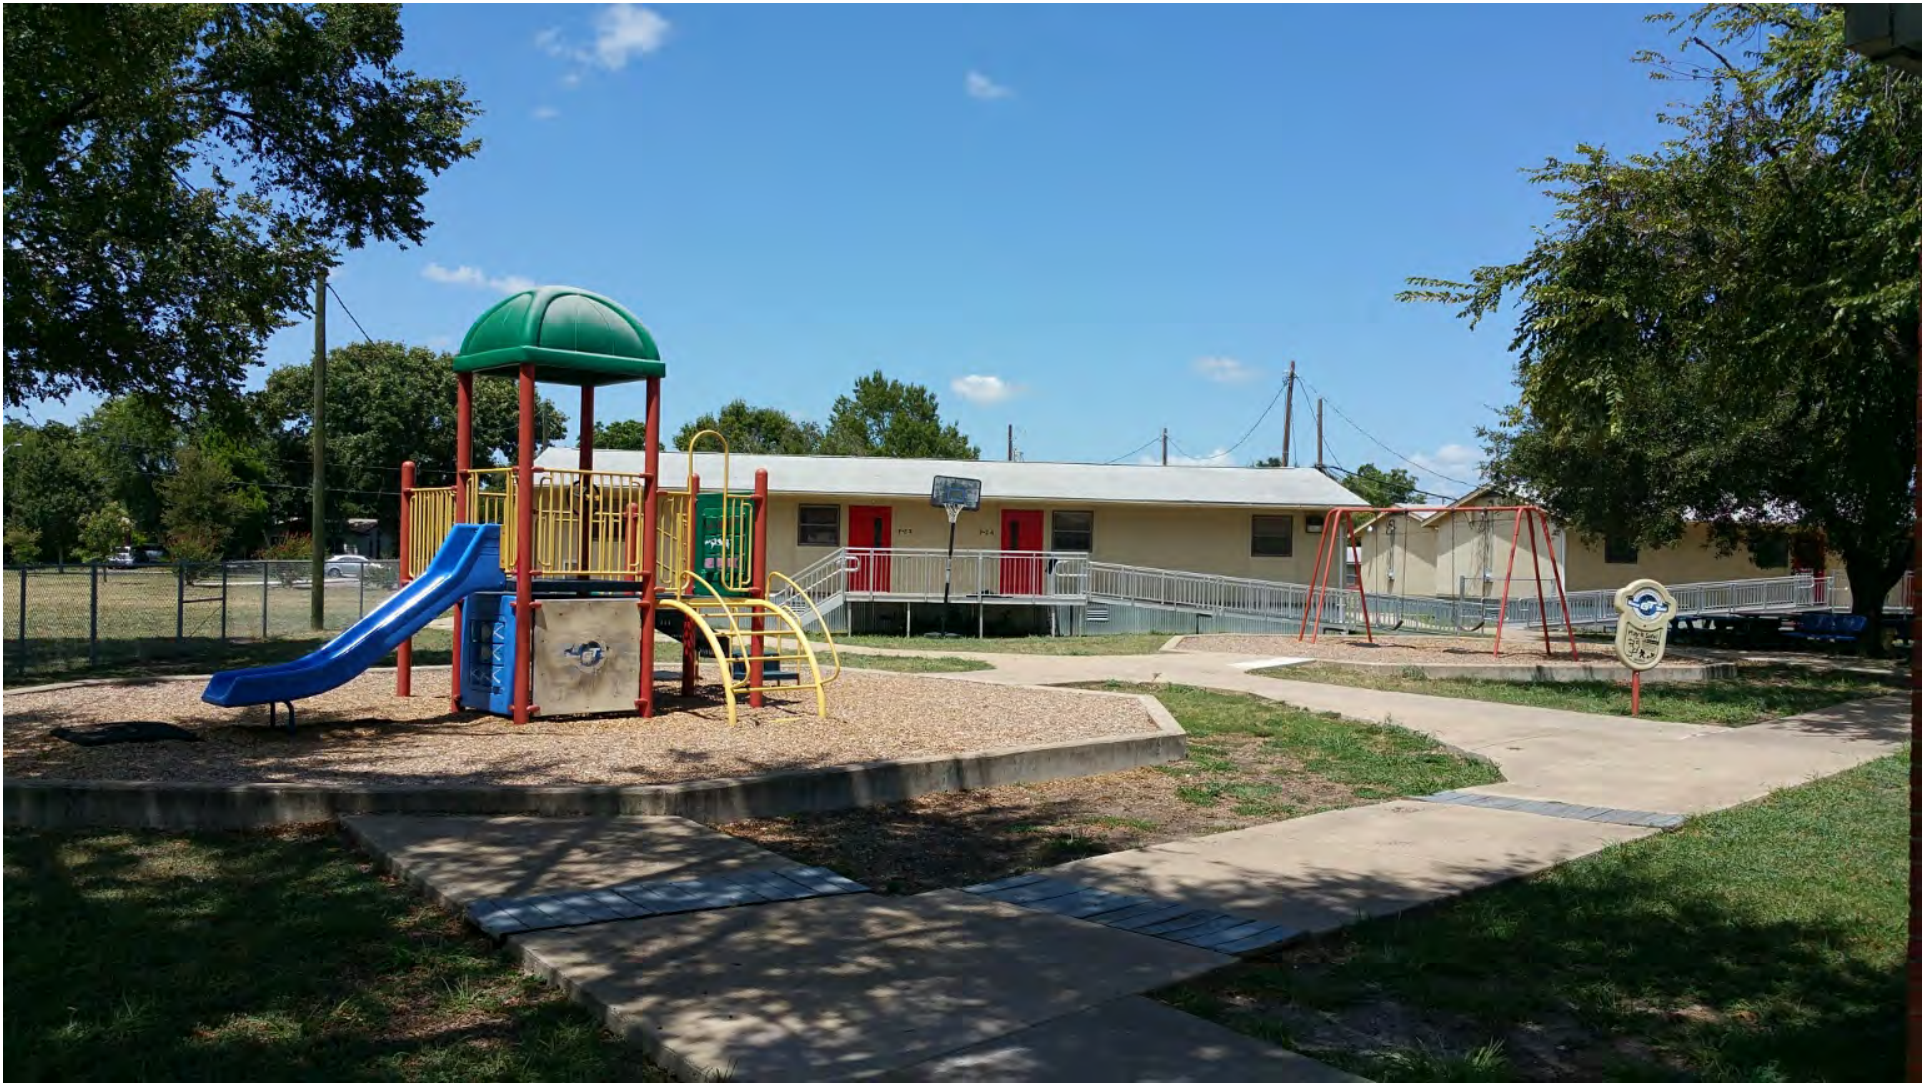
Photo 6. Outdoor Play

1.3	Are outdoor play spaces and playfields adequate in size and configuration?				4			Comments	1.00 4.00
	1) Outdoor play space exists, not developed 2) Outdoor play space exists but is not connected to gym or other athletic support areas or is too small. 3. Outdoor play spaces exist, are connected to other athletic areas, are the right size, but are not in good condition. 4. Outdoor play spaces need minor improvements to function well. 5. Outdoor play spaces are in excellent condition. N/A) Does not apply.							The playground is shared with the city of Austin. <i>CAC comments: More playground space.</i>

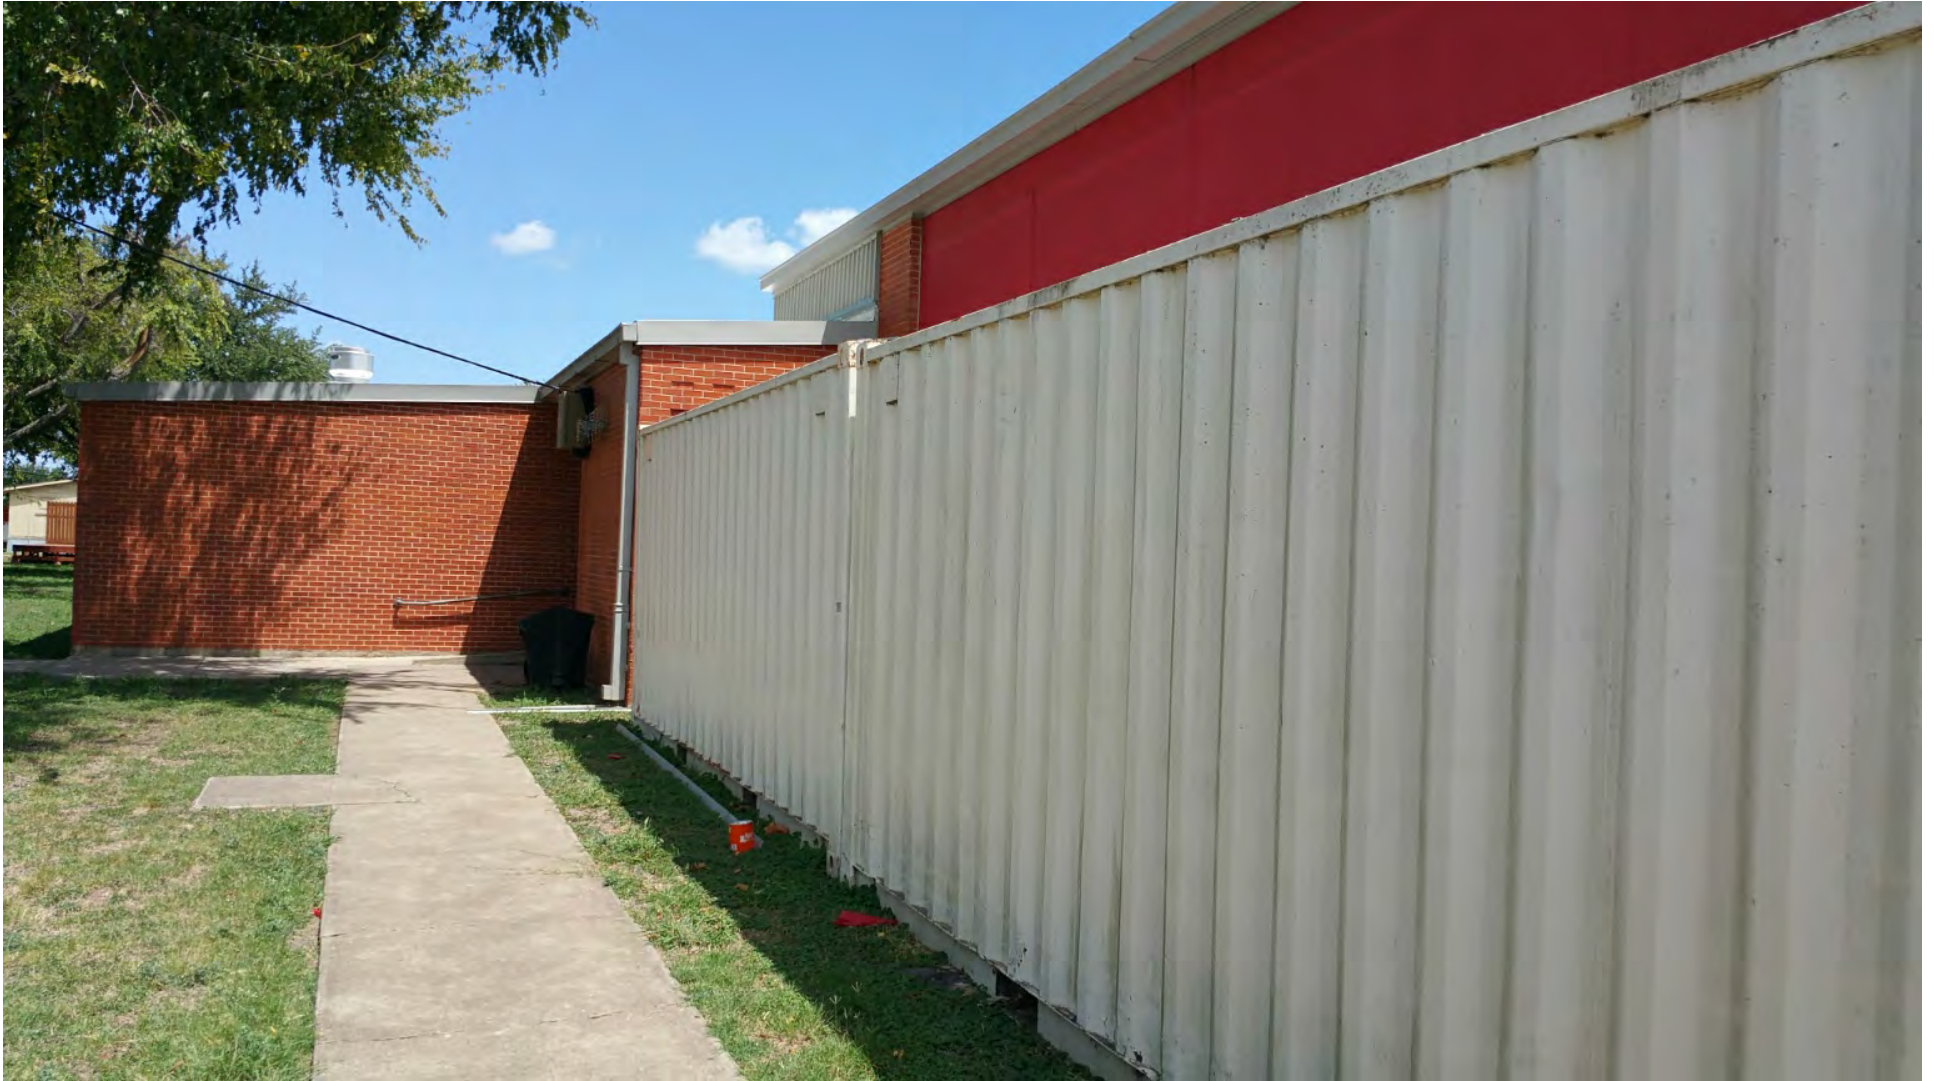
Photo 7. Metal Storage Containers

General building storage is very inadequate and allocated to the corridors. Additionally, classroom storage spaces are equipped with only minimal built-in cabinets that are in need of replacement. The campus currently stores records and other items in metal storage containers placed around the campus.

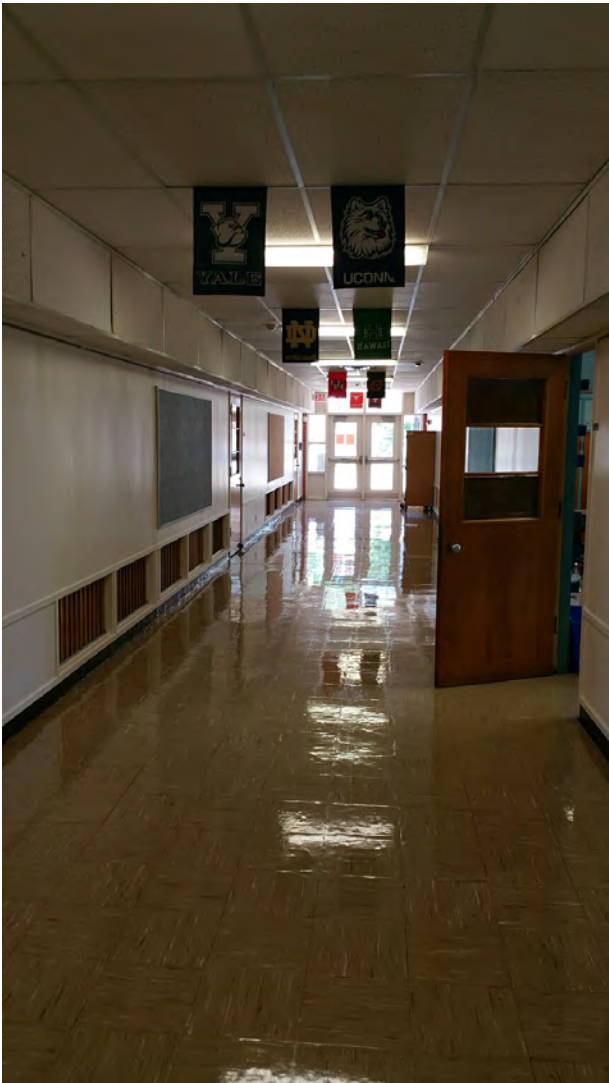
Photo 9. Typical Corridor

The corridor spaces are adequate in width, but the low ceiling creates an uninviting feeling to the campus. To reach some classrooms, the student and teachers must go outdoors to reach their destinations, which becomes a security concern.

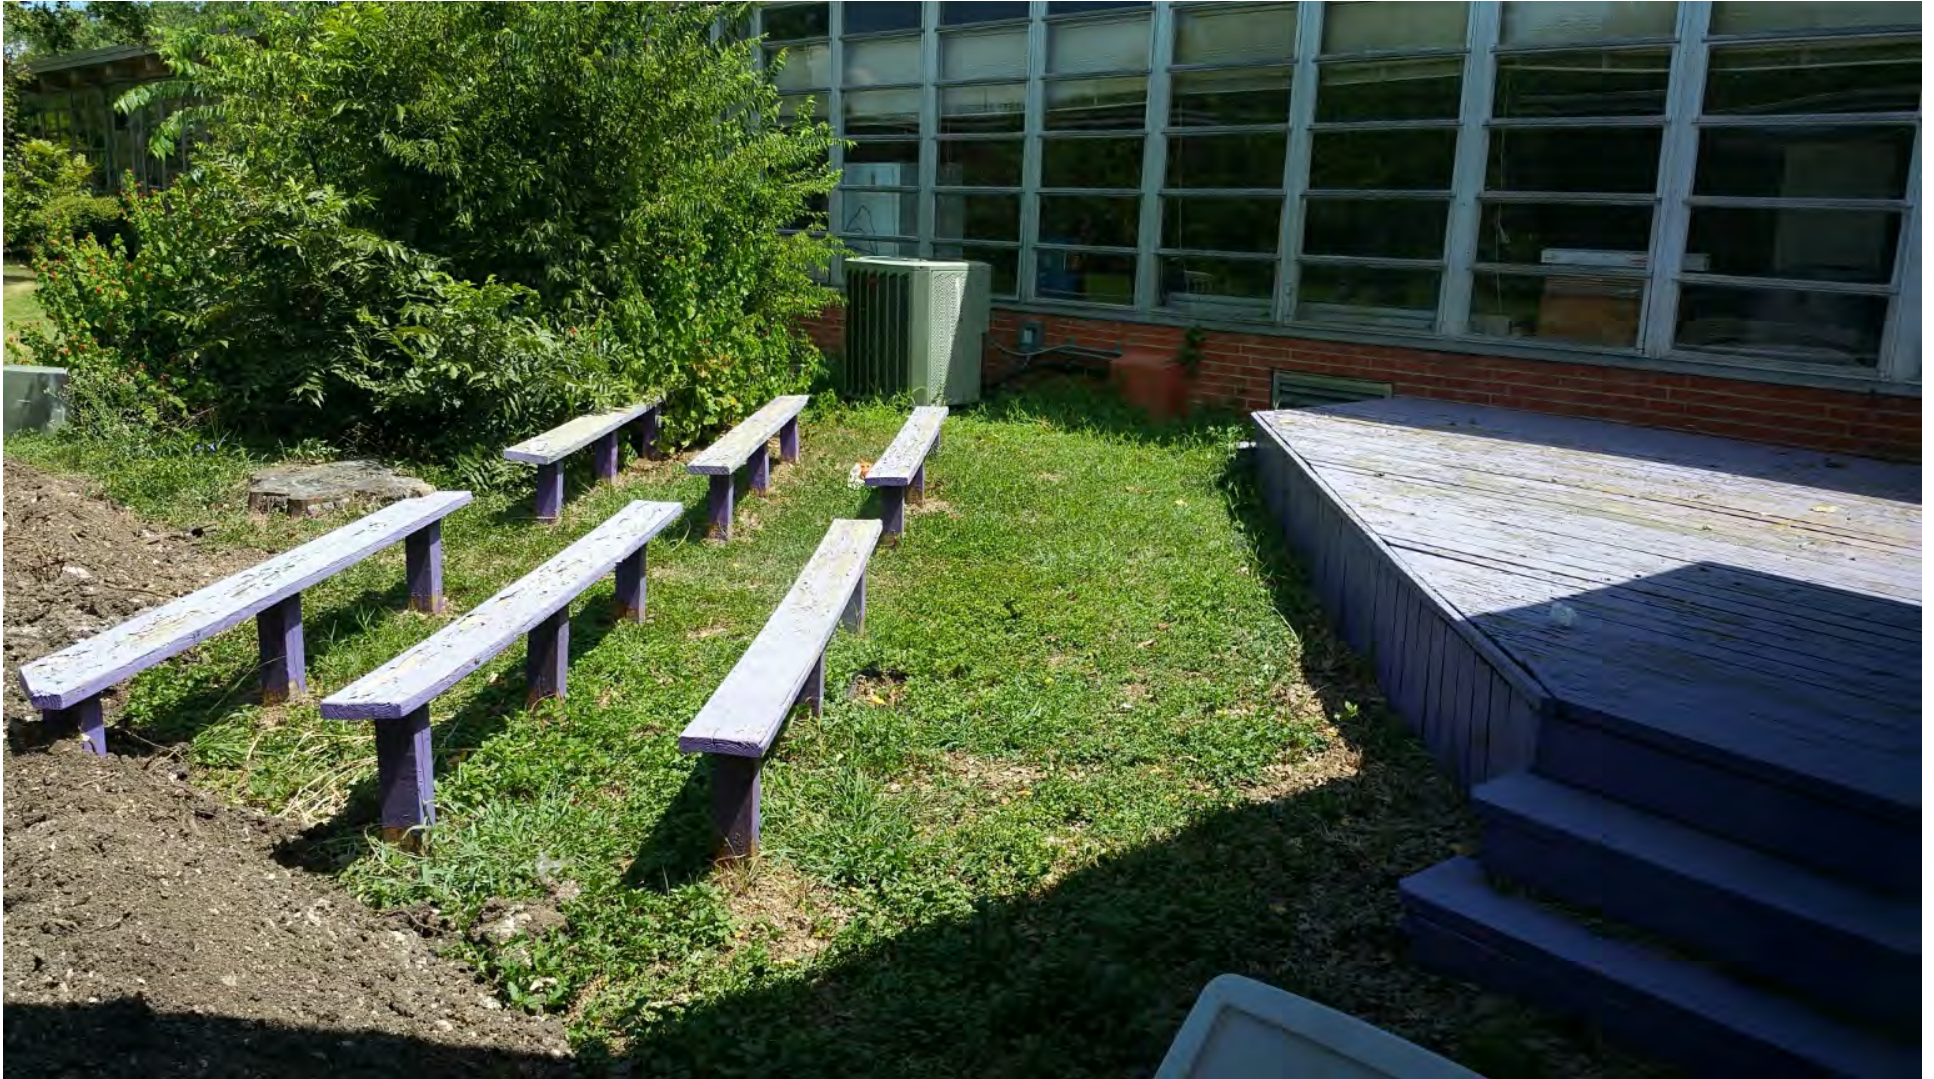
Photo 10. Outdoor Classroom

1.2	Are opportunities provided for outdoor learning (outdoor classrooms, gardens, etc.)?		2					Comments	1.00 2.00
	1) Outdoor space exists is not developed 2) Outdoor space for learning exists but not connected to classroom learning areas. 3. Outdoor learning spaces exist and are accessible but not in good condition. 4. Outdoor learning spaces need minor improvements to function well. 5. Outdoor learning spaces are in excellent condition. N/A) Does not apply.							There are courtyards between the classroom wings. The campus staff has started some small gardens in the back of the campus.
