Educational Suitability Summary Report

Zilker Elementary School – BLDG 146

Date: 08/10/2016

Austin ISD Educational Suitability Assessment Criteria

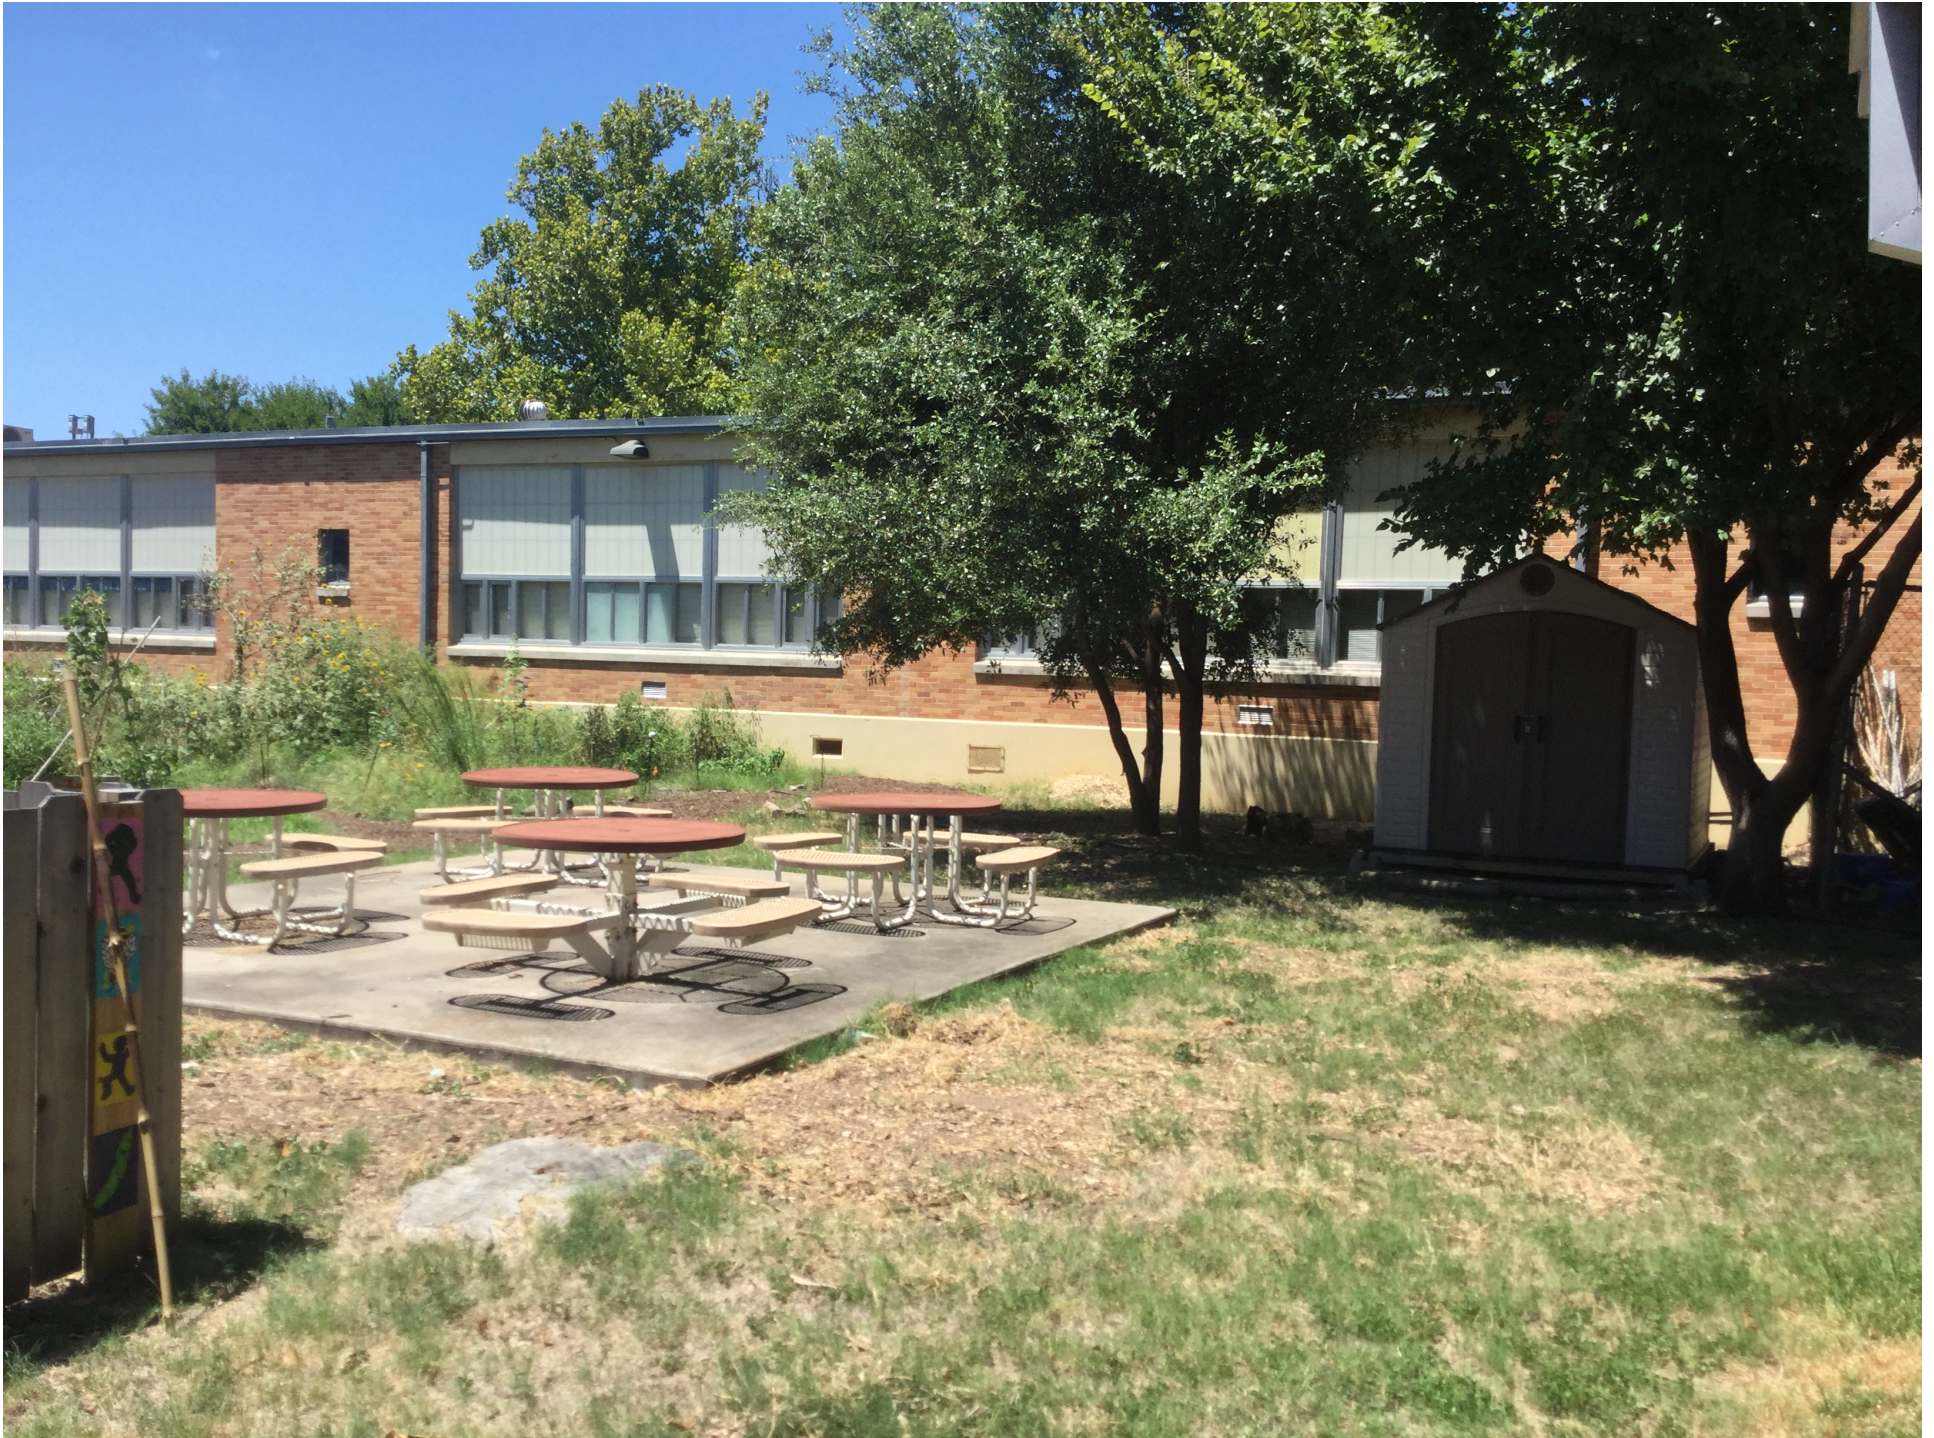
Photo 1.
1.2 Outdoor Learning Space

The site does not permit ideal traffic circulation. Buses, cars and pedestrians are not separate. Signage is visible but not apparent. There are multiple areas for outdoor learning, and playspaces are adequate in size and configuration. The playground area is relatively new.

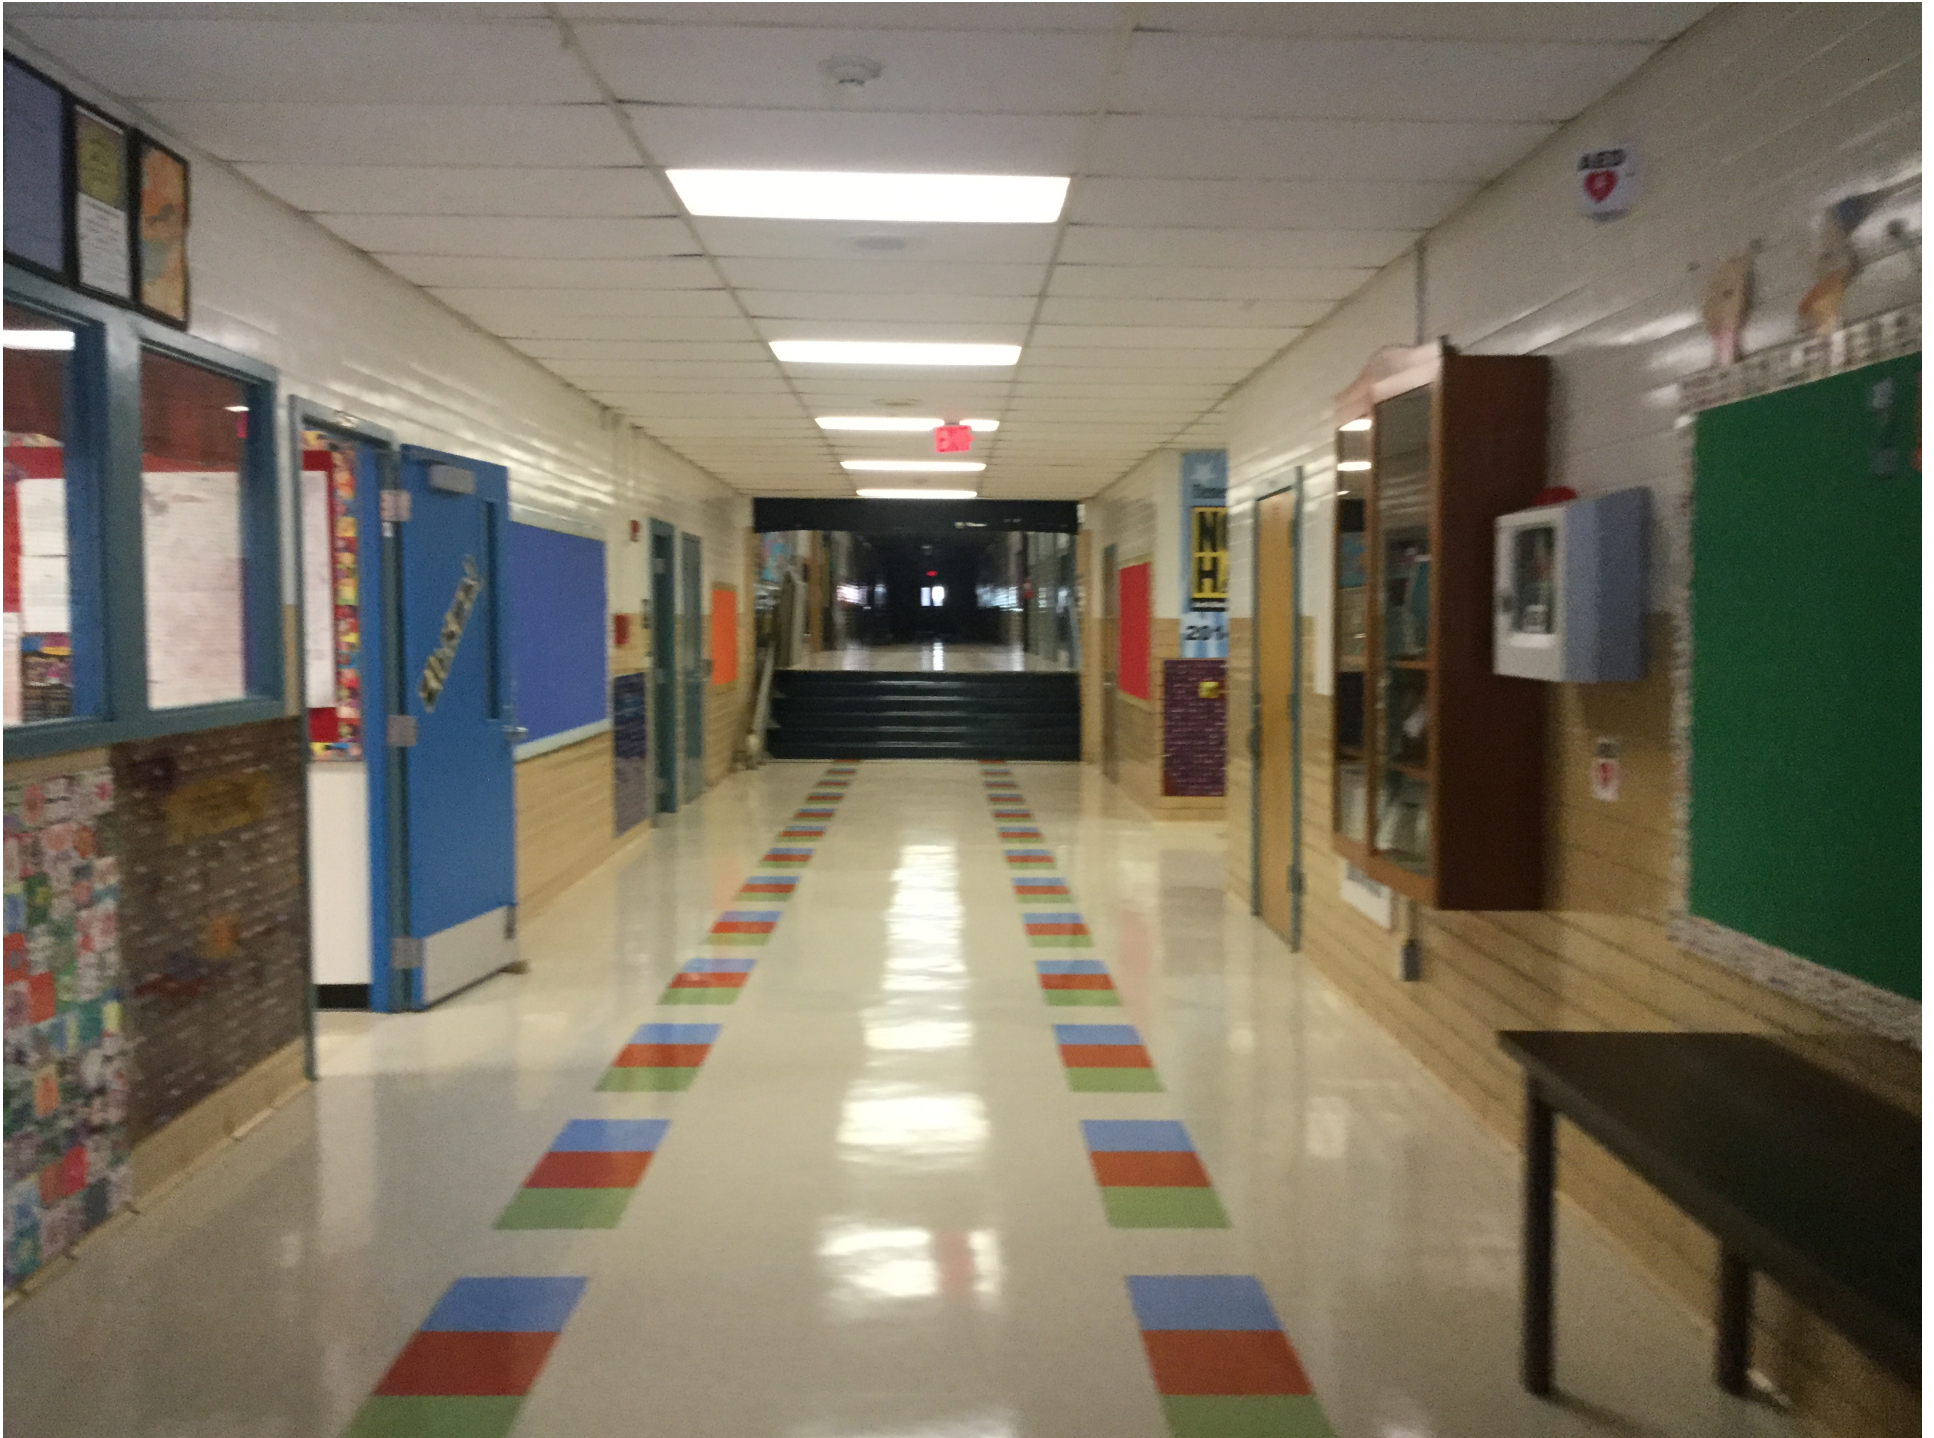
Photo 2.
2.1 Corridor

2 - General Building		1	2	3	4	5	N/A		5.75
2.1	Are interior circulation routes wide enough to safely and effectively accommodate student movement?				4			Comments	0.50 2.00

1) Primary circulation is 5'-0" to 6'-0" wide. 2) Primary circulation is 6'-0" to 7'-0" wide 3) Primary circulation is 7'-0" to 8'-0" wide 4) Primary circulation is 8'-0"-10'-0" wide 5) Primary circulation is 10'-0"+ wide N/A) Does not apply.								see photo 2

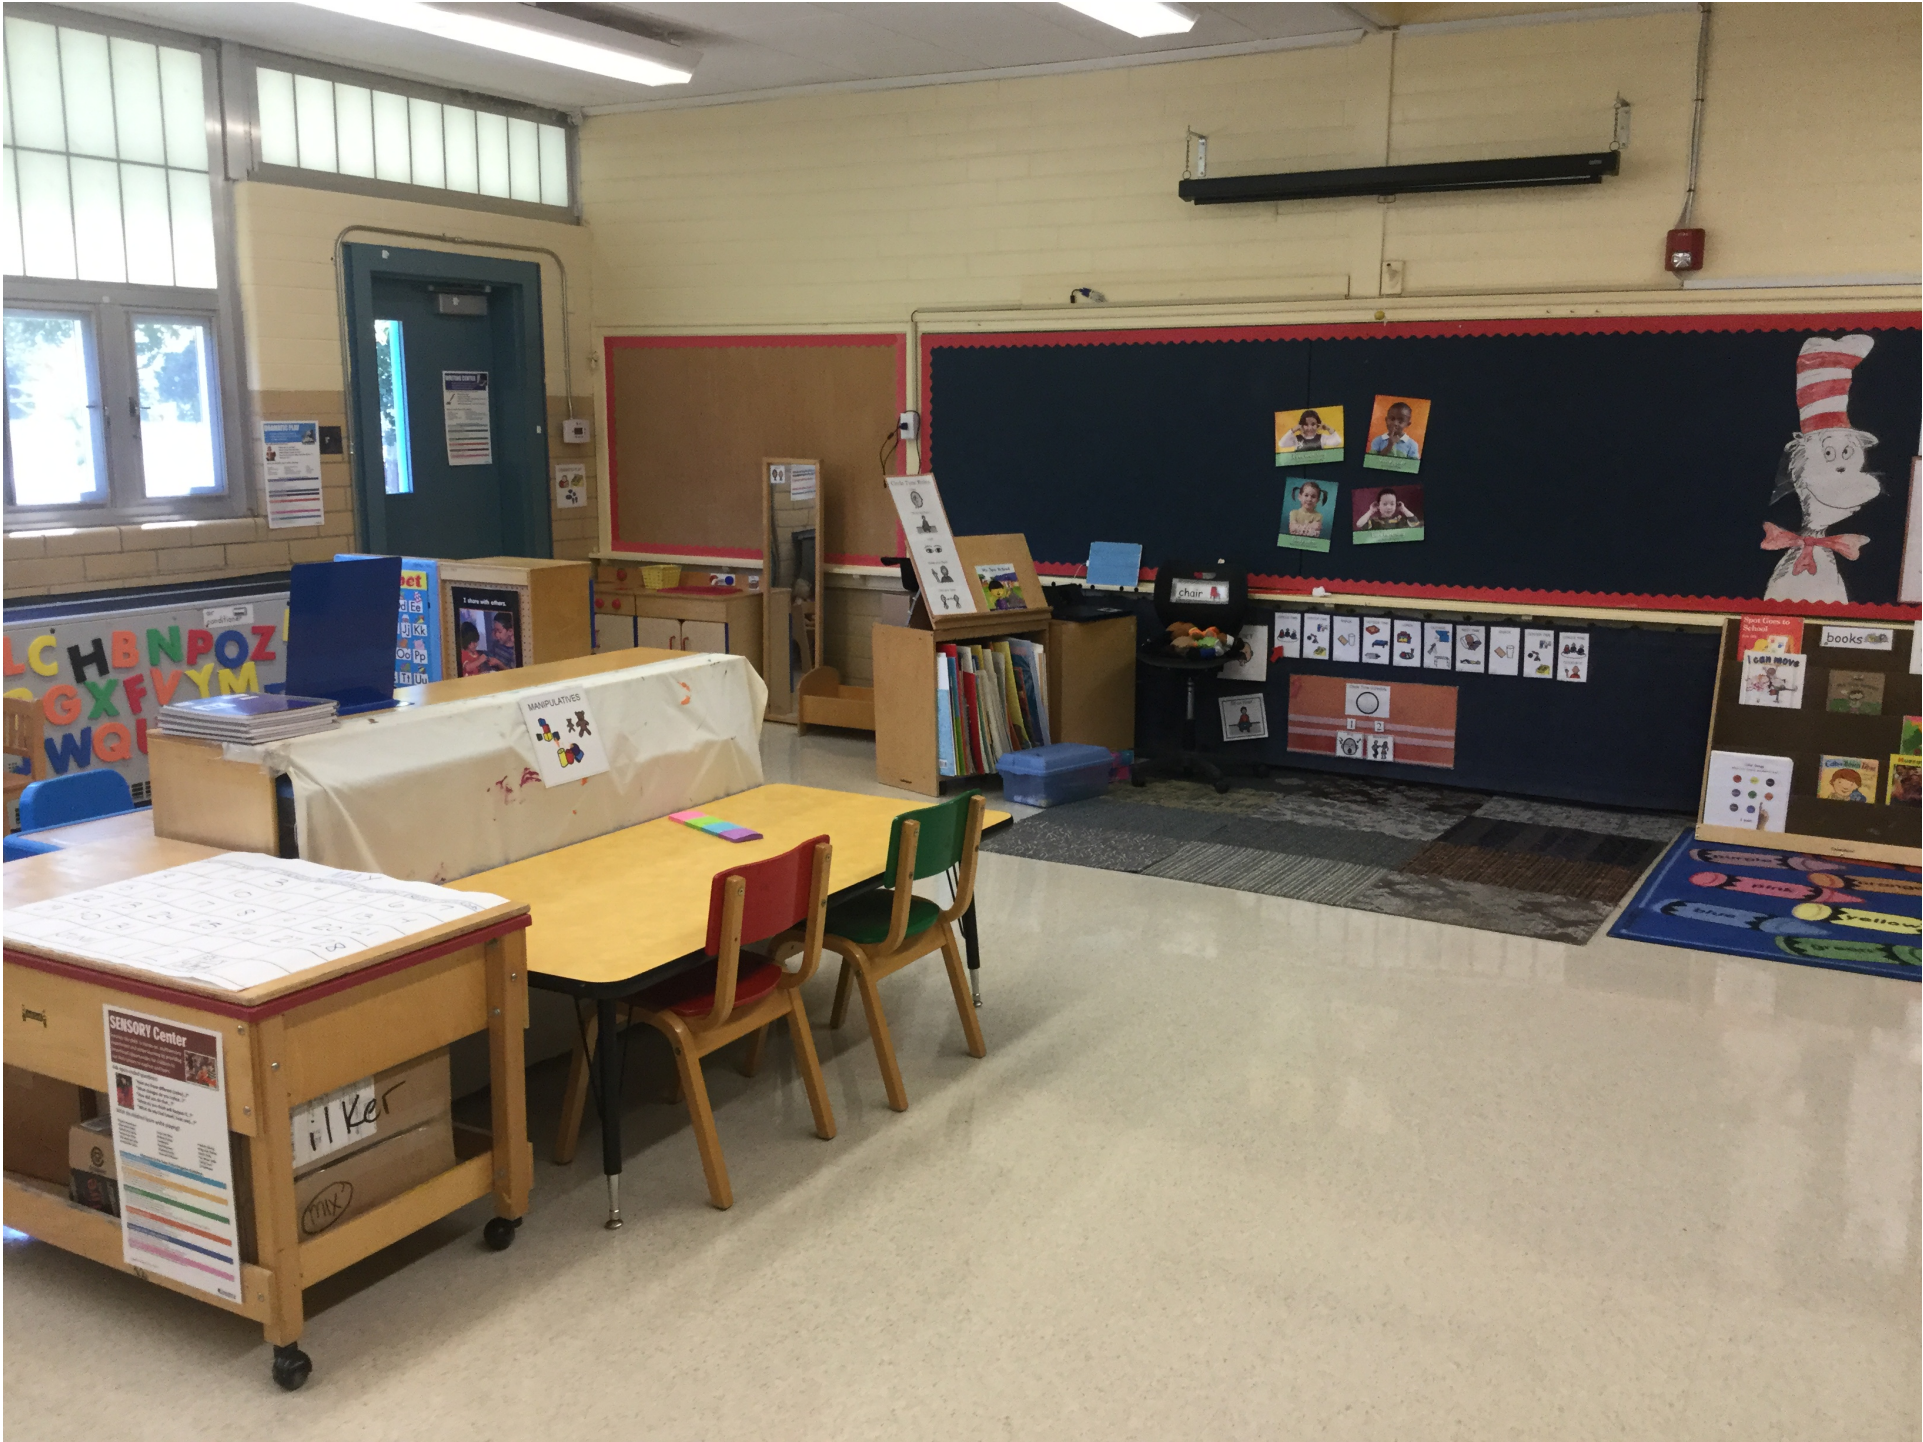
Photo 3.
3.2 Pre-K Space

3 - Academic & Co-Curricular Support								1	2	3	4	5	N/A	35.00	
3.2	Are Pre-K and Kinder classrooms appropriately configured per the ed spec? (elementary school only)				4								Comments	1.00	4.00

1) Very unsatisfactory - Too small, awkward layout, does not meet needs 2) Unsatisfactory - Too small, only one area for all teaching methods, limited flexibility 3) Neutral - Moderate size, two areas for different teaching methods, some flexibility, access to student storage/casework 4) Satisfactory - Good size, at least two zones for different teaching methods, flexibility and student storage, not new 5) Very Satisfactory - Good size, two zones for different teaching methods, flexibility and student storage/casework, adequate display area and visual teaching tools N/A) Does not apply.															
see photo 3

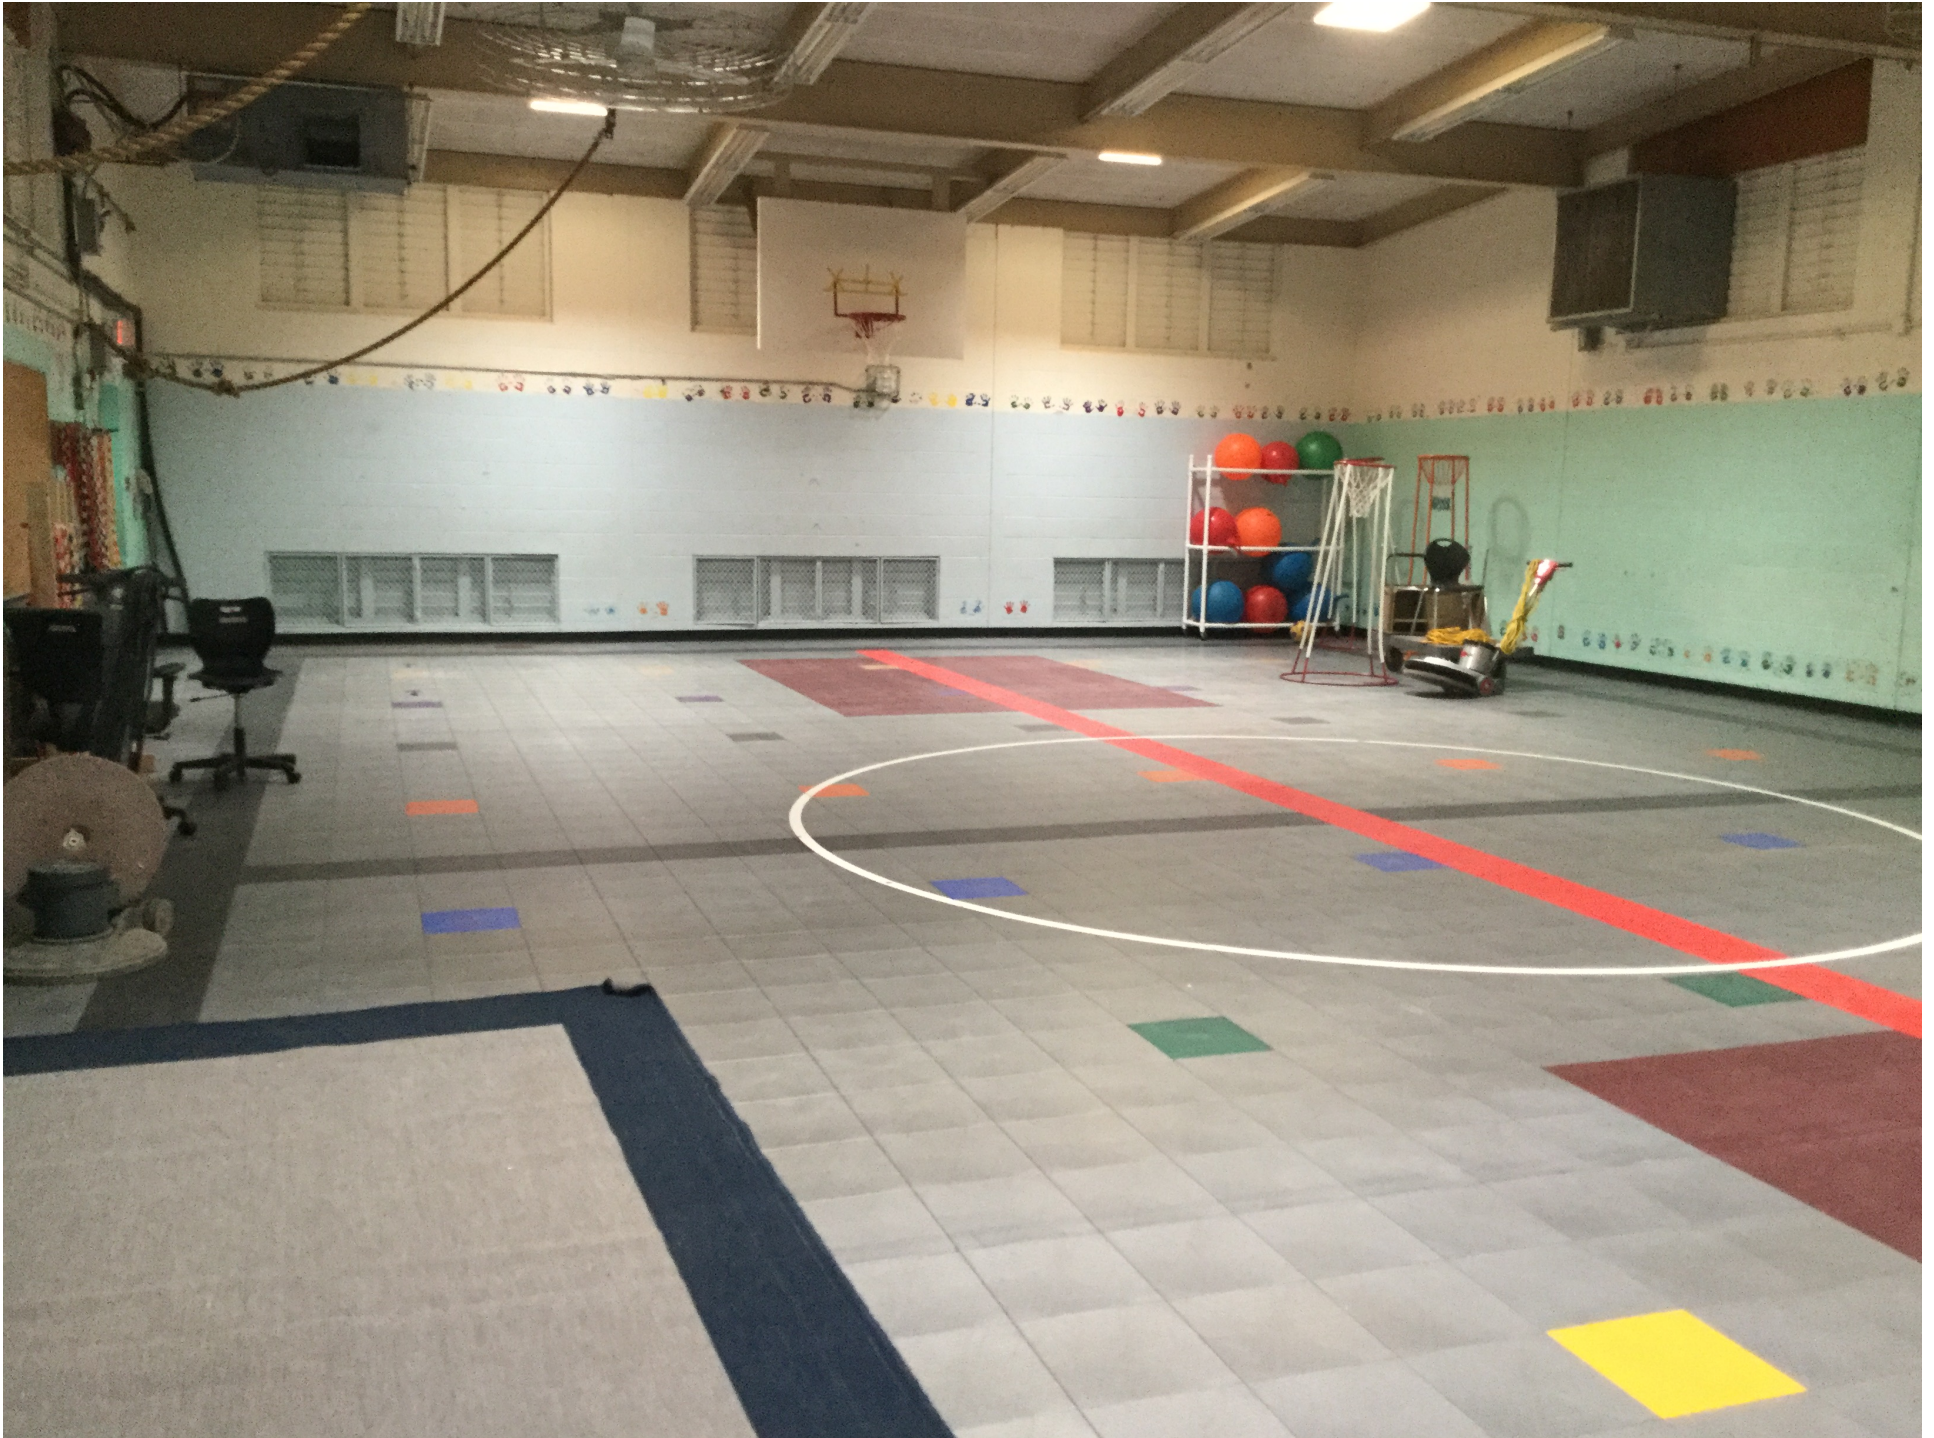
Photo 4.
3.6 Gym

3 - Academic & Co-Curricular Support - Continued		1	2	3	4	5	N/A		
3.6	Are Physical Education and Athletic spaces appropriately configured per the ed spec?		2					Comments	1.002.00
1) Very unsatisfactory 2) Unsatisfactory 3) Average 4) Good 5) Very good N/A) Does not apply.							The gym space is small and very dated. <

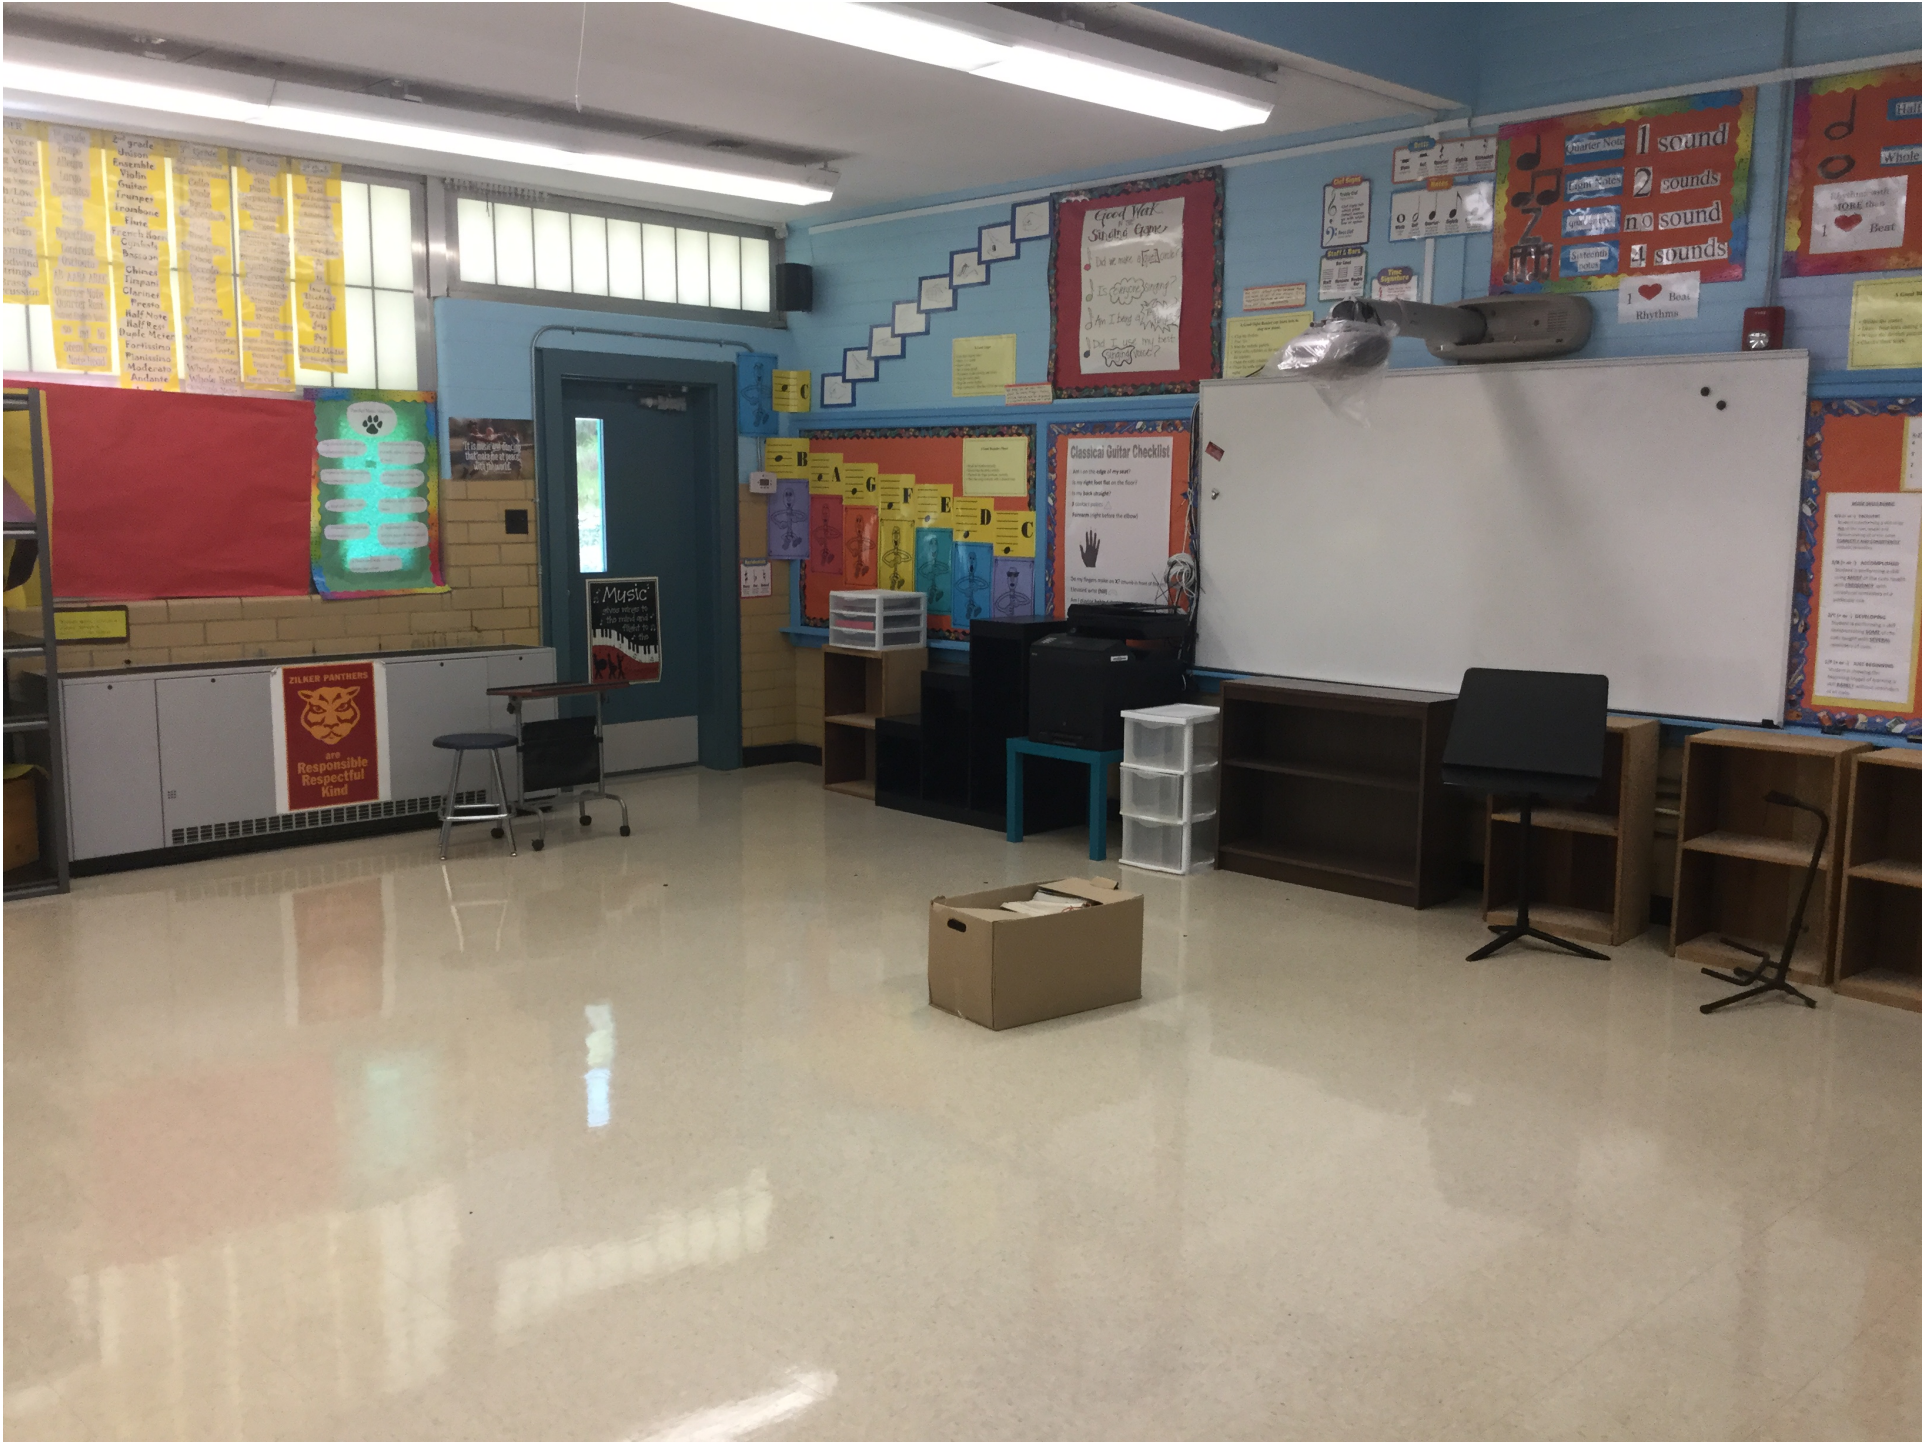
Photo 5.
3.8 Music Room

Typical classrooms are too small due to the age of the building. Storage space is insufficient in classrooms and for the campus overall. The music room is a converted typical classroom at the end of the pre-k and kinder wing. The art room is not properly configured with the appropriate sinks. The computer lab is in the separate library building and lacks storage space. The SBS class is in a portable.

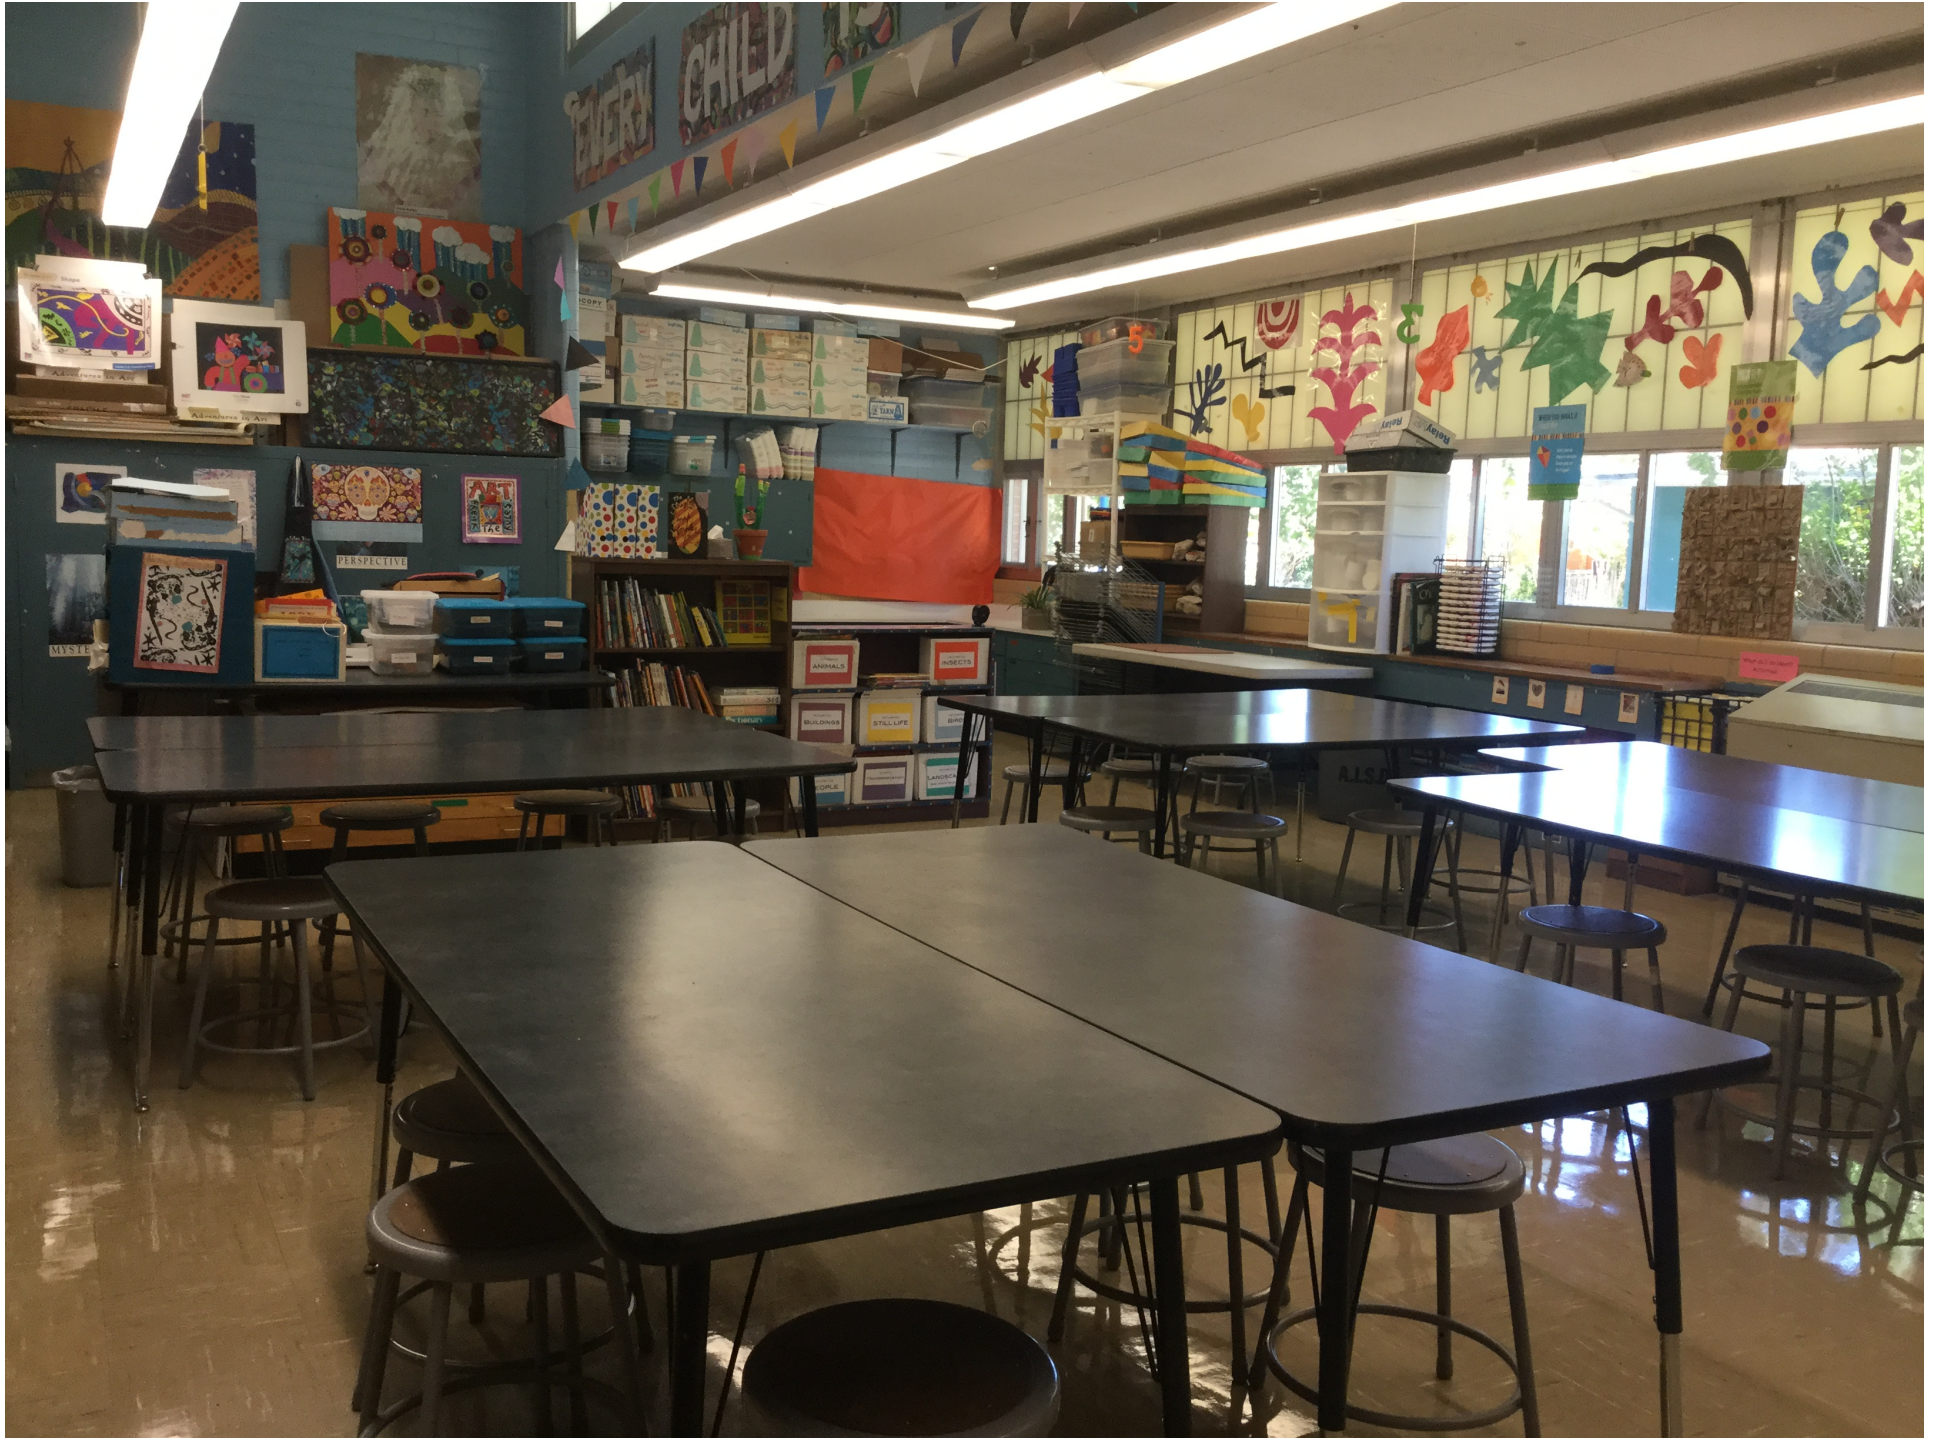
Photo 6.
3.10 Art Room

3 - Academic & Co-Curricular Support - Continued								1	2	3	4	5	N/A			
3.10	Are Visual Arts spaces appropriately configured per the ed spec?										4			Comments	1.00	4.00

1) Very unsatisfactory 2) Unsatisfactory 3) Average 4) Good 5) Very good N/A) Does not apply.													The art room is not properly configured with the appropriate sinks.			
													see photo 6

3.11	Are Visual Arts support spaces appropriately configured per the ed spec?								2					Comments	1.00	2.00
1) Very unsatisfactory - Support spaces are disconnected from served spaces, too small, do not meet needs 2) Unsatisfactory - Support spaces are connected, but too small, inadequate for needs 3) Average - Connected, moderate size, but need some renovations or updates to function well 4) Good - Connected, good size/layout, meets needs/functions well 5) Very good - connected, generous size, nice condition, functions appropriately N/A) Does not apply.																
													see photo 6

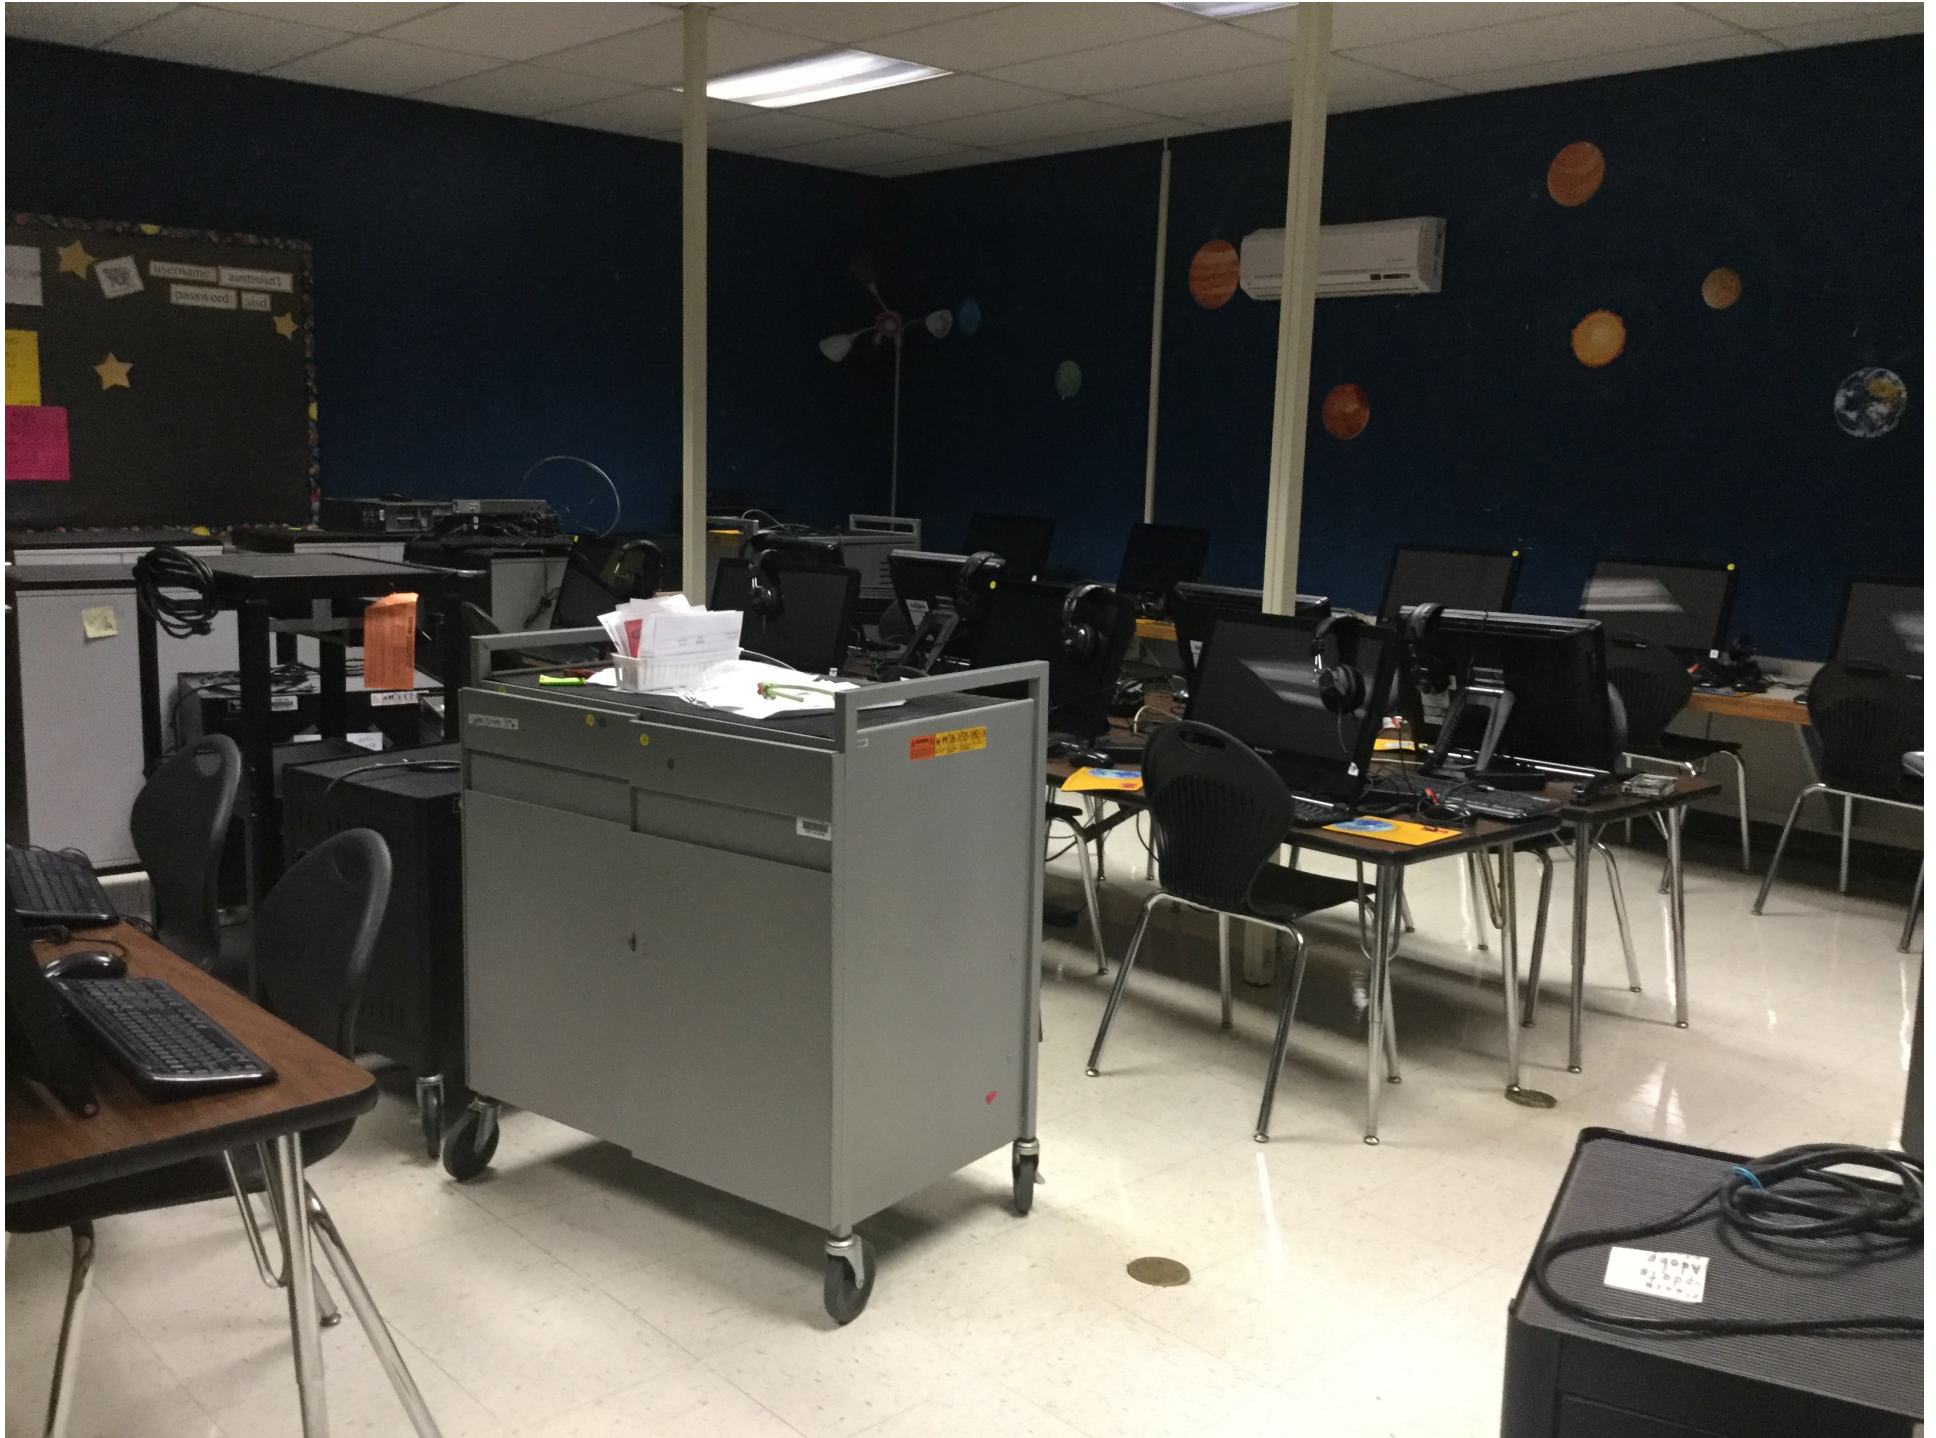
Photo 7.
3.12 Computer Lab

3.12	Are computer lab spaces appropriately configured?										4			Comments	1.00	4.00
1) Very unsatisfactory 2) Unsatisfactory 3) Average 4) Good 5) Very good N/A) Does not apply.													The computer lab is in a separate building by the library.			
													see photo 7
