Educational Suitability Summary Report

Zilker Elementary School – BLDG 146

Date: 08/10/2016

Austin ISD Educational Suitability Assessment Criteria

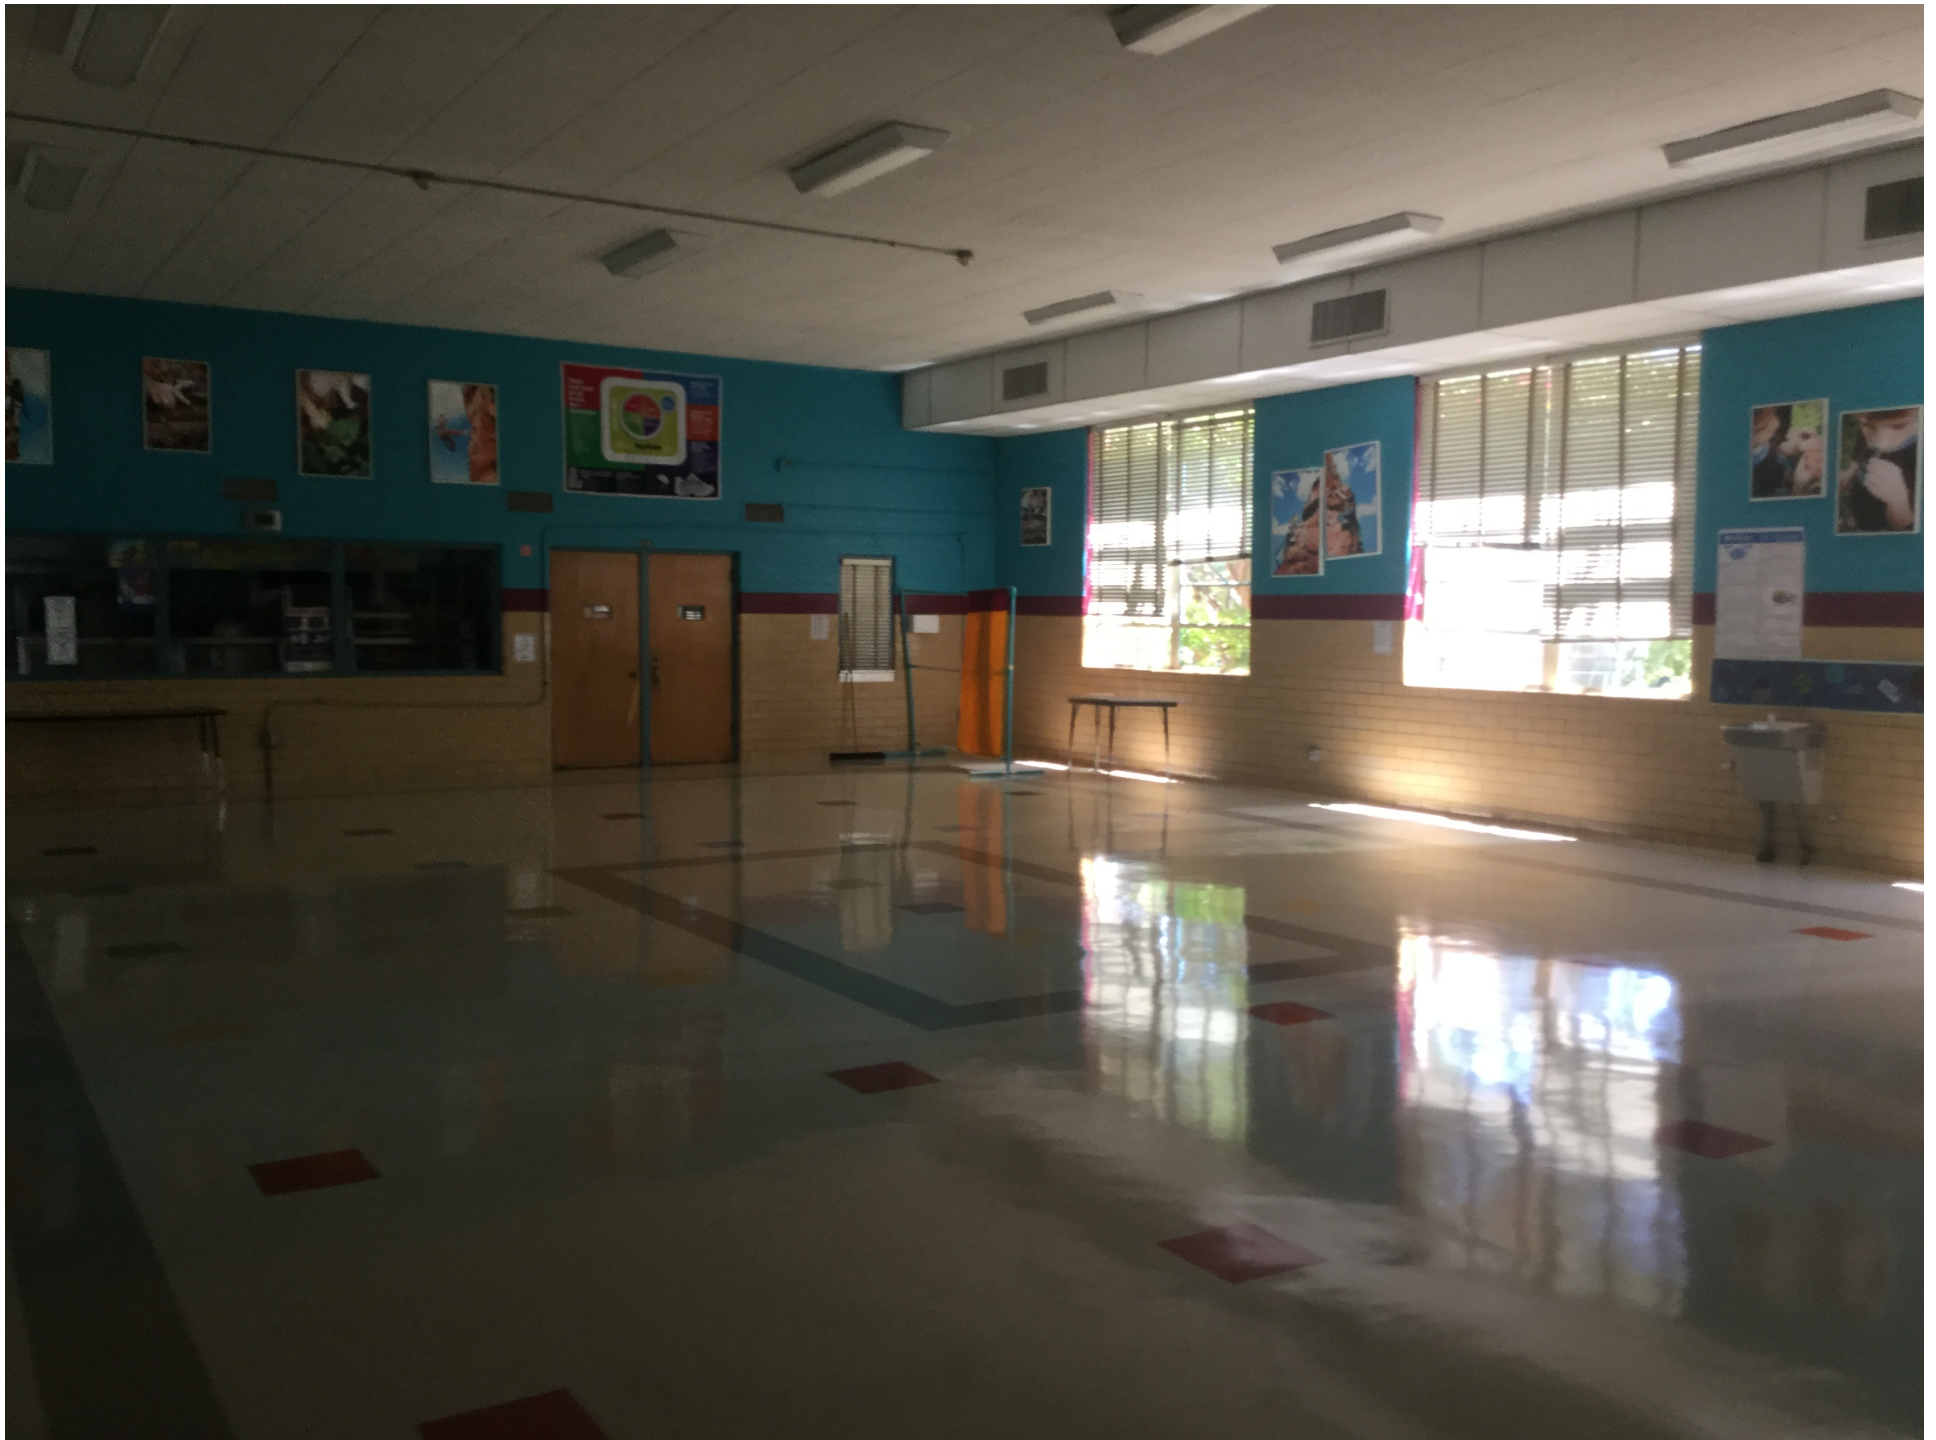
Photo 8.
3.16 Cafeteria

3.16	Are the student dining facilities appropriately configured?			3								Comments	1.00	3.00
1) Very unsatisfactory - Too small, poor circulation, inflexible seating in poor condition 2) Unsatisfactory - Too small or inadequate circulation, seating in poor condition 3) Average - moderate size, with adequate circulation, seating in okay condition 4) Good - good size, adequate circulation, seating in good condition 5) Very good - good size, adequate circulation, seating in good condition, with more than one option for eating space (ex: connection to outdoor eating space) N/A) Does not apply.							<div>see photo 8</div>

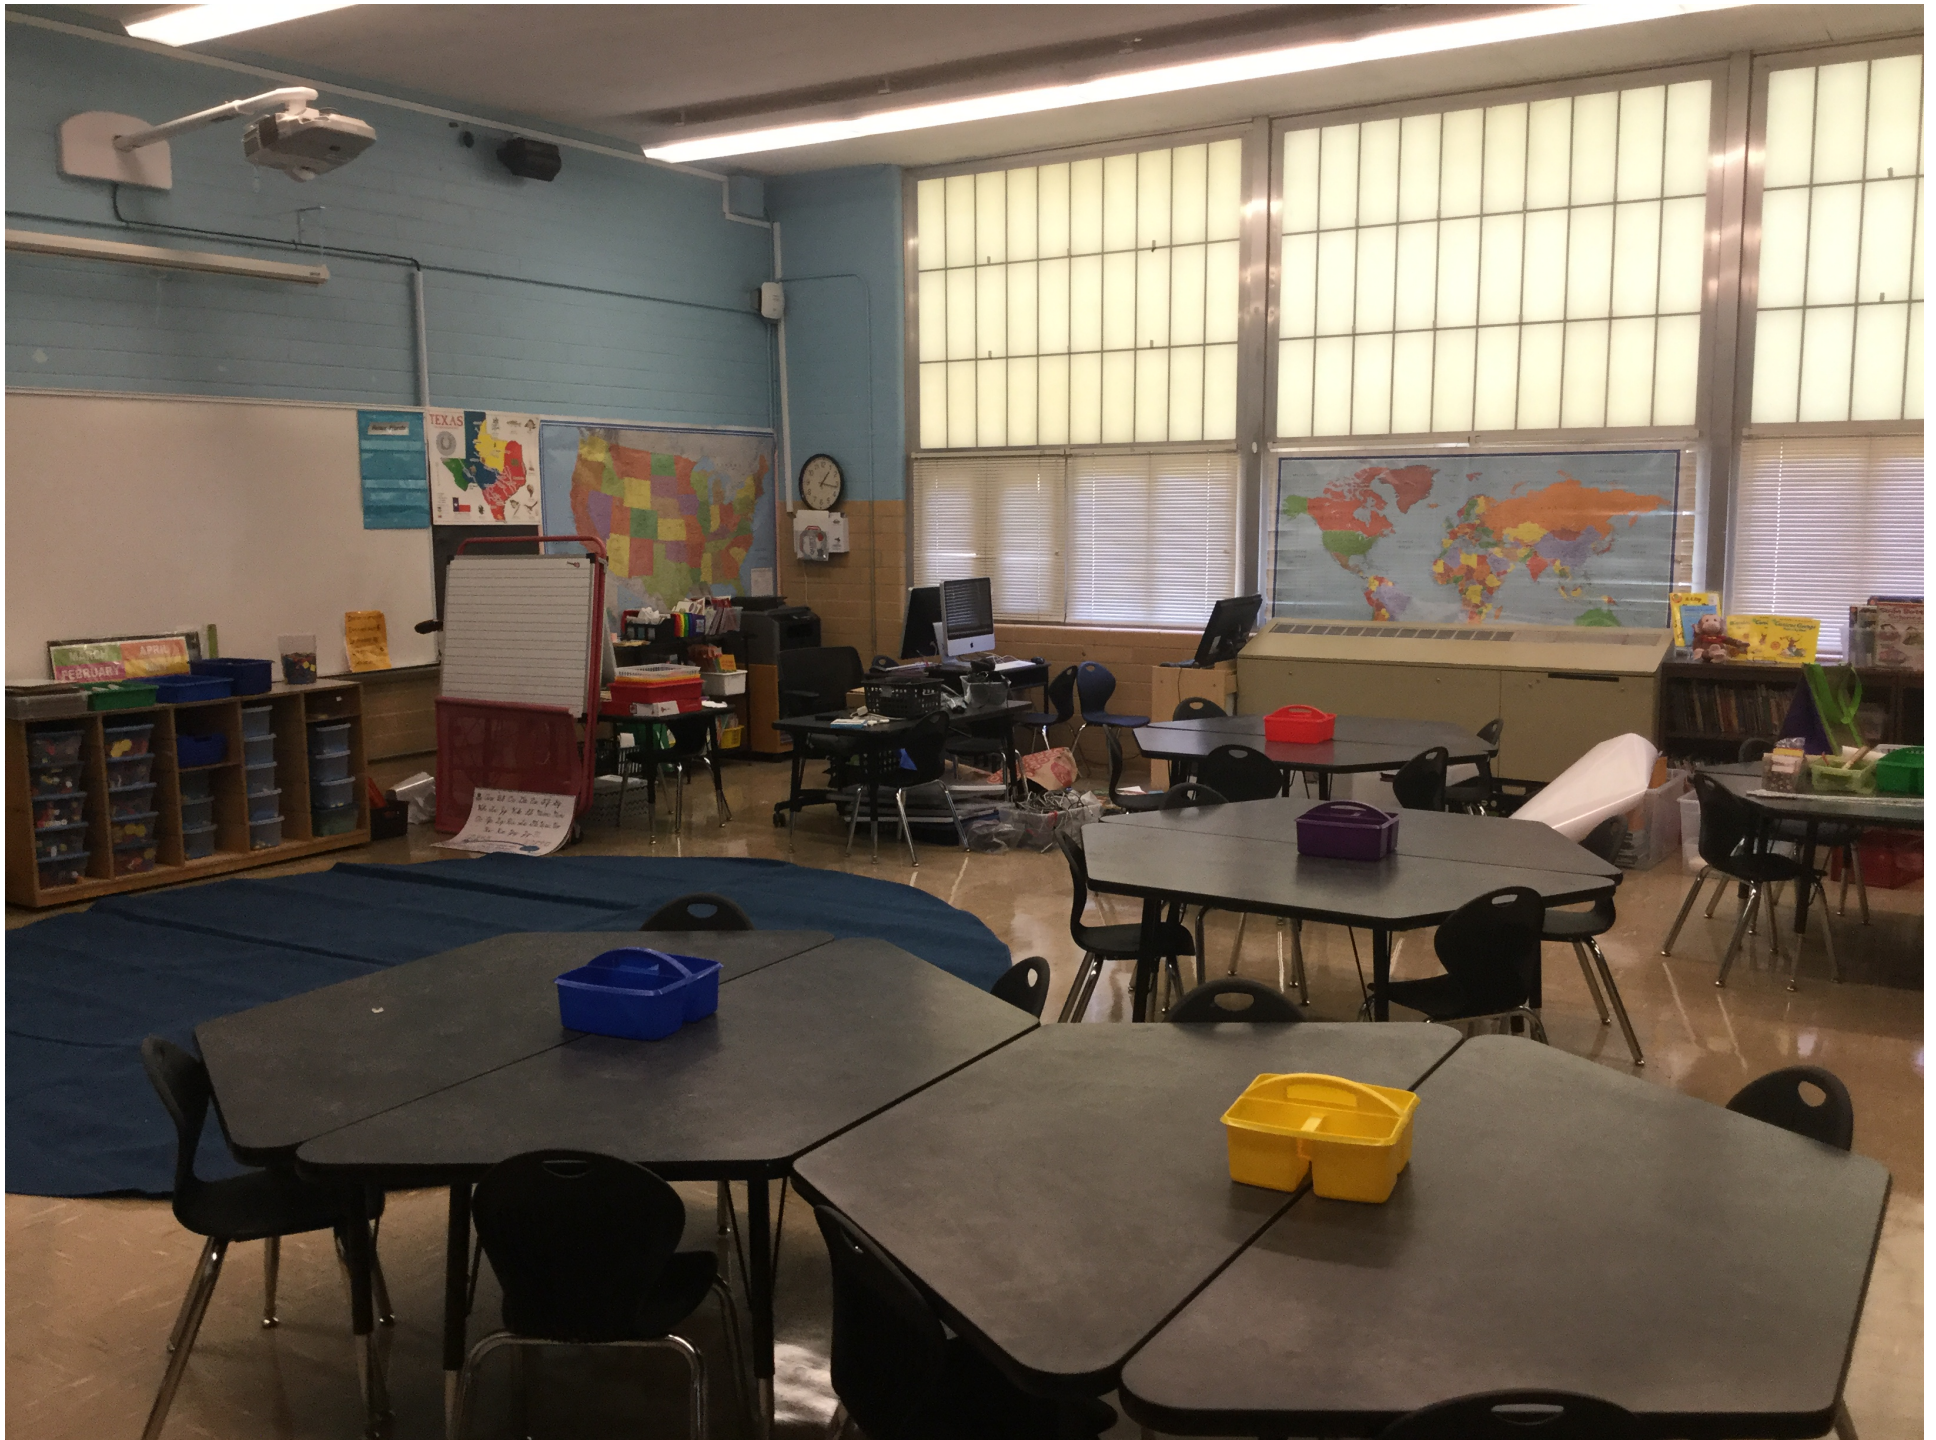
Photo 9.
4.2 Standard Classroom

4.2	Are general classrooms large enough to support project-based learning and multiple teaching modalities?			3				Comments	1.00 3.00
1) Very unsatisfactory -too small to move, set for lecture only, no connectivity, no flexibility 2) Unsatisfactory - adequate size but set for lecture only, no connectivity, no flexibility 3) Neutral - have flexibility and space for hands on or project based learning 4) Satisfactory - have flexibility and space for hands on or project based learning and connectivity for global learning 5) Very Satisfactory - space for hands on learning, flexibility for different groupings, and connectivity for global classrooms N/A) Does not apply.

4.4	Are there adequate places to display the evidence and artifacts of learning (both 2D and 3D)?			3				Comments	1.00 3.00
1) Very unsatisfactory - No display cases or wall space for display 2) Unsatisfactory - 1 wall in classrooms or very few spaces for display 3) Average - 2 walls in classrooms or some hallway spaces for display 4) Good - 3 walls in classrooms or multiple hallway spaces for display 5) Very good - ample classroom display space or many hallway spaces, including display cases N/A) Does not apply.

see photo 9

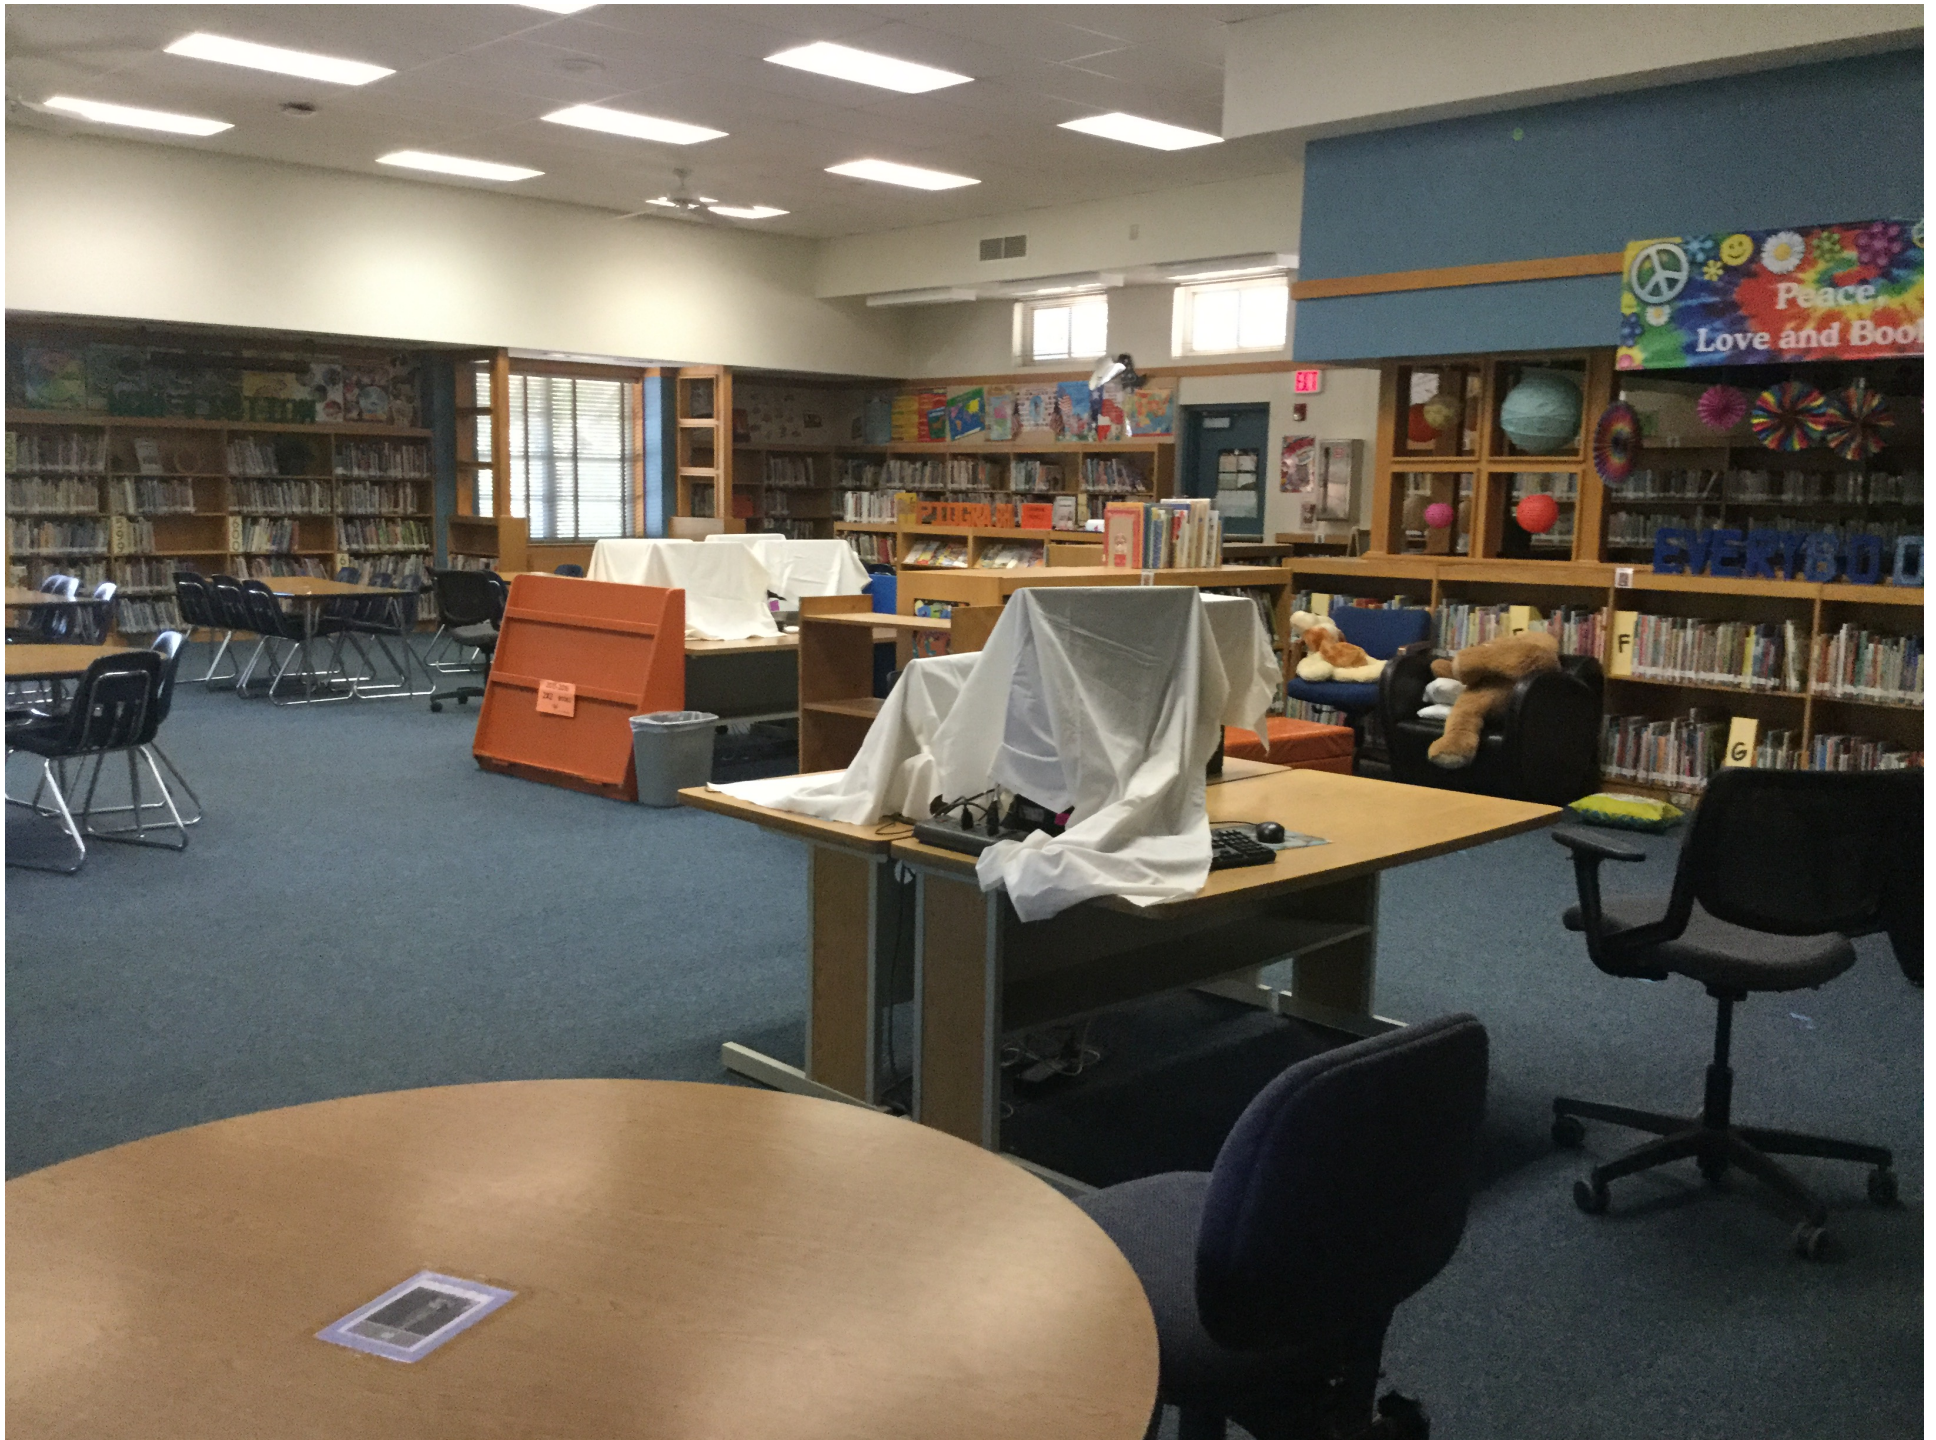
Photo 10.
5.4 Library

1) Very unsatisfactory 2) Unsatisfactory 3) Average 4) Good 5) Very good N/A) Does not apply.										
5.4	How well does the Library/Media Center support collaborative work in small groups (4-8 students)?				4			Comments	1.00	4.00

1) Very unsatisfactory 2) Unsatisfactory 3) Average 4) Good 5) Very good N/A) Does not apply.								There is a lack of appropriate sized and reconfigurable furniture.

see photo 10
