Educational Suitability Summary Report

Rosedale School

Date: 08/11/2016

Score 25% Very Unsatisfactory

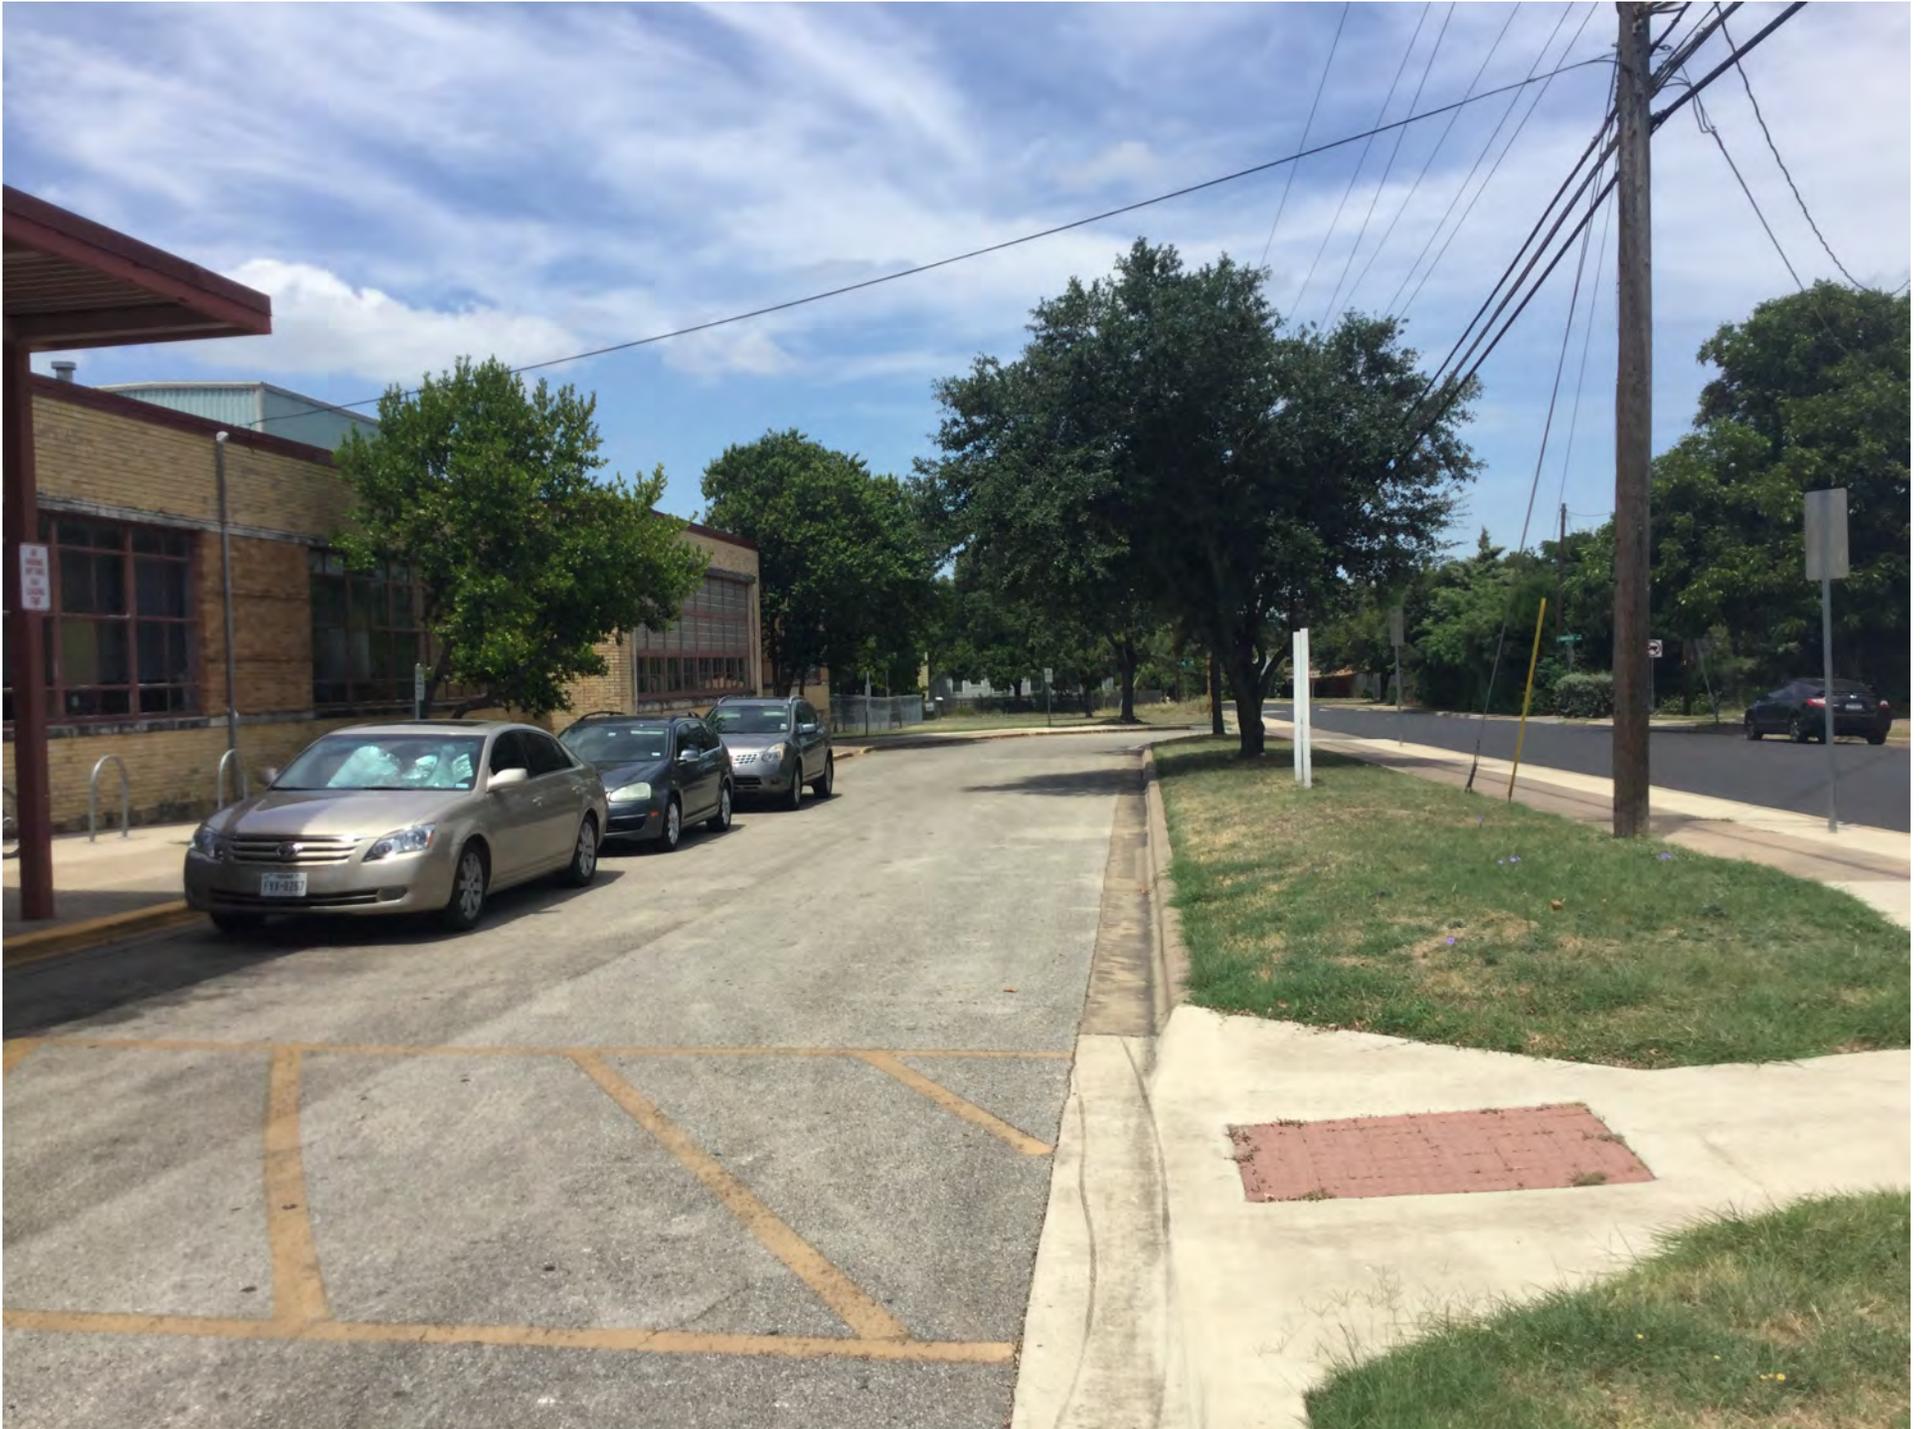
1.1 Traffic Circulation

1 - Exterior		1	2	3	4	5	N/A			4.25
1.1	Does the site permit desirable separation of vehicular, bus and pedestrian traffic?	1						Comments	1.00	1.00
1) Bus , car and pedestrian all happen at the same location. 2) Cars and buses mix, pedestrians are separated. 3) Buses, cars, and pedestrians are separate but stack space is small. 4) Buses, cars, and pedestrians are separate but drop off does not have a canopy or a holding place like a commons or cafeteria. 5) Buses, cars, and pedestrians are separate and drop off area has a canopy and destination. N/A) Does not apply.

Traffic circulation for vehicles and buses occurs in the same, undersized front loop. This area is not safe when both parents and buses are present, and there is one small curb cut for students in wheelchairs. The building is lacking clear signage as well as adequate lighting for nighttime use. Outdoor play spaces are unsatisfactory due to lack of necessary shade and accessible equipment. The outdoor learning spaces also need additional shade and improved access for barrier-free use.

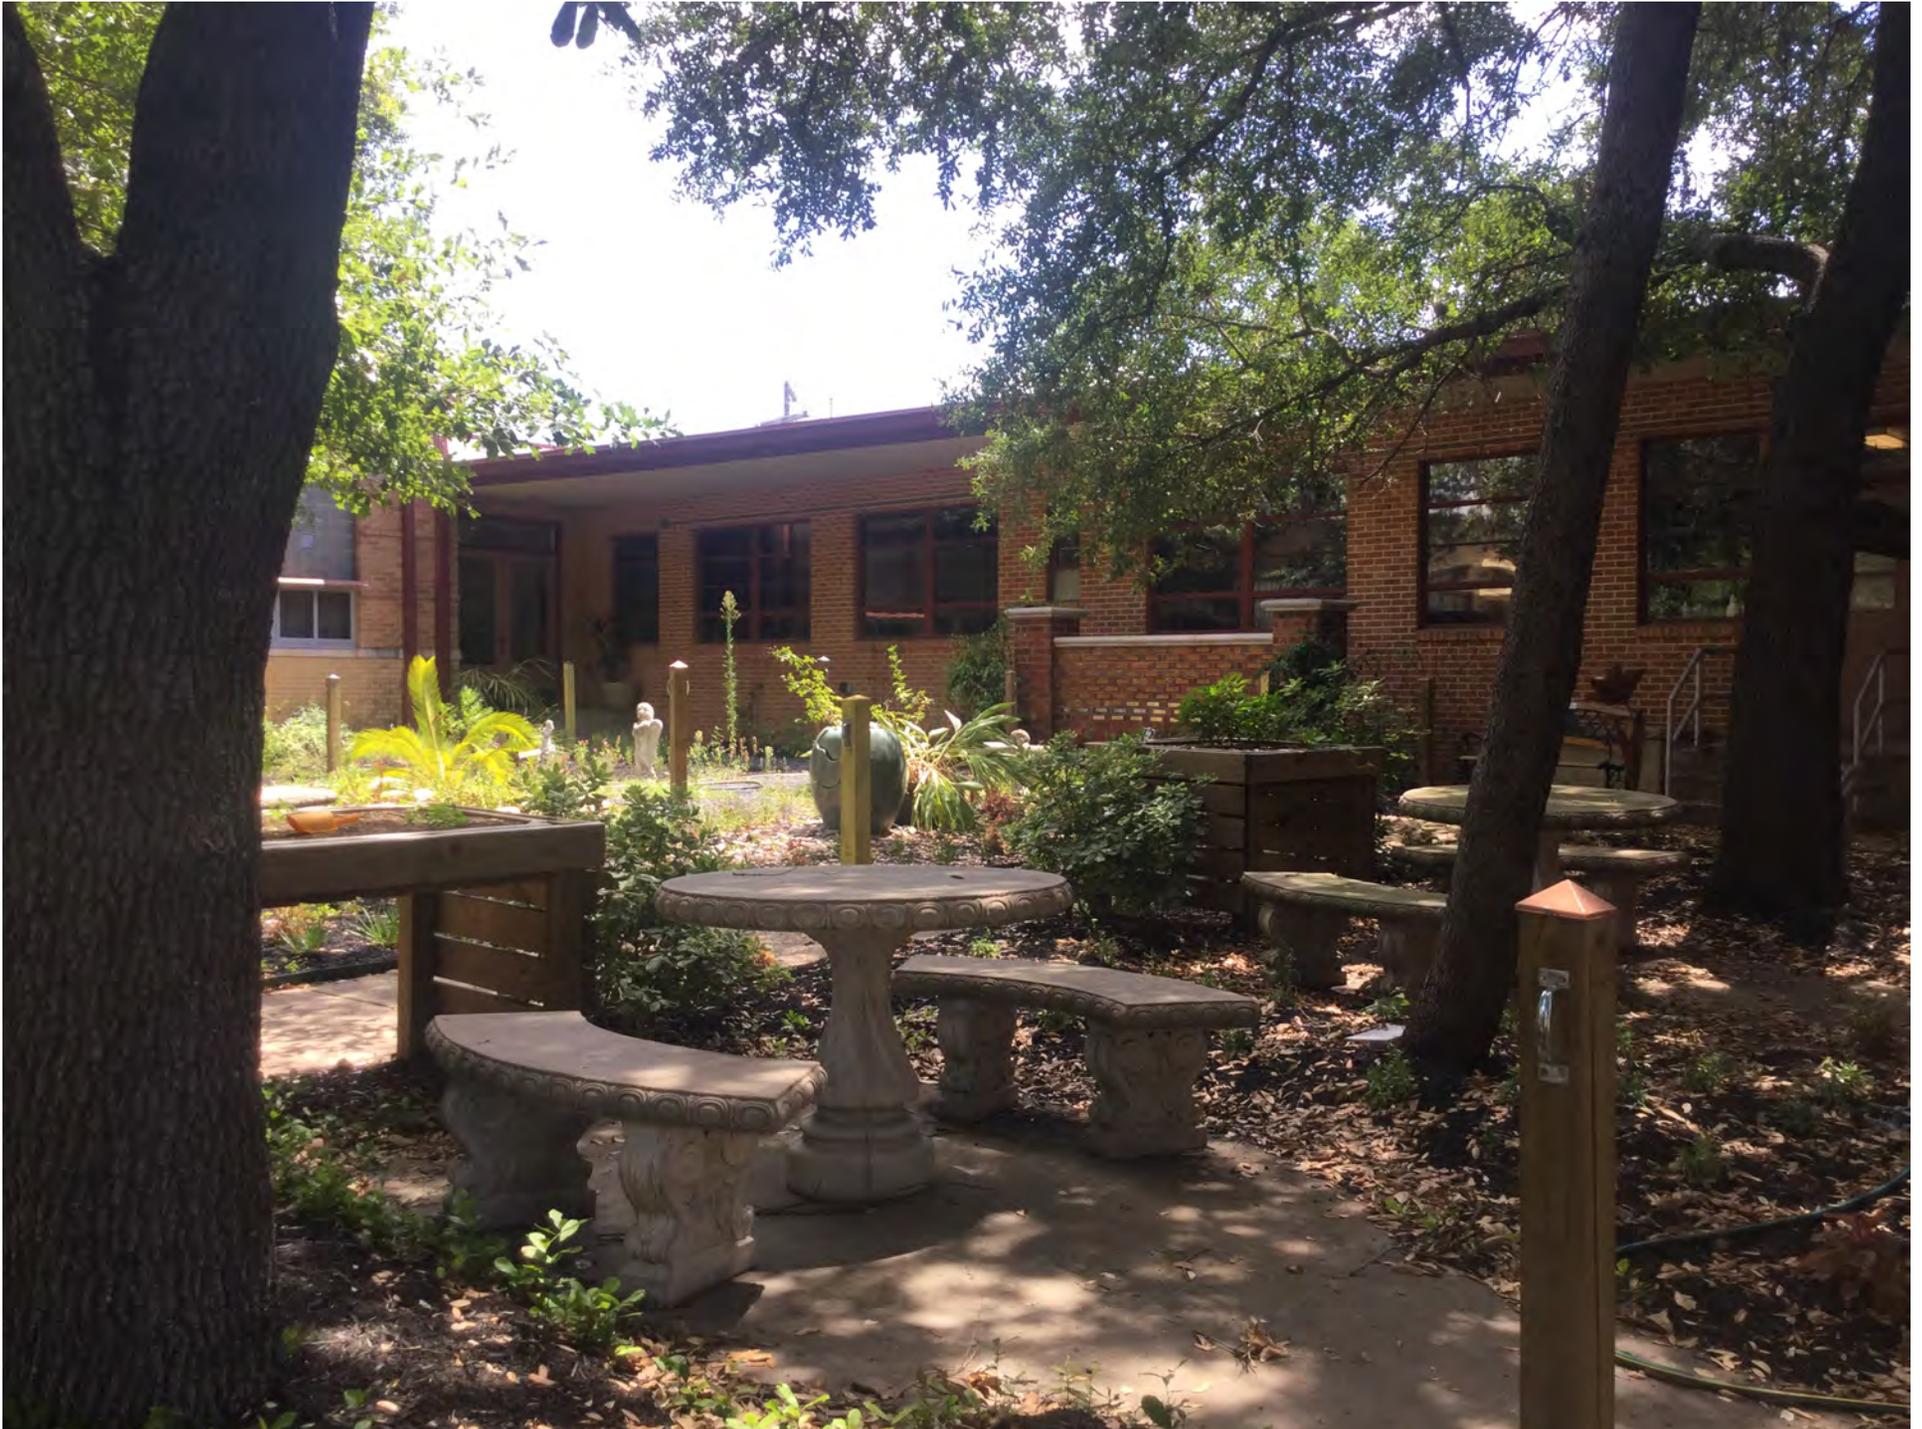
1.2 Memorial Garden

1.2	Are opportunities provided for outdoor learning (outdoor classrooms, gardens, etc.)?		2					Comments	1.00	2.00
1) Outdoor space exists is not developed 2)Outdoor space for learning exists but not connected to classroom learning areas. 3. Outdoor learning spaces exist and are accessible but not in good condition. 4. Outdoor learning spaces need minor improvements to function well. 5. Outdoor learning spaces are in excellent condition. N/A) Does not apply.

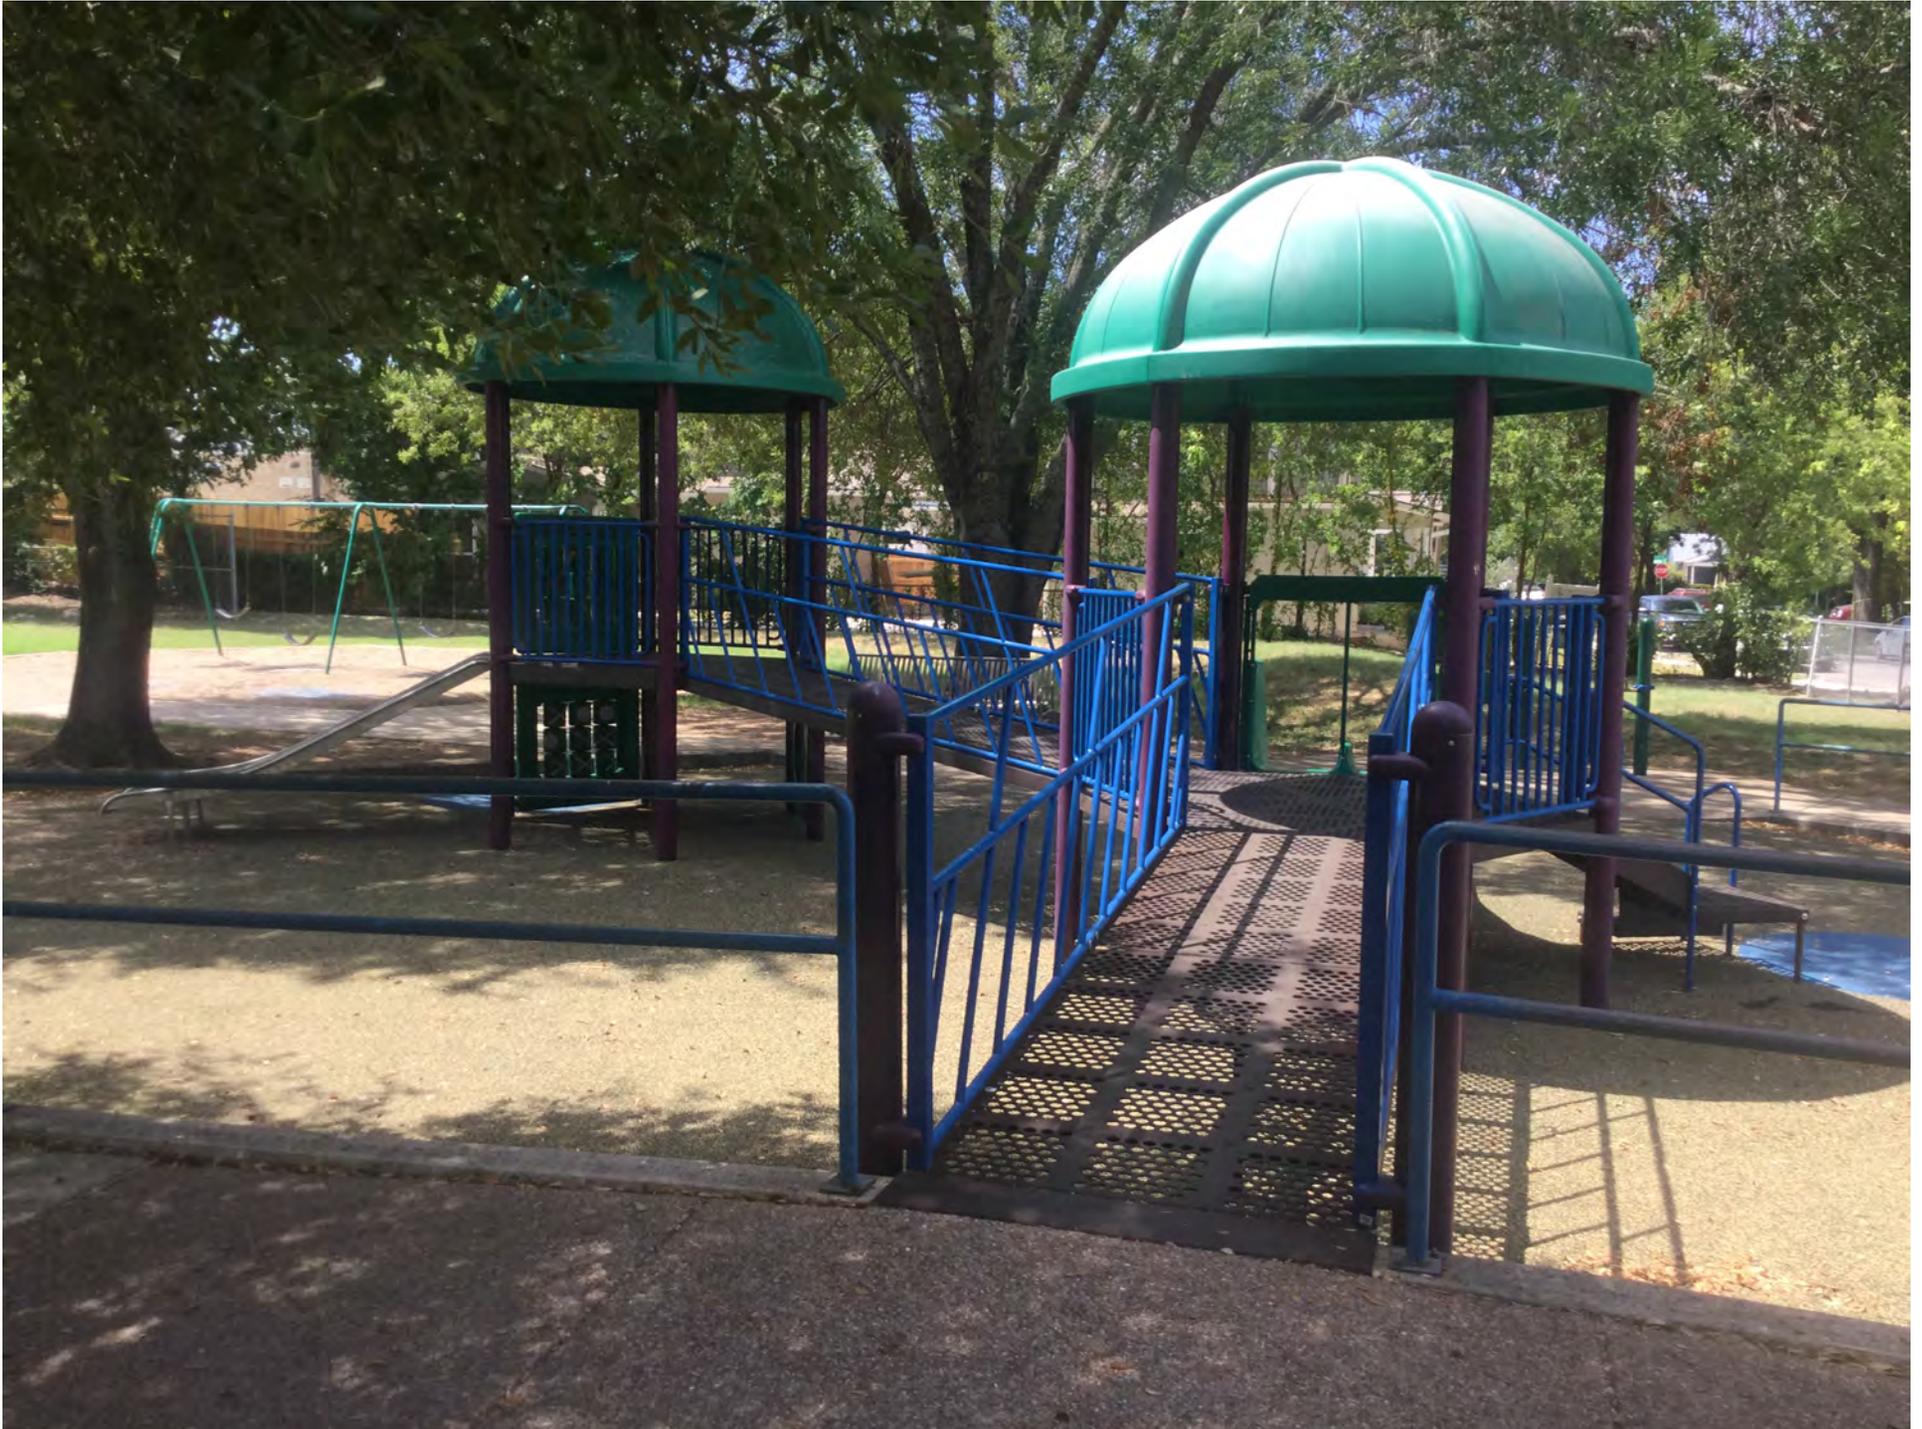
1.3 Playground

1.3	Are outdoor play spaces and playfields adequate in size and configuration?	1						Comments	1.00	1.00
1) Outdoor play space exists, not developed 2)Outdoor play space exists but is not connected to gym or other athletic support areas or is too small. 3. Outdoor play spaces exist, are connected to other athletic areas, are the right size, but are not in good condition. 4. Outdoor play spaces need minor improvements to function well. 5. Outdoor play spaces are in excellent condition. N/A) Does not apply.

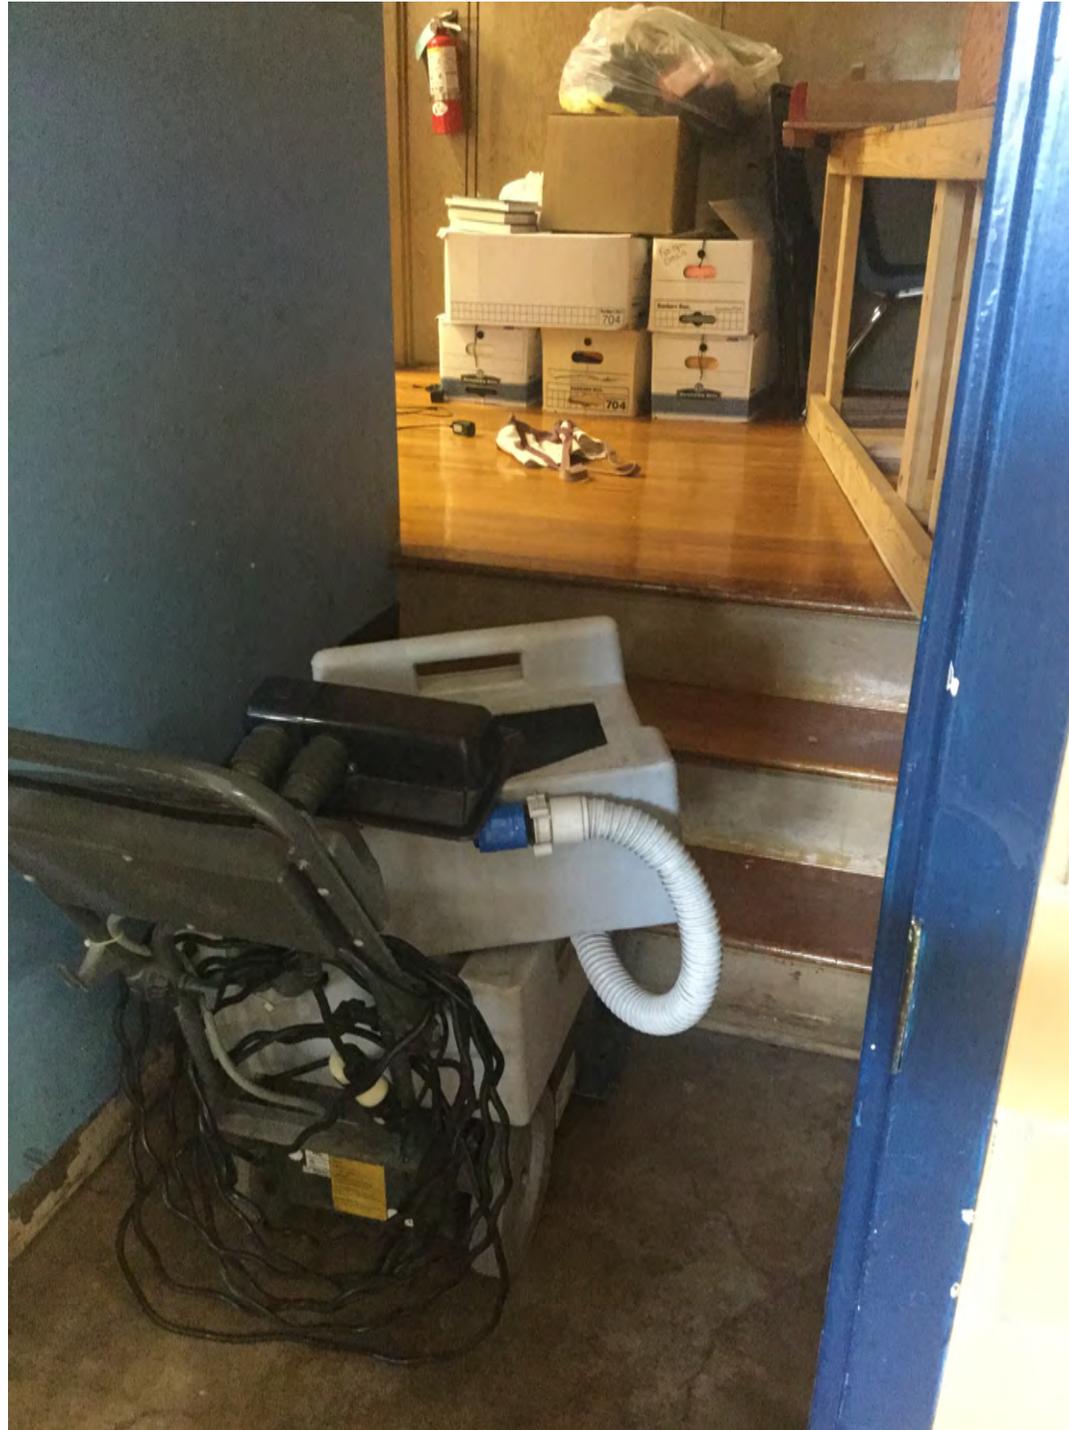
3.8 Stage Access with
Homemade Ramp

3.8	Are music, drama, or performance spaces appropriately configured per the ed spec?	1							Comments	1.00	1.00
1) Very unsatisfactory 2) Unsatisfactory 3) Average 4) Good 5) Very good N/A) Does not apply.		The stage is undersized and does not have ADA access. It is lacking equipment.

The facility lacks a computer lab or technology classroom. The cafeteria is small, and there is no handicapped accessible stage access. There is a homemade plywood ramp that they have used to bridge over the existing stairs. This is not an appropriate or safe access. The storage space is very limited. The kitchen area is used as a teaching kitchen, because they do not prepare food at this campus. Their food comes from Lamar Middle School and is served to students from very old, dirty serving equipment. This equipment is in unacceptable condition. The classrooms at this facility should be configured in accordance with the Life Skills standards; however, they are severely lacking. The classrooms do not have the appropriate configuration of the kitchen spaces and accessible restrooms. The changing facilities are non-existent, so this occurs in the general classroom space. This configuration is unsanitary and unacceptable for creating the appropriate privacy and sense of dignity for students. The classroom spaces are not large enough for different group sizes and the equipment necessary for instruction. The classrooms also lack any de-escalation areas for students that need a quiet, comforting

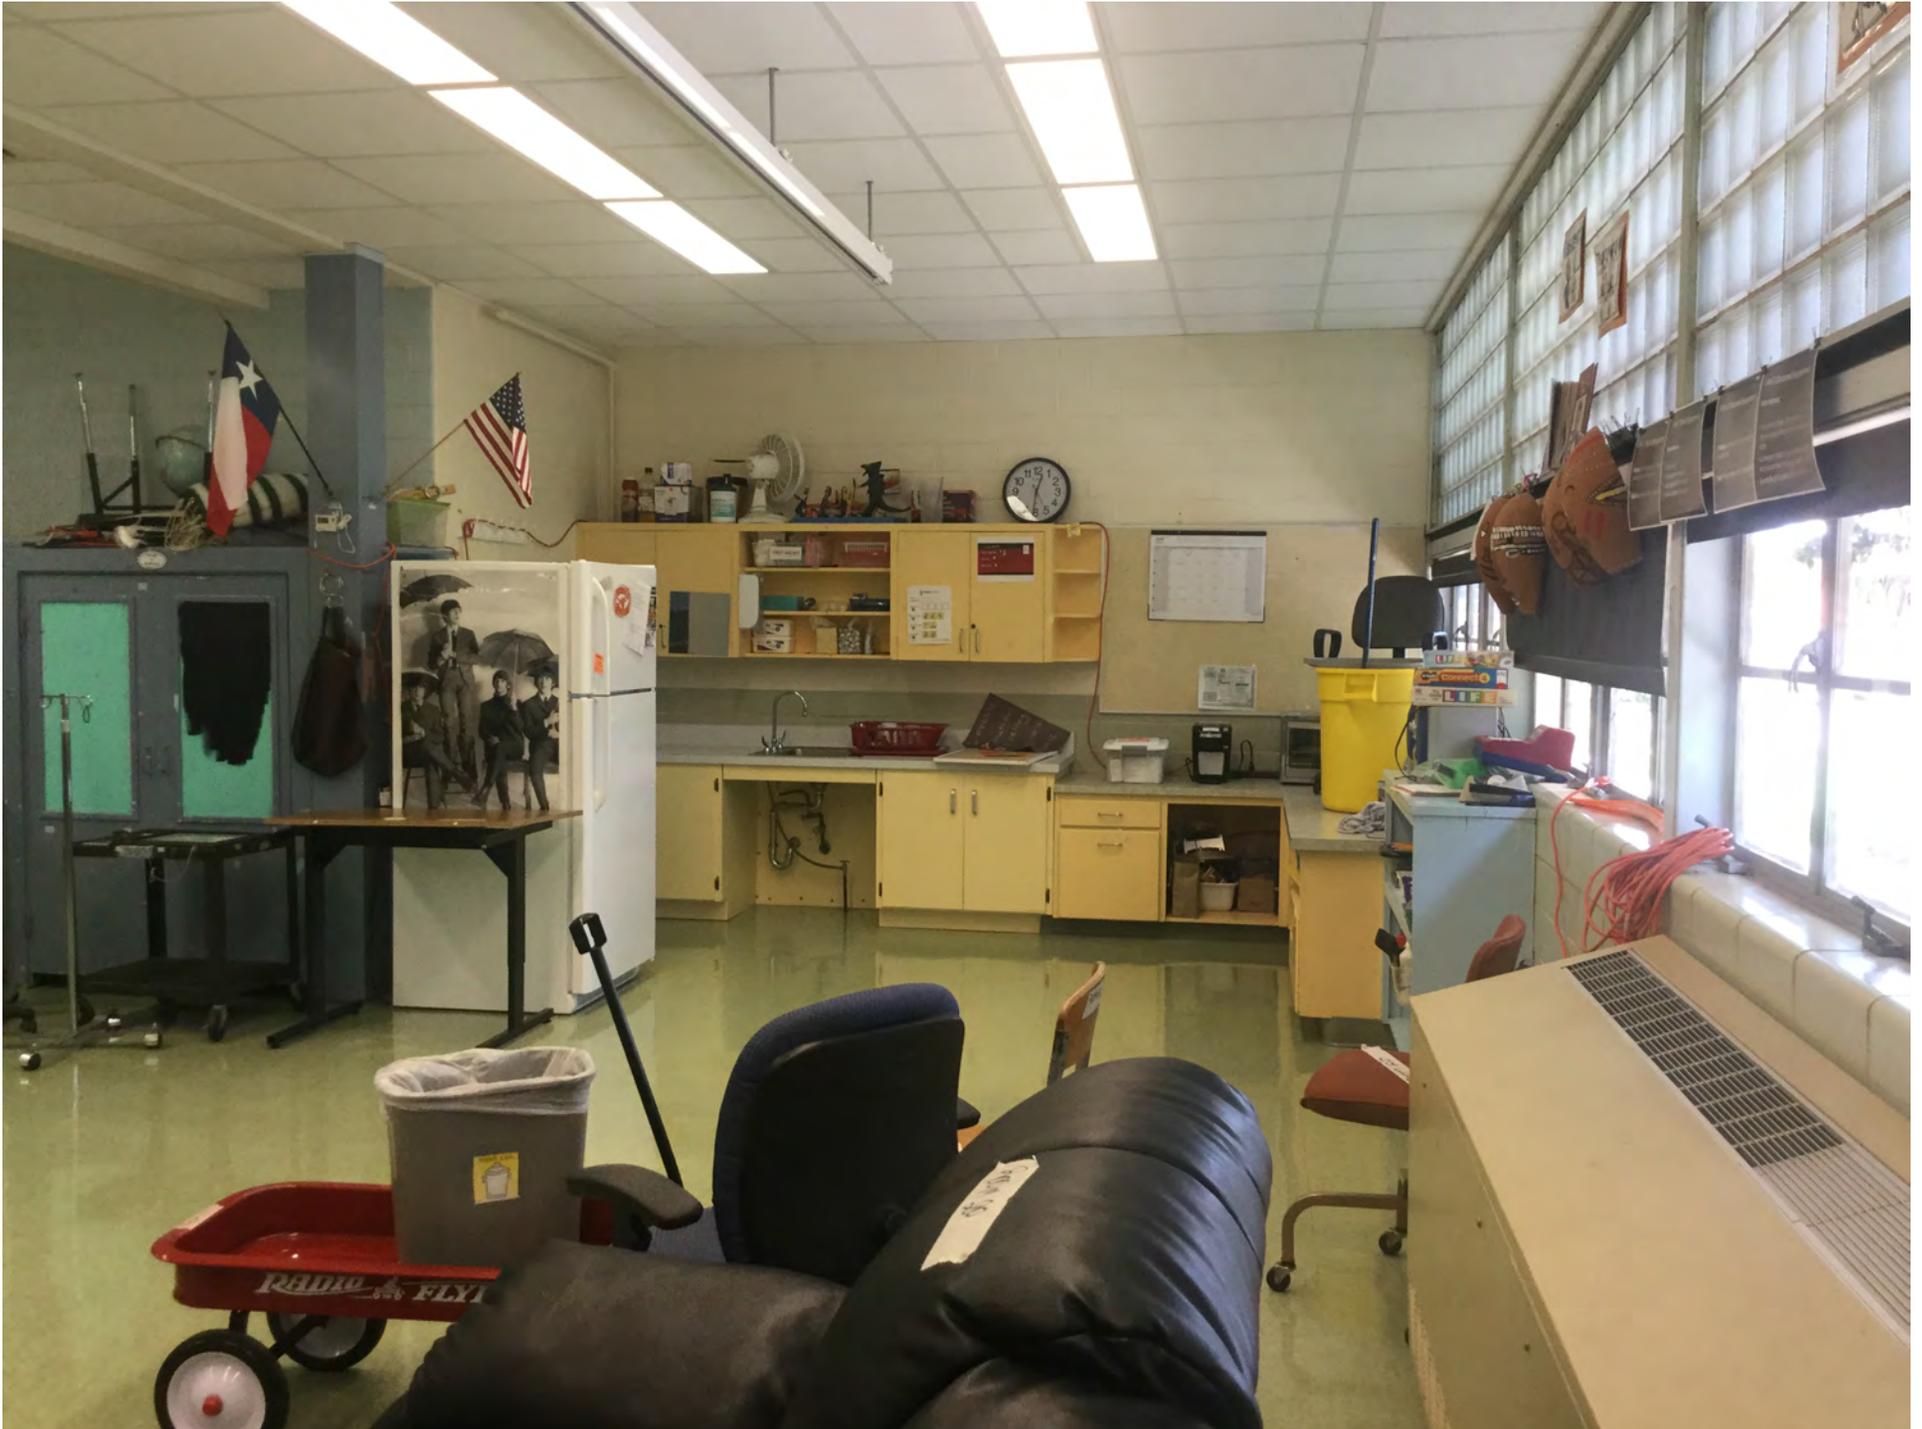
3.14 Classroom

1) Very unsatisfactory 2) Unsatisfactory 3) Average 4) Good 5) Very good N/A) Does not apply.								The classrooms are undersized and lacking the appropriate equipment.

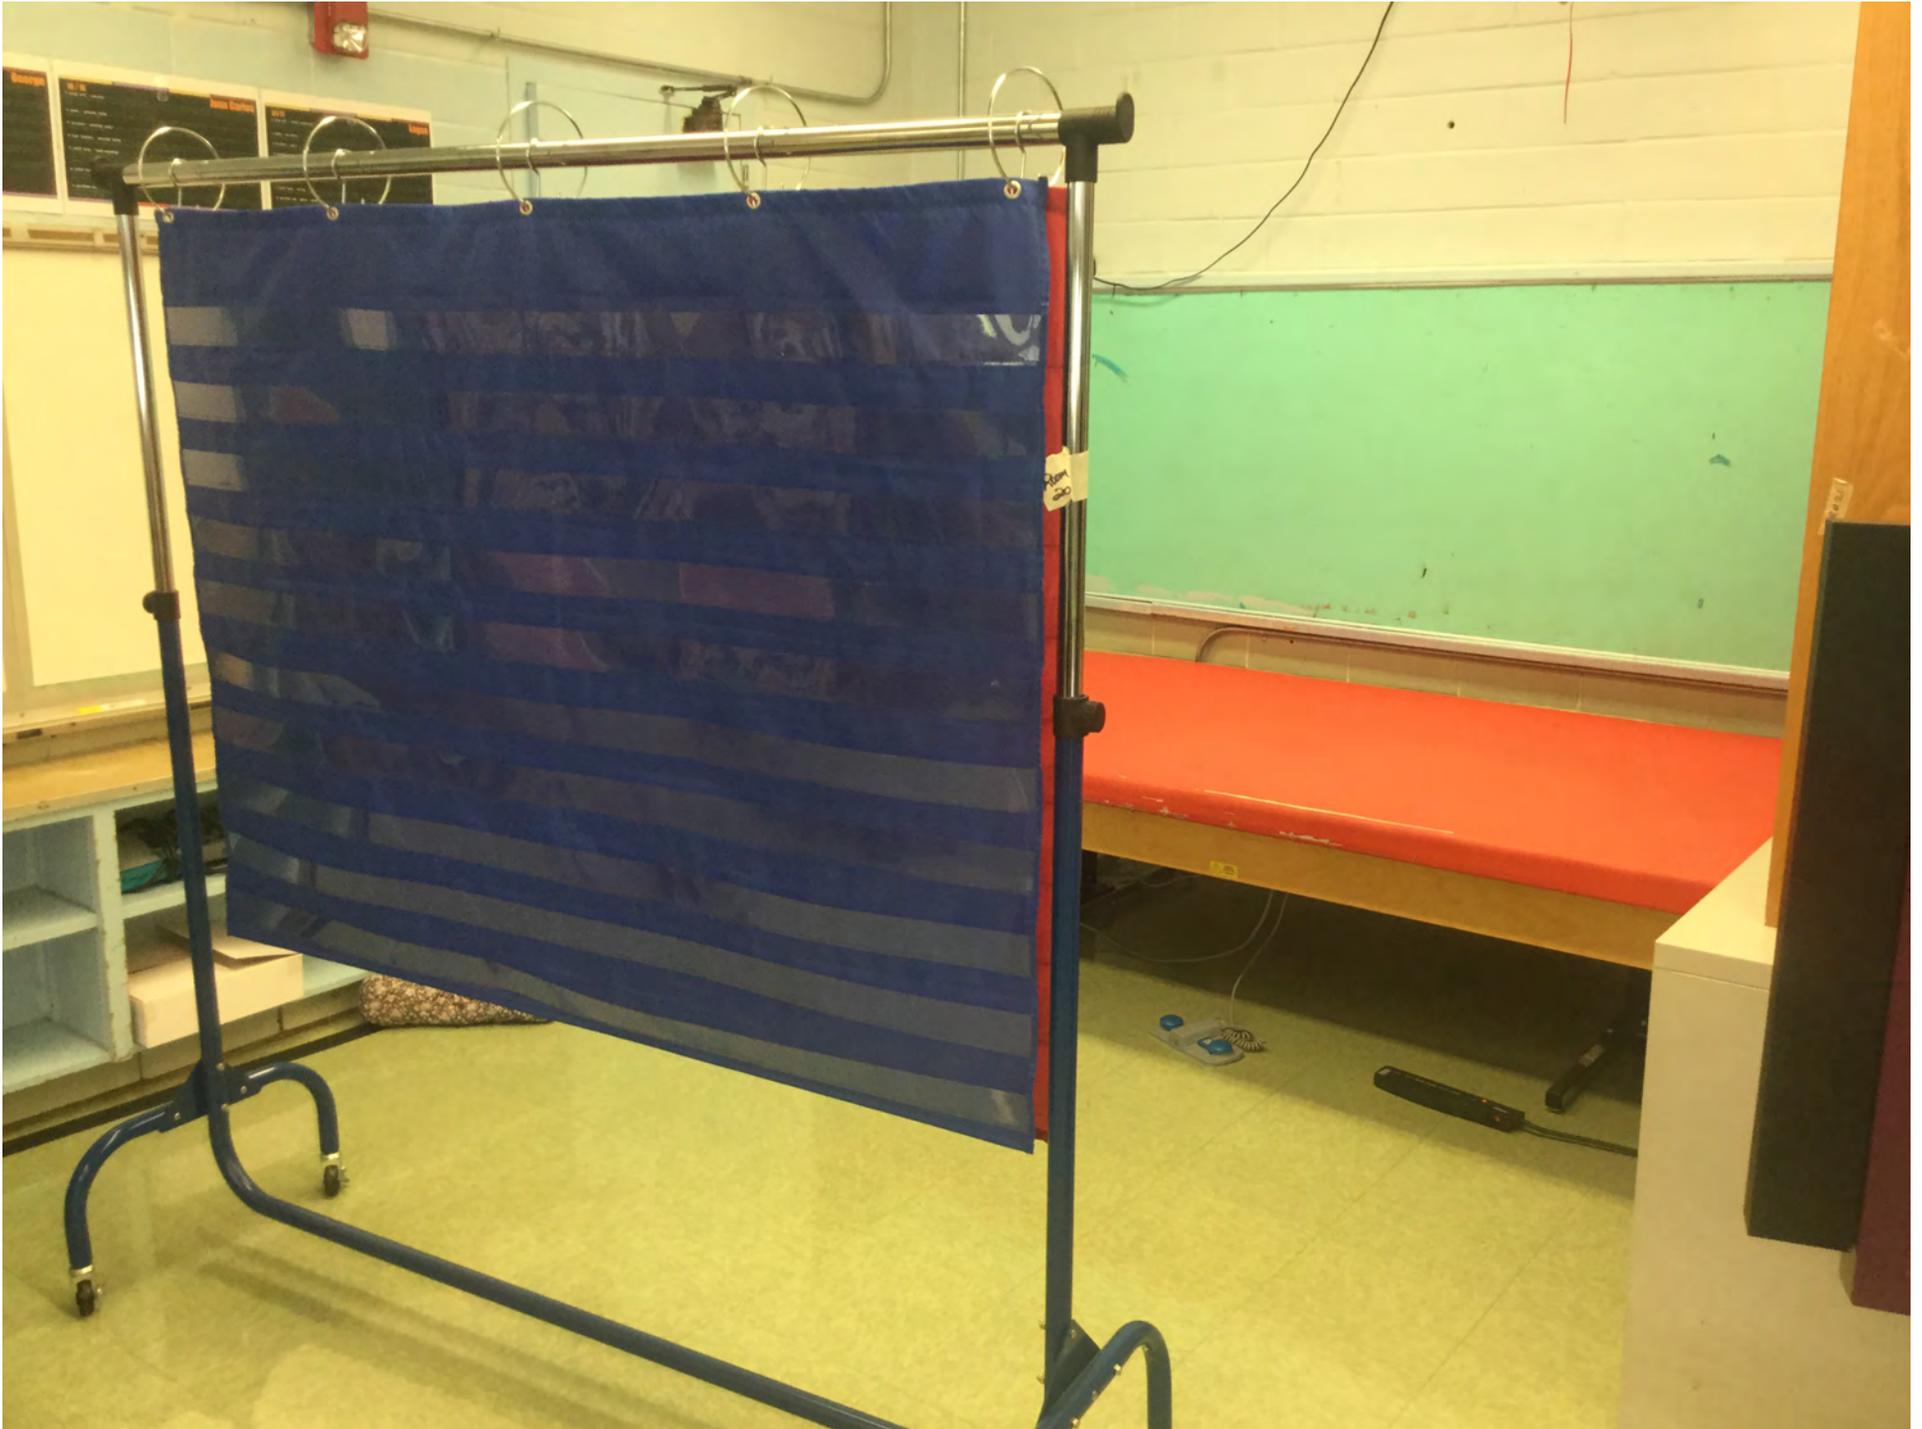
3.15 Changing Area in the Classroom

3.15	Are Special Education support spaces appropriately configured per the ed spec?	1						Comments	1.00 1.00
1) Very unsatisfactory - Support spaces are disconnected from served spaces, too small, do not meet needs 2) Unsatisfactory - Support spaces are connected, but too small, inadequate for needs 3) Average - Connected, moderate size, but need some renovations or updates to function well 4) Good - Connected, good size/layout, meets needs/functions well 5) Very good - connected, generous size, nice condition, functions appropriately N/A) Does not apply.								The storage space and restrooms are lacking. The laundry facilities are unsatisfactory and difficult to access.

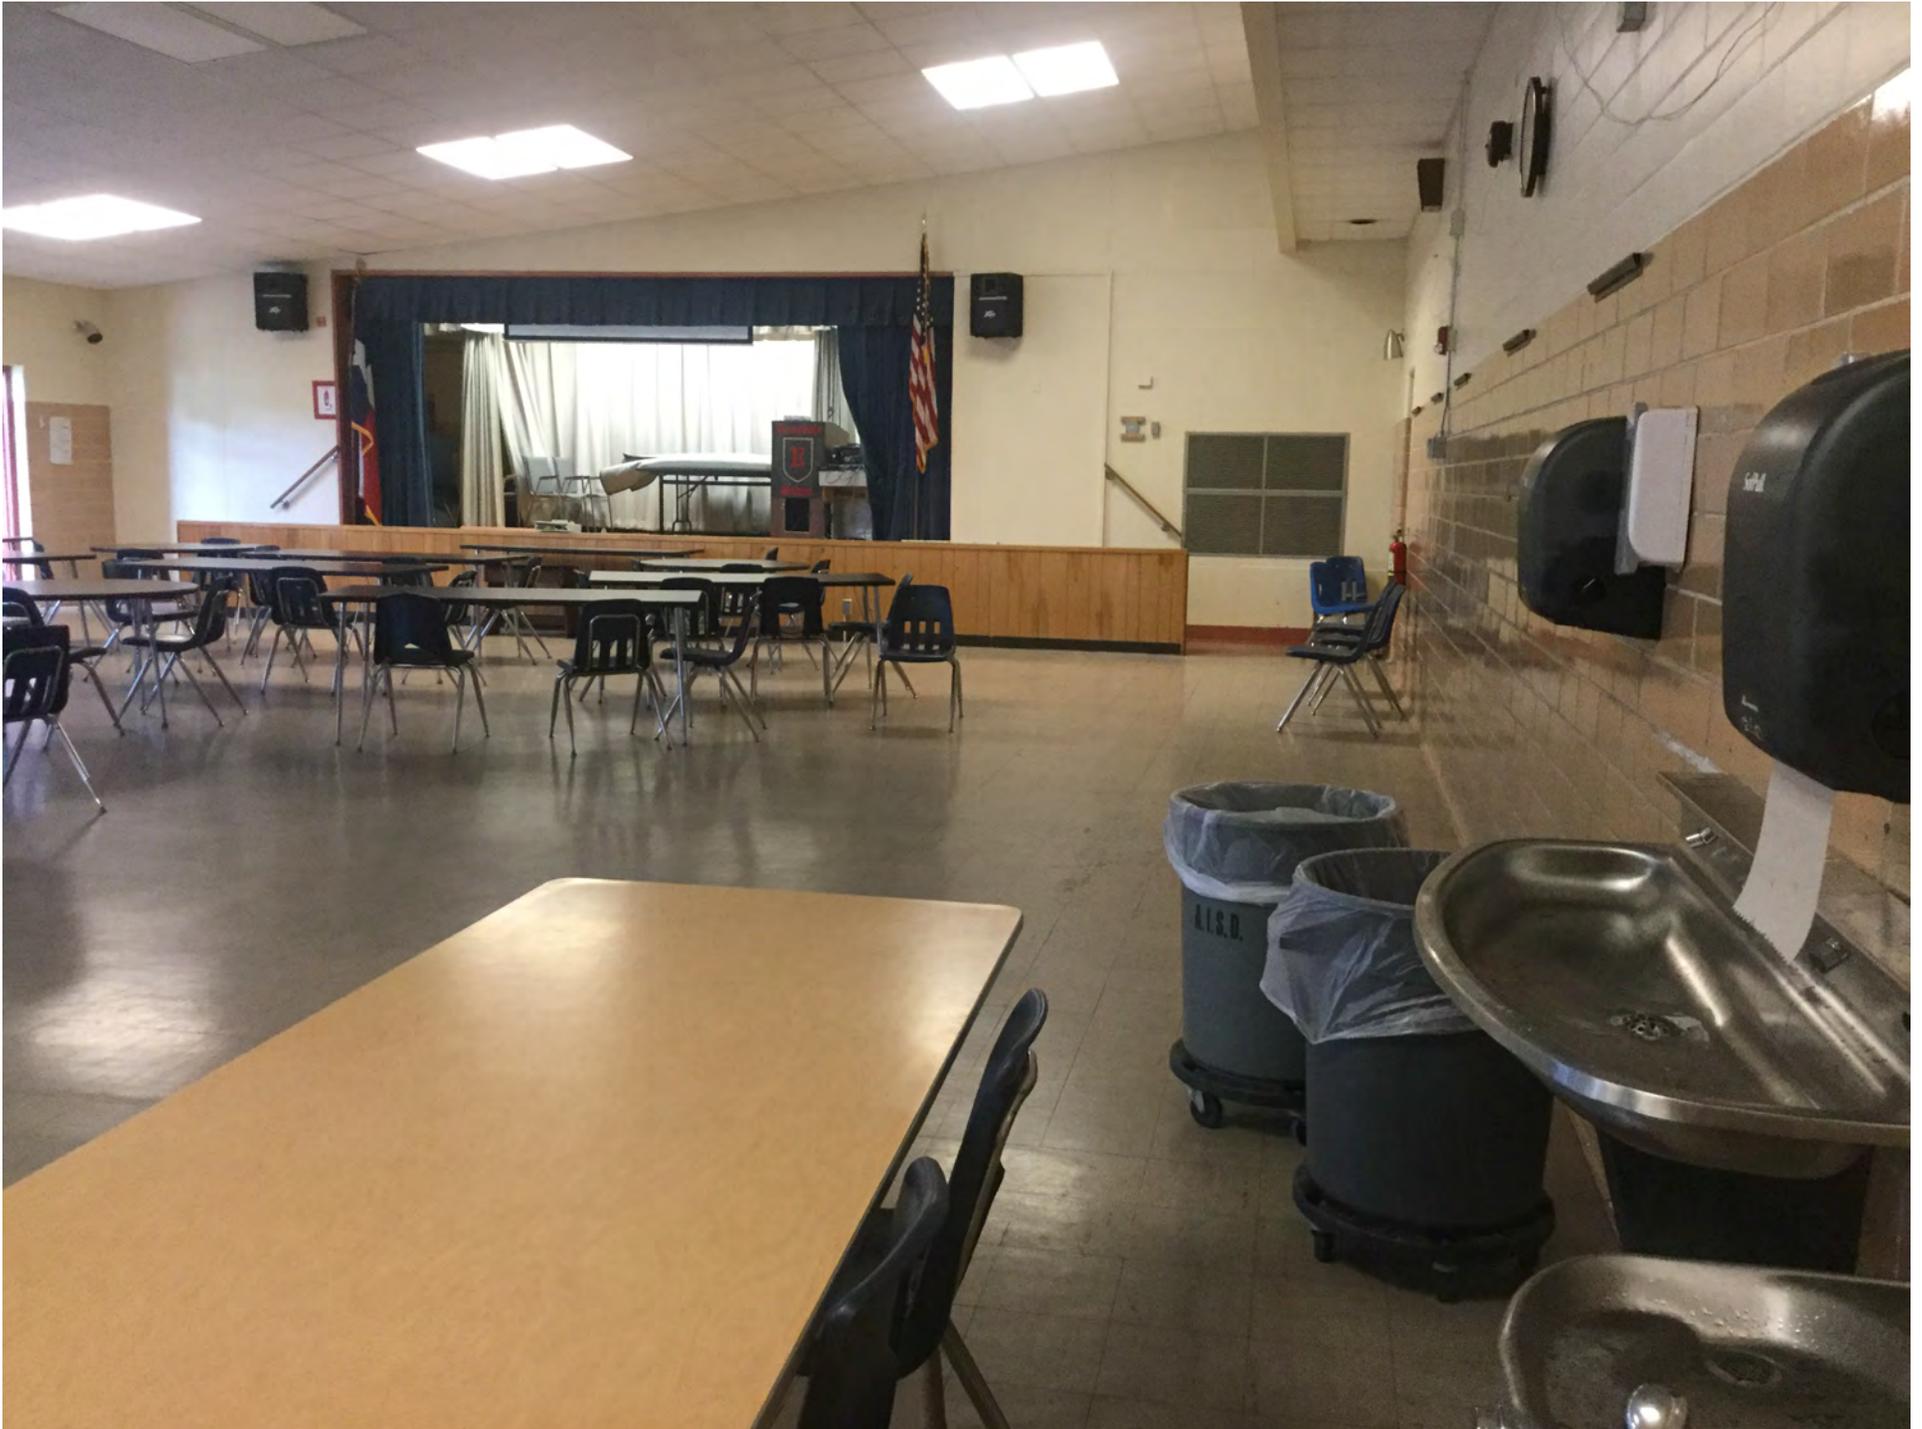
3.16 Cafeteria

3.16	Are the student dining facilities appropriately configured?	1						Comments	1.00 1.00
1) Very unsatisfactory - Too small, poor circulation, inflexible seating in poor condition 2) Unsatisfactory - Too small or inadequate circulation, seating in poor condition 3) Average - moderate size, with adequate circulation, seating in okay condition 4) Good - good size, adequate circulation, seating in good condition 5) Very good - good size, adequate circulation, seating in good condition, with more than one option for eating space (ex: connection to outdoor eating space) N/A) Does not apply.

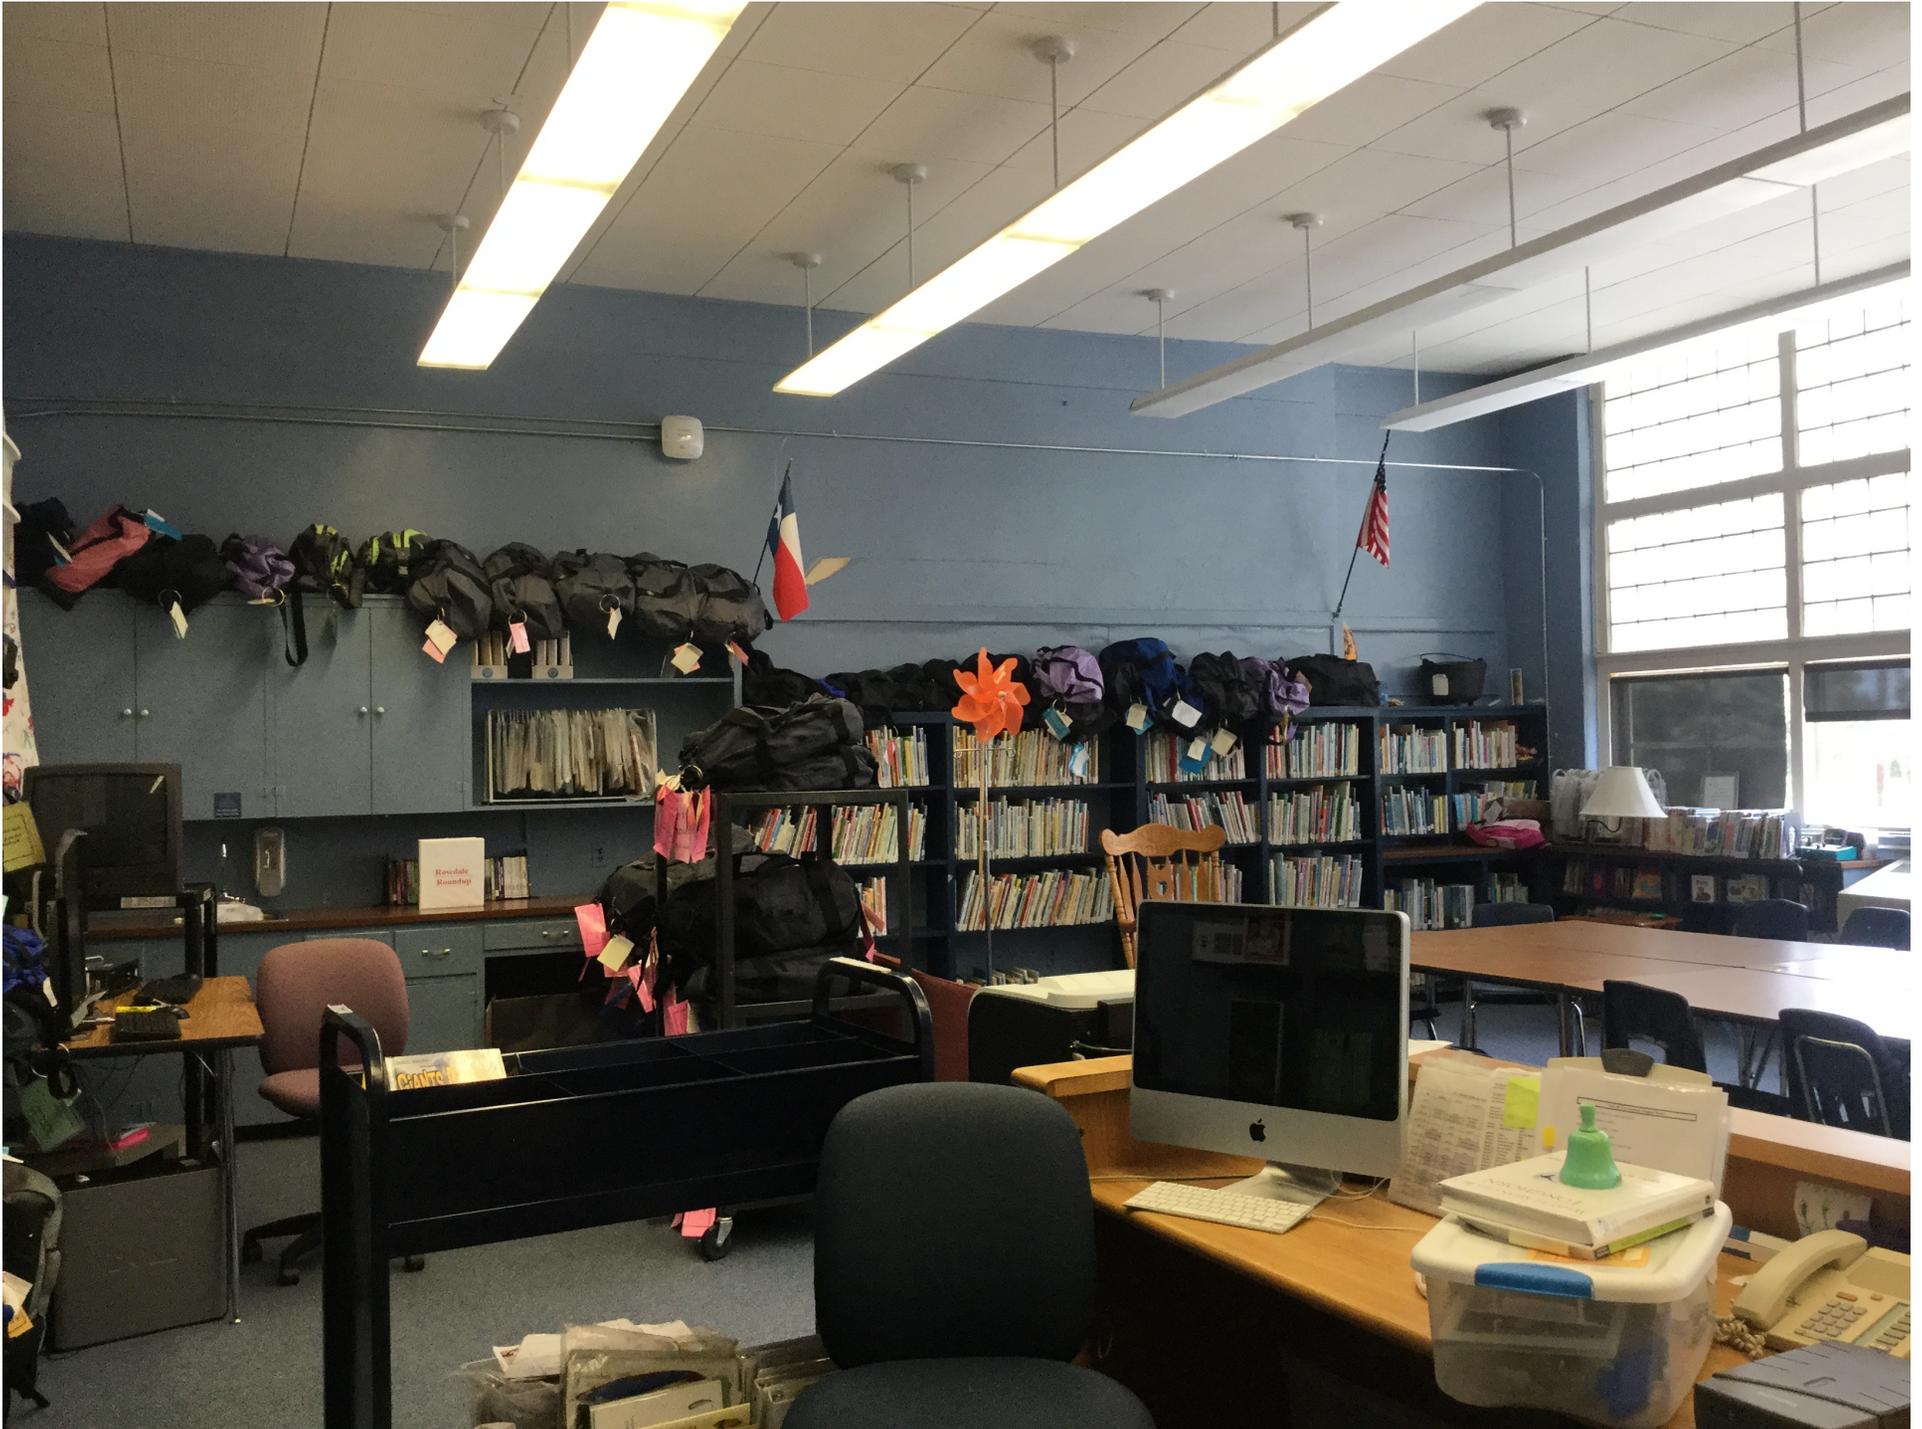
5.5 Library

5 - Library/Media Center - Continued		1	2	3	4	5	N/A				
5.5	How well does the Library/Media Center support collaborative work in larger groups (10-25)?			3				Comments	1.00	3.00

The library is inadequate in size and configuration. There is limited accessibility and there is no separation of the space for different group sizes. The space is the size of a typical classroom in a newer facility. The library has unsatisfactory technological support.
